# Evaluation of High Temperature Microcontrollers and Memory Chips for Geothermal Applications

Andrew A. Wright<sup>1</sup> and Avery Cashion<sup>1</sup>

Sandia National Laboratories, Albuquerque, New Mexico, USA

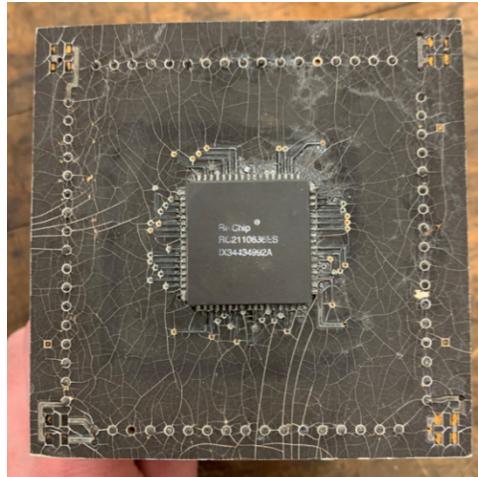
**Figure 5: RC2110836 SRAM packaged on a custom Rogers 3003 PCB. The board was initially green before it was exposed to temperatures above 300°C.**

The RC2110836 SRAM is designed specifically for the RC10001 to effectively use the I/O pins between the two ICs. Just like the RC10001, it is a surface mount device (SMD). This IC was packaged on Rogers 3003 material, unlike the other board discussed above. The Td is shown in Table 2. The PCB was originally designed for a different project but was reused for this project with a different material than its predecessor. The trace width and clearance are 10 mils with no copper fill. As shown in Figure 5, the SRAM is packaged onto the PCB. Unfortunately, no pictures were taken before the oven testing; thus, only the severely damaged PCB is shown here. The code written for the SRAM continuously cycles all the registers to check if any registers begin to fail.

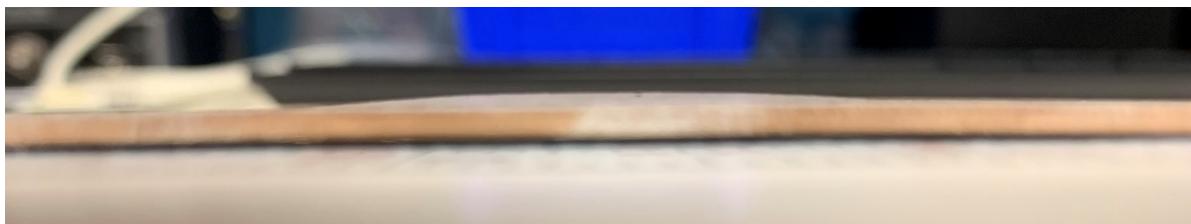
Figure 7: Rogers 4003™ PCB bulging in the center due to the moisture expanding as well as CTE mismatch between layers.

Multiple issues, including bulging of the PCB, CTE mismatch, degradation of the solder, trace shorting, and delamination of the IC away from the PCB, occurred during testing of the packaged device preventing full evaluation of some components to 300°C. As shown in Figure 7, a bulge in the center of the Rogers 4003™ PCB had formed, which was caused by moisture in the board and CTE mismatch. The PCB is a four-layer board; hence, two Rogers 4003™ panels are bonded by a PCB core with similar properties to the Rogers 4003™. Separation had formed at the PCB core, likely due to CTE mismatch. The moisture in the board also caused an increase in pressure, allowing the bulge to form. Bulging then created strain on the IC, causing debonding of the pins from the PCB pads. To mitigate this issue, the PCBs were baked at 100°C for 24 hours to remove most of the moisture.
