Analysis of High Nickel Alloys Partially Submerged in a Ternary Chloride Salt

Aaron Overacker, Kenneth Armijo, Dimitri Madden,
Patrick Burton, Minghui Chen

ANS Annual Conference 2022, Anaheim, California

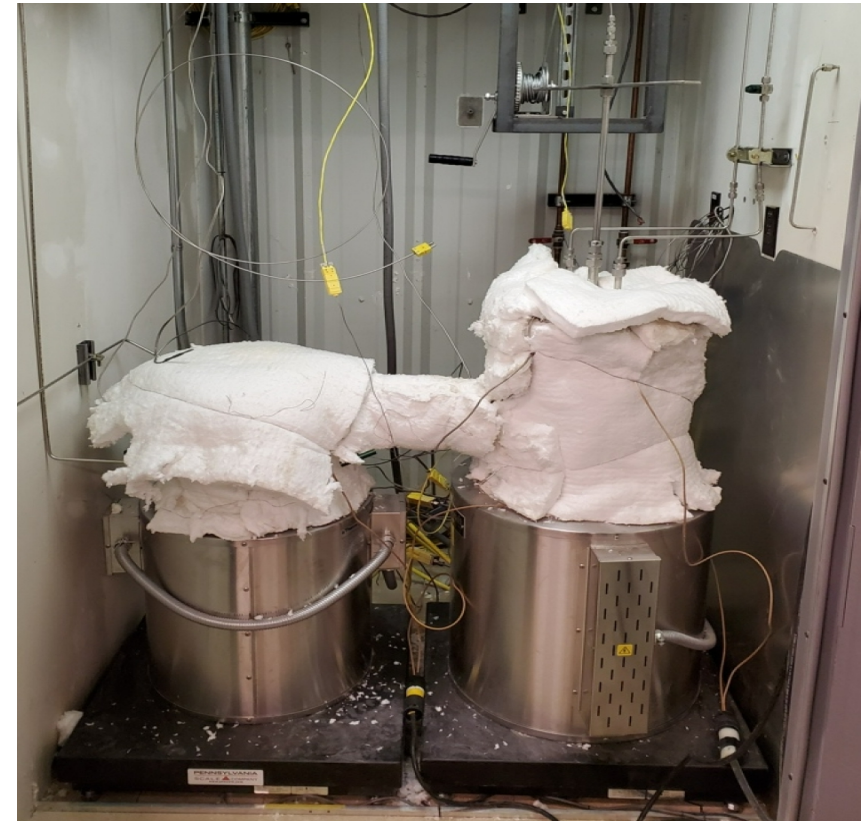
Salt Pot Work

- Nitrogen gas, vacuum pump, & gas condensation lines detachable via VCR fittings for lid removal
- Addition of a Liner or cladding
- Re-making lid out of $\text{Al}_2\text{O}_3/\text{SiC}$
- Ullage Gas systems
