Developing Technologies for Composite Overwrapped Pressure Vessels (COPV)

Comparing Traditional Inspections to Advanced 3D Rendering Techniques

David G. Moore, Ciji Nelson Caleb
Schauble and Dorian K. Balch, PhD

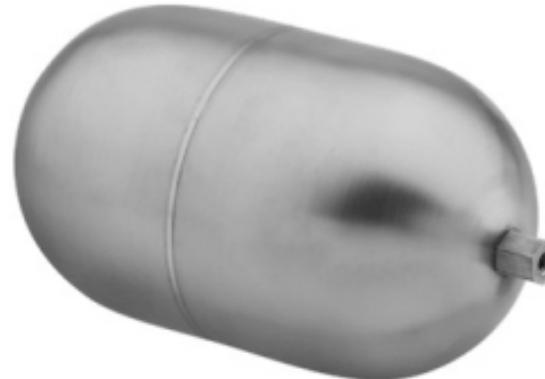
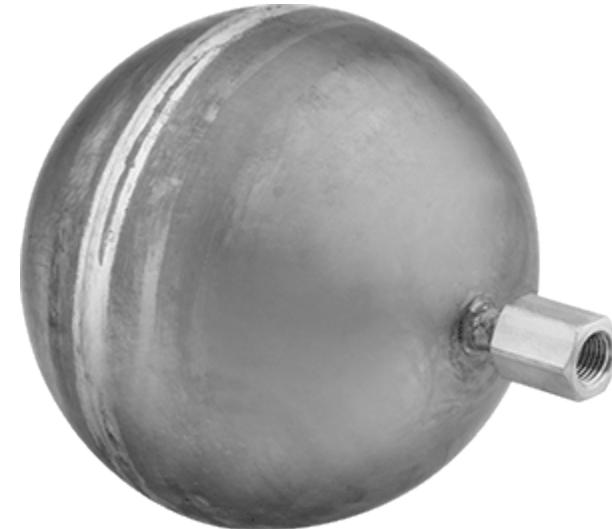
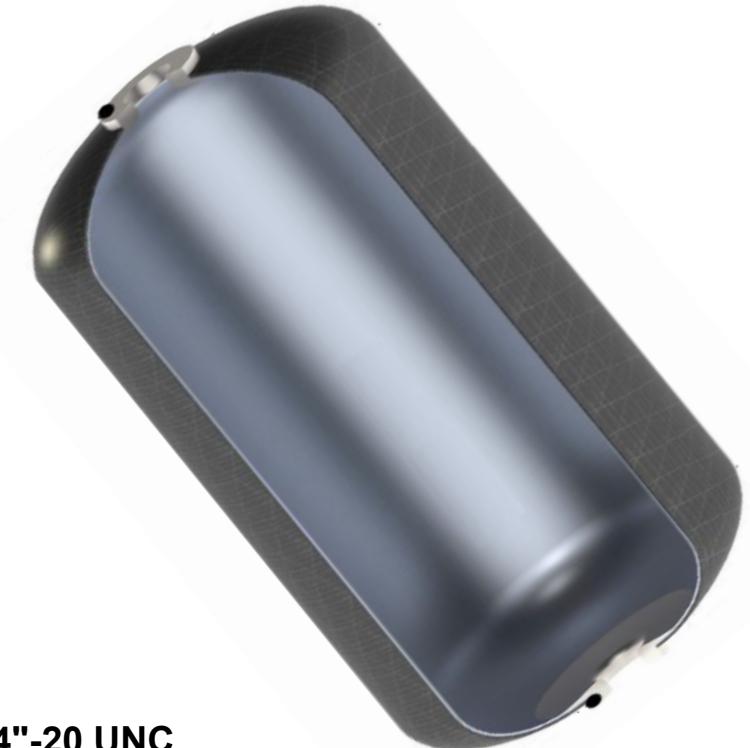
**304 Stainless Steel Threaded Float,
Oblong, 3" Diameter, 6" Long**

**304 Stainless Steel Threaded Float, 2" Diameter, 1/4"-20 UNC
Thread Size, 750 Maximum PSI**

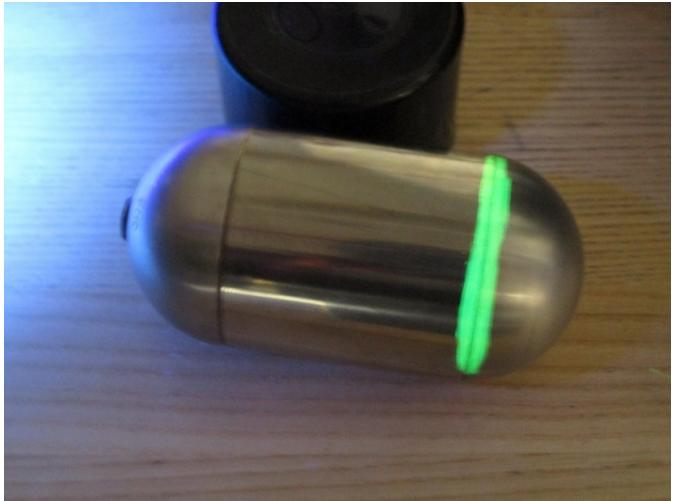
Liner Inspection Fluorescent Penetrant and Eddy Current

Capabilities

- Detection of VERY small defects on the surface ($\approx 5 - 10 \mu\text{m}$)
- Crack, pore, leak detection
- Ability to inspect complex shapes

Limitations

- Defects MUST be open to the surface and the surface must be free of anything that could interfere with penetrant material
- Excess surface roughness/porosity can hide relevant defects
- Visual acuity of inspector

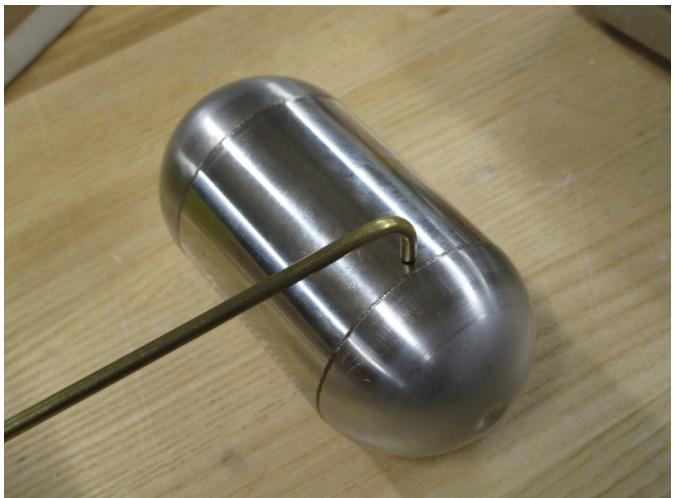
Eddy Current Inspection

Capabilities

- Detect surface and some subsurface cracks detection.
- Metal identification and sorting using conductivity techniques.
- Measures thickness of thin metals, conductive coatings, and non-conductive coatings on conductive substrate.

Disadvantages

- Hand-held systems are generally used in localized small areas but can be automated on surfaces.
- The surface of the inspection area must be clean.
- Several human factors: probe lift off and physical positioning can impact results. Effective inspection depth in a material is $\frac{1}{4}$ " up to $\frac{1}{2}$ " max.

No indications were detected with eddy current

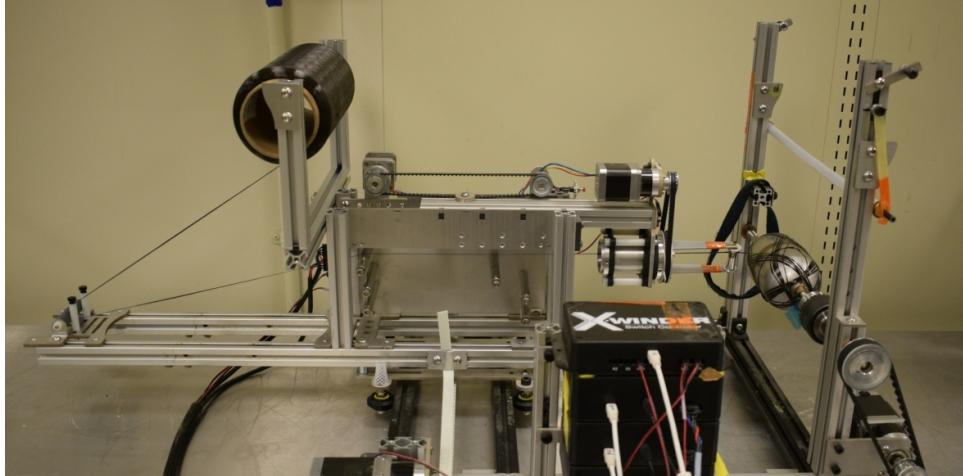
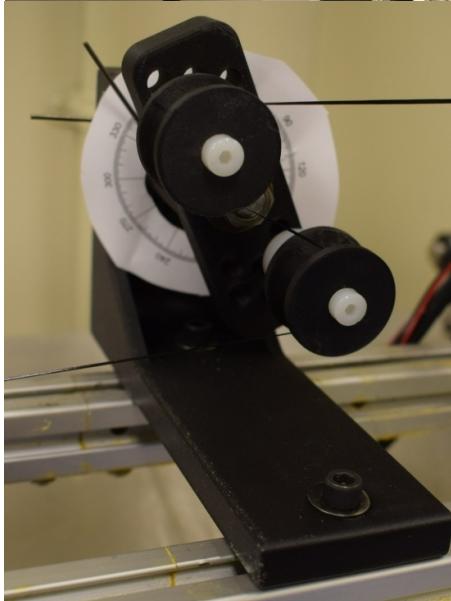
Winding Process (Steep Learning Curve)

Low cost X-winder with limited capability (no complex mandrel geometries).

Layer	Angle (°)
1	5.8
2	65.0
3	11.5
4	75.0
5	80.0
6	20.0
7	85.0
8	90.0
9	7.0
10	90.0

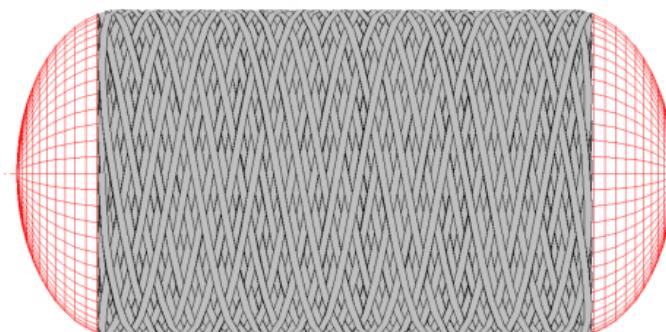
80° Layer

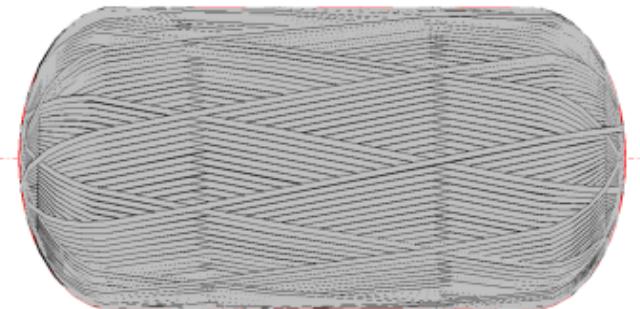
11.5°
Layer

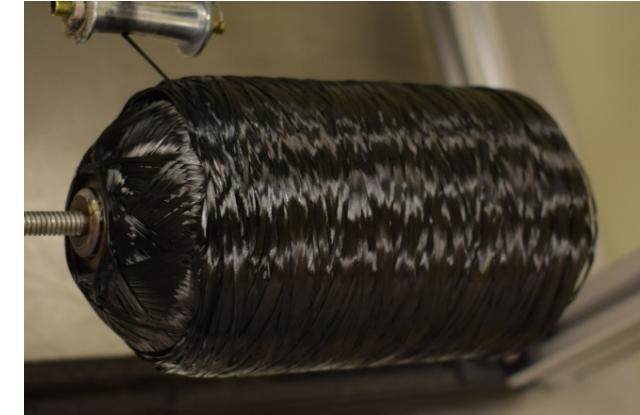
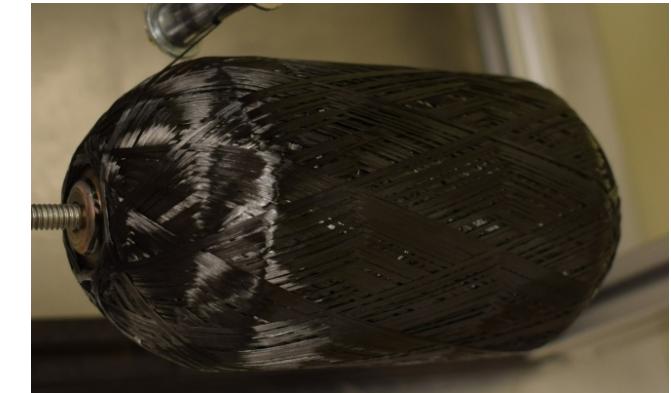
Curing Process

- Wrapped in heat shrink tape to aid with compaction
 - Developing vacuum bagging technique
- Cured in an oven with a “rotisserie” action
- Experienced some audible popping after cure
 - The composite is disbonding from liner due to residual thermal stresses (difference in linear coefficients of expansion).

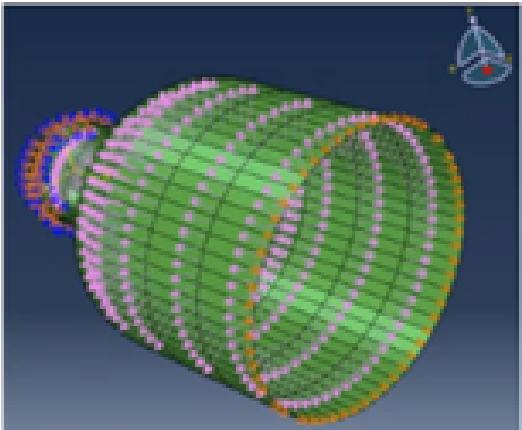
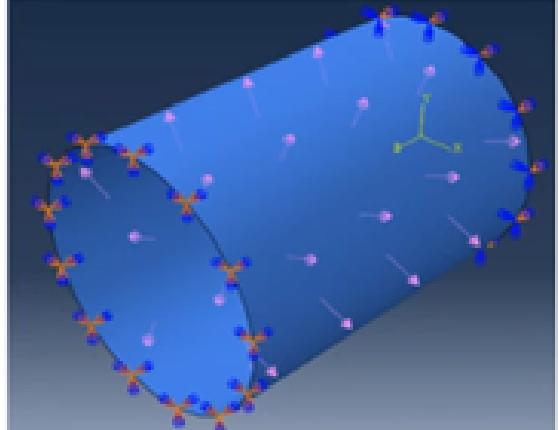
Finite Element Analysis of Composite Layup

- Isolate center section

- 32mm radius
- 86mm length
- 0.1414mm ply thickness
- Material: elastic lamina
 - Density 1583
 - $E_{11} = 165$ GPa, $E_{22} = 8.83$ GPa, $\nu_{12} = 0.3$, $G_{12}=G_{13}=G_{23} = 4.3$ GPa
- number plies = 6plies (0, 15, 70)sym

- Boundary conditions:

- Fixed end: $u_1=u_2=u_3=ur_1=ur_2=ur_3=0$
- Sym end: $u_3=0$, $ur_1=ur_2=ur_3=0$ (just z-dir)

- Loading: pressure 1MPa

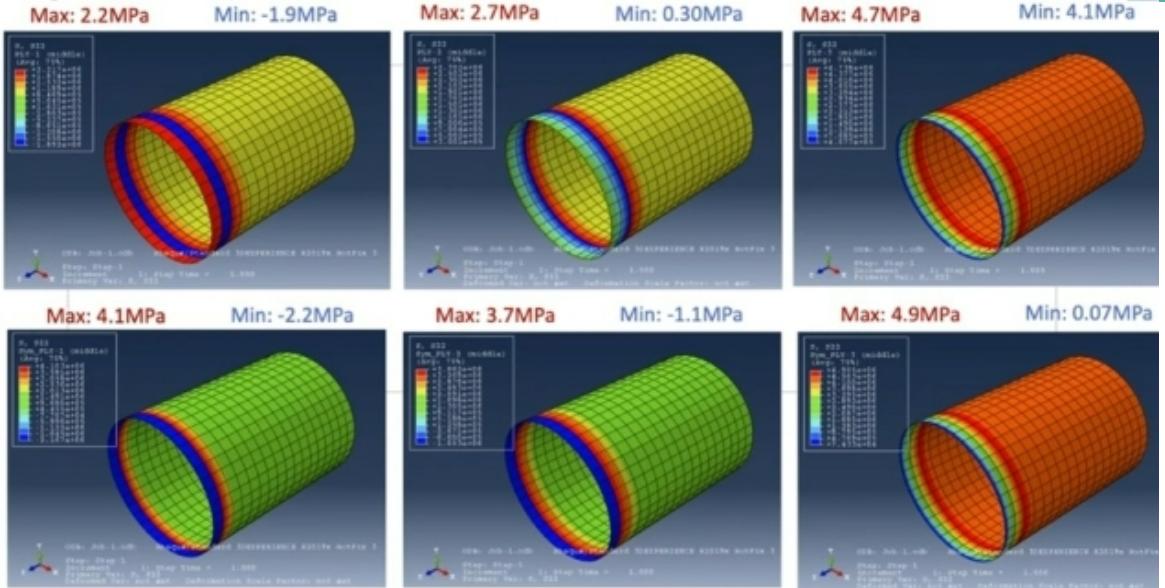
Axial Stress

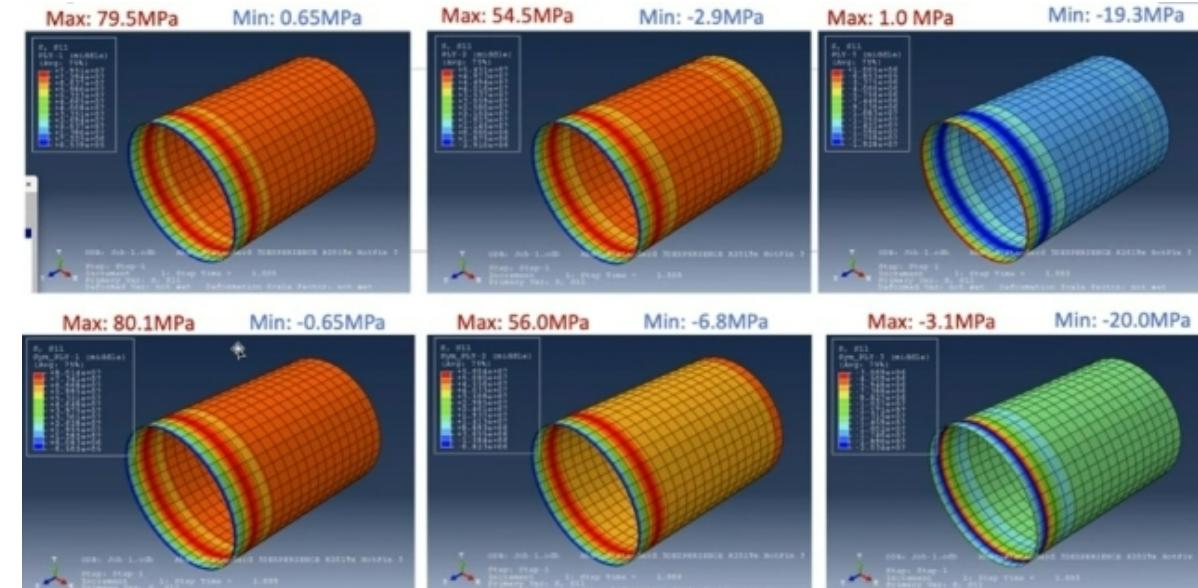
Hoop Stress

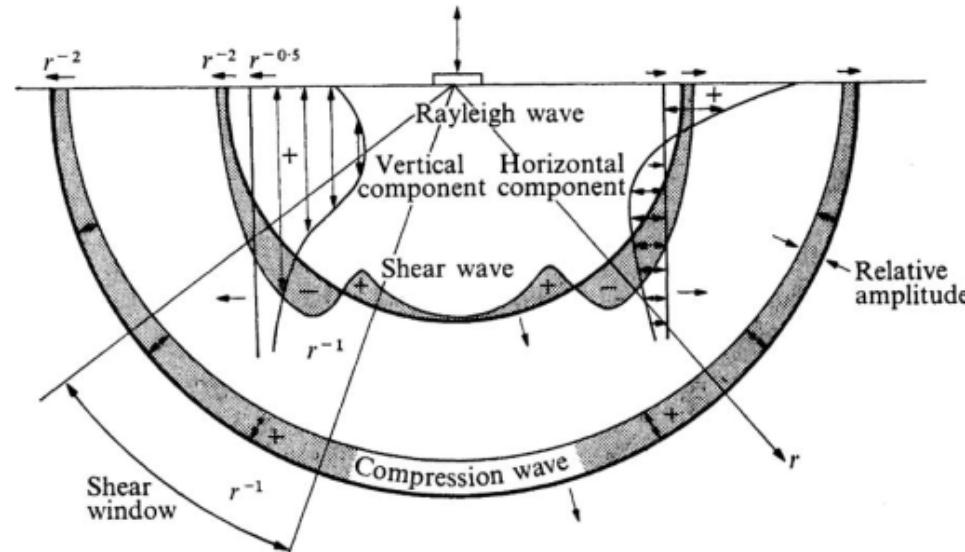
Wave Scatter Theory

Materials that demonstrate frequency dependent velocity variation are known as dispersive materials. In these types of materials there is a distinction made between the group velocity and the phase velocity.

Group velocity (v_g) is defined as a rate at which the point of maximum amplitude in the ultrasonic pulse (many frequencies) propagates through the material.

Phase velocity (v_p) is defined as the velocity of a continuous sinusoidal wave (one frequency) in the material.

These two velocities are related to each other through dispersive properties (frequency dependence of the phase velocity).

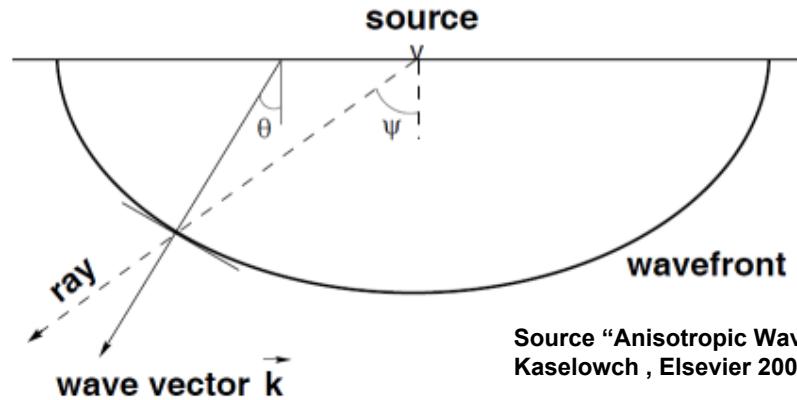
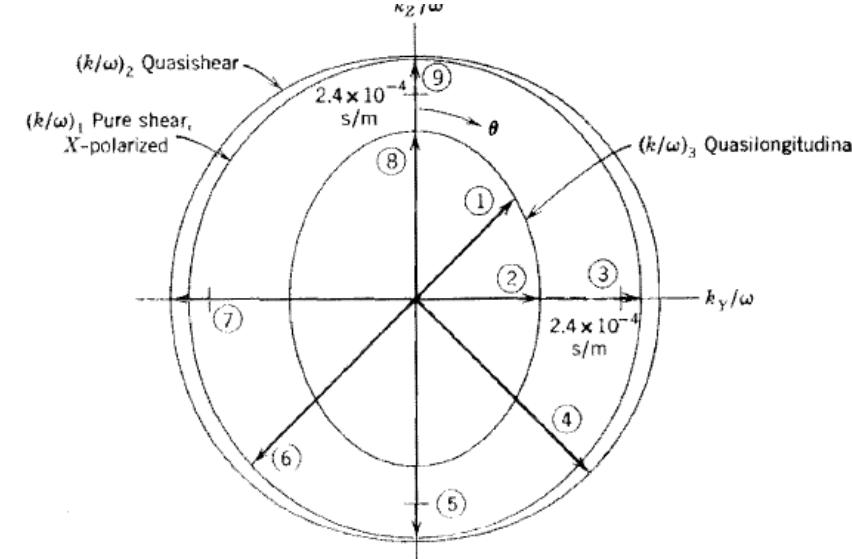
Plane Wave in Orthotropic Materials

Phase (Wavefront) Velocity (Angle θ) and Group (Ray) Velocity (ψ)

The elastic modulus for composite materials is generally not isotropic in nature, but is orthotropic. Most composites contain voids and micro-cracks within the structure. These manufacturing anomalies result in; a higher ultrasonic noise and texture appearance in the inspection images.

Sound dispersion and absorption causes signal losses as thickness increases. All these variables make the bondline interface between metals and composites more difficult to detect and quantify.

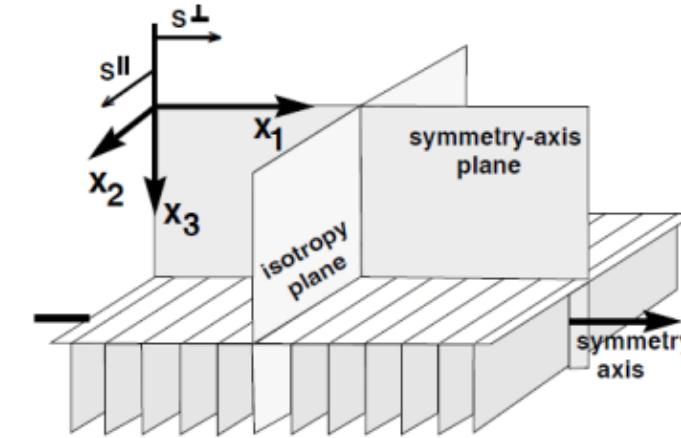
Source: Horizontal Transverse
Isotropic axis definition,
MIT OpenCourseWare
<http://ocw.mit.edu/terms/>

Orthotropic constitutive equations have two orthogonal planes of symmetry and properties are independent of direction within each plane. These materials require 9 independent variables (i.e. elastic constants) in their constitutive matrices. This equation is based on orthotropic elasticity up to failure.

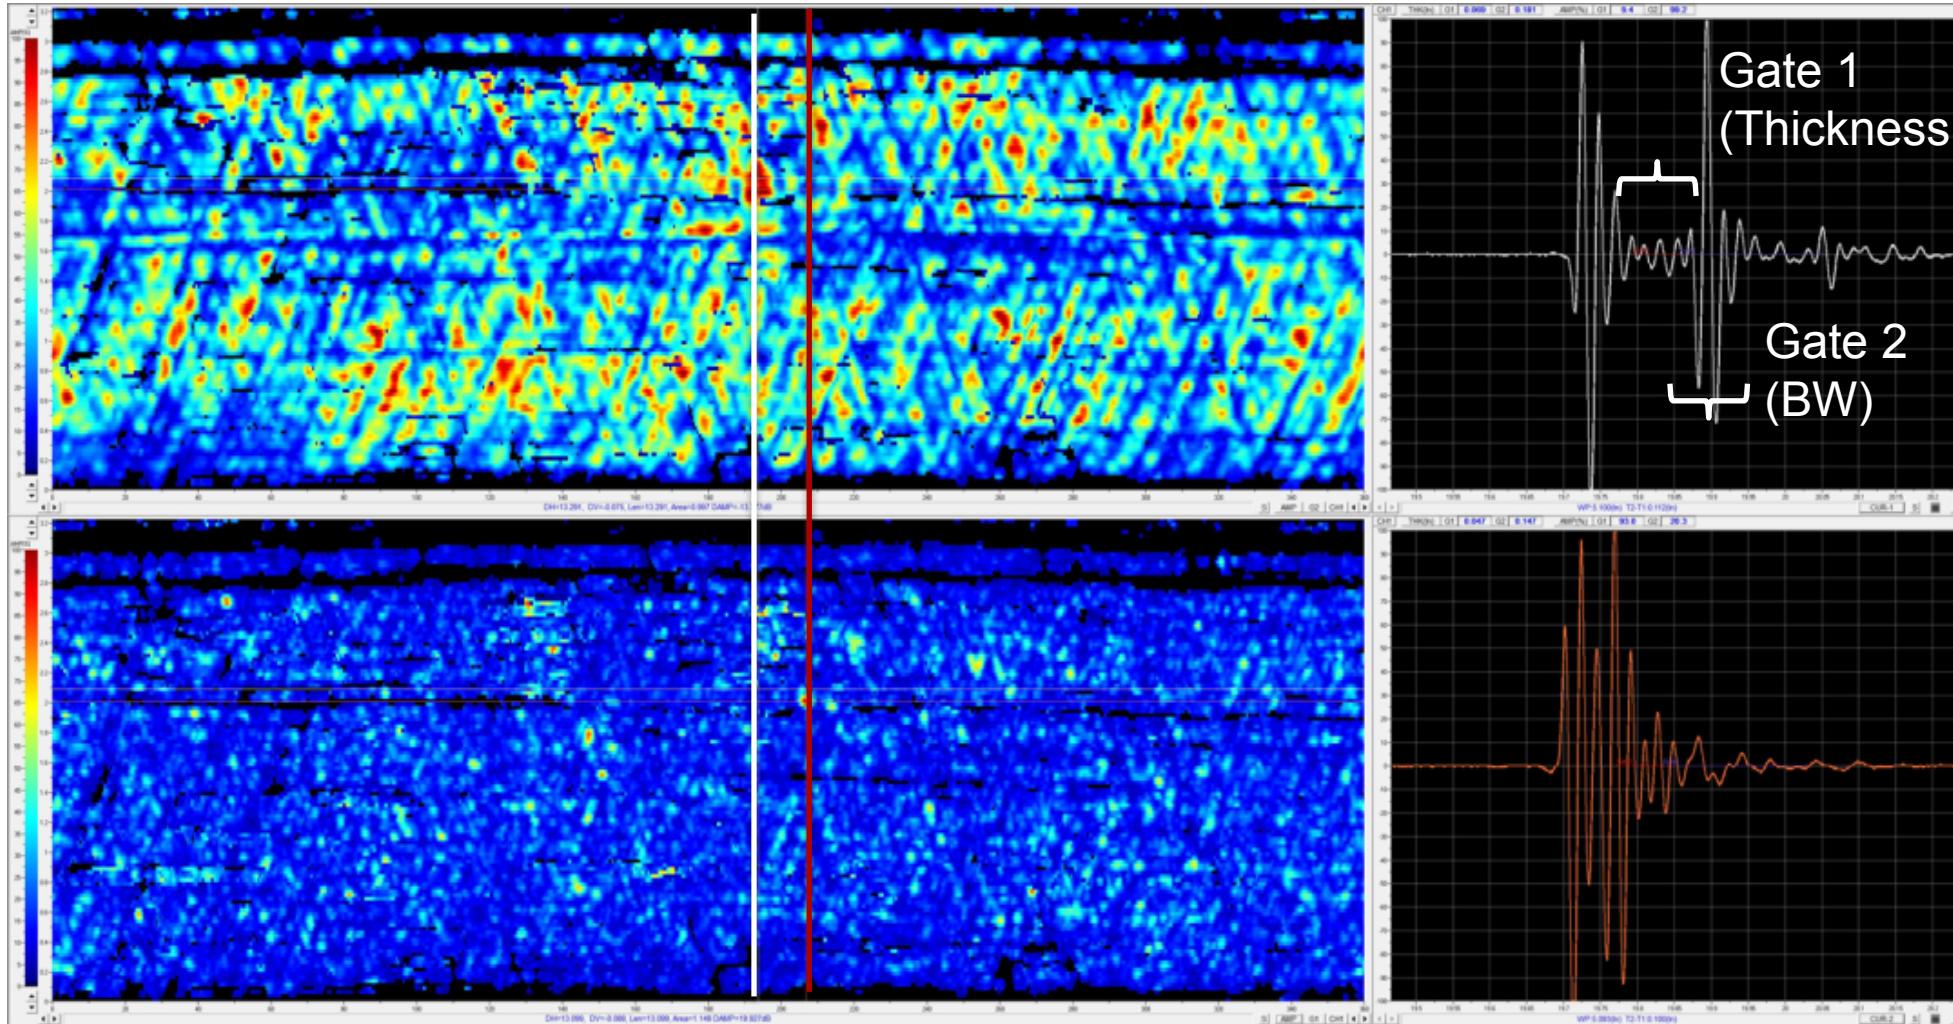
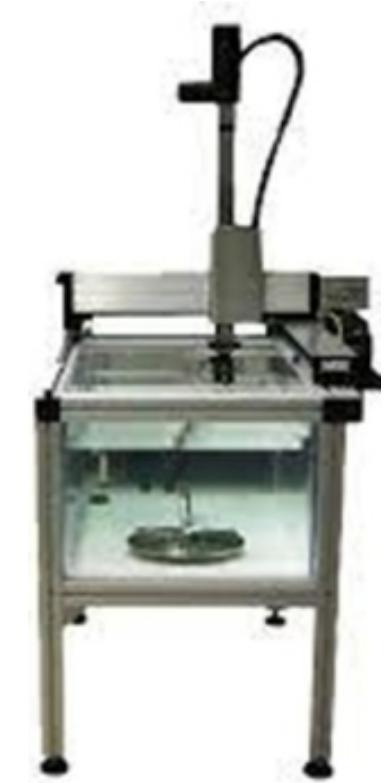
ULTRASONIC INSPECTION/RESULTS (COPV 4)

Frequency 5 MHZ
Probe Diameter 25.4 mm
Focal Length 12.7 cm

Ultrasonic C-scan images above reveal the weave pattern of COPV 4 (barrel section only) sample. Top image (gate 2) shows composite wrap backwall signal amplitude and the dependence of the liner interface. The lower image displays the signal amplitude between the outside surface and backwall of the composite wrap (composite thickness).

- The ultrasonic elastic wave interacts with the wound fiber structure. Factors that affect the ability to detect bondline variance are: composite surface texture (random or periodic surface roughness, fiber orientation and binder concentration).

- Sound dispersion and absorption causes signal losses. These variables make the bondline interface between the liner and composite wrap difficult to detect and quantify.

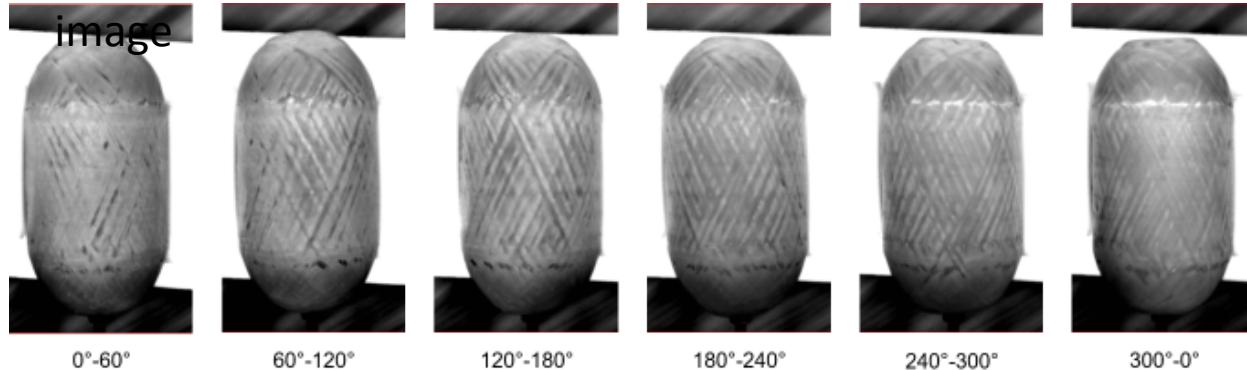
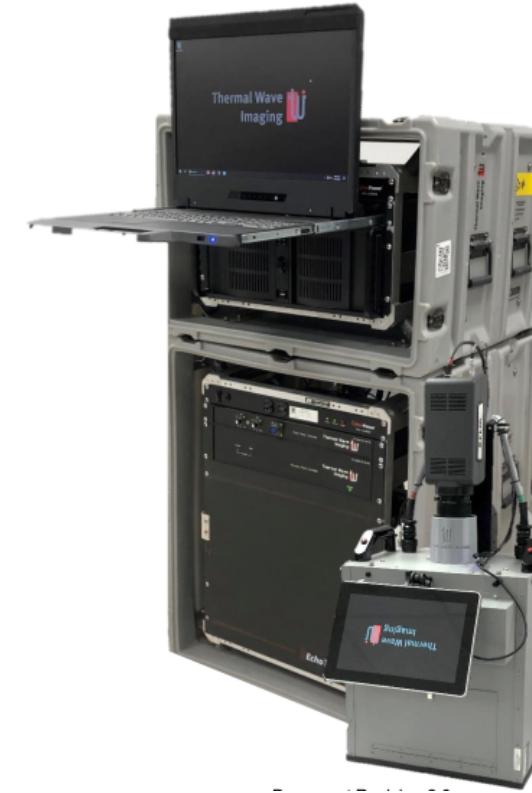
Time slice of reconstructed raw thermography

All images at 12.9 seconds after
flash sample COPV 4

- If the surface is shiny the infrared technique will reflect large “noise” signals. This may not allow enough heat to be deposited into the COPV (low signal). A coating of low reflective paint (black) is needed. Painted surfaces can be deceptive however, the IR emissivity and optical absorption may be enough to produce usable data.

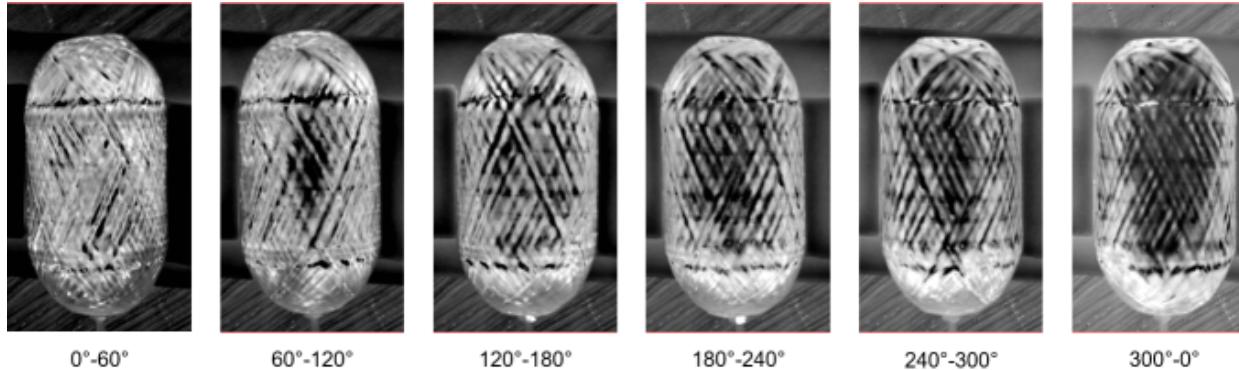
Time slice of reconstructed (first derivate) thermography image

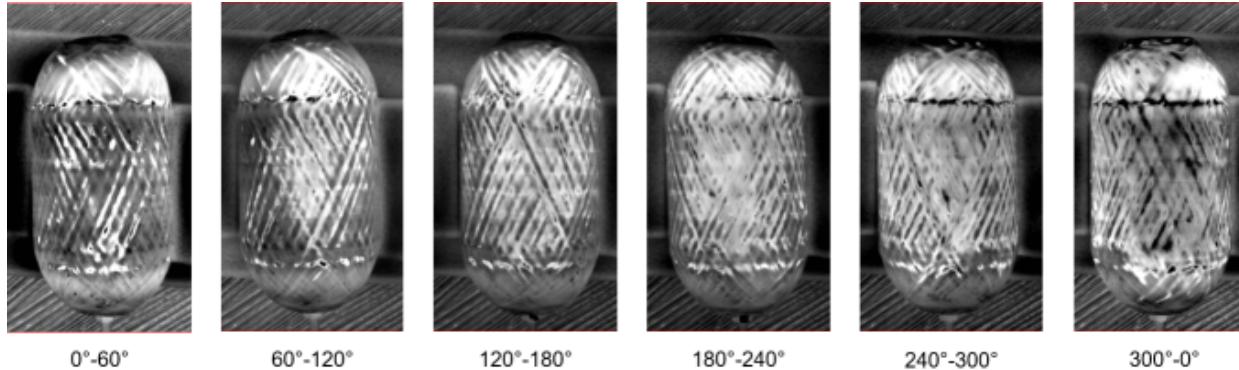
Time slice of reconstructed (second derivate) thermography image

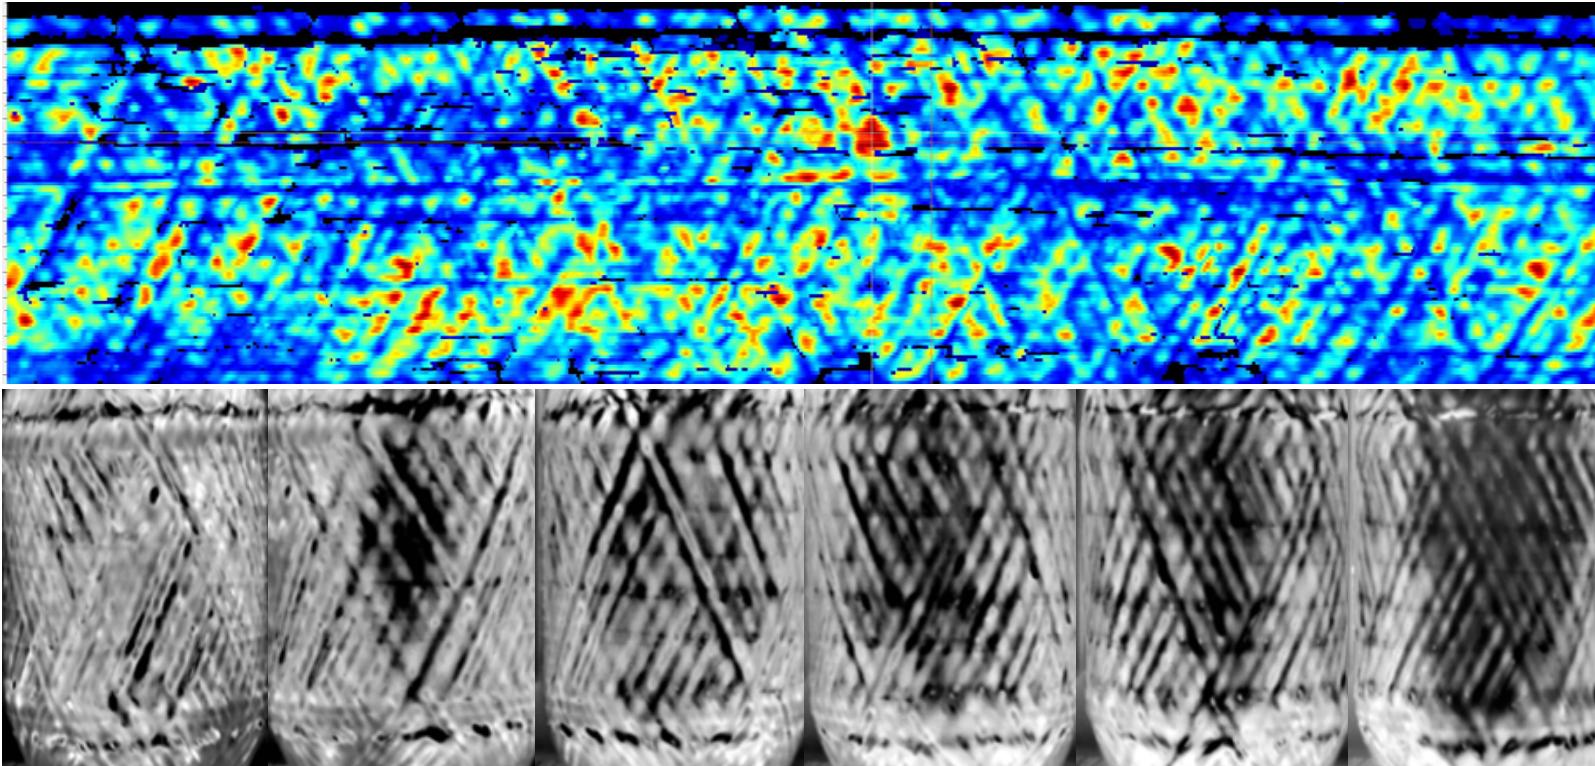
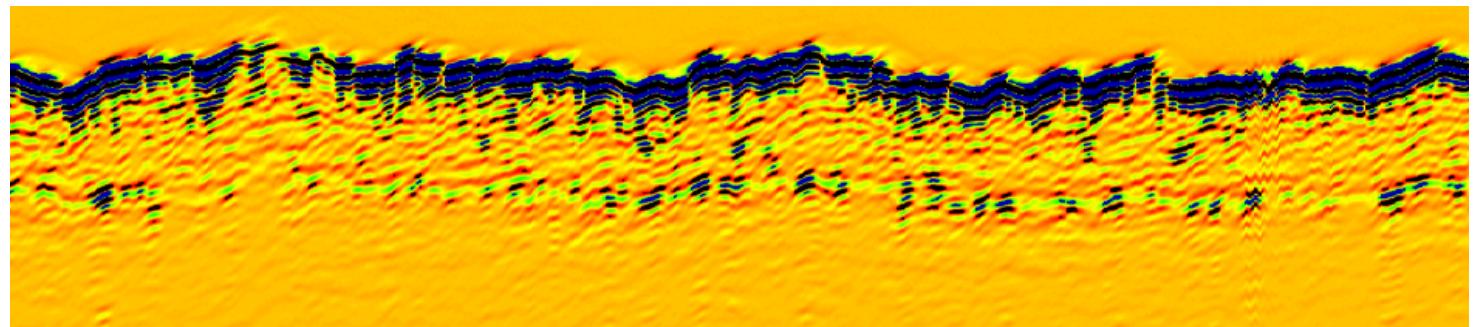
ULTRASONIC AND FLASH THERMOGRAPHY COMPARISON (COPV 4)

B-scan of composite thickness reveals voids in the wrap.

Bonded area reflects sound into the liner and sends a weaker reflection back to the probe (blue). Poorly bonded areas return no interface signal from the liner this results in a higher amplitude signal (red). The thermography reveals cool spots where the composite wrap has lack of resin and air pockets.

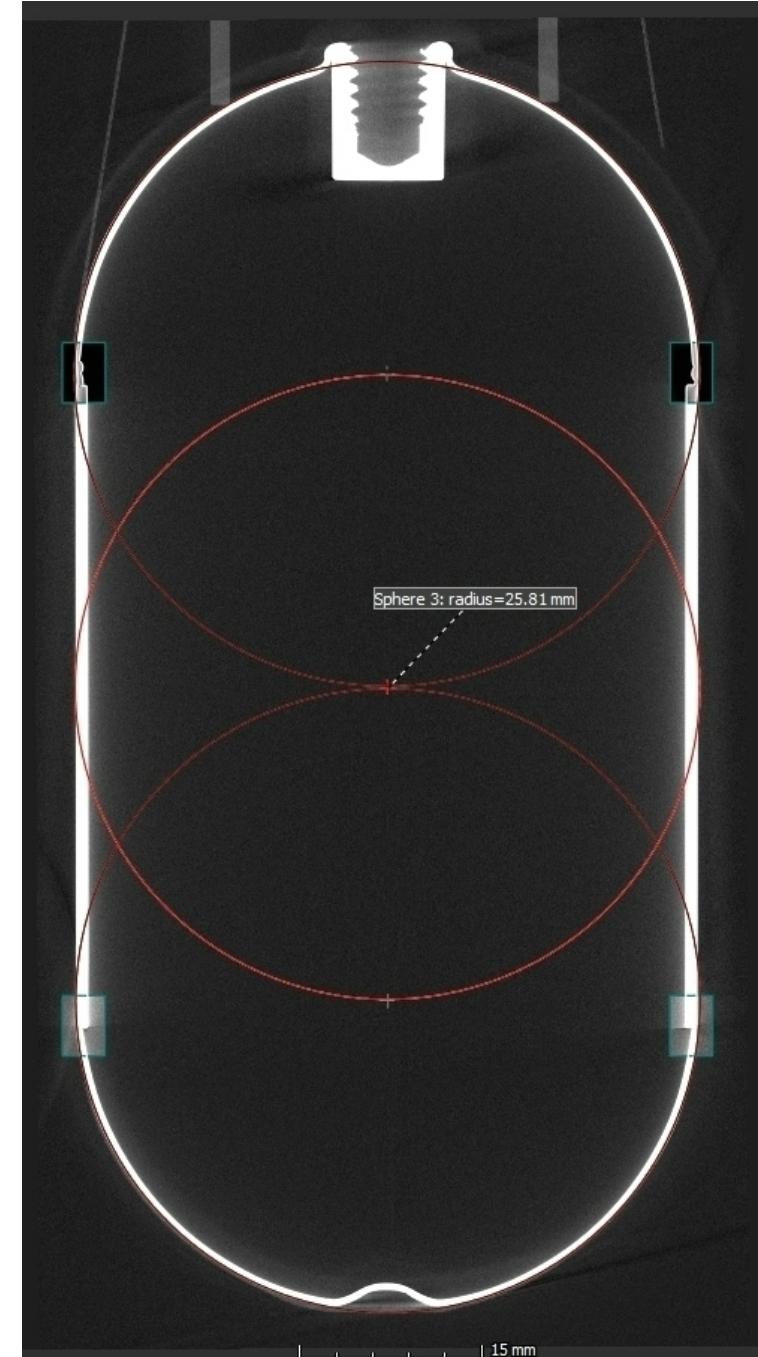
COPV Image Registration

- Liner were digitally registered using the metal section of the scan data.
- The coordinate system was defined using:
 - A cylinder defined using points on the outer metal surface
 - A sphere (shown on right) created by averaging two spheres defined with points on the top/bottom hemispheres
 - A line defined using the tapped hole to “clock” the sample
- The origin of the coordinate system is the middle sphere center location.

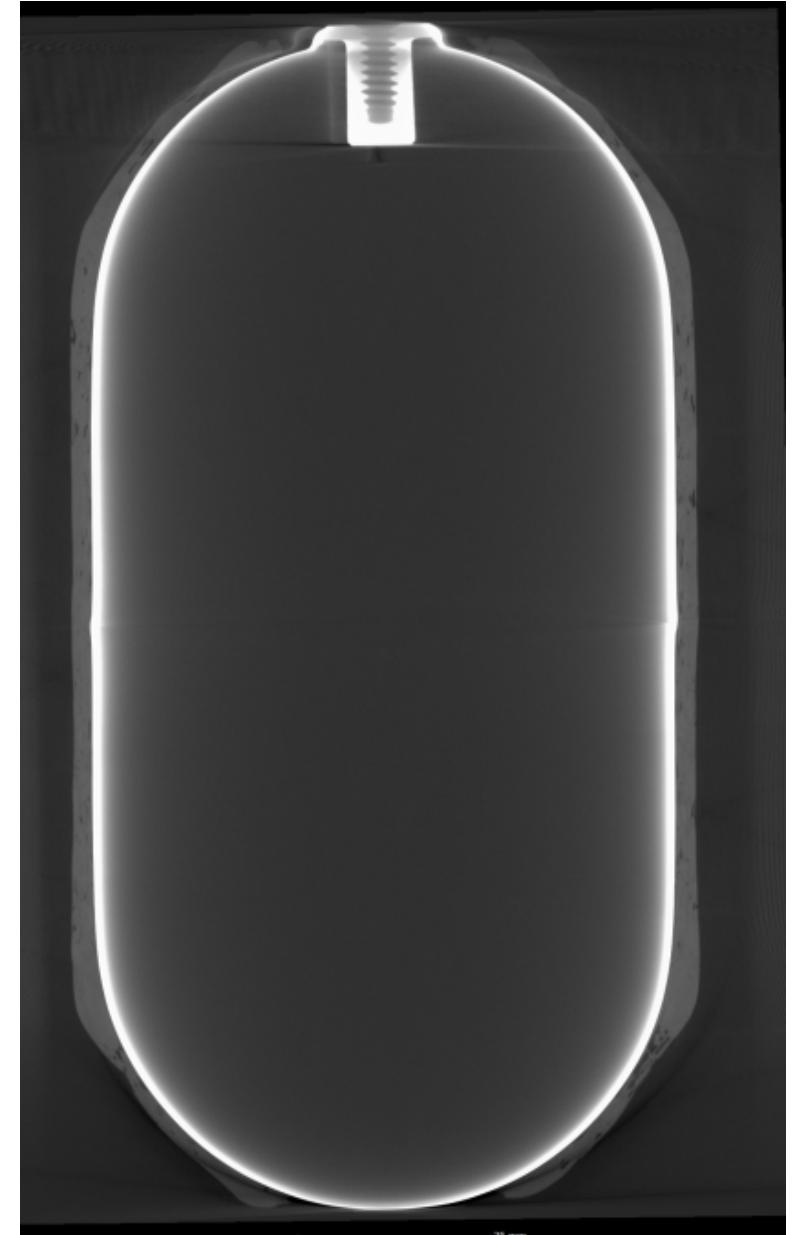
Image Segmentation

- Image segmentation was completed by using a region growing to separate composite from metal and aid in the analysis.
- The following procedure was used:
 - Perform advanced multi-material surface determination with an over-sized composite region
 - Use material region growing to create ROI of metal
 - Invert this metal ROI so that new ROI is everything but metal
 - Use region growing (not material) with the following settings
 - Mode: Static: Tolerance: 1.5
 - Starting Point: in composite ~halfway up z-direction
 - Radius: 120 mm
 - Use material region growing to remove any significant defects from new ROI
 - Intersection new ROI with inverted metal ROI to remove any metal parts, creating a composite ROI
 - Extract metal and composite ROIs to create new volumes

- A CT inspection technique was developed which segments the multi-material data into composite and metal regions. Wrapping patterns are difficult to estimate. The damaged liner was easy to detect.

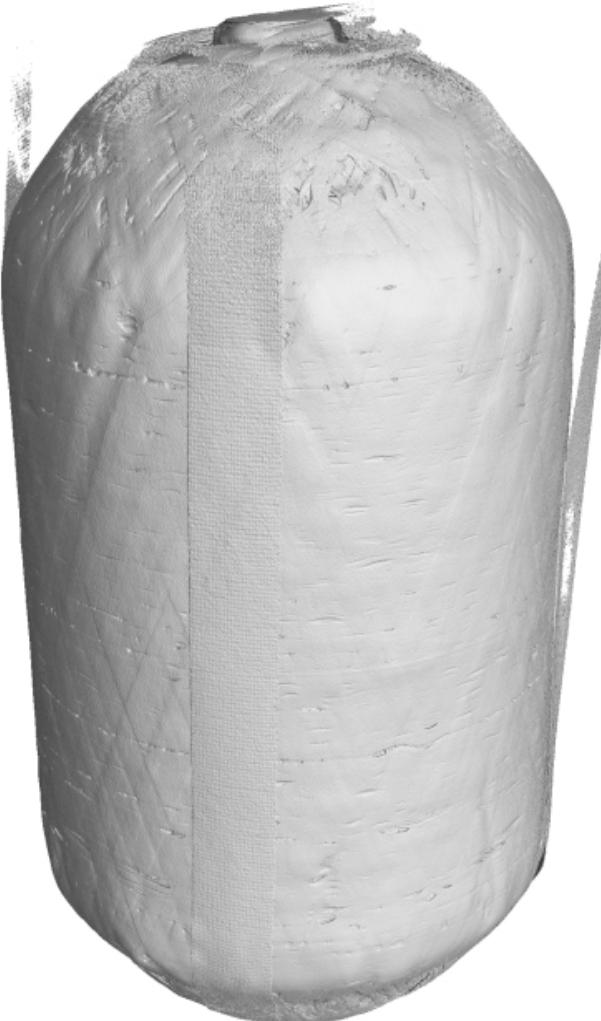
Composite

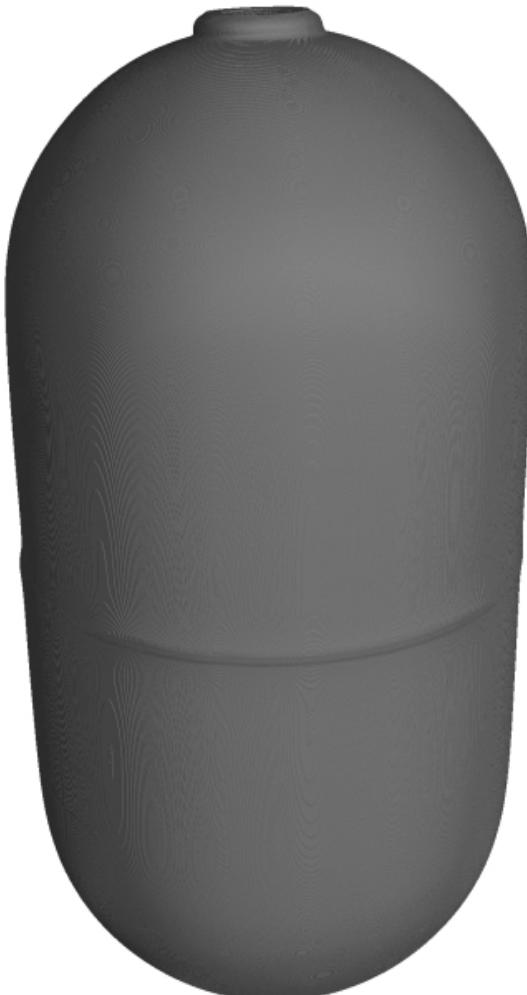
Metal

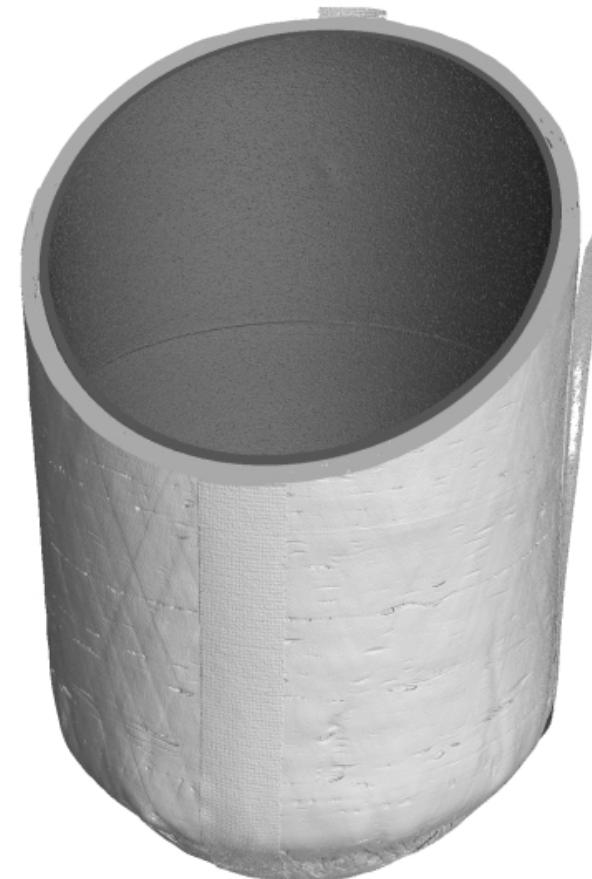
Both

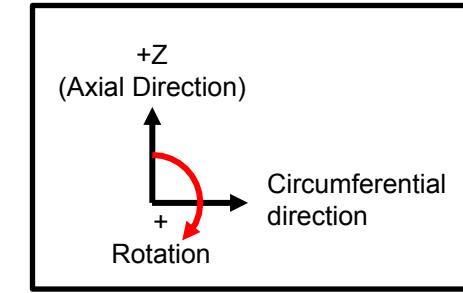
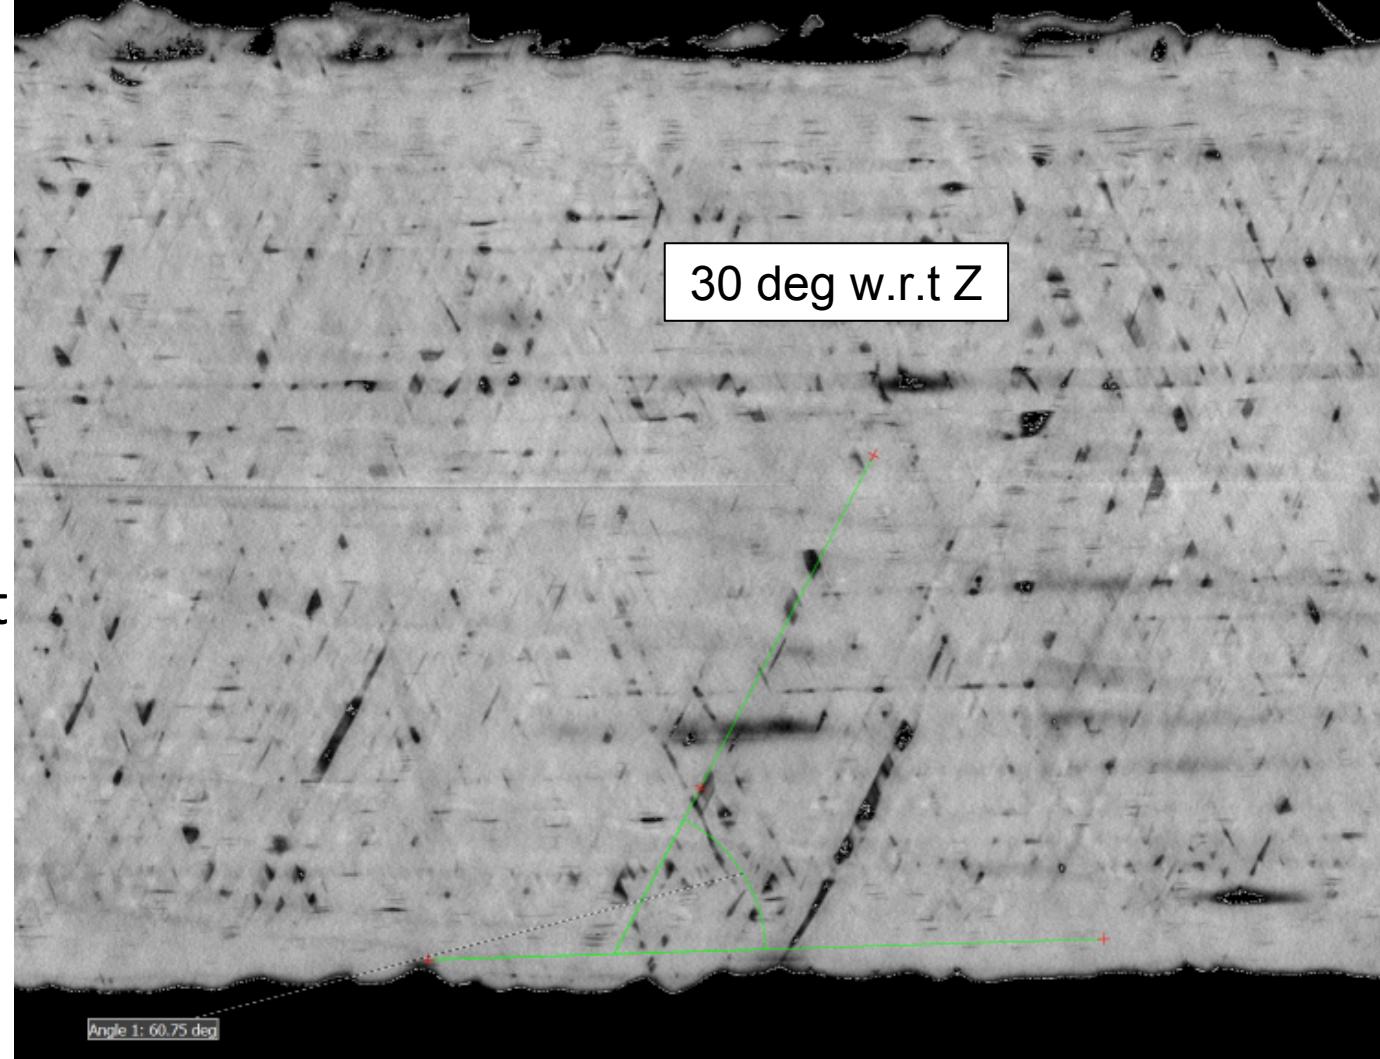
CT Results of COPV 4

- Wrap angle estimated at 30 deg w.r.t. cylinder Z-axis (60 deg w.r.t. XY tangential direction)
- Stochastic gaps in wrap (black in image) are wrap imperfections and inconsistent winding tension.
- Wrap direction seems consistent through radial direction (nonplanar image stack)

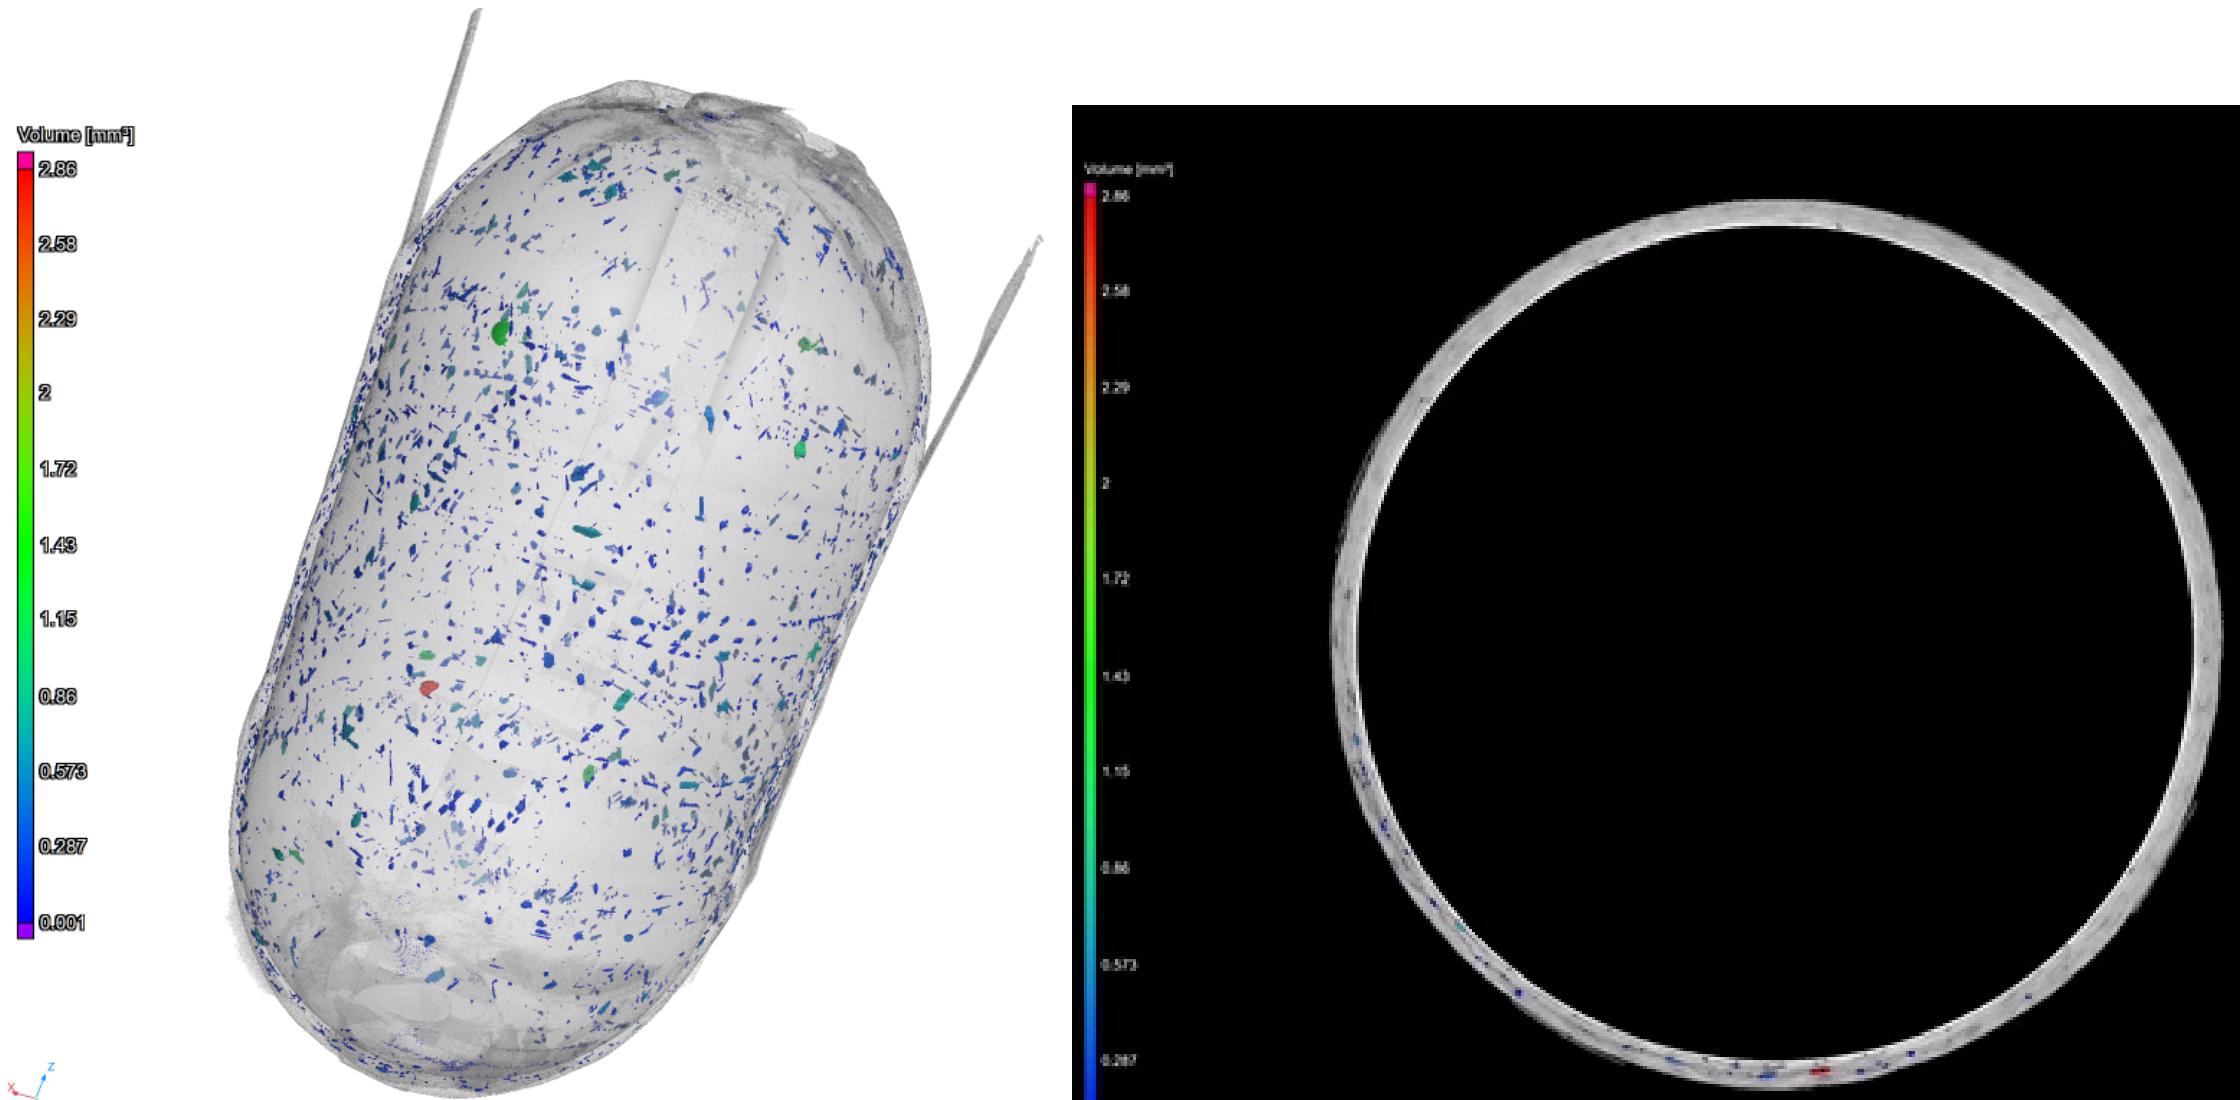
CT MISSES SOME OF PORES WITHIN COPV 4
