Developing Technologies for Composite Overwrapped Pressure Vessels (COPV)

Comparing Traditional Inspections to Advanced 3D Rendering Techniques

David G. Moore, Ciji Nelson Caleb
Schauble and Dorian K. Balch, PhD

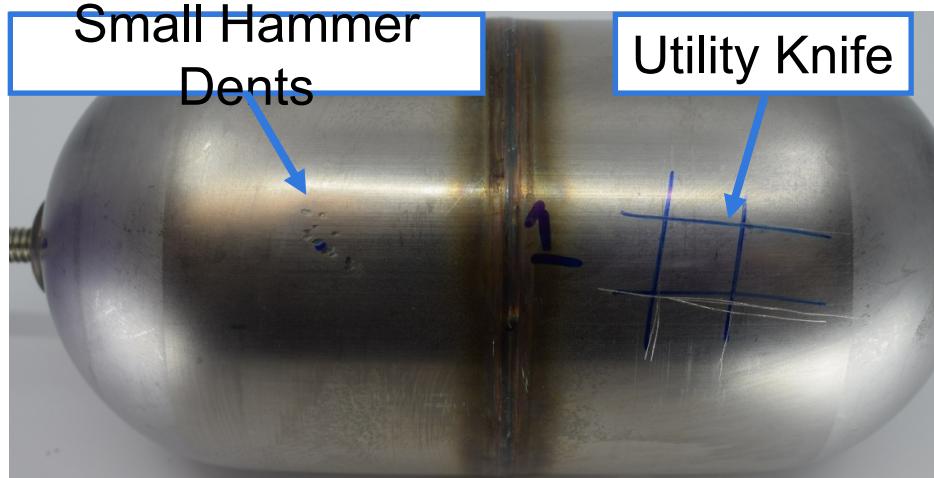
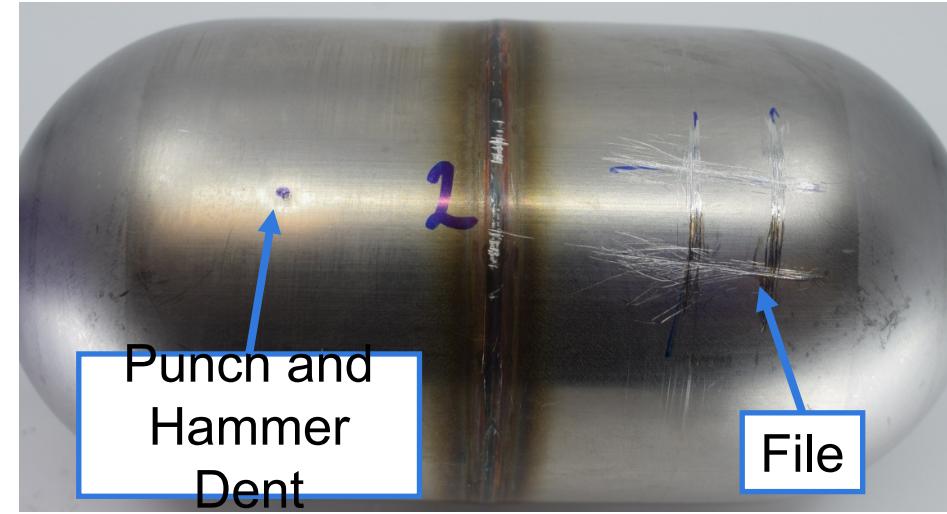
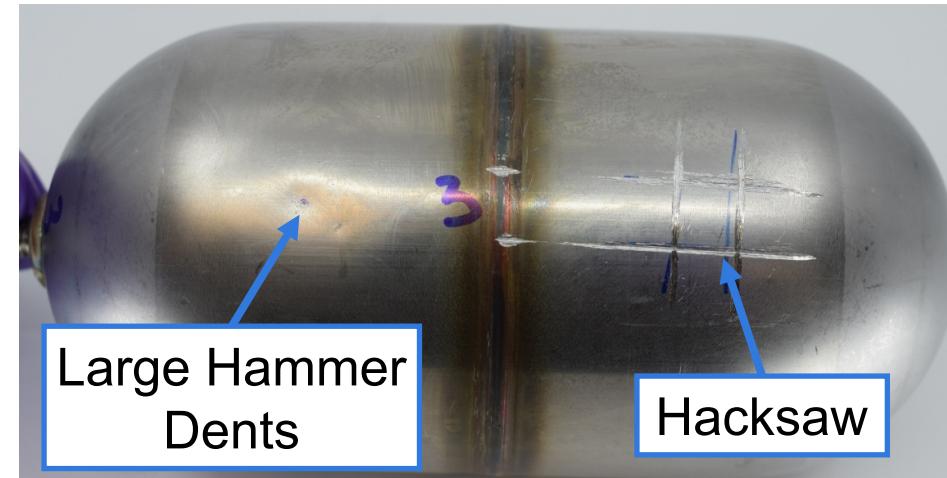
Introduction of Manufacturing “Defects”

- Introduced intentional defects in metal liner for to determine if NDI can detect
 - Linear defects with utility knife, file and hacksaw
 - Point defects with hammer or hammer and punch

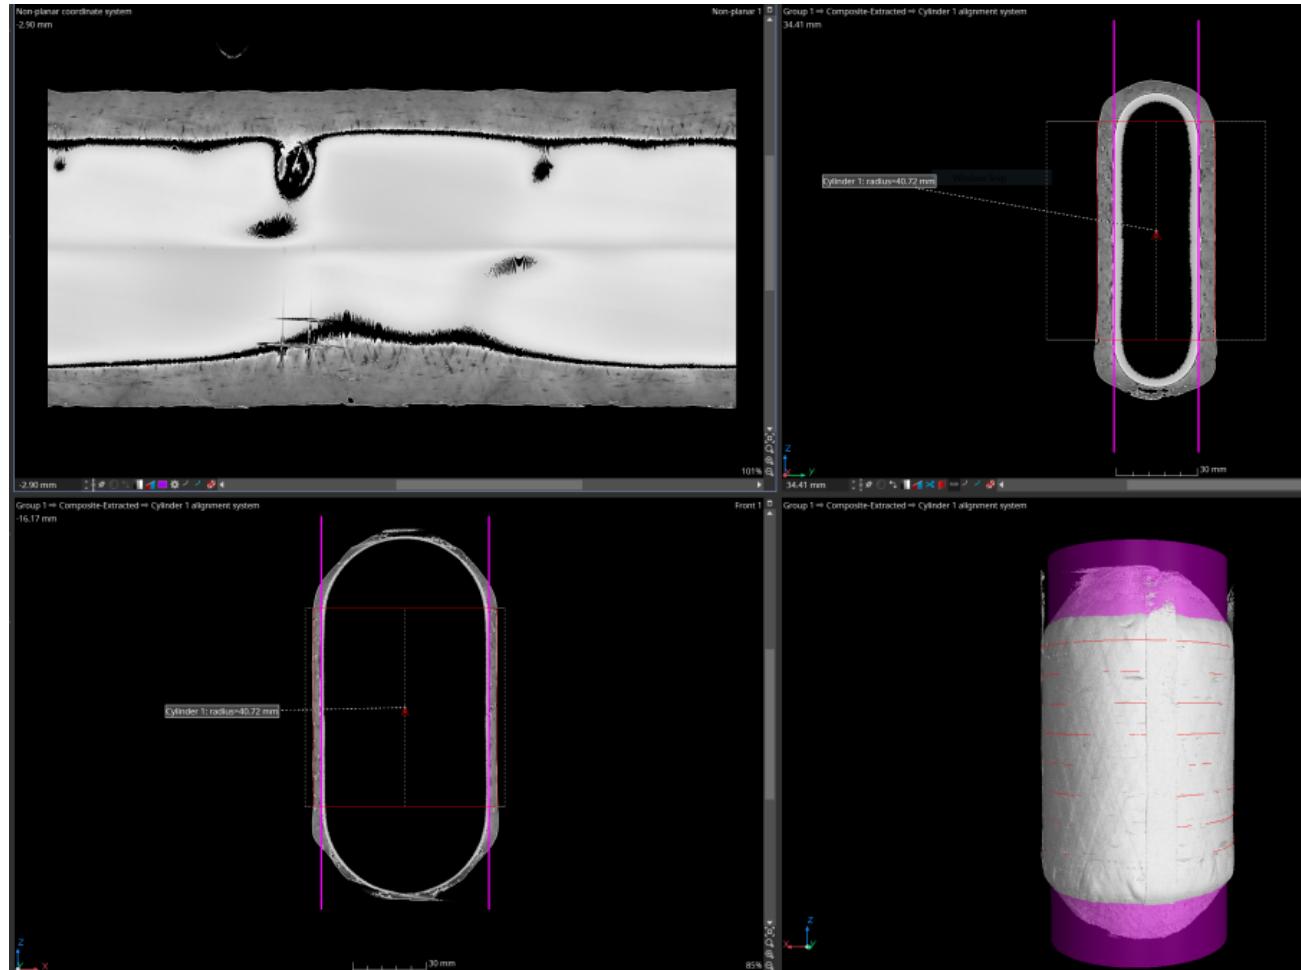
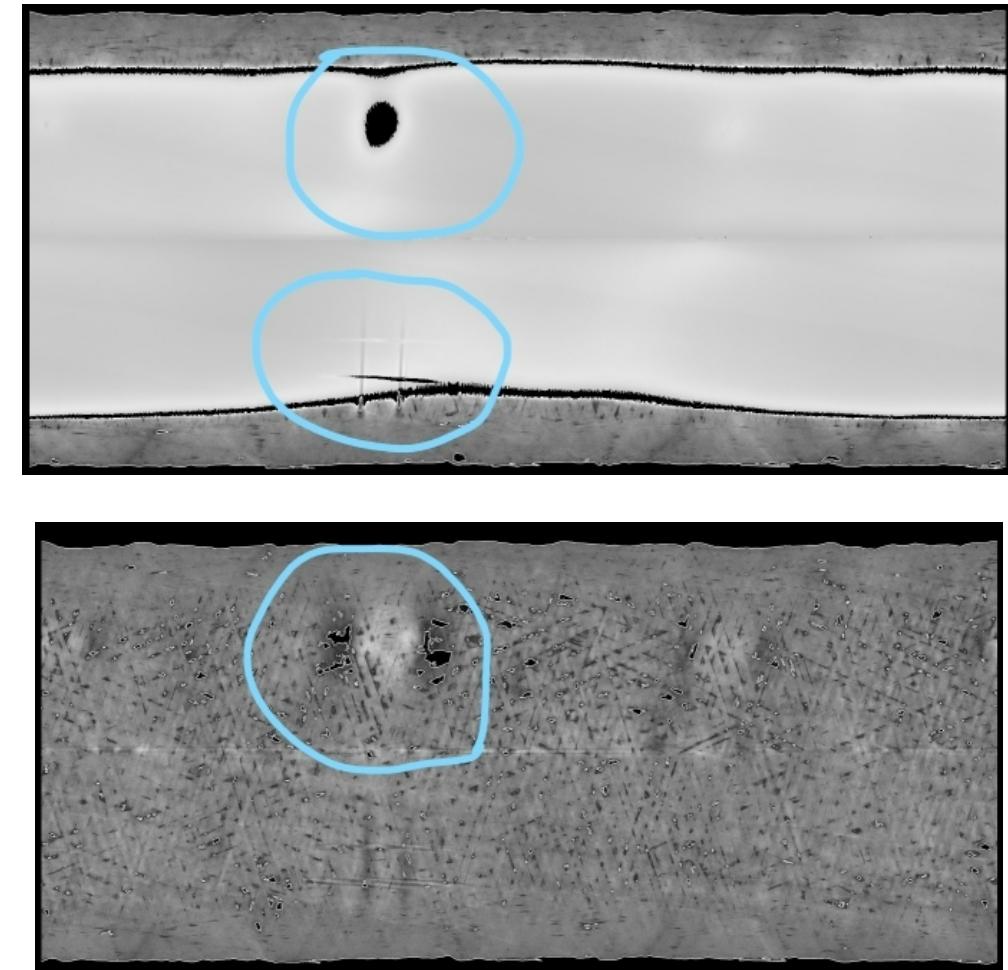
Computed Tomography Detection of Liner Defects

COPV #6 reveals engineering generated defects are detectable with computed Tomography.

- A CT inspection technique was developed which segments the multi-material data into composite and metal regions. Wrapping patterns are difficult to estimate. The damaged liner was easy to detect.

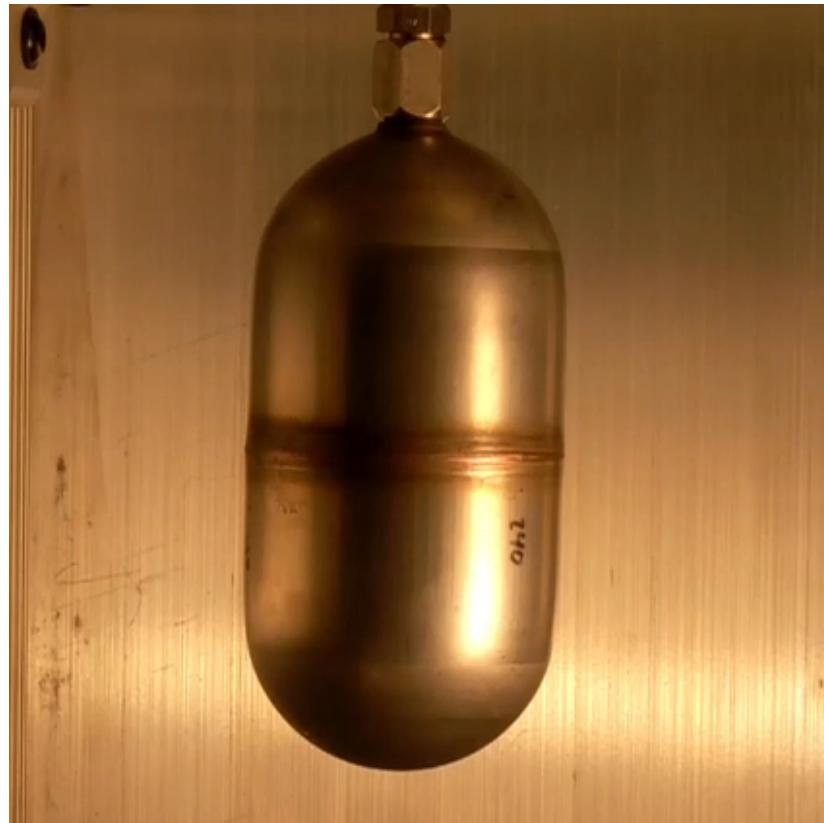
Liner 1 (real time and high speed video)

SN	Float Type	Burst Pressure psi	Time elapsed	Location of failure
01	Liner	3873psi	12: 05 min	Waist weld
02	Liner	3733psi	8:55 min	Waist weld
03	Liner	3601psi	6:54 min	Waist weld
04	Overwrap marked "1"	7413psi	10:00 min	Waist weld
05	Overwrap w/adhesive marked "3"	5250psi	~5 min	Top Curve
06	Overwrap marked "2"/Flawed	No burst; leaked around 7ksi	~10 min	Inside

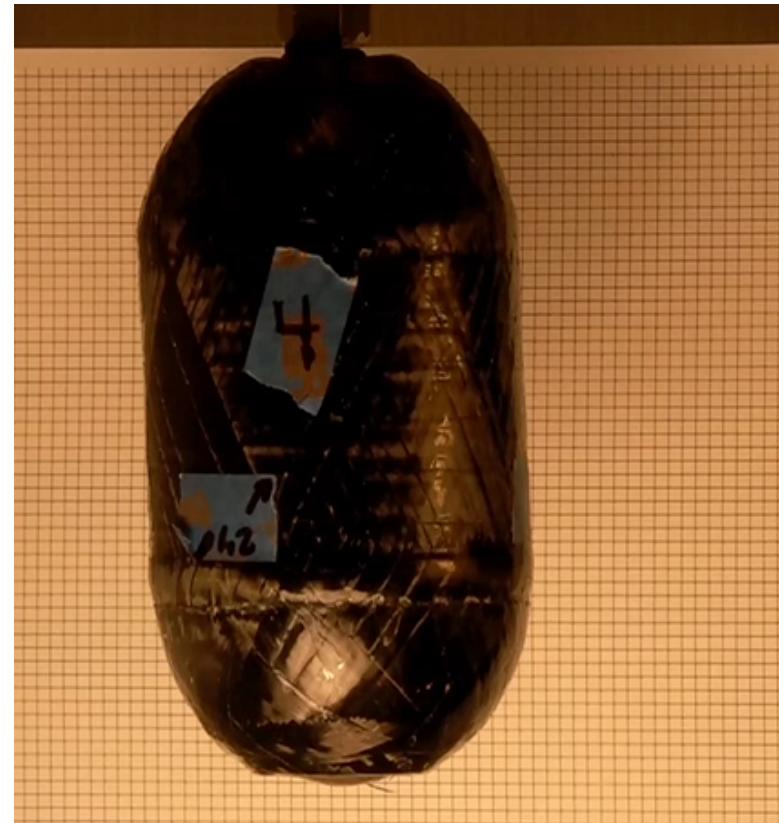
COPV 4 (real time)

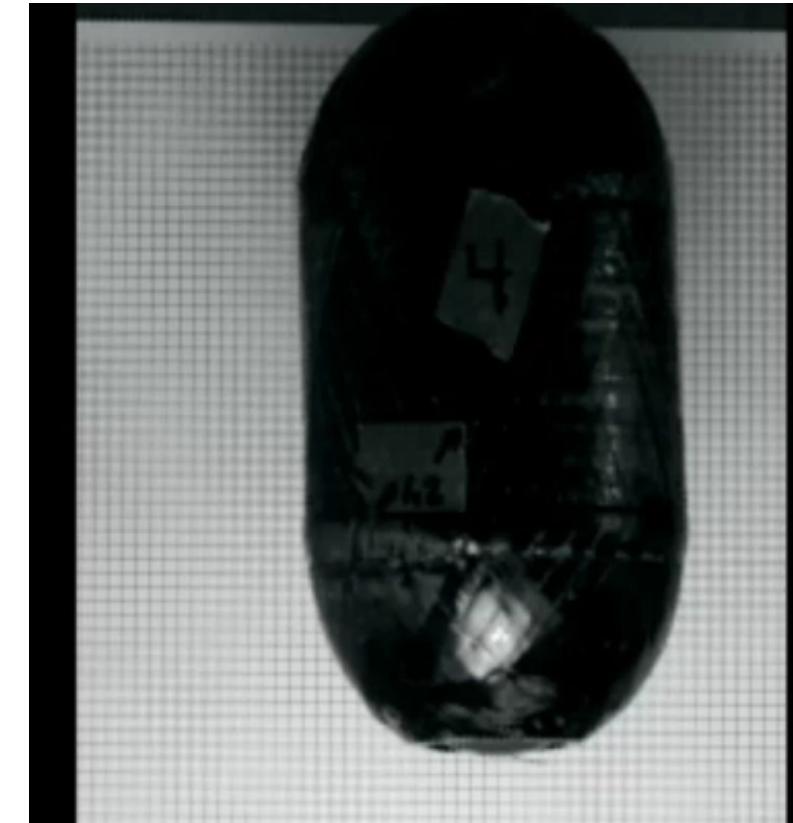
COPV 4 (high speed video)

Edgertronic Camera: frame rate was 10k frames per second with a camera resolution of 1280 by 128.

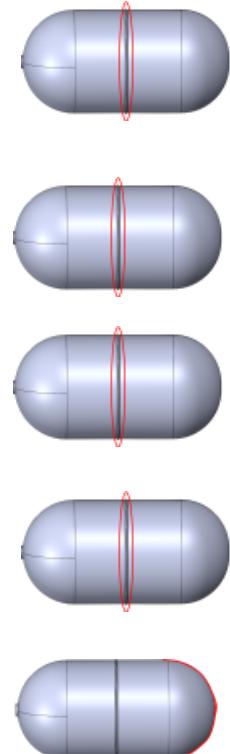
Float SN	Weight (g)	Diameter (inches)	
Liner 01	254.64	120°	2.99
		240°	3.01
		360°	2.97
Liner 02	249.52	120°	2.99
		240°	2.99
		360°	3.00
Liner 03	249.94	120°	2.98
		240°	3.00
		360°	3.00
COPV 04	365.80	120°	3.14
		240°	3.14
		360°	3.14
COPV 05	416.76	120°	3.25
		240°	3.24
		360°	3.23
Adhesive	398.64	120°	3.22
		240°	3.21
		360°	3.21

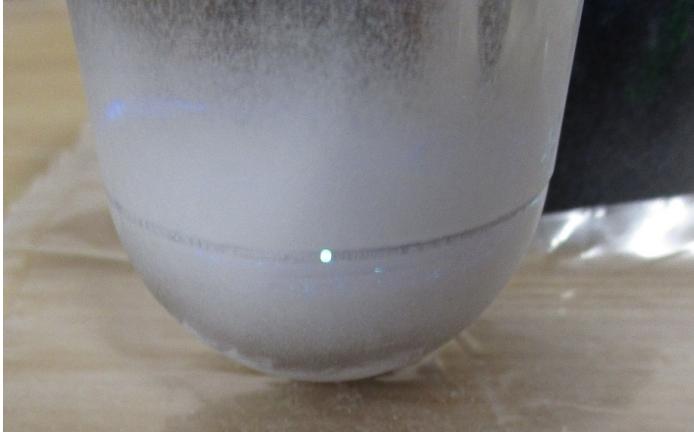
Solvent Removal

- A nonaqueous solvent was used to clean the samples.
- A level III fluorescent penetrant was strategically applied and allowed to dwell on the weld and heat effected zone for 45 minutes. The excess penetrant was wiped away using dry wipes.
- A nonaqueous developer was applied and allowed to dwell for 30 minutes.
- The parts were inspected using a black-light, looking for surface breaking defects. The parts were also visually inspected under low magnification for defects. After the inspection, the samples were cleaned once again with the nonaqueous solvent.

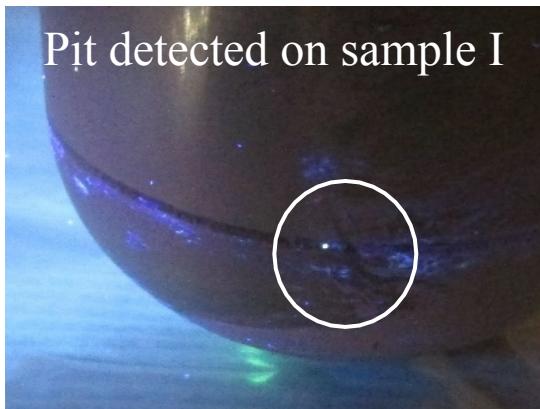
Nonaqueous developer applied to the inspection surface.

Pit detected on sample I

Part No.	Indications	Notes
I	Yes, pit	A pit was detected on the weld surface during the penetrant inspection.
II	Yes, lap	Small lap was detected during the penetrant inspection.

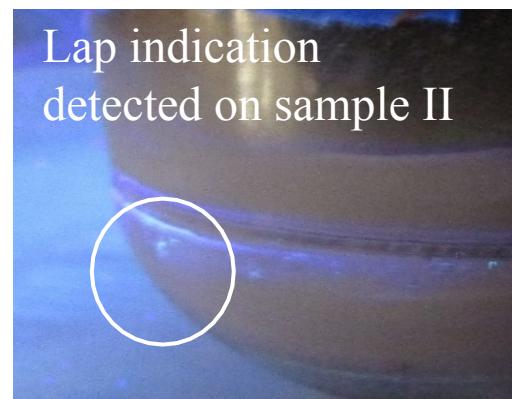
Lap indication detected on sample II

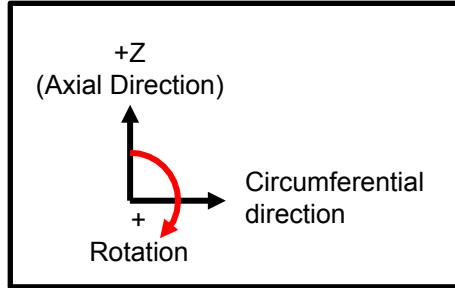
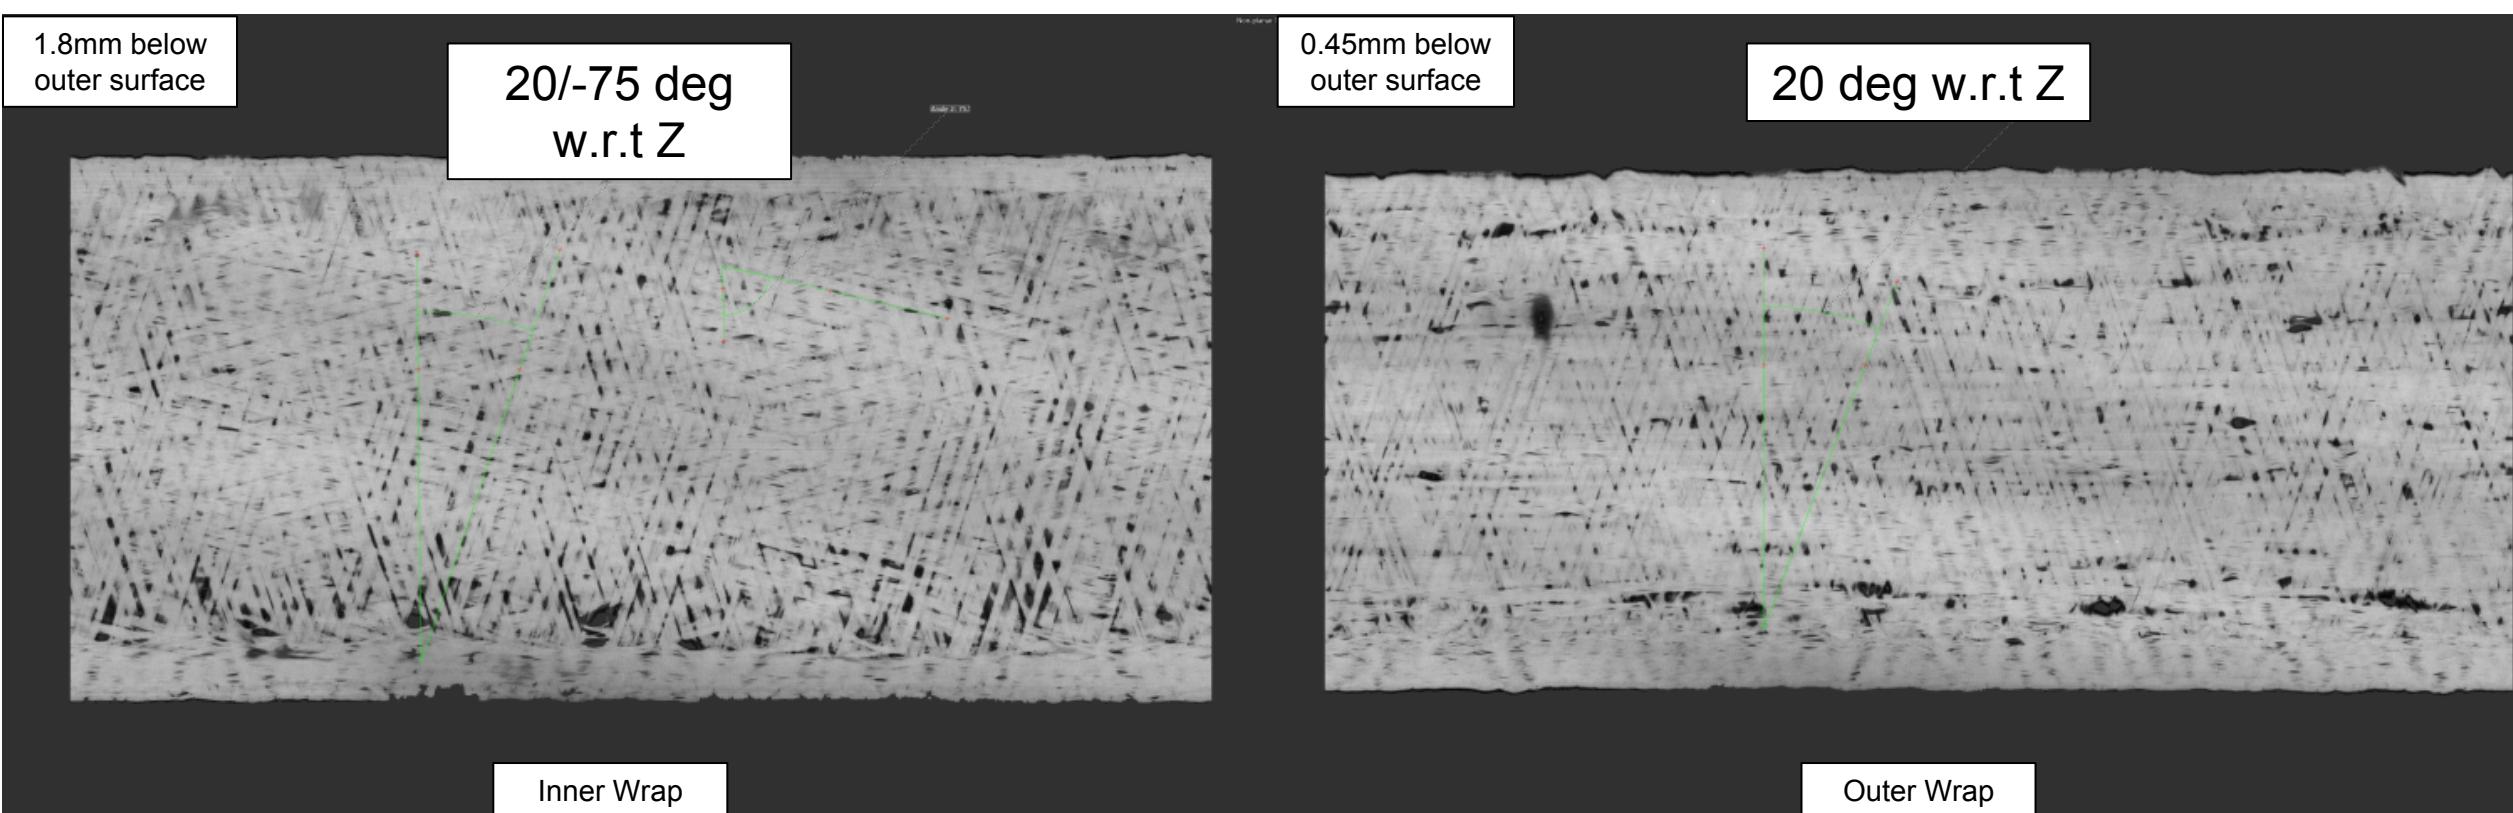
Sample (COPV - 5)

Wrap pattern on inner layers is a 20/75 degree pattern (left), whereas it moves to just a 20 degree pattern on the outer layers (right).

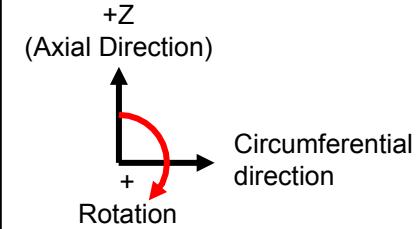
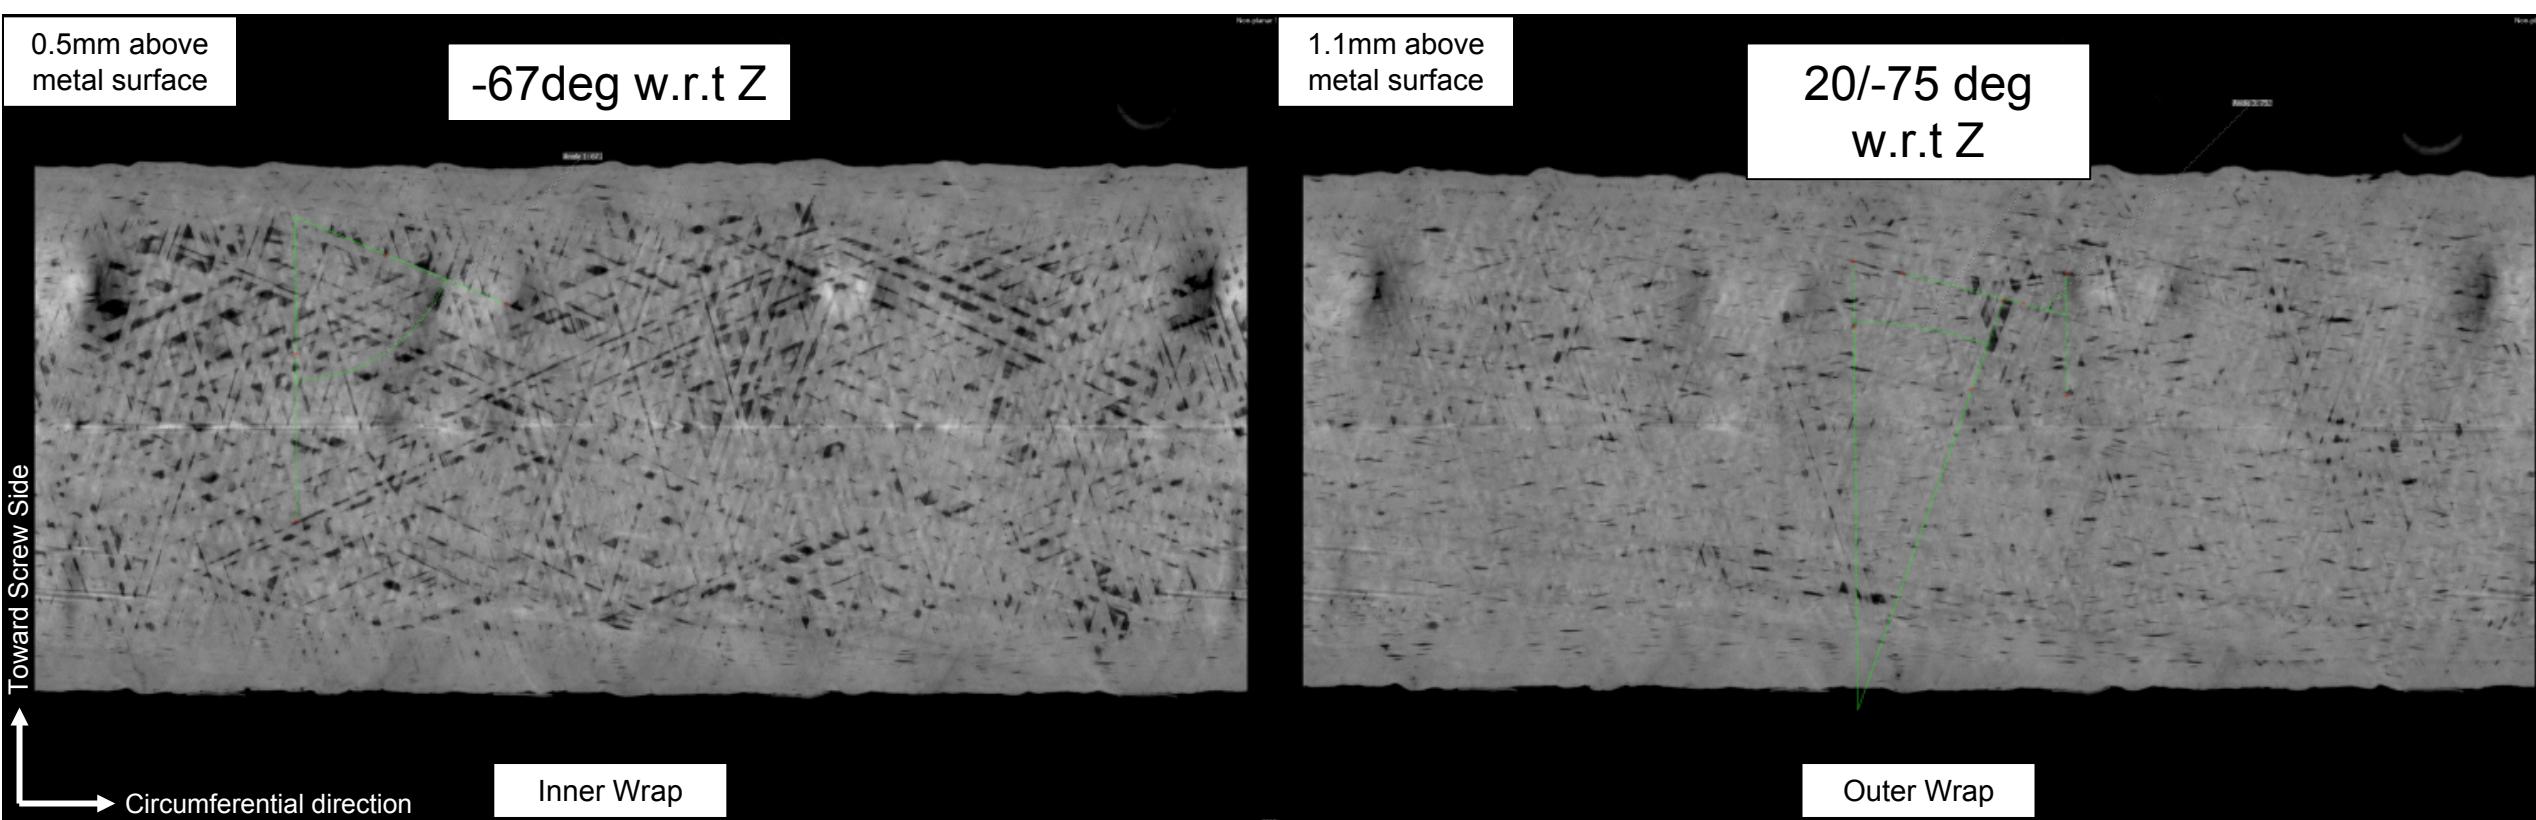
Sample (COPV - 6)

Wrap pattern on inner layers is -67 degree pattern (left), whereas it moves to a 20-75 degree pattern on the outer layers (right).

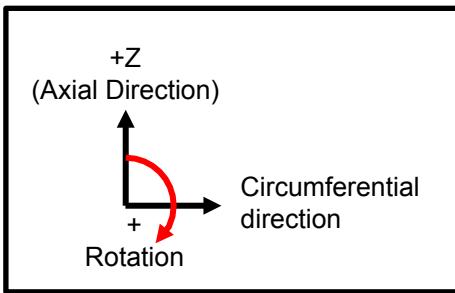
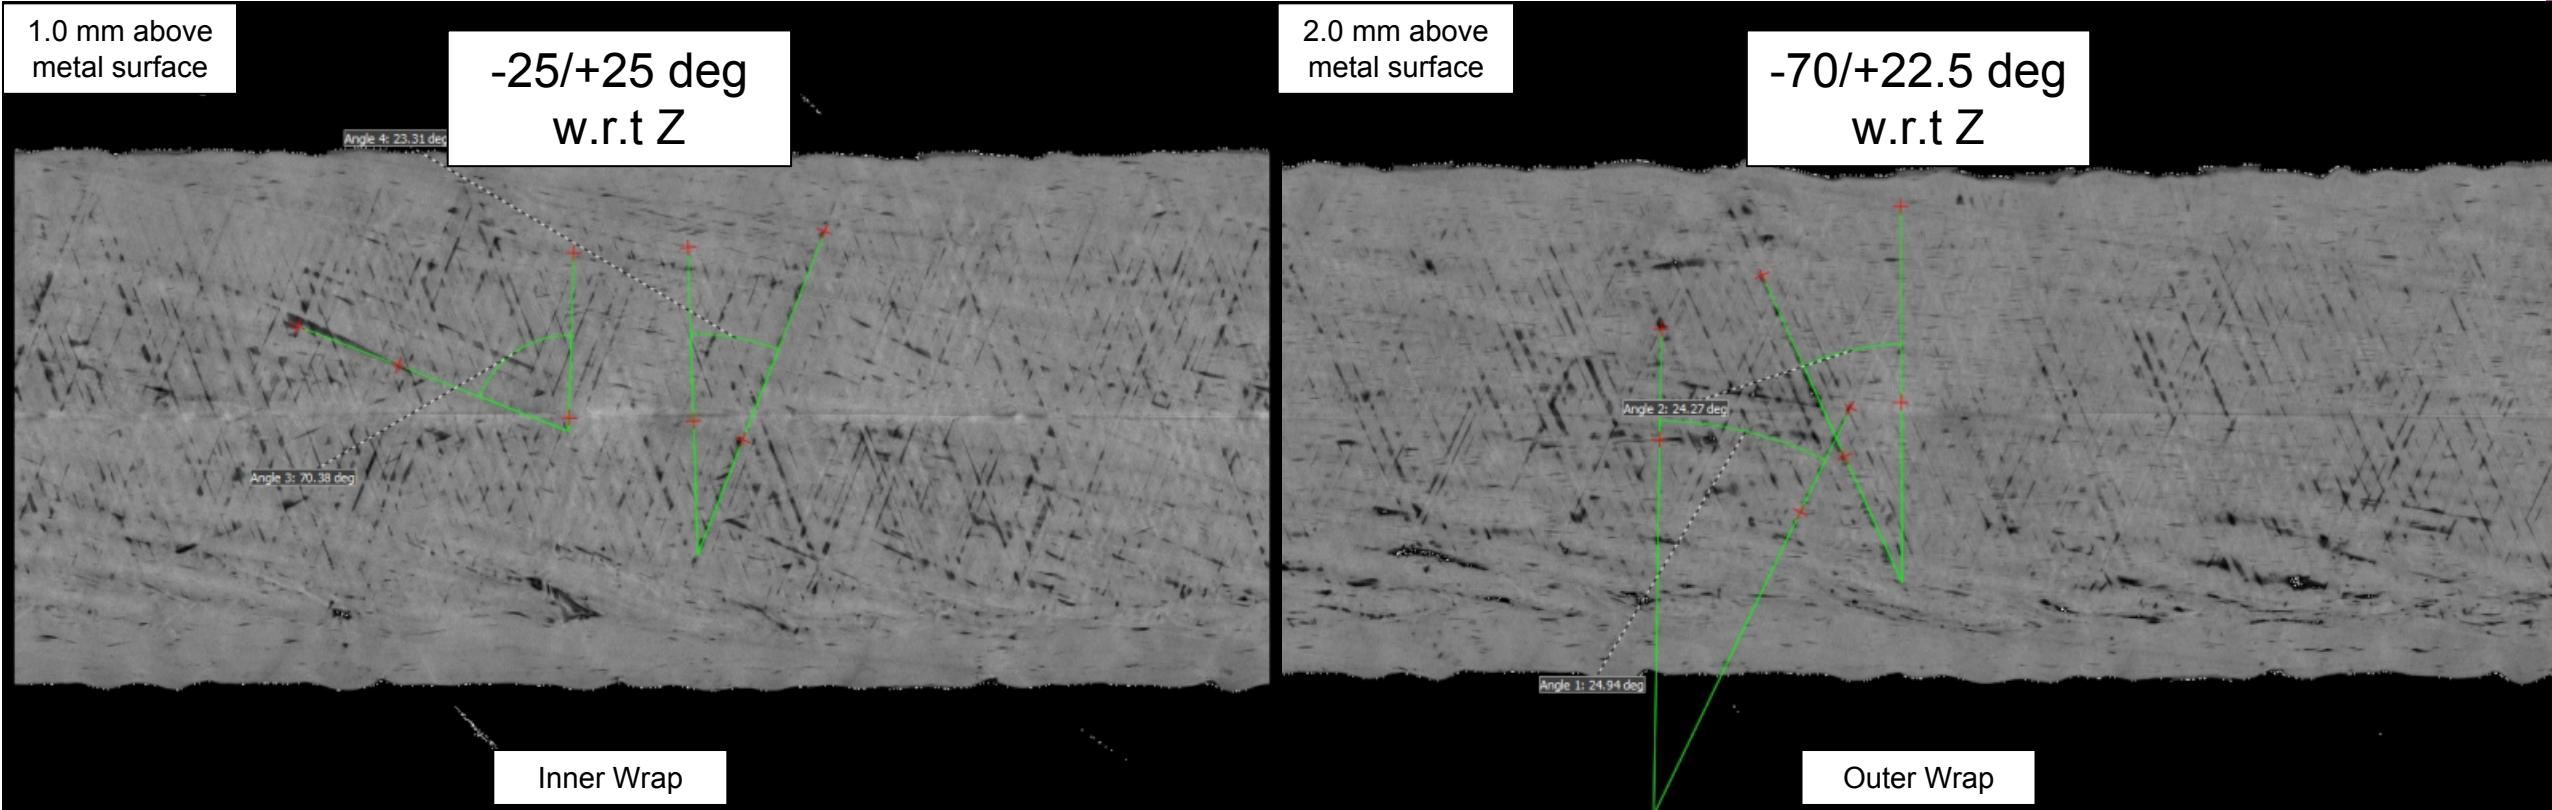
Sample (COPV - 7)

Wrap pattern on inner layers is a $-25/+25$ degree pattern (left), whereas it moves to just a $-70/+22.5$ degree pattern on the outer layers (right).
