Development of a high-temperature and high-pressure electrical feedthrough

Problem statement – 1000°C and 1000 psi

Design and build a small sized electrical feedthrough capable of maintaining hermeticity during and after high temperature and high pressure exposure.

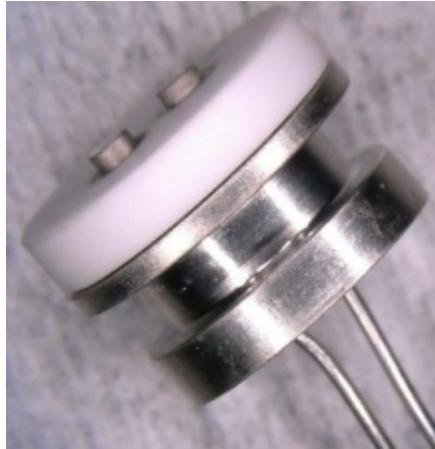
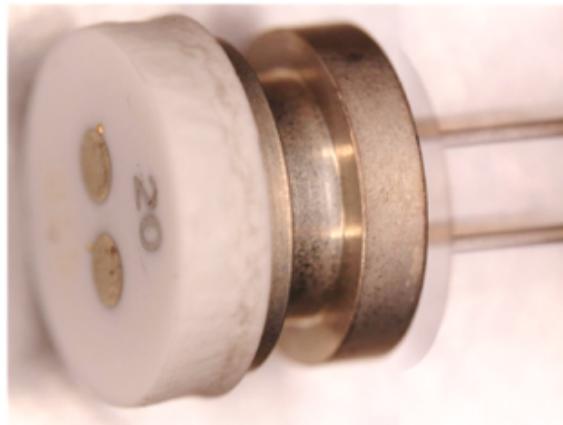
Brazed pins

- Kovar or Ni pins
- Kovar or Ni leads
- Kovar flange
- Ni plate and Non

- Brazes fail due to oxidation: Focus on better braze fit up on pin brazes - thinner brazes.
 - Oxidation appears slower when brazes are thin. Flange braze is thin enough.
- Ni pins better for oxidation than Ni-plated Kovar.
 - 2x Ni plating. Kovar flange before and after brazing.
- Metallization has good adhesion.
- Investigation of Au-based braze alloys to increase oxidation resistance.

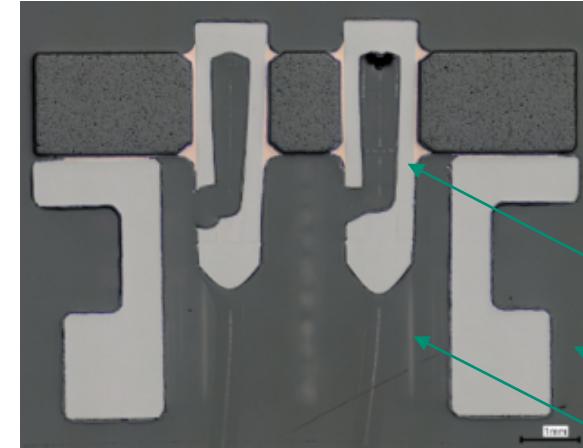
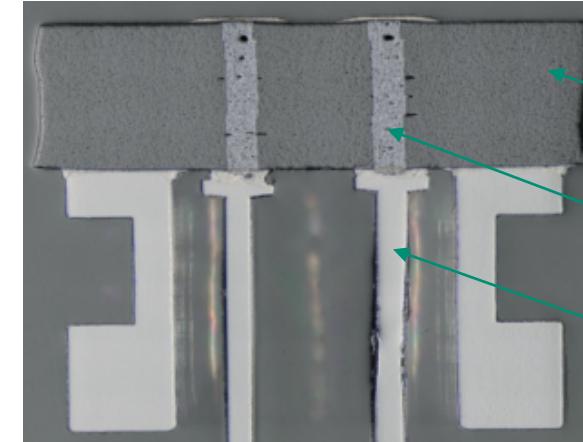
Cermet Vias

- Kovar leads
- Kovar flange
- Ni plated

Optical cross section

- Brazes fail due to cracking of metallization/ceramic interface: Focus on metallization strength.
- Vias are hermetic after high-temperature exposure.
- Improvement needed on lead braze strength.
 - Geometry change to larger lead head in a metallized ceramic blind hole.
- 2x Ni plating. Kovar flange before and after brazing.

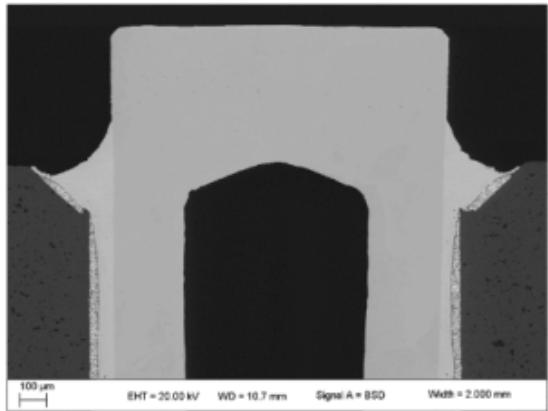
EDX maps of Pin type feedthrough – as manufactured

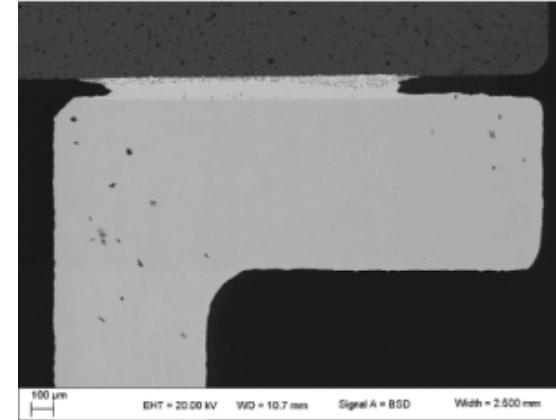
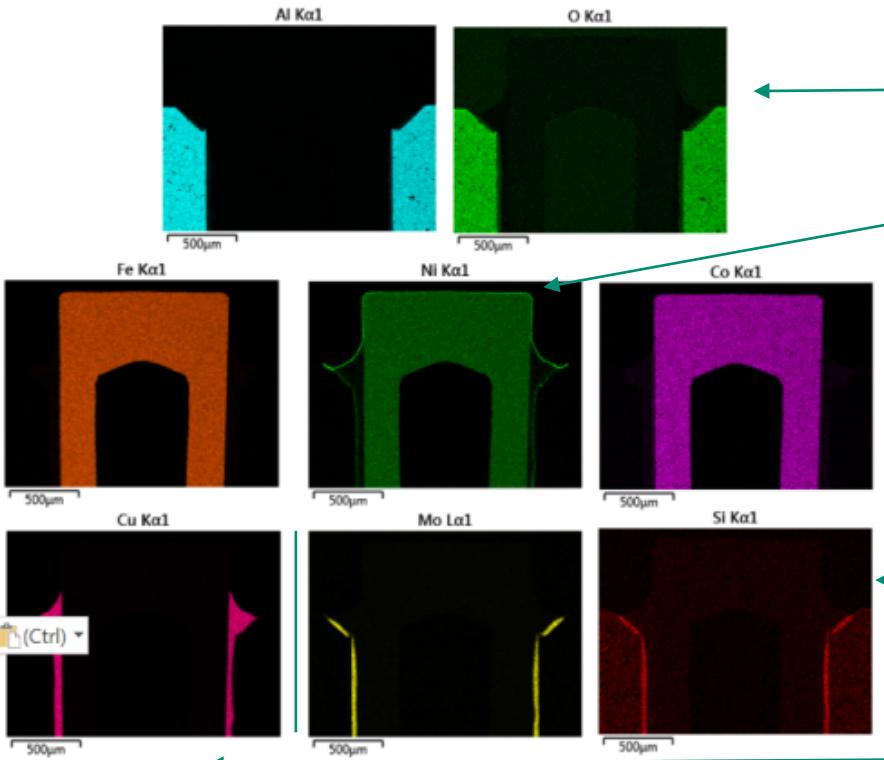
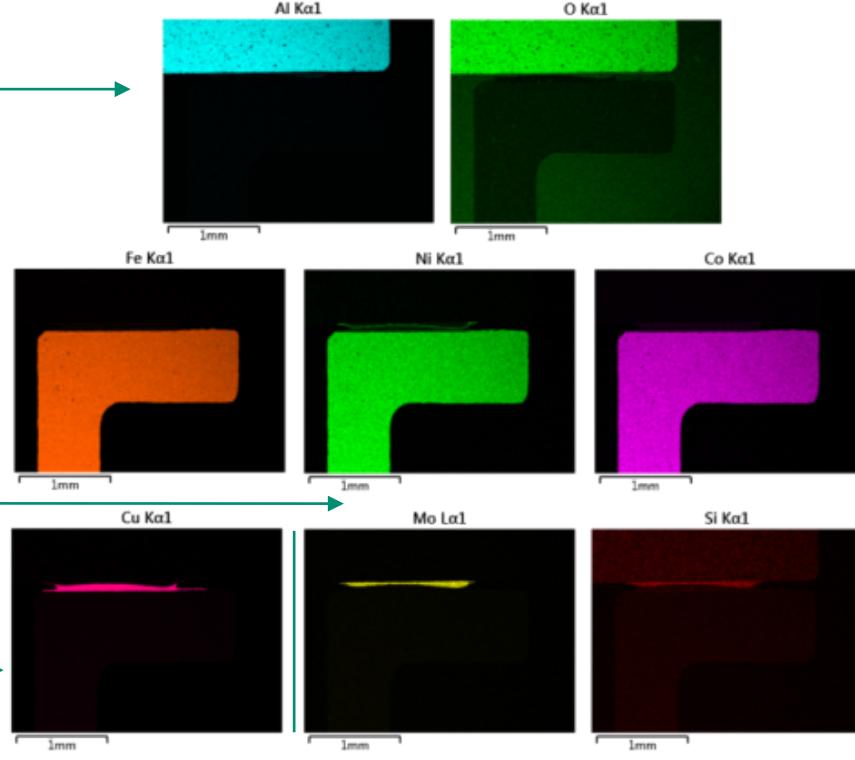
Back scattered
SEM

Alumina Ceramic
Ni-plate
Kovar
Metallization/Cu braze

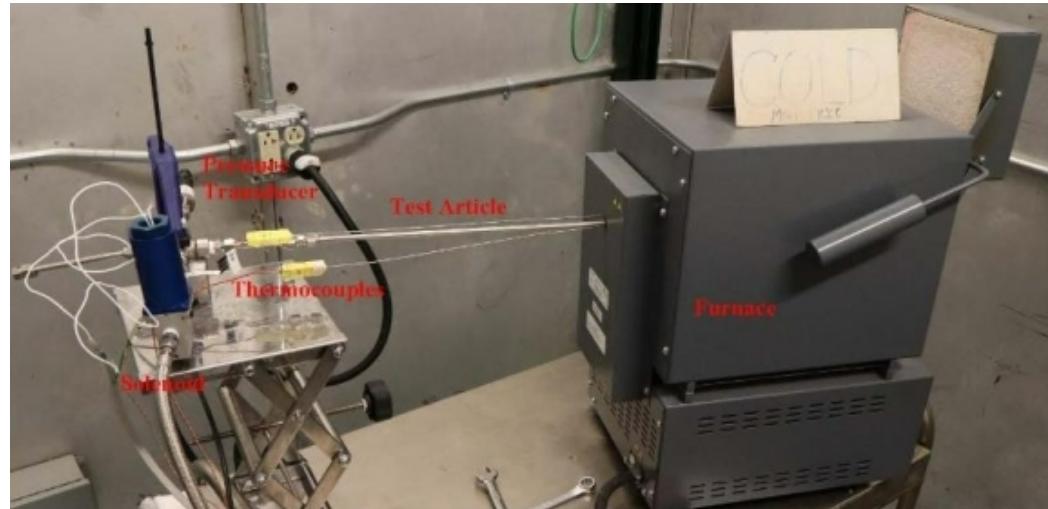
Furnace and pressure experimental setup

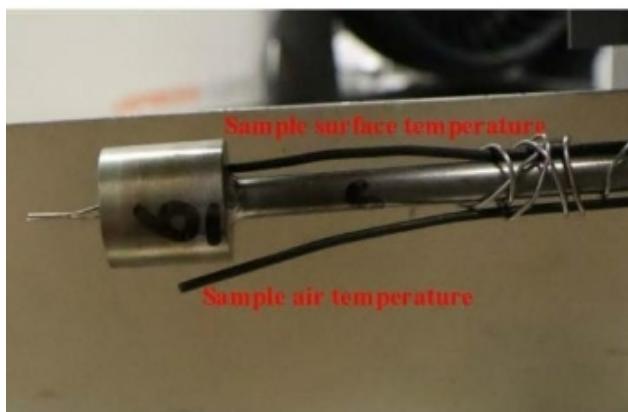
Thermocouple setup

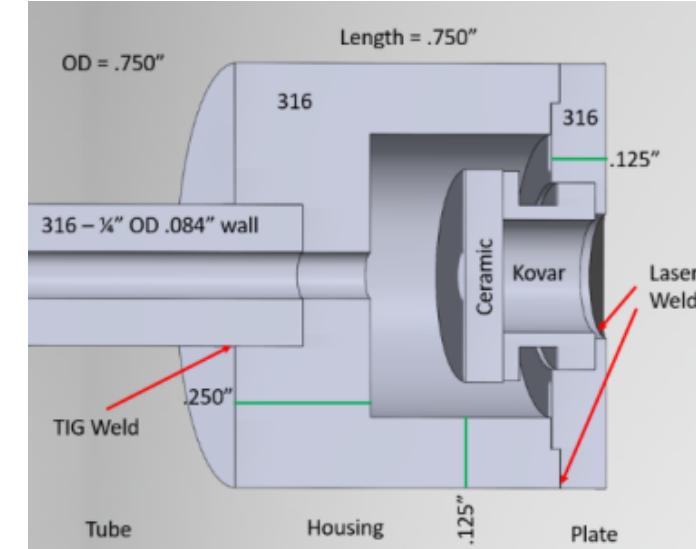
Pressure test housing design & first round failures

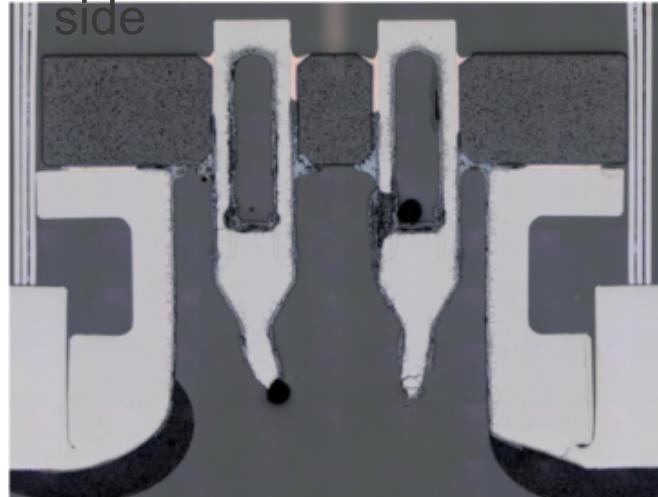
Pin type – after high temperature and pressure

High pressure - Inert gas

Oxidation side

Cu braze
material still
present and
NDL (no
detectable
leak).

Kovar although
Ni plated is still
heavily
oxidized.

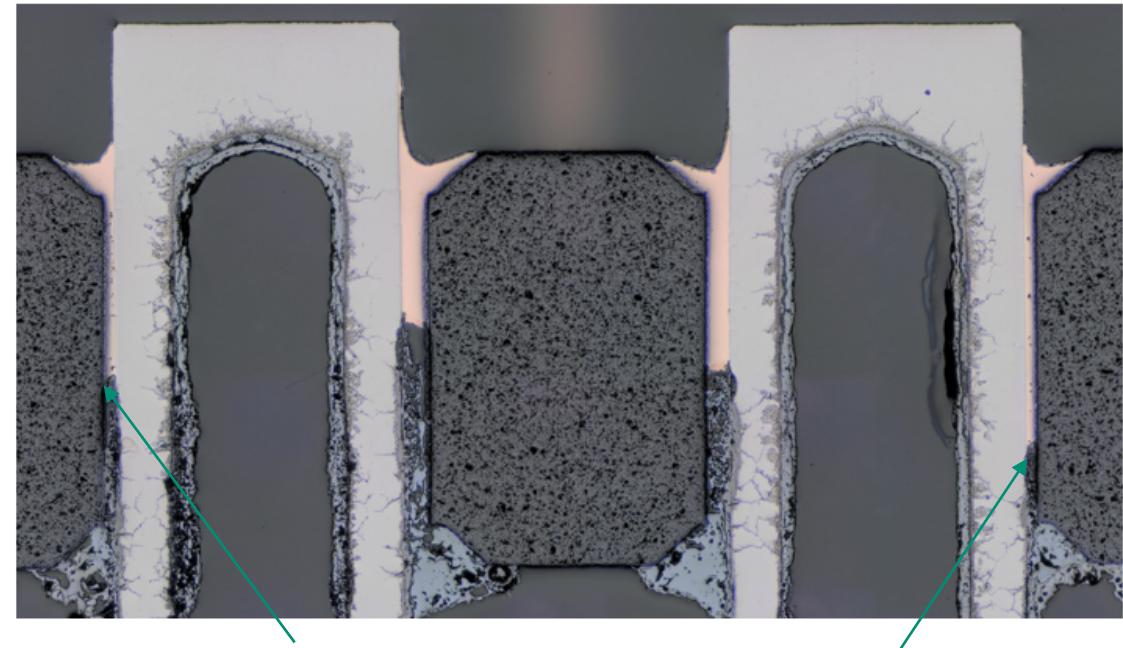
Oxidation is less on thinner side of braze
joint.

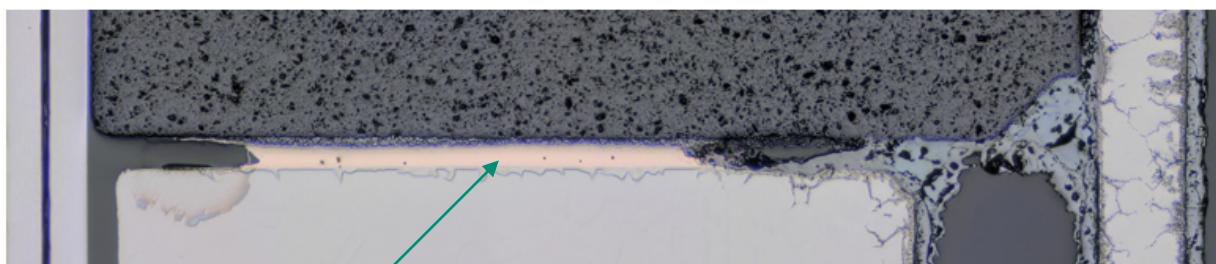
Most of braze material is
present

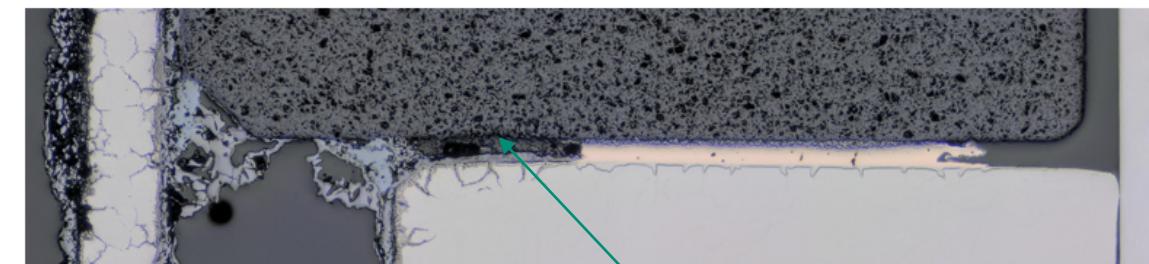
Oxidation side

Metallization removed with braze
alloy

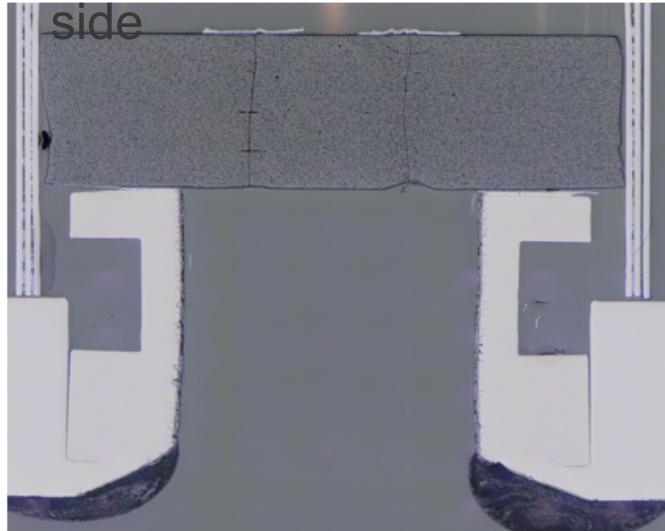
Via type – after high temperature and pressure

High pressure - Inert gas

Oxidation side

Sample exposed to air on both sides.
Minimal oxidation of vias.

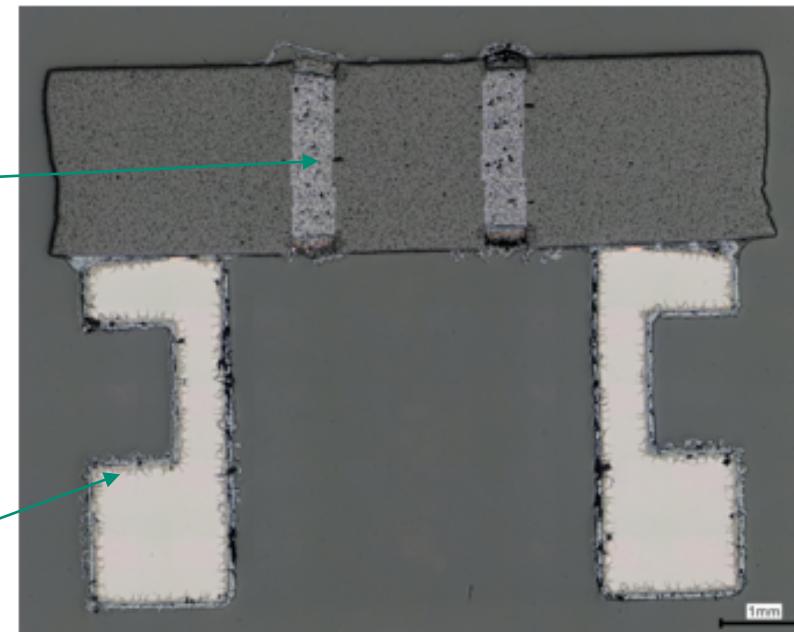
All sample still NDL after exposure.

Heavy oxidation seen on Ni plated Kovar flange.

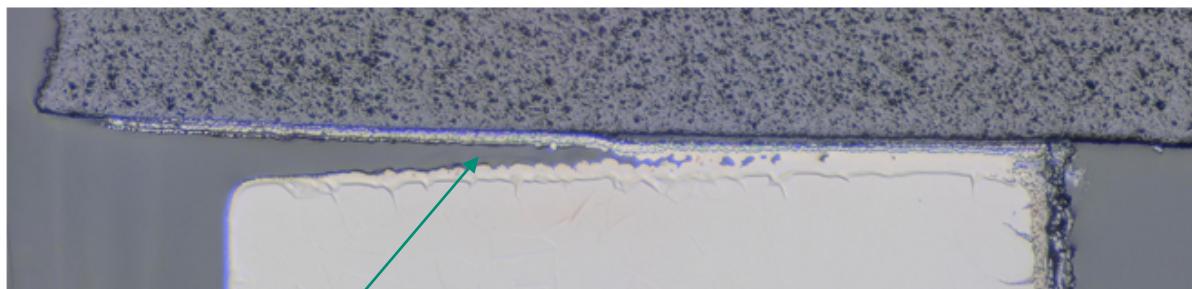
Incomplete braze fill

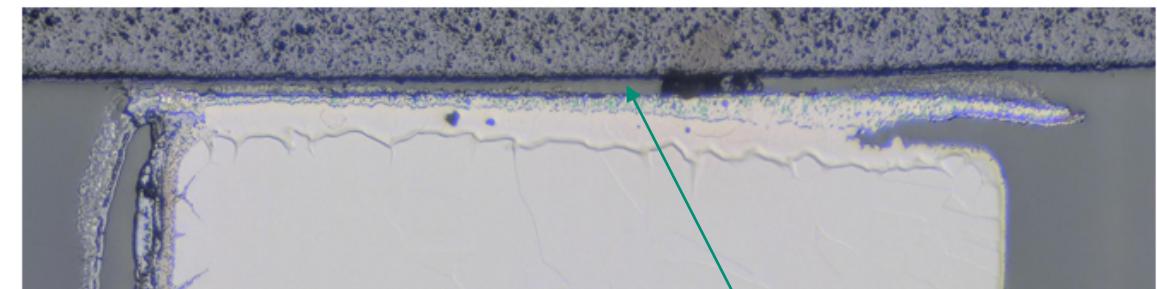
Oxidation side

Failure at metallization/alumina interface

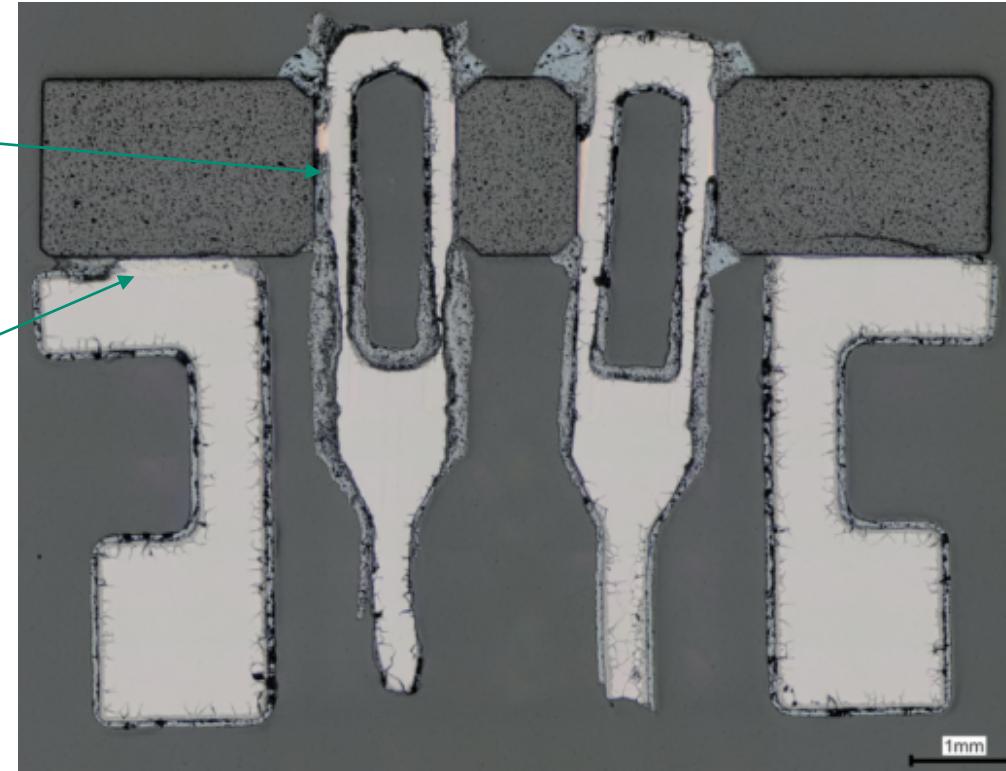
9 | Palniro – air fired both sides exposed

Cu pin braze
◦ Heavily oxidized

Palniro flange braze
◦ Au25Ni25Pd
◦ Minimal oxidation

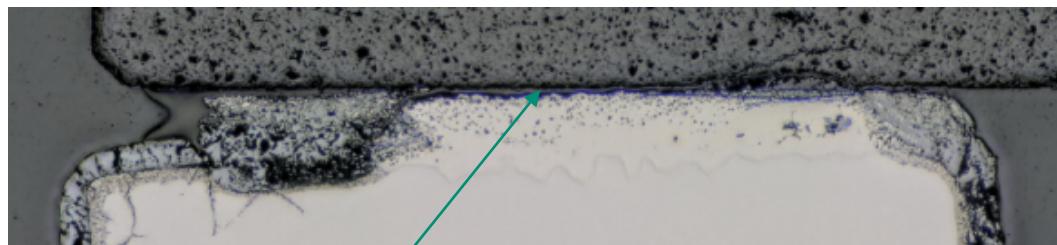
Metallization/Alumina interface
failure

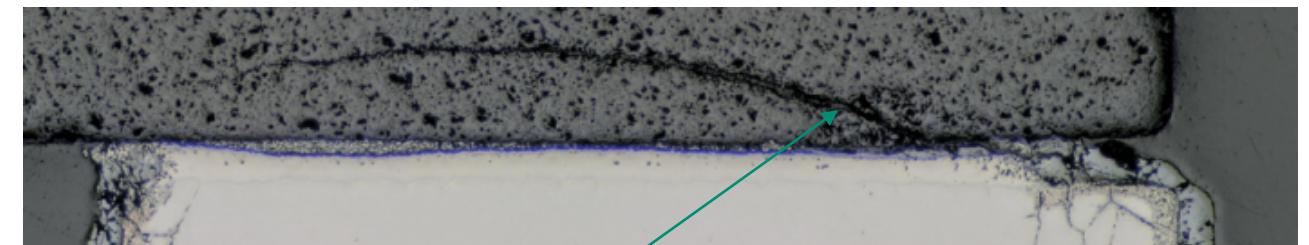
Bulk Alumina
failure
