Morphology and Electrochemistry Drive Corrosion of Electroless Nickel Immersion Gold Films: A Multi-Technique Analysis

Elliott Fowler, Sandia National Labs (NM)

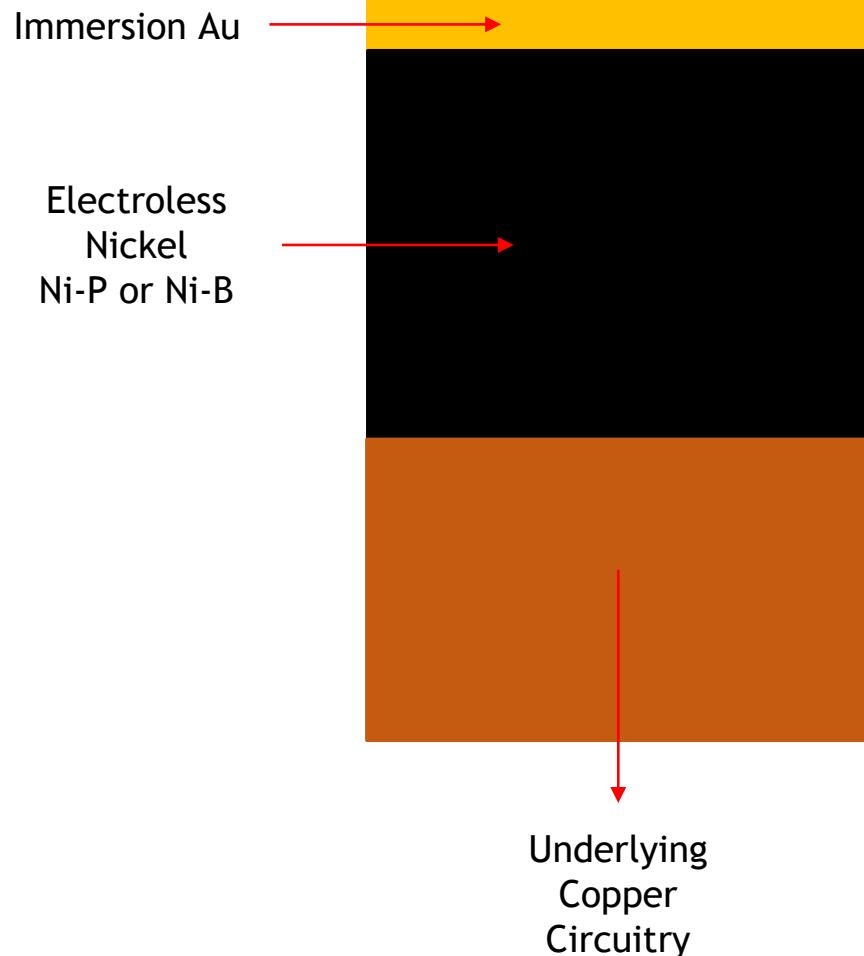
Electroless Nickel Immersion Gold (ENIG)

Enhance solderability to copper pads

Minimize oxidation of base Cu layer

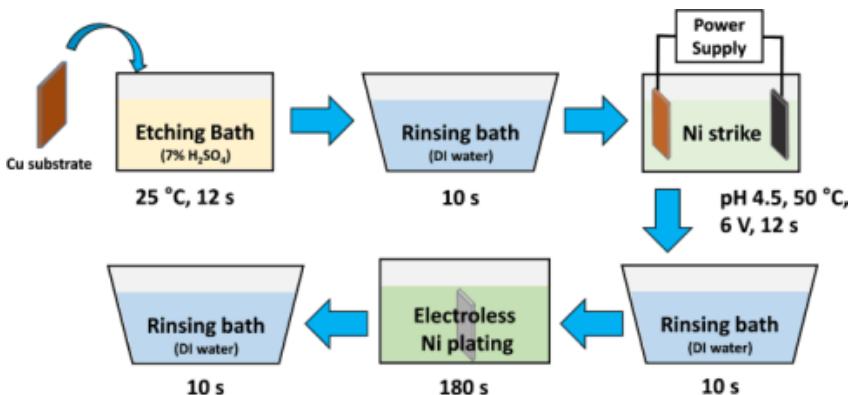
1) Electroless Nickel

Metal salt concentration
 Additive 1 concentration
 Additive 2 concentration
 pH
 Temperature
 Current density
 Agitation

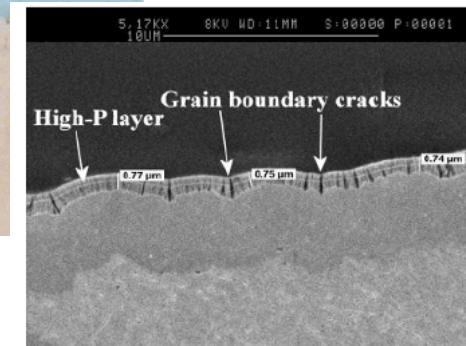
Too Much (or Too Little) Phos.

Galvanic Hyper-Corrosion of Ni(P)

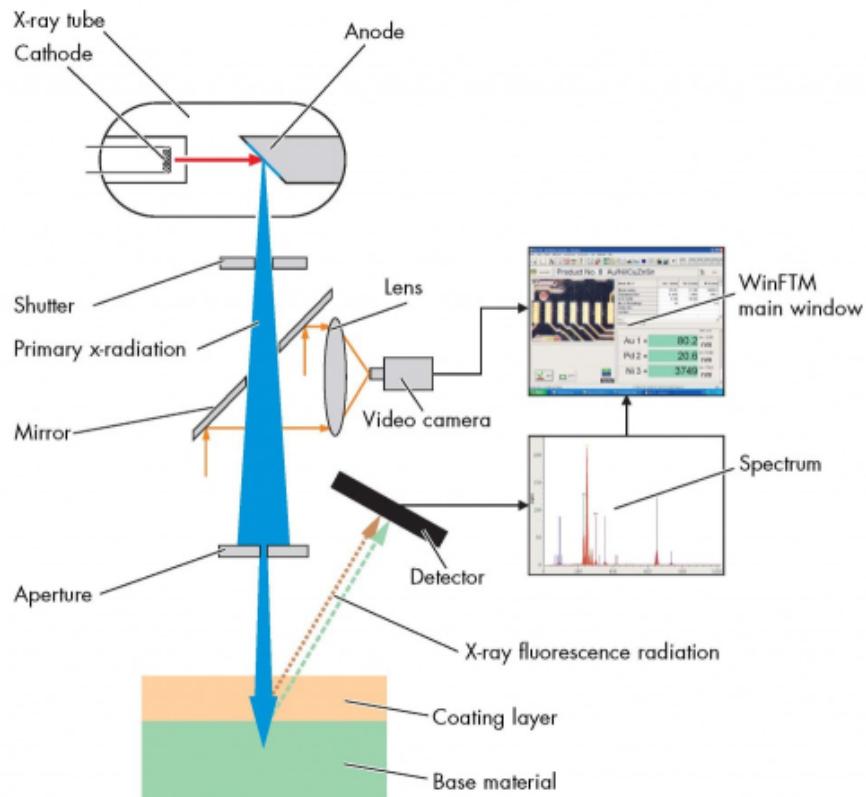
X-Ray Fluorescence (XRF) Spectroscopy

Chemical speciation, some structural information

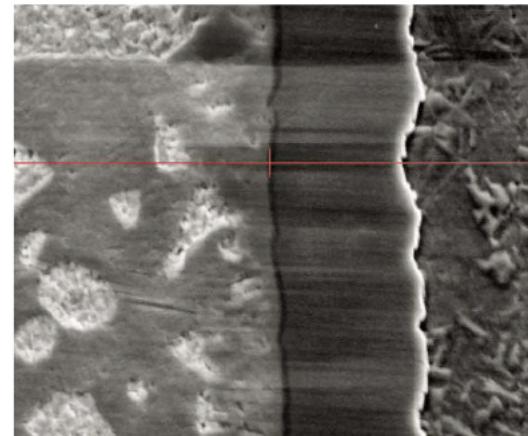
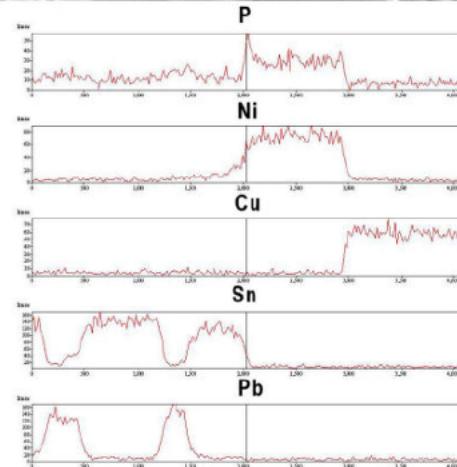
FIB Section and SEM/EDS

Low-quality chemical speciation, high-quality structural information

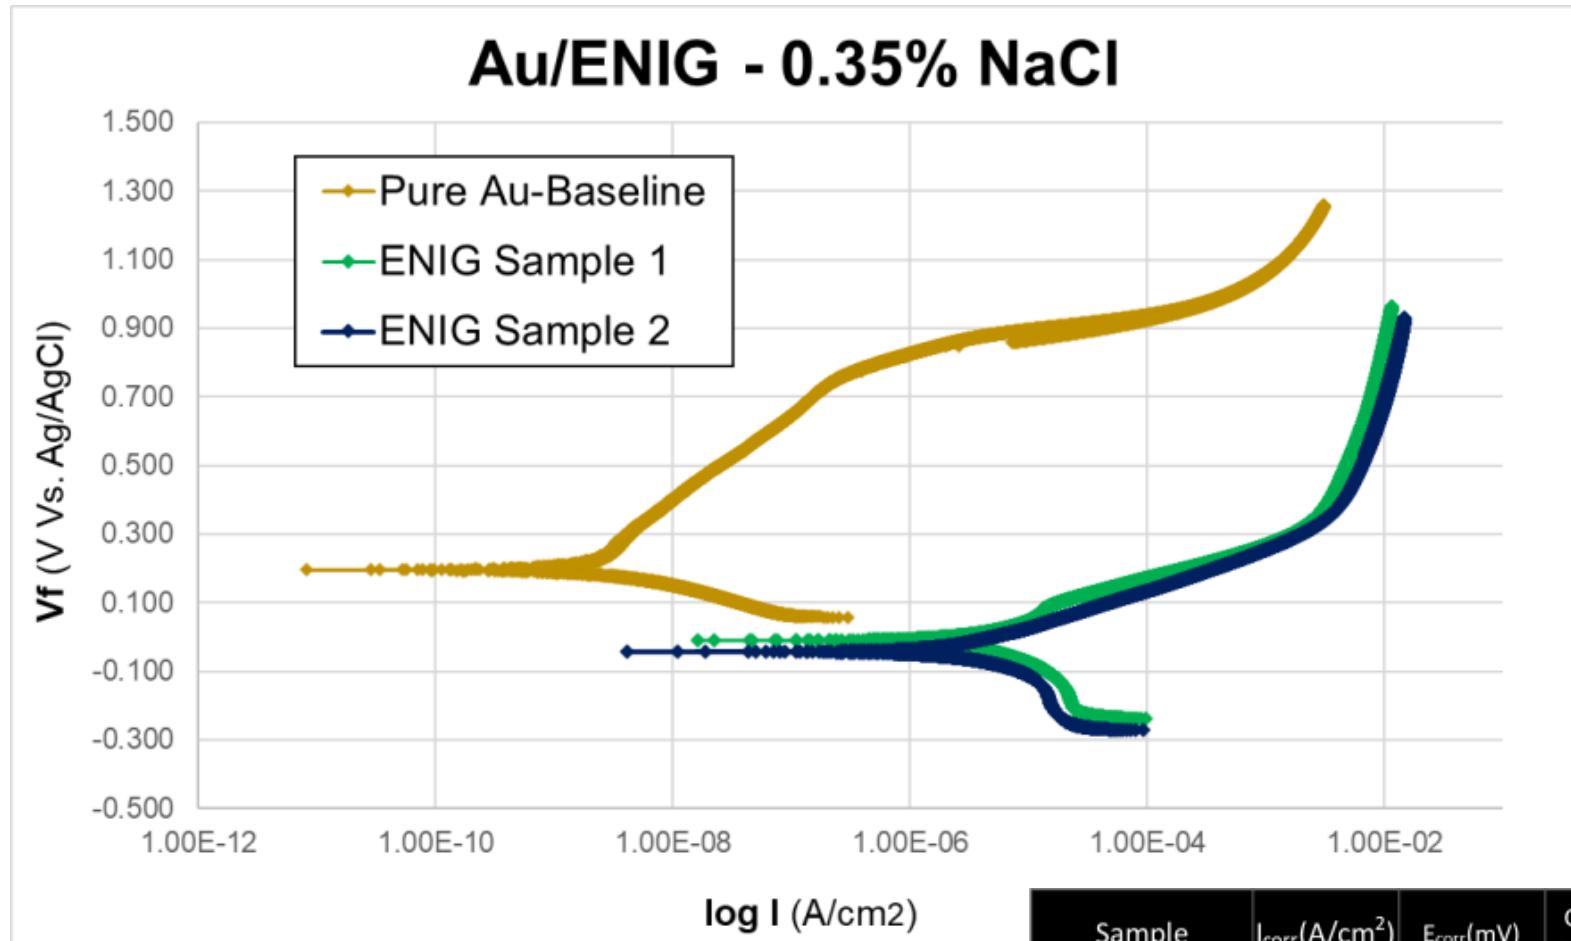
Results (Cyclic Polarization)

Vendor Samples Have Similar Passivity (or lack thereof)

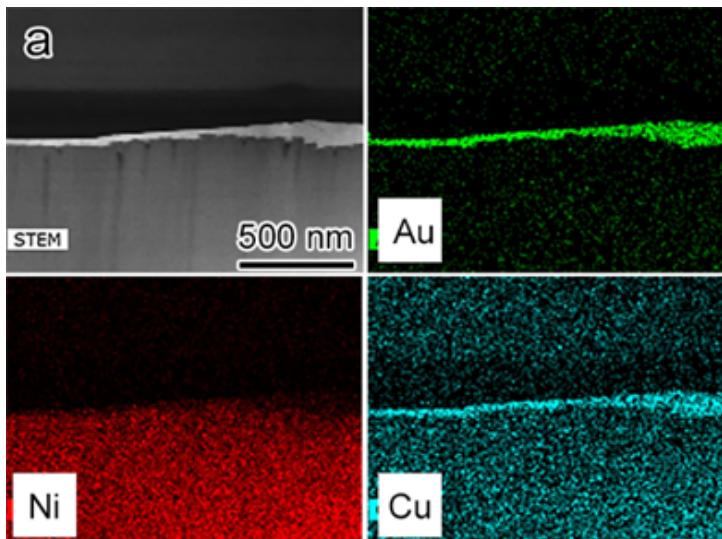
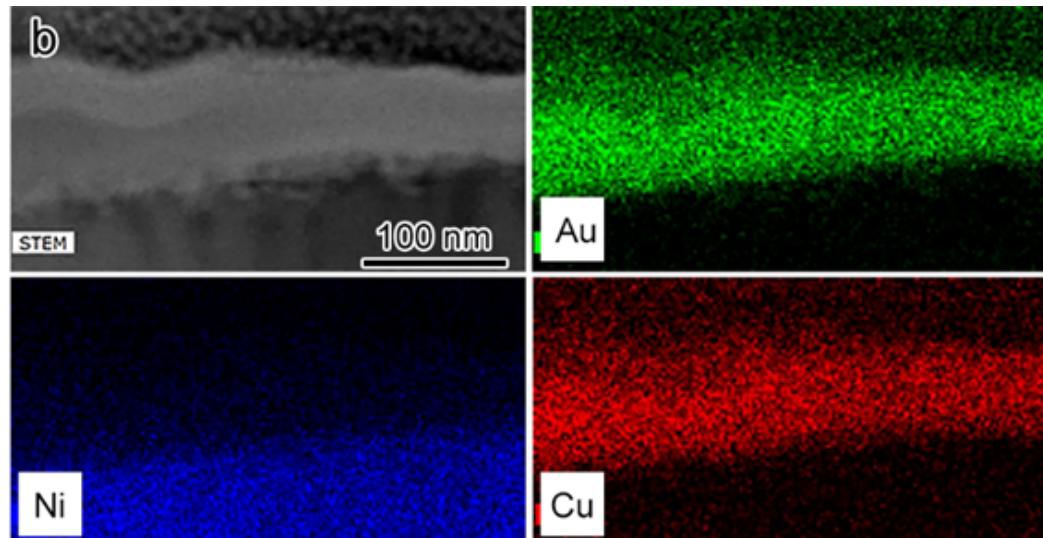
Results (Scanning/Transmission Electron Microscopies)

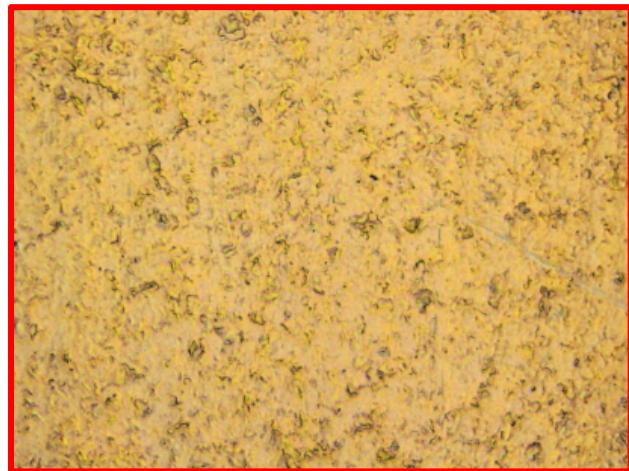
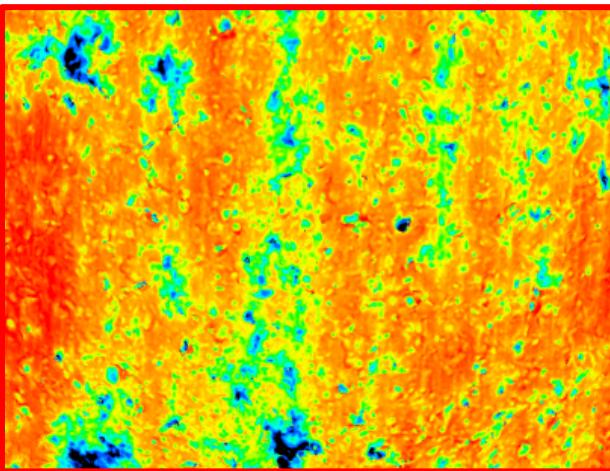
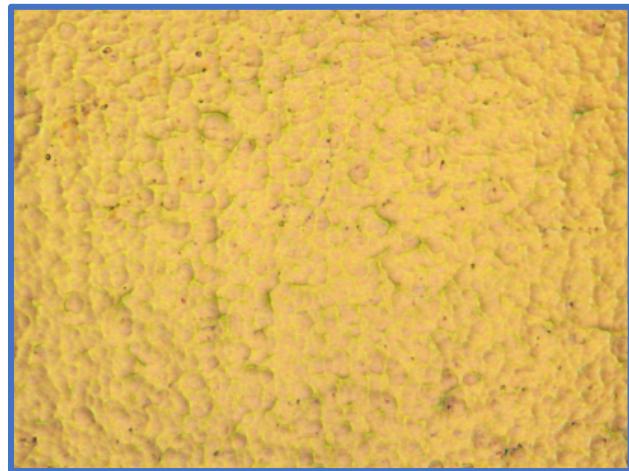
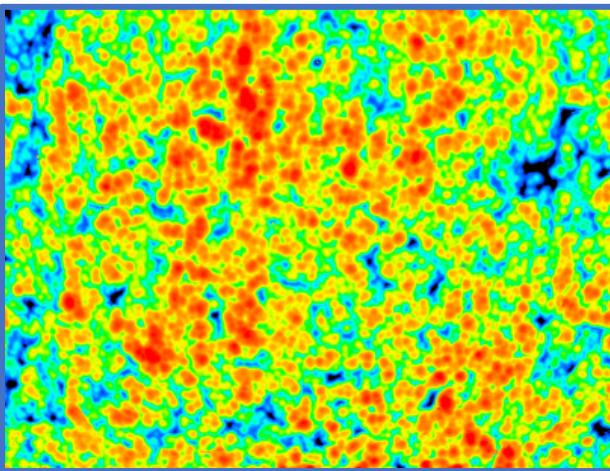
Aside - Surface Topology (Laser Scanning Confocal Microscopy)

← 272 μm →

Vendor Samples Have Similar Morphological Defects and Contaminant Chemistry, Different Roughnesses

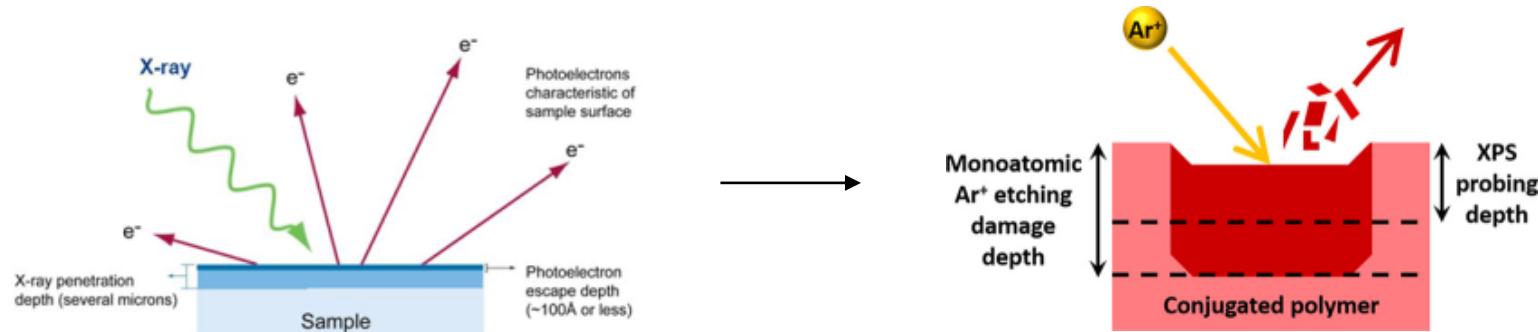
Results (X-Ray Photoelectron Spectroscopy)

Sample Identifier (Vendor, Spot, Sputter Cycle)	Au 4f %	C 1s %	Cu 2p %	Ni 2p %	O 1s %	P 2p %
Vendor A 1.1	37.88	42.53	3.01	1.26	13.86	1.46
Vendor A 1.2	82.62	10.06	2.56	2.46	2.30	0.00
Vendor A 2.1	50.73	28.21	5.23	0.84	12.40	2.60
Vendor A 2.2	86.63	6.81	2.81	2.24	1.51	0.00
Vendor B 1.1	23.35	48.44	0.56	2.47	24.19	1.00
Vendor B 1.2	98.36	0.00	0.00	1.64	0.00	0.00
Vendor B 2.1	22.71	50.70	0.45	2.38	21.55	2.23
Vendor B 2.2	99.47	0.00	0.00	0.53	0.00	0.00

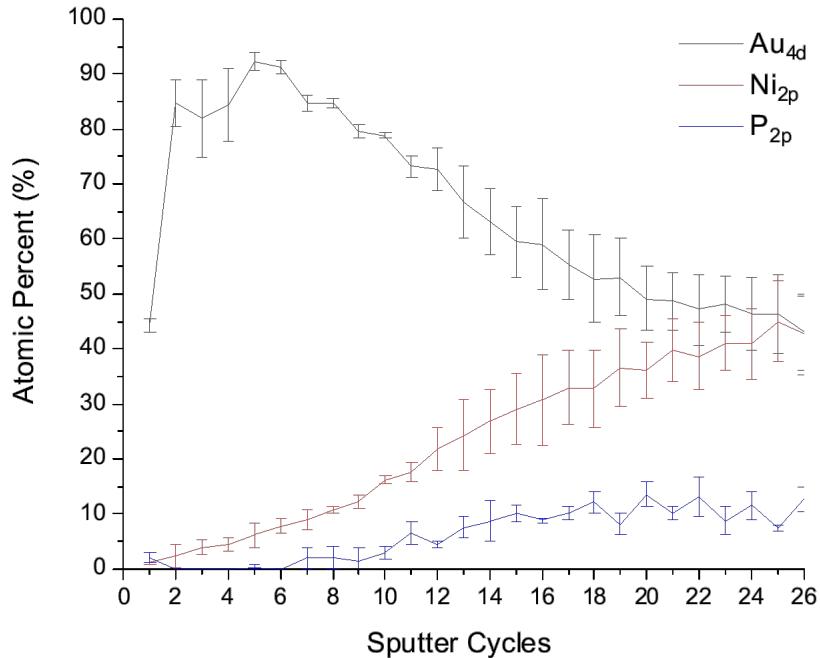
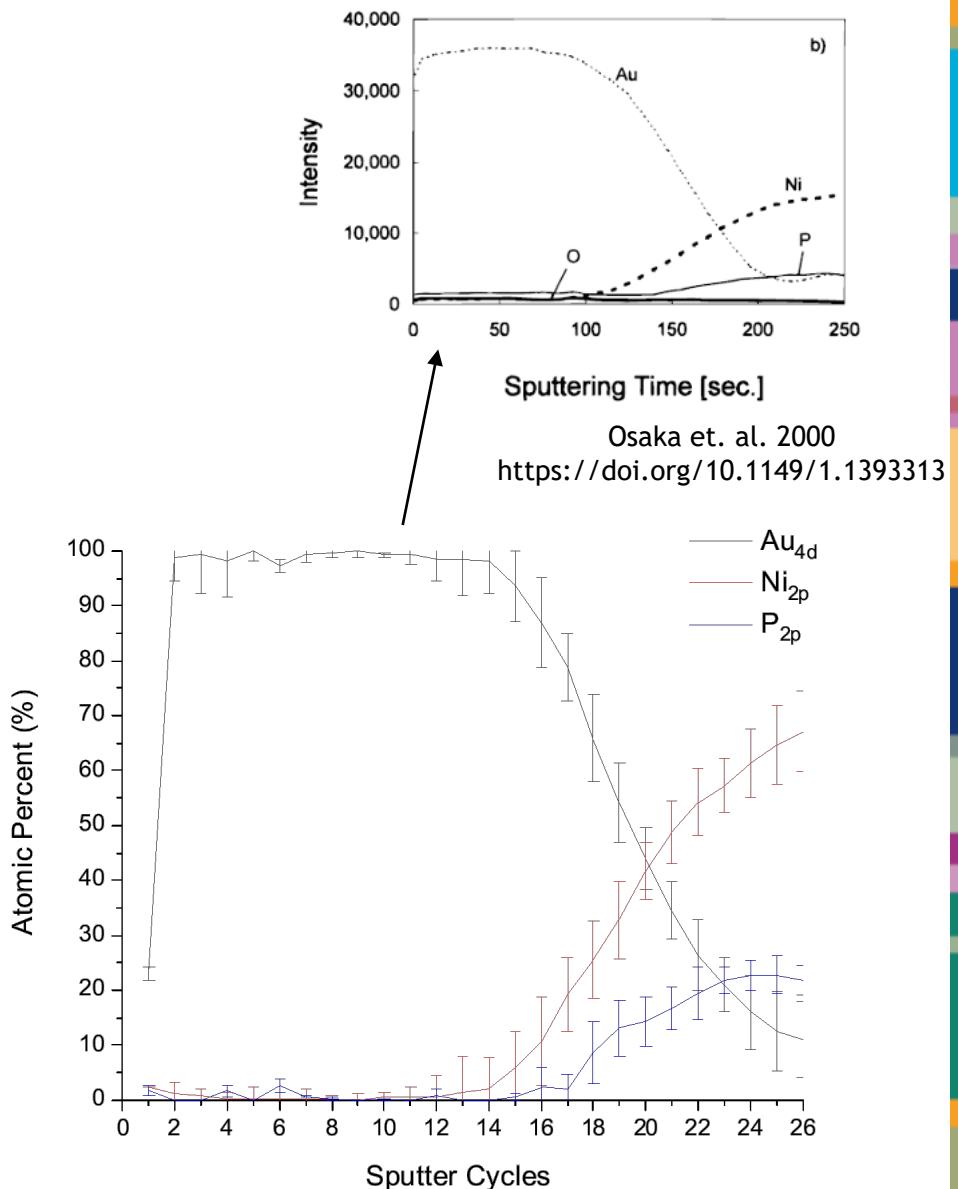
Results (X-Ray Photoelectron Spectroscopy Depth Profiling)

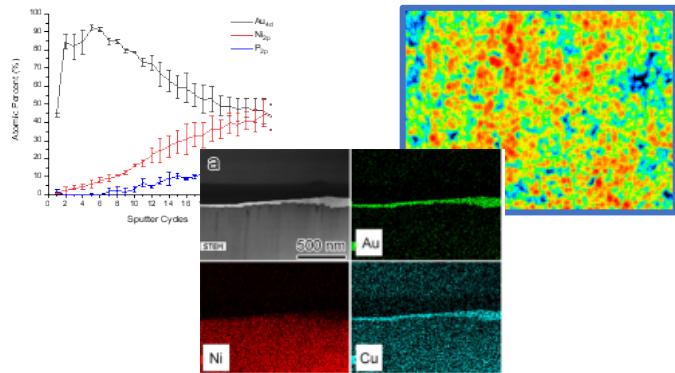
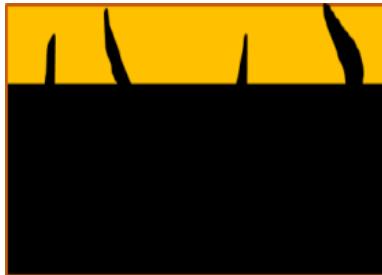
Vendor A

Poorly controlled plating conditions led to high Au porosity, susceptibility to Ni hyper corrosion in sol'n

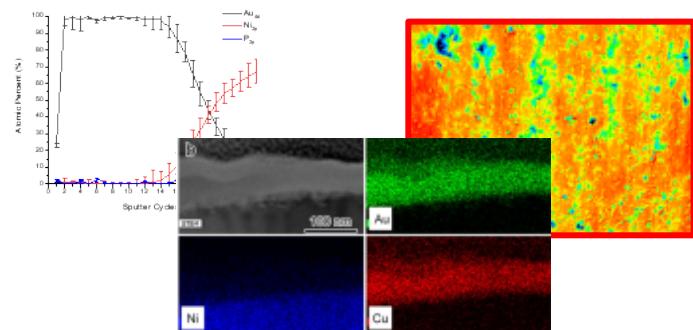
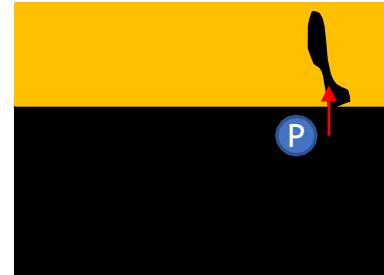
Vendor B

More ideal Au plating conditions, but choice of bath additives may have led to P-enrichment at Ni-Au interface, reducing film passivity

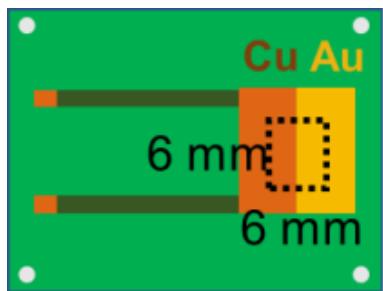
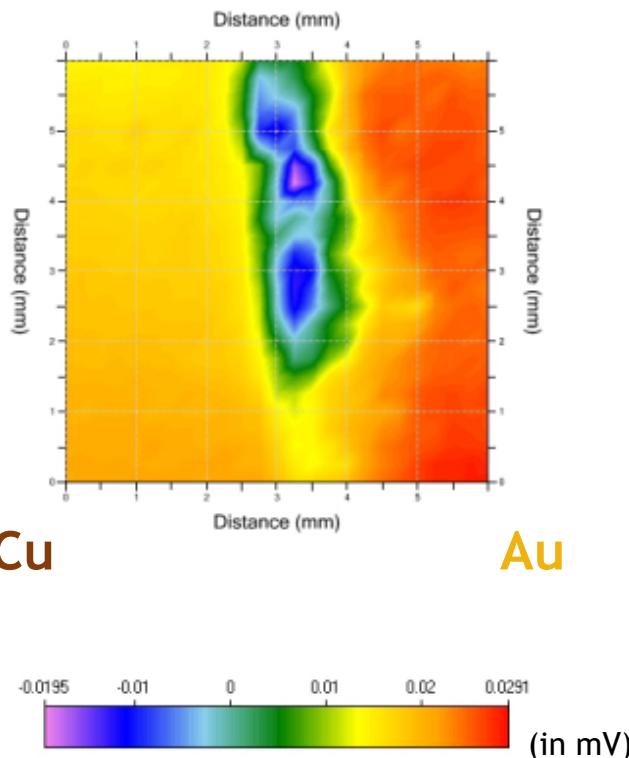
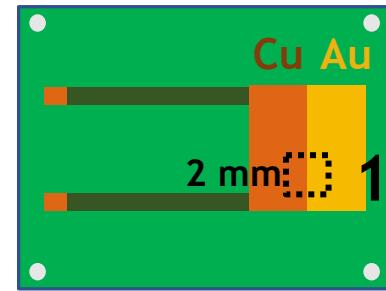
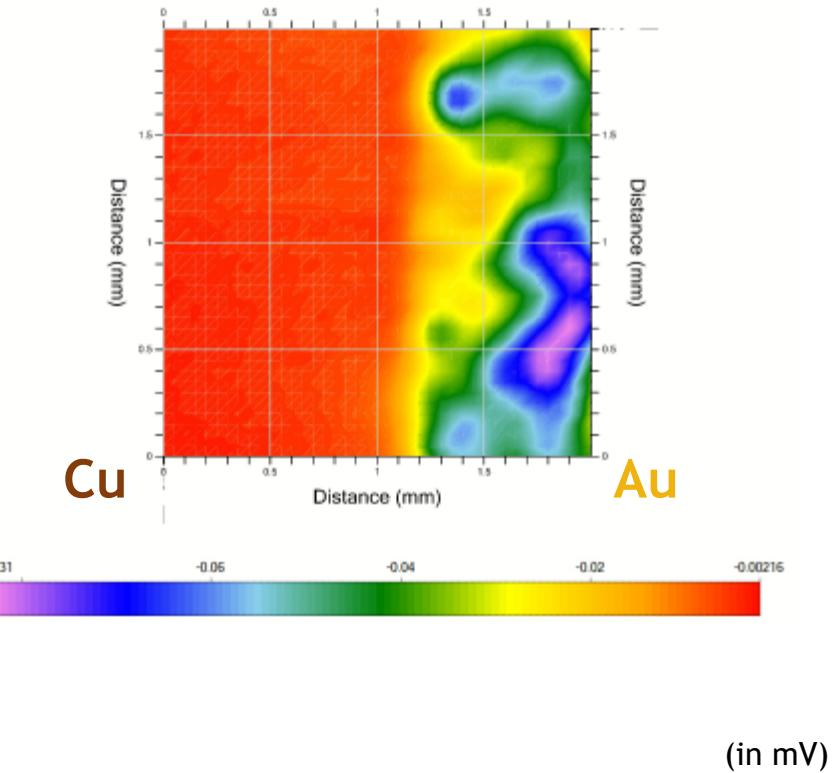
Results (Scanning Vibrating Electrode Technique)

Vendor Samples Have Clearly Different Heterogeneity / Porosity
