Sandia National Laboratories

Impact of Relative Humidity and Salt Loading Densities on the Localized Corrosion Behavior of Additively Manufactured and Wrought Stainless Steels

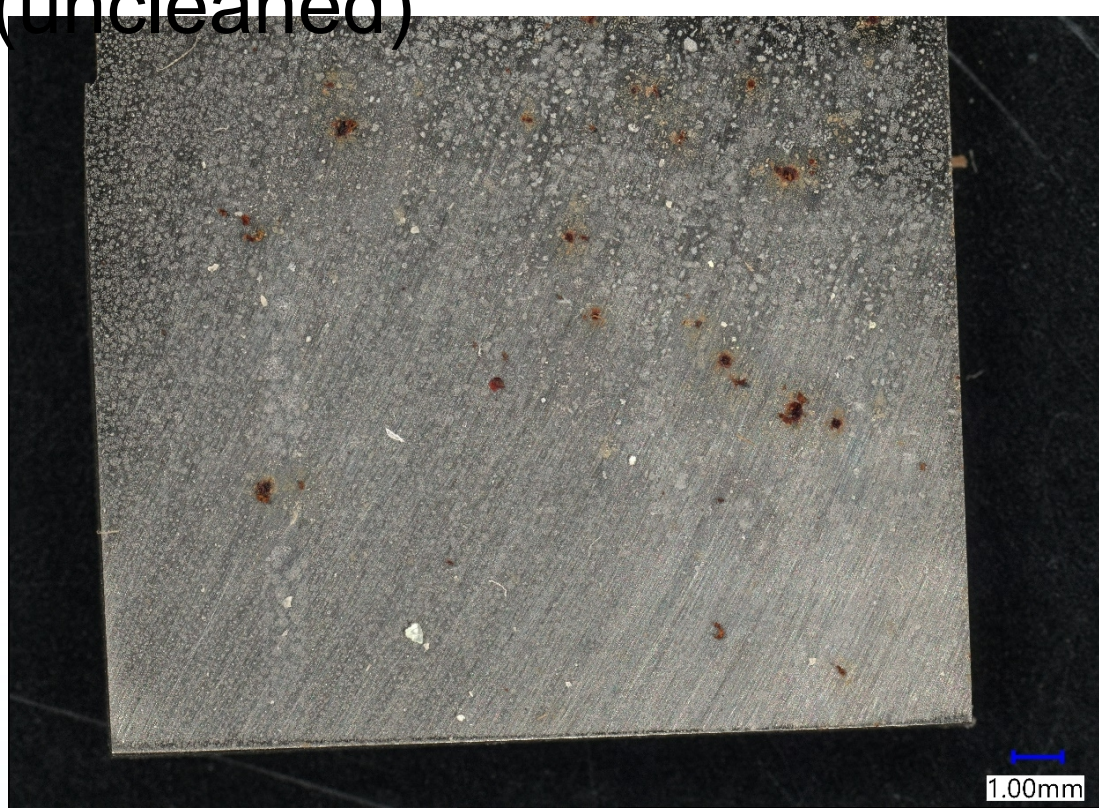
LB-PBF 316L

Samples were then cleaned with dilute Nitric acid solution to remove any corrosion product. Immediately before measuring, samples were wiped once more with water and a wetted Politex polishing cloth to remove dust, etc.

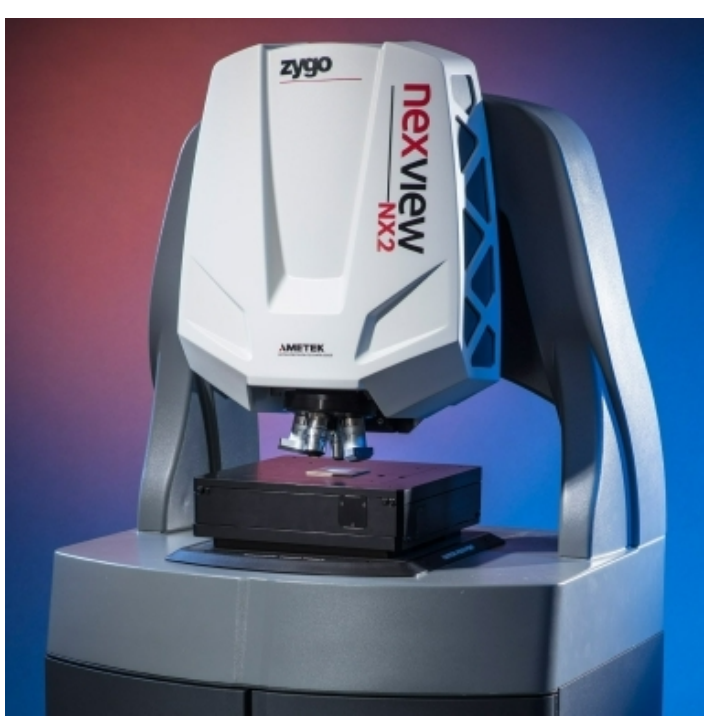
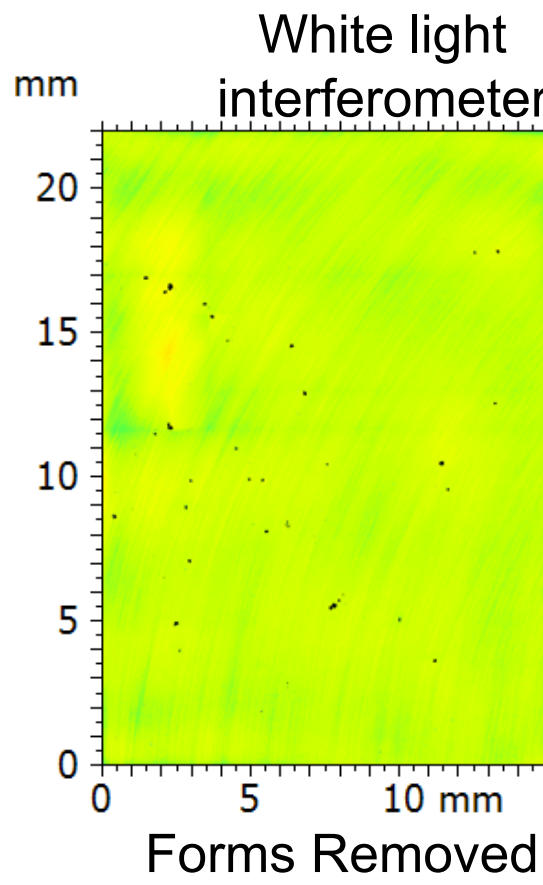
Zygo/ Mountain Maps Process

- Extracted area used to minimize edge effects.
- Surface is smoothed using a polynomial multi-form removal.
- Non-measured points are filled in and measurement is mirrored in the z-axis to convert pit depth into height
- Particle Analysis performed on the surface with a planar threshold at 0.5 μm.

This study quantified pitting severity using MountainsMap software followed by spatial filtering parameters. The method we developed measures and analyzes pitting across entire sample surfaces while also removing most false pits.
