Sandia
National
Laboratories

Characterization of Heterogeneity and Mechanical Properties of SiC-SiC Composites

Presenter: James Nance

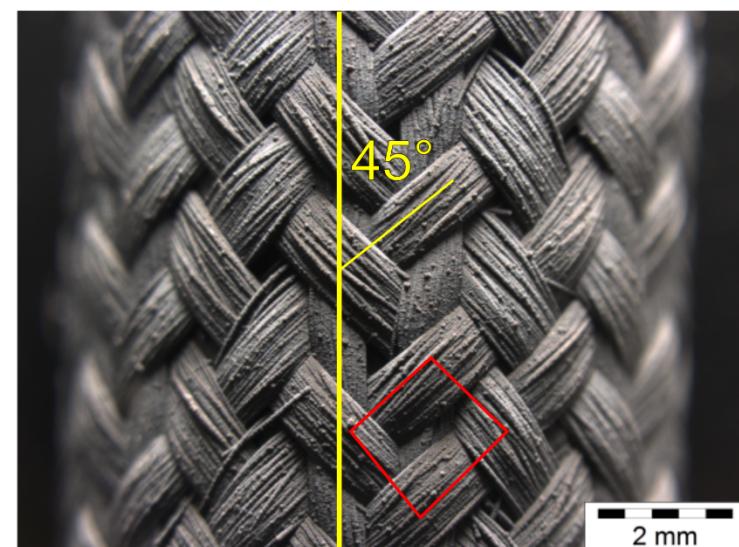
Mechanical Testing - Architectures

45° 2-ply
biaxial

45° 3-ply
biaxial

60° 2-ply
biaxial

45° 2-ply
triaxial

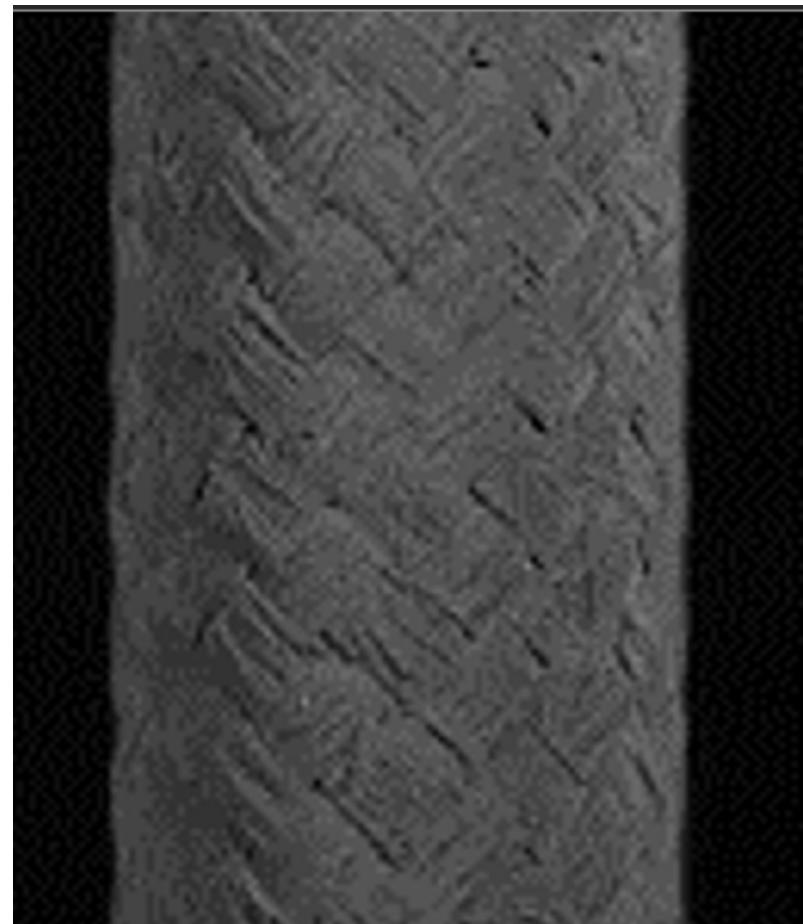
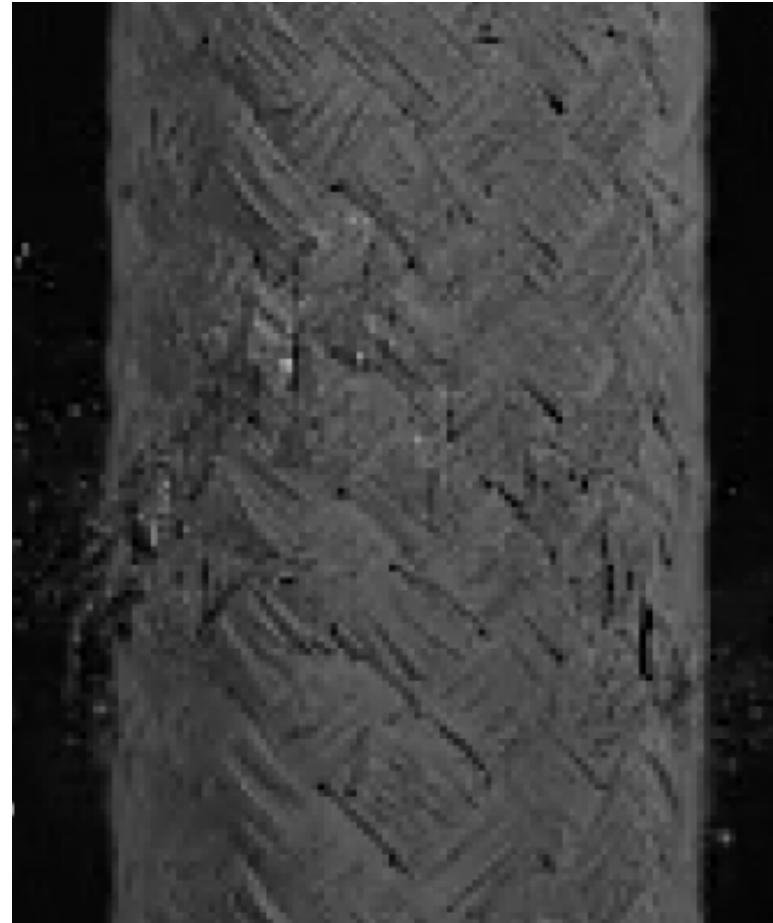
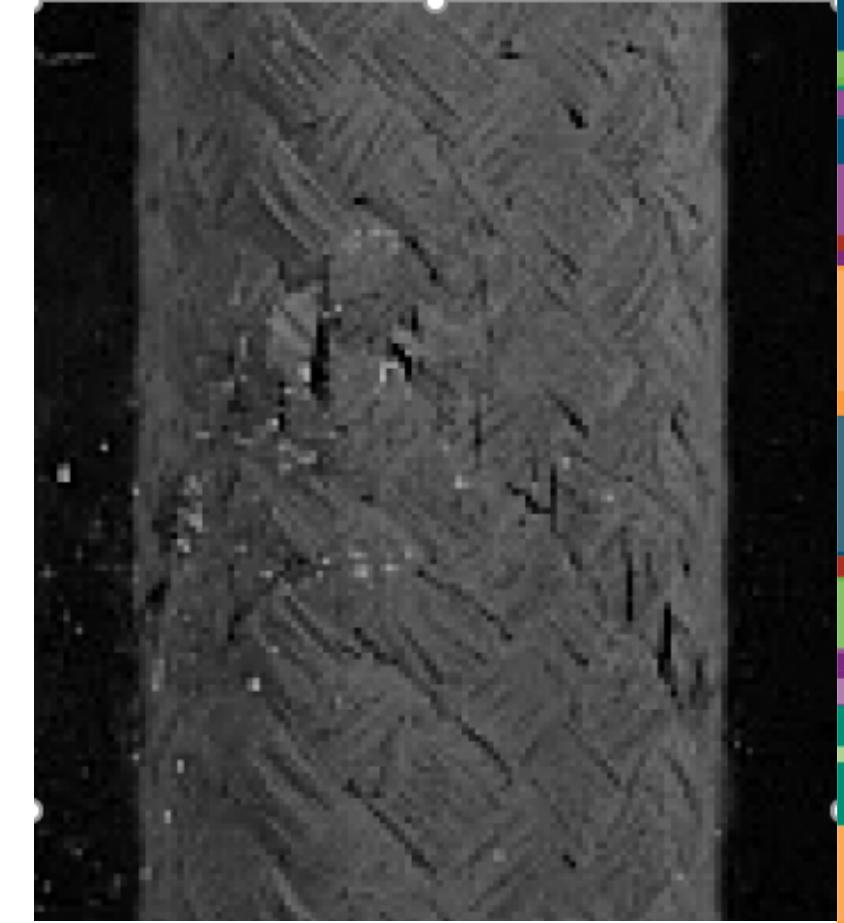
Tensile Hoop Burst - 45° 3-ply Biaxial Failure Mode

t = 0s

t = 0.2s

t = 0.4s
