# Probing Grain Boundary Segregation in 304L Stainless Steel using Time-of-Flight Secondary Ion Mass Spectrometry (ToF-SIMS)

Unraveling the composition of Complex Systems with SIMS  
AVS 68, Thursday, November 10, 2022, Room 320

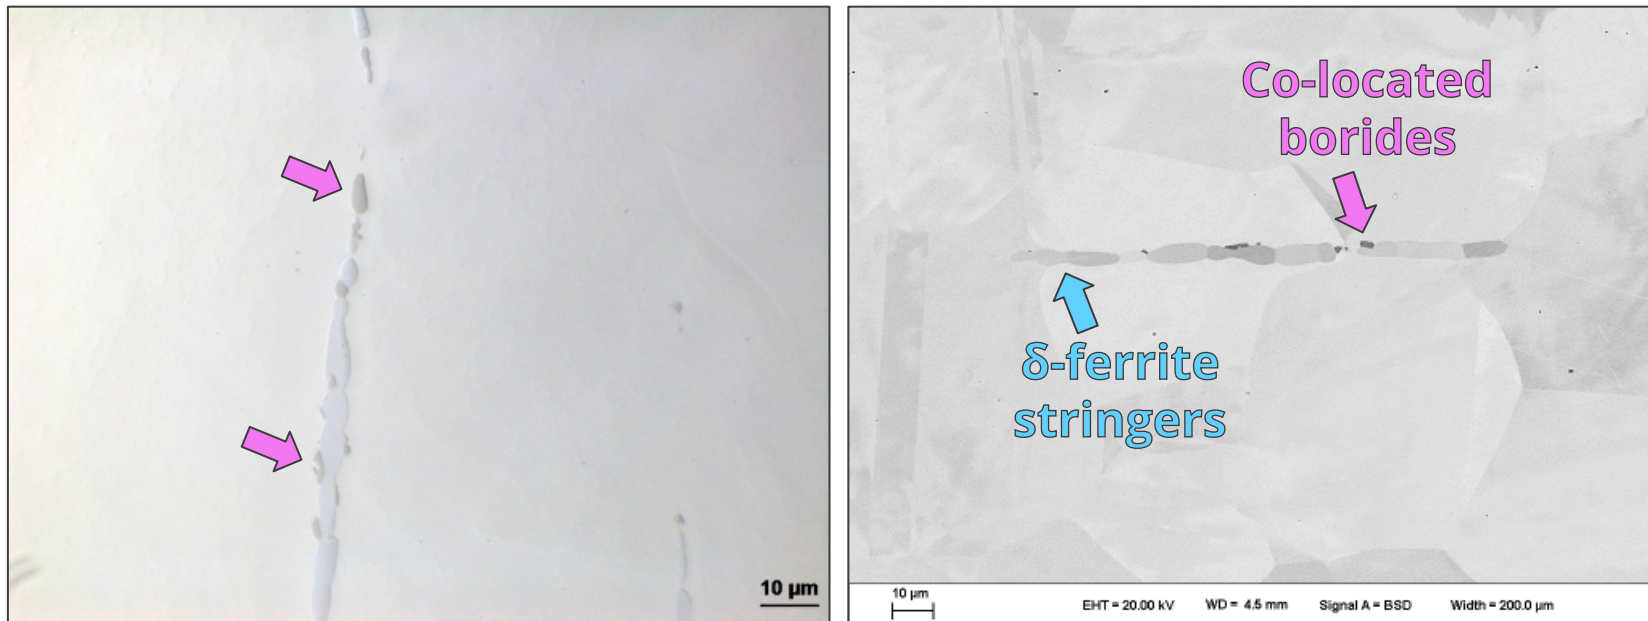
Inconel 718 Heat Affected Zone  
liquation cracks; 43 ppm B

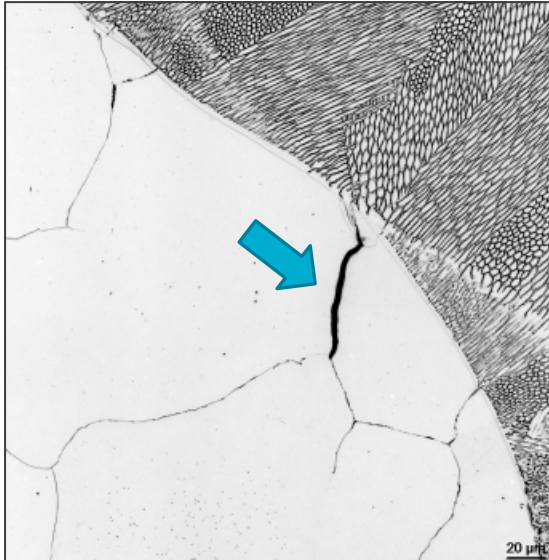
ToF-SIMS Boron Map

# ToF-SIMS enables boron location identification

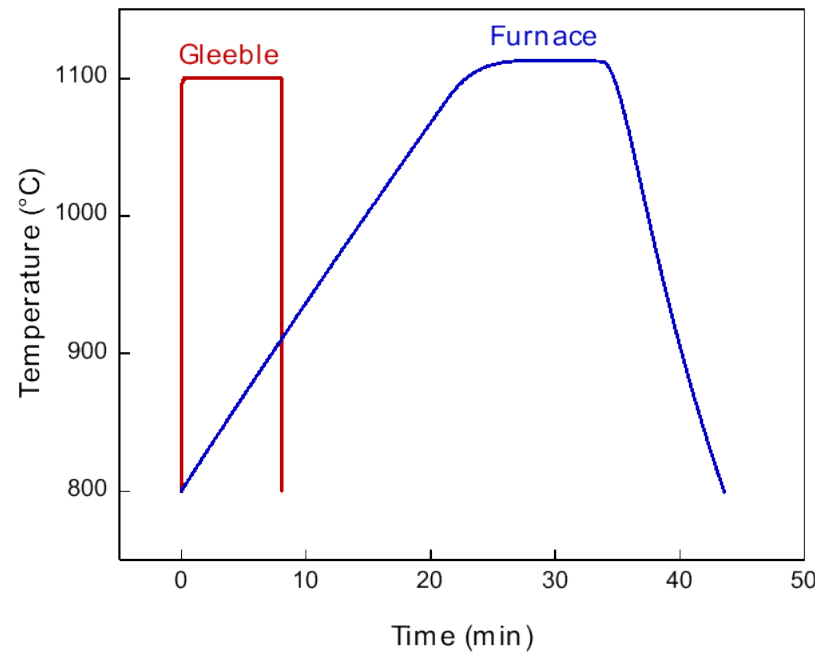
1100°C 8 min

Rapid heating and cooling rates  
to restrict phase transformations  
to a single temperature

**Temperatures:** 1000°C, 1100°C, 1200°C, 1300°C

**Hold Times:** 1 min, 8 min, 32 min, 64 min

Utilized 304L composition with **16 wt ppm B**

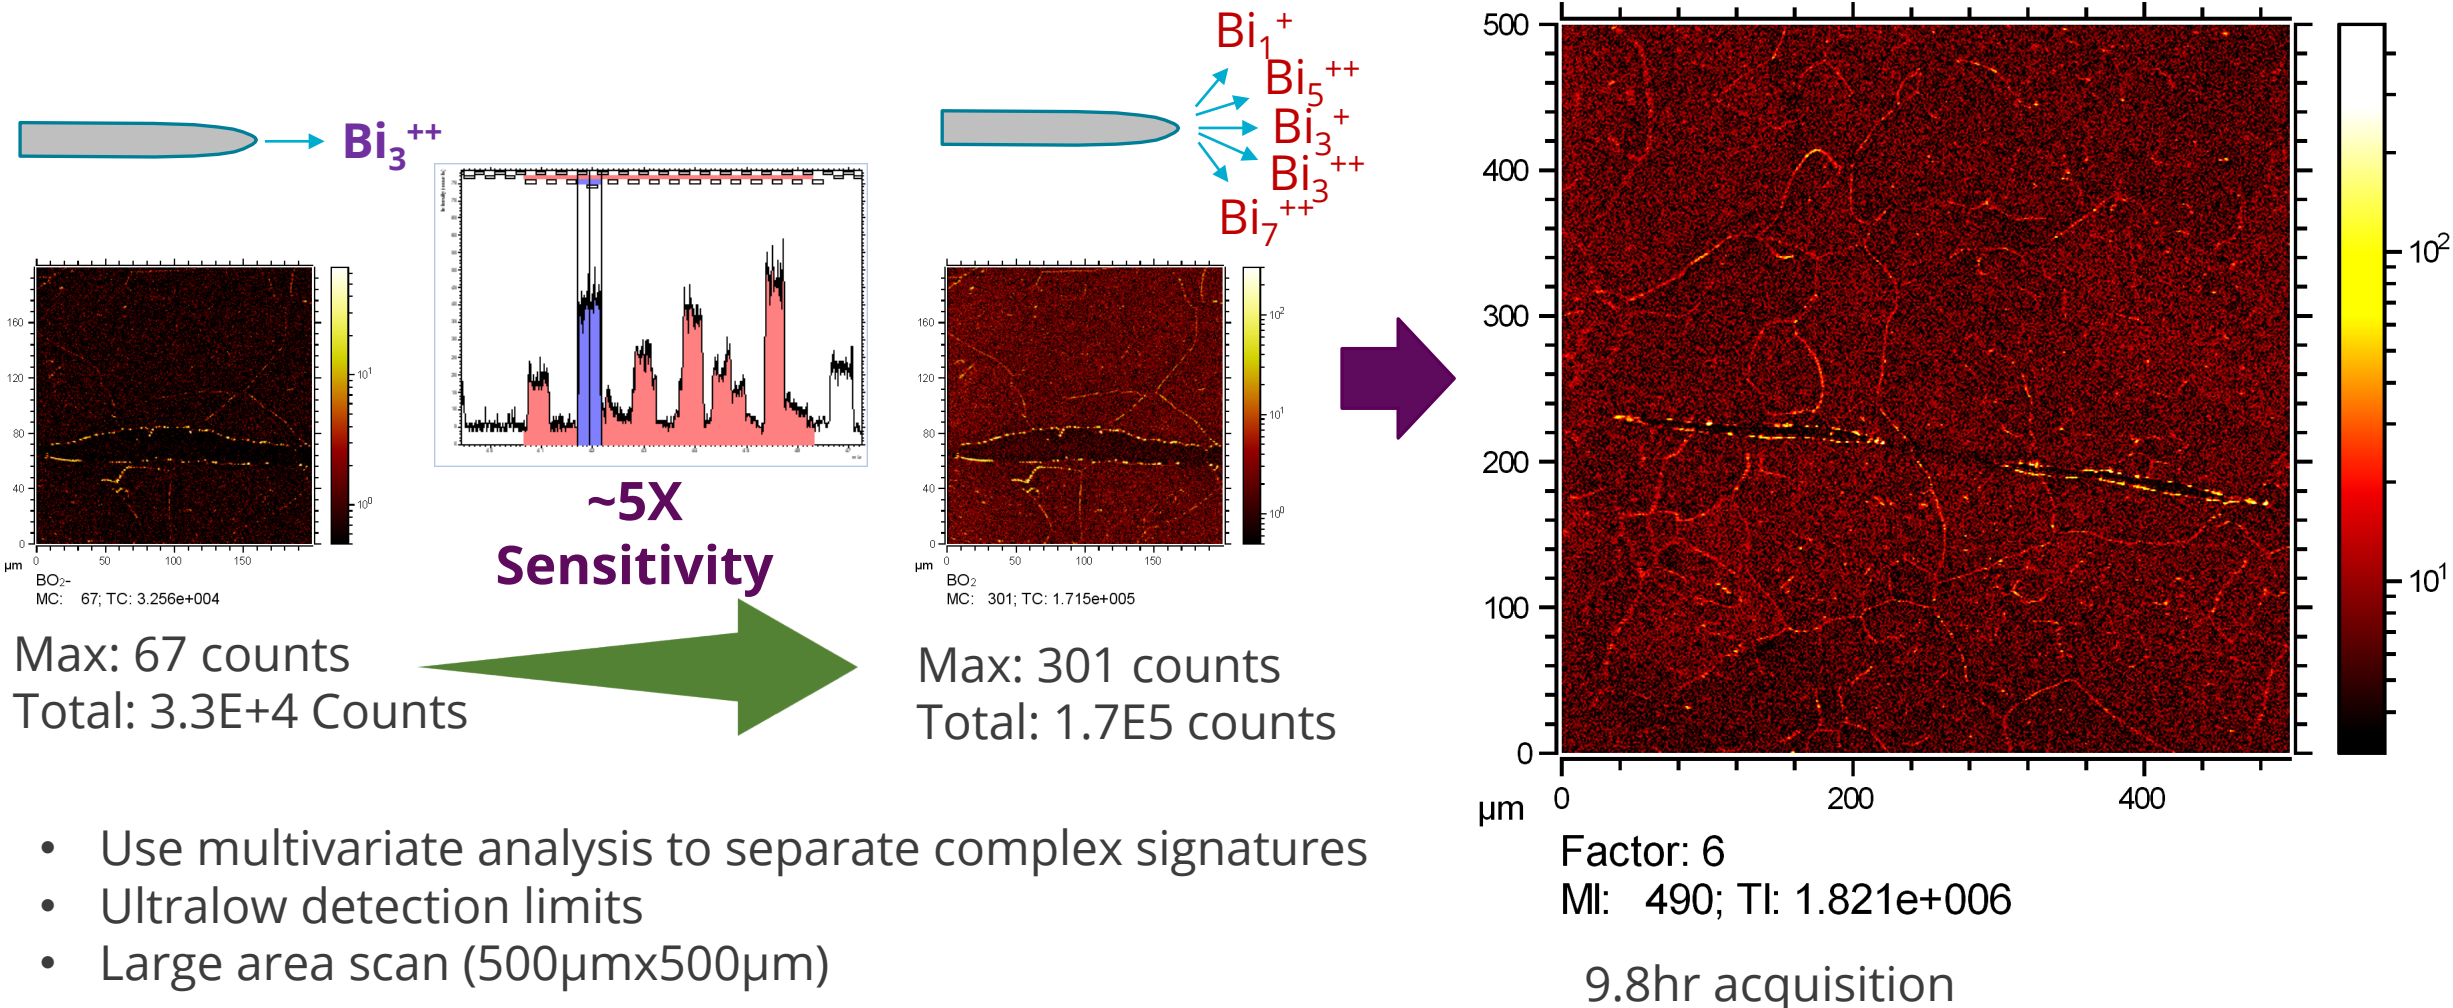
# Optimizations enable high sensitivity, large area Boron measurements in ToF-SIMS

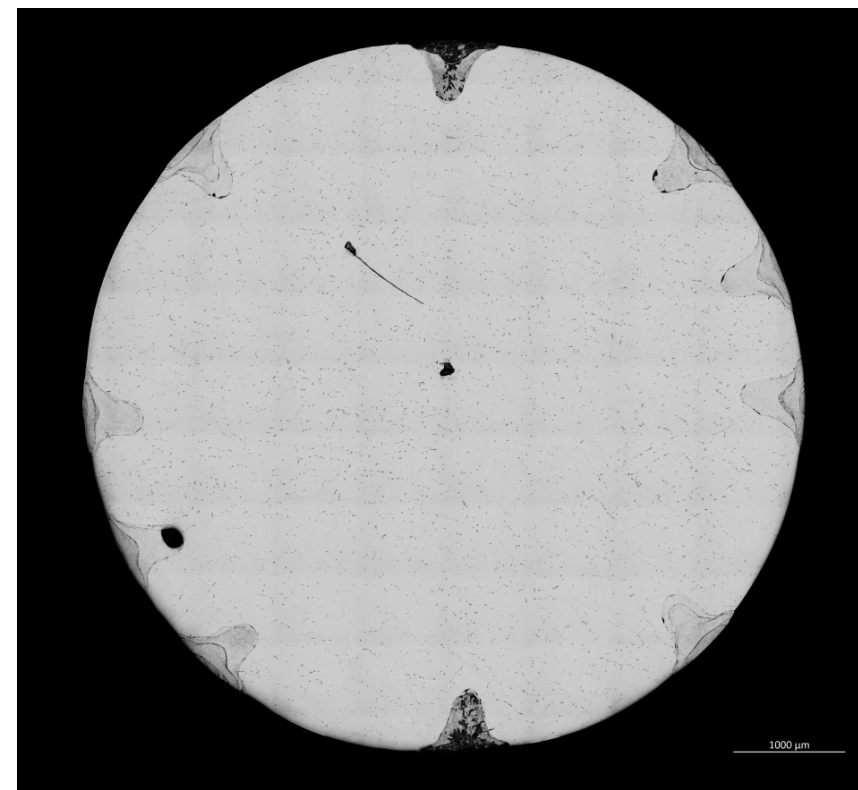
Step 3: Section welds in transverse, scan HAZ for cracks

60 weld cross-sections surveyed per Gleeble condition

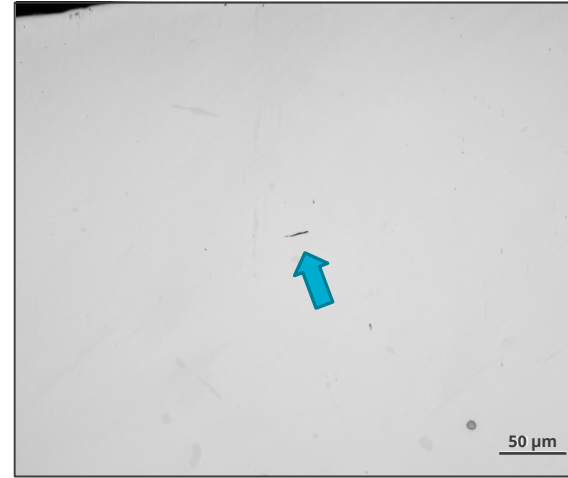
# Furnace profile condition is crack-susceptible

Unambiguous crack determination in as-polished condition
