Failing to Fail: Lessons Learned from Attempting to Fatigue a Bolt Using Structural Dynamics

Ben Pacini, Moheimin Khan, Patrick Hunter

IMAC XL

February 7-10, 2022

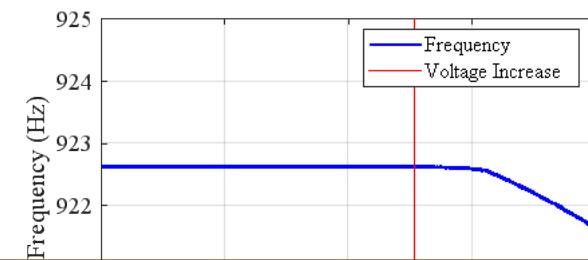
Zoom Out

Structure appears to go unstable at a certain energy level

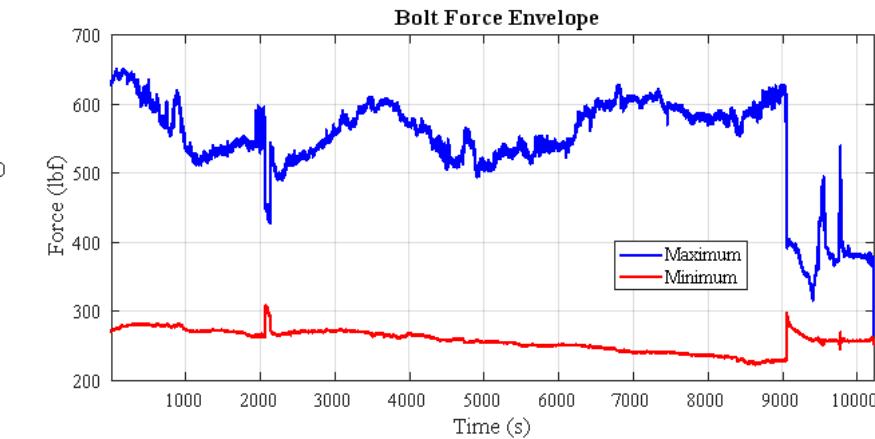
Attempt	Outcome	Reason
1	Did not fail bolt	Test equipment limitations
2	Did not fail bolt	NFA controller/structure instability
3	Did not fail bolt	Insufficient cycle count or incorrect bolt type
4	Did not fail bolt	Uncertainty in bolt loading

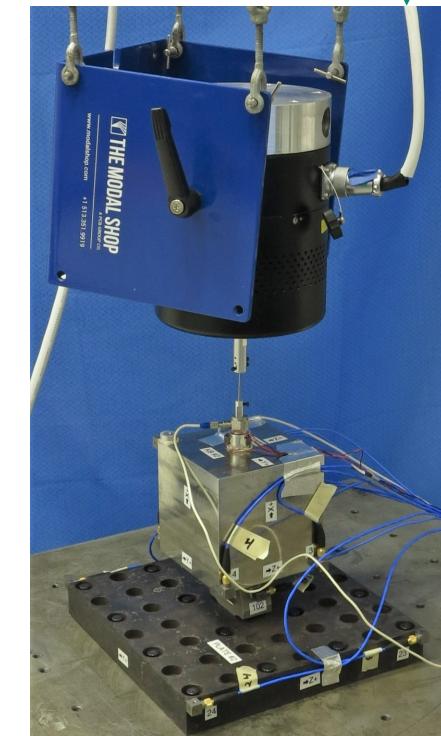
Test Method—Nonlinear Force Appropriation

- Nonlinear force appropriation is a method used in nonlinear structural dynamics testing where the excitation is maintained 90° out of phase (i.e. in phase quadrature) with the acceleration response
- Under this phase condition, the excitation is assumed to balance the energy dissipated by the system, and thus the response is that of the underlying ~~conservative system~~, i.e. a Nonlinear

This cycle repeats until the desired excitation level is achieved, after which the controller will maintain the structure at resonance until bolt failure
