Fatigue Behavior Of Additively Manufactured Ti-5553 (and Ti-6Al- 4V)

**Jay D. Carroll, Zachary Casias, Christopher Laursen, Philip
Noell, John Emery**

Sandia National Laboratories, Albuquerque, NM

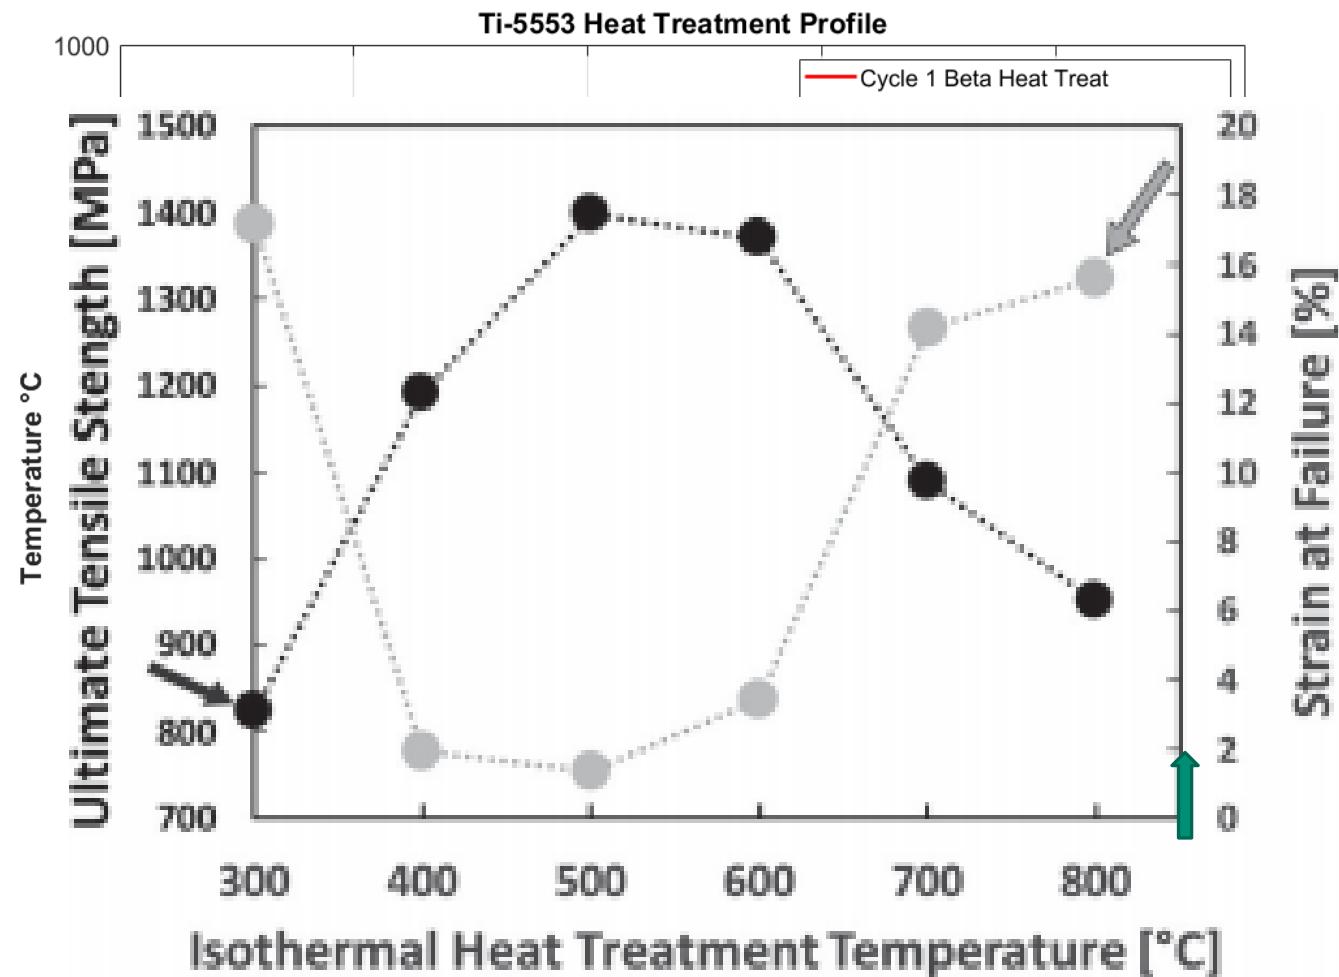
Ti-5553 Heat Treatment

- Elastic modulus can change by factor of 2 depending on α/β mixture!

Heat-treatment temperature (°C)	E (GPa)
Our as-built	300	$\sim 100\% \beta$
	400	66 ± 3
	500	98 ± 4
	600	97 ± 1
	700	92 ± 1
Our heat treated (900°C)	800	$25\% \alpha, 75\% \beta$
	900	$25\% \alpha, 75\% \beta$
		91

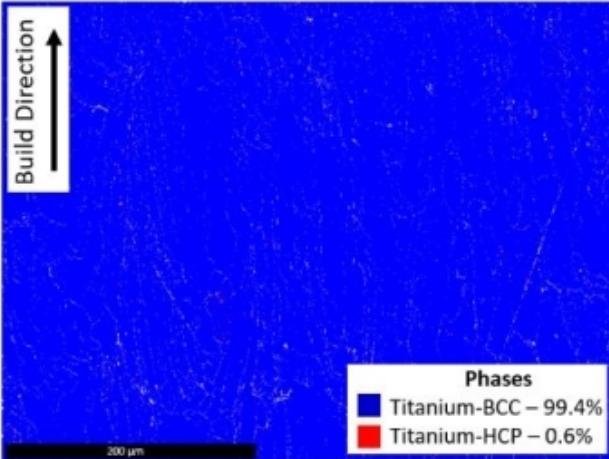
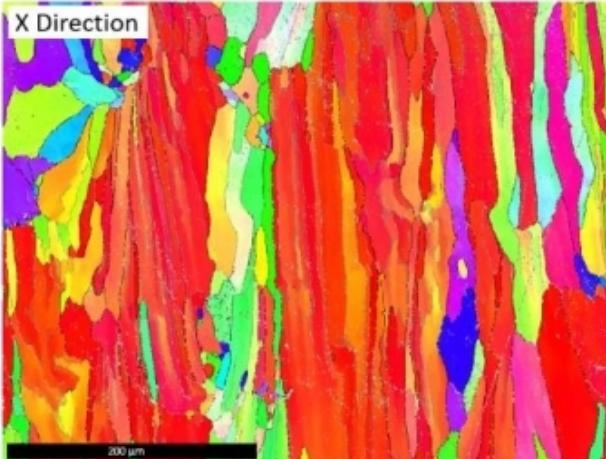
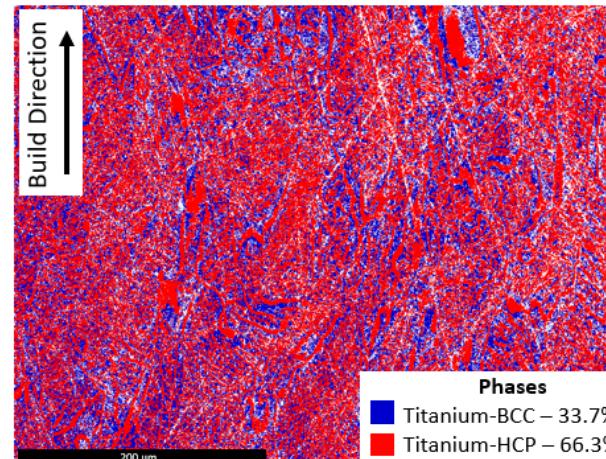
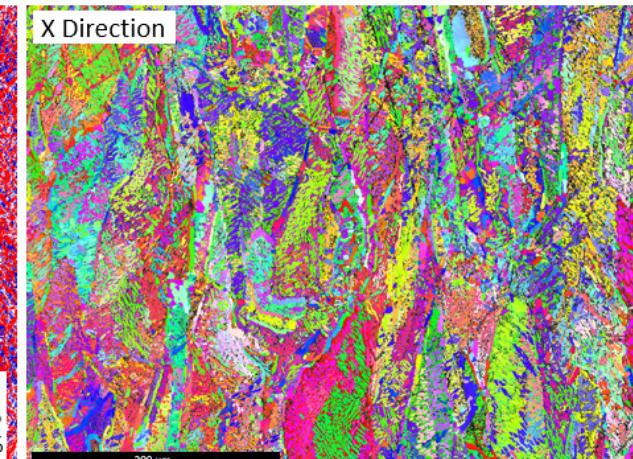
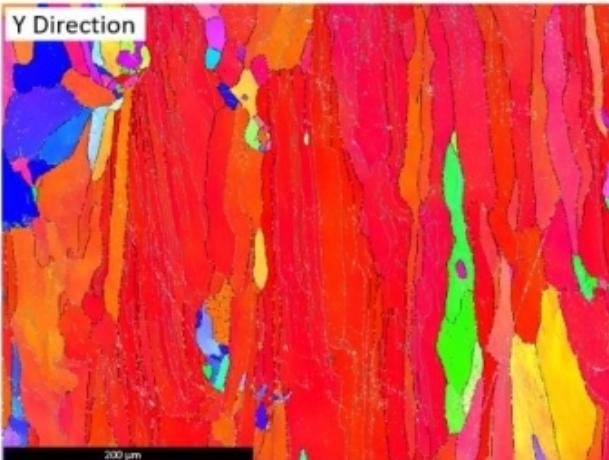
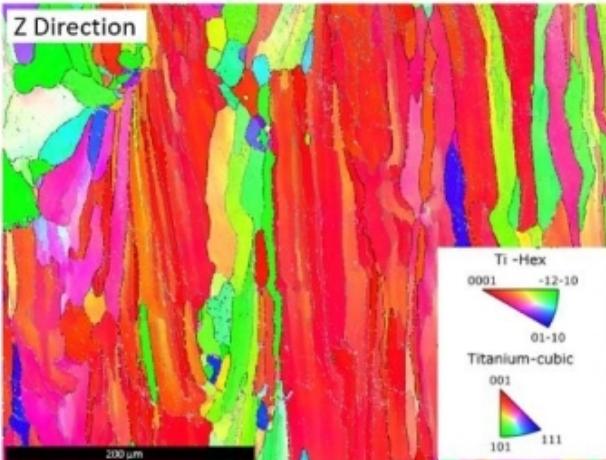
AM Ti-5553 Microstructure

α = HCP (red)

β = BCC (blue)

ω = Hexagonal (detrimental, not detected)

- As-printed has columnar microstructure, pure BCC with [100] in the build direction.
- Heat treated has 33% Beta and 67% alpha in laths at several size scales:
- $\sim 7 \times 1 \mu\text{m}$ and $\sim 300 \times 50 \text{ nm}$.

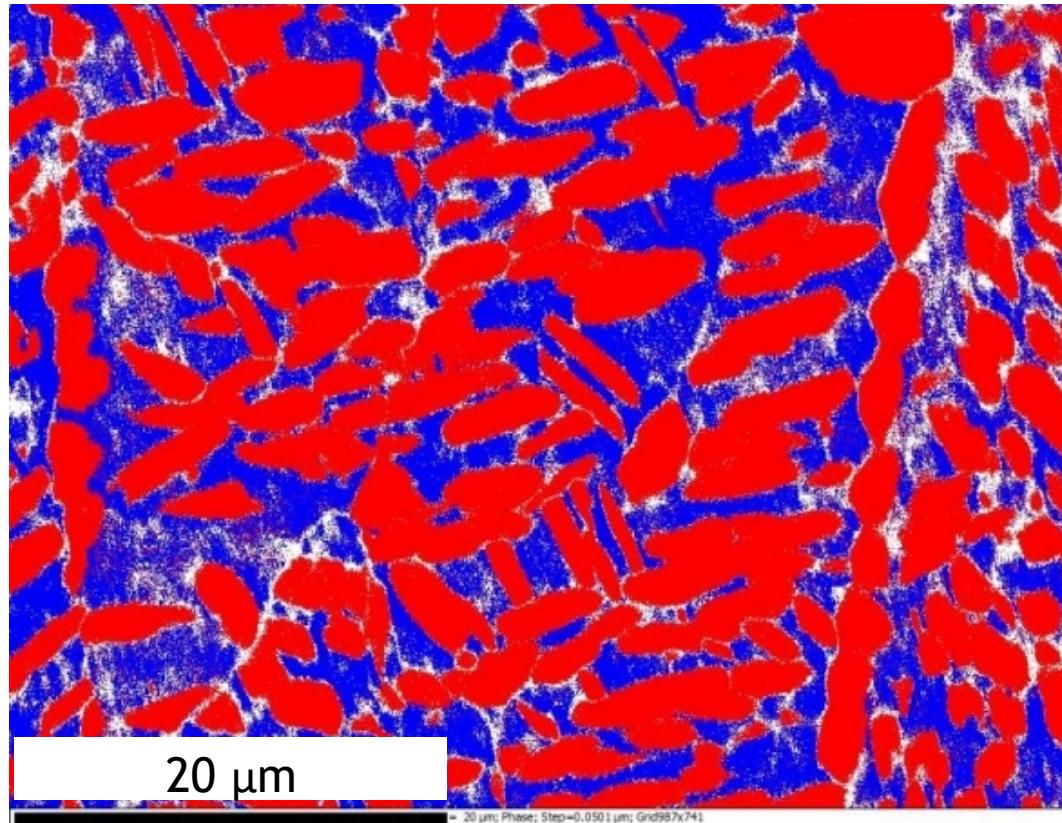
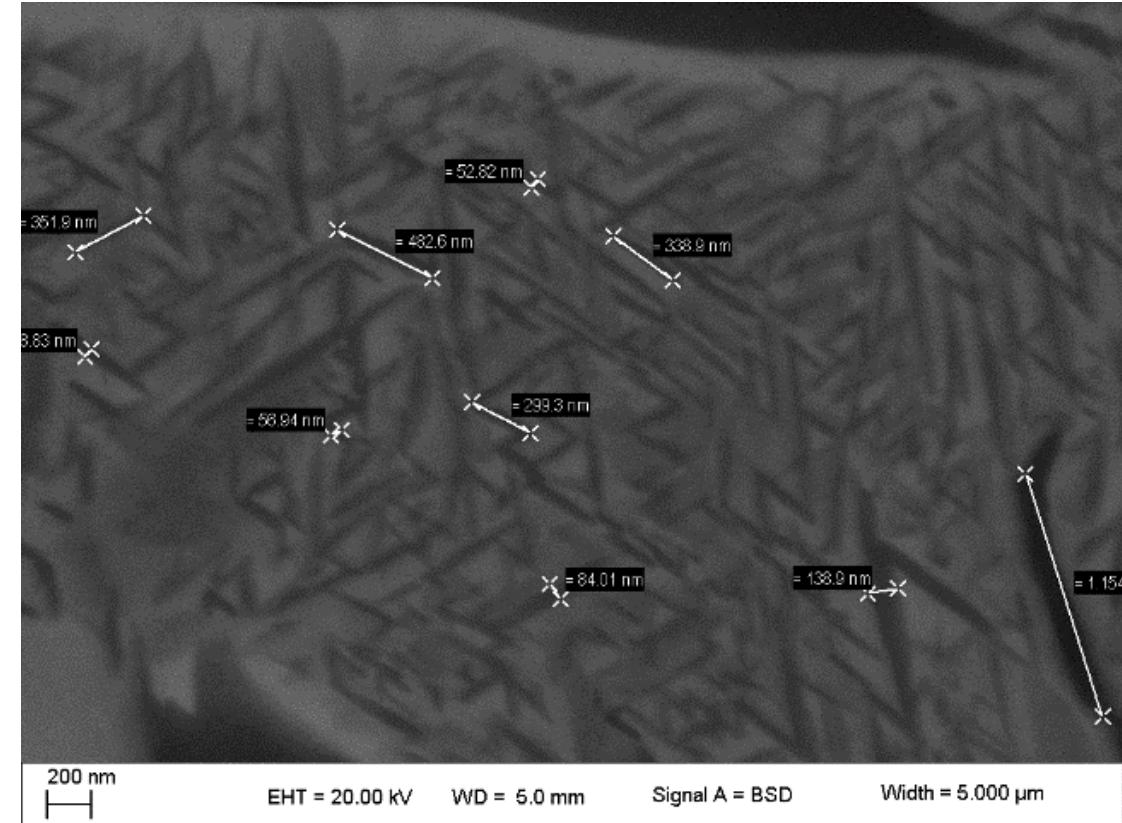
AM Ti-5553 Microstructure

α = HCP (red)
 β = BCC (blue)
 ω = Hexagonal (detrimental, not detected)

- Heat treated Ti-5553 has 33% β and 67% α in laths at several size scales:
- Fine α laths $\sim 7 \times 1 \mu\text{m}$
- Coarse α laths $\sim 300 \times 50 \text{ nm}$.

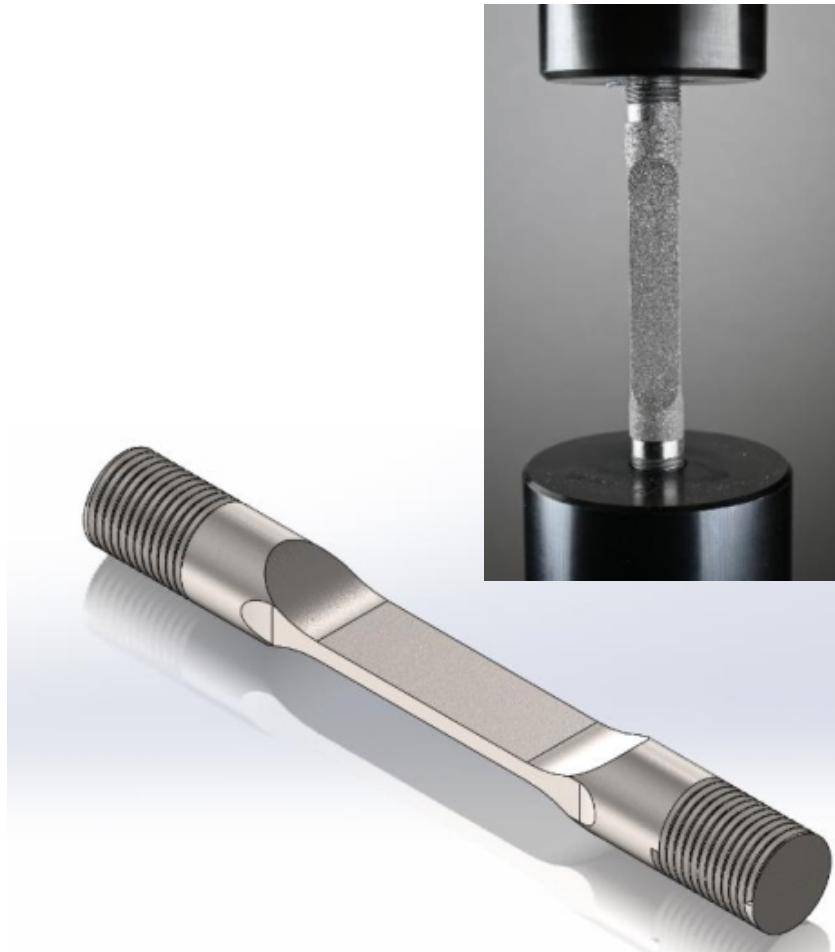
This AM Ti-5553 is inline with published values

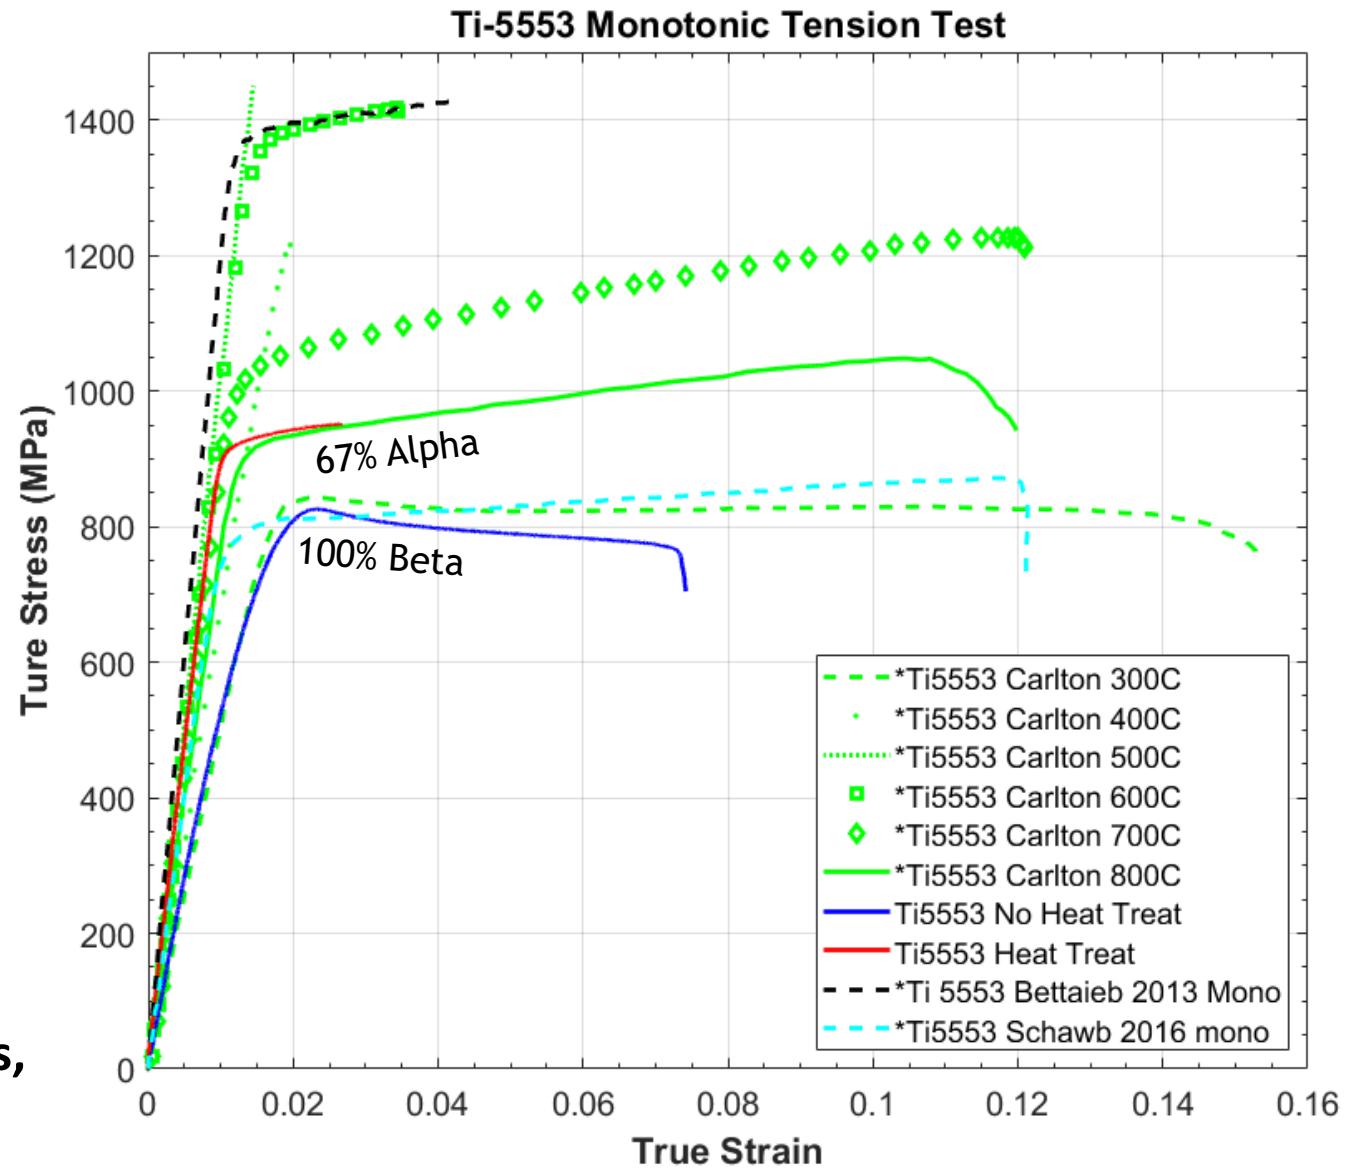
- Strengths are in-line with published values, but ductilities are lower.

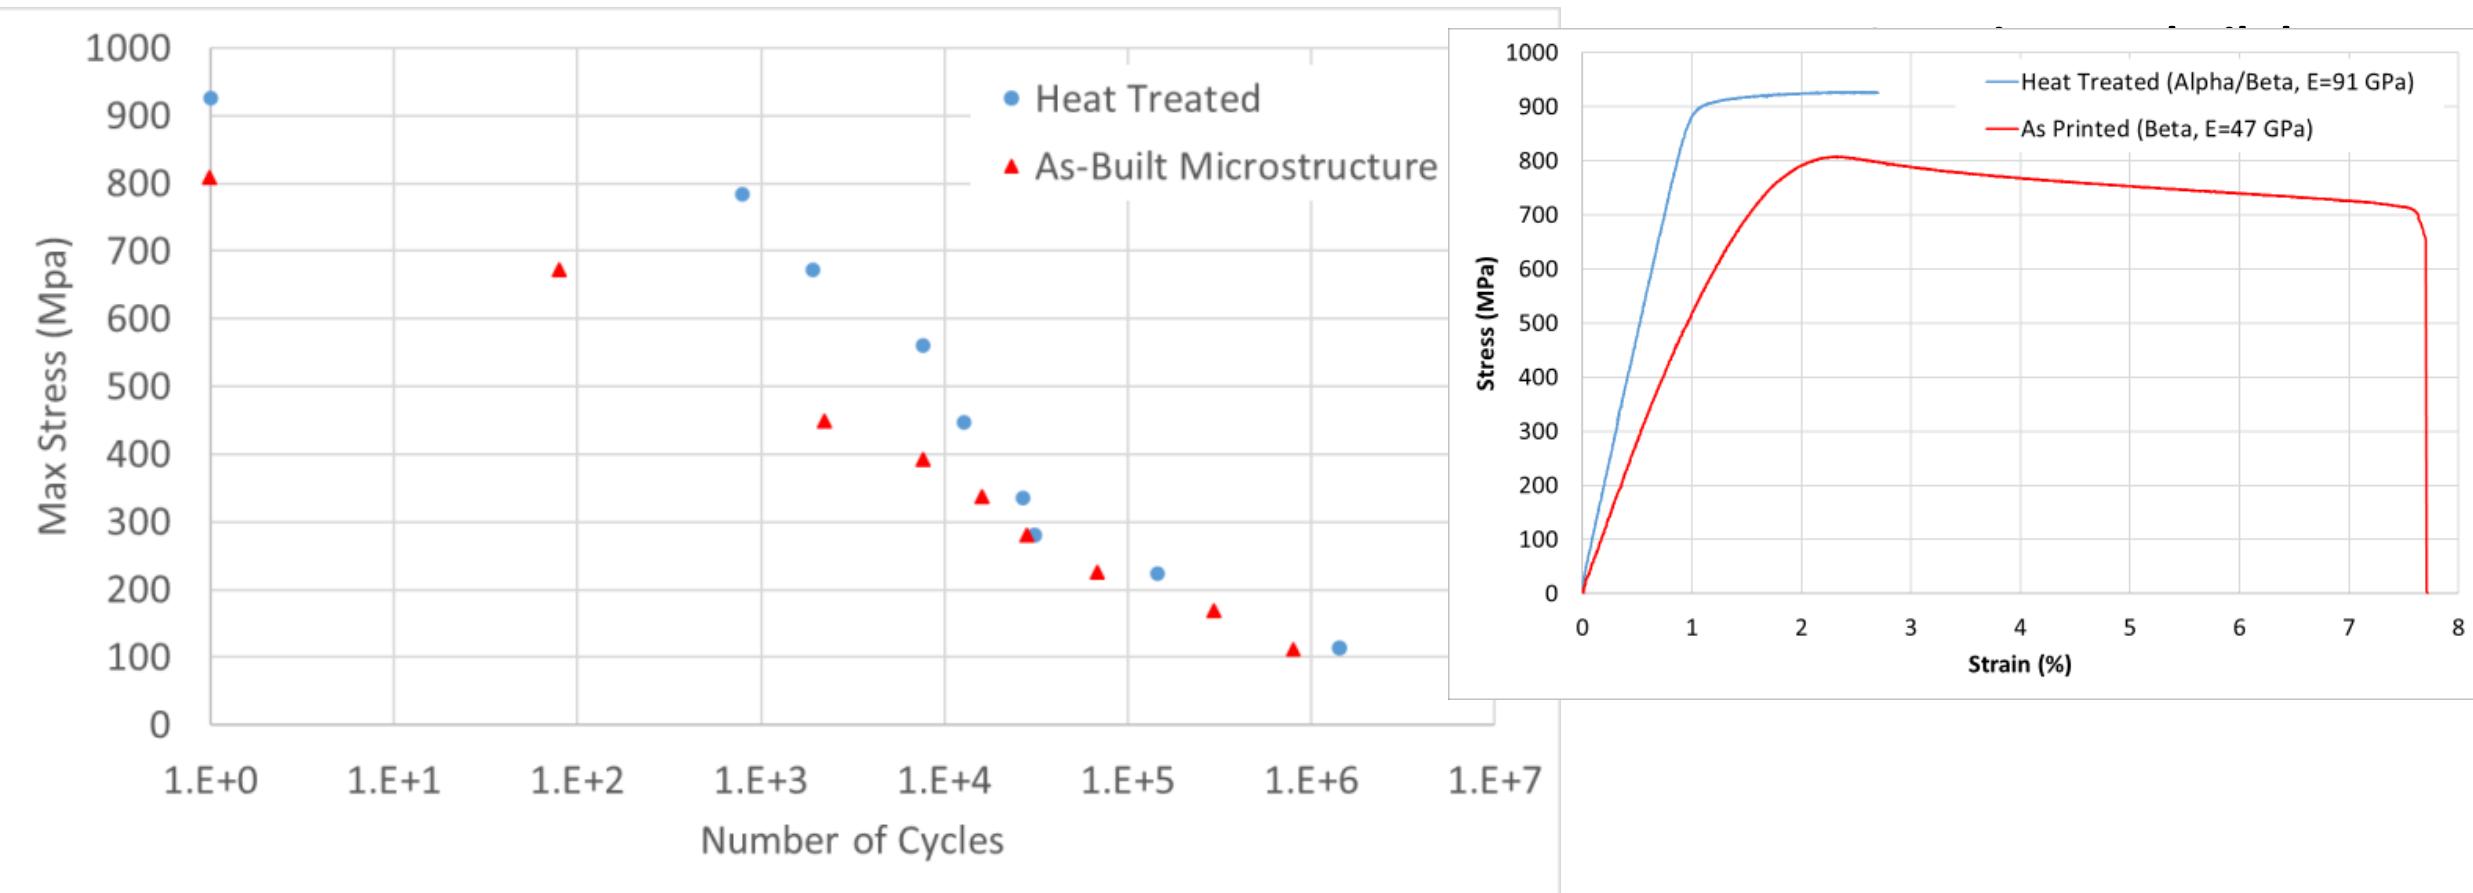
AM Ti-5553 Stress Life Fatigue Curves

- Steep drop-off in fatigue strengths with no clear threshold.
- Similar behavior in high cycle fatigue regime ($>10,000$ cycles).
- Heat-treated experiences more microplasticity in the LCF regime leading to shorter lifetimes.

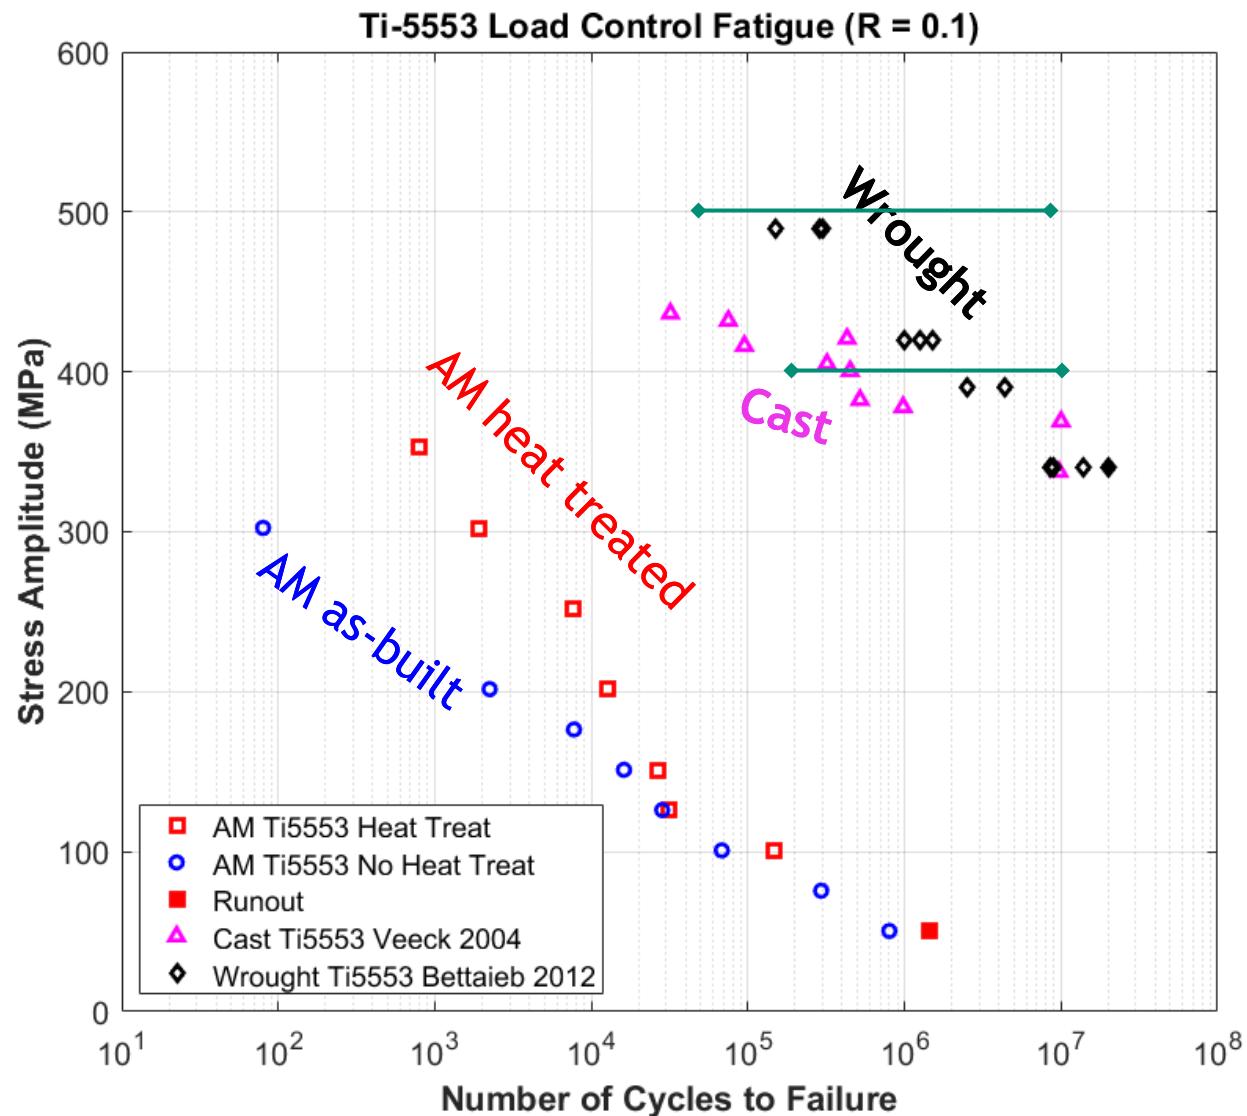
This AM Ti-5553 has fatigue lives far below published values for wrought and cast Ti-5553.

- This AM Ti-5553 has fatigue properties far below conventionally processed Ti-5553.
- Is it inherent to AM or just our AM.
- Yasin also tested AM Ti-5553 in fatigue, at $R=-1$, round, heat treat to 900C.

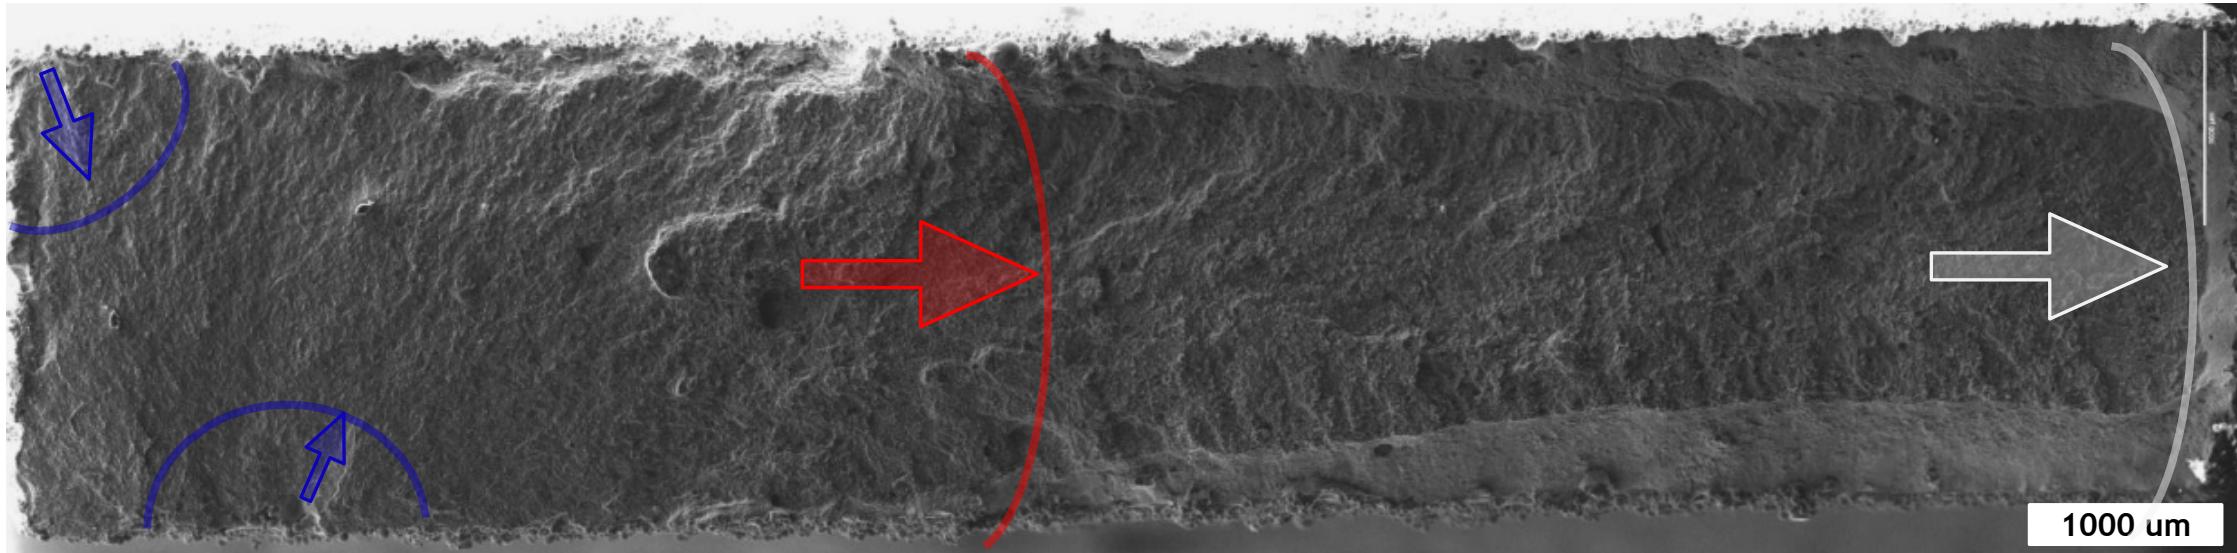
AM Ti-5553 fatigue nucleates at near-surface voids

- Fracture surfaces show failure dominated by surface defects.
- Machining specimens could remove near-surface voids and lead to artificially high fatigue strengths.

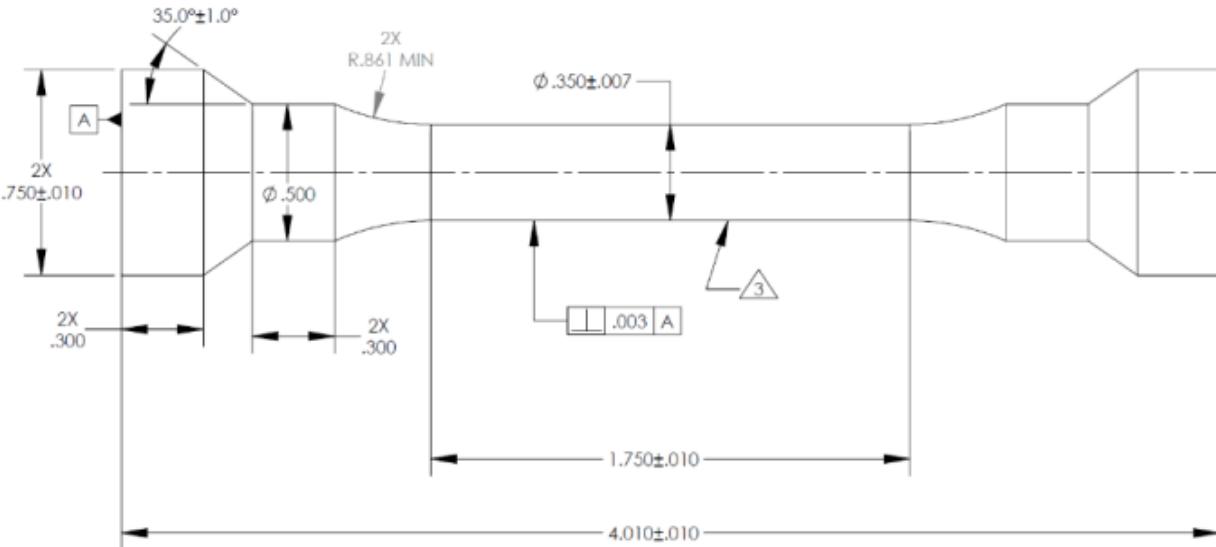
AM Ti-6Al-4V Tensile/fatigue samples

- Annealing heat treatment at 704°C for 2 hrs in vacuum $<10^{-5}$ torr. Cooling rates of 5°Cmin.

R6
15.9 mm long x 2mm dia

R4
19 mm long x 4.1 mm dia

R2
45 mm long x 8.9 mm dia

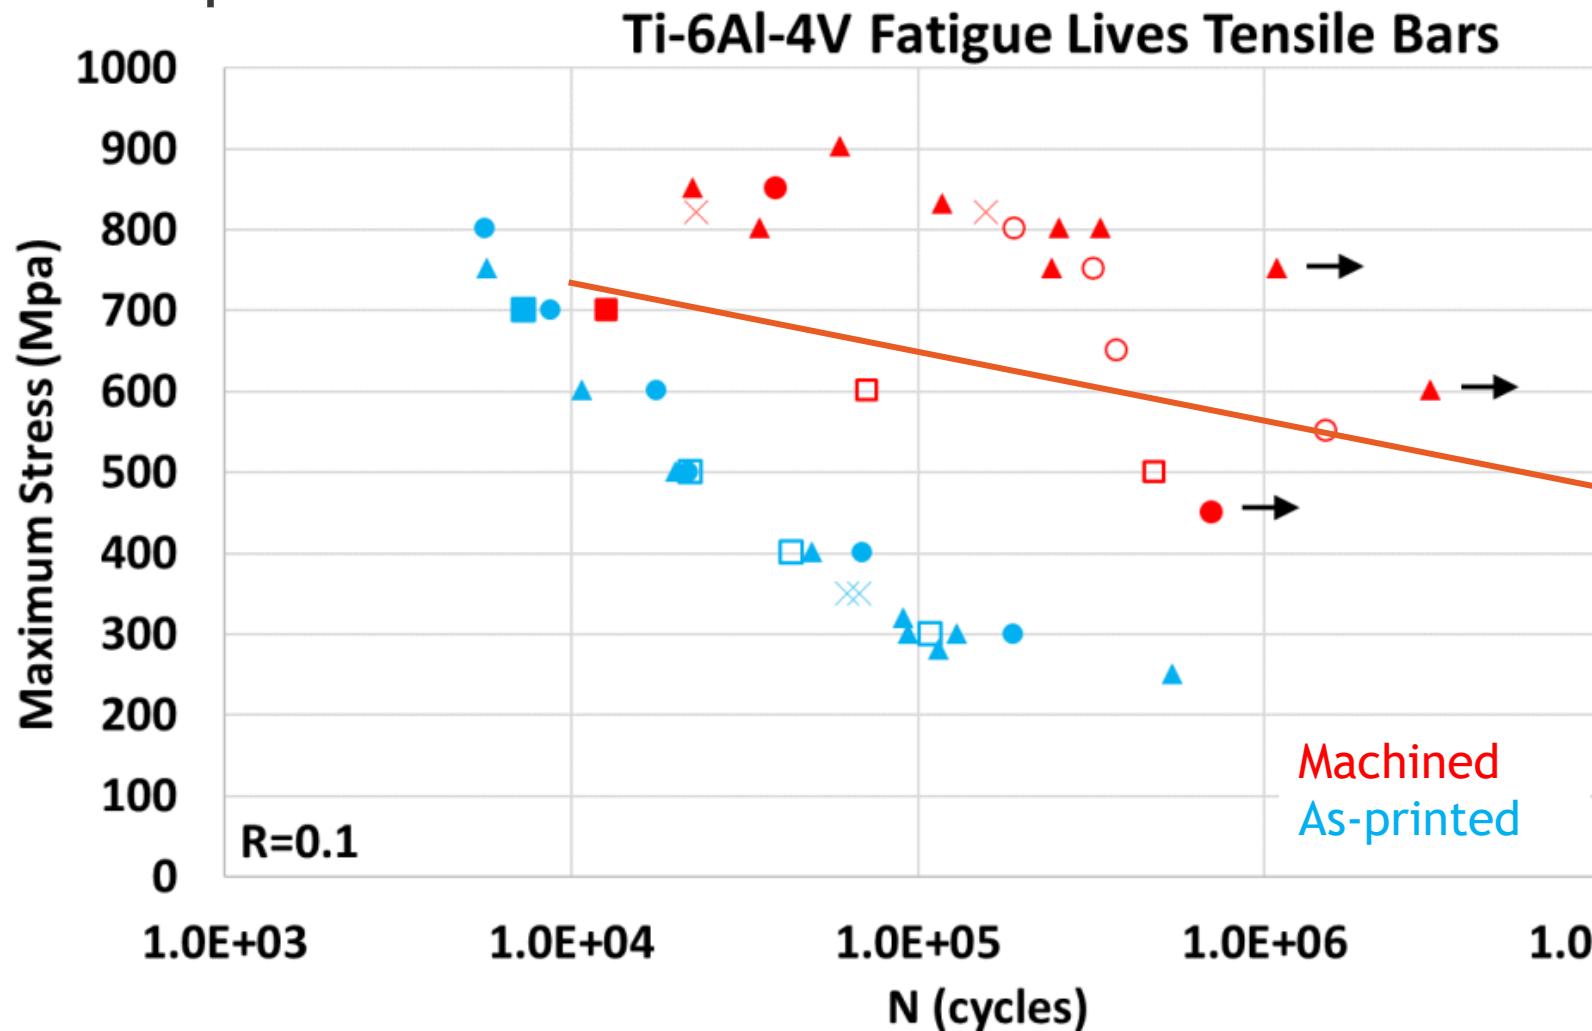
AM Ti-6Al-4V fatigue lives appears to be size-independent

- Machined specimens outperform AM surfaces.
- Specimens with AM surfaces are much more predictable.
- No measurable size effects between as-printed R2, R4, R6 samples

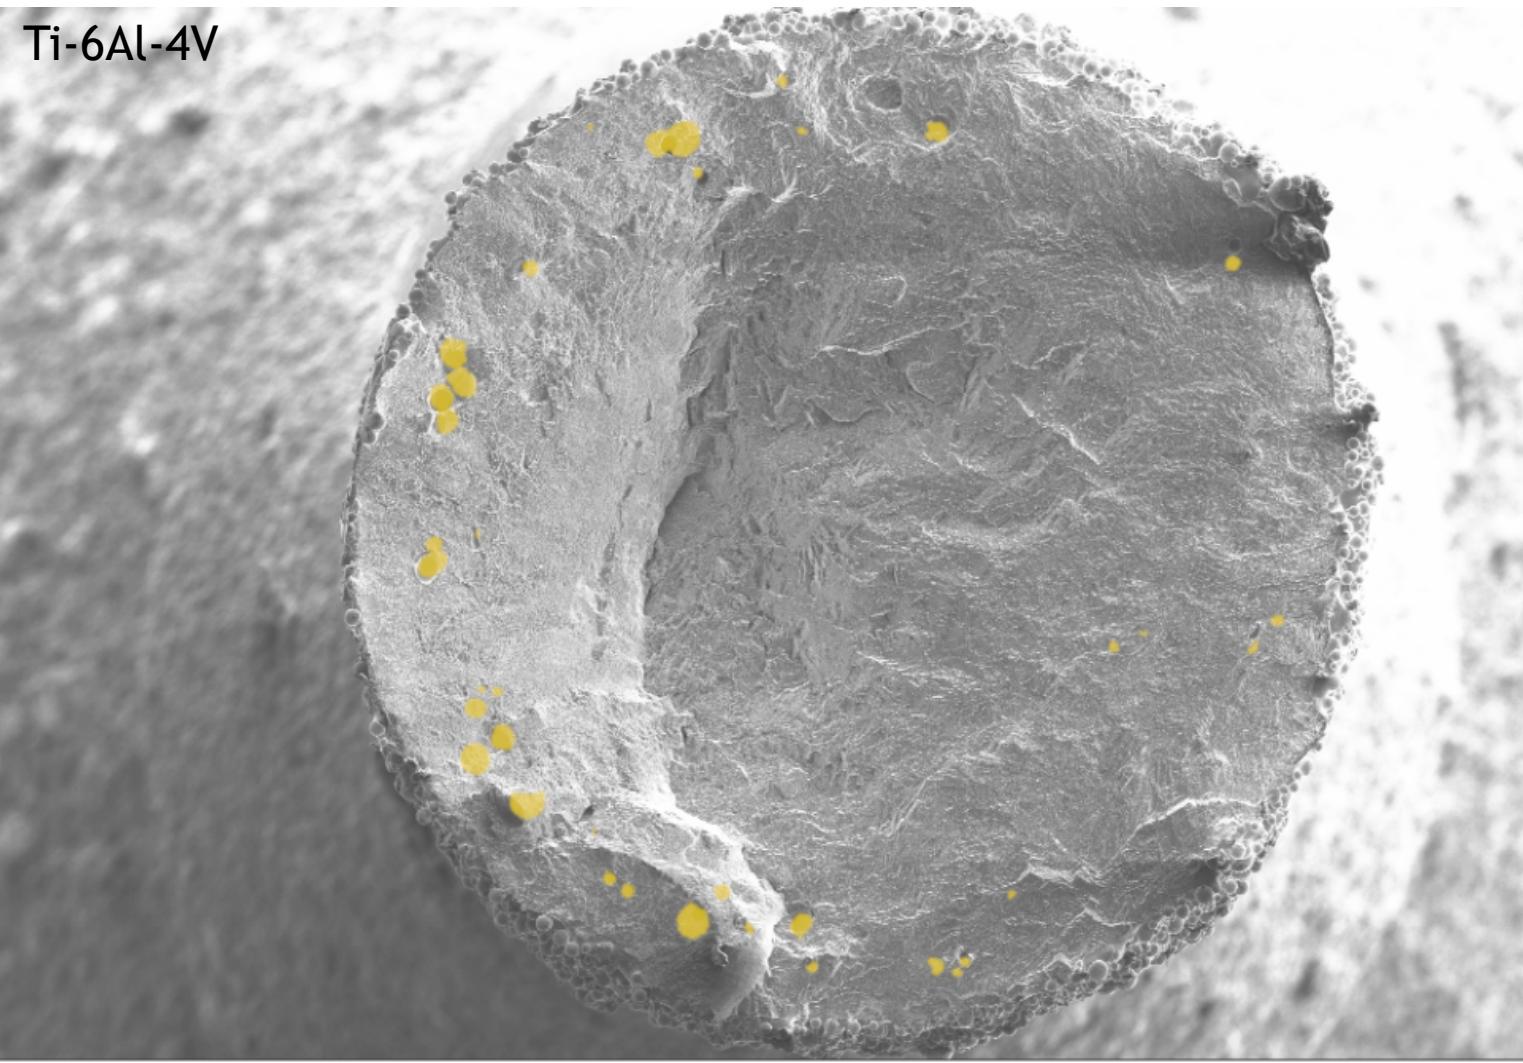
AM Ti-6Al-4V size independence may be related to voids at the contour-fill interface

- **Machined specimens significantly outperform as-printed specimens, but with more noise.**
 - **Enough voids in as-printed to make lives deterministic?**
- **Voids near surfaces due to interface between contour pass and fill hatch.**

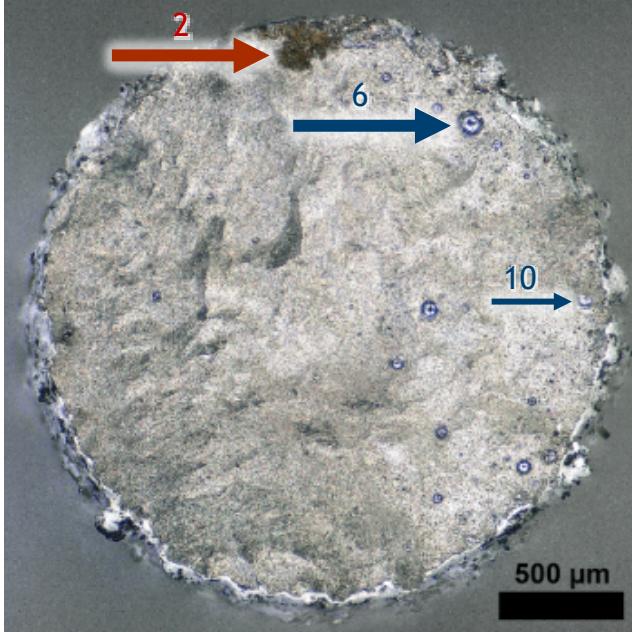
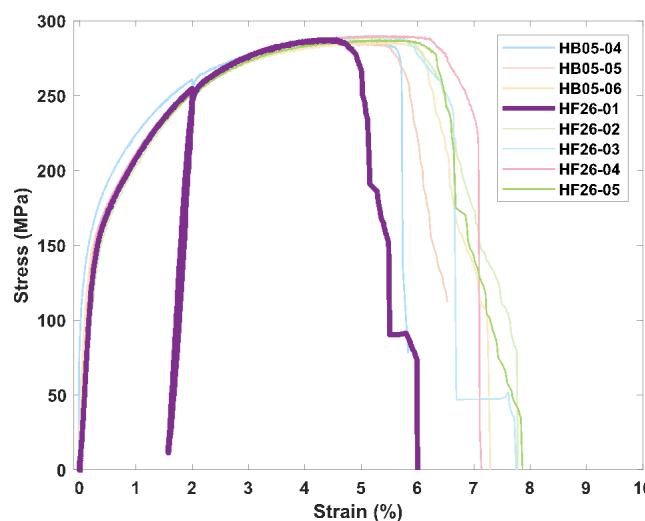
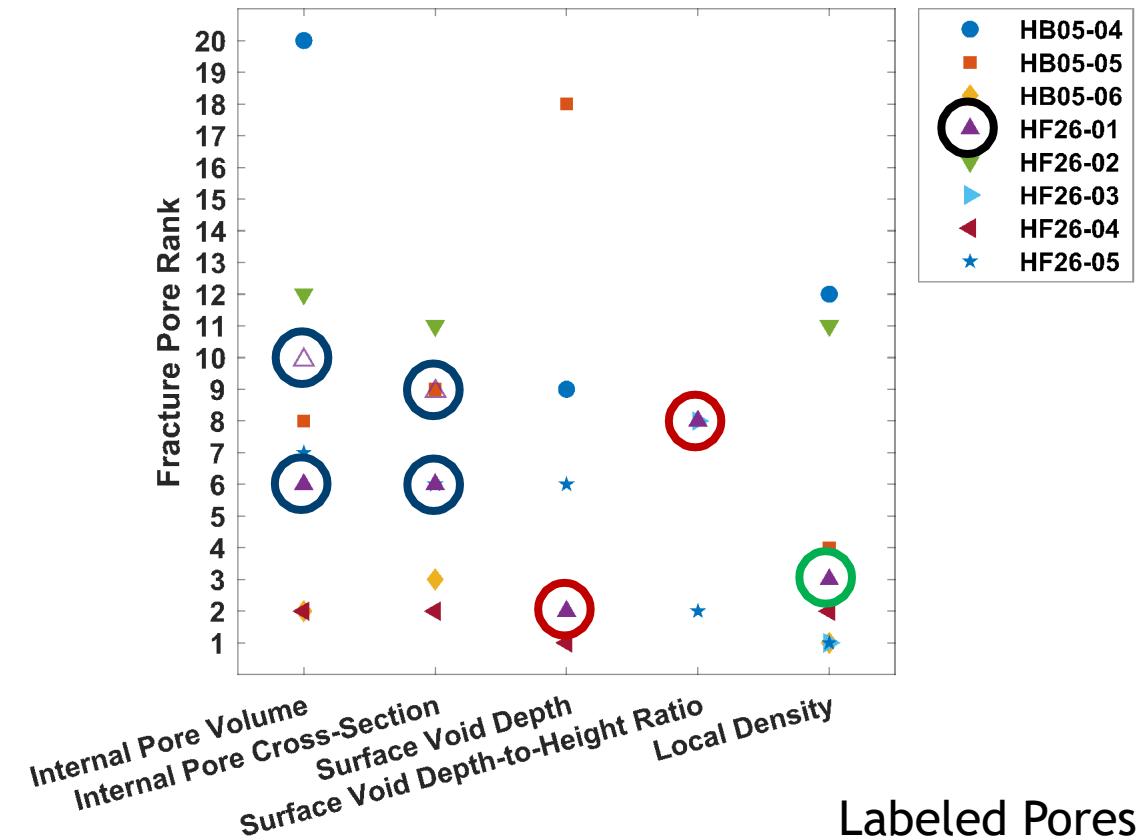
Failure of specimen HF26-01 was largely determined by surface void depth.

HF26-05	Internal Pore Volume	Internal Pore Cross-Section	Surface Void Depth	Surface Void Depth-to-Height	Local Density
Rank	6	6	2	8	3
Pore Label	83322	83322	83964	7520	1297
Fracture Value	730,294 μm^3	10,522 μm^2	168.8 μm	9.49	99.727 %
Peak Value	2,045,810 μm^3	24,204 μm^2	197.1 μm	16.67	99.687 %

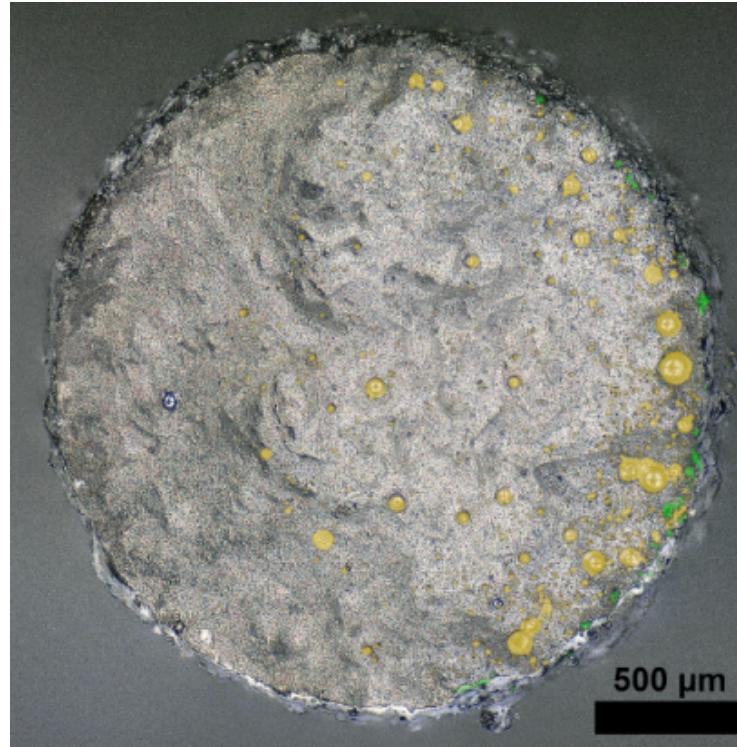
Surface flaws and internal pores are primary two features of interest.

- 10 tensile bars
- Internal pores
- Surface flaws

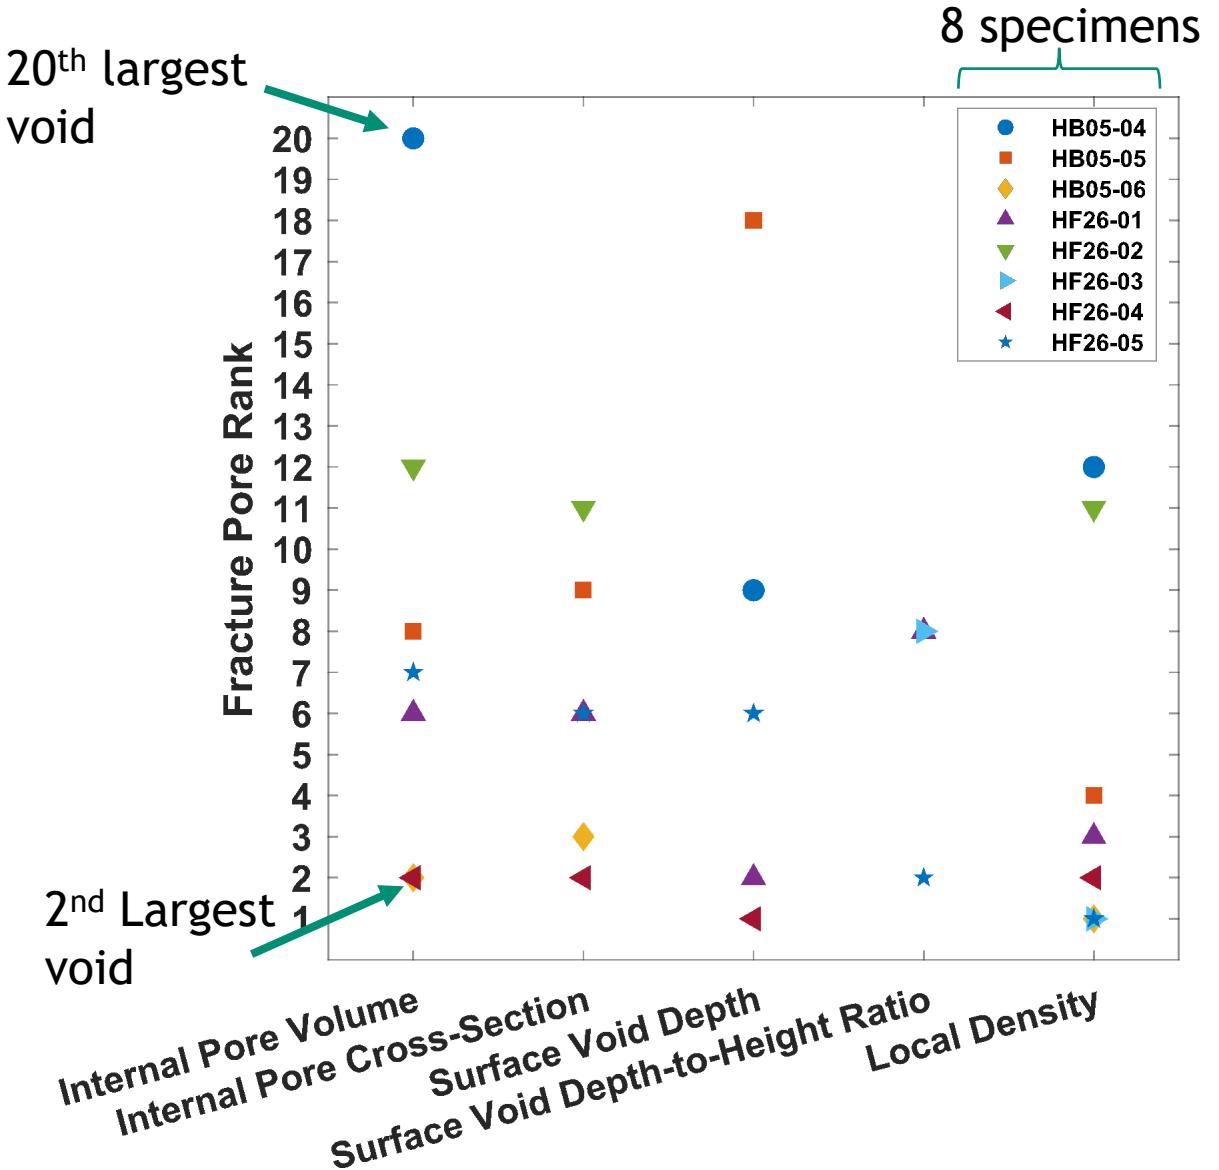
Identify dominant parameters leading to fracture by ranking.

- Rank flaws on several metrics.
- Dominant parameters will have many high-ranked features on the fracture surface.

- Largest pore volume on fracture surface
- Largest cross-sectional area of internal pores
- Deepest surface Void
- Sharpest surface void (height-to-depth ratio)
- Lowest regional density (200 μm thick slices, ~100 per specimen)

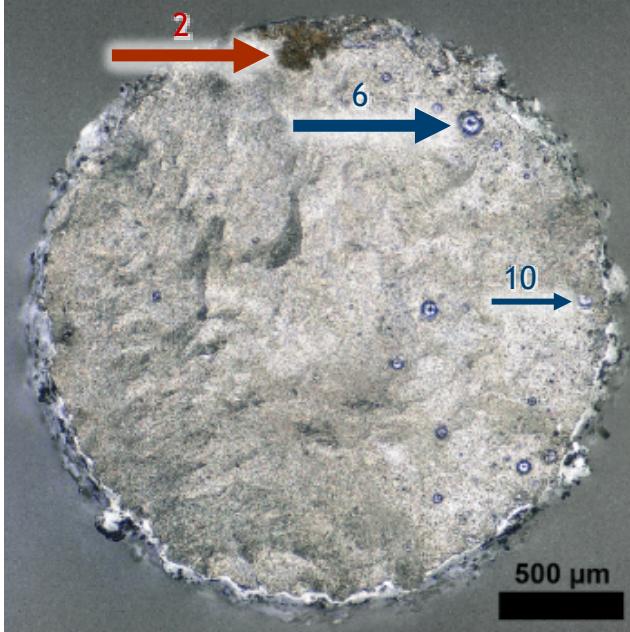
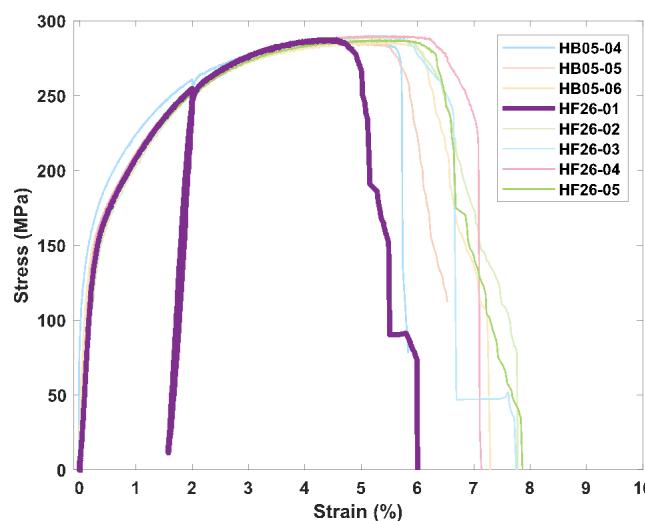
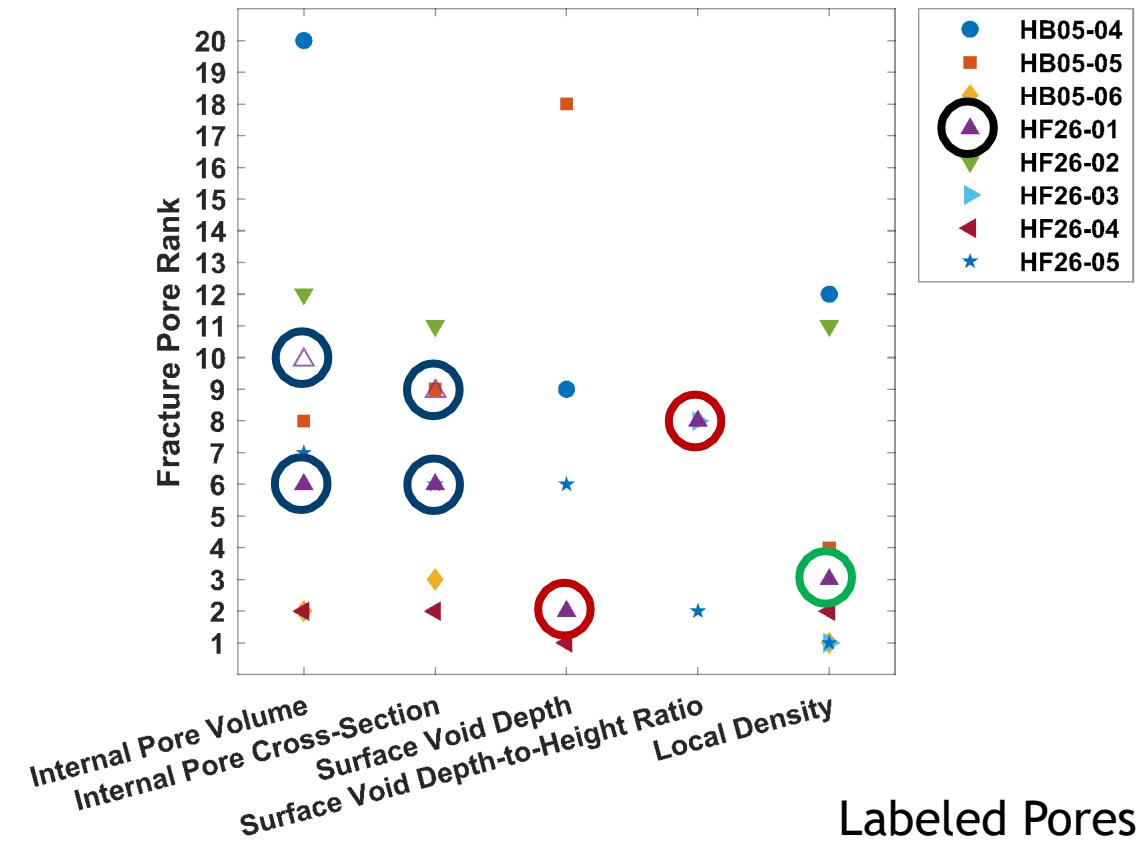
Failure of specimen HF26-01 was largely determined by surface void depth.

HF26-05	Internal Pore Volume	Internal Pore Cross-Section	Surface Void Depth	Surface Void Depth-to-Height	Local Density
Rank	6	6	2	8	3
Pore Label	83322	83322	83964	7520	1297
Fracture Value	730,294 μm^3	10,522 μm^2	168.8 μm	9.49	99.727 %
Peak Value	2,045,810 μm^3	24,204 μm^2	197.1 μm	16.67	99.687 %
