Fatigue Behavior Of Additively Manufactured Ti-5553 (and Ti-6Al- 4V)

**Jay D. Carroll, Zachary Casias, Christopher Laursen, Philip
Noell, John Emery**

Sandia National Laboratories, Albuquerque, NM

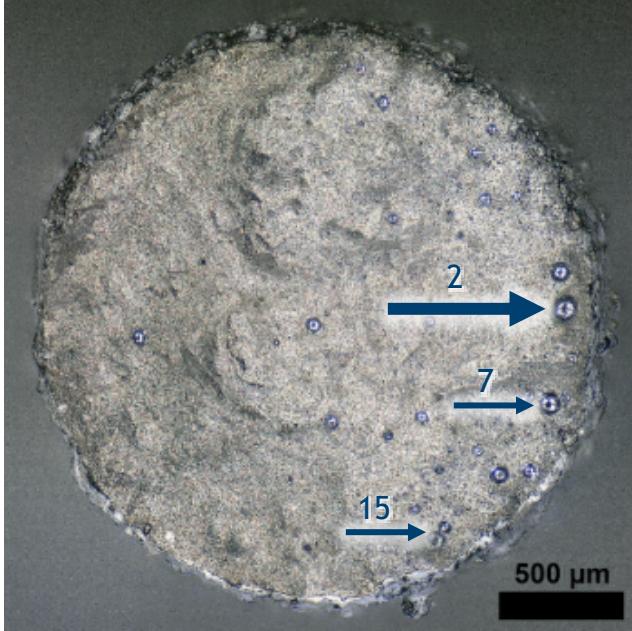
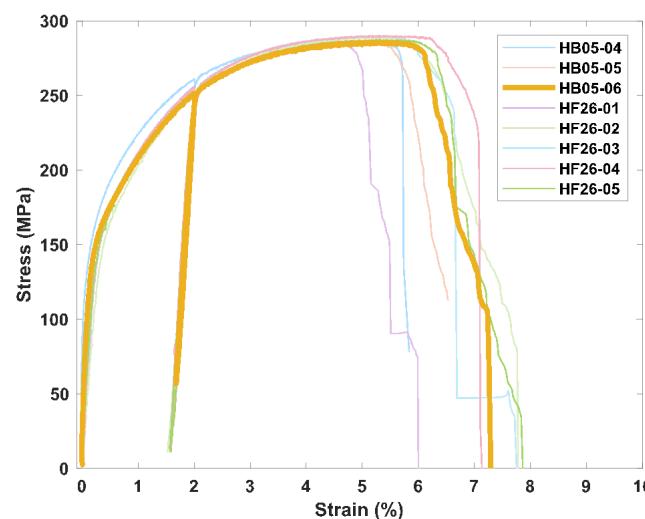
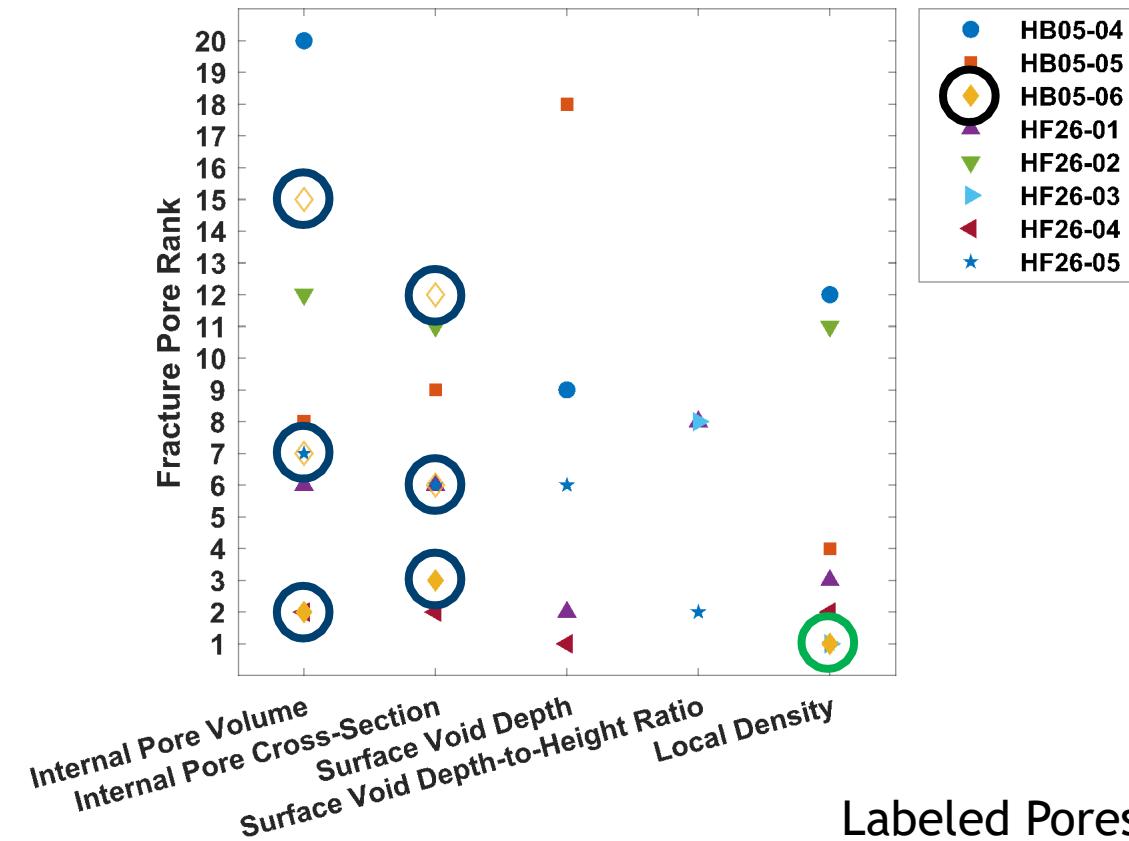
Failure of specimen HB05-06 was largely determined by local density and several large pores.

HF26-05	Internal Pore Volume	Internal Pore Cross-Section	Surface Void Depth	Surface Void Depth-to-Height	Local Density
<i>Rank</i>	2	3	77.5	47	1
<i>Pore Label</i>	41030	41030	43203	45059	1617
<i>Fracture Value</i>	1,113,681 μm^3	12,081 μm^2	72.2 μm	9.23	99.402 %
<i>Peak Value</i>	1,447,799 μm^3	13,191 μm^2	128.0 μm	20.25	99.402 %

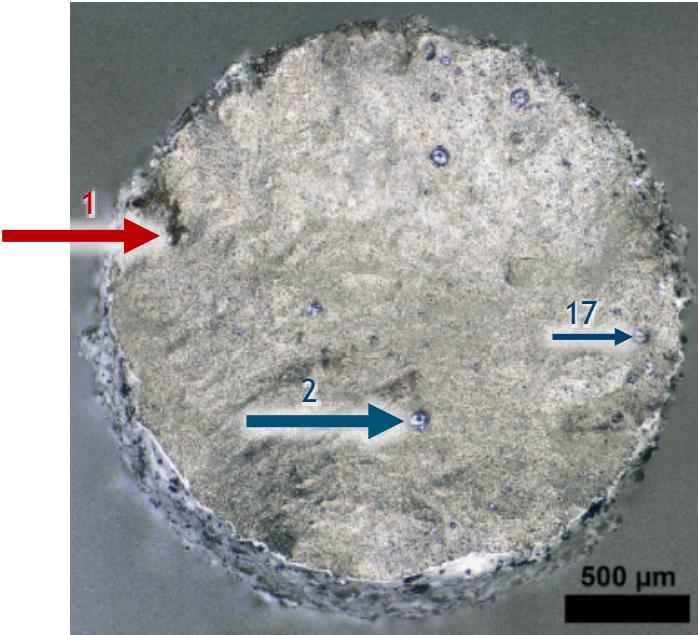
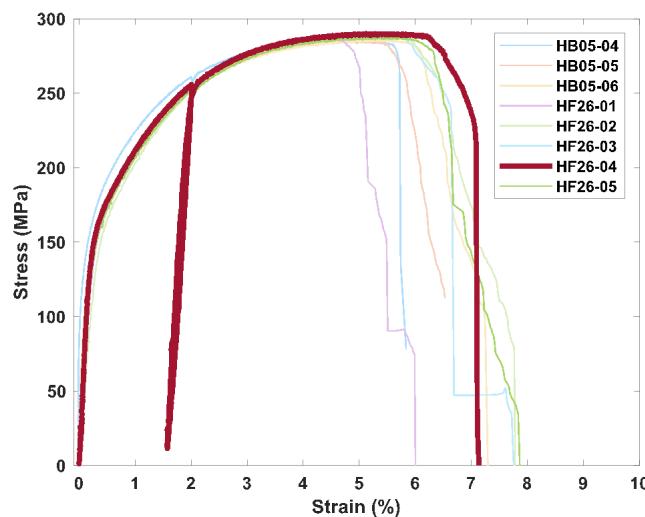
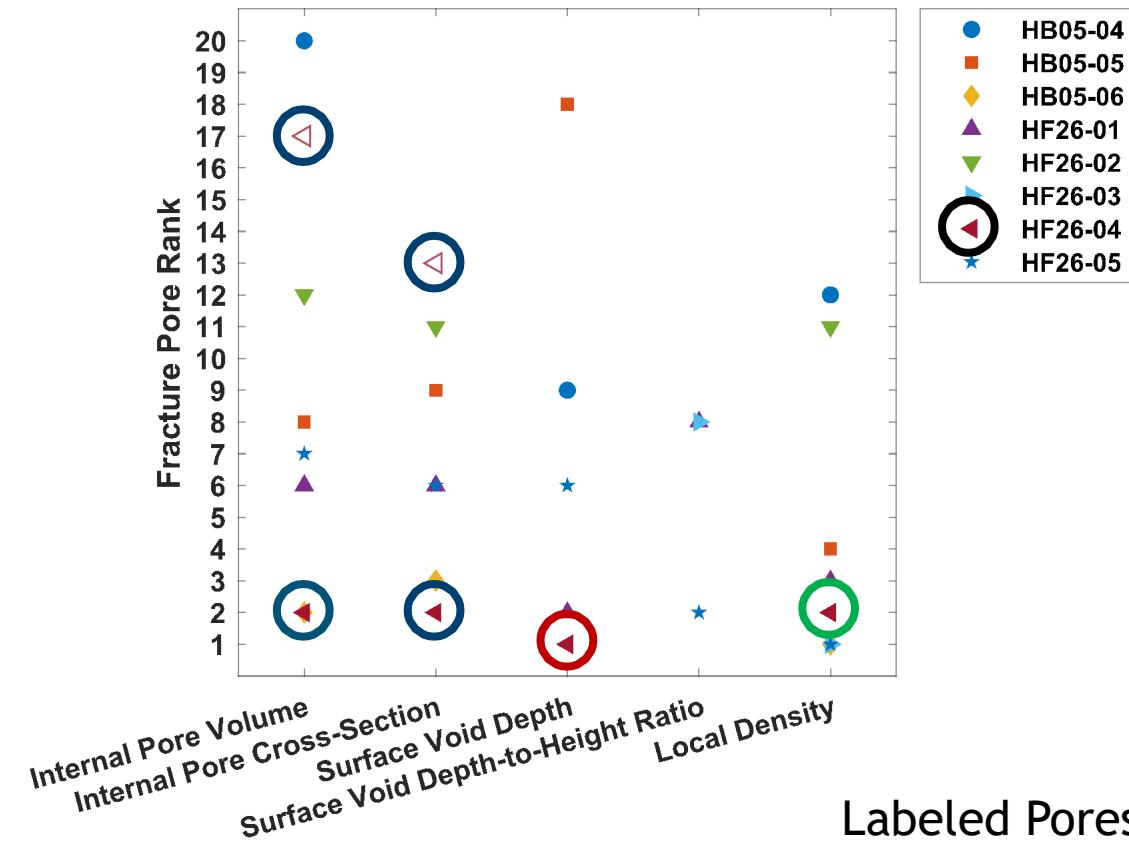
Failure of specimen HF26-04 was caused by many factors: a large surface flaw, several large internal voids, and low local density.

HF26-05	Internal Pore Volume	Internal Pore Cross-Section	Surface Void Depth	Surface Void Depth-to-Height	Local Density
Rank	2	2	1	43.5	3
Pore Label	7565	7565	9480	8040	1156
Fracture Value	580,576 μm^3	12,975 μm^2	264.4 μm	5.66	99.786 %
Peak Value	880,867 μm^3	14,514 μm^2	264.4 μm	15.68	99.783 %
