Integrity Assessment Plan for
PNL 300 Area Radioactive
Hazardous Waste Tank System

Final Report

March 1996

Prepared for Pacific Northwest National Laboratory
by Science Applications International Corporation
1845 Terminal Drive
Richland, Washington 99352
Under Contract Number 143920-A-C7

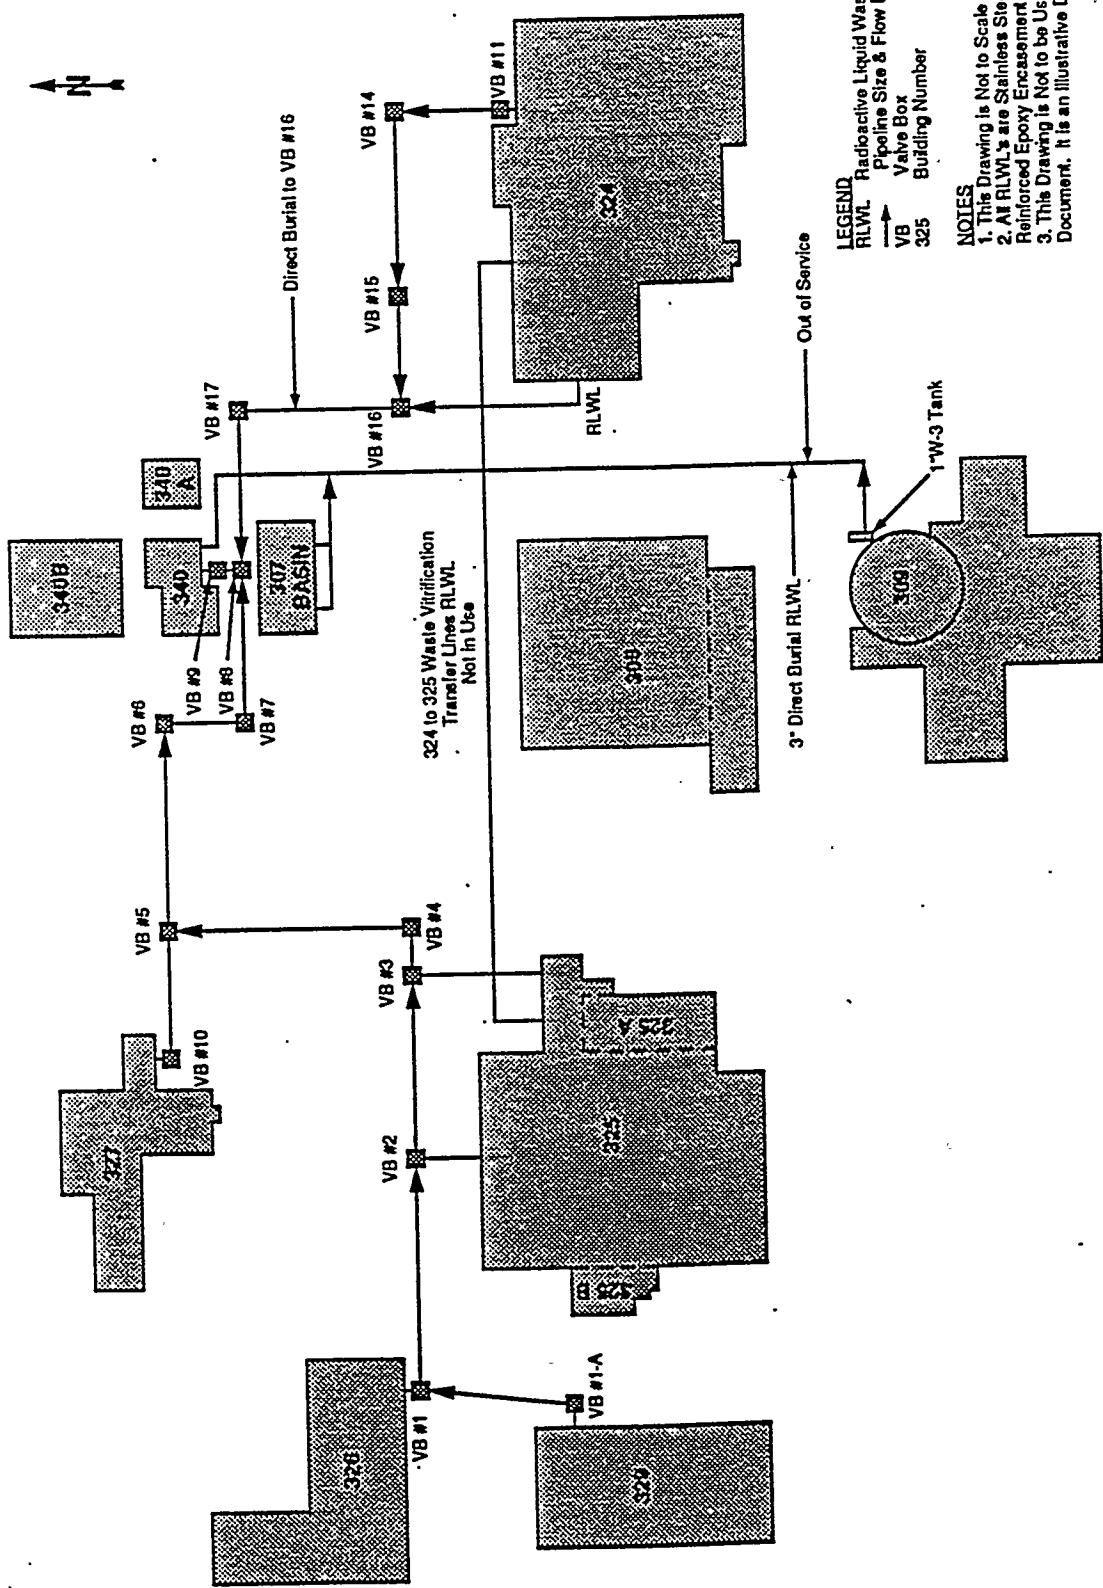
FIGURE 2.1. 300 Area Radioactive Liquid Waste System Schematic

The 324, 325, 326, 327 and 329 Buildings, which are managed by PNL, generate liquid radioactive and hazardous wastes that are accumulated and transferred to the 340 Building (Waste Management Facility) and the 340A and 340B Buildings for disposal. Westinghouse Hanford Company (WHC) manages the 340, 340A, and 340B Buildings and the underground RLWS. The 307 and 309 Buildings are not owned or managed by PNL.

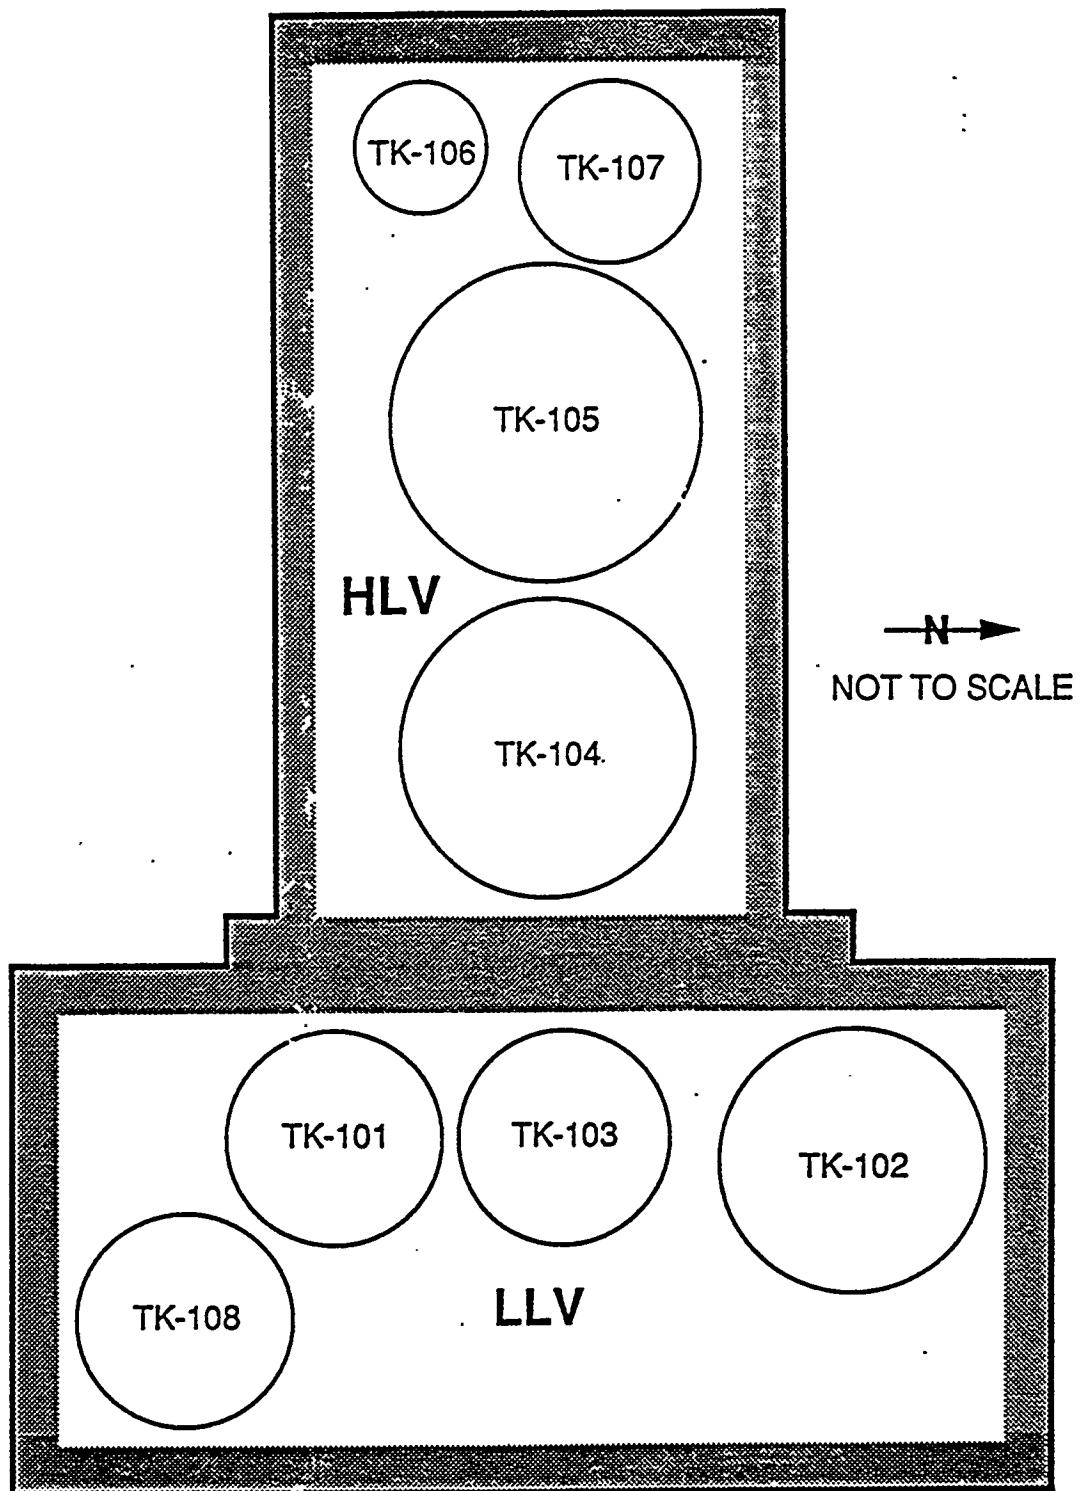
FIGURE 2.2. Tanks in the 324 Building

The RLWS within the 324 Building is composed of tanks and piping that discharges to the 340 Building; it excludes the diverter stations monitoring the RPS. Figure 2.2 shows the tank layout. Table 2.1 (provided at the end of Section 2.0) contains a description of the tanks associated with the 324 Building that will be addressed by this IAP. Transfer is accomplished by jetting the waste via the RLWS line, a double containment pipe with a leakage alarm. The 324 Building tanks serve the B-Cell, the load-out station (LOS), cubicle drains, the Room 18 diverter system pressure relief, tanks in the Low-Level Vault (LLV), the LLV sump, tanks in the High-Level Vault (HLV), the HLV sump, the Room 4 sump, the Room 147 glovebox and hood sink drain, Room 146 hood sink drains and safety shower drains, the truck lock sump, the personnel decontamination sink and shower drains, sink drains from Room 3F, and Tank TK-177, located in the wall of the fissile materials storage vault.

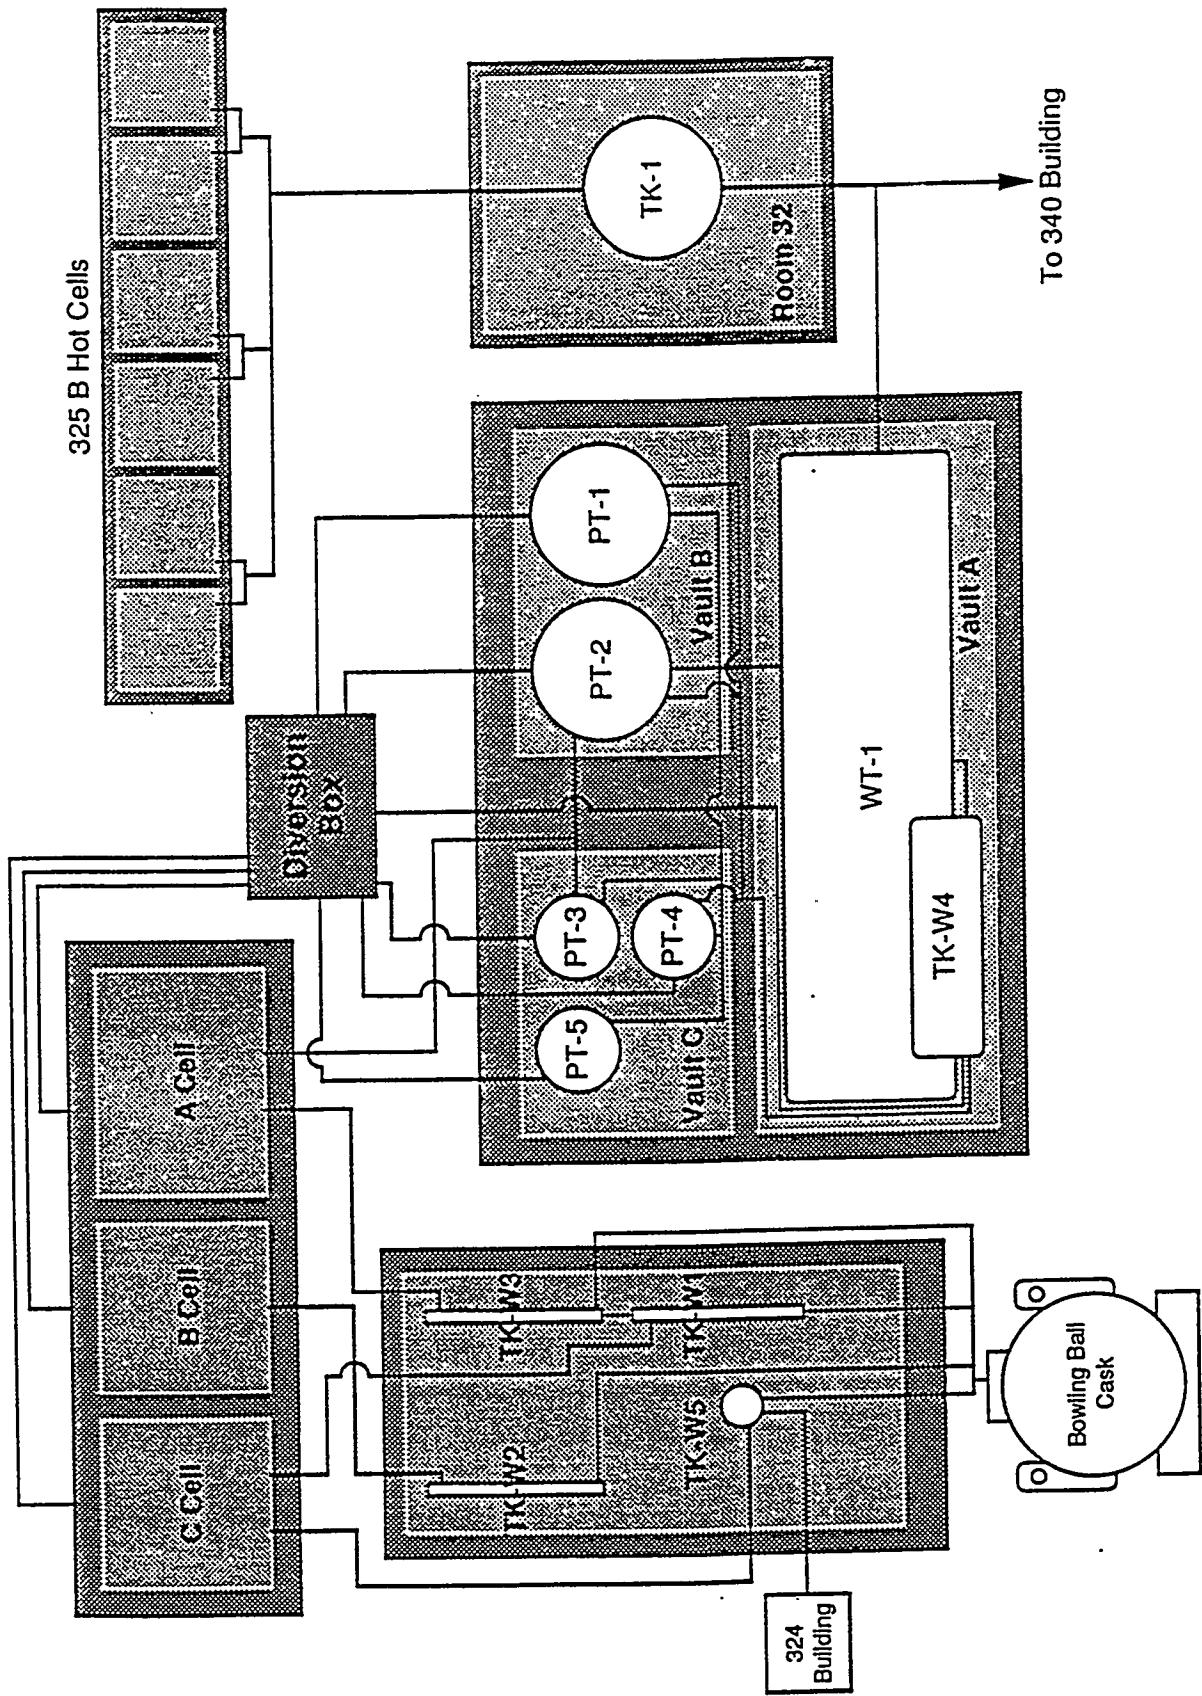
FIGURE 2.3. 325 Building Schematic Diagram

The 325 Building RLWS is composed of pipes and holding tanks within the 325 Building and the 325A High-Level Radiochemistry Facility (HLRF) and 325B Building additions. Waste from the pipes or holding tanks is jettied or pumped to the 340 Building via the RLWS line (a double containment pipe provided with a sump alarm if leakage occurred from the primary pipe) or to a cask in the liquid transfer hood, which is then transported by truck to the 200 Area tanks. The waste in holding tanks is sampled at the 325 Building before it is transferred to the 340 Building. However, one portion of the RLWS that includes a hood and floor drain (now plugged) in the central portion of the 325 Building is not connected to a holding tank. Waste through this portion flows directly through RLWS

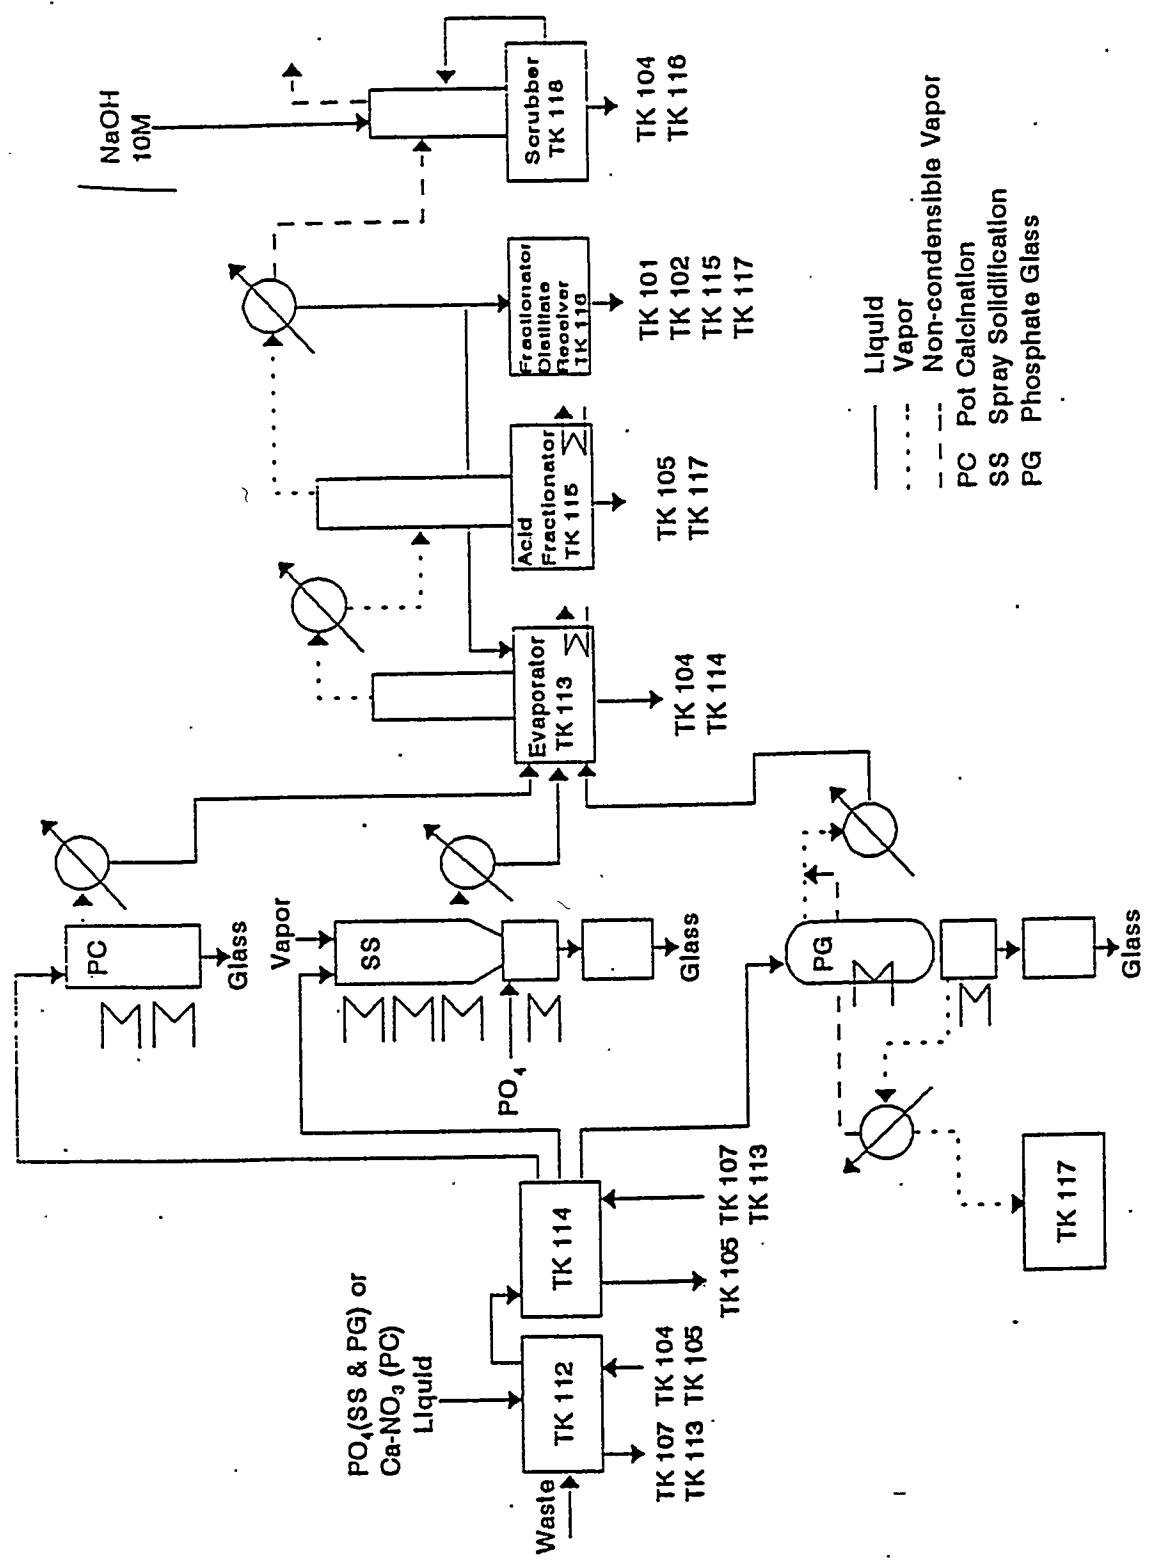
FIGURE 3.1. WSEP Auxiliary System

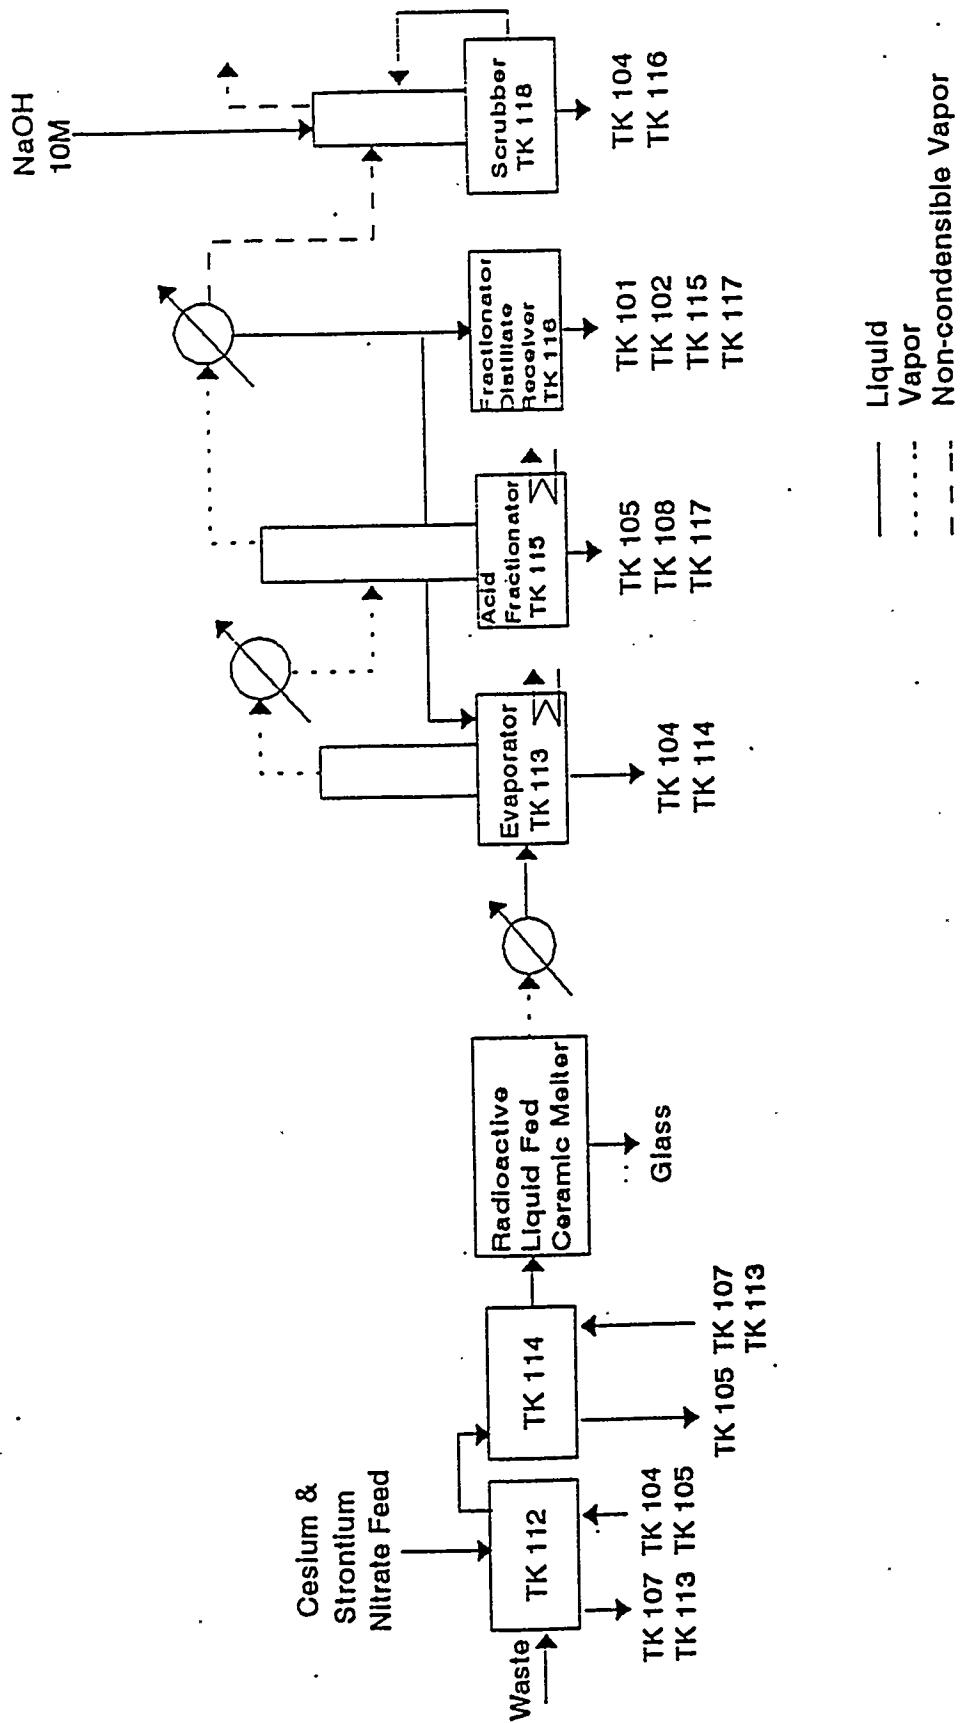
FIGURE 3.2. FRG Program Auxiliary Systems

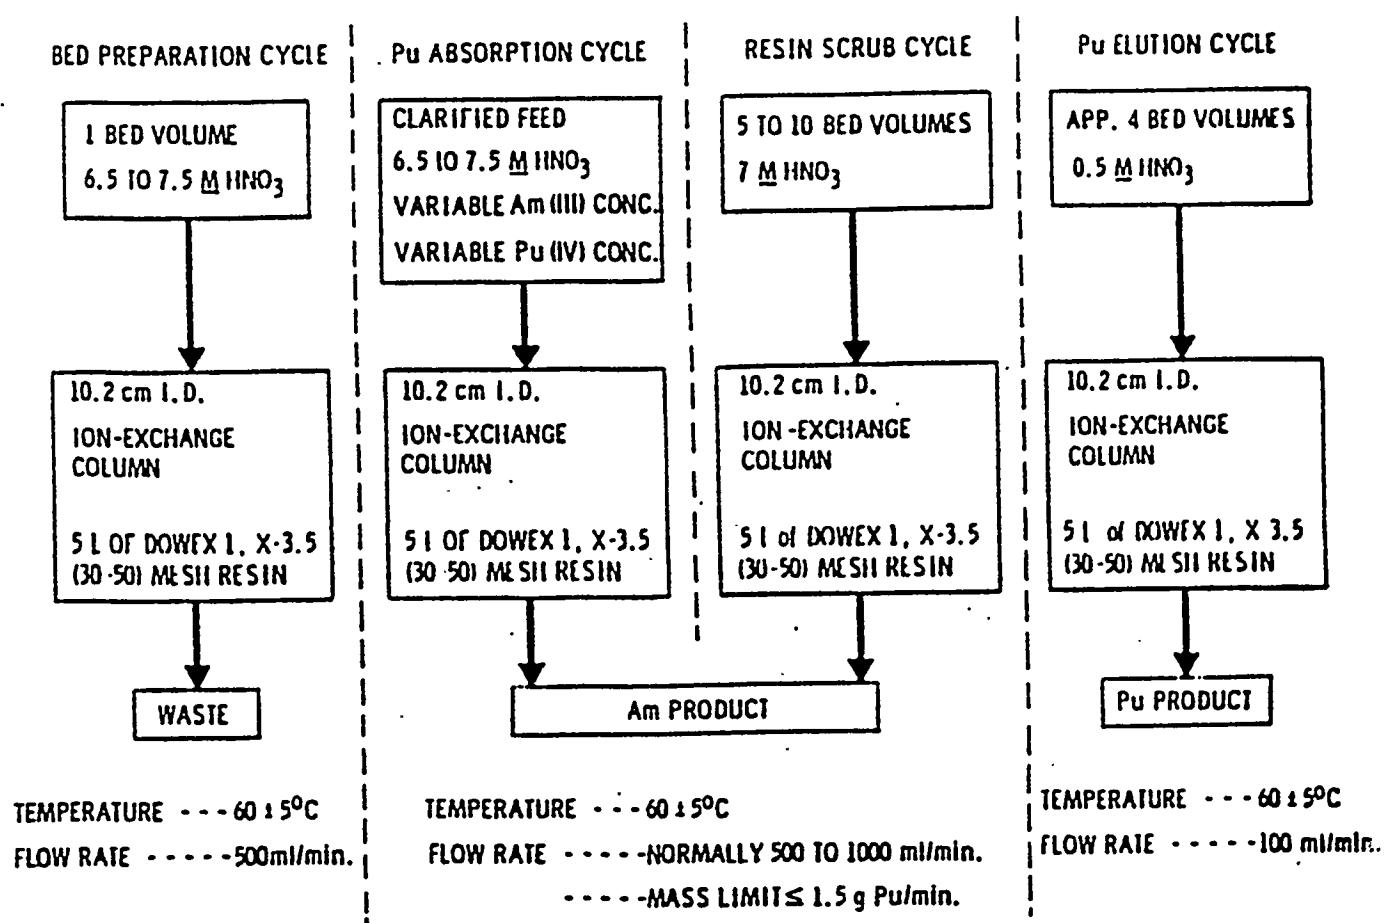
FIGURE 3.3. Flowsheet Used for the Anion-Exchange Separation of Americium from Plutonium

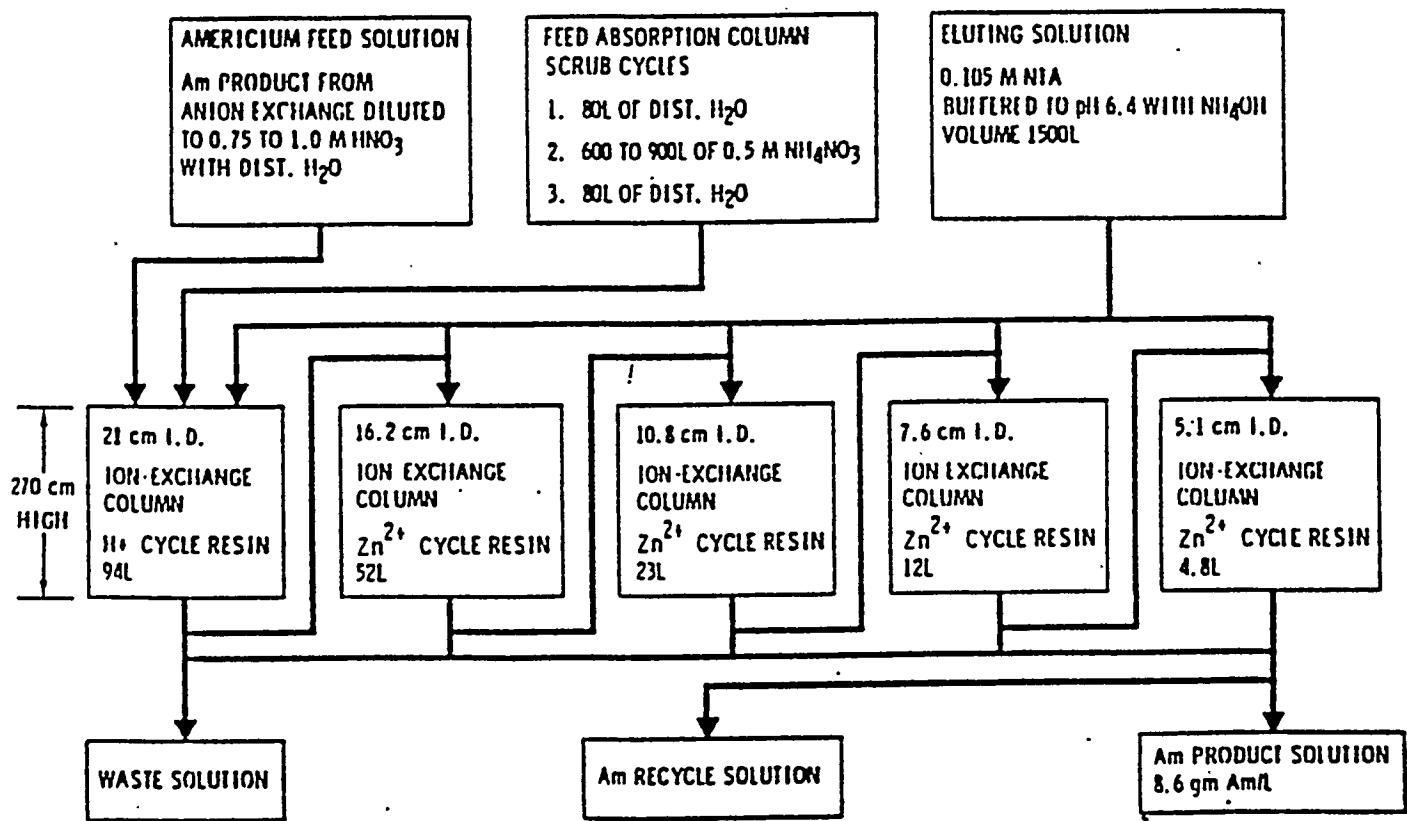
RESIN DOWEX 50W, X-8 150-100 MESH
 FEED AND SCRUB CYCLE TEMPERATURE AMBIENT
 ELUTION TEMPERATURE 60 ± 5°C
 FEED AND SCRUB CYCLE FLOW RATES 110 2 L/min
 ELUTION CYCLE FLOW RATE 8 ml/min · cm²
 RATE OF BAND ADVANCE 43 ± 4 cm/hr

FEED CYCLE FEED DEPENDENT
 SCRUB CYCLE 16 hrs
 ELUTION CYCLE 40 hrs

FIGURE 3.4. Flowsheet Used for the Cation-Exchange Purification of Americium

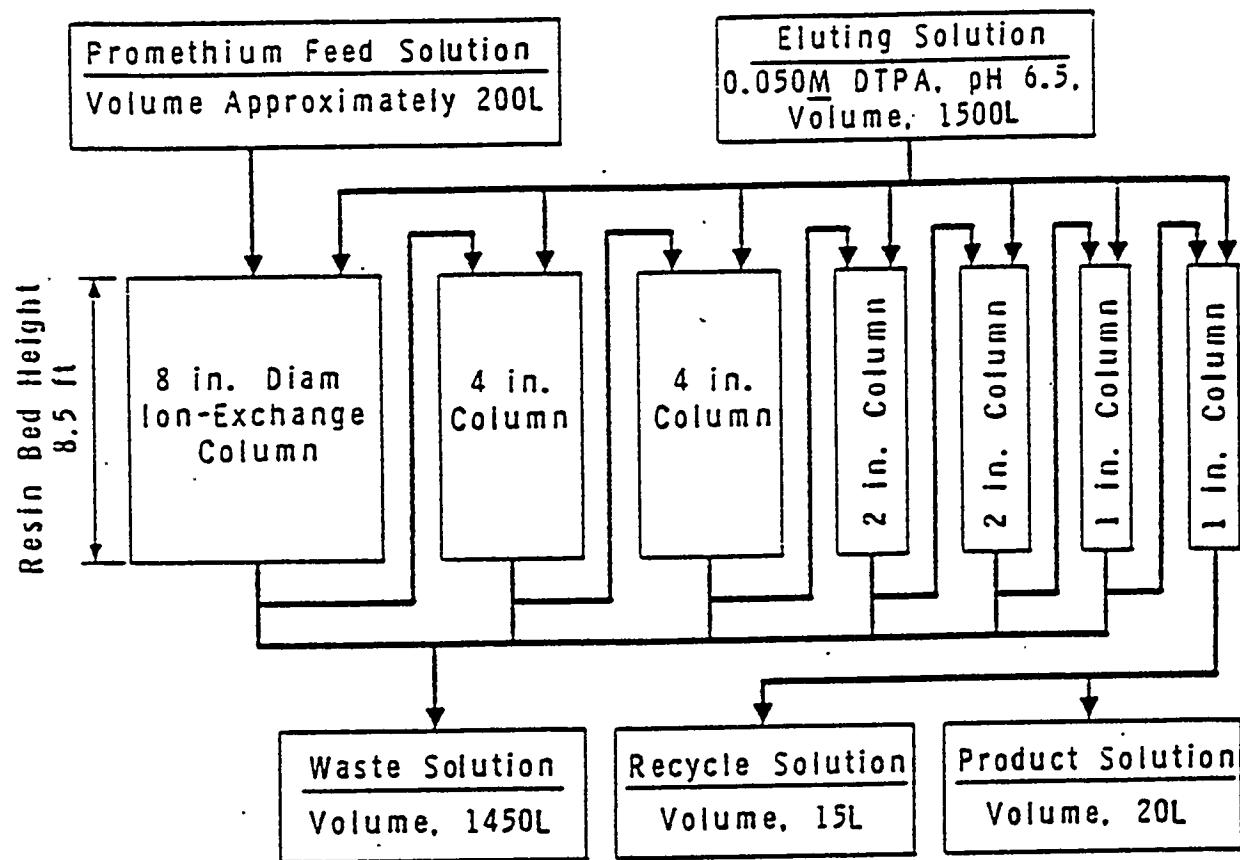
Elution Temperature	65 C
Elution Flow Rate	4 ml/min-cm ²
Rate of Band Advance	16-18 cm/hr

Absorption Cycle	4 hr
Elution Cycle	160 hr
Turn Around Time	72 hr

FIGURE 3.5. Promethium Purification Flowsheet

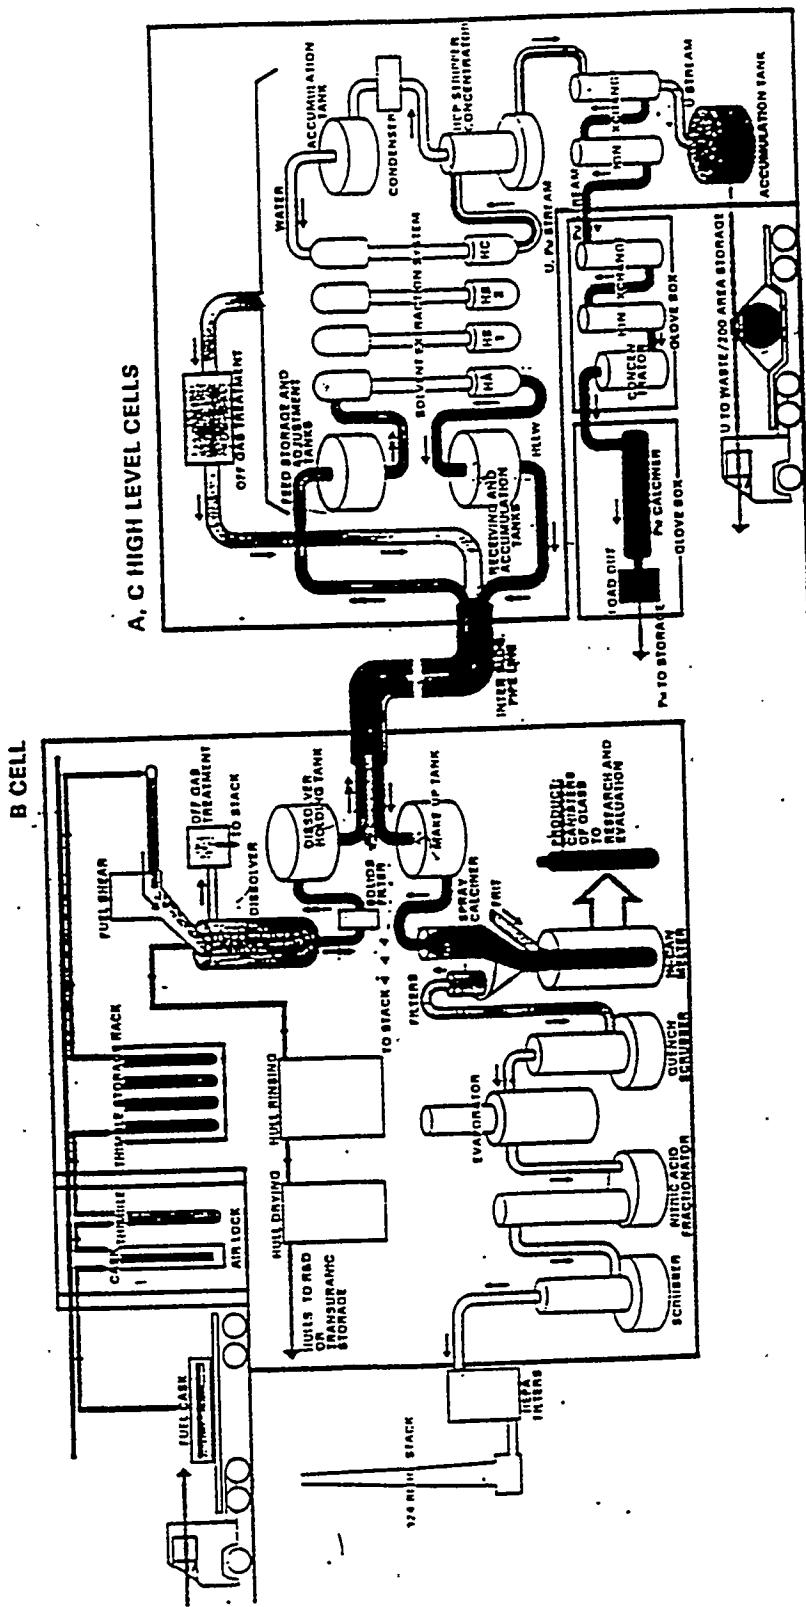
FIGURE 3.7. Nuclear Waste Vitrification Project

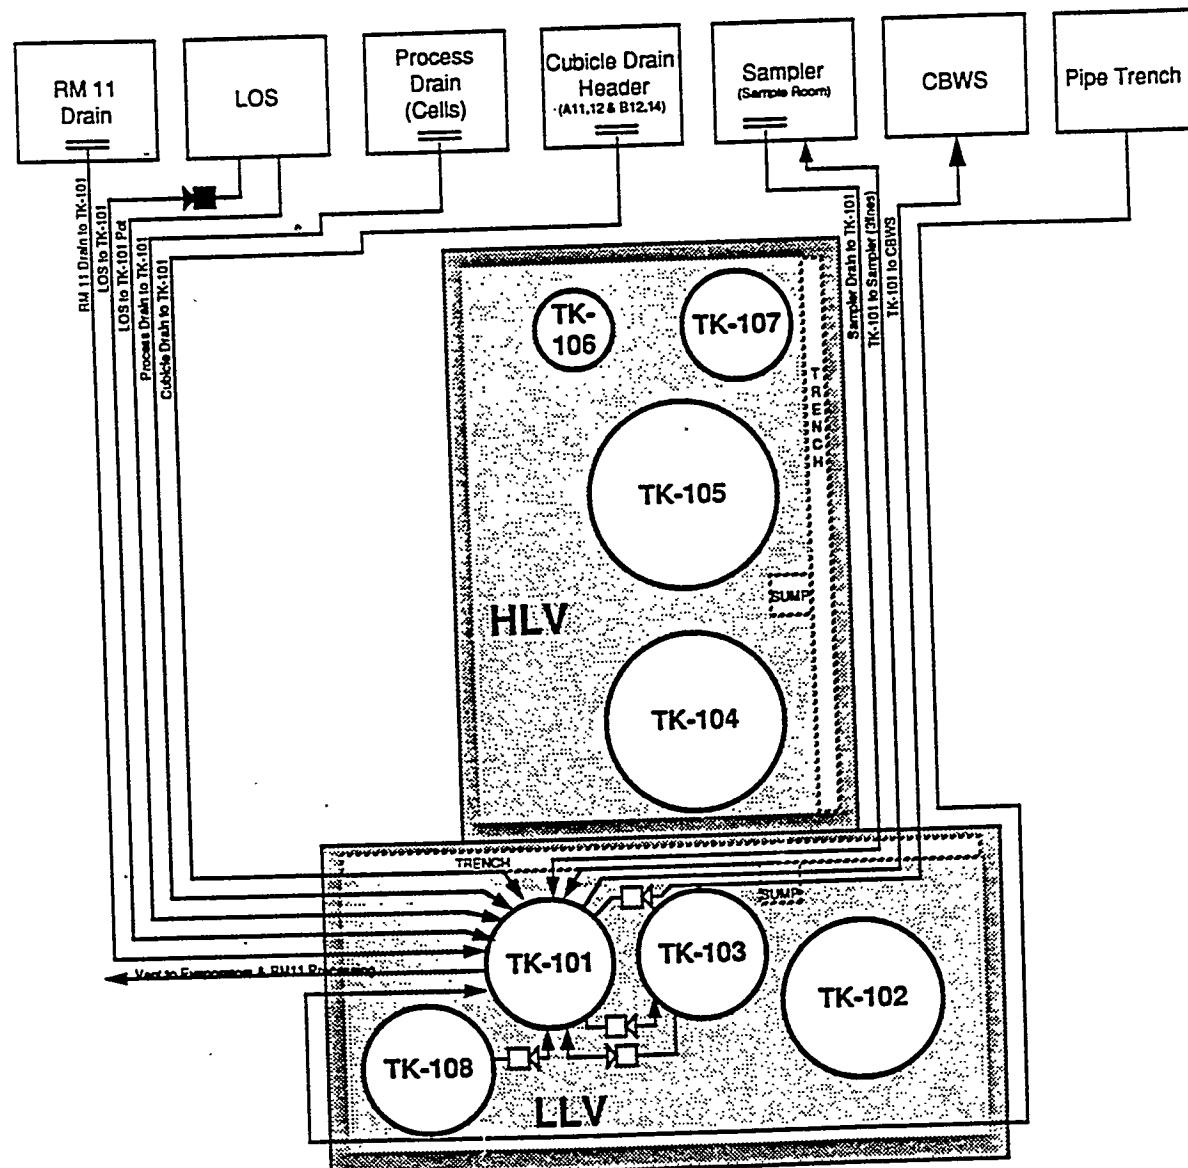
Figure 4.1

Nozzle Schematic TK-101, 324 Bldg.

- Instrument, Tank Pot Connection, and Compressed Air Lines Ommitted
- ◻ Jet Pump inside Vault (Regardless of Location on Graphic)
- Jet Pump outside Vault (Regardless of Location on Graphic)

Tanks TK-101, TK-103, and TK-108 are 6.5 ft in diameter by 13.86 ft high and have a storage capacity of 3,380 gal. Each tank's shell, top, and bottom plate consists of 0.5-in.-thick 25-12 CB stainless steel plate with a 1/8-in.-thick 18-8 CB stainless steel jacket, to enable circumferential heating and cooling of the tanks. The tank rests on 18 pads placed in two concentric circles about the longitudinal axis of the tank and one in the center. The roof of the tank is flat and the floor is sloped. The tank operates at a very slight negative pressure.

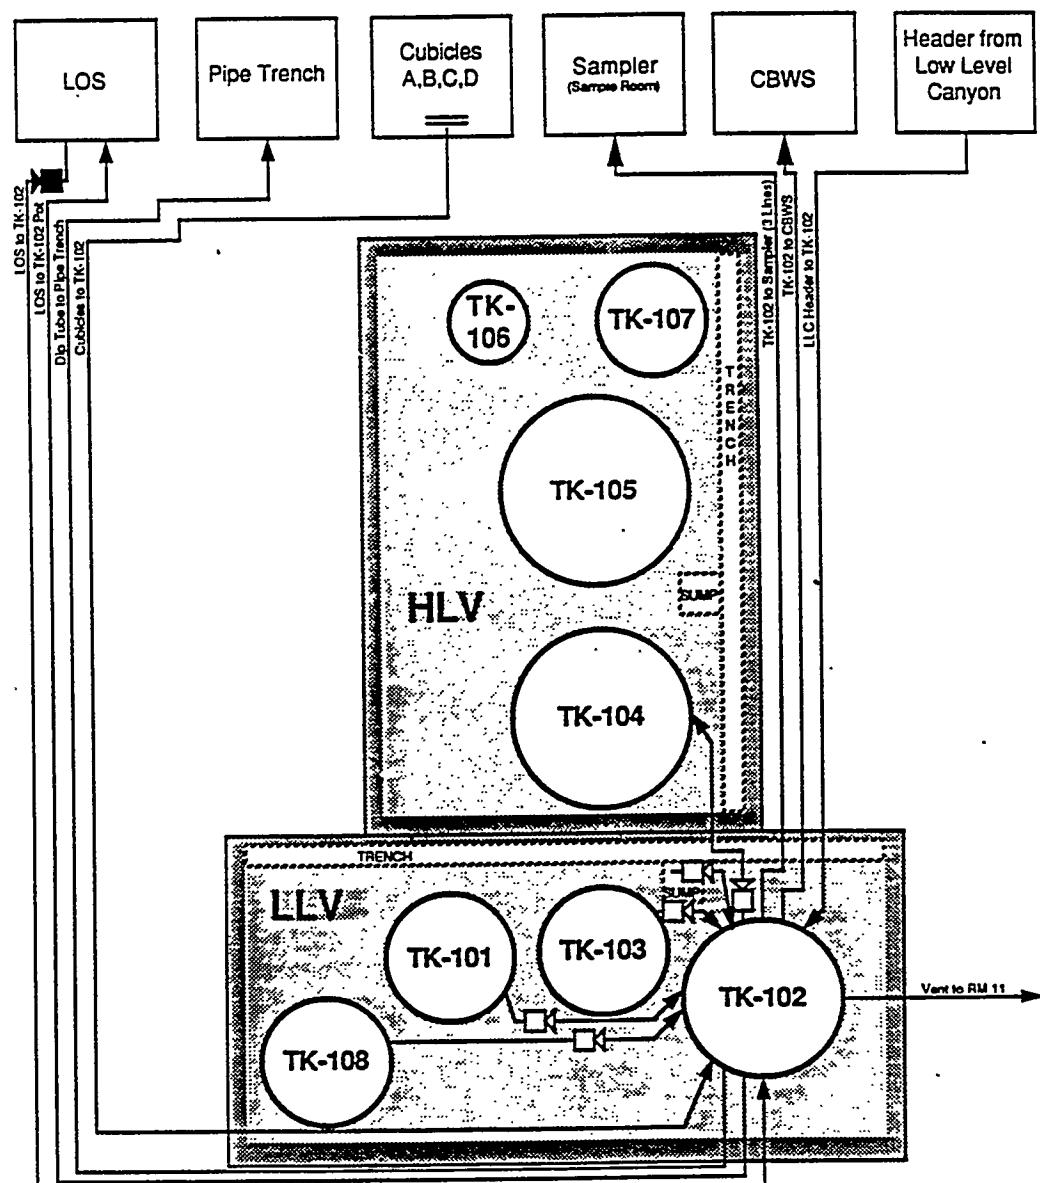
Figure 4.2

Nozzle Schematic TK-102, 324 Bldg.

- Instrument, Tank Pot Connection, and Compressed Air Lines Omitted

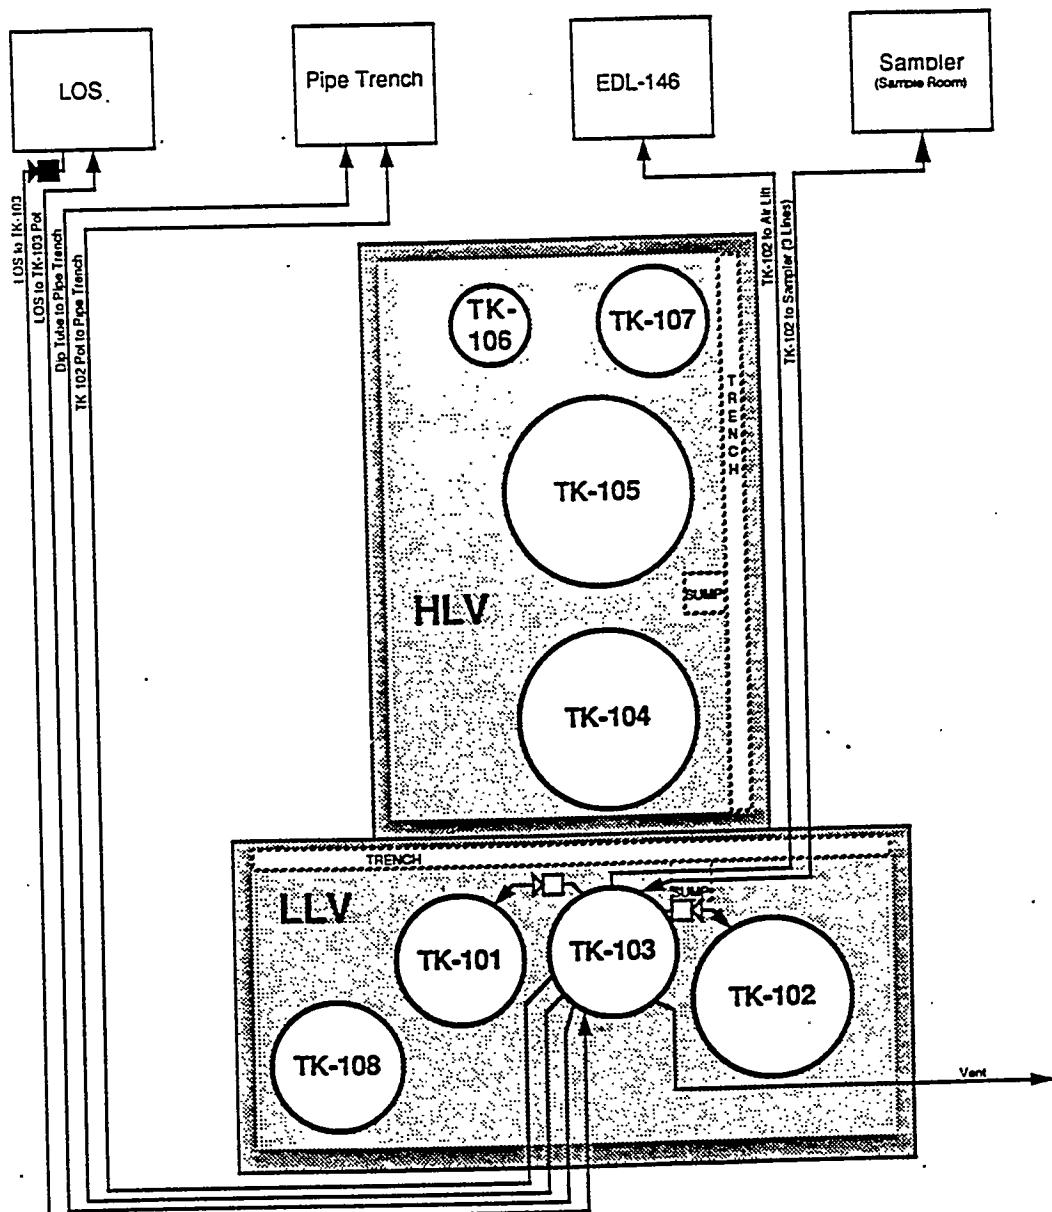
Figure 4.3

Nozzle Schematic TK-103, 324 Bldg.

- Instrument, Tank Pot Connection, and Compressed Air Lines Ommitted
- ◻ Jet Pump inside Vault (Regardless of Location on Graphic)
- Jet Pump outside Vault (Regardless of Location on Graphic)

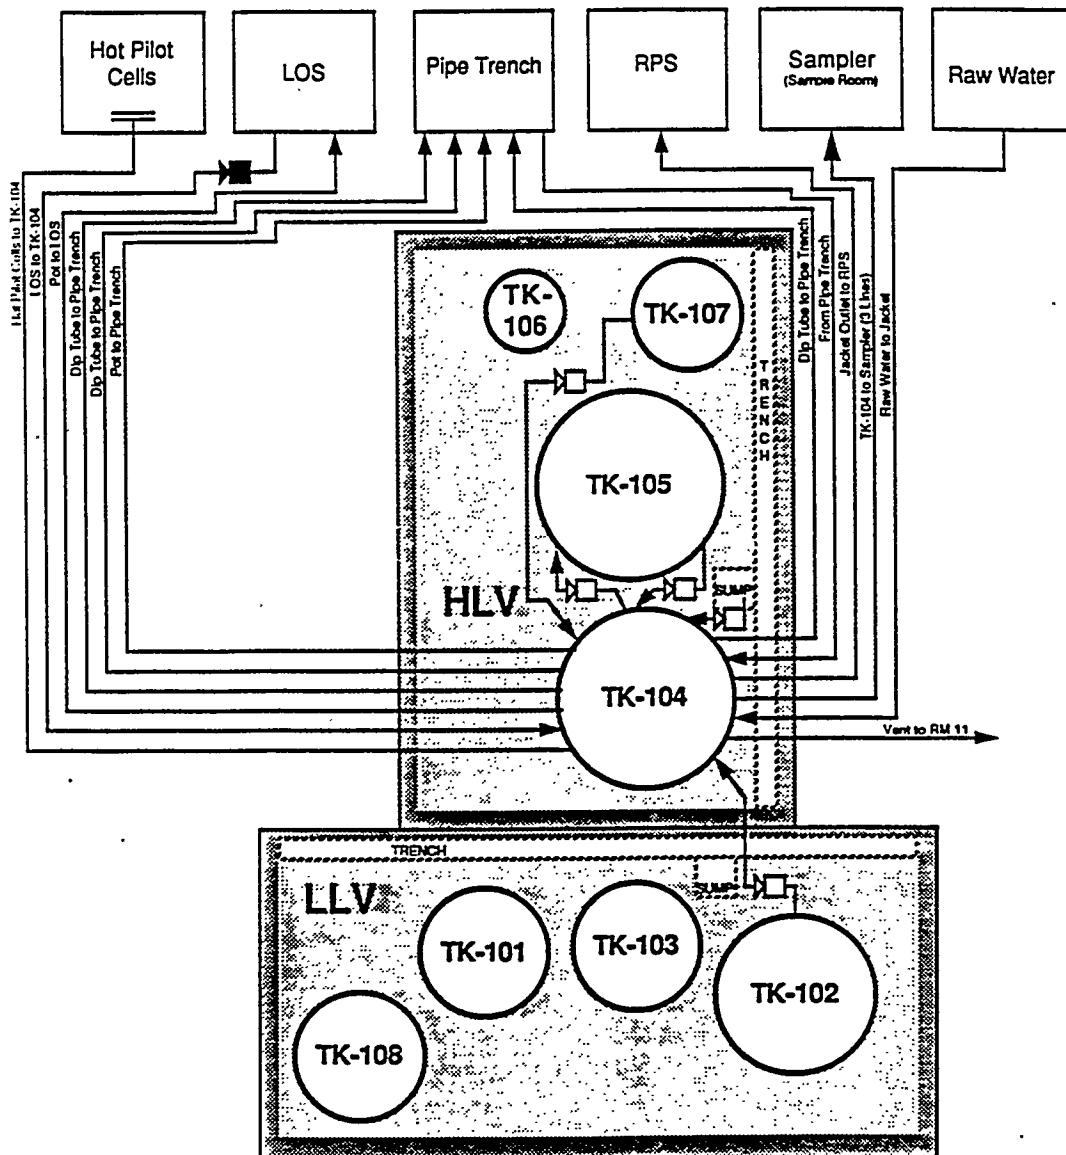
Figure 4.4

Nozzle Schematic TK-104, 324 Bldg.

- Instrument, Tank Pot Connection, and Compressed Air Lines Omitted
- Jet Pump inside Vault (Regardless of Location on Graphic)
- Jet Pump outside Vault (Regardless of Location on Graphic)

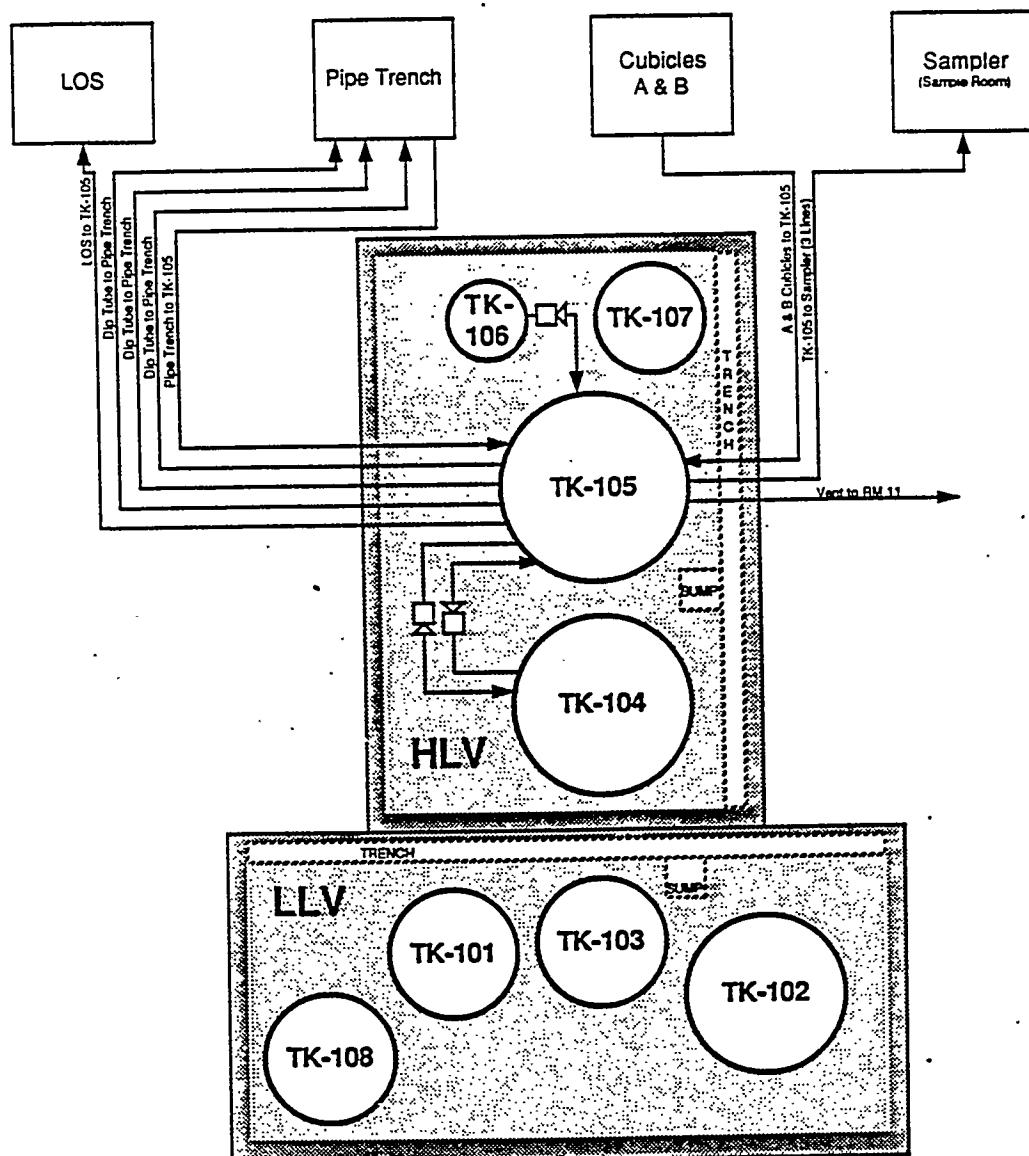
Figure 4.5

Nozzle Schematic TK-105, 324 Bldg.

- Instrument, Tank Pot Connection, and Compressed Air Lines Ommitted
- Jet Pump inside Vault (Regardless of Location on Graphic)
- Jet Pump outside Vault (Regardless of Location on Graphic)

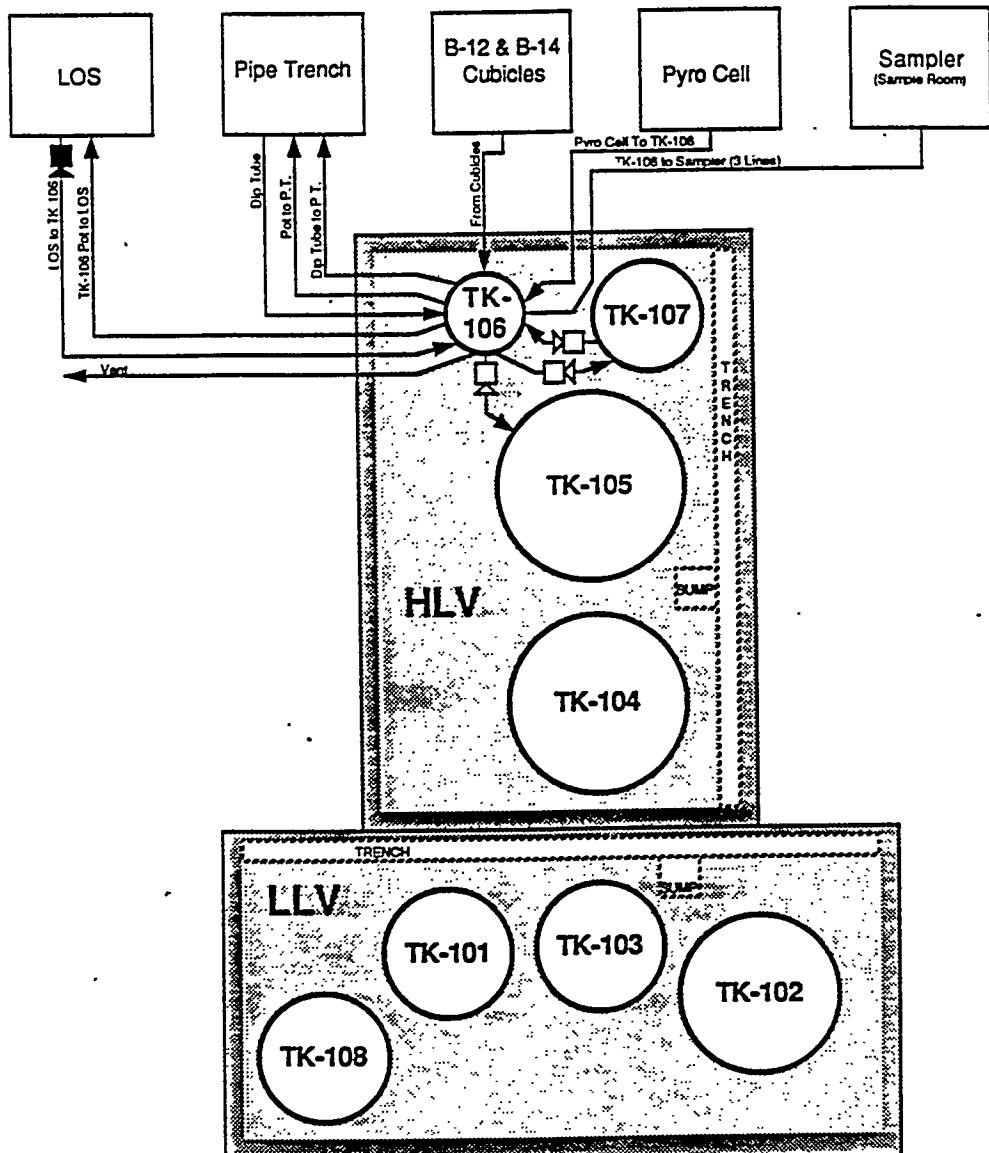
Figure 4.6

Nozzle Schematic TK-106, 324 Bldg.

- Instrument, Tank Pot Connection, and Compressed Air Lines Omitted
- Jet Pump inside Vault (Regardless of Location on Graphic)
- Jet Pump outside Vault (Regardless of Location on Graphic)

Tank TK-106 is 4.0 ft in diameter by 5.00 ft high and has a storage capacity of 450 gal. The tank's walls and bottom consist of 1/4-in.-thick stainless steel plate with a 3/16-in.-thick stainless steel plate jacket. The tank roof consists of 3/8-in.-thick stainless steel plate. The roof of the tank is flat and the floor is sloped. The tank operates at a very slight negative pressure.
