Integrity Assessment Plan for
PNL 300 Area Radioactive
Hazardous Waste Tank System

Final Report

March 1996

Prepared for Pacific Northwest National Laboratory
by Science Applications International Corporation
1845 Terminal Drive
Richland, Washington 99352
Under Contract Number 143920-A-C7

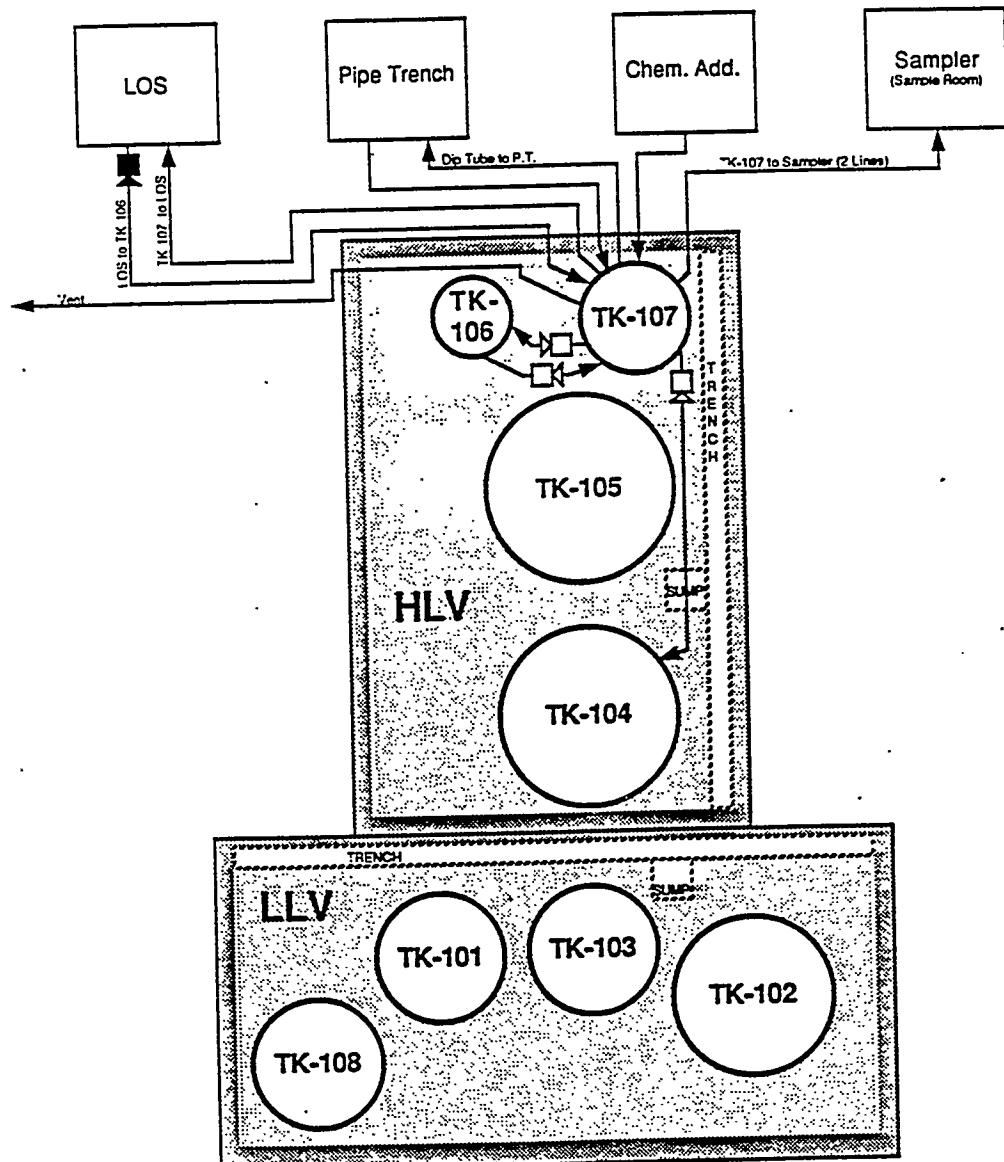
Figure 4.7

Nozzle Schematic TK-107, 324 Bldg.

Tank TK-107 is 5.5 ft in diameter by 6.0 ft high and has a storage capacity of 974 gal. The tank's walls, top, and bottom consist of 1/4-in.-thick type 304L stainless steel

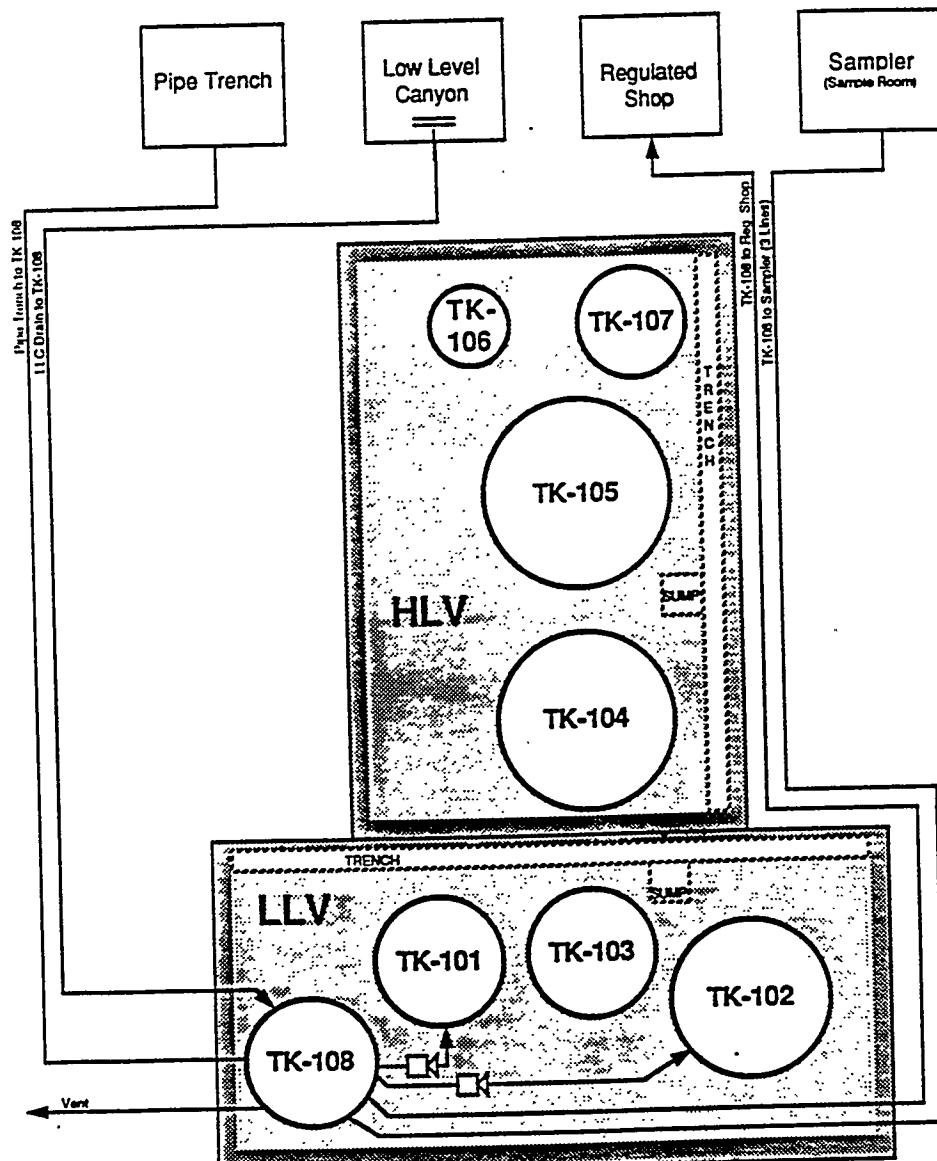
Figure 4.8

Nozzle Schematic TK-108, 324 Bldg.

- Instrument, Tank Pot Connection, and Compressed Air Lines Ommited
- Jet Pump inside Vault (Regardless of Location on Graphic)
- Jet Pump outside Vault (Regardless of Location on Graphic)

Tanks TK-101, TK-103, and TK-108 are 6.5 ft in diameter by 13.86 ft high and have a storage capacity of 3,380 gal. Each tank's shell, top, and bottom plate consists of 0.5-in.-thick 25-12 CB stainless steel plate with a 1/8-in.-thick 18-8 CB stainless steel jacket, to enable circumferential heating and cooling of the tanks. The tank rests on 18 pads placed in two concentric circles about the longitudinal axis of the tank and one in the center. The roof of the tank is flat and the floor is sloped. The tank operates at a very slight negative pressure.

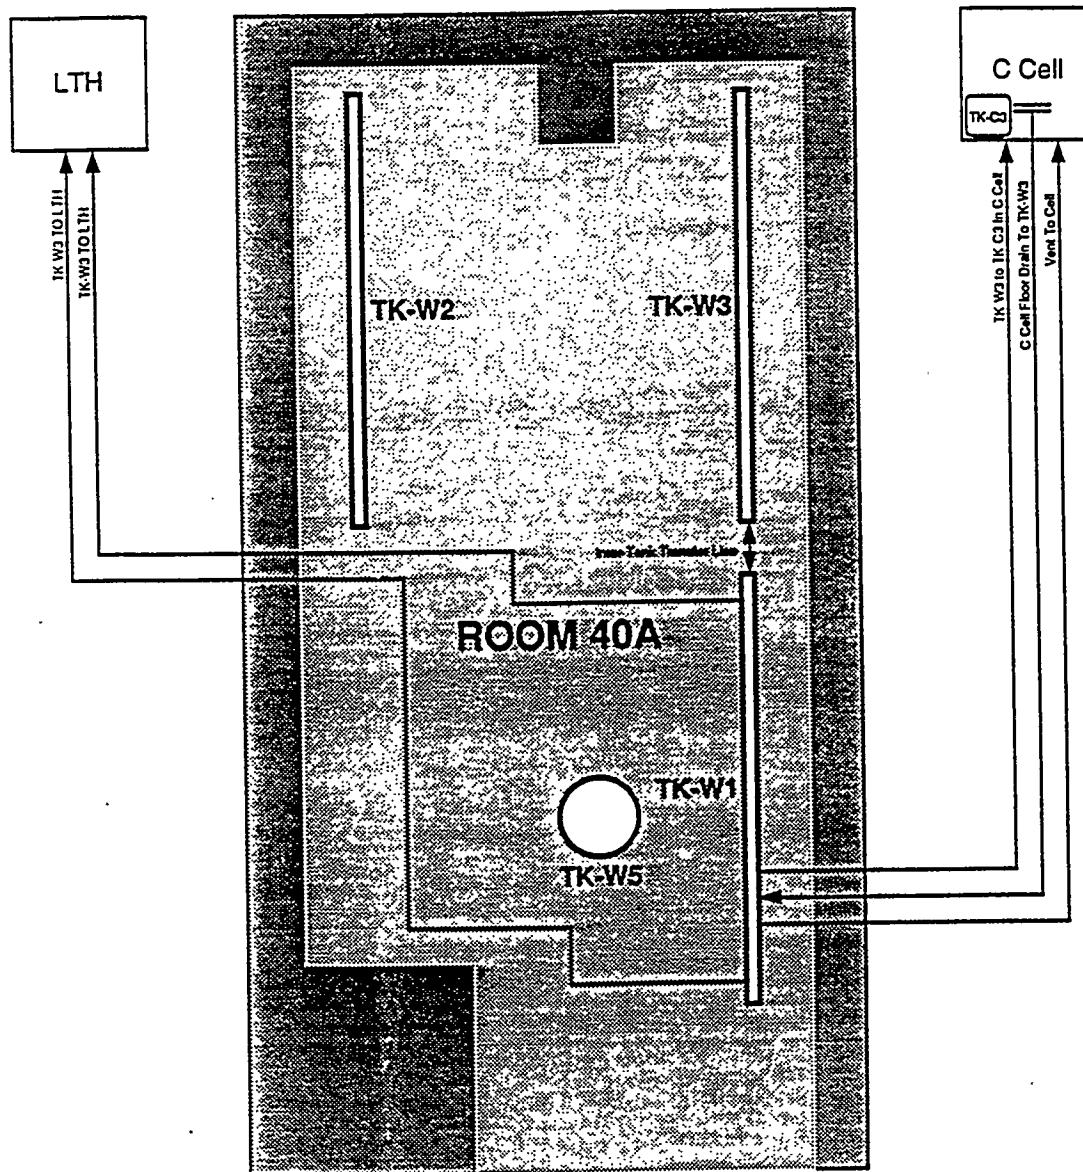
Figure 4.9

Nozzle Schematic TK-W1, 325 Bldg.

- Instrument, Tank Pot Connection, and Compressed Air Lines Omitted
- Jet Pump inside Vault (Regardless of Location on Graphic)
- Jet Pump outside Vault (Regardless of Location on Graphic)

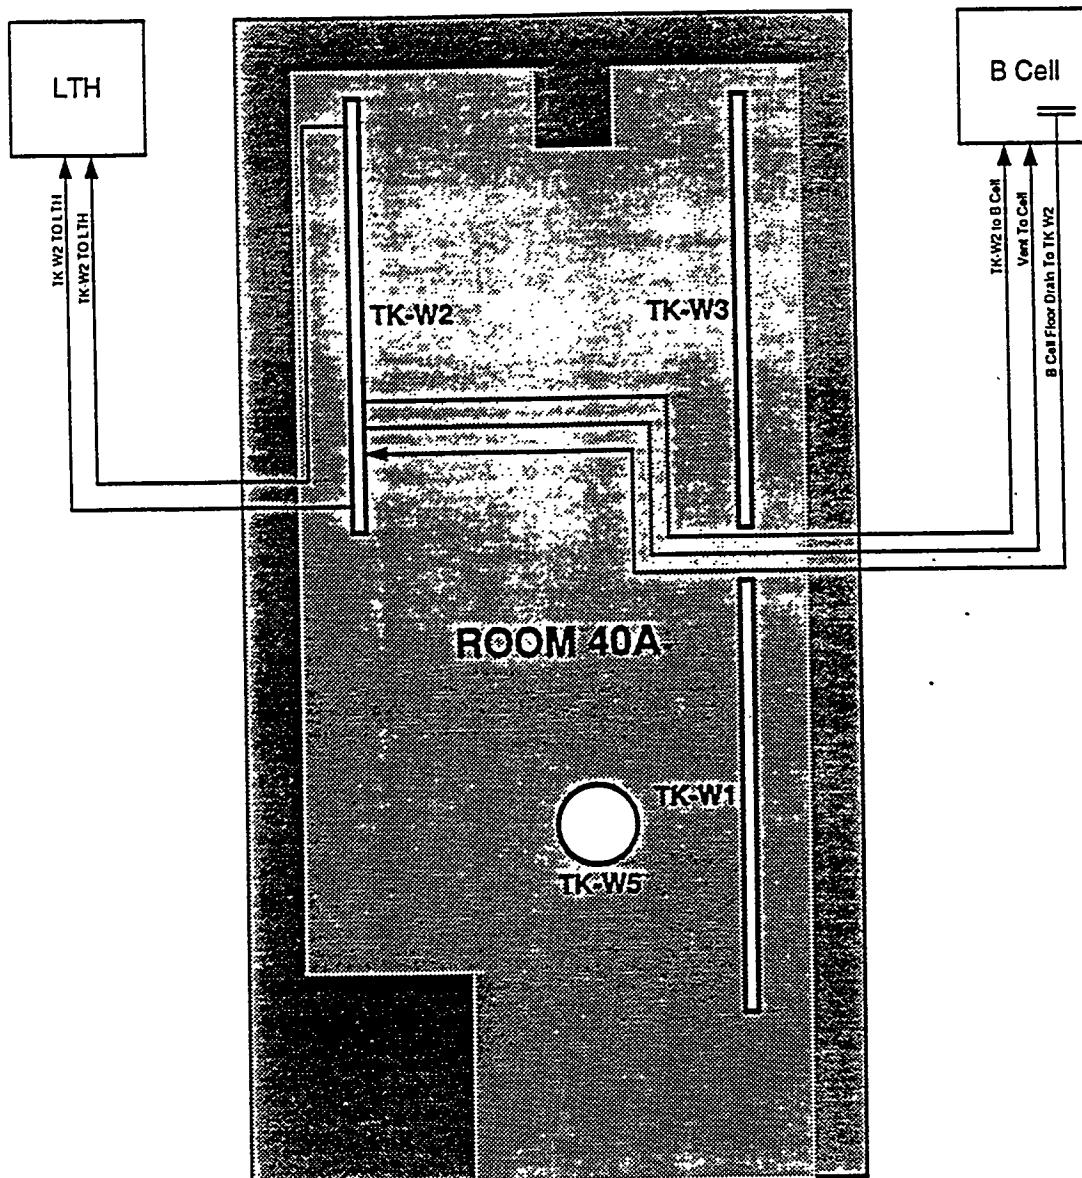
Figure 4.10

Nozzle Schematic TK-W2, 325 Bldg.

- Instrument, Tank Pot Connection, and Compressed Air Lines Omitted
- Jet Pump inside Vault (Regardless of Location on Graphic)
- Jet Pump outside Vault (Regardless of Location on Graphic)

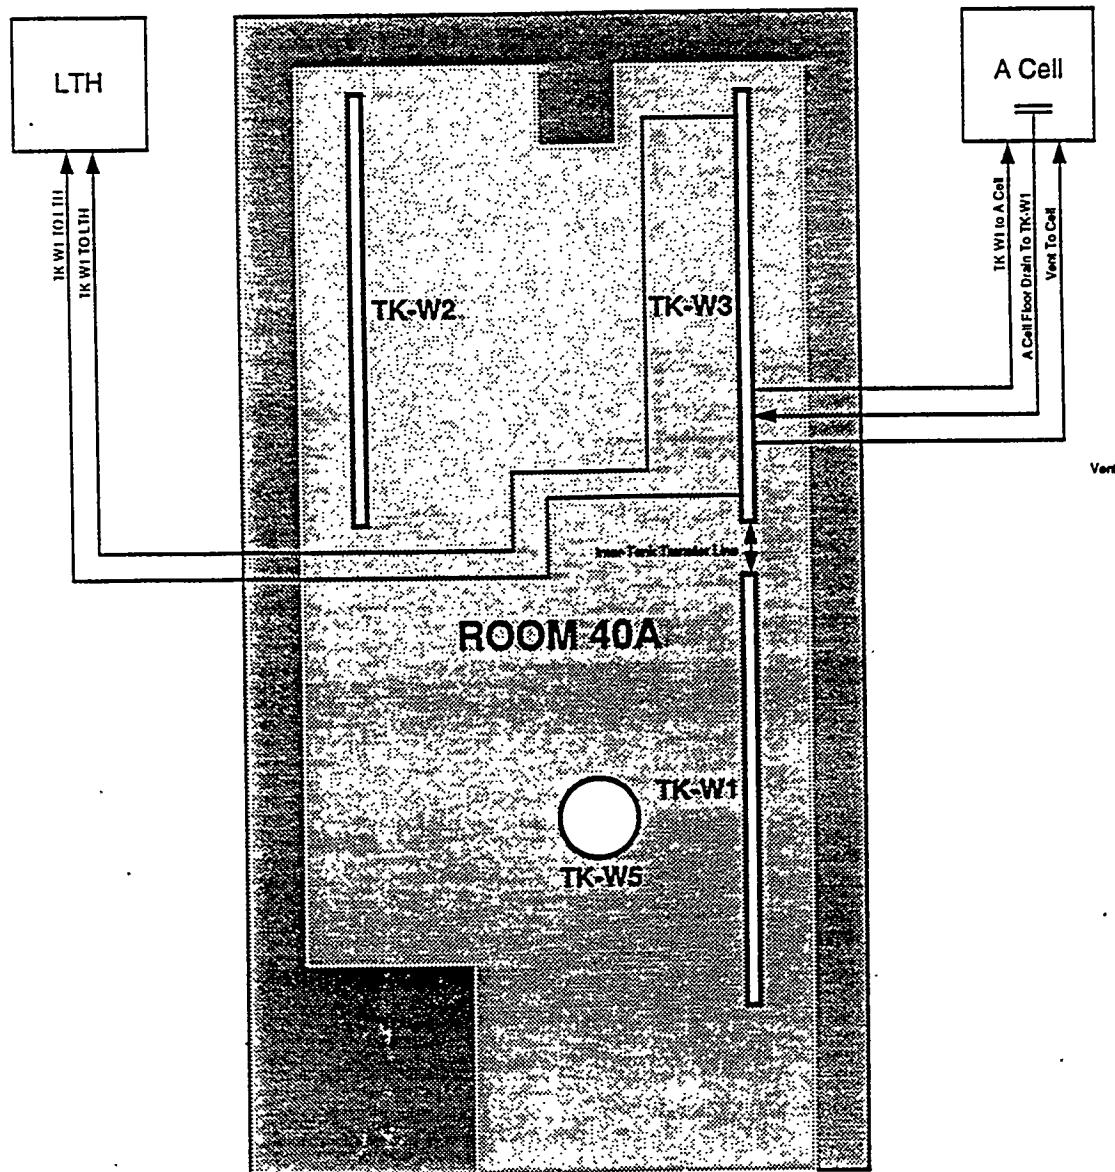
Figure 4.11

Nozzle Schematic TK-W3, 325 Bldg.

- Instrument, Tank Pot Connection, and Compressed Air Lines Omitted
- Jet Pump inside Vault (Regardless of Location on Graphic)
- Jet Pump outside Vault (Regardless of Location on Graphic)

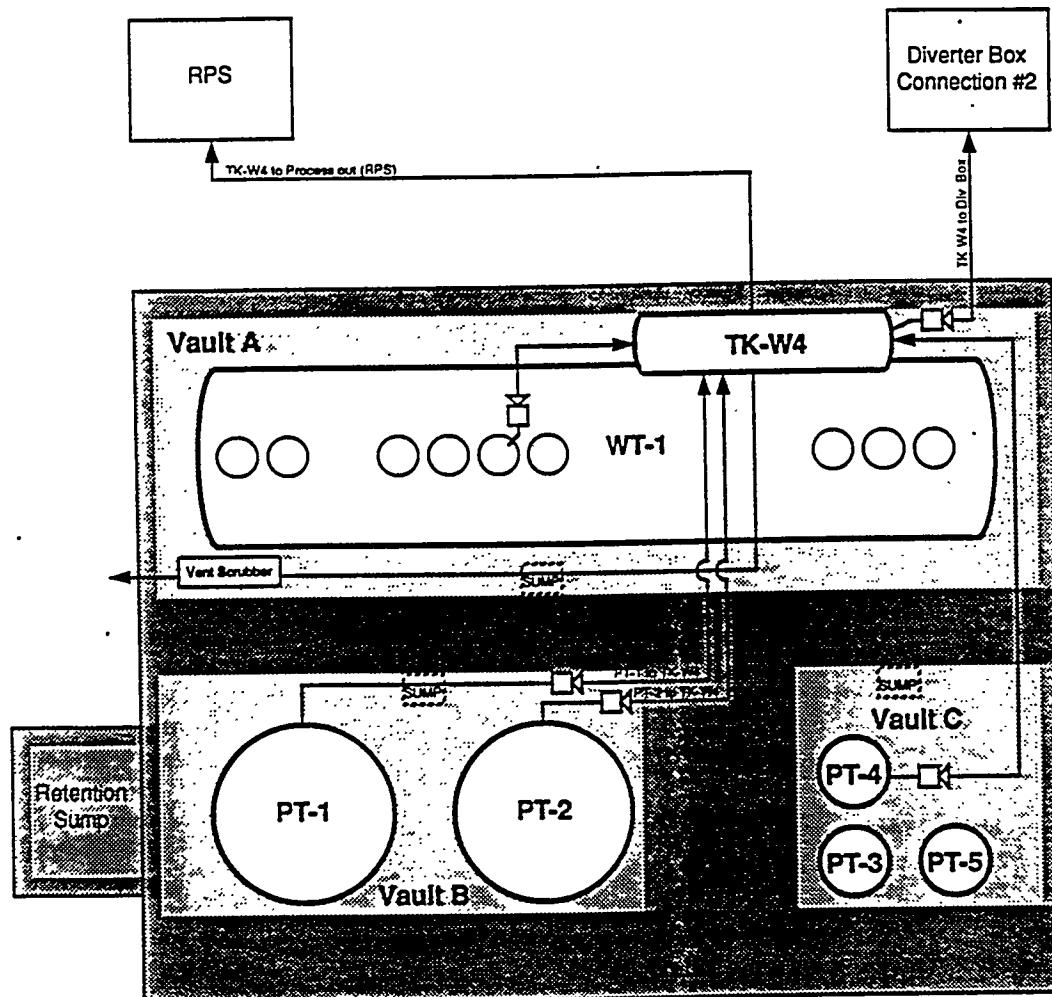
Figure 4.12

Nozzle Schematic TK-W4, 325 Bldg.

- Instrument, Tank Pot Connection, and Compressed Air Lines Omitted
- Jet Pump inside Vault (Regardless of Location on Graphic)
- Jet Pump outside Vault (Regardless of Location on Graphic)

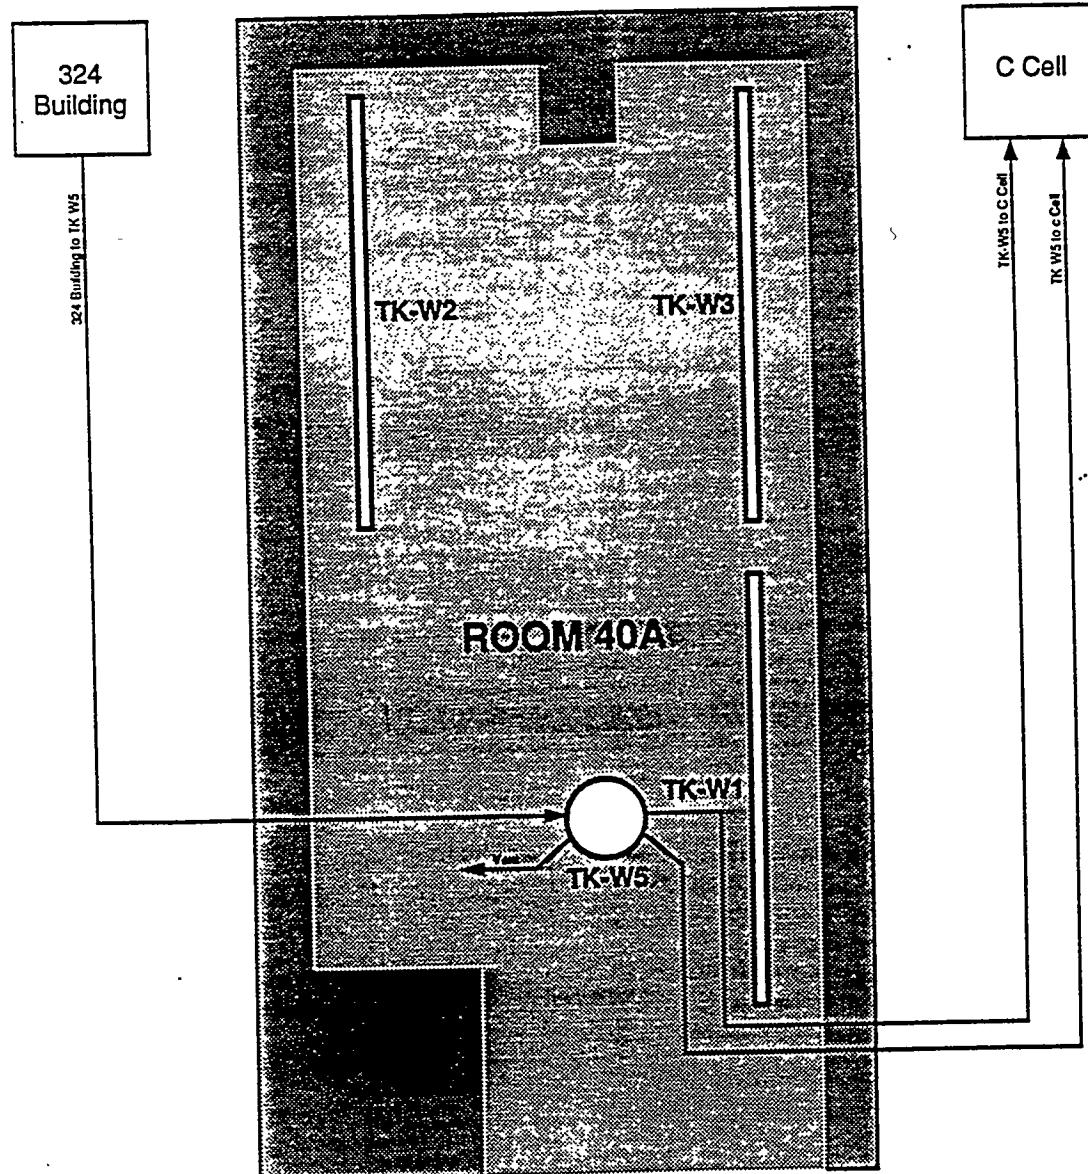
Figure 4.13

Nozzle Schematic TK-W5, 325 Bldg.

- Instrument, Tank Pot Connection, and Compressed Air Lines Omitted
- Jet Pump inside Vault (Regardless of Location on Graphic)
- Jet Pump outside Vault (Regardless of Location on Graphic)

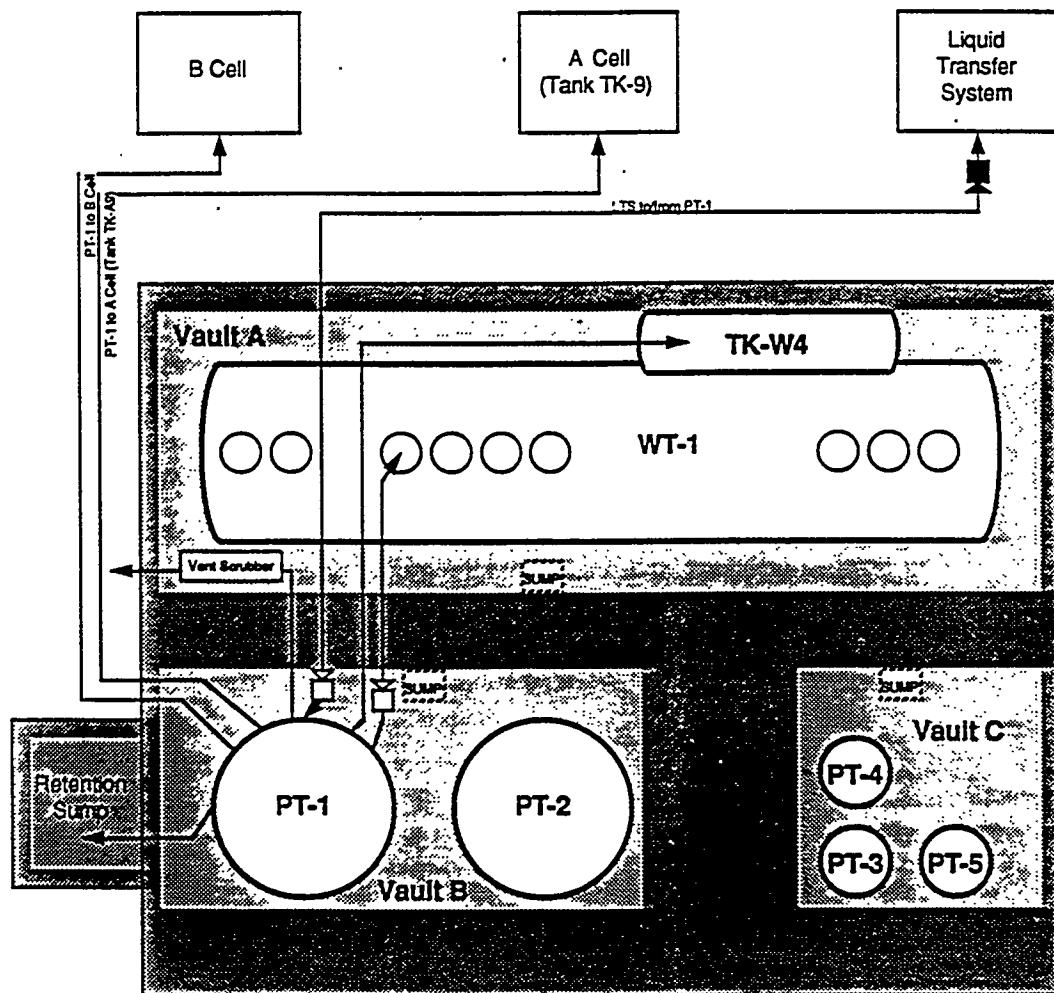
Figure 4.14

Nozzle Schematic PT-1, 325 Bldg.

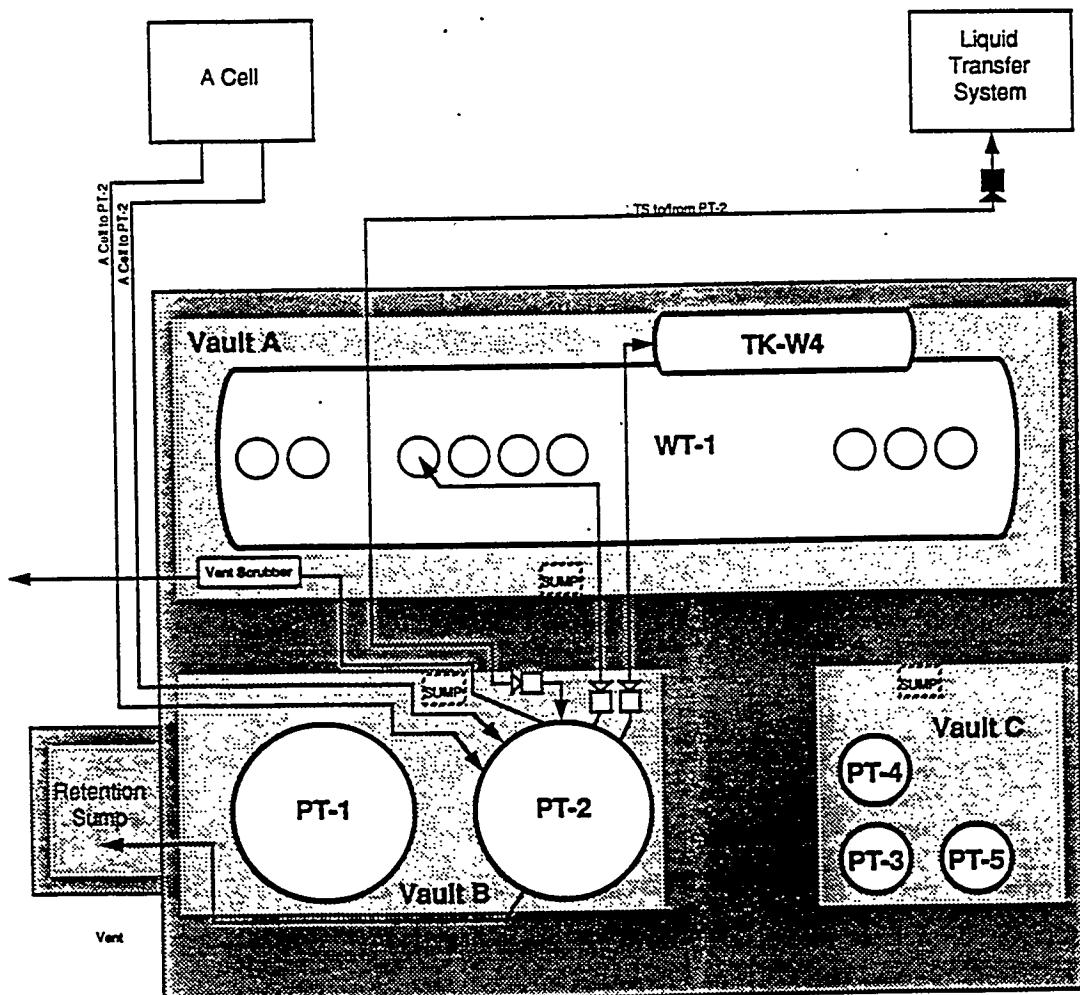
Figure 4.15

Nozzle Schematic PT-2, 325 Bldg.

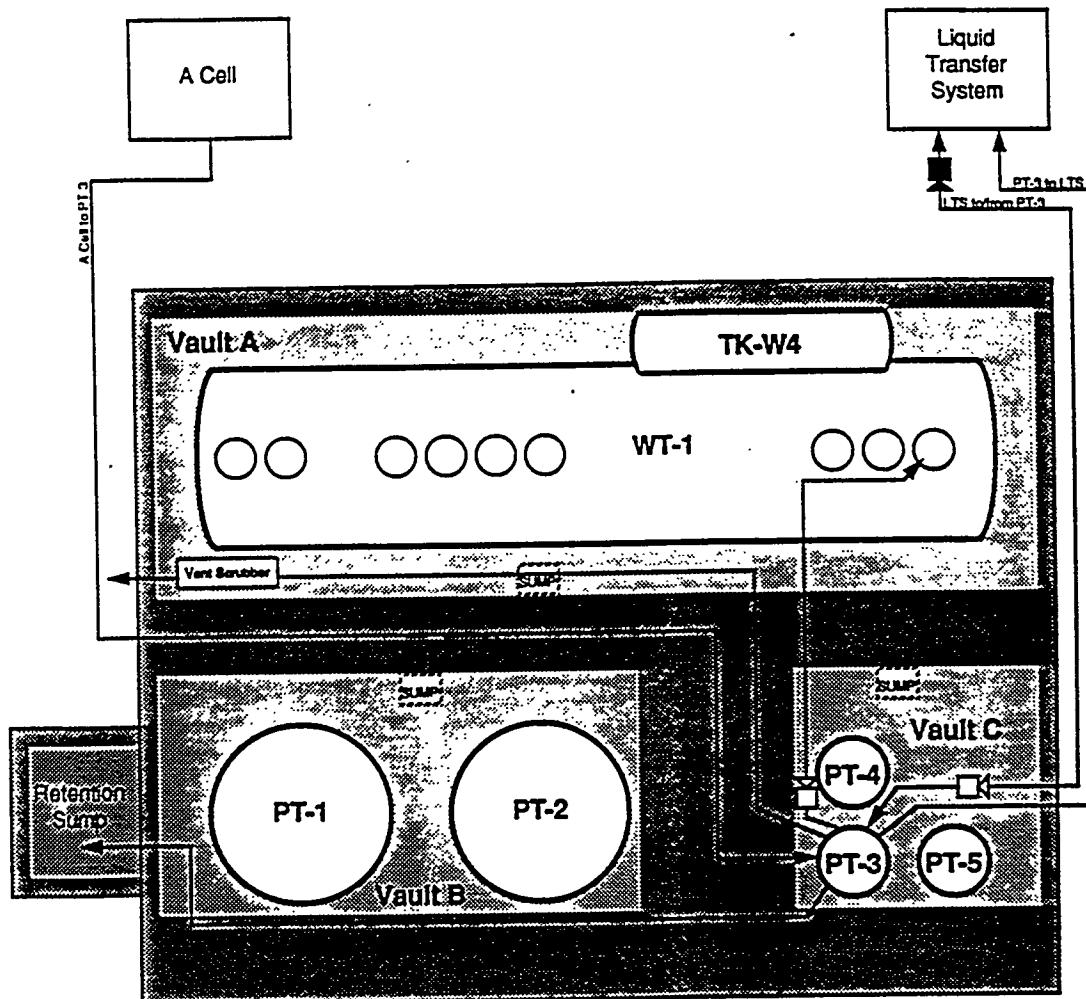
Figure 4.16

Nozzle Schematic PT-3, 325 Bldg.

- Instrument, Tank Pot Connection, and Compressed Air Lines Omitted
- Jet Pump inside Vault (Regardless of Location on Graphic)
- Jet Pump outside Vault (Regardless of Location on Graphic)

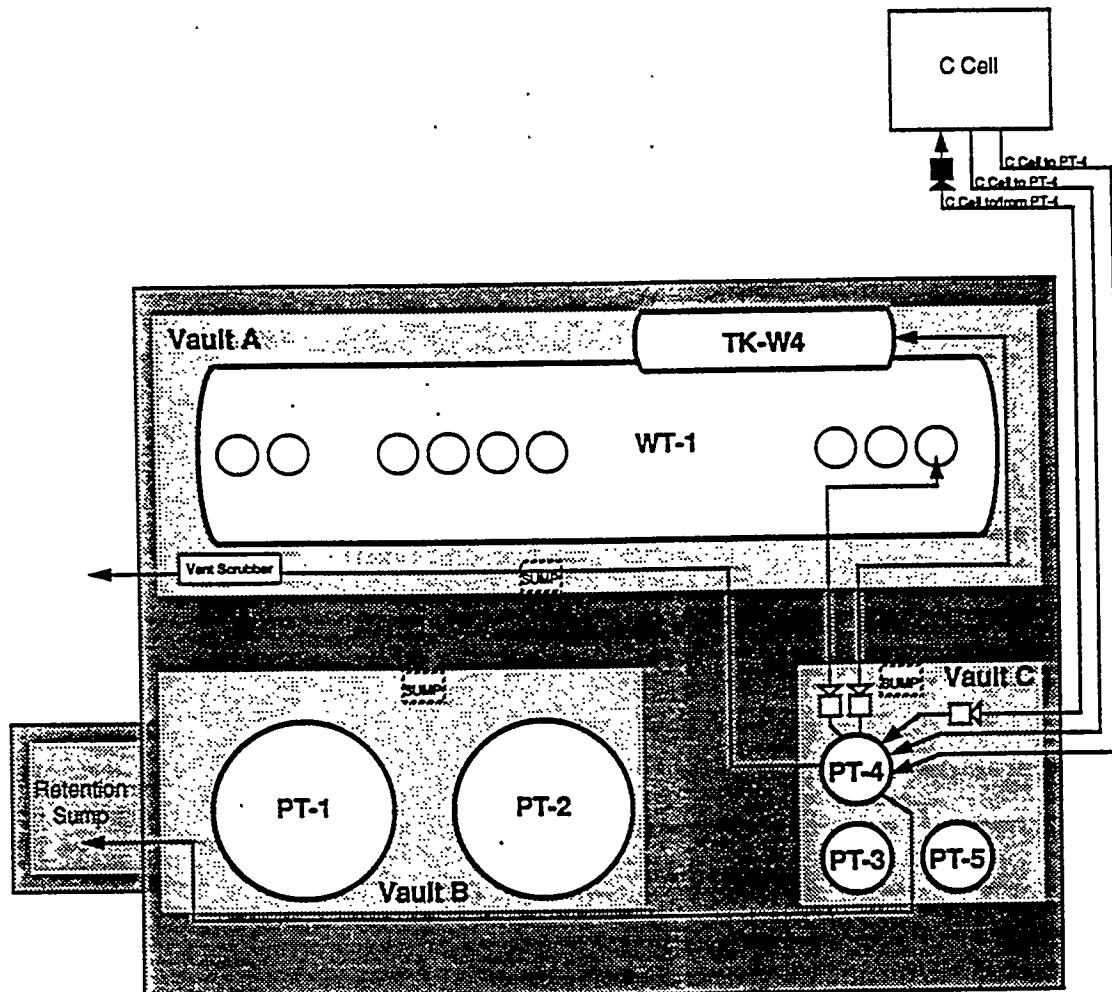
Figure 4.17

Nozzle Schematic PT-4, 325 Bldg.

- Instrument, Tank Pot Connection, and Compressed Air Lines Omitted
- Jet Pump inside Vault (Regardless of Location on Graphic)
- Jet Pump outside Vault (Regardless of Location on Graphic)

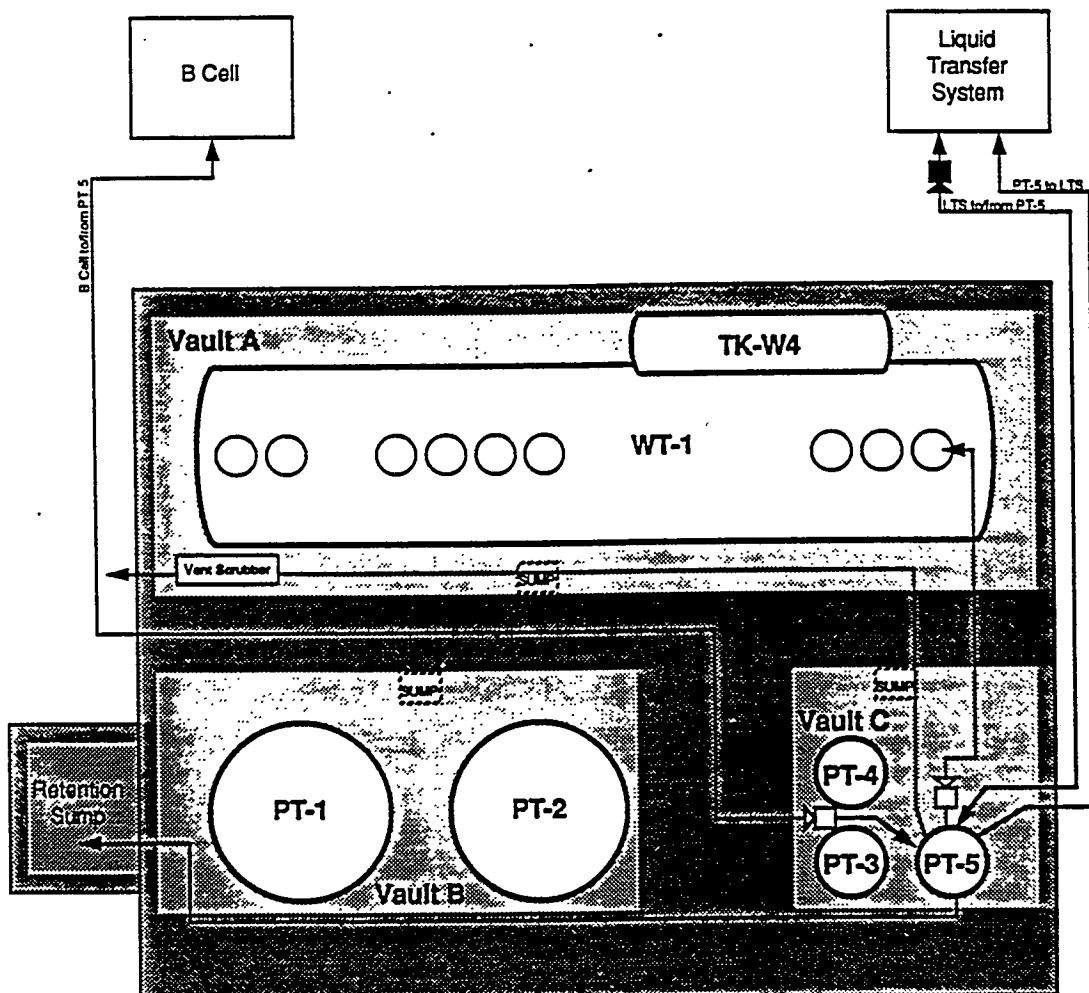
Figure 4.18

Nozzle Schematic PT-5, 325 Bldg.

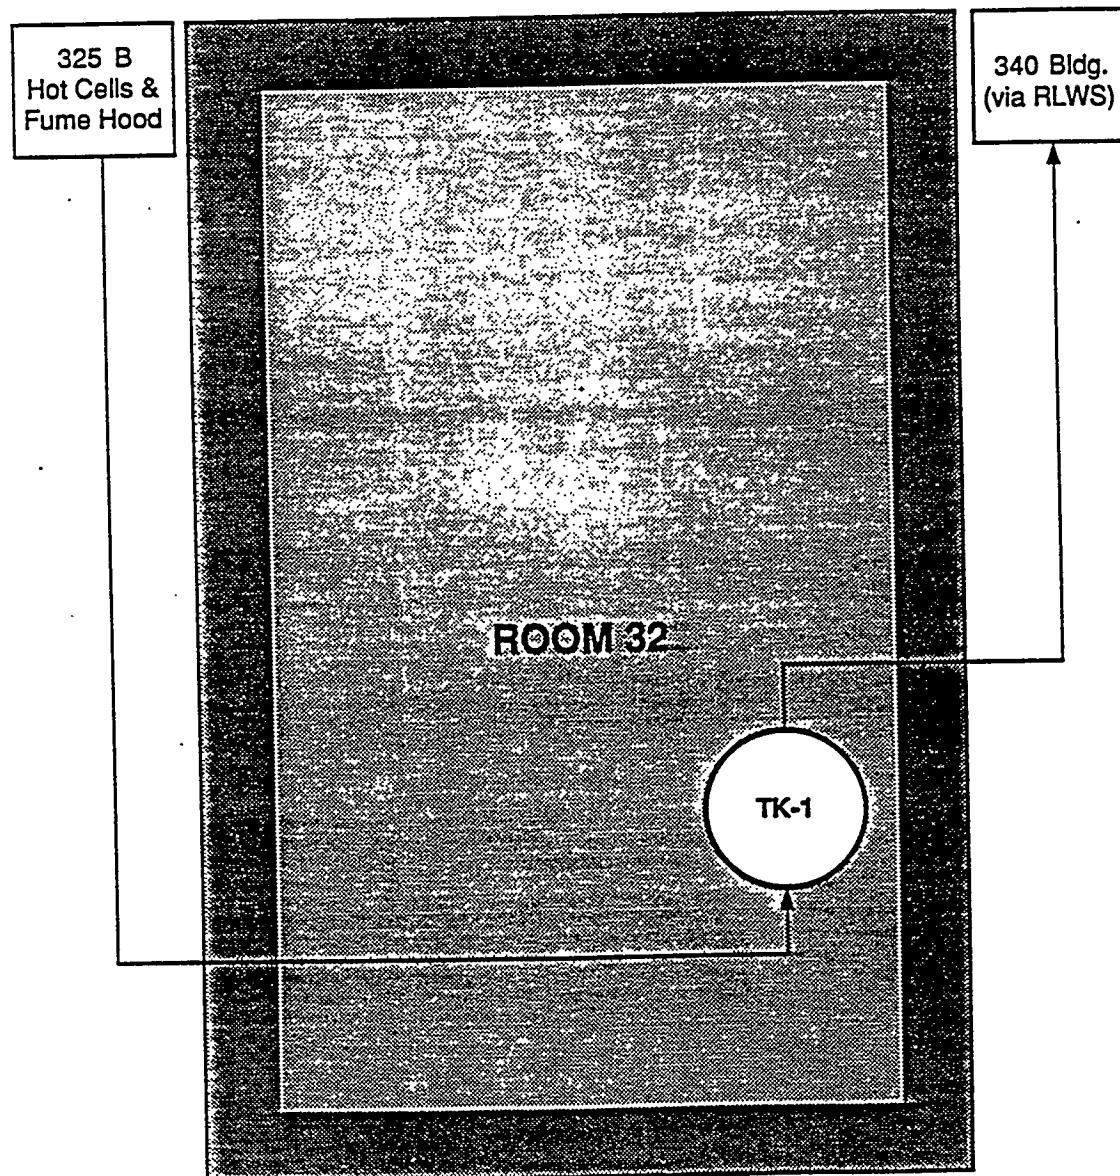
Figure 4.19

Nozzle Schematic TK-1, 325 Bldg.

- Instrument, Tank Pot Connection, and Compressed Air Lines Omitted
- Jet Pump inside Vault (Regardless of Location on Graphic)
- Jet Pump outside Vault (Regardless of Location on Graphic)

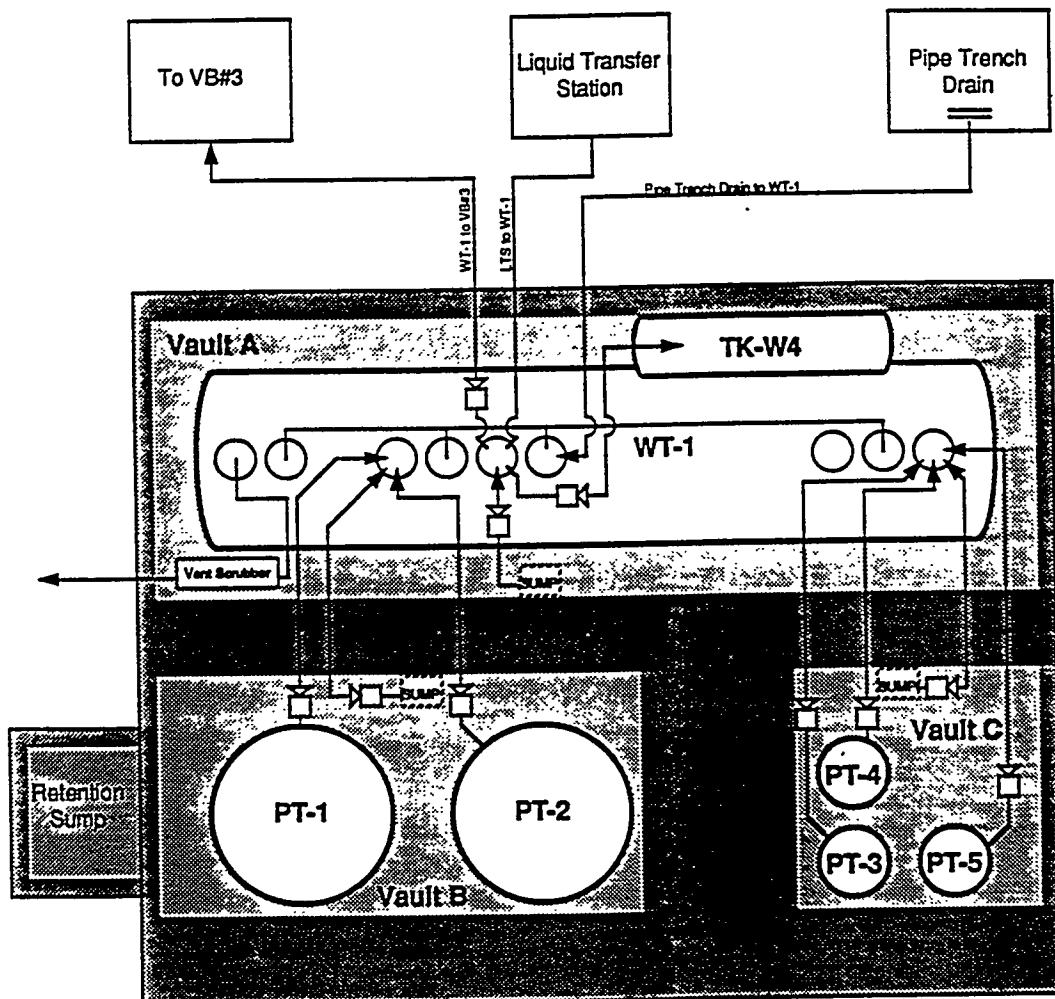
Figure 4.20

Nozzle Schematic WT-1, 325 Bldg.

• Instrument, Tank Pot Connection, and Compressed Air Lines Omitted

The 325 Building contains twelve storage tanks. All the tanks have a vertical longitudinal axis except Tanks WT-1 and WT-4, which are positioned horizontally. Tanks PT-1 through PT-5 transfer their contents into Tank WT-1, which in turn is jet pumped to the 340 Building. Currently, only two of the tanks, WT-1 and TK-1, are directly connected to the RLWS and discharge directly to the 340 Building. The jet pump from WT-1 remains out of service despite repeated attempts by 325A personnel to repair it. (Tank WT-4 is not currently being considered by PNL to be part of the RLWS. It can only be used for conveying liquid waste to the 324 Building and as previously stated this connection is not in service.) The tanks were originally built in 1944 and modified in 1961. The shells for Tanks PT-1 through PT-5 were leak tested by filling with water at atmospheric pressure after all the modifications were completed in 1961. The tank modifications focus on making the old tank connections and transfer mechanisms compatible with the RLWS. The modifications are mostly updates of connections, instrumentation, and dip tubes. In addition the jackets were hydrostatically tested to a pressure of 20 psi for 1 h. Tank WT-1 was hydrostatically tested at a pressure 60 psi for 1 h (Ebasco 1990).

Tank WT-1 has been one of the most frequently used tanks in the 325 Building. During its usage, nitric acid and relatively high levels of radioactivity have been stored in it. Evaluation of the documentation of volume of waste transferred to the 340 Building during the time frame of September 20, 1988 to November 1, 1988 showed that 5 transfers took place. The volumes for the transfers were 1500, 2000, 1000, 1600, and 1650 gal for a total of 7750 gal. Another request for batch transfer included the following information: volume - 7000 gal, total uranium - 14.4 kg of depleted uranium (DU); total plutonium - 15.4 g, ²³⁷Np - 0.1 g; pH - 1.2; dose rate at 1 ft from 2-oz. sample was 1.75 mR/h.

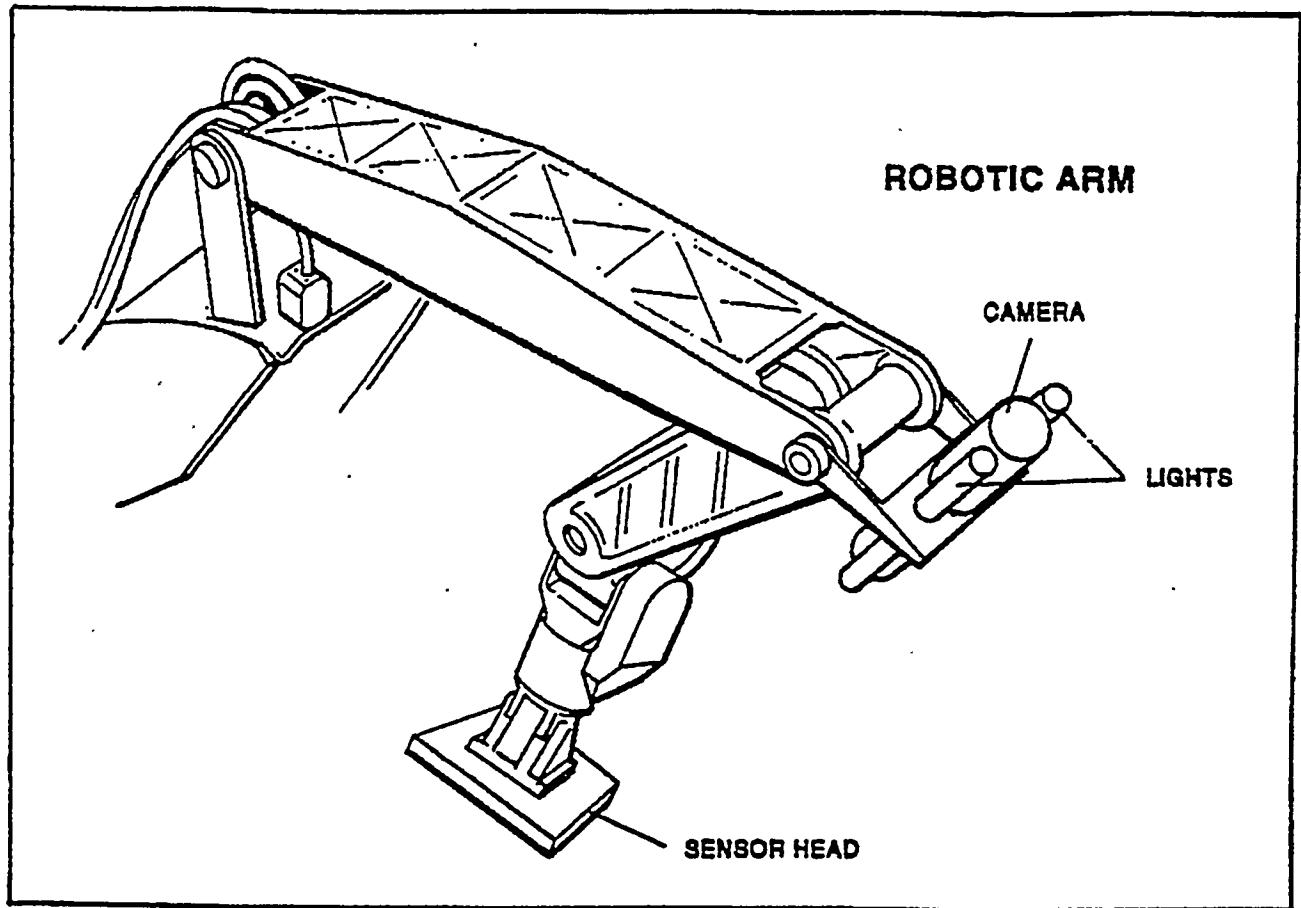
FIGURE C.1. Schematic Robotic Arm with Camera and Sensor Head

As described above, ultrasonic imaging is the best NDE method for examining corruptions or corrosion cracking inside a material. But it is not practical to inspect the entire surface of the RLWS components with the method. In fact, only strategic areas on the components needed to be inspected. These strategic areas for the tank are on the tank bottom and the tank wall where liquid waste may still remain, the tank wall where the liquid surface line and the weld seams in the lower part of the tank. For the piping, the areas to be inspected are the local bends and the welded seams.
