PFBC HGCU Test Facility  
Technical Progress Report

Third Quarter, CY 1995

American Electric Power Service Corporation  
Columbus, Ohio 43215

Appendix 1 presents the results of filter candle posttest examination by Westinghouse performed on selected filter candles following final shutdown of the system.

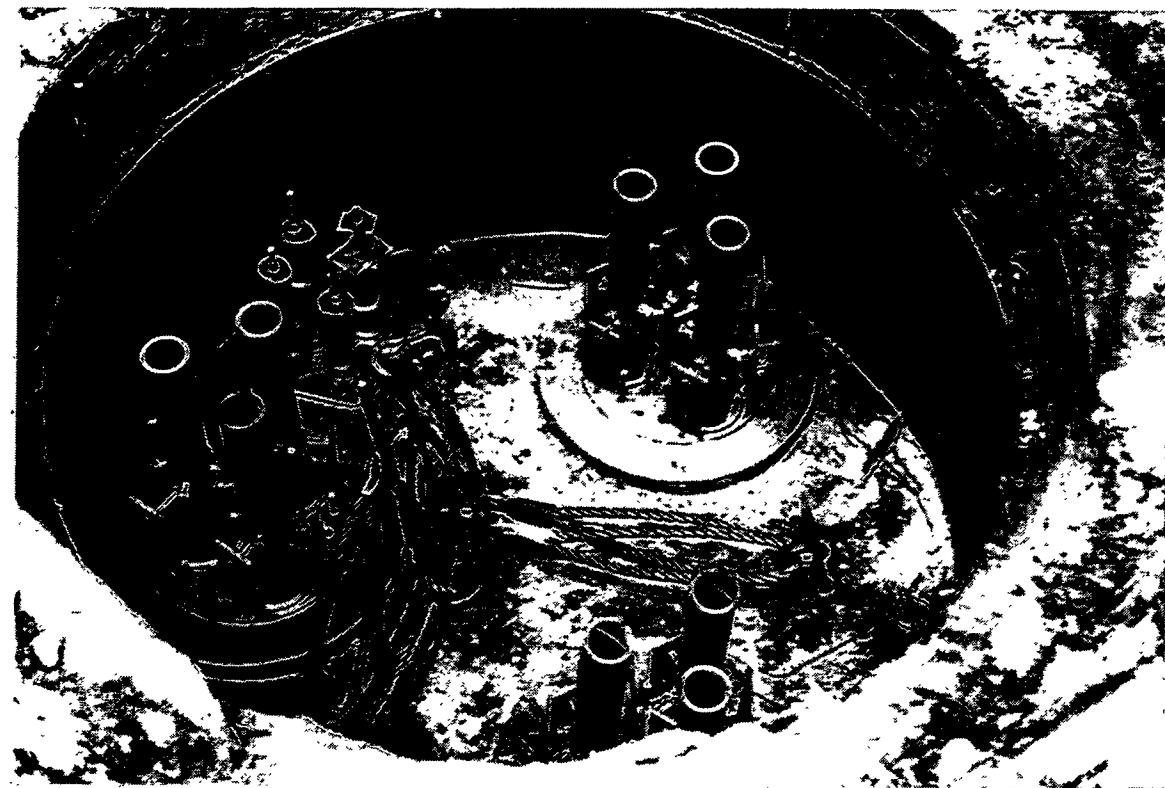
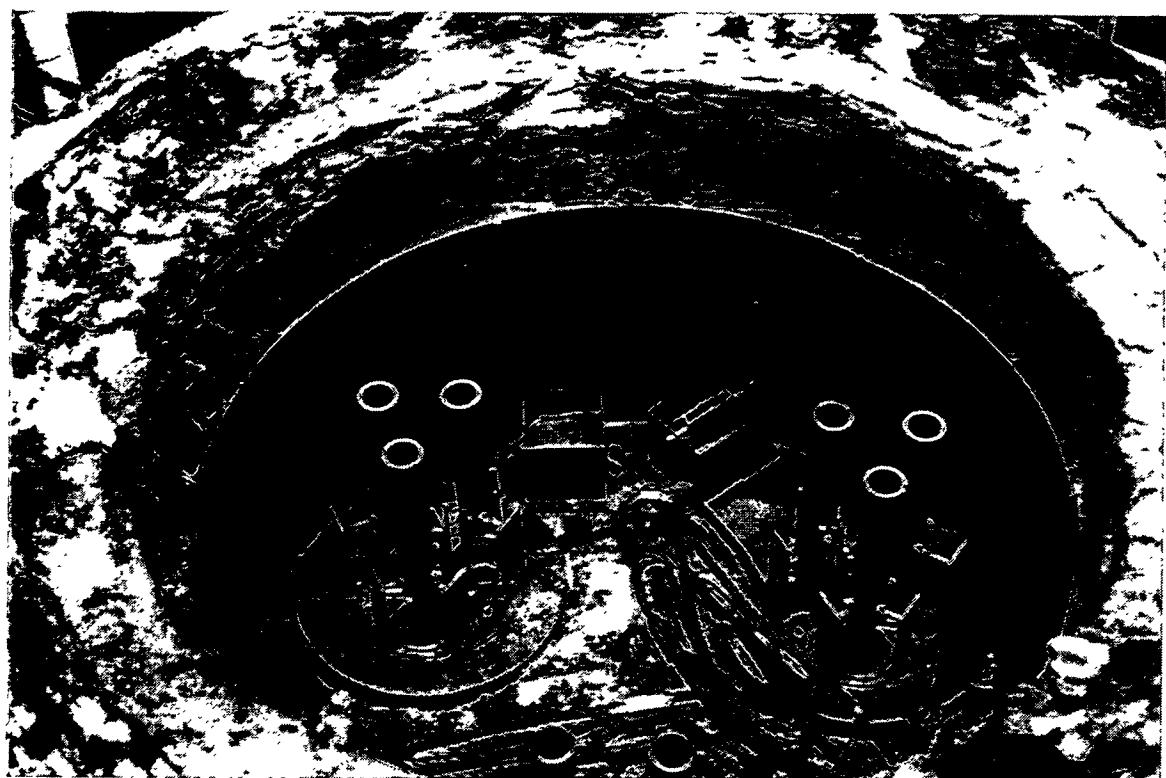
Figure 1 – W-APF Tubesheet After Test Segment #5

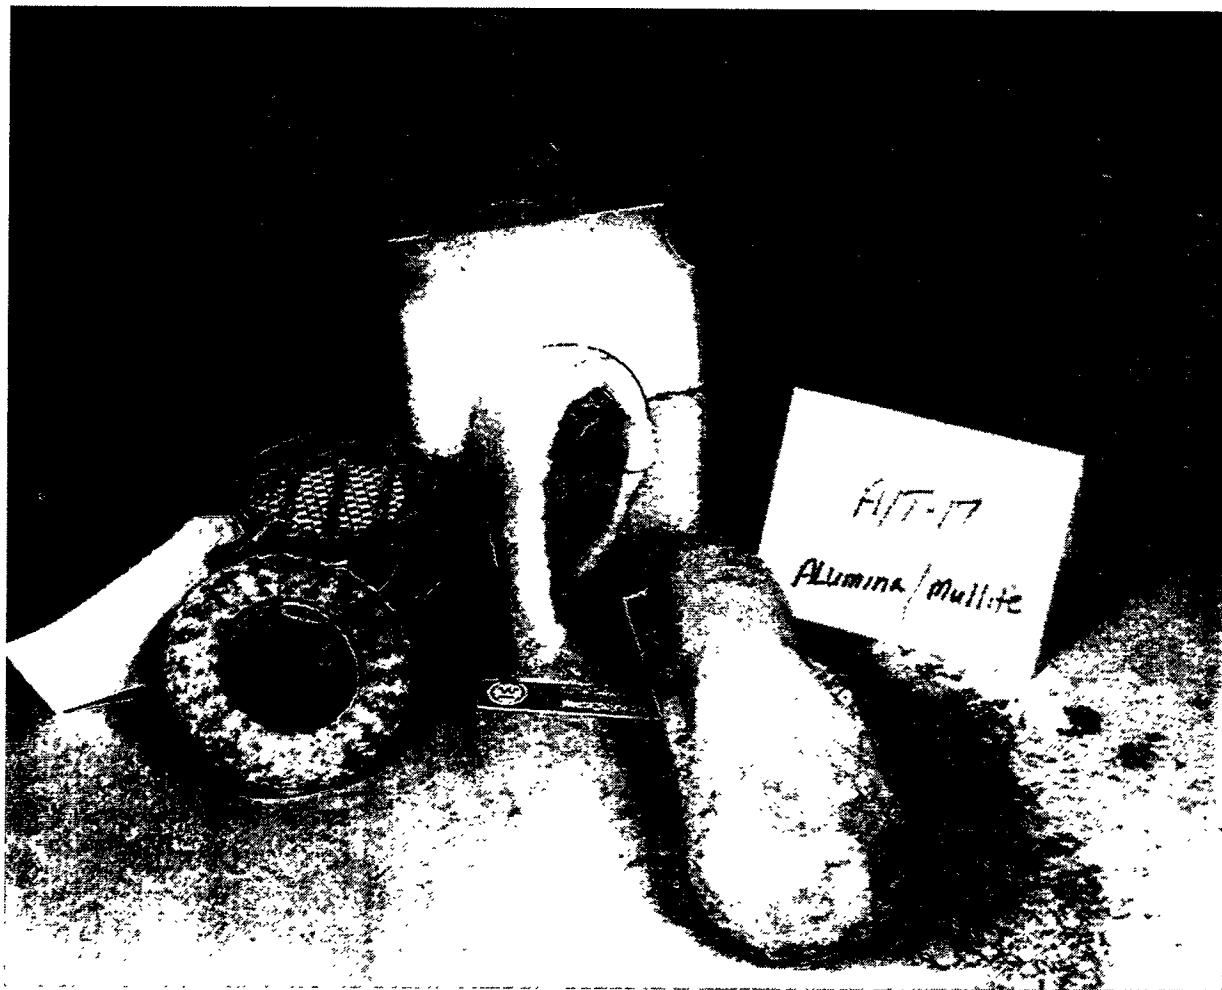
Figure 7a — Ash Filled ID Bore Of A Coors Alumina/Mullite Candle Filter

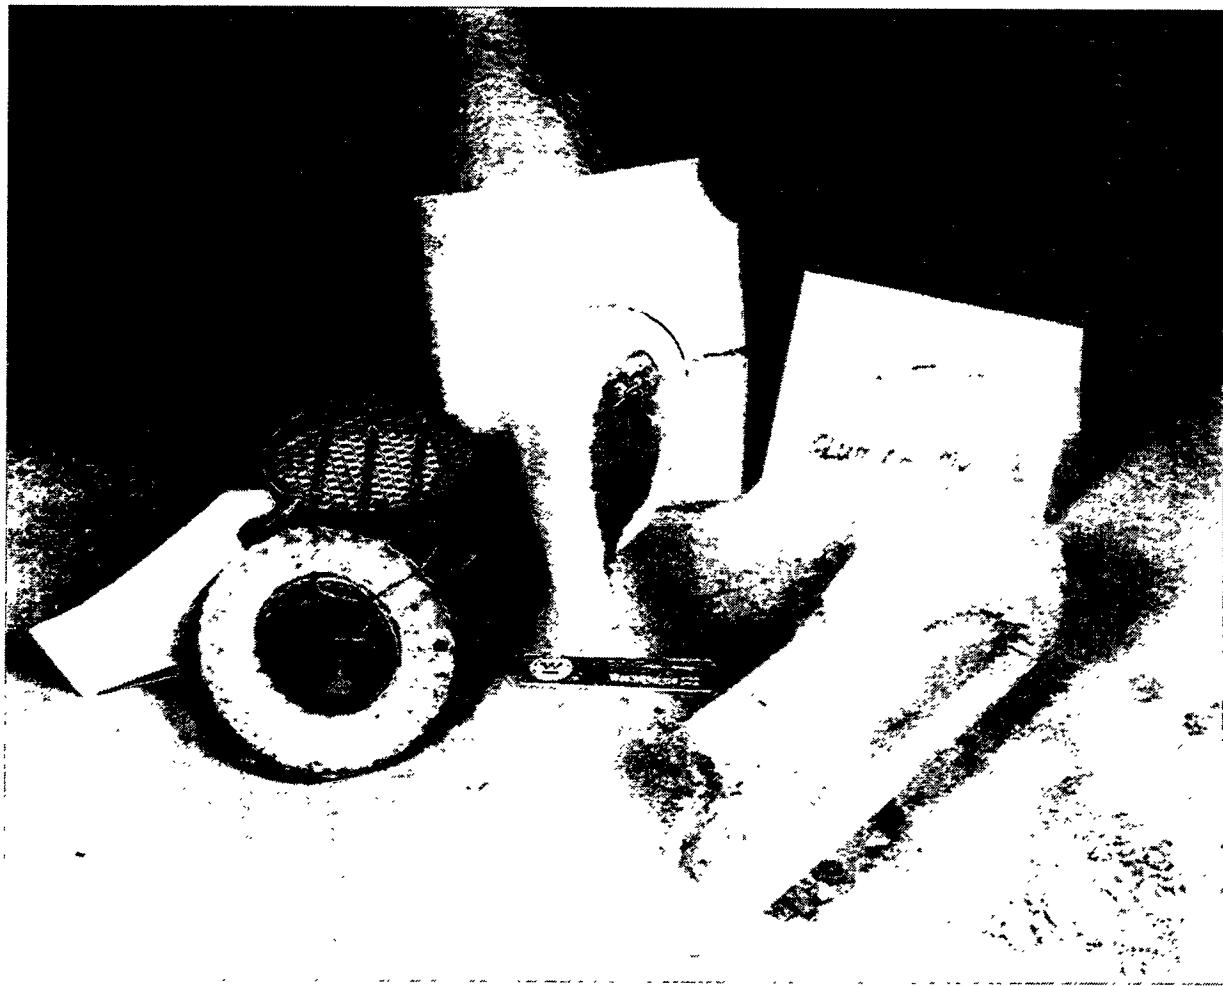
Figure 7b — Ash Filled ID Bore Of A Coors Alumina/Mullite Candle Filter

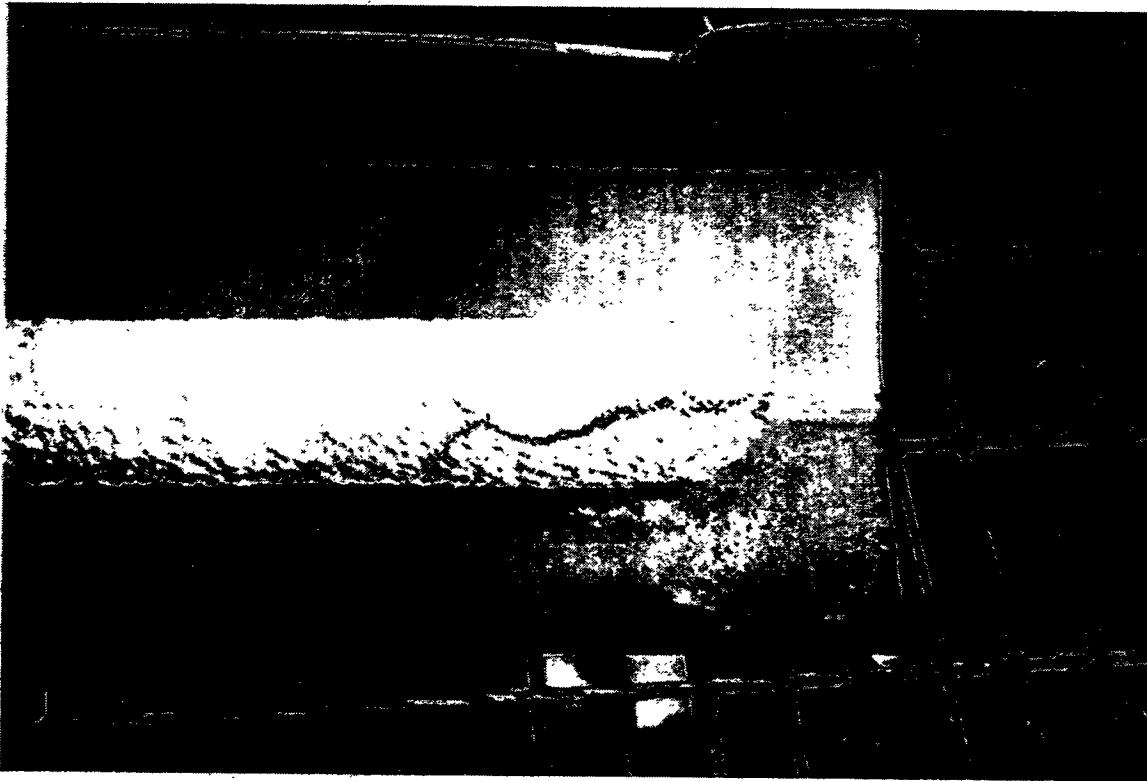
Figure 20 – Graceful Failure Of The Ash Filled ID Bore Of The 3M CVI-SiC Composite Filters. Virtually Ash-Free Top Gasket And Fail-safe/Regenerator Device Above The Failed 3M CVI-SiC Composite Filter

photograph of the ash filled 3M CVI-SiC composite filter that ruptured along the end cap, but which remained as an intact candle during testing in Test Segment #5. As shown in the top photograph of Figure 19, the top gasket and fail-safe/regenerator are virtually clean, even though ash filled the bottom of the 3M CVI-SiC composite filter.

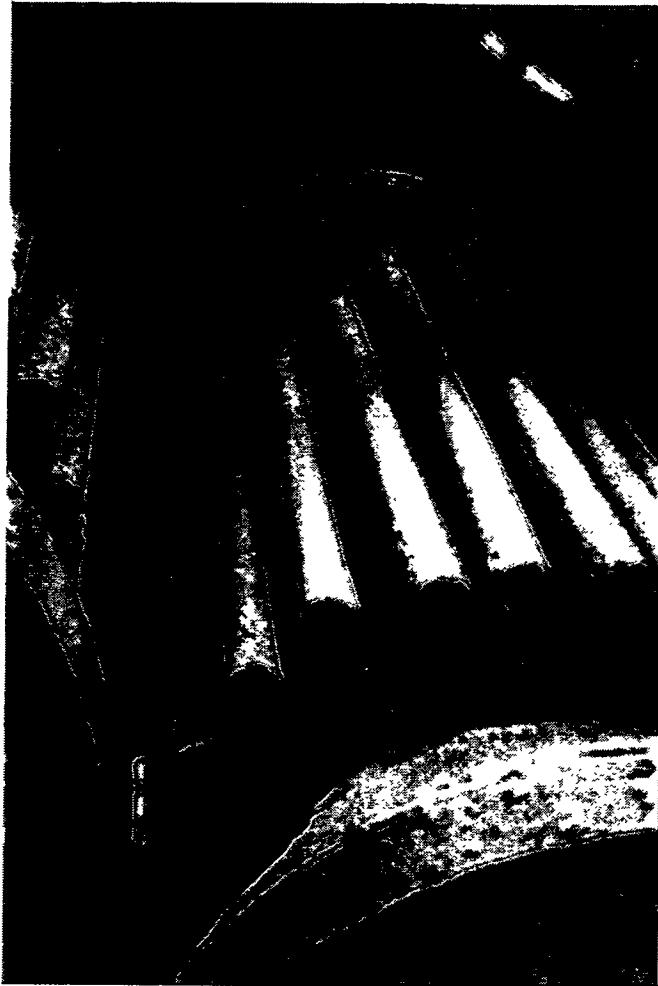
Figure 21 – Ash Free W-APF System At The Conclusion Of Test Segment #5

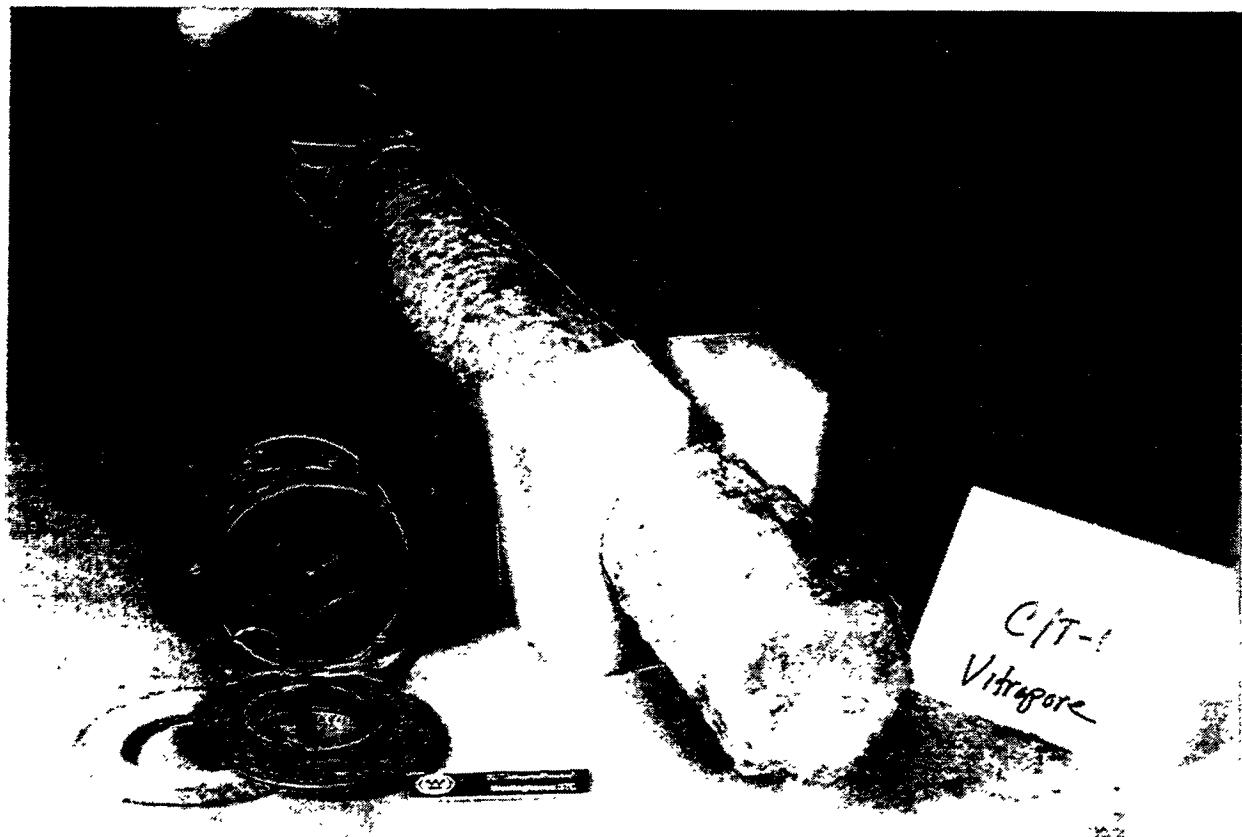
Figure 23b – Thick Ash Cake Deposit Along The Bottom End Cap Of The Pall Vitropore 442T Candle Filter That Had Been Located In Position C/T-1 During Test Segment #5

A relatively thick ash cake layer remained along the surface of the Schumacher Dia Schumalith F40 surveillance candle filter which had been positioned in location A/T-16 after 1110 hours of operation in Test Segment #5 (Figure 22). Similarly, a thick ash cake formed along the outer surface of the Pall Vitropore 442T filter elements (Figure 23). Initiation of the elephant foot formation was also evident along the bottom of the Pall Vitropore 442T candles (i.e., bottom photograph in Figure 23). Both the top gasket and fail-safe/regenerator unit which were positioned above the Pall Vitropore 442T candle filter which had been located in position C/T-1 were relatively clean after 1110 hours of operation in Test Segment #5.

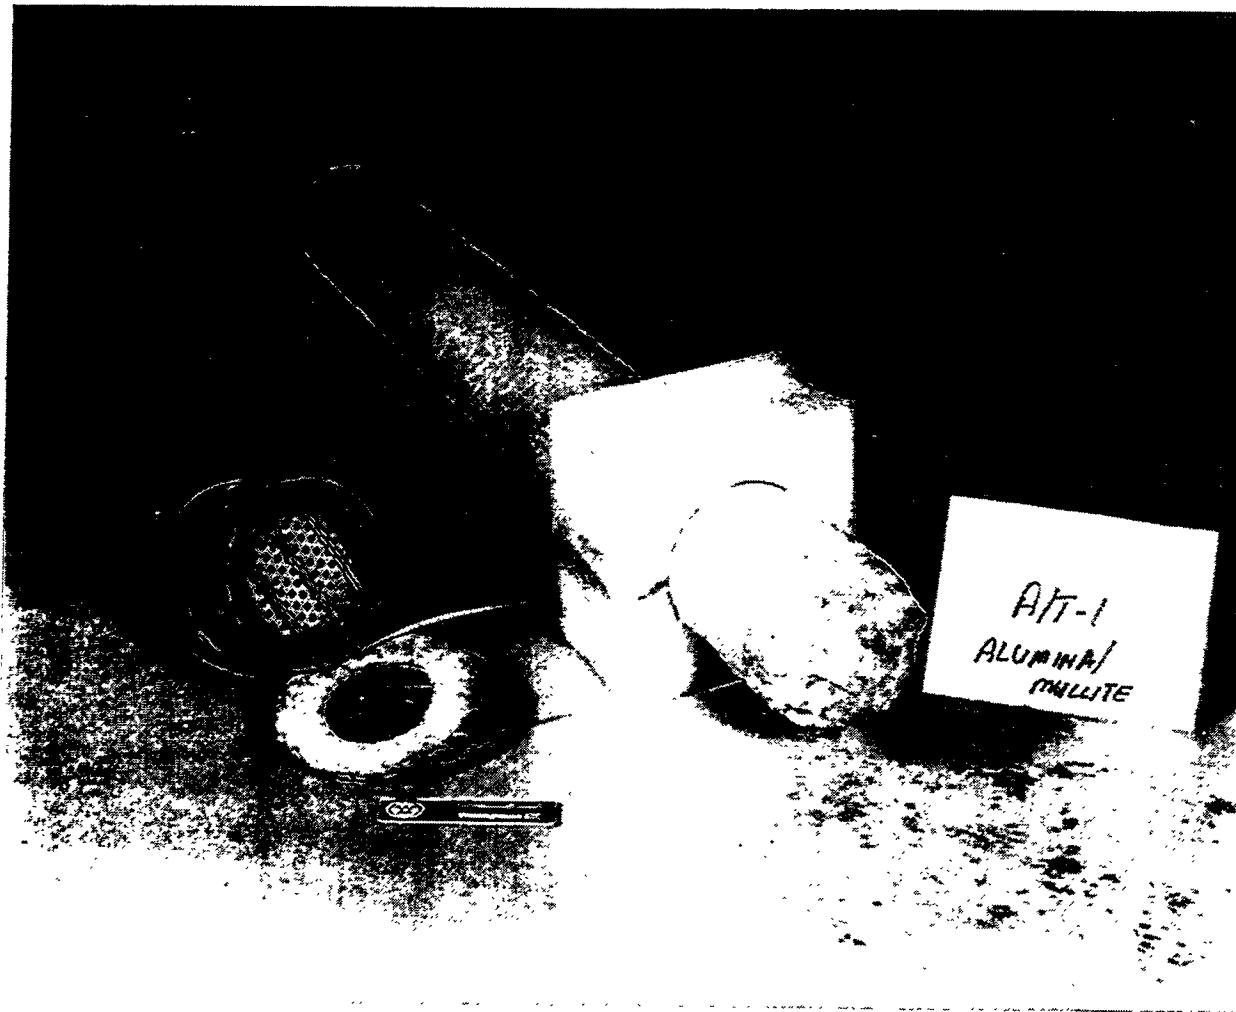
Figure 25 -- Ash Cake Formation Along The End Cap Of The Coors Alumina/Mullite Candle Filter In Position A/T-1

A thinner ash cake formation resulted along the alumina/mullite candle filters that were positioned in locations A/T-1 and A/T-17 (Figure 24). A thicker ash cake formation, however, resulted along the bottom end cap of the alumina/mullite candle filter that was located in position A/T-1 (Figure 25).

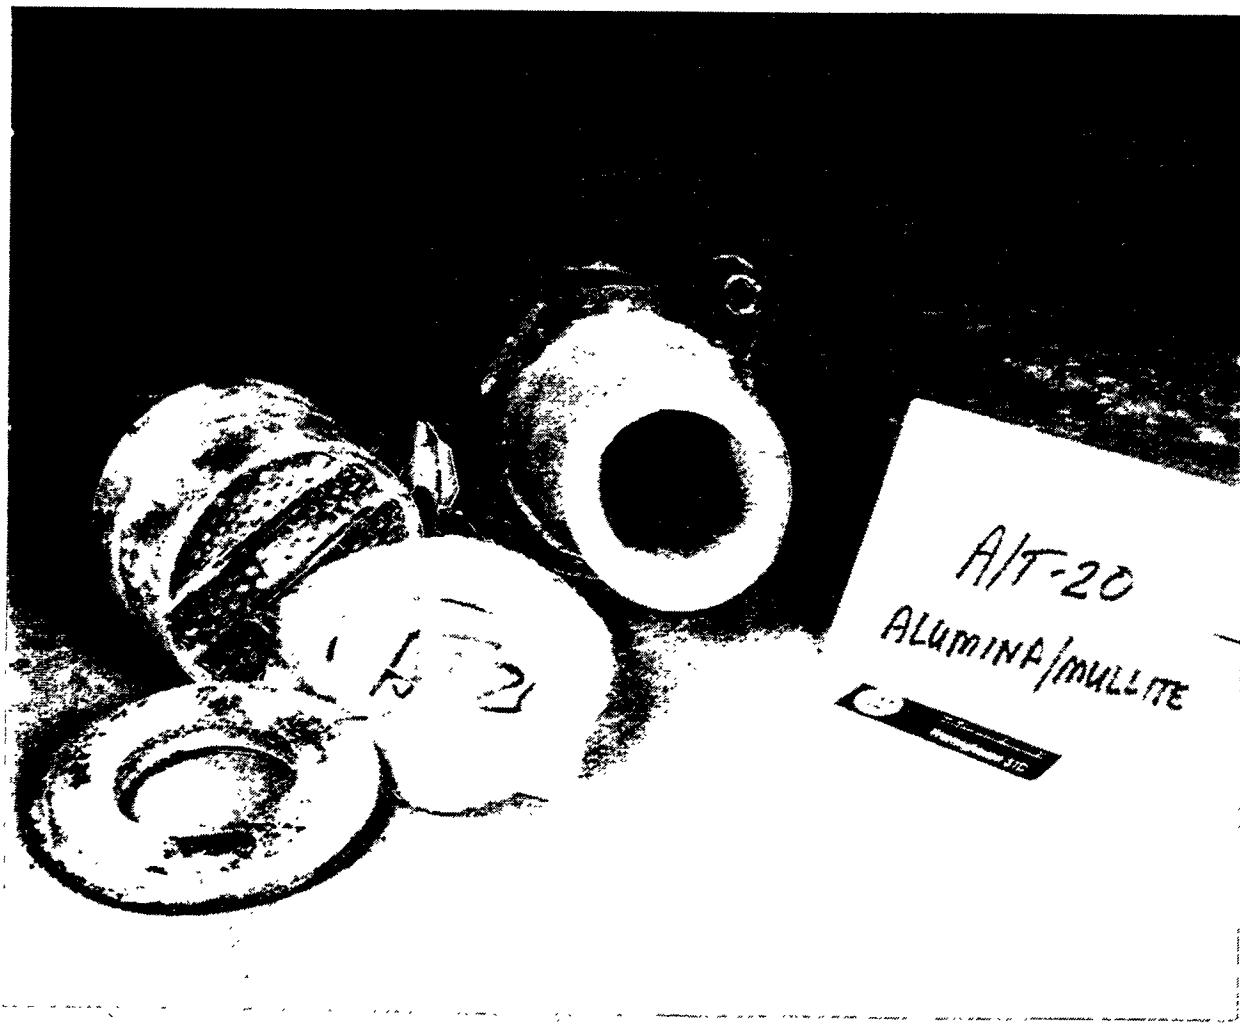
Figure 26a — Top Gasket, Metal Ring, And Fail-Safe/Regenerator Device Positioned  
Above The Coors Alumina/Mullite Candle Filter In Position A/T-20

Since the alumina/mullite candle that was positioned in A/T-20 had suffered failure at the base of its flange, the fail-safe/regenerator device that was positioned above the failed filter showed evidence of dust collection and/or plugging along its surface (Figure 26). The top gasket and the top surface of candle filter A/T were relatively clean, indicating the absence of a leak path in this area. In contrast, the top of the adjacent metal ring which contacted the fail-safe/regenerator was encrusted with ash fines, possibly indicating a leak path between the top ring and fail-safe/regenerator due back pulsing of fines and/or the normal PFBC gas/fines forward flow after plugging of the fail-safe unit.

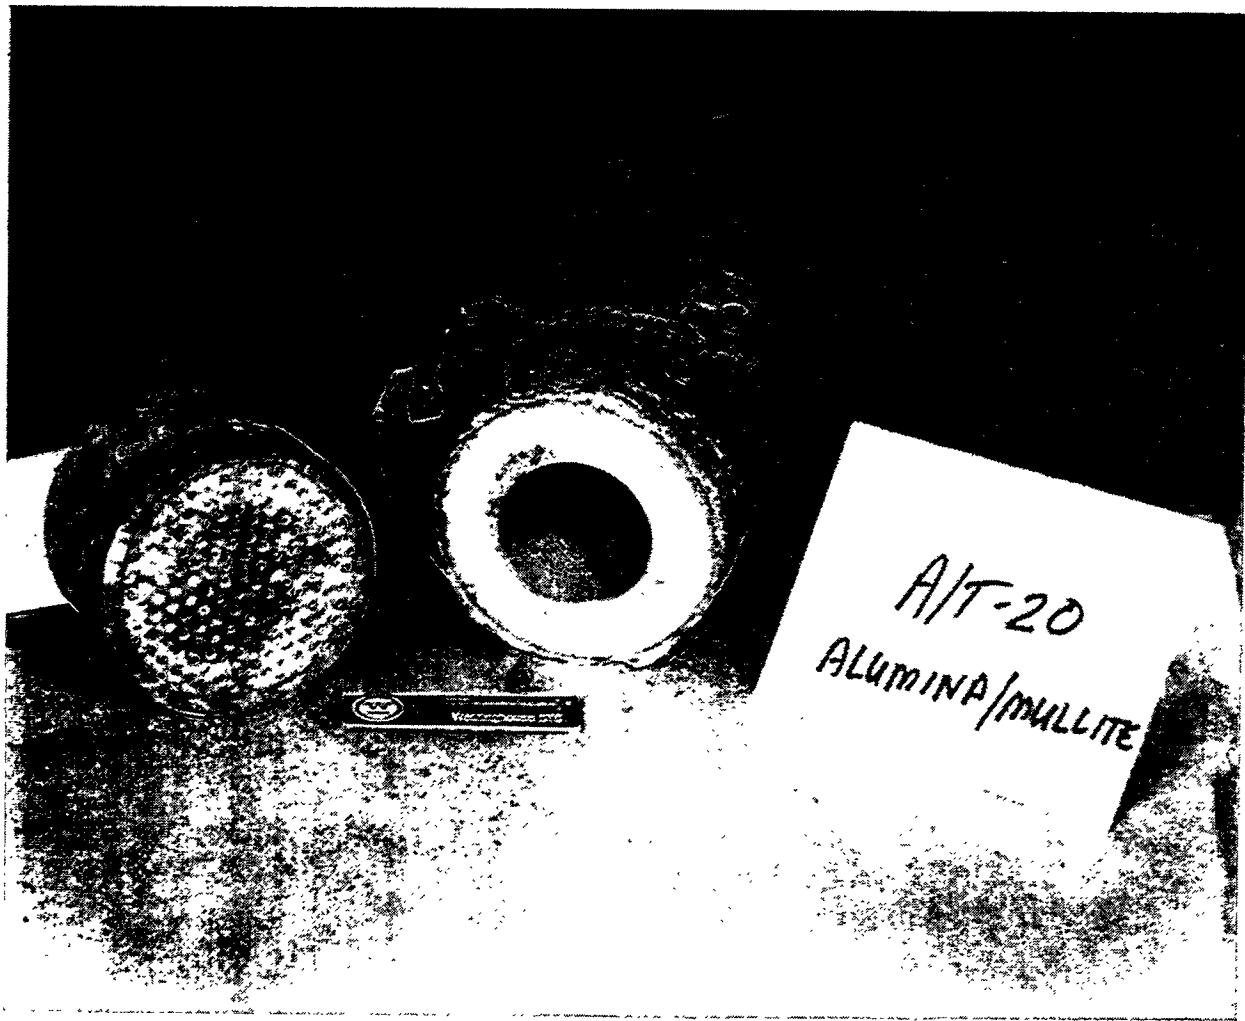
Figure 26b – Fail-Safe/Regenerator Above The Failed Coors Alumina/Mullite Candle Filter Located In A/T-20

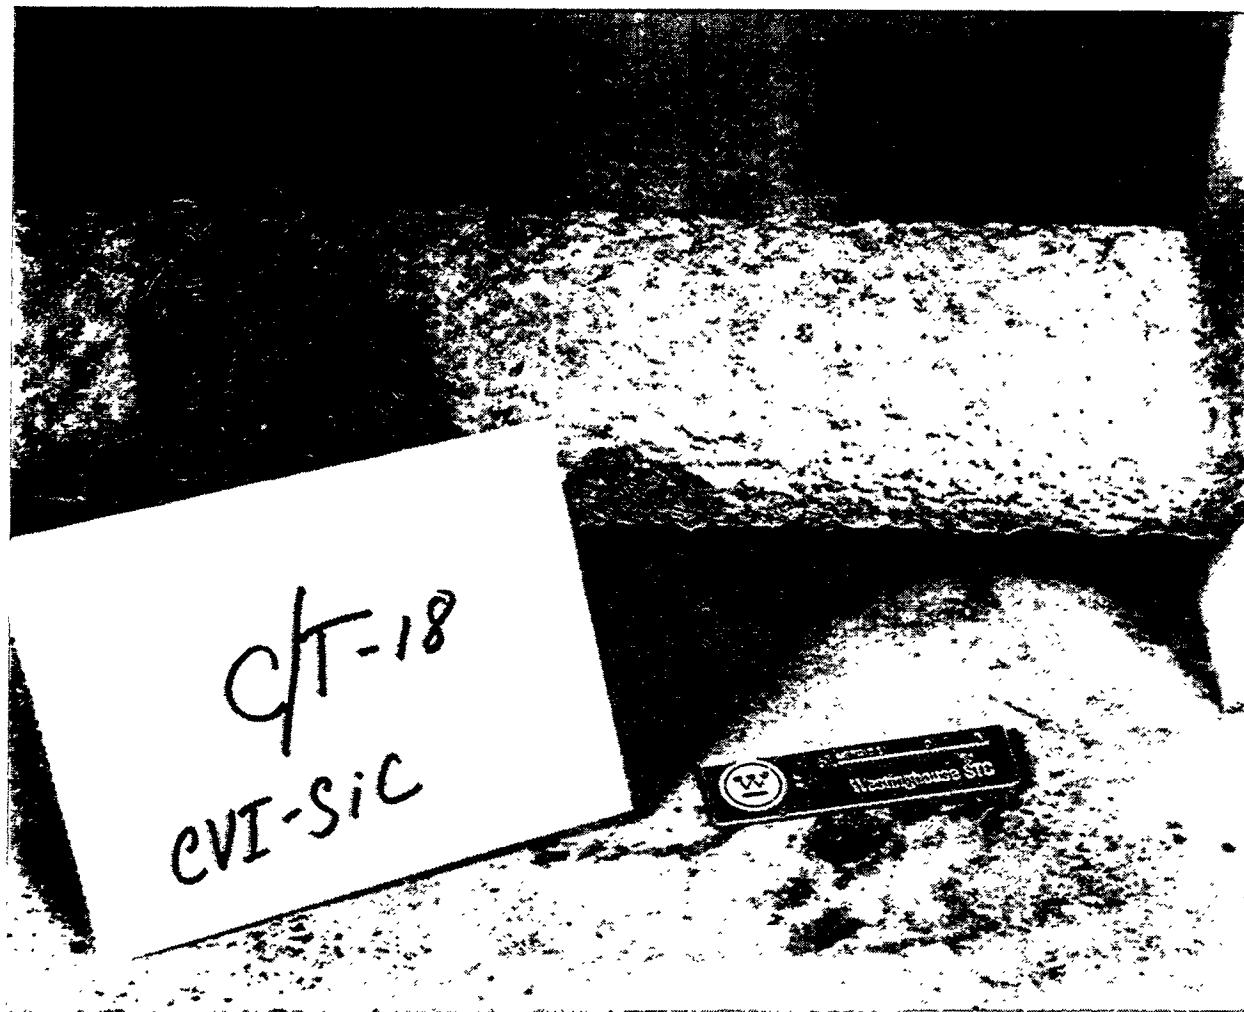
Figure 27 illustrates the ash cake formations that remained along the surface of the 3M CVI-SiC composite candle that was positioned in location C/T-18. Thick ash nodules were not evident along the outer surface of the 3M filter as those which were observed along the surface of the Pall Vitropore 442T candle filters. The "sesame seed" pin-holes which resulted along the surface of the ash cake deposit during Test Segment #4, were not evident along the relatively thick ash cake deposit that formed along the 3M filters during operation in Test Segment #5.

Figure 27 – Ash Cake Formation Along The 3M CVI-SiC Composite Candle Filter in Position C/T-18

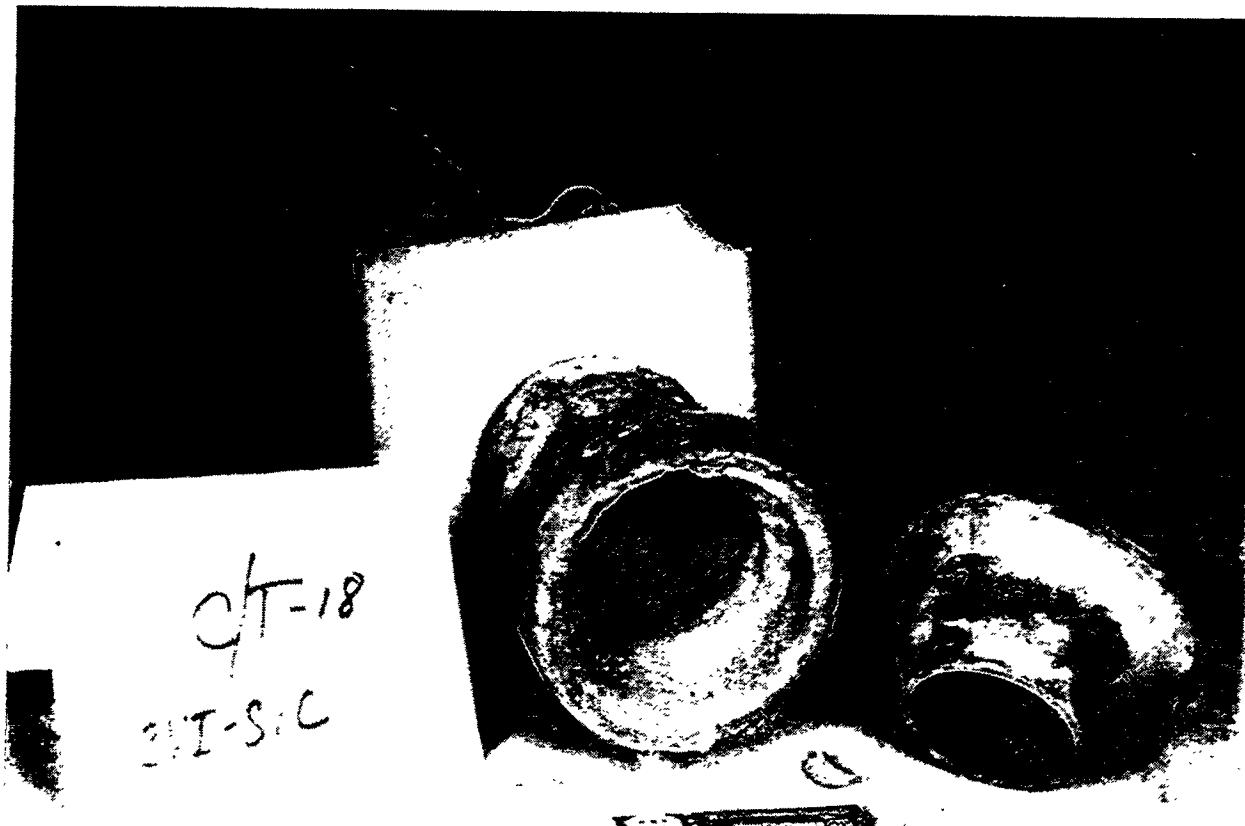
Ash was readily observed along the outer gasketed flange surface of the 1100 hour PFBC-exposed 3M CVI-SiC composite candle that had been positioned in C/T-18. Ash was also found along the top of the flange and along the metal insert which was used to stabilize the 3M CVI-SiC composite candle filter in the Westinghouse filter mount (Figure 28). Dust accumulation was generally observed between the metal insert and the primary or internal gasket seal. The ash cake that formed along the outer surface of the flange was considered to have resulted from a gas path leak between the Westinghouse holder mount and the 3M filter flange.

Figure 28 – Ash Cake Formation Along The Outer And Inner Surfaces Of The 3M CVI-SiC Composite Flange (Position C/T-18; Test Segment #5)

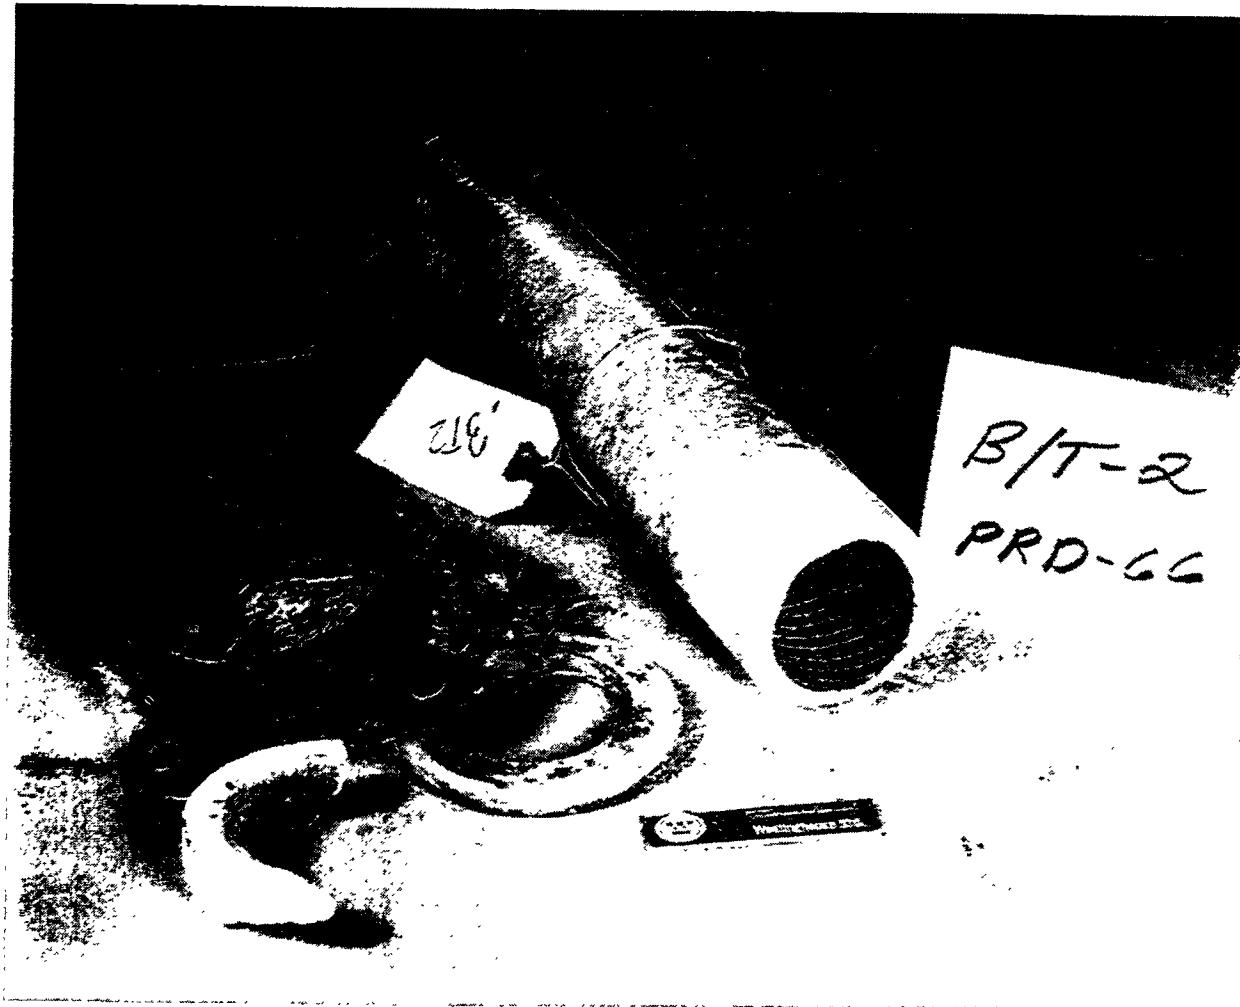
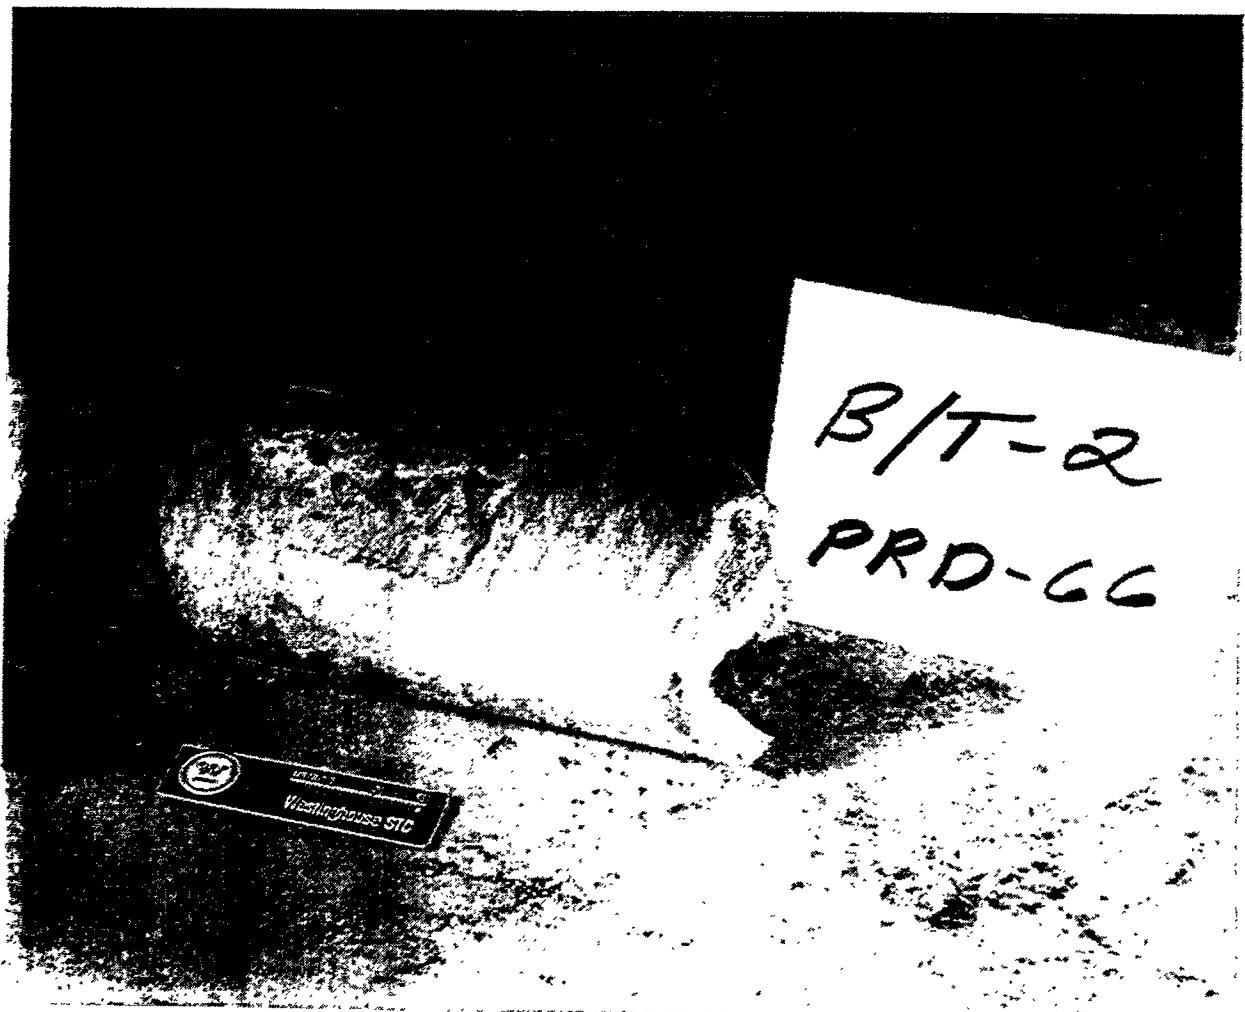
Figure 29 illustrates the fractured DuPont PRD-66 filter element which had been located in position B/T-2. Failure of the element resulted at approximately the mid-body, forming a "step-like" fracture through the filament wound or layered 6-7 mm PRD-66 filter matrix. During removal of the DuPont PRD-66 filter from position B/T-2, failure also occurred along the flange which had been tightly held in the filter mount. A heavy deposit of ash was evident along the bottom nut of the filter holder mount (Figure 29b). A dark red stain was prominent along a section of the filter body below the gasket sleeve. In several areas, sections of the membrane, as well as subsurface filament wound layers were removed, forming ~1-2 inch "divot-like" areas along the outer surface of the filter element. The DuPont PRD-66 filter element which had been positioned in B/T-2 also contained ash along its ID surface, as well as within its matrix.

Figure 29a – Failed DuPont PRD-66 Candle Filter (Position B/T-2; Test Segment #5)

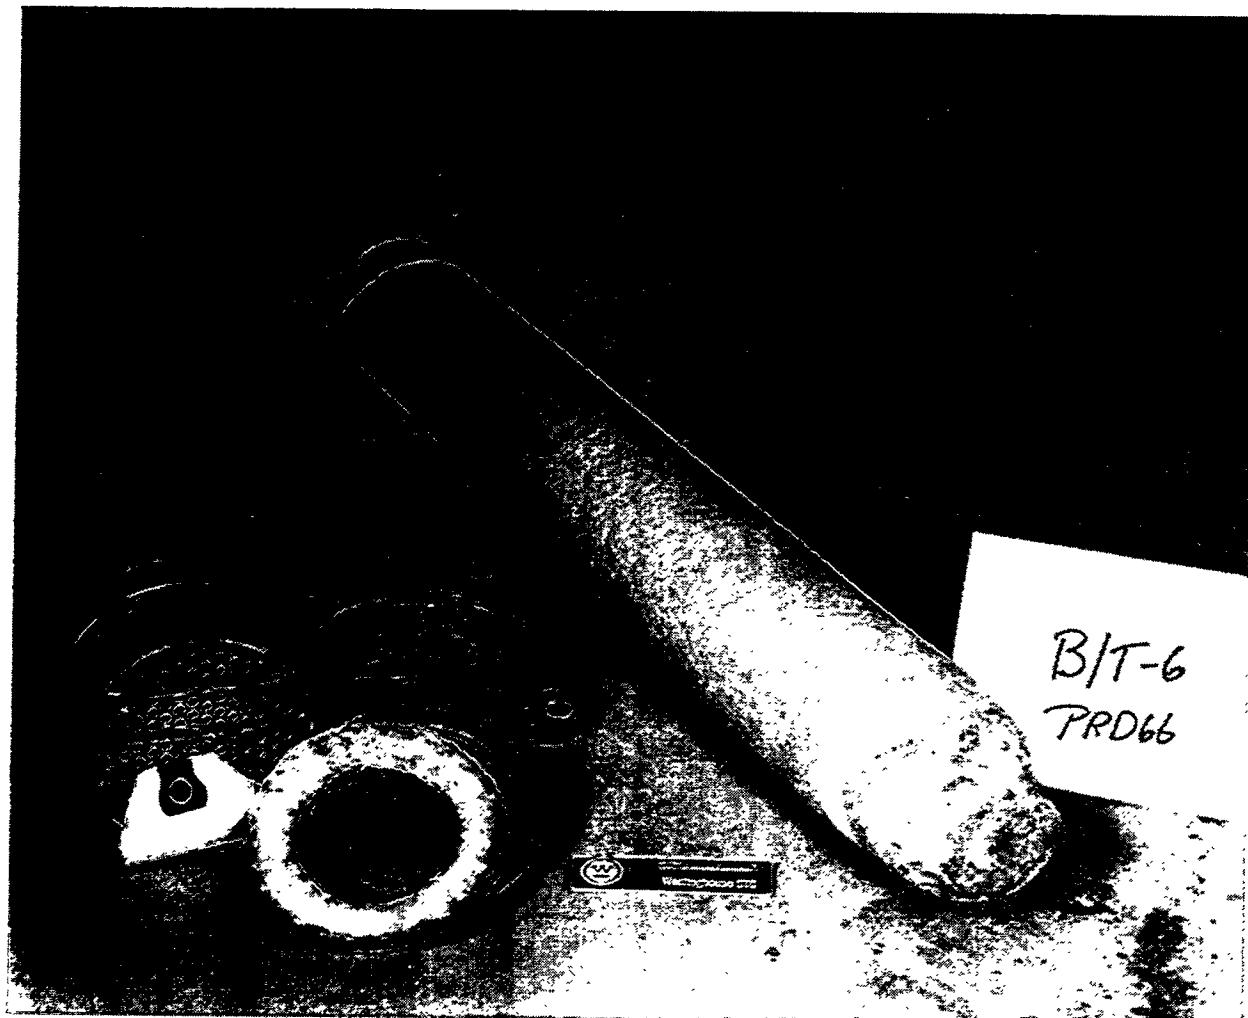
An intact DuPont PRD-66 filter element was removed from location B/T-6. A thin 1-2 mm ash cake layer remained along the outer surface of the filter element (Figure 30). Ash was seen to be heavily caked along the inside wall of the filter holder mount, while the top gasket seal that contacted the DuPont PRD-66 filter flange was relatively clean (Figure 30a). Dust was evident within the fail-safe/regenerator device that was positioned above the DuPont PRD-66 candle filter located in position B/T-6.

"Divot-like" formations were also evident along the outer surface of the PRD-66 filter that was positioned in B/T-6. The series of photographs shown in Figure 30 were taken down the length of the filter body, beginning at the flange and moving towards the end cap. The darkened red stain was not as prominent along the B/T-6 PRD-66 filter element as it had been along the B/T-2 PRD-66 filter element. The "divot-like" formation typically tracked as two lines down the length of the filter body. The "divot-like" formation resulted along the surface of the filter element that was off-tangent to the plenum.

Figure 30a – Intact DuPont PRD-66 Candle Filter (Position B/T-6; Test Segment #5)

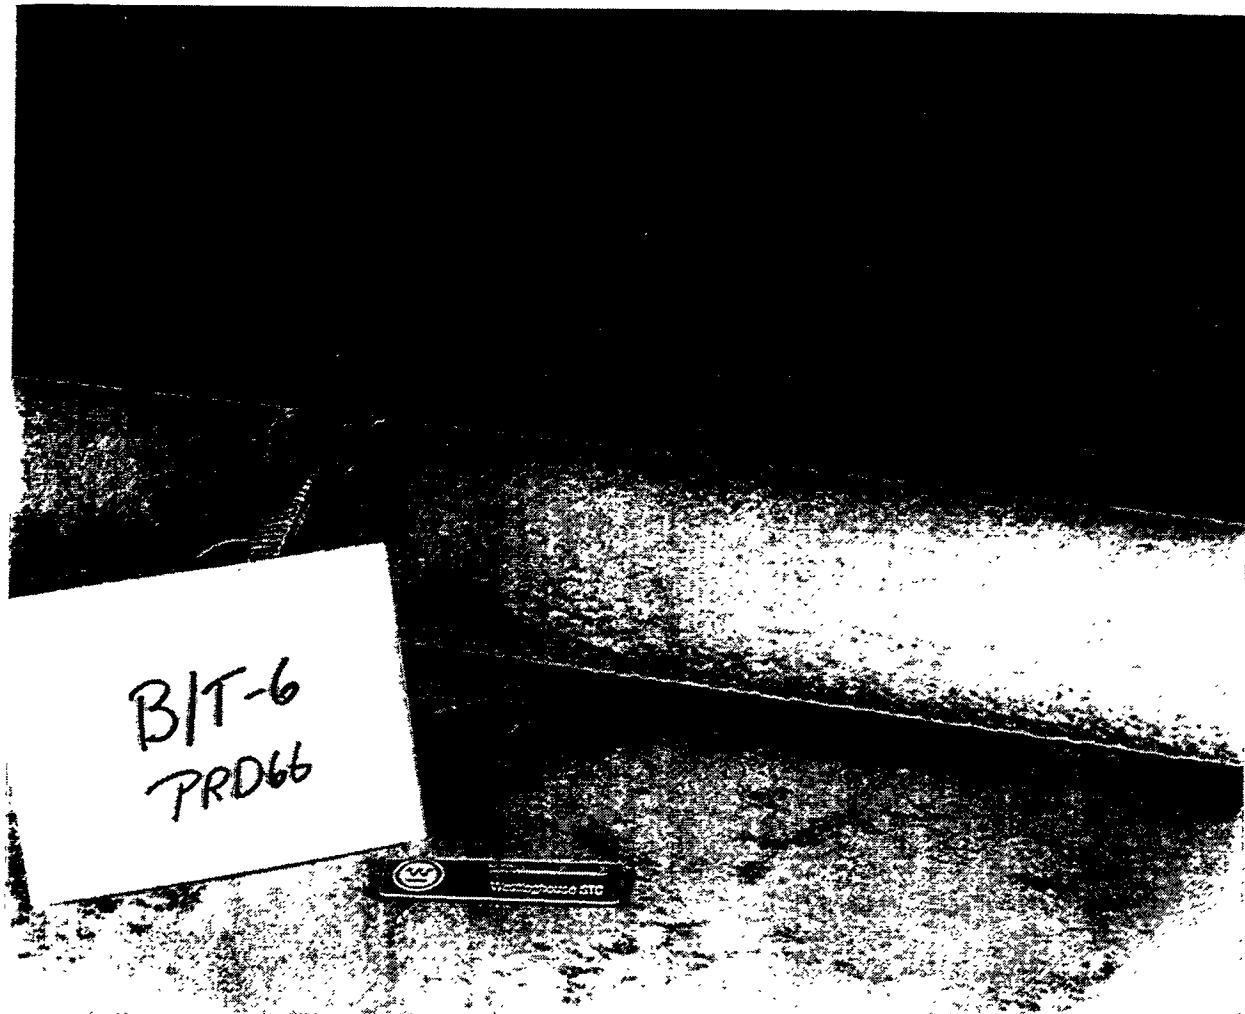
Figure 30b – Intact DuPont PRD-66 Candle Filter (Position B/T-6; Test Segment #5)

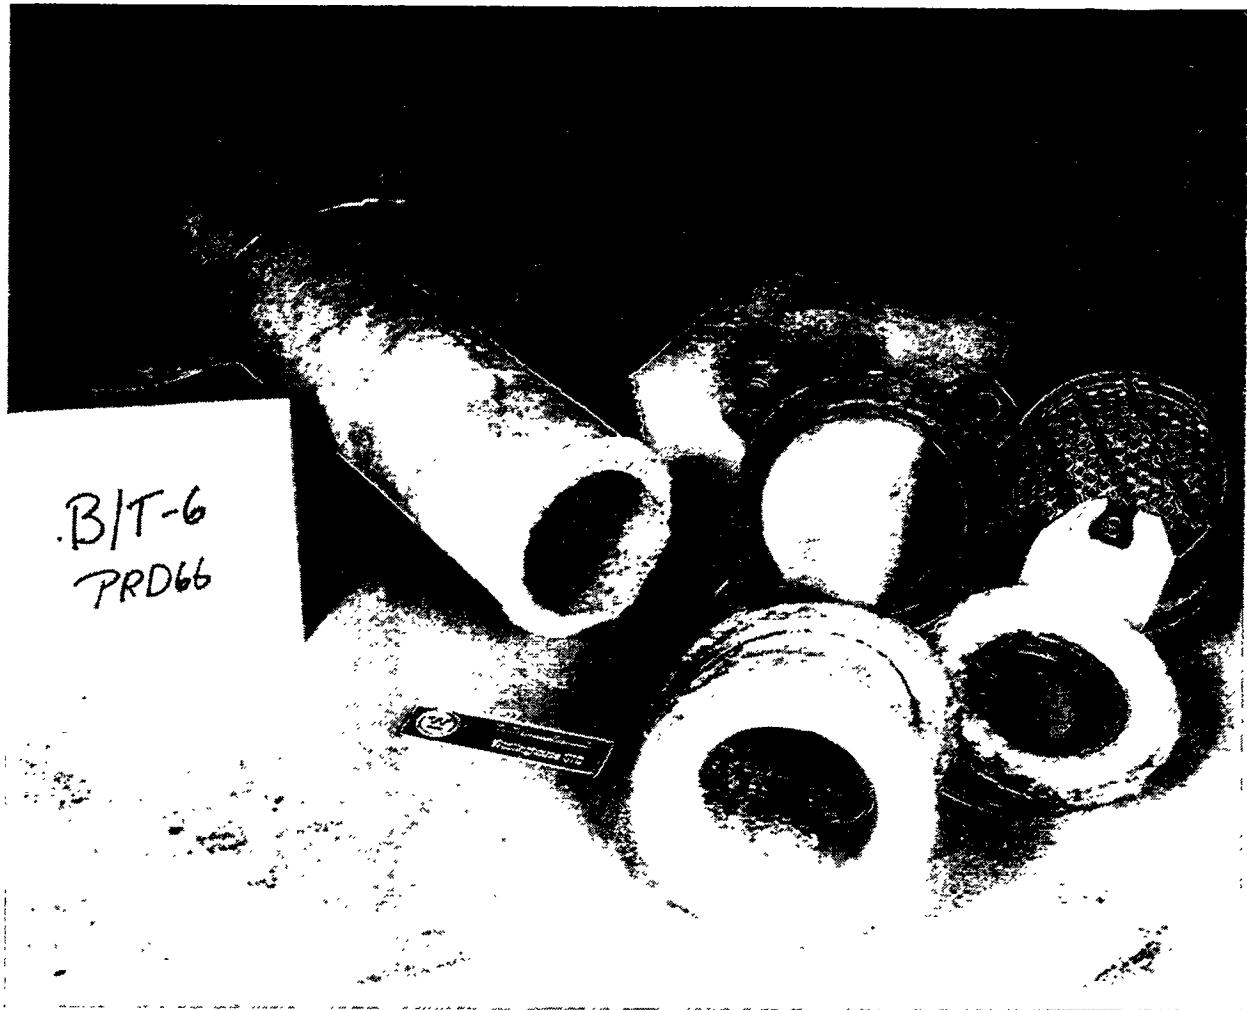
Figure 30c – Intact DuPont PRD-66 Candle Filter (Position B/T-6; Test Segment #5)
