PFBC HGCU Test Facility  
Technical Progress Report

Third Quarter, CY 1995

American Electric Power Service Corporation  
Columbus, Ohio 43215

Appendix 1 presents the results of filter candle posttest examination by Westinghouse performed on selected filter candles following final shutdown of the system.

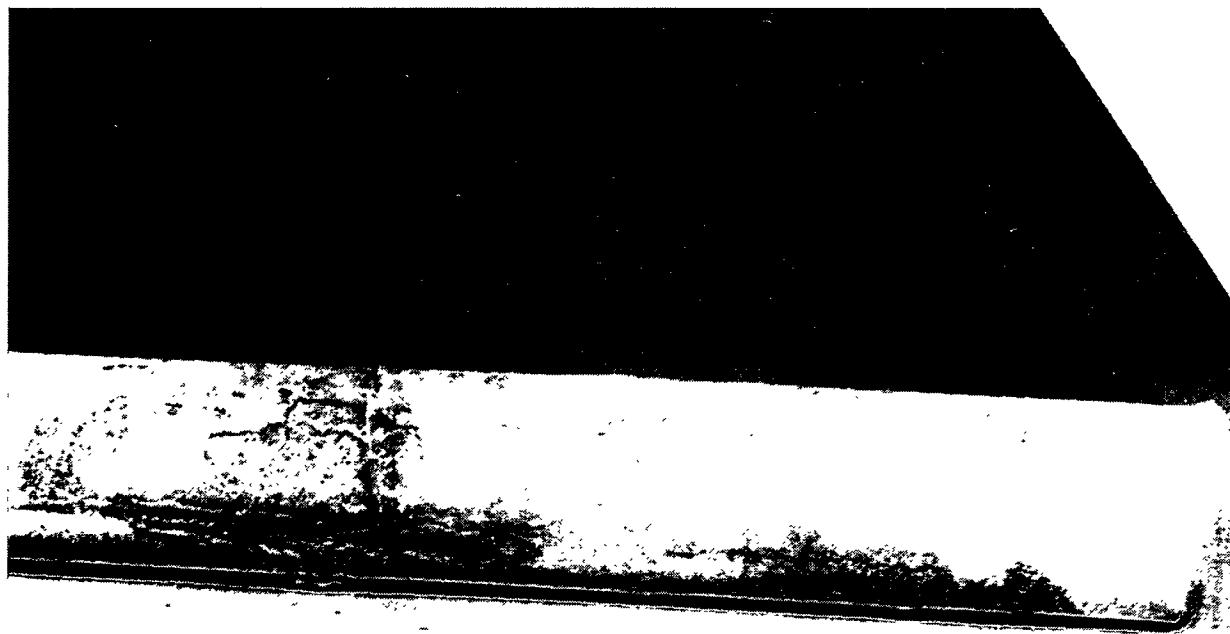
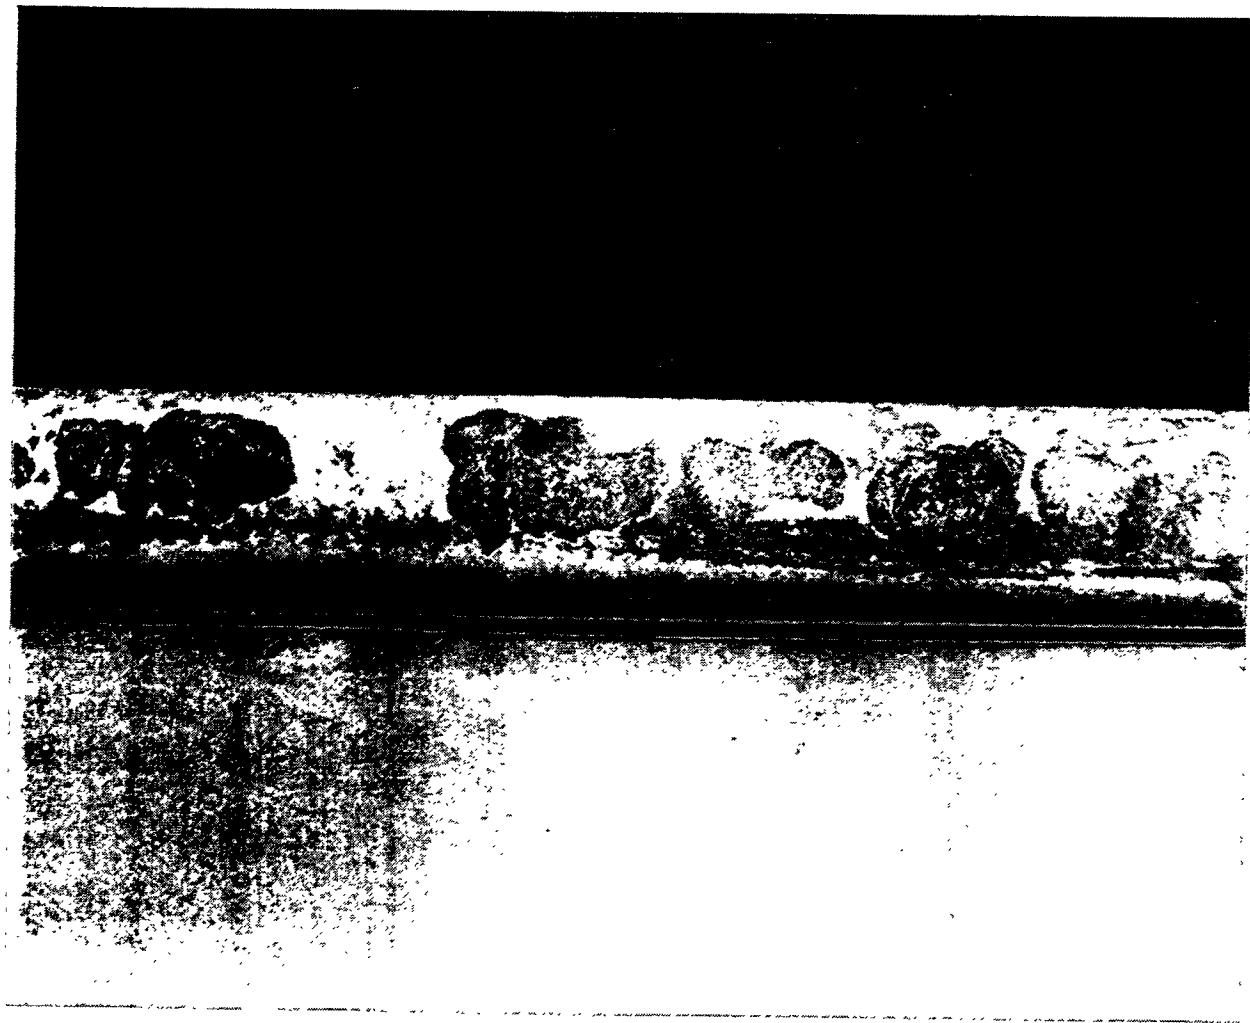
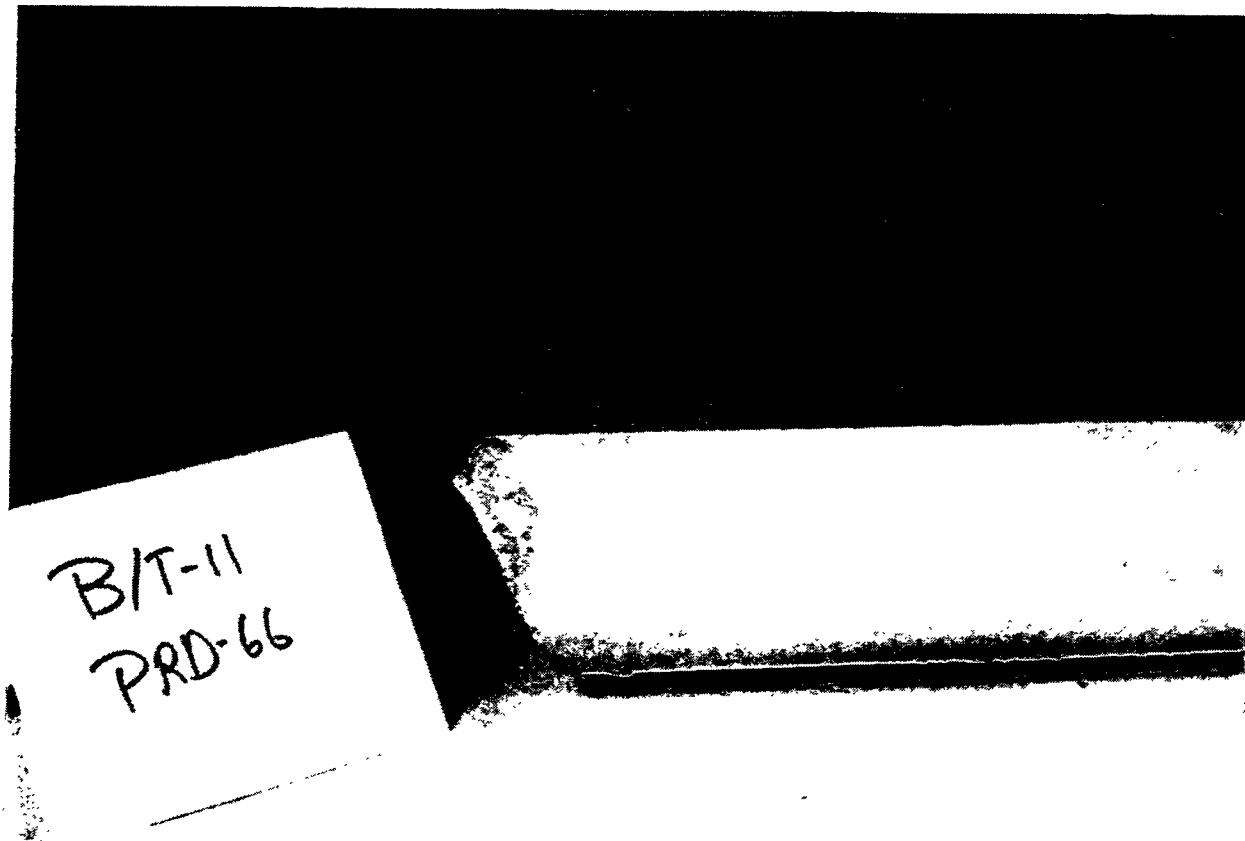
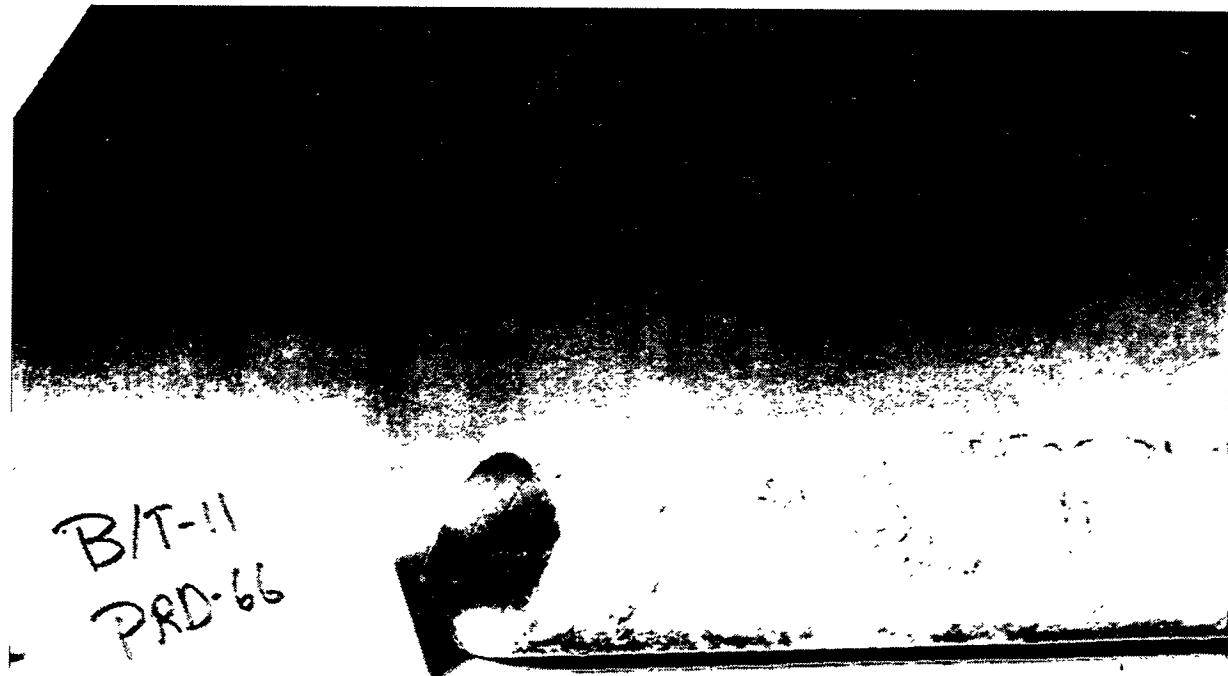
Figure 31 illustrates the failed DuPont PRD-66 filter element that had been located in position B/T-11. Again failure of the filter element's flange resulted during disassembly and removal from the filter holder. The red ash stain was once again evident in isolated areas along the surface of the B/T-11 filter element. Divots were also evident, again tracking in line formations. Divots resulted along both the red stained areas of the filter element, as well as along the as-manufactured white sections of the DuPont PRD-66 filter matrix. The fractured surface of the PRD-66 filter typically followed the filament winding pattern (i.e., diagonal diamond weave), with slight layering through the filament wound structure (Figures 31g and 31h). The red stain was also evident along the ID surface of the candle, near the fractured surface.

Figure 31a – Failed DuPont PRD-66 Candle Filter (Position B/T-11; Test Segment #5)

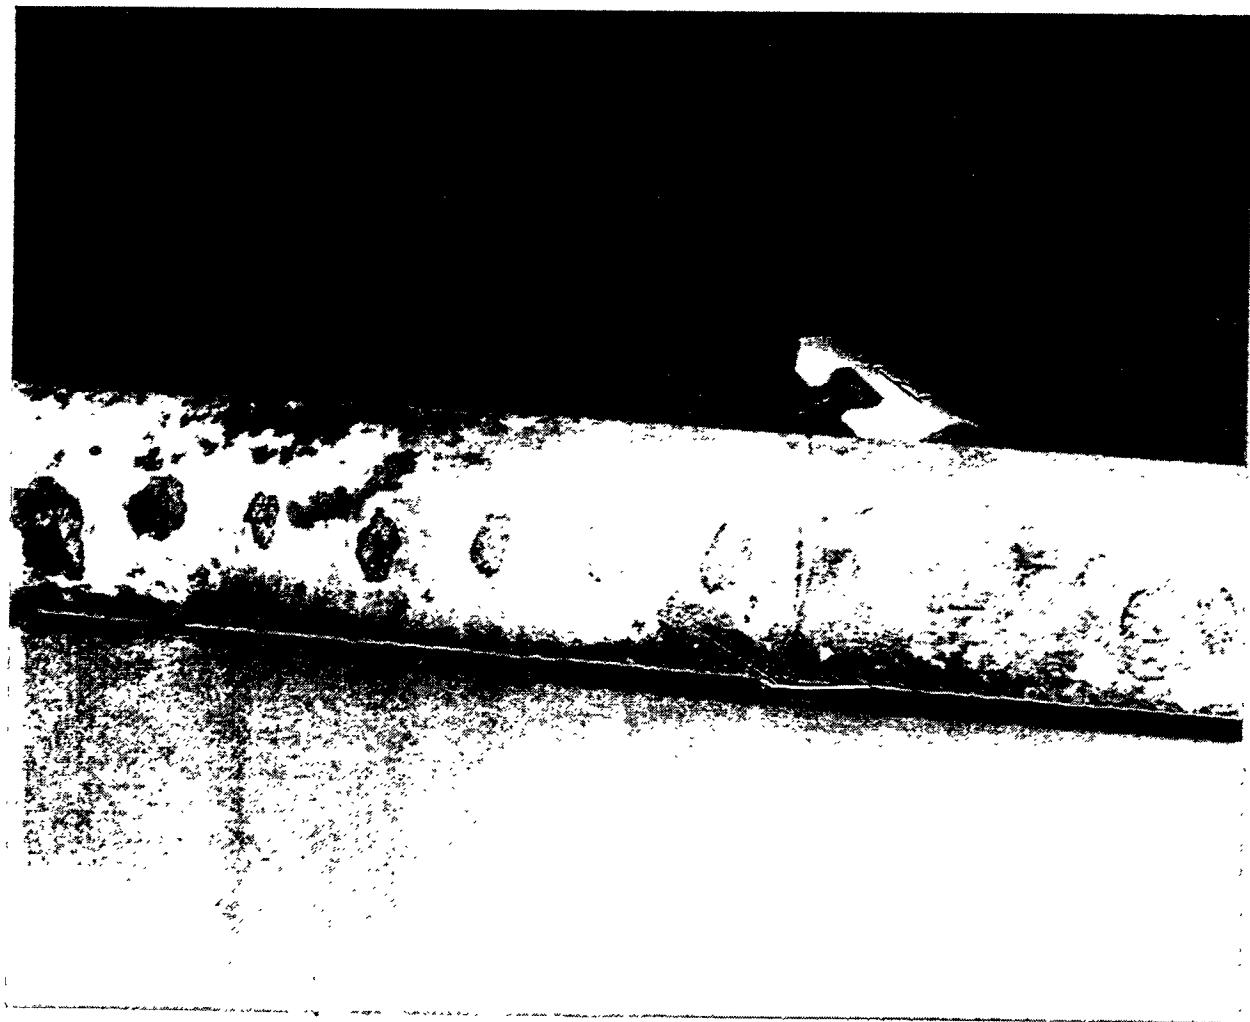
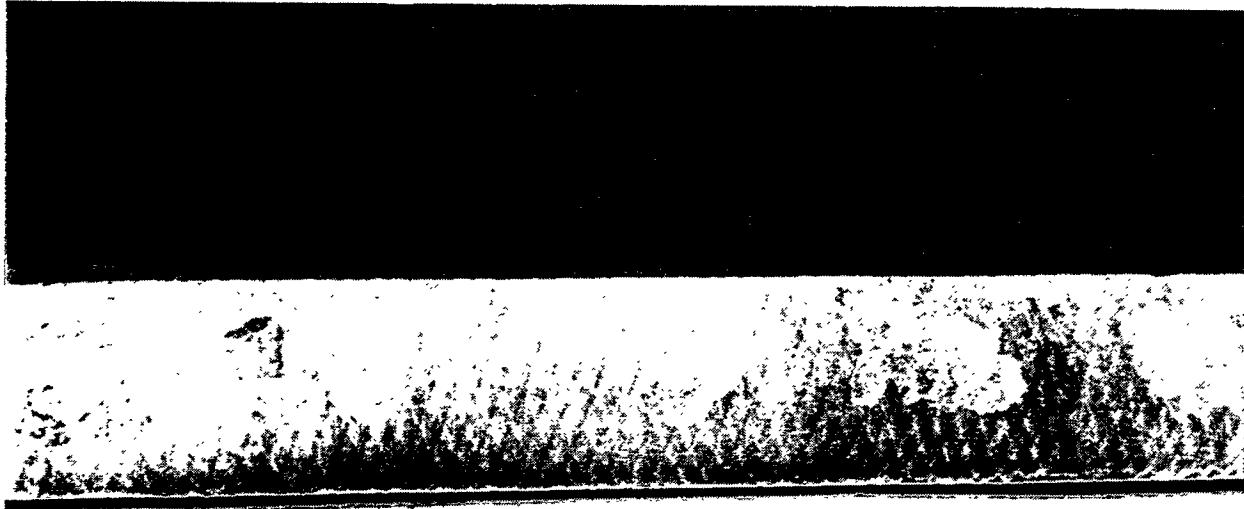
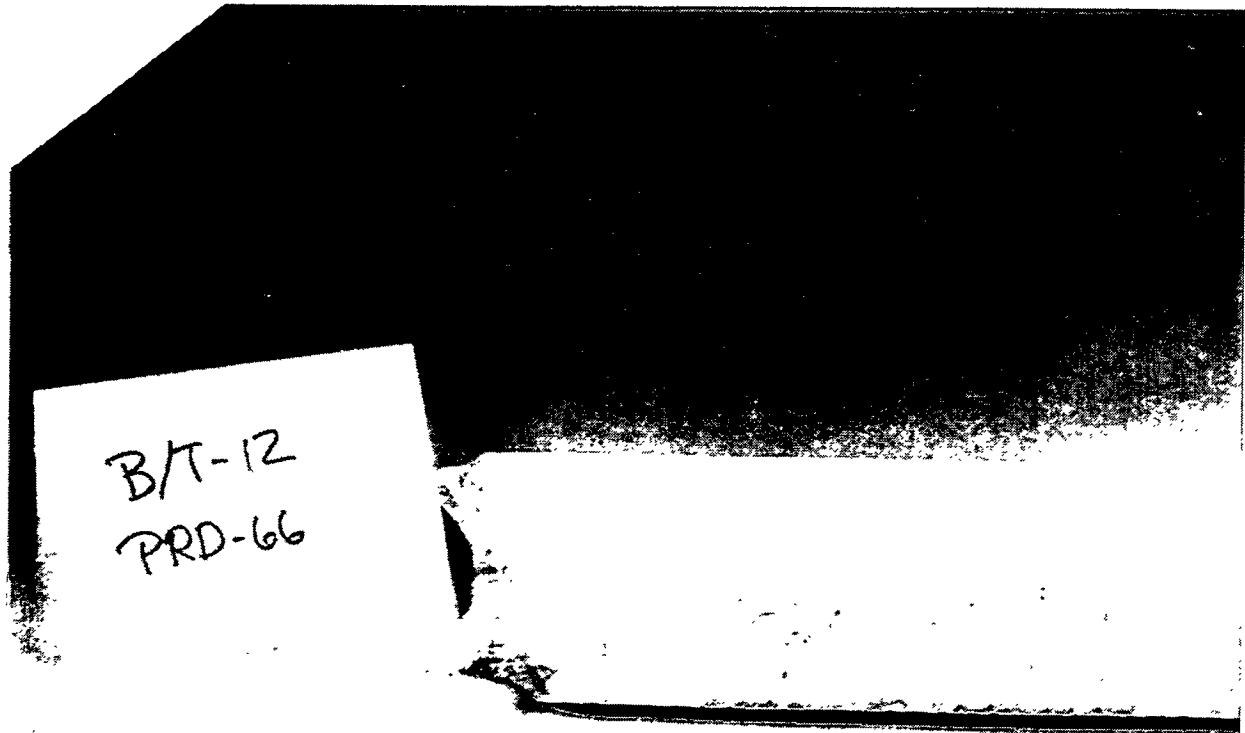
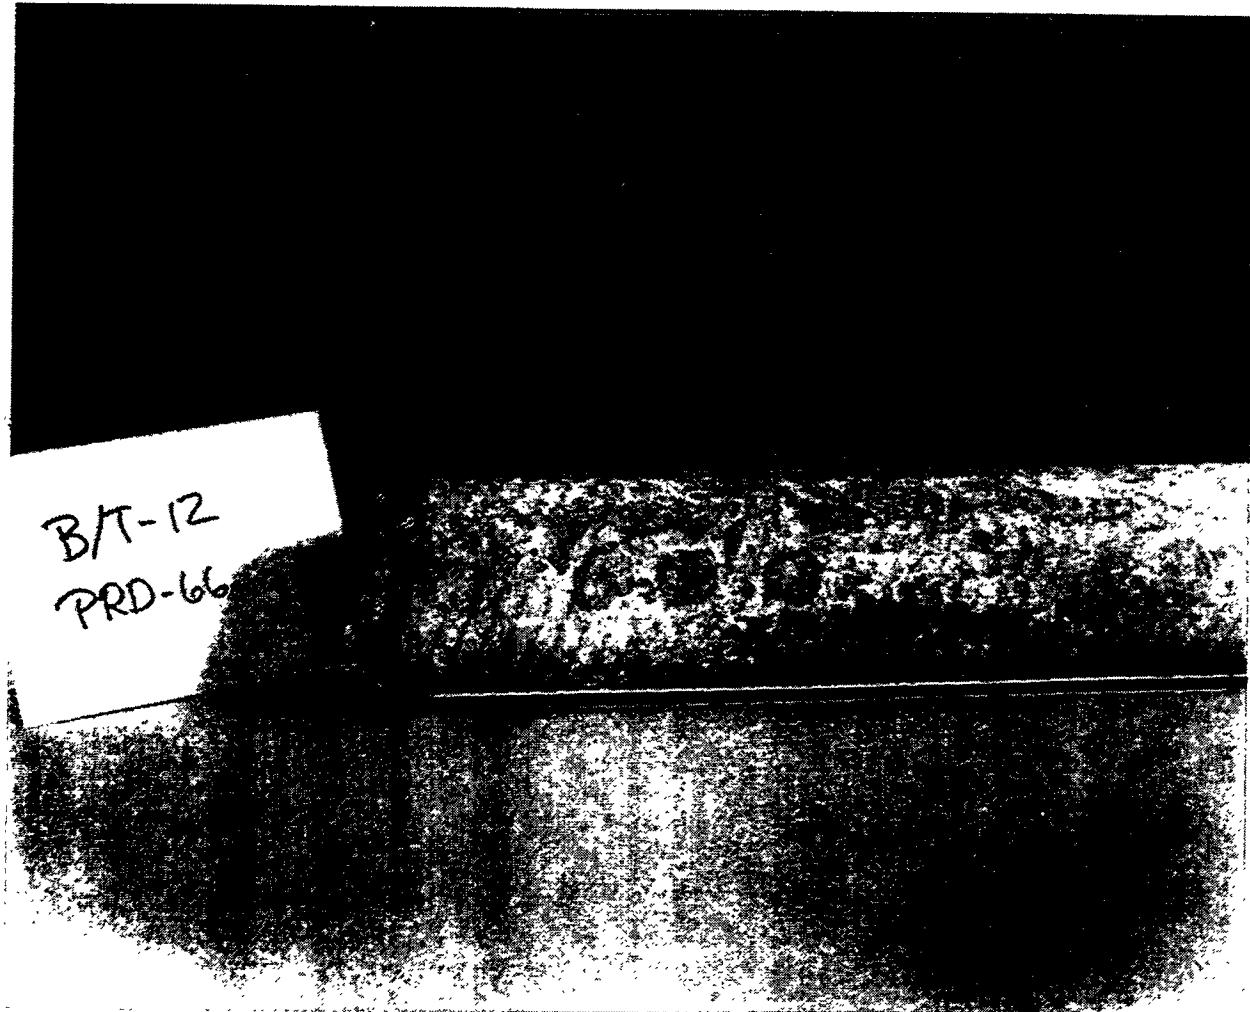
Figure 32 illustrates the failed DuPont PRD-66 filter element that was located in position B/T-12. Again the red stain was evident along the filter body. Divots were also present along both the red stained and as-manufactured white filter body. Again the divots resulted in line formations. The fractured surface followed the diamond diagonal weave, as well as the filament wound layering.

Figure 32a – Failed DuPont PRD-66 Candle Filter (Position B/T-12; Test Segment #5)

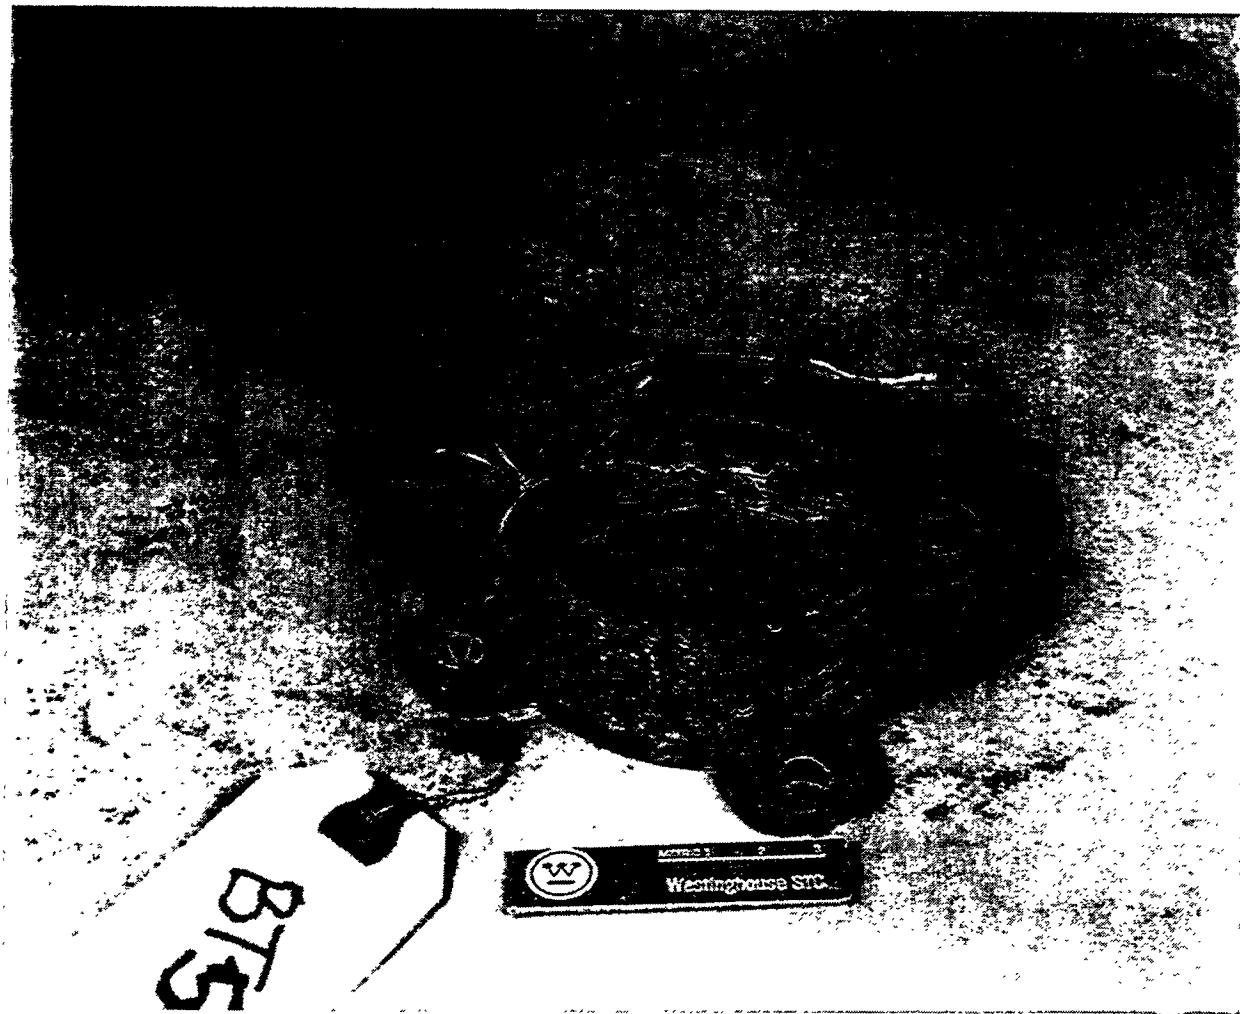
Figure 33 illustrates the thick ash deposit that had been formed at the base of the flange along the outer surface of the DuPont PRD-66 candle which had been located in position B/T-5. This candle failed during operation at AEP in Test Segment #5. The thick ash deposit was below the external mat-filled, middle gasket that was positioned at the base of the filter's flange.

Figure 33 — Bottom Holder Nut From A Failed DuPont PRD-66 Candle Filter That Was Located In Position B/T-5 (Test Segment #5)

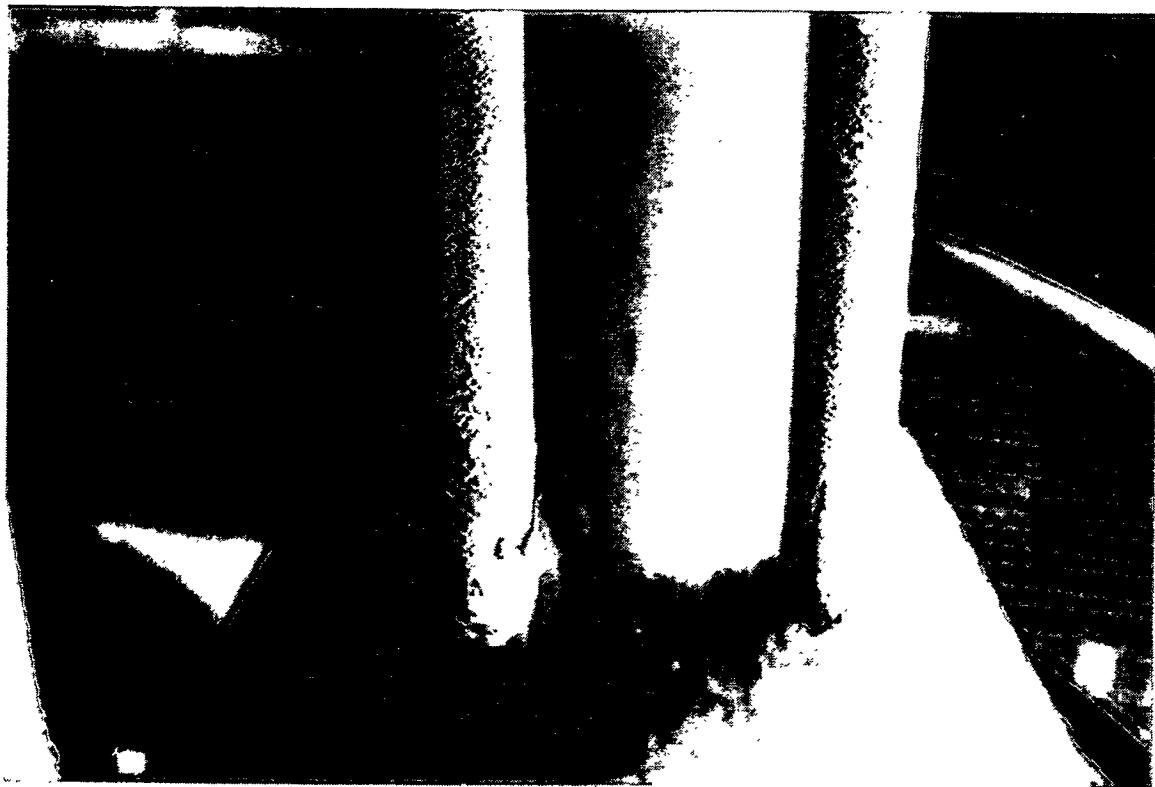
Figure 34 — Red Ash Stain Along The Top And Middle Dust Sheds

Frequently during inspection of the failed DuPont PRD-66 filters, the red stain followed a contour that may have suggested condensation and/or gas/ash flow lines along the length of the filter element. These flow lines were typically observed along one side of the filter element, generally off-center from the candle/plenum tangent point. The red stain was also evident along the dust sheds, directly below the PRD-66 candle end caps (Figure 34). Tracking of ash as it falls from the filter elements is expected to have resulted along the dust shed. Perhaps the gas flow path in the top arrays, and/or pulse cleaning gas as it was emitted from an adjacent failed candle filter may be responsible for the red stain that resulted along the PRD-66 candle filters. The red stain along the top array PRD-66 dust sheds was commonly found along the alternate top and middle array sheds. Figure 34 also illustrates the thicker ash cake formation that resulted along the bottom of the PRD-66 candle filters. Shedding and/or spalling of the ash cake layers was evident.

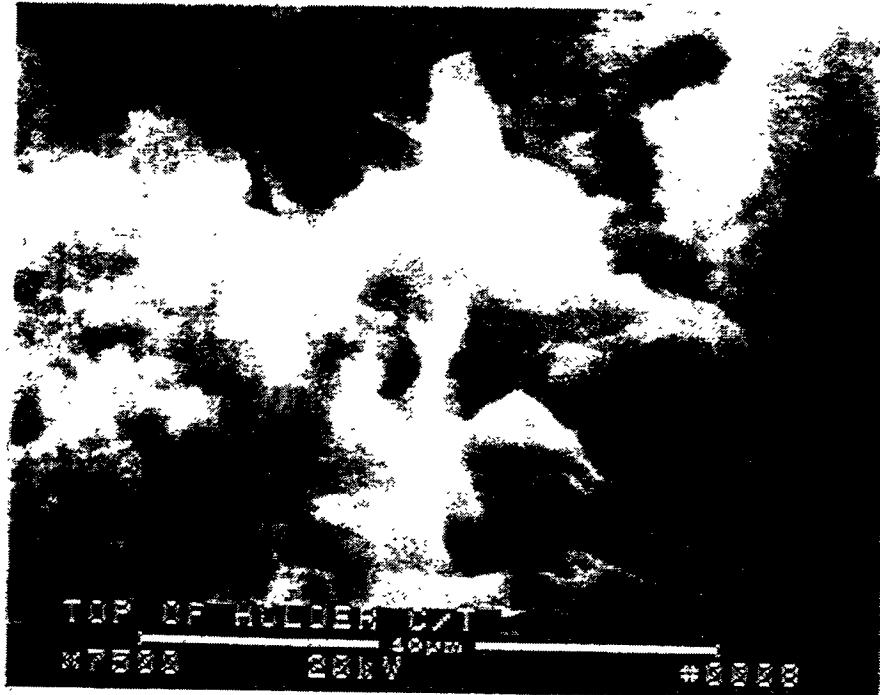
Figure 2e – Morphology Of The Fines Collected In Layer 2 Of The C/T Filter Holder Mount. Crystal Growth Is Evident.

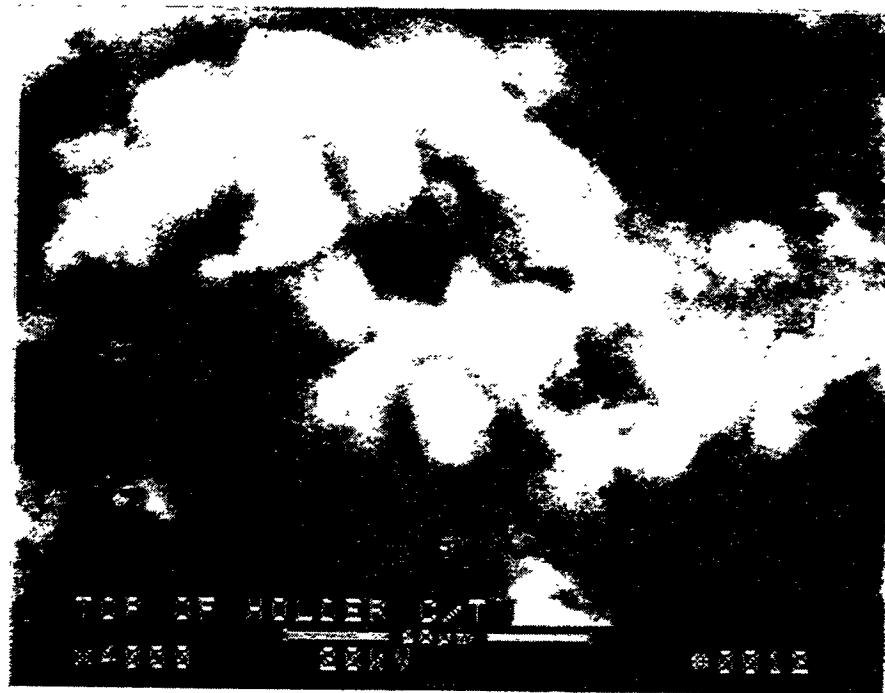
Figure 2g – Morphology Of The Ash Deposit Which Formed Along The C/T Filter Holder Mount (Layer 3)

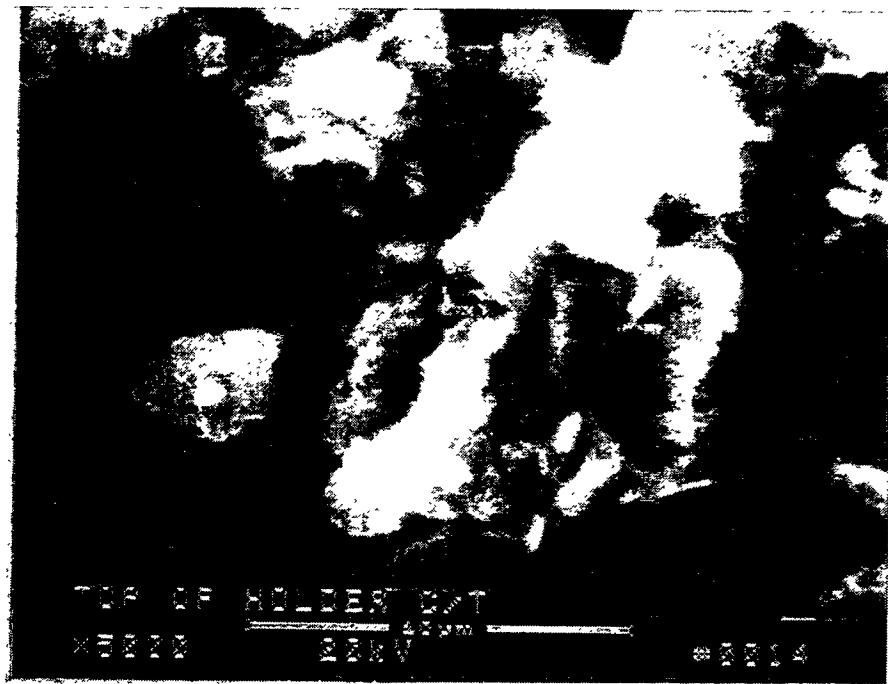
Figure 2h – Morphology Of The Ash Deposit Which Collected Along The C/T Filter Holder Mount (Layer 3)

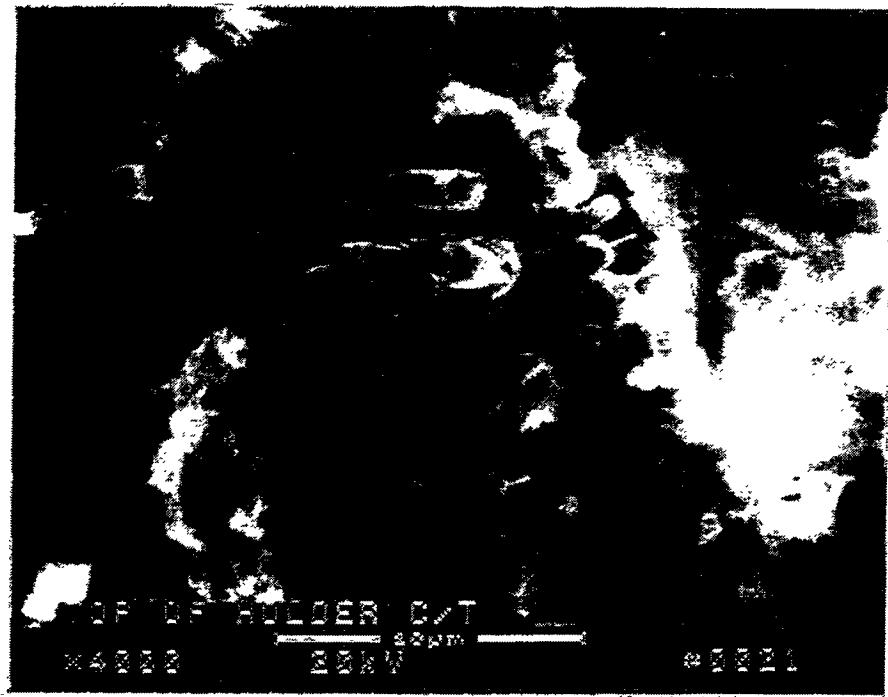
Figure 21 # Crystal Growth Within The Ash Formation That Collected Along The C/T  
Filter Holder Mount At ~2 mm From The Layer 4/Layer 5 Interface

Layer 5 consisted of ~8 mm of ash/sorbent fines. SEM and/or SEM/EDAX analyses were conducted at consecutive 2 mm intervals moving toward the surface of the ash that was in contact with the metal filter holder. A "web-like" structure was evident between adjacent sintered or agglomerated fines (Figure 2k). Dendritic or "whisker-like" crystalline phases were also present within the ash/sorbent fines collected in Layer 5 (Photo 20, Figure 2k; Photo 21, Figure 2l).

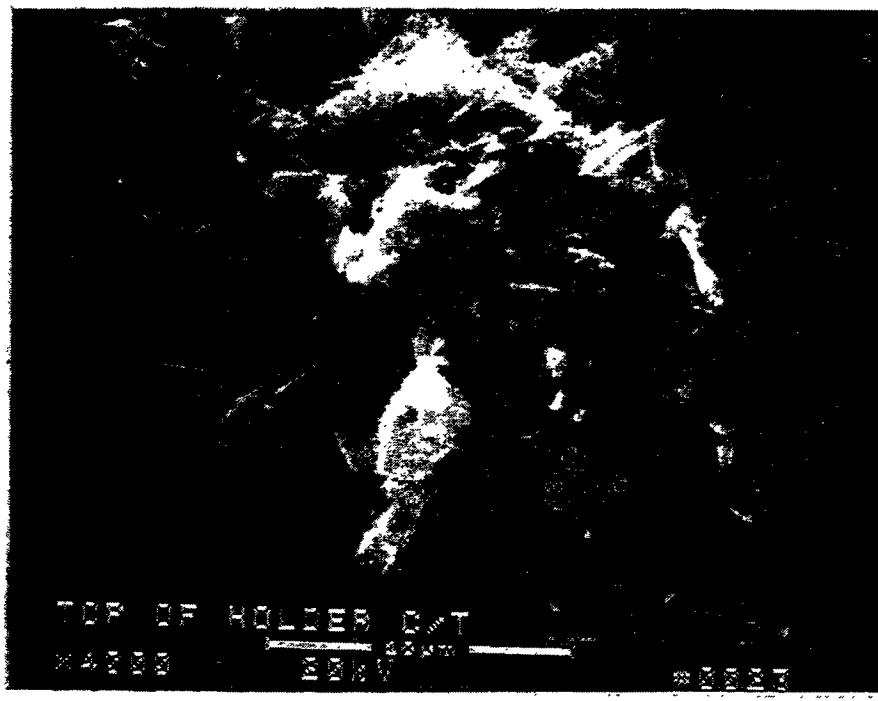
Figure 2m—Extensive Crystal Growth Within The Ash Formation That Collected Along The C/T Filter Holder Mount At ~4 mm From The Layer 4/Layer 5 Interface

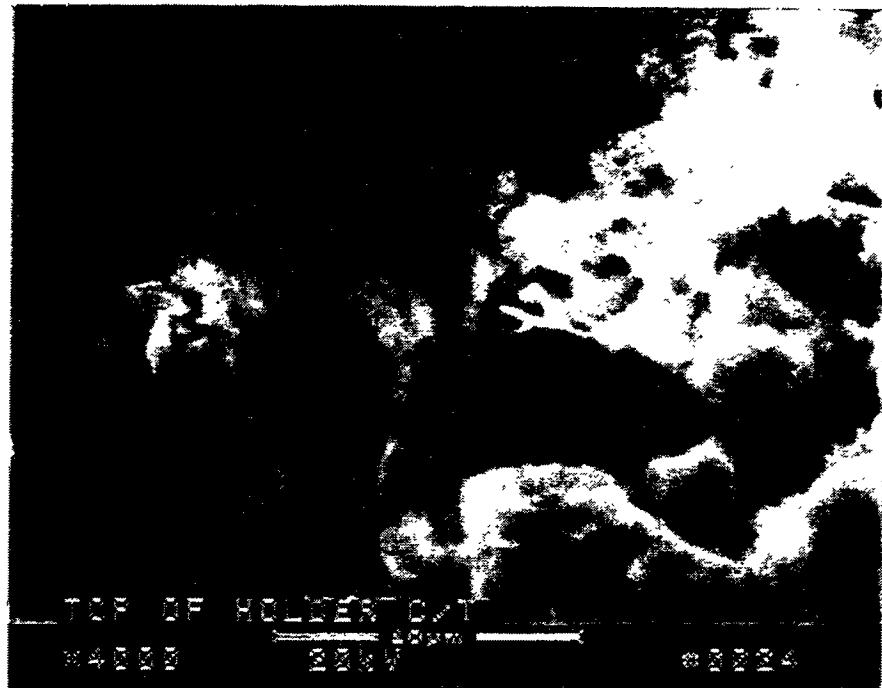
Figure 2n – Crystal Growth Within The Ash Formation That Collected At An Alternate Location Along The Filter Holder Mount At ~4 mm From The Layer 4/Layer 5 Interface

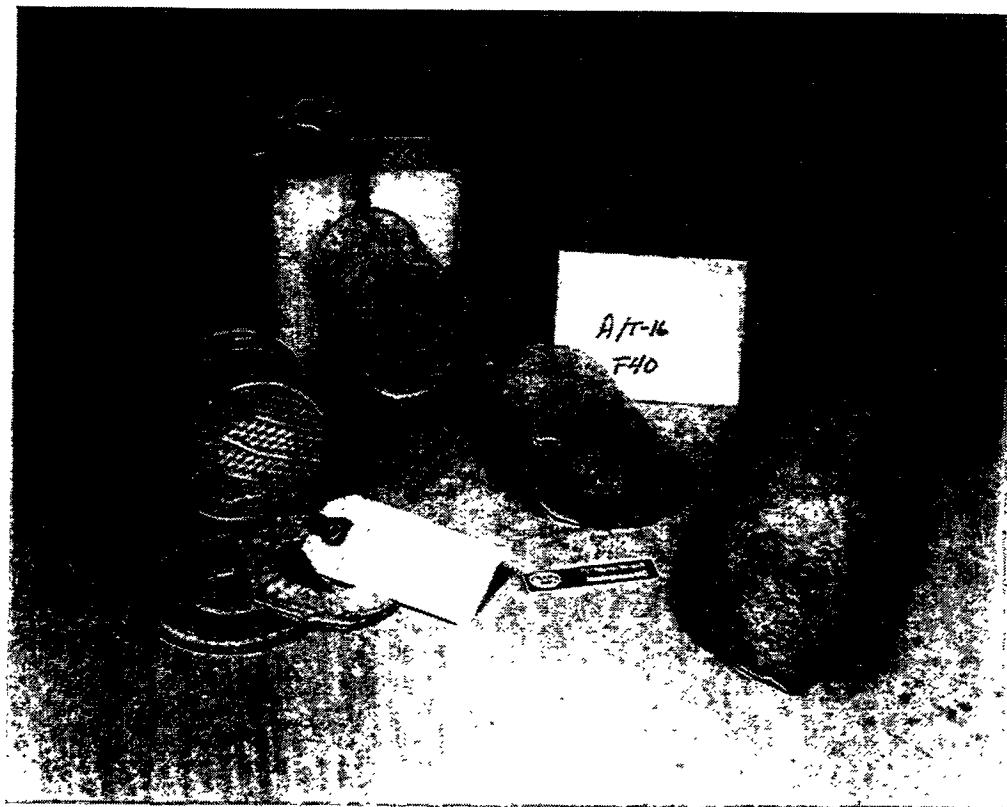
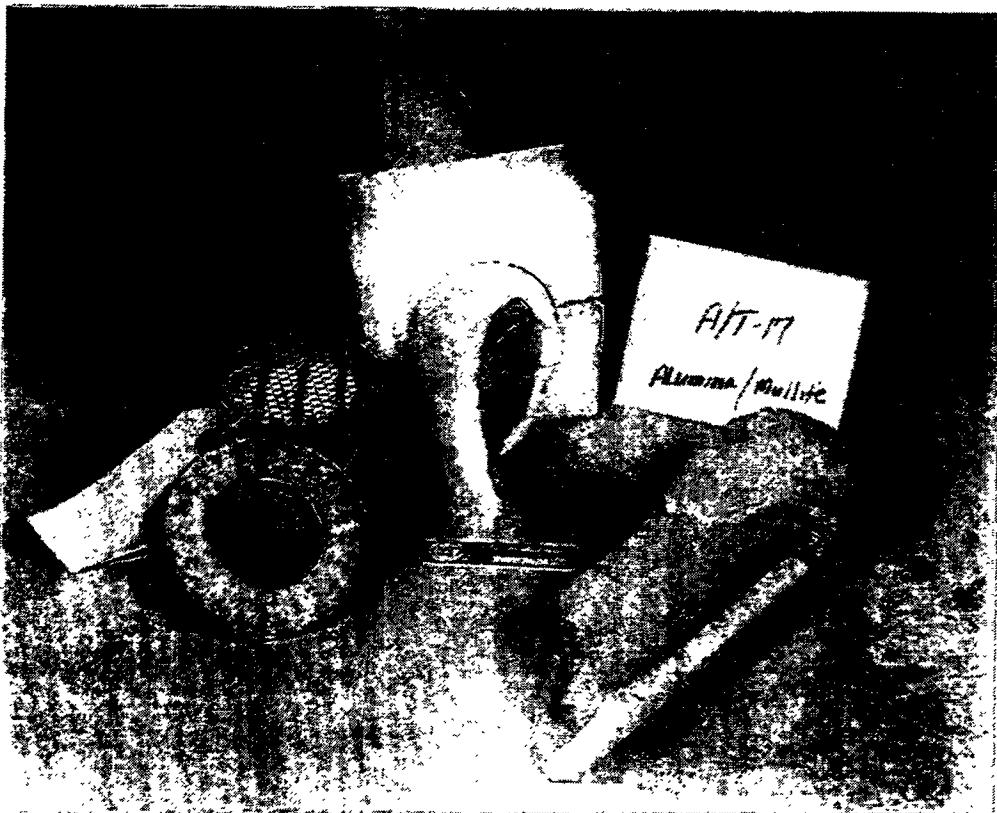
Figure 3 — Tightly Packed Ash Within The ID Bore Of The Porous Ceramic Candles  
(Test Segment #5)

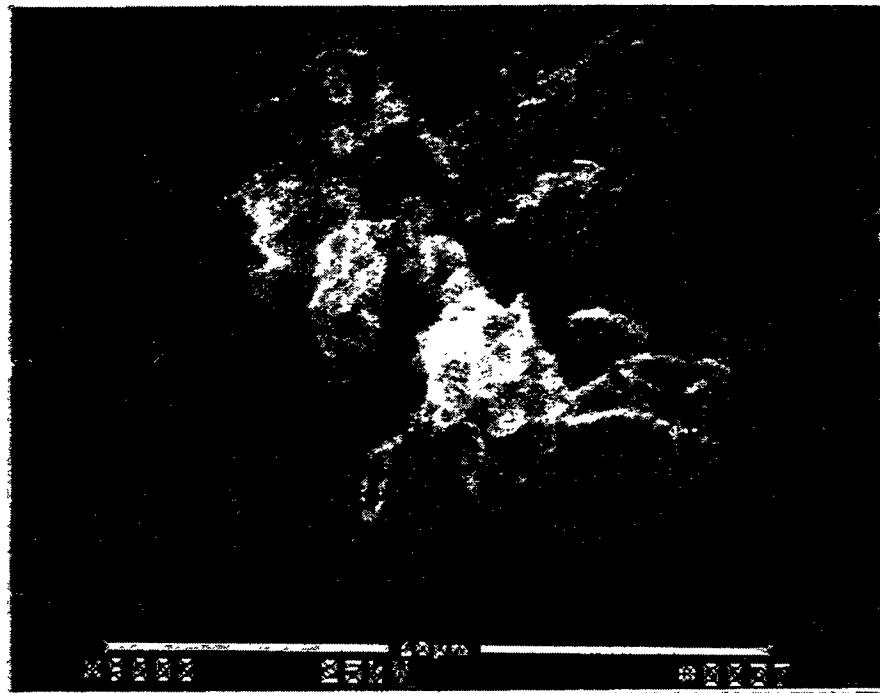
Figure 2s – Higher Magnification Micrograph Illustrating The Morphology Of The Inner Surface Of The Candle Filter Ash Deposit

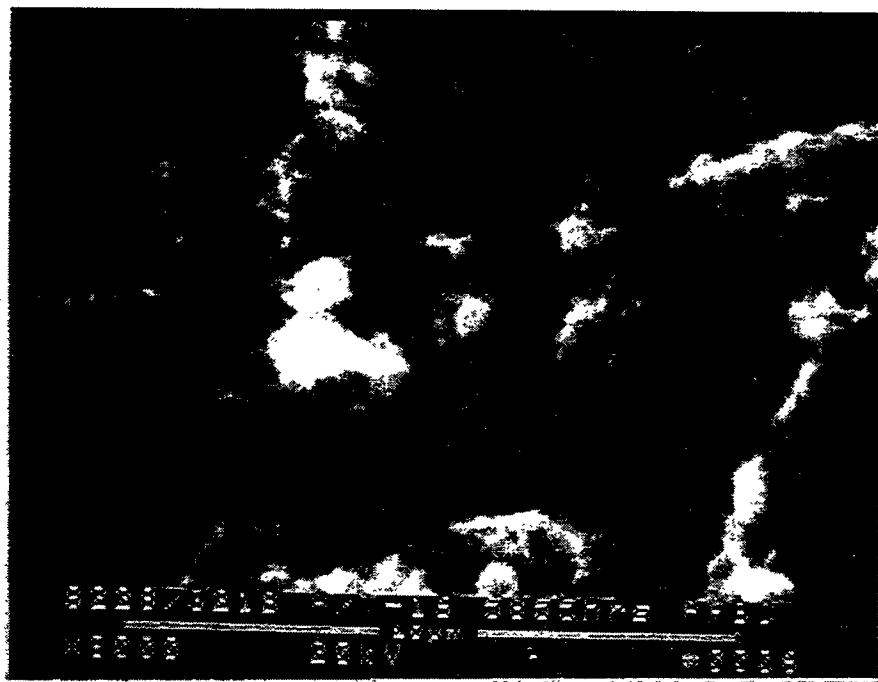
Figure 3c – Morphology Of The Ash Fines That Remained Along The Membrane Surface  
Of The 5855 Hour PFBC-Exposed Schumacher Dia Schumalith F40 Candle  
Filter

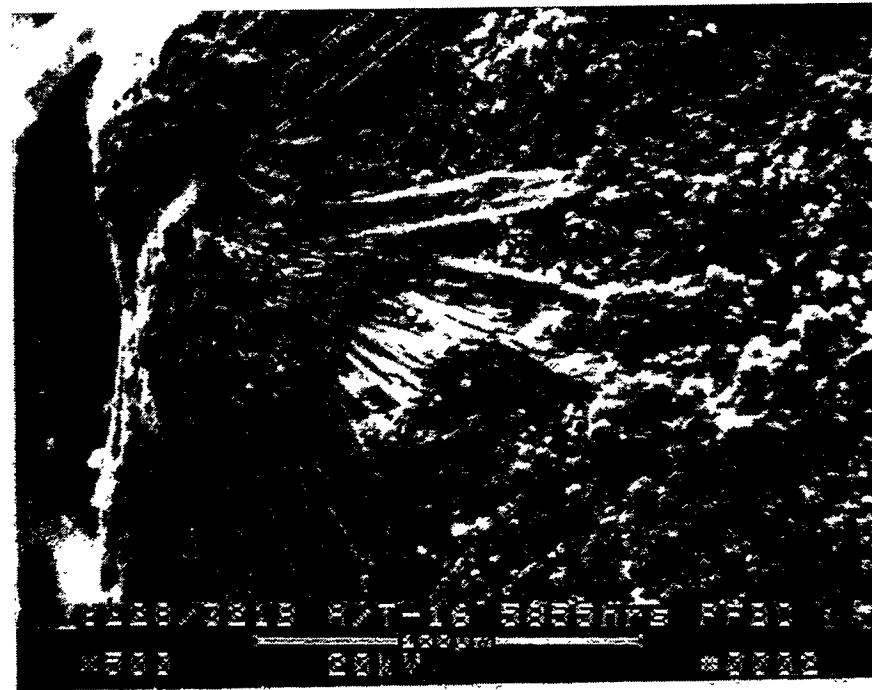
Figure 5a – Calcium Sulfate-Enriched Dendritic Formations That Resulted Along The 5855 Hour PFBC-Exposed Schumacher Dia Schumalith F40 Filter Matrix After Wet Cutting

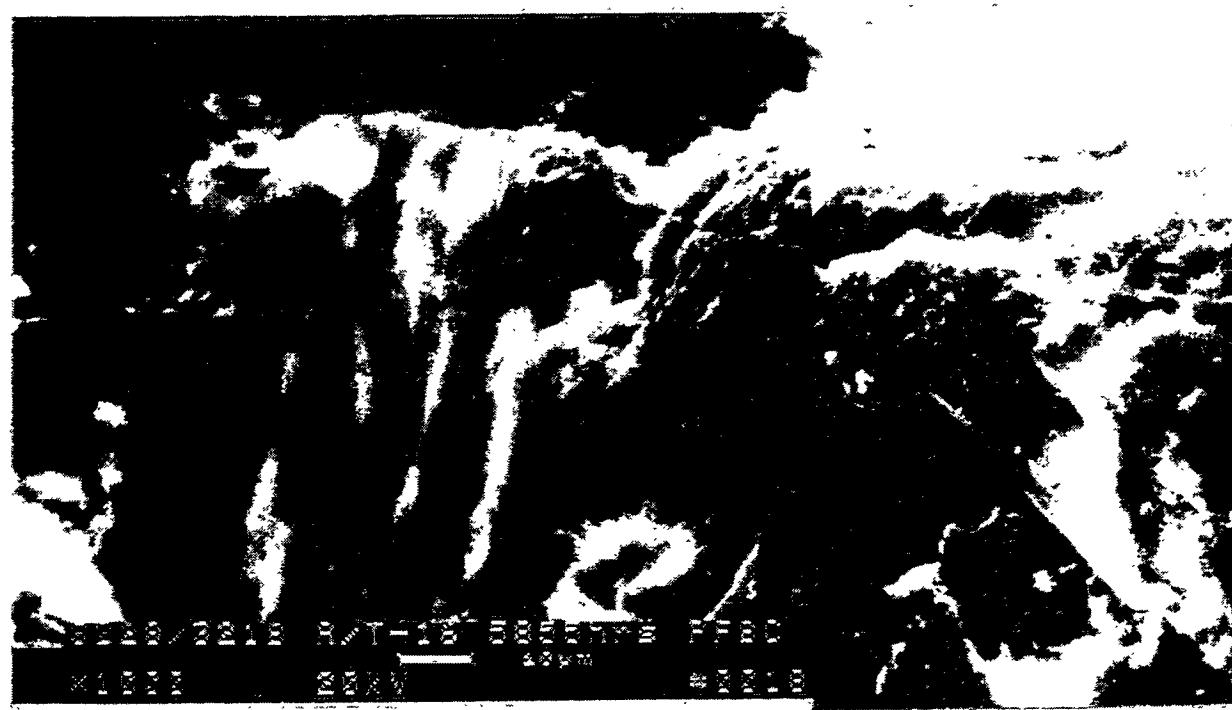
Figure 5g – Higher Magnification Micrographs (Grains In The 5855 Hour PFBC-Exp Filter Matrix

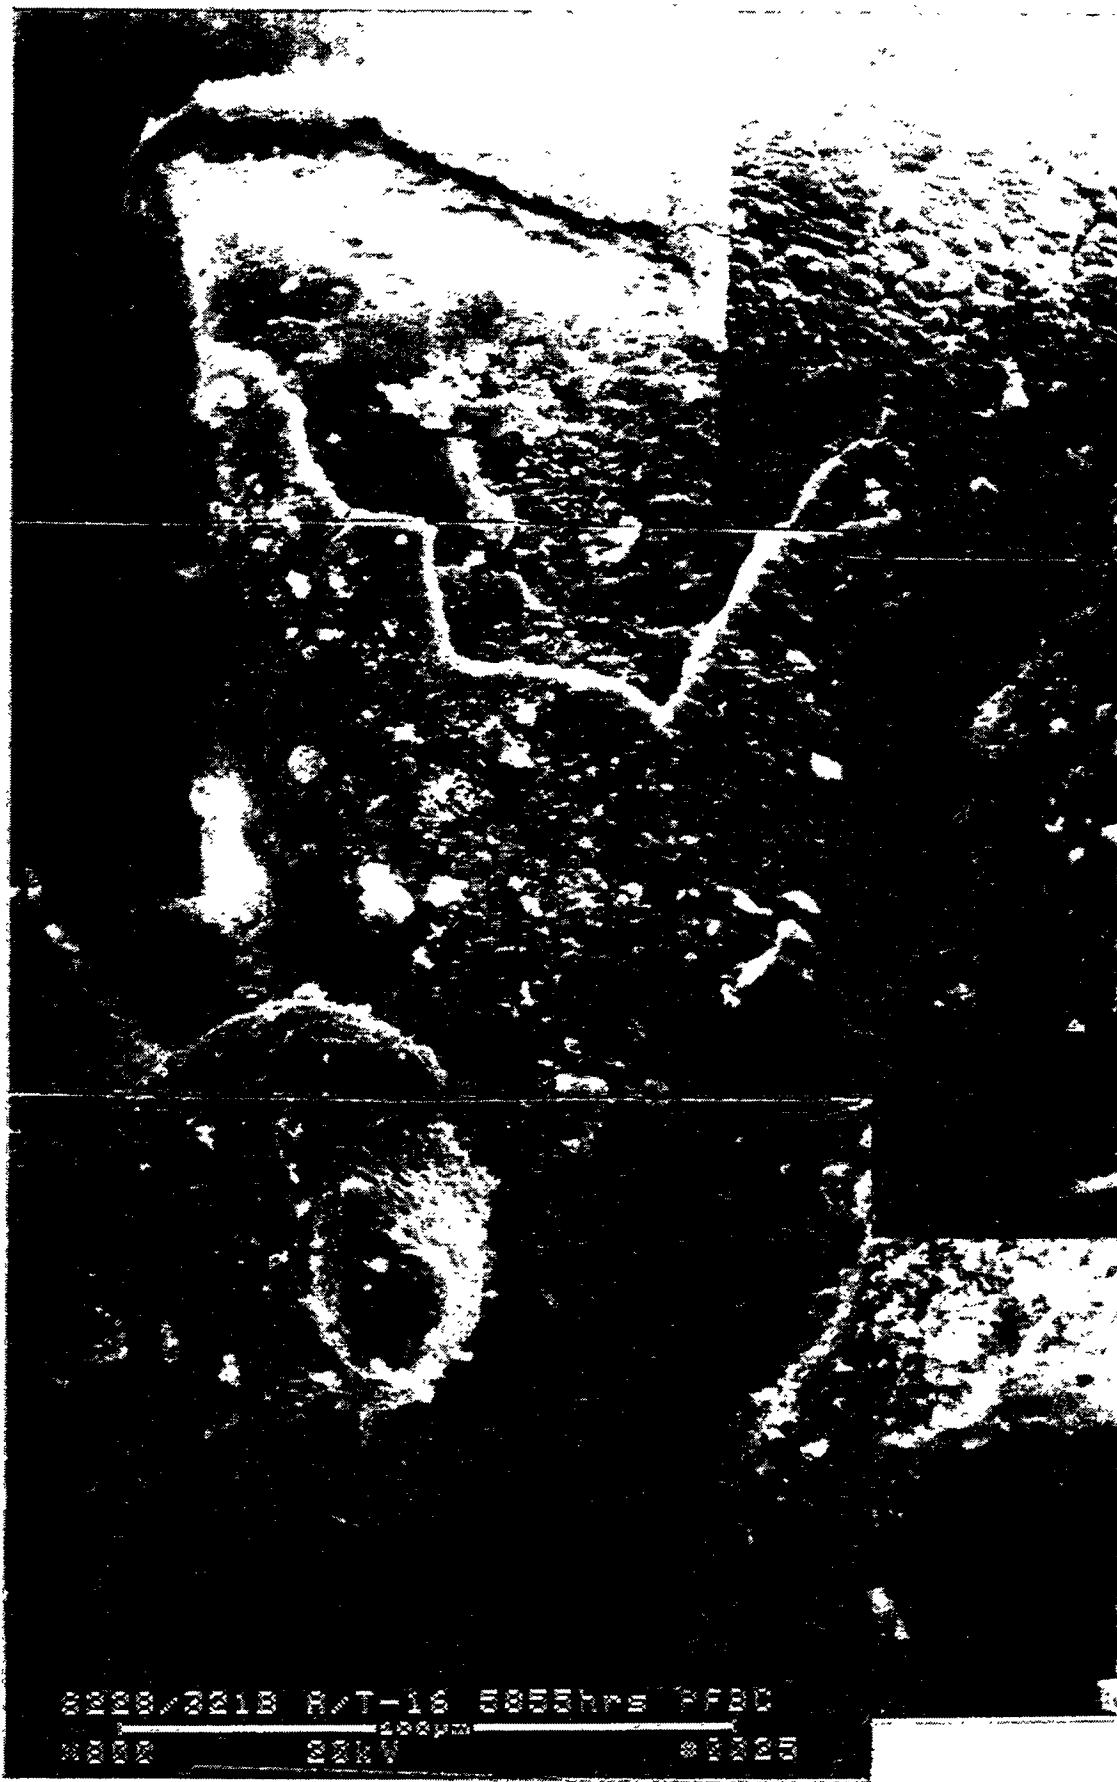
Figure 5i — Extensive Crystallization Of The E  
5855 Hour PFBC-Exposed Schumacher

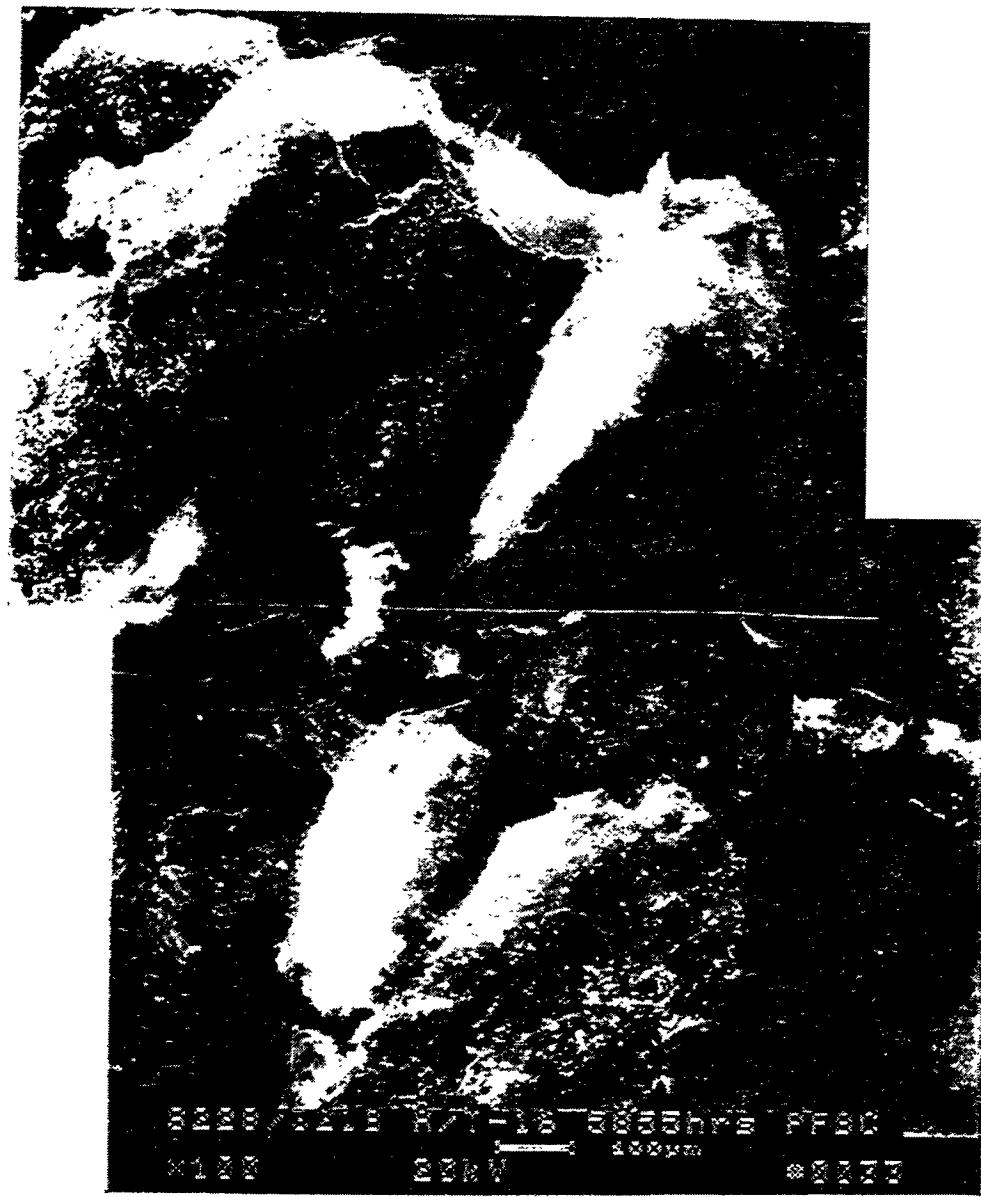
Figure 5m—Morphology Of The Crystallized Clay Binder At ~15 Grains Below The OD Membrane Surface
