PFBC HGCU Test Facility  
Technical Progress Report

Third Quarter, CY 1995

American Electric Power Service Corporation  
Columbus, Ohio 43215

Appendix 1 presents the results of filter candle posttest examination by Westinghouse performed on selected filter candles following final shutdown of the system.

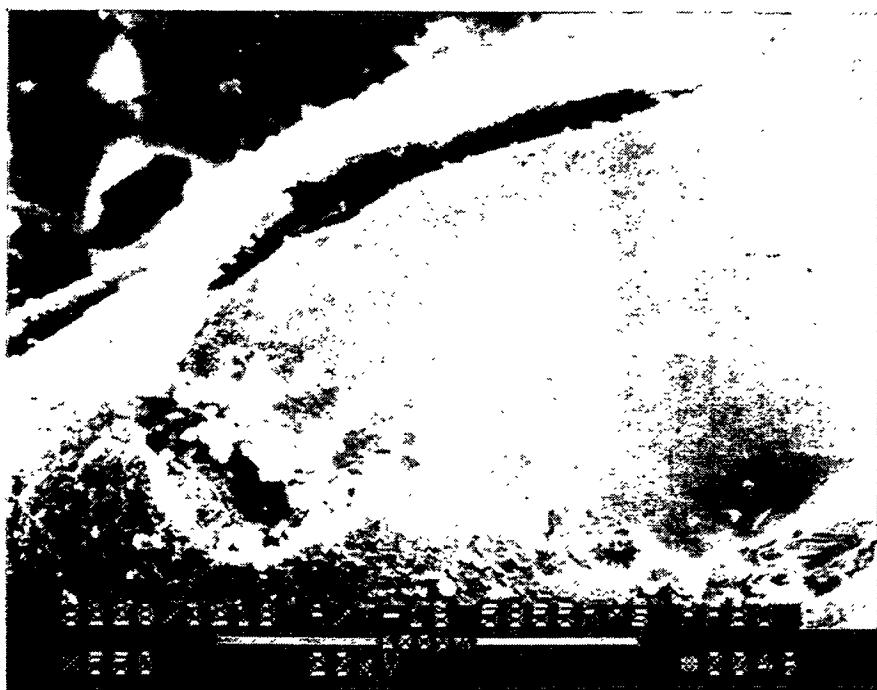
Figure 5u — Morphology Of The Crystallized Binder At An Alternate Location Within The Schumacher Dia Schumalith F40 Filter Matrix

Figure 5u illustrates the morphology of additional silicon carbide grains at an alternate location along the mid-section of the filter body. Crystallization of the binder phase occurred, as well as spalling and lifting of the binder from the support grain.

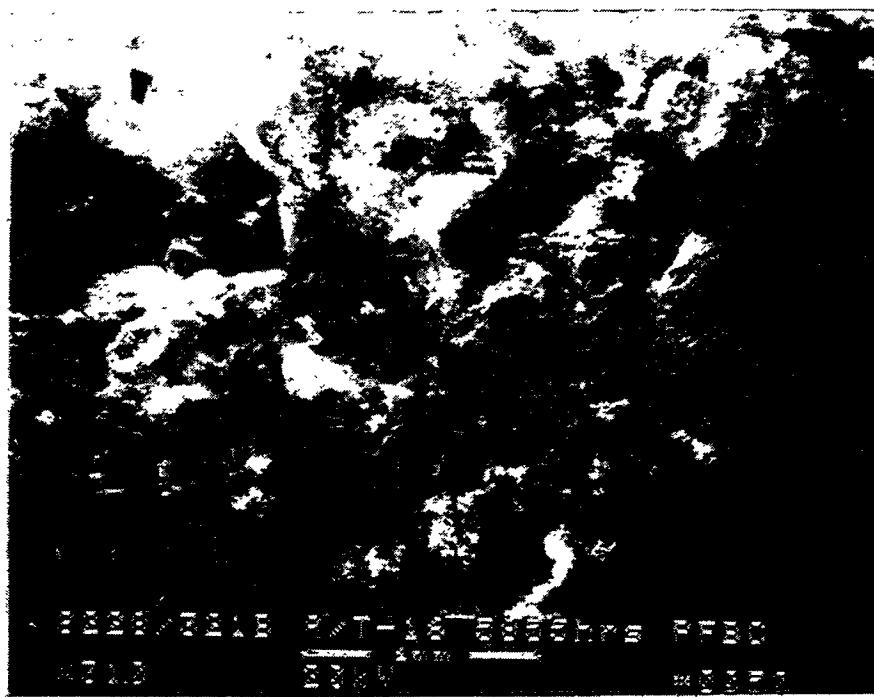
Figure 5v – Morphology Of The 5855 Hour PFBC-Exposed Schumacher Dia Schumalith F40 Filter Matrix (ID Wall)

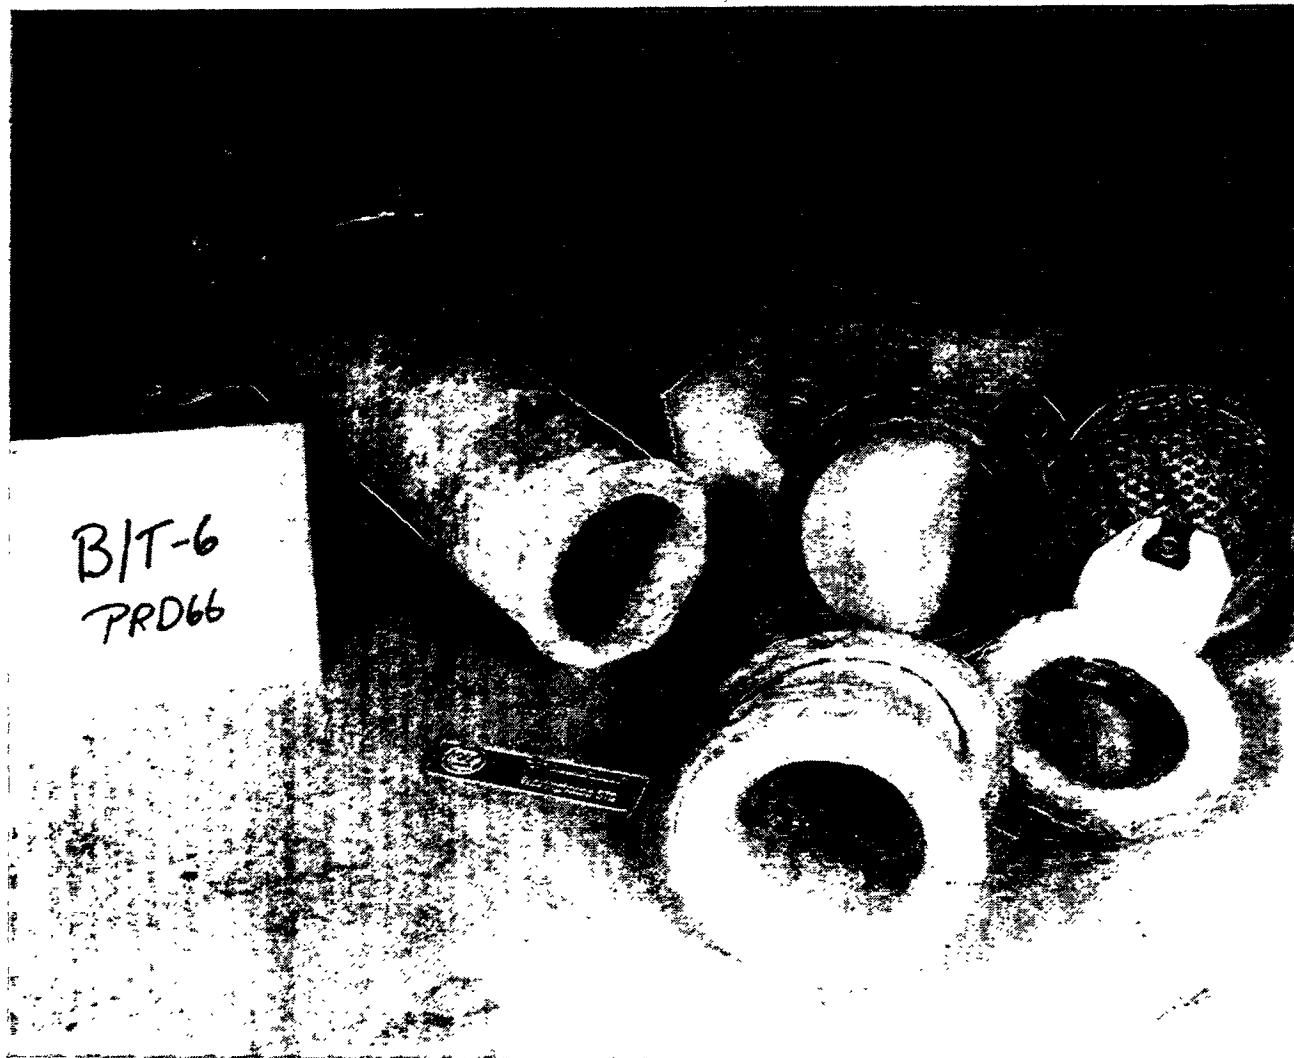
Figure 2 — Flange Failure Of The DuPont PRD-66 Filter Elements In Test Segment #5

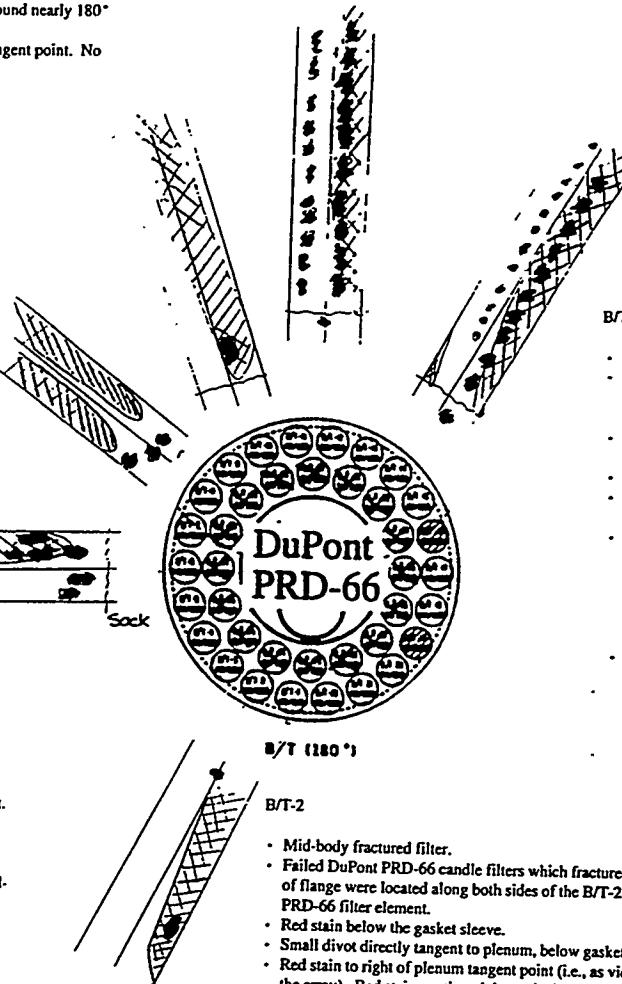
- Three-quarter length body fracture.
- Three-quarter fracture filter on one side of the B/T-12 filter element; flange fractured filter on the opposite side of the B/T-12 filter element.

Figure 4 — Location Of The Red Ash Stain And Divot Formations Along The Remaining Intact And Failed DuPont PRD-66 Candle Filters

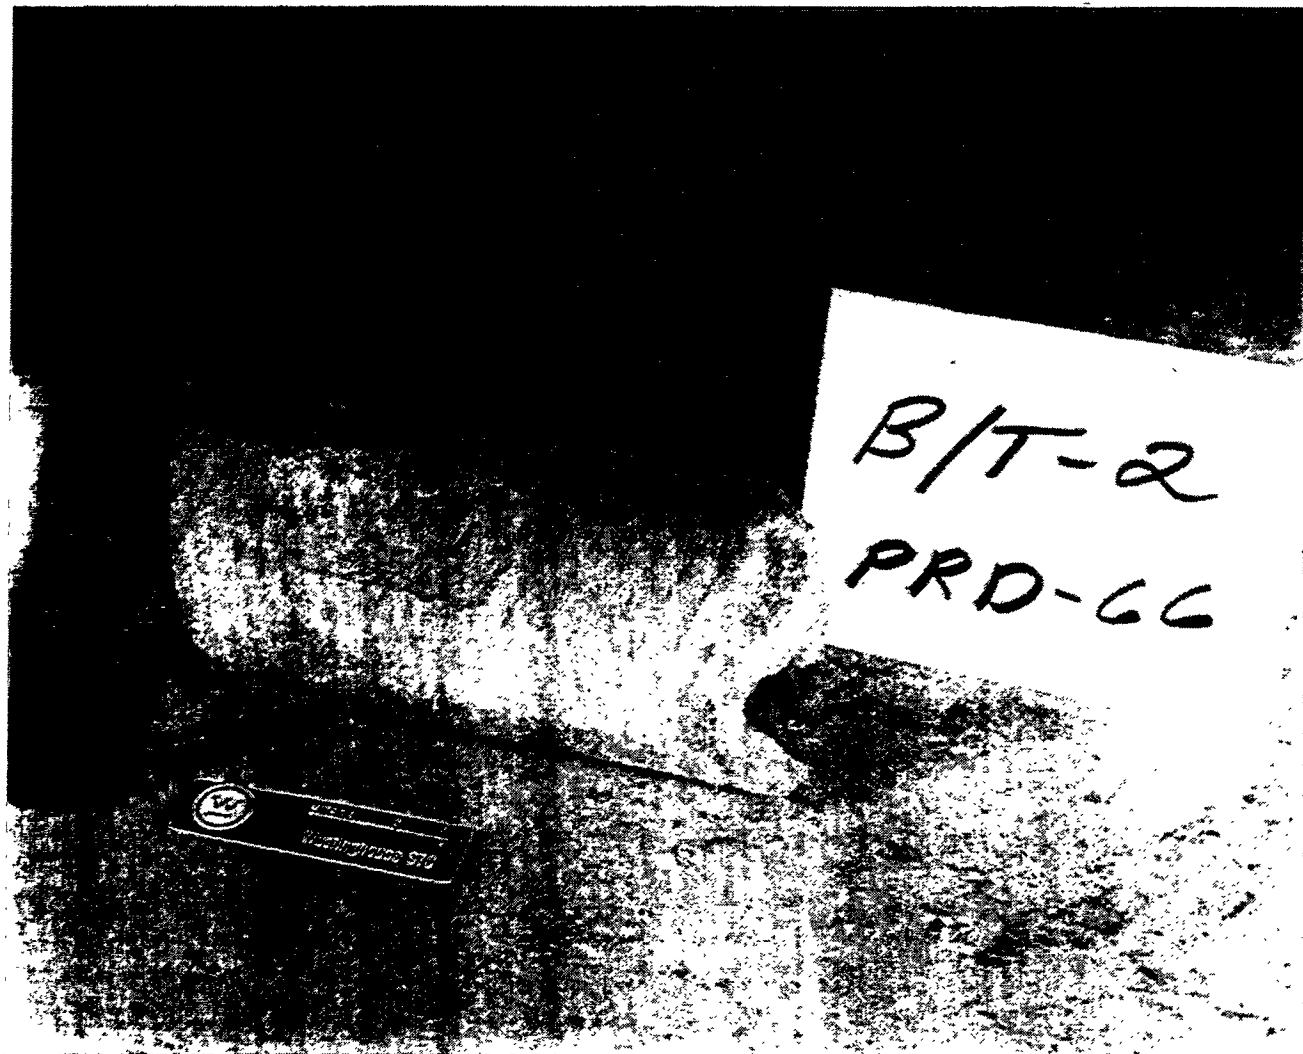
Figure 6a — Divot Formations Along The Fractured Surfaces Of The Failed DuPont PRD-66 Filter Elements In Test Segment #5

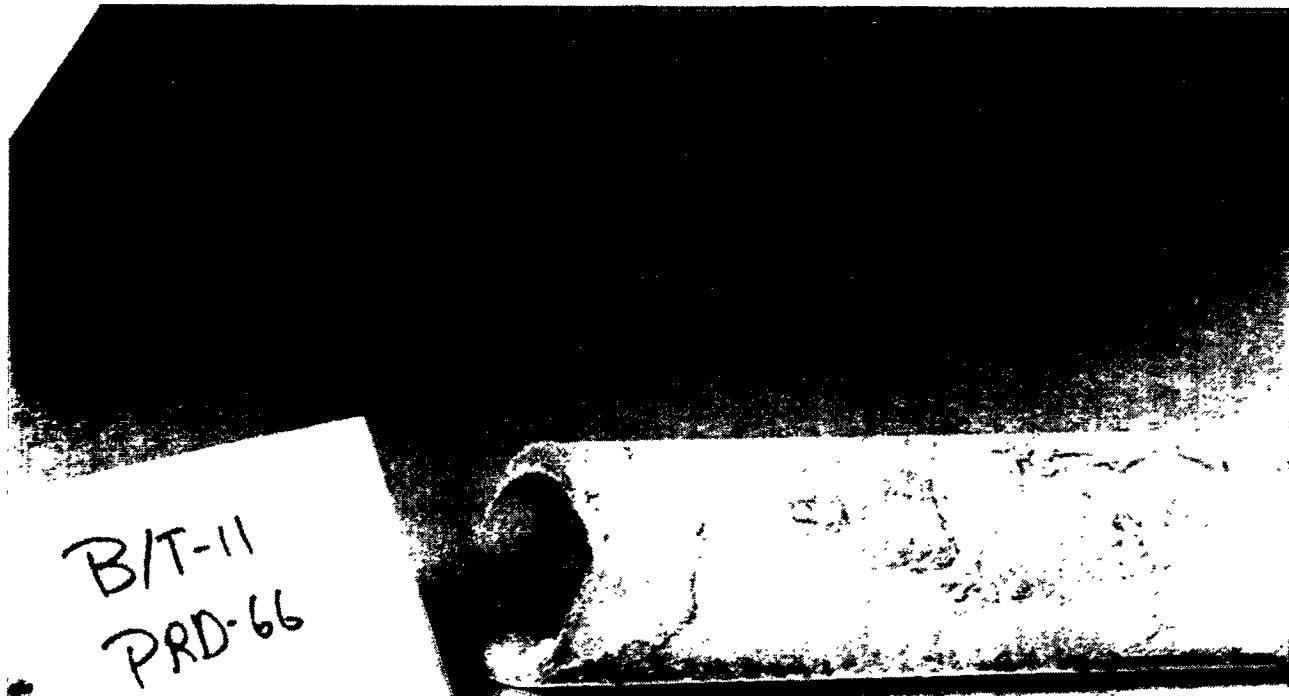
BIT-11  
PRD-66

Figure 6b — Divot Formations Along The Fractured Surfaces Of The Failed DuPont PRD-66 Filter Elements In Test Segment #5

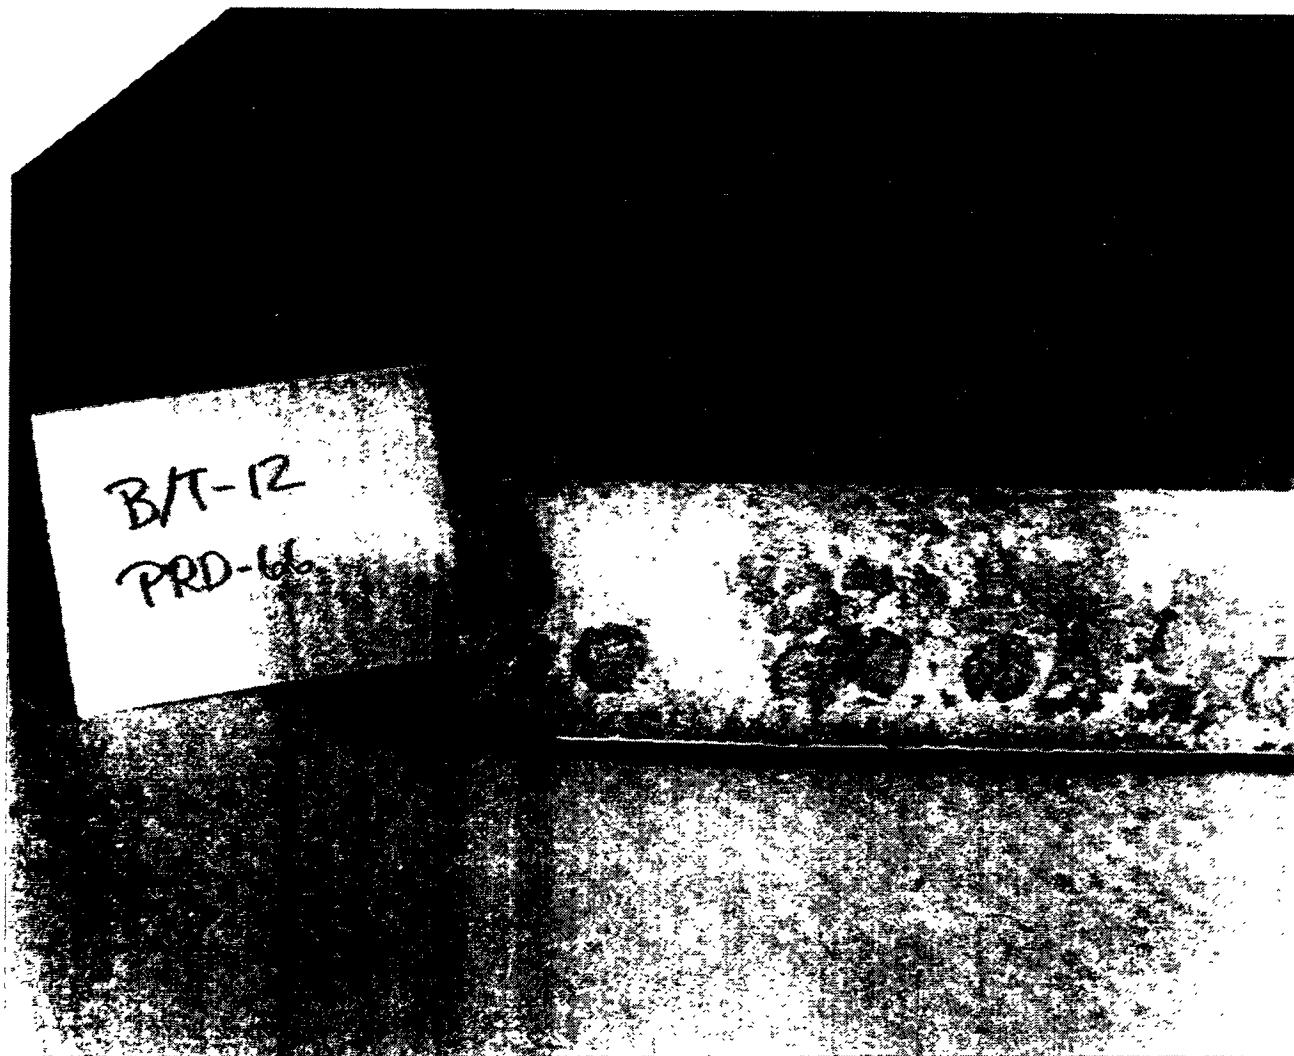
Figure 6c – Divot Formations Along The Fractured Surfaces Of The Failed DuPont PRD-66 Filter Elements In Test Segment #5

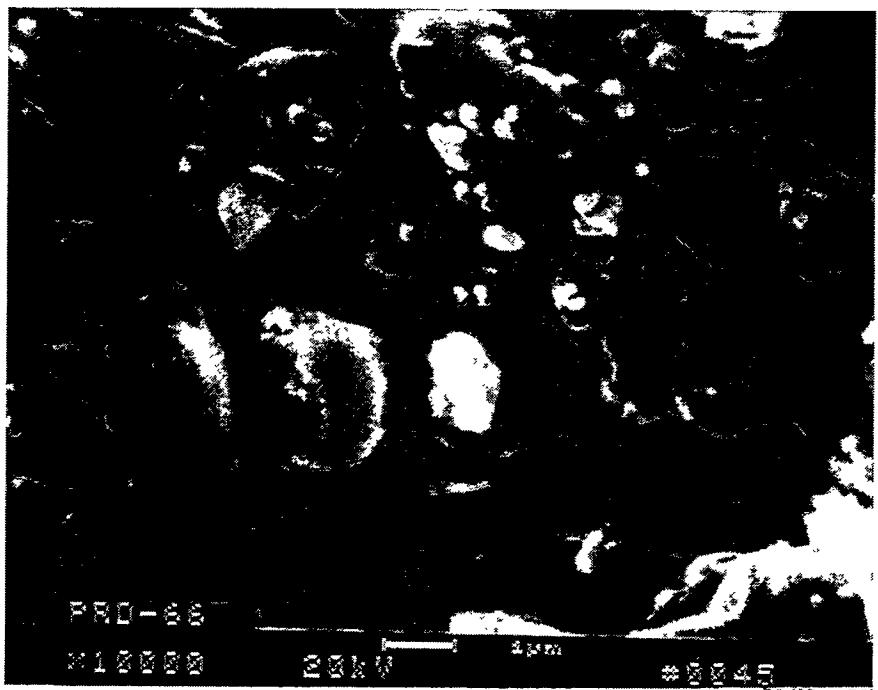
Figure 1c – Polycrystalline Nature Of The Outer Surface Of The DuPont PRD-66 Filter Membrane

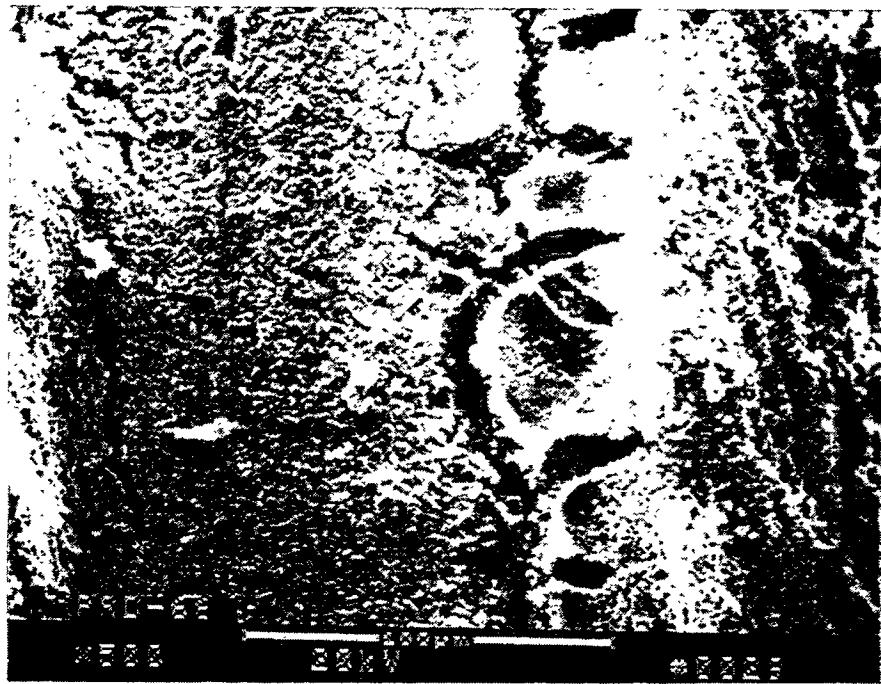
Figure 2k – Fractured Filaments In The DuPont PRD-66 Filter Matrix. Alumina-Enriched Mud Cracks Are Evident As Fillet Areas Between Adjoining Filaments.

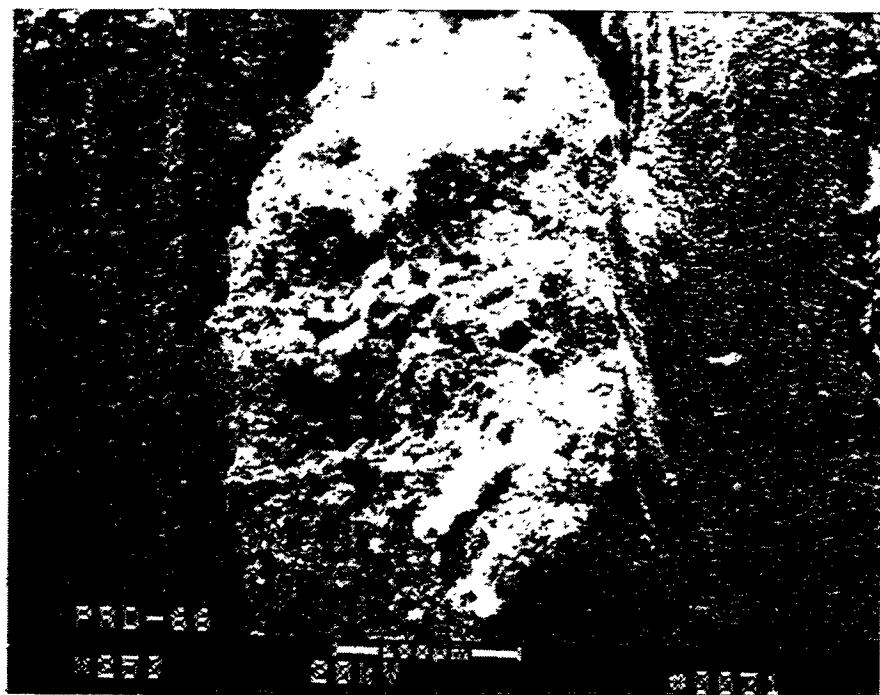
Figure 2m - Fractured Filaments In The DuPont PRD-66 Filter Matrix

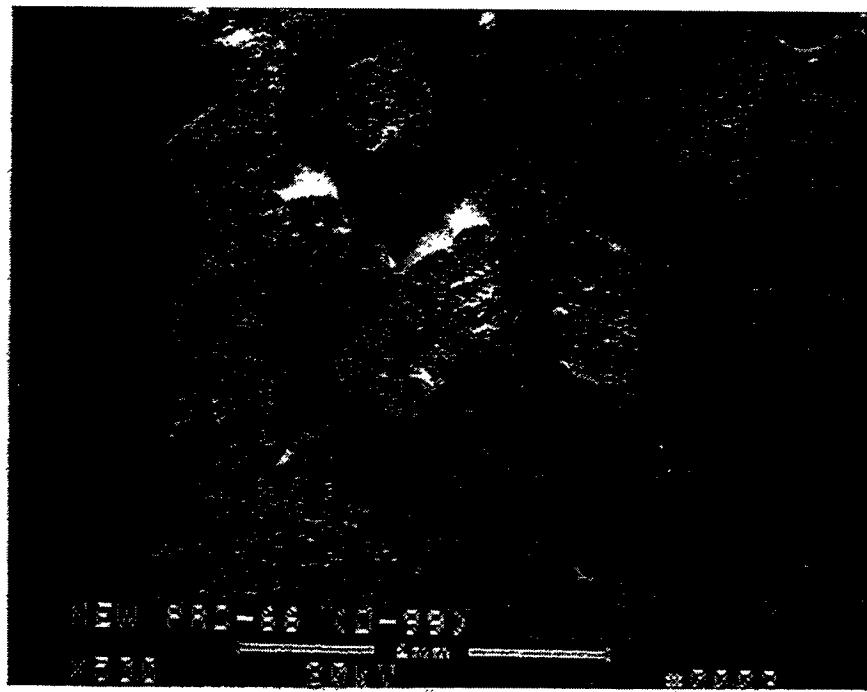
Figure 2s – Cross-Sectioned As-Manufactured DuPont PRD-66 Filter Element

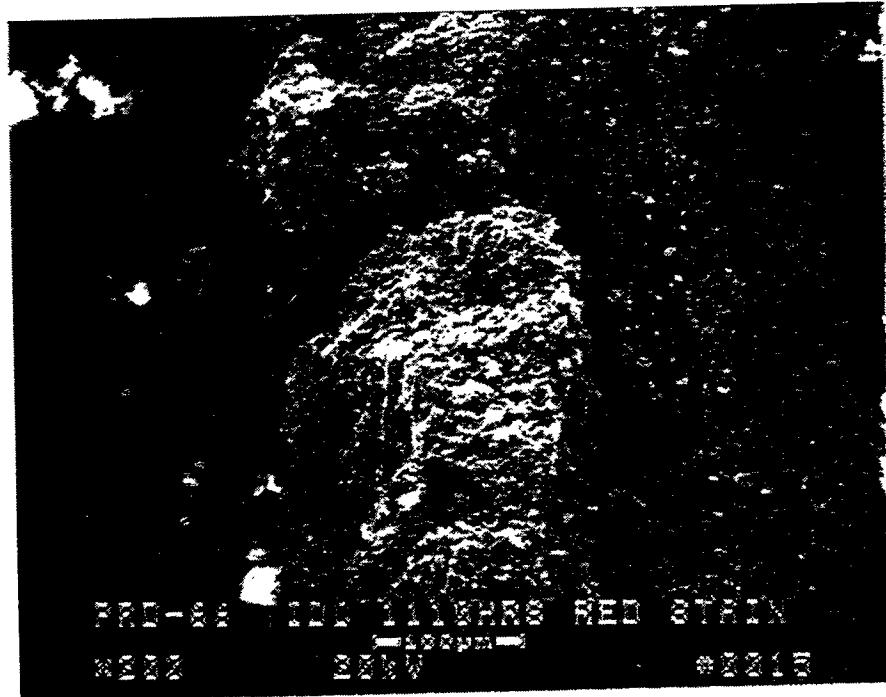
Figure 4j – Blunted, Alumina-Enriched Filament Yarn In The 1110 Hour PFBC Exposed DuPont PRD-66 Filter Matrix

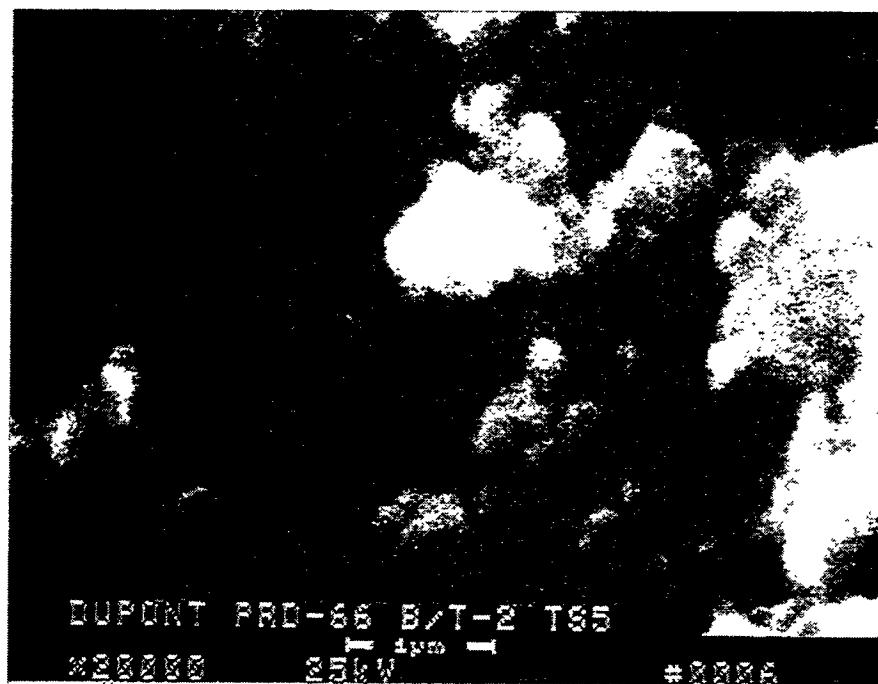
Figure 5e – Higher Magnification Micrographs Of The Ash/Sorbent Fines

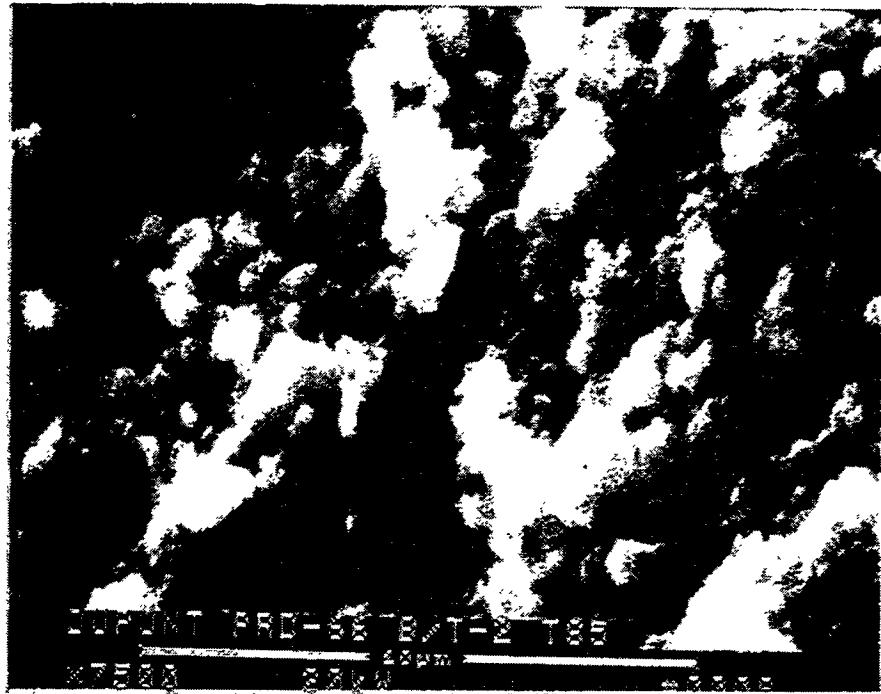
Figure 5g — Higher Magnification Micrograph Of The Deposited Ash/Sorbent Fines

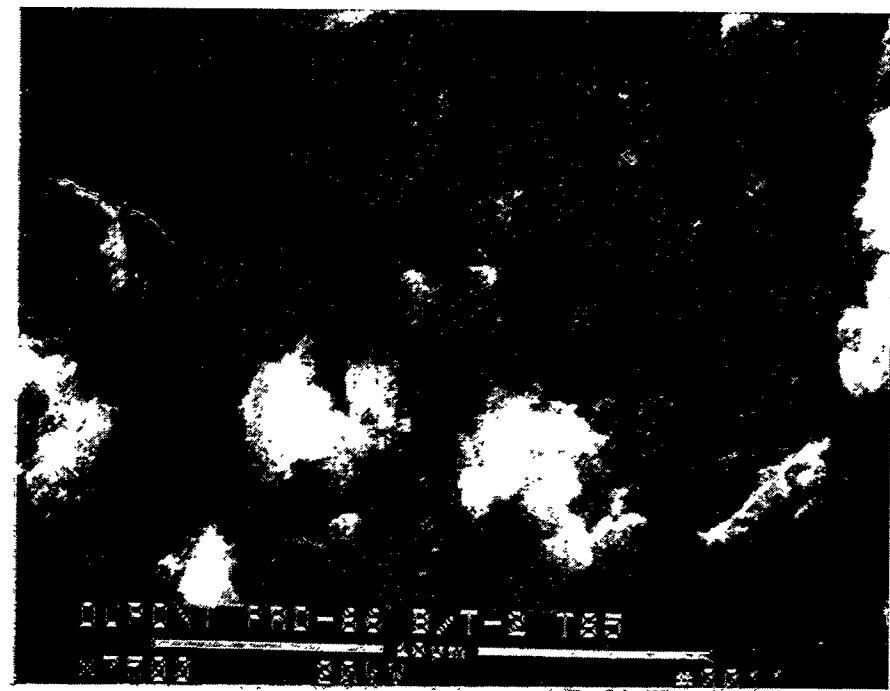
Figure 5h – Ash/Sorbent Deposited Fines Within The Pore Cavity Of The DuPont PRD-66 Filter Matrix

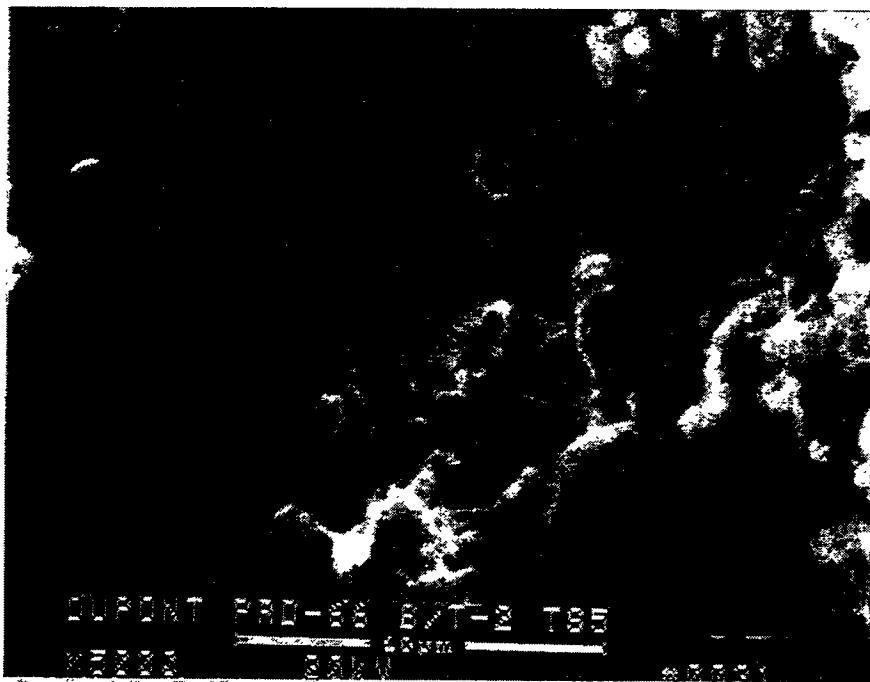
Figure 5m—Morphology Of The Ash/Sorbent Fines That Were Located At The Edge Of The Divot Formation Near The Fractured Membrane

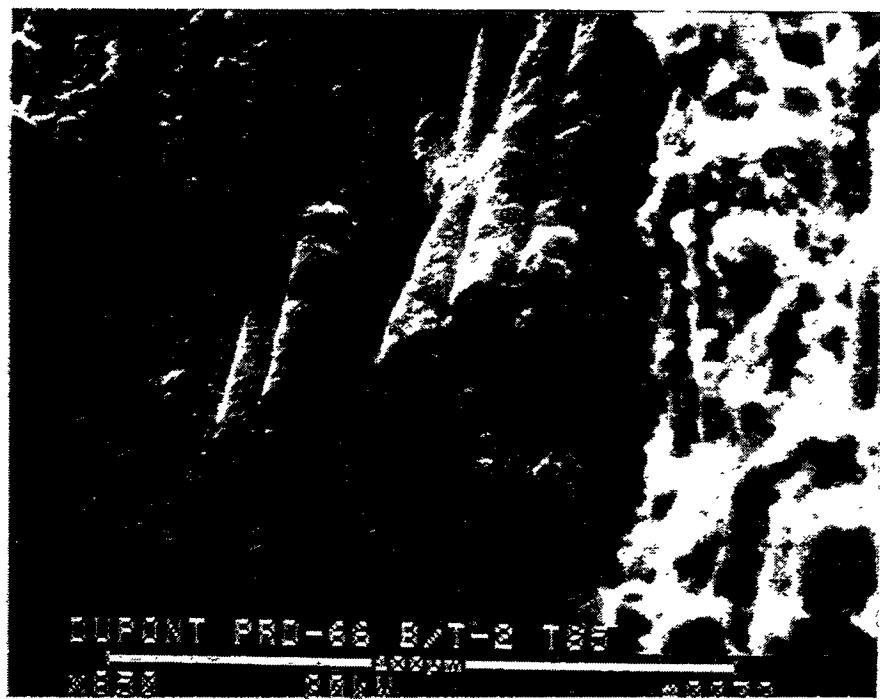
Figure 5t -- Fused Or Sintered Fibers In The Filament Bundles Of The Divoted DuPont PRD-66 Filter Membrane

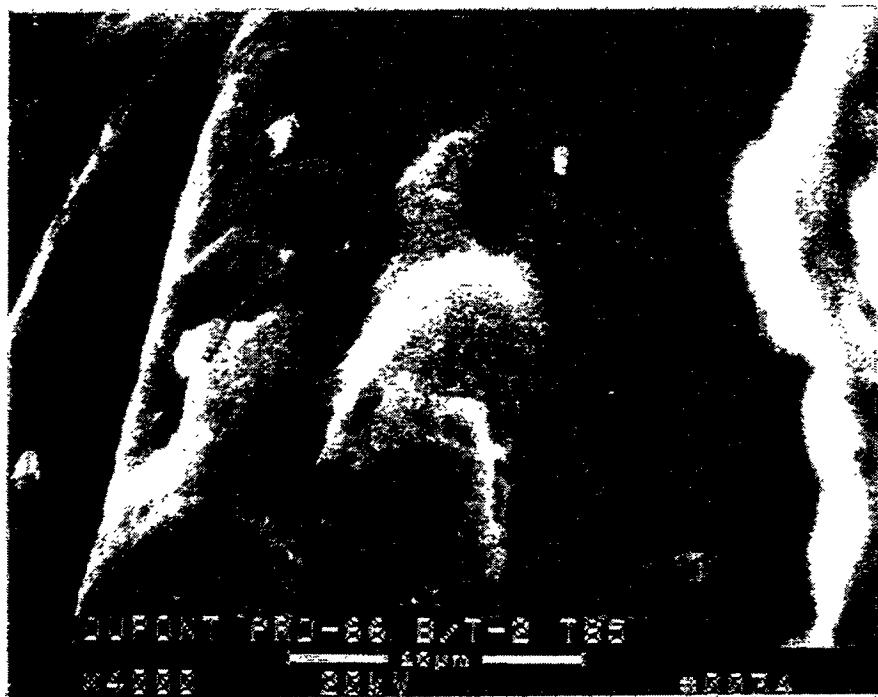
Figure 5u — Higher Magnification Micrograph Of The Fiber Surface In The Filament Bundles In The Divoted DuPont PRD-66 Filter Membrane

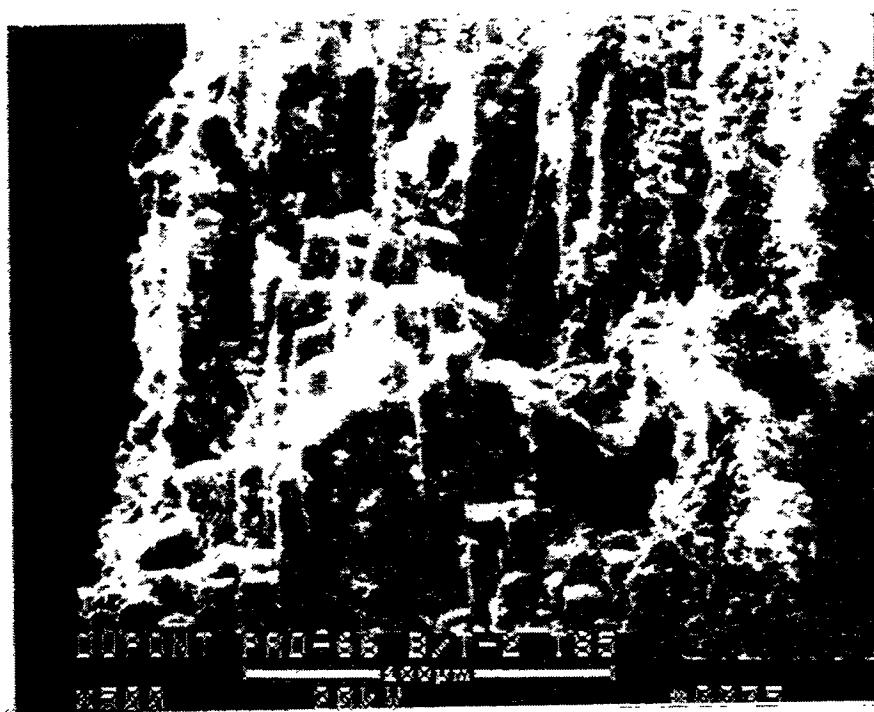
Figure 5v – Fibers In The Filament Bundles At An Alternate Location Of The Membrane  
In The Divoted DuPont PRD-66 Filter Matrix

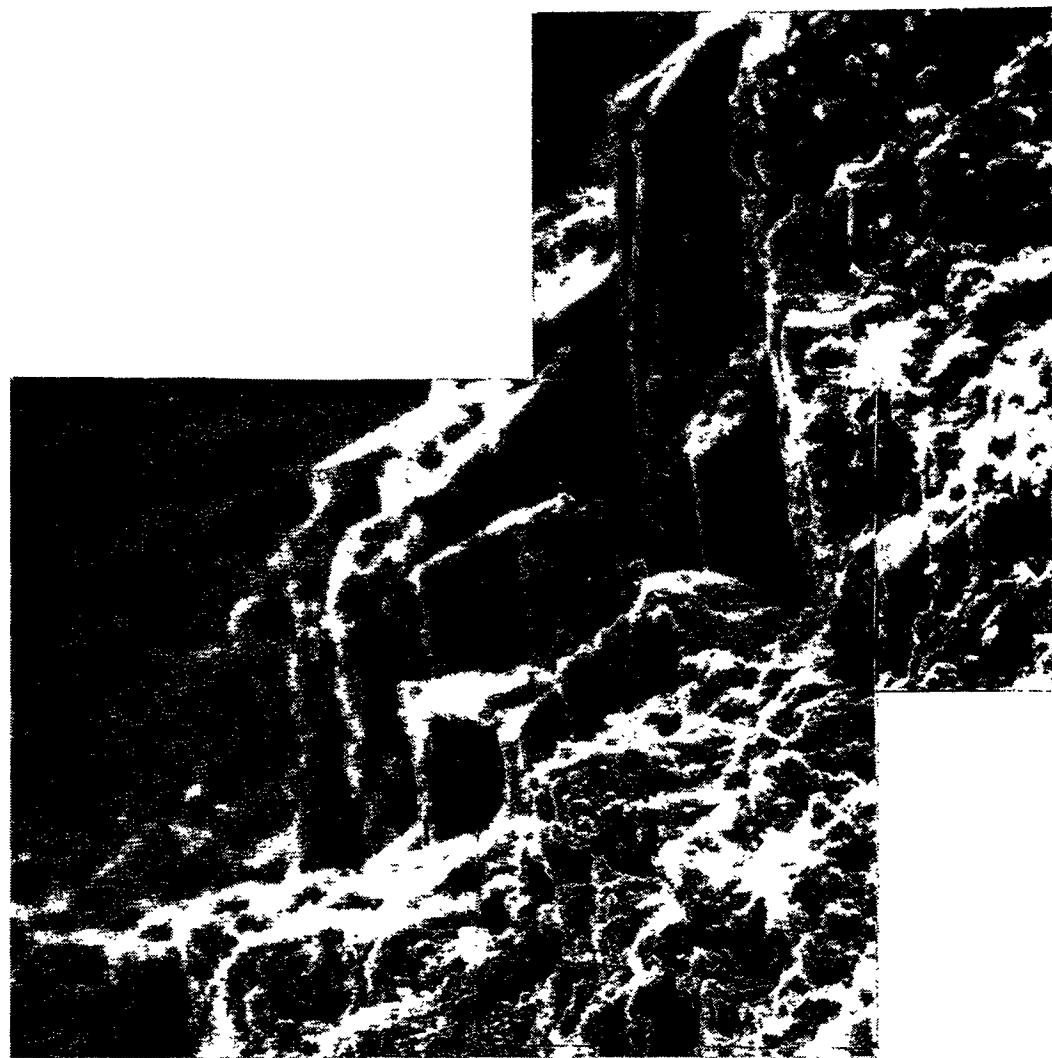
Figure 5z — Fresh Fractured Cross-Sec  
Coarse Support Wall In Ti  
Matrix

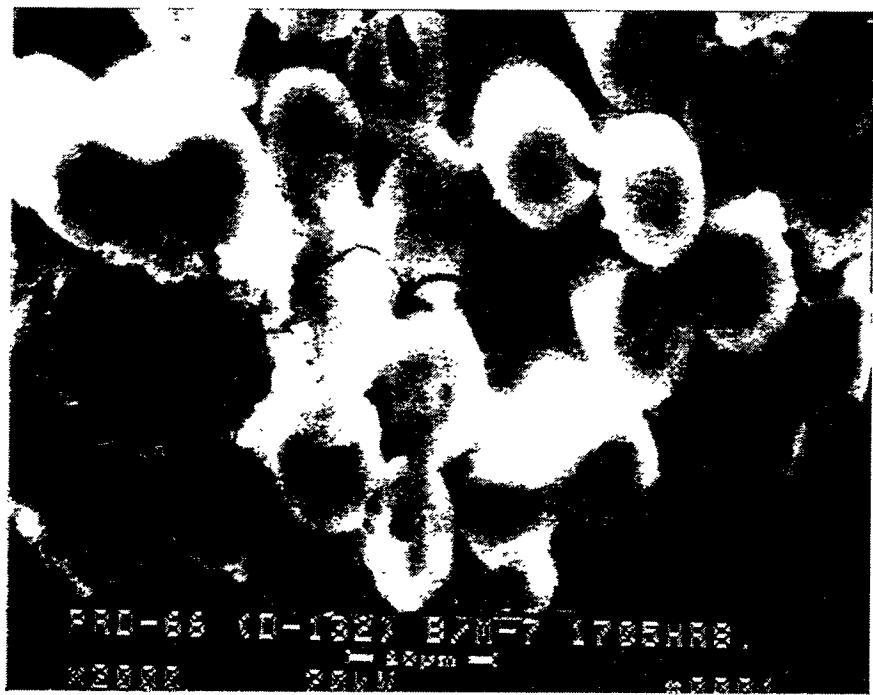
Figure 6a – Cross-Sectioned DuPont PRD-66 Filter Matrix Which Had Been Exposed To PFBC Operating Conditions For 1705 Hours At AEP (Carbon Coated)

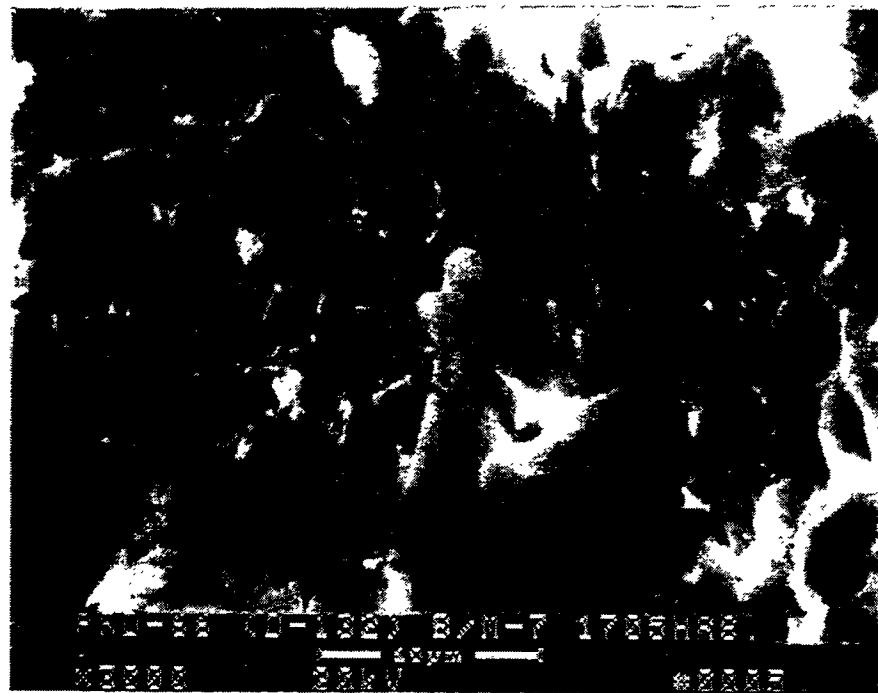
Figure 6c -- Higher Magnification Micrograph Of The Magnesium-Sulfur-Calcium-Enriched Phase Which Remained Along The Outer Surface Of The Filament Bundle Polycrystalline Phase After 1705 Hours Of Operation At AEP (Wet Cut For Strength Testing; Carbon Coated)

An additional area of the polycrystalline surface is shown in Figure 6c. The "melt-like" matrix consisted of 72.69% O, 13.06% Al, 6.51% S, 3.95% Mg, 3.07% Ca, and 0.73% Si.
