# Light Water Reactor Sustainability Program

## Extended Bandwidth Spread Spectrum Time Domain Reflectometry Cable Test for Thermal Aging, Low Resistance Fault, and Water Detection

# **Extended Bandwidth Spread Spectrum Time Domain Reflectometry Cable Test for Thermal Aging, Low Resistance Fault, and Water Detection**

**S.W. Glass, J. Tedeschi, M.P. Spencer, J. Son, D. Li, M. Elen, L.S. Fifield  
Pacific Northwest National Laboratory**

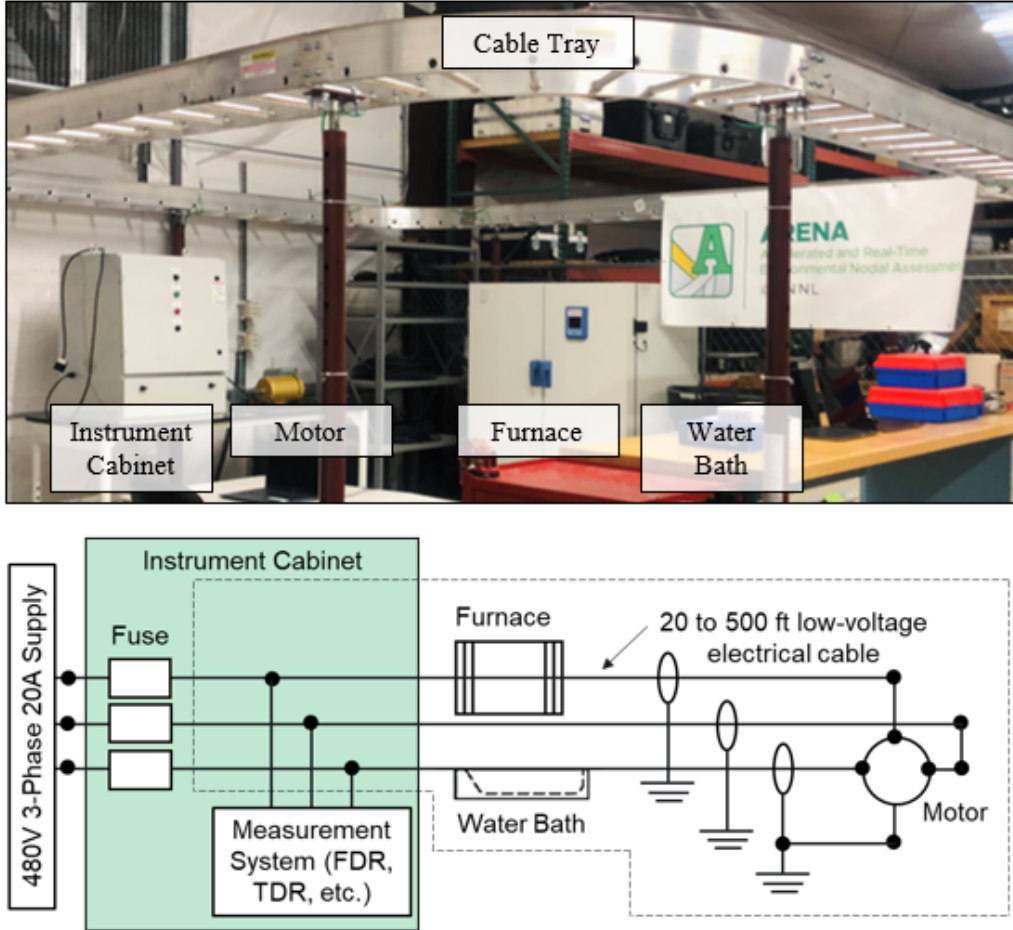
Figure 5. The ARENA test bed (top) digital image and (bottom) schematic (Glass et al. 2023).

To evaluate the degradation of electrical cables, particularly the interaction of electrical cable test technologies with various damage mechanisms, PNNL developed the ARENA test bed (Glass et al. 2023); see Figure 5. The vision behind creating this facility was to establish a modular test facility that allows for implementation of a broad range of test methods to detect faults and anomalies in a variety of cables and systems in a controlled environment. The test setup was similar for the 2022 work, and as much as possible, the test arrangement was repeated for this round of FDR and SSTDR cable tests.

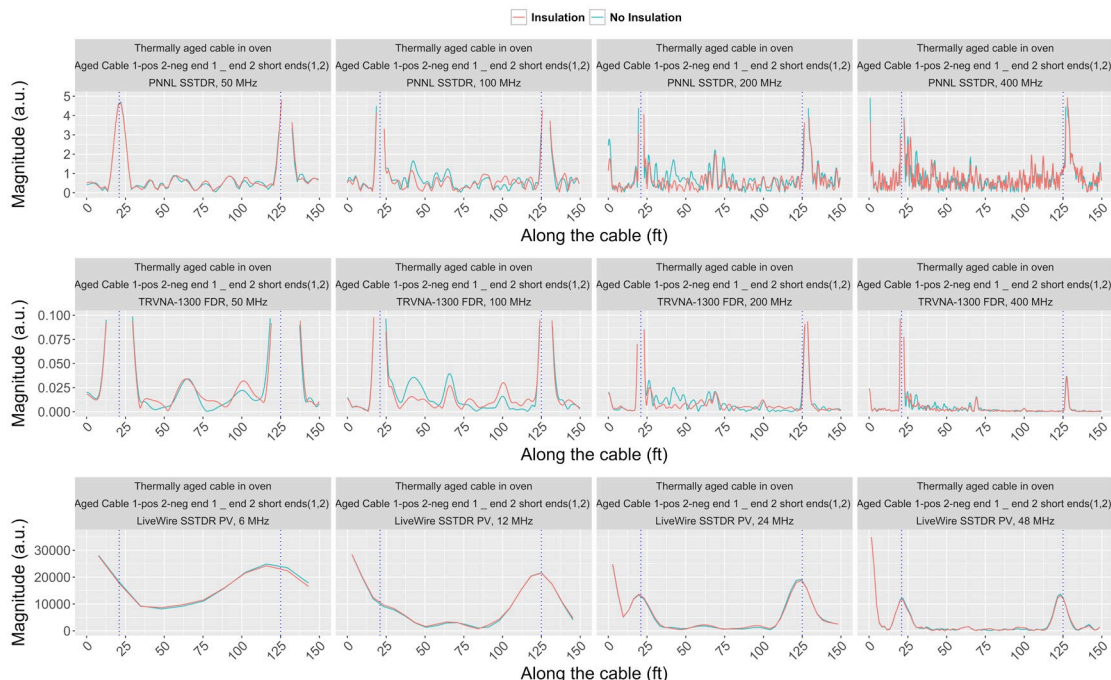
Figure 13. Overlaid reflectometry plot with and without foam insulation between cable and cable rack. Note reduced peak amplitude at 40 ft, particularly for 100 and 200 MHz BW plots with foam insulation. Entry and exit from the oven at 60 and 100 ft are observed clearly on the FDR plots at 50 and 100MHz and to a lesser degree only on FDR 200 and 400 MHz and perhaps (mostly for oven entry) for PNNL SSTDR @ 50 and 100 MHz.

Signal noise was affected in the unshielded cable by the local in-tray cable arrangement including proximity to metal edges and rungs of the cable tray. Foam isolation of the cable from the tray metal reduced in both FDR and SSTDR responses.

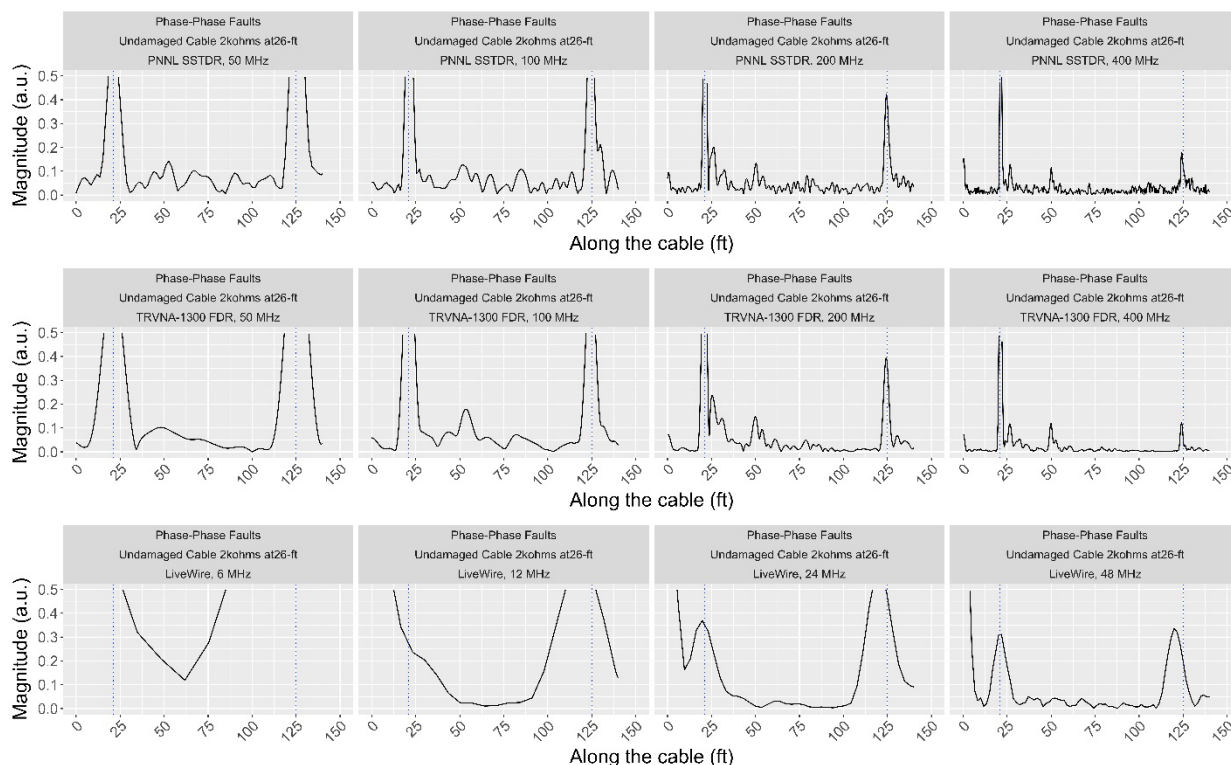
Figure 15. Magnitude response for 100 ft cable with 2k ohm fault at 26 ft (26 ft on cable, 50 ft on plot due to test lead).

Phase-to-phase faults were detected to varying degrees depending on the instrument and BW. Responses to 100, 312, and 2k ohms at 26 ft are shown in Figure 7, Figure 14, and Figure 15. Generally, the higher frequency PNNL SSTDR and FDR plots showed responses most clearly. The 100 ohm fault was seen by FDR, PNNL SSTDR, and LiveWire, but LiveWire did not detect the 312 ohm or 2k ohm faults. This seemed to be a case where the higher PNNL SSTDR BW improved detection.

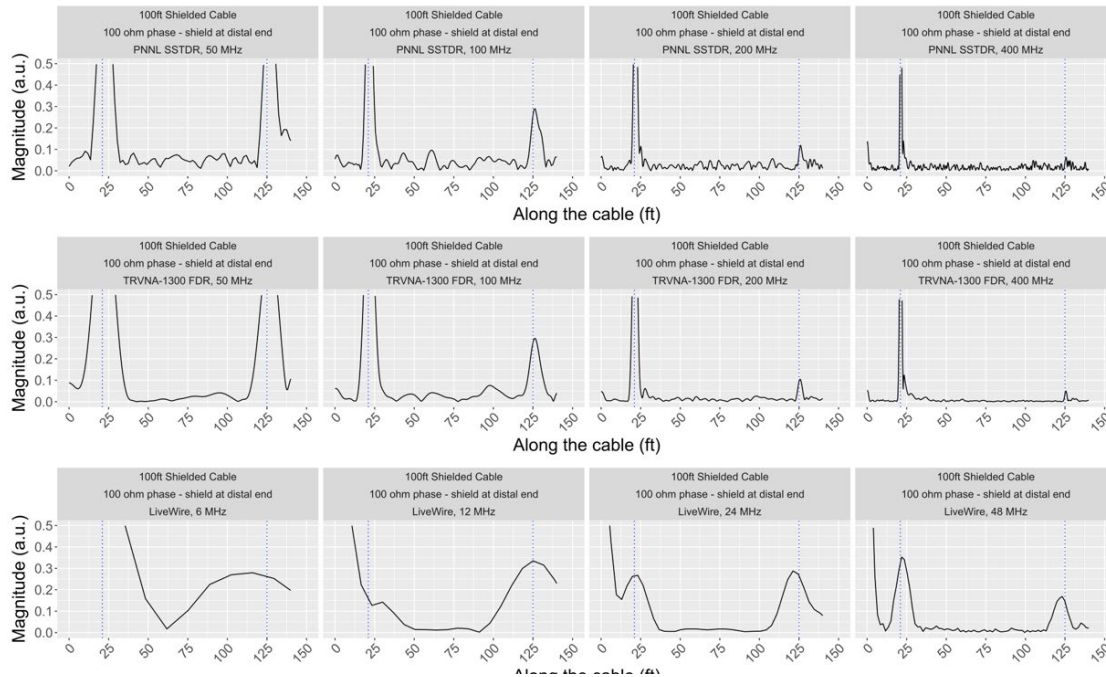
## 1. 100ft Shielded Cable, 100 ohm phase - shield at distal end

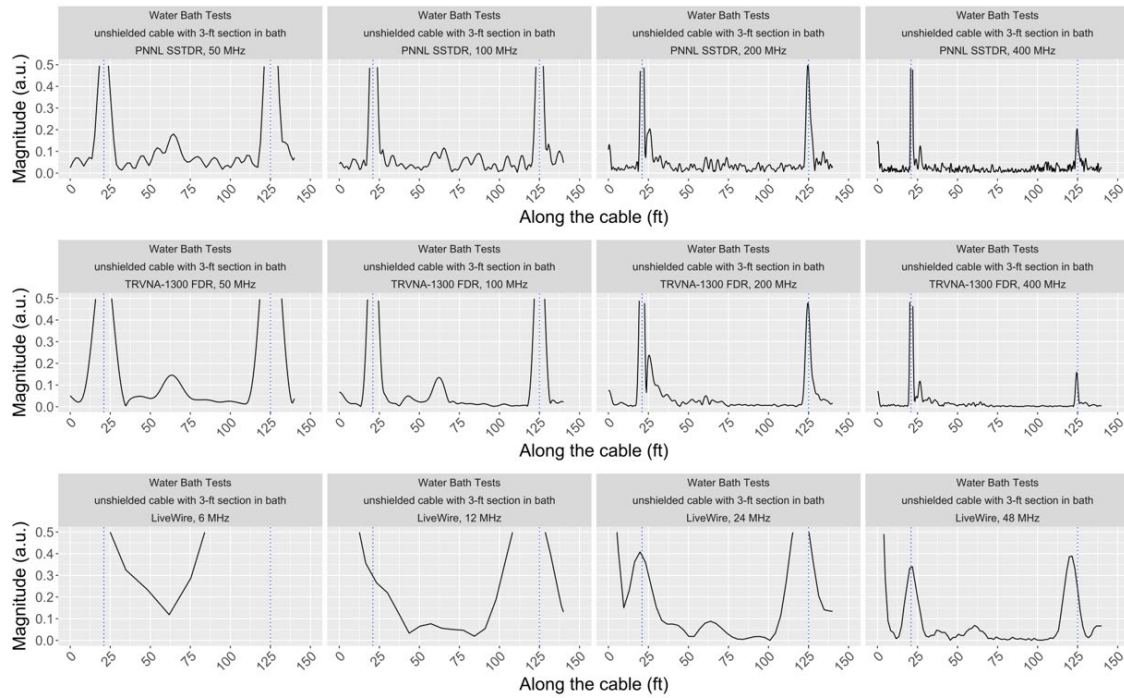
#### 41. Water Bath Tests, unshielded cable with 3-ft section in bath

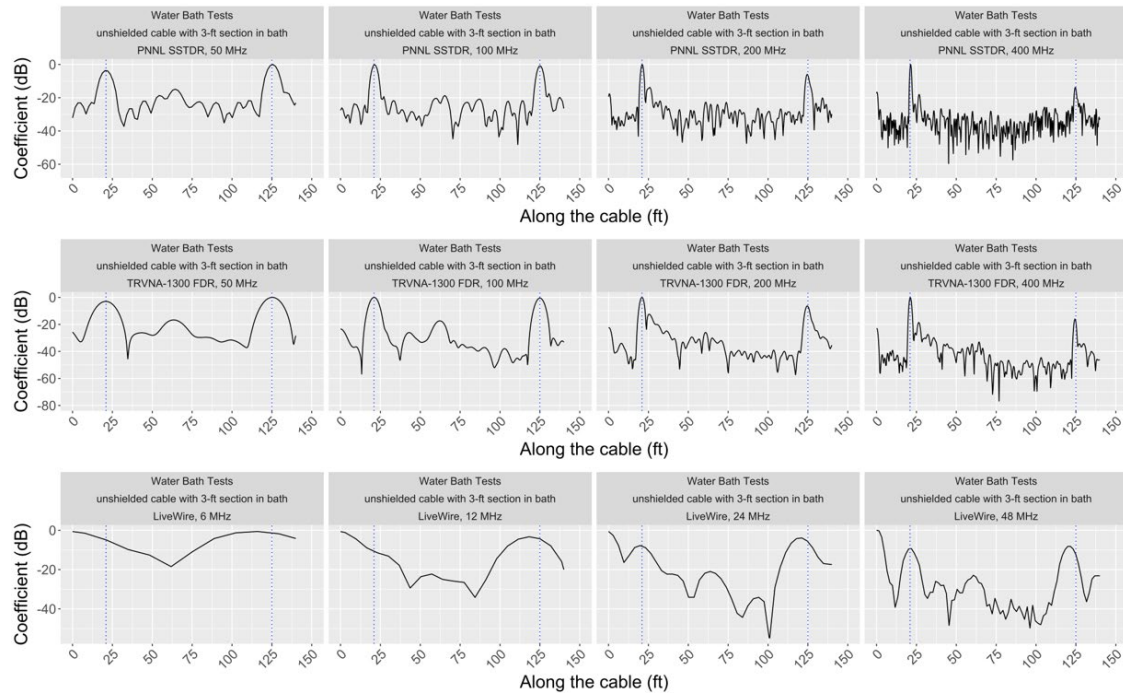
#### 41. Water Bath Tests, unshielded cable with 3-ft section in bath
