**Characterization and Failure Analysis of Ceramic Filters Utilized**

**Emission Control During Coal Gasification**

**Final Technical Report**

**March 1998**

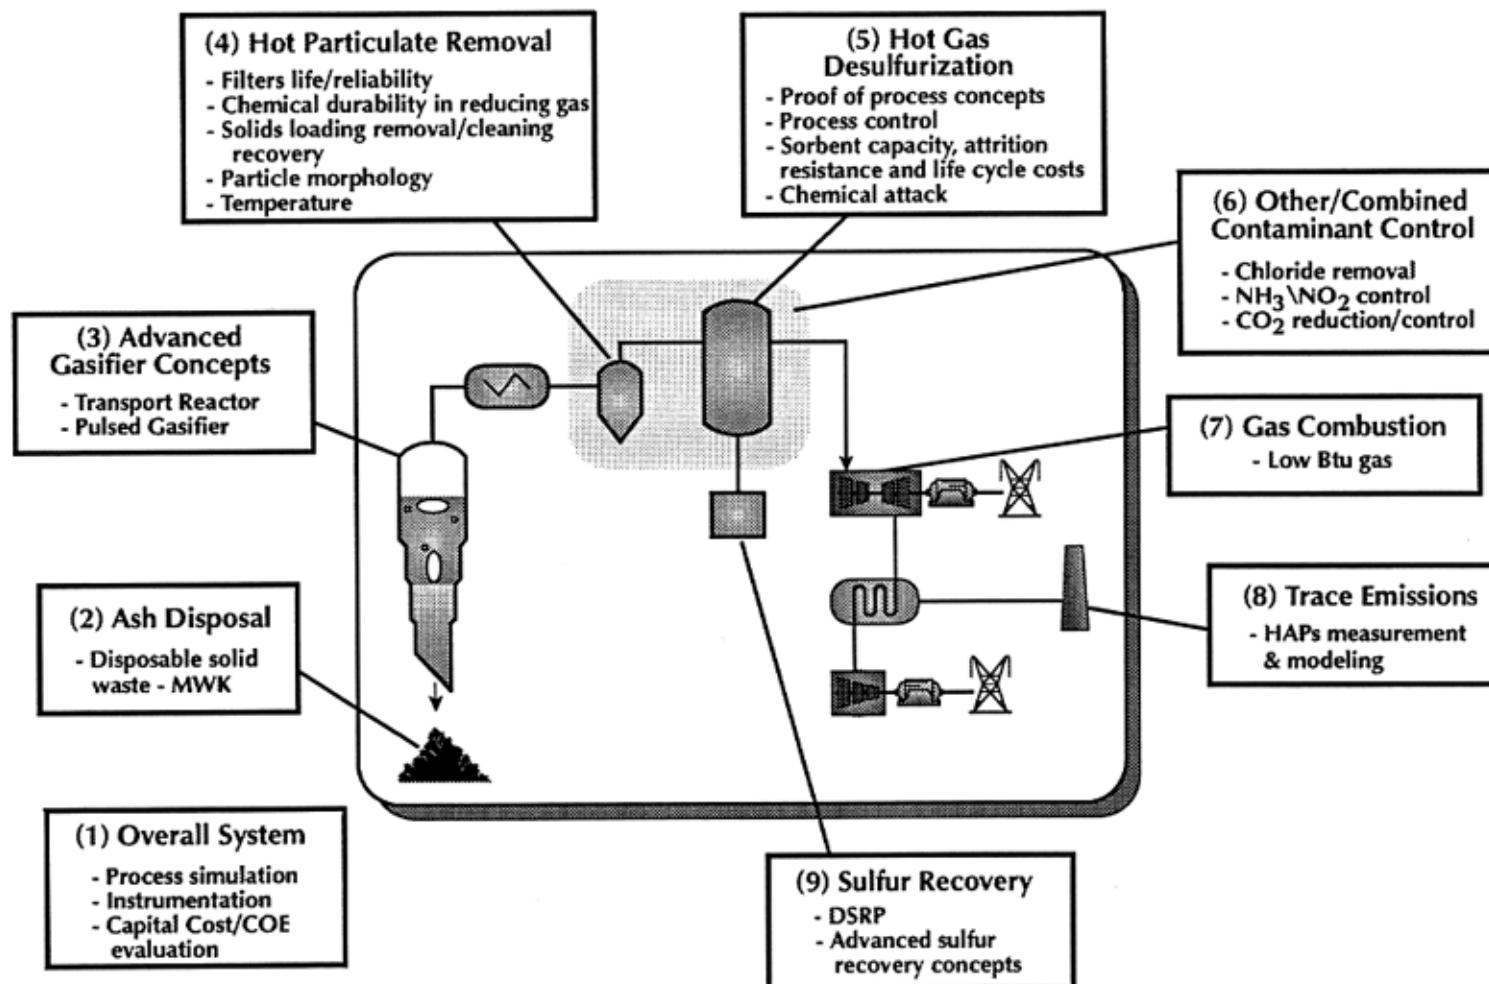
Figure 1-1 Schematic of IGCC and R&D Issues

# IGCC R&D Issues

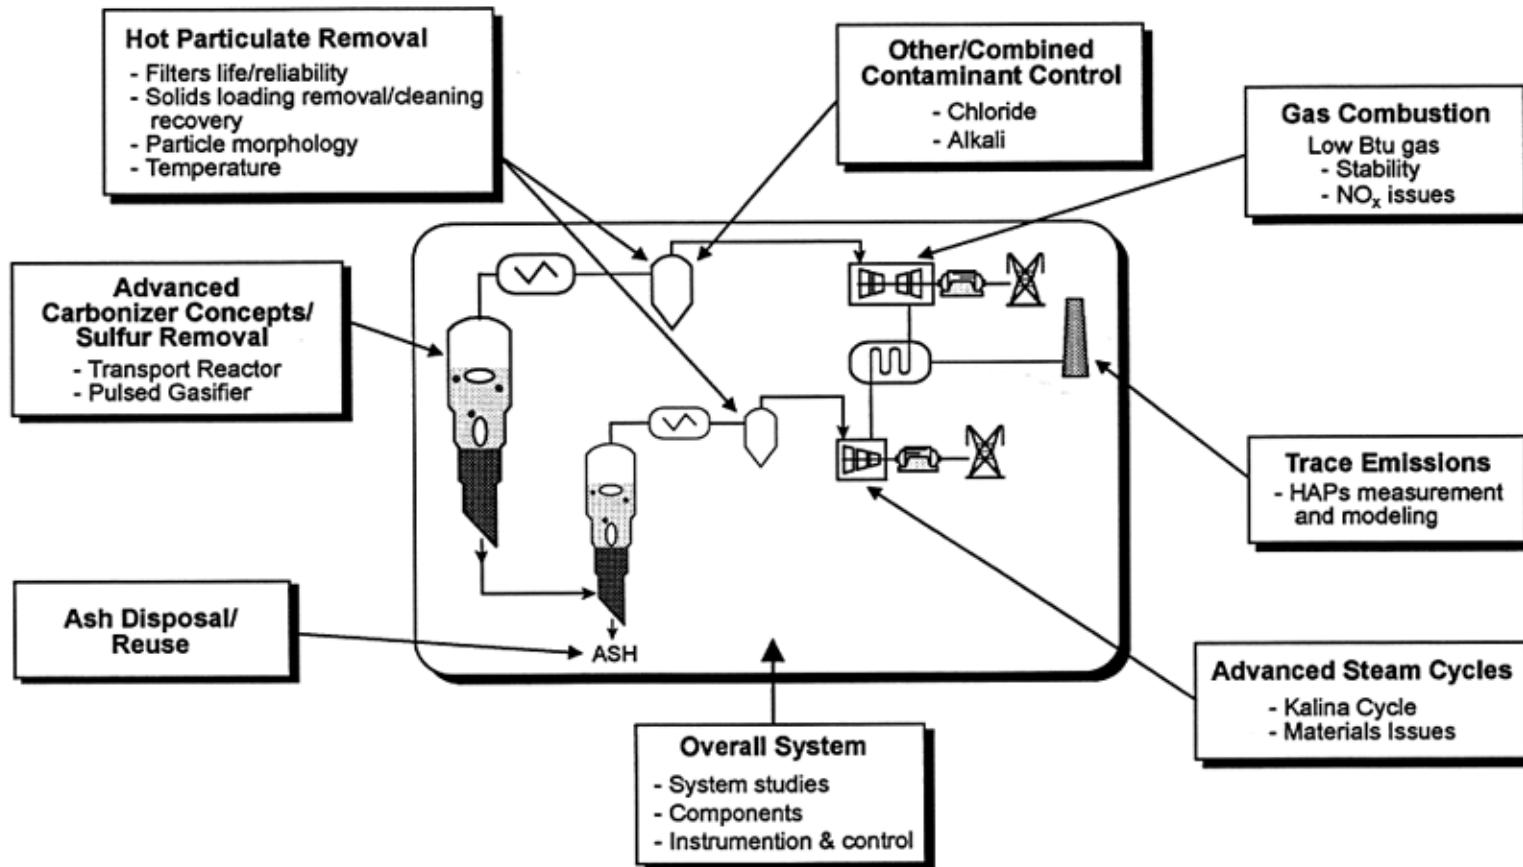
Figure 1-2 Schematic of PFBC and R&D Issues

# PFBC R&D Issues

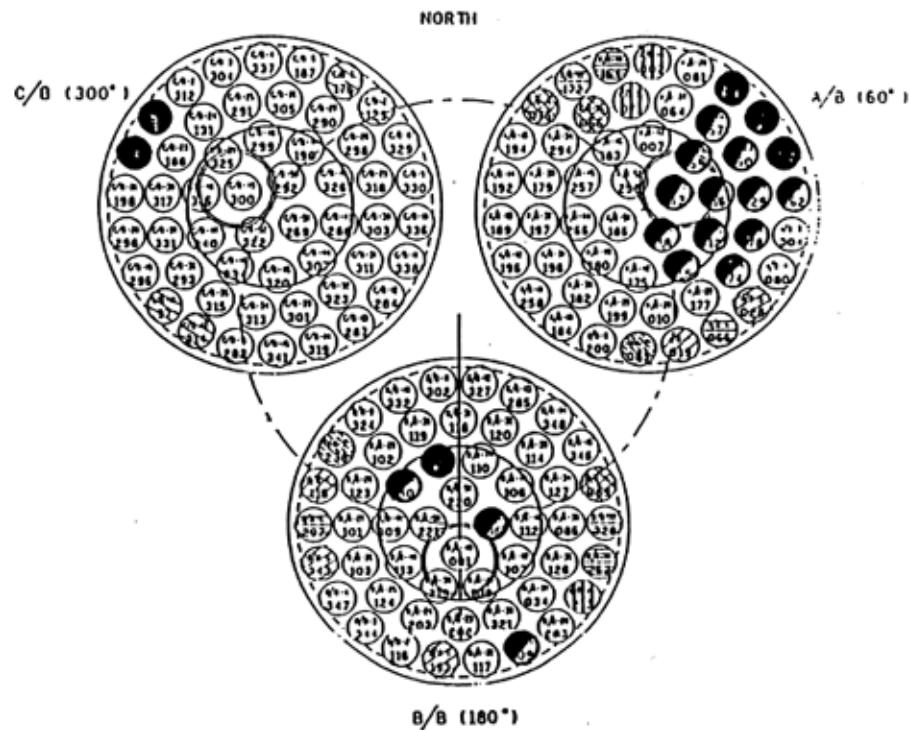
Figure 1-3 AEP candle filter failure locations

## AEP Candle Failure Locations

To evaluate the design and performance of ceramic filters, different long term filter testing programs were conducted. To fulfill this purpose, two Advanced Particle Filter (APF) systems were complete at Tidd PFBC Demonstration Plant, in Brilliant, Ohio in late 1990 as part of the Department of Energy's (DOE) Clean Coal Technology Program. But the most undesirable issues ever happened were the sudden functional and physical failures of filters prior to its designed life time. In Tidd APF filter vessel, twenty eight (28) filters failed one time (AEP candle failure locations are shown in **Figure 1-3**).

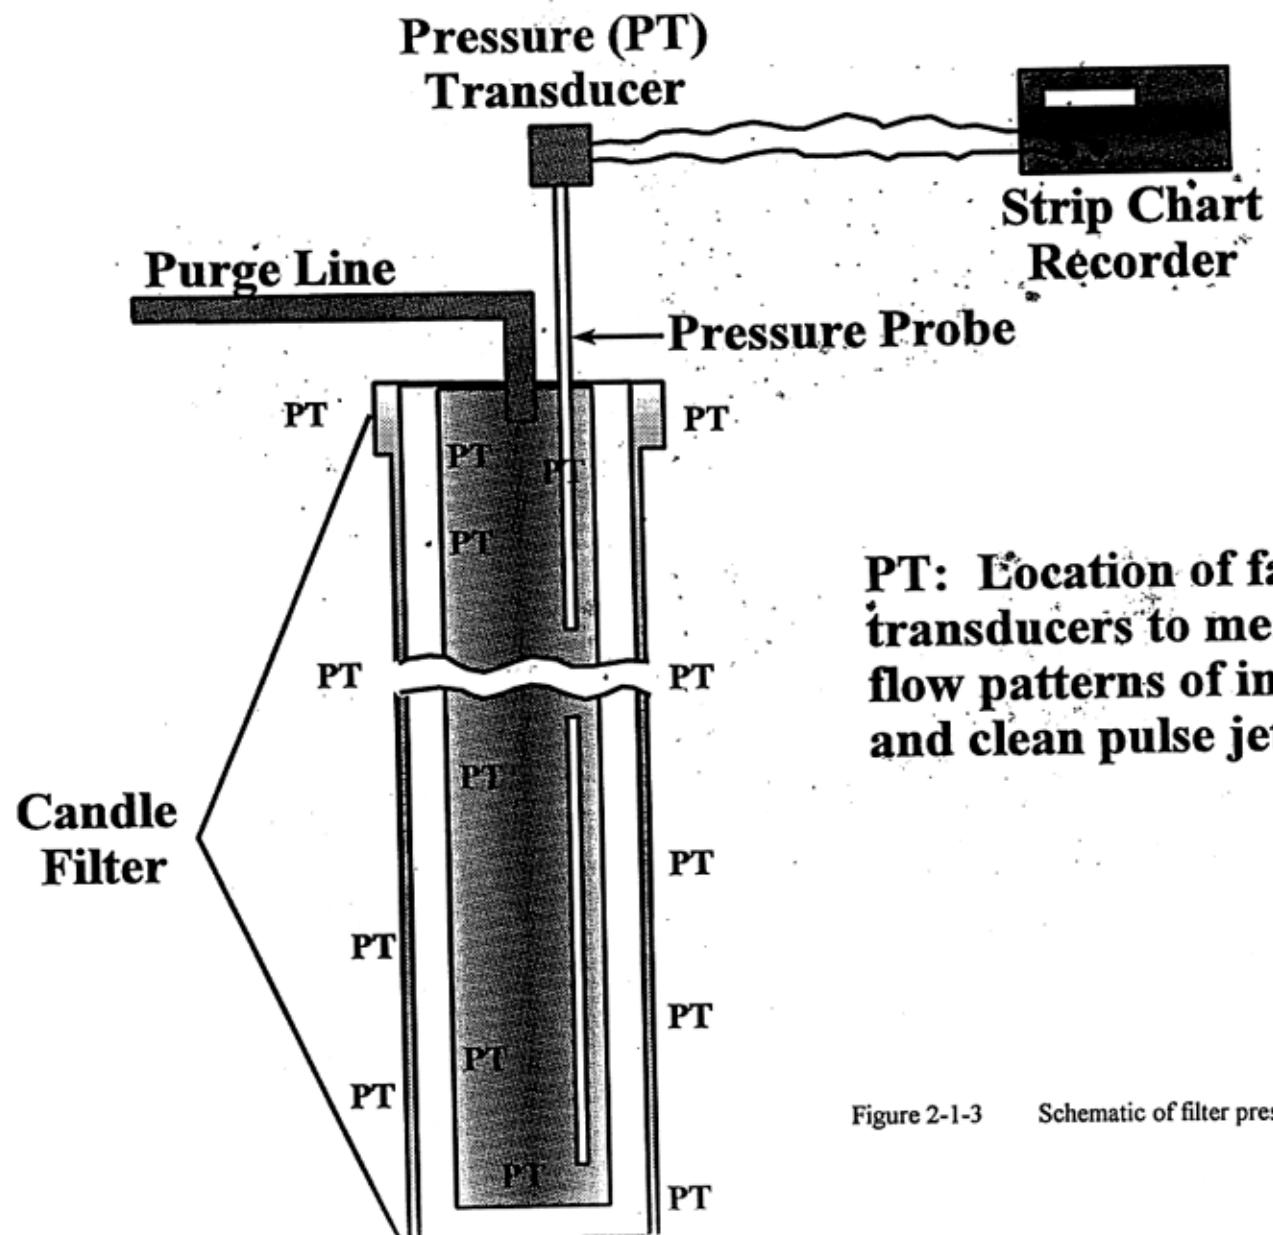
Figure 2-1-3 Schematic of filter pressure field test setup

**PT: Location of fast pressure transducers to measure the flow patterns of inlet, filtrated and clean pulse jets.**

During the testing of chamber pressure field, the inlet gas stream pressure was monitored continuously; and the pressure outputs of the wall mounted transducers were recorded by the data acquisition system. The output deviation between the reference pressure and the transducers were plotted as a measure of the pressure field in the filtration chamber. Based on the test data, it appears that a non-uniform pressure field was detected as the gas stream flew through the used filter. Reversed gas stream flow were also observed during the testing at few sections along the filter axis.

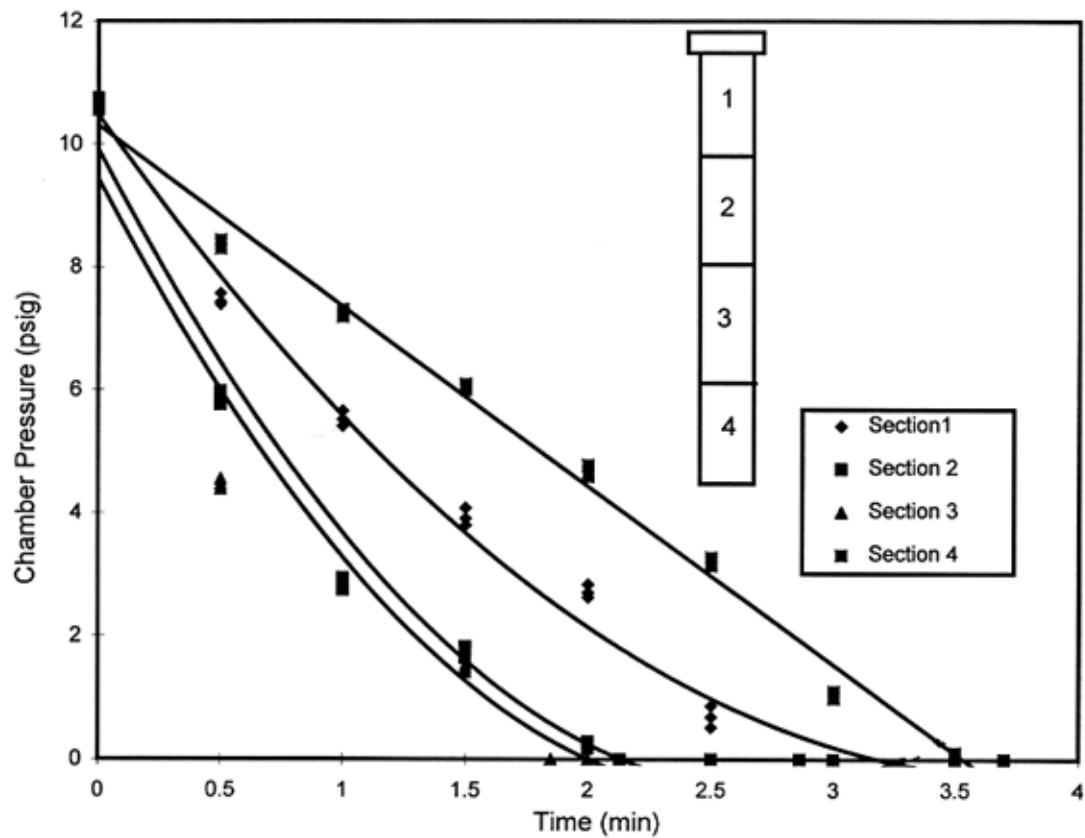
Figure 2-1-6 Permeability variation of used filter (10) psi

**Permeability Variation at different Sections of Used Filter  
(Pressure Level 10 Psig)**

The filtration chamber pressure distribution vs elapsed time measured per the test plan with an unused and used filter were shown in **Figure 2.1.5, 2.1.6, 2.1.7, 2.1.8, and 2.1.9**. As shown in the test results, the pressure deviations of the four different sections along the filter axis were negligible. The same test results were also observed for the circumferential permeability evaluation (shown in **Figure 2.1.10**). It can be concluded that the filter permeability of an unused filter is uniform along the entire filter surface.

On the contrary, for used filter, the pressure deviations of the four different sections along the filter axis were significant. These pressure deviation was worse as the chamber pressure increased. This phenomena was consistent with the finding that filter resistance to filtration gas stream increased with filter face velocity. Reversed gas flow were observed as clean nitrogen flew through the used filter. Similar pressure deviation pattern was observed within the filter cavity.

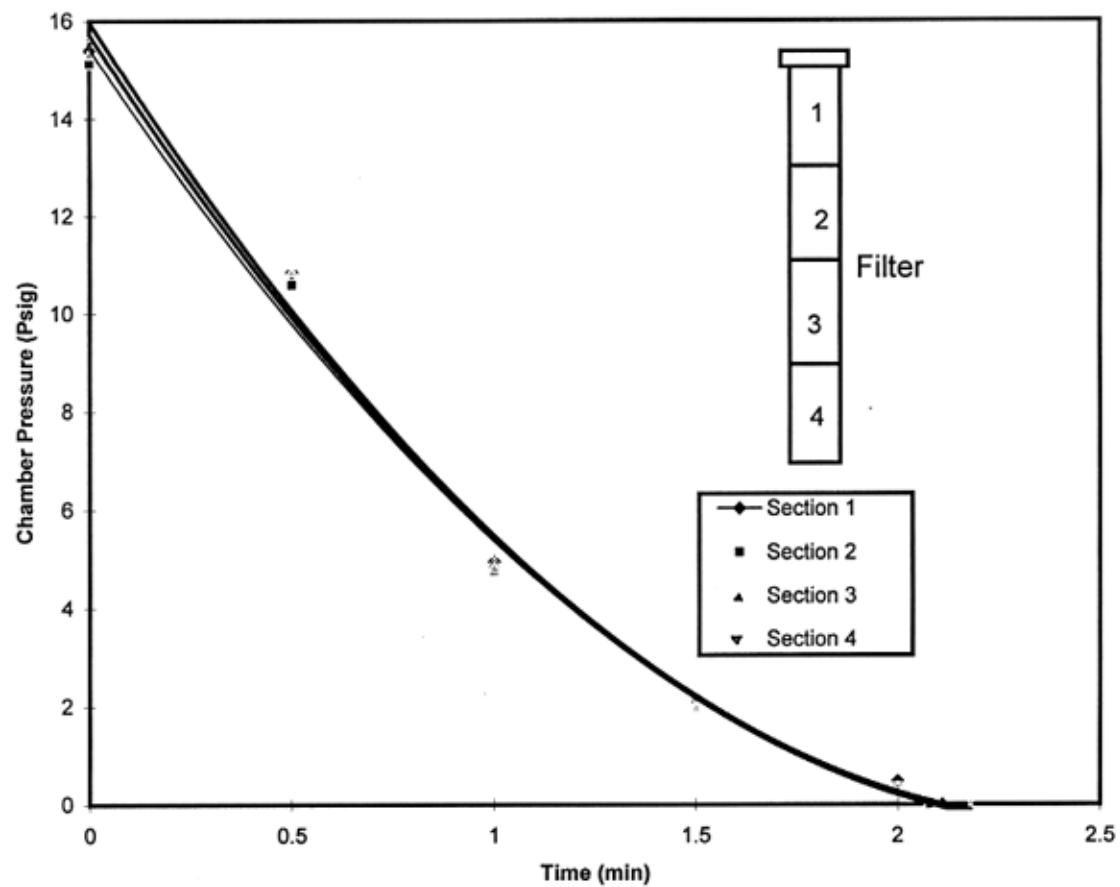
Figure 2-1-9(a) Permeability variation of unused filter (15) psi

**Permeability Variation at different Sections of Unused Filter  
(Pressure Level 15 Psig)**

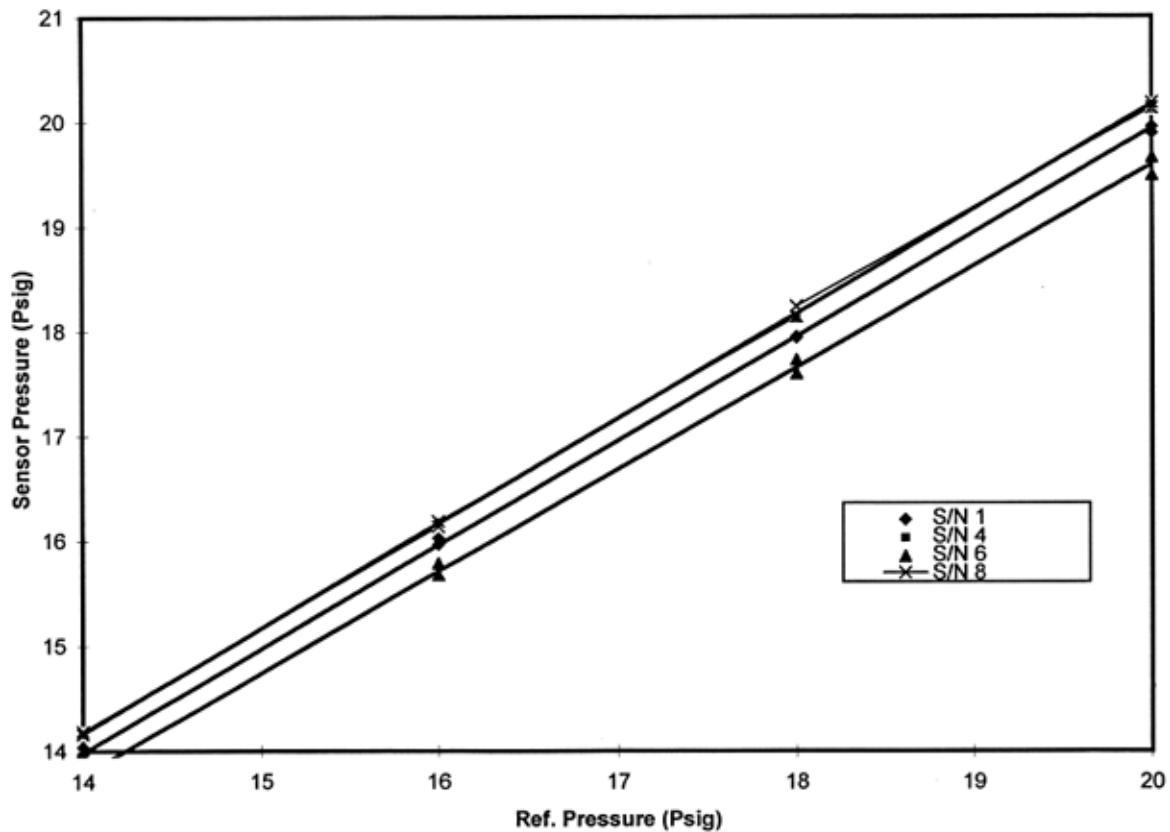
**Figure 2-1-11 Pressure sensor output of used filter (20) psi, outside filter**

**Sensor Pressure Readings at different Outside location of Used Filter  
(Pressure Level 20 Psig)**

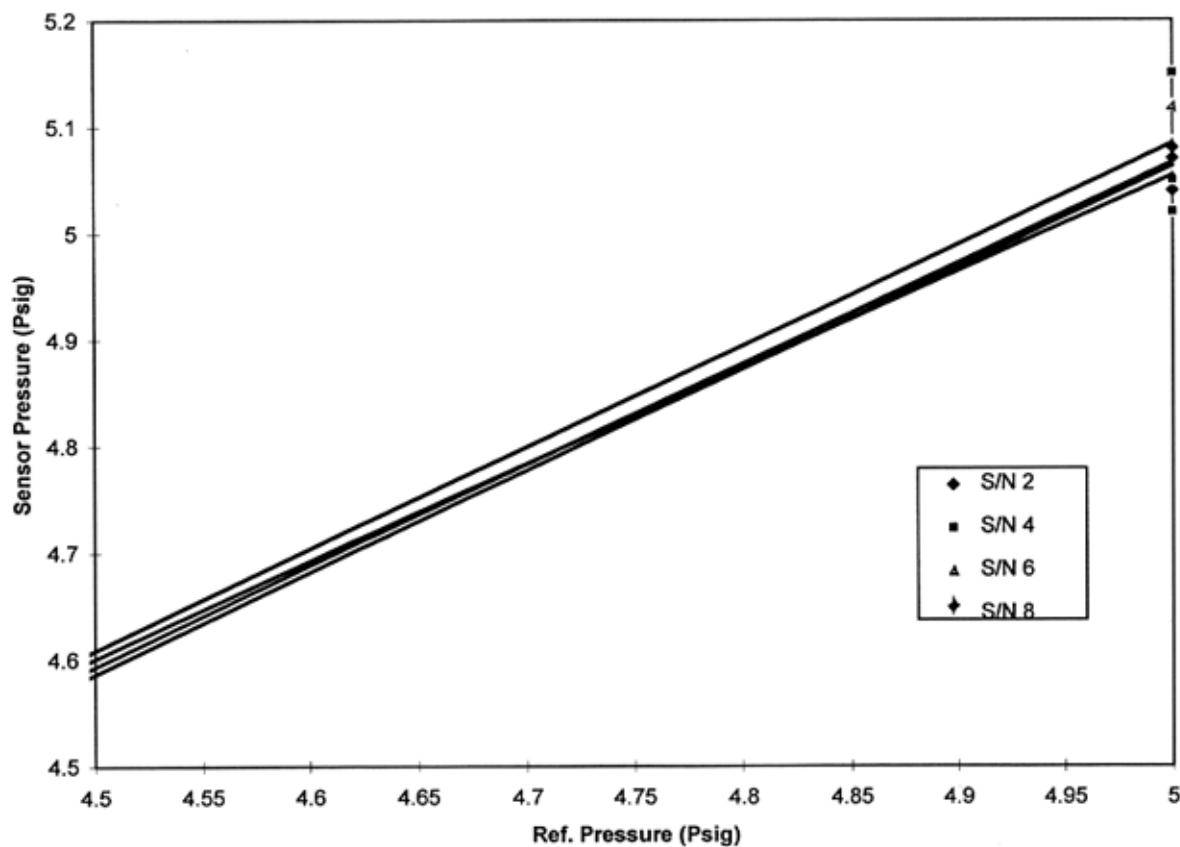
**Figure 2-1-13 Pressure sensor output of used filter (5) psi, inside filter**

**Sensor Pressure Reading at different Locations inside the Used Filter  
(Pressure Level 5 Psig)**

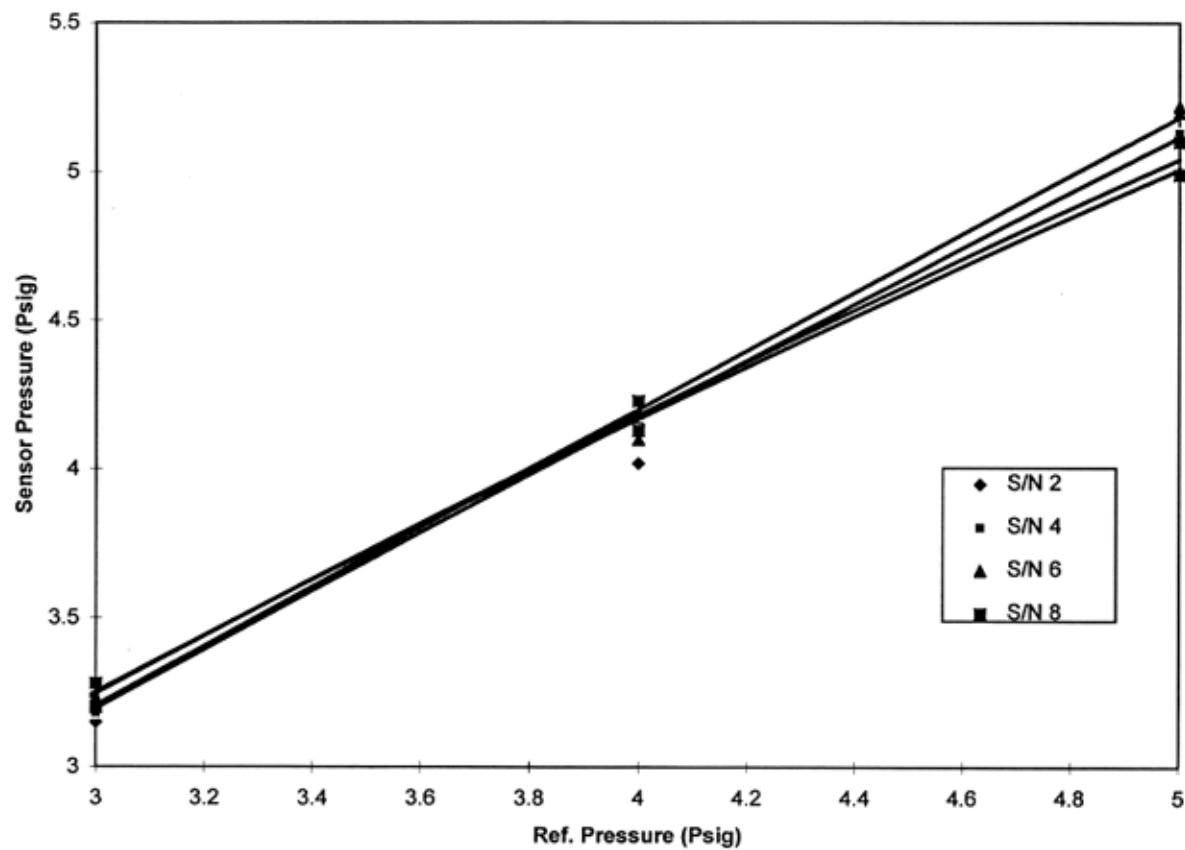
Figure 2-1-14 Pressure sensor output of unused filter (5) psi, inside filter

**Sensor Pressure Reading at different Locations inside the Unused Filter**

**(Pressure Level 5 Psig)**

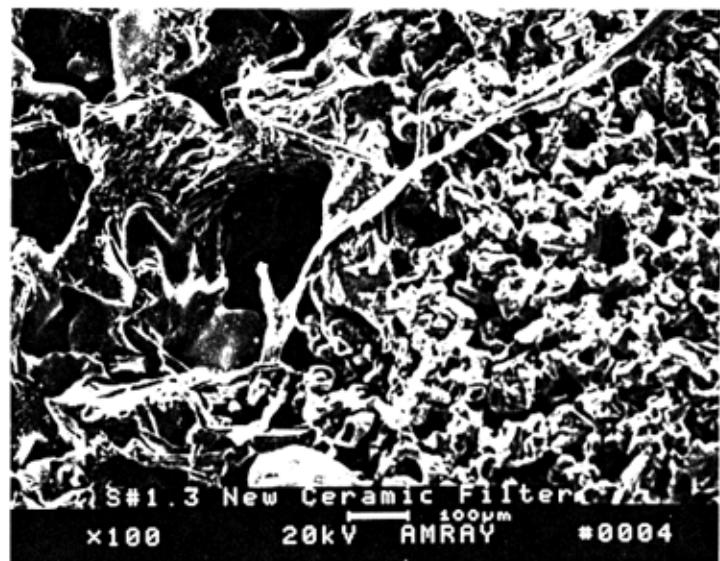
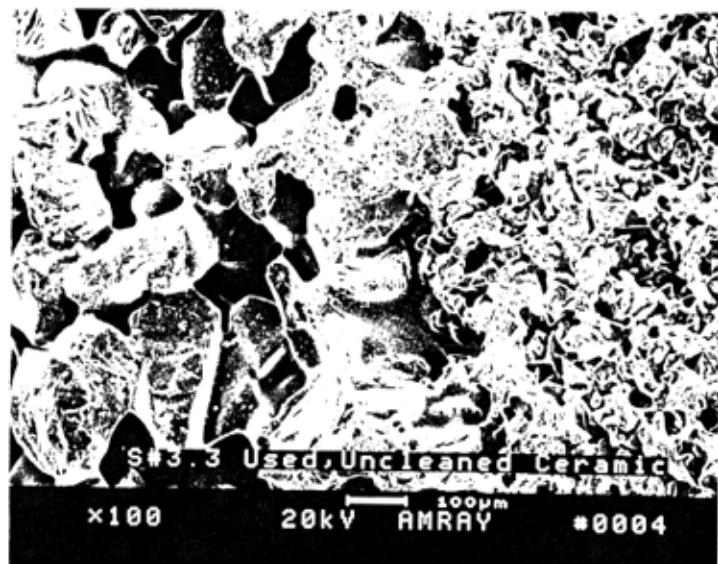
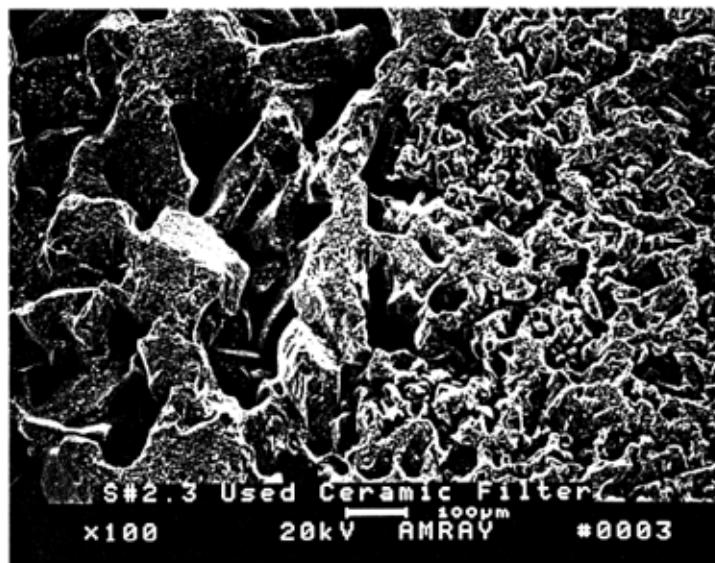
Figure 2-2-1 SEM micrographs of unused, used and ultrasonically cleaned filters

SEM Micrographs of: (a) unused; (b) used; (c) used and ultrasonically cleaned ceramic filters, illustrating the double layer structures.

Figure 2-1 SEM Micrographs of the (a) unused (b) used and (c) used ultrasonically cleaned ceramic filters, illustrating the double layers structures.

The micro-features and surface topography of unused, used, and used but ultrasonically cleaned ceramic filter samples were primarily analyzed by SEM. The results of the SEM showed that the unused ceramic filters have porous microstructural features, and the dimensions of the pores are about several ten micrometers with no fractured or broken surface. As for the used filter, the SEM pictures revealed broken and fractured surfaces in the inner and the outer layer due to thermal stress induced by cold back pulse cleaning and structural stress caused by thermal volume expansion. Also, traces of particulate and ashes were found in both layers of the used filter samples.

The micrographs of used (with or without ultrasonically cleaning), and unused filter samples are presented in **Figure 2.2.1**. The pictures show that the micro-structure of the filter can be divided into three regions. The first is the outer layer with a fine microstructure feature which correspond to aluminosilicate membrane of ceramic filter. The inner layer with coarse grains represents the support matrix (clay-bonded silicon carbide) of the ceramic filter. The third one is the interfacial region between the first and second layer. In this region, the microstructural characteristic transforms from one to another, i.e., from fine to coarse. Although there is no abrupt transition in the interfacial microstructure, the differences of microstructure features in the inner and outer region are easily to be differentiated. The outer layer has a porous cotton-like microstructural features, and the dimensions of the pores are about several ten micrometers. In the inner layer, with a porous microstructure too, the grains with several ten micrometers in size are bonded by clay and the pores are generally formed at the boundaries between the grains.

For the used ceramic filter, the volume expansion generated by the changes in microstructure of the grains might induce stress fields inside in the filter matrix, which would further promote the nucleation and propagation of the micro-cracks at some inclusions and defects sites leading to the fatigue fracture failure of the ceramic filter. the inconsistency in changes of crystal constants and structure between inner and outer layer would cause delimitation of the ceramic filter structure. The unused filter usually have a fine coherence between inner and outer layer, while the used filters show that some particles have been dropped off the interfacial region. In addition, the growth of grain and volume expansion of the used filters may lead to the reduction of volume ratio of the pores, and as a result, decrease the permeability of the ceramic filters.

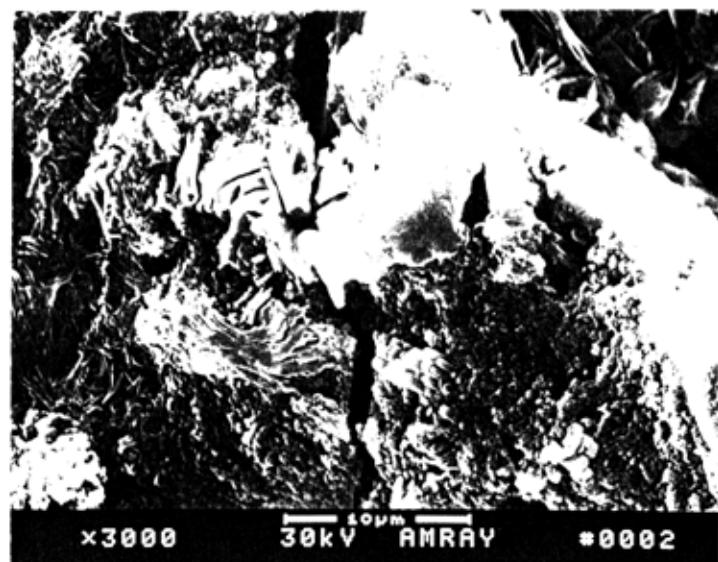
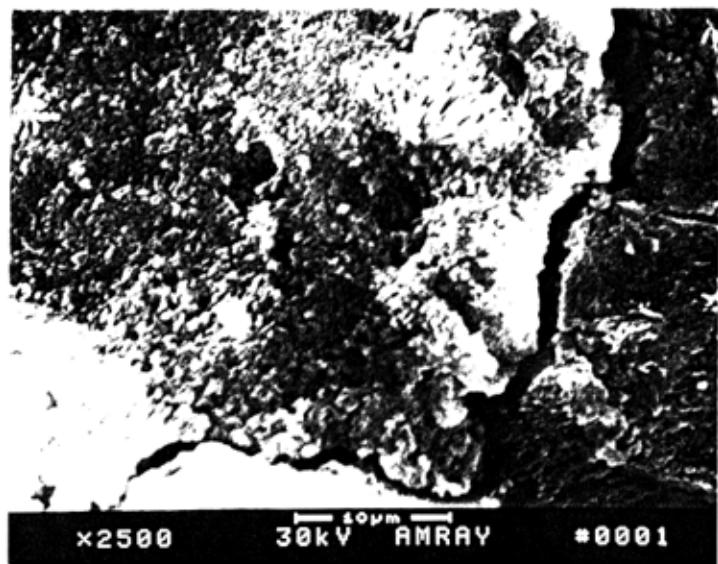
Figure 2-2-2 SEM micrographs of unstable cracks penetration on inner and outer filter surface

SEM micrographs of unstable cracks penetrating on: (a) the outer surface; and (b) inner surface of the used ceramic filter.

Observation of the post-run filters also show that there are numerous cracks developed on the surface of the failed ceramic filter and **Figure 2.2.2** displays a typical example of the defects. Some of them first initiated along the longitudinal direction, and then developed in about 45

degree away; and finally intersect with each others and caused fracture failure of the ceramic filter.

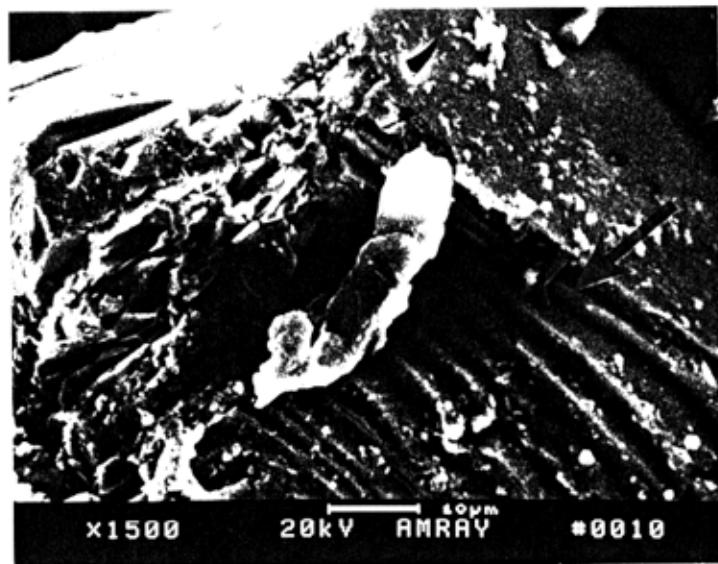
SEM micrographs of cleavage fracture "river marks" through the outer layer of the used ceramic filter caused by reverse pulse cleaning: (a) at 1500 X; and (b) at 6000 X.

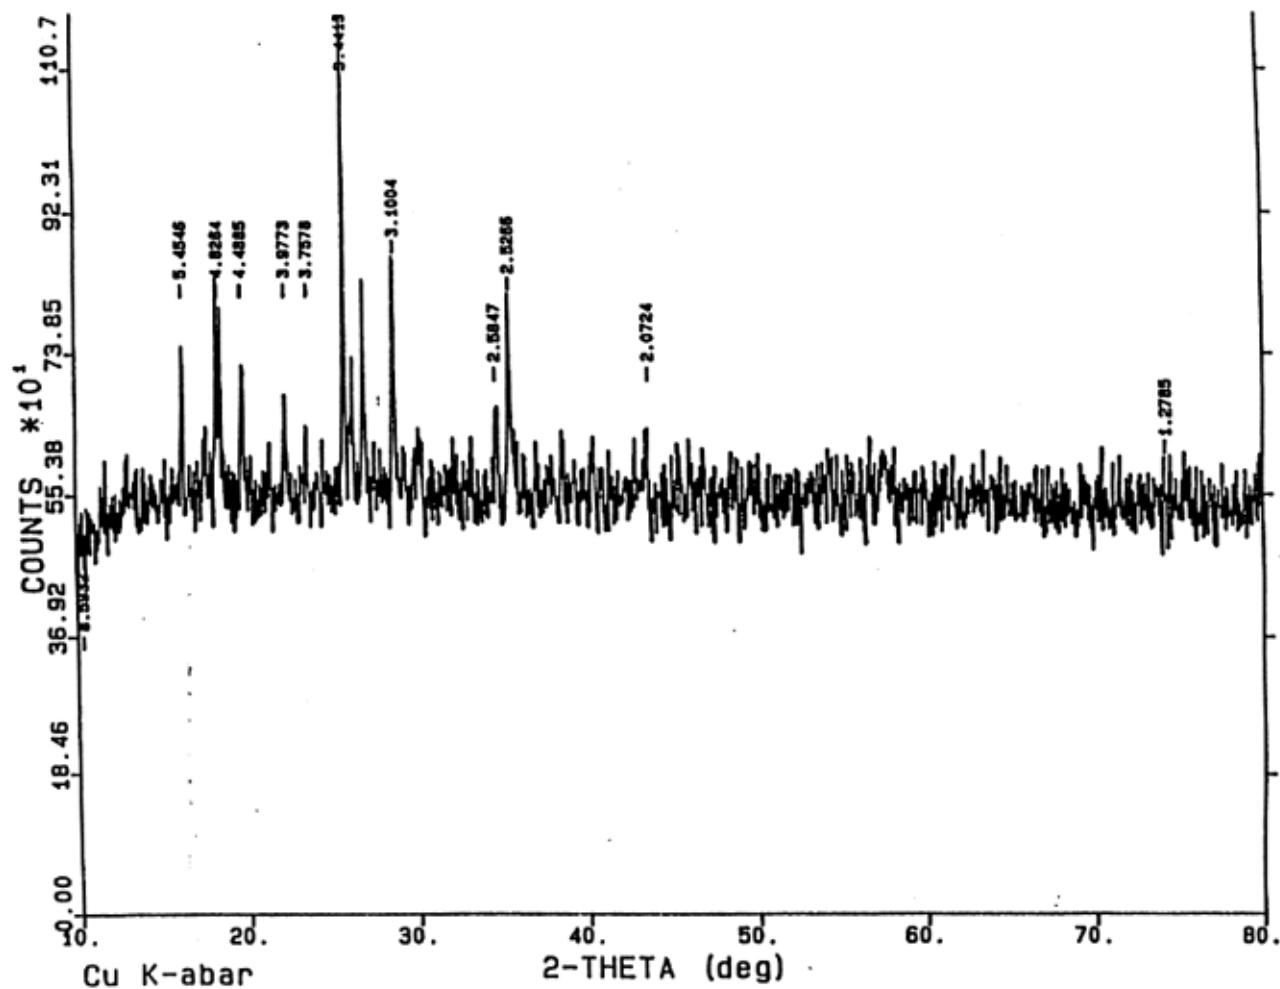
Figure 2-2-5 XRD spectra of the layer formed by depositions and reactions on the surface of the used ceramic filter.

XRD spectra of the layer formed by depositions and reactions on used filter surface

The unused ceramic filter is a double-layer porous candle with gray color. The broken used filter samples were in dark yellow color. The yellow color surface layer is the product of emission particle deposition and the chemical reactions between emission gases and filter material. The composition of this layer are mainly  $\text{SiO}_2$ ,  $\text{Al}_2\text{O}_3$  and  $\text{Al}_2\text{Si}_4\text{O}_{10}$  according to the XRD analysis. This layer could reduce the efficiency of ceramic filters.
