PNNL-32829

Alternate Methods for Cleaning Zirconium Plate

April 2022

Abstract

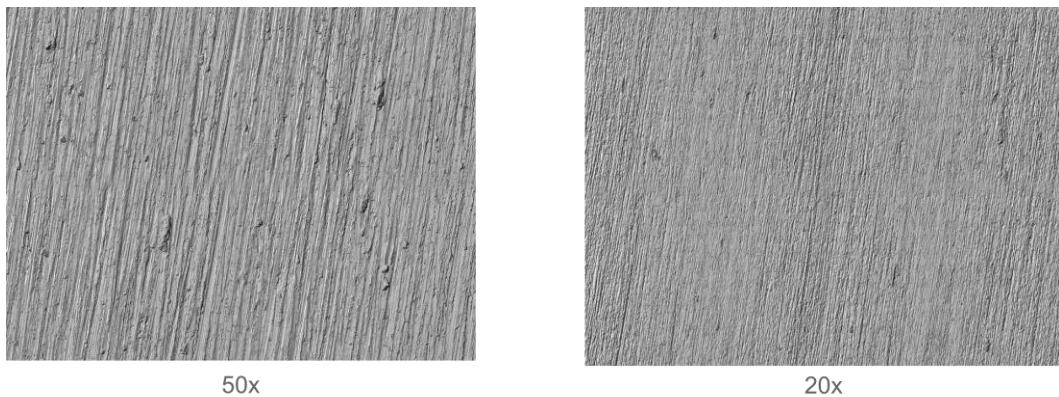
Figure 1. The 50x and 20x magnification images of As-Received 702 Zirconium Sheet.

Sheets of 702 Zirconium (Zr) were acquired to test different cleaning methods utilized before and after hot rolling of zirconium to uranium. The plates were nominally 12 inches by 24 inches in size with thickness either 0.020 inch or 0.040 inch and received with an initial polish with measured surface roughness ranging between 0.2-1.0 μm (8-40 μin) Ra, measured by LCM. The 50x and 20x magnification C-DIC images are shown in Figure 1. XRD and surface analysis with SEM was also performed on the as-received material. XRD found carbon compounds on the surface that were identified as carbides (Figure 2). However, surface scans by SEM (Figure 3) did not find carbide inclusions on the surface so the carbon recognized by XRD is likely part of the microstructure of the purchased material and not a surface defect.

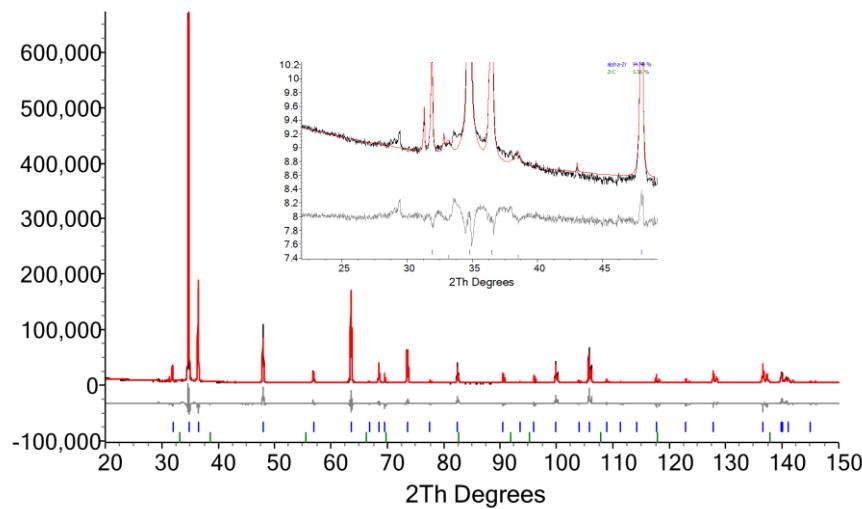
Figure 2. XRD Scan of As-Received 702 Zirconium Sheet.

Note: The blue markers identify peaks associated with Zr metal while the green markers identify peaks associated with zirconium carbide.

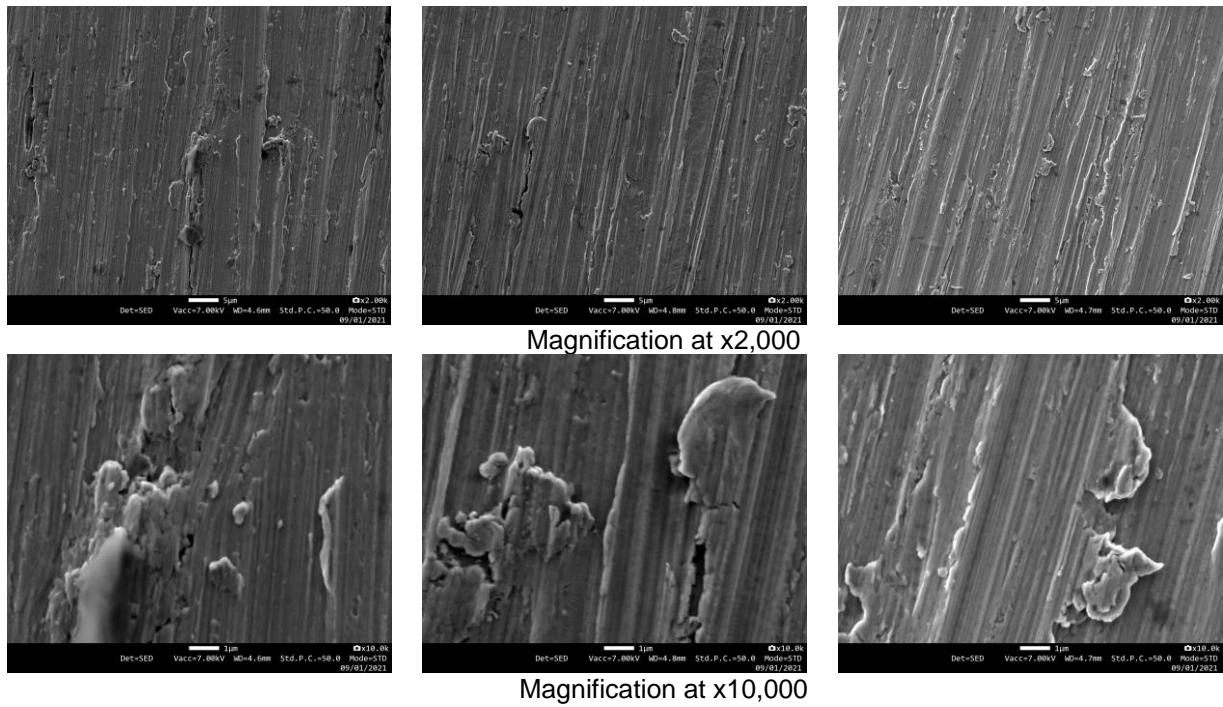
Figure 3. SEM Surface Scan Images of As-Received 702 Zirconium Sheet at x2k and x10k Magnification

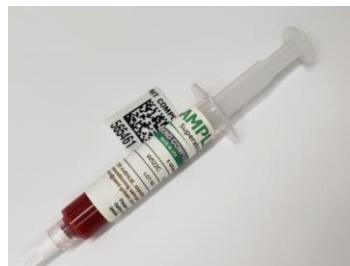
Figure 4. Amplex Grade 30 Water Soluble Abrasive Diamond Paste

- Amplex Grade 30 Water Soluble Diamond Paste (Figure 4)
- 3M Wet-polishing Triazat™ abrasive belts (253FA; Grades A80/A45/A30)
- Scotch-Brite™ polishing pads (Grades Fine and Ultra Fine)
- Neolube No.1 Dry Film Graphite Lubricant
- Laboratory grade chemicals
 - Ethanol
 - Hydrofluoric Acid
 - Nitric Acid
- Deionized water

The baseline process for cleaning the as-received zirconium uses Amplex Grade 30 water soluble diamond abrasive paste (Figure 4). This approach was evaluated using a 2-inch by 6-inch strip of zirconium plate. The paste was applied to the surface of the plate and then hand-polished until all the compound was removed from the surface. Measurements of the surface roughness were evaluated at three 1.25-inch square locations on the sample before and after cleaning. These locations were subsampled afterwards and evaluated for oxide thickness by SEM and contamination by spectrometry.

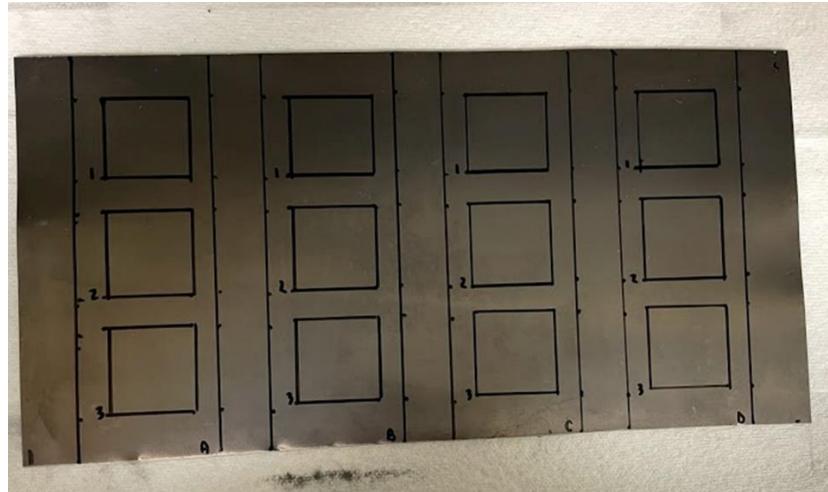
Figure 5. Divisions of each sheet evaluated before and after cleaning.

The plates were removed from the furnace and cleaned with ethanol and Wypall® wipes until no more Neolube was removed. Each sheet was divided into four 2-inch strips and three, 1.25 x 1.25-inch squares were marked in each strip for further analysis.

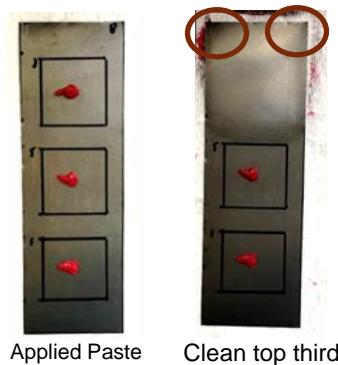
Figure 6. Application of the diamond paste to zirconium sheet and results of hand polishing top third of sheet

The diamond paste was applied to each section of a sheet as shown in Figure 6 and then hand polished over the surface of the metal. While the center of the sheet could be polished within a few minutes, a great deal of time was spent hand polishing the edges of the sheet to remove the polish. Figure 6 shows the initial results of polishing the top third of a sheet where the edges still show indications of the paste after 5 minutes, indicating that this process requires a great deal of effort and experience to perform well.

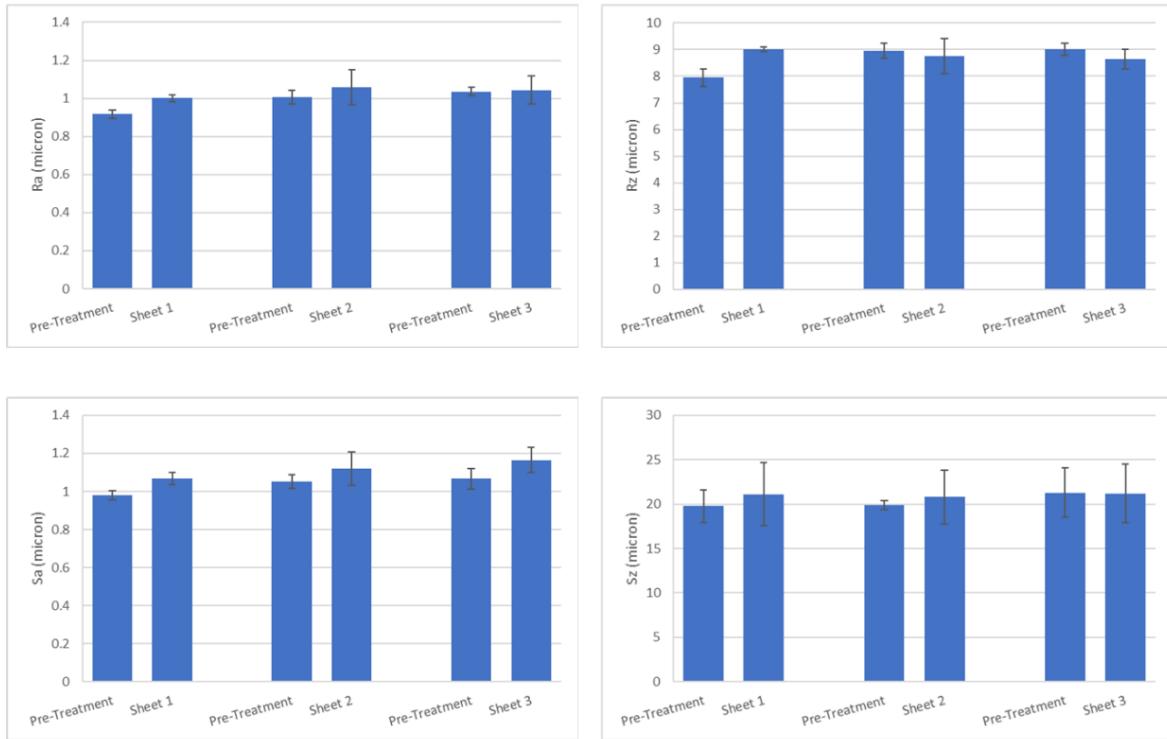
Figure 7. Comparison of the Ra, Rz, Sa, and Sz before and after polishing with diamond paste for each sheet.

An LCM data comparison is shown in Figure 7. The 10x magnification C-DIC images are shown in Figure 8. The LCM data indicates that the surface roughness was not improved by polishing with the red diamond grit paste as compared to the as-received sample.

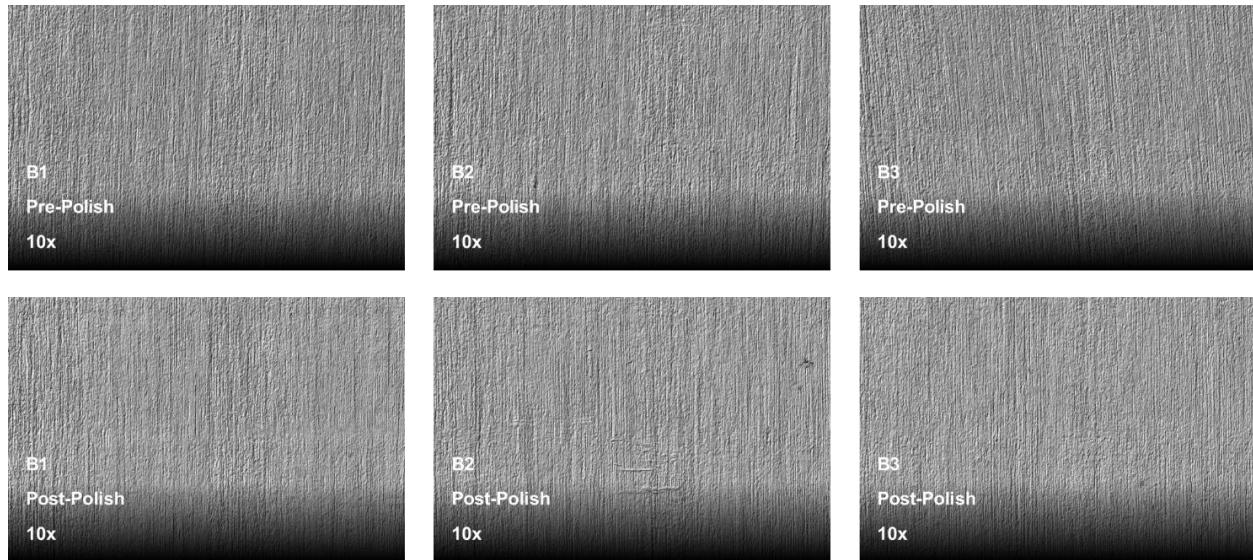
Figure 8. The 10x magnification C-DIC images from Sheet 1 before and after polishing with the diamond grit buff compound.

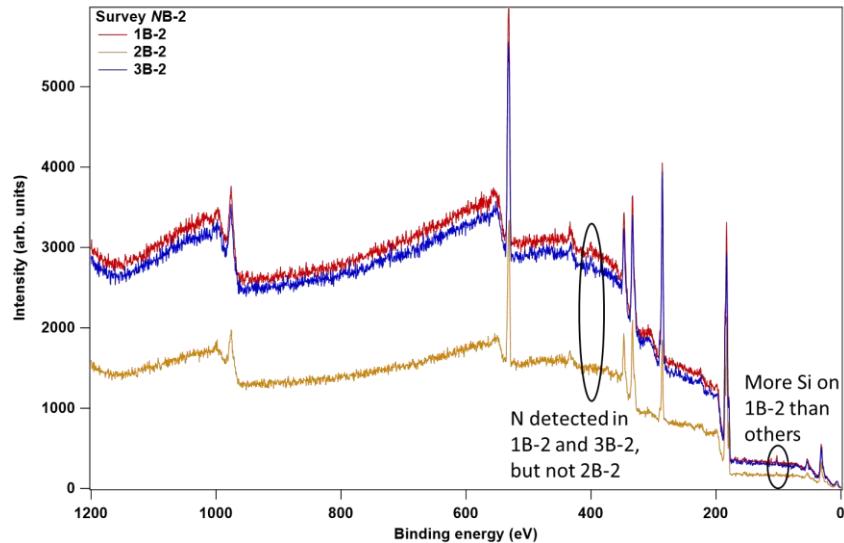
Figure 9. XPS Scan of Zirconium Plate after Diamond Paste Polish

The XPS data (Figure 9) indicated the presence of oxygen and zirconium at a valence state (Zr^{+4}) indicating an oxide layer is still present even after polishing. Silicon and nitrogen were also detected which are present in the diamond grit paste. XRD indicated the presence of carbon at levels similar to the as-received sheet.

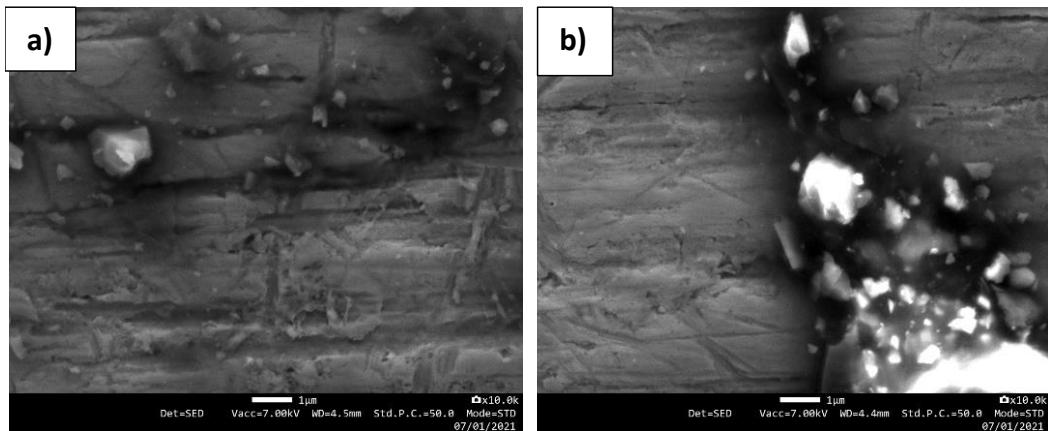
Figure 10. SEM images for the samples polished by hand. Images a) and b) represent two regions analyzed at 10,000x magnification. The inclusions are remnants of the diamond grit paste.

Figure 10 shows SEM images of the polished surface with remnants of the diamond grit buff compound on or embedded zirconium surface, which correlates with the results from the XPS. Figure 11 shows the results of cross-sectional images of the polished sheet. As indicated from XPS, oxide layers were found present on the surface, with a measured thickness between 3 to 6 μm . While XRD indicated the presence of carbon, no carbide inclusions were seen on the surface by SEM.

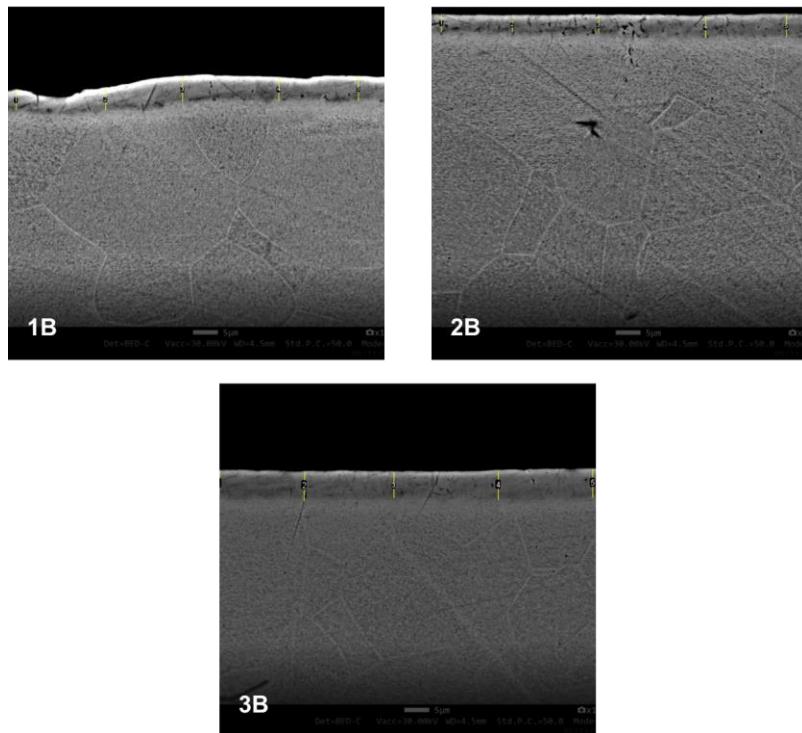
Figure 11. SEM cross section images showing the oxide layers for the hand-polished sheets.

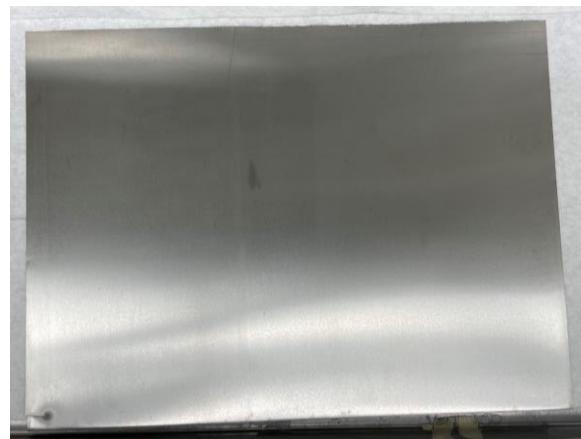
Figure 12. The Zr sheet following wet polishing at 3M.

The Zr sheet following wet polishing at 3M is shown in Figure 12. Staining was found present on the surface from the water-soluble coolant not being completely cleaned off the surface upon exiting the wet polisher. Zirconium can easily stain after machining and either requires hand cleaning with a solvent (acetone/alcohol) that quickly dries or allowed to passivation in water to allow the oxide layer to grow to a level where irregular growth does not occur. While the impact is cosmetic, it indicates possible contaminates from the coolant may be present.

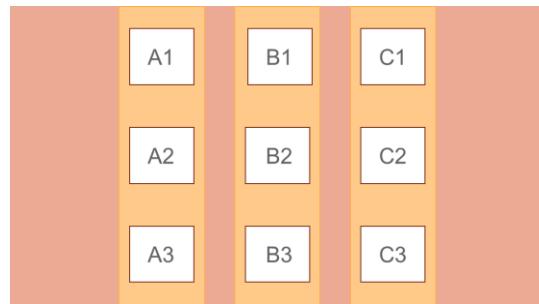
Figure 13. The locations of LCM data collection for the wet-polished Zr sheets.

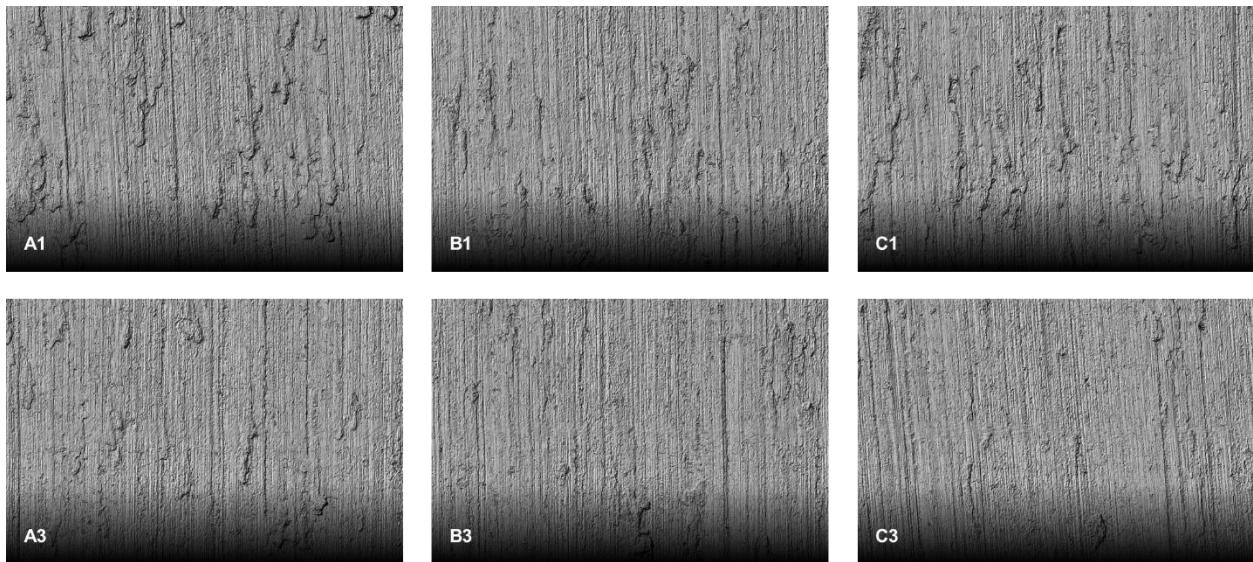
Figure 14. C-DIC images for rows 1 and 3 at 20x magnification.

plate is slightly better than the as-received ($R_a = 0.9\text{-}1.0 \mu\text{m}$) and diamond polished plate ($R_a \sim 1.0 \mu\text{m}$). The C-laser differential interference contrast (C-DIC) images for each location are shown in Figure 14 for the 20x magnification and are within a surface roughness range expected from the Trizact™ belt sequence used for this testing.

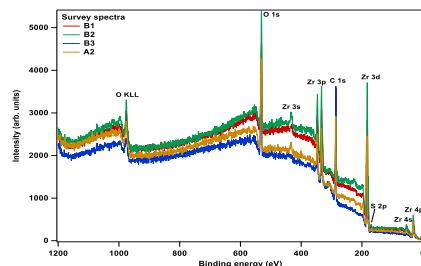
Figure 15. XPS results for wet polished surface

XPS analysis indicated the presence of Zr, O, and trace amounts of sulfur as shown in Figure 15. The carbon and sulfur present were likely from the water-soluble coolant used for the polishing, and the zirconium again was seen at a valence state indicating the presence of an oxide layer, like the as-received sample. XRD analysis also found similar levels of carbon present as found in the as-received material.

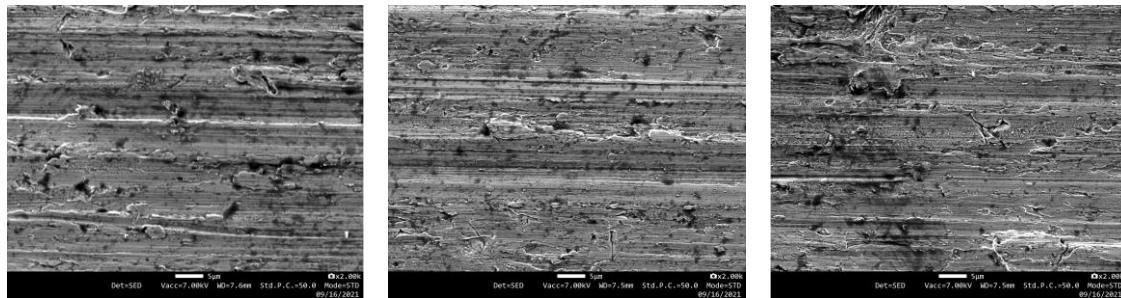
Figure 16. SEM images at three different locations on sample C2

SEM images are shown in Figure 16, showing no abrasive or carbide inclusion were detected on the surface.

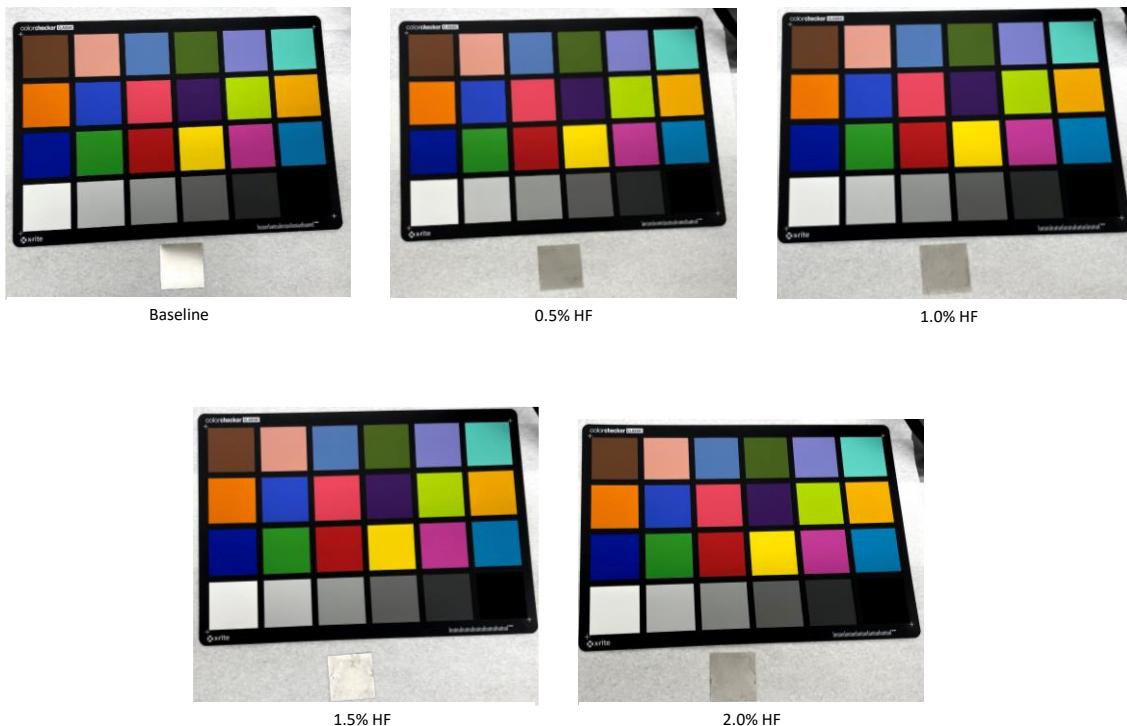
Figure 17. Flash etching Set 1 samples compared to a color chart. Each etched sample had brown staining and more of a matte finish than the shinier, silver baseline sample.

Samples were etched for 20 seconds in etchant solutions with 30 wt% nitric acid and varying concentration of hydrofluoric acid (0.5 wt% to 2.0 wt%). The pre-etched baseline and etched samples visual appearances are compared to a color chart in Figure 17. Each etch had brown staining on the surface and an increase in surface roughness. As the concentration of HF was increased, the etch was faster, correlating to an increase in staining. LCM surface roughness measurements of baseline and etched sample were taken and summarized in Figure 18. The plates were consistently rougher after etching with nitric acid/HF as compared to the baseline diamond polished material. The 20x magnification C-DIC images are shown and Figure 19.

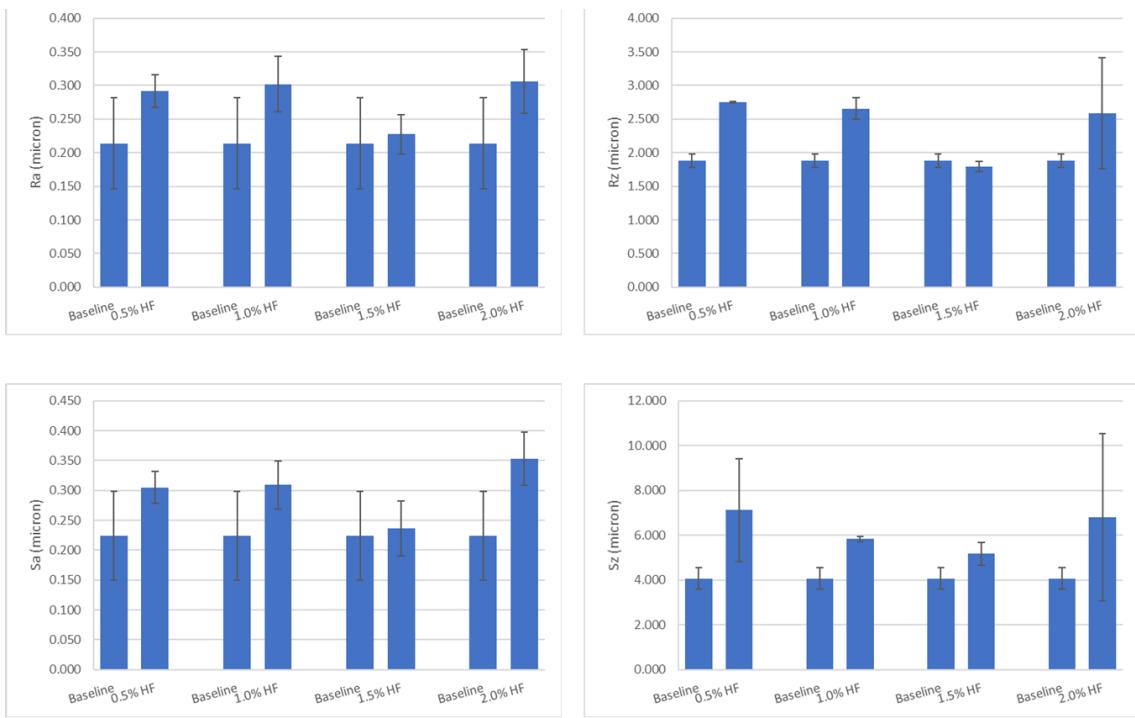
Figure 18. Comparison of the Ra, Rz, Sa, and Sz values before and after etching for Set 1 samples etched in 30% HNO₃ and varying concentrations of HF.

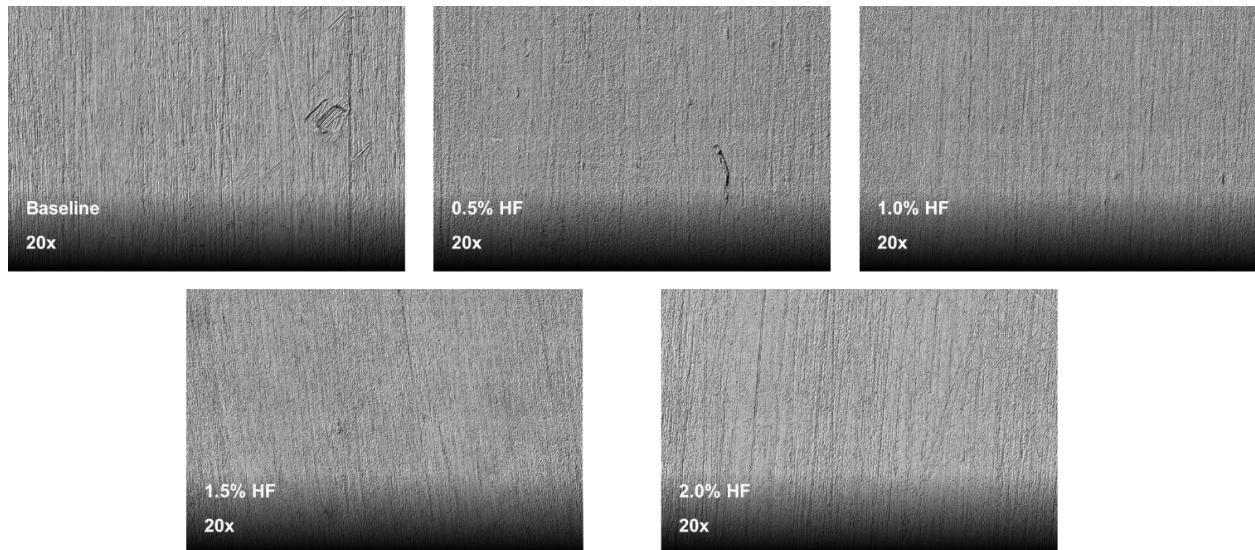
Figure 19. C-DIC images at 20x magnification for Set 1 etched samples in 30% HNO₃ and varying concentrations of HF.

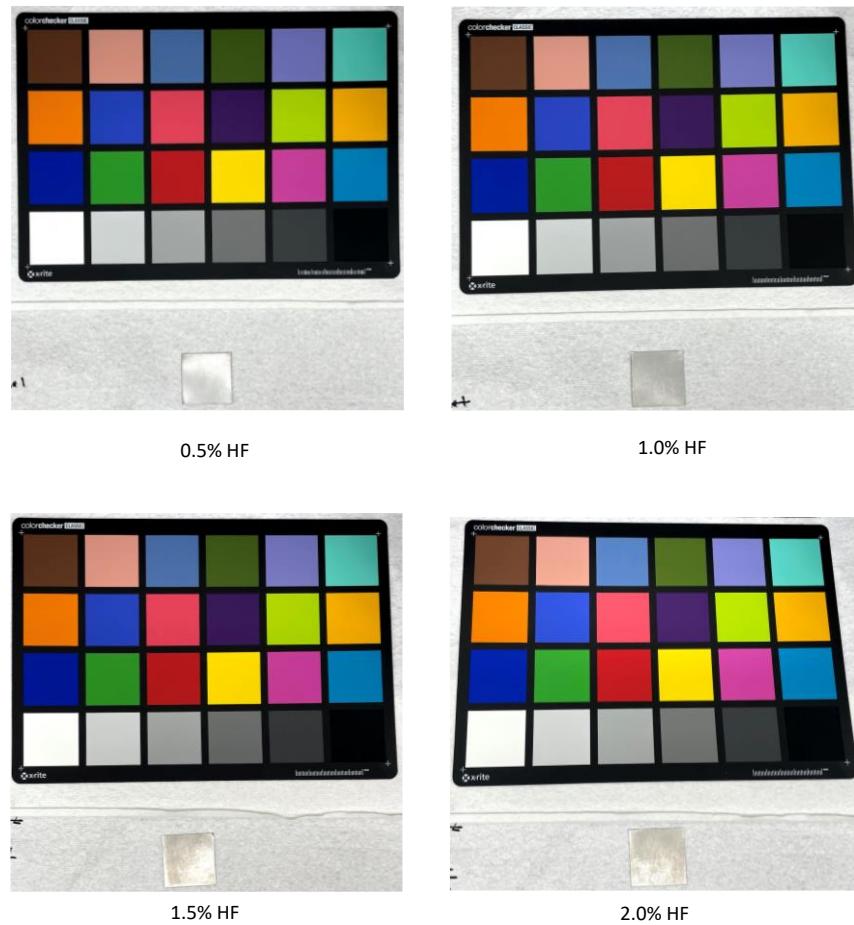
Figure 20. Etch Set 2 samples compared to a color chart from the duplicate flash etch testing at 30 wt% nitric and varying hydrofluoric concentrations. Etch time was 20 seconds.

The initial set of flash etching testing (Set 1) at 30 wt% nitric acid and varying hydrofluoric acid conditions for 20 seconds was repeated (Set 2) to collect mass loss data. Images of each sample etched for 20 seconds is shown in Figure 20. The comparison data for each square and the baseline sample analyzed via LCM is shown in Figure 21. The 20x magnification C-DIC images are shown in Figure 22. Results were comparable to the first etch test with increases in surface roughness measured afterwards and increased staining with increasing hydrofluoric acid concentration.

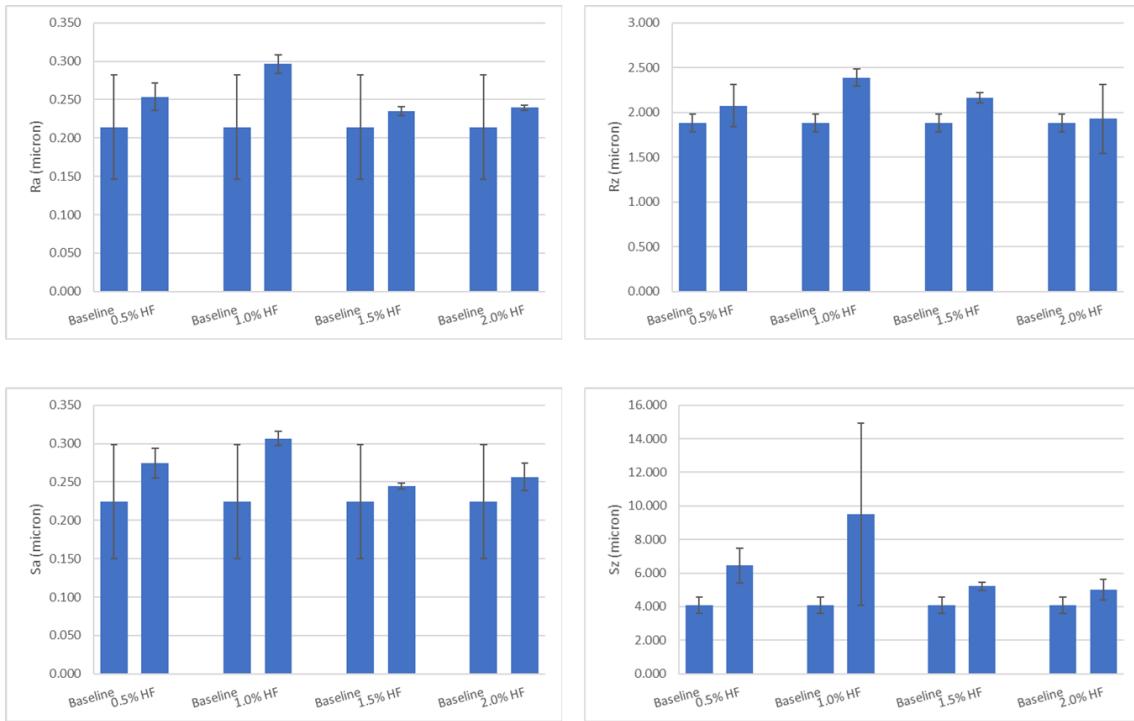
Figure 21. Comparison of the Ra, Rz, Sa, and Sz values before and after etching for Etch Set 2 samples etched for the duplicate in 30% HNO_3 and varying concentrations of HF. Each etch lasted for 20 seconds.

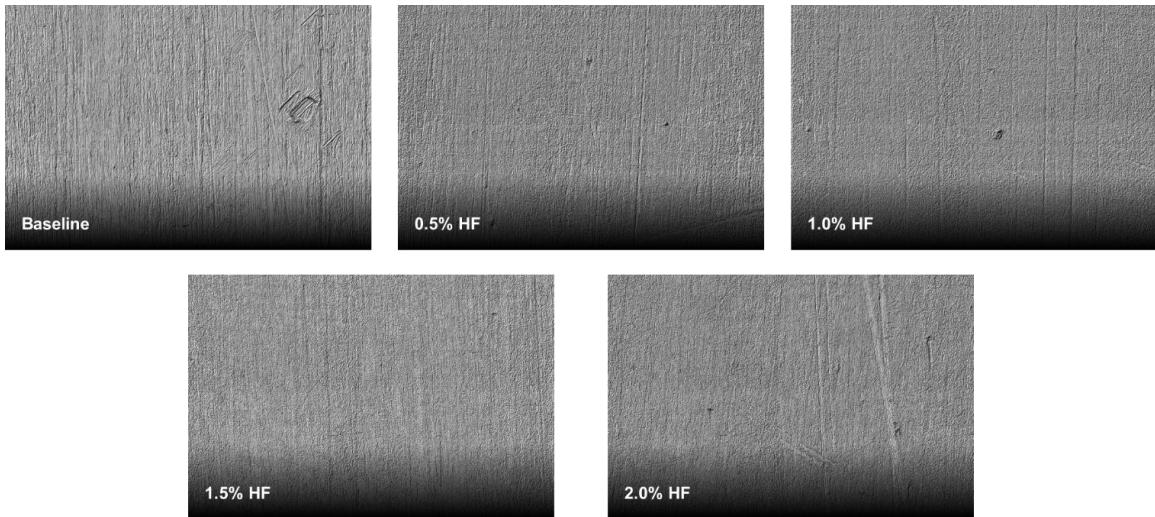
Figure 22. C-DIC images at 20x magnification from etched Set 2 samples from the duplicate testing at 30% HNO_3 and varying concentrations of HF. Each etch lasted for 20 seconds.

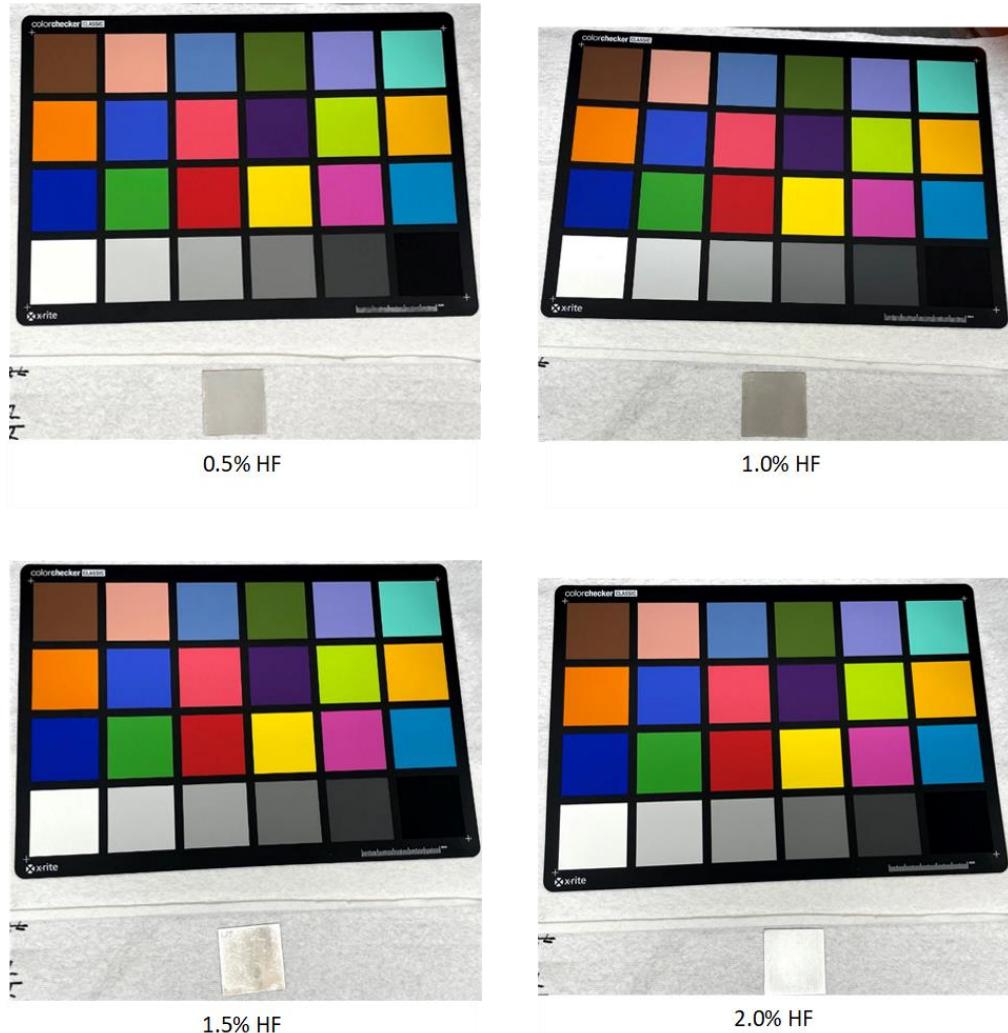
Figure 23. Set 3 samples etched at 30 wt% nitric and varying hydrofluoric concentrations compared to a color chart. Etch time was for 40 seconds.

For the third flash etching test (Set 3), the concentrations of the solutions remained the same, but the etch time was increased to 40 seconds. Images of the Zr metal squares following the 40 second etch are shown in Figure 23. The data comparison for each sample and the baseline for the 40 second etch are shown in Figure 24. The 20x magnification C-DIC images are shown in Figure 25. The surface roughness changes at 2 wt% HF were not as significant as they were at the lower concentrations with the increased time and the surface appears brighter. Staining was still present on all samples.

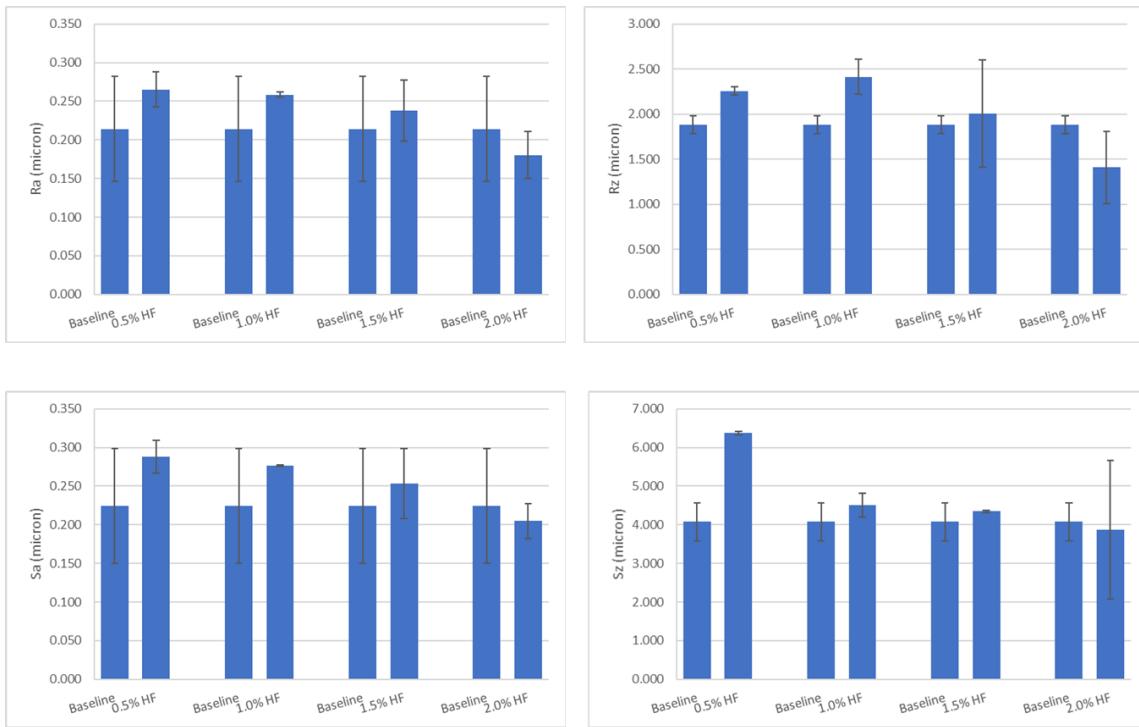
Figure 24. Comparison of the Ra, Rz, Sa, and Sz values before and after etching for Set 3 samples etched in 30% HNO_3 and varying concentrations of HF. Each etch lasted for 40 seconds.

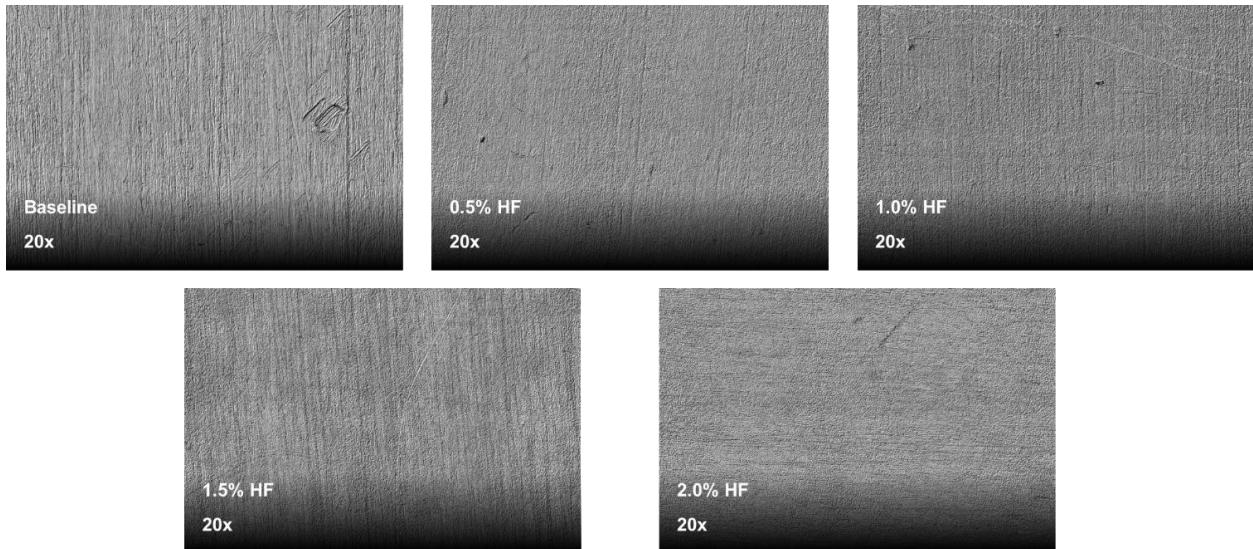
Figure 25. C-DIC images at 20x magnification for Set 3 samples etched in 30% HNO_3 and varying concentrations of HF. Each etch lasted for 40 seconds.

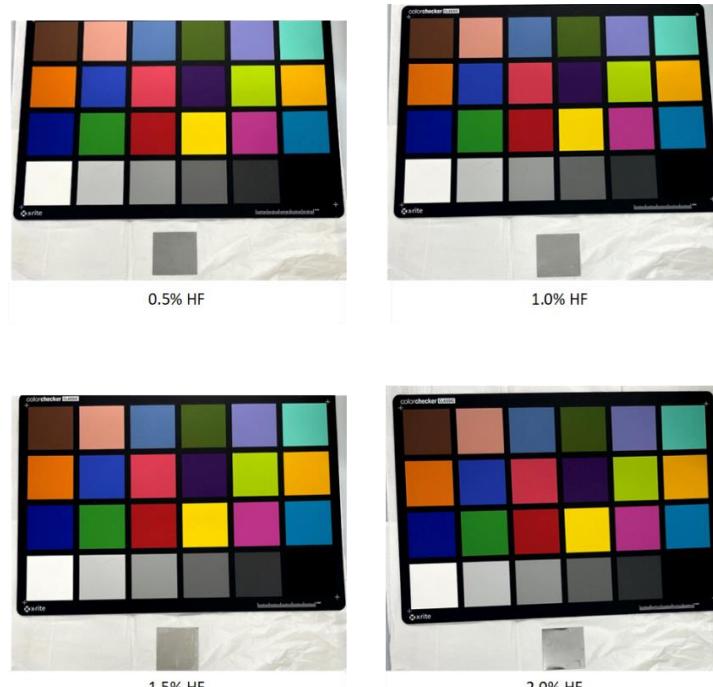
Figure 26. Comparison of the Set 4 post-etch samples and a color chart etched in 40wt% HNO₃ at varying HF concentrations. The etch time was 20 seconds.

Flash etching test for Sets 2 and 3 were repeated, but the concentration of nitric acid was increased to 40 wt%. Images of the Set 4 post-etch samples, etched at 40 wt% nitric and varying hydrofluoric acid concentrations for 20 seconds is shown in Figure 26. The LCM data for this data set are shown in Figure 27. The 20x magnification C-DIC images are shown in Figure 28, respectively. Surface roughness changes were more significant at lower hydrofluoric concentration while staining is more prominent with increasing hydrofluoric concentration when compared to against the as-manufacture material and baseline hand abrasive polish.

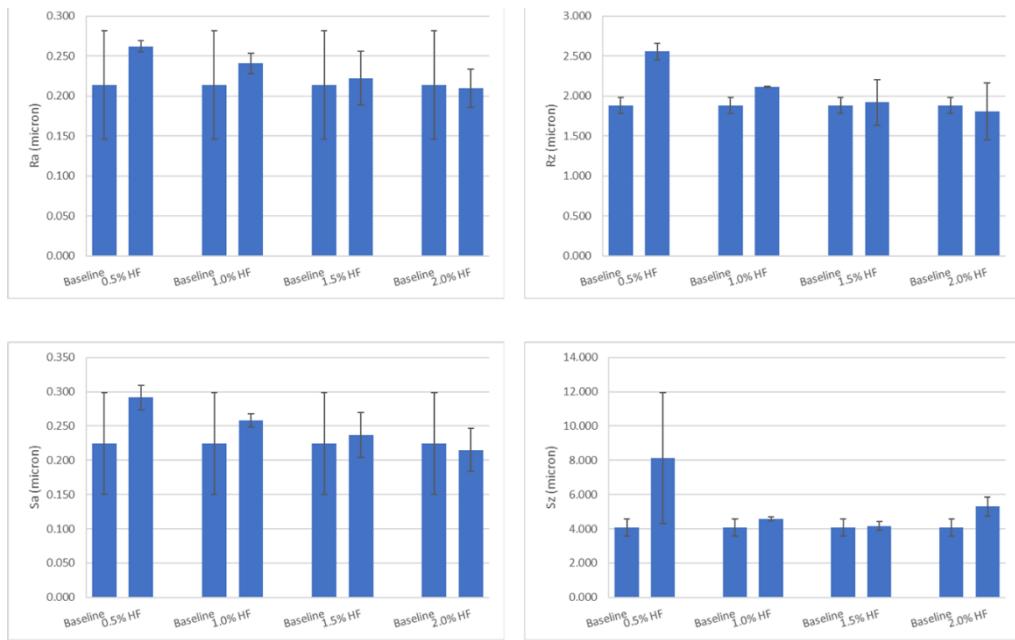
Figure 27. Comparison of the Ra, Rz, Sa, and Sz values before and after etching Set 4 samples etched in 40wt% HNO₃ and varying concentrations of HF. Each etch lasted 20 seconds.

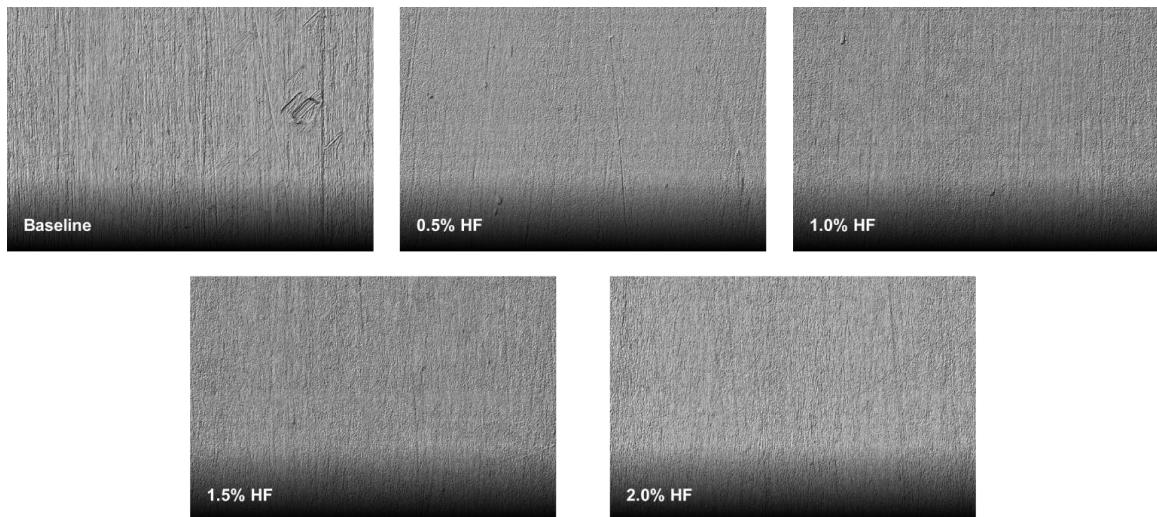
Figure 28. C-DIC images at 20x magnification for Set 4 samples etched in 40% HNO₃ and varying concentrations of HF. Each etch lasted for 20 seconds.

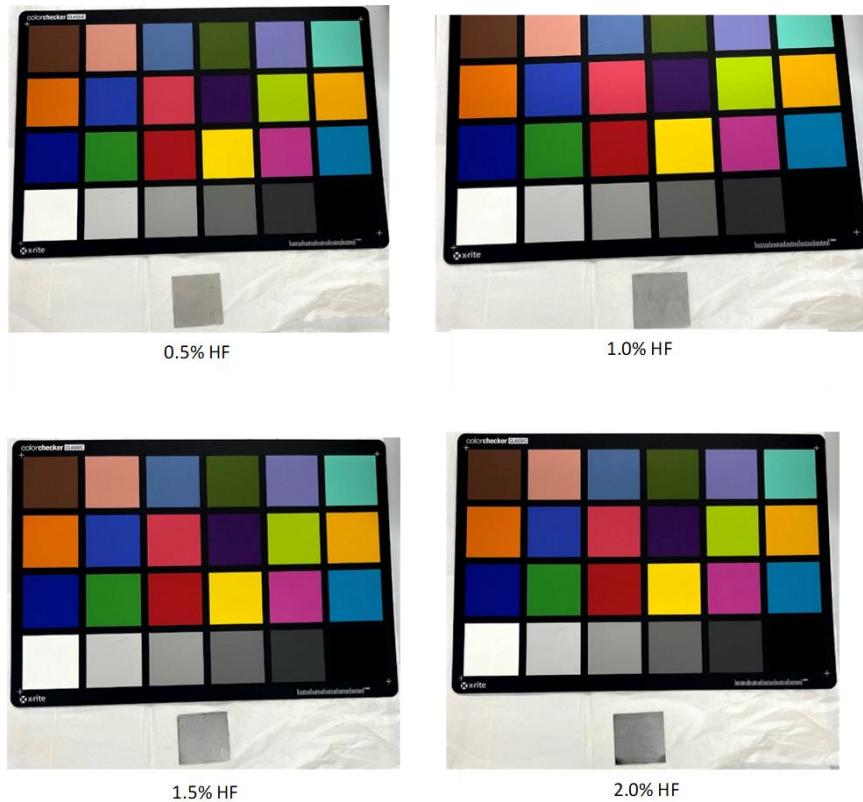
Figure 29. Comparison of the Set 5 post-etch samples and a color chart etched in 40wt% HNO_3 at varying HF concentrations. Etch time was 40 seconds.

Set 5 zirconium samples etched in 40wt% HNO_3 and varying HF concentrations, but the etch time was increased to 40 seconds. The comparison between each etched square and a color chart is shown in Figure 29. The LCM data for this data set are shown in Figure 30 with the C-DIC images at 20x magnification for each sample are shown in Figure 31. The results are very similar to all the previous test results with staining on the surface that increased with increasing HF concentration.

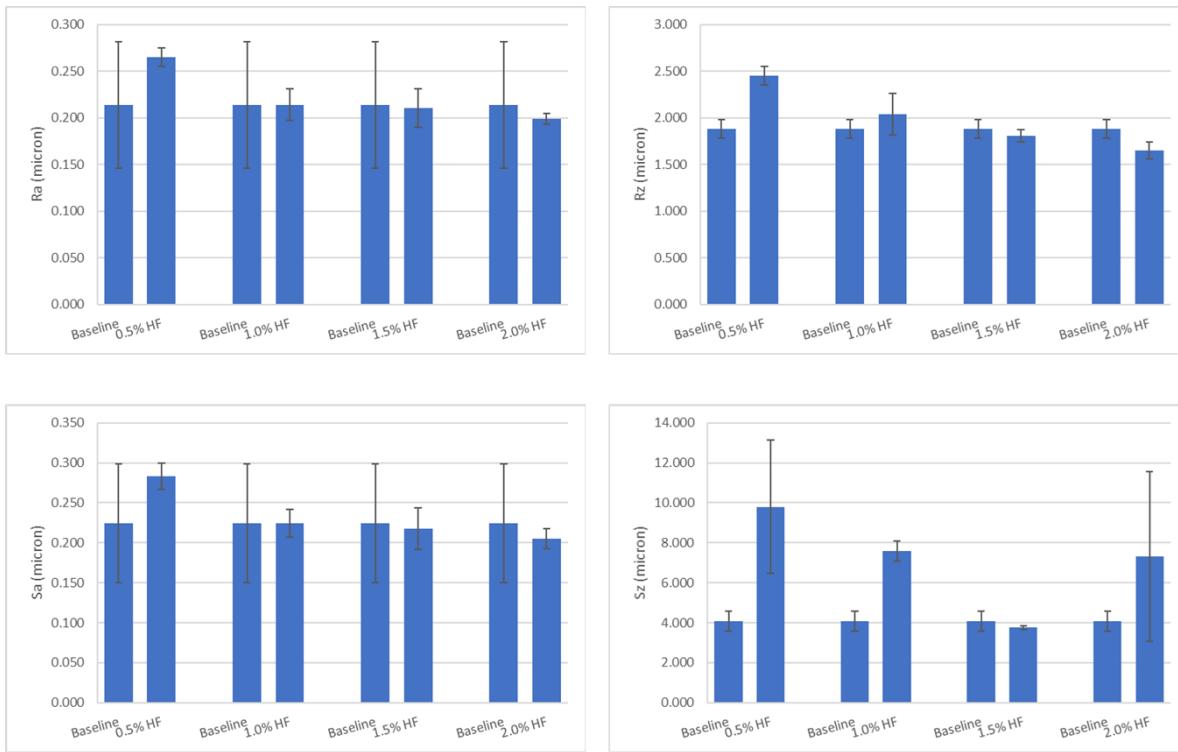
Figure 30. Comparison of the Ra, Rz, Sa, and Sz values before and after the Set 5 were etched in 40wt % HNO₃ and varying concentrations of HF. Each etch lasted for 40 seconds.

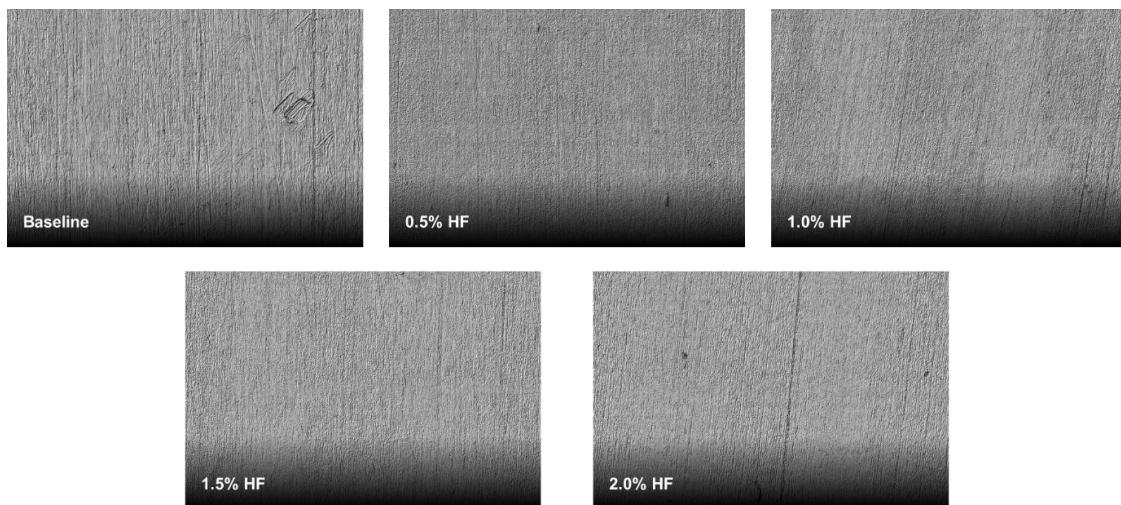
Figure 31. C-DIC images at 20x magnification for the Set 5 samples etched in 40% HNO₃ and varying concentrations of HF. Each etch lasted for 40 seconds.

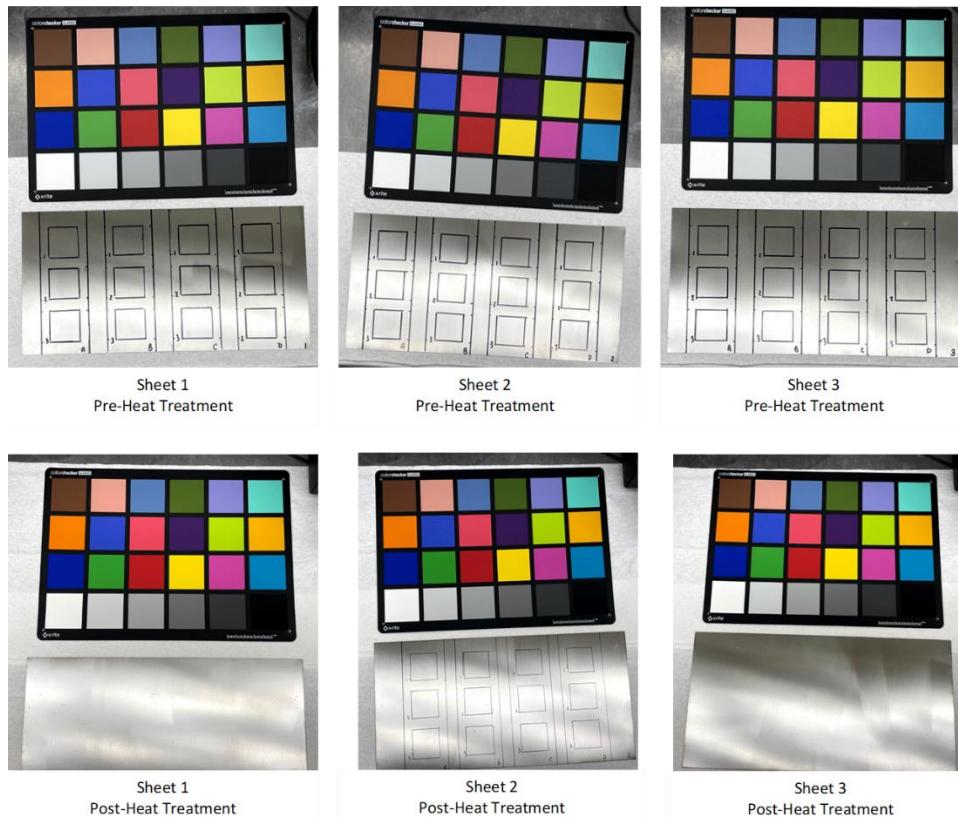
Figure 32. Sheets 1–3 before and after heat treatment between two Neolube-coated, stainless-steel sheets.

Three Zr sheets were heat treated in close contact with Neolube-coated steel plate as described in Section 2.3.1. The three Zr sheets prior to heat-treatment are compared to those heat-treated as shown in Figure 32. No visual difference in the surface appearance was found.

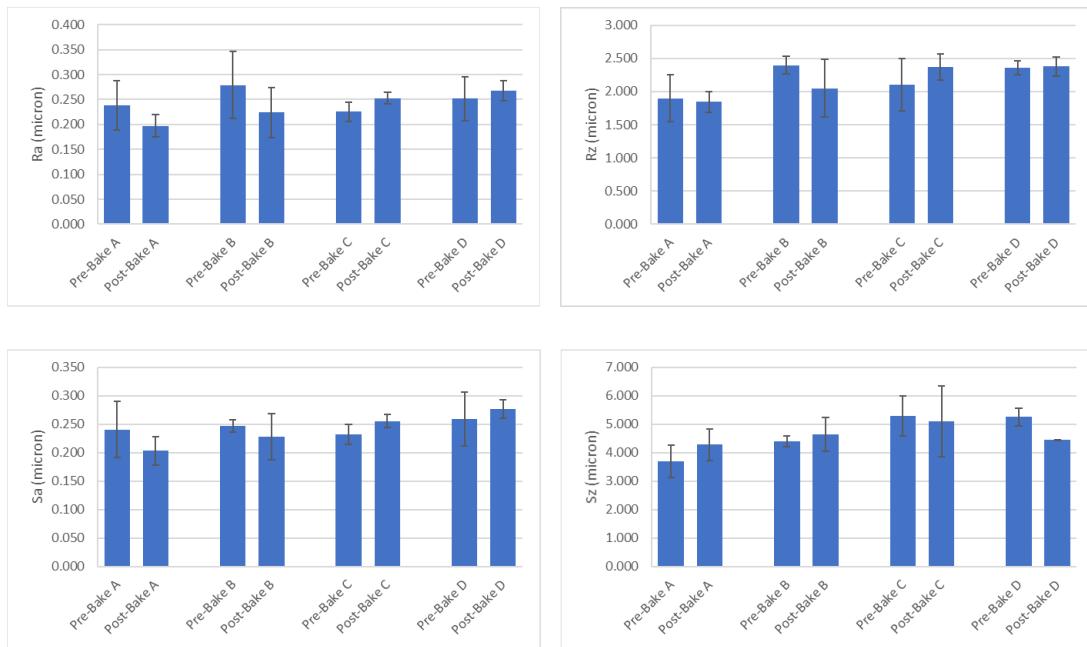
Figure 33. Ra, Rz, Sa, and Sz values for Sheet 2 before and after alcohol cleaning after heat treatment in contact with Neolube.

Sheet 2 was further analyzed via LCM before and after heat treatment to evaluate possible changes in the surface condition. A data comparison before and after heat-treatment/cleaning on this plate is shown in Figure 33 and C-DIC image comparisons are shown in Figure 34. No significant change to the surface was observed by LCM.
