PNNL-32829

Alternate Methods for Cleaning Zirconium Plate

April 2022

Abstract

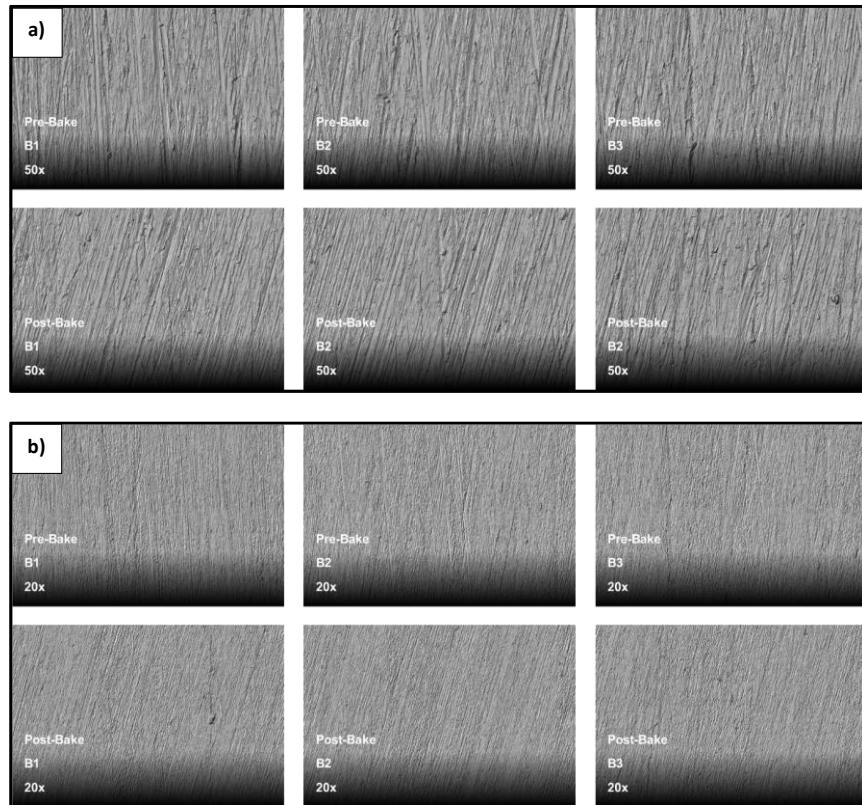
Figure 34. C-DIC images at (a) 50x and (b) 20x magnification of Sheet 2 before and after alcohol cleaning after heat treatment in contact with Neolube.

Sheet 2 was further analyzed via LCM before and after heat treatment to evaluate possible changes in the surface condition. A data comparison before and after heat-treatment/cleaning on this plate is shown in Figure 33 and C-DIC image comparisons are shown in Figure 34. No significant change to the surface was observed by LCM.

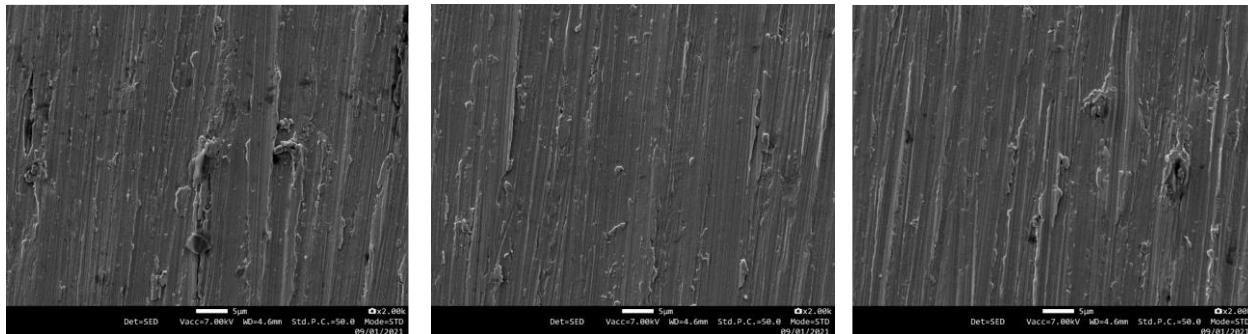
Figure 35. SEM surface images from Plate 2 after alcohol cleaning after heat treatment in contact with Neolube

Sheet 1 was analyzed via XRD, XPS, and SEM to determine if contaminants or inclusions were present on the surface. XRD and XPS indicated the presence of oxygen and carbon on the surface, consistent with the as-received material. SEM images from each location are shown in Figure 35. No inclusions were found on the surface of the heat-treated samples during SEM analysis.

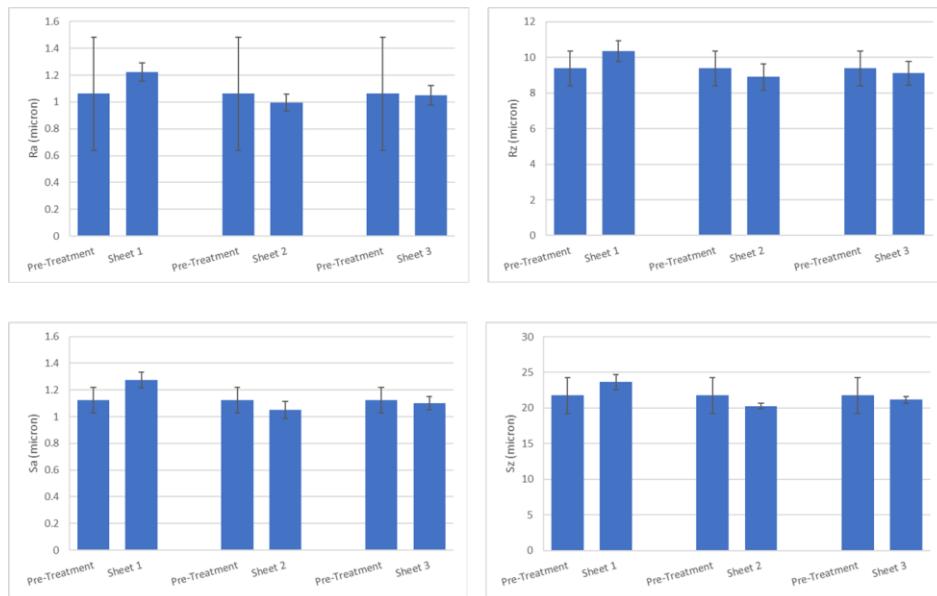
Figure 36. Ra, Rz, Sa, and Sz values for Section A cleaned with ethanol before and after heat treatment and Neolube removal. There was little difference in surface roughness values.

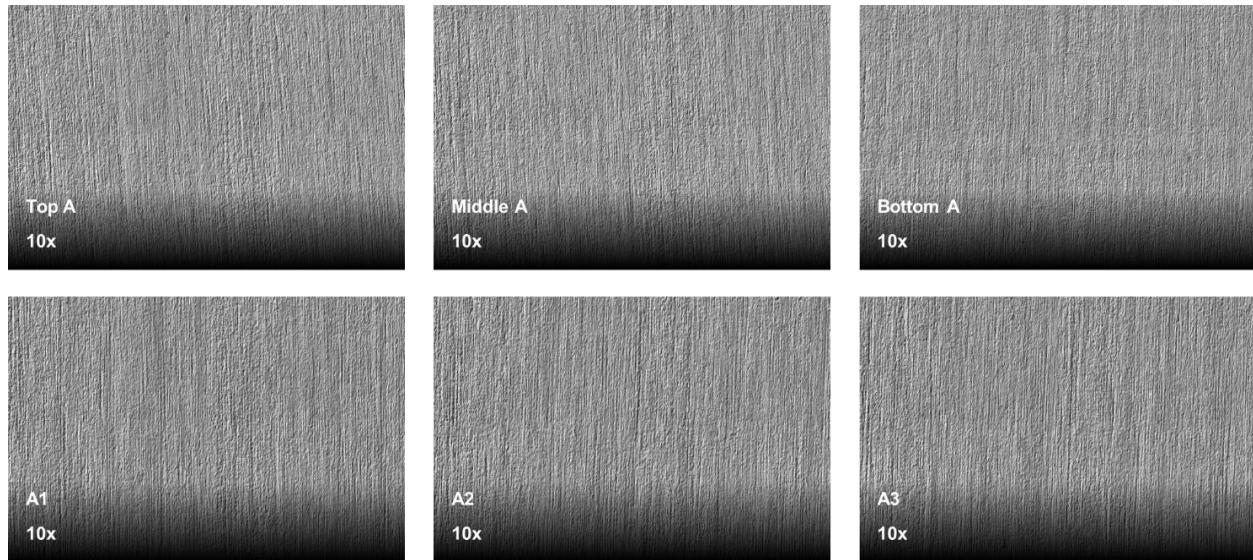
Figure 37. The 10x magnification C-DIC images before and after heat treatment and Neolube removal with ethanol.

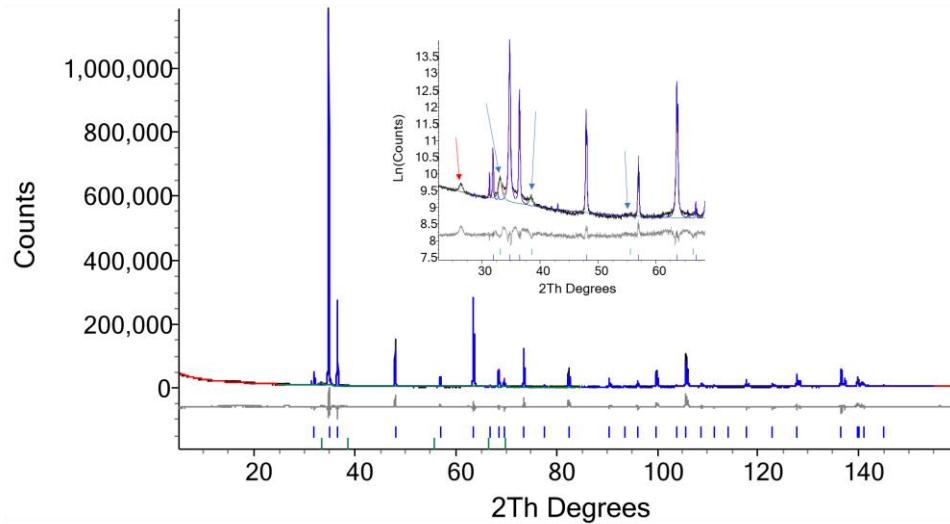
Figure 38. XRD scan of alcohol clean plate heat treated with Neolube on surface. Similar pattern found on as-received material.

The XRD scan data of the surface of the ethanol cleaned samples are shown in Figure 38. The scans indicate carbon compounds present on the surface. XPS analysis indicates the presence of Zr, O, and C, which confirms the information obtained by XRD analysis. However, similar scans by XRD indicate similar patterns on the as-received material as well. SEM analysis of the surface found no sign of carbide inclusions on the surface (Figure 39). SEM imaging of the cross sections indicated an oxide layer with a thickness of between μm 2-4 shown in Figure 40. This is a similar thickness as seen on the as-received Zr samples indicating no significant impact of Neolube presence after the alcohol wipe.

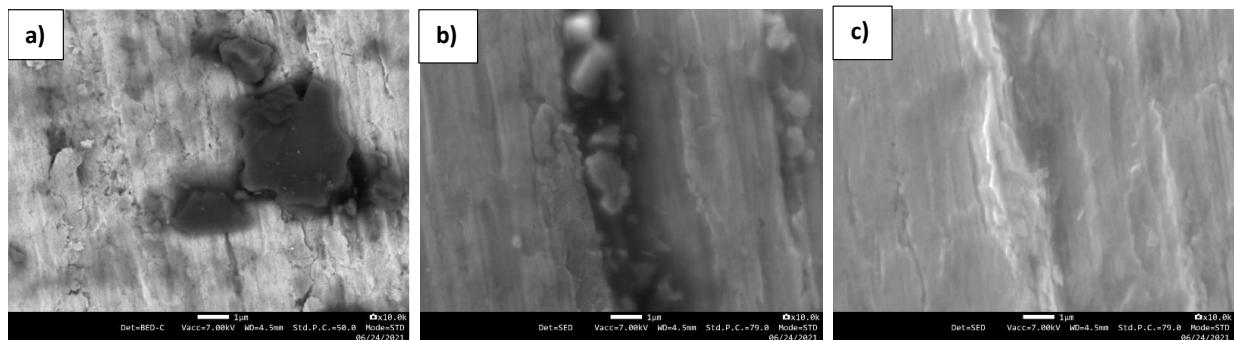
Figure 39. SEM images for the samples cleaned with ethanol. Images a), b), and c) represent three different regions analyzed at 10,000x magnification. These images show no carbide inclusions.

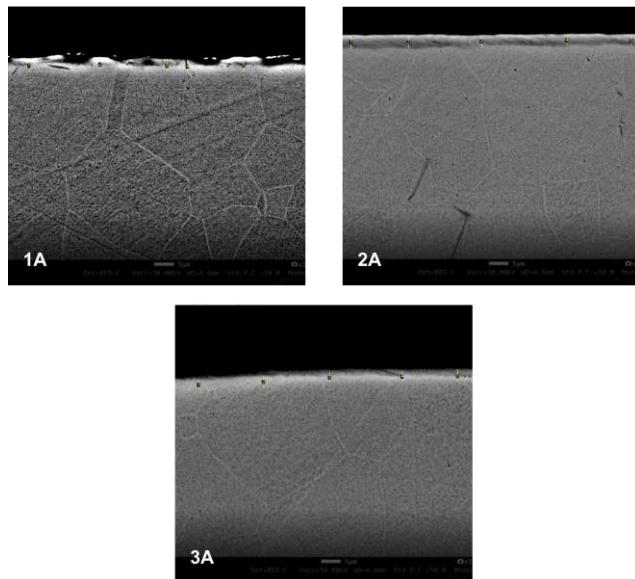
Figure 40. Oxide layers found on the ethanol cleaned sheets

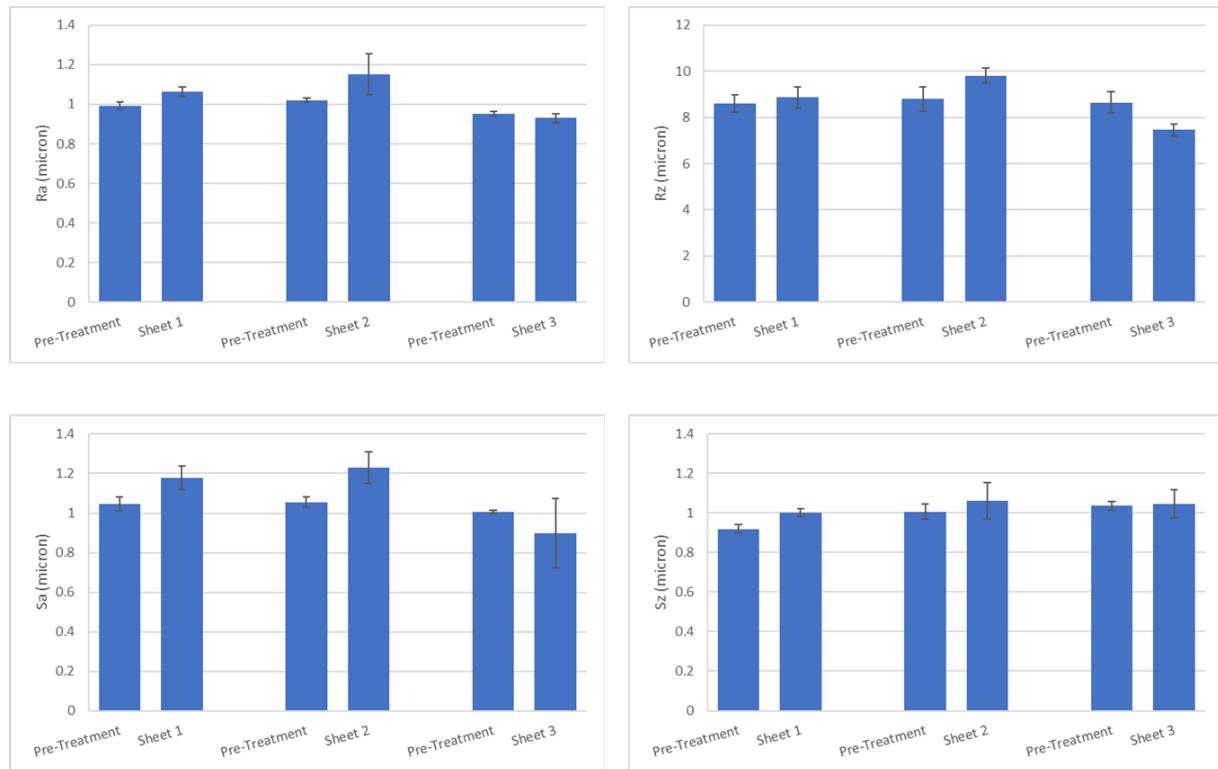
Figure 42. Comparison of the Ra, Rz, Sa, and Sz values before and after polishing with Scotch-Brite™ to remove residual Neolube on surface of heat-treated zirconium.

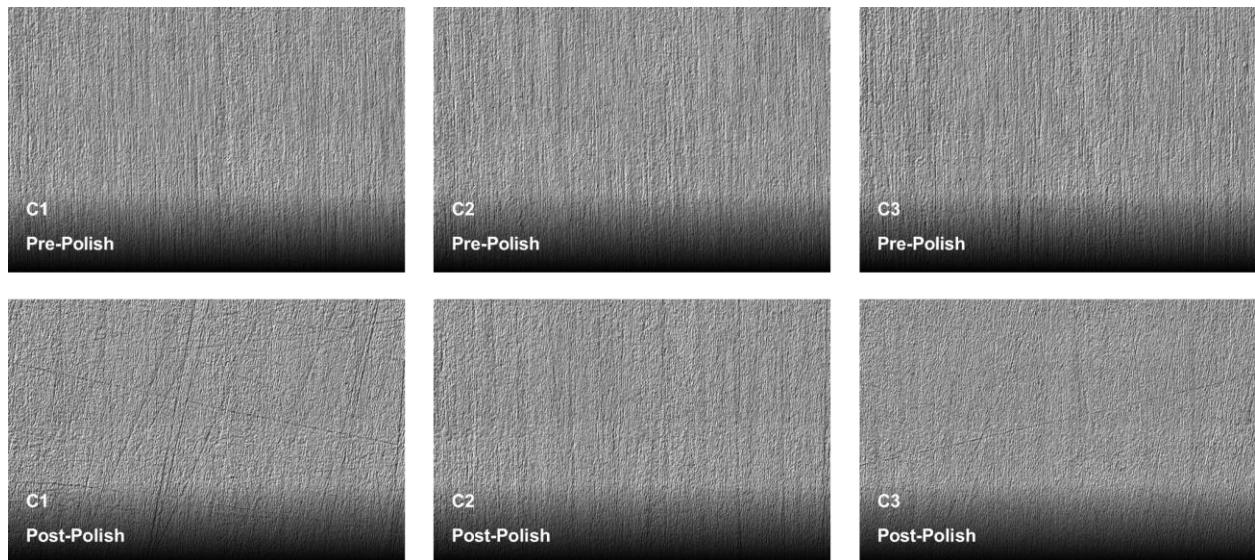
Figure 43. The 10x magnification C-DIC images for Section C from Sheet 1 before and after polishing with the Green Fine Grade Scotch-Brite pads to remove residual Neolube on surface of heat-treated zirconium.

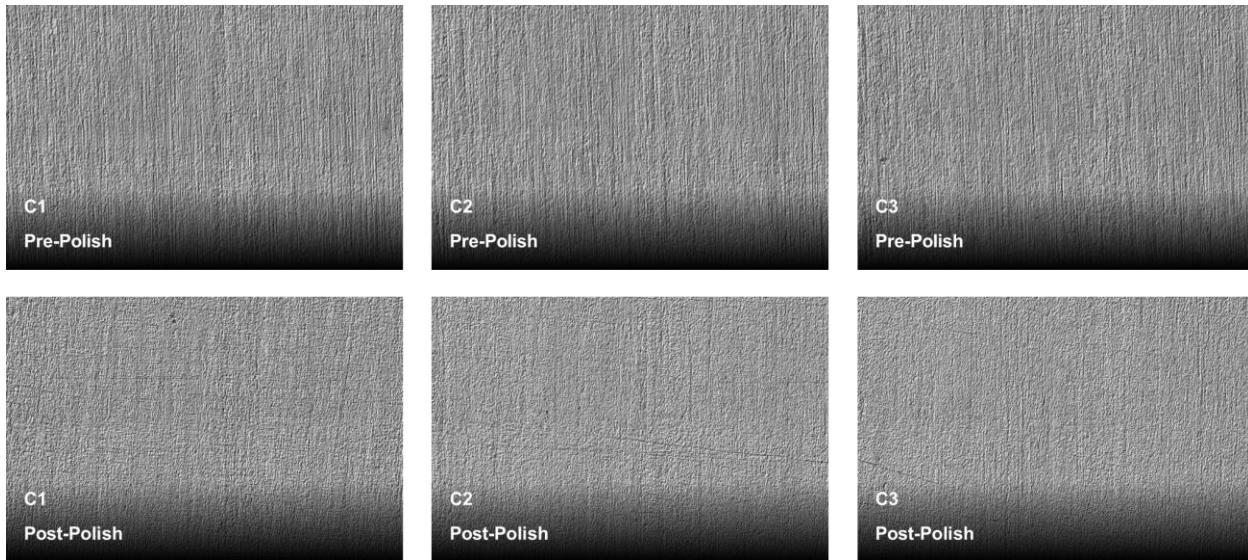
Figure 44. The 10x magnification C-DIC images from Section C of Sheet 3 before and after hand polishing with the Ultra Fine Scotch-Brite™ pad to remove residual Neolube on surface of heat-treated zirconium.

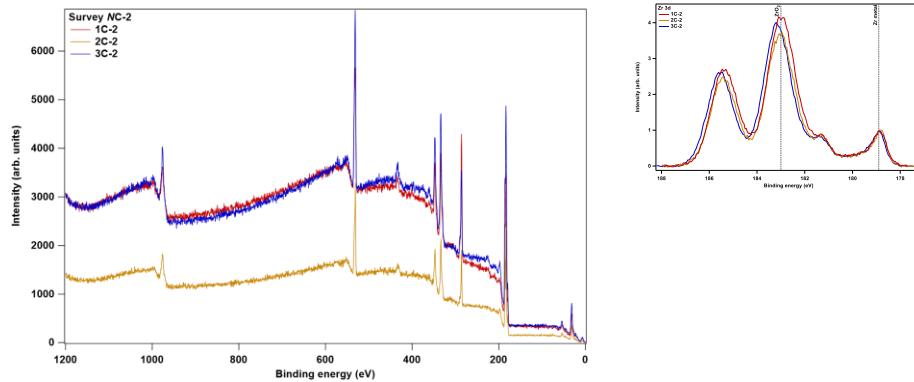
Figure 45. XPS scans of hand polished surface using Scotch-Brite™ pad to remove residual Neolube on surface of heat-treated zirconium.

XRD analysis data found of carbon compounds on the surface like that found on the received plate. The XPS analysis (Figure 45) found carbon present as well along with an oxide layer on the polished plate. XPS also found indications of trace amounts of nitrogen on some of the plates, which is present in the nylon backing of the pads.

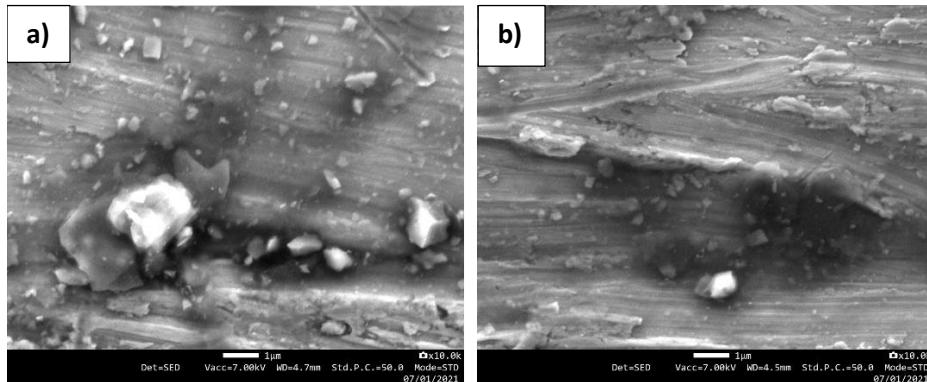
Figure 46. SEM images for samples polished using Scotch-Brite™ pads. Images a) and b) represent locations analyzed at 10,000x magnification.

The SEM surface scans and found no carbide inclusions present. However, imbedded grit particles on the surface are shown in Figure 46, which is a concern when implementing a dry polishing method. Oxide layers were found on the surface of by SEM inspection of the plate cross sections as shown in Figure 47. Thickness measurements were between 2 to 5 μ m, similar to the other measurements performed.

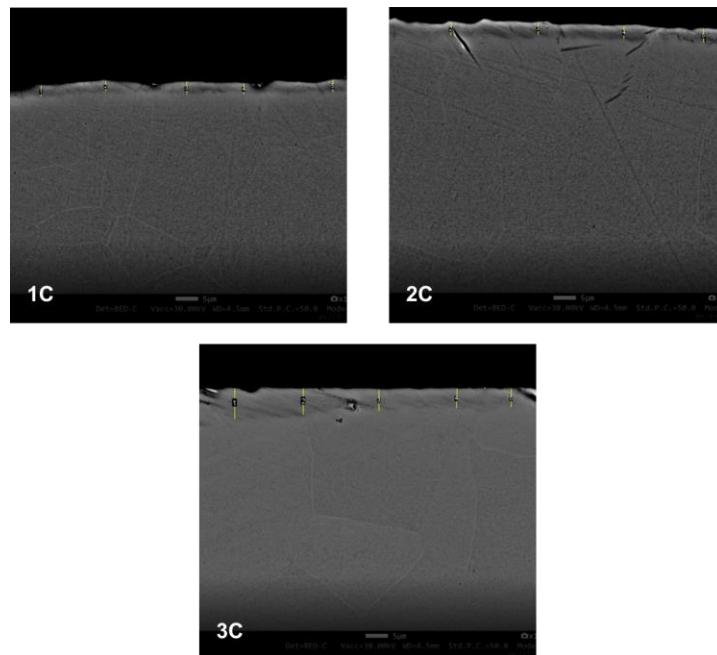
Figure 47. SEM images for the Scotch-Brite™ polished sheets. An oxide layer is visible on each sheet.

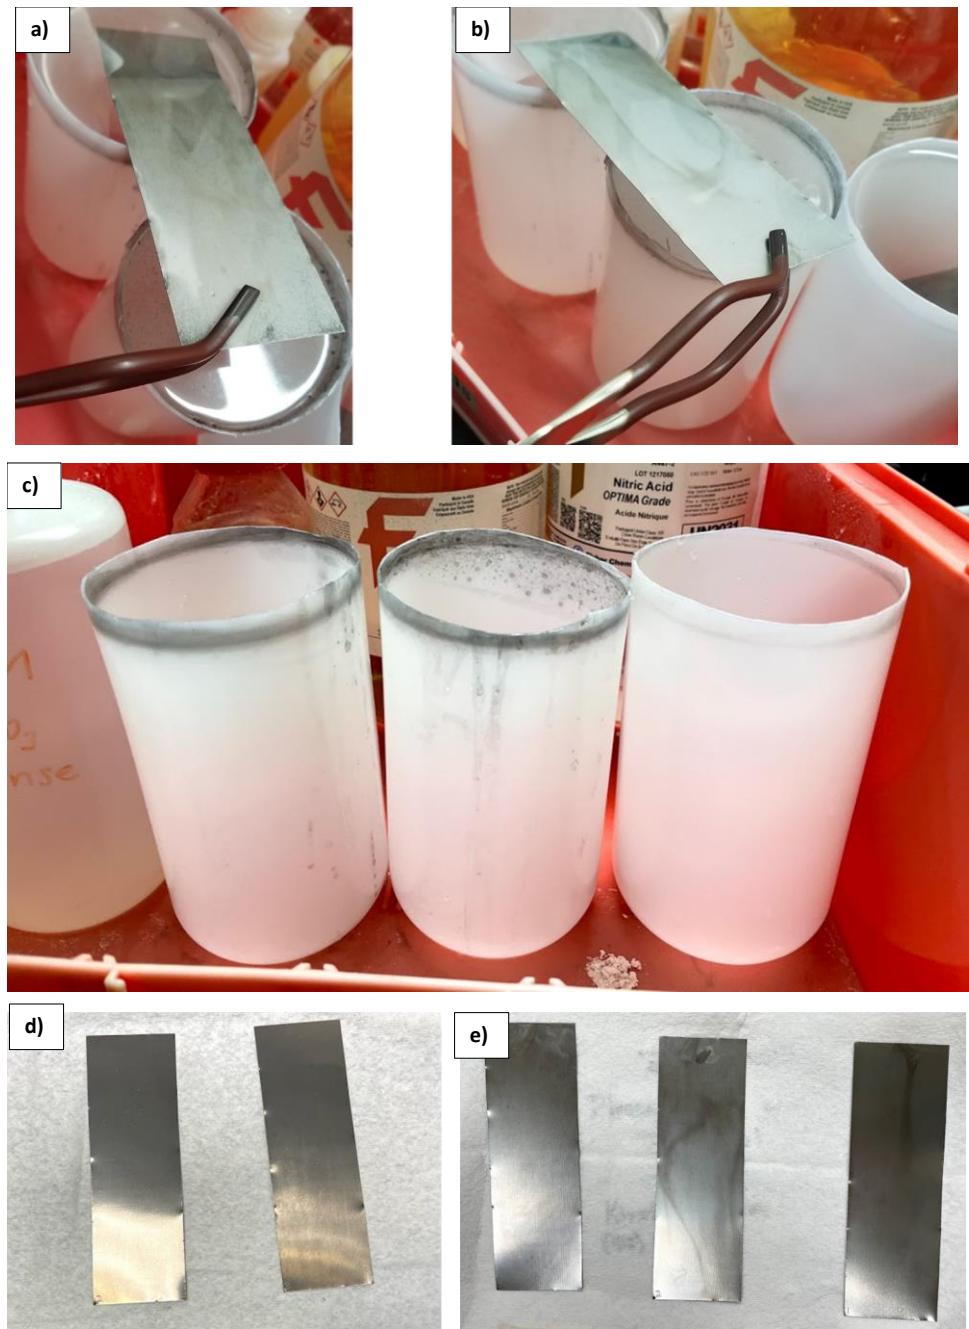
Figure 48. The flash etching process for removing residual Neolube from heat-treated zirconium.

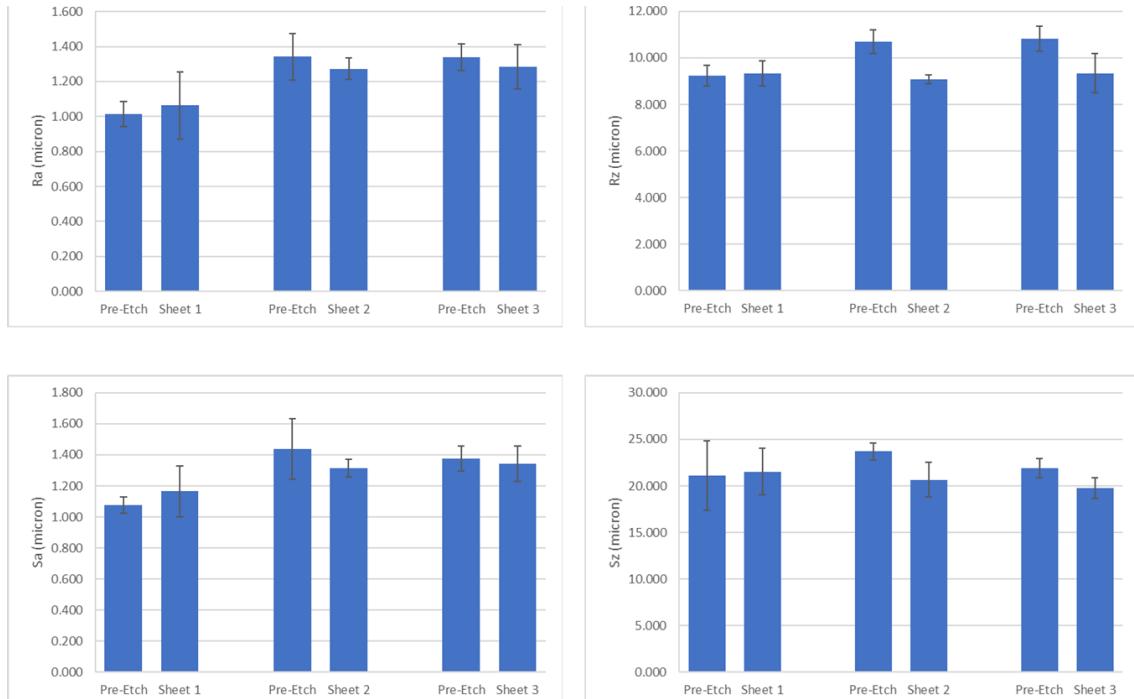
Figure 49. Comparisons of the Ra, Rz, Sa, and Sz values before and after flash etching with HF/nitric acid mixture to remove residual Neolube on surface of heat-treated zirconium.

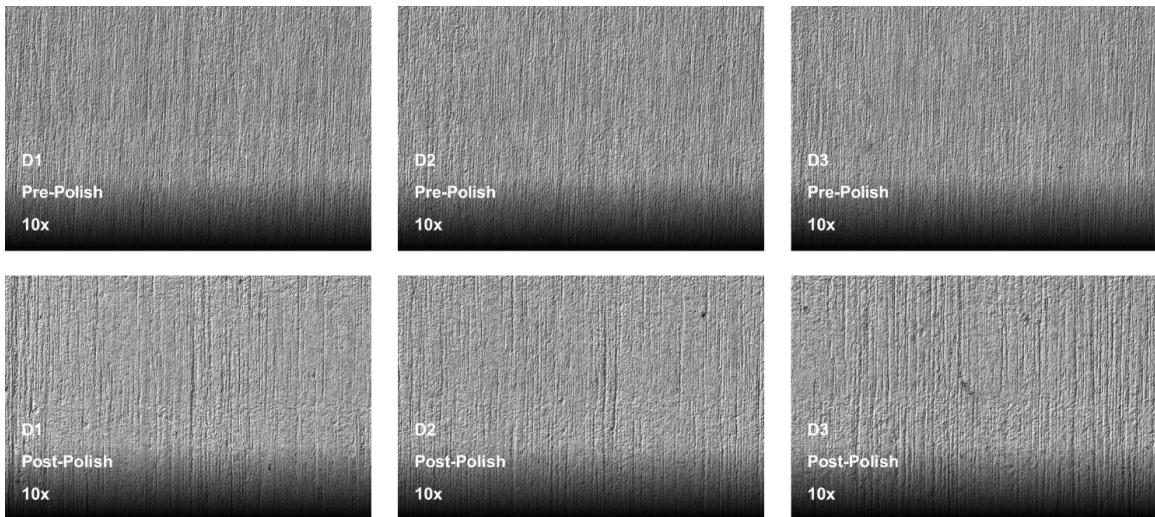
Figure 50. The 10x magnification C-DIC images before and after flash etching with HF/nitric acid mixture to remove residual Neolube on surface off heat-treated zirconium.

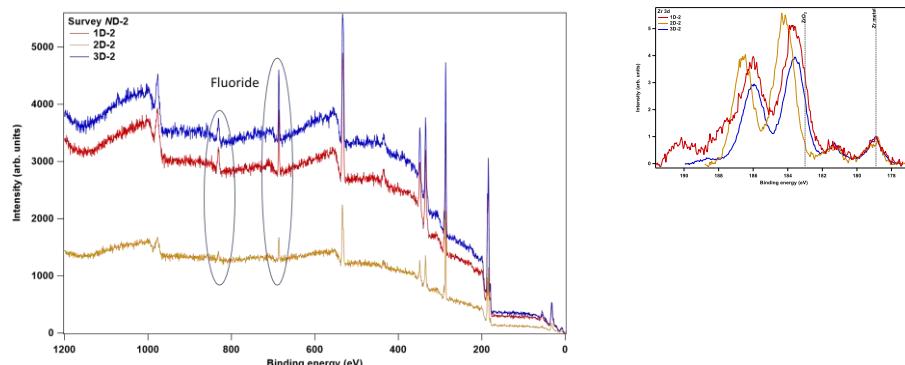
Figure 51. XPS scans of flash etched heat-treated zirconium using HF/nitric acid mixture to remove residual Neolube from surface.

The XRD data and XPS analysis did not find any traces of carbon on the surface, unlike the other testing performed. However, XPS analysis (Figure 51) found strong indications of fluoride present, likely from the use of hydrofluoric acid in the etchant. XPS also found strong indications of a zirconium oxide layer present with a noticeable shift in the binding energy when compared to the other oxide layers detected (Figure 51). The shift is believed to be caused by the presence of fluoride in the oxide layer.

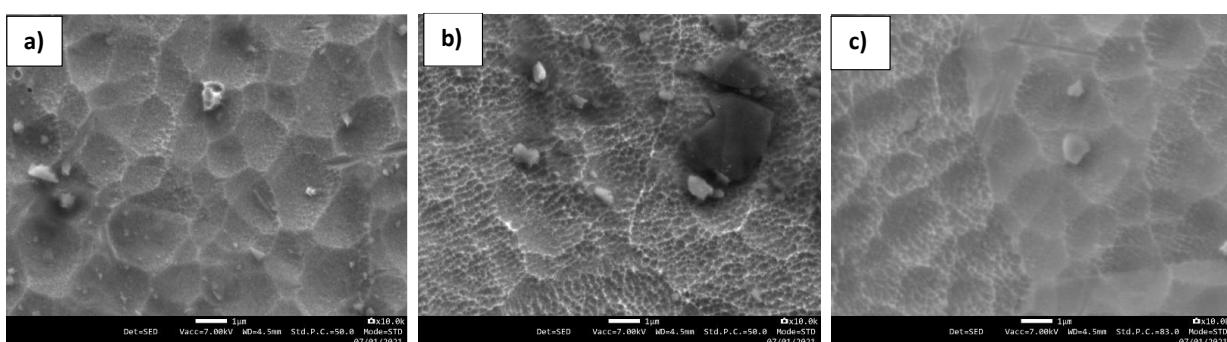
Figure 52. SEM images for etched samples. Images a), b), and c) represent the three locations imaged at 10,000x magnification. No inclusions were found on the surface.

SEM images of the surface (Figure 52) found the surface free of any carbide inclusions. Comparison with the polished surfaces show differences from the etch, with a “cratered” appearance that comes from the generation of gas on the surface from the etchant, versus the “scratched” surface seen from abrasive media. SEM examination of the cross-sections of the surface (Figure 53) indicate an oxide layer was present like other cleaning methods, supporting the XPS findings.

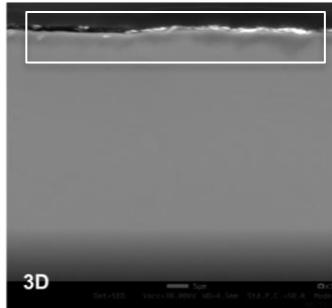
Figure 53. The SEM images for the cross sections of the flash etched sample with indication of oxide layer present.
