SANDIA REPORT

SAND2024-04777

High Energy Arcing Fault (HEAF) Sandia National Laboratories 2023 Report

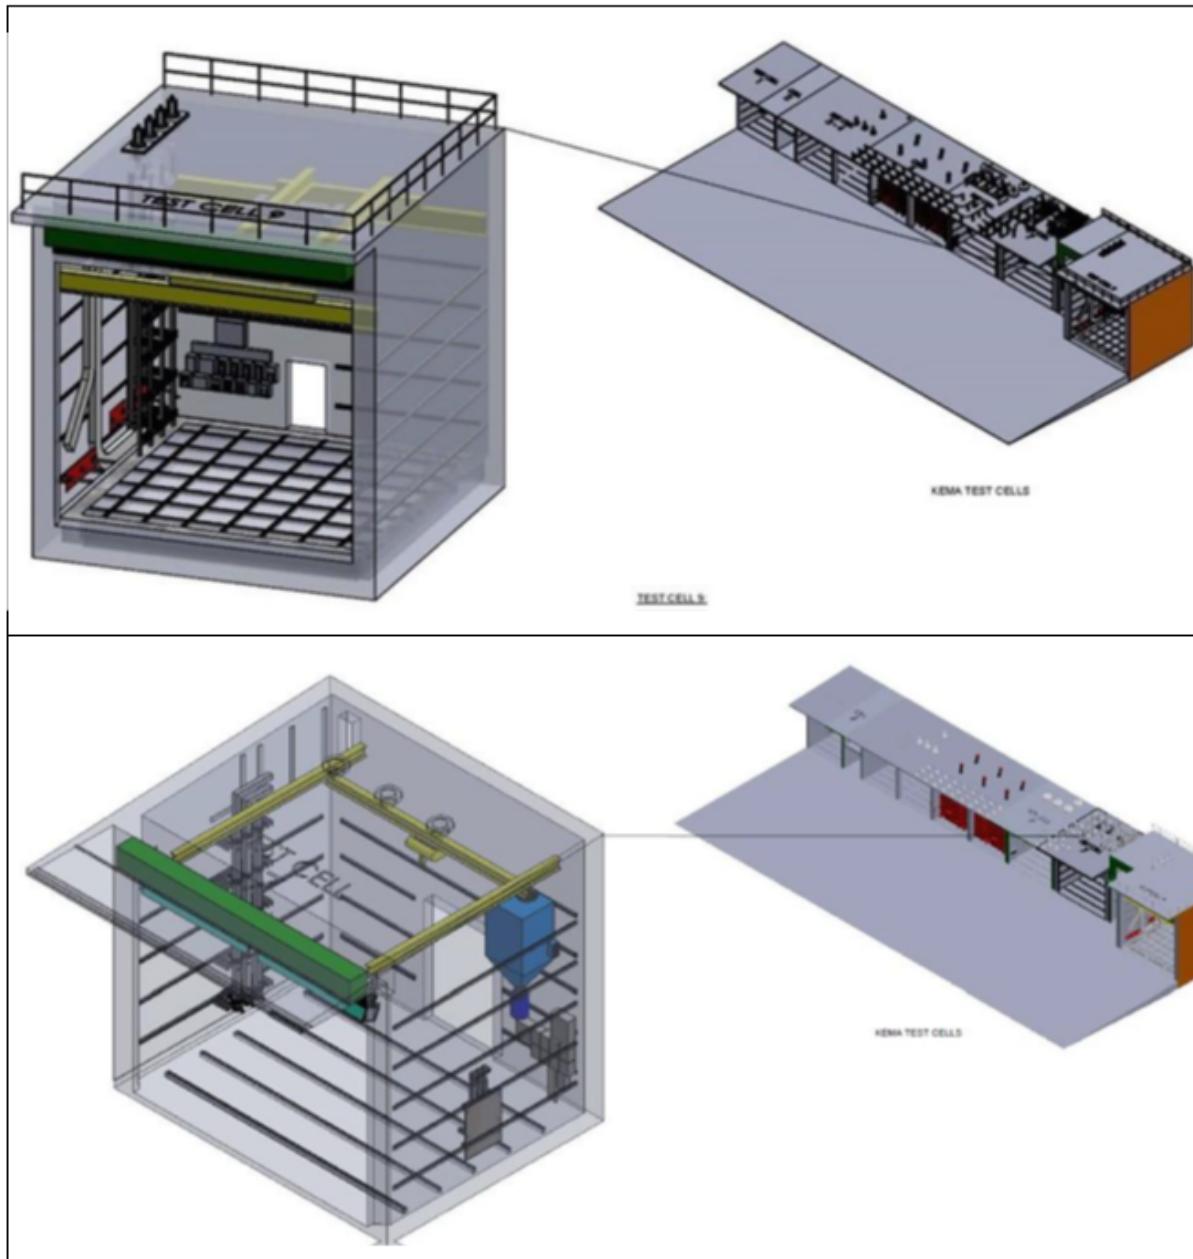
Figure 1-2 Isometric view of Test Cell 9 (top) and Test Cell 7 (bottom) with respect to KEMA facility test bay locations – (KEMA Source).

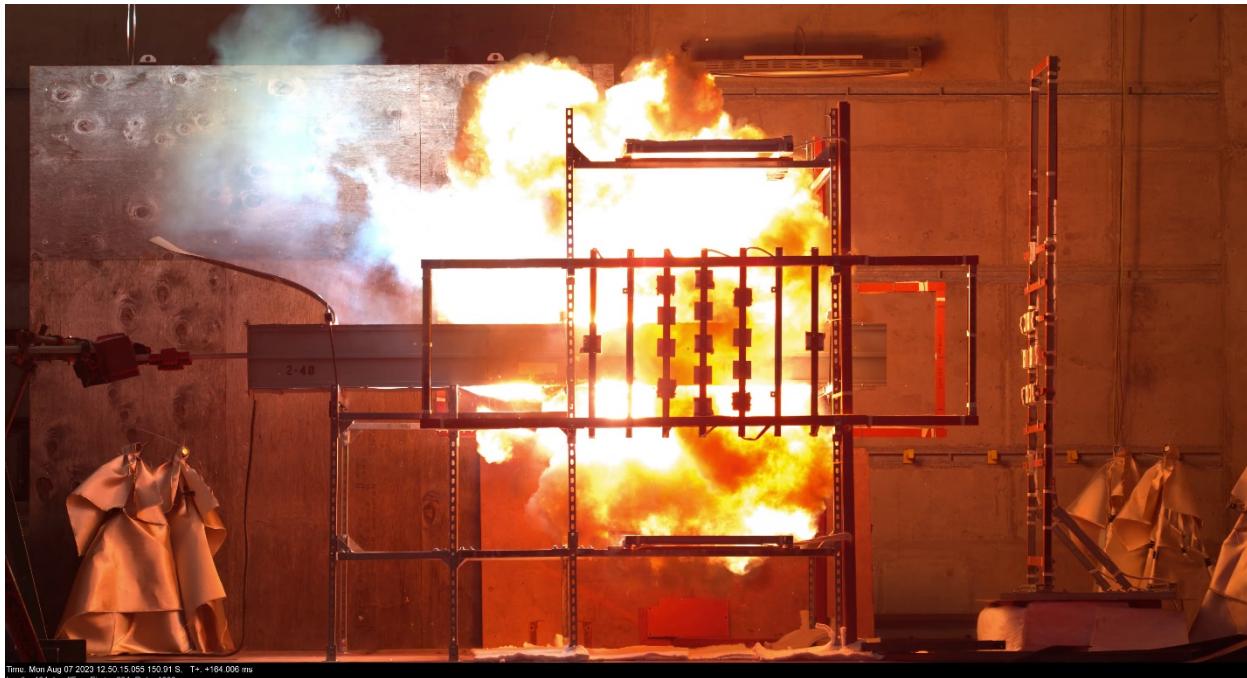
Figure 2-2: Test 2-40 imaged through 4k camera – camera imaging at 1000 fps. Notice the orange/red color in the background from the burning of the Cu bus.

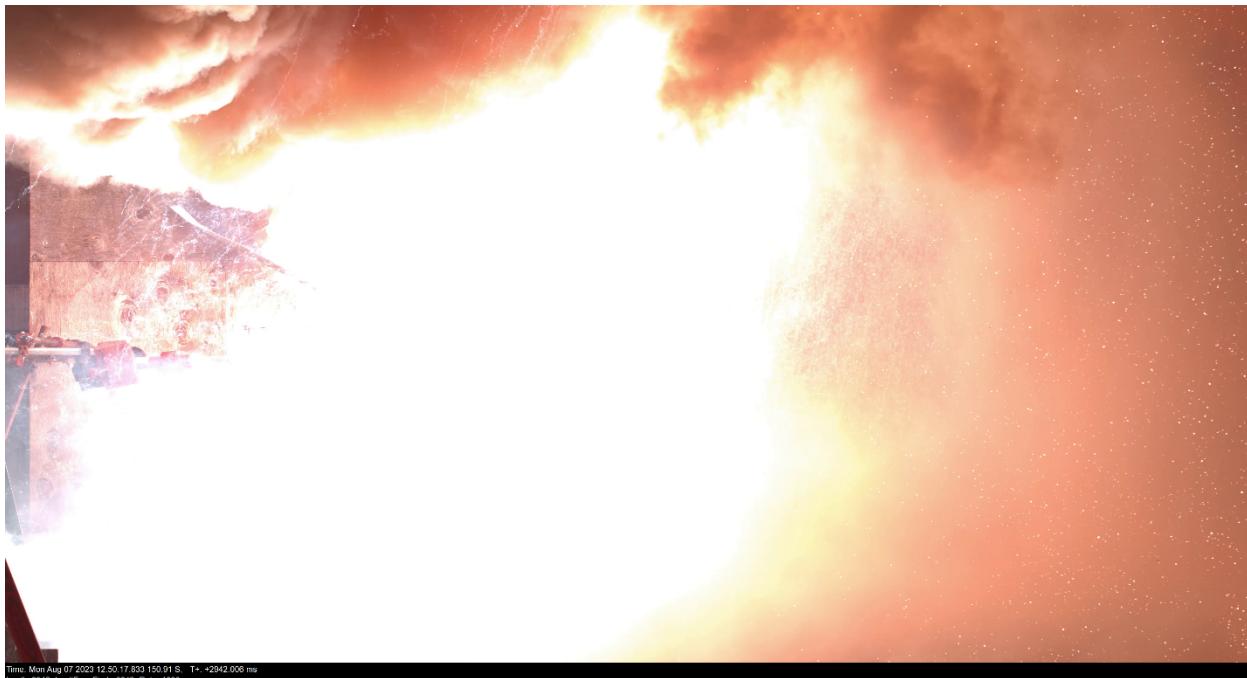
Figure 2-3: Test 2-40 imaged through 4k camera – camera imaging at 1000 fps. Notice that there is no visibility of the test as the enclosure is being consumed by the arc/fire 3 seconds into the test.

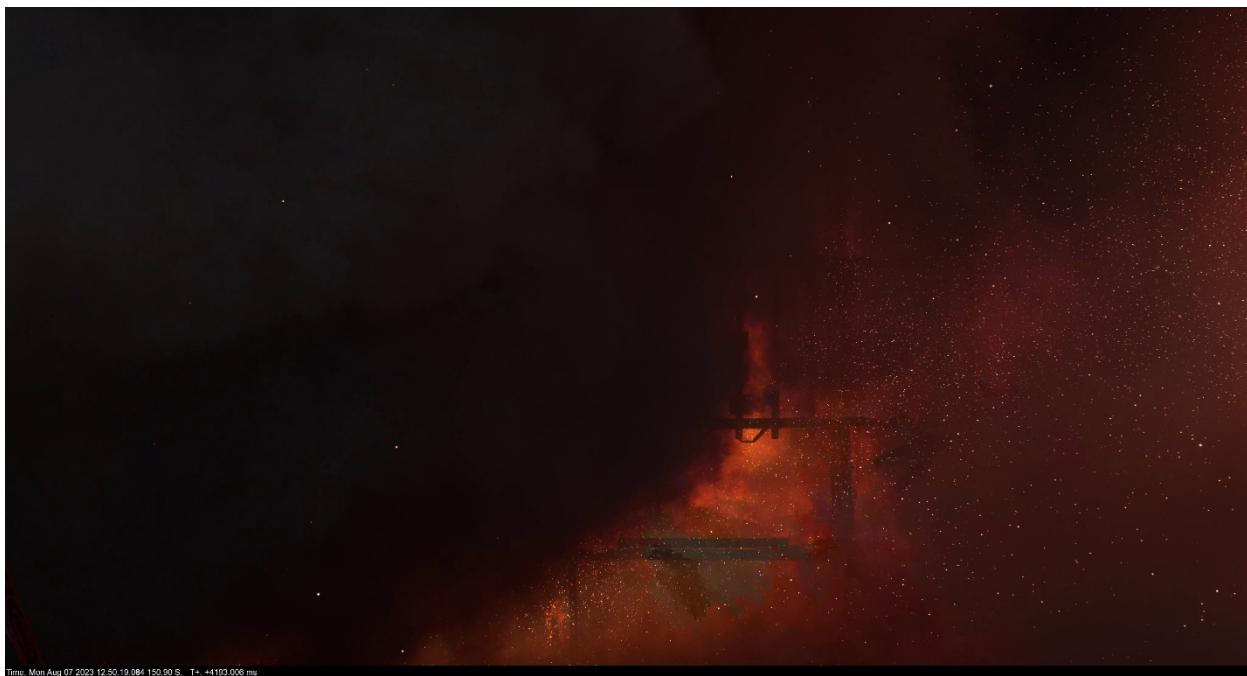
Figure 2-4: Test 2-40 imaged through 4k camera – camera imaging at 1000 fps. Notice that a dark cloud envelope the test bay 4 seconds even if the arc is still going.

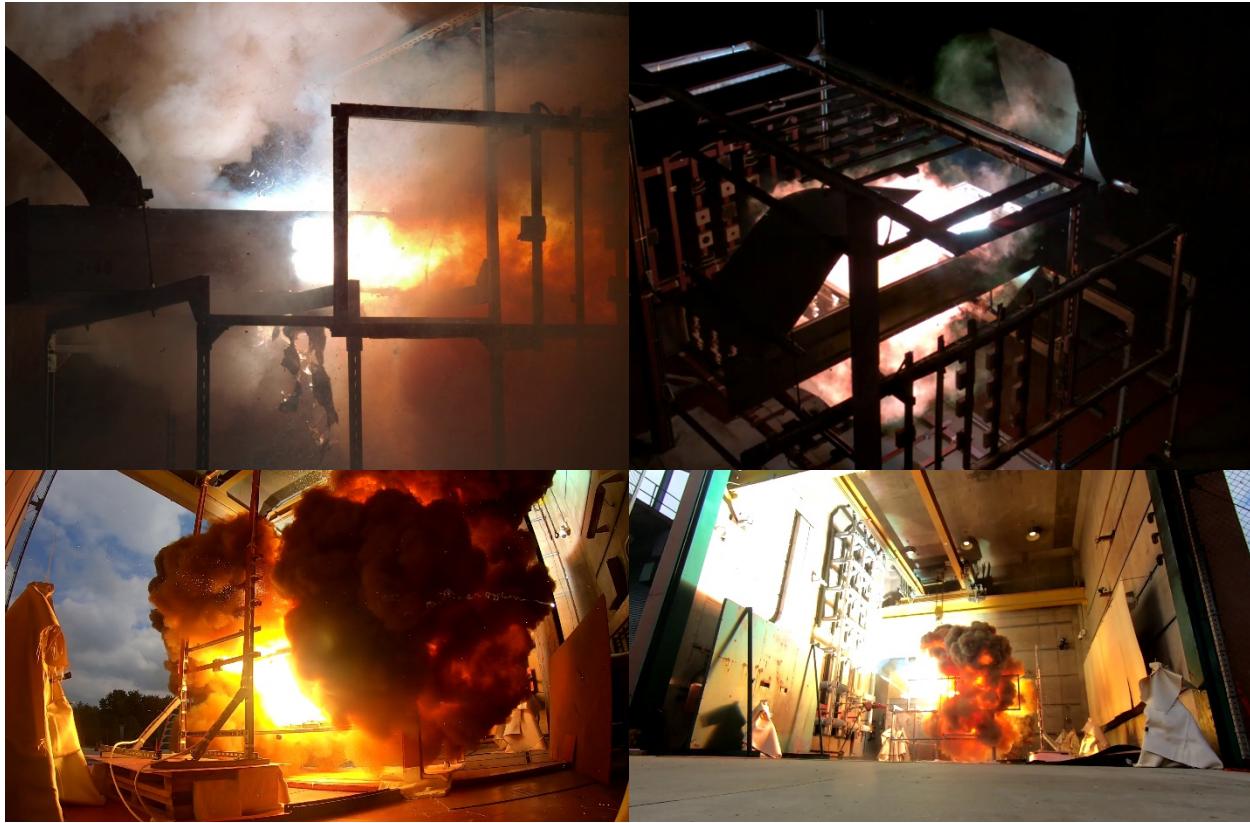
Figure 2-5: From top left (clockwise): v1310 at southwest side showing the enclosure being consumed by the arc; v7 elevated from the northeast showing the initial breach; GoPro outside southeast; GoPro inside floor northeast.

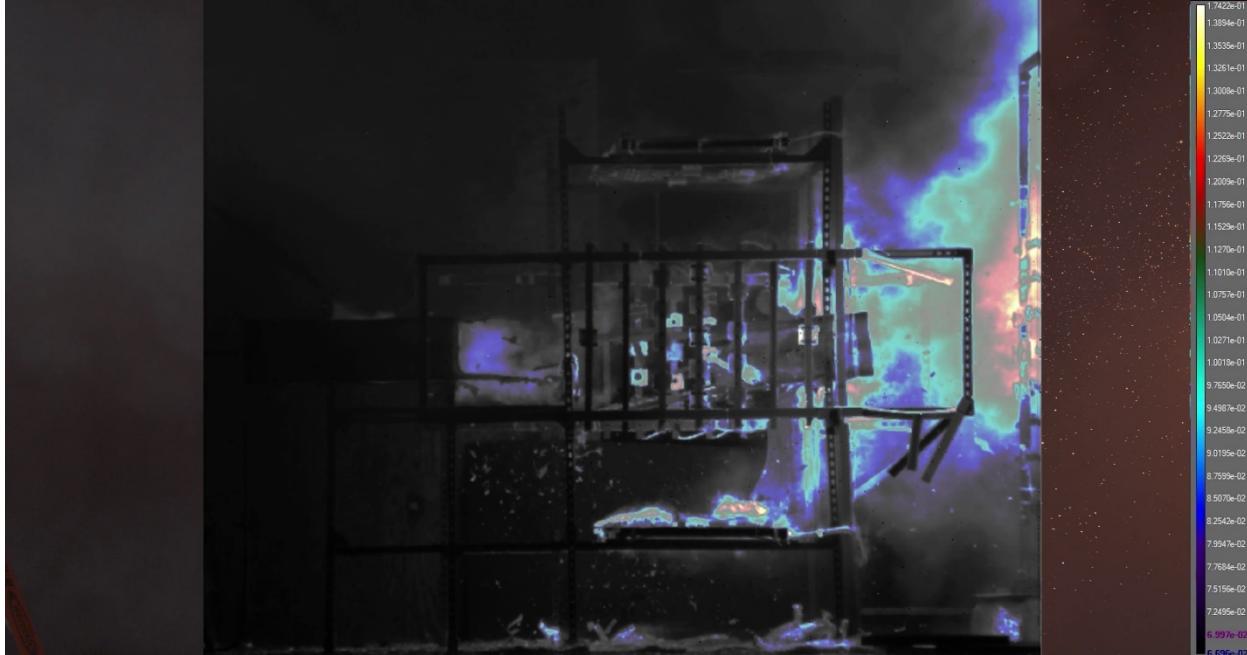
Figure 2-6: Image fusion of IR cameras (MWIR & LWIR – in radiance units of $\text{W}/\text{cm}^2 \text{ sr}$) synchronized with a visible color camera at the end of the test.

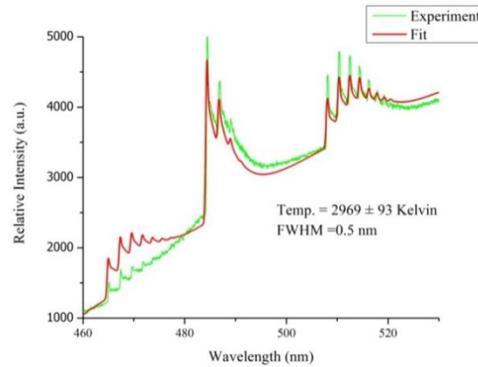
Figure 2-8: Fit to measured AIO spectrum from a solid rocket experiment – Gill et al. [1]. The curve indicates the spectral location of AIO emission. Expected temperatures for burning Aluminum should be in the range of 2800K to 3300K [2].

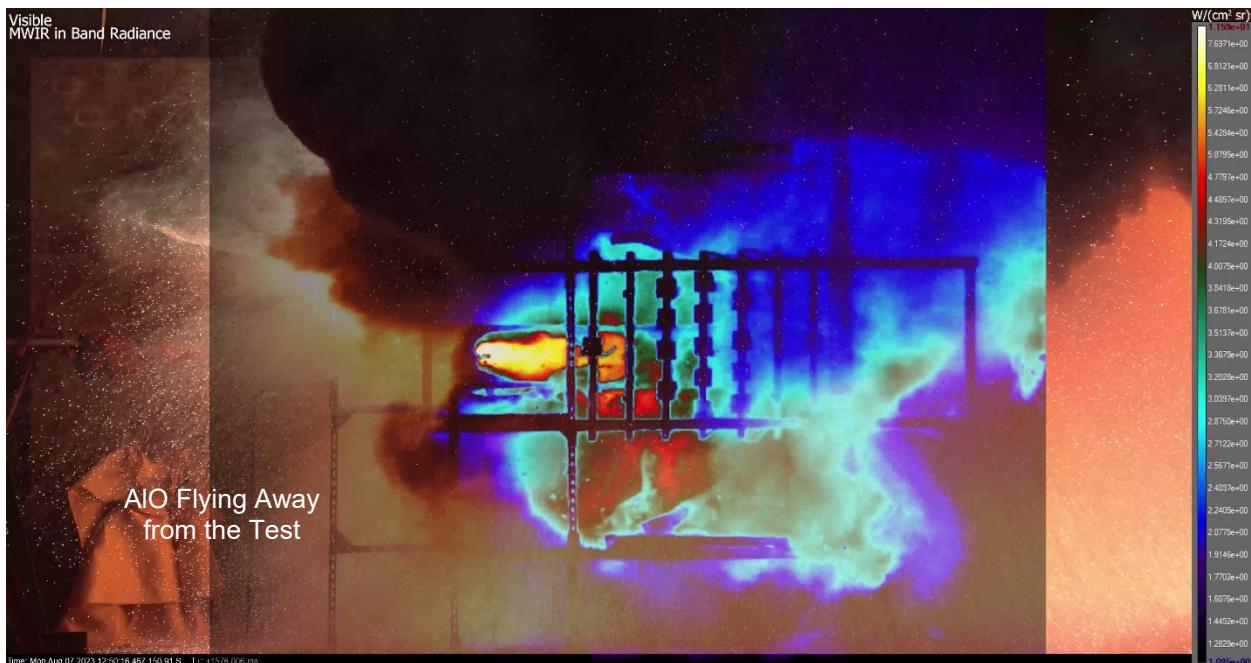
Figure 2-9: Image fusion of IR cameras (MWIR & LWIR – in radiance units of $\text{W}/\text{cm}^2 \text{ sr}$) synchronized with a visible color camera

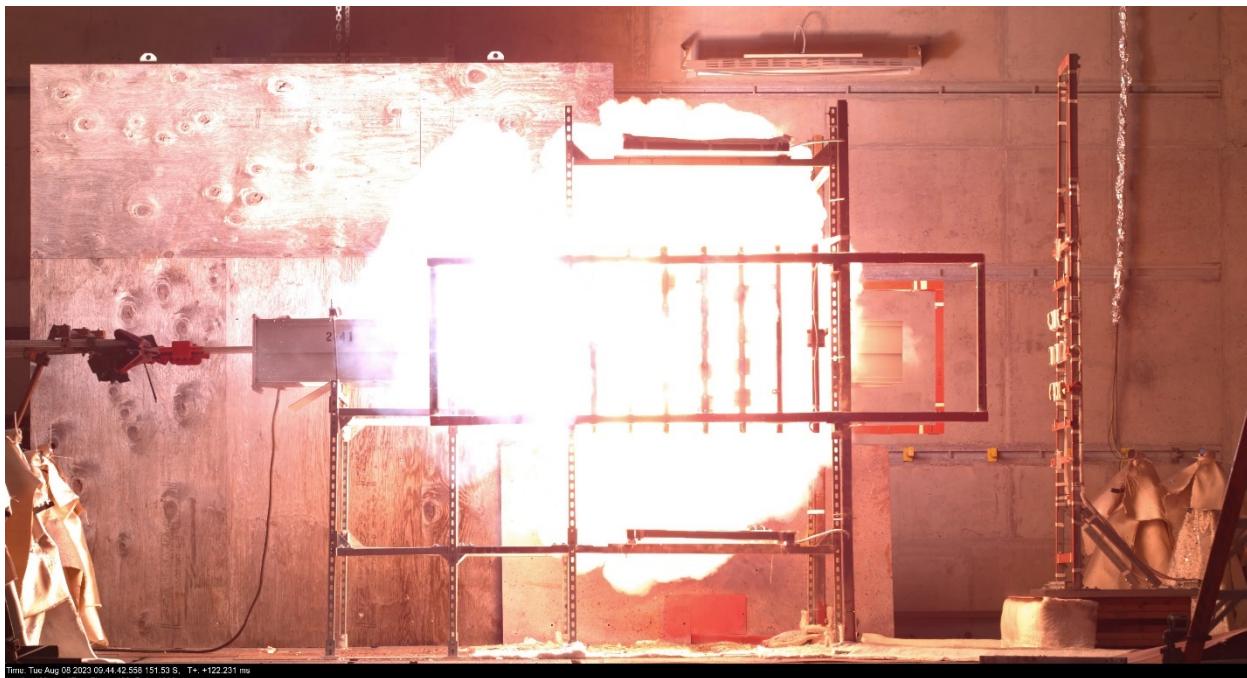
Figure 2-10: Test 2-41 imaged through 4k camera – camera imaging at 1000 fps. Notice the white fireball (burning the Al bus). Compared to Test 2-40 where the fireball has more brown and orange colors from burning the Cu bus.

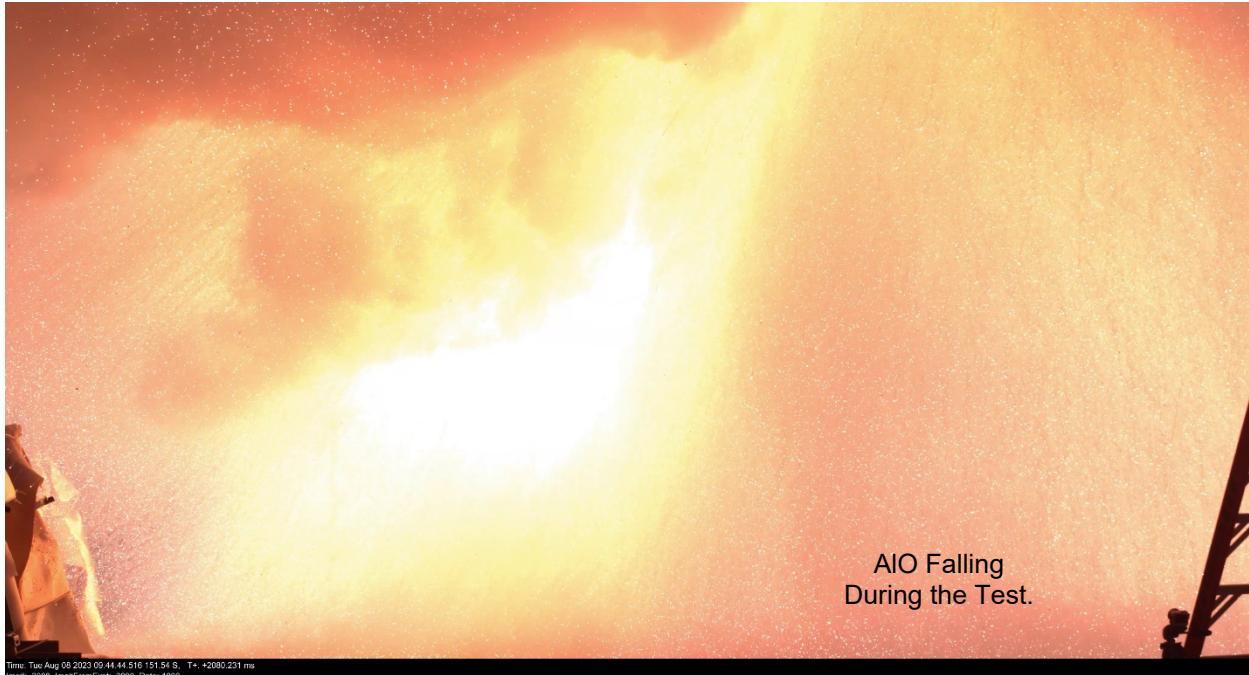
Figure 2-11: Test 2-41 imaged through 4k camera – camera imaging at 1000 fps. Notice that there is no visibility of the test as the enclosure is being consumed by the arc/fire 2 seconds into the test.

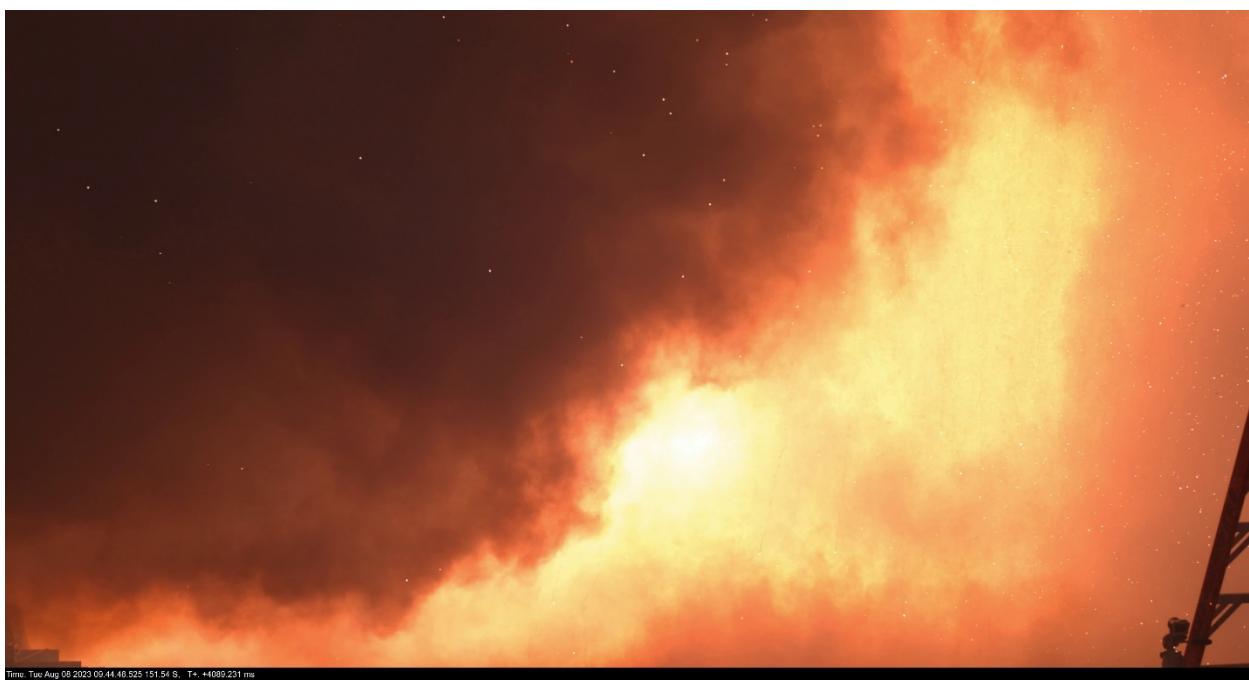
Figure 2-12: Test 2-41 imaged through 4k camera – camera imaging at 1000 fps. Notice that a dark cloud envelopes the test bay 4 seconds at the end of the test, but the cloud is not as dark as in Test 2-40 due to the high flux from the arc and the aluminum from the bus and the enclosure being burned.

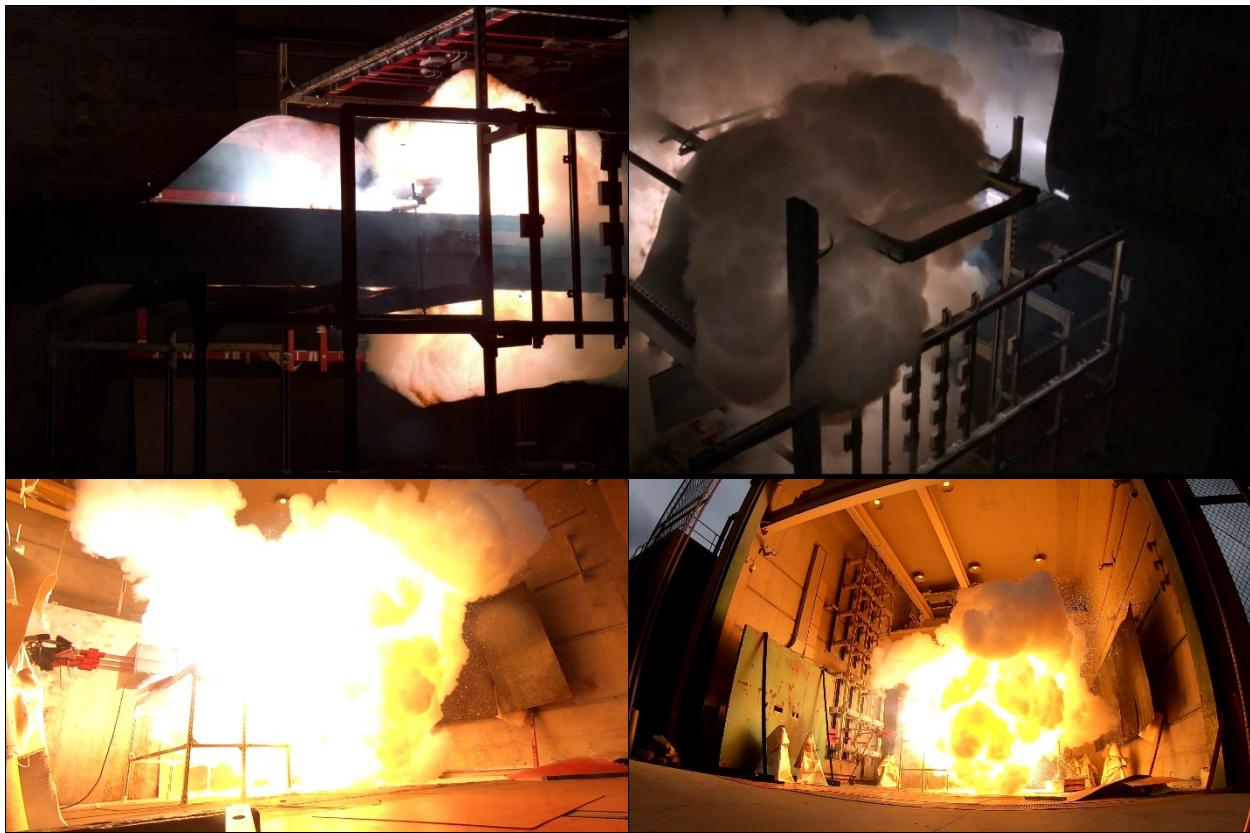
Figure 2-13: From top left (clockwise): v1310 at southwest side; v7 elevated from the northeast of the test; GoPro outside southeast; GoPro inside floor southwest.

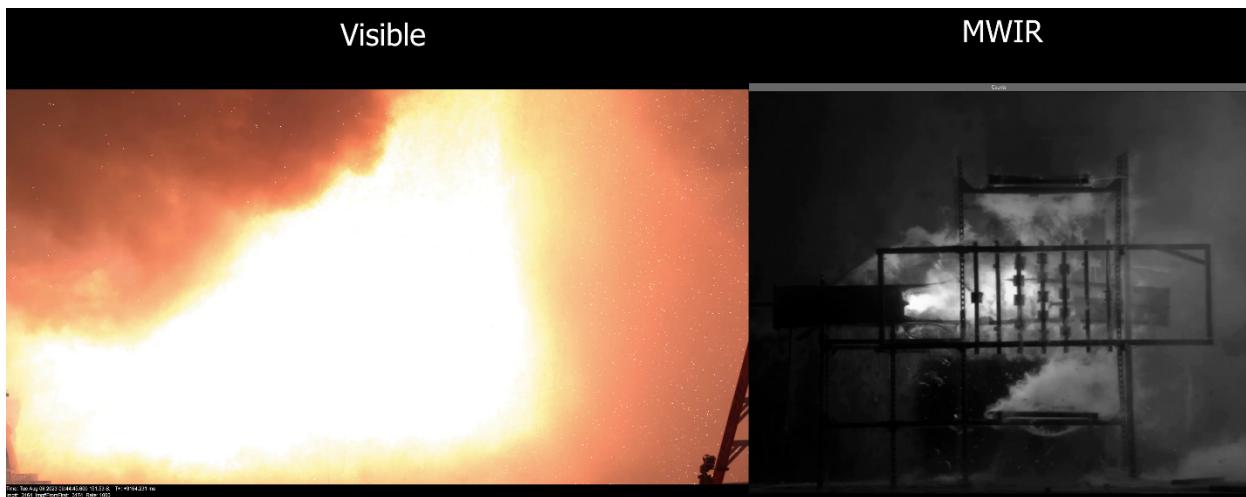
Figure 2-16: Sample frames from synchronized video of 4k and LWIR cameras 3 seconds into the test.

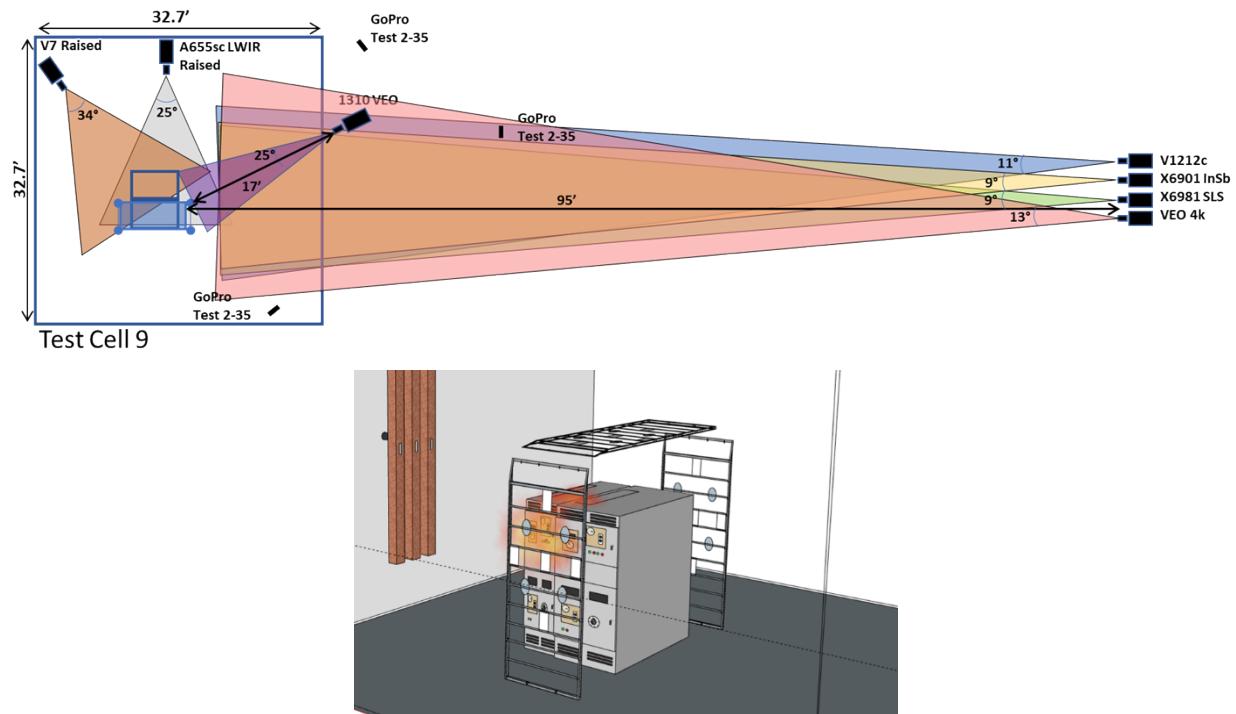
Figure 3-1: Electrical Enclosure (Test 2-35) cameras locations (top) with switchgear enclosure configuration (bottom)

The test has the front door fly open right away at the switchgear with the starting arc. Eventually the damage will transfer to the adjacent switchgear, where plumes of orange particles are ejected. The particles are not detected by the MWIR and LWIR cameras, this would indicate another burning metal. We can detect the timing of the venting and start of fire in the adjacent switchgear and detect venting of the orange particle ejecta on the right side. Figure 3-2 through Figure 3-9 show images of notable features and select events that occurred during Test 2-35.

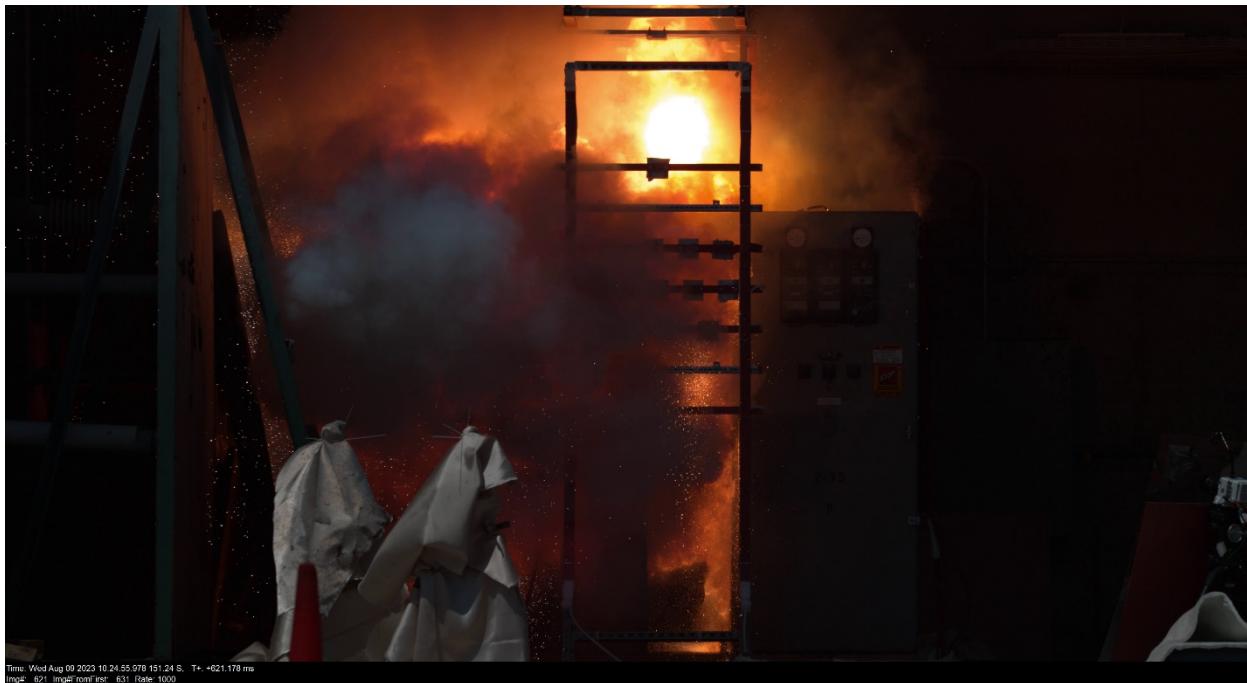
Figure 3-3: Test 2-35 imaged through 4k camera – notice enclosure door blown open and venting on top – camera imaging at 1000 fps.

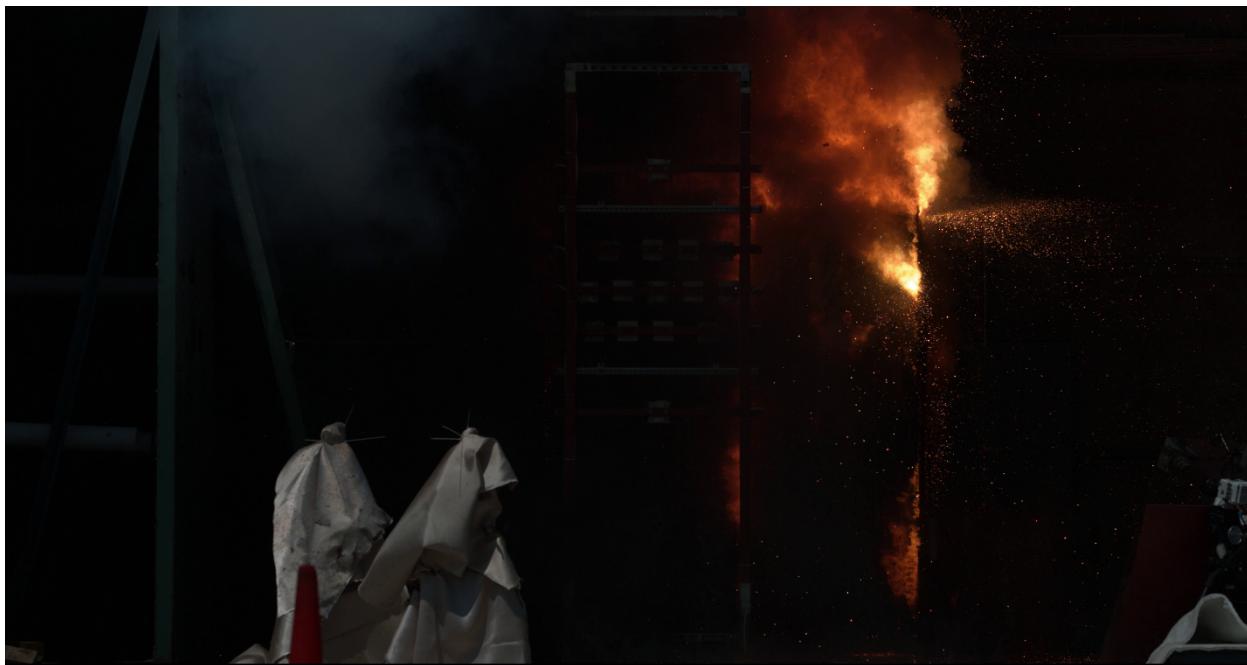
Figure 3-4: Test 2-35 imaged through 4k camera – notice fireball venting from adjacent enclosure and burning particulate ejection – camera imaging at 1000 fps.

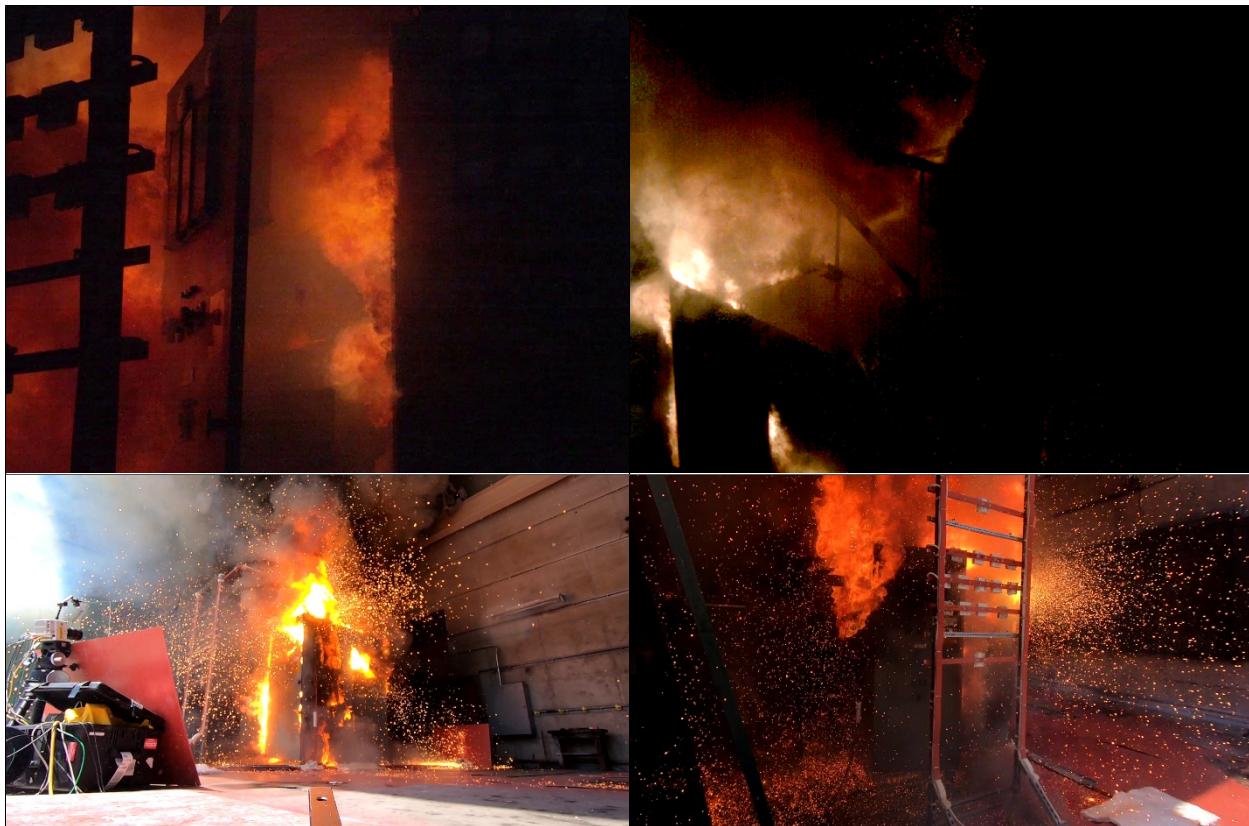
Figure 3-5: From top left (clockwise): v1310 while the door is being blown open; v7 elevated from the northeast of the test while the east side enclosure vents; GoPro outside southwest; GoPro outside floor southeast while molten material is dumped out of the east enclosure.

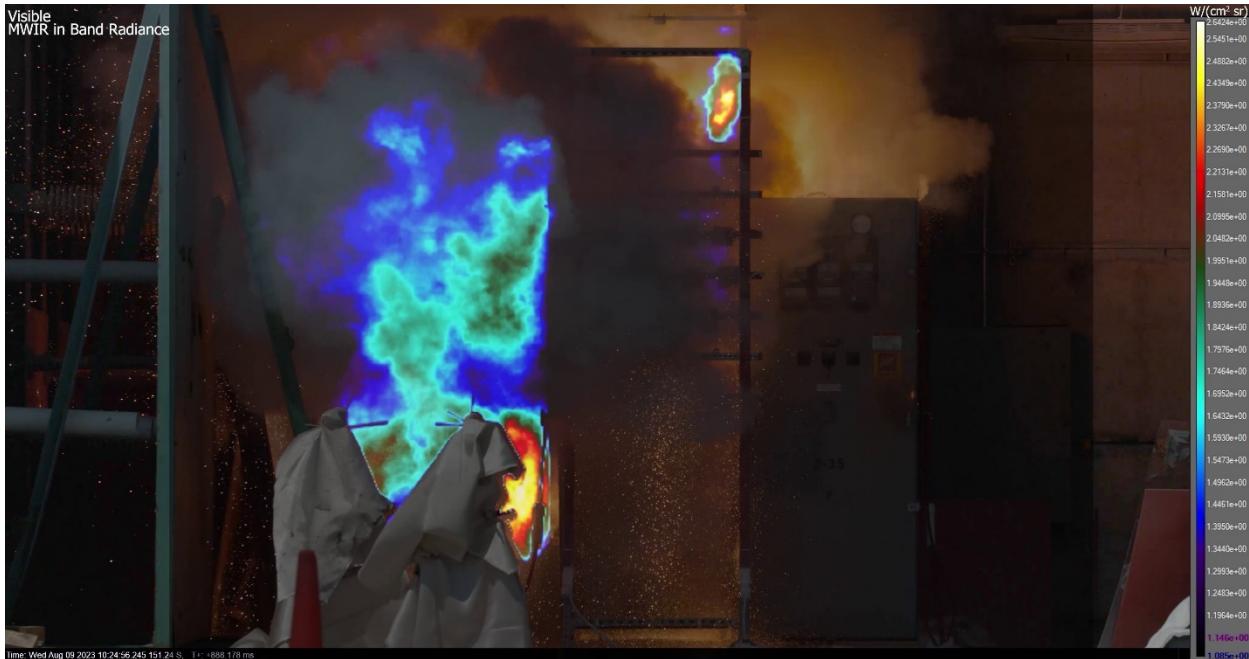
Figure 3-6: Image fusion of IR camera (in radiance units of W/cm² sr) synchronized with a visible image 0.8 seconds into the test.

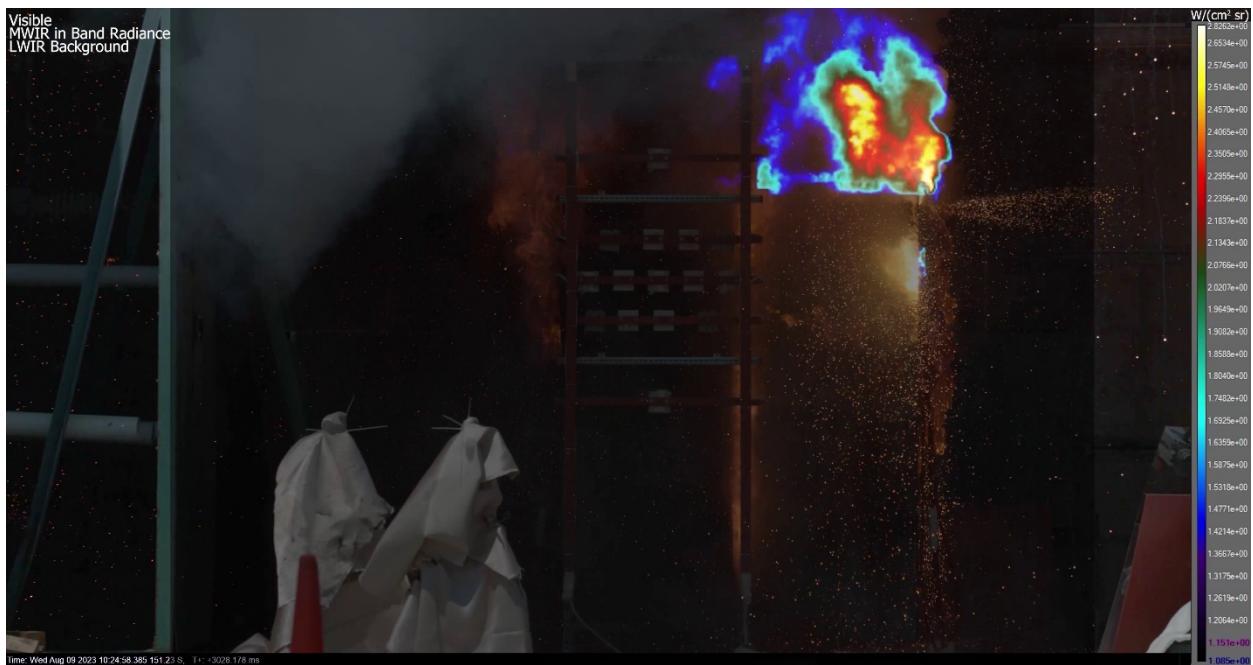
Figure 3-7: Image fusion of IR camera (in radiance units of $\text{W}/\text{cm}^2 \text{ sr}$) synchronized with a visible image 3 seconds into the test. Notice that the higher fire activity is occurring on the adjacent enclosure.

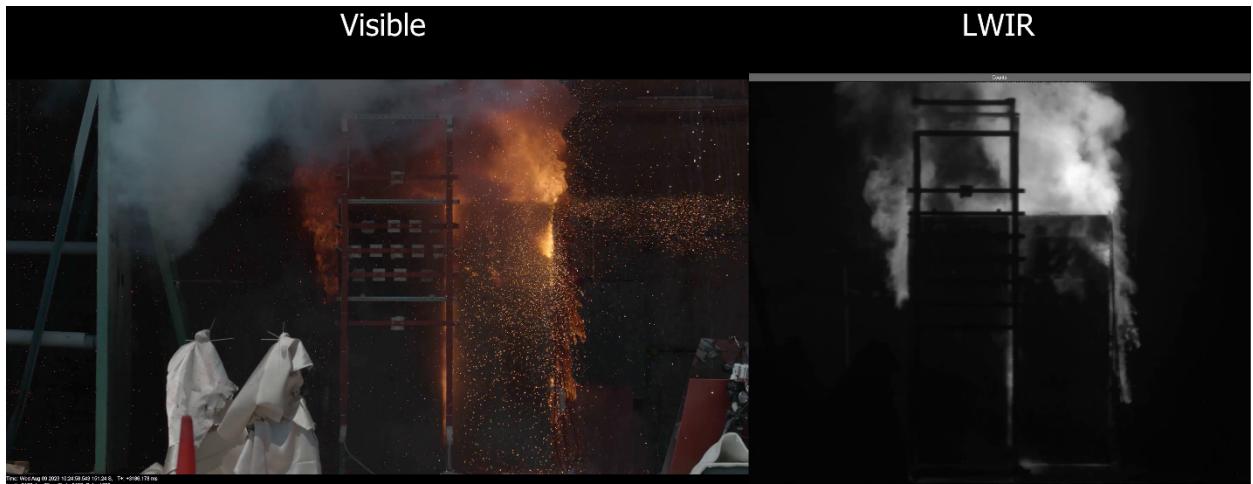
Figure 3-8: Sample frames from synchronized video of 4k and LWIR cameras 3 seconds into the test. Notice that the IR doesn't show the metal spray to the right of the second enclosure. The spray of metal particulate that probably emitting light in the visible in a narrow band instead of the continuum from a Planck curve profile.

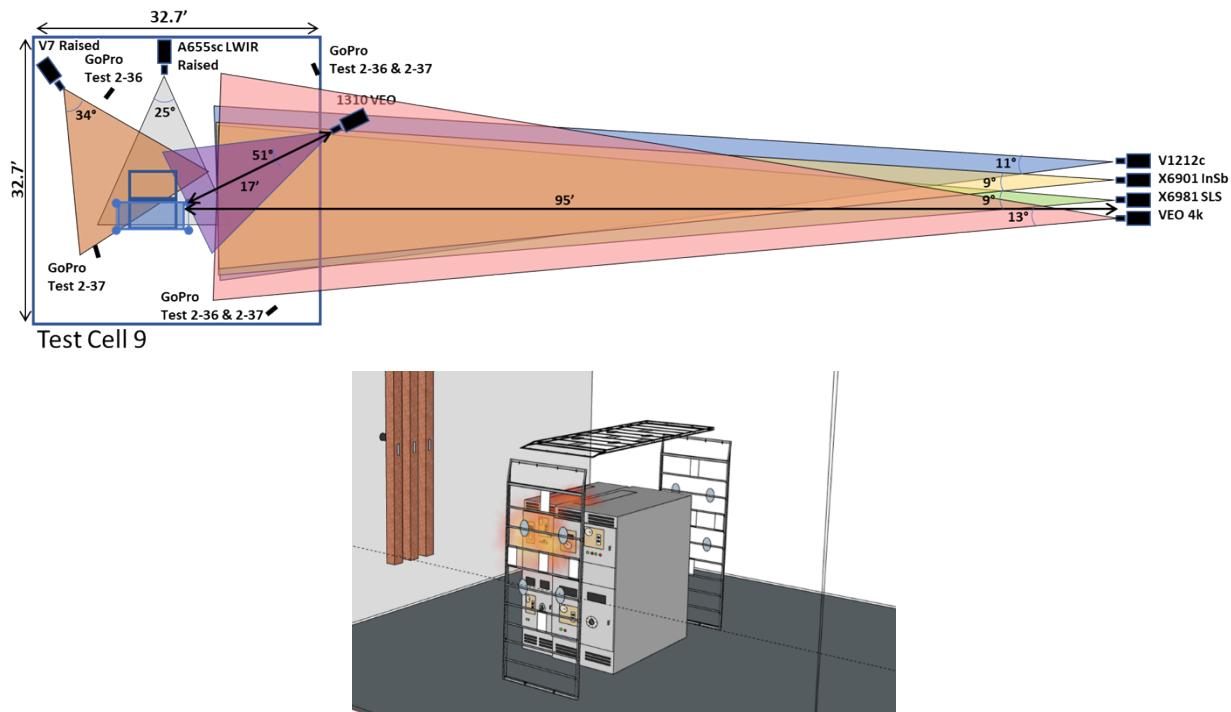
Figure 3-10: Electrical Enclosure (Test 2-36 & Test 2-37) cameras locations (top) with switchgear enclosure configuration (bottom). Main difference to Test 2-35 is the shorter focal length for the 1310 VEO giving it a wider view.

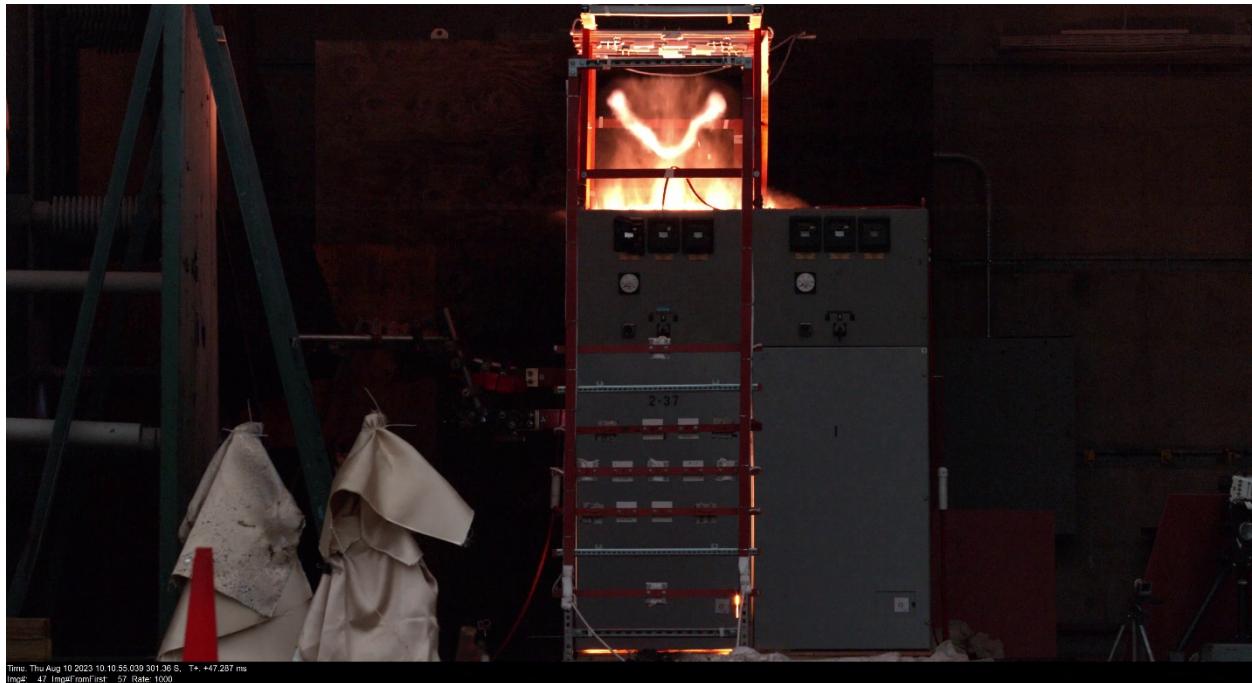
Figure 3-11: Test 2-37 imaged through 4k camera first millisecond into the test – camera imaging at 1000 fps – showing a v-shape object being ejected on the top.

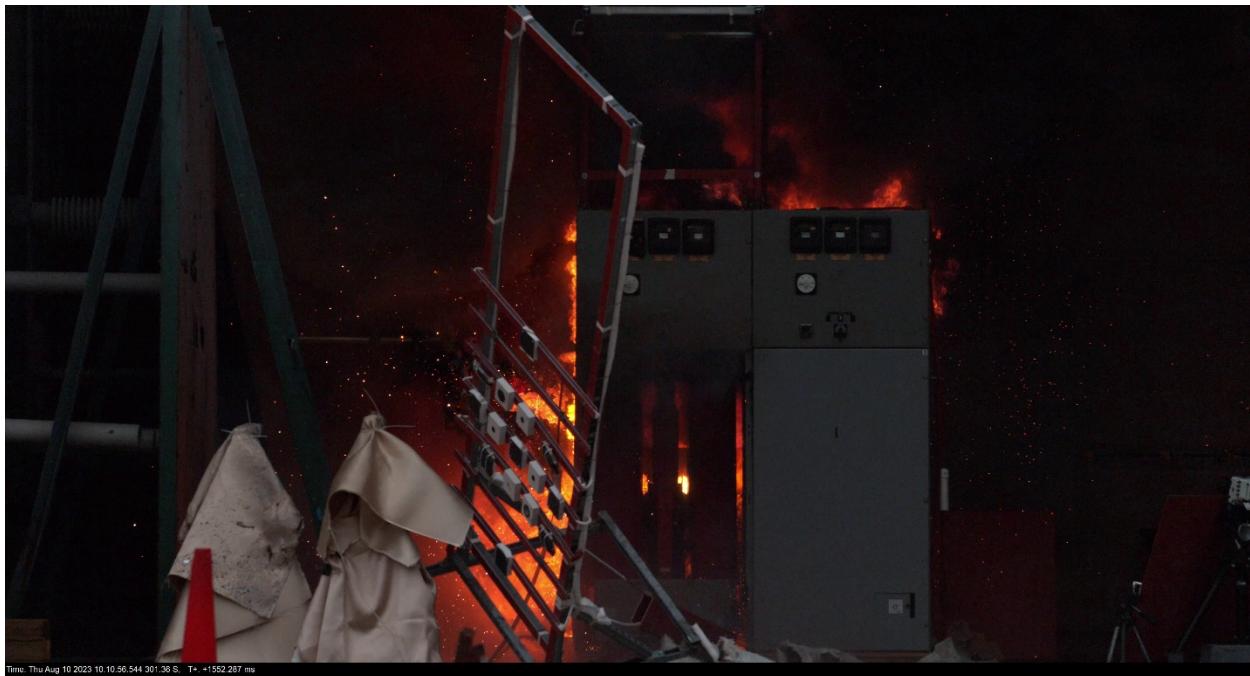
Figure 3-12: Test 2-37 imaged through 4k camera 1 second into the test – camera imaging at 1000 fps – where the instrument stand is falling after being pushed by the ejected door from the enclosure where the arc is initiated.

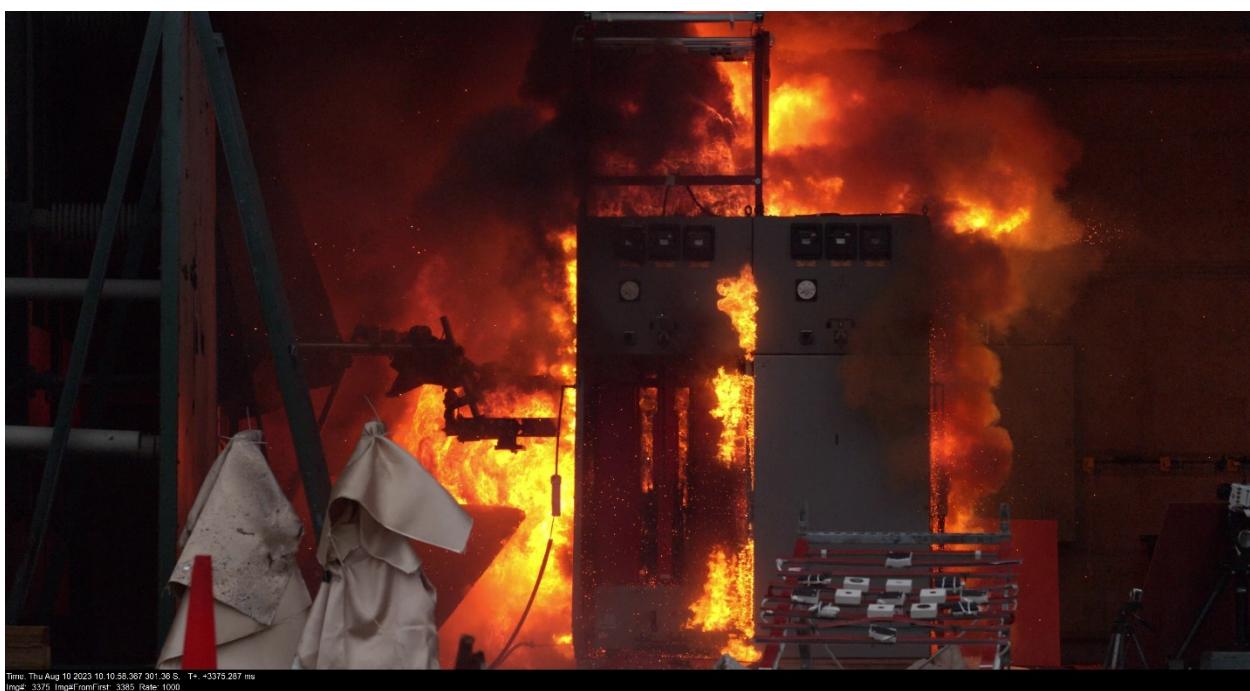
Figure 3-13: Test 2-37 imaged through 4k camera 3 second into the test – camera imaging at 1000 fps – where the arc is affecting the second enclosure (mostly in the back). Notice the instrument stand on the ground by this time.

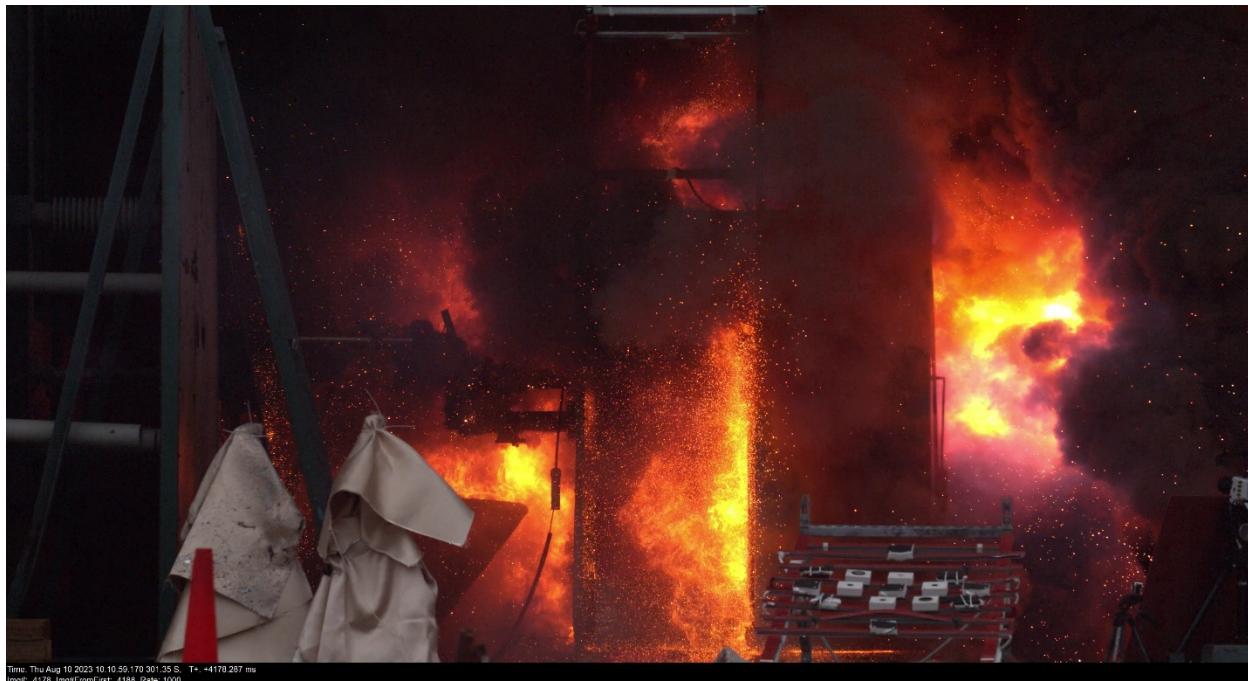
Figure 3-14: Test 2-37 imaged through 4k camera 3.5 seconds into the test – camera imaging at 1000 fps – The second enclosure ejecting a large fireball in side pointing north (this has been going on for half a second), while the first enclosure is consumed by the fire and ejecting sprays of burning metal particulate to the south.
