SANDIA REPORT

SAND2024-04777

High Energy Arcing Fault (HEAF) Sandia National Laboratories 2023 Report

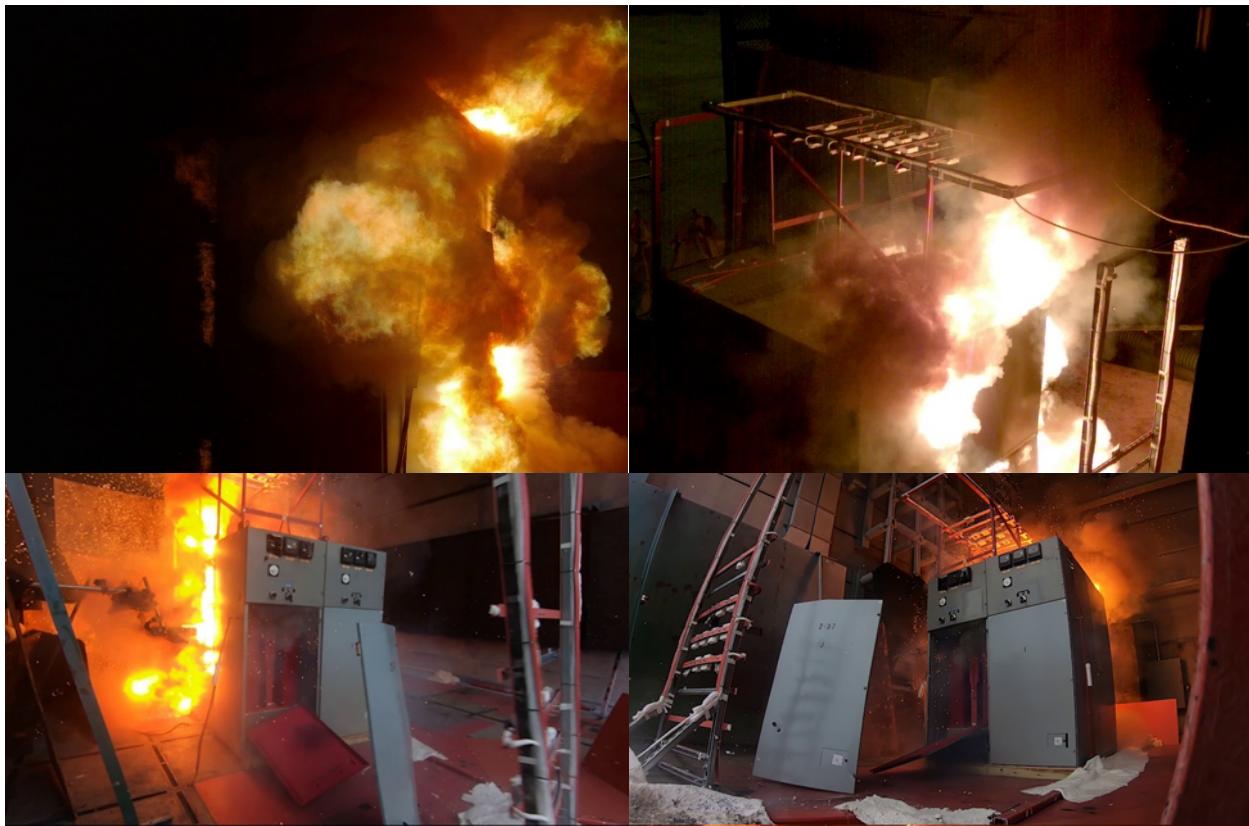
Figure 3-15: From top left (clockwise): v1310 while there is venting in the adjacent enclosure; v7 elevated from the northeast of the test while the west side enclosure vents in the back; GoPro outside southwest while access door is being ejected; GoPro outside floor southeast view of the same event. Notice instrument stand is being pushed by the ejected door.

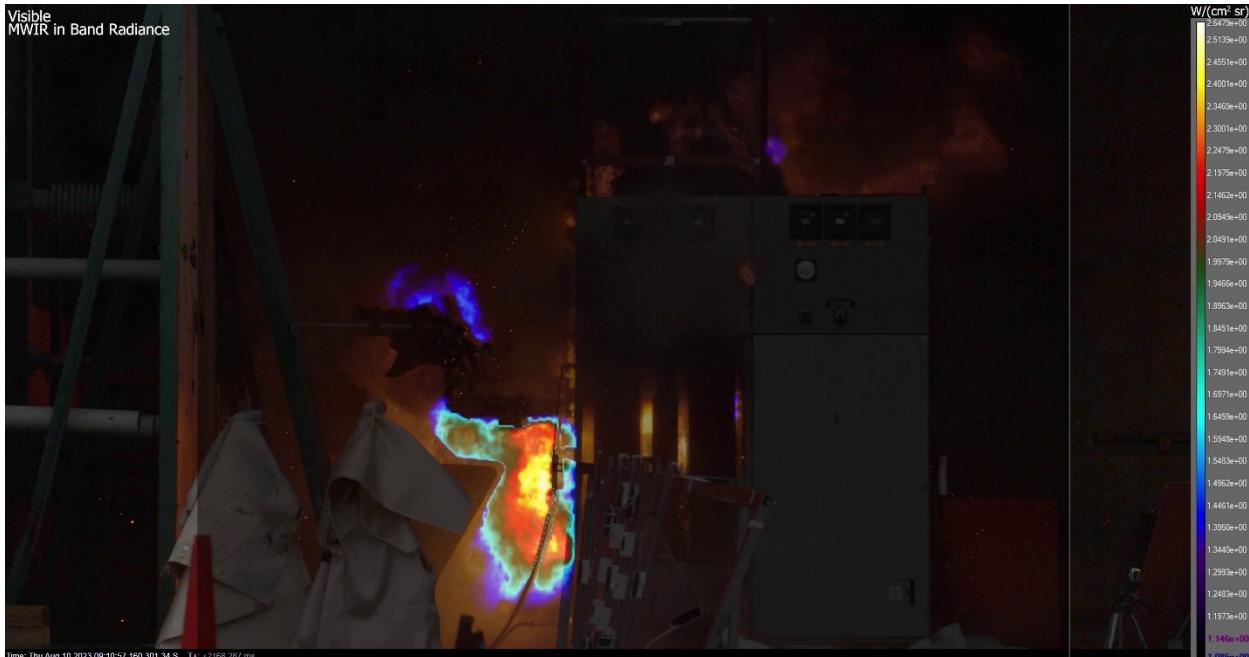
Figure 3-16: Image fusion of IR camera (in radiance units of $\text{W}/\text{cm}^2 \text{ sr}$) synchronized with a visible image 2 seconds into the test.

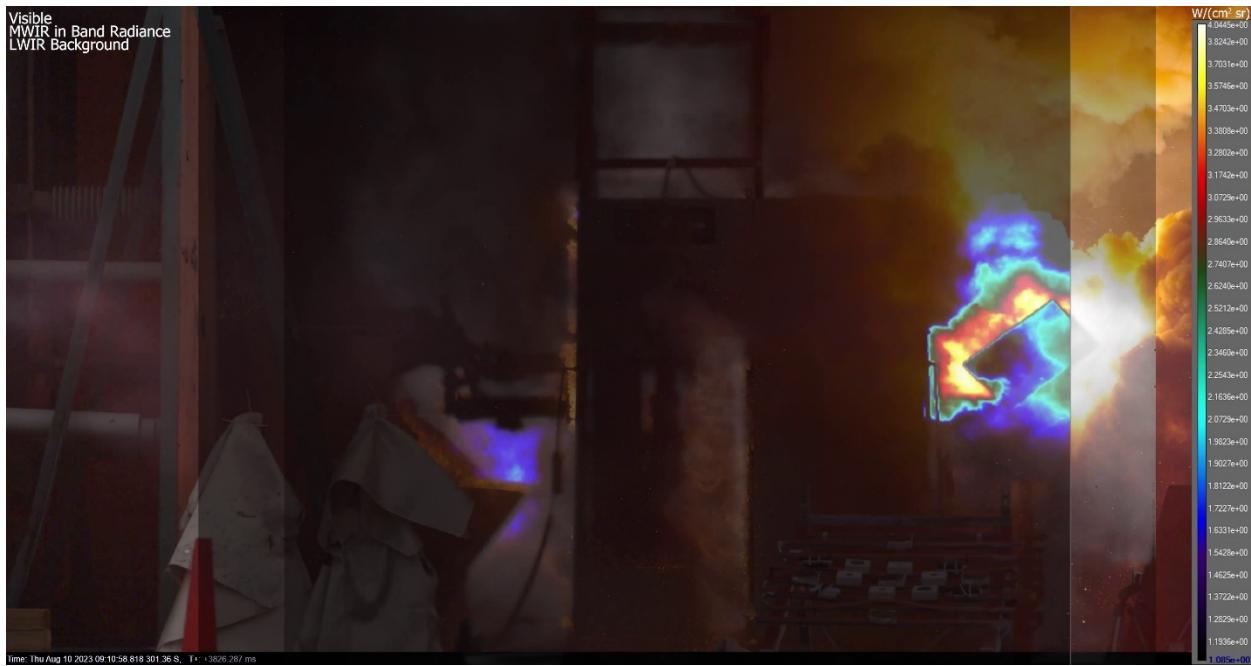
Figure 3-17: Image fusion of IR camera (in radiance units of $\text{W}/\text{cm}^2 \text{ sr}$) synchronized with a visible image almost 4 seconds into the test showing the ejection of a panel of the adjacent enclosure.

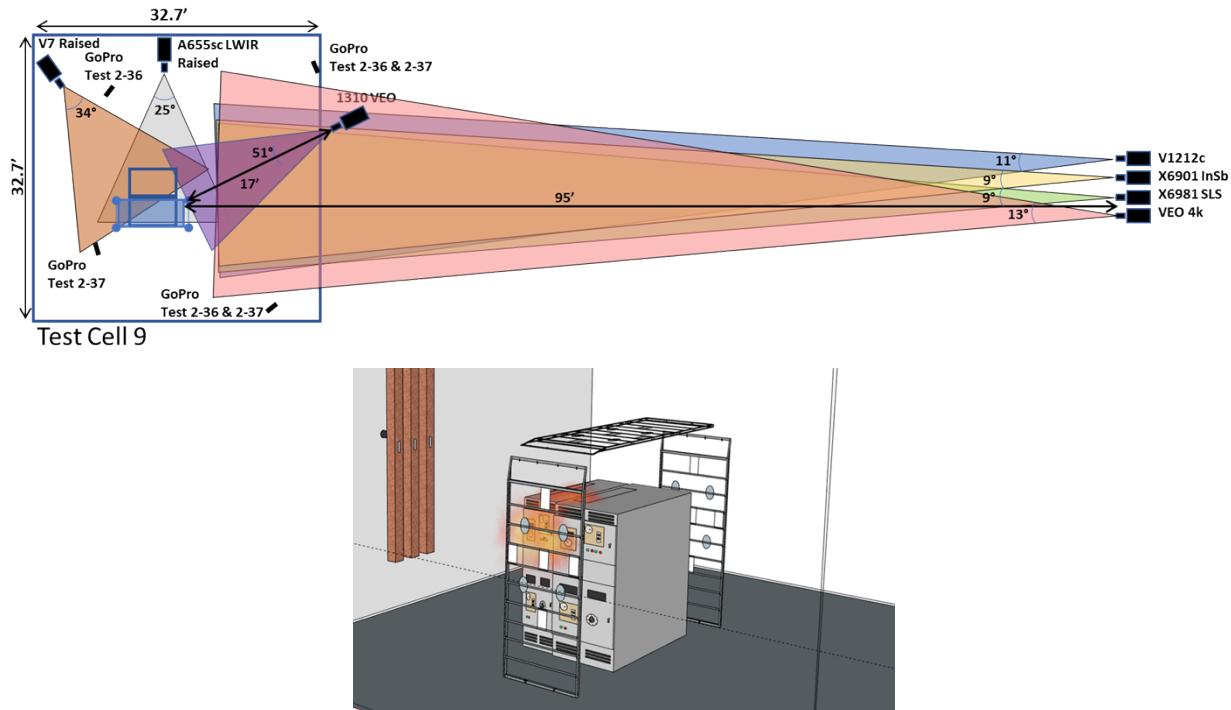
Figure 3-20: Electrical Enclosure (Test 2-36) camera locations (top) with switchgear enclosure configuration (bottom). Main difference to Test 2-35 is the shorter focal length for the 1310 VEO giving it a wider view.

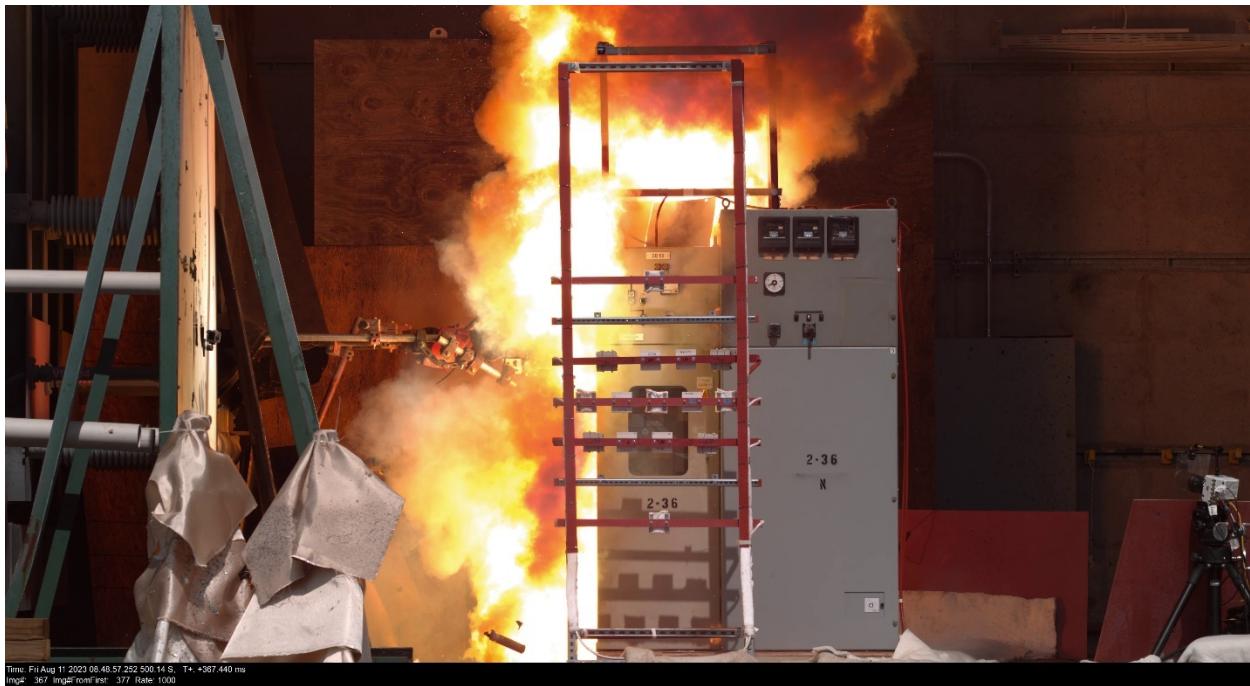
Figure 3-21: Test 2-36 imaged through 4k camera – camera imaging at 1000 fps

This test seems to have most of the arc activity to the main switchgear, with some fire and venting on the adjacent switchgear, but not as significant as previous tests. Notice that the connection to the 3-phases with the KEMA facility significantly shakes at two distinct times: 37 ms and 3.38 seconds into the test. Figure 3-21 through Figure 3-28 show images of notable features and select events that occurred during Test 2-36.

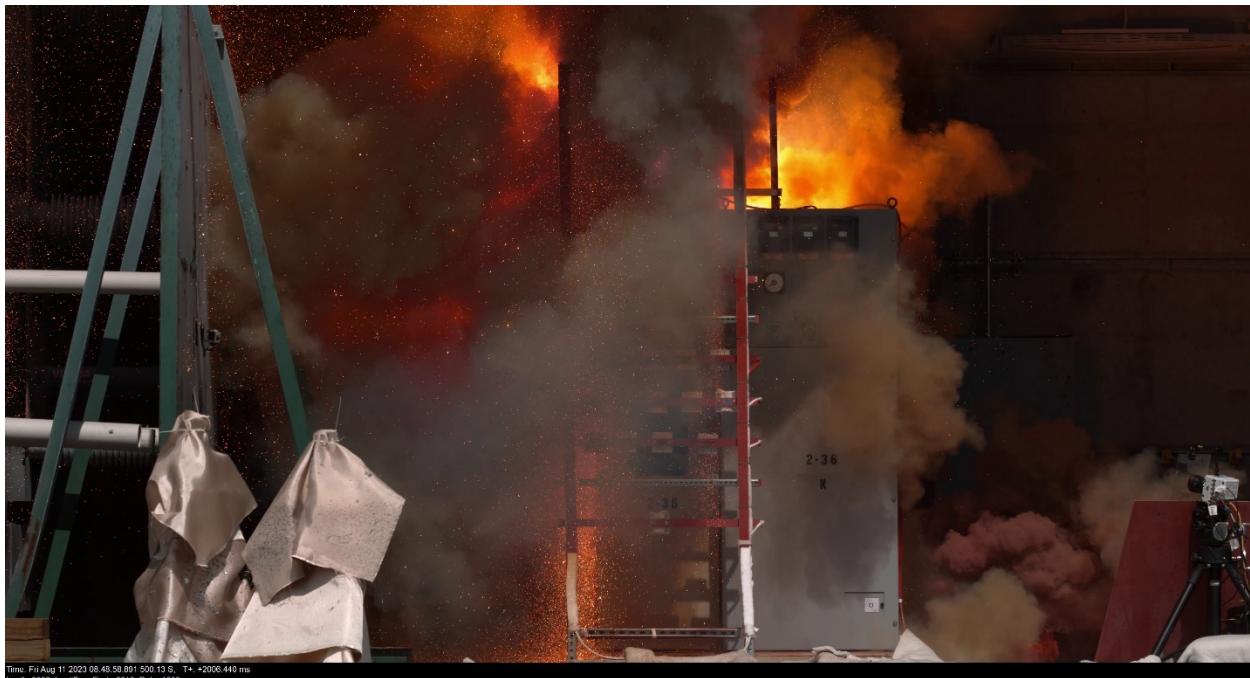
Figure 3-22: Test 2-36 imaged through 4k camera – camera imaging at 1000 fps – 2 seconds into the test. The view from the south seems to be dominated by dark smoke and there is fire activity in the north side.

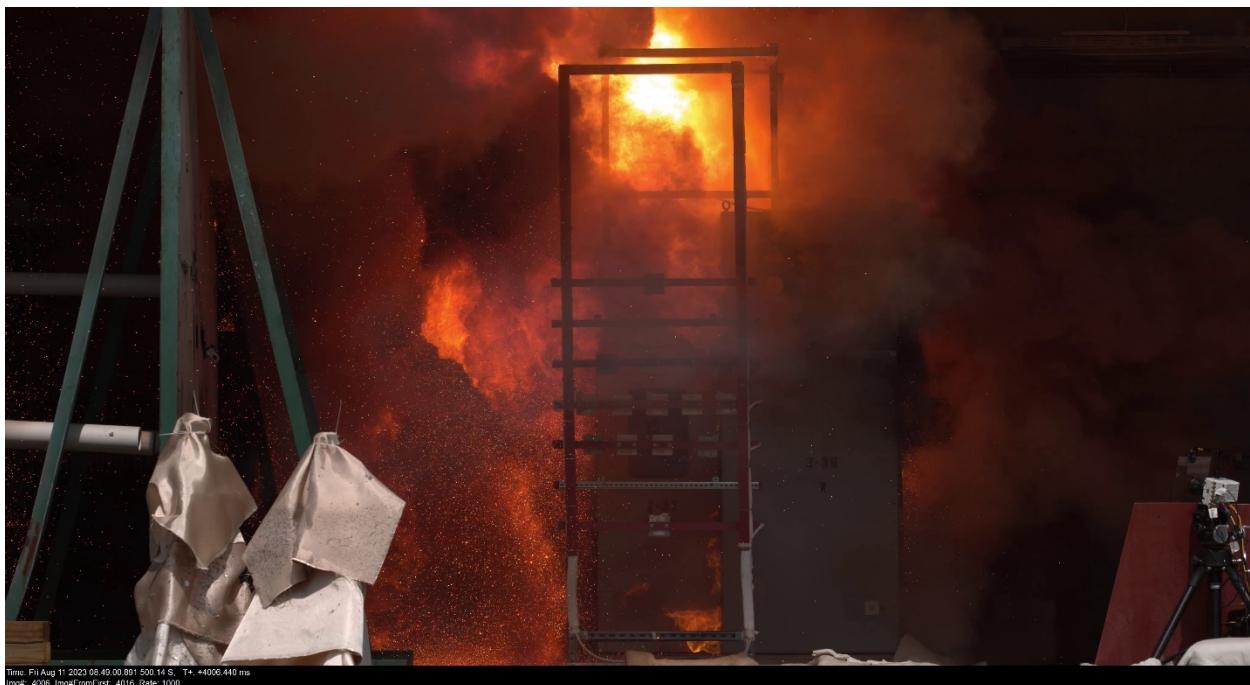
Figure 3-23: Test 2-36 imaged through 4k camera – camera imaging at 1000 fps – 4 seconds into the test. There is a fire engulfing the enclosure where the arc was initiated, also there is spray of burning metal particulate. The second enclosure seems to be mostly engulfed by the dark smoke with some fire activity on the east side.

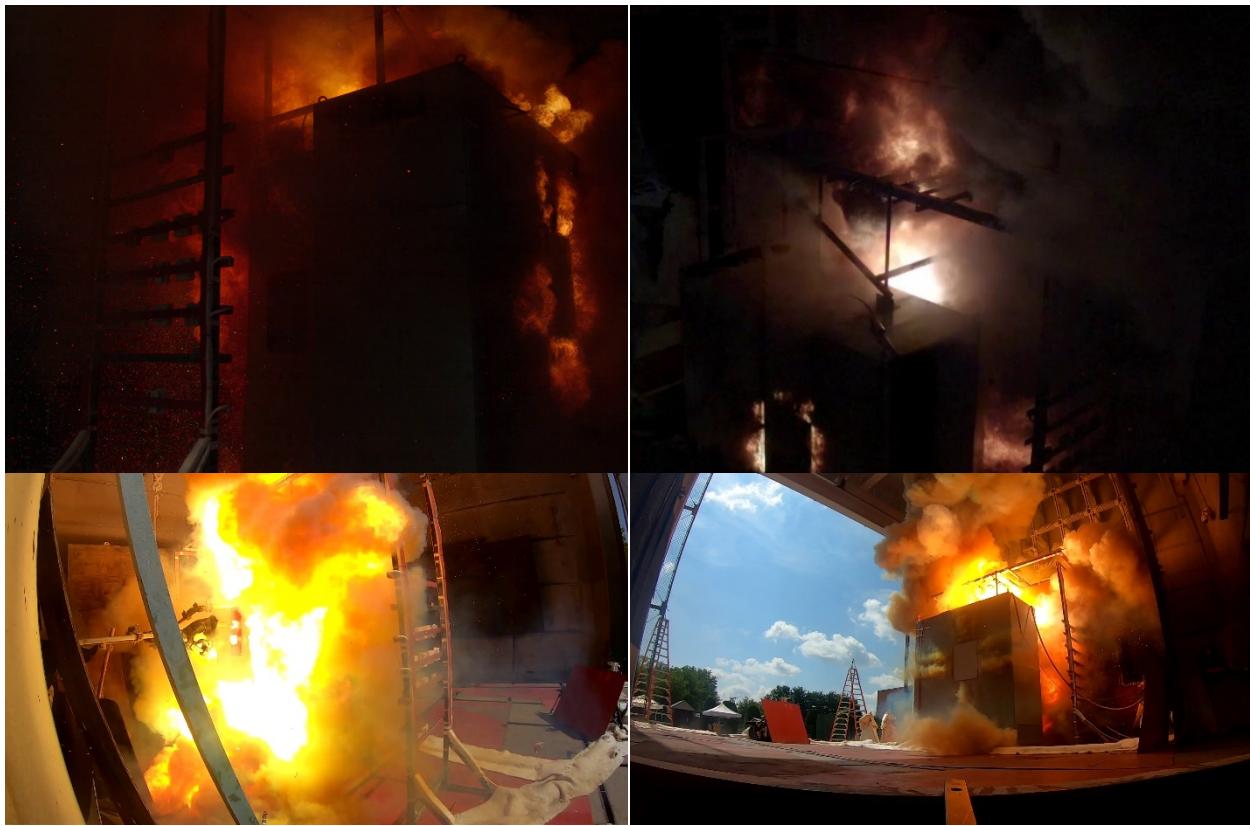
Figure 3-24: From top left (clockwise): v1310 view at 1.5 seconds into the test while venting in the adjacent enclosure; v7 elevated from the northeast of the test while the east side enclosure vents but the arc starting enclosure suffers the brunt of the test; GoPro outside west during the arc on the west side enclosure; GoPro inside floor northeast view of the damage to the first enclosure while the second enclosure starts venting gases.

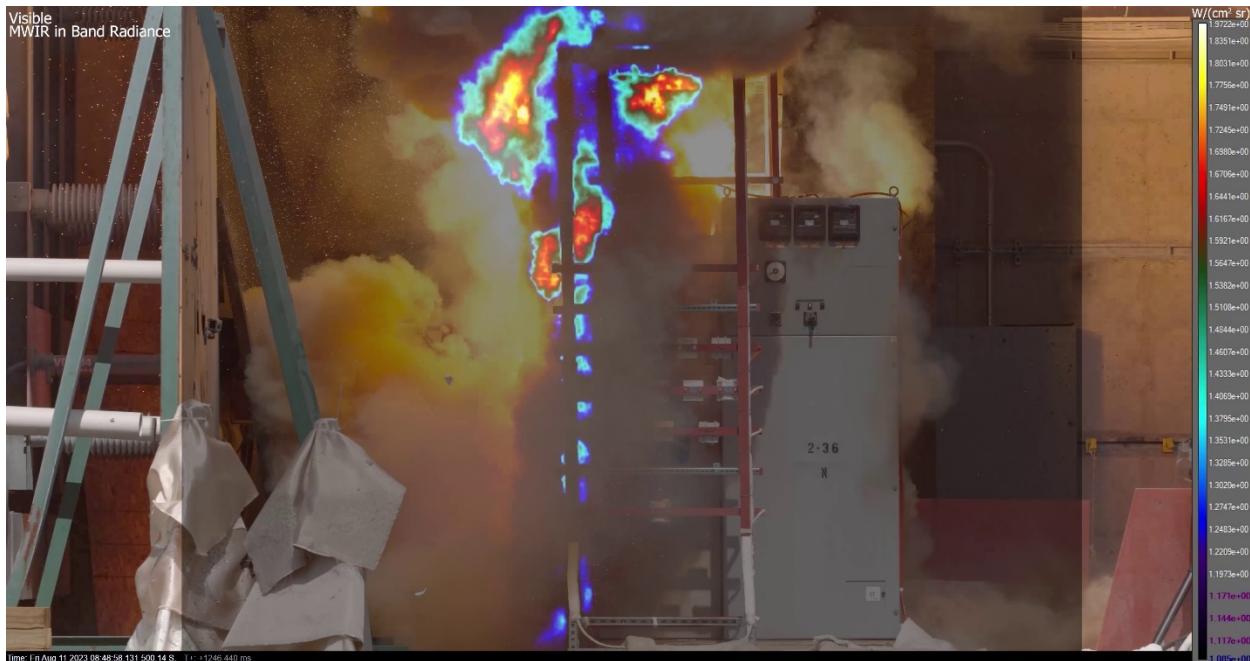
Figure 3-25: Image fusion of IR camera (in radiance units of $\text{W}/\text{cm}^2 \text{ sr}$) synchronized with a visible image 1 second into the test.

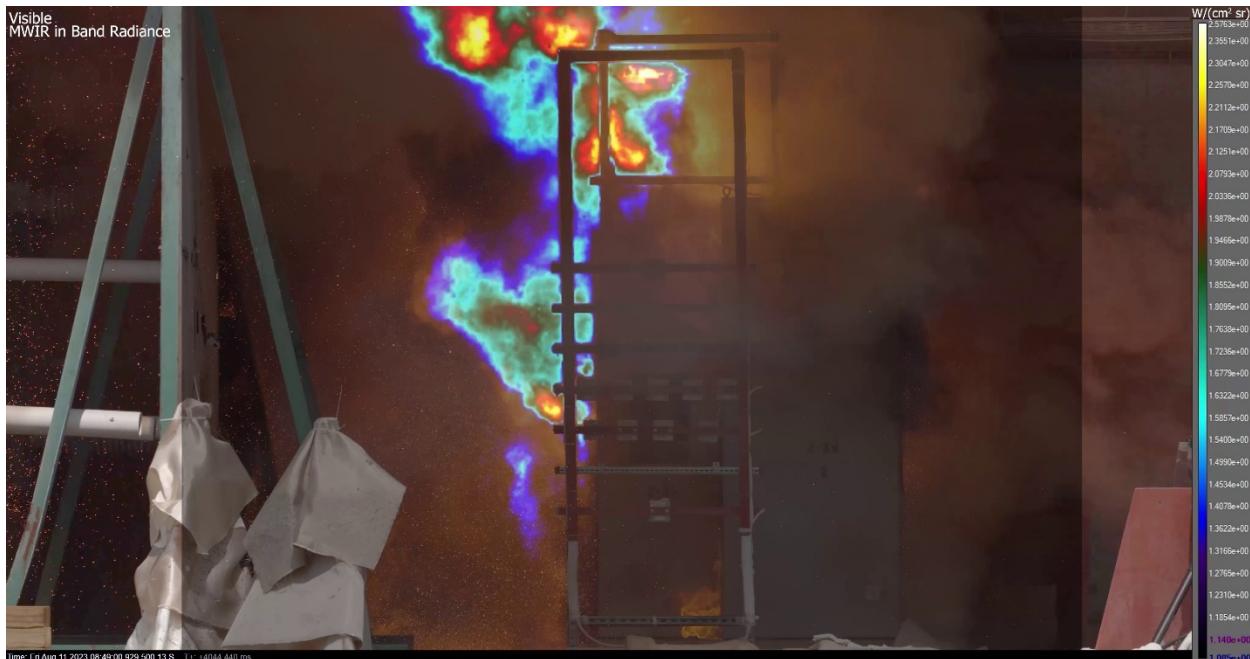
Figure 3-26: Image fusion of IR camera (in radiance units of $\text{W}/\text{cm}^2 \text{ sr}$) synchronized with a visible image 4 second into the test and not that different than at the beginning of the test.

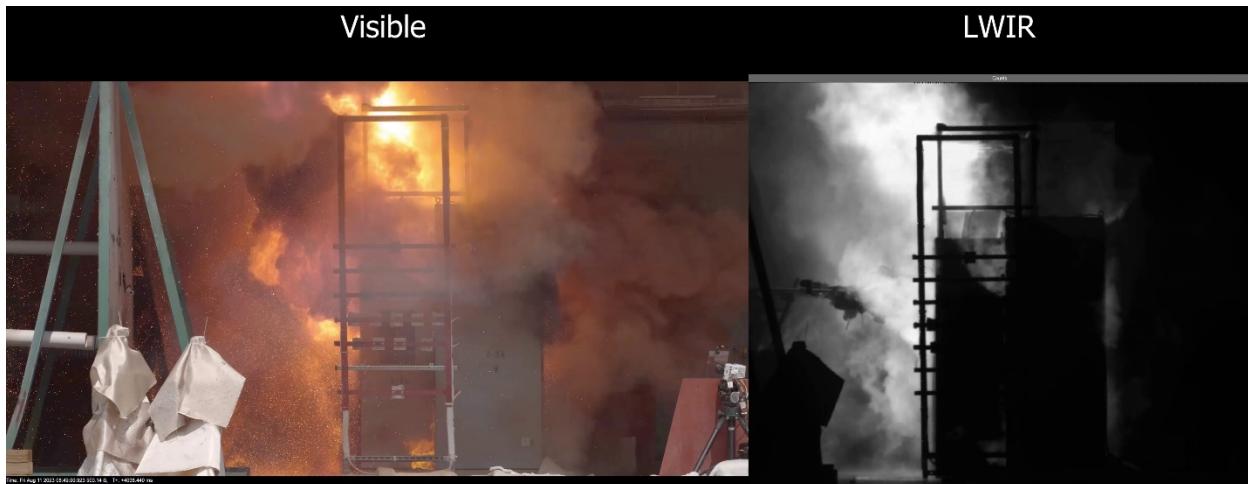
Figure 3-27: sample frames from synchronized video of 4k and LWIR cameras close to 4 seconds into the test. While there seems to be activity in IR and visible in the back (north side), the IR seems to indicate that the second enclosure is not that hot, even if the first enclosure keeps burning for several minutes after the test.

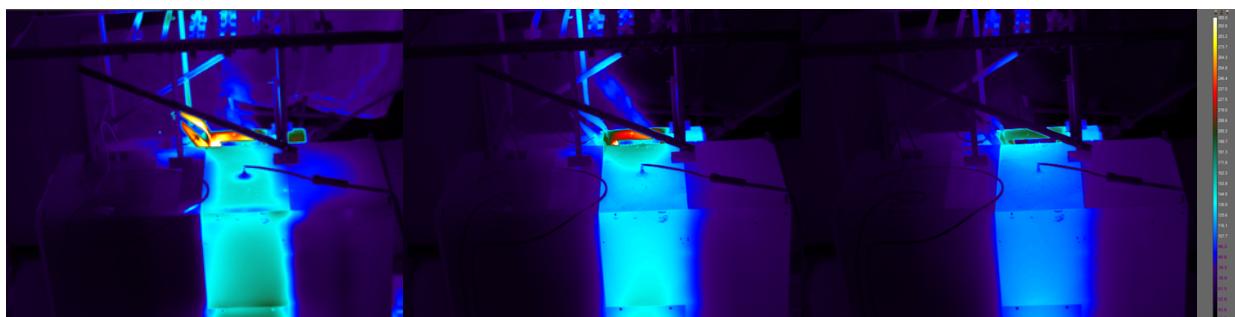
Figure 3-28: Temperature images from the LWIR camera A655 through 5 minutes intervals, starting ~1 minute after the test. Arc is induced in the lower background enclosure. Temperature range from 20 to 150 °C. Notice that the there is minimum change in temperature during the 15 minutes of the three frames, indicating a continuos fire in the enclosure where the arc was started.

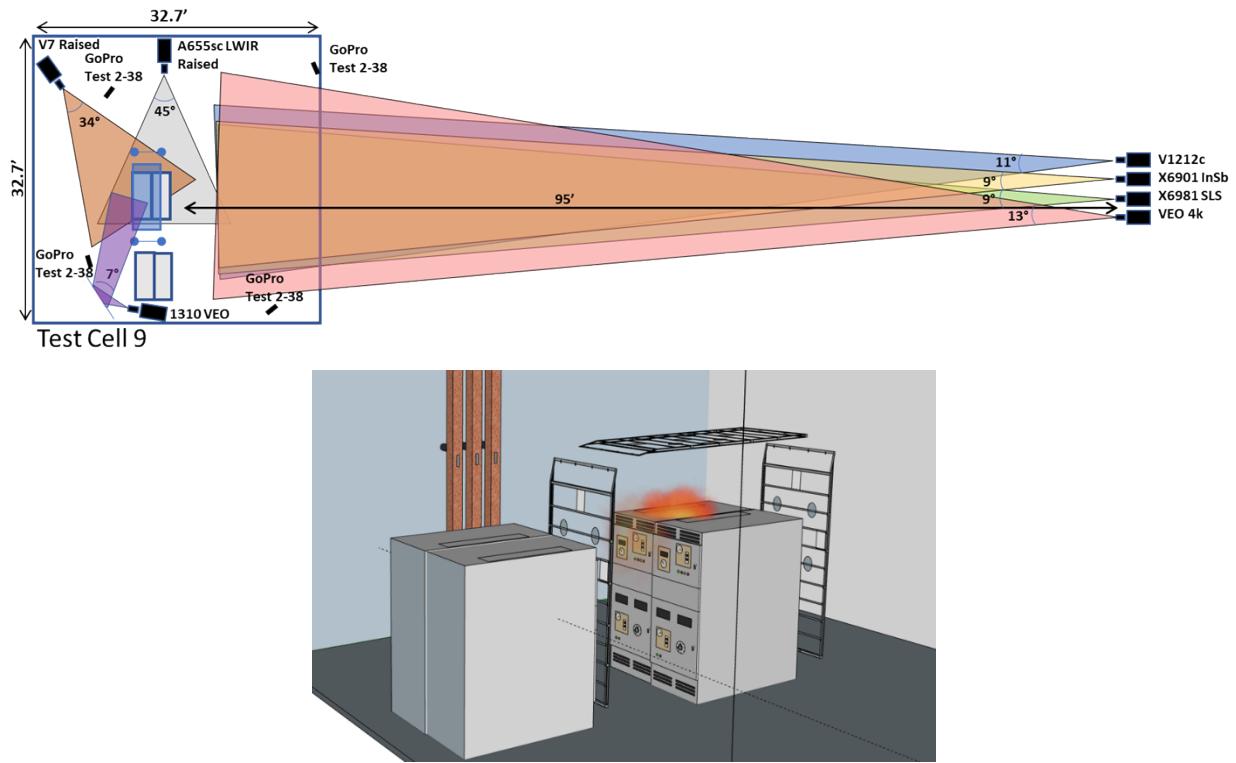
Figure 3-29: Electrical enclosure cross-aisle configuration (Test 2-38) cameras locations (top) with switchgear enclosure configuration (bottom).

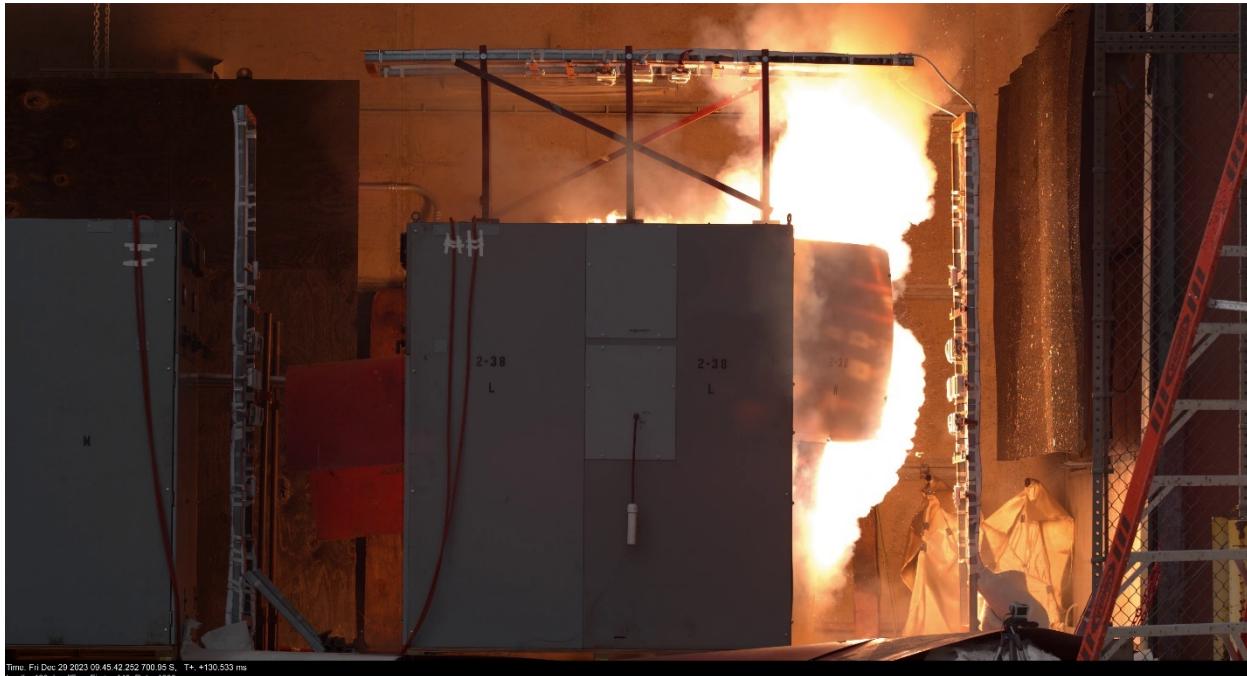
Figure 3-30: Test 2-38 imaged through 4k camera – camera imaging at 1000 fps. Notice the panel ejected to the east. The arc was initiated in the north enclosure – behind the enclosure in view.

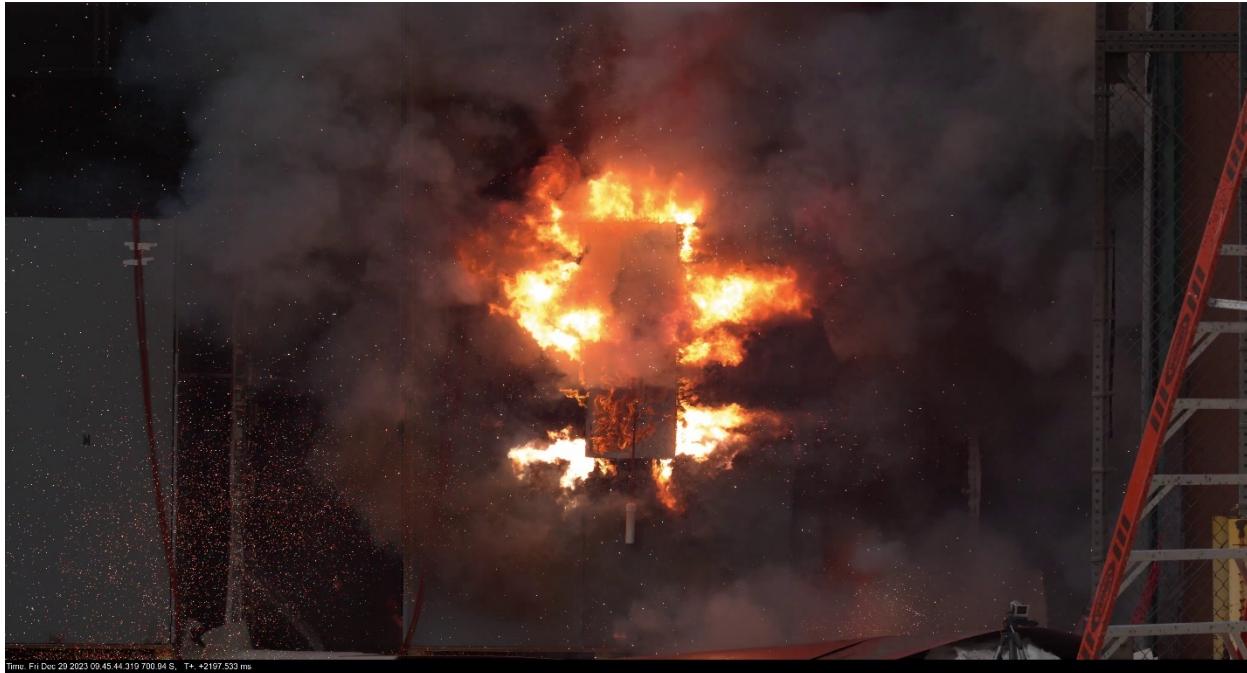
Figure 3-31: Test 2-38 imaged through 4k camera – camera imaging at 1000 fps – 2 seconds into the test. Burning metal particles are flying out from both adjacent enclosures and the south enclosure is venting fire through its southern panel. Notice the smoke engulfing the test bay.

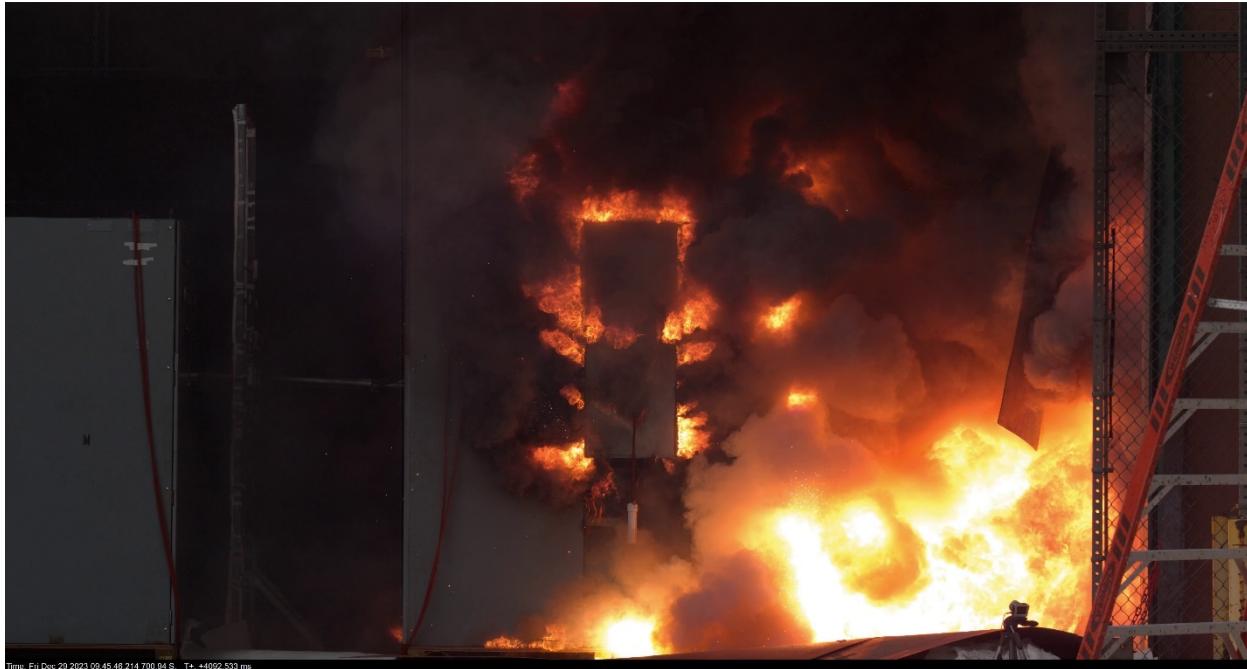
Figure 3-32: Test 2-38 imaged through 4k camera – camera imaging at 1000 fps – 4 seconds into the test. A fireball is now engulfing the east side of the test bay.

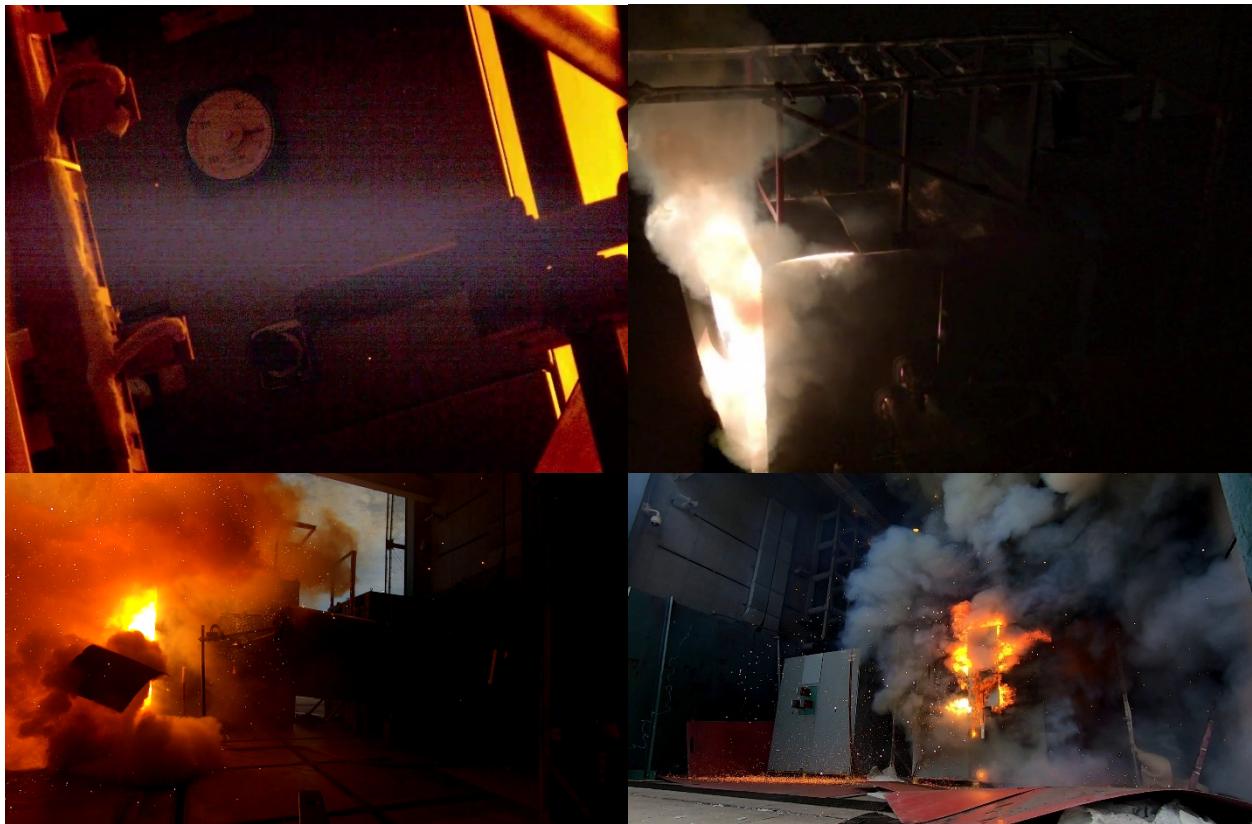
Figure 3-34: From top left (clockwise): v1310 view at 1 second into the test before the testbay becomes engulfed by smoke on the west side; v7 elevated from the northeast of the test while showing the east panel being ejected from enclosure where the arc was started; GoPro inside floor northeast view showing a panel flying from the enclosure where the arc started; GoPro outside southeast view during the test.

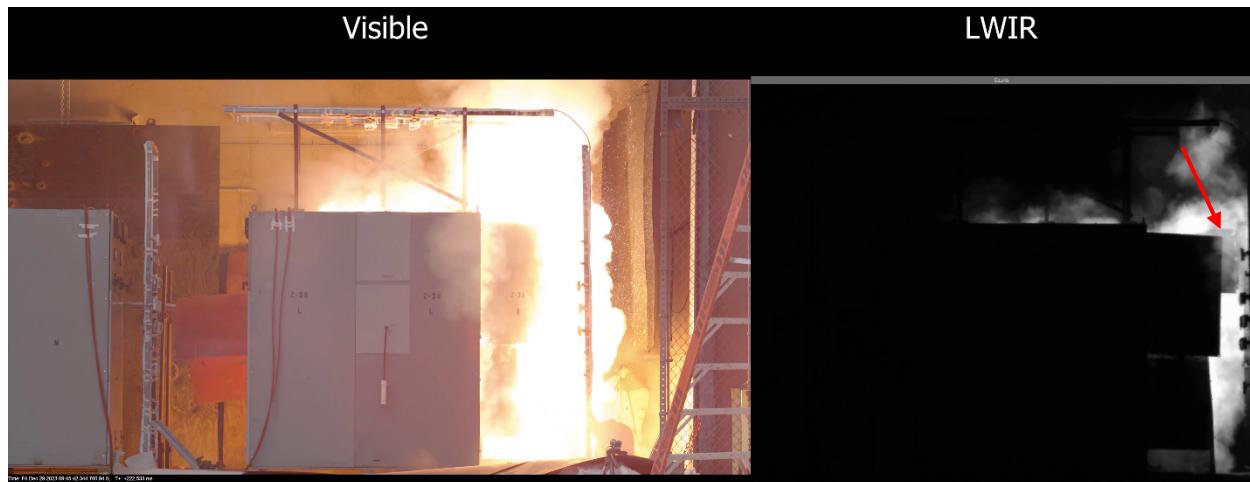
Figure 3-37: Sample frames from synchronized video of 4k and LWIR cameras at the beginning of the test. The LWIR image shows the square profile of the panel ejected from the enclosure where the arc was started, see red arrow.

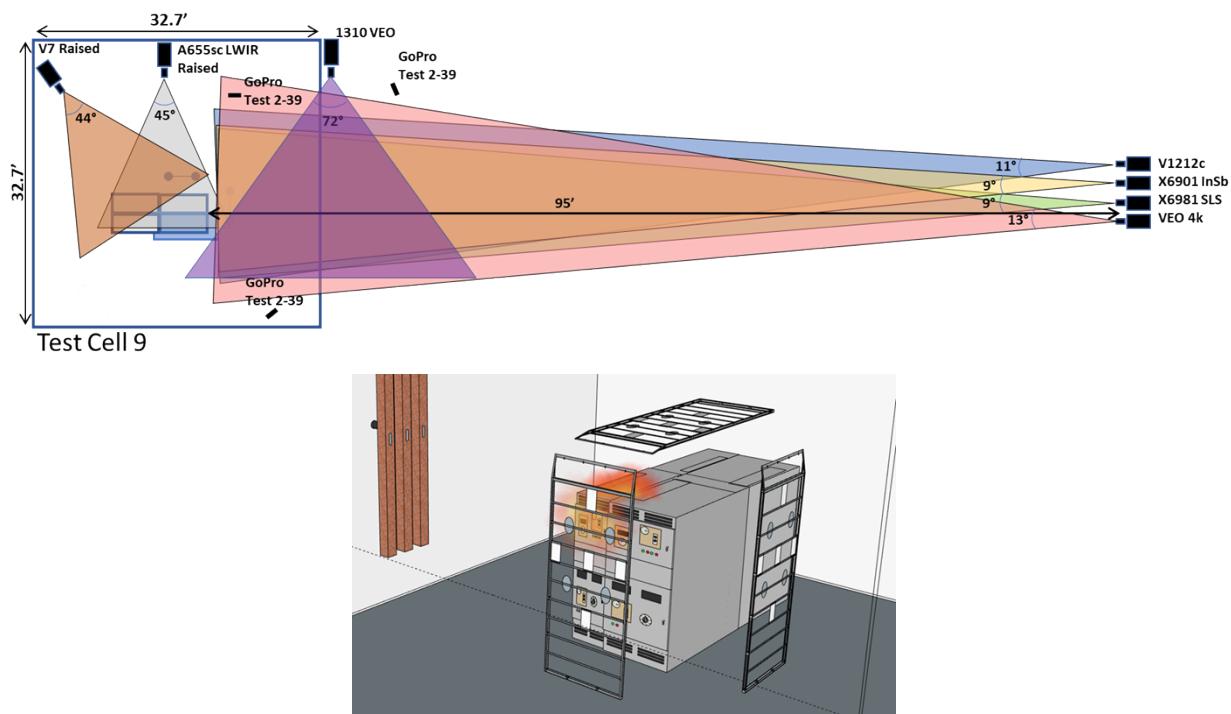
Figure 3-39: Electrical enclosure back-to-back configuration (Test 2-39) cameras locations (top) with switchgear enclosure configuration (bottom).

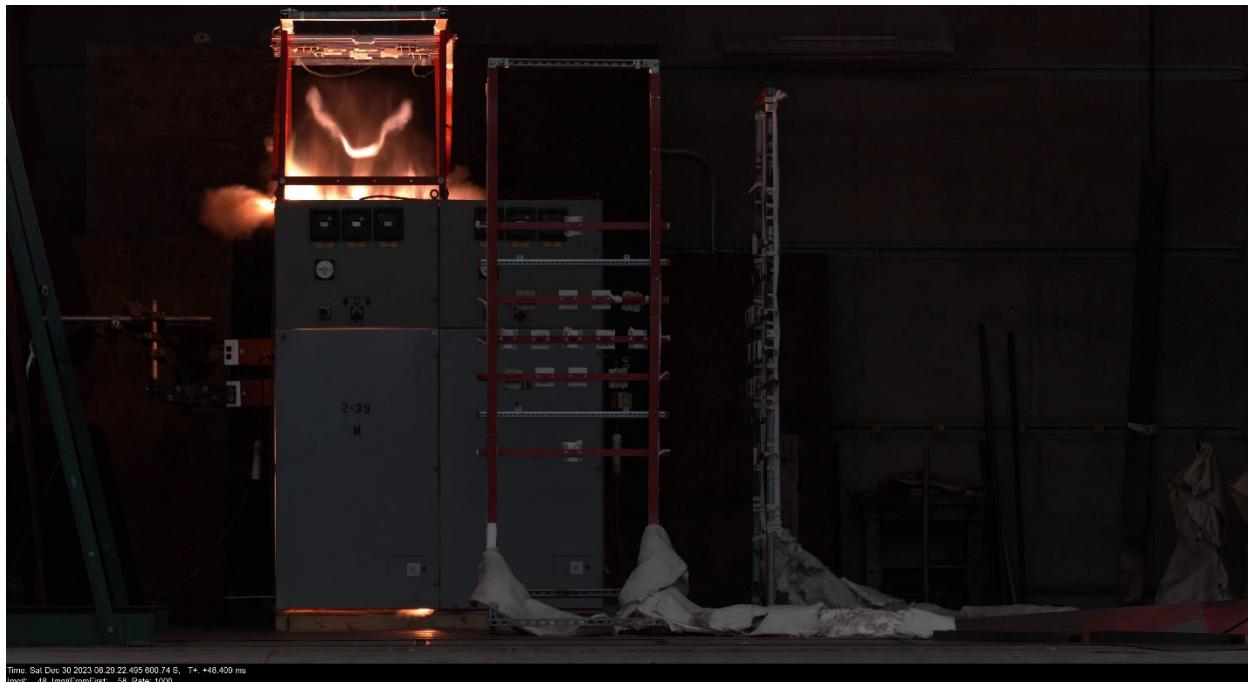
Figure 3-40: Test 2-39 imaged through 4k camera first millisecond into the test – camera imaging at 1000 fps – showing a v-shape object being ejected on the top, similar to Test 2-37 where the front access door was also ejected.

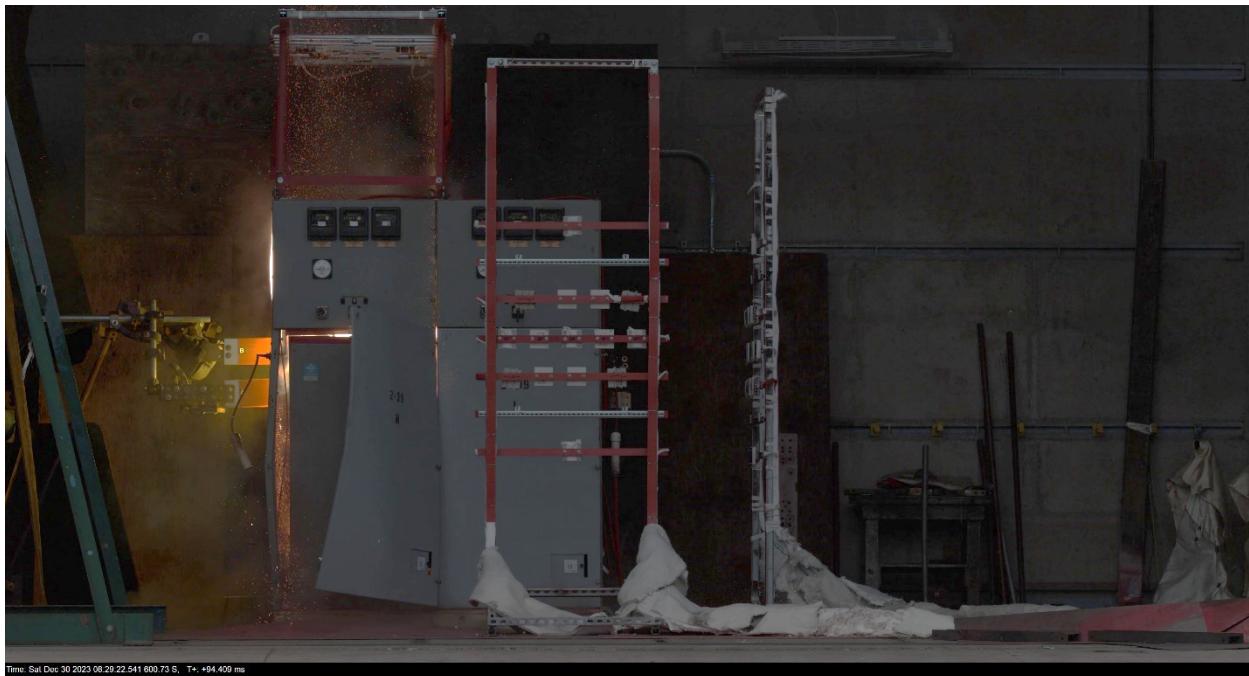
Figure 3-41: Test 2-39 imaged through 4k camera 46 ms after the previous image in Figure 3-40 – camera imaging at 1000 fps – showing access door being ejected and deforming.

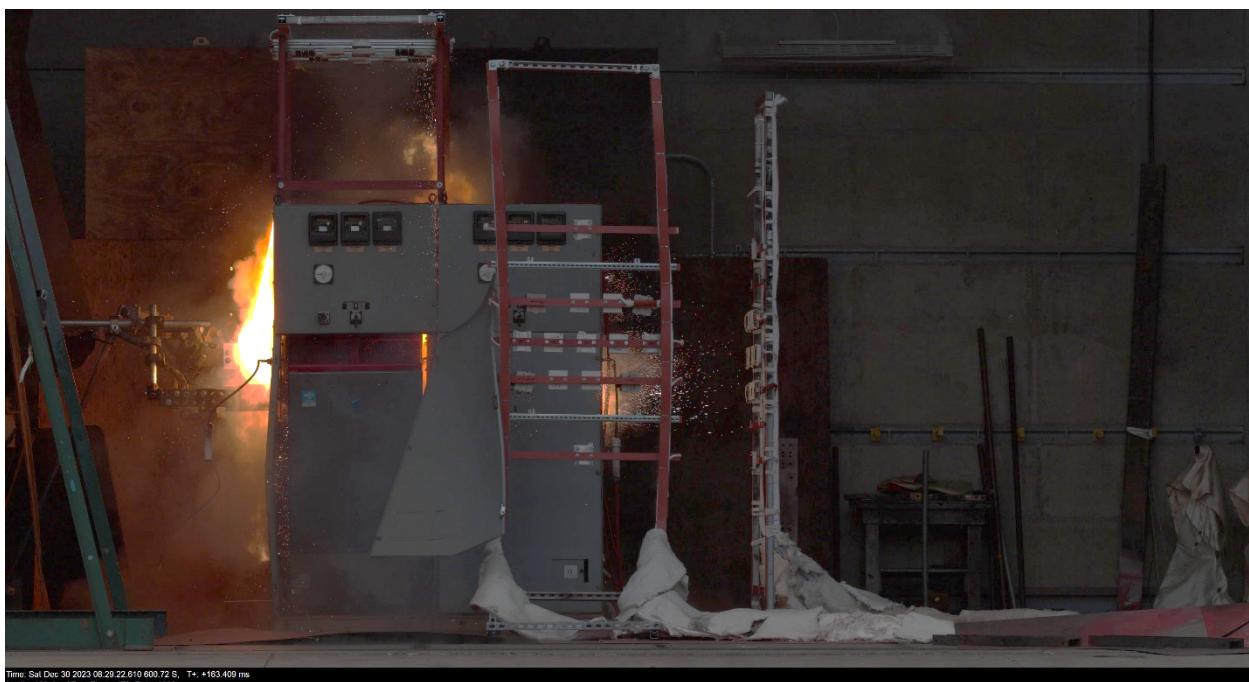
Figure 3-42: Test 2-39 imaged through 4k camera 120 ms after the previous image in Figure 3-40 – camera imaging at 1000 fps – showing access door hitting the instrument stand.

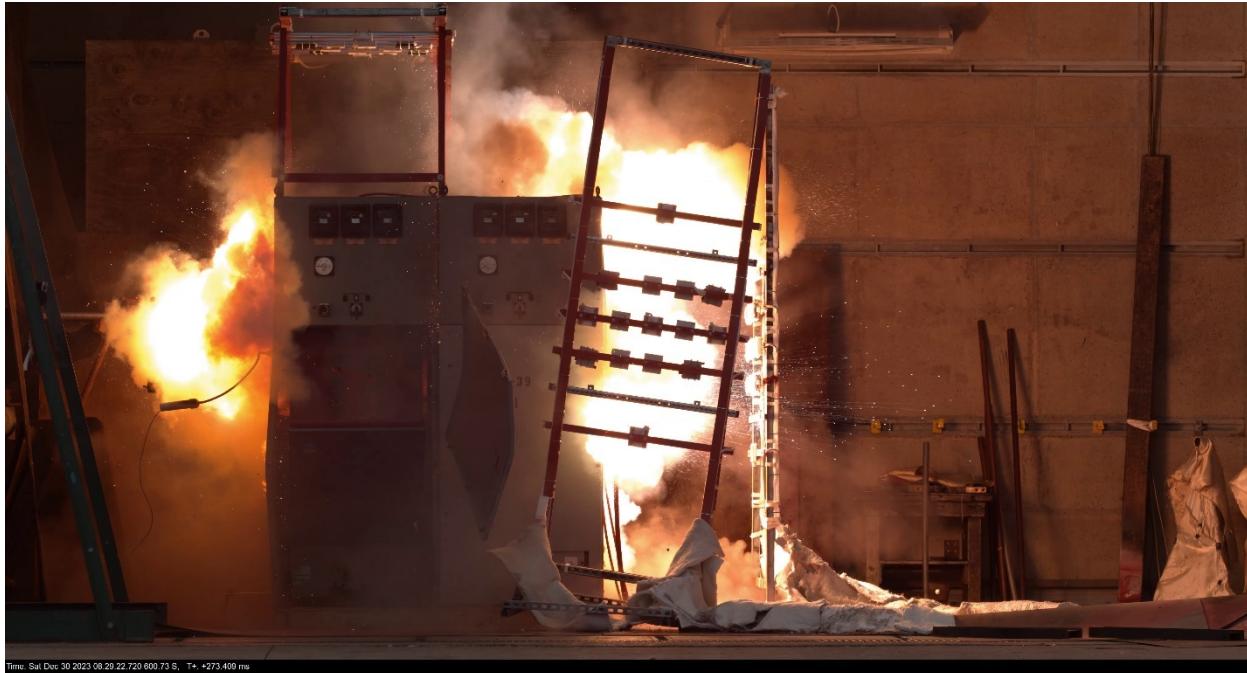
Figure 3-43: Test 2-39 imaged through 4k camera 230 ms after the previous image in Figure 3-40 – camera imaging at 1000 fps – showing multiple explosion while the rack is falling.

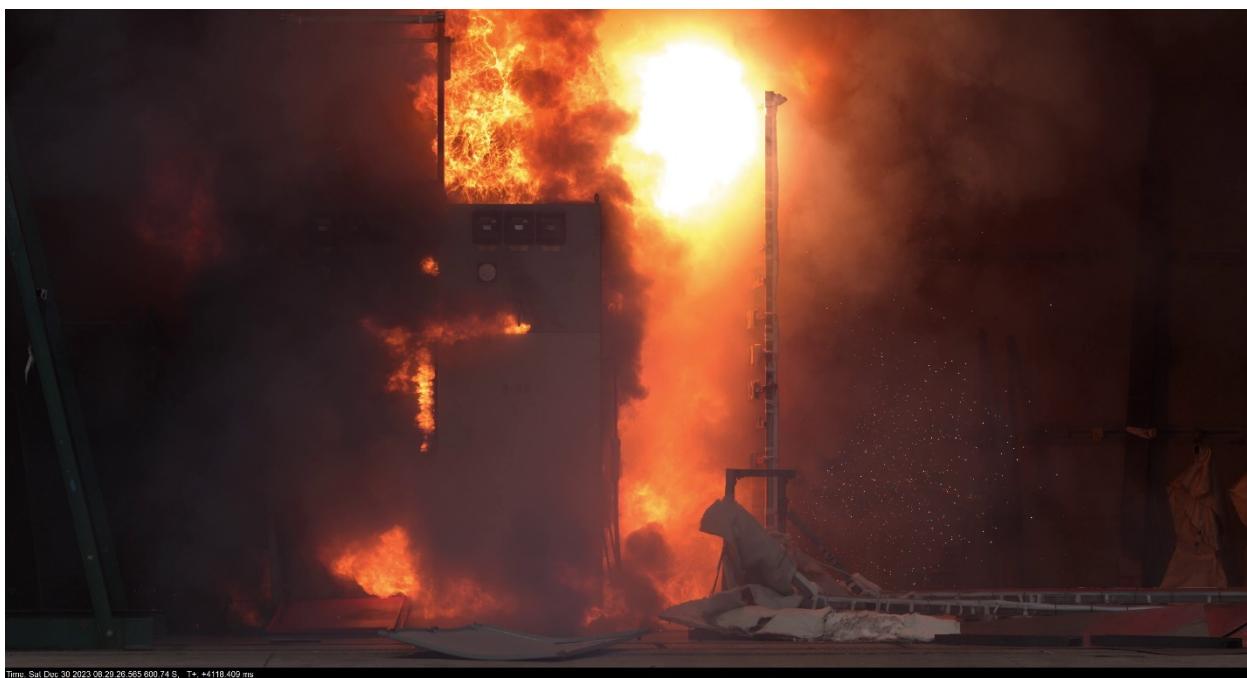
Figure 3-44: Test 2-39 imaged through 4k camera 3 seconds into the test – camera imaging at 1000 fps – showing the instrument stand on the ground and the burning in the back of the southeast and northeast enclosures. The southeast enclosure also shows fire coming out from one of its access door.

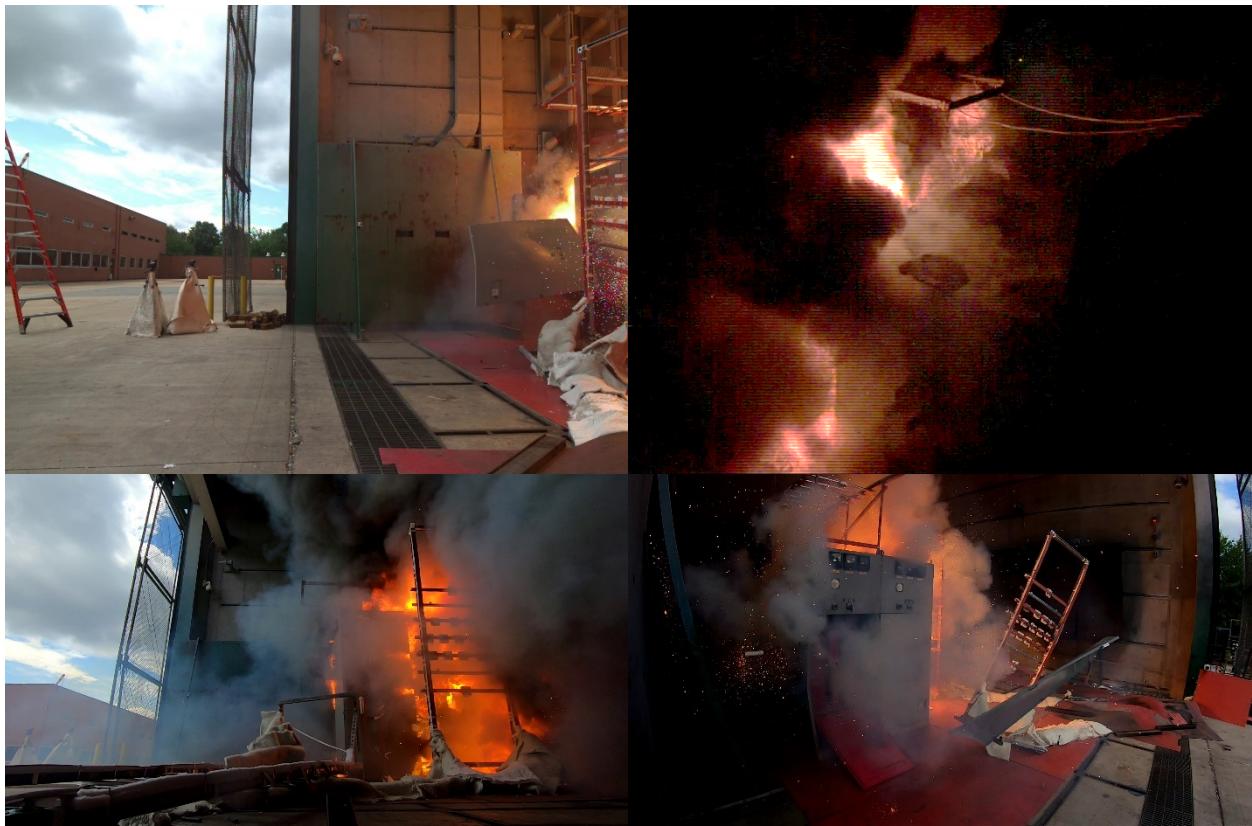
Figure 3-45: From top left (clockwise): v1310 view 0.25 seconds into the test with the access door twirling away from the enclosure; v7 elevated from the northeast of the test bay, at 2.5 seconds, while showing fire at the interface of the southeast and northeast enclosures; GoPro inside floor southeast view showing instrument stand in the ground and he southeast enclosure east side ejecting fire during the test; GoPro southwest view while instrument stand and door encluserue fall to the ground.
