SANDIA REPORT

SAND2024-04777

High Energy Arcing Fault (HEAF) Sandia National Laboratories 2023 Report

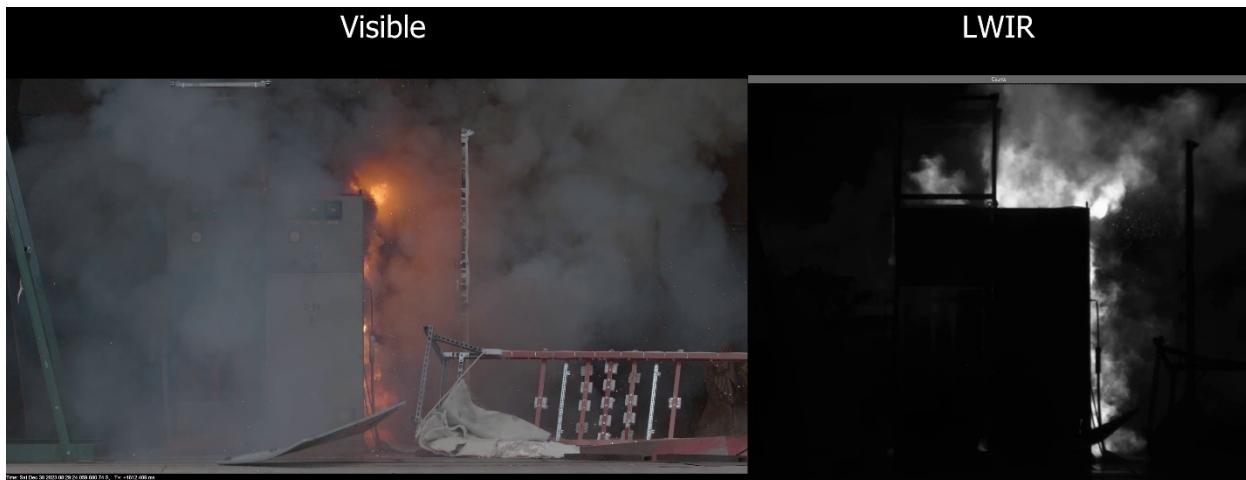
Figure 3-47: Sample frames from synchronized video of 4k and LWIR cameras close to 1.5 seconds into the test. The LWIR image shows heat (probably fire) at the interface between the north and south enclosures and that part of it is occluded by the smoke.

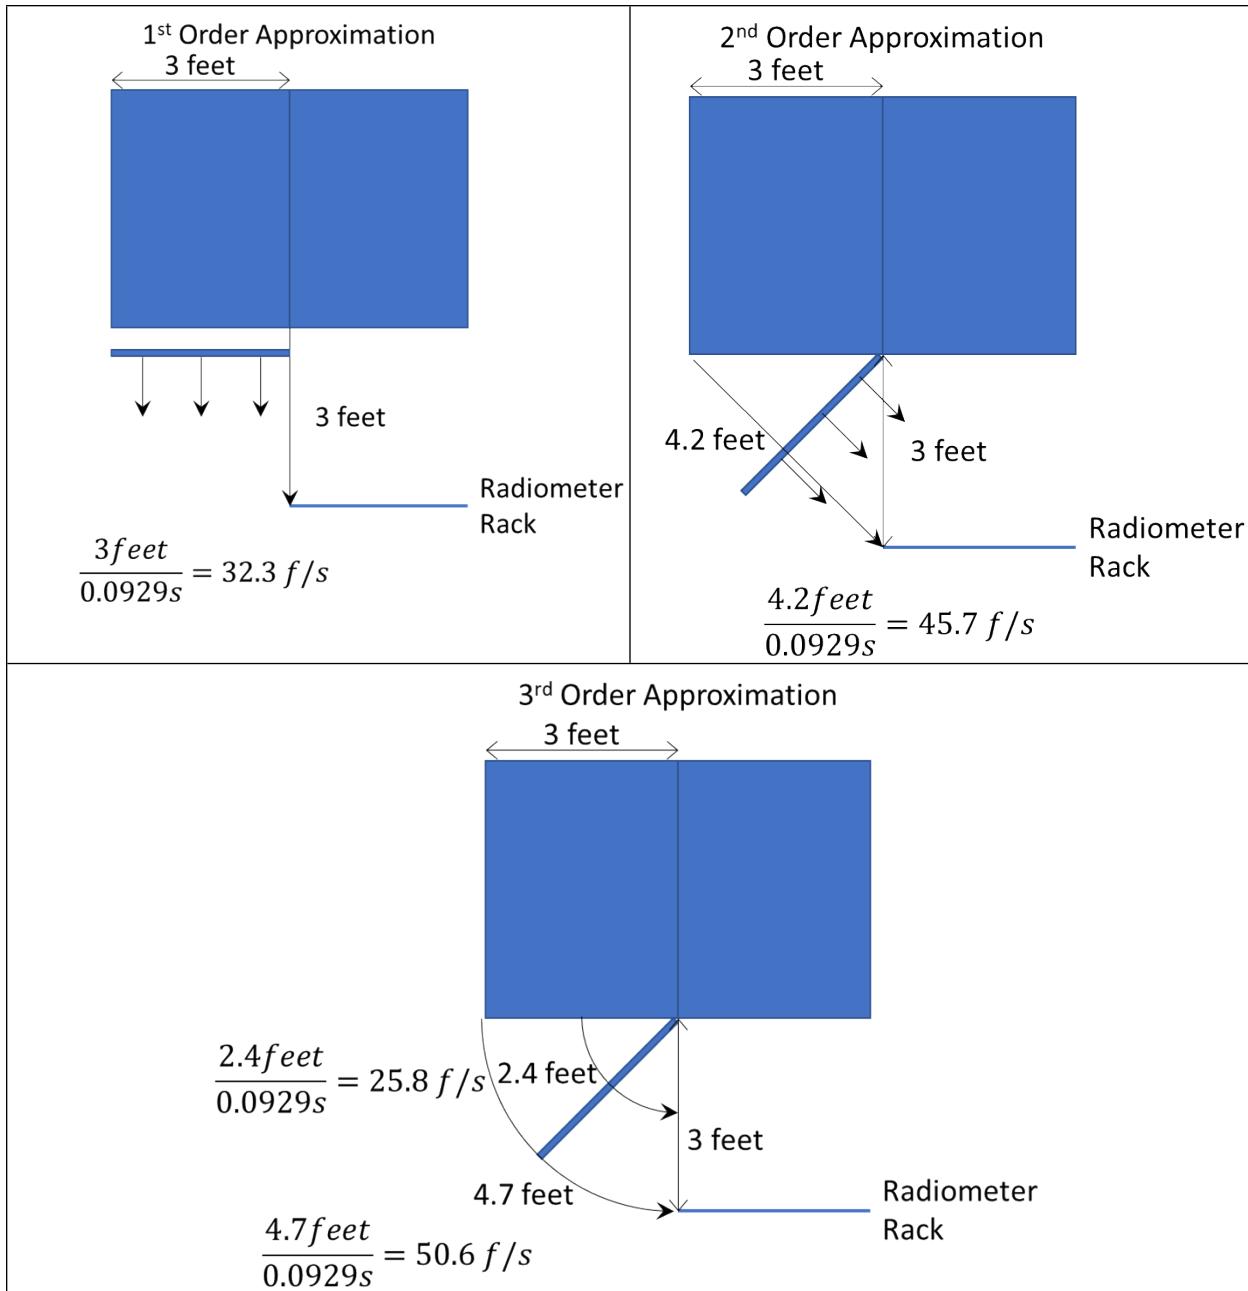
Figure 3-49: Different approximations to estimate the velocity of the ejected access door in Test 2-39. Top-left shows a first order approximation where the door is assumed to be ejected straight. Top-Right assumes the door is ejected at an angle, because we can see that it hits the instrument stand. Bottom shows a more complex approximation where the door rotates on one of its hinges before hitting the instrument stand

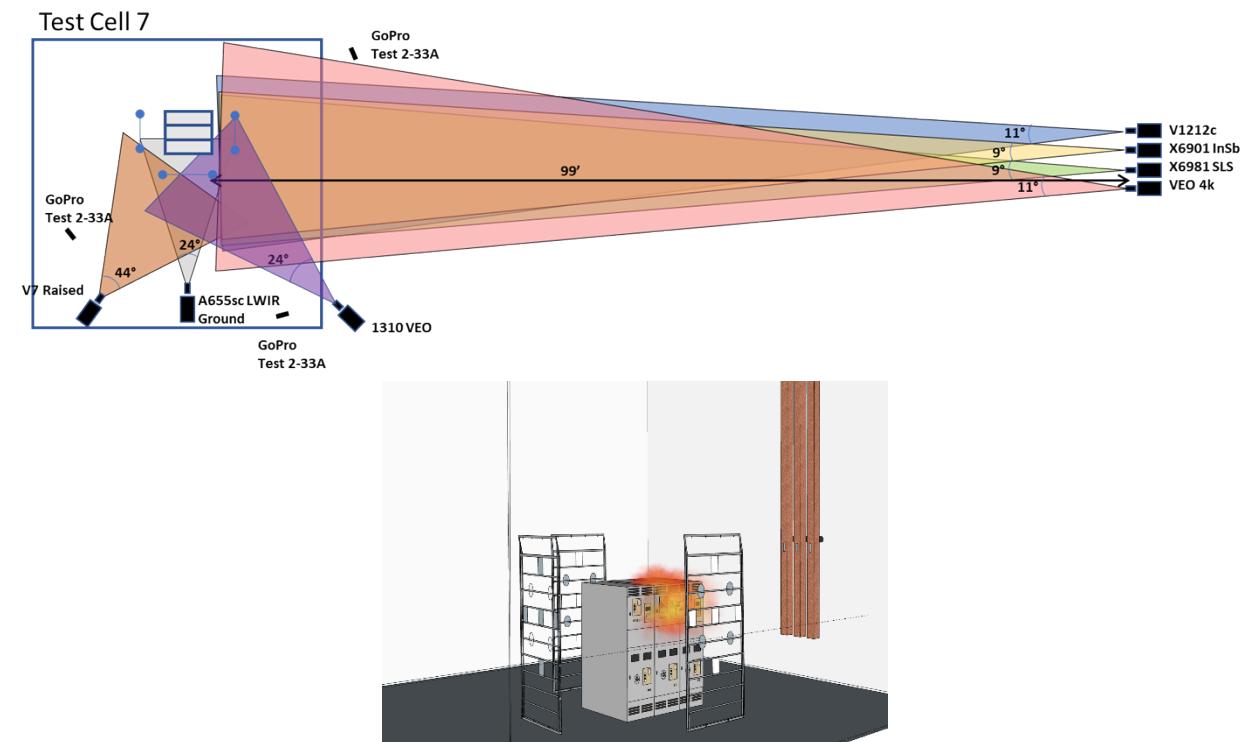
Figure 4-1: Electrical enclosure lineup configuration (Test 2-33A) cameras locations (top) with switchgear enclosure configuration (bottom).

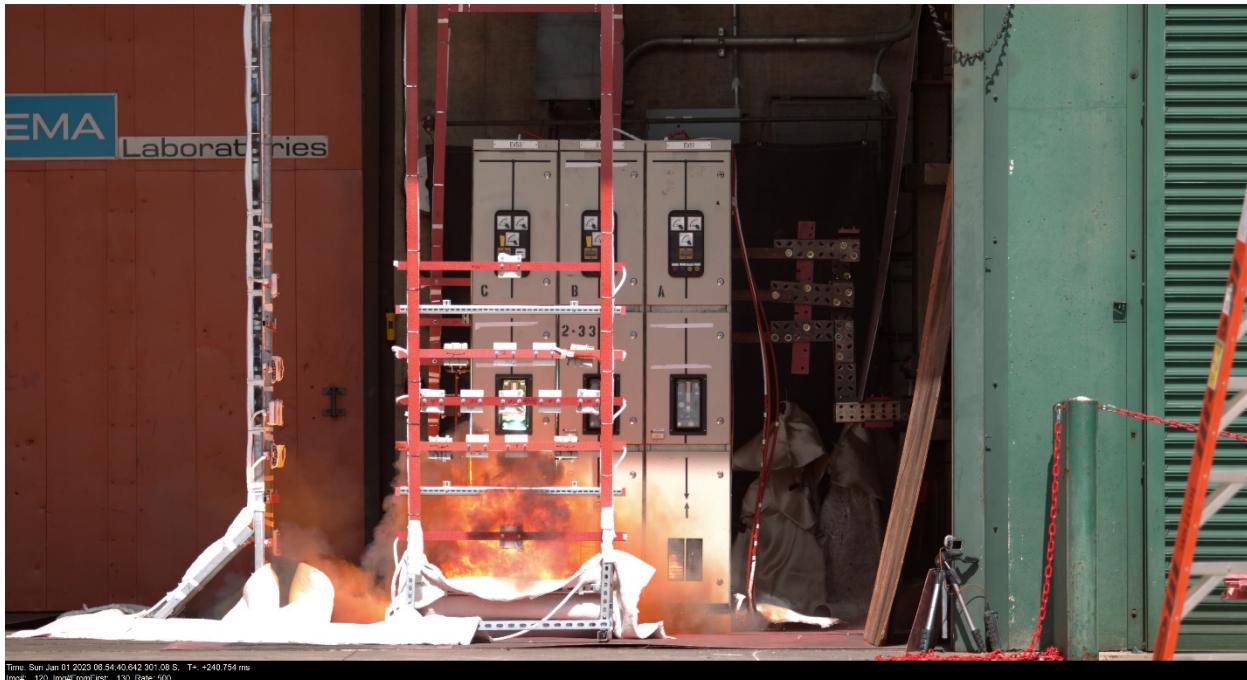
Figure 4-2: Test 2-33A imaged through 4k camera 200 ms into the test – camera imaging at 500 fps.

Figure 4-2 through Figure 4-9 show images of notable features and select events that occurred during Test 2-33A. Note that although the test was planned for 8 seconds, it only lasted 0.5 seconds. The test produced a light brown cloud at the end with some flame out in the front and some hot gases coming from orifices in the back. A breach occurs in the left side of the left switchgear around 350 ms.

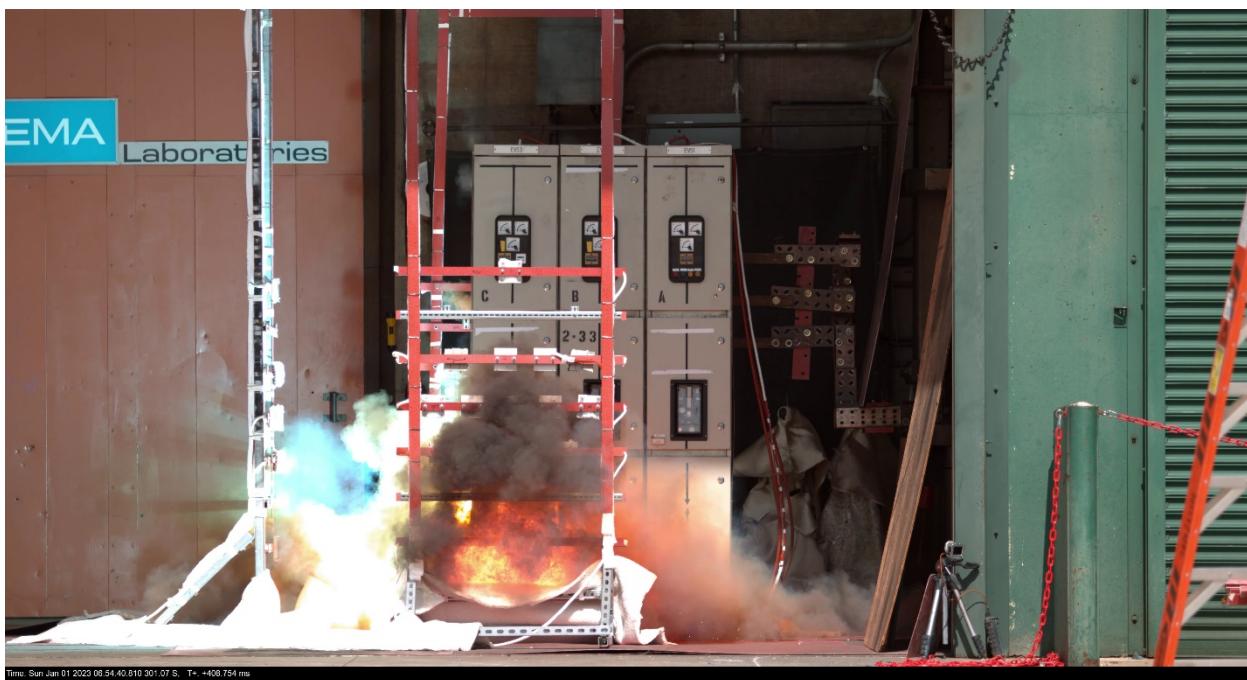
Figure 4-3: Test 2-33A imaged through 4k camera 0.5 second into the test – camera imaging at 500 fps.

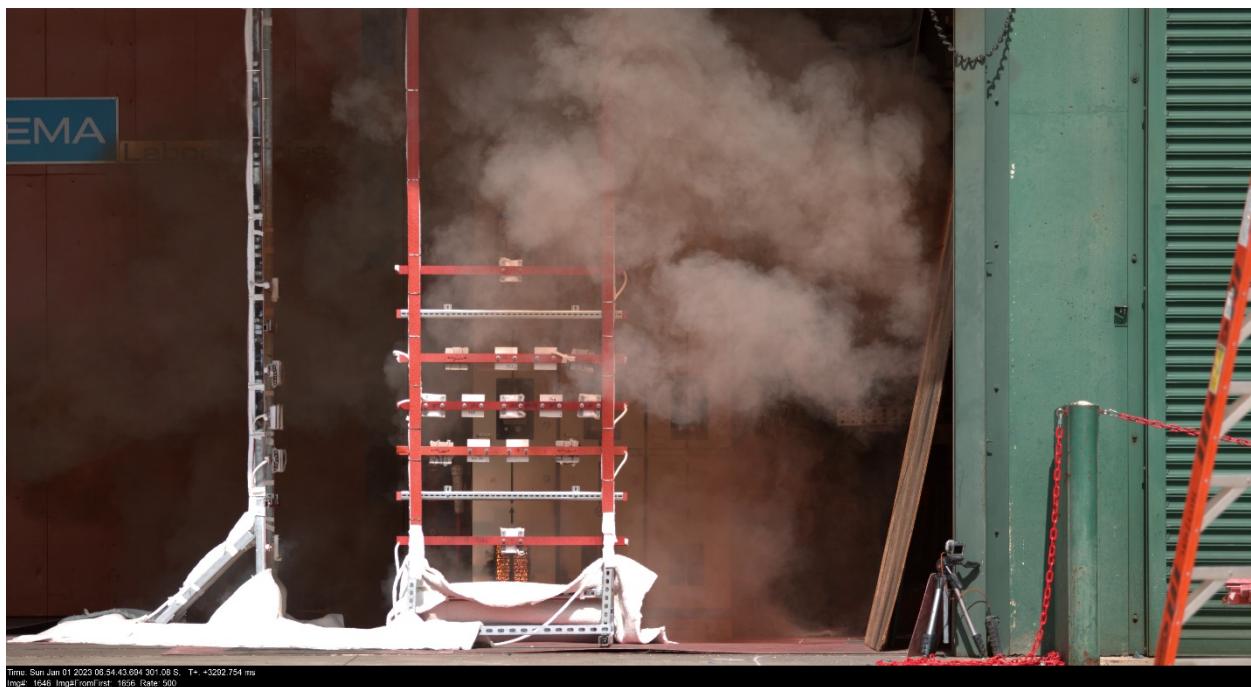
Figure 4-4: Test 2-33A imaged through 4k camera 2.6 seconds after the test finished – camera imaging at 500 fps.

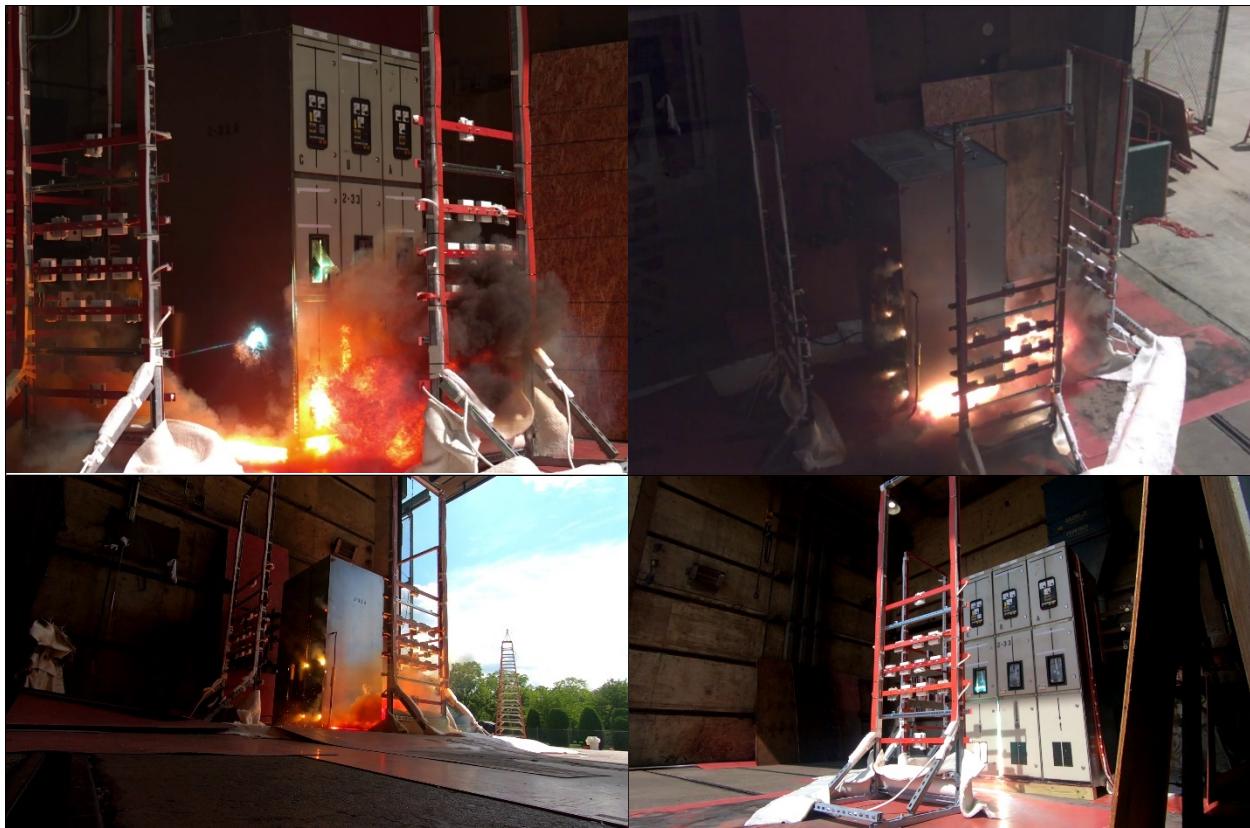
Figure 4-5: From top left (clockwise): v1310 view 350 ms into the test; v7 elevated from the northwest of the test bay, at 300 ms; GoPro inside floor northwest view; GoPro southeast view right at the beginning of the test.

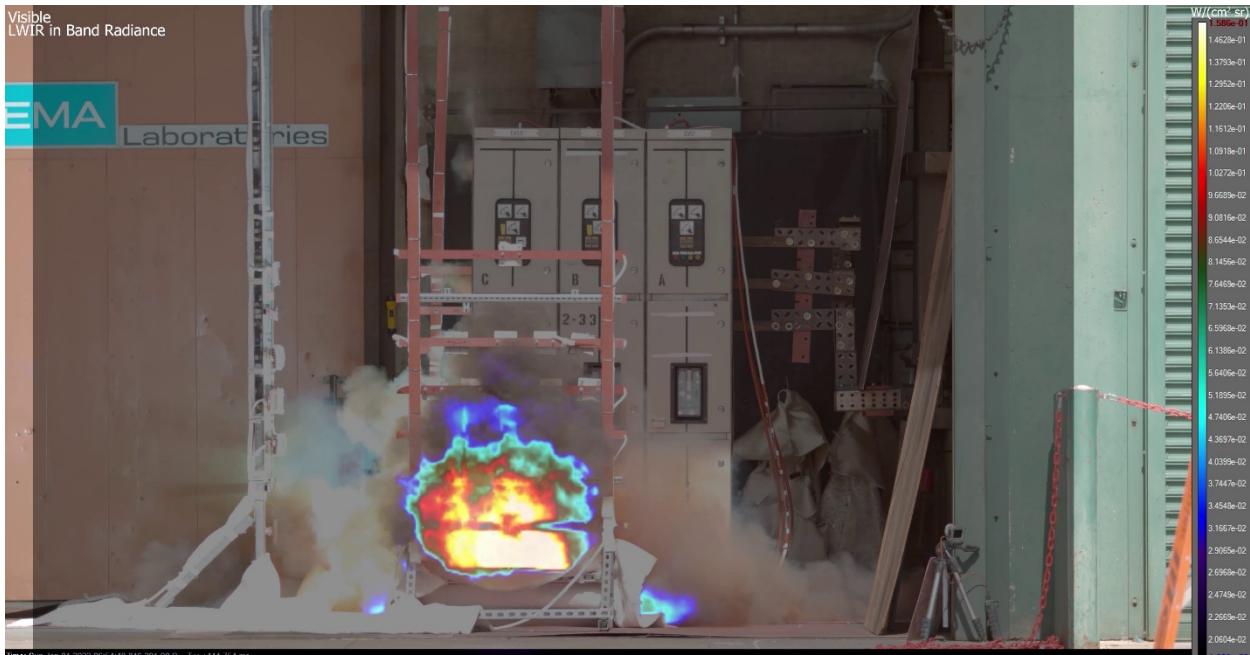
Figure 4-6: Image fusion of IR camera (in radiance units of $\text{W}/\text{cm}^2 \text{ sr}$) synchronized with a visible image 400 ms into the test.

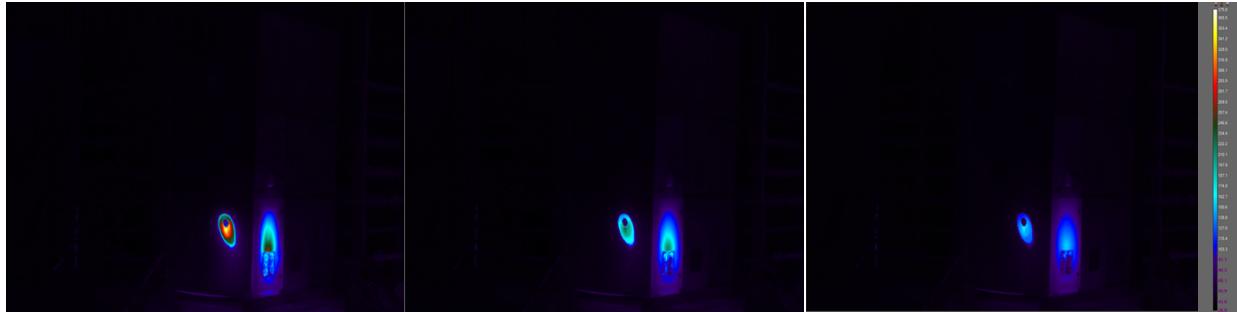
Figure 4-9: Temperature images from the LWIR camera A655 through 1 minute intervals, starting ~1 minute after the test. Arc is induced in the west most enclosure (red hot on top). Temperature ranges from 28.9 to 375 °C.

Another metric that the cameras were able to capture during this test series was the temperature of the enclosure. This data shows the difference that the enclosure material, bus material, and test duration can have on the maximum temperature. This data was collected mostly by the A655sc real-time LWIR camera. For Test 2-40 and Test 2-41 the camera was not available, and some of the data was estimated from the X6901 MWIR and X6981 LWIR cameras. Table 5-1 shows the maximum temperature for a select group of tests, along with their unique test conditions. As shown, the maximum temperature is higher for the tests with aluminum as the bus or enclosure material.

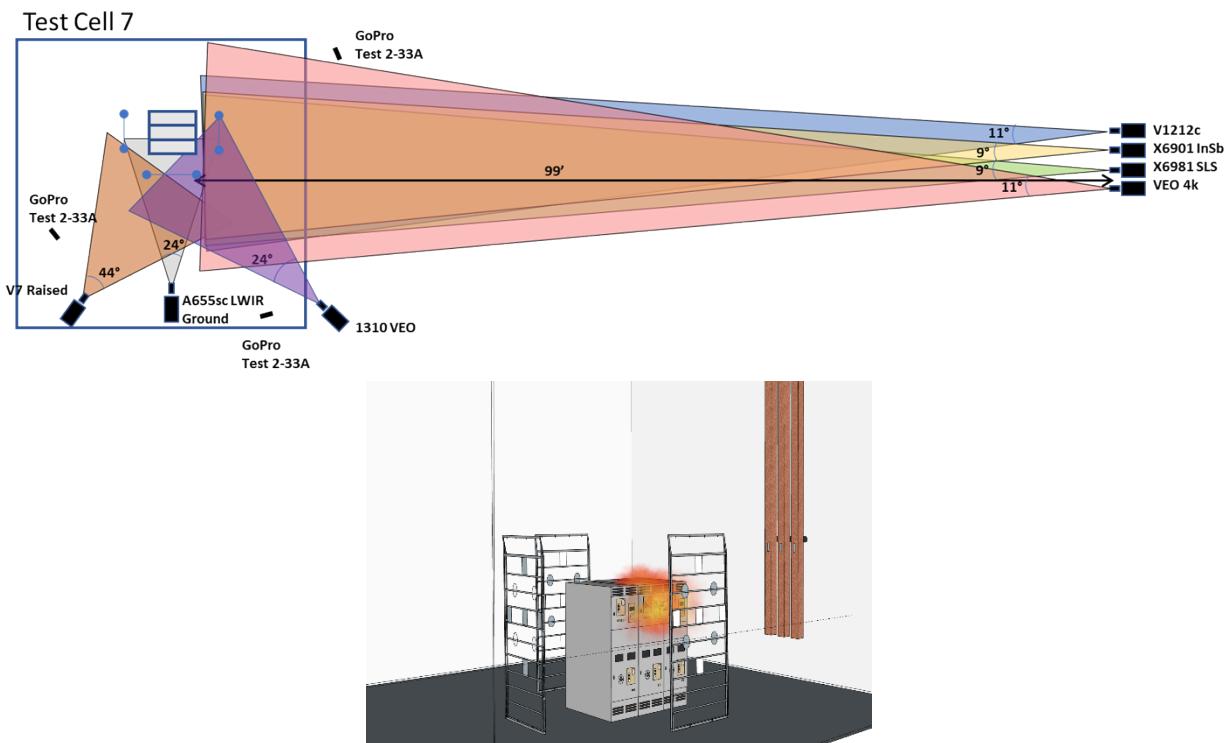
Figure 4-10: Electrical enclosure lineup configuration (Test 2-33B) cameras locations (top) with switchgear enclosure configuration (bottom).

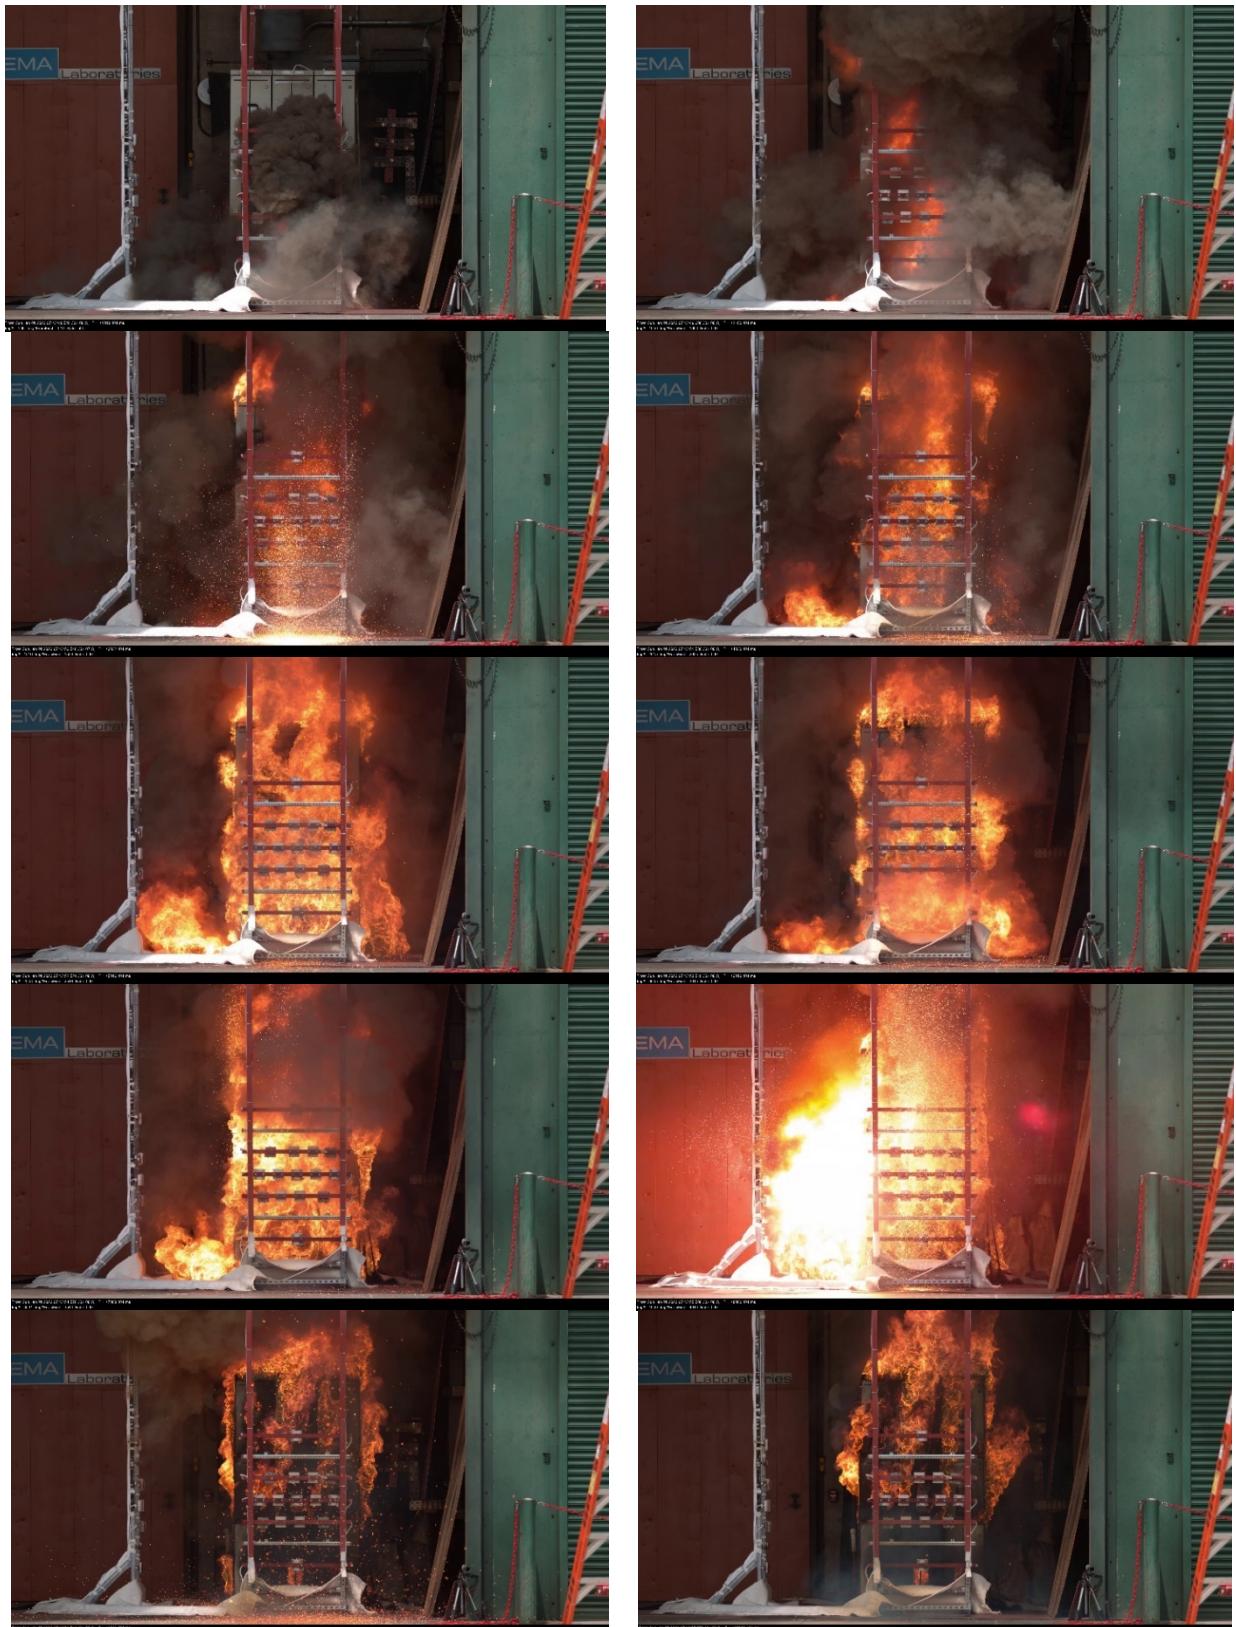
Figure 4-11: Test 2-33B imaged through 4k camera. Test that lasted 8 seconds. Pictures are shown at ~1 second intervals during the test (sequenced left to right, top to bottom) – camera imaging at 500 fps.

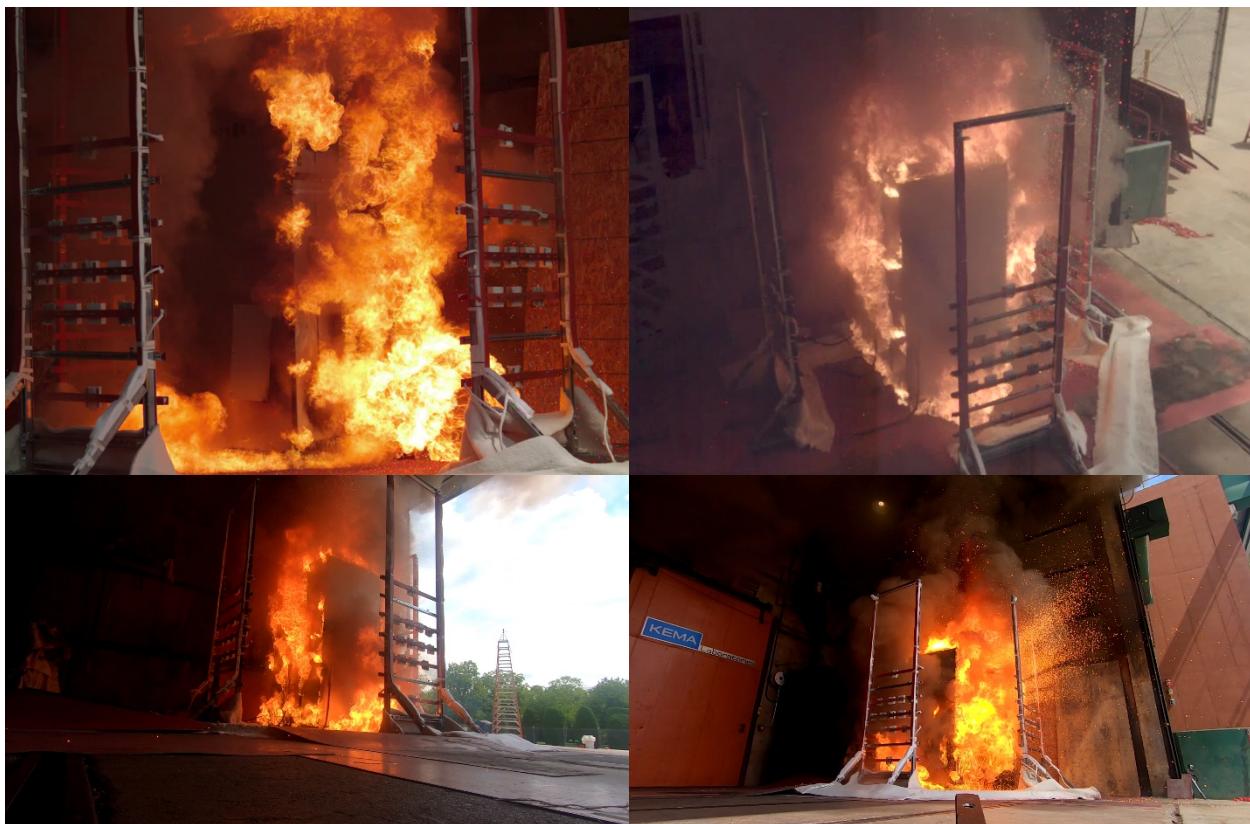
Figure 4-12: From top left (clockwise): v1310 view ~6 seconds into the test; v7 elevated from the northwest of the test bay, at ~7 seconds; GoPro inside floor northwest view; GoPro southwest view in the middle of the test.

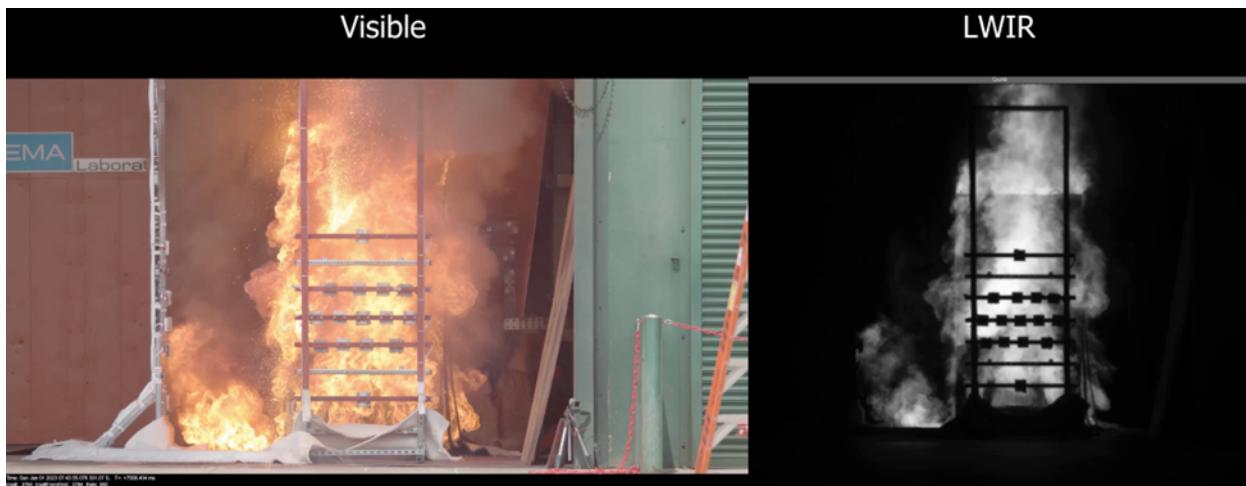
Figure 4-14: Sample frames from synchronized video of 4k and LWIR cameras close to 7.5 seconds into the test. The LWIR image shows heat profile similar to the one collected by the visible camera.

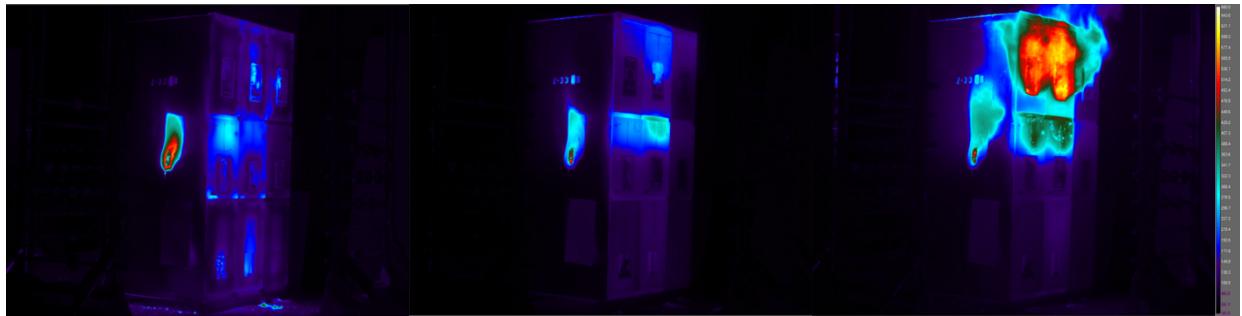
Figure 4-15: Temperature images from the LWIR camera A655 through 8.5 minutes intervals, starting right after the test. Arc is induced in the west most enclosure (red hot on top). Temperature ranges from 38.9 to 660°C.

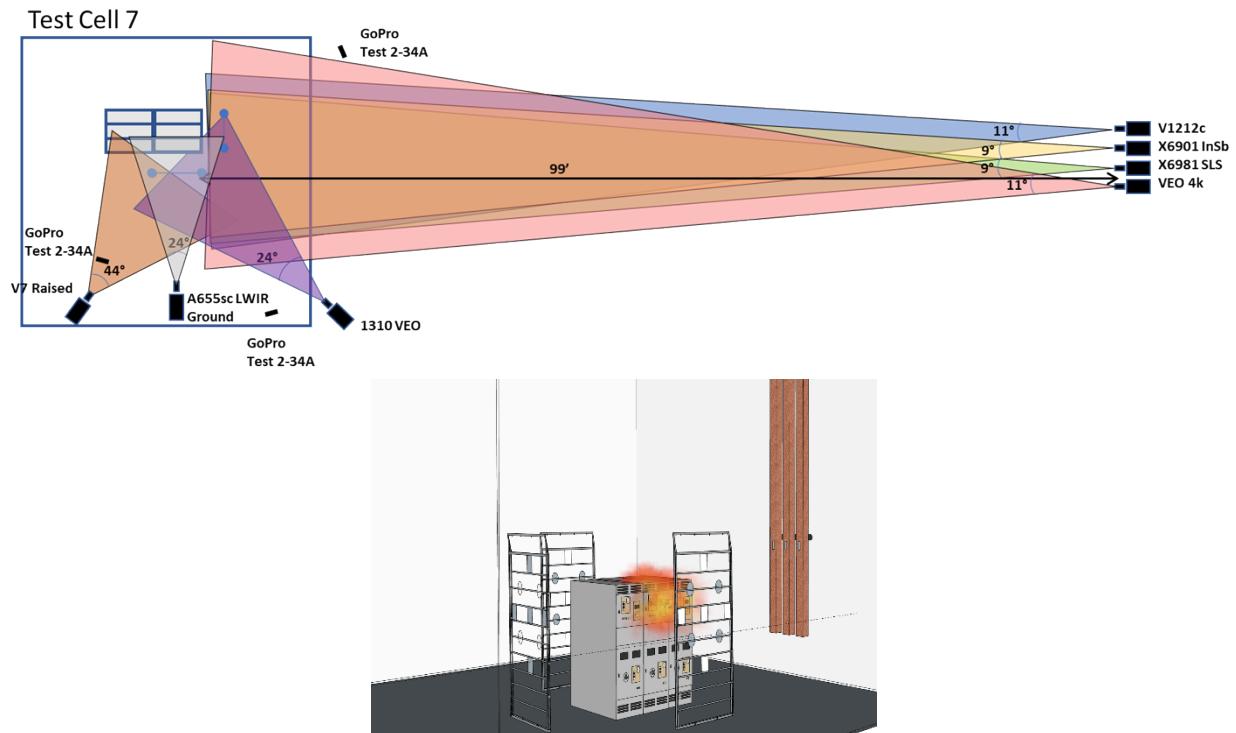
Figure 4-16: Electrical enclosure lineup configuration (Test 2-34A) cameras locations (top) with switchgear enclosure configuration (bottom).

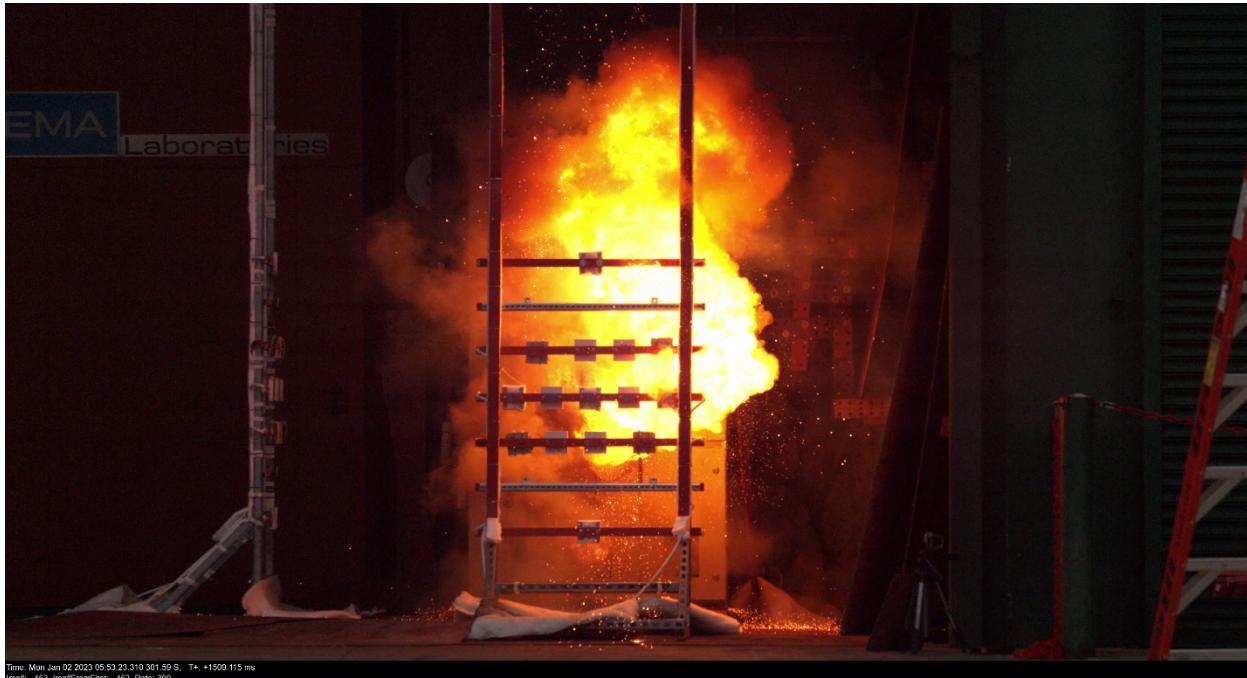
Figure 4-17: Test 2-34 imaged through 4k camera. Test lasted 4 seconds. Picture shows at ~1.5 seconds into the test – camera imaging at 300 fps.

This test starts in the middle switchgear with flameouts early in the test at about 1.6 seconds. The arc passes to the left side switchgear and breaches ~2.45 seconds into the test, filling the test cell with extreme bright light that overwhelms some of the cameras. This seems to indicate that the arc was exposed. The IR cameras show puffs of gases coming out of the two breaches. The first breach points diagonally downward. The second breach starts puffing 300 ms later in a diagonal upward direction from the first one. Figure 4-17 through Figure 4-24 show images of notable features and select events that occurred during Test 2-34A.

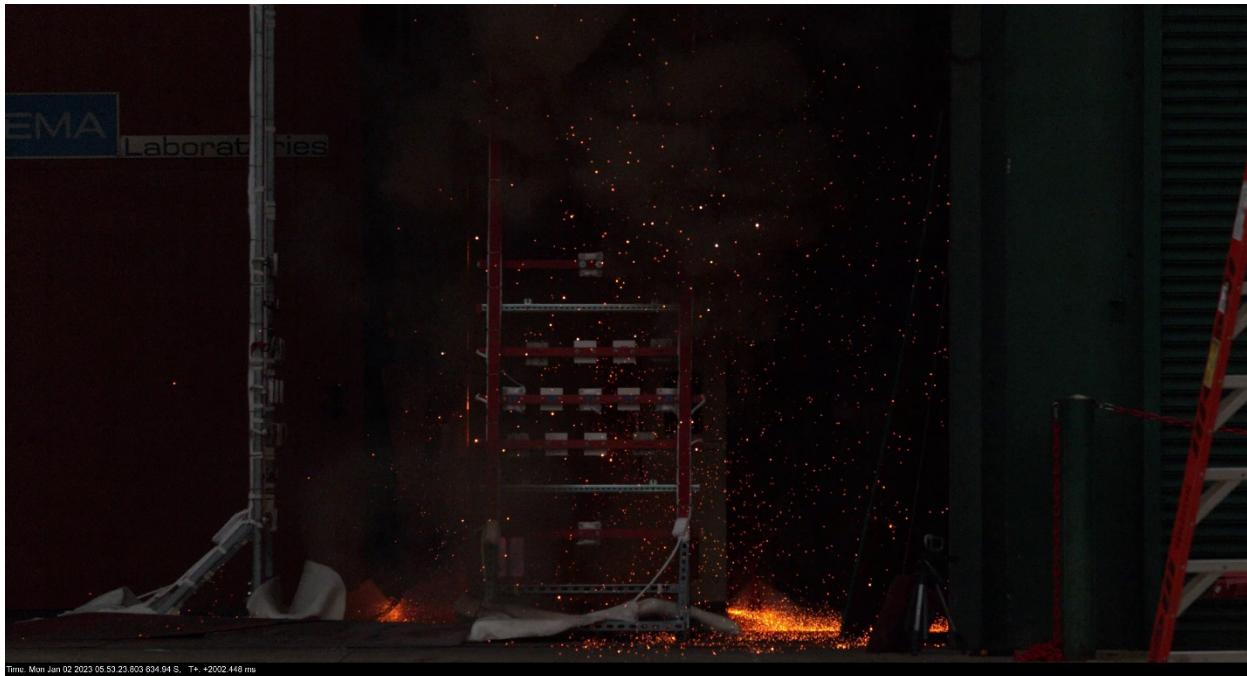
Figure 4-18: Test 2-34 imaged through 4k camera. Test lasted 4 seconds. Picture shows at ~2 seconds into the test – camera imaging at 300 fps.

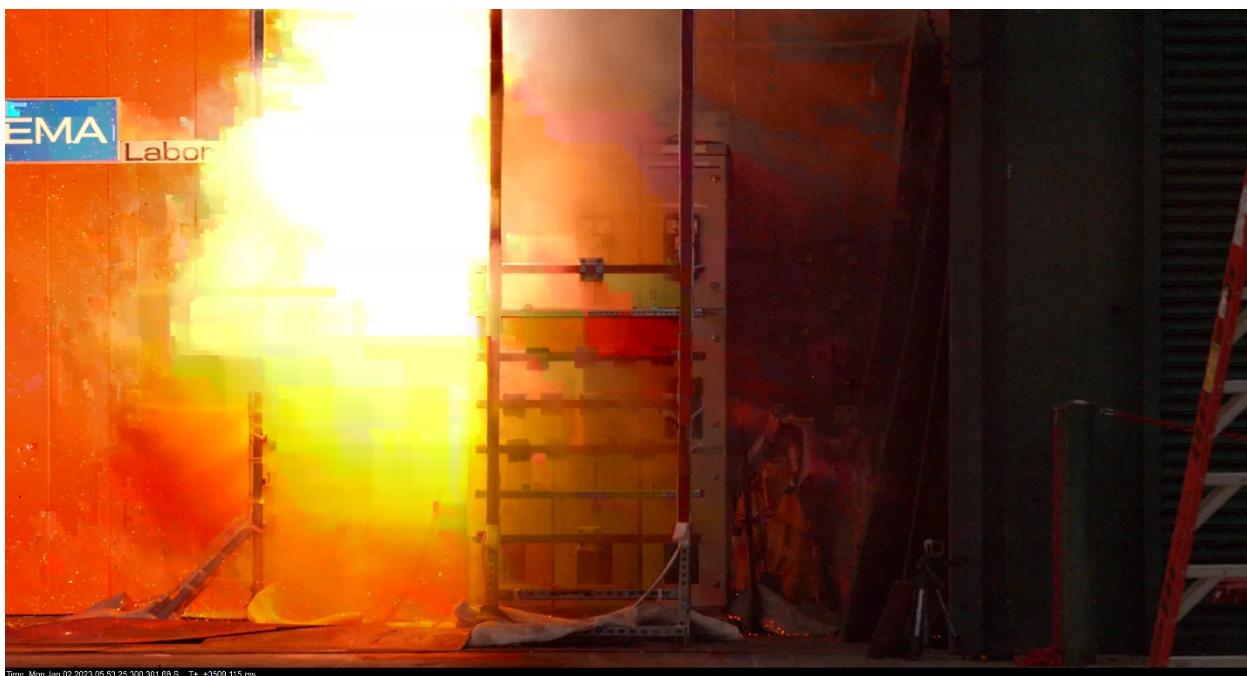
Figure 4-19: Test 2-34 imaged through 4k camera. Test lasted 4 seconds. Picture shows at ~3.5 seconds into the test – camera imaging at 300 fps.

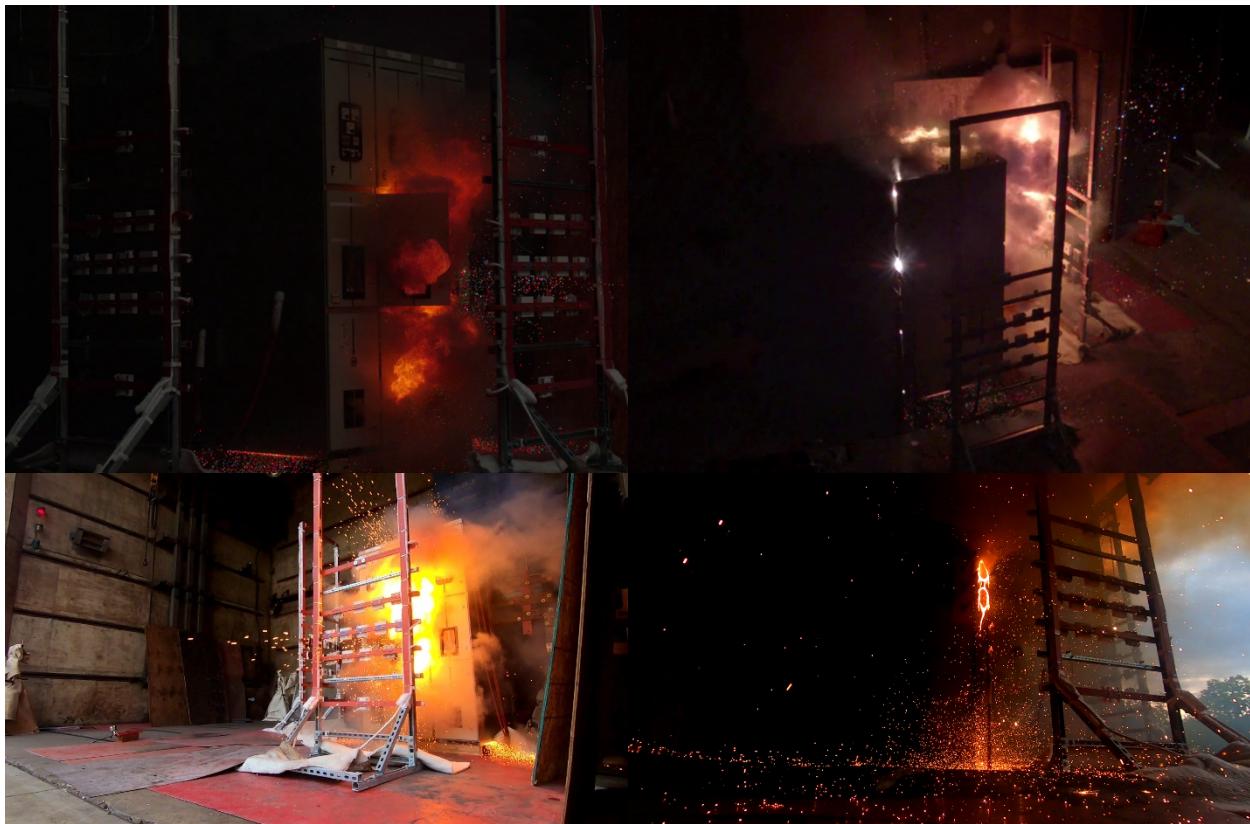
Figure 4-20: From top left (clockwise): v1310 view ~1 second into the test; v7 elevated from the northwest of the test bay, at ~1.5 seconds; GoPro outside floor southeast view early on the test; GoPro northwest view at the end of the test.

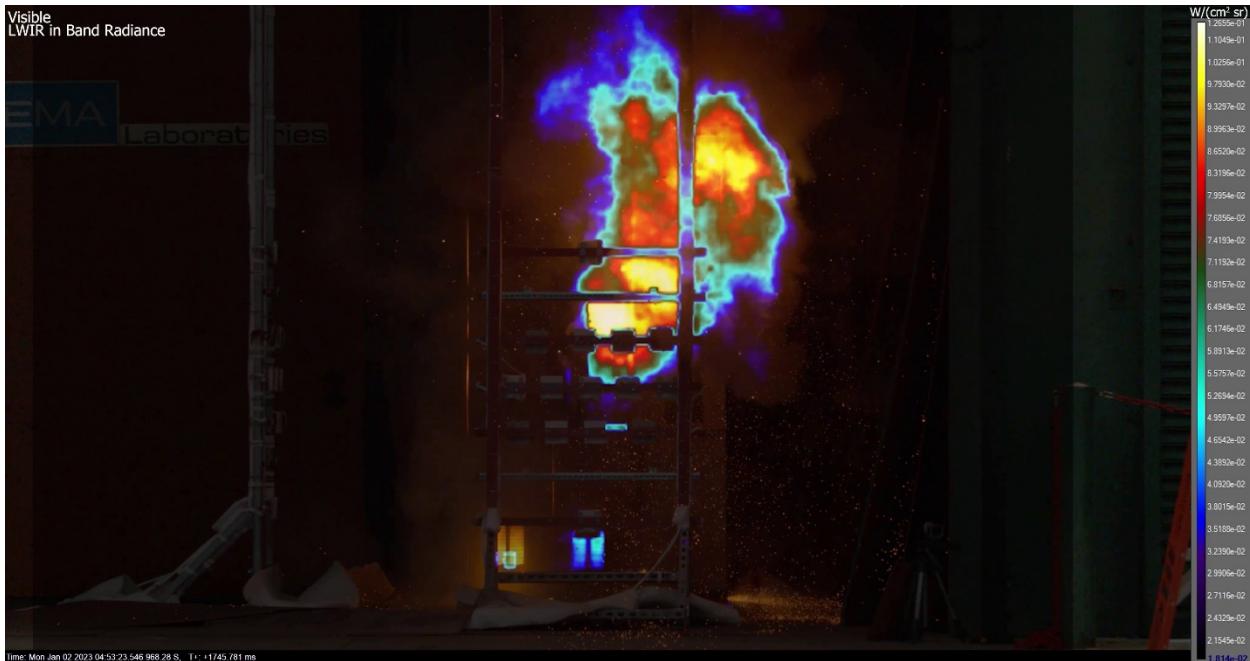
Figure 4-21: Image fusion of IR camera (in radiance units of W/cm² sr) synchronized with a visible image 1.7 seconds into the test.

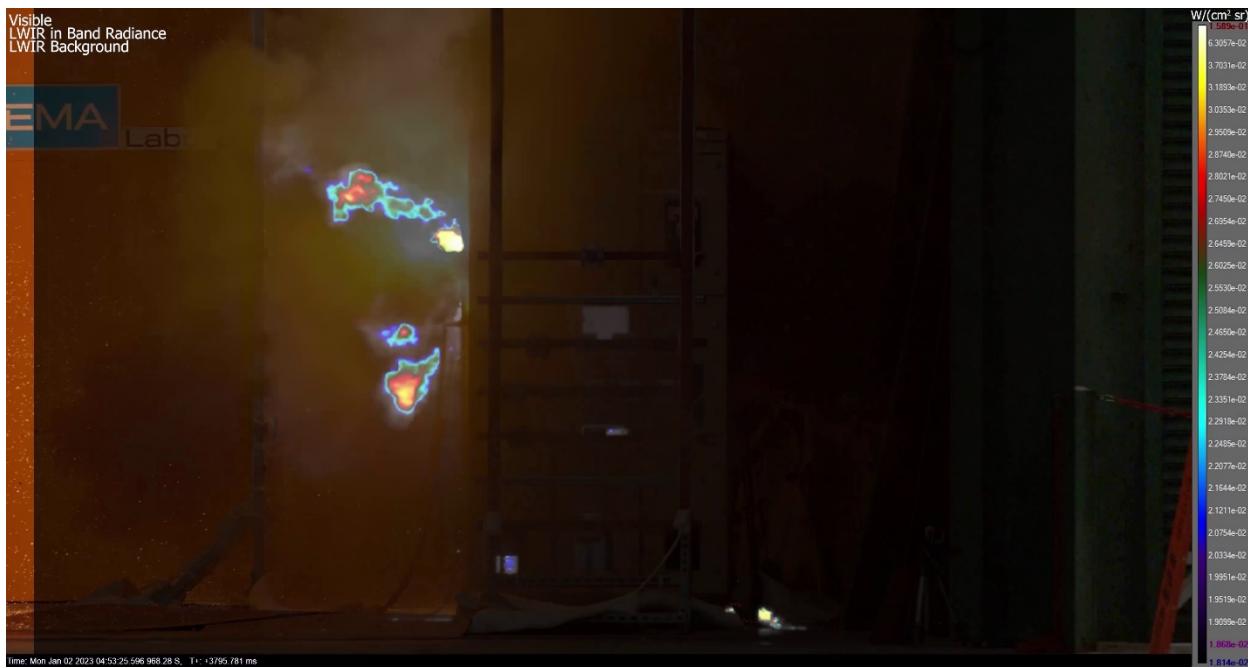
Figure 4-22: Image fusion of IR camera (in radiance units of $\text{W}/\text{cm}^2 \text{ sr}$) synchronized with a visible image 3.8 seconds into the test.

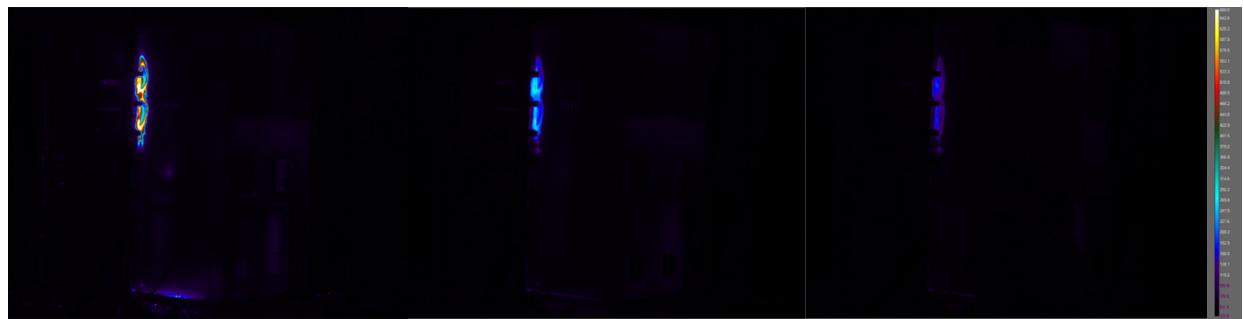
Figure 4-24: Temperature images from the LWIR camera A655 through 2 minutes intervals, starting half a minute after the test. Arc is induced in the west most enclosure (red hot on top). Temperature ranges from 23.89 to 660°C.
