Proceedings of the 20th International  
Symposium on the Packaging and  
Transportation of Radioactive Materials

## DEVELOPMENT OF A DUCTILE RUPTURE FAILURE SURFACE FOR A HIGH-STRENGTH STEEL USING THE XUE-WIERZBICKI FAILURE MODEL

Sandia National Laboratories<sup>1</sup>

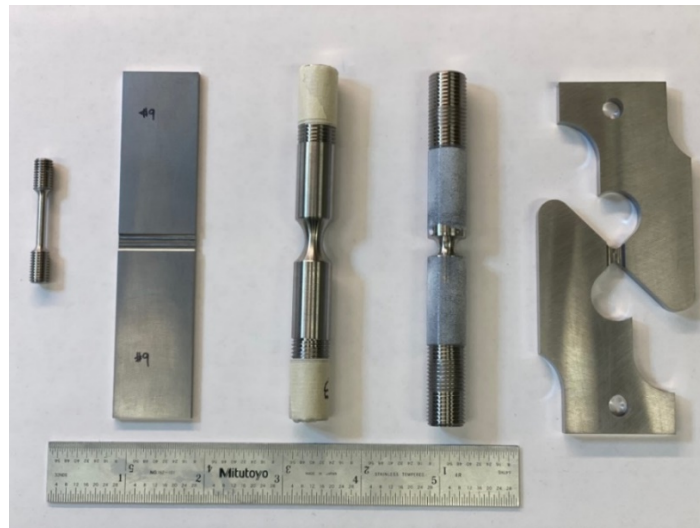
**Figure 1. Test Specimen Geometries (Left to Right: R5, Flat-Groove, 9 mm Notch, 3 mm Notch, and Shear).**

Mechanical tests were conducted [5, 6] to collect the data needed to build a X-W fracture model for PH13-8Mo H950. Tests were conducted at both 20 °C and -40 °C. Five test specimens of differing geometry (Figure 1) were used in the test campaign. The geometries of these specimens are identical to those described in reference [3]. These test specimens vary in both stress triaxiality and deviatoric state parameter as indicated in Table 2. Three of the specimen geometries (R5, 9 mm Notch, and 3 mm Notch) generate stresses with a deviatoric state parameter of approximately 1.0, while the remaining two specimens (Flat-Groove and Shear) generate stresses with a deviatoric state parameter of approximately 0.0. All test specimens were extracted from a cylindrical ring of material with their primary tensile axis oriented parallel to the axis of the cylinder. A duplicate set of R5 specimens were created from the same ring of material with their primary tensile axis oriented radially. This duplicate set of R5 specimens was used to characterize any anisotropy in the material response.

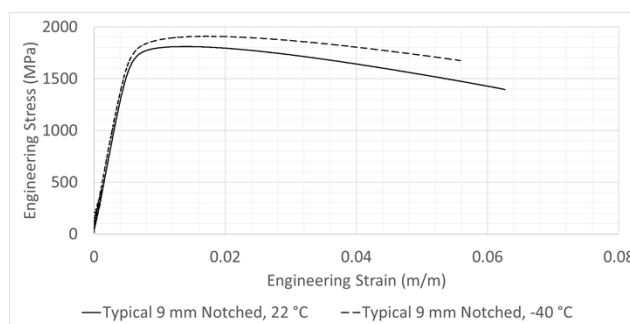
a) Test Setup

b) Stress-Strain Curves

c) Fracture Location (22 °C)

d) Failure Surface of a 3 mm Notch  
Specimen Tested at 22 °C

e) Failure Surface of a 3 mm  
Notch Specimen Tested at -40 °C

**Figure 3. 9 mm Notch Specimen Test Setup and Typical Test Results.**

The 9 mm notch test specimens exhibited modestly different mechanical behaviors at the two tested temperatures. The UTS and YS of specimens tested at -40 °C was 3% to 5% greater than those tested at 22 °C, whereas the ductility and RA were slightly lower. The fracture surfaces of the 9 mm notch specimens tested at both temperatures are characteristic of ductile, cup and cone fracture, with no significant differences observed between the fracture surfaces of specimens tested at 22 °C and -40 °C (Figure 3d and e).

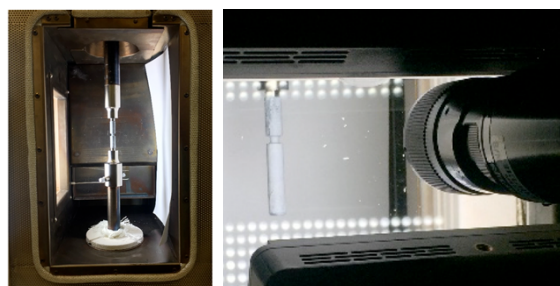
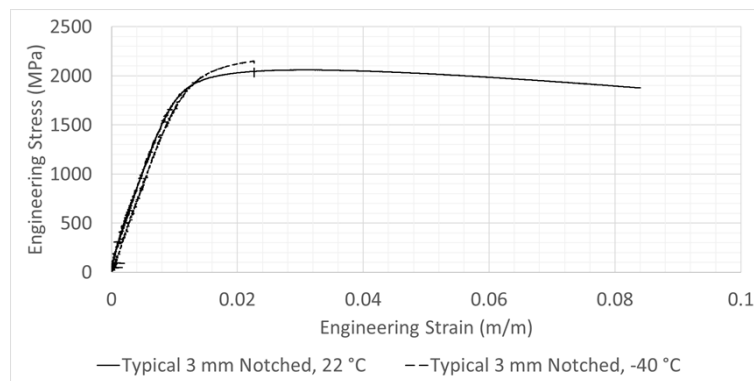
a) Test Setup

b) Stress-Strain Curves

c) Fracture Location (22 °C)

d) Failure Surface of a 3 mm Notch Specimen Tested at 22 °C

e) Failure Surface of a 3 mm Notch Specimen Tested at -40 °C

**Figure 4. 3 mm Notch Specimen Test Setup and Typical Test Results.**

The 3 mm notch test specimens exhibited significantly different mechanical behaviors at the two tested temperatures. While the UTS and YS at -40 °C was 4% to 5% greater than at 22 °C, the ductility was 66% lower and RA was 75% lower. Fracture surfaces of samples tested at 22 °C suggest ductile fracture, exhibiting cup and cone type failure (Figure 4d) like those observed in the R5 samples. Samples tested at -40 °C suggest ductile fracture, but also exhibit features reminiscent of brittle failure including indications of trans-granular fracture and significantly smaller shear lips (Figure 4e).

In general, fracture surfaces of all samples exhibited ductile failure features, including those from the 3 mm notch samples, although the 3 mm notch samples tested at -40 °C also included features typical of brittle cleavage, suggesting a combination of failure mechanisms. Images of the fracture surfaces of the 3 mm notch specimens indicate a transition in fracture mechanism from one dominated by void nucleation, growth, and coalescence at room temperature to a mix of brittle cleavage and void nucleation, growth, and coalescence at -40 °C. This suggest that the ductile-to-brittle transition temperature for PH13-8Mo H950 is near -40 °C.

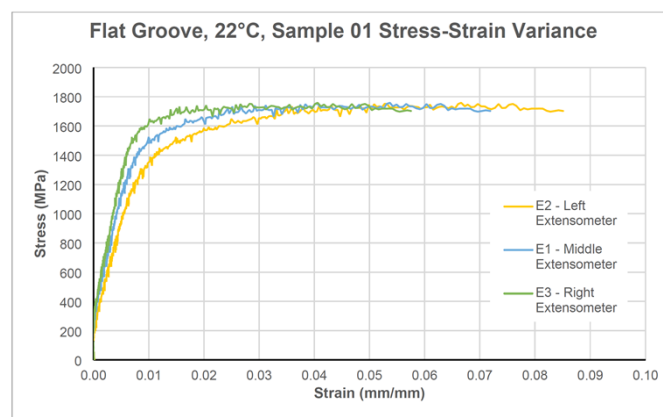
a) Test Setup

b) Stress-Strain Curves

c) Fracture Location (22 °C)

**Figure 5. Flat-Grooved Specimen Test Setup and Typical Test Results.**

The flat-grooved specimens, like the other specimens tested, had an UTS at -40 °C approximately 4% greater than at 22 °C. The YS varied significantly ( $\pm 4\%$ ) specimen-to-specimen so it is not possible to conclude if YS varied with temperature. Strain across the width of the specimen varied significantly (Figure 5d), with the strains differing across the width by 3% to 4%. Full-field strain data indicate strain localization would occur on one side of the sample before fracture (Figure 5d). Little difference was observed in the fracture surfaces of samples tested at 22 °C and -40 °C.

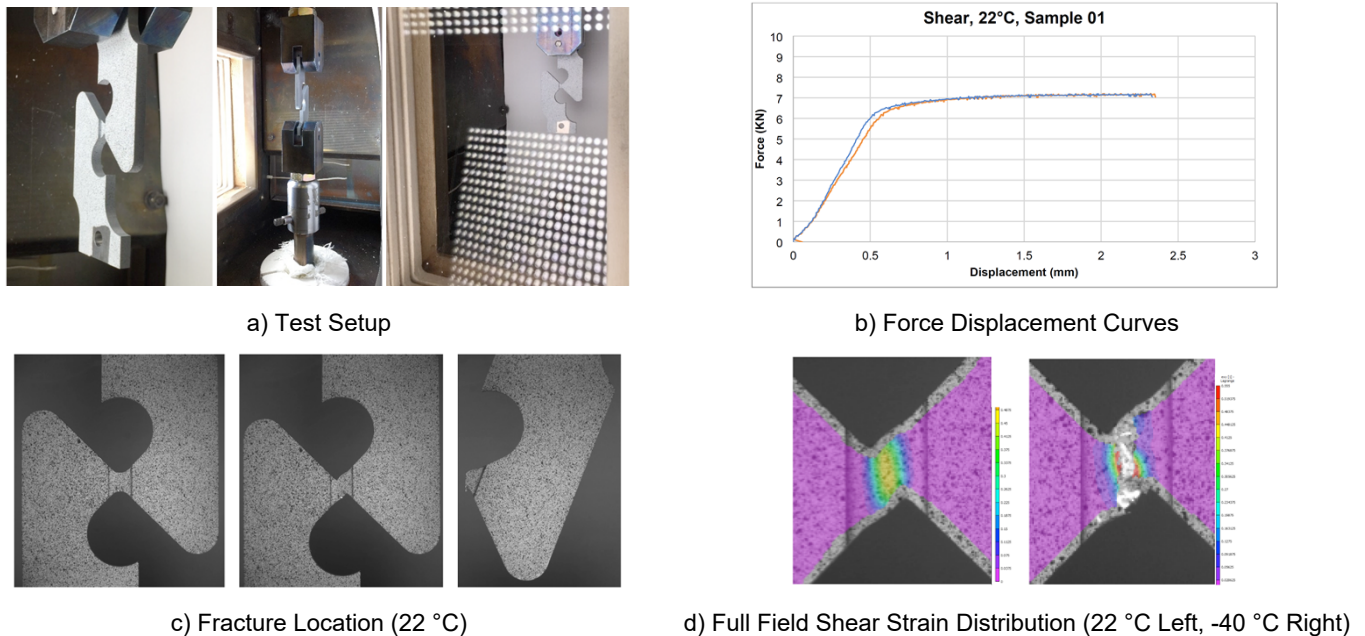
**Figure 6. Shear Specimen Test Setup and Typical Test Results.**

For the shear specimens, the ultimate tensile and yield forces increased with decreasing test temperature, with no measurable decrease in ductility. Shear dimples were observed across the fracture surfaces of specimens tested at both temperatures.

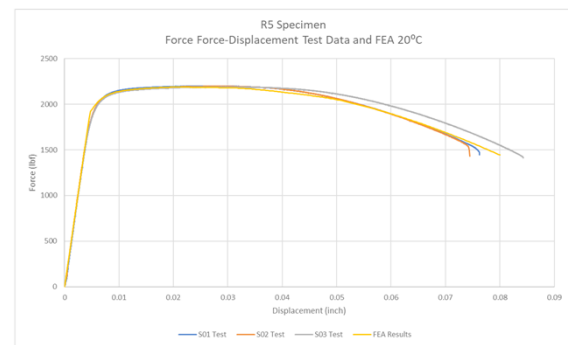
a) Hardening Curve.

b) Comparison of FEM and Test Data.

**Figure 7. Room Temperature Hardening Curve Developed from R5 Tensile Test Data and Comparison of the Resulting FEM Response with the Test Data.**

To develop the material hardening curves from the R5 specimen data, an automated fitting process was employed. FEM simulations were completed using the non-linear, implicit, transient-dynamics module within Sandia National Laboratories' Sierra Solid Mechanics (SIERRA/SM) finite element code [7]. Figure 7 shows the room temperature true-stress vs. true-strain hardening curve developed from the R5 specimen test data, and a comparison of the resulting force vs. displacement response of the FEM with the test data.
