FY22 Status Update: SNF Interim Storage Canister Corrosion and Surface Environment Investigations

Spent Fuel and Waste Disposition

M2SF-22SN010207056

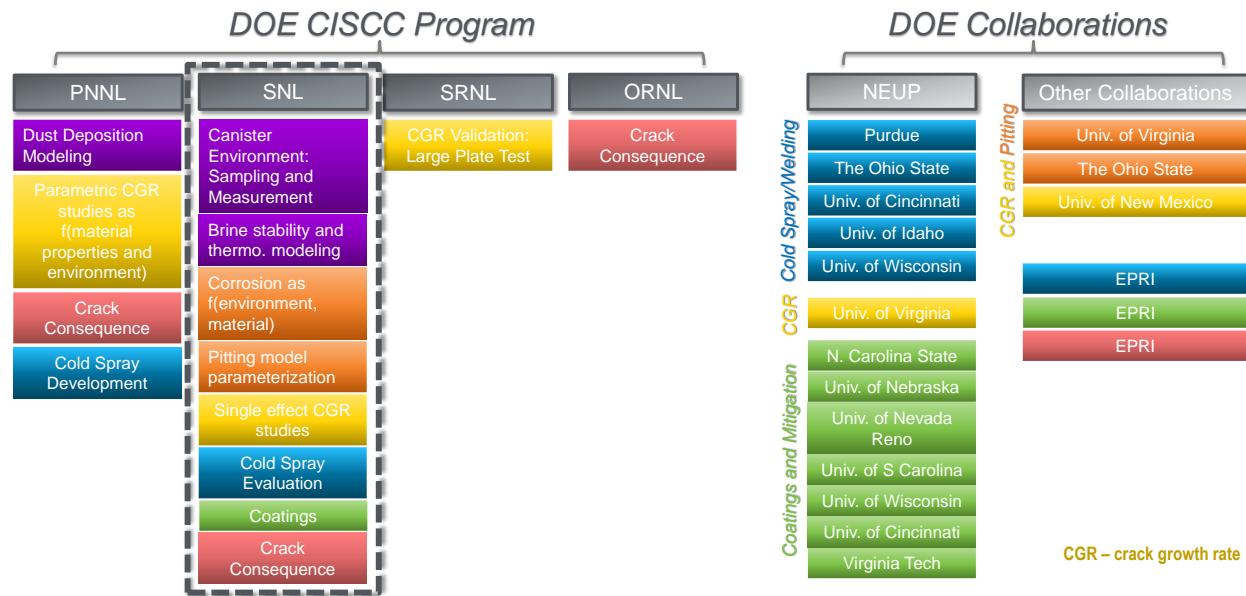
Figure 1. Experimental work on canister SCC currently being carried out by SNL, other national laboratories, and collaborators.

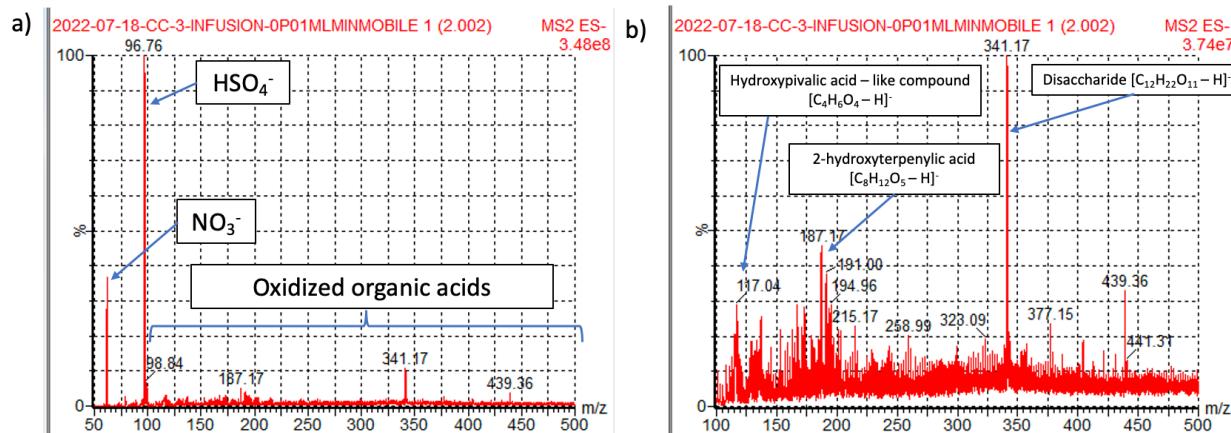
Figure 4. a) Mass spectrum obtained from the analysis of C-3 and b) mass spectrum zoomed into 100- 500 m/z showing the peaks associated with the organic acids from sample C-3.

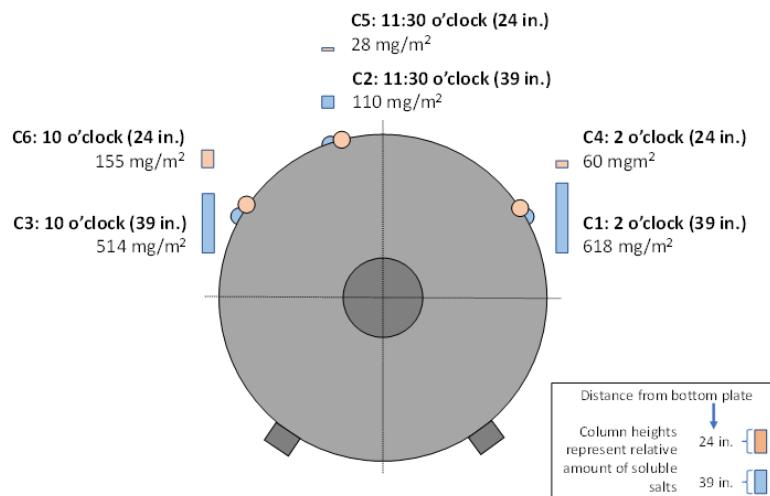
Figure 5. Total soluble salt loads (mg/m^2) at each sampled location.

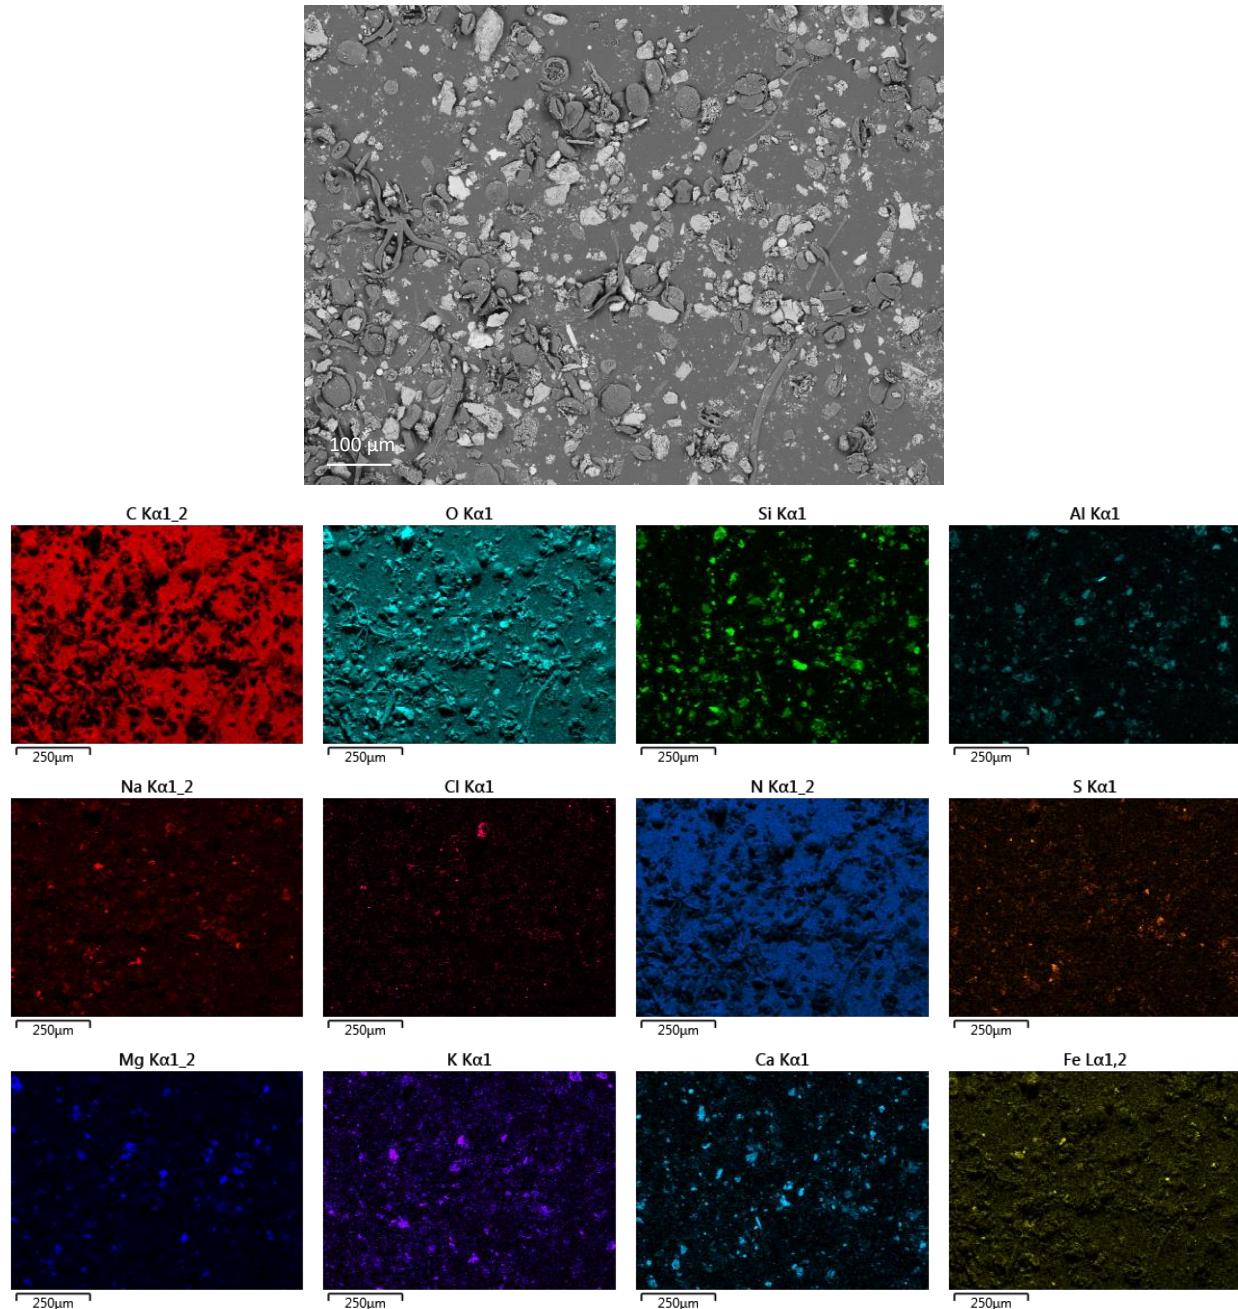
Figure 8. SEM BSE image and EDS element maps for a region on the sample C-3 Biotape™. Image shows mineral grains and organic particles and fibers. Chloride-rich grains were then evaluated at higher magnification to determine morphology and mineralogy.

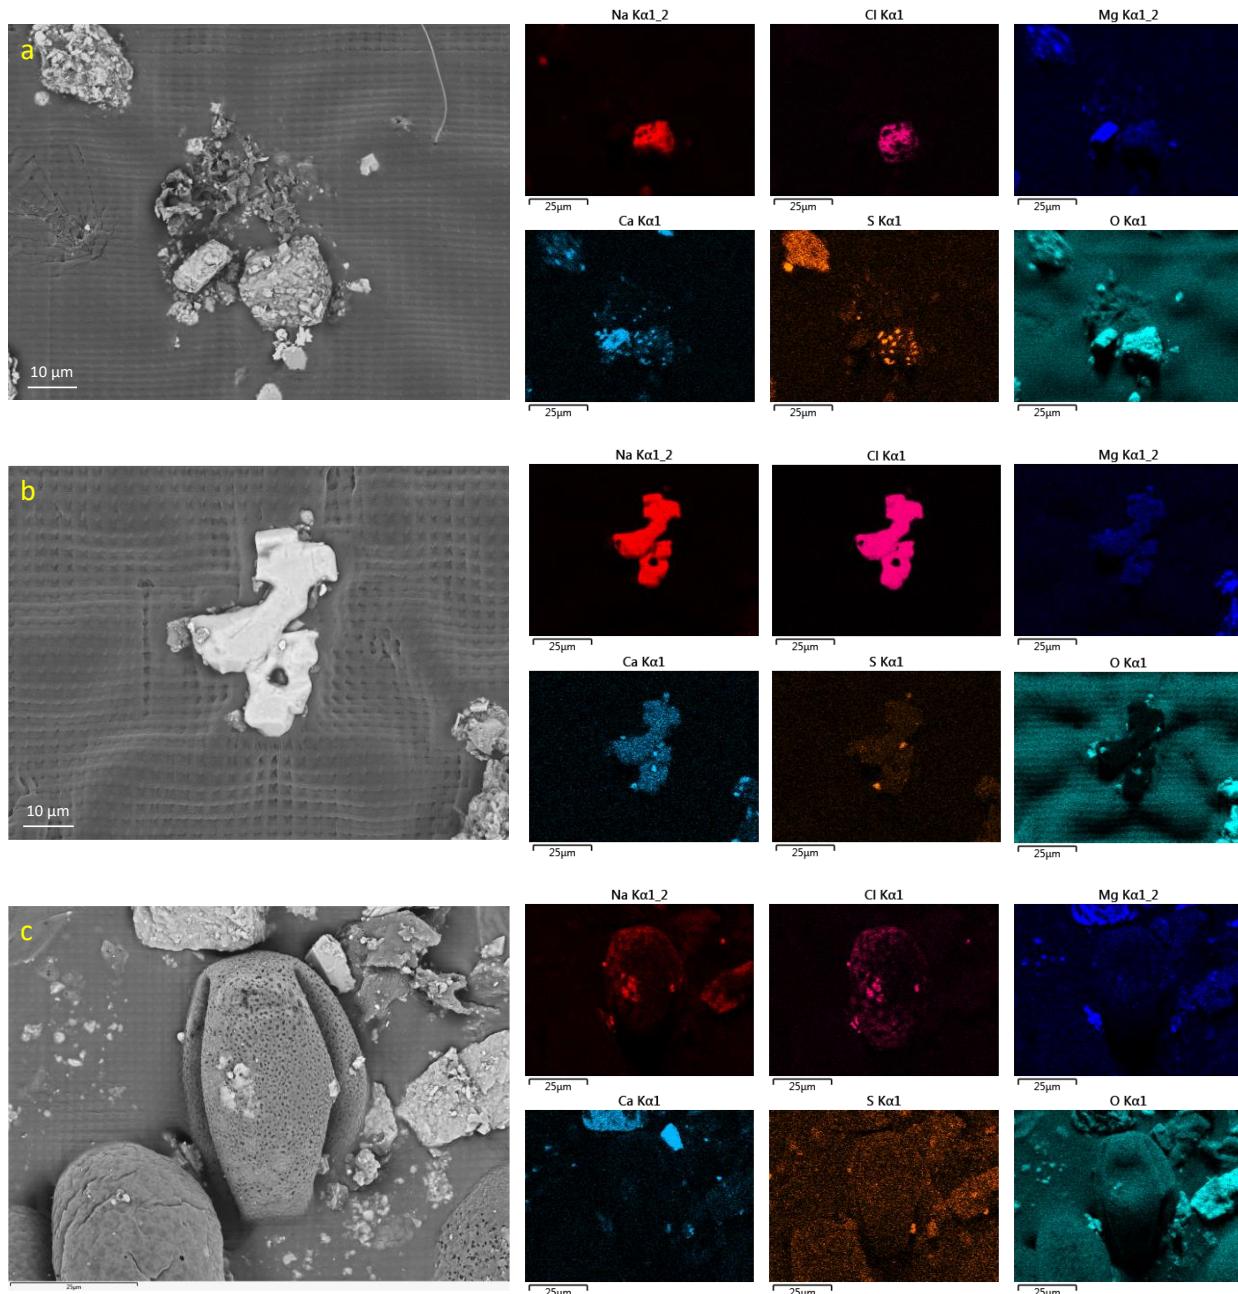
Figure 9. SEM BSE images and EDS element maps of sea-salt aggregates. a) Sample C-1. Euhedral halite cube decorated with small calcium sulfate crystals. Adjacent grain is detrital dolomite, $\text{CaMg}(\text{CO}_3)_2$. b) Sample C-3. Large, heavily corroded halite grain with a few small grains of calcium sulfate. c) Sample C-3. Halite plating out on a pollen grain. Note that other sea-salt components do not appear to be present.

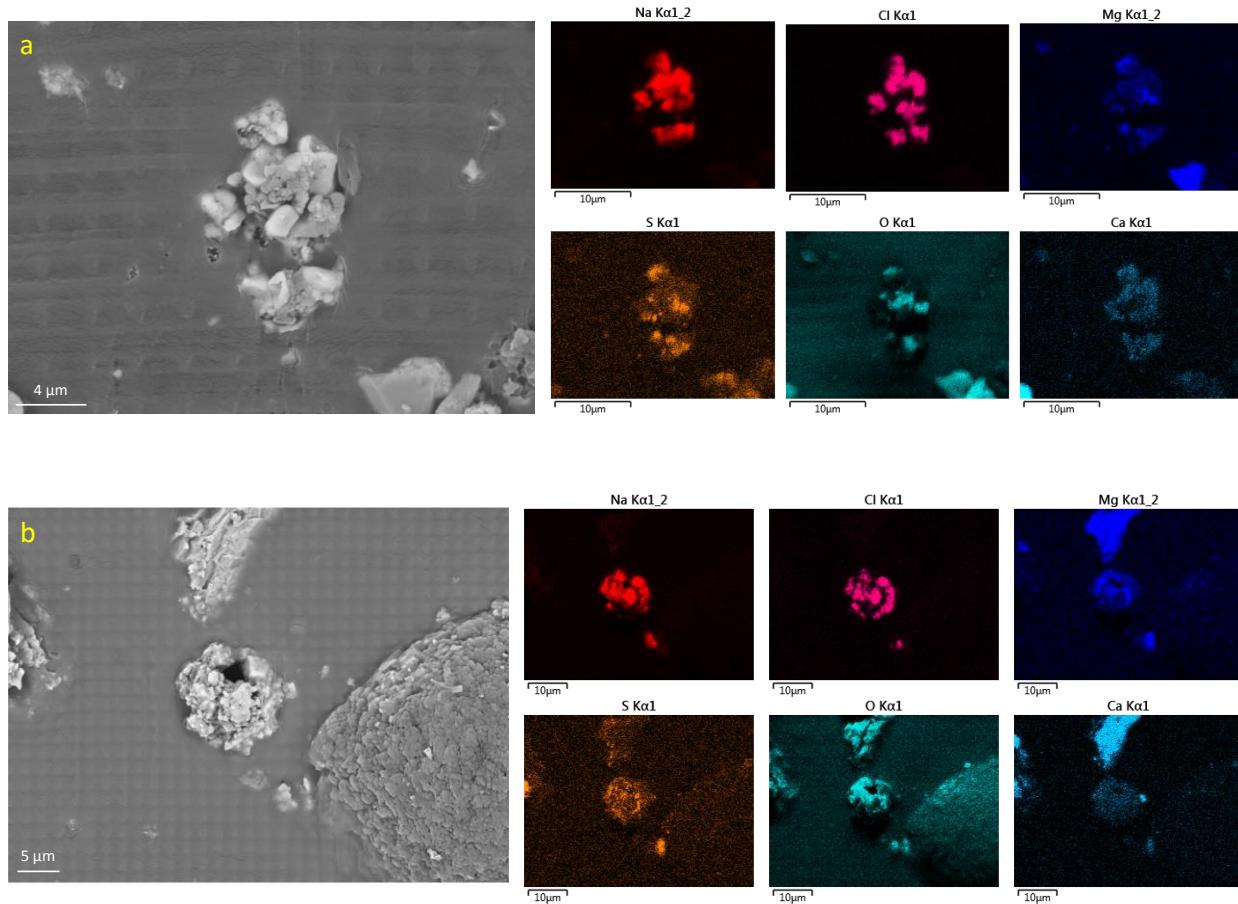
Figure 10. SEM BSE images and EDS element maps of sea-salt aggregates, consisting of NaCl and Mg-SO₄. a) Sample # C-1. Note that the grain was crushed when the BiotapeTM was applied. b) Sample #C-3. Sea-salt aggregate showing typical spherical morphology.

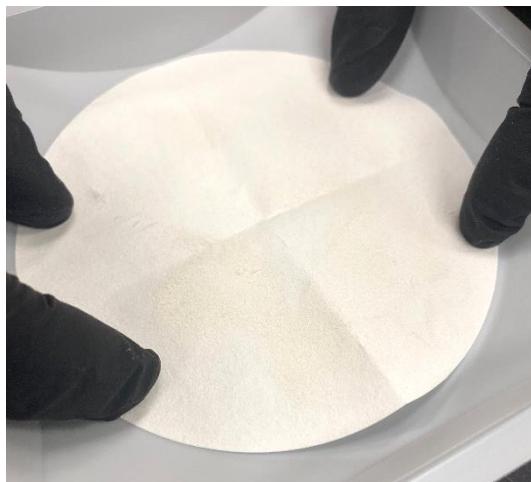
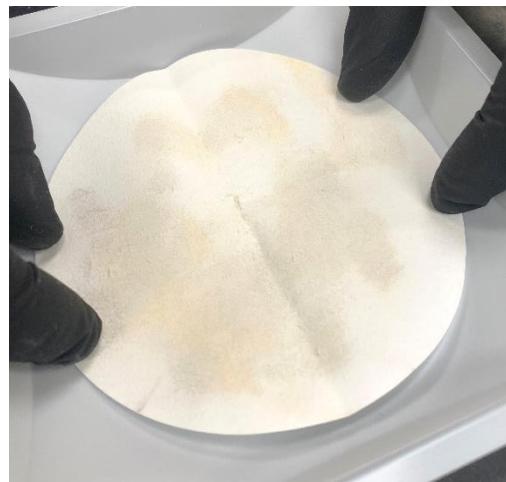
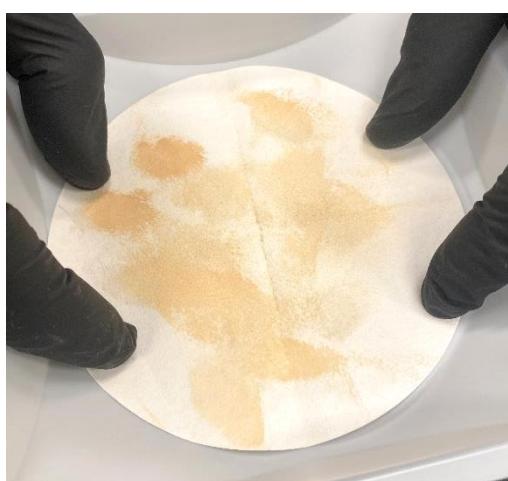
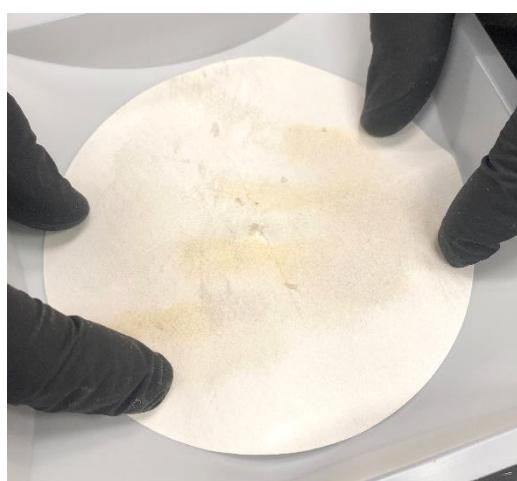
The swipe samples were collected on 11 cm diameter filters, which were then folded and placed in sealable plastic baggies, and then sealed within a plastic Tupperware® style container containing desiccant cartridges to eliminate moisture. The samples were shipped overnight to SNL, where they were counted using gamma spectroscopy to ensure that they were not radioactive. Then, the samples were removed from the baggies, unfolded, and photographed. Sample photos are shown in Figure 11. Each pad was significantly abraded from being rubbed across the metal surface of the outlet vents and was discolored; one pad, YR-3, had pale rust-like stains. A whitish residue was observed on all samples.

Figure 11. Photographs of the filters after collection of the canister dust at Yankee Rowe.

During leaching of the Yankee Rowe filters, a small segment of one filter, YR-4, was collected and retained for SEM analysis. After coating with Au/Pd to minimize charging, the sample was imaged using BSE imaging. Typical images of the dust are shown in Figure 14. Although a few large detrital mineral grains are present, the dust consists almost entirely of submicron-sized grains adhering to the filter fibers. Based on the chemistry, they are mostly calcium sulfate and calcium carbonate. One possible source for these particles is concrete efflorescence, which was observed deeper into the vents; however, when observed previously, efflorescence is coarsely crystalline as opposed to being very fine particles. The size and morphology of the particles on the Yankee Rowe filters suggests that they are atmospheric aerosols. The particles were too fine to analyze by EDS (the electron beam interaction volume is several

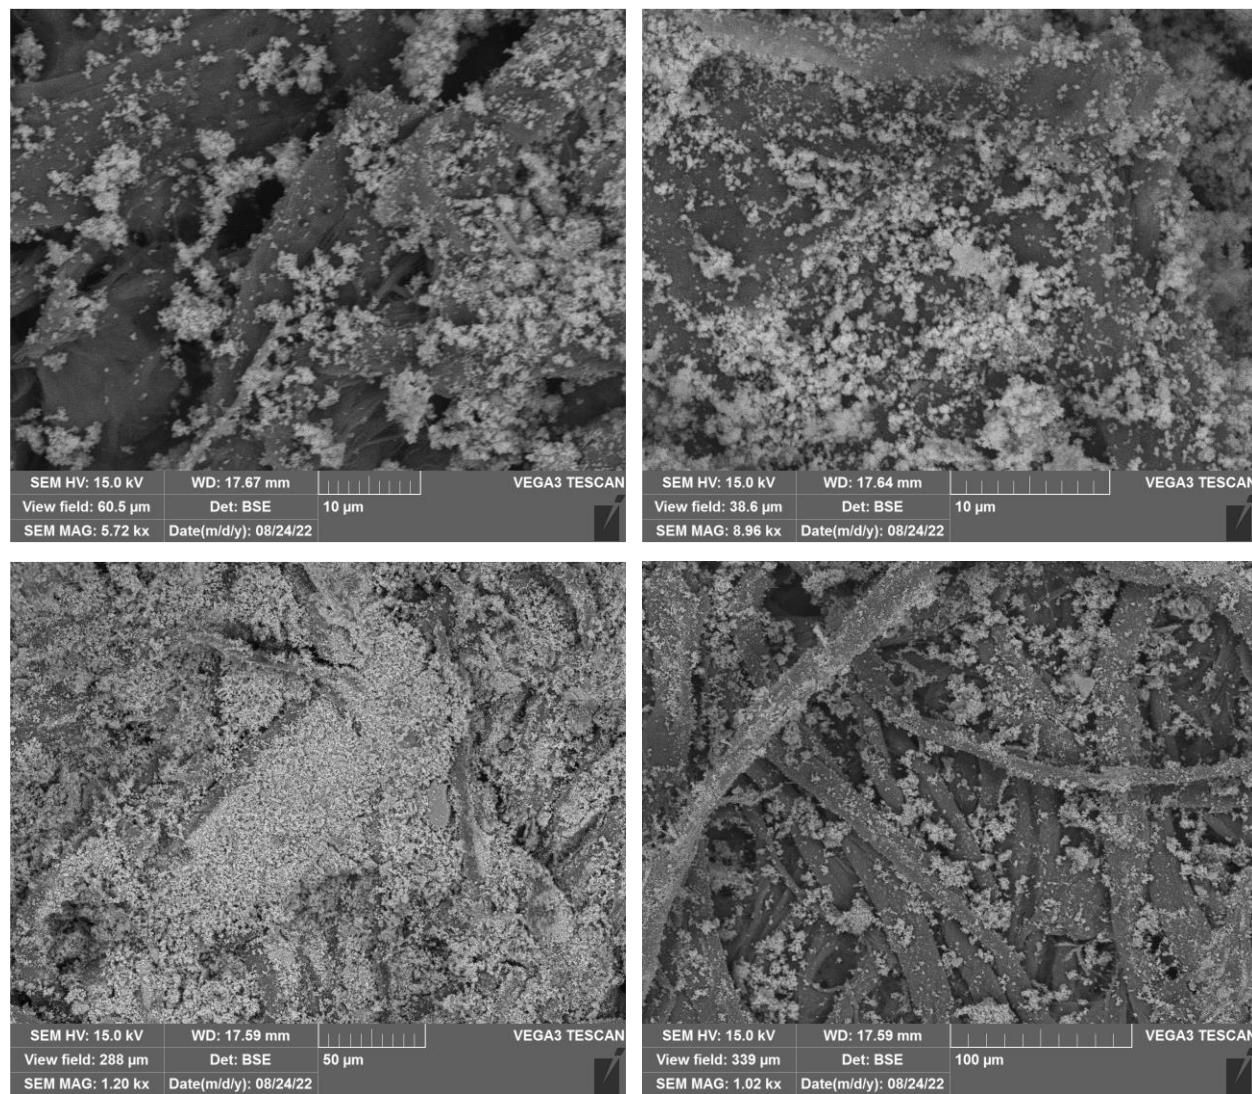
Figure 14. SEM BSE images of dust particles adhering to the Whatman #41 filter paper used to sample at Yankee Rowe.

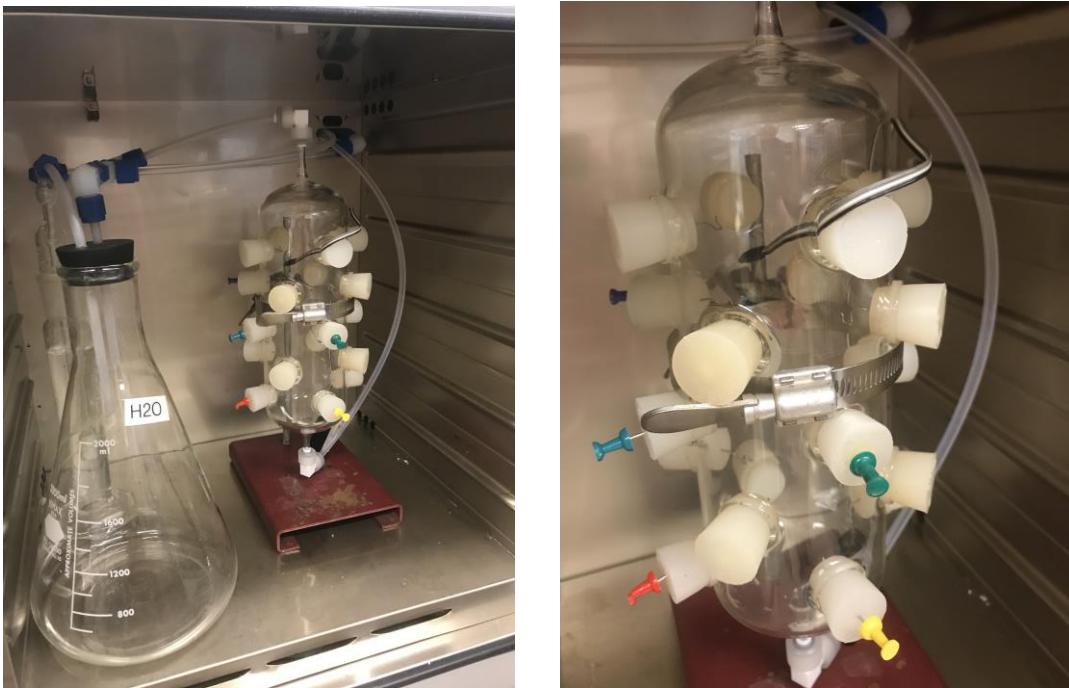
Figure 16. Photos of the modified environmental chamber in order to increase the airflow rate to 9 L/min [40].

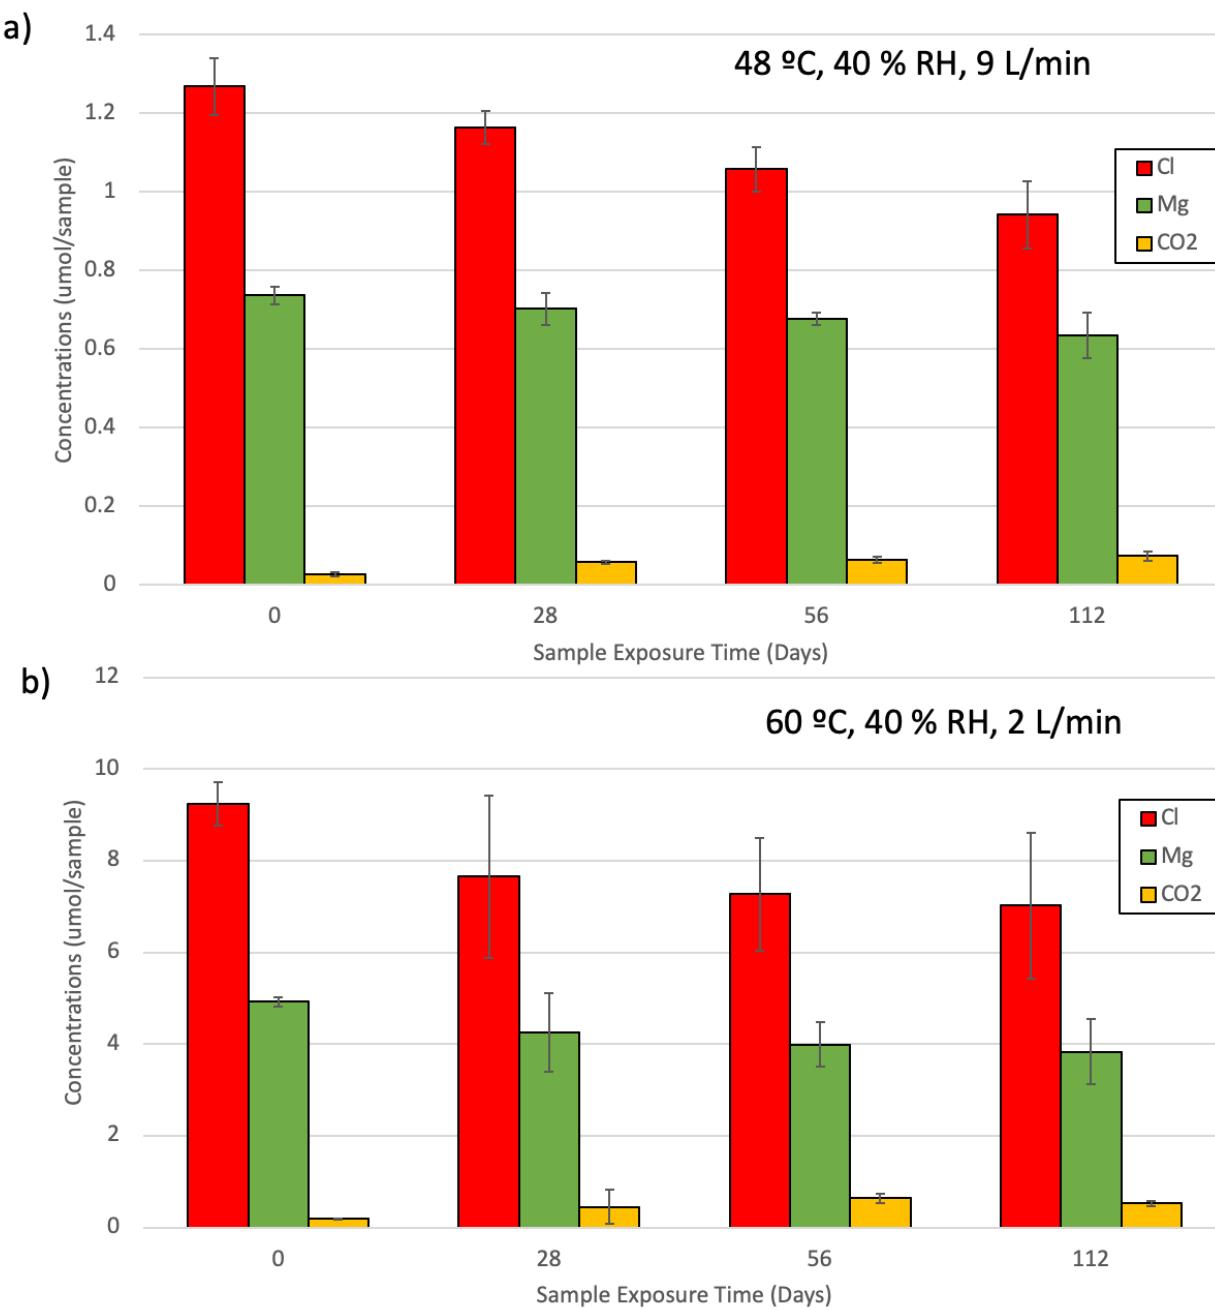
Figure 17. Average composition of the salt after environmental exposure for a) FY21 study at 48 °C, 40% RH and 9 L/min airflow, and b) FY22 study at 60 °C, 40% RH, and 2 L/min airflow.

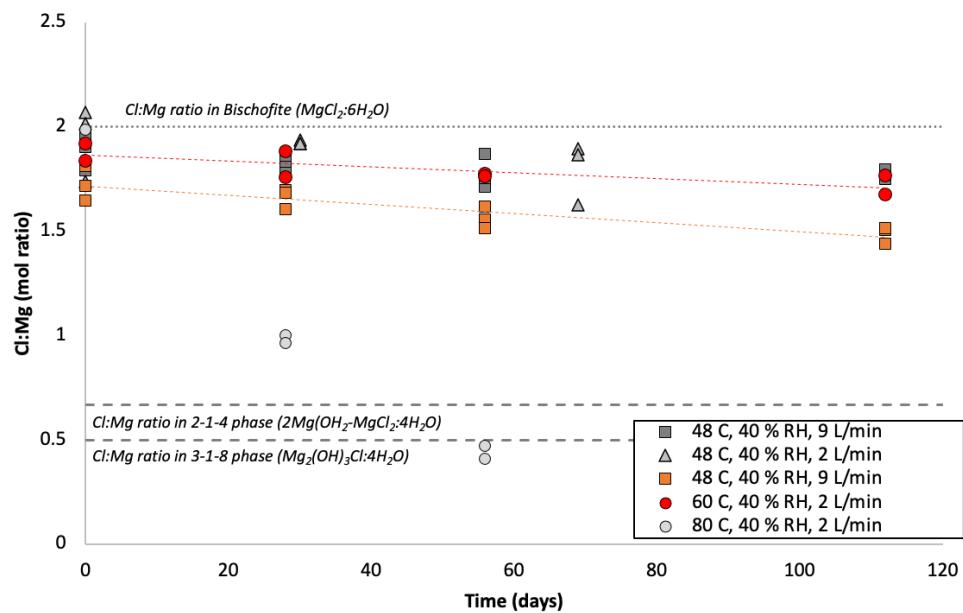
Figure 18. Cl:Mg ratio as a function of exposure time of all MgCl₂ degas experiments performed to date shown with Cl:Mg ratio of possible Mg-bearing mineral phases.

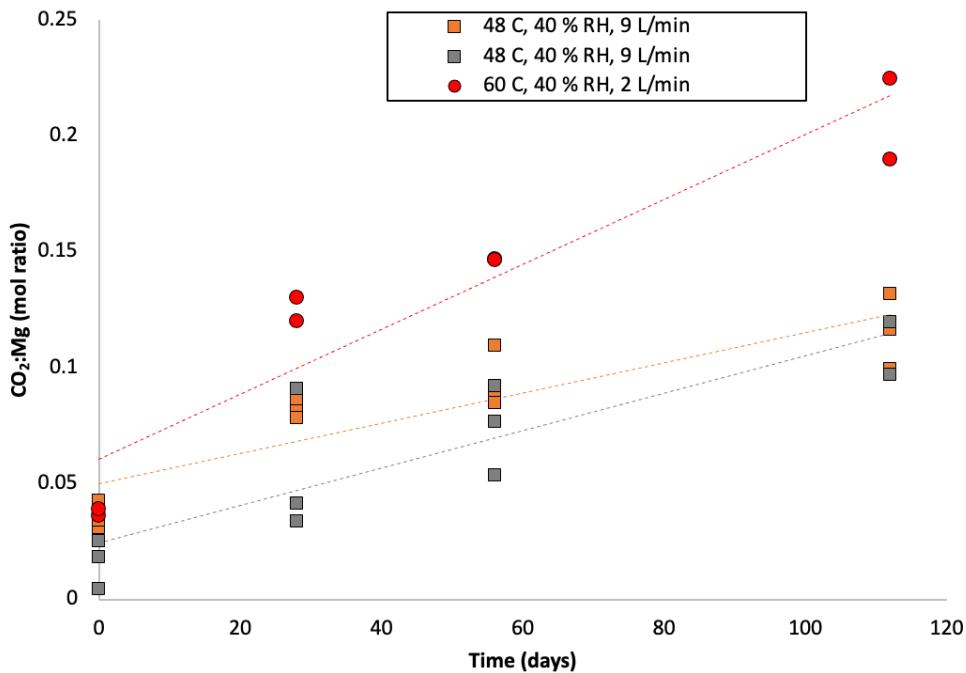
Figure 20. CO₂:Mg ratio as a function of exposure time of all MgCl₂ degas experiments performed since SNL obtained the dissolved organic carbon analyzer.

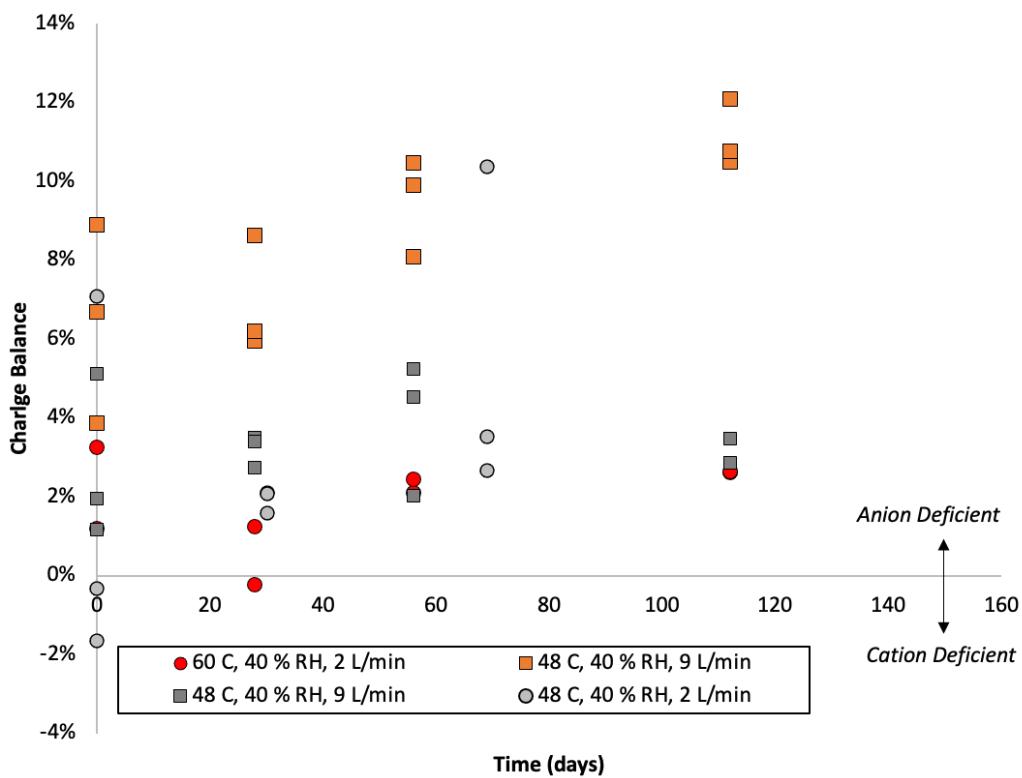
Figure 21. Charge balances for the MgCl_2 degas experiments (excluding the experiment at 80°C) demonstrating how the anionic deficiency changes with exposure time.

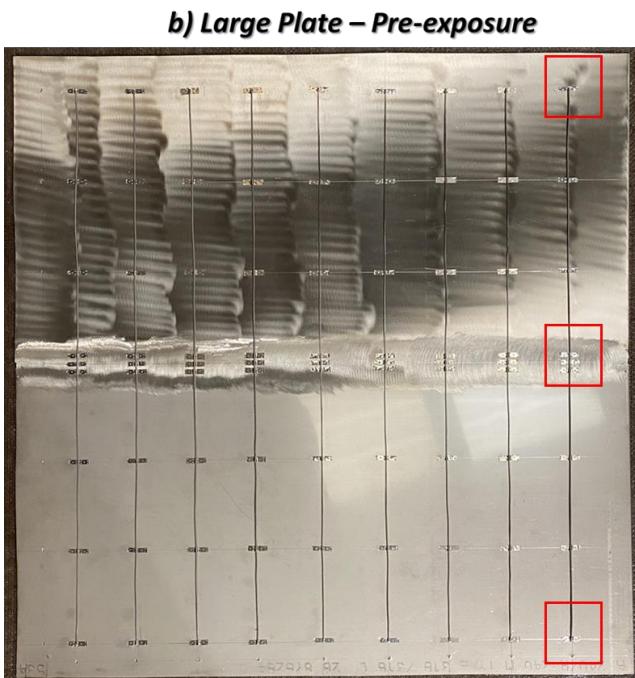
Figure 23. a) Schematic of plate mockup for spot weld, attachment shim, and thermocouple testing, and b) image of actual plate (red boxes highlight shims shown in Figure 25).

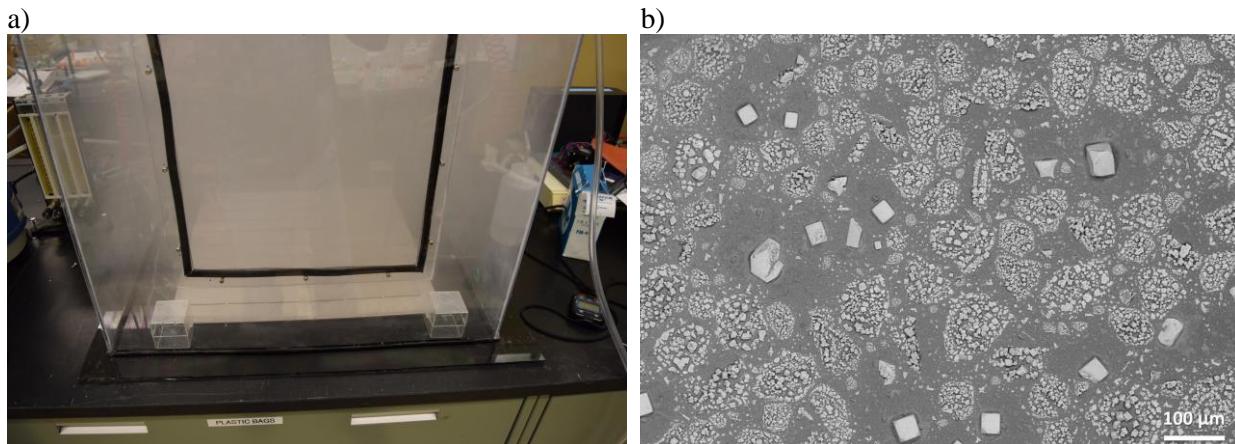
Figure 24. Salt deposition a) image of SS316L mockup plate in nebulizer chamber with salt fog and b) example SEM image of nebulized sea salt deposition.

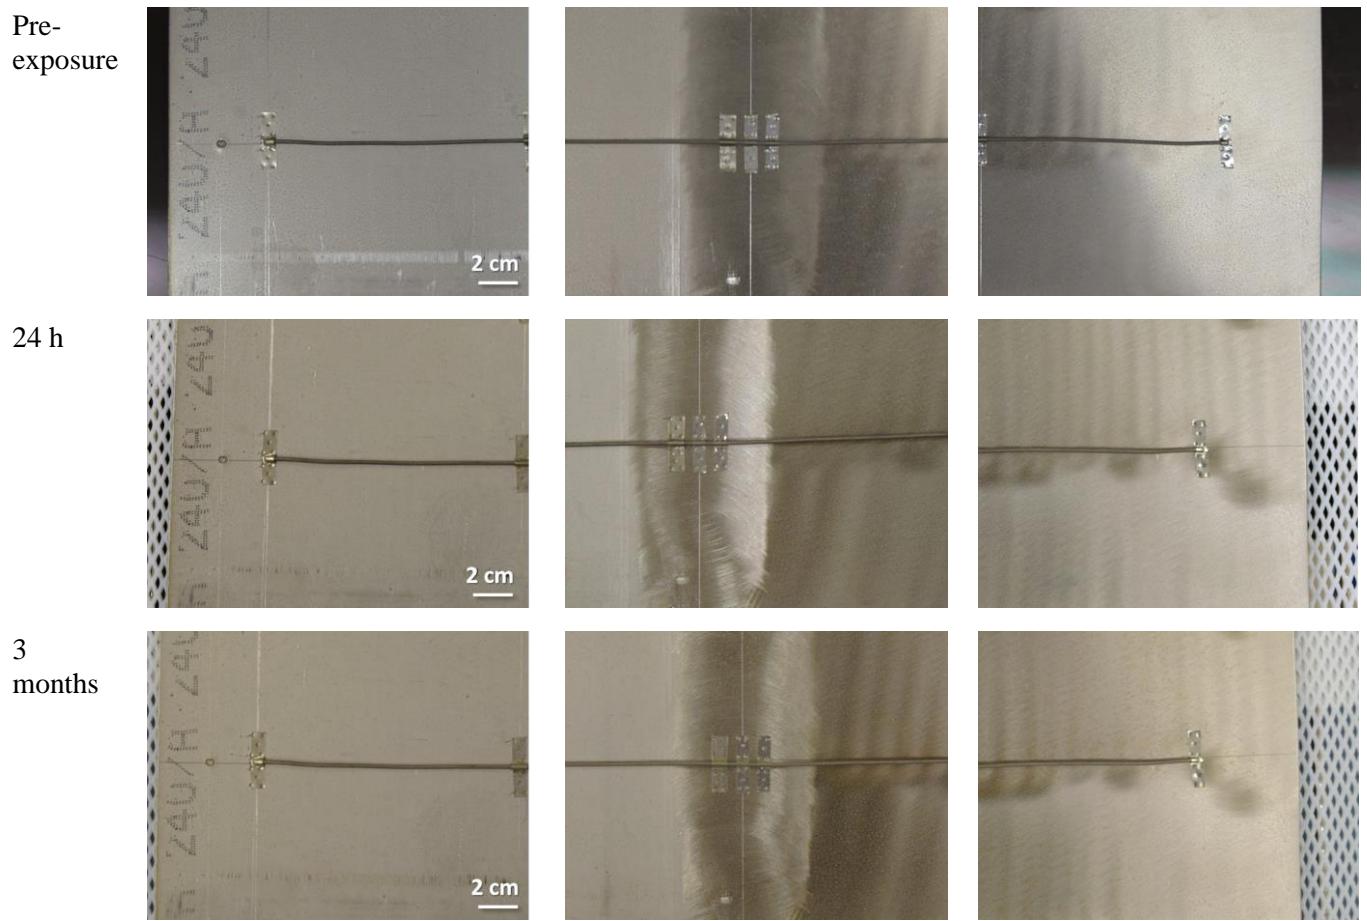
Figure 25. Select shim locations versus exposure time (left on mill scale, center in the weld, and right on ground surface).

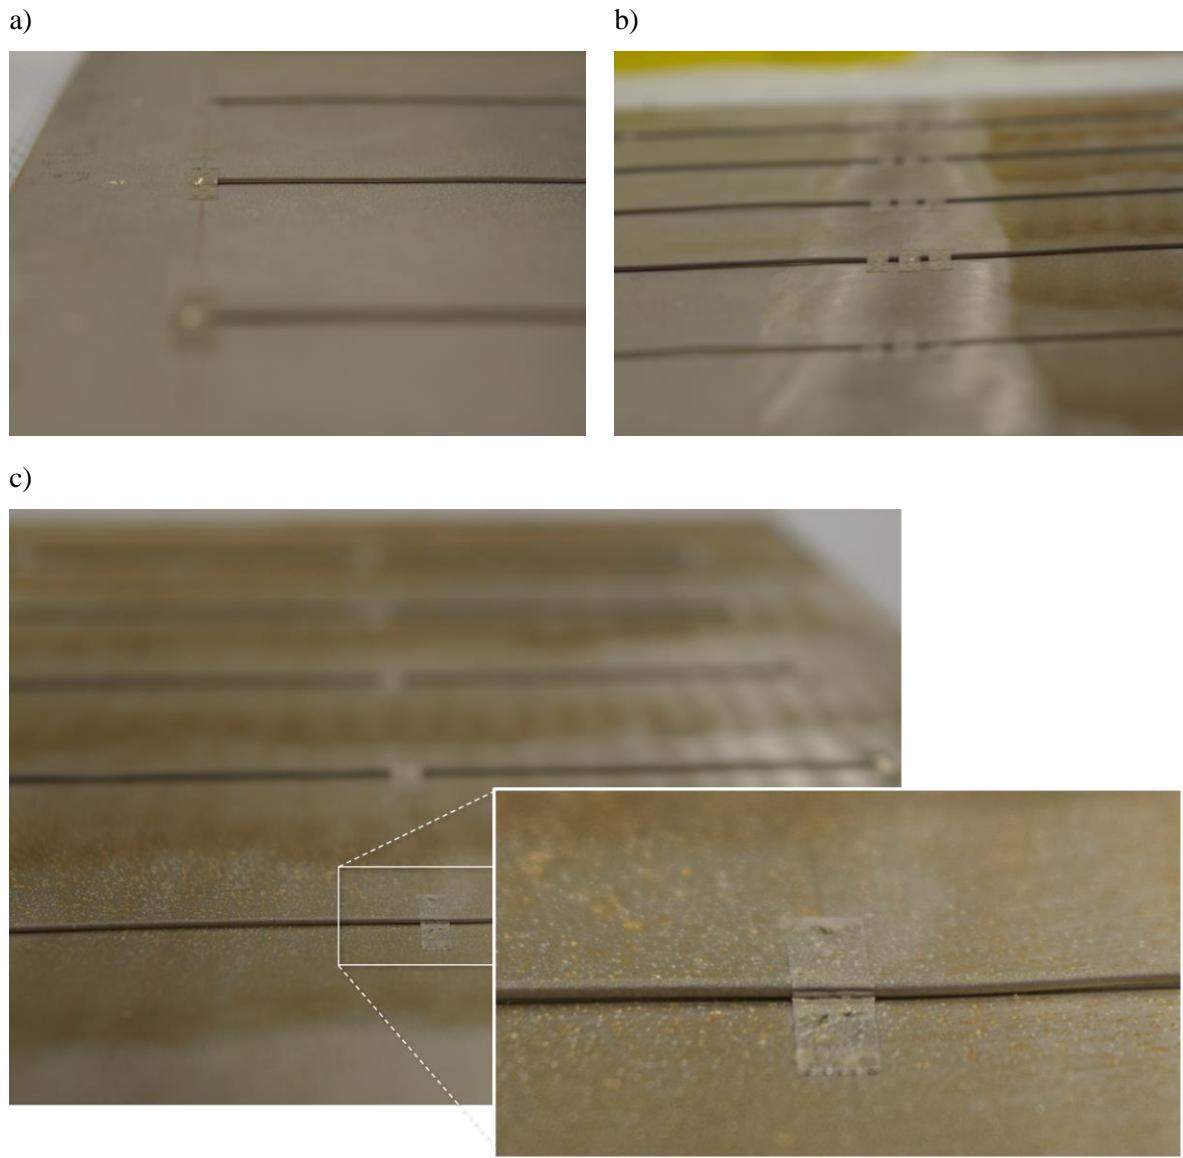
Figure 26. Representative shim locations after 3 months exposure for a) mill scale, b) within the weld, and c) rough grind. Images are angled to better view salt and potential corrosion product.

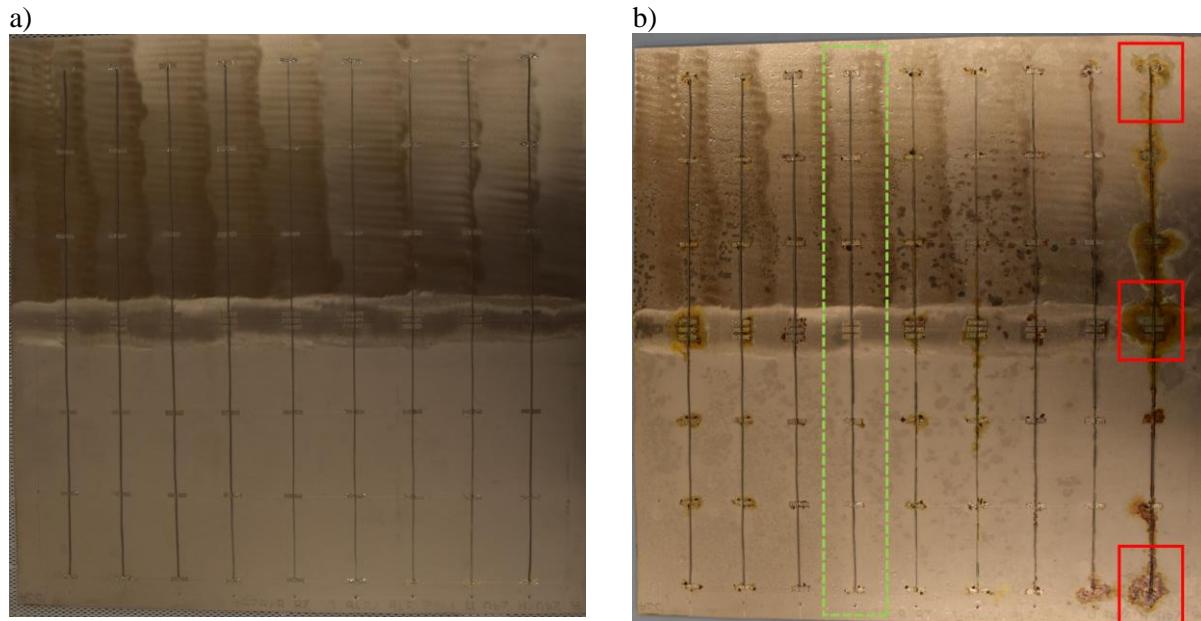
Figure 27. Overall plate images post atmospheric exposure a) 3-month in cyclic conditions and b) with additional salt deposition and 2 weeks in static 75 %RH and 25 °C. Red boxes highlight shims shown in Figure 25 and Figure 28. Green dotted box highlights shims displayed in

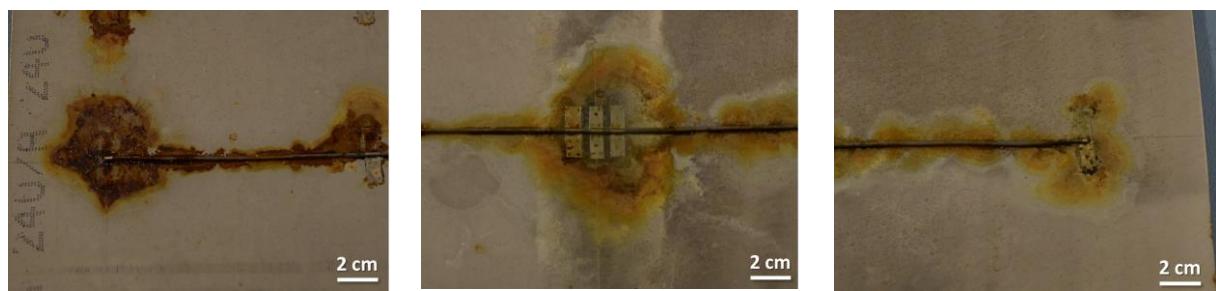
Figure 28. Select shim locations (same as Figure 25) versus exposure time after redeposition of sea salt and second exposure (left on mill scale, center in the weld, and right on ground surface).

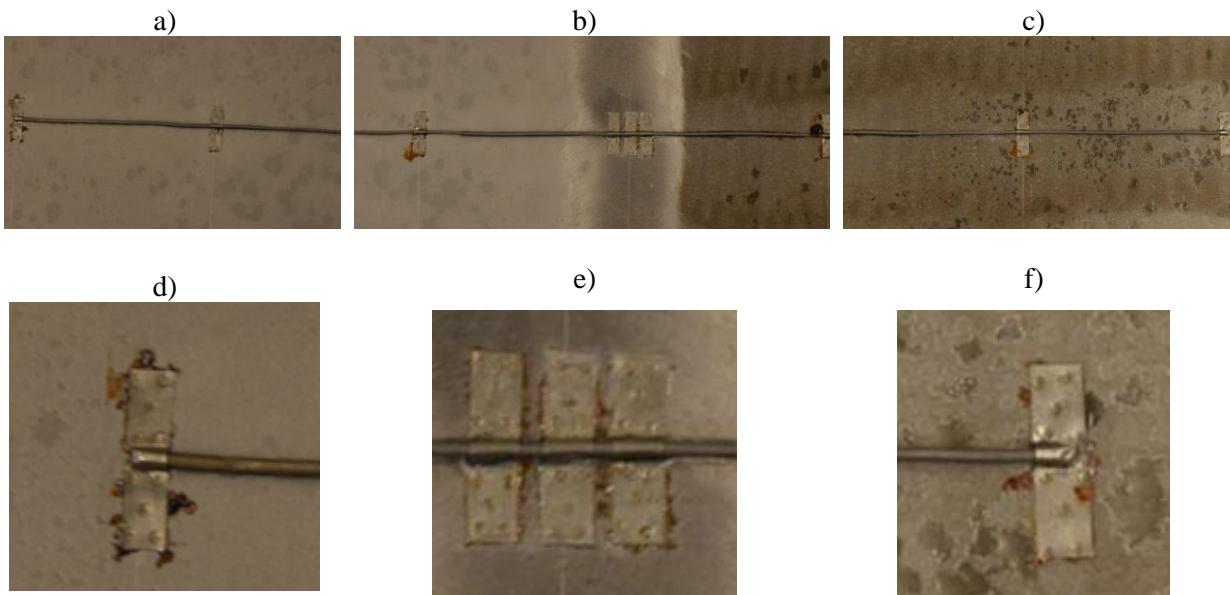
Figure 29. Images of stainless shims with Stainless TC along entire TC line (a, b, and c) and select shims d) shim at edge on mill scale side of plate, e) shims on weld, and f) shim at edge on ground side of plate.

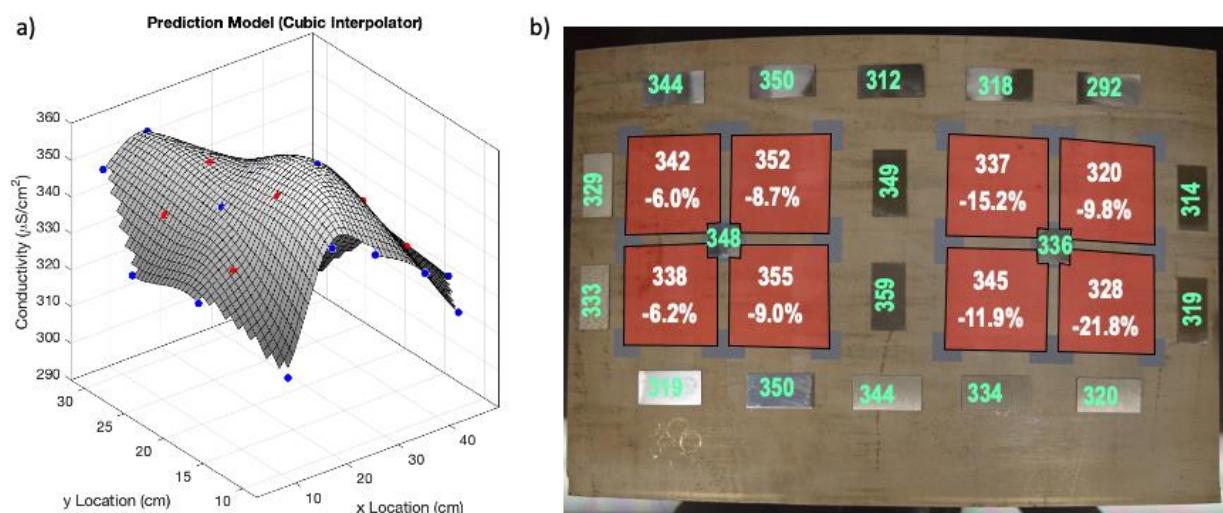
Figure 30. Test #5. a) Surface fitted to the measured conductivities for the witness coupons (blue points) and used estimate the expected conductivity of the grid cells (red points). b) Measured conductivities for the witness coupons and the calculated conductivities for the sampling areas, shown with the % of under-sampling.

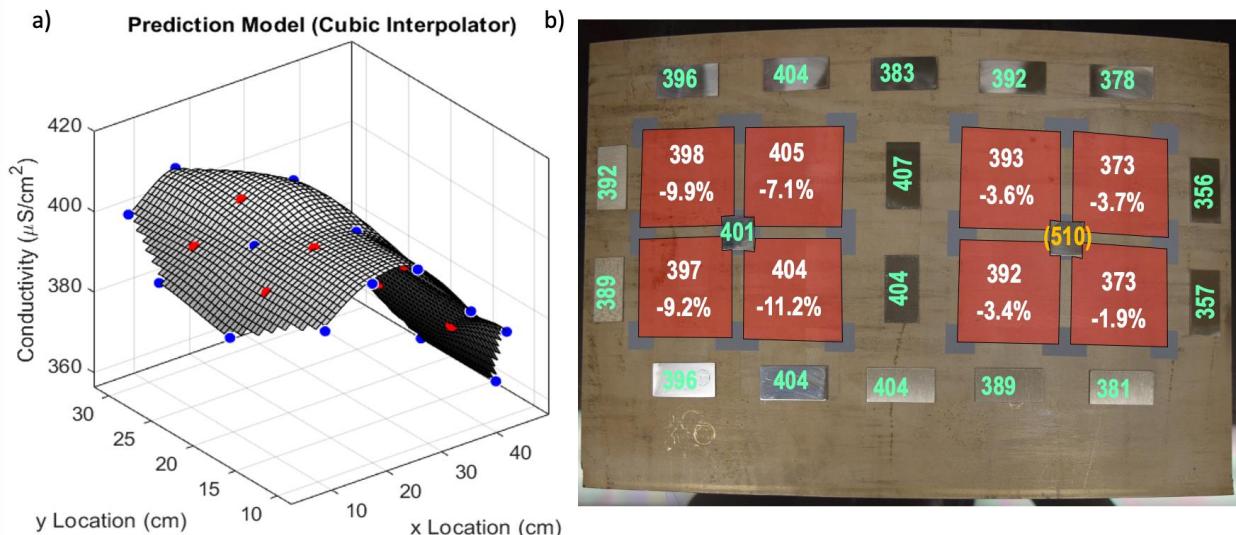
Figure 31. Test #6. a) Surface fitted to the measured conductivities for the witness coupons (blue points) and used estimate the expected conductivity of the grid cells (red points). b) Measured conductivities for the witness coupons and the calculated conductivities for the sampling areas, shown with the % of under-sampling. Note that the right grid-center coupon (shown in yellow) was not used to fit the plane due to being unrealistically high.

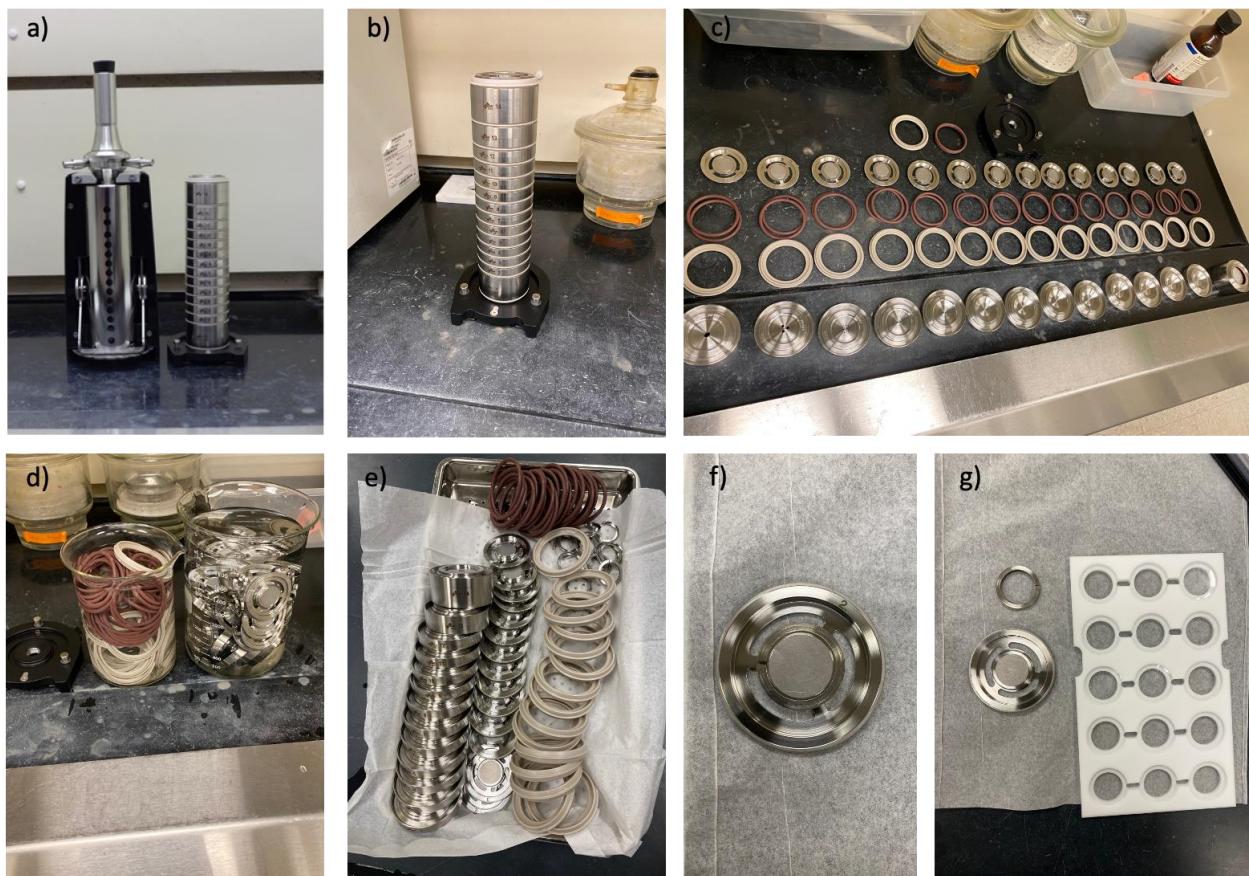
Prior to measurement, the cascade impactor tower must be cleaned, the targets greased, and the tower reassembled with the targets. This task will be performed at the laboratory that will perform the chemical analysis of the targets. In FY23, SNL will write a detailed procedure for this task and visit the analysis lab to demonstrate the procedure. A few steps are shown in Figure 34. The tower must be removed from the cartridge (a) and the impactor stages removed (b) and fully disassembled (c). Then all parts must be washed in DI water with sonication (d) and set out to fully dry (e). The maroon O-rings will need to be greased on occasion to ensure a proper seal. The polycarbonate targets must be greased with Apiezon™ vacuum grease using the template provided by Dekati (f, g). Once greased, the polycarbonate targets must be carefully mounted on the target stages using the metal O-rings. Then, the cascade impactor must be reassembled. Each unique piece is numbered, and the assembly must follow the correct number order. Each impactor stage consists of several pieces (Figure 35) and must be assembled in the correct order. Once the tower is fully re-constructed, it can be remounted in the cartridge and placed into the ELPI+.

Figure 34. Photos demonstrating the disassembly of the cascade impactor column (a-c), cleaning of each component (d-e), and mounting the greased polycarbonate targets on a impactor stage (f-g).
