FY22 Status Update: SNF Interim Storage Canister Corrosion and Surface Environment Investigations

Spent Fuel and Waste Disposition

M2SF-22SN010207056

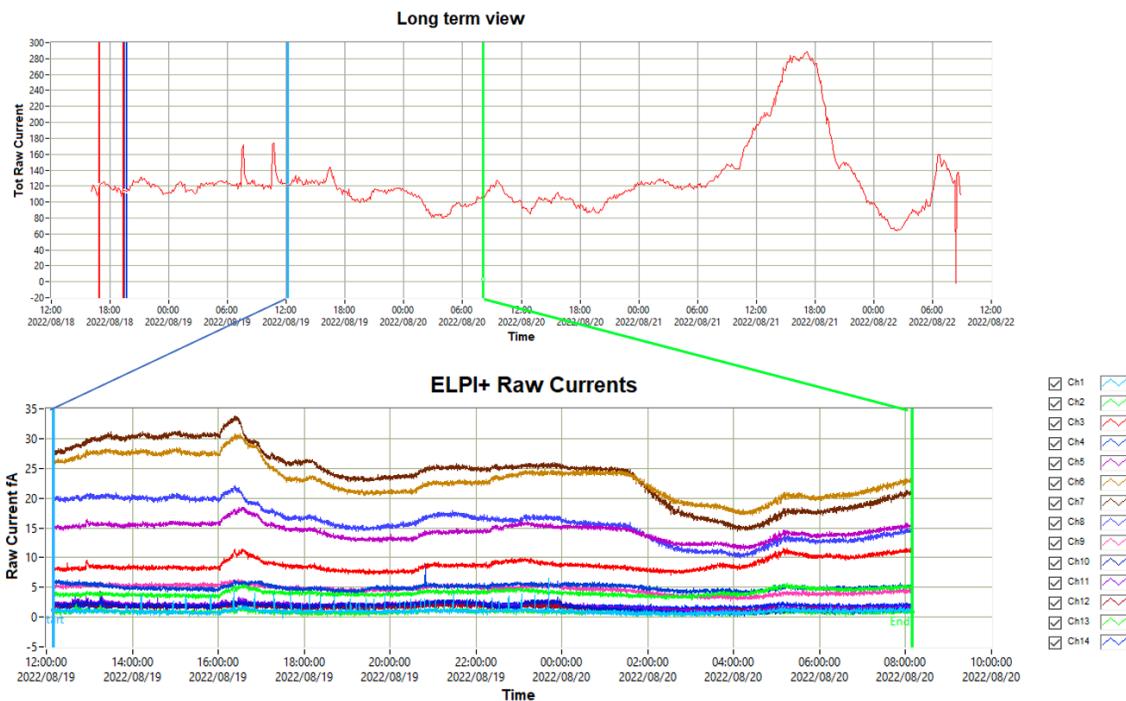
Figure 36. Long term view showing the total raw current, of all stages, collected from 8/19/2022 12:00:00 – 08/20/2022 8:00:00 (top), and raw current of each individual stage for a 20-hour period (8/19/2022 12:00:00 – 08/20/2022 8:00:00) (bottom) using the Dekati ELPI+ Data Analysis Tool (beta mode)

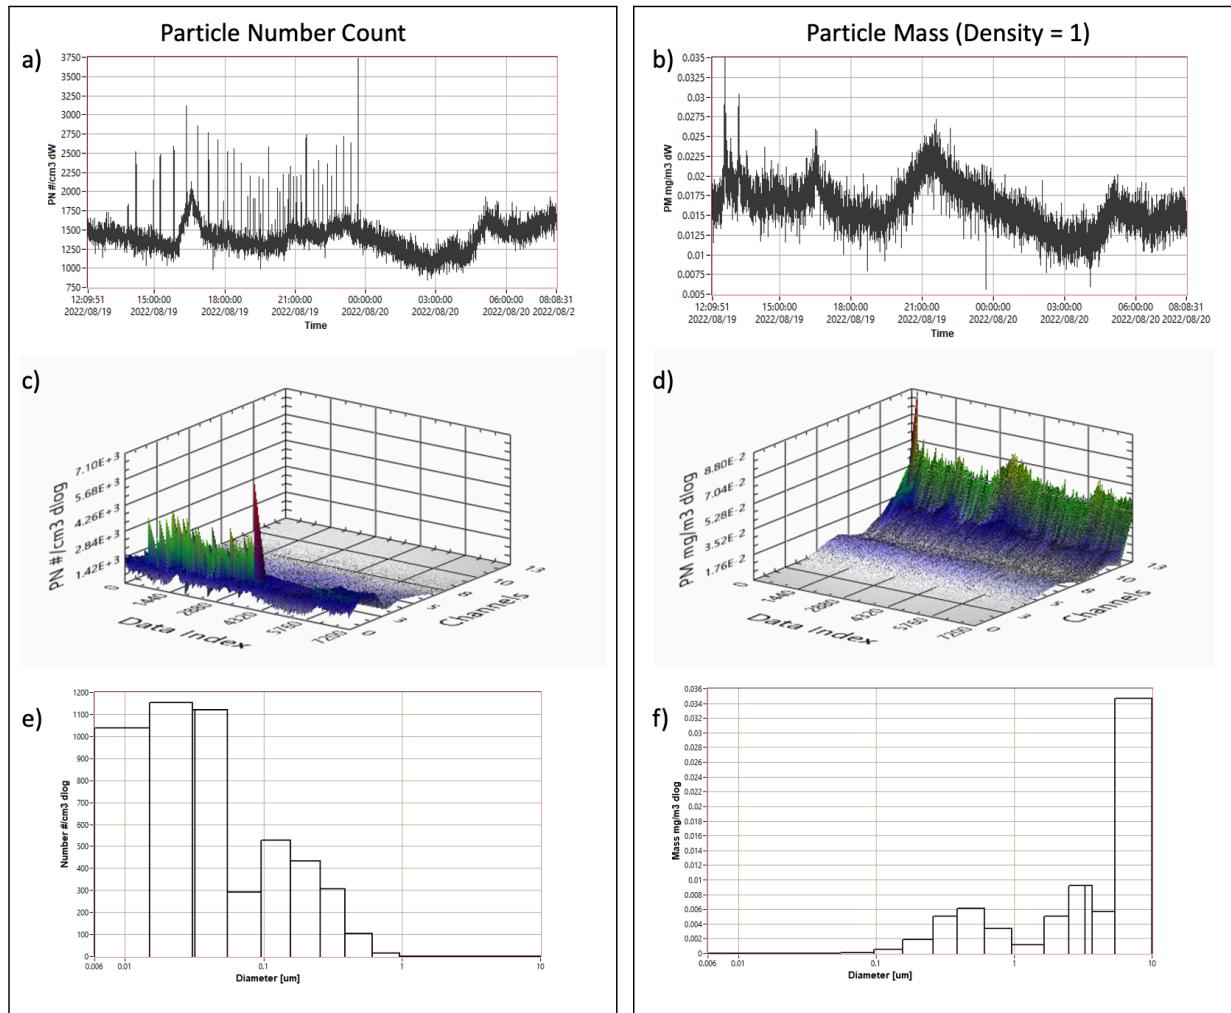
Figure 37. From the raw currents collected during the 20-hour period (8/19/2022 12:00:00 – 08/20/2022 8:00:00) the total particle number count (a) and mass assuming a density of 1 (b), the particle number concentrations (c) and mass concentrations (d), the particle number distribution (e), and mass distribution (f).

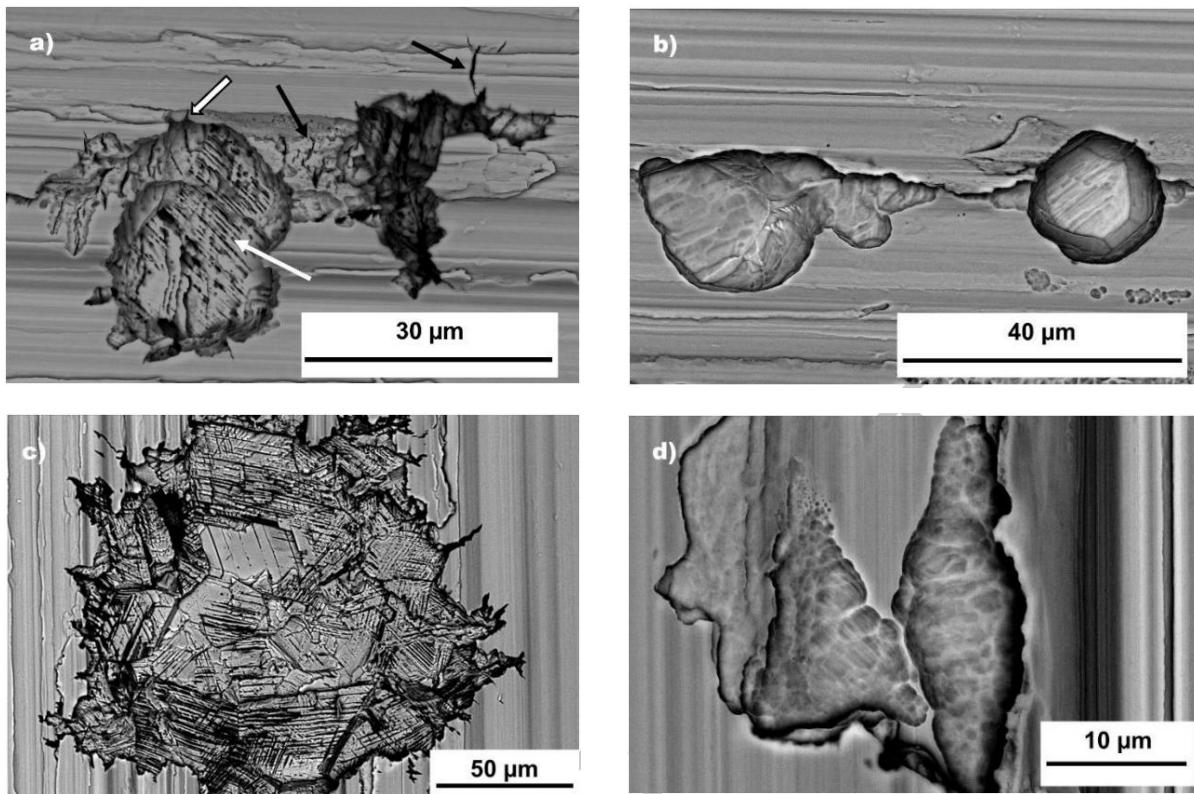
Figure 44. Example SEM comparison of pit morphology observed on stainless steel exposed under atmospheric and fully immersed conditions. Atmospheric exposures for 4 weeks at 35 °C with sea salt brines equilibrated to a) 40% RH and b) 76% RH, and full immersion exposures for 47 days in bulk solutions of equivalent compositions for c) 40% RH and d) 76% RH. In a), white arrows indicate cross-hatching, black arrows indicate micro-cracks, and white arrows with a black border indicate smaller fissures.[12]

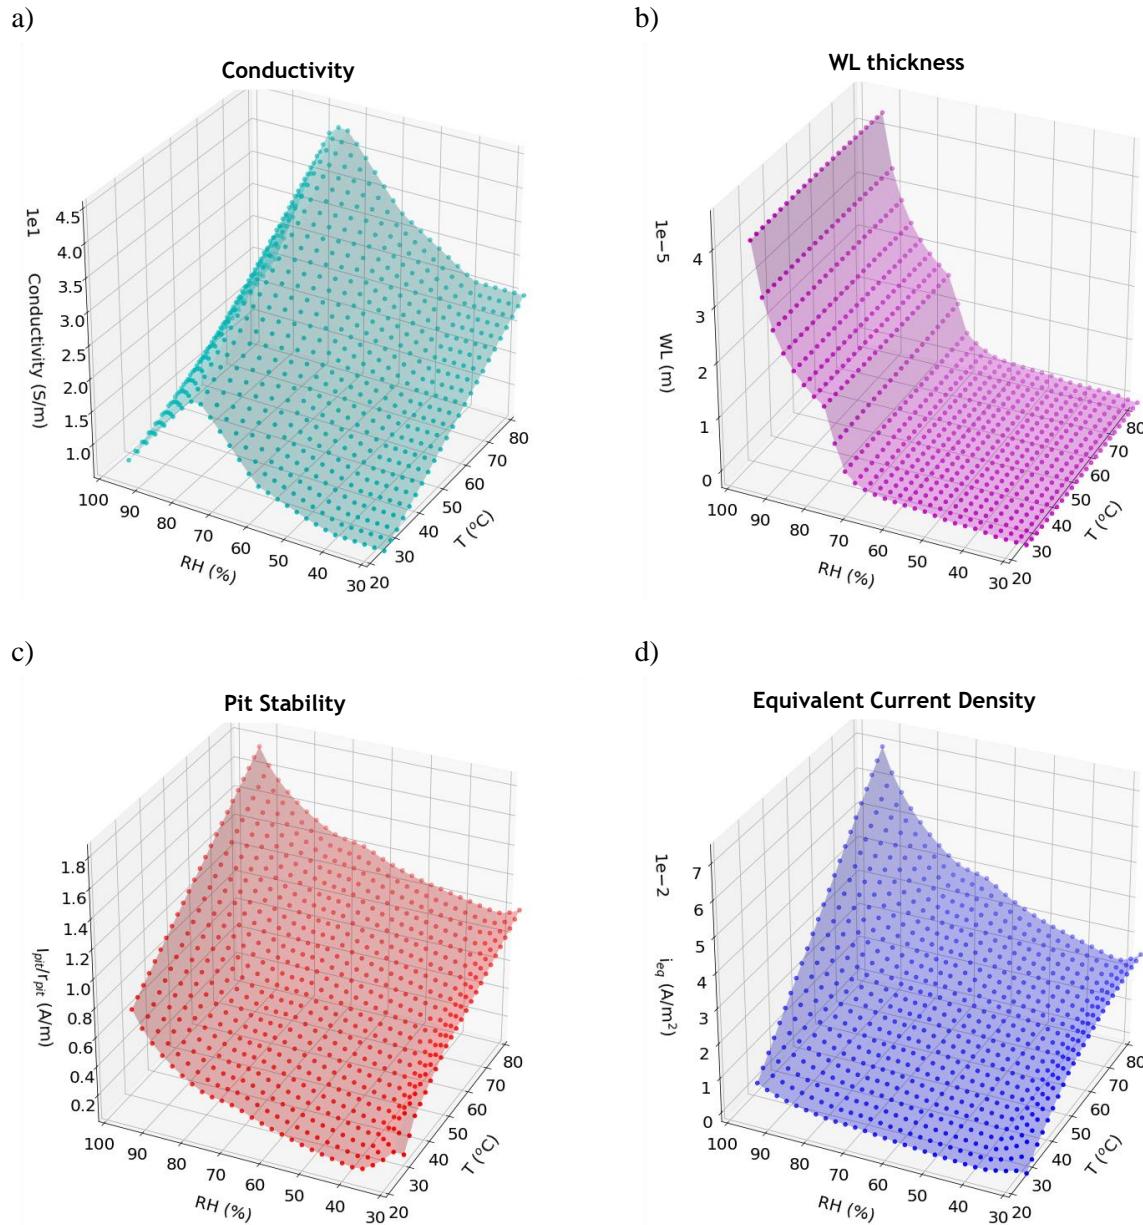
Figure 45. Significant parameters to the maximum pit size model as function of RH and temperature: a) Brine conductivity (Siemens/meter), b) calculated brine thickness for a chloride loading density of 1 g/m^2 , c) critical pit stability product (assumed to be 50 % of saturation) for a hemisphere pit, and d) equivalent current density.

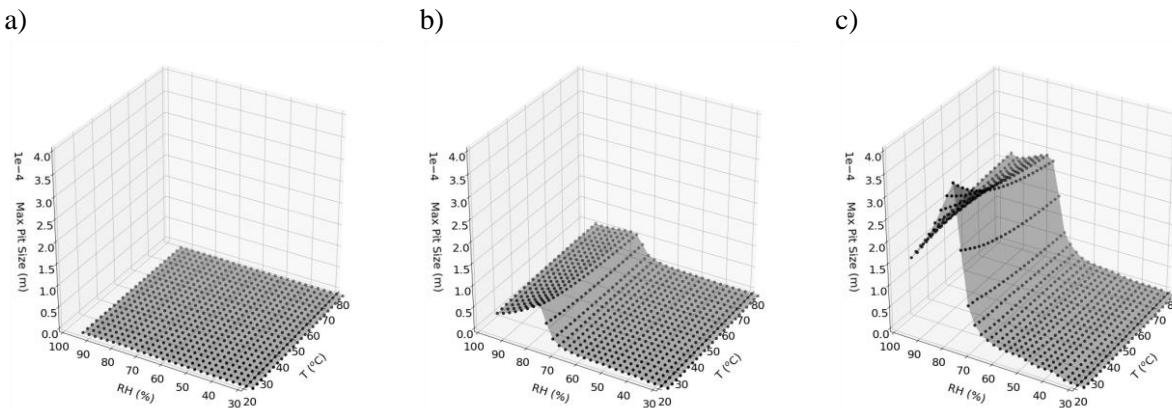
Figure 46. Maximum pit size versus RH and temperature for salt loading densities of a) 0.1, b) 3, and c) 10 g/m² of chloride.

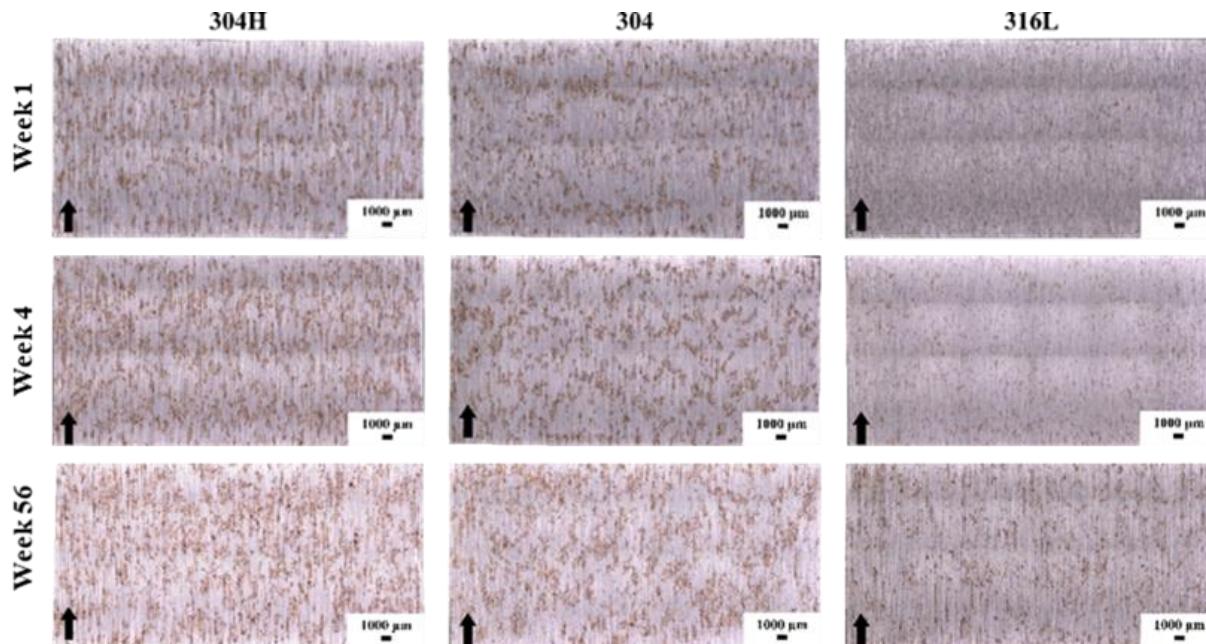
Figure 48. Example optical imaging of post-exposure rough ground (#4 finish) 304H, 304, and 316L coupons versus exposure time in weeks. Black arrows indicate grind direction.

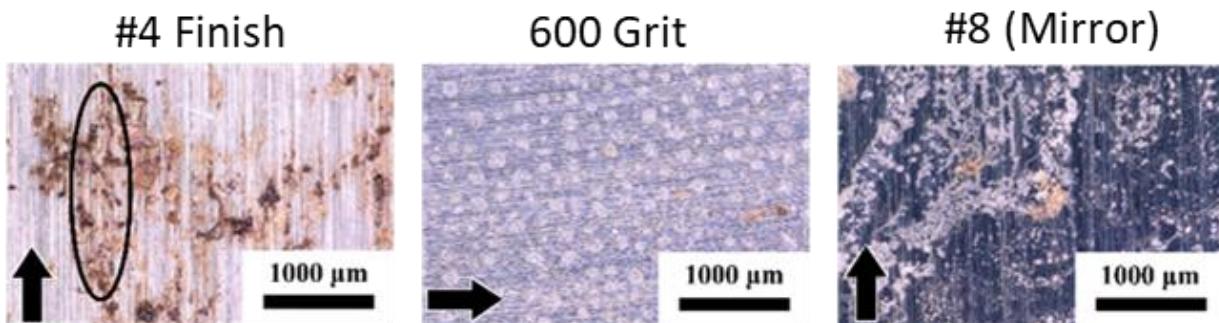
Figure 49. Higher magnification example optical images of post-exposure coupons versus surface finish after 26 weeks exposure. Ovals indicate corrosion product grind lines for #4 finish and black arrows indicate grind direction.

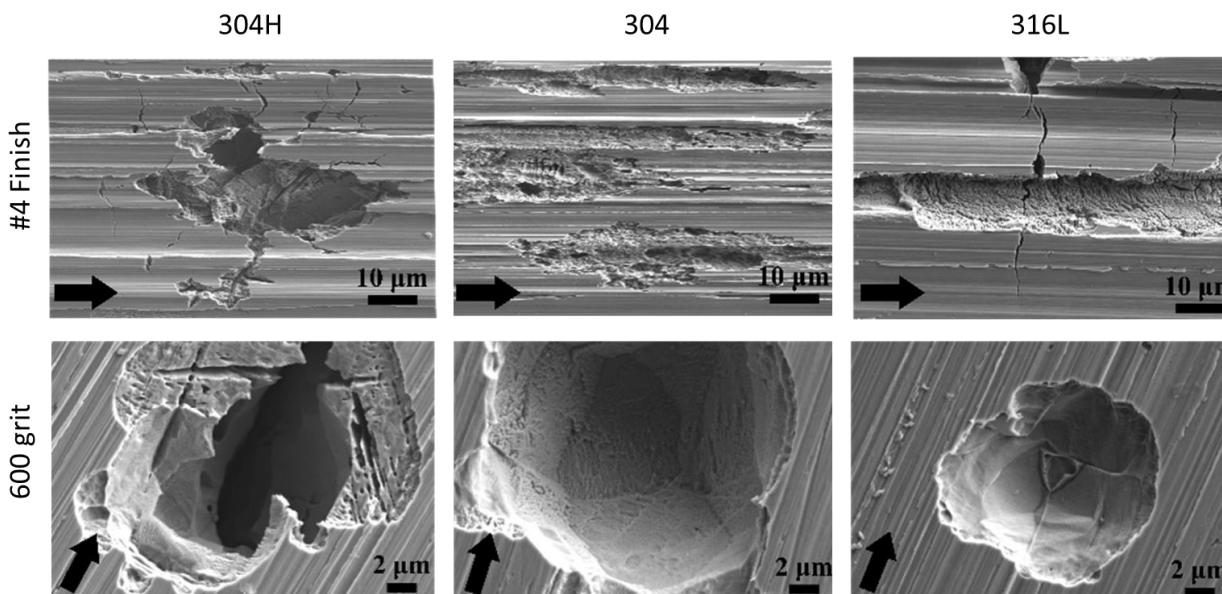
Figure 50. Example post exposure corrosion analysis of pits after 52 weeks exposure in cyclic conditions. Pits continue to exhibit similar morphologies as observed in FY21, with morphology dependent on both surface roughness and alloy.

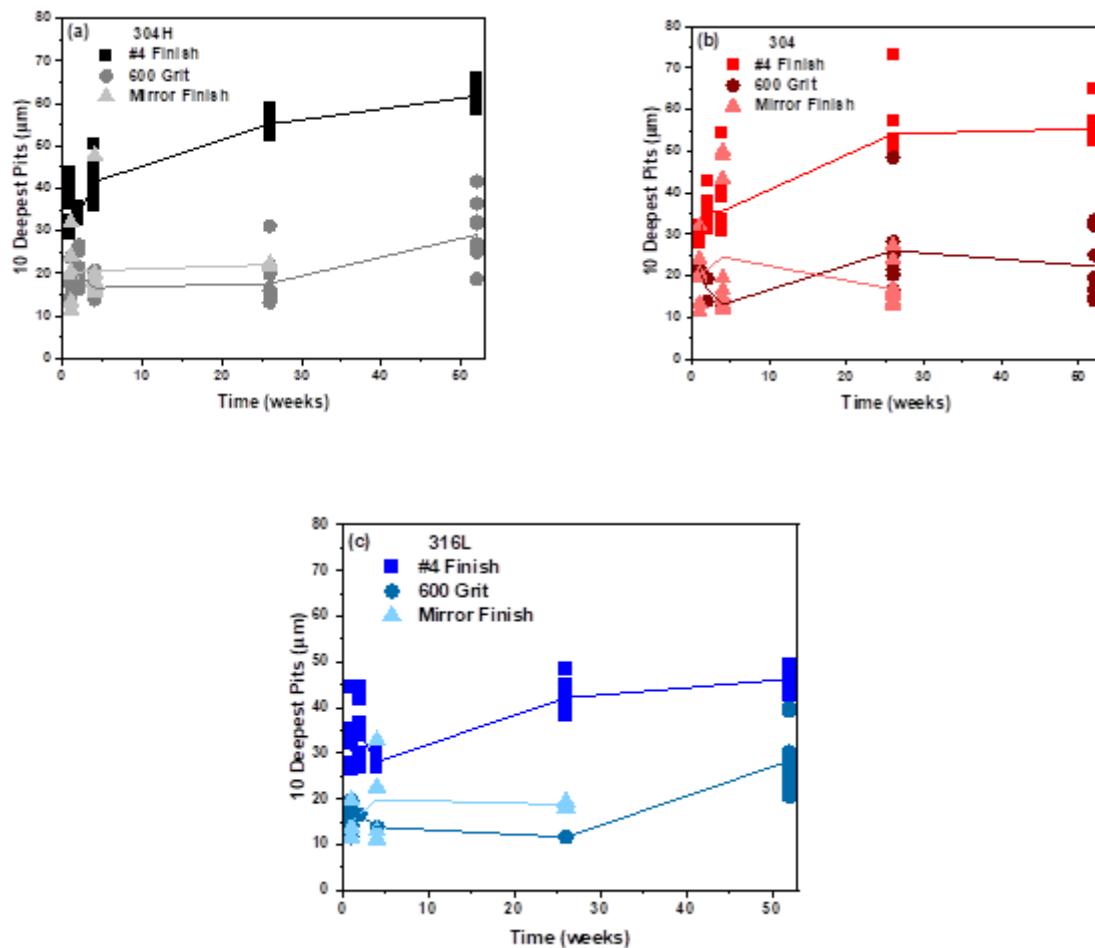
Figure 51. Ten deepest pits measured by profilometry across all surface finishes for a) SS304H, b) SS304, and c) SS316L.

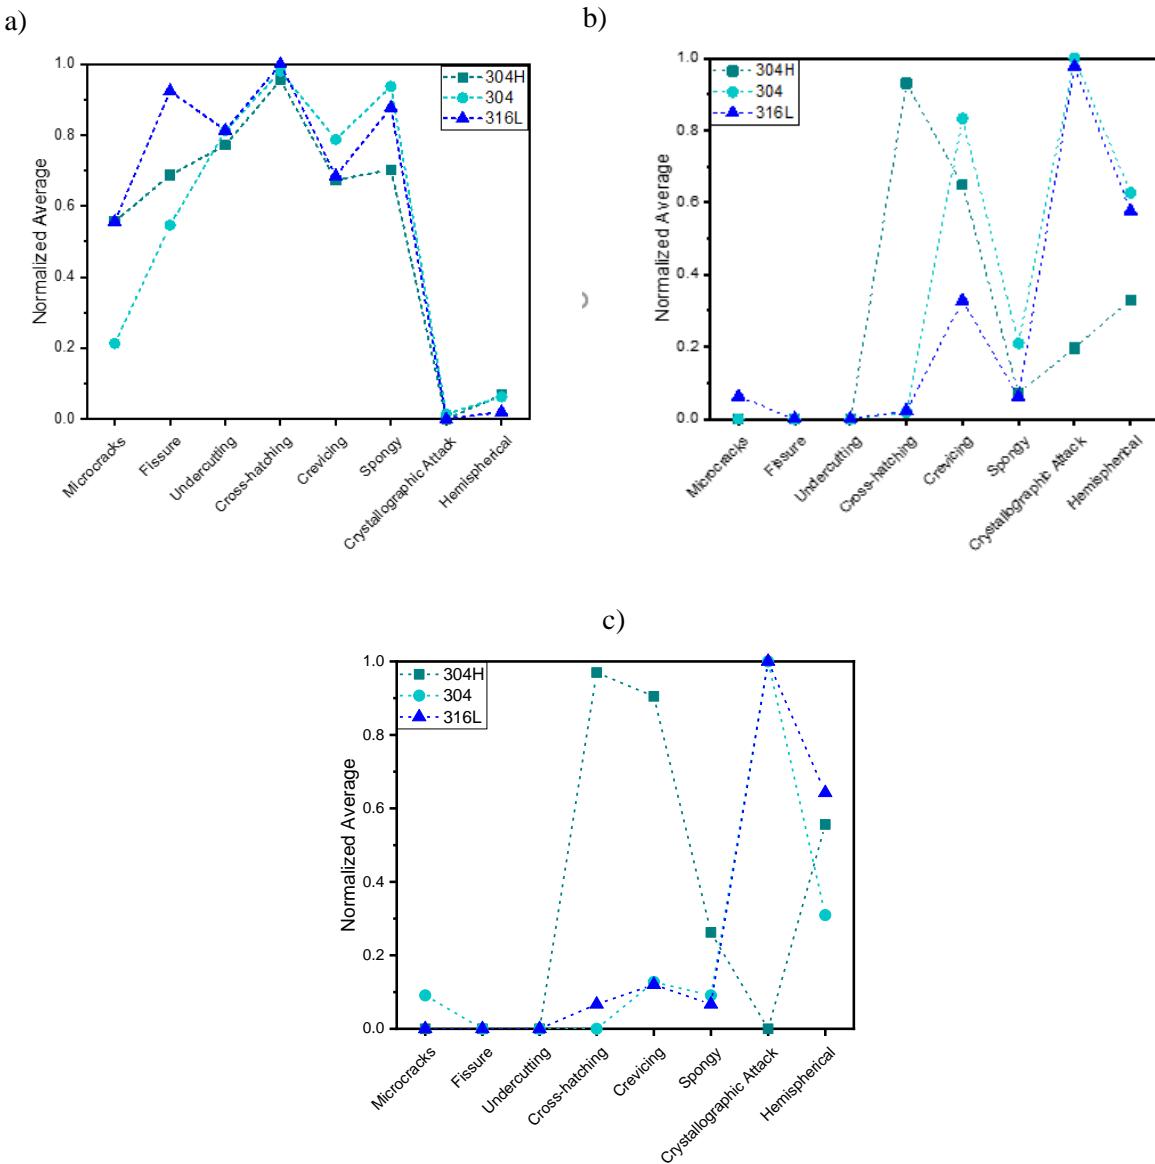
Figure 52. Qualitative assessment of pit morphology for SS304H, SS304, and SS316L for a) #4 finish, b) 600 grit, and c) #8 (mirror) finish.

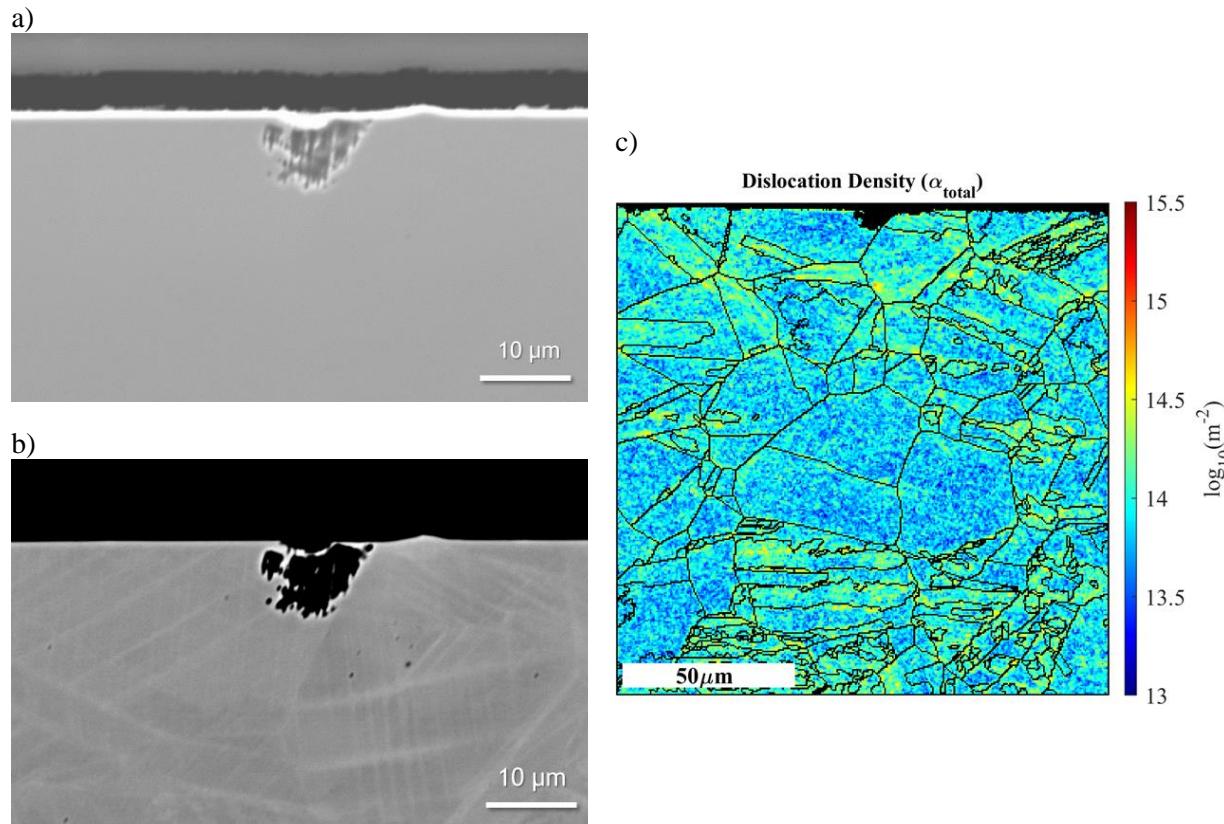
Figure 54. Example cross-sectional images of SS304H #8 mirror finish exposed for 1 month under diurnal cyclic conditions; a) SEM SE image, b) SEM BSE image, and c) corresponding dislocation density developed from HREBSD mapping.

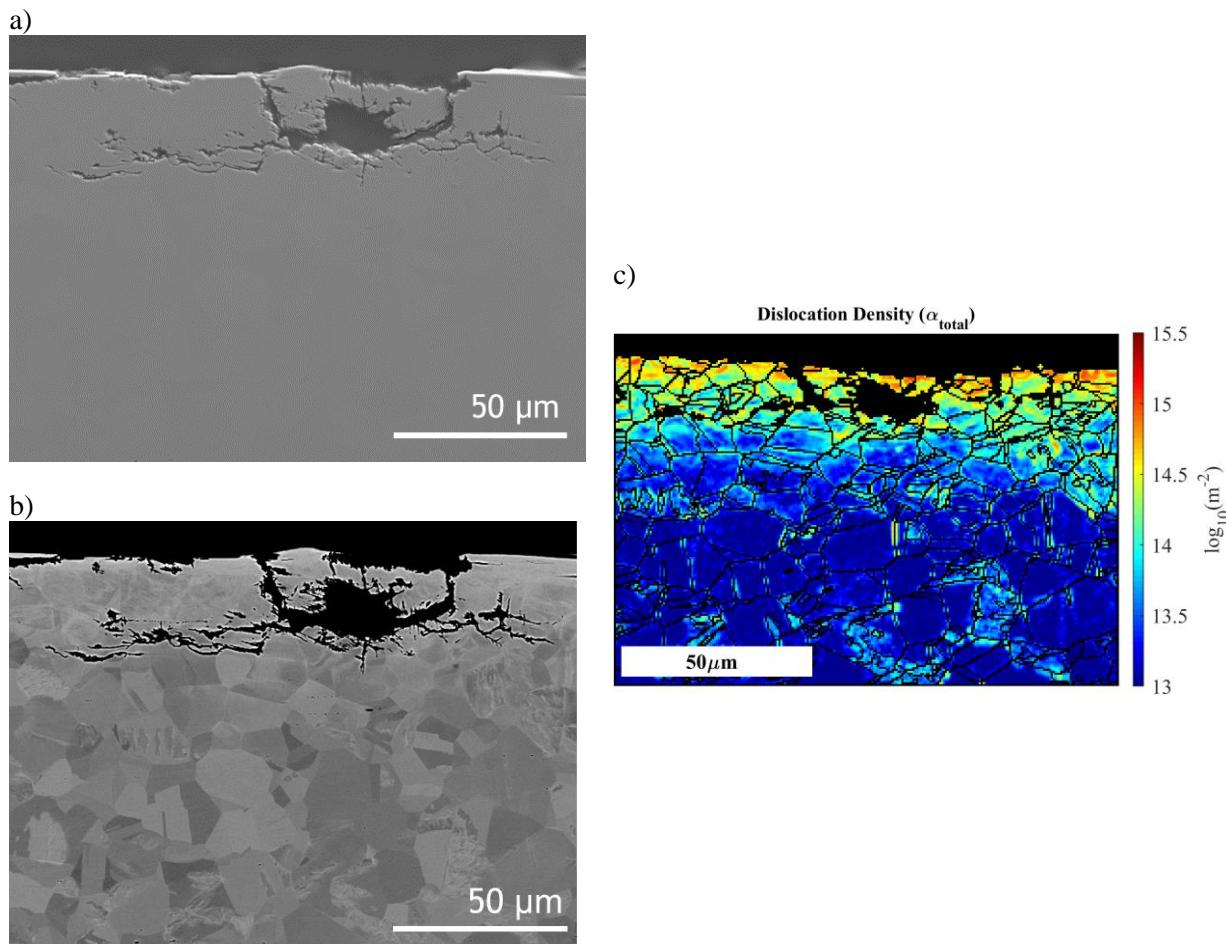
Figure 55. Example cross-sectional images of SS304 #4 rough finish exposed for 1 month under diurnal cyclic conditions; a) SEM SE image, b) SEM BSE image, and c) corresponding dislocation density developed from HREBSD mapping.

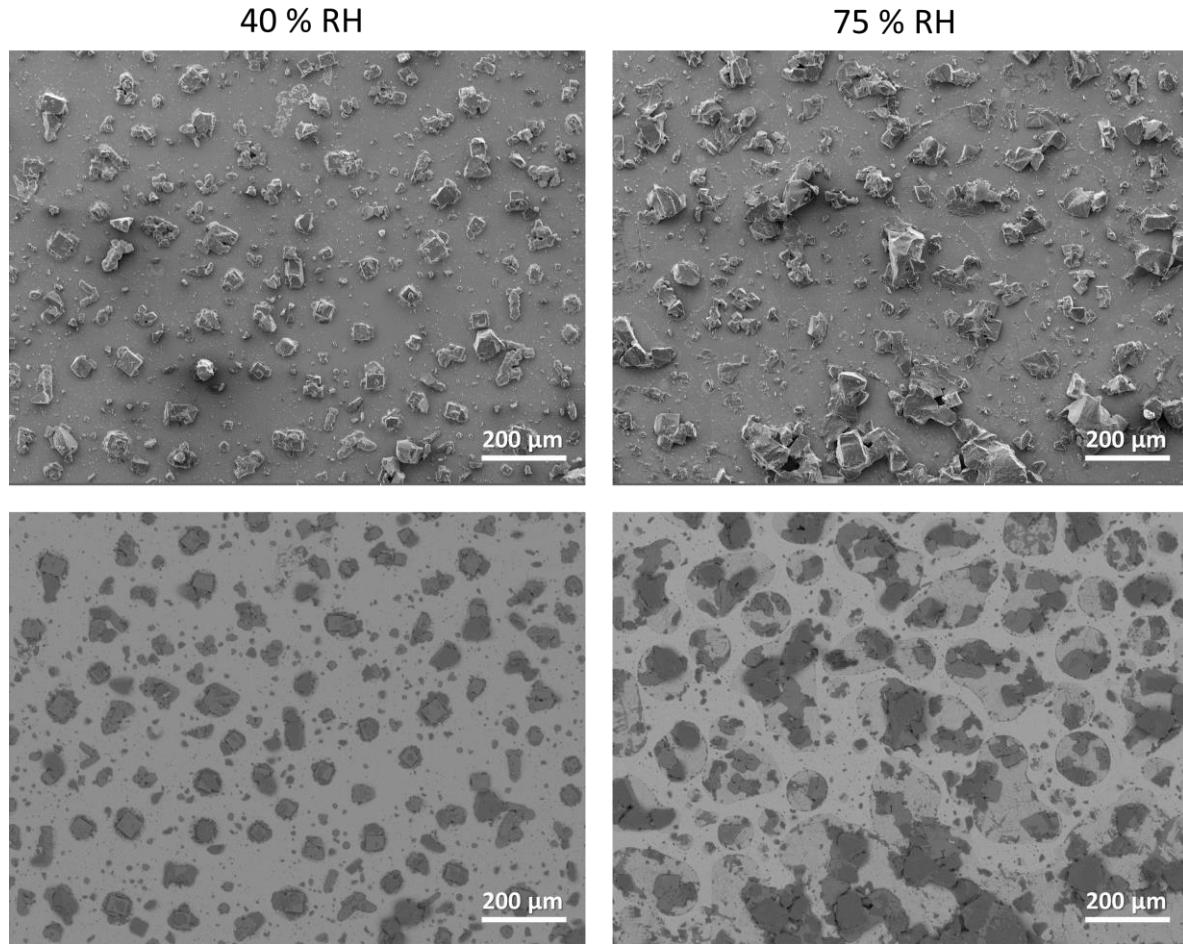
Figure 56. Example images of SS304 coupons post 1-month atmospheric exposure with 300 $\mu\text{g}/\text{cm}^2$ deposited 74 μm dust and ASW at static 40% or 75% RH and 50 °C. SE SEM in top row with corresponding BSE SEM below. All images taken prior to corrosion product removal.

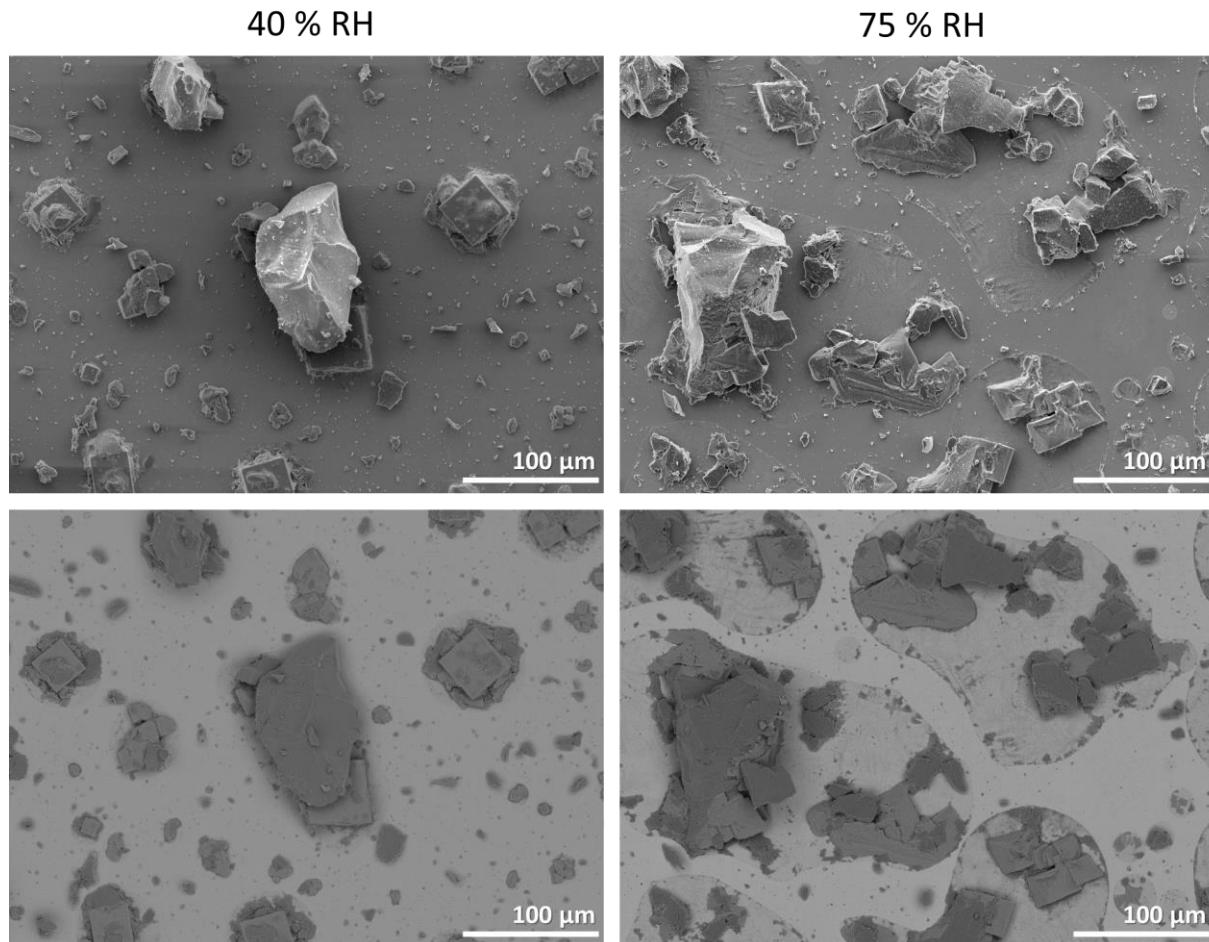
Figure 57. Higher resolution example images of SS304 coupons post 1-month atmospheric exposure with $300 \mu\text{g}/\text{cm}^2$ deposited $74 \mu\text{m}$ dust and ASW at static 40% or 75% RH and 50°C . SE SEM in top row with corresponding BSE SEM below. All images taken prior to corrosion product removal.

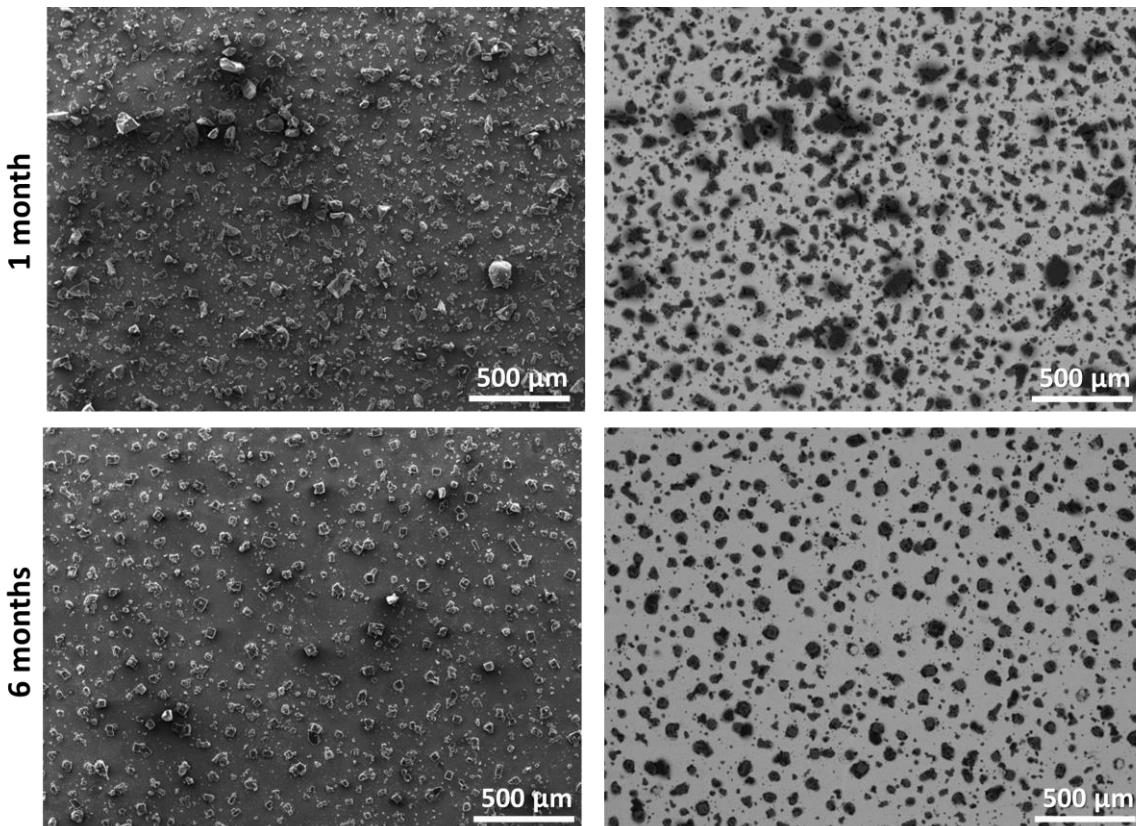
Figure 58. Example images of SS304 coupons post 1 and 6-month atmospheric exposure with 300 $\mu\text{g}/\text{cm}^2$ deposited 74 μm dust and ASW under cyclic conditions. SE SEM in left column with corresponding BSE SEM to the right. All images taken prior to corrosion product removal.

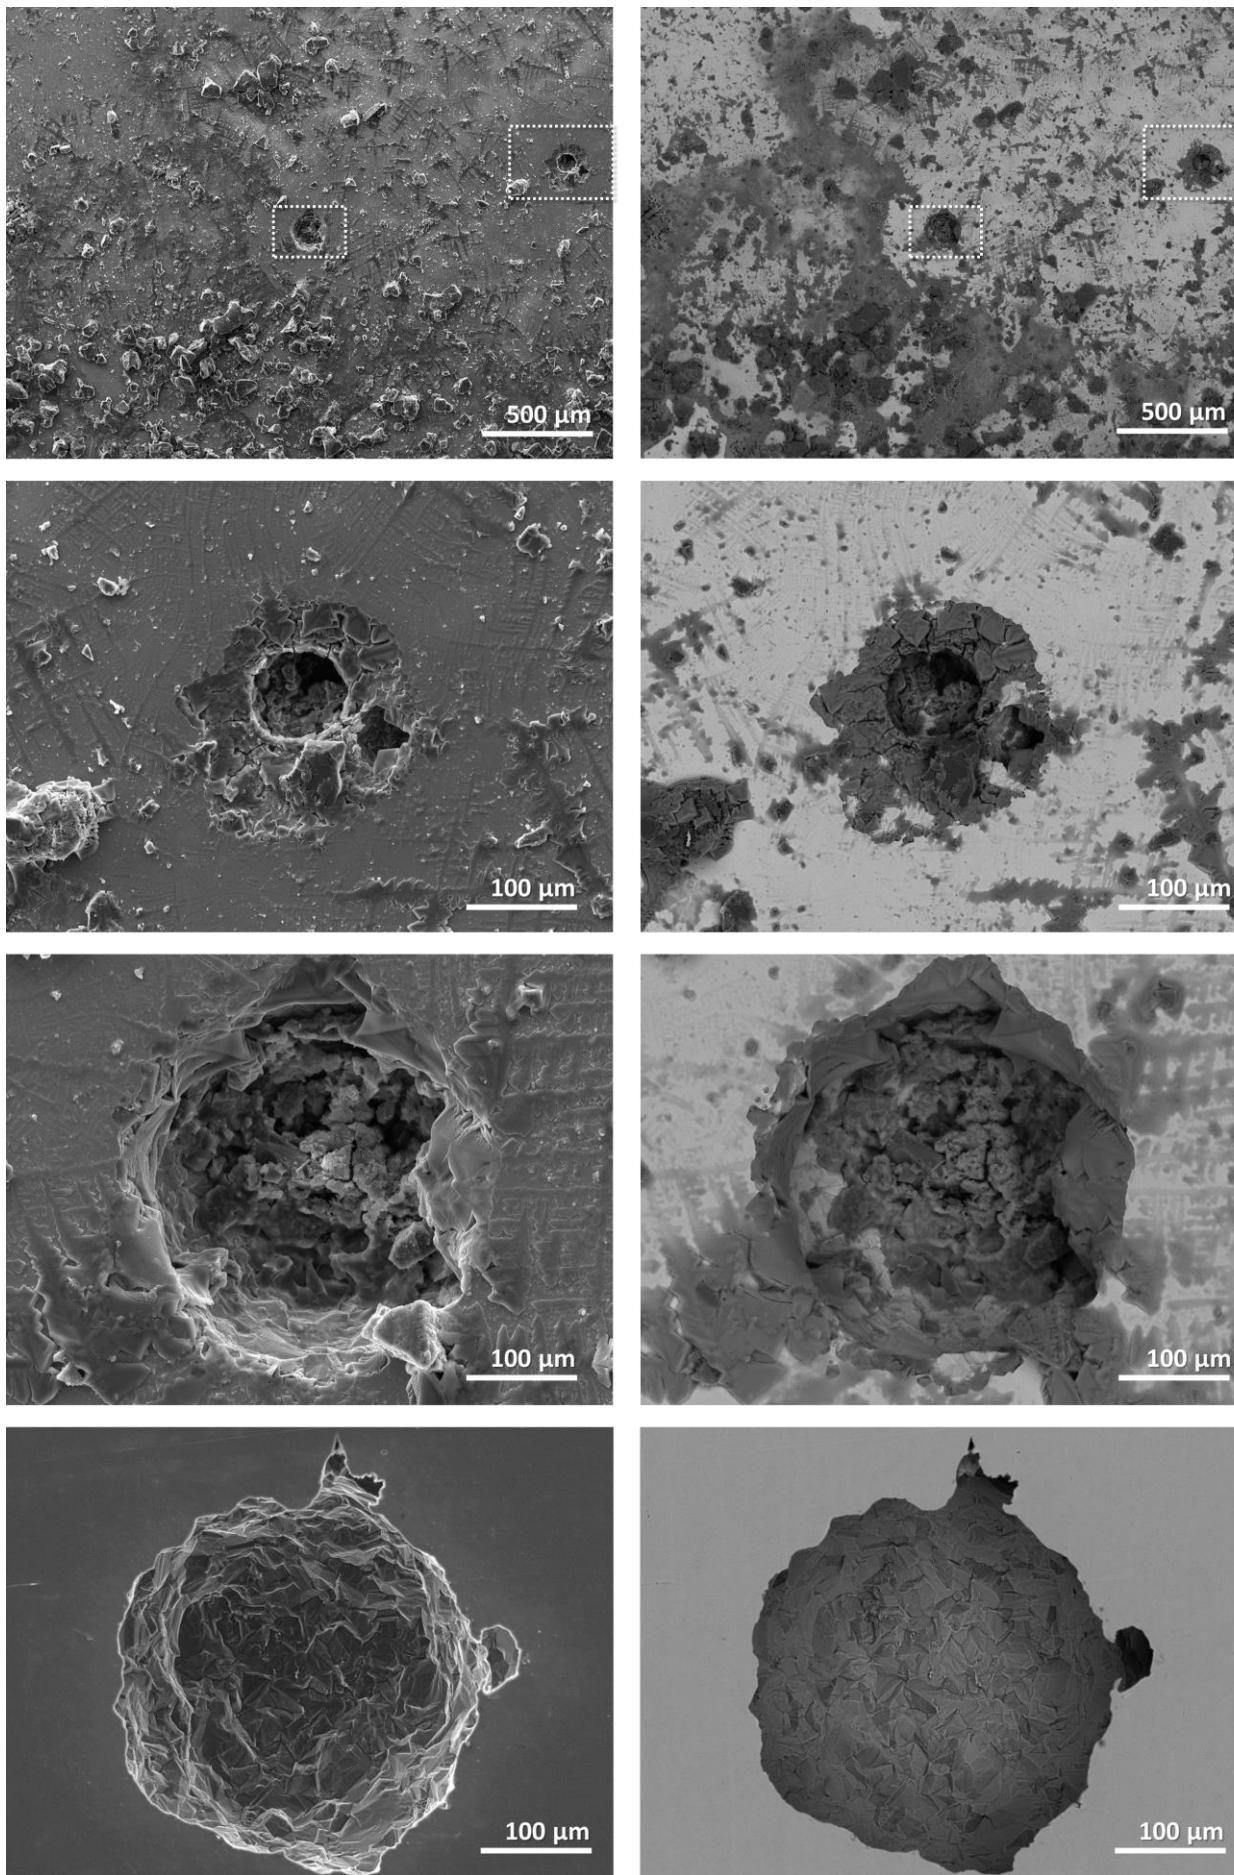
Figure 59. Example pits observed on the SS304 coupons post 1-month atmospheric exposure with 300 $\mu\text{g}/\text{cm}^2$ deposited 74 μm dust and ASW at static 75% RH and 50 °C. SE SEM images to the left with corresponding BSE SEM to the right. All images taken prior to corrosion product removal except the last row.

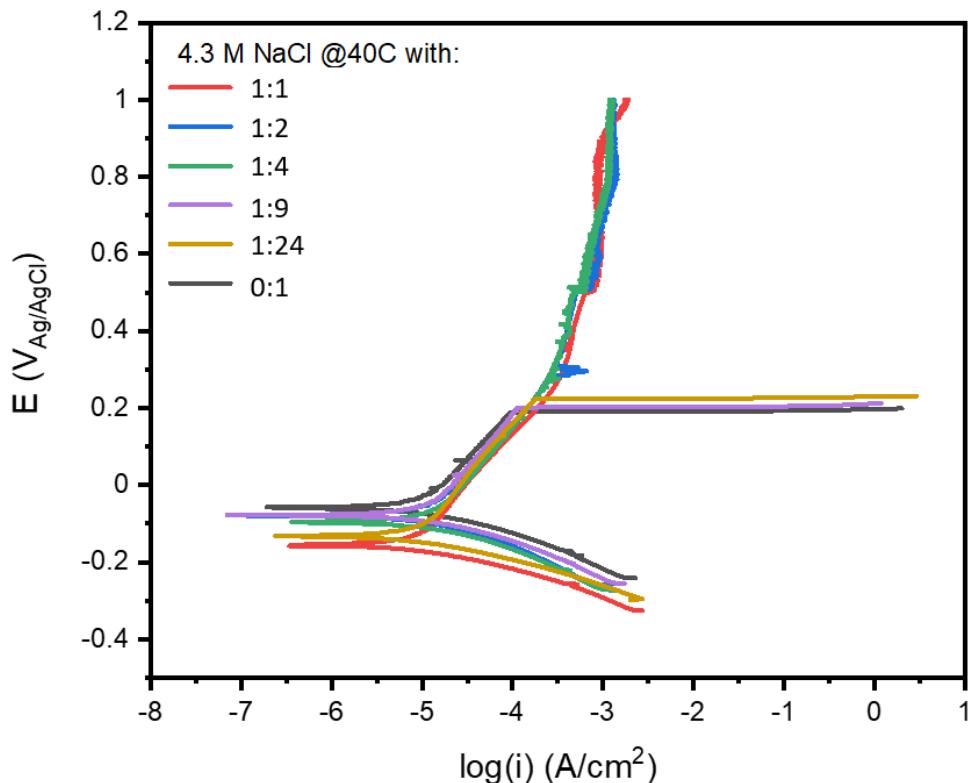
Figure 60: Polarization scans exploring the influence of varying nitrate:chloride ratios at 40 °C in 4.3 m NaCl.

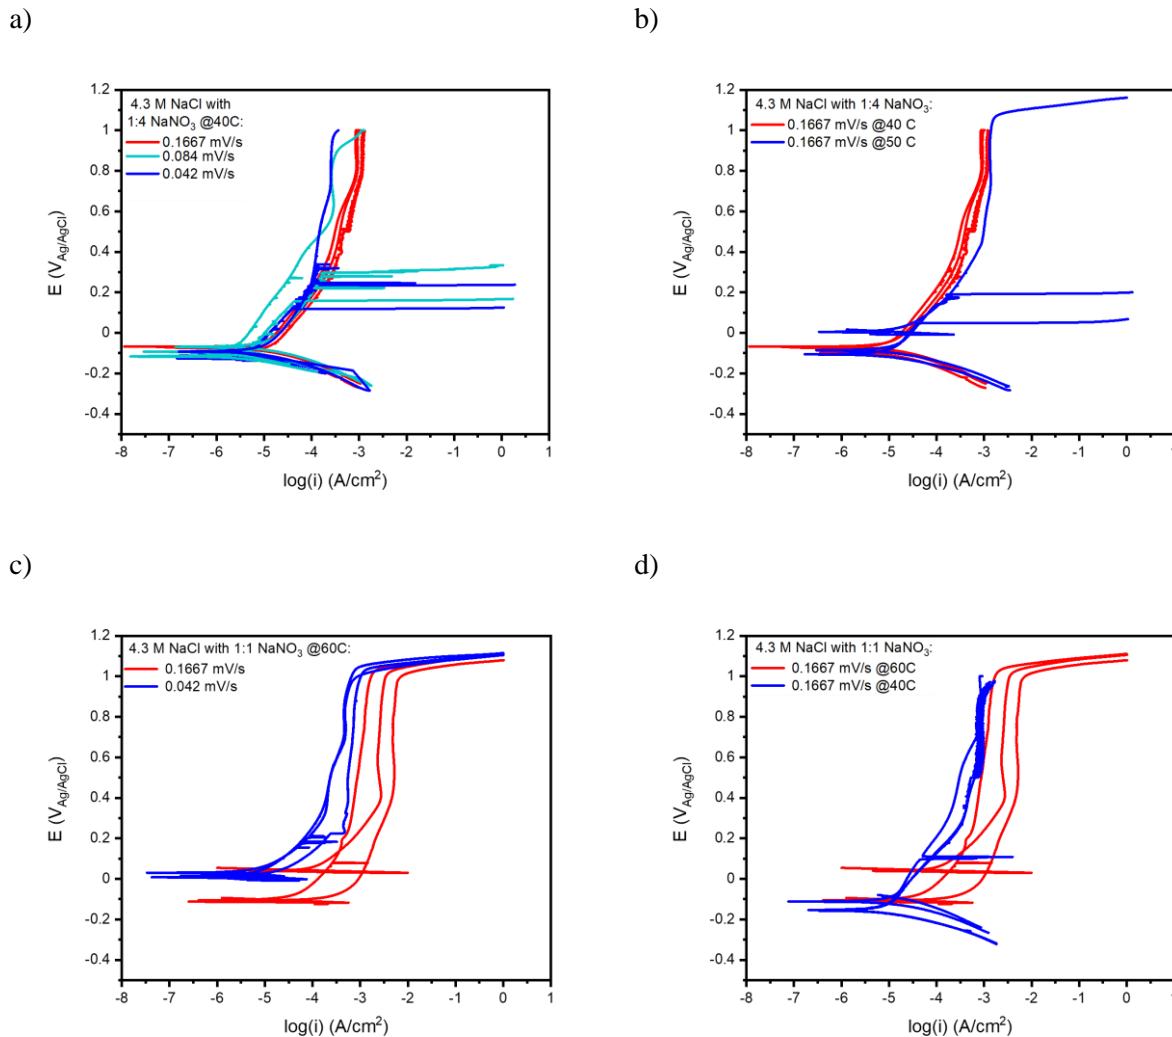
Figure 61: Polarization scans of SS304 in 4.3 m NaCl with 1:4 nitrate:chloride ratio at (a) 60 °C at three different scan rates and (b) comparison of 40 and 50 °C, and 1:1 nitrate:chloride ratio at (a) 60 °C at two different scan rates and (b) comparison of 40 and 60 °C.

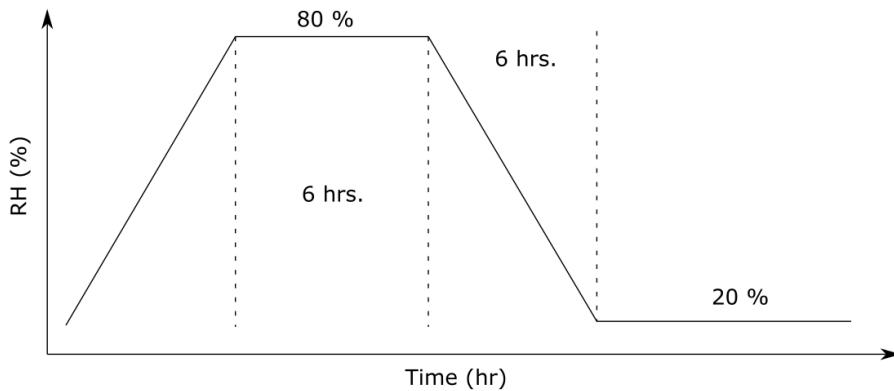
Figure 62: RH profile utilized for nitrate testing of SS304 nitrate droplets.

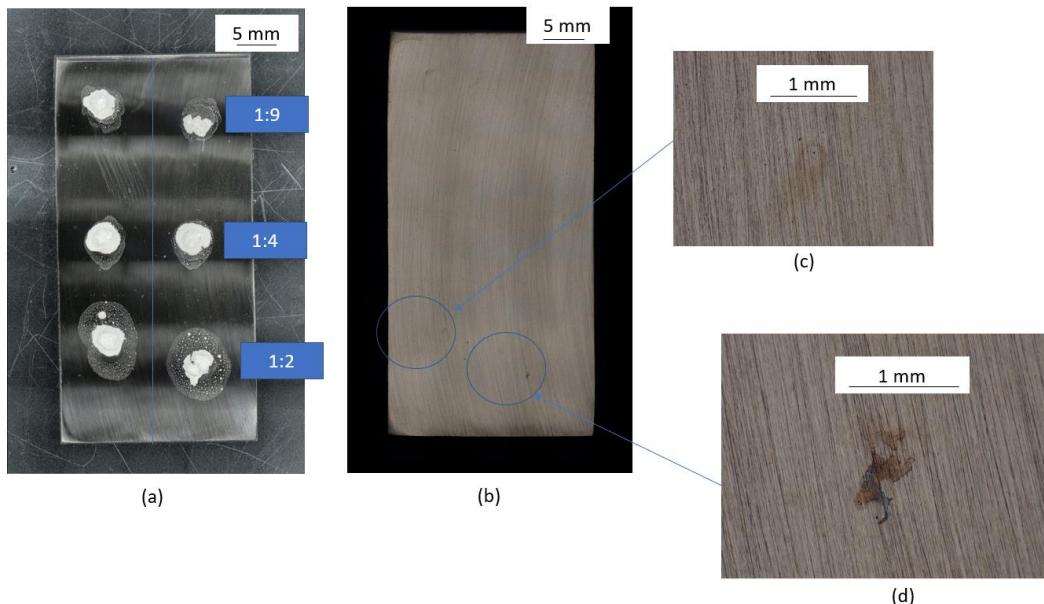
Figure 63: Exposure of SS304 under droplets to 4.3 M NaCl with varying droplet compositions of Nitrate:Chloride ratios (NO₃:Cl). (a) Salt distributions after exposure to the RH cycle in Figure 62. (b) Optical imaging after salt cleaning. (c) and (d) represent optical images of rust spots observed in (b).

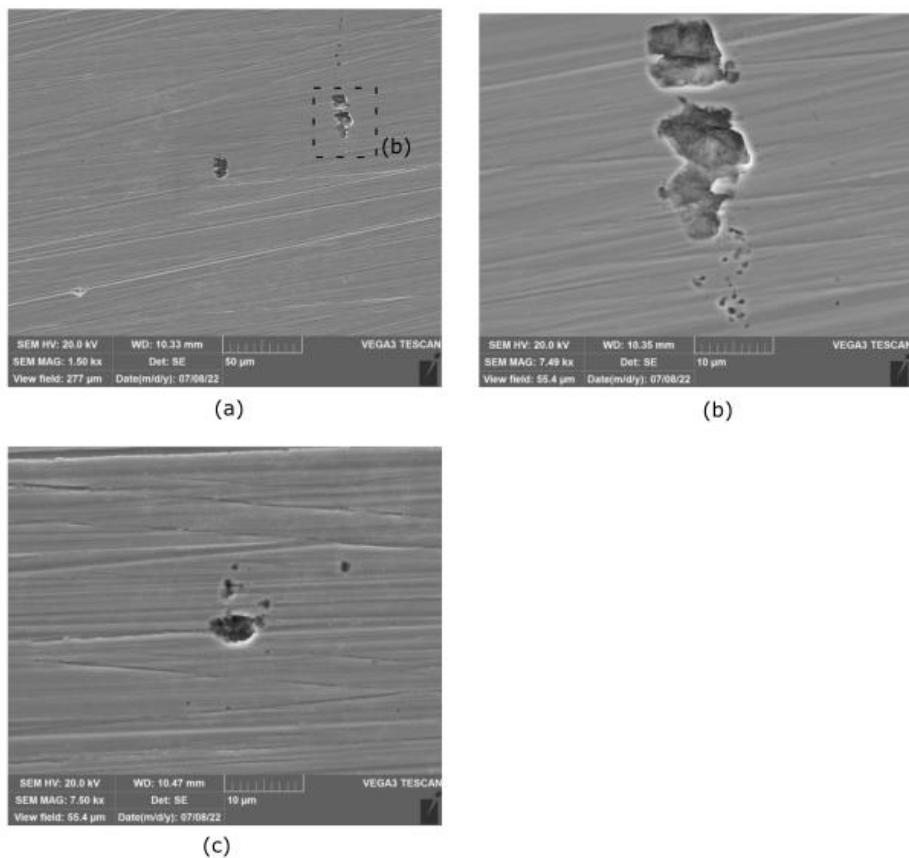
Figure 64: SS304 coupon exposed to (a) 4.3 m NaCl (1:1 NO₃:Cl; 3 μ L) under the relative humidity cycle presented in Figure 62. (b) Detailed view of pits noted in (a). (c) Pit observed after exposure to 4.3 m NaCl (1:1 NO₃:Cl; 2 μ L).

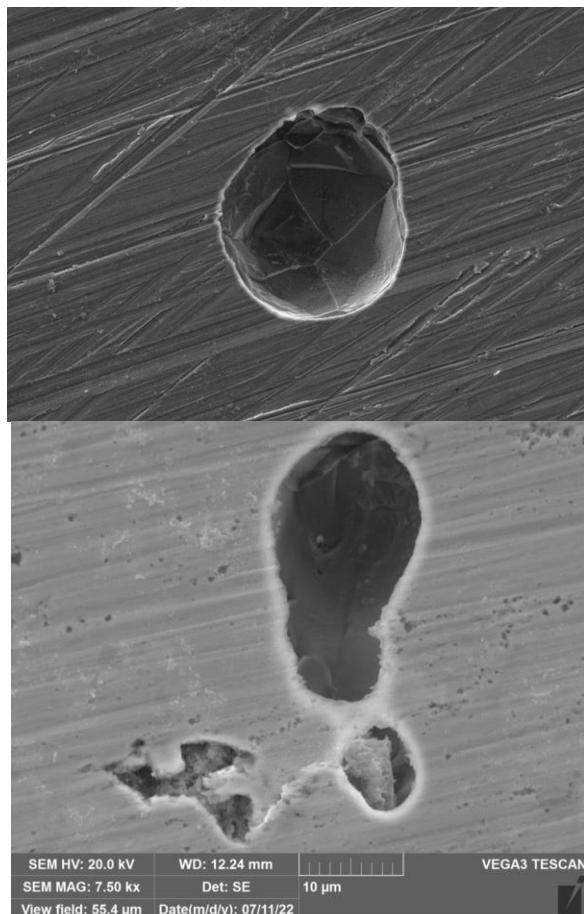
Figure 65: SS304 exposed to a 4 μ L droplet of 2.15 M NaCl (upper) and to 2.15 M NaCl: 2.15 M NaNO₃ (lower) at the RH cycle presented in Figure 62. Note that images are at the same scale.

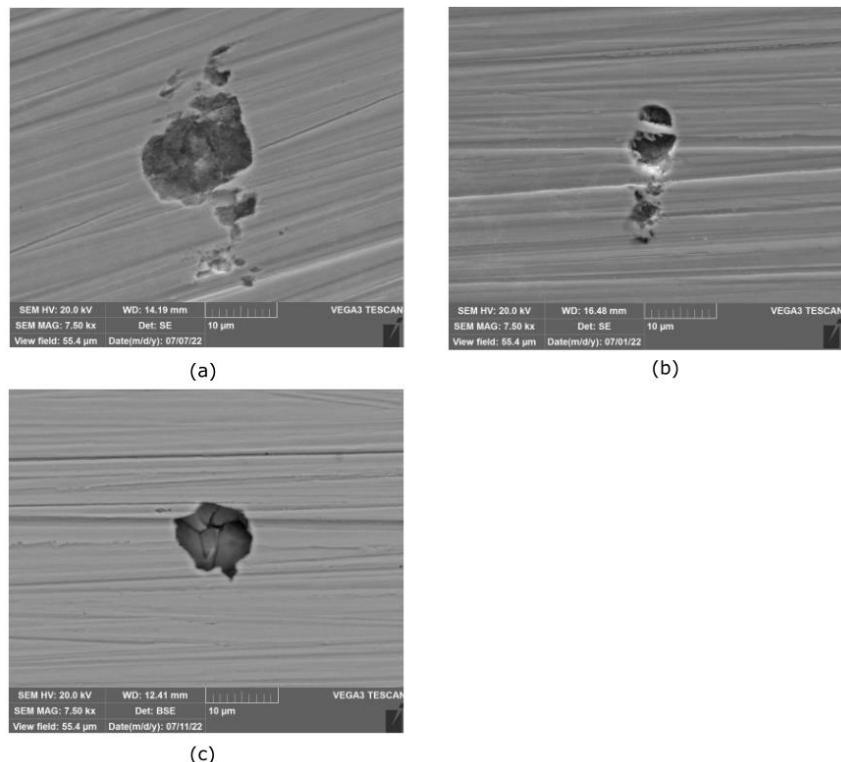
Figure 67: SS304 exposed to the RH cycle in Figure 62 with (a) 1.075 m NaCl (1:1 NO₃:Cl; 4 μL), (b) 1.075 m NaCl (1:1 NO₃:Cl; 3 μL), and (c) 1.075 m NaCl (1:1 NO₃:Cl; 1 μL)
