FY22 Status Update: SNF Interim Storage Canister Corrosion and Surface Environment Investigations

Spent Fuel and Waste Disposition

M2SF-22SN010207056

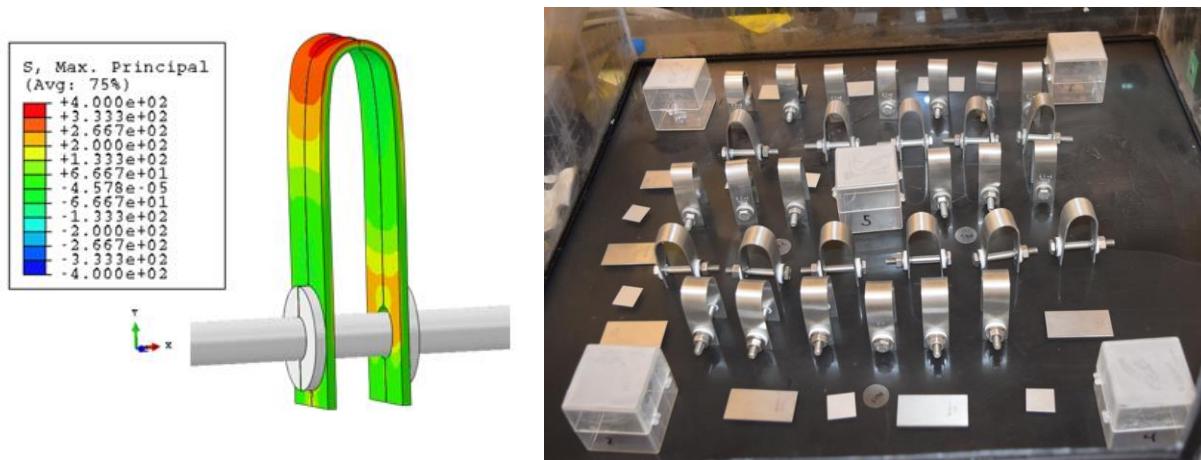
Figure 68. a) Schematic of maximum principle stress in the U-bends as calculated through FEM modeling (sample was assumed to be bent through horizontal displacement as described in the ASTM G30. **b)** Example of ASW deposition using the SNL nebulizer system.

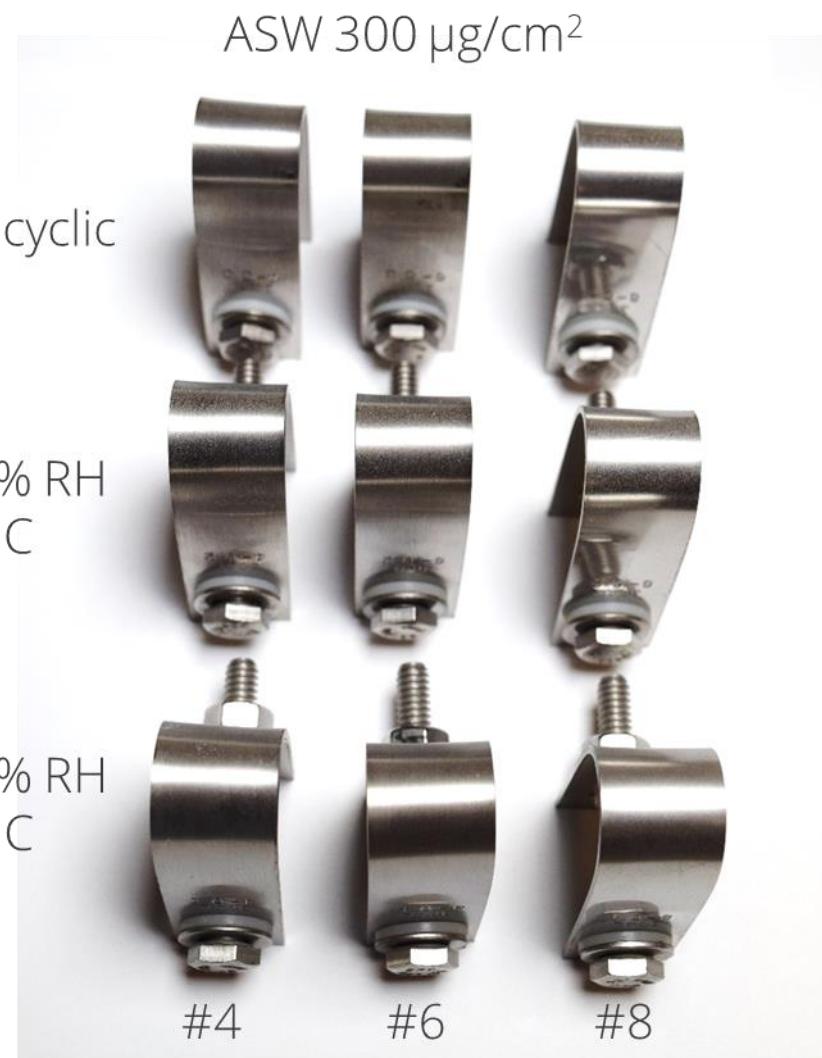
Figure 69. Optical images post 3-day atmospheric exposure of the U-bend samples finished to three different surface finishes.

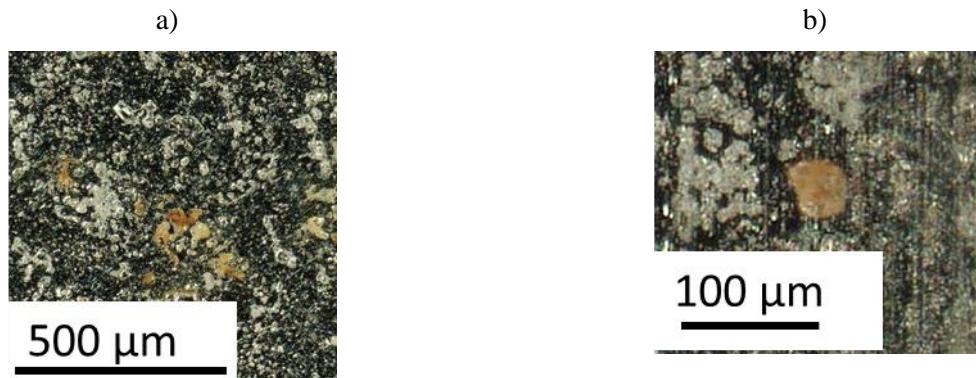
Figure 70. Example higher resolution optical images of post-exposure corrosion damage on a) the #8 surface finish diurnal cyclic exposure and b) the #4 surface finish 75 %RH static exposure.

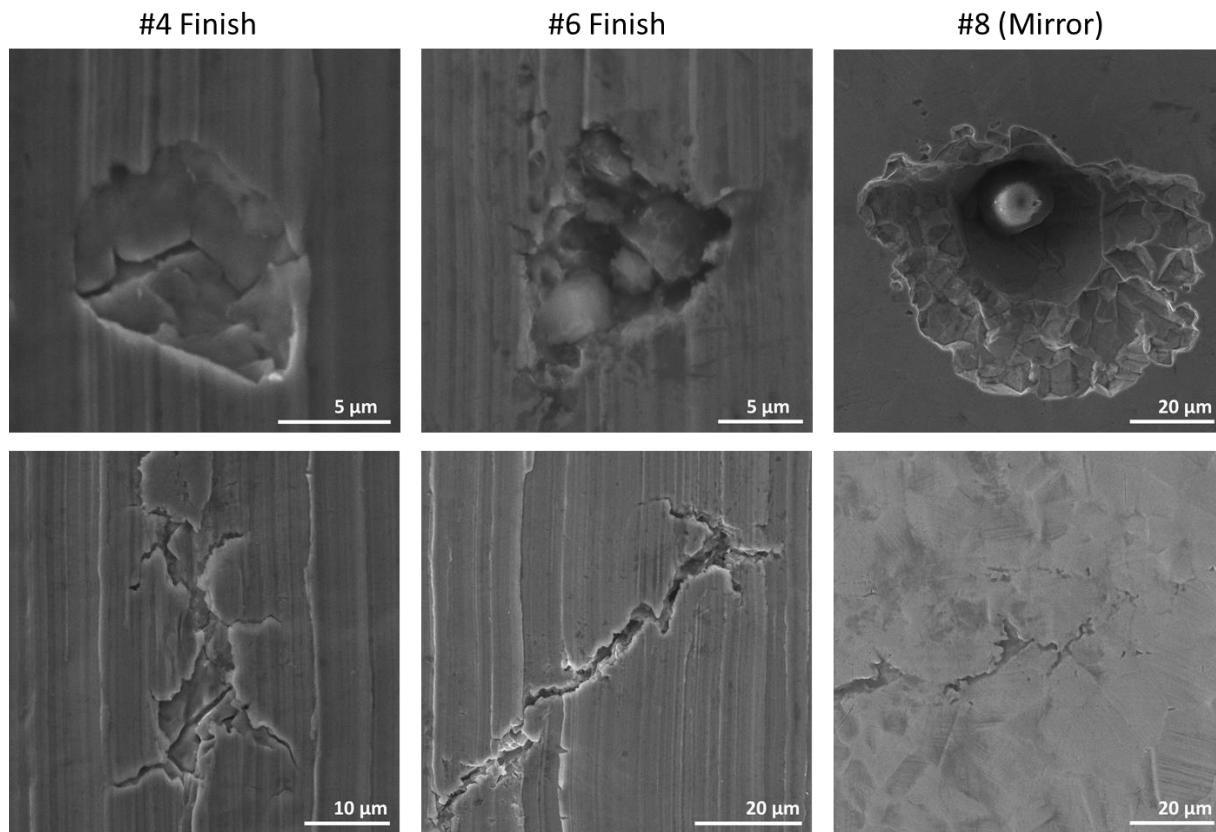
Figure 71. Exemplar pit and surface crack morphologies on SS340 U-bend samples exposed for 1 month at 75% RH, 35 °C with 300 $\mu\text{g}/\text{cm}^2$ ASW printed on the surface for #4, 6, and 8 surface finishes.

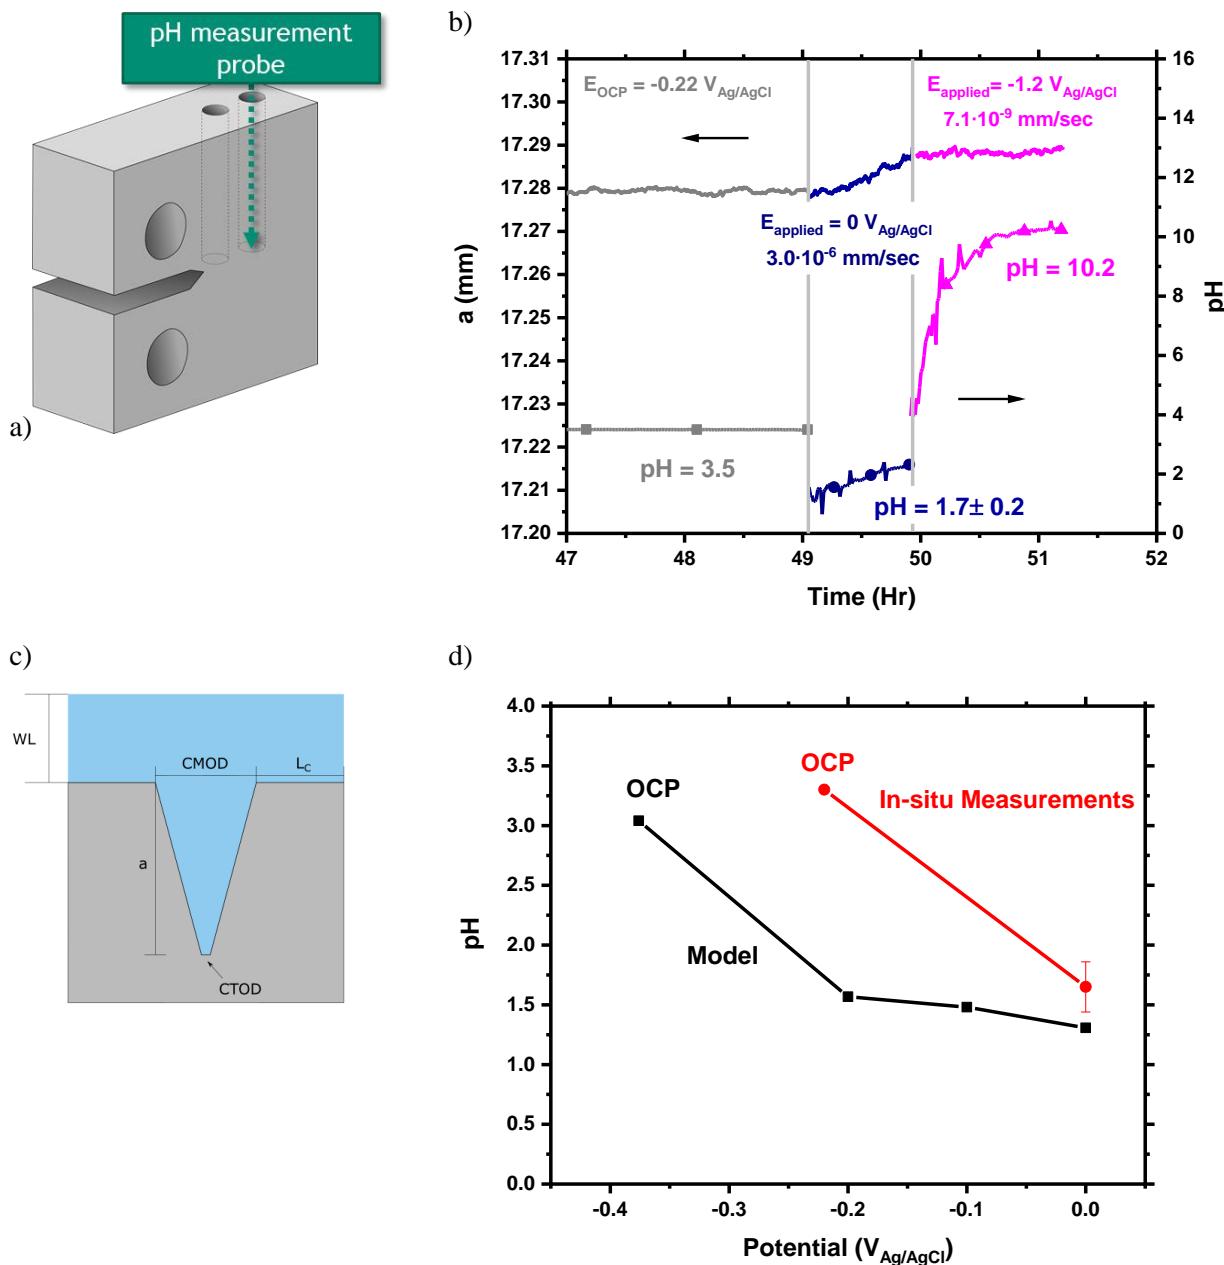
Figure 72. a) Schematic of a compact tension specimen altered for in-situ pH probe measurement, b) crack length vs. time for 304L exposed to room temperature 3 M NaCl and 20 MPa(m) $^{1/2}$ at various external polarizations (none, anodic, and cathodic) compared to in-situ pH measurement, c) schematic of FEM crack tip, and d) modeled vs measured pH as a function of applied potential.

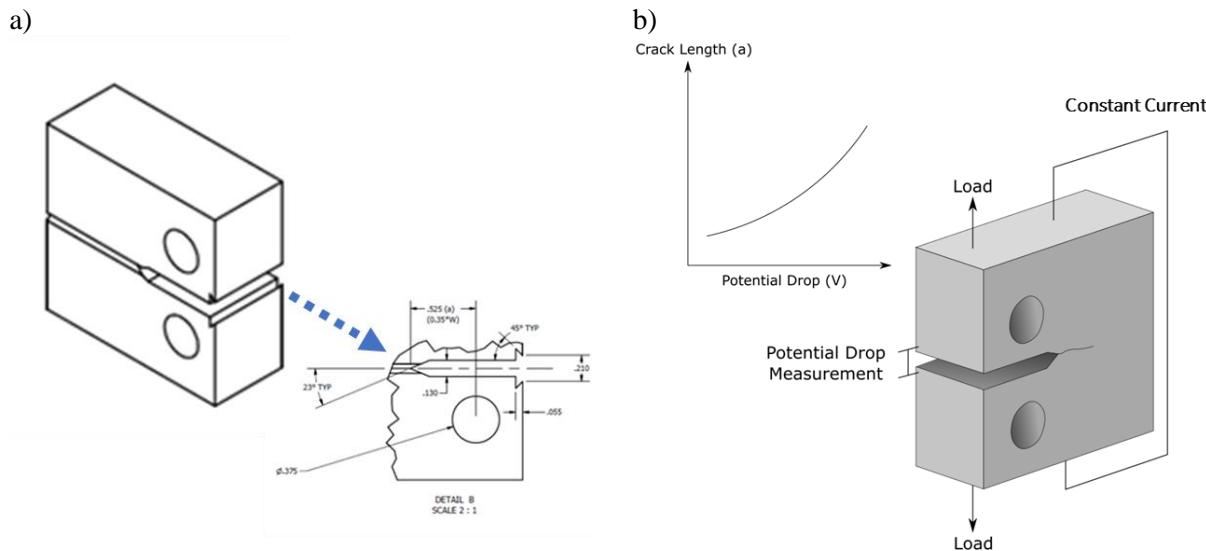
Figure 73. Schematic of a) CT specimen with notch dimensions and b) DCPD measurement setup and “example” measurement output.

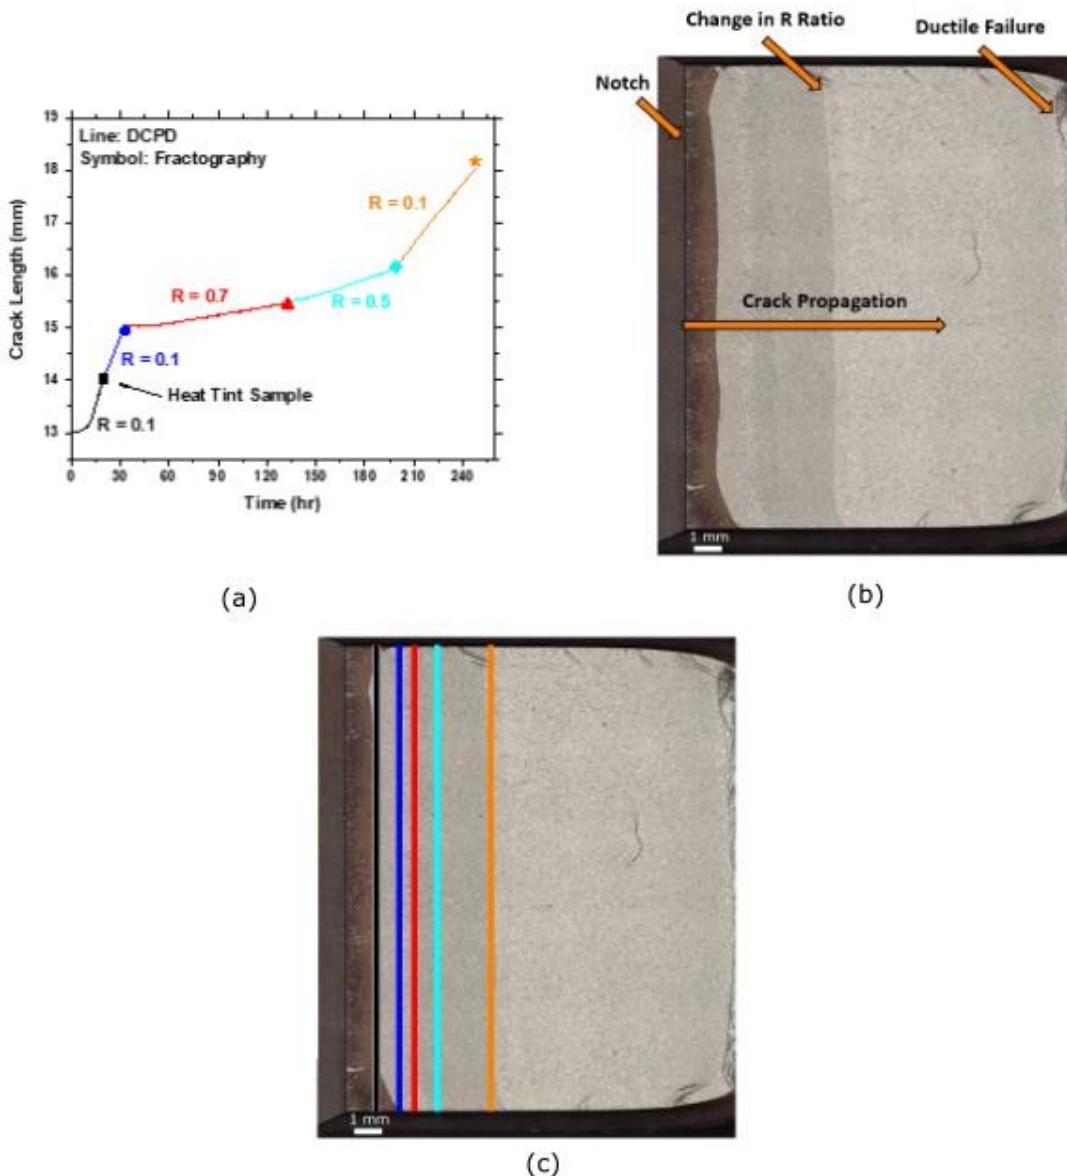
Figure 76: (a) Crack Growth vs. time for Lot 1 under air fatigue for different r ratios. (b) Corresponding fractography for air fatigue test with different test steps labeled and (c) average measurement lines corresponding to the symbols in (a).

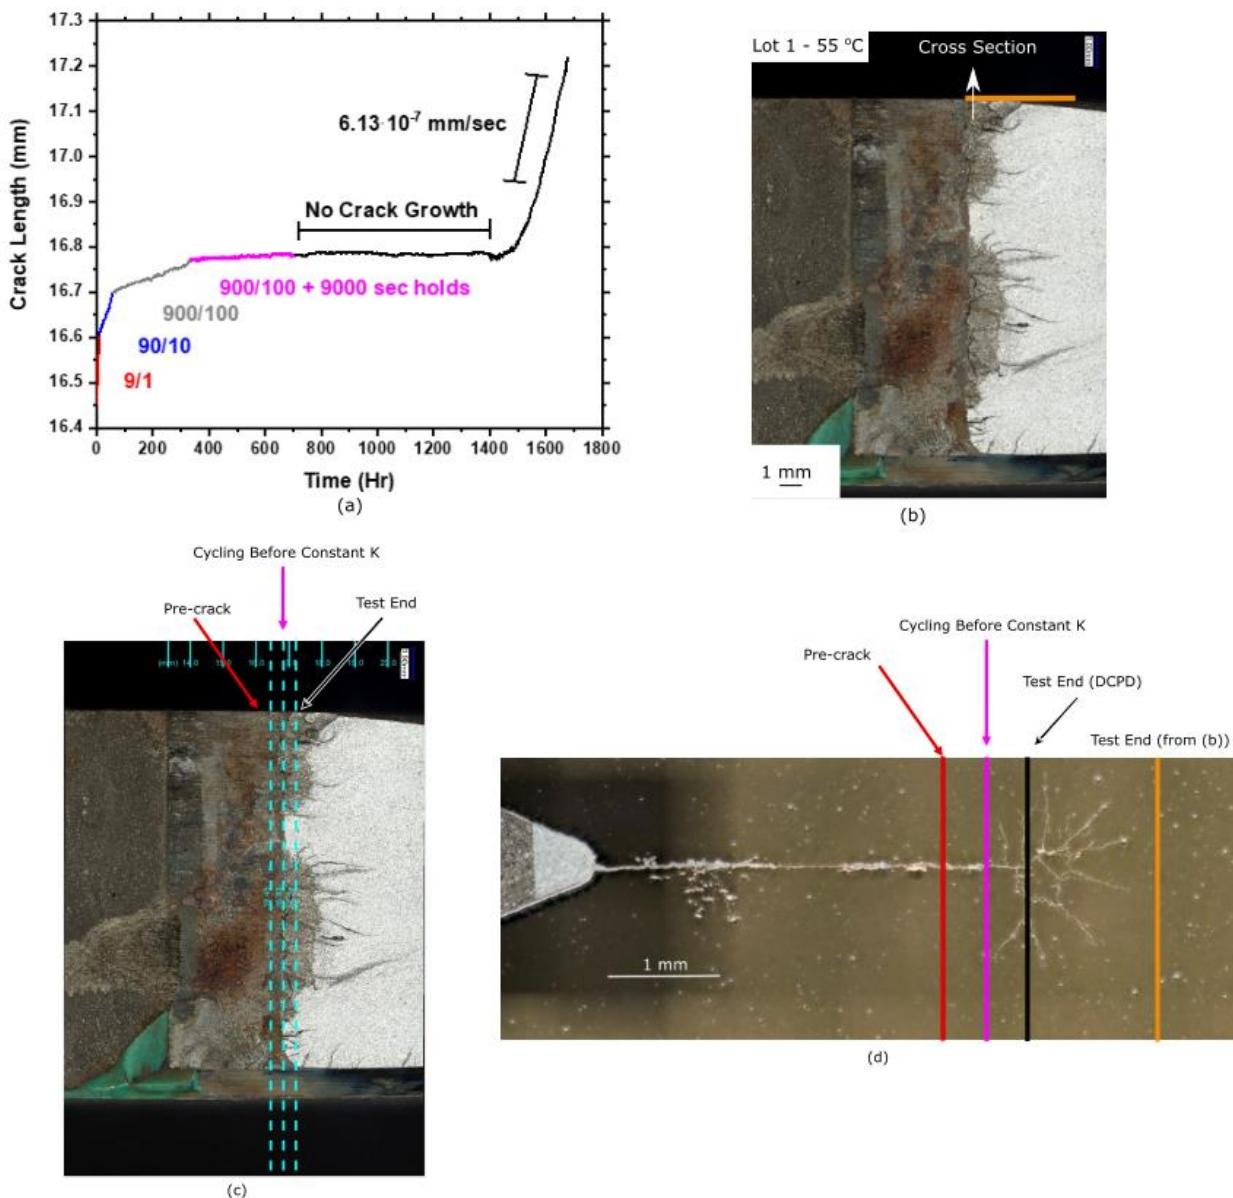
Figure 77: (a) Crack length vs. time for SN0007 (Lot 1) in saturated MgCl_2 at 55 °C. (b) A portion of the fracture surface and (c) optical cross section of the crack tip.

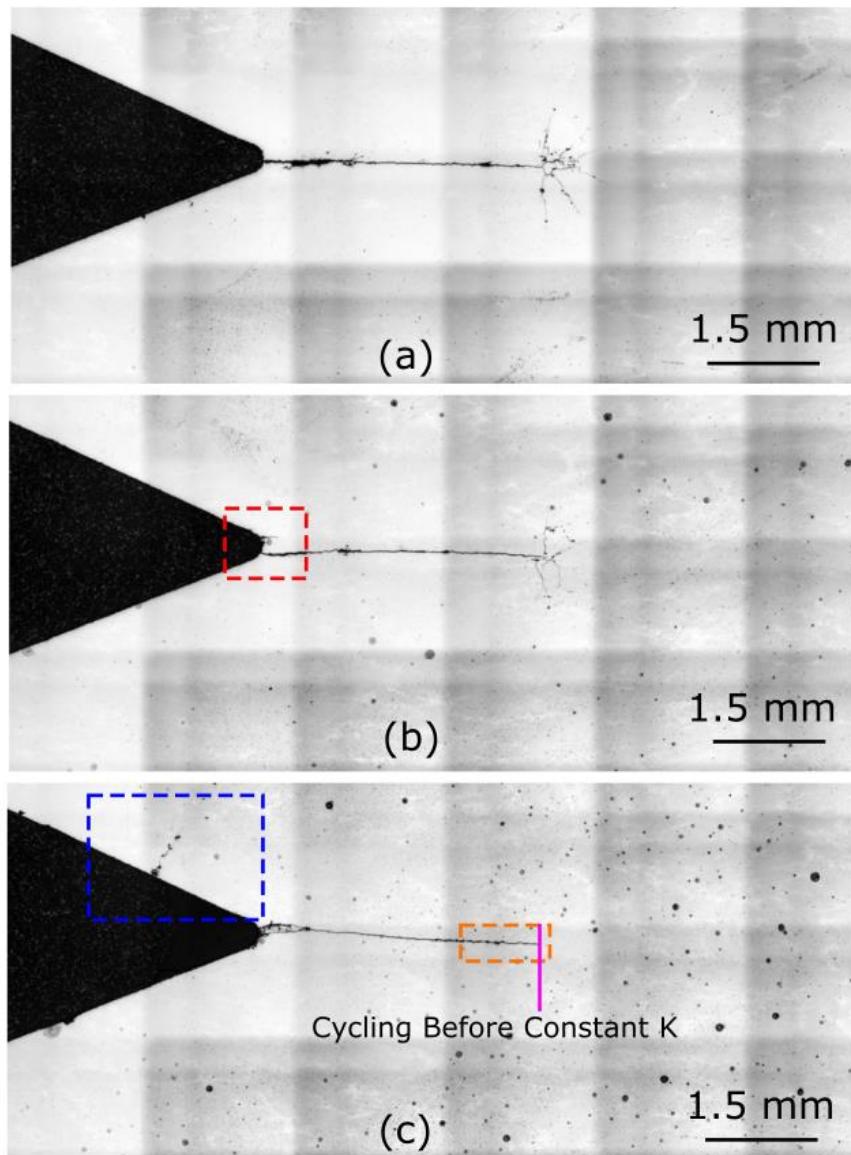
Figure 78: Detailed serial sectioning of SN0007 from Figure 77.

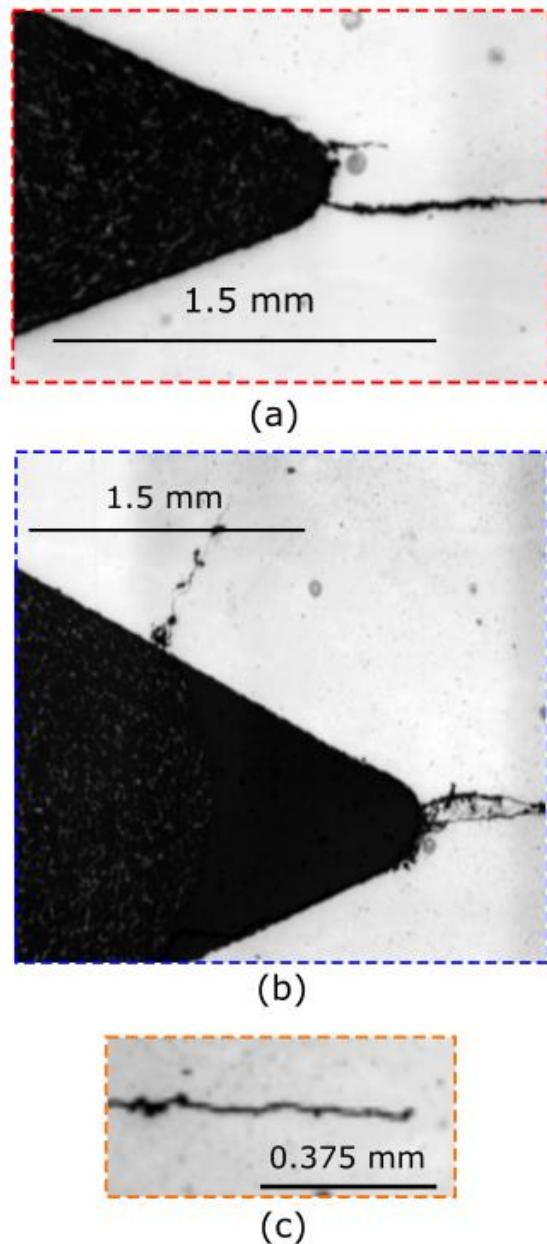
Figure 79: Detailed look at the serial cross section from Figure 78.

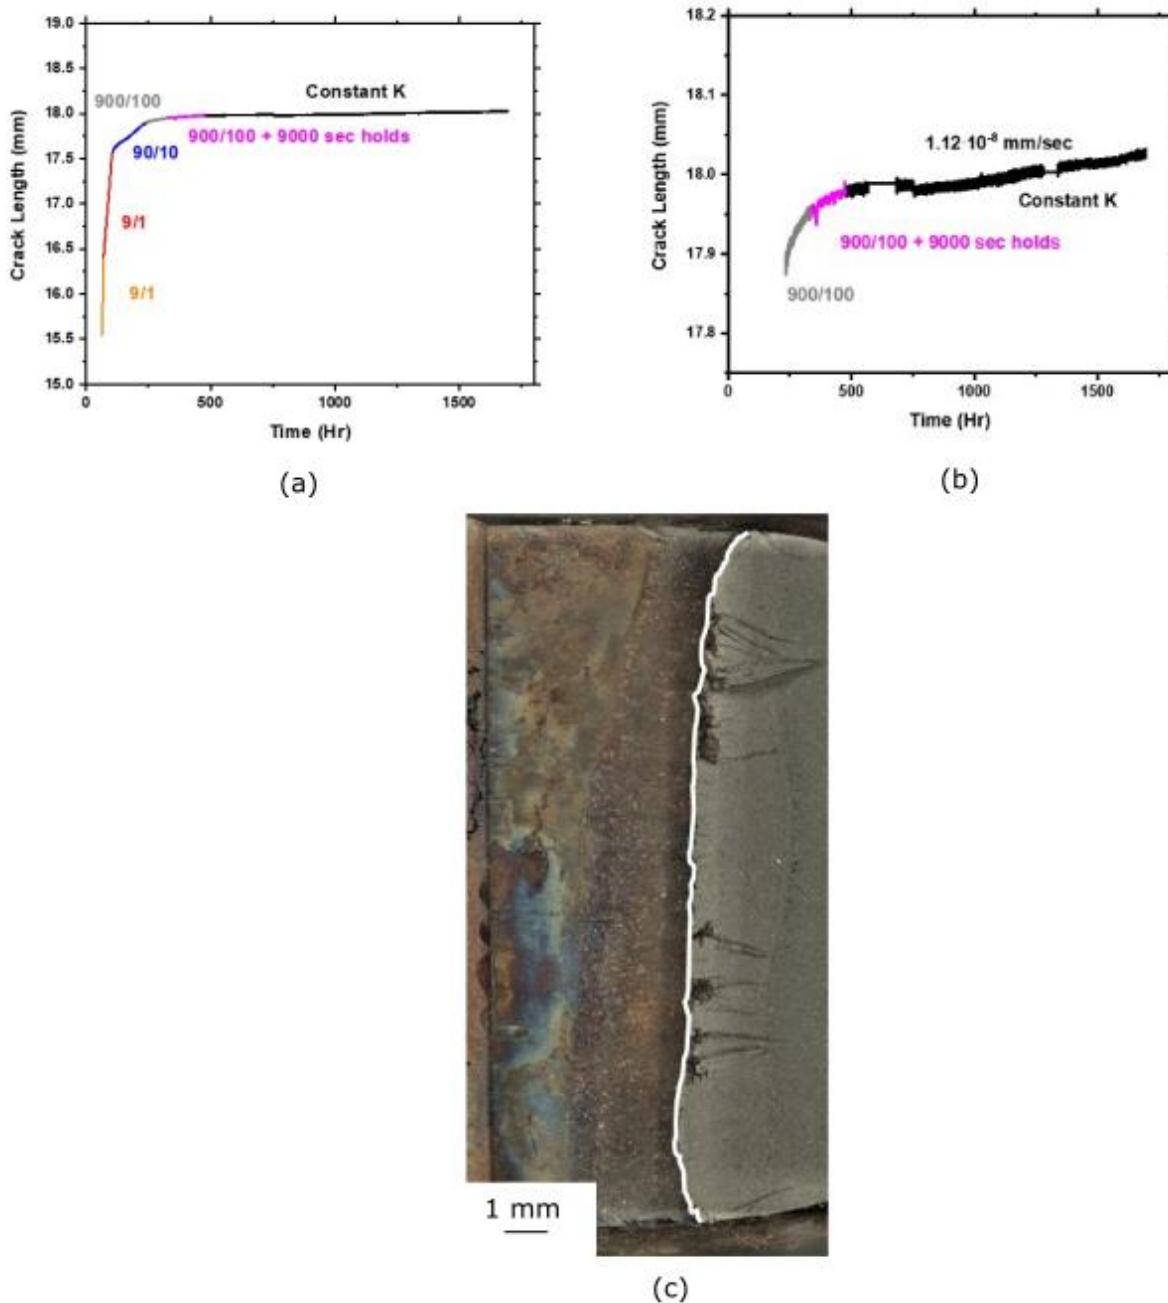
Figure 80: (a) Crack Growth vs. time for SN0033 from Lot 1 exposed to saturated MgCl_2 at 22°C for the entire test duration and (b) zoomed in showing the constant K behavior. (c) Optical fractography for sample SN0033 with overlay of CGR measurement line.

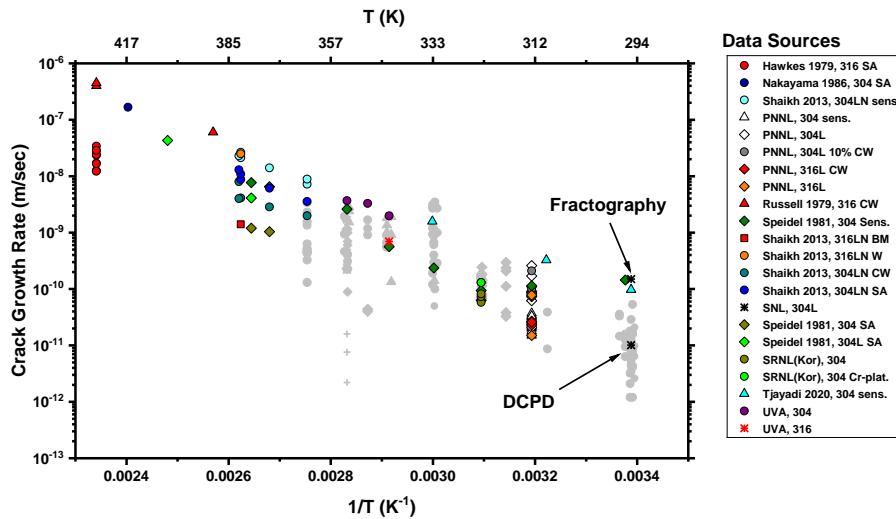
Figure 81: Comparison of CGR measured by DCPD and fractography for SN0033 with literature values for CGR [ref-CRB report].

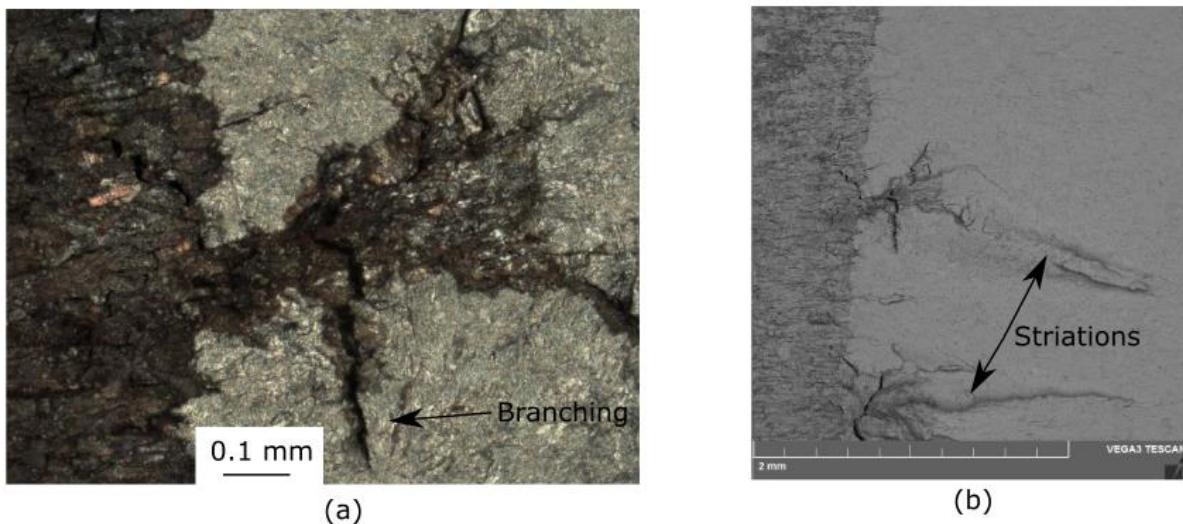
Figure 82: (a) Optical and (b) SEM image of protrusions on the fracture surface of SN0033.

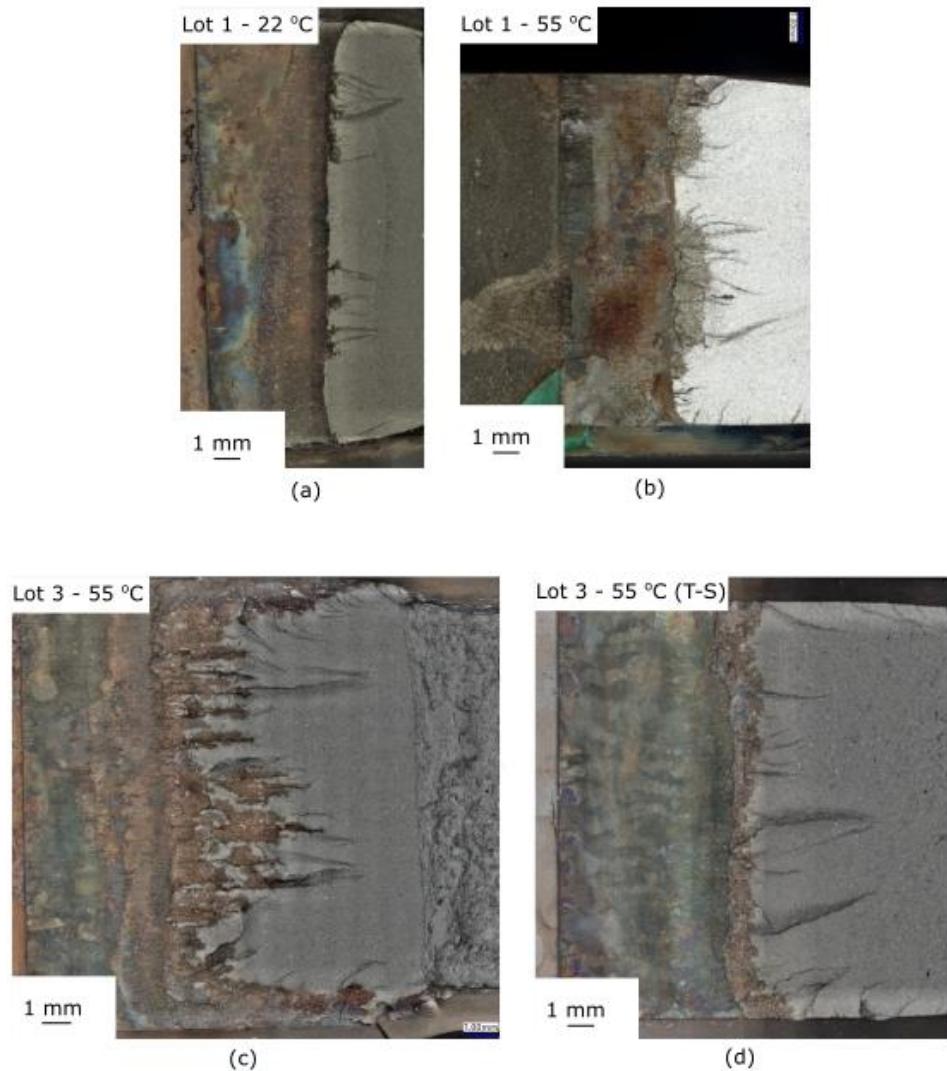
Figure 83: Fractography for samples ran in saturated MgCl₂ on various lots, temperatures, and directions. The figures correspond to (a) Lot 1 - 22 °C (SN0033), (b) Lot 1 - 55 °C (SN0007), (c) Lot 3 - 55 °C (SN0100), (d) Lot 3 - 55 °C (SN0107), T-S. It is noted that if the directions are not noted they are performed in the L-T direction.

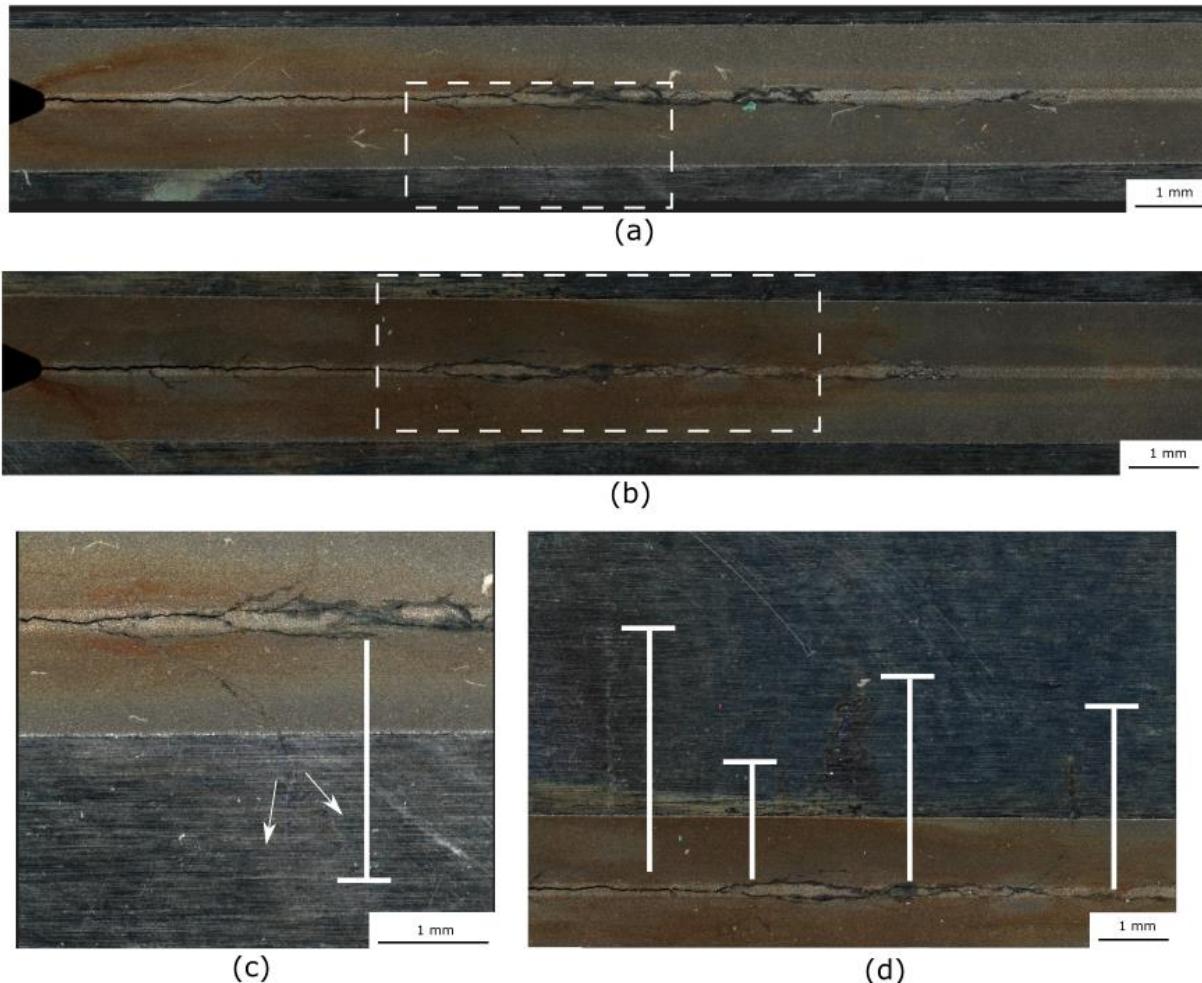
Figure 84: Fractography of the crack path for Sample SN0107 ran in saturated MgCl_2 at 55 °C.

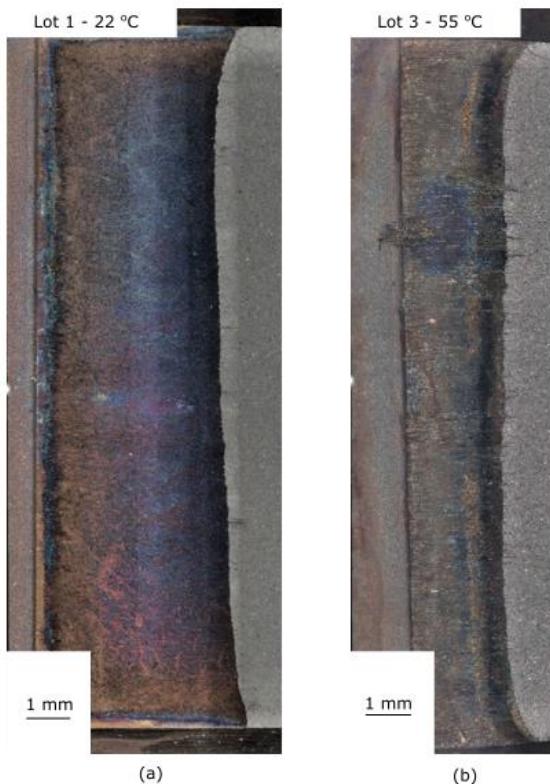
The fracture morphologies of SN0028 and SN0095 are shown in Figure 86-a and b respectively. In comparison to crack fronts observed for MgCl_2 exposures (Figure 83), the crack fronts for NaCl solutions (Figure 86) are linear in nature and do not contain protrusions ahead of the primary crack front. Additionally, there is not significant evidence of the cracks branching as indicative striations did not appear during the final fatiguing process as were present in the samples cracked in MgCl_2 (Figure 82). Despite the linear crack fronts, significant corrosion is present in the crack wakes of these samples and is shown in the SEM micrographs in Figure 87 for SN0095. It is possible that due to the selective trench-like behavior of these features that the microstructure is playing a significant role in the corrosion and SCC behavior of these materials.

Figure 86: Fractography for samples ran in saturated $MgCl_2$ on various lots, temperatures, and directions. The figures correspond to (a) SN0028 (Lot 1 - 22 °C) and (b) SN0095 (Lot 3 - 60 °C). It is noted that if the directions are not noted they are performed in the L-T direction.

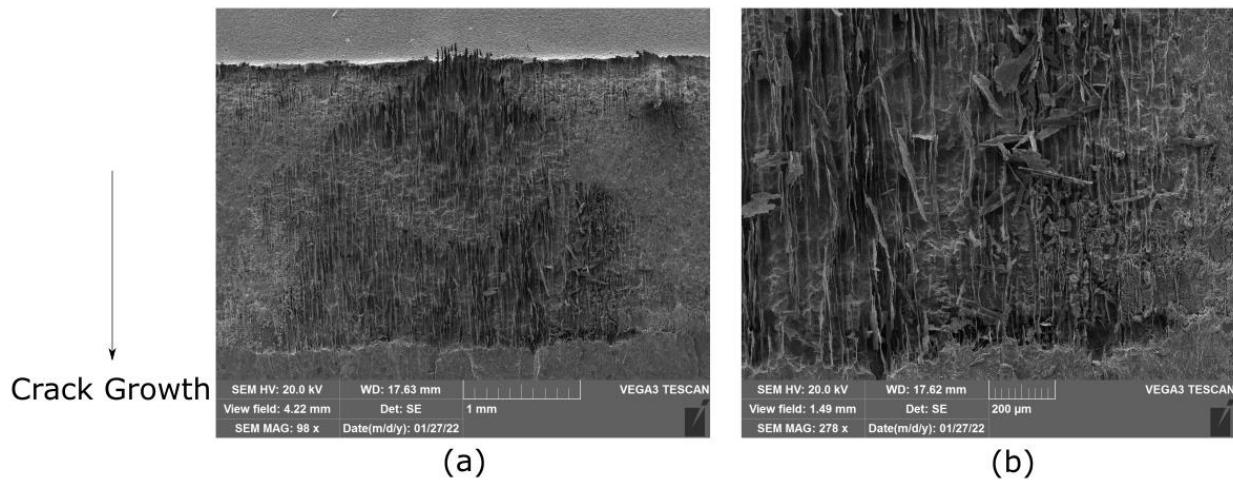
Figure 87: SEM images showing crack wake corrosion in SN0095.
