SAND2024-12109

Bryan Mound Collar Compression Study

This report presents a study of collar compression for the wells at the Bryan Mound site. The study includes a comprehensive review of all available Multi-Arm Caliper (MAC) logs from the site, which has been used to identify specific wells that are experiencing casing restrictions at collar joints. A summary of wells with collar restrictions and the corresponding deformation depths has been provided. Additional site-wide analysis of Bryan Mound well temperature data, proximity to sulphur wells, pulsed eddy current (PEC) logs, and a general spatial analysis has been included to investigate any potential correlations with wells experiencing collar compression at the site.

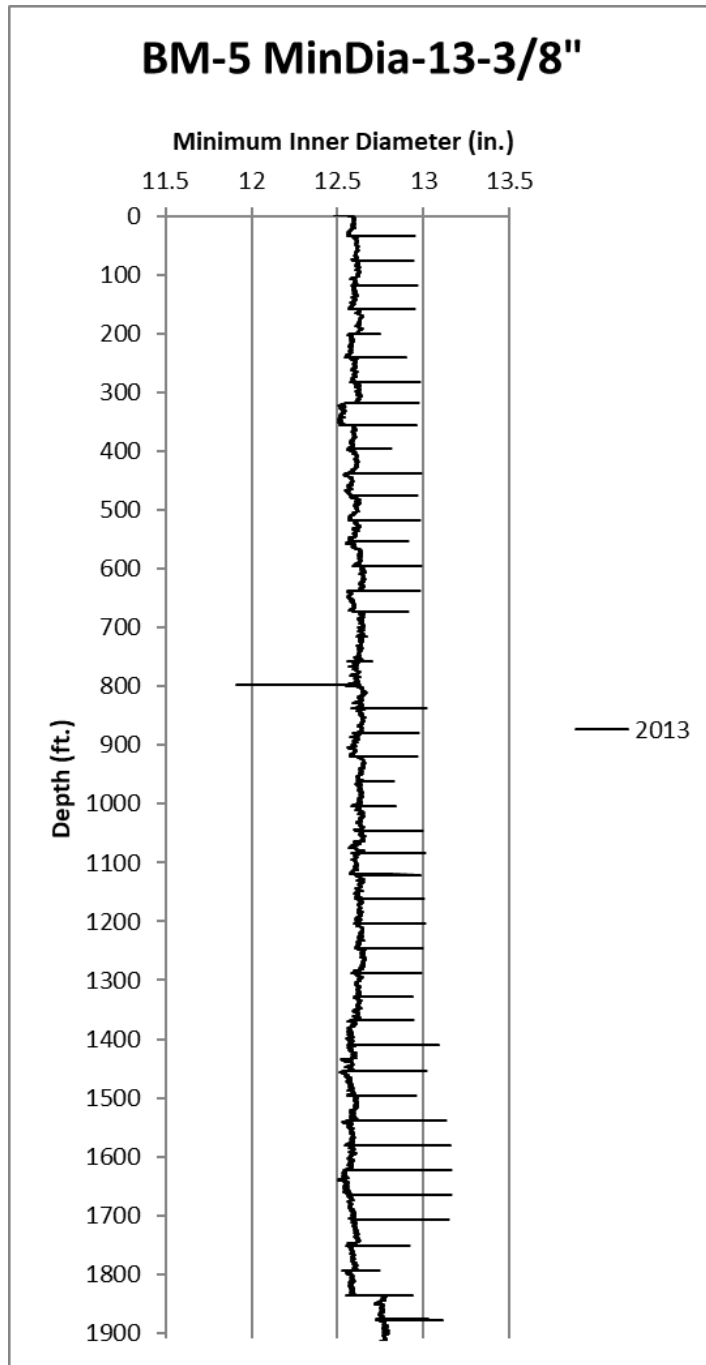
Figure 3-1. BM-5 minimum diameter curve from 2013 MAC data

An example below shows data from well BM-5, where a casing compression has been identified around 797'. Figure 3-1 shows minimum diameter measurements for the entire 13 3/8" casing. In the minimum diameter data, a clear decrease in the inner diameter of the well can be identified in the collar at approximately 797'. Although identifying a decrease in the minimum diameter curve is a good first check, is not sufficient enough to conclusively say that there is a collar restriction at that depth. There are several cases where a decrease in the minimum diameter is caused by a single arm reading or debris in the well that is only present in a small number of radial arm measurements at a given depth. A suspected casing restriction should always be confirmed with a comprehensive review of radial arm data from the MAC log at the depth of concern. Even in cases where a decrease is seen in the maximum diameter curve as well, signaling that all diameter measurements at a given depths have been reduced, the radial arm data provides a better picture of what is going on and can help characterize the uniformity and severity of the collar restriction. Figure 3-2 shows radial arm data taken from the 2013 MAC log run on well BM-5, with cross sections taken both at and above the collar restriction. From this data, a clear and uniform decrease in the diameter can be observed at 797'.

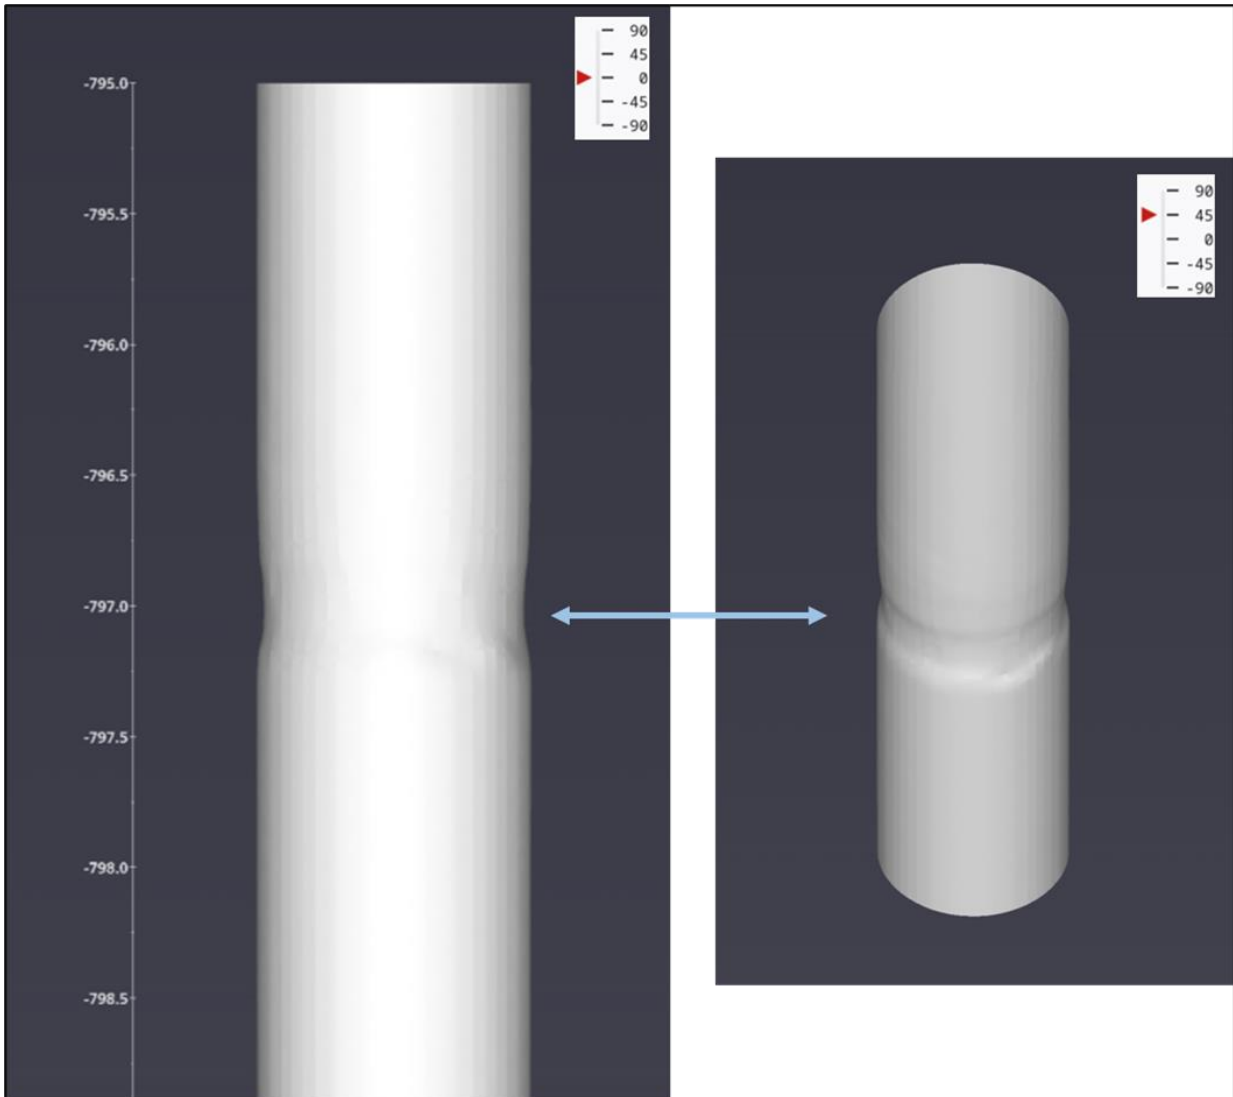
Figure 3-3. 3D visual of BM-5 2013 MAC radial arm data at the casing restriction

A 3D visual of the radial arm data near the casing collar restriction can be seen in Figure 3-3. As observed in the cross sections shown above, a clear restriction in the casing can be seen at 797'. Again, this is the opposite of what we would expect to see at a typical STC casing collar. Figure 3-4 provides an example of a normal casing collar in BM-5, with a small collar kick at the joint location as expected. There are several cases in this report where a radial restriction is present at a casing collar but appears minimal in the MAC data. It should be noted that even in cases where a collar restriction is present but not severe, the absence of a normal collar kick is likely indicative of a compression issue at the collar.

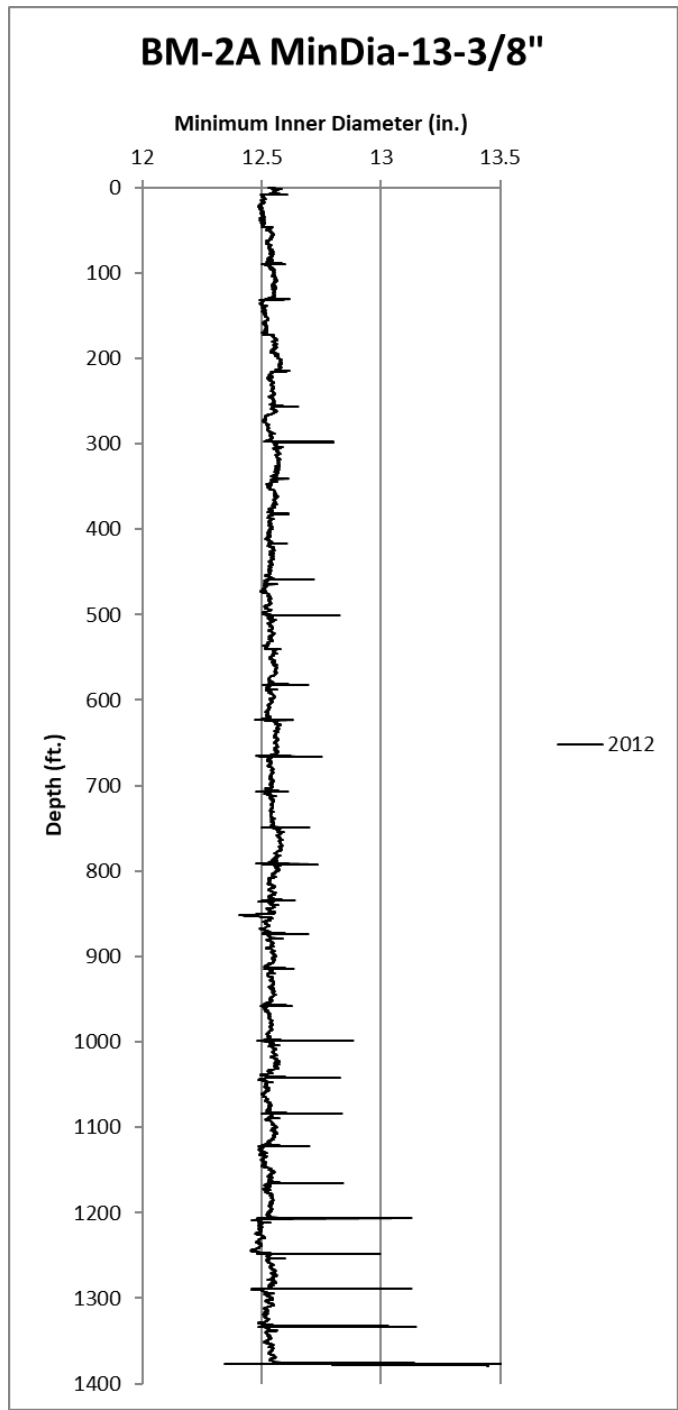
Figure 3-12. BM-2A minimum diameter curve from 2012 MAC data

BM-2A has one MAC log from 2012, which was taken on the 13 3/8” casing. Figure 3-12 shows the minimum diameter curve for the 13-3/8” casing which was calculated from the 2012 MAC log. Although there are no major restrictions at the casing collars, there is a slight decrease in the minimum diameter between collar locations around 851.8’.

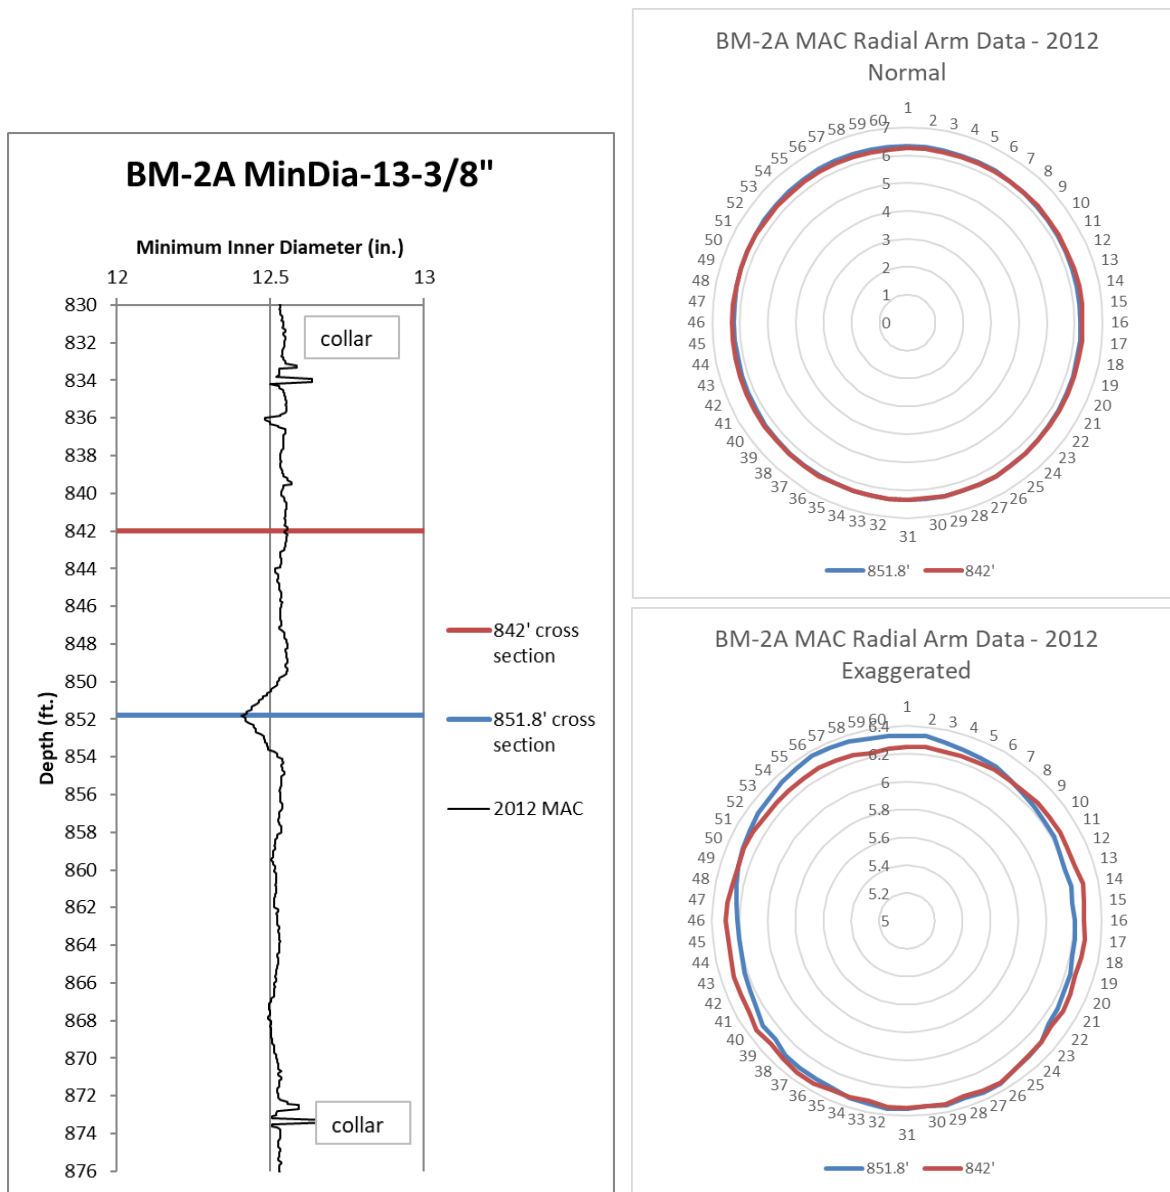
Figure 3-13. Cross sections of BM-2A 2012 MAC data at the depth of casing ovality (blue) and below the ovality (red).

Figure 3-13 shows cross sections taken at and below the depth of interest at 851.8'. An ovality in the casing can be observed at this depth as seen in the figure below. The two radial arm plots show the same data, with the scale in the lower plot being exaggerated to highlight the ovality seen at a depth of 851.8'. The 2012 MAC does not show the deformation at this depth to be severe, however it should be noted as an area to monitor going forward, especially in light of recent events at BM-116A, where extreme deformation occurred in-between casing collars.

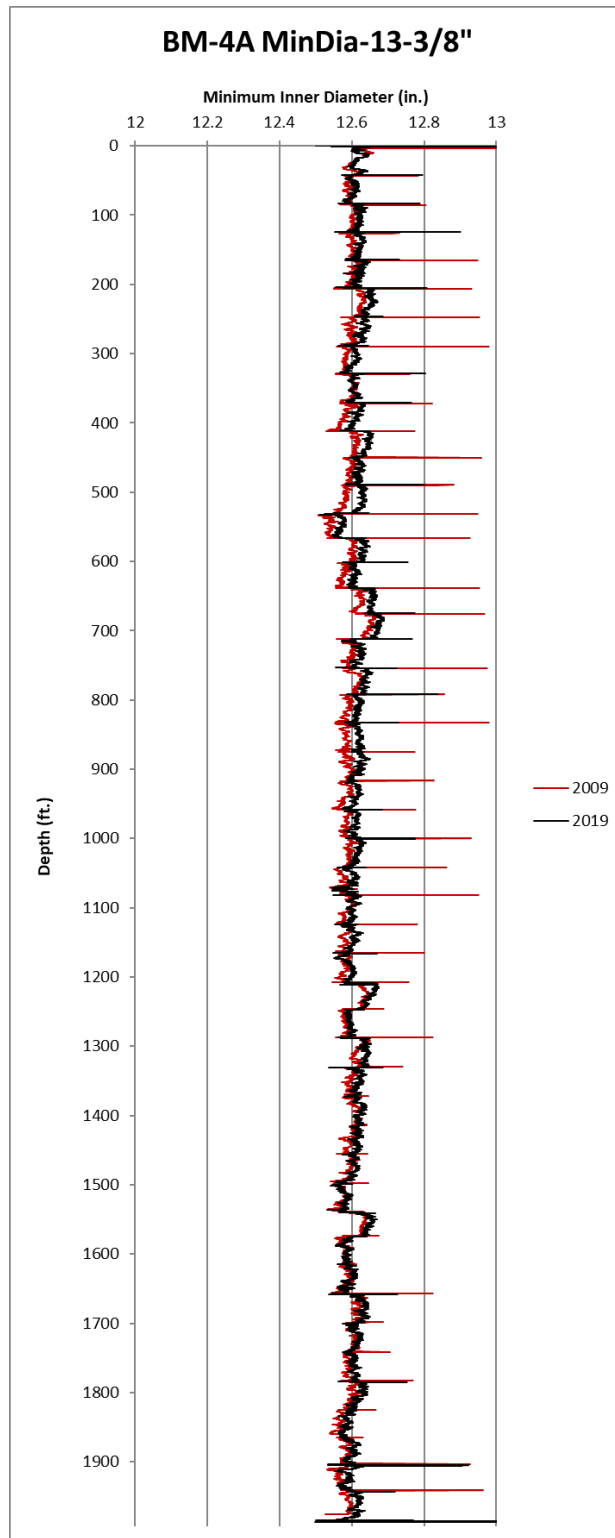
Figure 3-14. BM-4A minimum diameter curves from 2009 and 2019 MAC data

BM-4A has a total of two MAC logs from 2009 and 2019. Both logs were taken on the 13 3/8" casing. Figure 3-14 shows the minimum diameter curves for the 13-3/8" casing which were calculated from the 2009 and 2019 MAC logs. There are no substantial casing restrictions as a result of collar compression observed in the MAC data for this well. There is some minimal deformation observed around the salt caprock interface which does not appear to be rapidly worsening that should be noted but it is not a major cause for concern at this time.

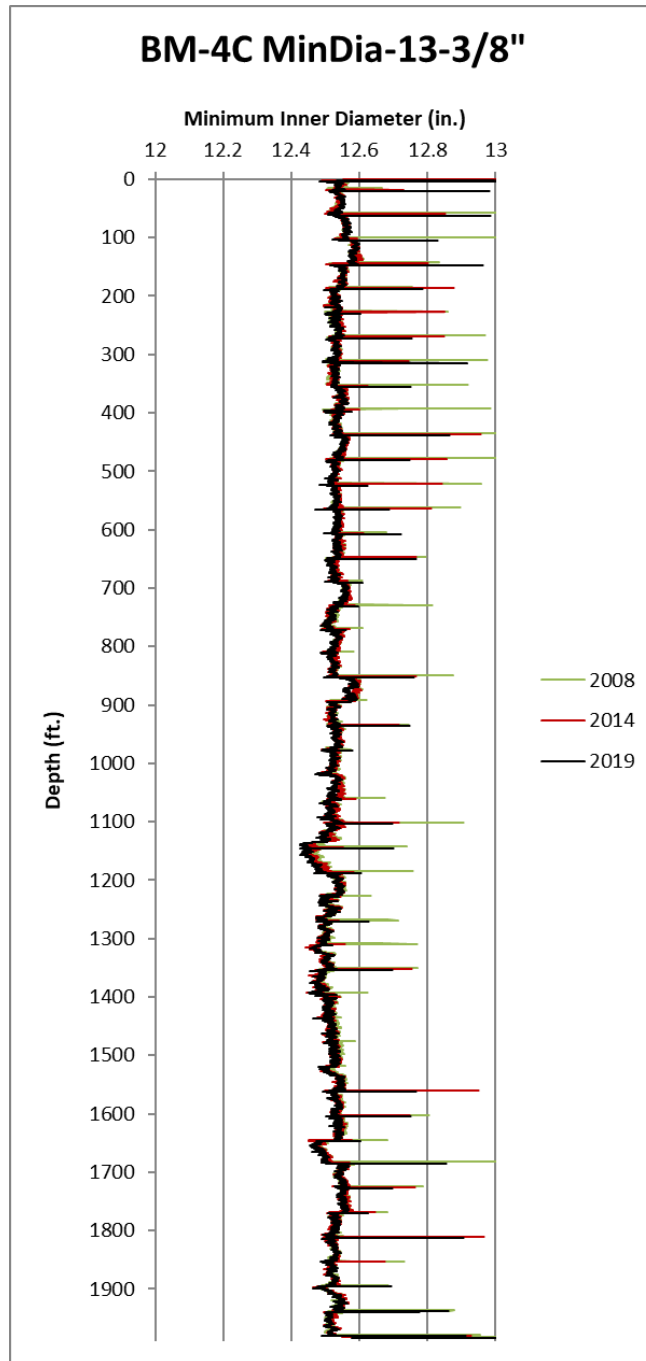
Figure 3-19. BM-4C minimum diameter curves from 2014 and 2019 MAC data

BM-4C has a total of three MAC logs from 2008, 2014, and 2019, which were all taken on the 13 3/8" casing. Figure 3-19 shows the minimum diameter curve for the 13-3/8" casing which were calculated from the 2008, 2014, and 2019 MAC logs. With the exception of some slight deformation below the salt-caprock interface around 1100'-1200' which does not appear to be rapidly worsening, there are no substantial casing restrictions or areas of notable deformation to cause concern from the available MAC data at this time.

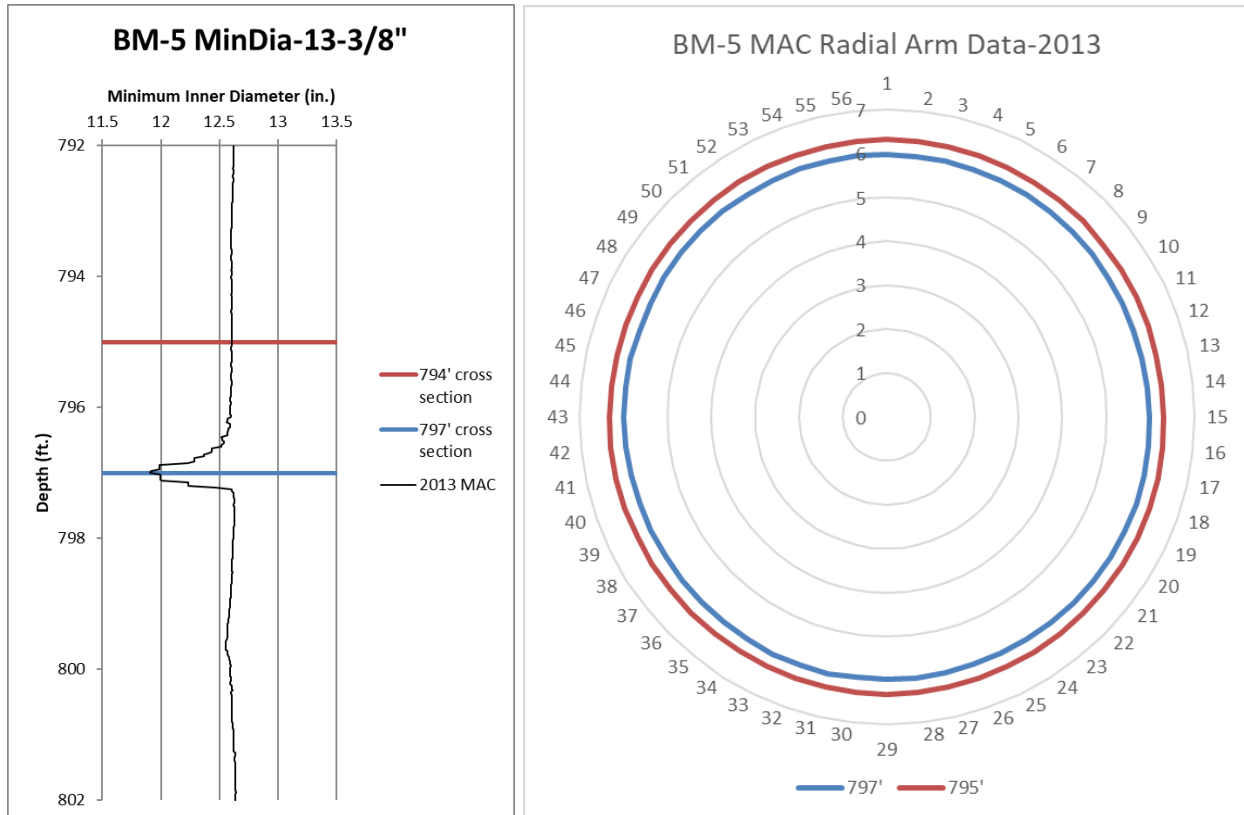
Figure 3-21. Cross sections of BM-5 2013 MAC data at the depth of casing restriction (blue) and above the restriction (red).

nearby depth that is not currently experiencing deformation. From the radial arm data, it is clear that the well is experiencing a uniform decrease in the inner diameter at the deformation depth. The minimum diameter at 797' is 11.91", which is notably lower than the minimum diameter of 12.61" at 794'. Figure 3-22 displays a 3D visual of the MAC radial arm data at the depth of interest, where a restriction in the casing can be clearly observed at 797'.

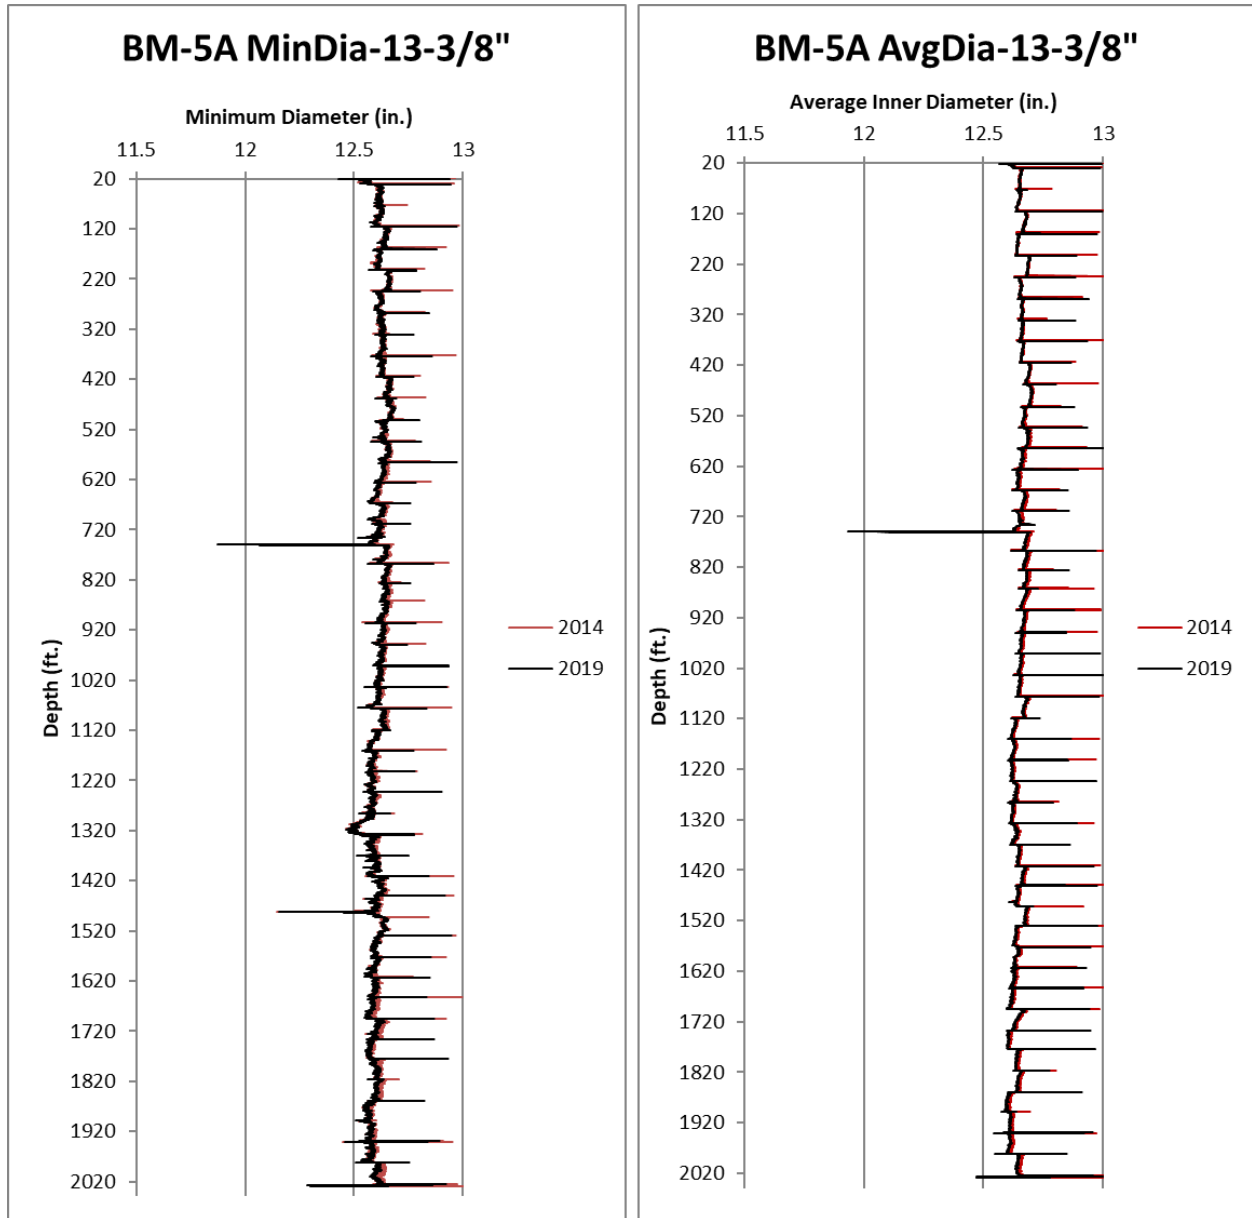
Figure 3-23. BM-5A minimum and average diameter curves from 2014 and 2019 MAC data

BM-5A has a total of three MAC logs from 2009, 2014, and 2019, which were all taken on the 13 3/8" casing. The 2009 log was excluded from this analysis as it had incomplete data. Figure 3-23 shows the minimum and average diameter curves for the 13-3/8" casing which were calculated from the 2014 and 2019 MAC logs. From this dataset, a casing restriction was identified at 750', and a decrease in the minimum diameter curve can be observed at this depth. Figure 3-24 shows the minimum diameter curves from the 2014 and 2019 logs around the deformation depth at 750', which shows a clear progression as the restriction appears to be worsening with time. There is also deformation observed around 1482', which is present in both the 2014 and 2019 logs. The deformation at this depth does not appear to be increasing with time and only effects a small radial

section at 1482', and it does not show up in the average diameter curve. In a classic case of collar restriction, the diameter would experience a relatively uniform decrease in diameter and most or all radial arm measurements would show a decrease in diameter, which could be observed from the average diameter measurement. It should be noted that non-circular deformation may not always show up in the average diameter curve, however it can be a helpful tool for identifying more classic cases of collar compression which are the focus of this report.

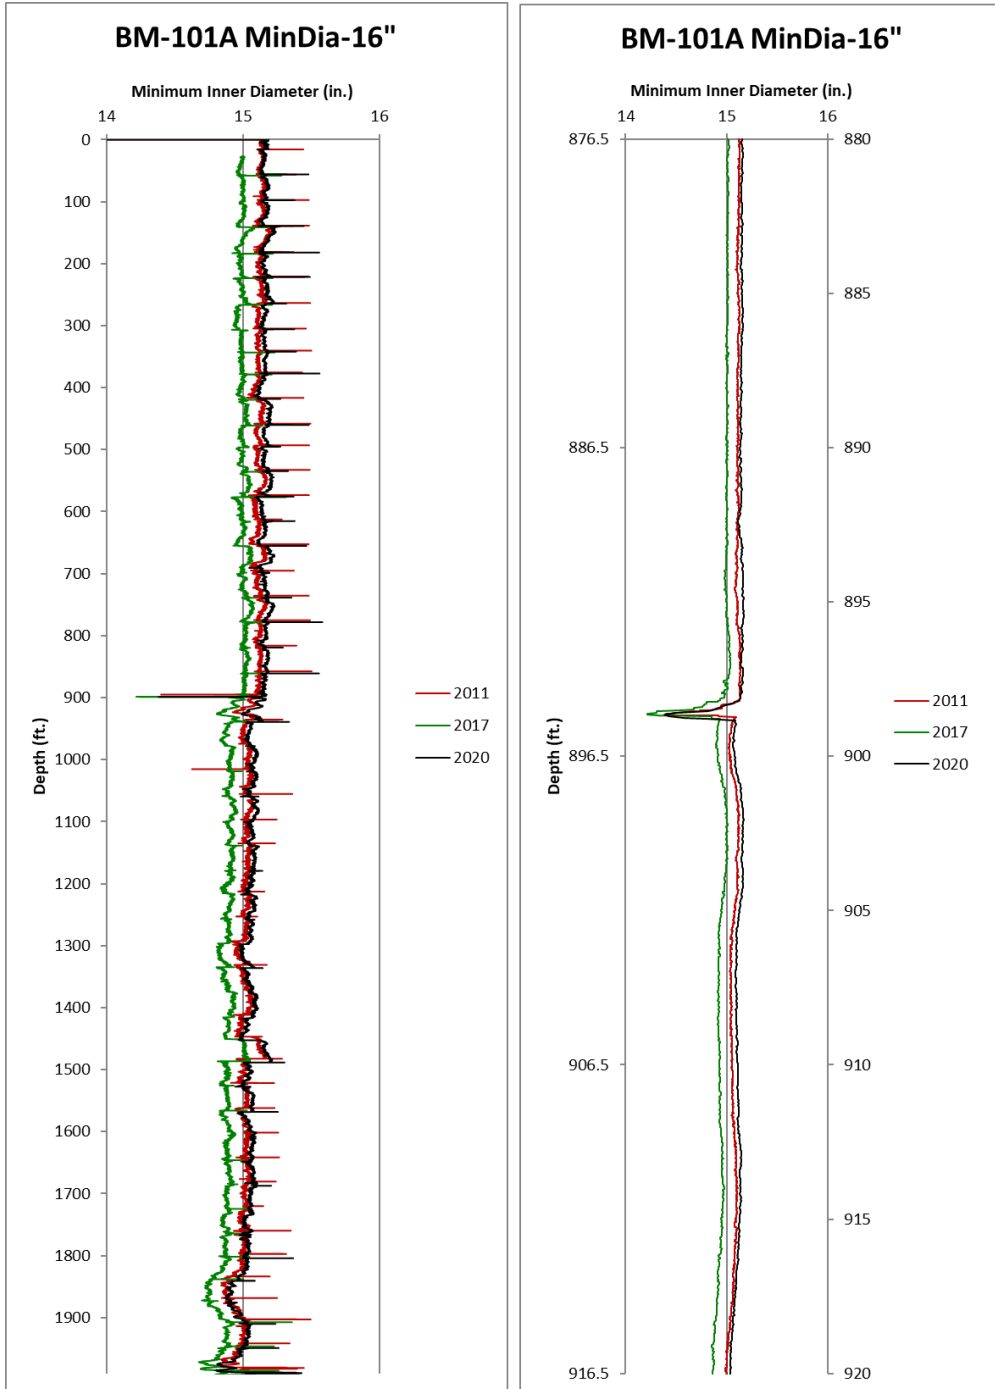
Figure 3-30. BM-101A minimum diameter curves from 2011, 2017 and 2020 MAC data

BM-101A has a total of four MAC logs from 2011, 2017, 2020, and 2021. The 2011, 2017, and 2020 logs were all taken on the 16” casing. The 2021 log was taken on the 13 3/8” liner after it was installed. Figure 3-30 shows the minimum diameter curves for the 16” casing which were calculated from the 2011, 2017, and 2020 MAC logs. From this dataset, a casing restriction was identified at 898.7’, and a decrease in the minimum diameter curve can be observed at this depth. The restriction does not appear to be substantially worsening in the time between the 2011 – 2020 MAC logs. There is also a decrease in the minimum diameter around 1015’ for the 2011 MAC, however this is the result of a single radial arm reading and does not show up in the average diameter curve. Minimal deformation has also been noted around 920’-930’ and 1970’-1988’ however it does not appear to be worsening with time. Figure 3-31 shows the minimum diameter curve for the 13 3/8” liner which was calculated from the 2021 MAC and does not show any issues at this time.

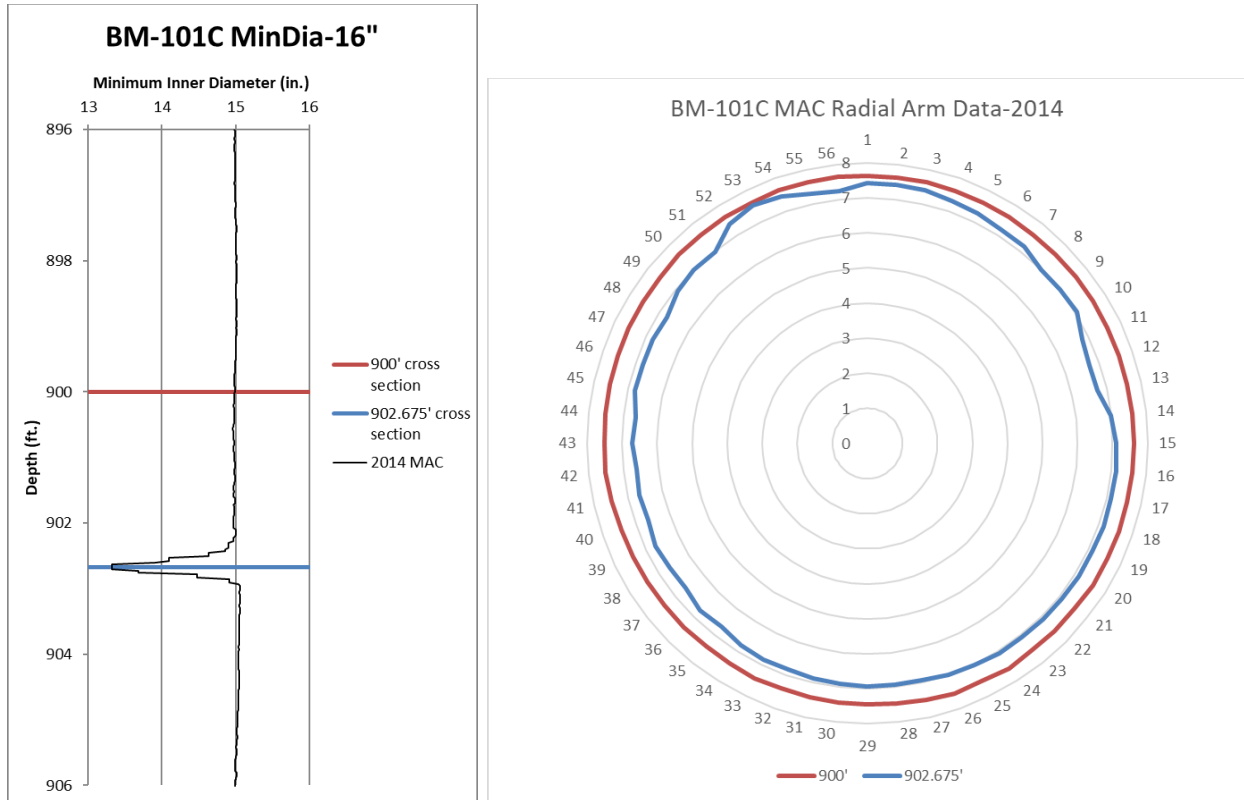
Figure 3-36. Cross sections of BM-101C September 2014 MAC data at the depth of casing restriction (blue) and above the restriction (red).

cross sections, it is apparent that the well is experiencing an overall decrease in the minimum diameter at the identified deformation depth. The minimum diameter at 902.63' is 13.33", which is notably lower than the minimum diameter of 14.99" at 900'. Figure 3-37 displays a 3D visual of the MAC radial arm data at the depth of interest, where a restriction in the casing can be clearly observed. It should also be noted that the decrease in diameter does not follow a uniform pattern as seen in both the radial cross section and 3D visual of the MAC data from September 2014. Although the well has been lined since the 2014 MAC, the deformation observed around 902.7 is likely ongoing and the well should continue to be monitored.

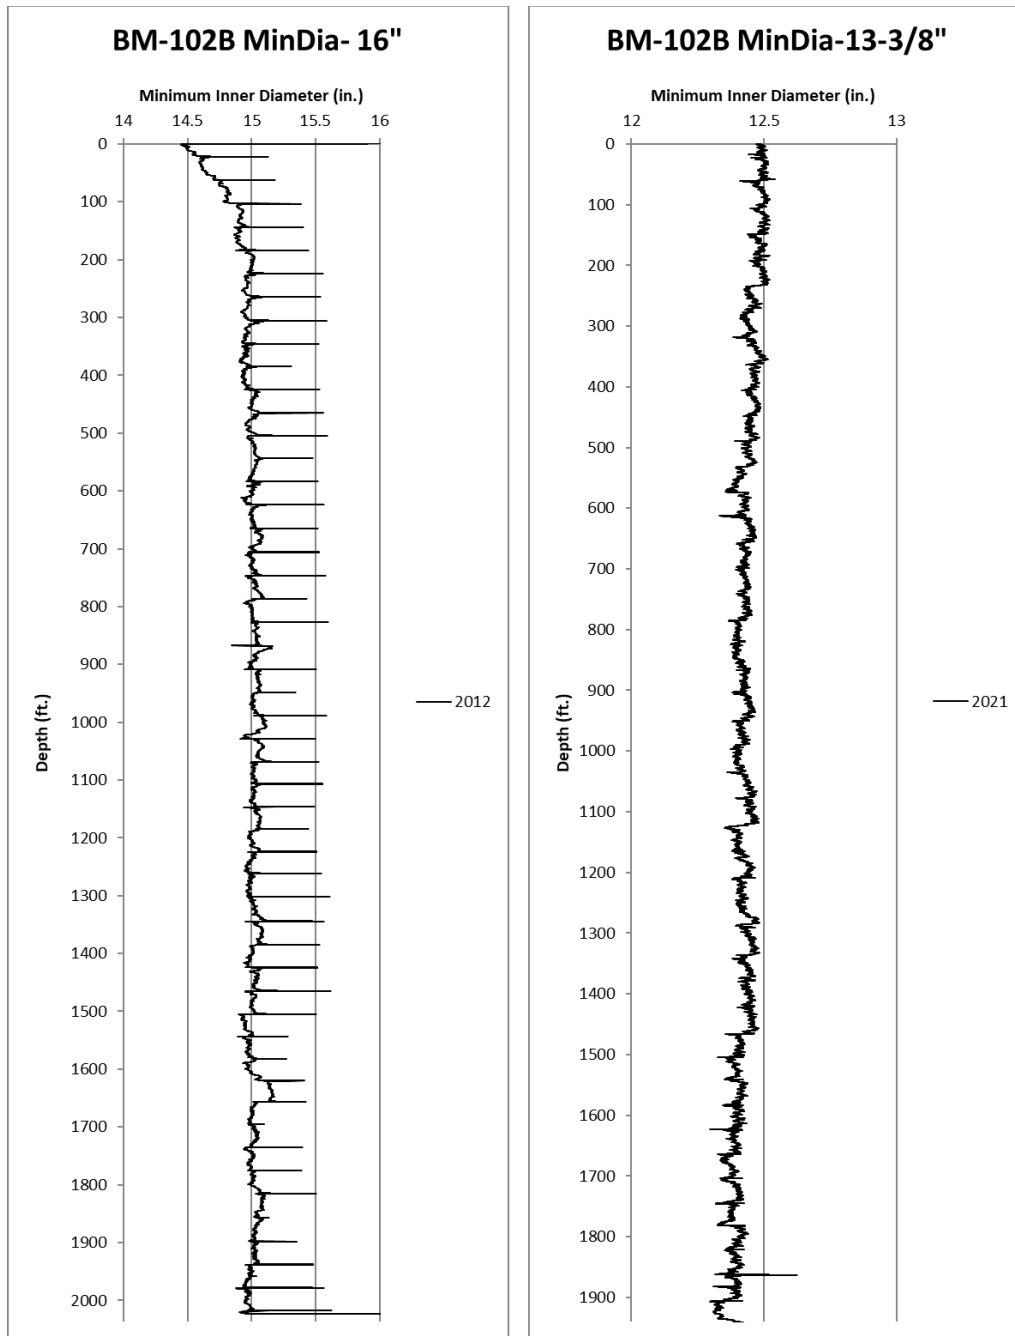
Figure 3-38. BM-102B minimum diameter curves from 2012 and 2021 MAC data

2012 and 2021 MAC logs. From this dataset, a casing restriction was identified at 867.6' in the 2012 MAC log, and a decrease in the minimum diameter curve can be observed at this depth.

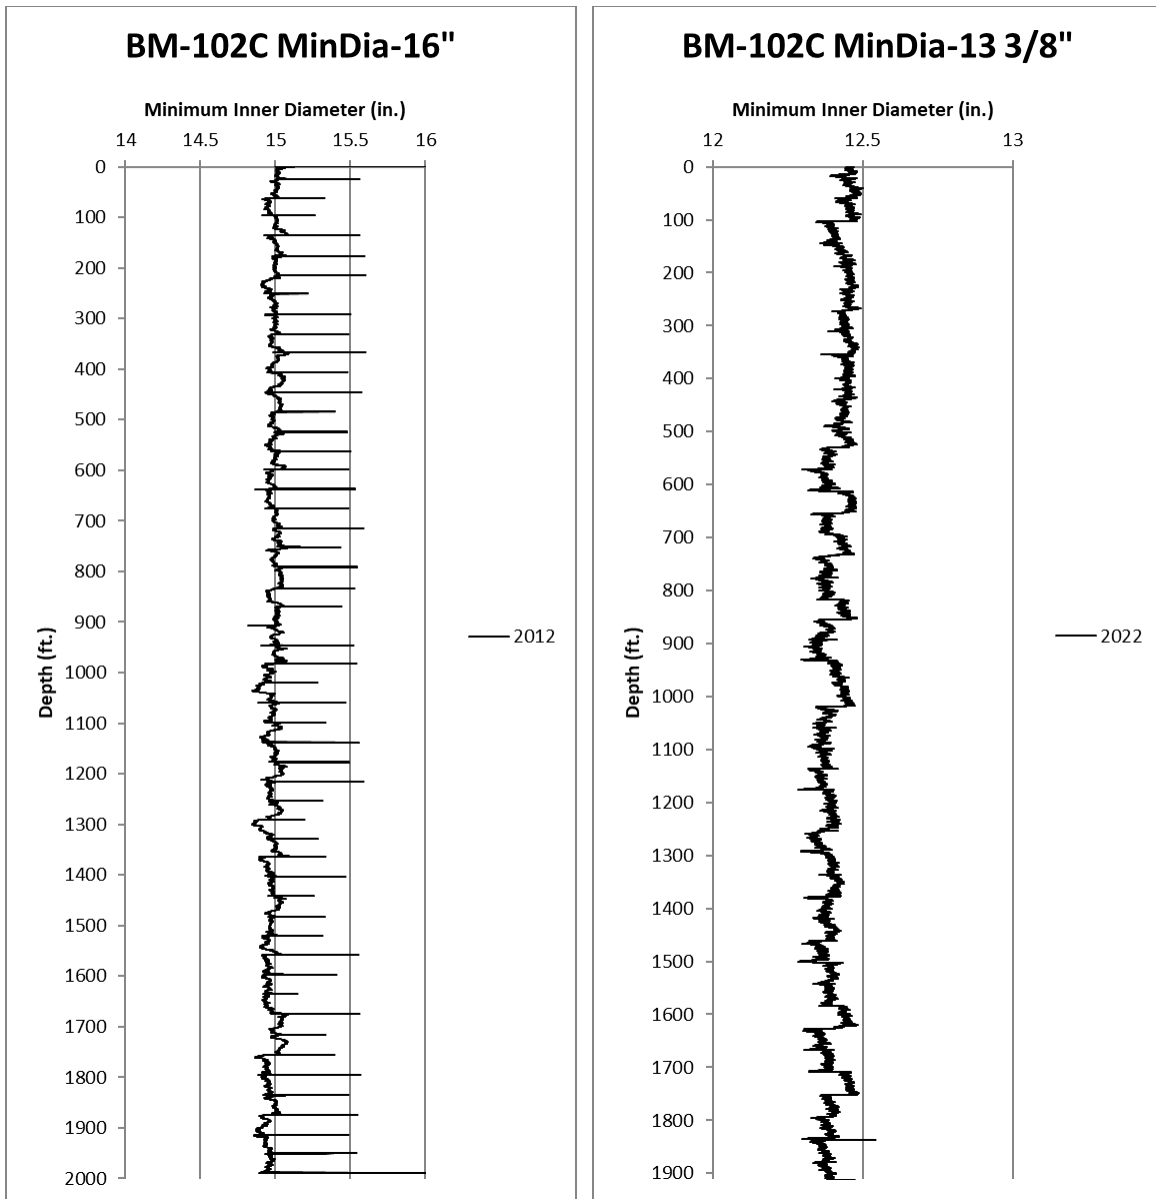
Figure 3-41. BM-102C minimum diameter curves from 2012 and 2022 MAC data

decrease in the minimum diameter curve can be observed at this depth in the 2012 MAC log. The 13 3/8" casing does not show any significant signs of deformation as of the 2022 MAC log.

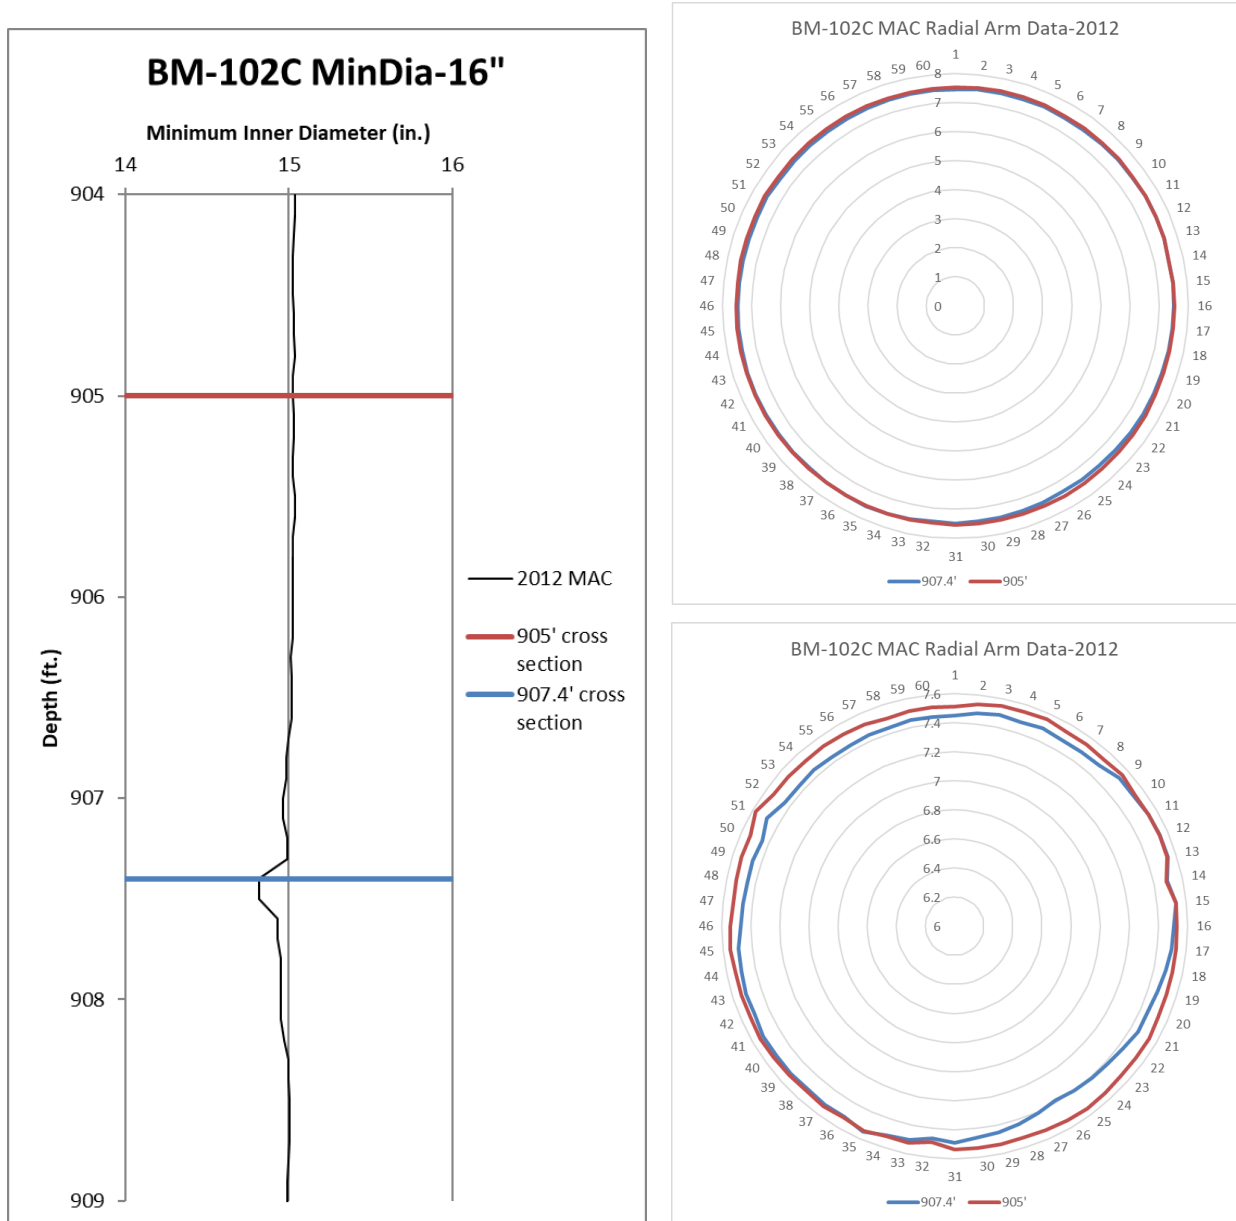
Figure 3-42. Cross sections of BM-102C 2012 MAC data at the depth of casing restriction (blue) and above the restriction (red).

diameter at the deformation depth. The minimum diameter at 907.4' is 14.82", which is lower than the minimum diameter of 15.03" at 905'. Figure 3-43 displays a 3D visual of the MAC radial arm data at the depth of interest, where a slight restriction in the casing can be observed around 907.4'. Although the well has been lined since the 2012 MAC, the deformation observed in the 16" casing around 907.4' is likely ongoing and the well should continue to be monitored.

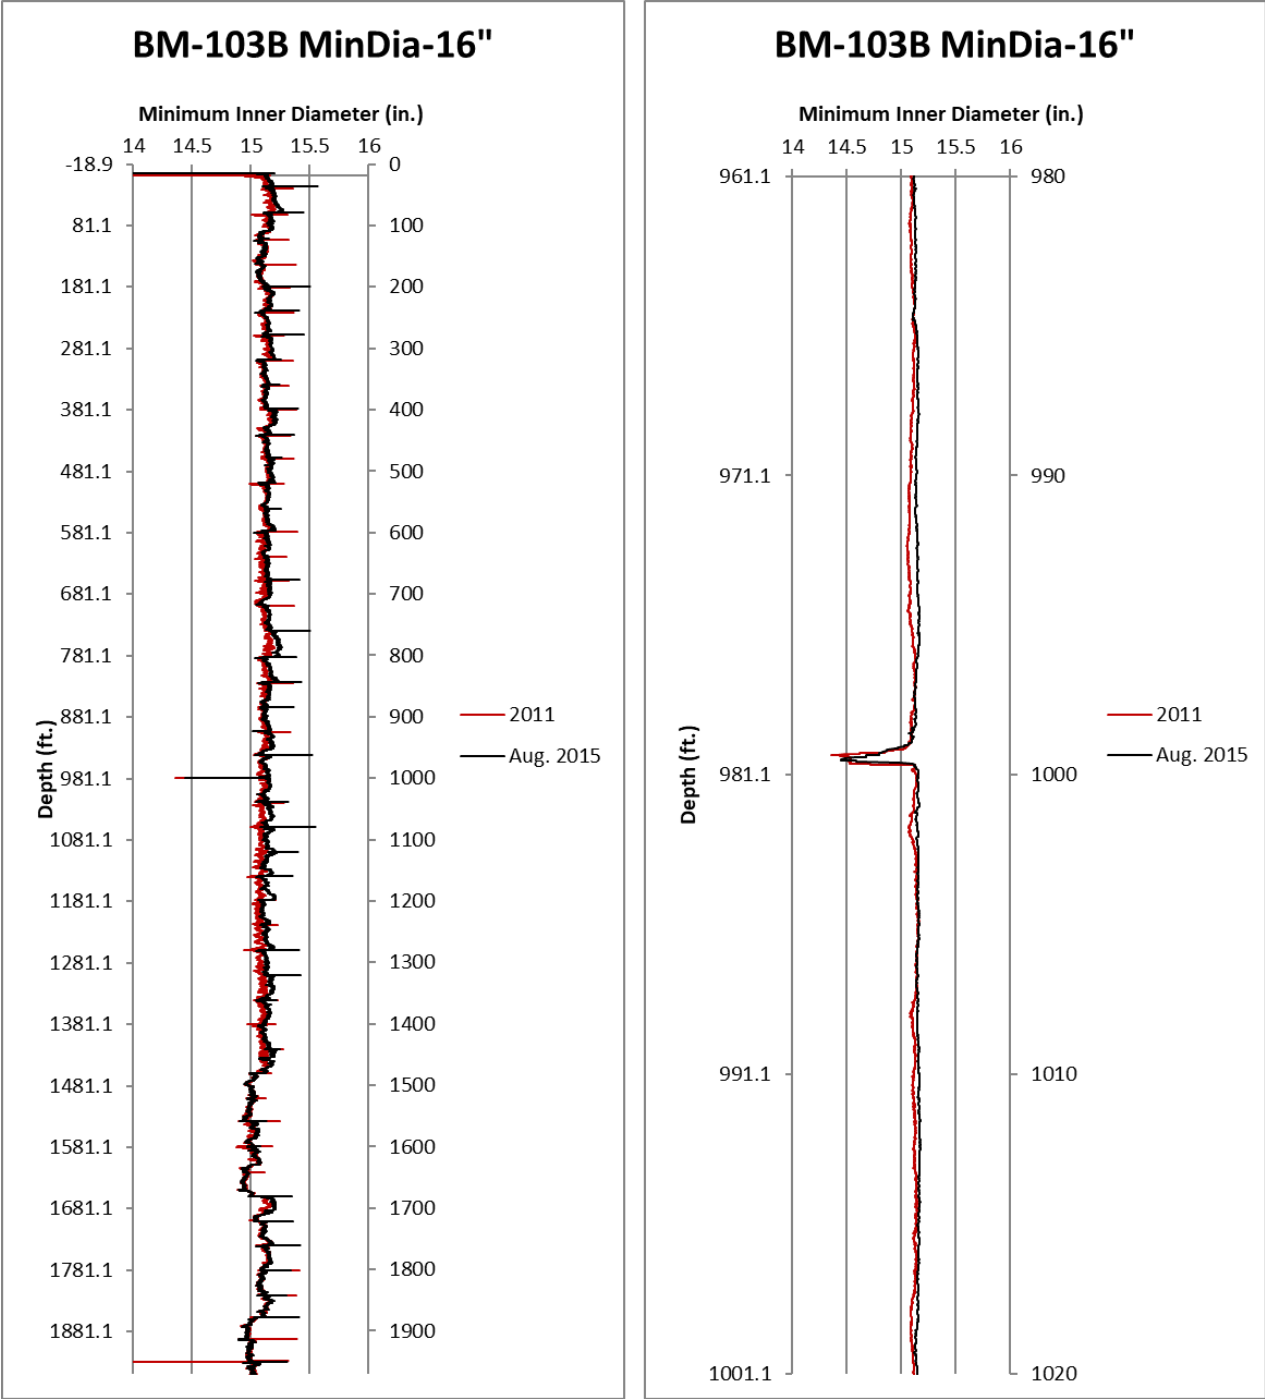
Figure 3-44. BM-103B minimum diameter curves from 2011 and August 2015 MAC data

BM-103B has a total of three MAC logs from 2011, August 2015, and December 2015. The 2011 and August 2015 logs were taken on the 16" casing. The well was then lined and the December 2015 log was taken on the 13 3/8" casing. Figure 3-44 shows the minimum diameter curves for the 16" casing which were calculated from the 2011 and August 2015 MAC logs. From this dataset, a casing restriction was identified at 999.5' in the 16" casing, and a decrease in the minimum diameter curve can be observed at this depth. The casing restriction in the 16" casing does not appear to have worsened between the 2011 and August 2015 logs. Minor deformation has also been noted around the salt-caprock interface around 1063' and lower in the well around 1455', which does not appear to be rapidly worsening. Figure 3-45 shows the minimum diameter curve for the 13 3/8" casing which was calculated for the December 2015 log and does not show any indications of deformation.

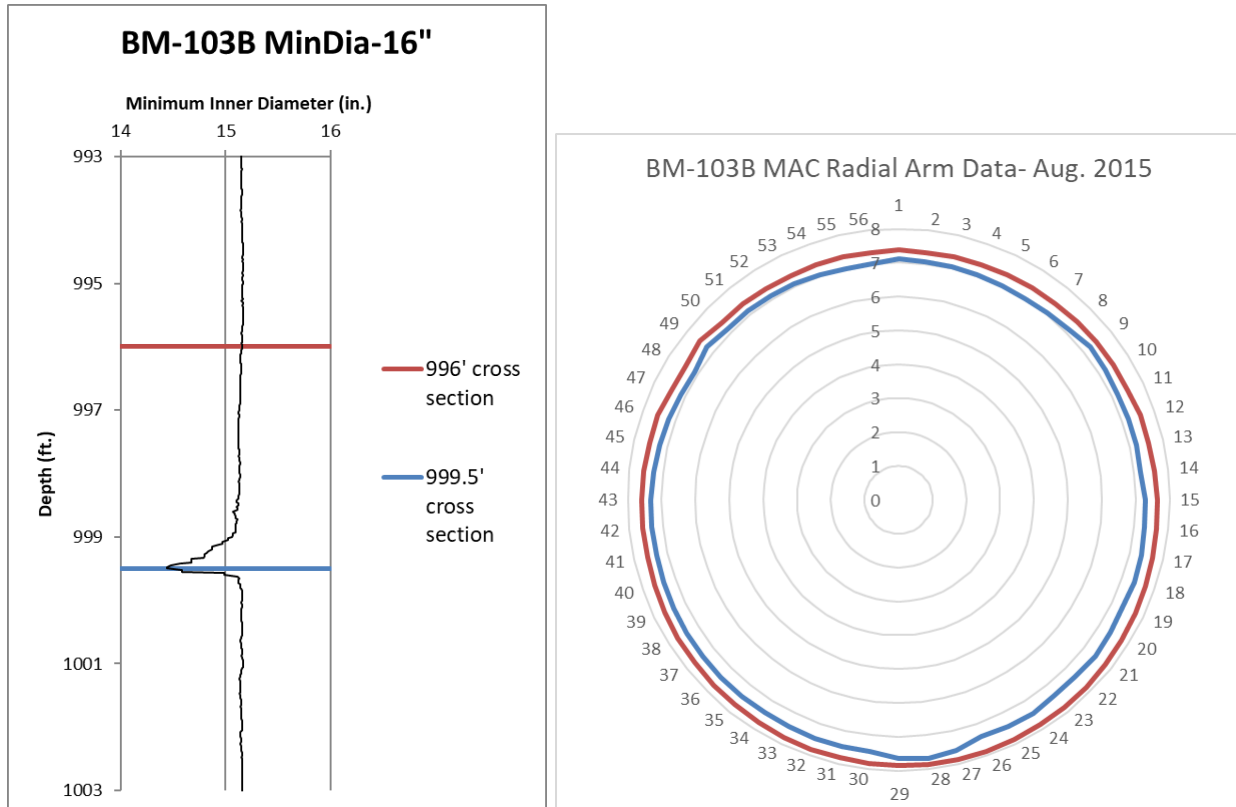
Figure 3-46. Cross sections of BM-103B August 2015 MAC data at the depth of casing restriction (blue) and above the restriction (red).

cross section from a nearby depth that is not currently experiencing deformation. From the radial arm data, it is clear that the well is experiencing a notable decrease in the inner diameter at the deformation depth, with the deformation occurring in a fairly uniform pattern. The minimum diameter at 999.5' is 14.44", which is notably lower than the minimum diameter of 15.15" at 996'. Figure 3-47 displays a 3D visual of the MAC radial arm data at the depth of interest, where a restriction in the casing can be clearly observed around 999.5'. There also appears to be some deformation above the restriction, which is likely a result of casing compression as well. Although the well has been lined since the August 2015 MAC, the deformation observed in the 16" casing around 999.5' is likely ongoing and the well should continue to be monitored.
