SAND2024-12109

Bryan Mound Collar Compression Study

This report presents a study of collar compression for the wells at the Bryan Mound site. The study includes a comprehensive review of all available Multi-Arm Caliper (MAC) logs from the site, which has been used to identify specific wells that are experiencing casing restrictions at collar joints. A summary of wells with collar restrictions and the corresponding deformation depths has been provided. Additional site-wide analysis of Bryan Mound well temperature data, proximity to sulphur wells, pulsed eddy current (PEC) logs, and a general spatial analysis has been included to investigate any potential correlations with wells experiencing collar compression at the site.

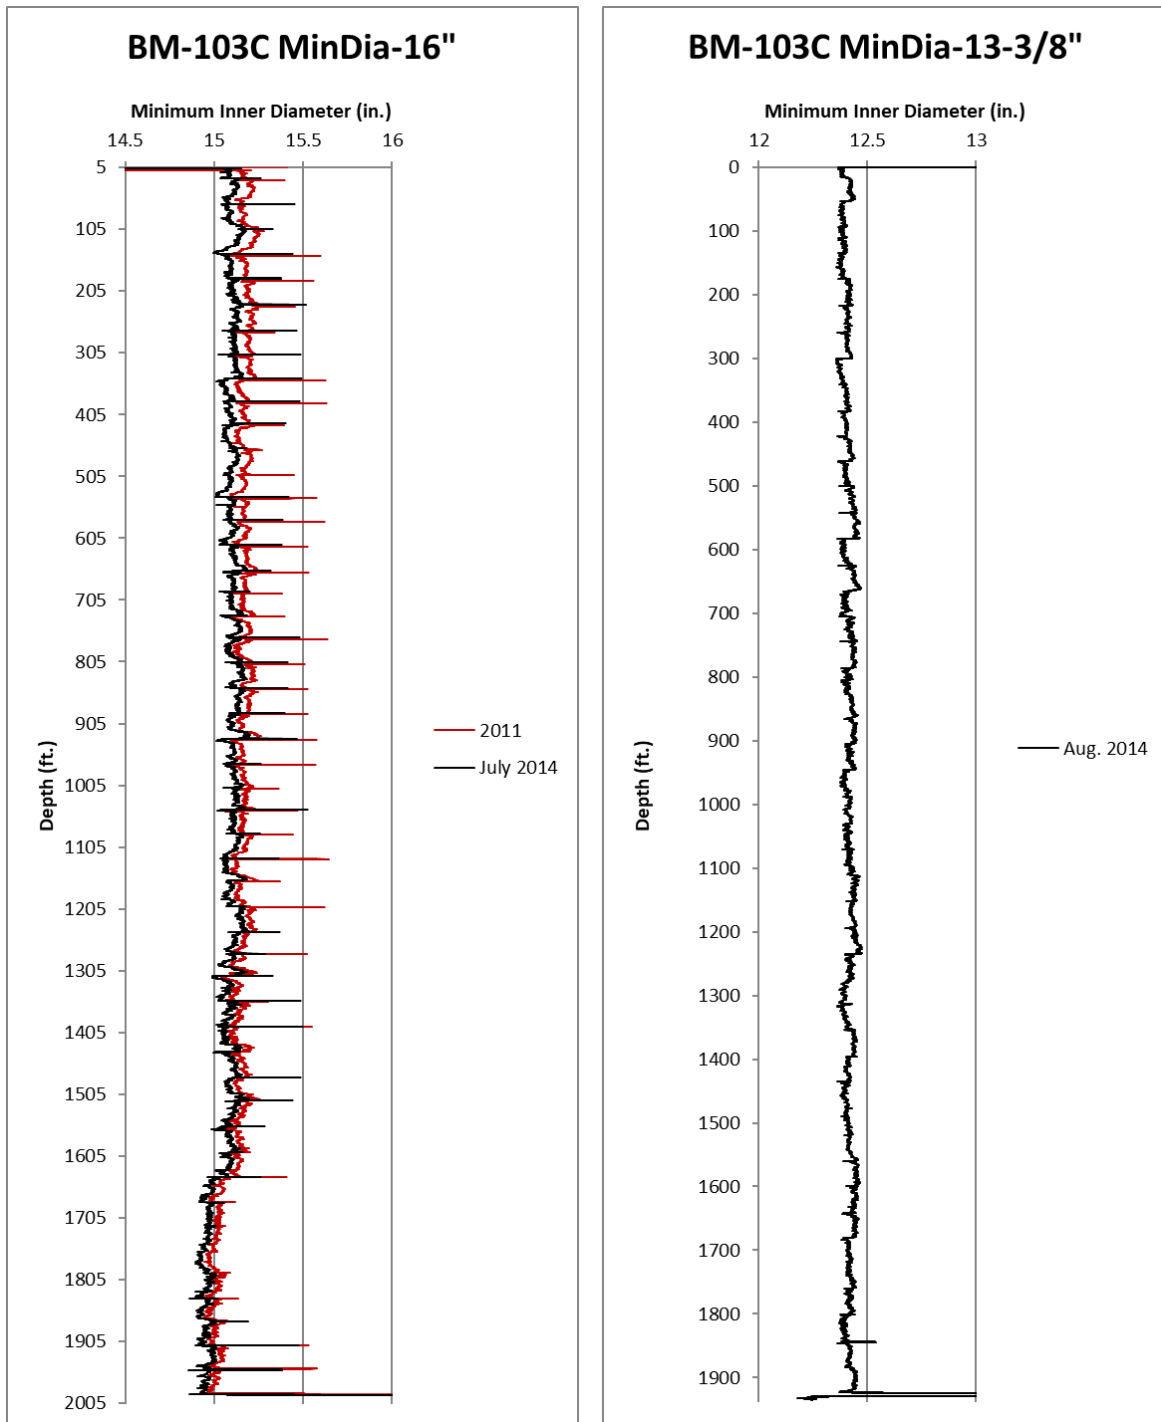
Figure 3-48. BM-103C minimum diameter curves from 2011, July 2014, and August 2014 MAC data

BM-103C has a total of three MAC logs from 2011, July 2014, and August 2014. The 2011 and July 2014 logs were taken on the 16" casing. The well was then lined, and the August 2014 log was taken on the 13 3/8" casing. Figure 3-48 shows the minimum diameter curves for the 16" and 13-3/8" casing which were calculated from the 2011, July 2014, and August 2014 MAC logs. There are no substantial casing restrictions or areas of notable deformation to cause concern from the available MAC data.

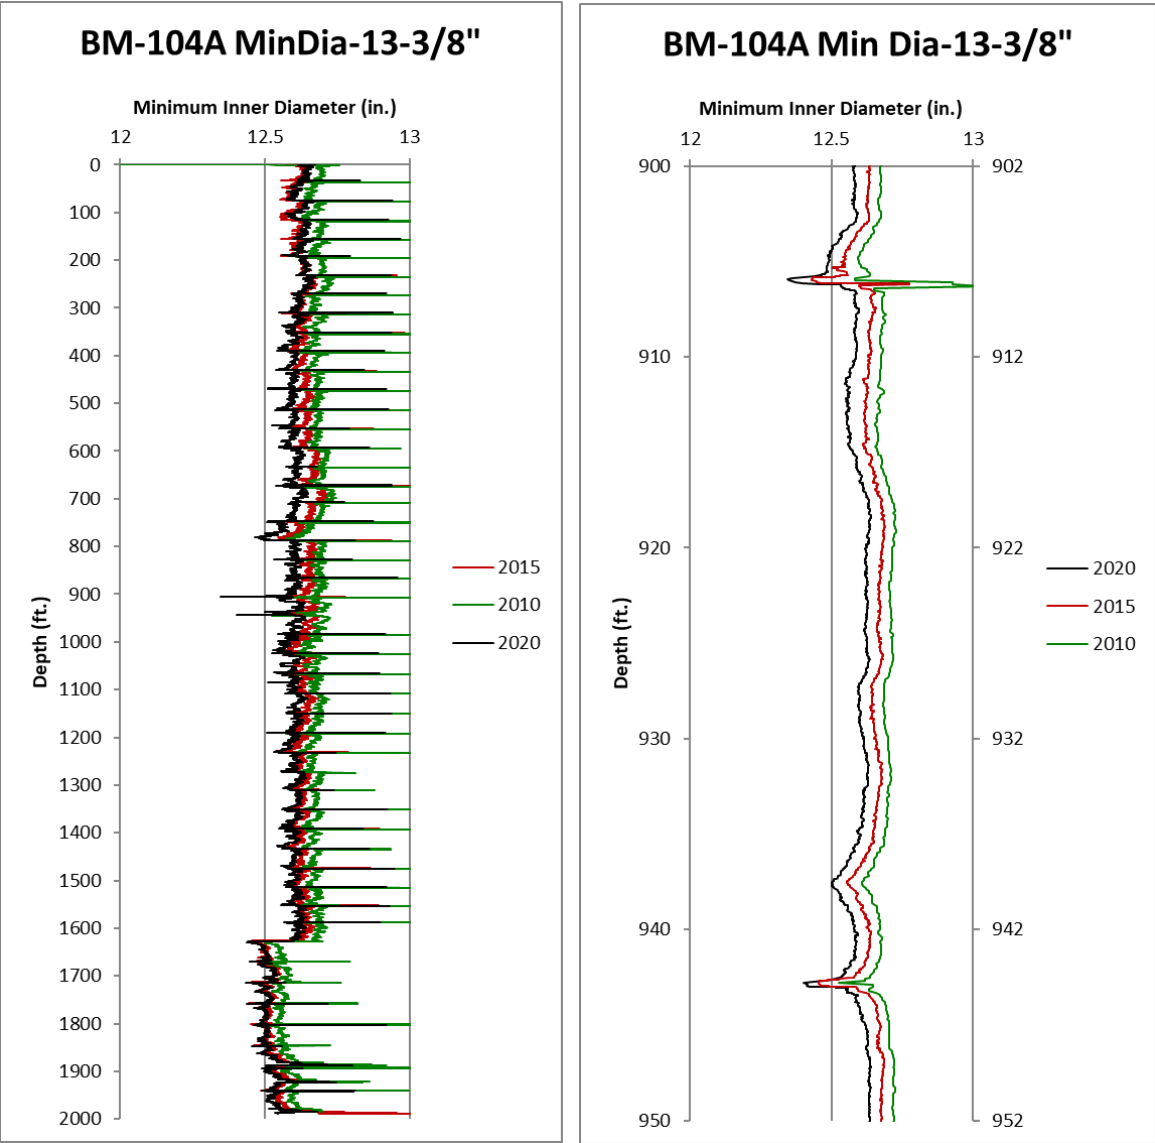
Figure 3-49. BM-104A minimum diameter curves from 2010, 2015, and 2020 MAC data

BM-104A has a total of three MAC logs from 2010, 2015, and 2020. All three logs were taken on the 13 3/8" casing. Figure 3-49 shows the minimum diameter curves for the 13-3/8" casing which were calculated from the 2010, 2015, and 2020 MAC logs. From this dataset, casing restrictions were identified at 905.9' and 942.8', and a decrease in the minimum diameter curve can be observed at these depths. Because there are slight offsets in the baseline data for each MAC (likely the result of differences in tool calibration), it is hard to determine whether the deformation is actually getting worse over time for the casing restriction at 942.8'. However, the casing restriction at 905' shows a clear progression from the 2010 log which shows an increase in minimum diameter at the collar (as expected at a casing collar joint) to the 2020 log where there is a decrease in the minimum diameter at the casing collar. Moderate deformation has also been noted at non-collar locations from 940'-1060' which does not appear to be rapidly worsening.

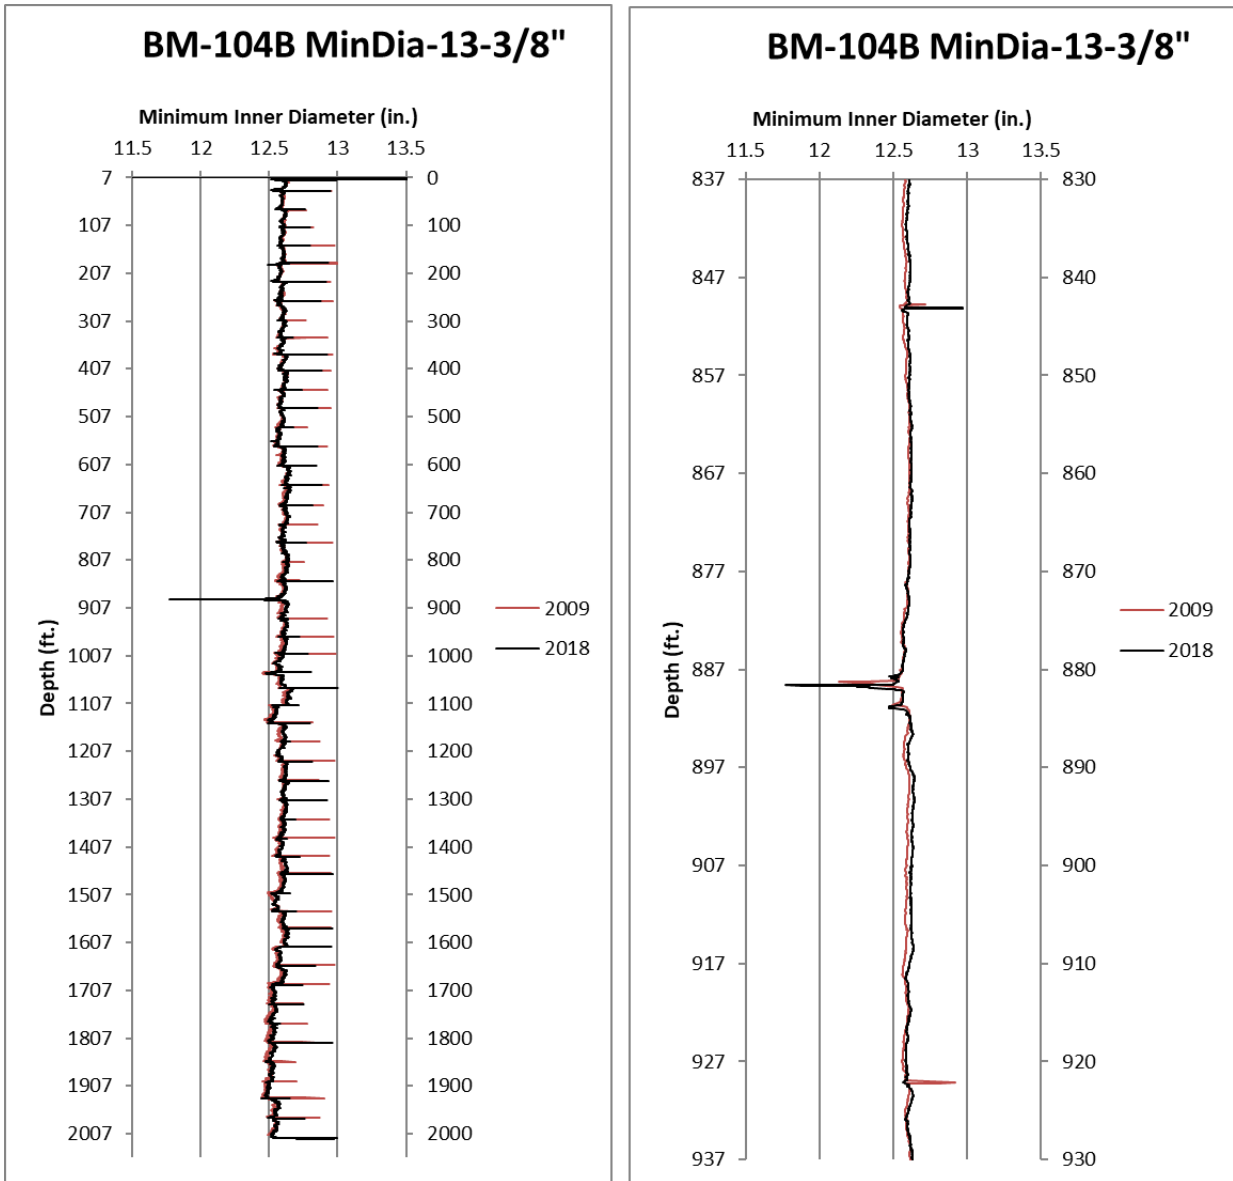
Figure 3-54. BM-104B minimum diameter curves from 2009 and 2018 MAC data

BM-104B has a total of two MAC logs from 2009, and 2018. Both logs were taken on the 13 3/8" casing. Figure 3-54 shows the minimum diameter curves for the 13-3/8" casing which were calculated from the 2009 and 2018 MAC logs. From this dataset, a casing restriction was identified at 881.6', and a decrease in the minimum diameter curve can be observed at this depth. The deformation at 881.6' appears to be worsening with time. Some moderate deformation near the salt-caprock interface has also been noted which does not appear to be rapidly worsening.

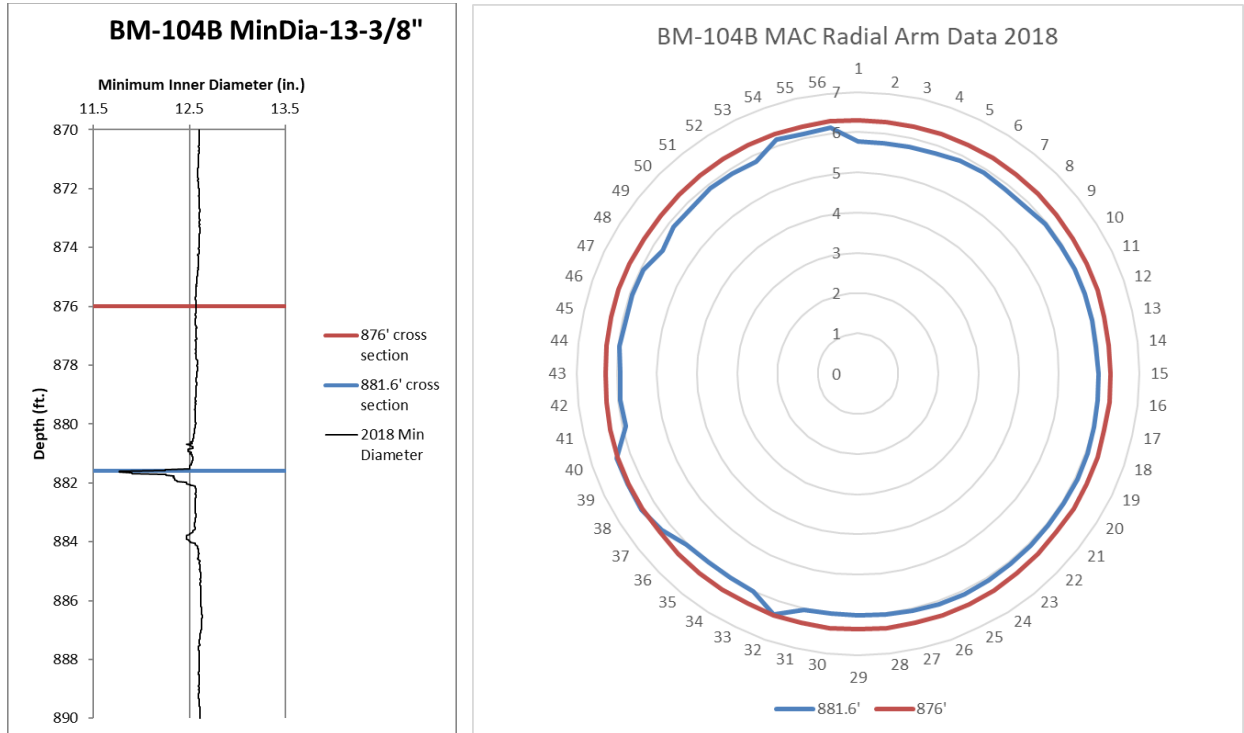
Figure 3-55. Cross sections of BM-104B 2018 MAC data at the depth of casing restriction (blue) and above the restriction (red).

881.6'. The deformation observed in the 13 3/8" casing around 882' is likely ongoing and the well should continue to be monitored.

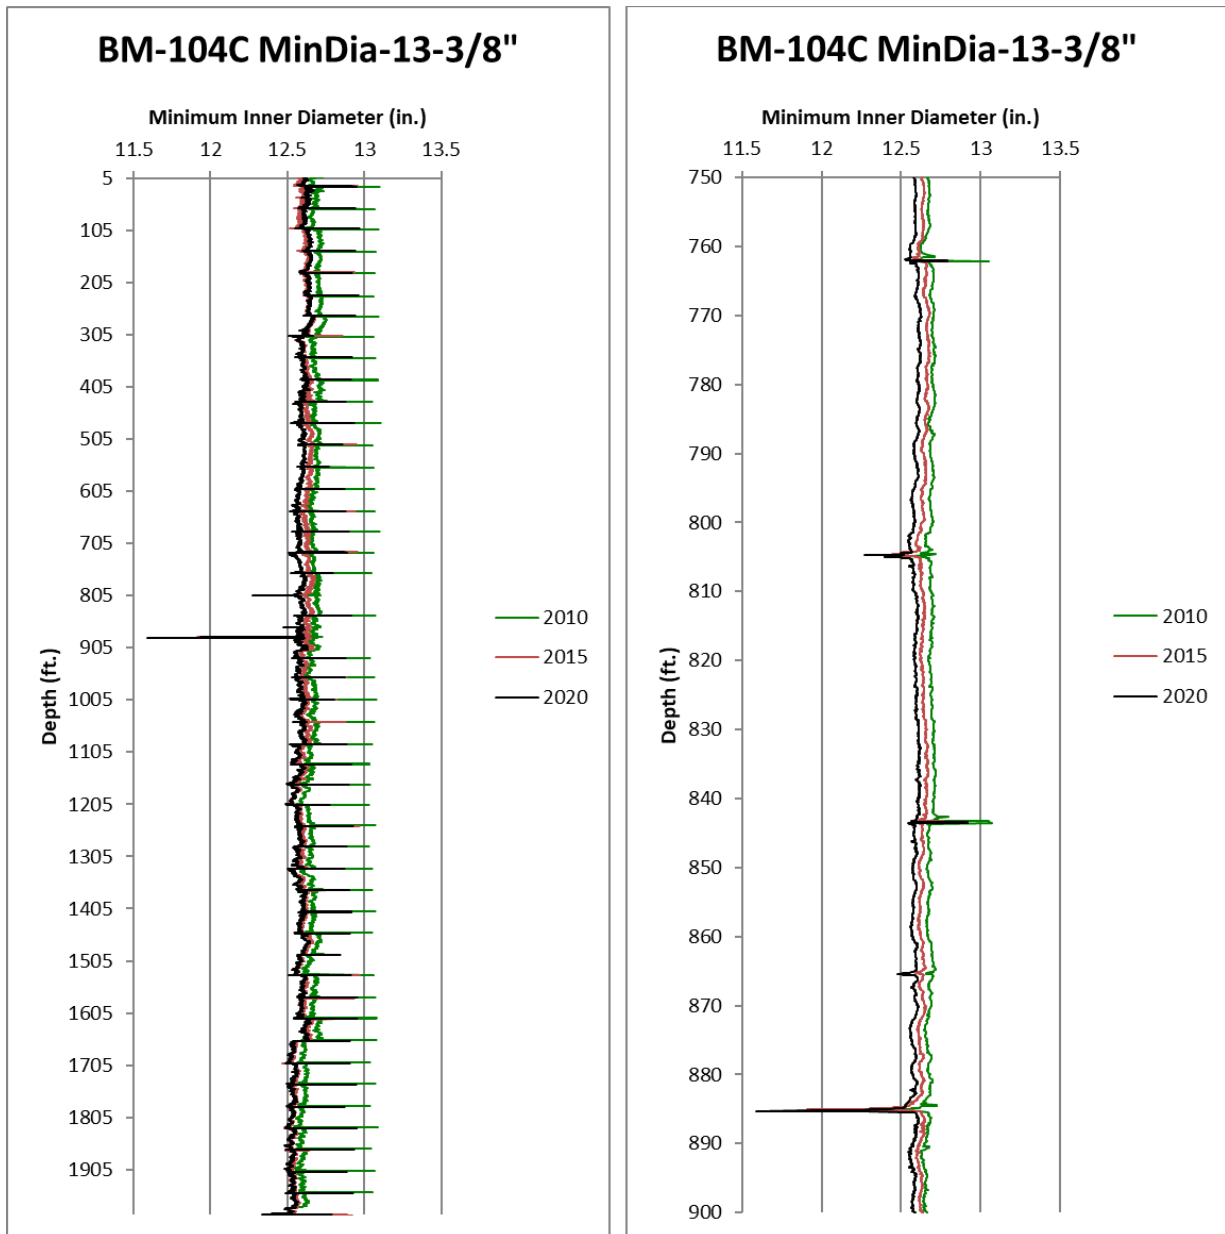
Figure 3-57. BM-104C minimum diameter curves from 2010, 2015, and 2020 MAC data

BM-104C has a total of three MAC logs from 2010, 2015, and 2020. All three logs were taken on the 13 3/8" casing. Figure 3-57 shows the minimum and average diameter curves for the 13-3/8" casing which were calculated from the 2010, 2015, and 2020 MAC logs. From this dataset, two casing restrictions were identified at 804.7' and 885.3', and a decrease in the minimum diameter curve can be observed at these depths. Because there are slight offsets in the baseline data for each MAC (likely the result of differences in tool calibration), it is hard to determine whether this deformation is actually getting worse over time for the casing restriction at 804.7'. However, the casing restriction at 885.3' does seem to be getting worse over time at the minimum diameter point, even after taking into account the baseline offset in the MAC data. Very minor deformation near the salt-caprock

interface has been noted around 1030', which does not appear to be rapidly worsening and is not a cause for concern at the moment.

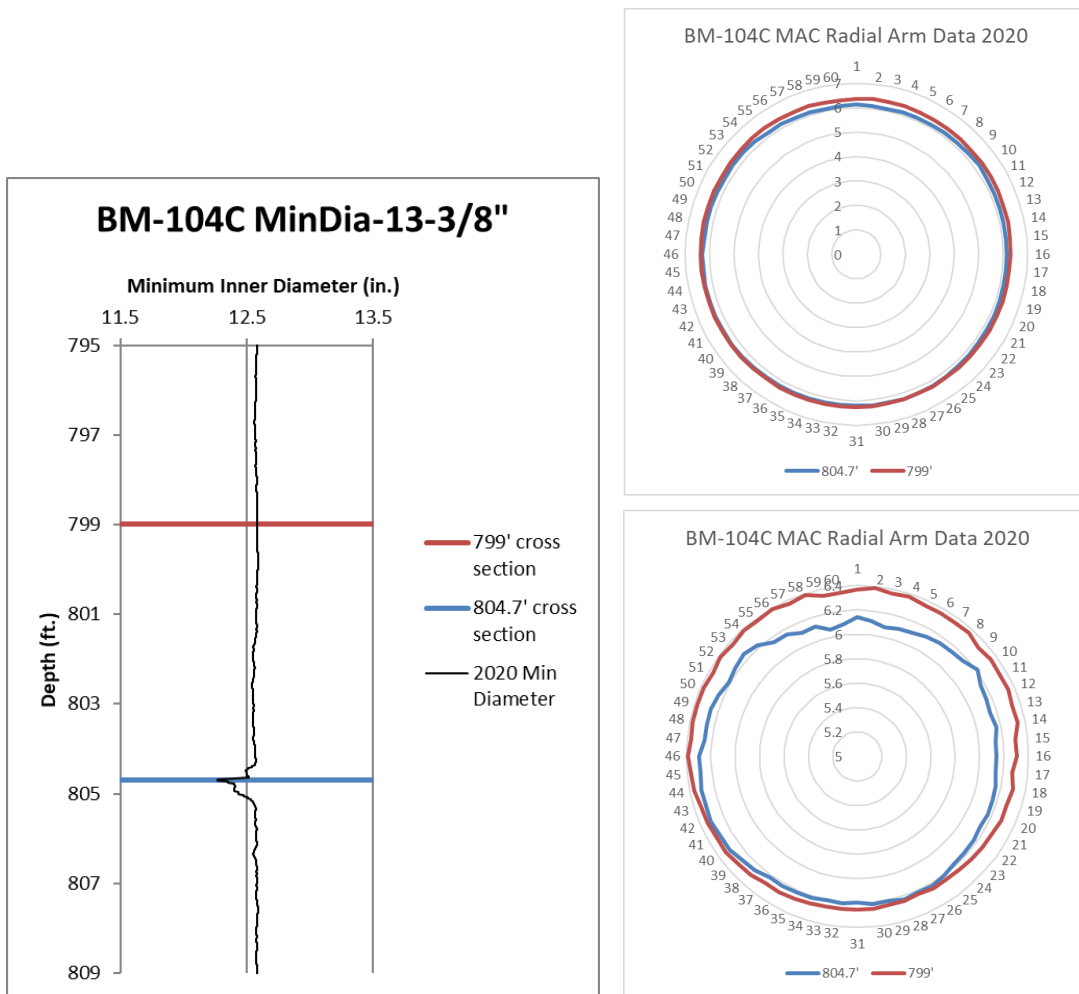
Figure 3-58. Cross sections of BM-104C 2020 MAC data at the depth of the 804.7' casing restriction (blue) and above the restriction (red).

cross section from a nearby depth that is not currently experiencing deformation. The two radial arm plots show the same data, with the scale in the lower plot being exaggerated to highlight the restriction seen at a depth of 804.7'. From the radial arm data, it is clear that the well is experiencing a decrease in the inner diameter at the deformation depth. The minimum diameter at 804.7' is 12.27", which is slightly lower than the minimum diameter of 12.58" at 799'. Although the restriction at this depth is not severe, it can still be observed in Figure 3-59 which displays a 3D visual of the MAC radial arm data at the depth of interest.

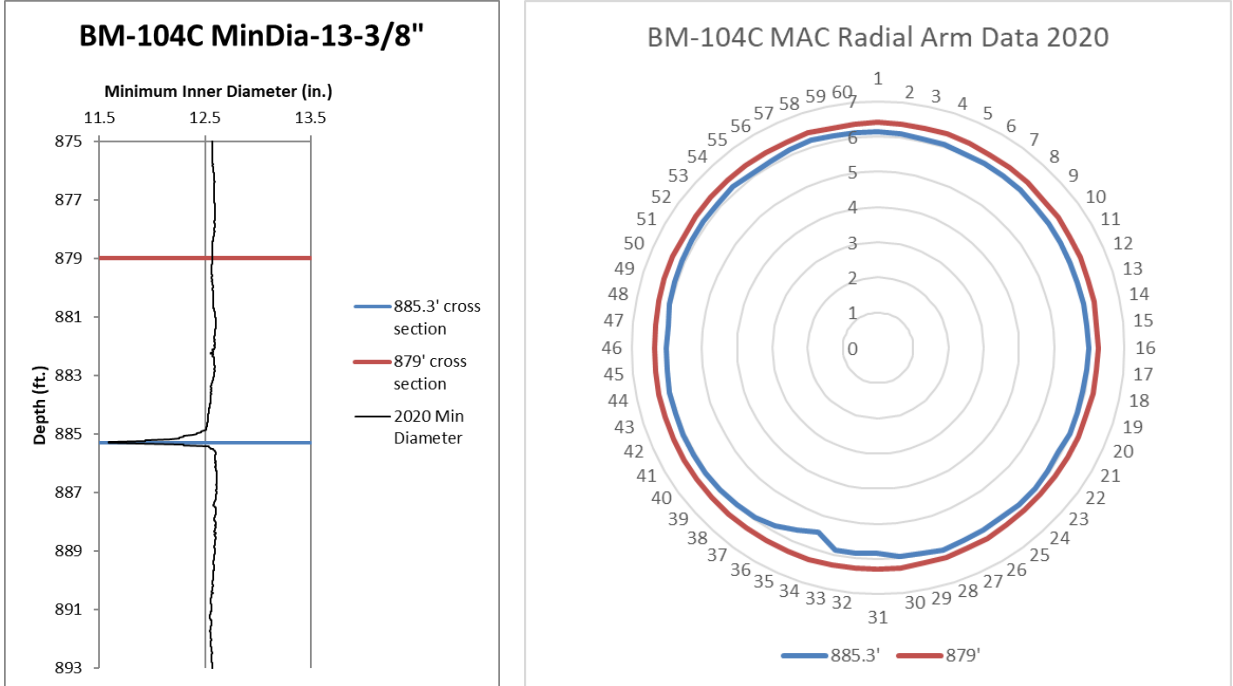
Figure 3-60. Cross sections of BM-104C 2020 MAC data at the depth of 885.3' casing restriction (blue) and above the restriction (red).

Figure 3-60 shows cross sections from the lower casing restriction location at 885.3'. From the radial arm data, it is clear that the well is experiencing an overall decrease in the inner diameter at this depth. The minimum diameter at 885.3' is 11.59", which is notably lower than the minimum diameter of 12.57" at 879'. Figure 3-61 displays a 3D visual of the MAC radial arm data at the depth of interest, where a restriction in the casing can be clearly observed at 885.3'.

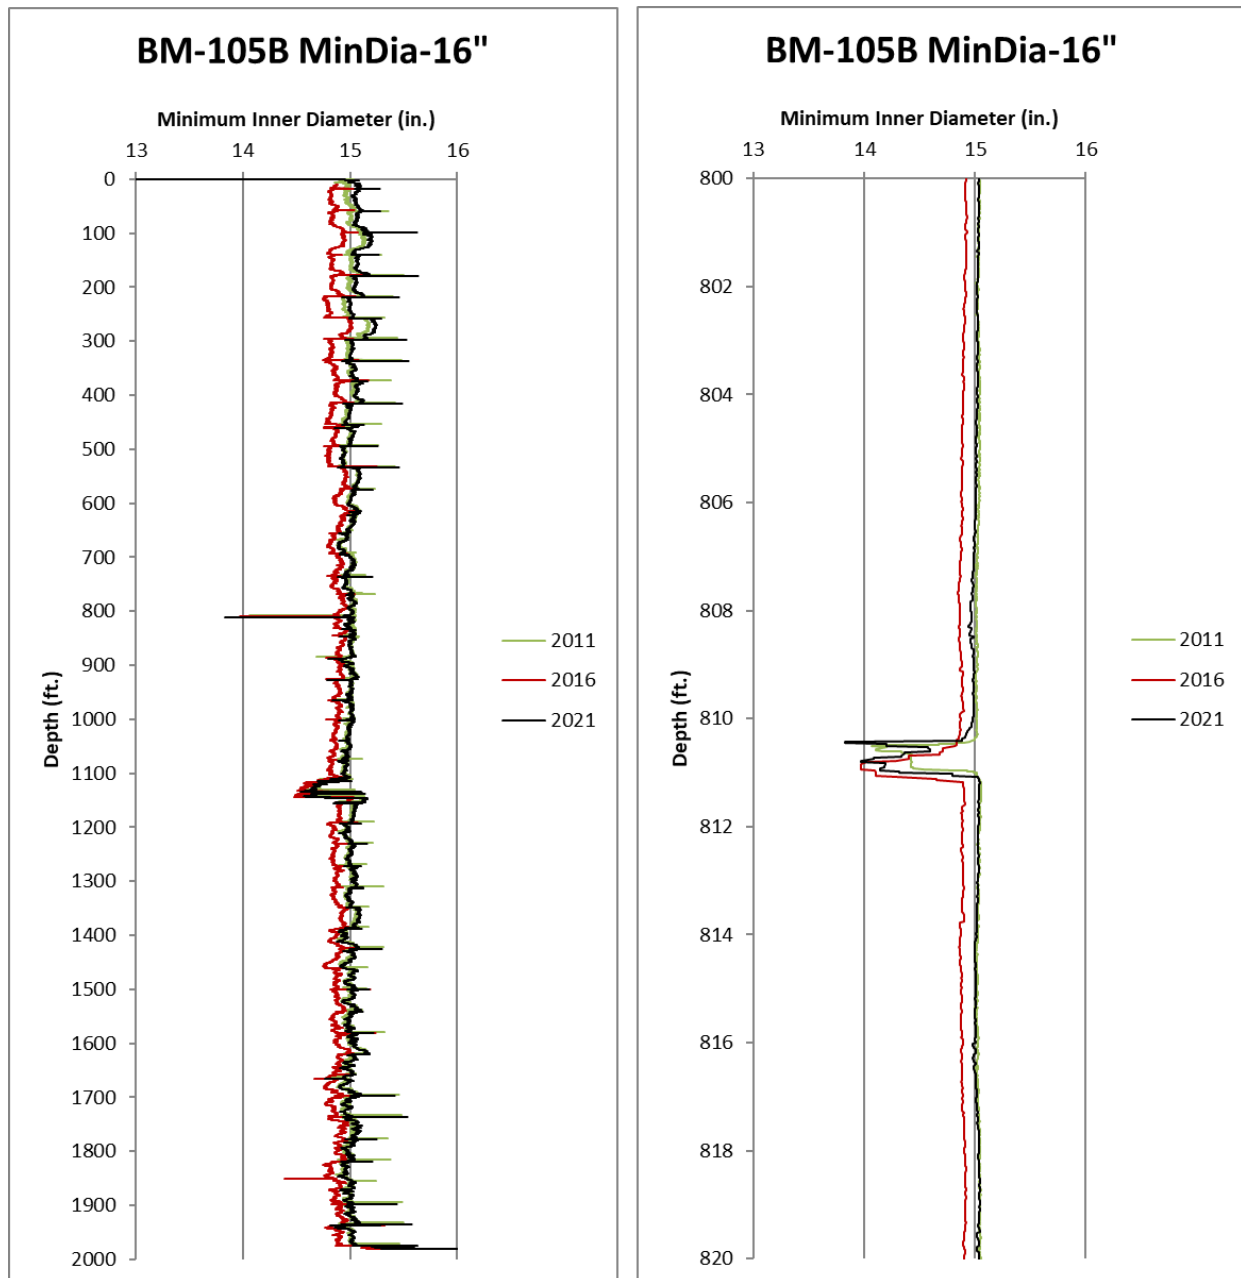
Figure 3-62. BM-105B minimum diameter curves from 2011, 2016, and 2021 MAC data

BM-105B has a total of three MAC logs from 2011, 2016, and 2021. All three logs were taken on the 16" casing. Figure 3-62 shows the minimum diameter curves for the 16" casing which were calculated from the 2011, 2016, and 2021 MAC logs. From this dataset, a casing restriction was identified at 810.8', and a decrease in the minimum diameter curve can be observed at this depth. Between 2016 and 2021 the restriction observed in the minimum diameter does not appear to be worsening. Some additional non-collar related deformation has also been noted around 1115' which does not appear to be rapidly worsening.

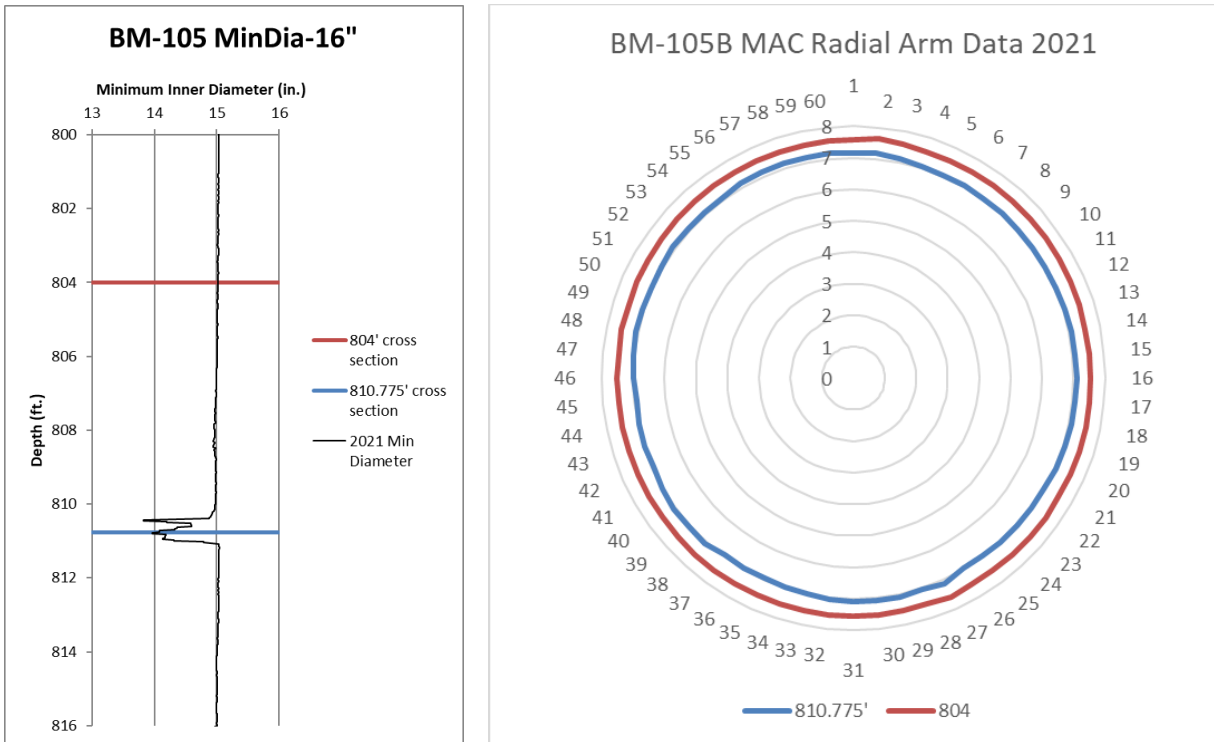
Figure 3-63. Cross sections of BM-105B 2021 MAC data at the depth of casing restriction (blue) and above the restriction (red).

diameter measurement in the area is seen at 810.45' however this is the result of one radial arm measurement, so a slightly lower depth of 810.775' was used. From the radial arm data, it is clear that the well is experiencing a notable decrease in the inner diameter at the deformation depth, with a fairly uniform radial distribution. The minimum diameter at 810.775' is 13.97", which is notably lower than the minimum diameter of 15.02" at 804'. Figure 3-64 displays a 3D visual of the MAC radial arm data at the depth of interest, where a restriction in the casing can be clearly observed at 810.775'.

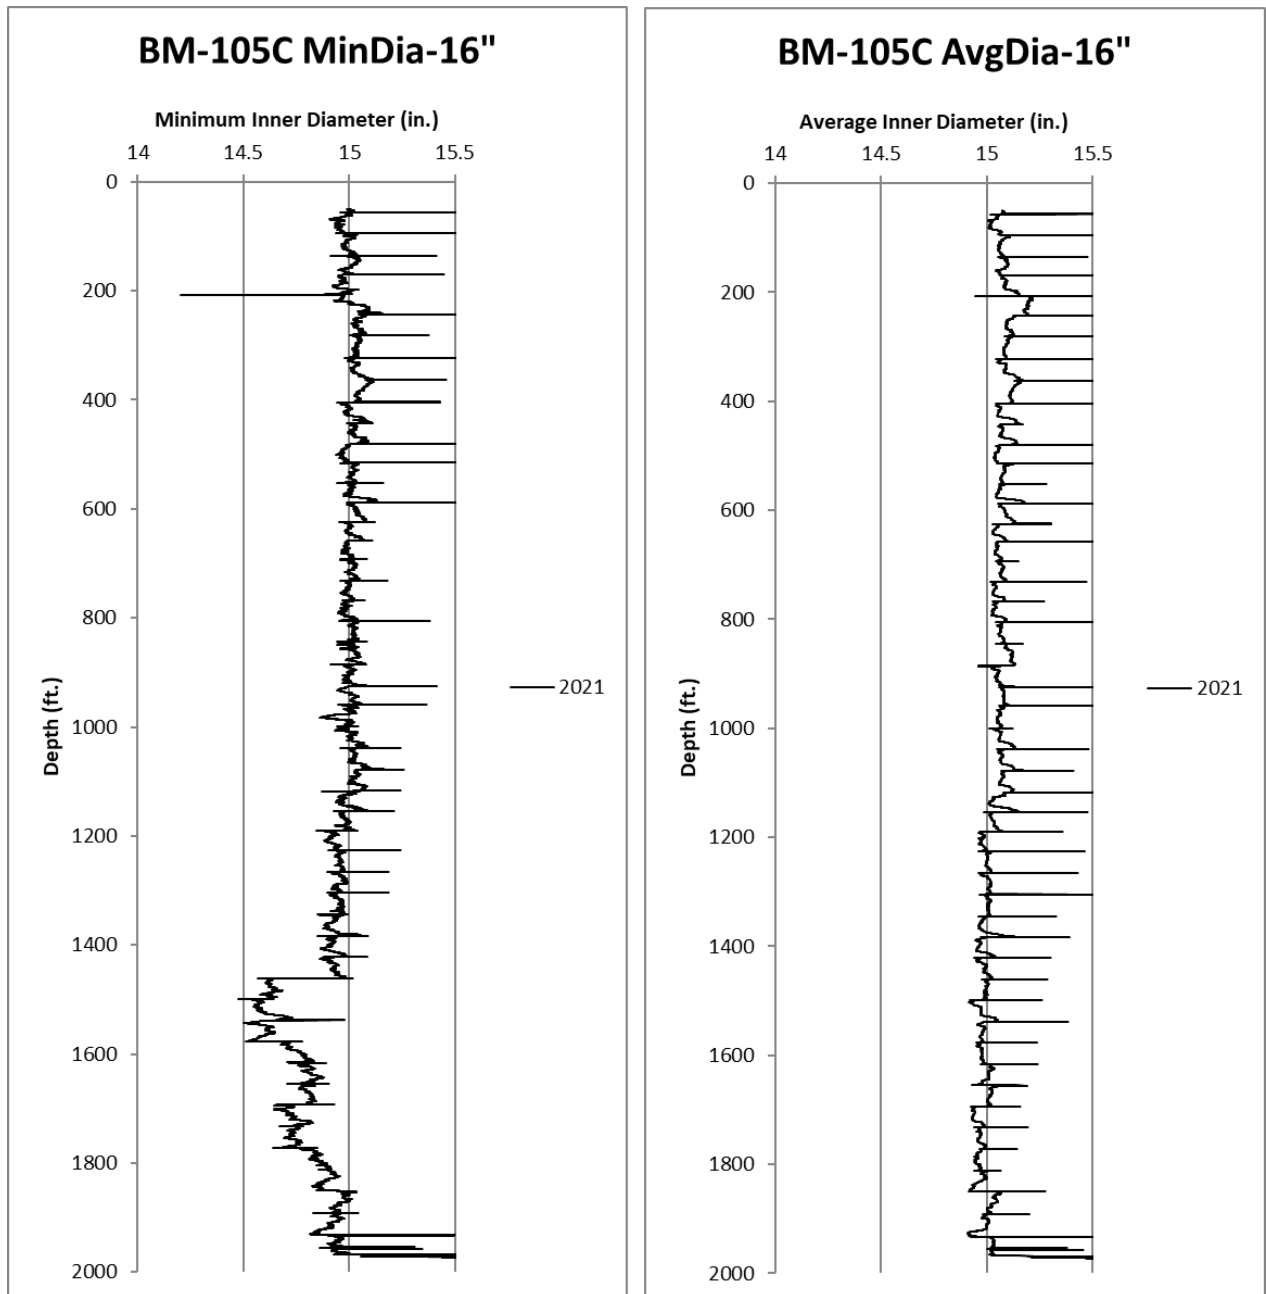
Figure 3-65. BM-105C minimum and average diameter curves from 2021 MAC data

BM-105C has a total of two MAC logs from 2012 and 2021, which were both taken on the 16" casing. The 2012 log was excluded from this analysis as the data file did not include individual radial arm measurements. Figure 3-65 shows the minimum and average diameter curves for the 16" casing which was calculated from the 2021 MAC log. From this dataset, a casing restriction was identified at 206.95', and a decrease in the minimum diameter curve can be observed at this depth. Although there is a notable decrease in diameter at the depth of interest, this does not appear to be a typical case of collar compression as seen at many of the other BM wells and is likely the result of some debris in the casing.

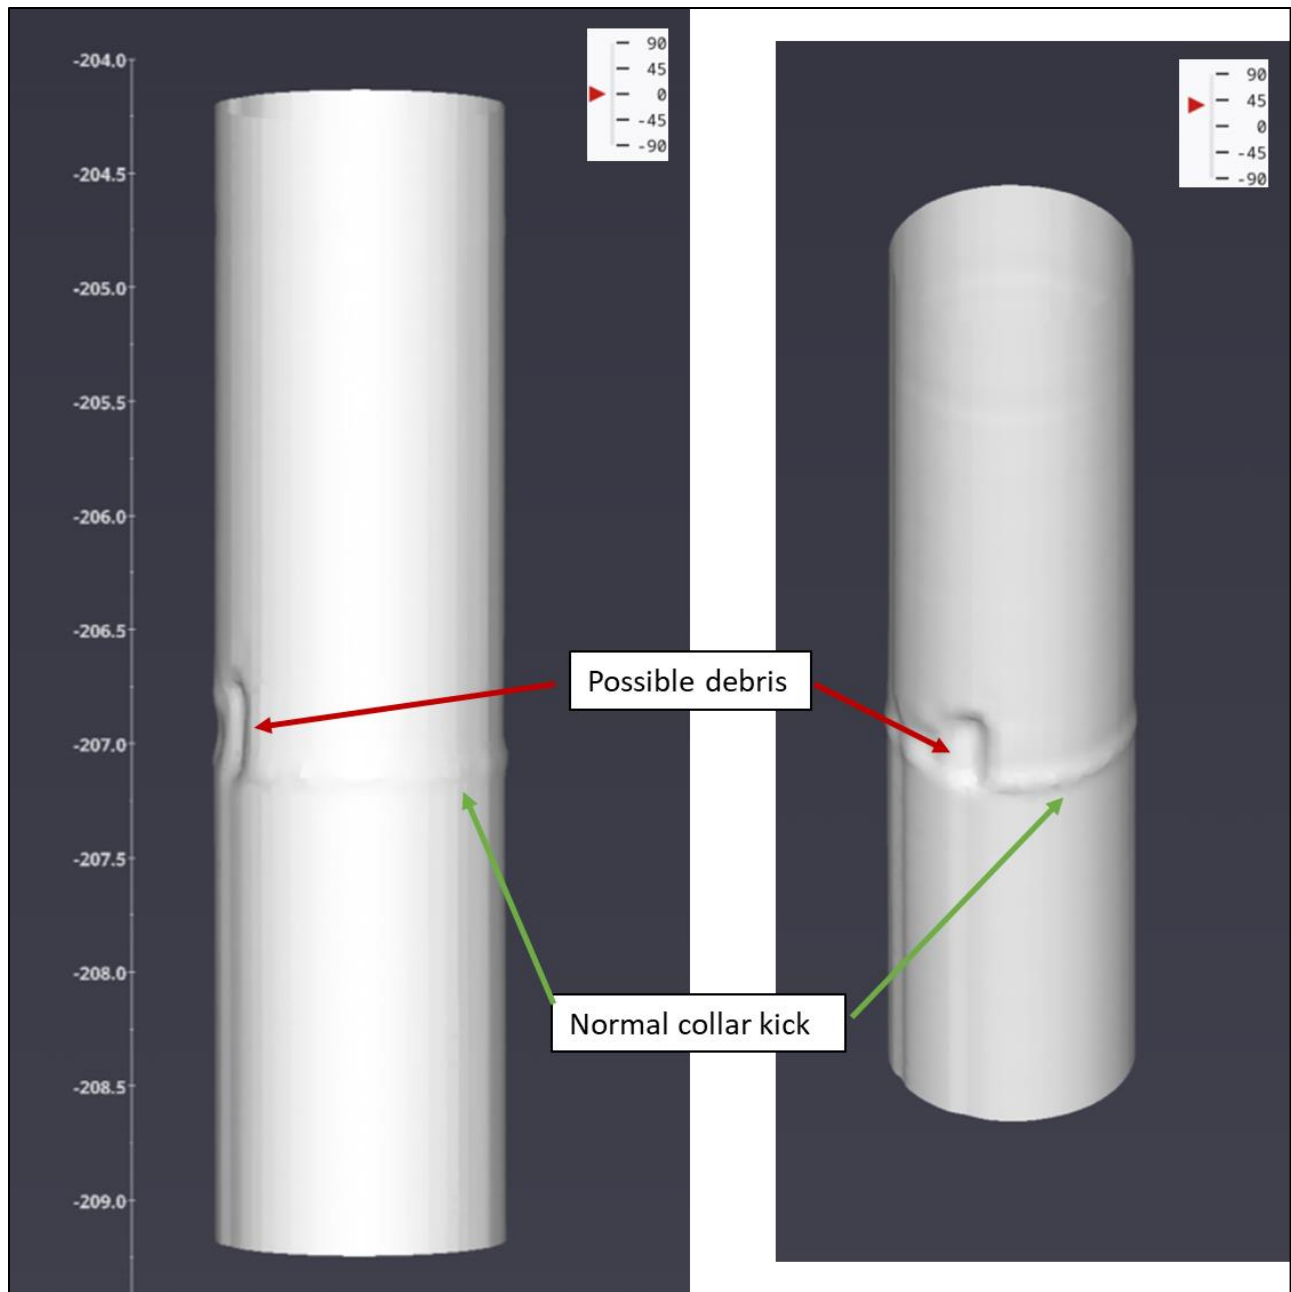
Figure 3-66. 3D visual of BM-105B 2021 MAC radial arm data near 207'

Figure 3-66 displays a 3D visual of the MAC radial arm data at the depth of interest. Although there is visible deformation occurring near a casing collar, it is limited to one side of the casing. Additionally, a normal collar kick can be observed in the remainder of this region, which is the opposite of what would typically be observed in cases of collar compression at Bryan Mound. While there is a true decrease in minimum diameter around this depth, it does not appear to be a result of geology and is not a major concern at this time. This case also serves as a good example of a situation where a decrease in the minimum diameter might not always be indicative of uniform radial deformation. To get a full picture of what is going on at a specific depth it is important to look at the radial arm data from that region.

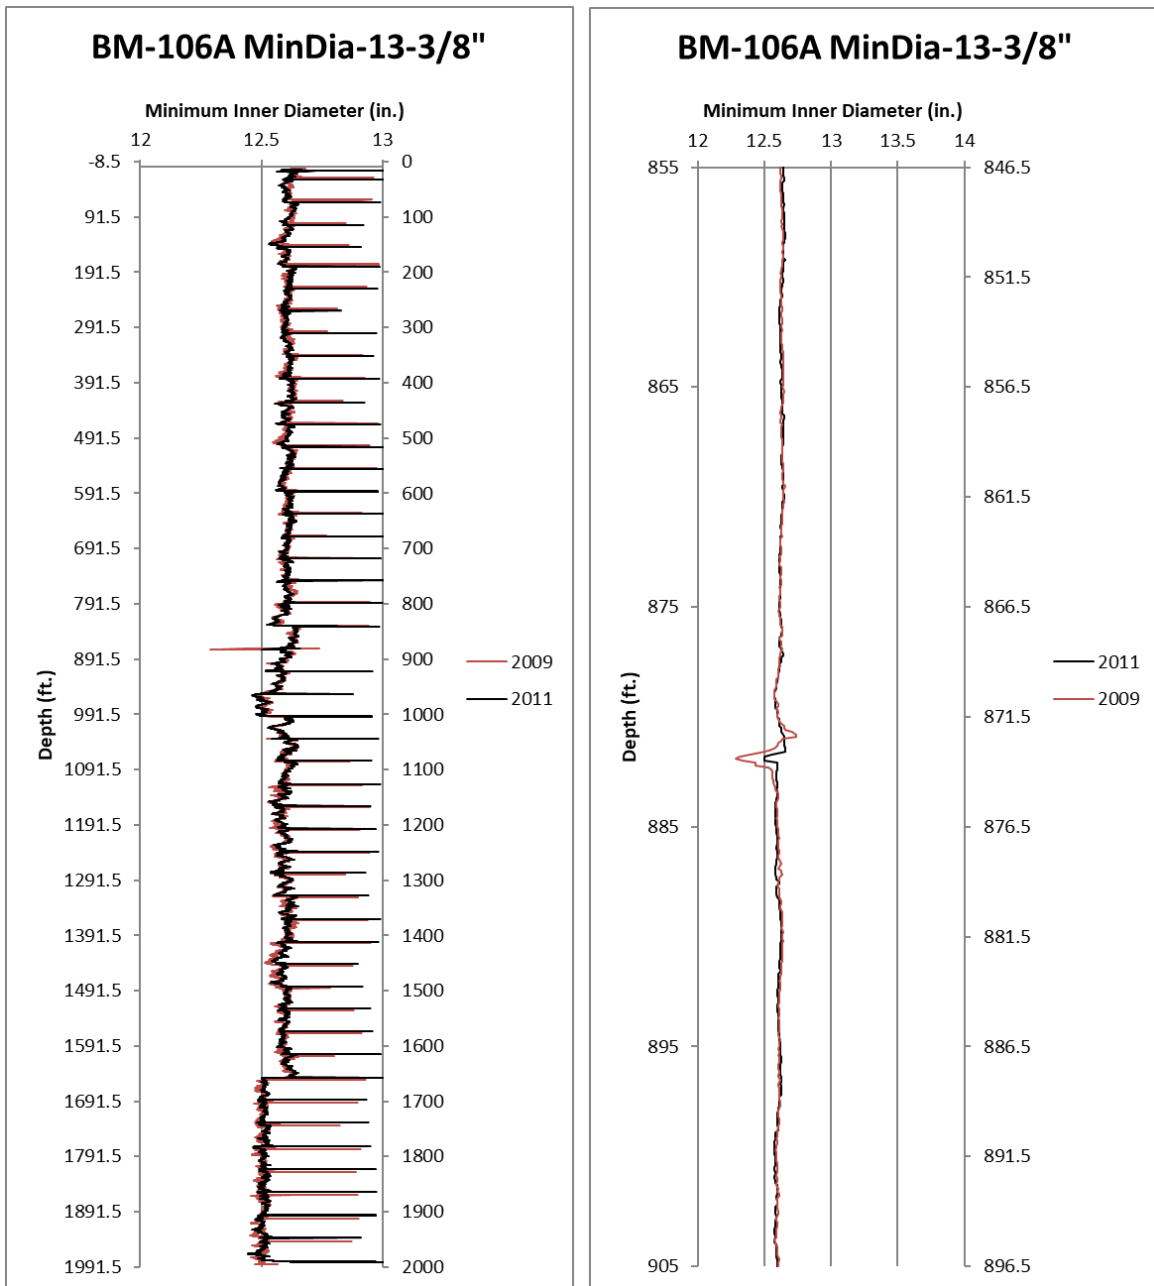
Figure 3-67. BM-106A minimum diameter curves from 2009 and 2011 MAC data

BM-106A has a total of three MAC logs from 2009, 2011, and 2020. The 2009 and 2011 logs were taken on the 13 3/8" casing. The well was then lined and the 2020 log was taken on the 10 3/4" liner. Figure 3-67 shows the minimum diameter curves for the 13-3/8" casings which were calculated from the 2009 and 2011 MAC logs. From this dataset, a casing restriction in the 13 3/8" casing was identified at 881.9', and a decrease in the minimum diameter curve can be observed at this depth, however it does not appear to be worsening between the 2009 and 2011 logs. Figure 3-68

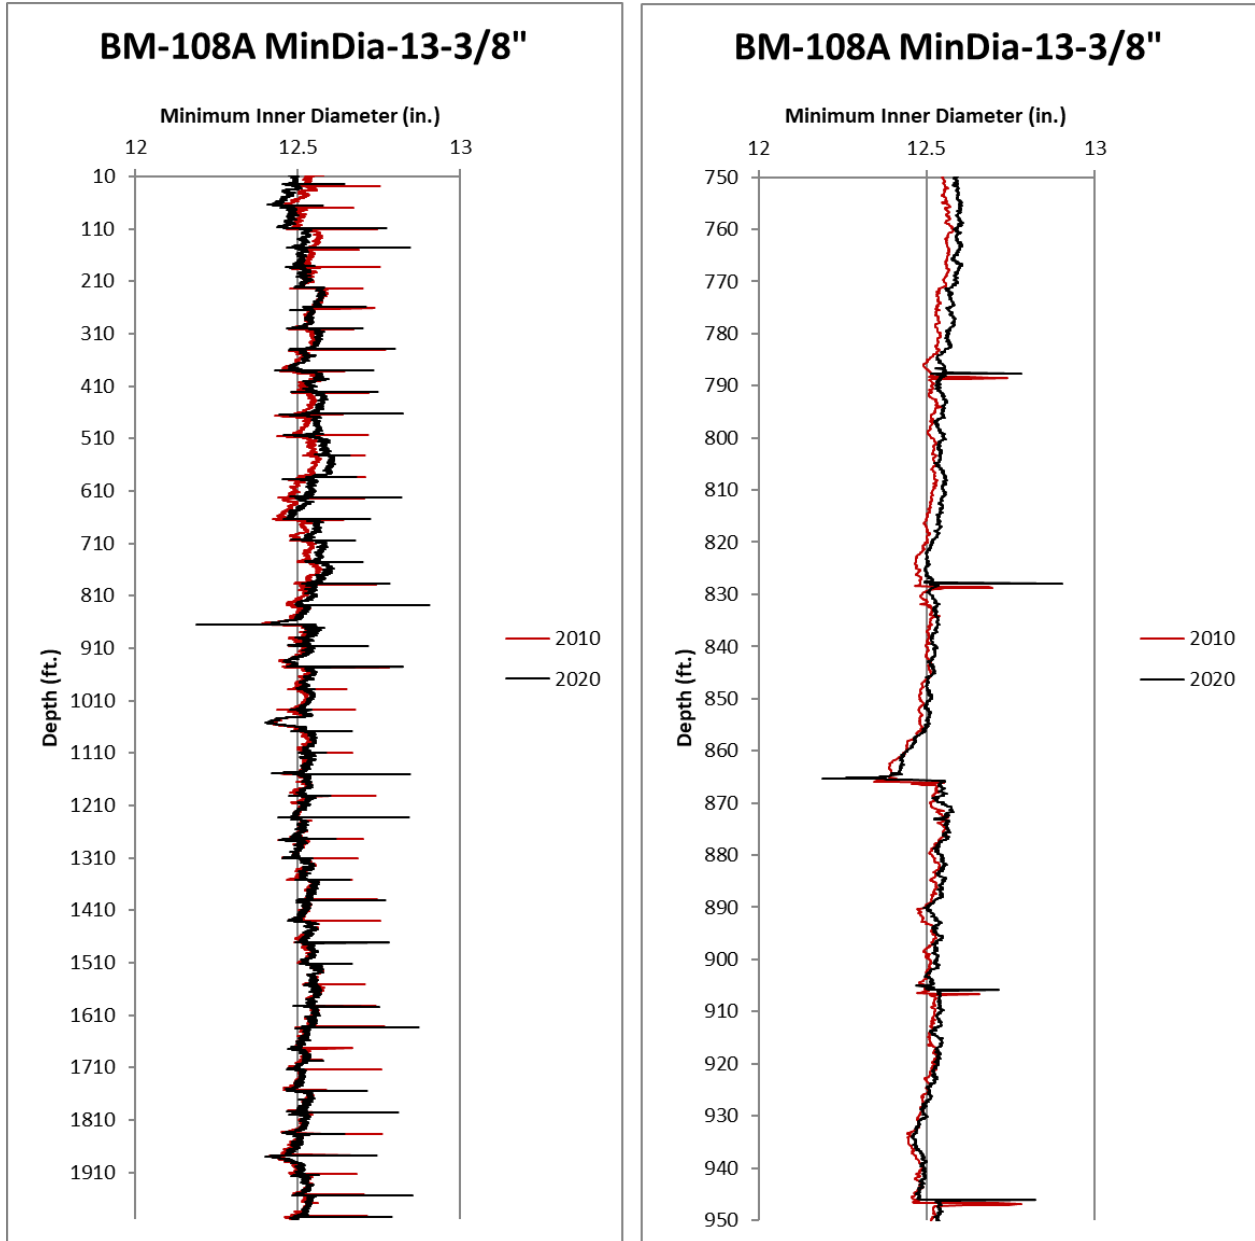
Figure 3-83. BM-108A minimum diameter curves from 2010 and 2020 MAC data.

between the two logs. Some deformation mid-casing has also been noted near the salt-caprock interface around 1040'-1060' which does appear to be moderately increasing over time.

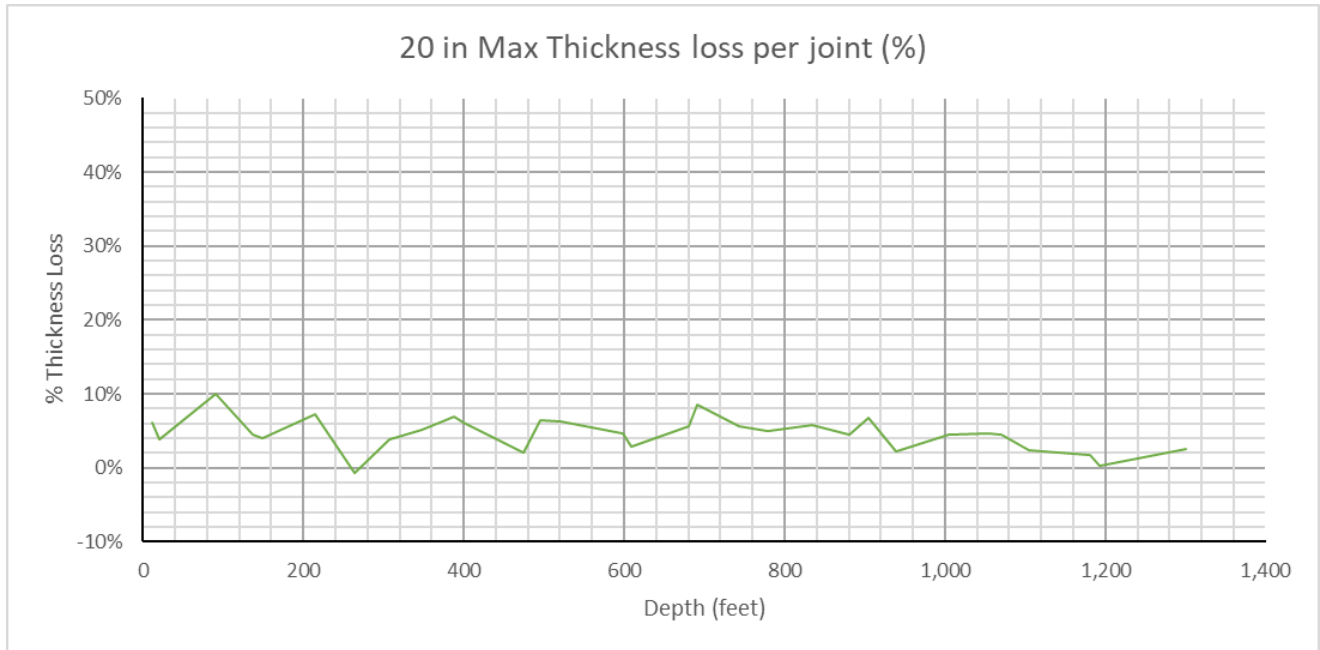
For all of the wells besides BM-116B, the PEC did not capture anything out of the ordinary. The BM-106C log did note an anomaly around 849' which had already been identified by the MAC data as a depth of collar compression. Most casings evaluated for each well had reported maximum thickness losses around 0-10% for each joint. An example of a typical max thickness figure (taken from the PEC report for the 20" casing in BM-111B) is shown in Figure 4-5 below (GOWell 2021).

Figure 4-5. BM-111B pipe thickness loss for the 20" casing
