TRIBOLOGY TEST BED TECHNICAL REPORT

NIWC3B CERMET, CHLORIDE SALTS

EVAN OGREN
UNIVERSITY OF WISCONSIN - MADISON
Rev: Dr. Mark Anderson

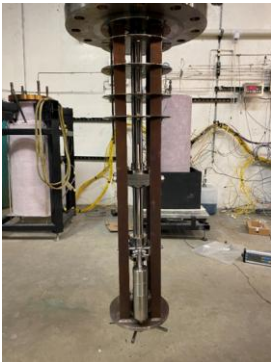
Figure 2. Internal structure before salt test.

The stainless vessel and inner column structure were black in color but otherwise were in good condition. It was observed that the salt drained almost completely with a thin film of salt on horizontal surfaces. There was also some condensed vapor on the upper portion of the shaft above two of the thermal isolation sections. This layer was thin and didn't hinder any operation. The thermal isolation sections worked well; discoloration of the SS316 structure decreased significantly in the upper zones.

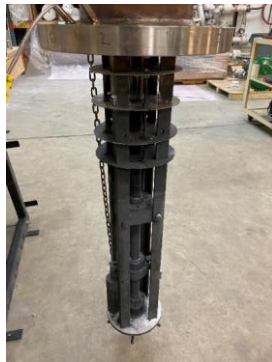
Figure 5. Internal structure after salt test.

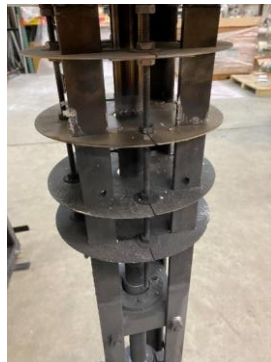
Figure 6. thermal isolation zones after salt test.

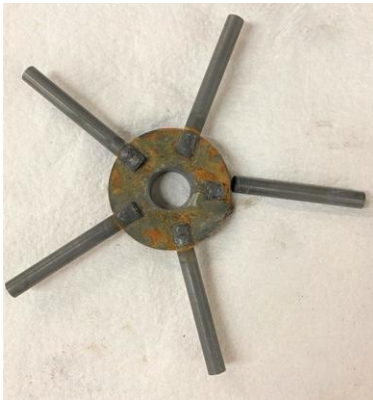
Figure 7. Pin specimen hub after removal from shaft. Pin samples are solid NiWC3B material

The bottom nut on the system that held the pin sample hub on the shaft had salt in the threads and it was required to cut this off to remove the pin samples. While removing the bottom hub one of the pin samples broke at the root where it was pinned into the hub. The rest of the samples were able to be removed with the hub. The hub was then sonicated in 50°C distilled water. During sonication a second pin broke at the hub, but the remaining three pins survived. Upon inspection all the bearing surfaces looked to be in good condition. Sleeve surfaces were in good condition with an apparent mark on each sleeves circumference where contact was made with the corresponding bushing.

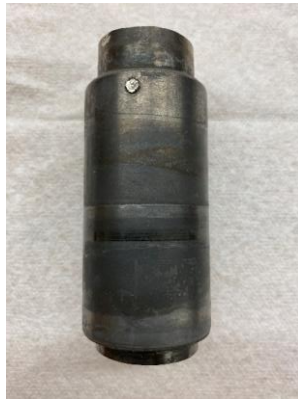
Figure 8. Upper shaft sleeve (solid-NiWC3B-coated SS316 material) after molten salt test.

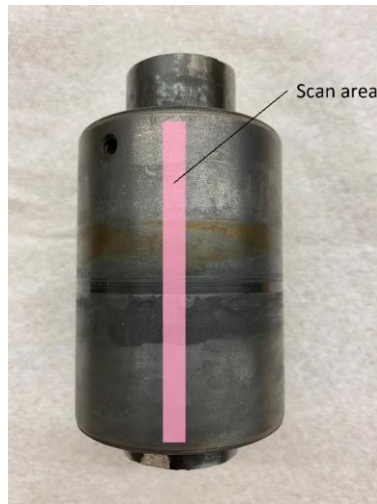
Figure 12. Diagram of surface scans taken on sleeve specimens.

Surface scans of sleeve specimens were taken along the length of each sleeve, as shown in figure 12. Four scans were taken from each sleeve at 90° spacings around the sleeve circumference. Figure 13 shows a scan taken for each sleeve where surface heights were averaged across a 1500-micron width of the scan. The plots show this average surface height along the length of the scan. The area of contact between the sleeve and its corresponding NiWC3b bushing is located between the two cursors on the plots.

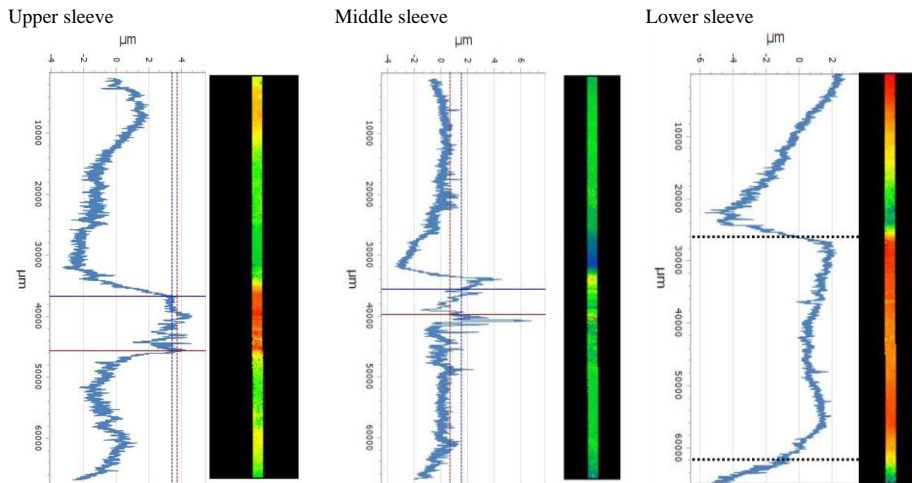
Figure 13. Surface scans of the three sleeve specimens (upper, middle, lower). Note that the area of contact with the bushing on each sleeve, shown as the area between the two cursors on each plot, is located in an area of elevated surface height relative to the rest of the sleeve.

The sleeve scans show the area of contact between the sleeve specimens and their corresponding bushings are in areas of elevated surface height relative to the rest of the shaft sleeve. To verify these results, measurements of the upper sleeve were taken with an Alicona optical profiler and a strip of the upper sleeve was coated with a 10 nm thickness of gold to increase reflectivity of the surface for more reliable measurements on the Zygo profiler. The Alicona measurements and Zygo measurements after gold-coating both confirmed the increased surface height at the area of contact.

One possible cause of the increased surface height in the contact area is material transfer from the NiWC3b bushings to the shaft sleeves. To look for material transfer from the bushings to the shaft sleeves, SEM imaging of the upper sleeve will be done to search for higher concentrations of nickel inside the contact area, which would suggest material transfer from the bushings.

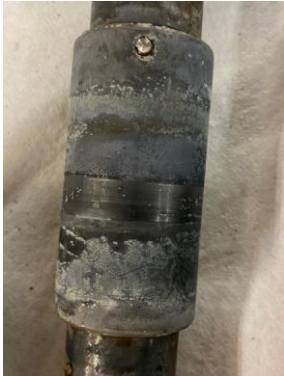
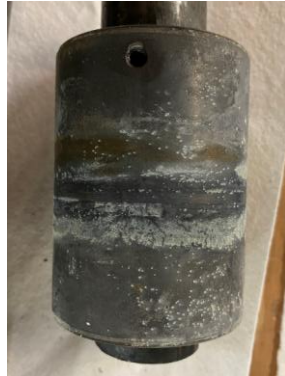
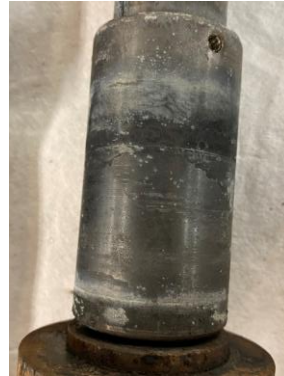
Figure 14. Shaft sleeves after removal from the inner column structure. There appears to be some corrosion outside of the contact areas and contact areas appear to be relatively clean.

Another possible cause of the increased surface height is corrosion of the shaft sleeve outside of the contact area. Figure 14 shows the three shaft sleeve specimens after being removed from the inner column assembly. From the images, it appears there may be some corrosion of the sleeves outside of the contact area while the contact areas themselves appear to be cleaner.
