**SANDIA REPORT**

SAND2024-15941

# CPS 38491 NSTTF Operations and Maintenance Project Final Report (FY22-24)

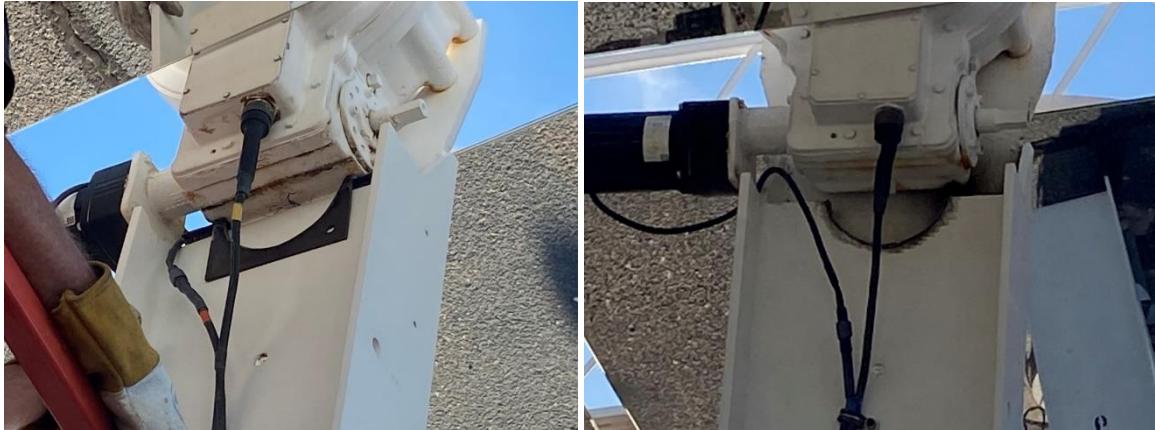
To access the oil port for the elevation drive on some units, it was necessary to plasma cut a half circle cutout as shown in Figure 2. This procedure was added to the work orders.

**Figure 2. Elevation drive oil port access modifications to a heliostat shown before (left) and after (right) plasma cutting.**

It was determined that the oil change procedure was a potential bottleneck in the PM process due to delays caused by low temperatures, oil supply chain, and plasma cutting time. During winter months, all PMs were paused as increased oil viscosity prevented easy pumping of the oil from the system, and as the oil supplier reported order delays. It was decided in the spring of FY23 that the work orders for the oil changes and general PM would be separated to allow them to proceed separately and in parallel from the rest of the PM procedure, and the PMs therefore resumed. The oil supply chain delays have since been resolved and the time commitment of each task has lessened as key personnel gain experience.

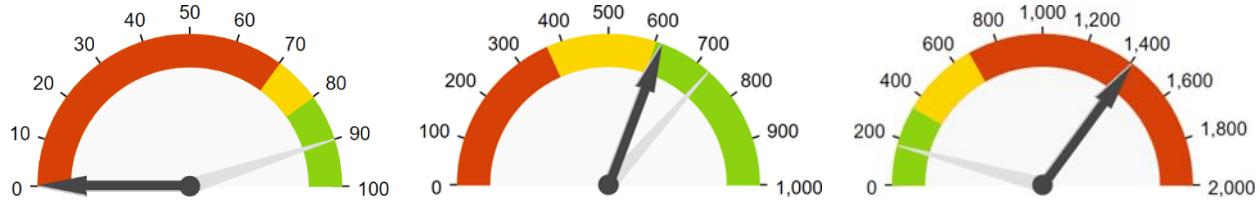
**Figure 3. Key performance indicators, from left to right, for preventative maintenance compliance percentage, mean time between failures (in days), and mean time to repair (in hours), shown as target metric (white dial) and current performance (dark arrow).**

The NSTTF Maximo implementation was modified to provide snapshot and detailed historical tracking of multiple site maintenance and repair metrics. Mean time between failures (MTBF) and mean time to repair (MTTR) metrics were implemented as key performance indicators (KPIs) with a graphical dashboard shown in Figure 3, along with a preventative maintenance compliance (PMC) metric defined as the percentage of work orders completed within the target date, currently four weeks from issue. The current PMC is shown as 0%, as all work orders were generated before the winter pause in FY23 and therefore not completed within the target time. In winter-spring, failure of the uninterruptible power supply for the heliostat field led to a several week downtime of the entire field, which caused the MTTR metric to fall outside of the target range of < 168 h. Previously, the MTTR was significantly lower than the target, so we do not expect this to be a persistent issue. Similarly, the event pushed the MTBF outside of the target range of 730 h, although still within the green level of performance. These results indicate that day-of failure of the heliostat field preventing testing is a rare occurrence despite some troubleshooting that often takes place during testing, but that failures, when they can occur, can cause extended downtimes due to the uniqueness of high-consequence, high-cost components.

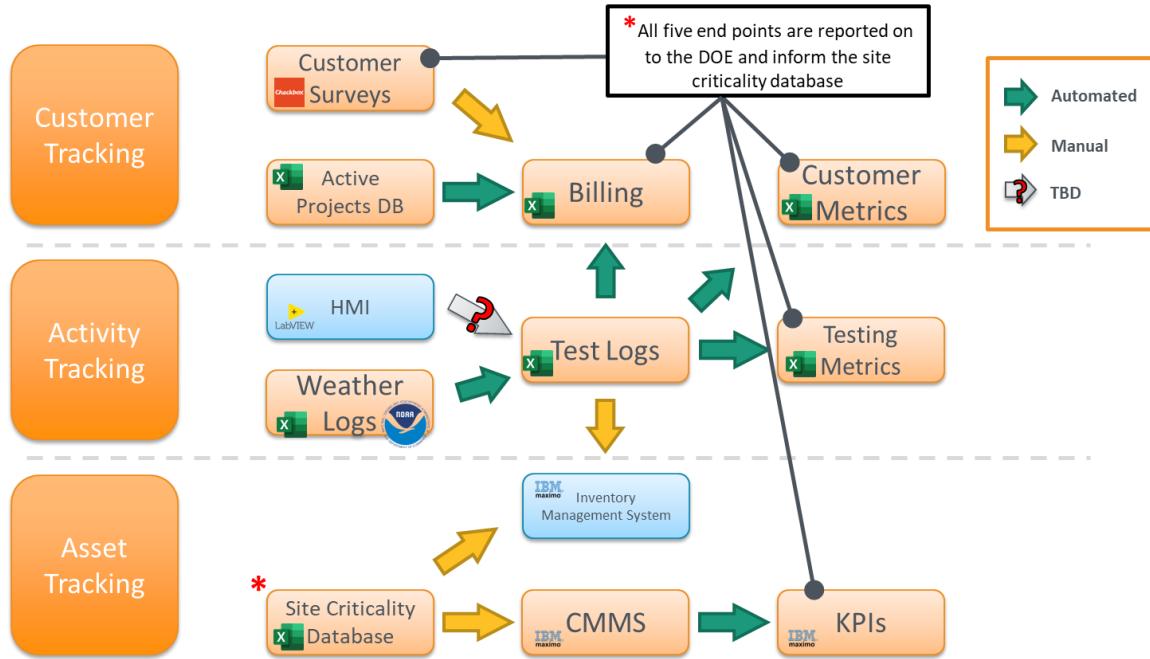
**Figure 4. Site tracking information flow. Blue boxes are future capabilities or those which don't currently communicate with other systems.**

Among the changes were standardization of site test logs at the solar tower, solar furnace, electric-heating test facility, and molten salt test facility (apartment complex). Test operators log setup and test activity on an hourly basis. This data is then automatically referenced by the NSTTF team calendar, which acts as a dashboard summarizing daily testing activity across the site. Logged tests are referenced against a database of active projects at the NSTTF to track test activity by customer type and subject area (solar or non-solar), and to track and create test billing requests. Test activity is referenced against local weather data in an automated manner to estimate NSTTF efficiency in making use of good weather conditions for testing, or as a percentage of days in a month for off-sun facilities. The system improvements led to complete coverage of utilization data for the first time, and for significant decrease in utilization tracking costs through the automated systems.

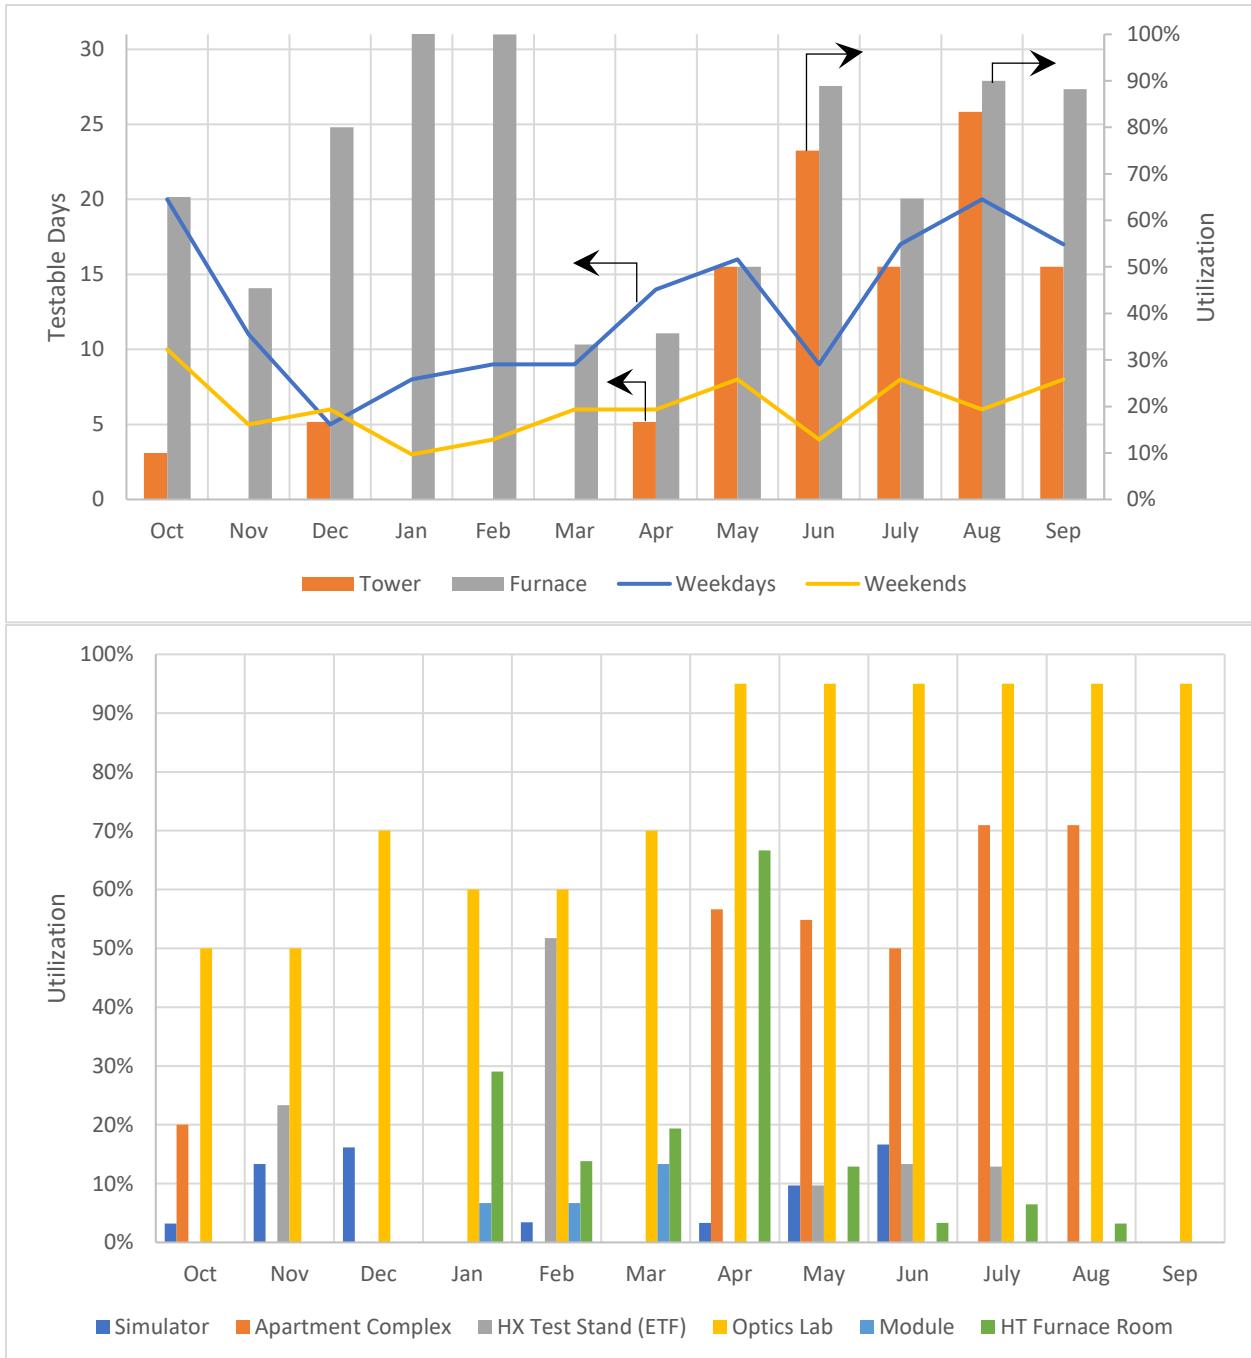
**Figure 5. Monthly site utilization metrics for on-sun (top) and off-sun capabilities (bottom). On-sun utilization is compared relative to the number of good weather days, which for the solar furnace is during the workweek (M-F) and for the solar tower is the weekend (F-Su) due to G3P3 construction restricting tower activity from M-Th. Off sun utilization percentages are relative to a 30-day month, except for the optics lab for which the percentage is an estimate of the usage of lab capabilities, which often takes place outside of the optics lab space.**

Site utilization for FY24 through mid-September is summarized monthly in Figure 5 and quarterly in Table 3Table 3. On-sun capability utilization percent is tracked relative to the number of good-weather test days in a reporting period. Due to the construction of the Generation 3 Particle Pilot Plant (G3P3), which began during the reporting period, weekday (Mon-Thurs) testing at the NSTTF solar tower was curtailed. Starting in February FY23, the utilization percentage for the solar tower was based on the number of weekend (Fri-Sun) good weather test days. The solar furnace was unaffected by construction and continued to be evaluated relative to weekday weather.

**FY24 Summary:** In general, testing at the solar tower was limited due to the constraints of construction and the challenge of transitioning to a weekend testing schedule for customers and personnel. The solar furnace and solar simulator experienced heavy demand for capabilities throughout the year. ETF utilization was reduced due to delays in the fabrication of a heat exchanger to be used by multiple customers. The solar simulator also was taken down for several weeks throughout the year for repairs and upgrades. The high-temperature furnace room began to be utilized as a multi-capability space and therefore saw an increase in utilization over the summer. The apartment complex became busier later in the year due to molten salt/metals projects becoming active. Optics lab capability utilization grew and remained high as optics capabilities began to be deployed throughout the site, both within the optics lab and, increasingly, in the field.

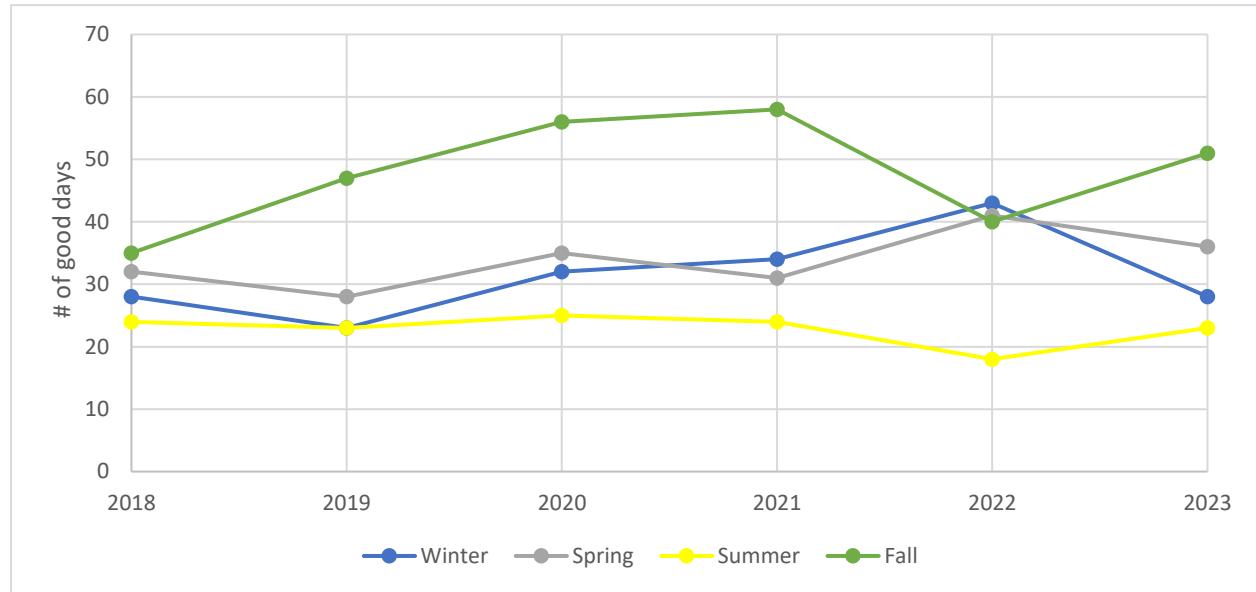
**Figure 6. Comparison of “good weather” weekdays, defined as average wind speeds below 15 mph and cloudcover below 30%, per season at the NSTTF.**

A simple analysis of historical weekday weather over a five-year period, shown in Figure 6m revealed that Fall test conditions were most often optimal, while Summer conditions were least often. Despite higher temperatures in the summer and higher direct normal irradiance on clear days, the Summer monsoon season limits testable days. While Spring testing is impacted by seasonal winds, seasonal conditions still were comparable to the Winter and more often optimal compared to the Summer. In FY24, 188 or 87% of total bad weather events were high cloudcover,

while 25 or 12% of events were high wind. Note that events were classified such that multiple bad weather events could occur on the same day.

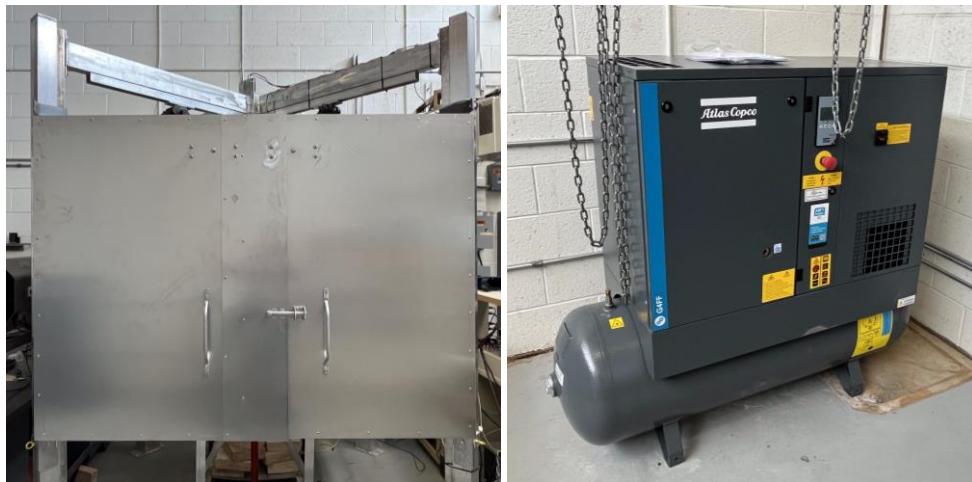
**Figure 7. (Left) automatic locking door on solar simulator; (right) compressor**

Hardware and software upgrades were performed on the solar simulator to improve functionality and repair or improve reliability of the system. The LabView data acquisition and control software was updated to be consistent with existing frameworks at the NSTTF for greater ease of adaptation in the future. A door (Figure 7, left) and maglock were installed on the west side of the enclosure (previously a partial-wall accessed by a rail-mounted robotic arm) to increase the ease of sample installation, particularly for large test articles, and improve system safety. The maglock was integrated into the control software to engage during lamp operation to prevent access by users. A water chiller was installed at the facility to provide cooling for flux mapping targets and reactor/receiver apertures. The room compressor (Figure 7, right) was upgraded by Sandia facilities to provide more reliable pressure supply for pneumatic components. Finally, a rotating table and improved sample shutter for shielding were built and integrated with the control software to allow reliable multi-sample and multi-exposure control of samples according to time- or target temperature-programmed heating schedules.

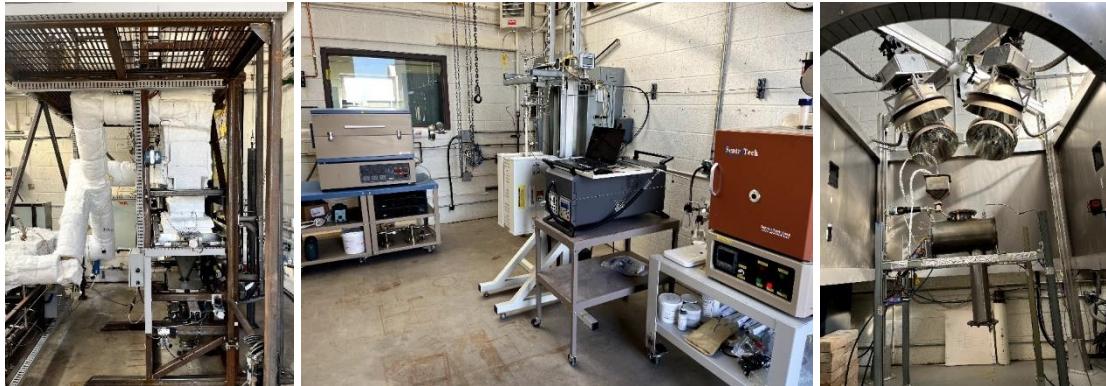
**Figure 14.** From left to right: test cell one (heat exchanger test stand), two (high temperature furnaces), and three (solar simulator) in the electric-heating test facility.

The previously named “engine test facility” (ETF) at the NSTTF was rebranded to the “electric-heating test facility” in recognition of the space’s shifted purpose and capabilities from its original scope as a facility to test dish Stirling systems and other components of parabolic dish CSP technologies. The three test cells of the ETF, shown in Figure 14, include:

1. The heat exchanger test stand, which enables sCO<sub>2</sub> and particle loop operation and testing of prototype systems on the order of 10 kW<sub>t</sub>,
2. The high temperature furnace facility, which offers a purge-capable box furnace and multiple tube furnaces for high temperature thermal and thermochemical processes,
3. The high flux solar simulator, for the high-throughput testing of materials and bench-scale concentrating solar components.

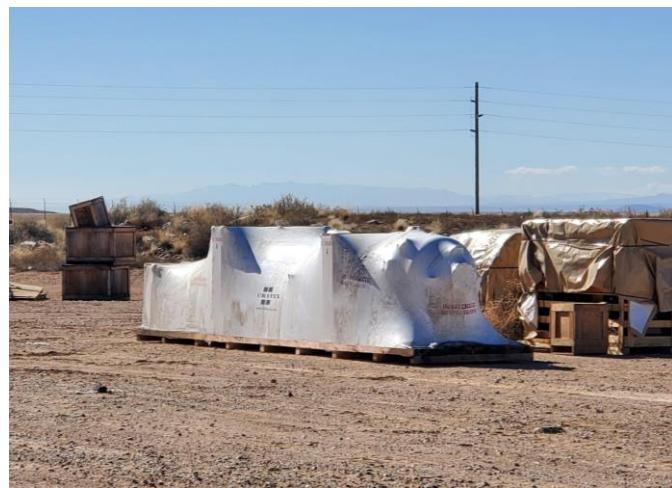
**Figure 15.** Solex heat exchanger stored at the NSTTF.

To support the procurement of a heat exchanger at the NSTTF for the CentRec noLimits project, funds in the amount of \$520K were allocated. The request for quote, purchase, receipt, and invoicing of the heat exchanger were completed in FY22 and FY23 (primary year: FY22). The heat exchanger unit is stored outdoors, southwest of the NSTTF solar tower and currently still packaged in the shrink-wrapped plastic that it was transported, as shown in Figure 15. As the heat exchanger is constructed solely of 300 series stainless steel, no corrosion degradation is expected as result of storing outside and exposure to weather and atmosphere. A storage and utilization plan was prepared with the culmination of the task and reported separately to DOE.

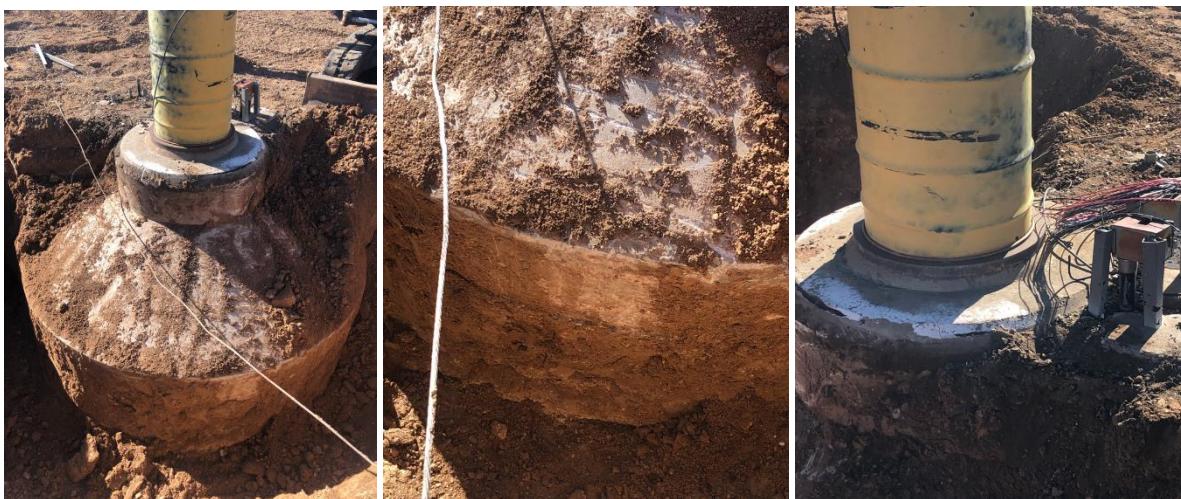
**Figure 16. Heliostat base extraction depicting (left to right), concrete support, a more detailed view, and electrical cables.**

Funds in the amount of \$150K were allocated to support a scoping study to support the refurbishment of communications and other components in the NSTTF heliostat field to promote the long-term health of the facility and the compatibility of field communications and data with CSP industry and academic customers (primary year: FY23). This work culminated in a costing study and technical work proposal (TWP) detailing the requirements of the field and the cost to update heliostat and control room hardware consistent with these requirements. Additionally, the extraction of an unused heliostat base necessary for the G3P3 tower construction was leveraged as an opportunity to obtain a cost-efficient, qualitative inspection of heliostat base structural, power, and communication component aging (see Figure 16). The evaluation didn't indicate significant specific concerns for the field. The TWP for future work on a separate project was generated which contained overall cost estimates and a work plan.
