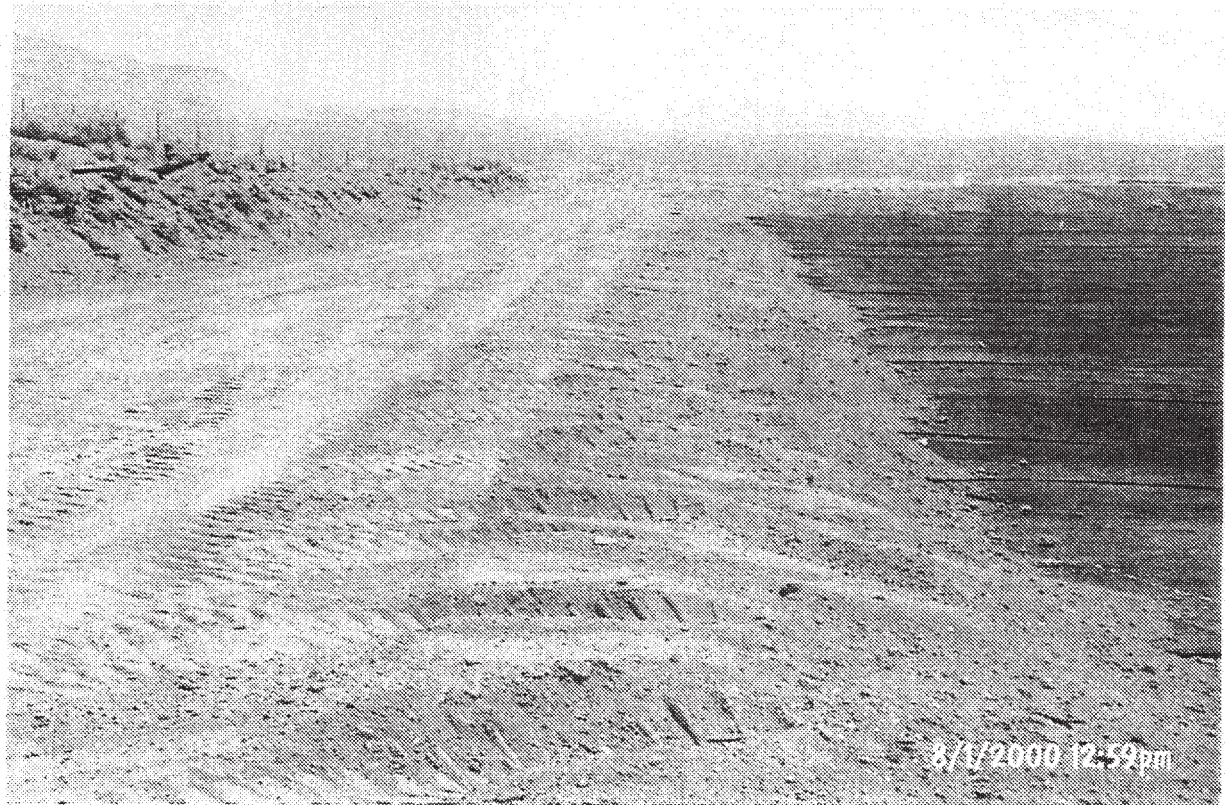
PHOTOGRAPH 3 - Geogrid anchored in place on CMP

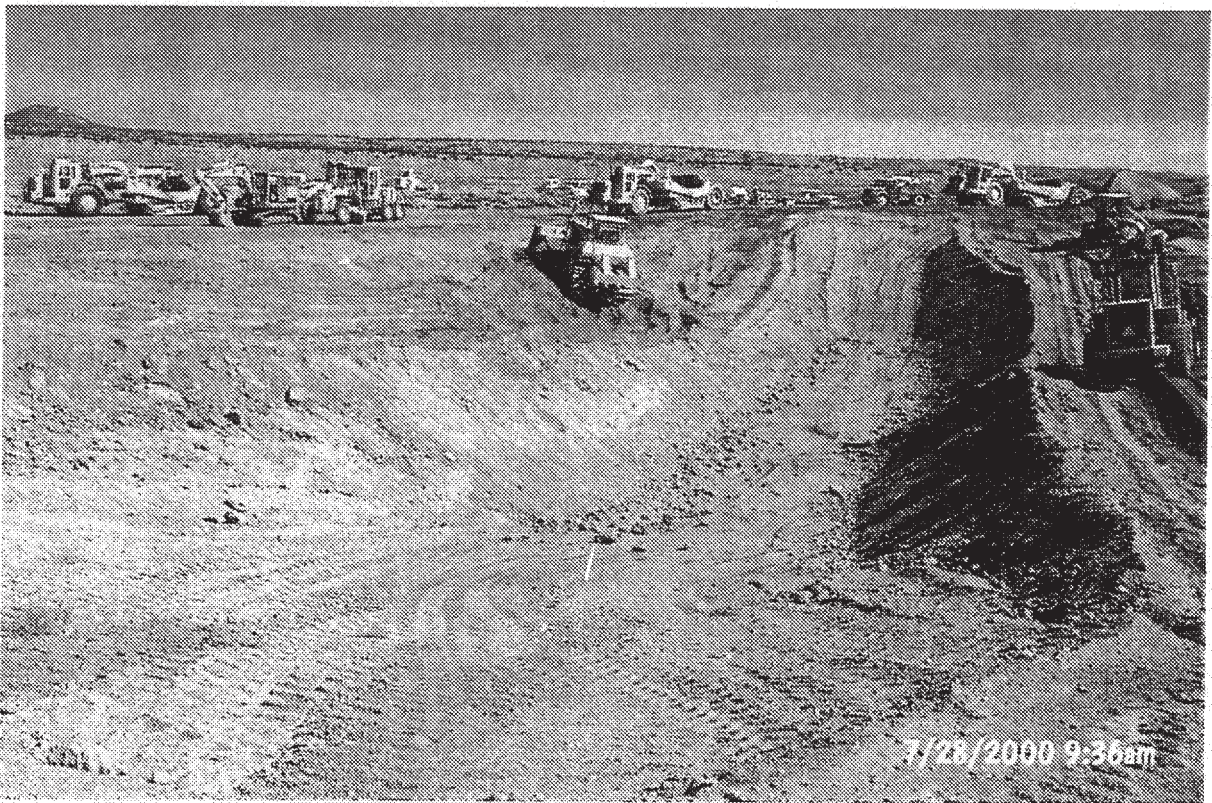
PHOTOGRAPH 6 - Excavation of the CMP Mud Relocation Trench

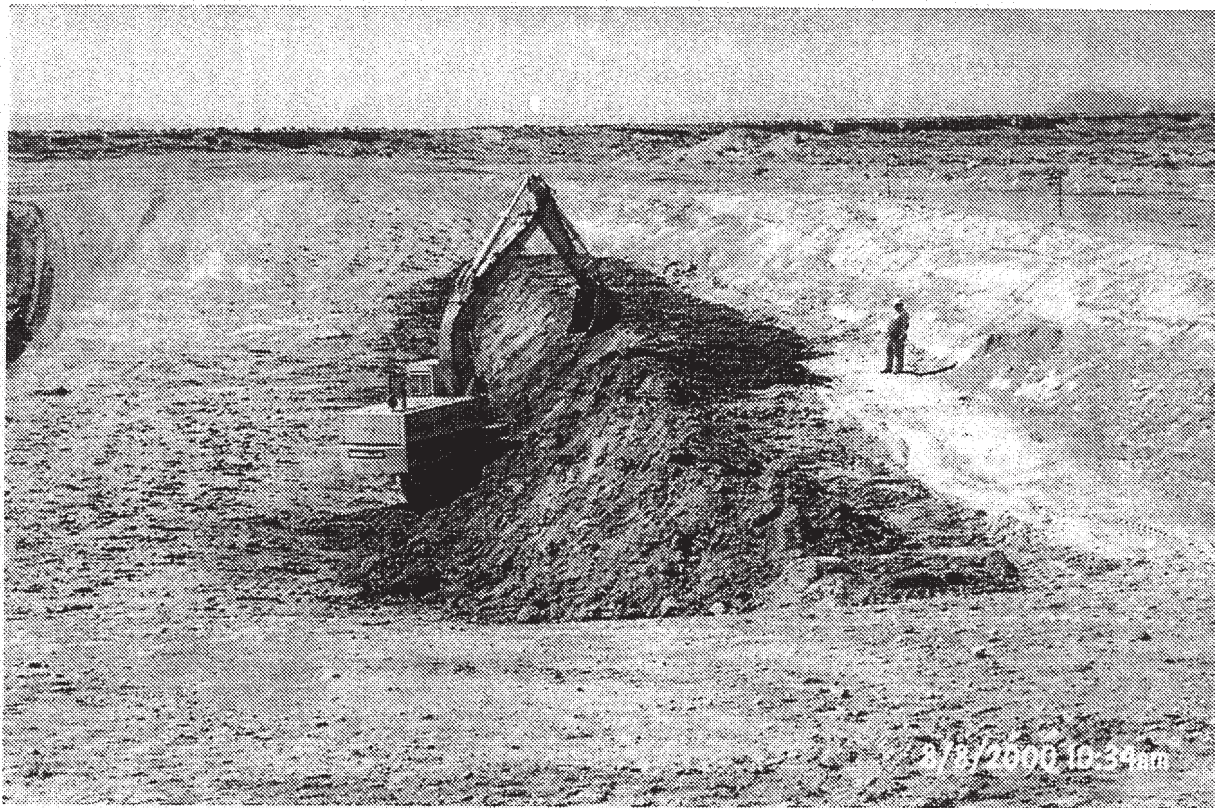
PHOTOGRAPH 10 - Leveling drilling material surface with Track Hoe

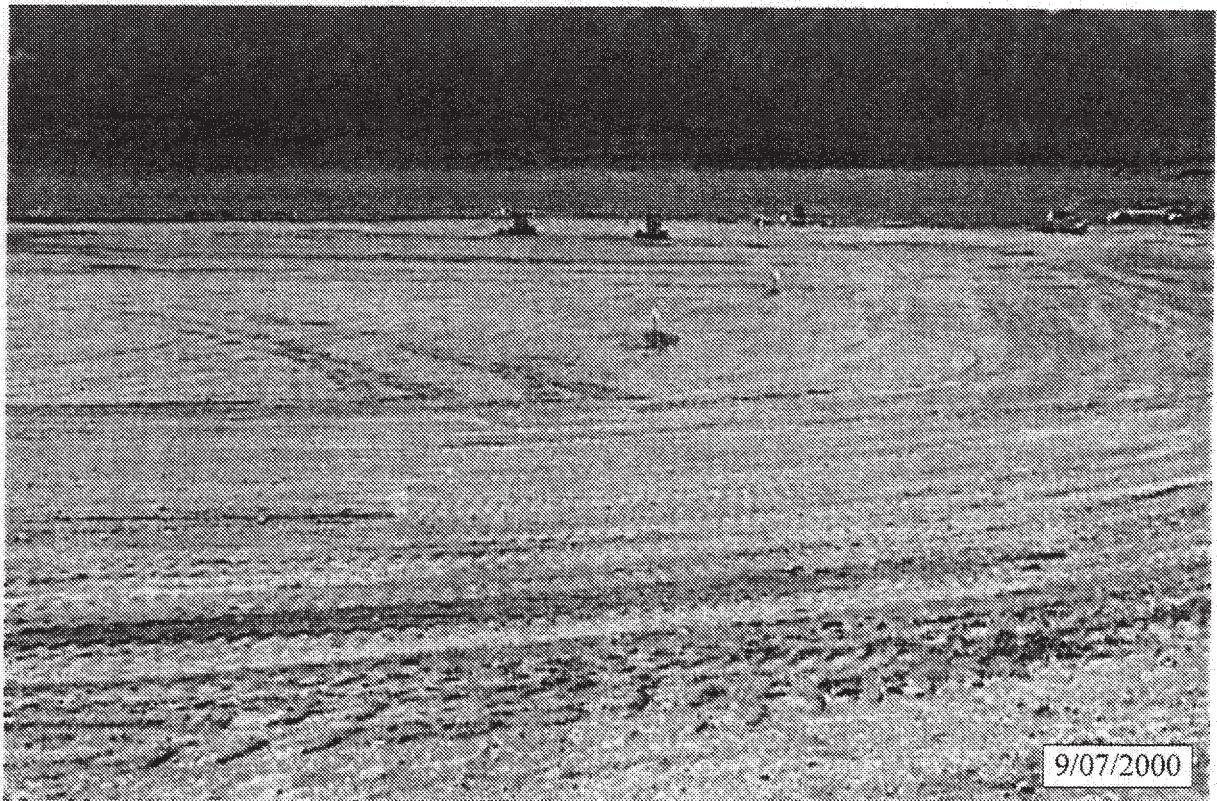
PHOTOGRAPH 14 - Completed 4 foot earthen mono-layer CMP cover

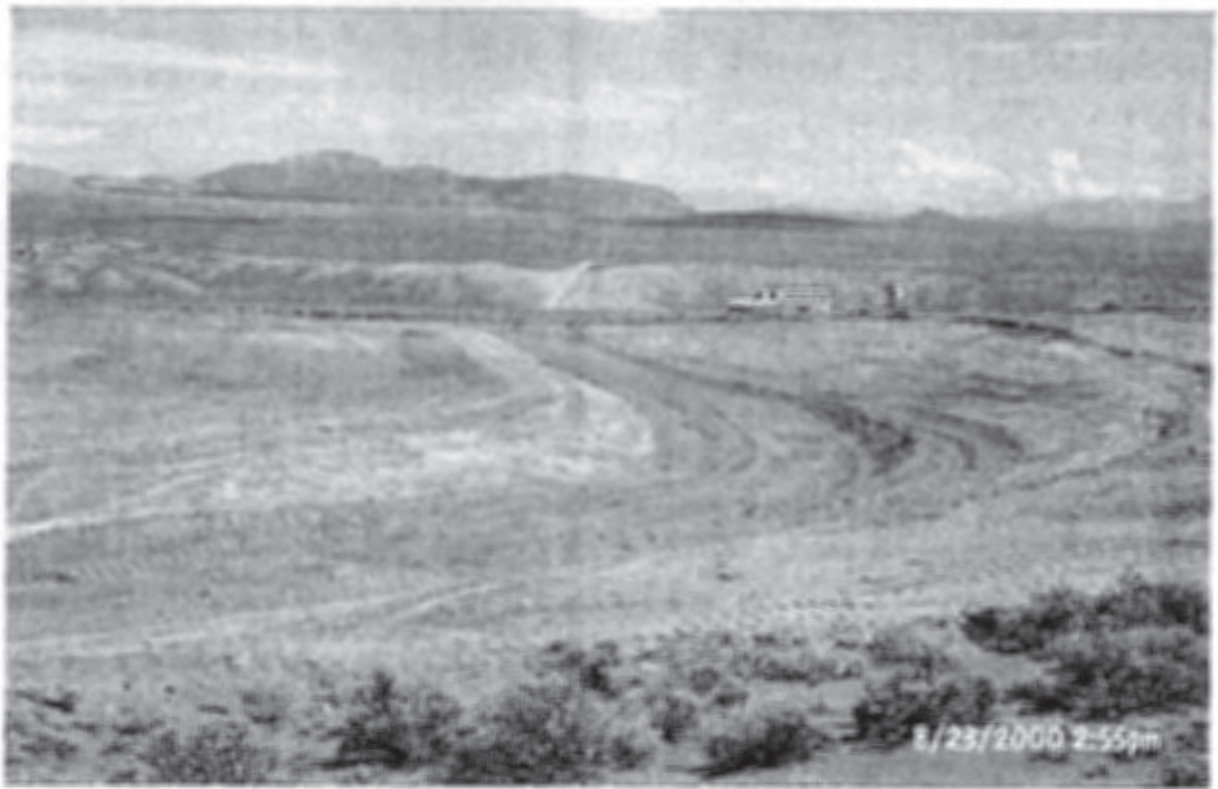
PHOTOGRAPH 15 - South portion of the West Diversion Channel

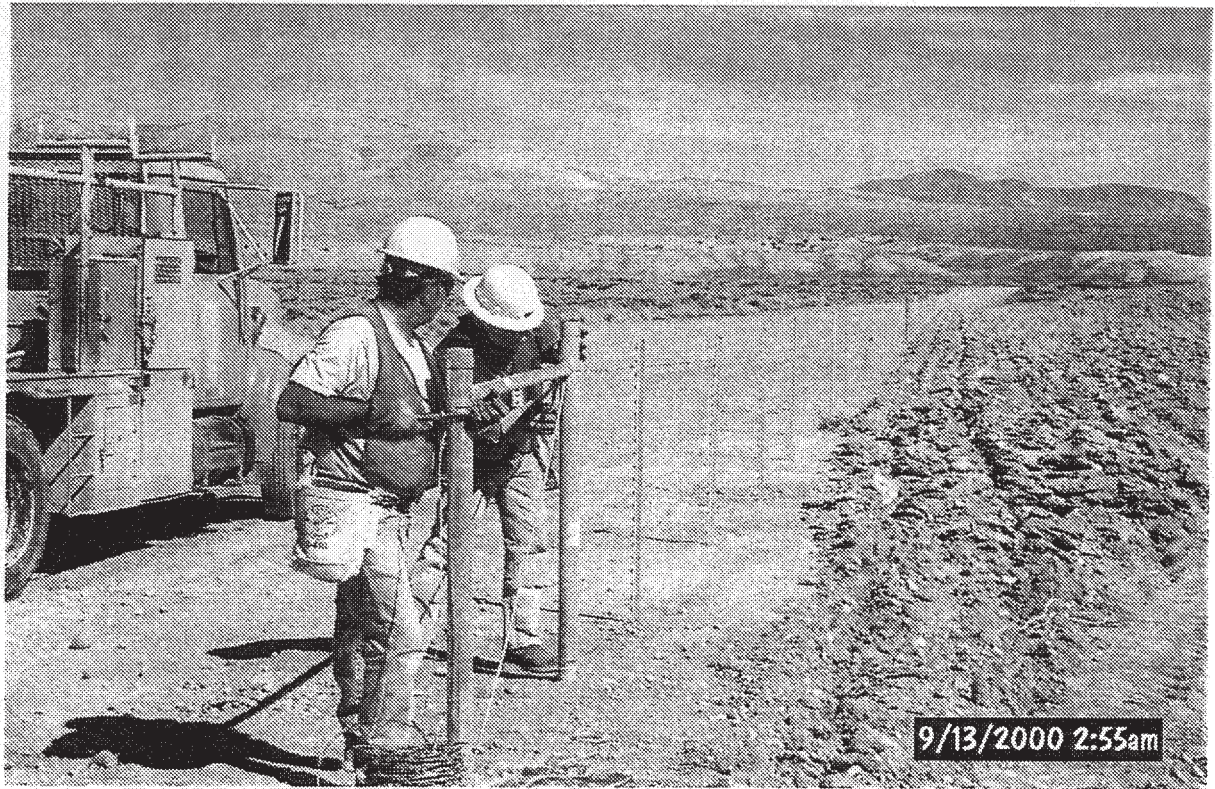
PHOTOGRAPH 17 - Erecting the CMP cover fence

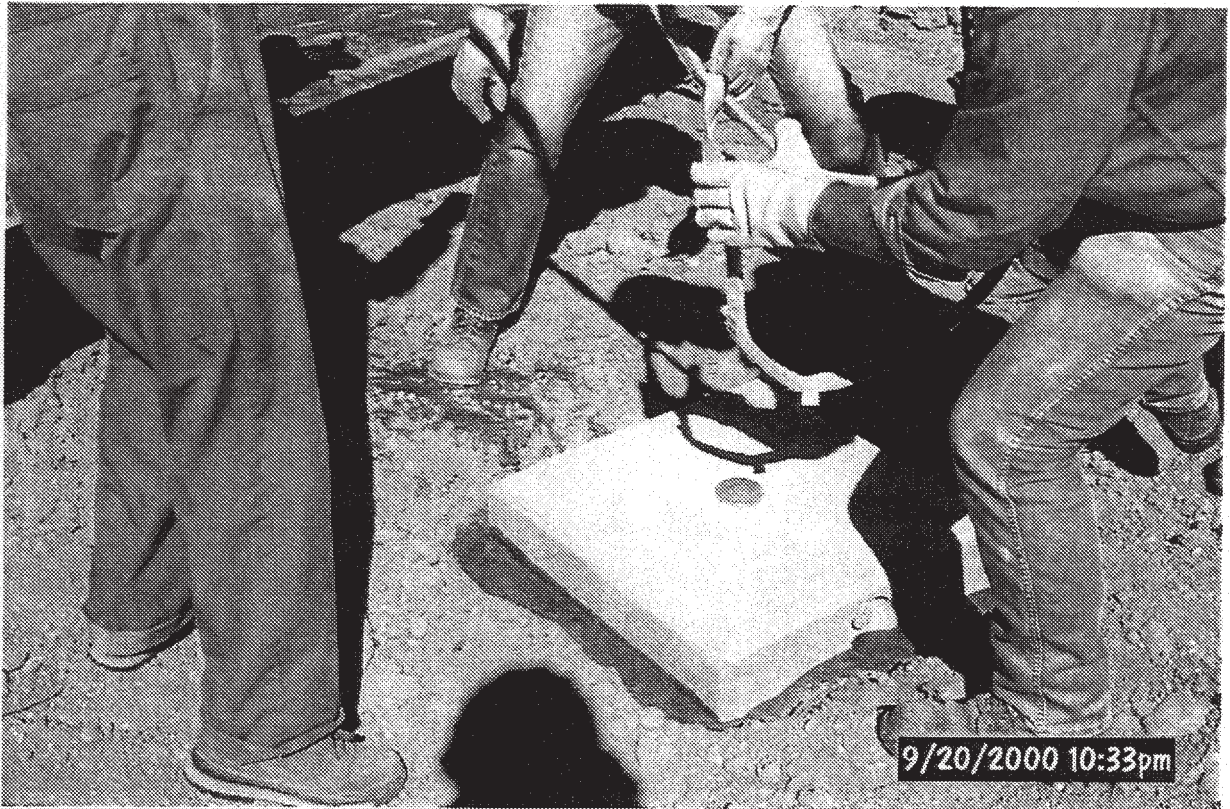
PHOTOGRAPH 20 - Placing subsidence monuments on the CMP cover

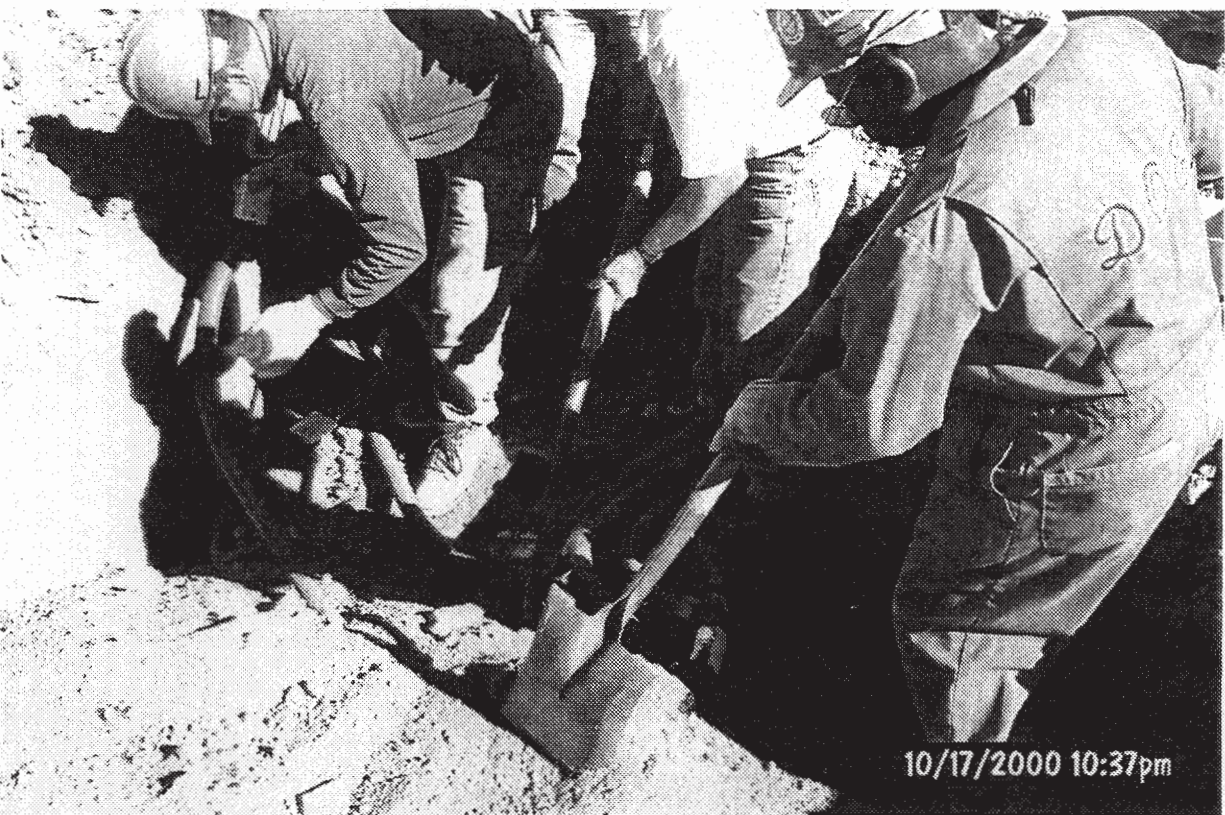
PHOTOGRAPH 22 - Placing and burying TDR sensors in CMP cover

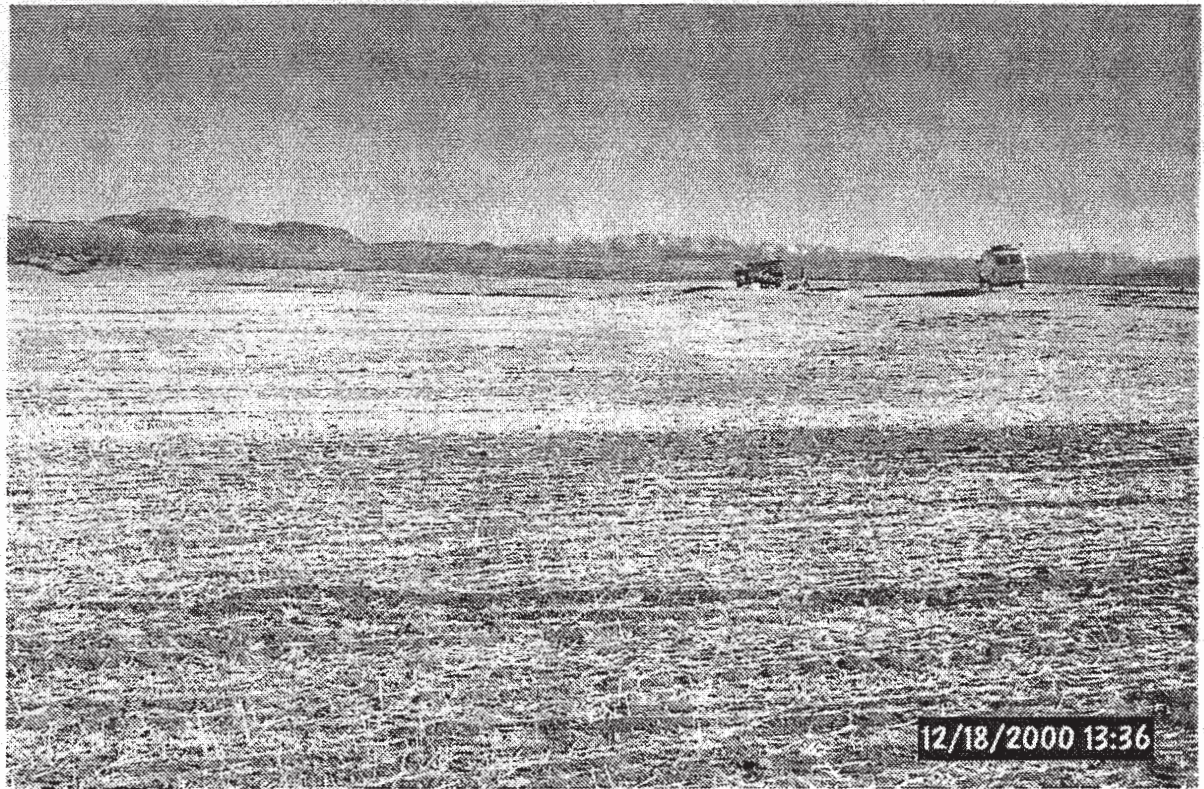
PHOTOGRAPH 23 - Seeded CMP cover

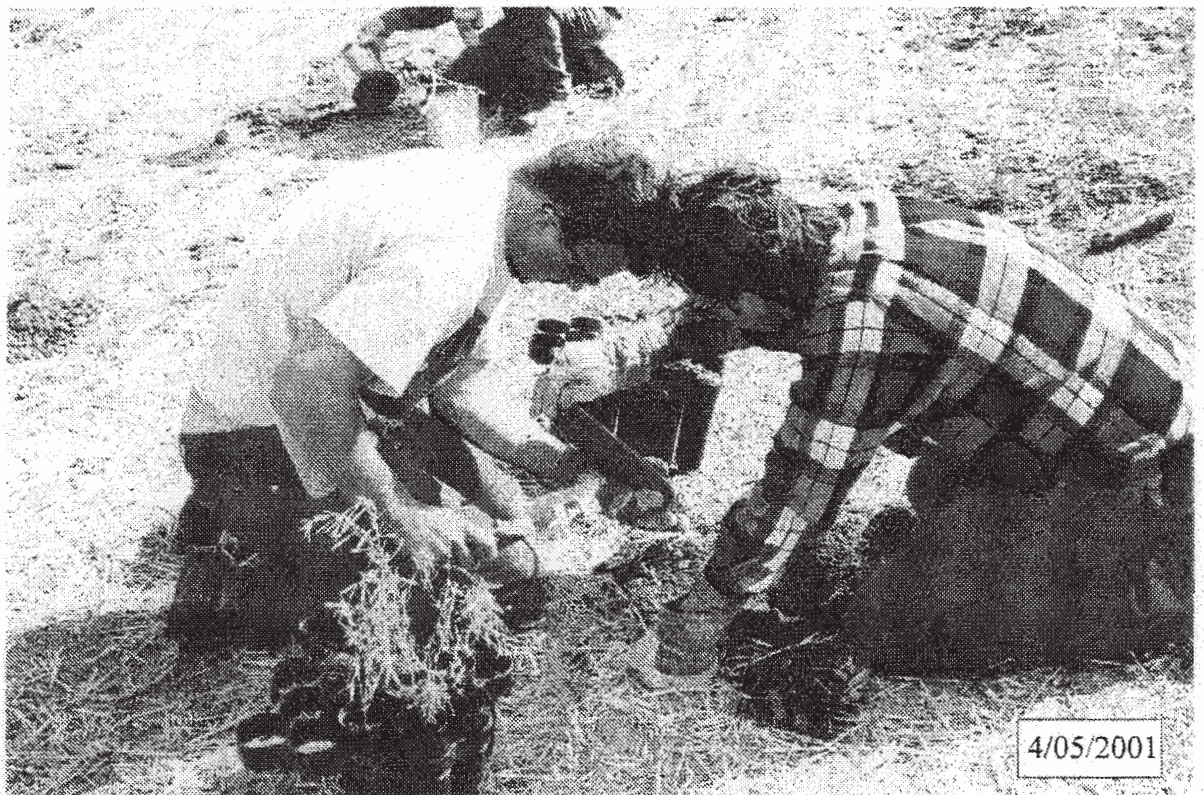
PHOTOGRAPH 24 - Transplanting seedlings to the CMP cover

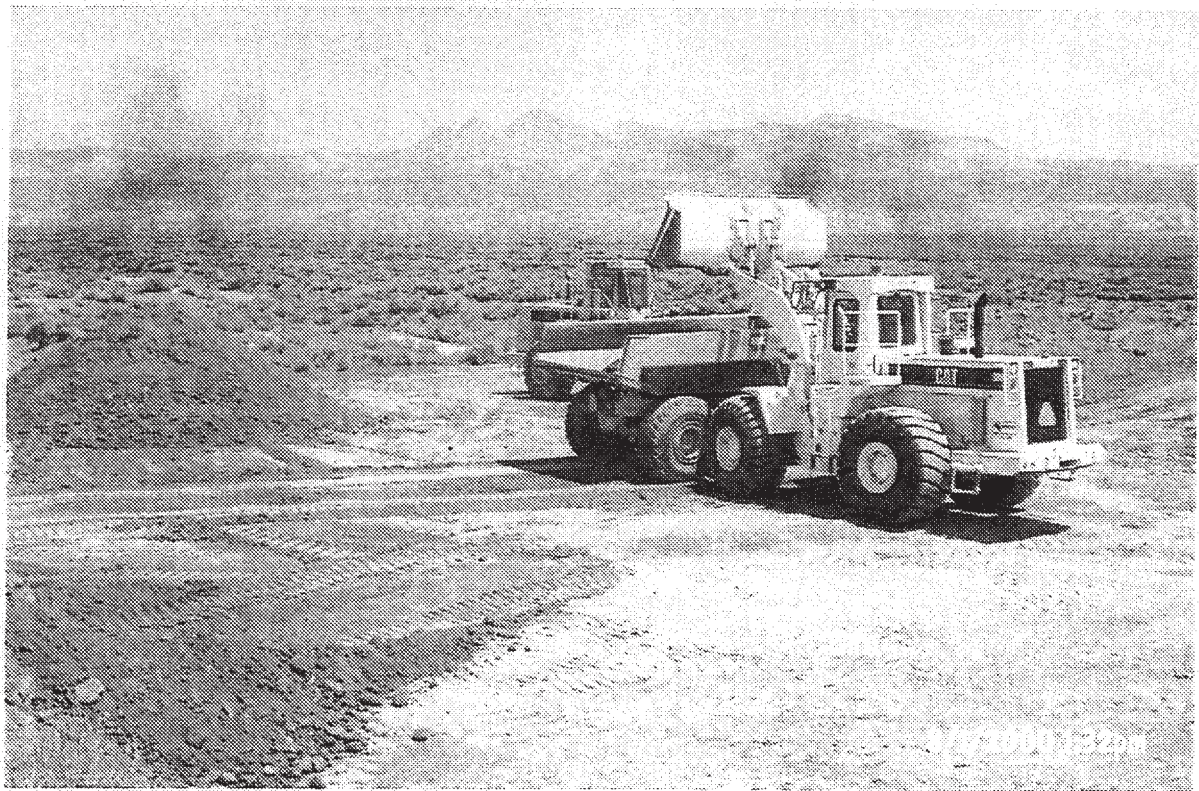
PHOTOGRAPH 25 - Clean closure by excavation of UC-1 Area S, CAS 58-10-03

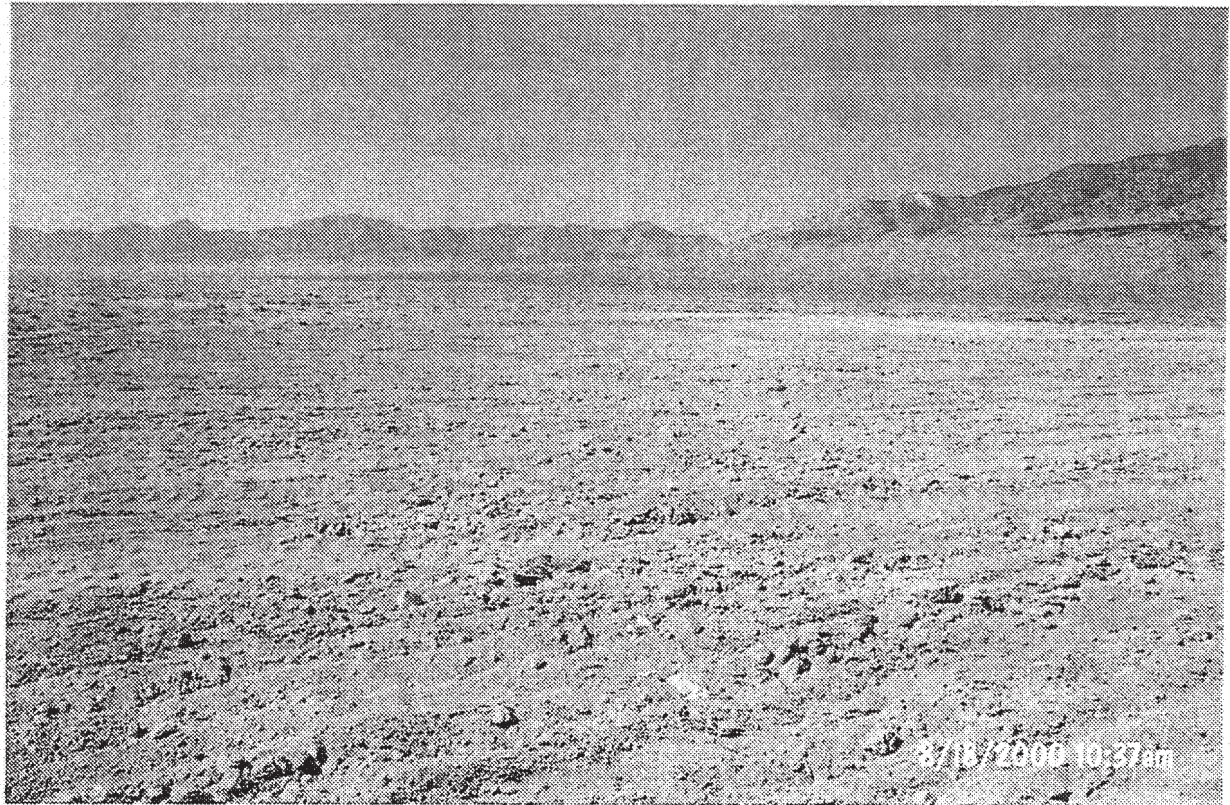
PHOTOGRAPH 27 - Clean closure by excavation of UC-3 Area Z, CAS 58-44-03

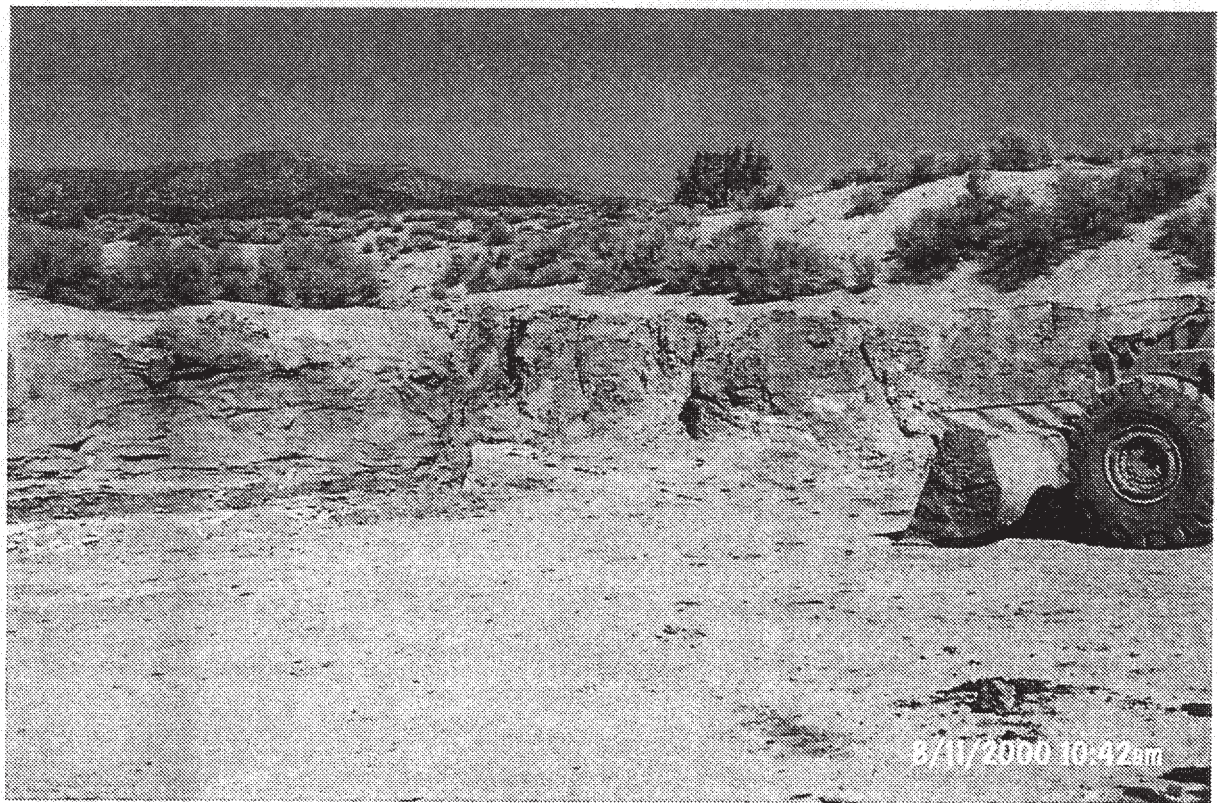
PHOTOGRAPH 29 - Drilling mud/material at UC-4 Area S, CAS 58-10-02

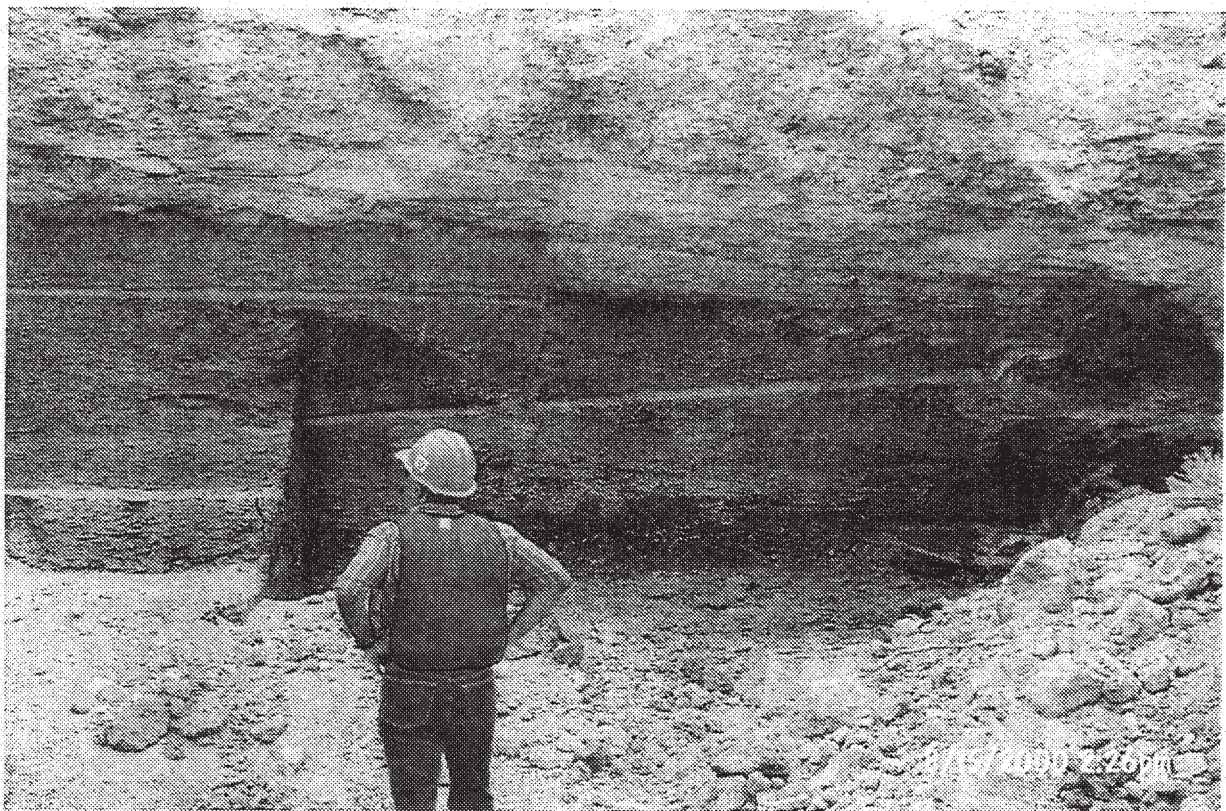
PHOTOGRAPH 30 - Drilling mud/material at UC-4 Area S, CAS 58-10-02

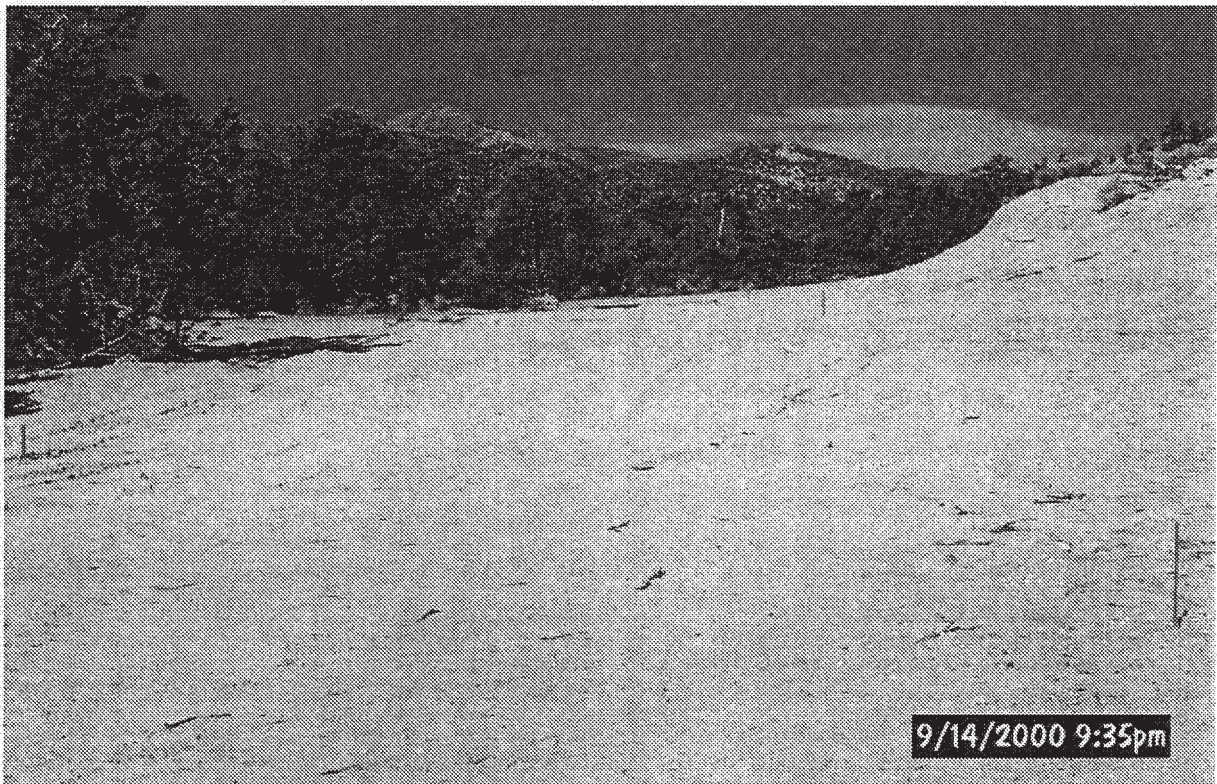
PHOTOGRAPH 32 - Clean closure of UC-4 Area W, CAS 58-10-04

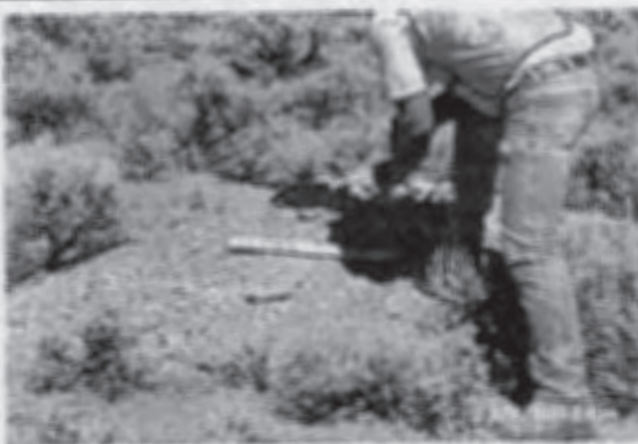
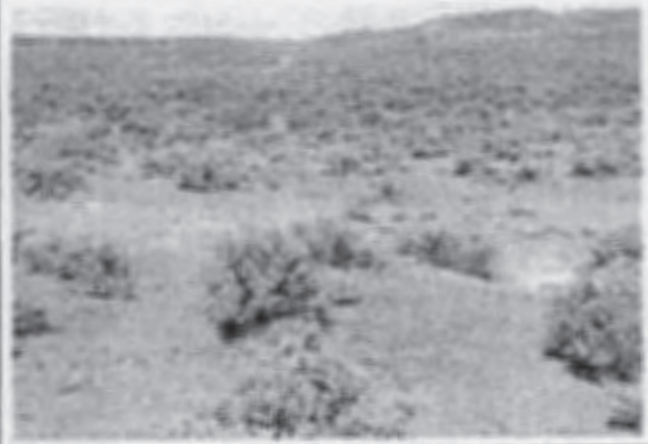
Housekeeping Site Prior to Clean Up
(taken 08/18/2000)

Housekeeping Site After Clean Up
(taken 06/07/2001)

Current Site Description/Observations: This CAS was first identified by the IT Off-sites group in a site survey performed on February 13, 1996. The south grout pile measured approximately 12 by 10 feet and 3 feet high. The grout pile was removed on August 23, 2000 using a front-end loader and was used in the construction of the UC-1 Central Mud Pit (58-09-01) cover. The current condition of the former location of the south grout pile is clean of all waste material.

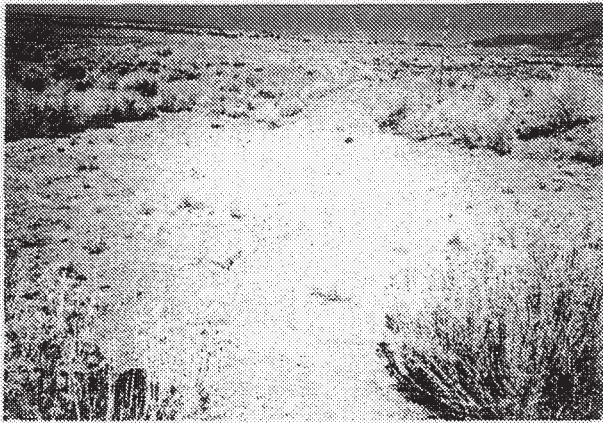
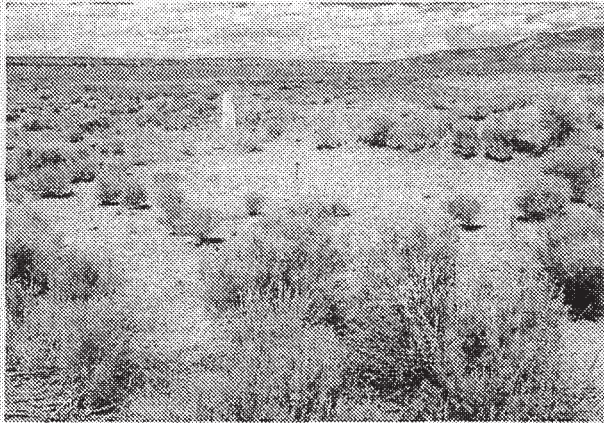
Housekeeping Site (berm) Prior to Closure (taken 02/13/1996)	Housekeeping Site After Closure (taken 06/07/2001)

This CAS was first identified by the IT Off-sites group in a site survey performed on February 13, 1996. The waste was scattered on a berm adjacent to UC-1 Mud Pit A (CAS 58-09-02). The berm measures approximately 320 ft long and 3 ft high. The waste was removed on June 23, 1998. The waste was discarded as sanitary trash. The current condition CAS 58-98-03 is clean of all discarded waste material.

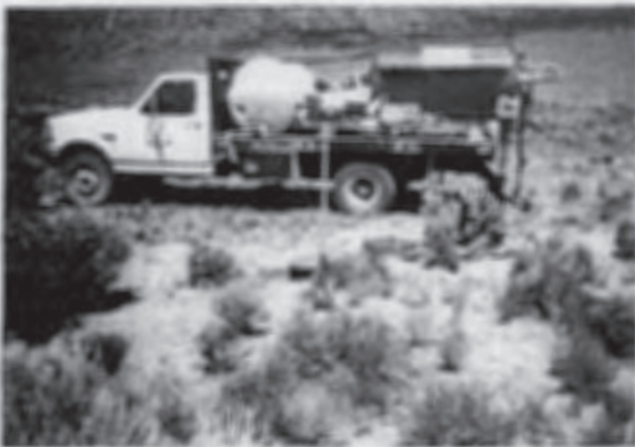
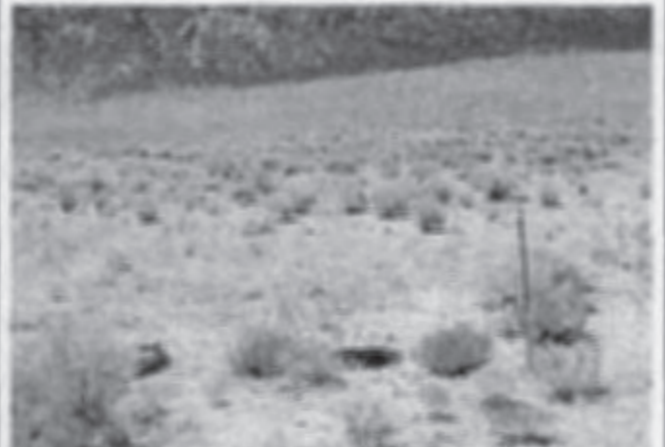
Housekeeping Site During Closure
(taken 06/23/1998)

Housekeeping Site After Closure
(taken 06/07/2001)

Current Site Description/Observations: This CAS was first identified by the IT Off-sites group in a site visit on October 28, 1997. The tank was sampled, pumped (7,570 liters [2,000 gallons] of sludge was removed and disposed of at an approved facility), and backfilled with clean material on June 23, 1998. Acknowledge of septic tank closure was received by the NNSA/NV from the NV Department of Health on 3 May 2001. The current condition of CAS 58-05-05 is clean closed.

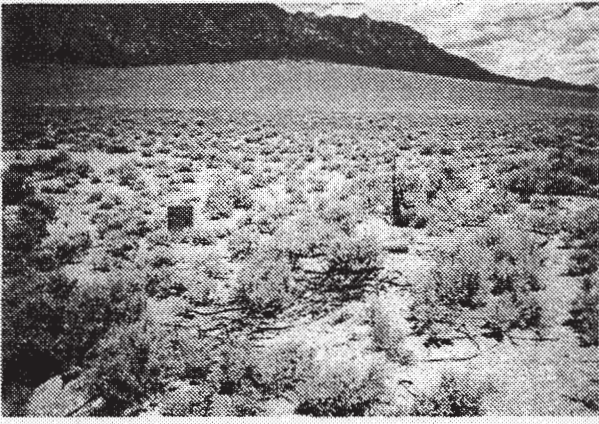
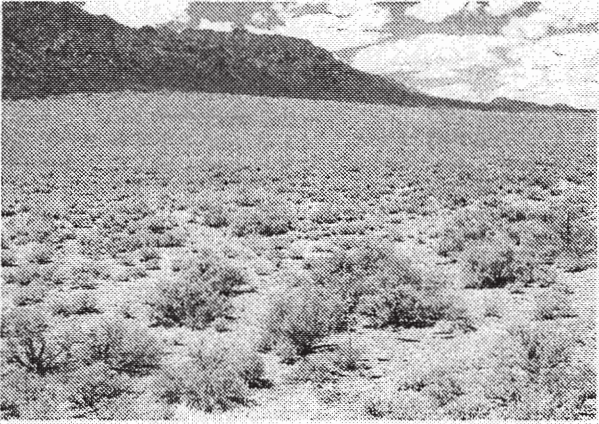
Housekeeping Site Prior to Clean Up (taken 06/23/1998)	Housekeeping Site After Clean Up (taken 06/07/2001)

Current Site Description/Observations: This CAS was first identified by the IT Off-sites group in a site survey performed on February 13, 1996. The waste was removed on June 23, 1998. Scrap metal was sent to NTS salvage and the remainder disposed of at the NTS U10c Landfill. The current condition of CAS 58-98-01 is clean of all waste material.

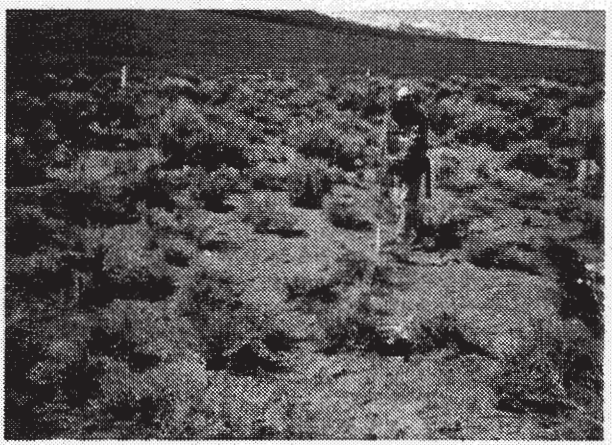
No Before Photograph of Housekeeping Site Available	Housekeeping Site After Closure (taken 04/10/2001)

Current Site Description/Observations: This CAS was first identified by the IT Off-sites group in a site survey performed on February 13, 1996. The waste was removed on June 23, 1998. Scrap metal was sent to NTS salvage, remainder disposed of at the NTS U10c Landfill. The current condition of CAS 58-98-04 is clean of all waste material.

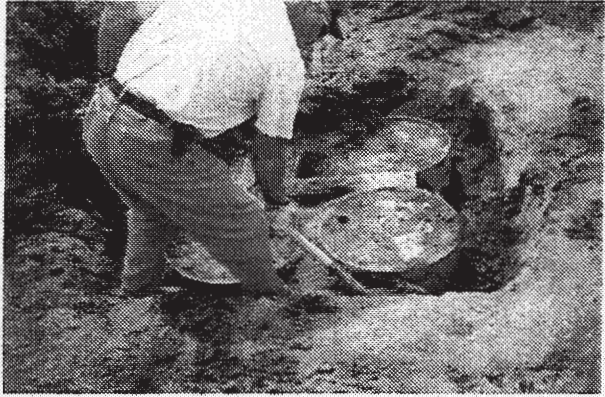
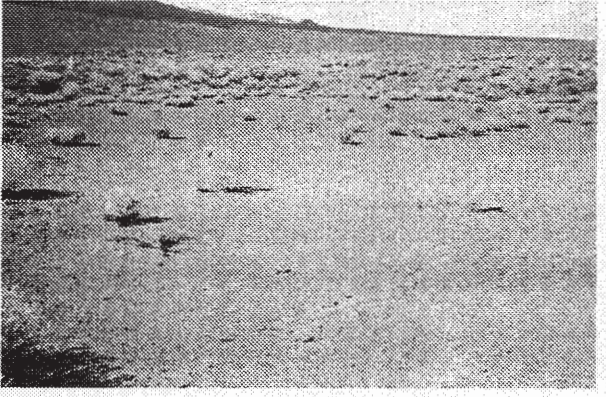
Housekeeping Site During Closure (taken 06/16/1998)	Housekeeping Site After Closure (taken 04/10/2001)
