*Effects of Internal and External Heat  
Sources on Cladding Microstructure  
and Rupture Performance*

**Nuclear Technology  
Research and Development**

*Mackenzie Ridley  
Brandon Johnston  
Samuel Bell  
Nathan Capps  
Oak Ridge National Laboratory  
05/30/2025  
M3FT-25OR020202043  
ORNL/SPR-2025/3923*

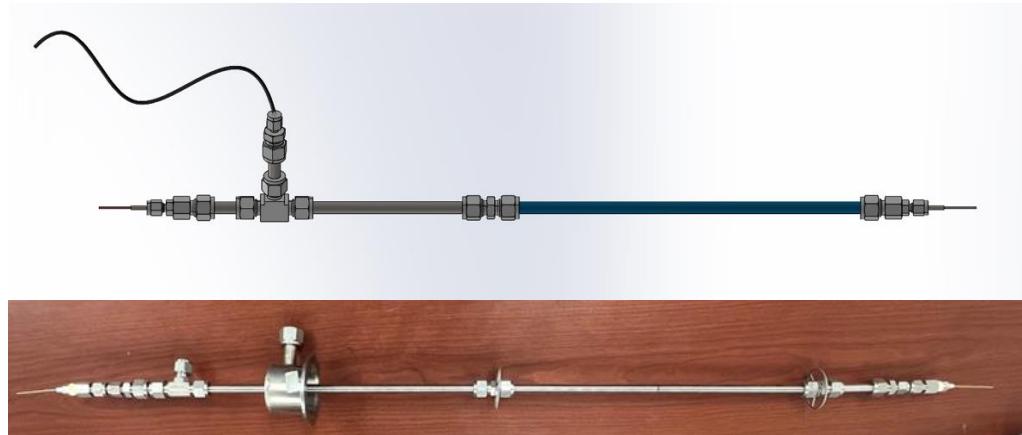
Figure 1. A computer mockup (top) and the first build prototype (bottom) of an internal heater within a 330.2 mm long cladding segment.

The top and bottom of the sample have alumina ceramic insulated National Pipe Taper (NPT) pressure fittings. The fittings allow for power to be conducted through without conducting the sample and leaking pressure. For added protection, a 15A 2 pole breaker was added and the whole assembly was insulation tested to a level of 99.99 MΩ. Heat shrink was used throughout.

A simplified approach of infrared heating was used for the initial design to re-establish internal heater LOCA test capability at ORNL. This heat source was chosen to allow for much higher heating rates than have been previously reported. Figure 1 shows the computer design of the internal heater test sample next to the finished prototype. The design uses a quartz lamp from the infrared (IR) furnace used for external heating that has been cut and modified to fit inside the test sample. The lamps were specifically ordered to be a reduced size, 8-9mm diameter. As received the lamps were rated for 240V and 1000W encased in clear quartz under vacuum. The lamps had a 10-inch filament heat zone and were 12 inches total. Once received, the lamps were cut down due to the ends and the quartz weld button in the middle of the filament not fitting inside the samples. Once the modifications were done, vacuum was repulled and the lamps were resealed.

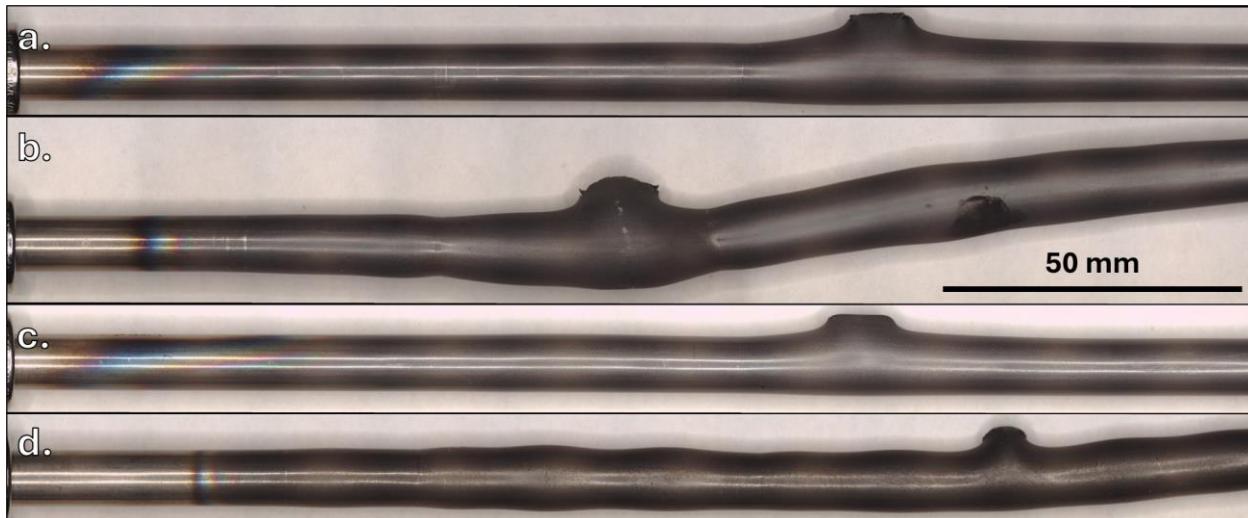
Figure 10 illustrates the significant bending of internally heated cladding, a deformation not captured by the diameter strain measurements presented in Figure 9. Rod bending is thought to result from the lack of internal structural support provided by the standard alumina filler rod used in the externally heated cladding tests to counteract temperature gradient effects leading to asymmetric deformation. The rupture openings depicted in Figure 11 further emphasize the distinct differences between the tests conducted with internal and external heating sources. In the external heating tests, the rupture openings exhibit standard geometry consistent with legacy

Figure 10. Optical images of the top of the cladding post-LOCA testing, a.  $5^{\circ}\text{C/s}$  externally heated, b.  $5^{\circ}\text{C/s}$  internally heated, c. max  $^{\circ}\text{C/s}$  externally heated, and d. max  $^{\circ}\text{C/s}$  internally heated.
