GENERAL-PURPOSE HEAT SOURCE: RESEARCH AND DEVELOPMENT PROGRAM

Cold-Process Verification Test Series

M. A. H. Reimus and T. G. George

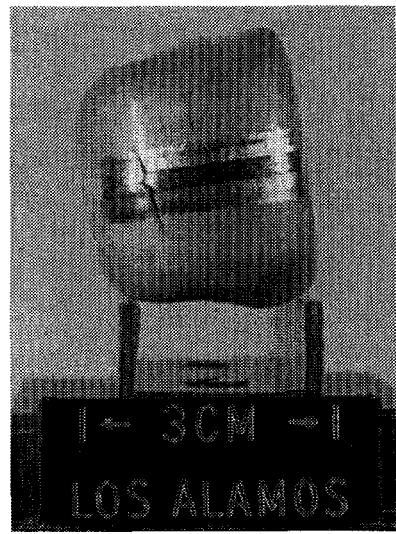
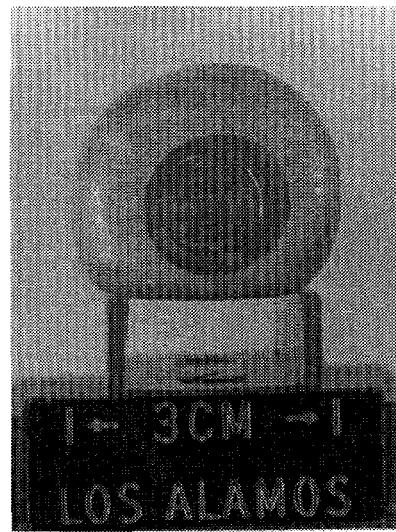
Figure 10. Capsule SC0020 was breached by an axial crack at approximately 120 deg. (a) impact face, (b) profile, (c) trailing face, (d) opposite profile, (e) vent end, (f) blind end, (g) fuel fragmentation. (NMT-9 Negs 93-85, 93-88, 93-87, 93-86, 93-84, 93-83, 94-15)

The axial breach at 120 deg had a length of approximately 10.4 mm and a maximum width of approximately 0.65 mm. Examination of the opened capsule revealed that the axial breach matched the differential displacement of a large urania fragment. Microscopic examination of the widest section of the crack, just below the weld in the weld shield cup, revealed that it was exclusively intergranular (Fig. 11). There was no evidence to suggest that the breaching crack resulted from any defects or anomalies in either the weld shield cup or the girth weld.

The axial weld cracks at 170, 180, and 225 deg were all contained within the weld metal. The cracks at 170 and 180 deg were approximately 1.3 mm long, and the crack at 225 deg had a length of approximately 2.3 mm. The network of hairline cracks at 180 deg had an approximate length of 10.0 mm and appeared to be related to severe localized deformation caused by the displacement of a sharp fuel fragment. Metallographic examination of these cracks revealed that they were all intergranular and occurred in regions of fine-grained microstructure.

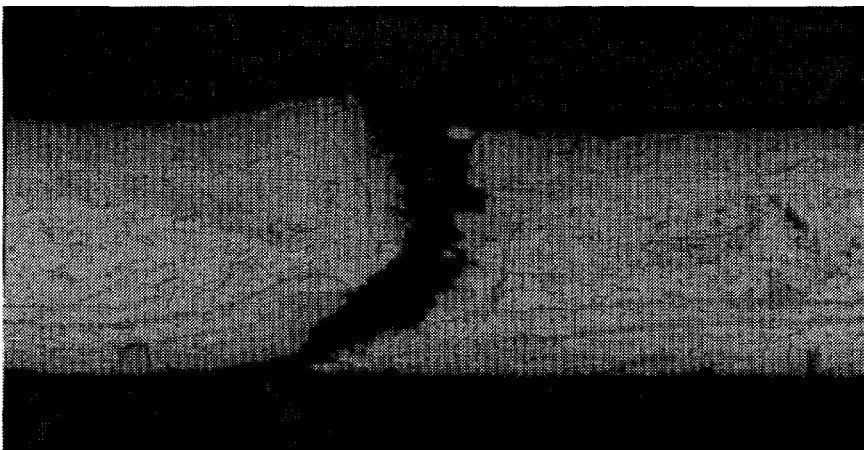
*Figure 21. Axial vent cup crack; etched, at 50 \times magnification.
(NMT-9 Neg 945-28)*

The transverse crack on the vent cup in the impact face had a length of approximately 7.9 mm, and the crack on the shield cup in the impact face was approximately 9.6 mm. Metallographic examination of these cracks revealed that the vent cup crack was a breaching, intergranular crack (Fig. 21). The shield cup crack was nonpenetrating but also intergranular. The hairline axial crack at 210 deg measured approximately 2.7 mm. This crack started just above the weld centerline and extended into the vent cup. This crack was also intergranular.

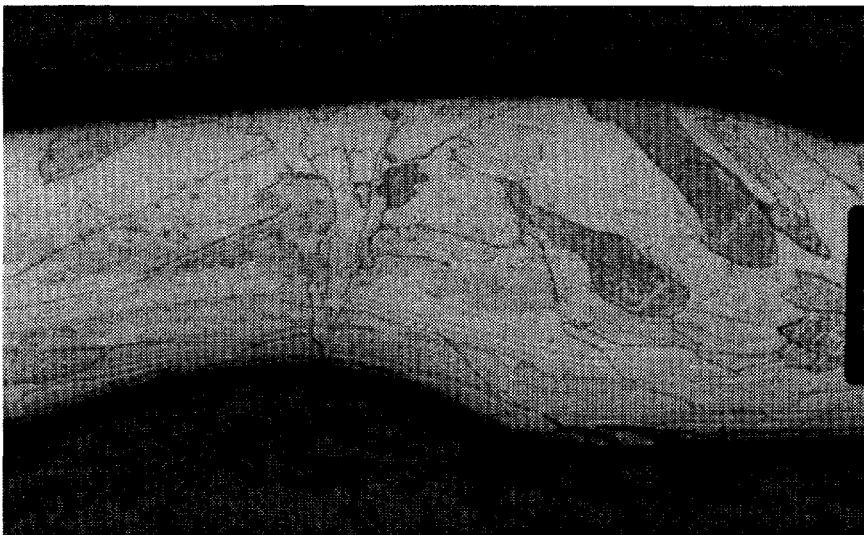
*Figure 22. Bulge in weld overlap area, etched, at 50 \times magnification.
(NMT-9 Neg 945-16)*

Examination of the weld overlap area revealed a slight bulge (Fig. 22). The minimum width of the capsule wall in this area was 0.57 mm. The maximum wall width measured approximately 0.75 mm. The microstructure in this area was somewhat coarse grained, however, the wall thinning that resulted from the weld bulge did not adversely affect the capsule's impact performance; no failures were observed in this region.

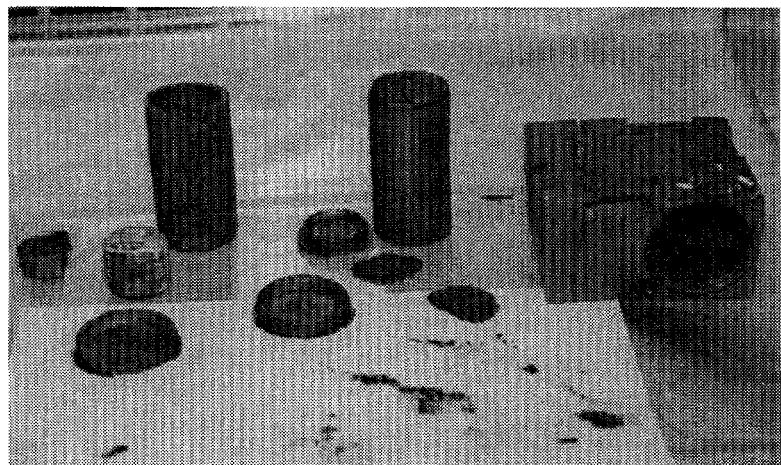
Figure 27. Module and GISs impacted in CPV-12; (a) GIS A , SC0073 in front, GIS C, impact face of module, left to right, (b) GIS A, SC0072 and SC0073 in front, GIS C, SC0075 and SC0074 in front, trailing face of module, left to right. (NMT-9 Negs B2126-32 and B2126-37)
