*General-Purpose Heat Source:
Research and Development Program*

*Radioisotope Thermoelectric Generator Impact Tests:
RTG-1 and RTG-2*

M. A. H. Reimus, J. E. Hinckley, and T. G. George

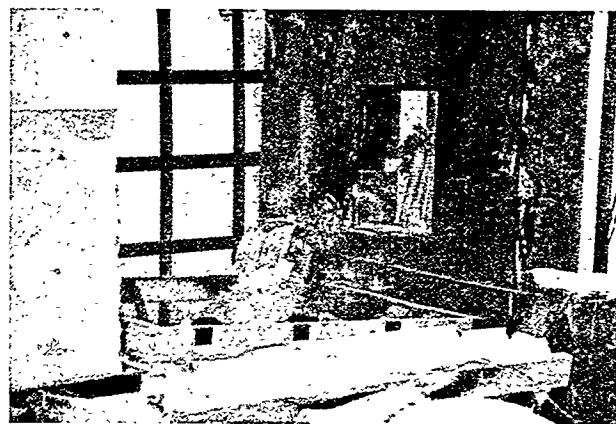
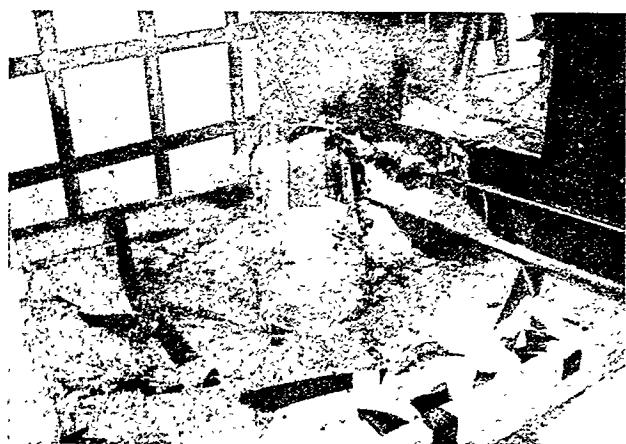
upon release from the sled. Most of the failure in the converter housing took place in the upper end of the outboard end above the circumferential rib (Figure 6). This rib was located 2.95 in. from the outboard end flange. There was considerable breakup of the module stack inside the converter. A piece of the stack tie rod and fitting, along with one intact module (Module 9), was ejected from the back end of the converter housing. Intact Modules 8, 7, and 6 fell free from the converter after the test as it was moved to accommodate an argon flush to prevent oxidation of graphite components in the converter (Figure 7).

Figure 6. Impacted converter housing, Test RTG-1; (a) side view, (b) close-up of side view, (c) opposite side view, 180 degrees. (NMT-9 Negs B2049, Roll 2, #11; B2049, Roll 2, #32; B2049, Roll 2, #29)

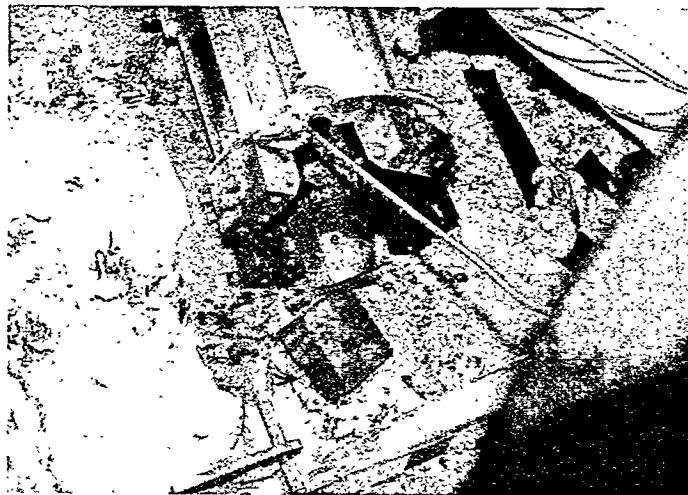
Figure 7. Rear end of impacted converter housing, Test RTG-1. (NMT-9 Neg B2049, Roll 3, #12)

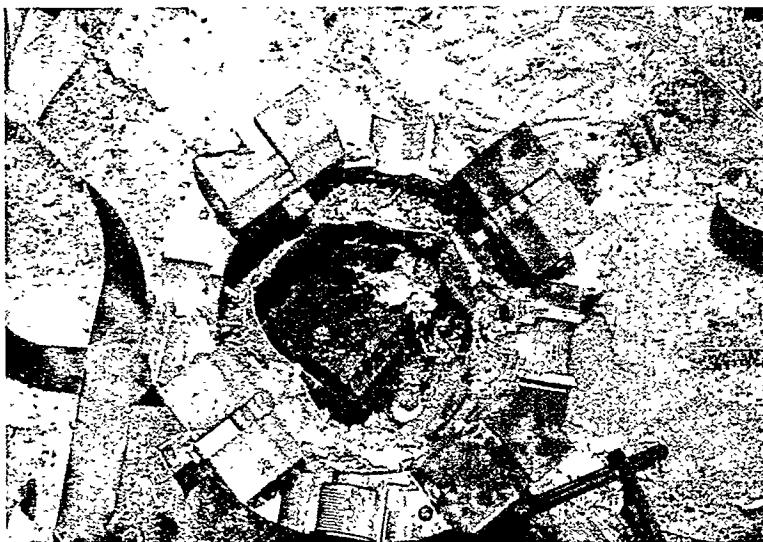
Field observations revealed that one clad had been ejected from its module and GIS but remained in the converter (Figure 8). This clad was observed upon removal of the end four modules. Upon disassembly of the converter in the laboratory, a second clad was observed to have been ejected from its module and GIS. These two clads were determined to have been in the A GIS in Module 2.

Figure 8. One clad was ejected from its module and remained in the converter, Test RTG-1. (Neg B2049, Roll 3, #24)

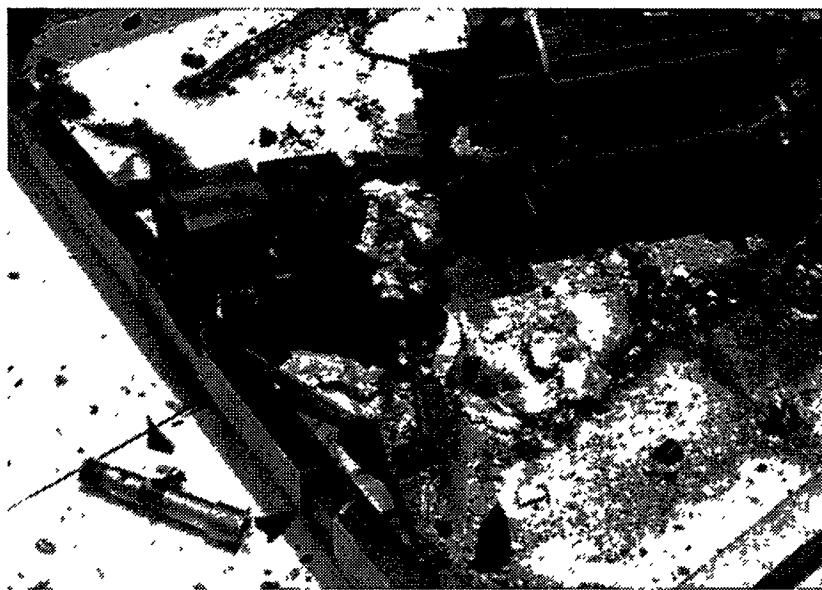
Four modules were ejected from the back of the converter (Figure 19). One of these was cracked in half and contained one intact GIS. The other GIS was cracked and its clads released. The other three modules were intact. The cracked module was Module 6; the others, Modules 7, 8, and 9, respectively.

Figure 19. Four modules were ejected from the rear end of the converter in Test RTG-2. (NMT-9 Neg B2267, Roll 4, #25)

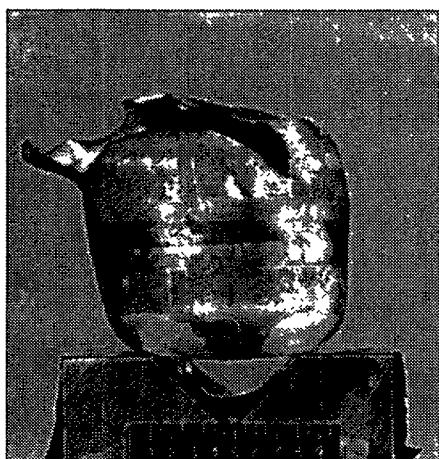
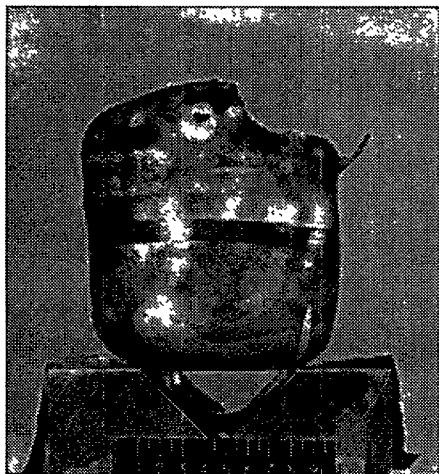
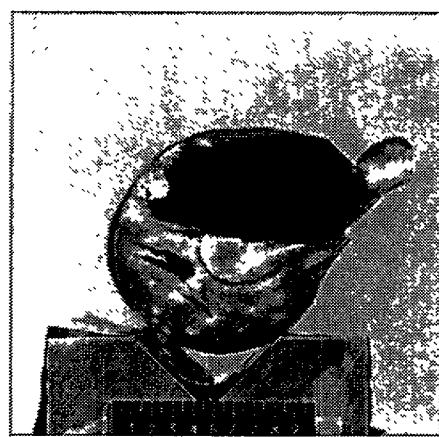
SC0092 was located in the open end of the C GIS in Module 1. The impact face of the clad was centered at approximately 0 degrees at the weld start. A large piece of the vent cup was torn off during the impact (Figure 20). The area of this breach was measured to be approximately 485 mm². This clad was defueled but not submitted for metallography.

Figure 20. A large piece of the vent cup of SC0092 was sheared off during impact in Test RTG-2; (a) impact face, (b) profile, (c) trailing face, (d) opposite profile, (e) vent end, (f) blind end. (NMT-9 Negs 953-81, 953-82, 953-83, 953-84, 953-79, 953-80)

Three of the capsules in test RTG-2 had capsule failures. Two of the clads, SC0092 and SC0096, appeared to fail due to contact with the titanium heat source support assembly. Capsule SC0092 had a large failure area (485 mm²) that resulted in a release of approximately 12 g of simulant fuel. Capsule SC0096 had a much smaller failure that resulted in a release of approximately 0.2 g of simulant fuel. Capsule SC0107 experienced a weld failure. The intergranular failure occurred between columnar grains located in the weld centerline. Fusion of the weld with the weld shield was also evident in this location. This failure appeared to be the result of fragment push-through and resulted in a release of approximately 0.026 g.
