**The Relationship Between Observed Stress Corrosion Cracking
Fracture Morphology and Microstructure in Alloy 600**

D. M. Symons and M. G. Burke
Westinghouse Electric Corporation
Bettis Atomic Power Laboratory
West Mifflin, PA 15122

Abstract

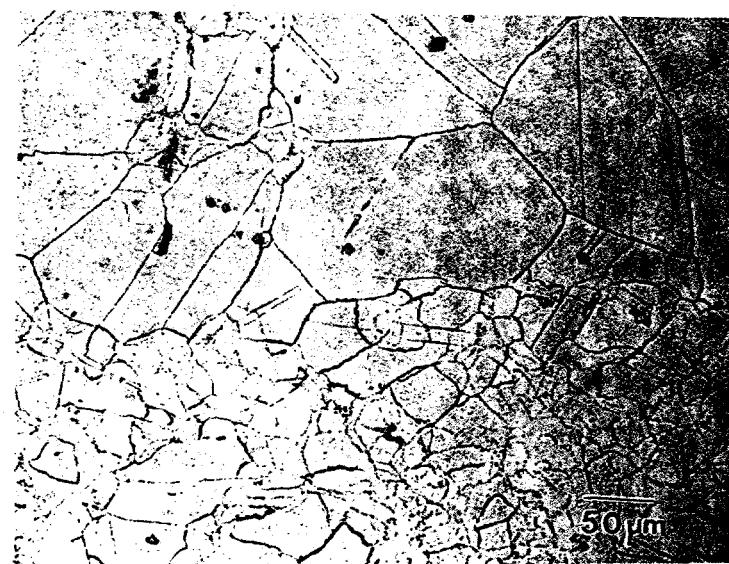
Figure 1: Light Optical Micrograph of the As-Received Material Showing Duplex Grain Structure

The as-received microstructure with 5% cold work had a duplex grain structure with the grain size varying from 15 to 150 μm in size, Figure 1. Further, this specimen exhibited carbide "banded" regions. AEM showed both intergranular and intragranular M₇C₃ carbides that ranged from 0.5 to 4 μm ; more intragranular carbides were observed in the fine grained regions, Figure 2. Further AEM examination showed a pronounced dislocation substructure consisting of fine (~0.5 to 1 μm), well-defined, clean subgrains throughout the material, Figure 3.

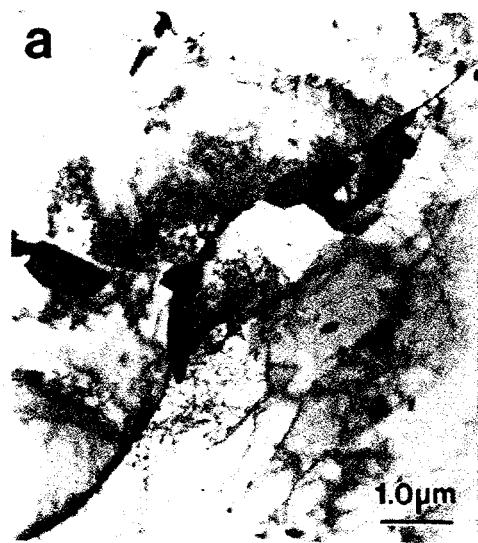
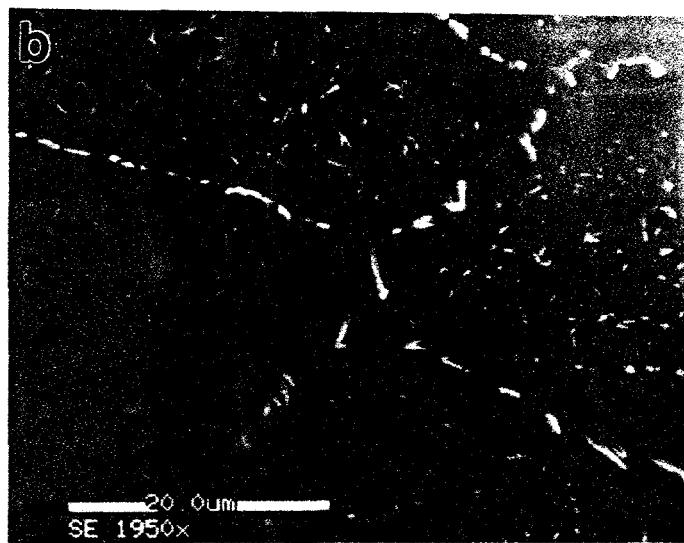
Figure 2: a)Transmission and b) Secondary Electron Micrographs of the As-Received Material Showing Extent of Intergranular and Intragranular Precipitation

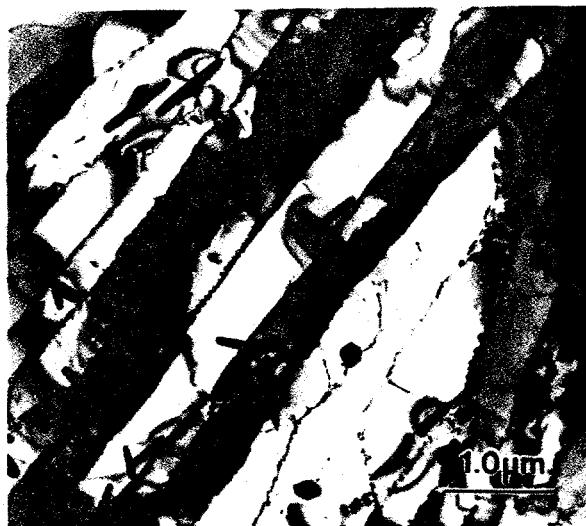
Figure 3: Transmission Electron Micrographs of the As-Received Material Showing Extensive Deformation Substructure

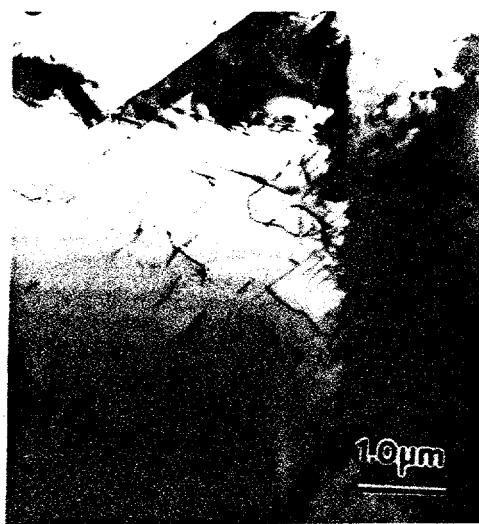
Figure 5: Transmission Electron Micrographs After an Anneal of 1075°C/ 24h/ Furnace Cool Showing No Deformation Substructure and Grain Boundary Carbides

An increase in grain size was noted after the 24 h anneal at 1075°C. The grains ranged from ~ 20 to 350 μm in size, Figure 4, in a banded structure consisting of fine grained regions and coarse grained regions. The dislocation subgrain structure was completely eliminated, as evidenced from the AEM analysis. This solution-annealing treatment did not, however, eliminate the "ghost" boundaries in this material. The ghost boundaries are M₇C₃ carbides that did not dissolve during the solution treatment while the grain boundaries moved away from the carbides. Residual dislocations were observed throughout the sample, Figure 5. The experimental STEM-EDS data for this material confirmed that the minimum Cr concentration in the vicinity of the grain boundary was ~ 11 wt.%. Cr depletion

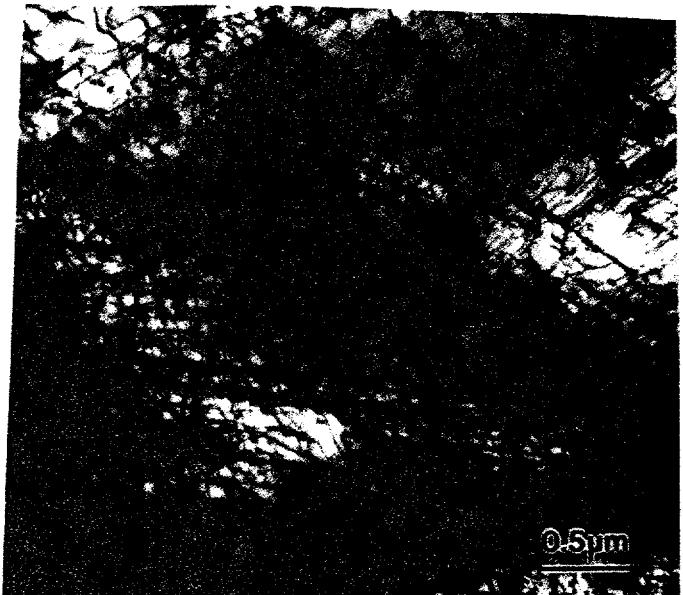
Figure 7a: Transmission Electron Micrographs After an Anneal of 1075°C/24h/Furnace Cool and Cold Worked Showing High Dislocation Density

The addition of 26% cold work resulted in a highly deformed dislocation structure consisting of many slip bands, as shown in Figure 7a. The intersection of the slip bands with grain boundary carbides resulted in cracked grain boundary carbides, Figure 7b. These sights may act as crack nuclei.

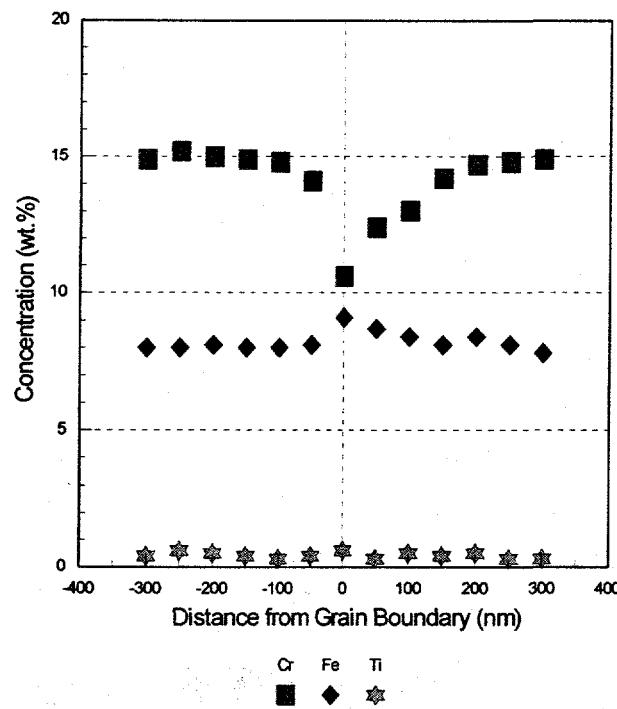
Figure 6: STEM-EDS Cr and Fe Profiles for Grain Boundary after an Anneal of 1075°C/24h/Furnace Cool

was observed up to 150 nm from the grain boundary as shown in Figure 6. This depletion of Cr was only noted for the M₇C₃ carbides that formed upon cooling from the solution-annealing temperature. No depletion was observed in the vicinity of the coarse, globular M₇C₃ carbides.

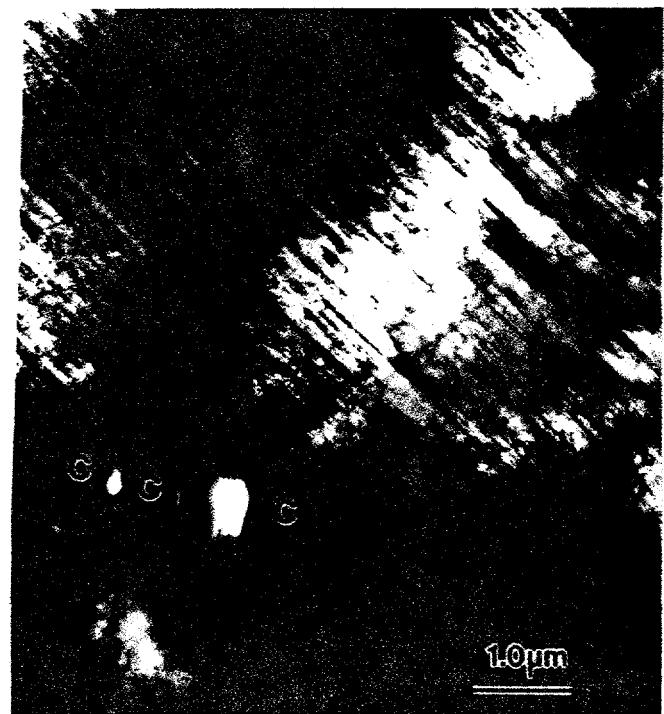
Figure 7b: Transmission Electron Micrographs After an Anneal of 1075°C/24h/Furnace Cool and Cold Worked Showing the Formation of Grain Boundary Voids

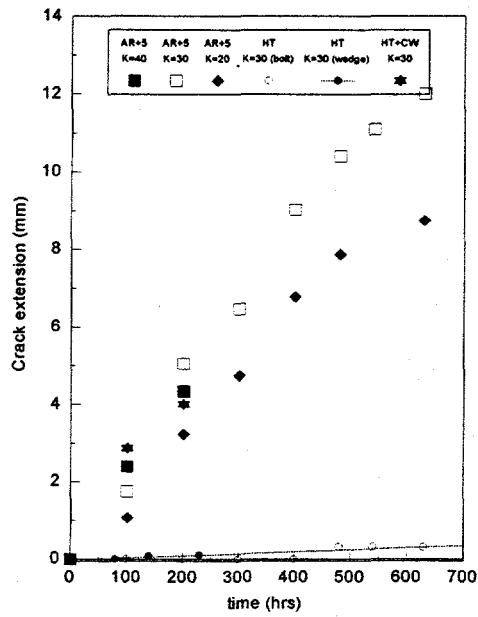
Figure 8: Plot of Crack Length vs. Time for the Three Material Conditions

The crack extension data are plotted in Figure 8 and the growth rates are plotted in Figure 9. The test data show that the AR+CW material is more susceptible to stress corrosion cracking than the HT material, with measurable crack growth in the first 100-h exposure. The crack growth rates of the HT material is also consistently below that for the AR condition. The crack extension measured for the HT+CW specimen was greatest in the first 100-h exposure (2.87 mm), but then the crack growth rate decreased by ~ 50%. This was within the scatter of the experimental data. The crack incubation times were calculated by back extrapolating the crack extension to 0. The crack incubation times were lower for the HT+CW specimen than for the AR+CW condition while the crack growth rates were similar. The HT material exhibited the most resistance to crack incubation as well as crack growth. The SCC in this environment shows a large range of Stage II (independent of applied stress intensity factor) crack growth rate behavior. It appears that for the as-received material at a K_I of 14-16 MPa $\sqrt{\text{m}}$, the crack growth shows a decreasing trend, suggesting the onset of Stage I crack growth and approaching a mechanically based threshold. The growth rates observed in the doped steam environment are similar to the rates observed in hydrogenated water environments (Reference 5) suggesting that the role of doped steam is to dramatically reduce the incubation time.

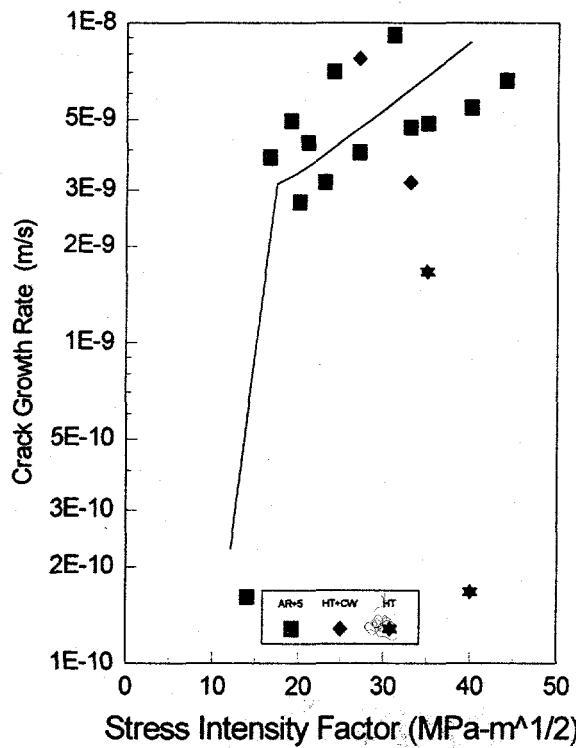
Figure 9: Plot of Crack Growth Rate vs. Stress Intensity Factor for the Three Material Conditions

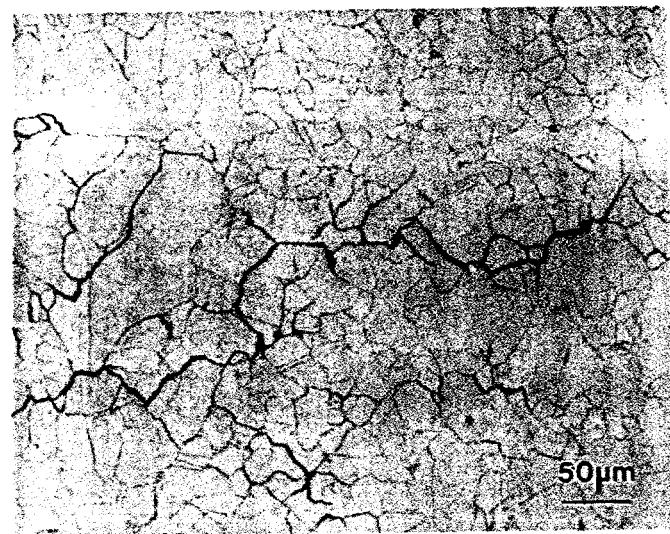
Figure 10: Light Optical Micrographs of the As-Received Material Showing Details of the Primary Intergranular Stress Corrosion Crack

Metallographic examination of this sample revealed extensive intergranular cracking, Figures 10 and 11, and a high proportion of secondary intergranular cracks. No evidence of transgranular cracking was obtained by optical metallography. The SEM observations were similar to those obtained by LOM. Figure 11 contains various examples of the intergranular cracks. Only one small

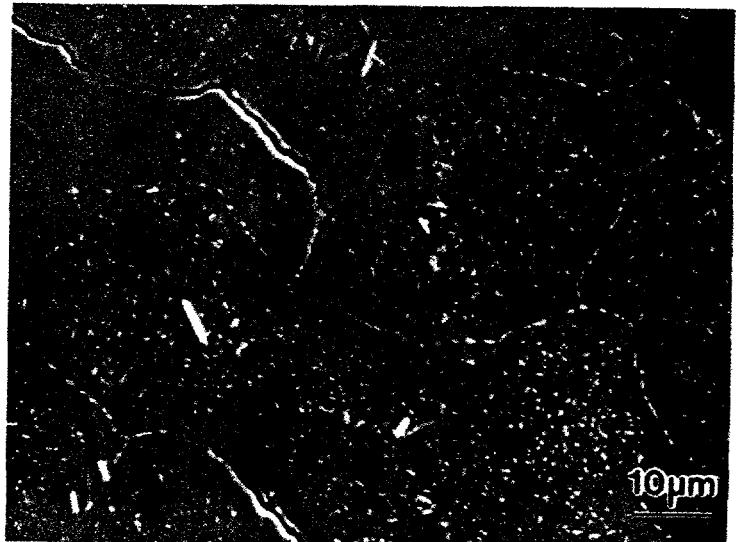
Figure 11a: Secondary Electron Micrographs of the As-Received Material Showing Details of the Primary Intergranular Stress Corrosion Crack

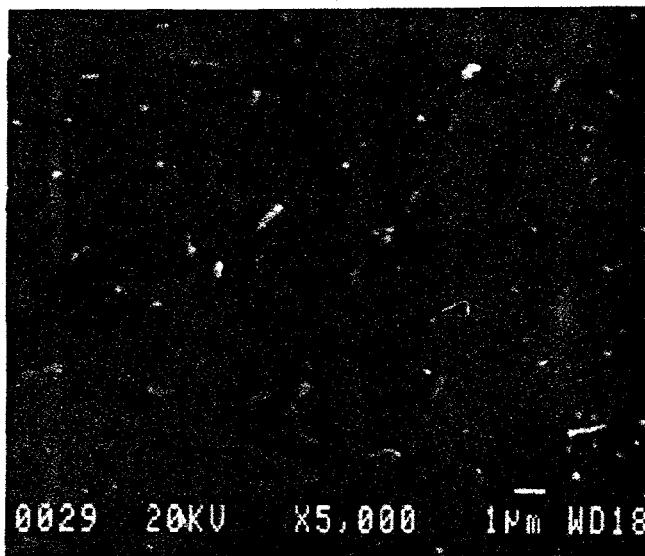
Figure 11b: Secondary Electron Micrographs of the As-Received Material Showing Details of Small Transgranular Crack

region, Figure 11b, showed what might be a "transgranular crack," although the "crack" is less than 5 μm from the grain boundary.

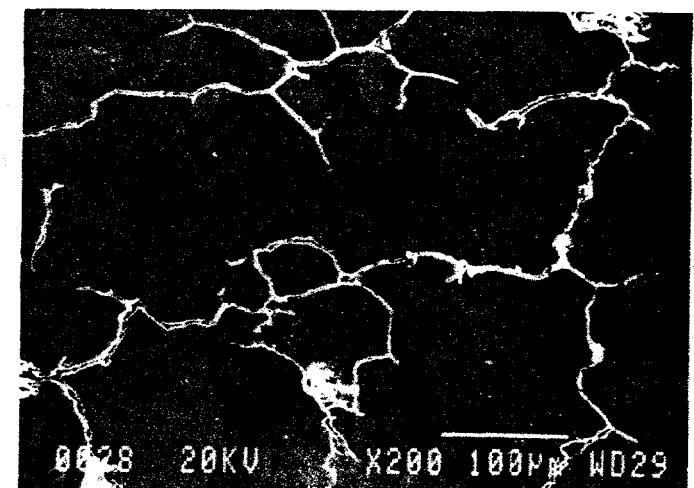
Figure 14: Secondary Electron Micrographs of the 1075°C/24h/Furnace Cool and Cold Worked Material Showing The Intergranular Fracture Morphology

The SEM micrographs obtained from the polished and etched cross-section sample clearly showed the intergranular nature of the primary and secondary cracks, Figure 14. In addition to the intergranular cracks, the presence of "ghost" boundaries and real grain boundaries can be observed in Figure 14 because the Br-methanol solution can reveal different grain orientations due to crystallographic etching effects. Thus, the crack path evident in Figure 14 is truly intergranular. Figure 15 shows a carbide-decorated grain face that lies parallel to the surface of the sample. The dendritic nature of the "semi-continuous" intergranular M_7C_3 carbides is clearly visible. The observation of the grain face is identical to the fractographic features further showing that the features on the SCC surface are impressions of grain boundary carbides.

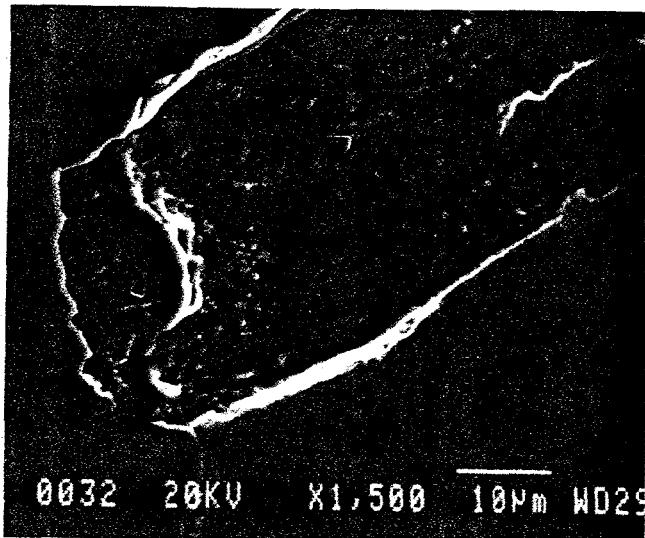
Figure 15: Secondary Electron Micrograph of the 1075°C/24h/Furnace Cool and Cold Worked Material Showing a Grain Boundary Slightly Inclined to the Plane of the Sectioned Sample - Arrow pointing to dendritic carbide

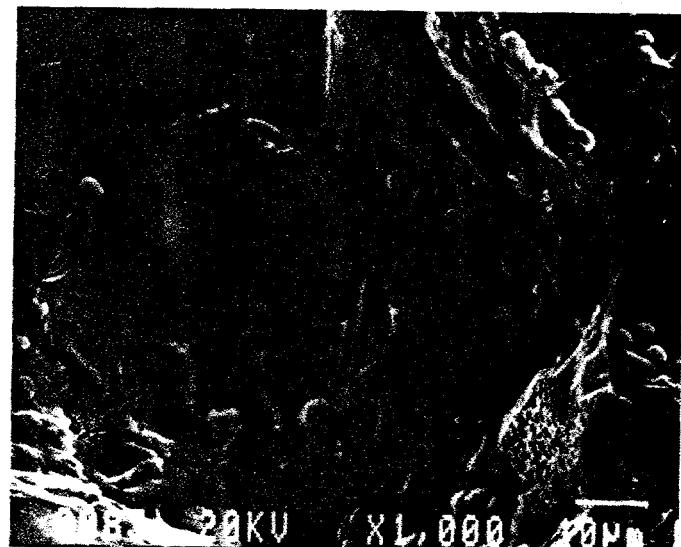
Figure 17: Secondary Electron Fractograph of the 1075°C/24h/Furnace Cool and Cold Worked Material Showing the Relatively Smooth Intergranular Fracture Surfaces

Low magnification SEM examination of the fracture surface of this material revealed an intergranular SCC morphology, Figure 16. The banded grain structure (coarse/fine/coarse) in this material is clearly evident in the intergranular fracture surface shown in Figure 16. More detailed SEM study of this fracture surface showed that it was actually a complex fracture containing some areas of smooth intergranular and rough intergranular fracture. Figure 17 contains several examples of the smooth intergranular fracture morphology, with numerous discrete globular carbides embedded in the fracture surface. The micrographs of Figure 18 present a distinctly different fracture morphology that is the rough intergranular fracture morphology. Further examination of these fractures surfaces showed that the rough intergranular regions were, in fact, related to the complex intergranular carbide morphologies, particularly the dendritic M_7C_3 . The dendritic carbide morphology is evident in the higher magnification micrographs of Figure 18. It is proposed that

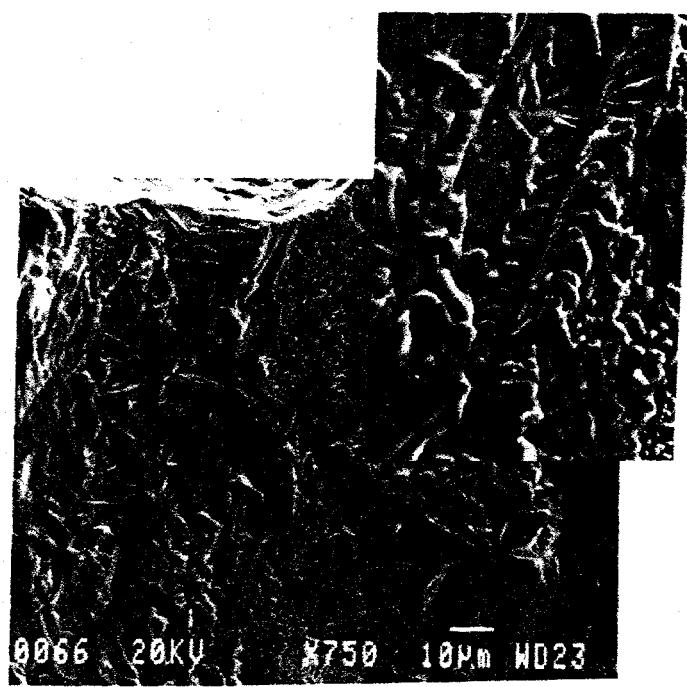
Figure 18: Secondary Electron Fractograph of the 1075°C/24h/Furnace Cool and Cold Worked Material Showing the Rough Intergranular Fracture Surfaces

the rough intergranular surface corresponds to the outline of the grain boundary carbides. Figure 19 shows a "mixed" region containing some smooth intergranular fracture with coarse carbides and regions with the dendritic intergranular carbides.

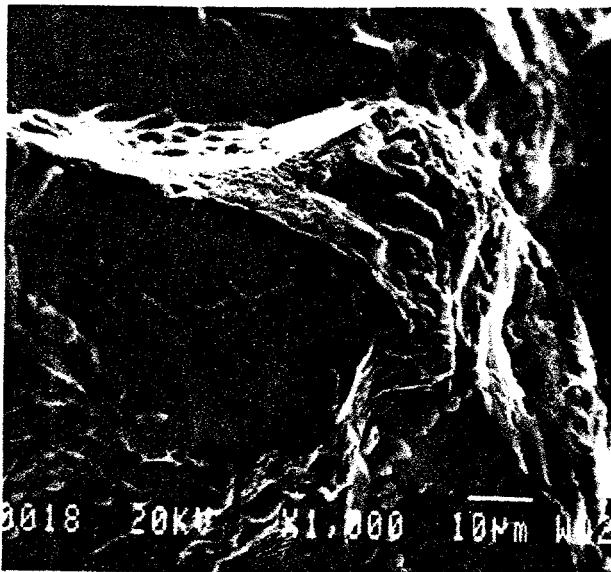
Figure 19: Secondary Electron Fractograph of the 1075°C/24h/Furnace Cool and Cold Worked Material Showing the Mixed Rough and Smooth Intergranular Fracture Surfaces - #1 is on dendritic carbide

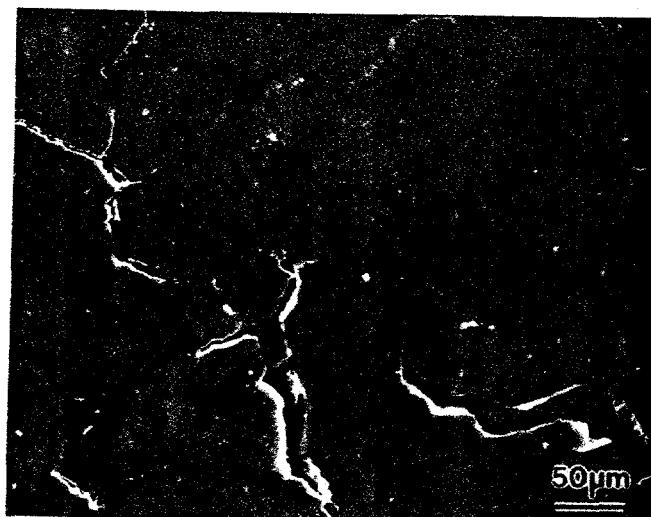
Figure 20: Secondary Electron Micrographs of the 1075°C/24h/Furnace Cool Material Showing The Intergranular Fracture Morphology

SEM examination of the metallographic cross-section of the sample revealed numerous branched intergranular cracks in addition to the primary intergranular crack. Examples are shown in Figure 20. No evidence of transgranular fracture was observed. The intergranular morphology of the SCC fracture is evident in Figure 21. Higher magnification examination, Figure 22, of this specimen revealed both smooth intergranular regions and some rough intergranular areas. The smooth intergranular regions were associated with the coarse discrete carbides; stereo images confirmed that some coarse carbides were "pulled" out of the grains. Some dendritic-type intergranular carbides were also observed on the fracture surface, but the evaluation was complicated by the presence of surface oxide. These were similar to the features shown in Figure 19. The sample appeared very similar to the HT+CW specimen, though with much less crack extension. Comparing HT and HT+CW, the cold work did not appear to affect the fracture morphology, only the growth rate.

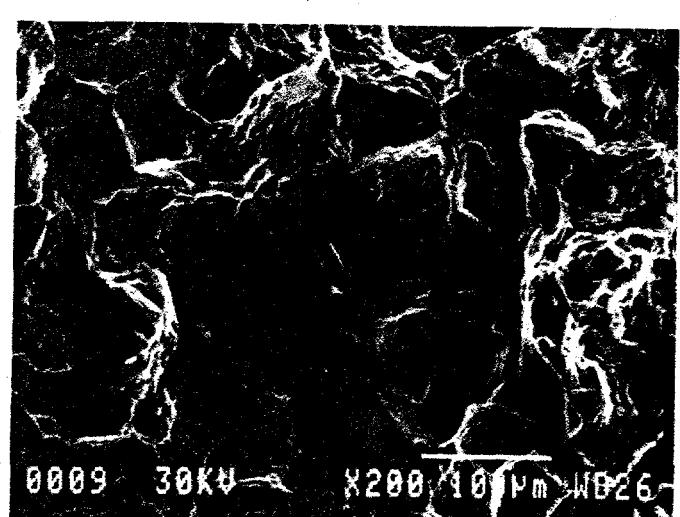
Figure 22: Secondary Electron Fractograph of the 1075°C/24h/Furnace Cool Material Showing the Mixed Rough and Smooth Intergranular Fracture Surfaces
