REPORT  
OF  
MATERIAL & EQUIPMENT  
SECTION'S  
ACTIVITIES  
AT  
NEW YORK SHIPBUILDING CORP.  
DURING FABRICATION  
OF  
AXC 167 $\frac{1}{2}$   
STARTING MAY 18, 1951

PART  
III

BY: JAMES RAY STEWART

NYX INSPECTION GAGES  
AND  
INSPECTIONS PERFORMED BY DU PONT  
IN BUILDING 10

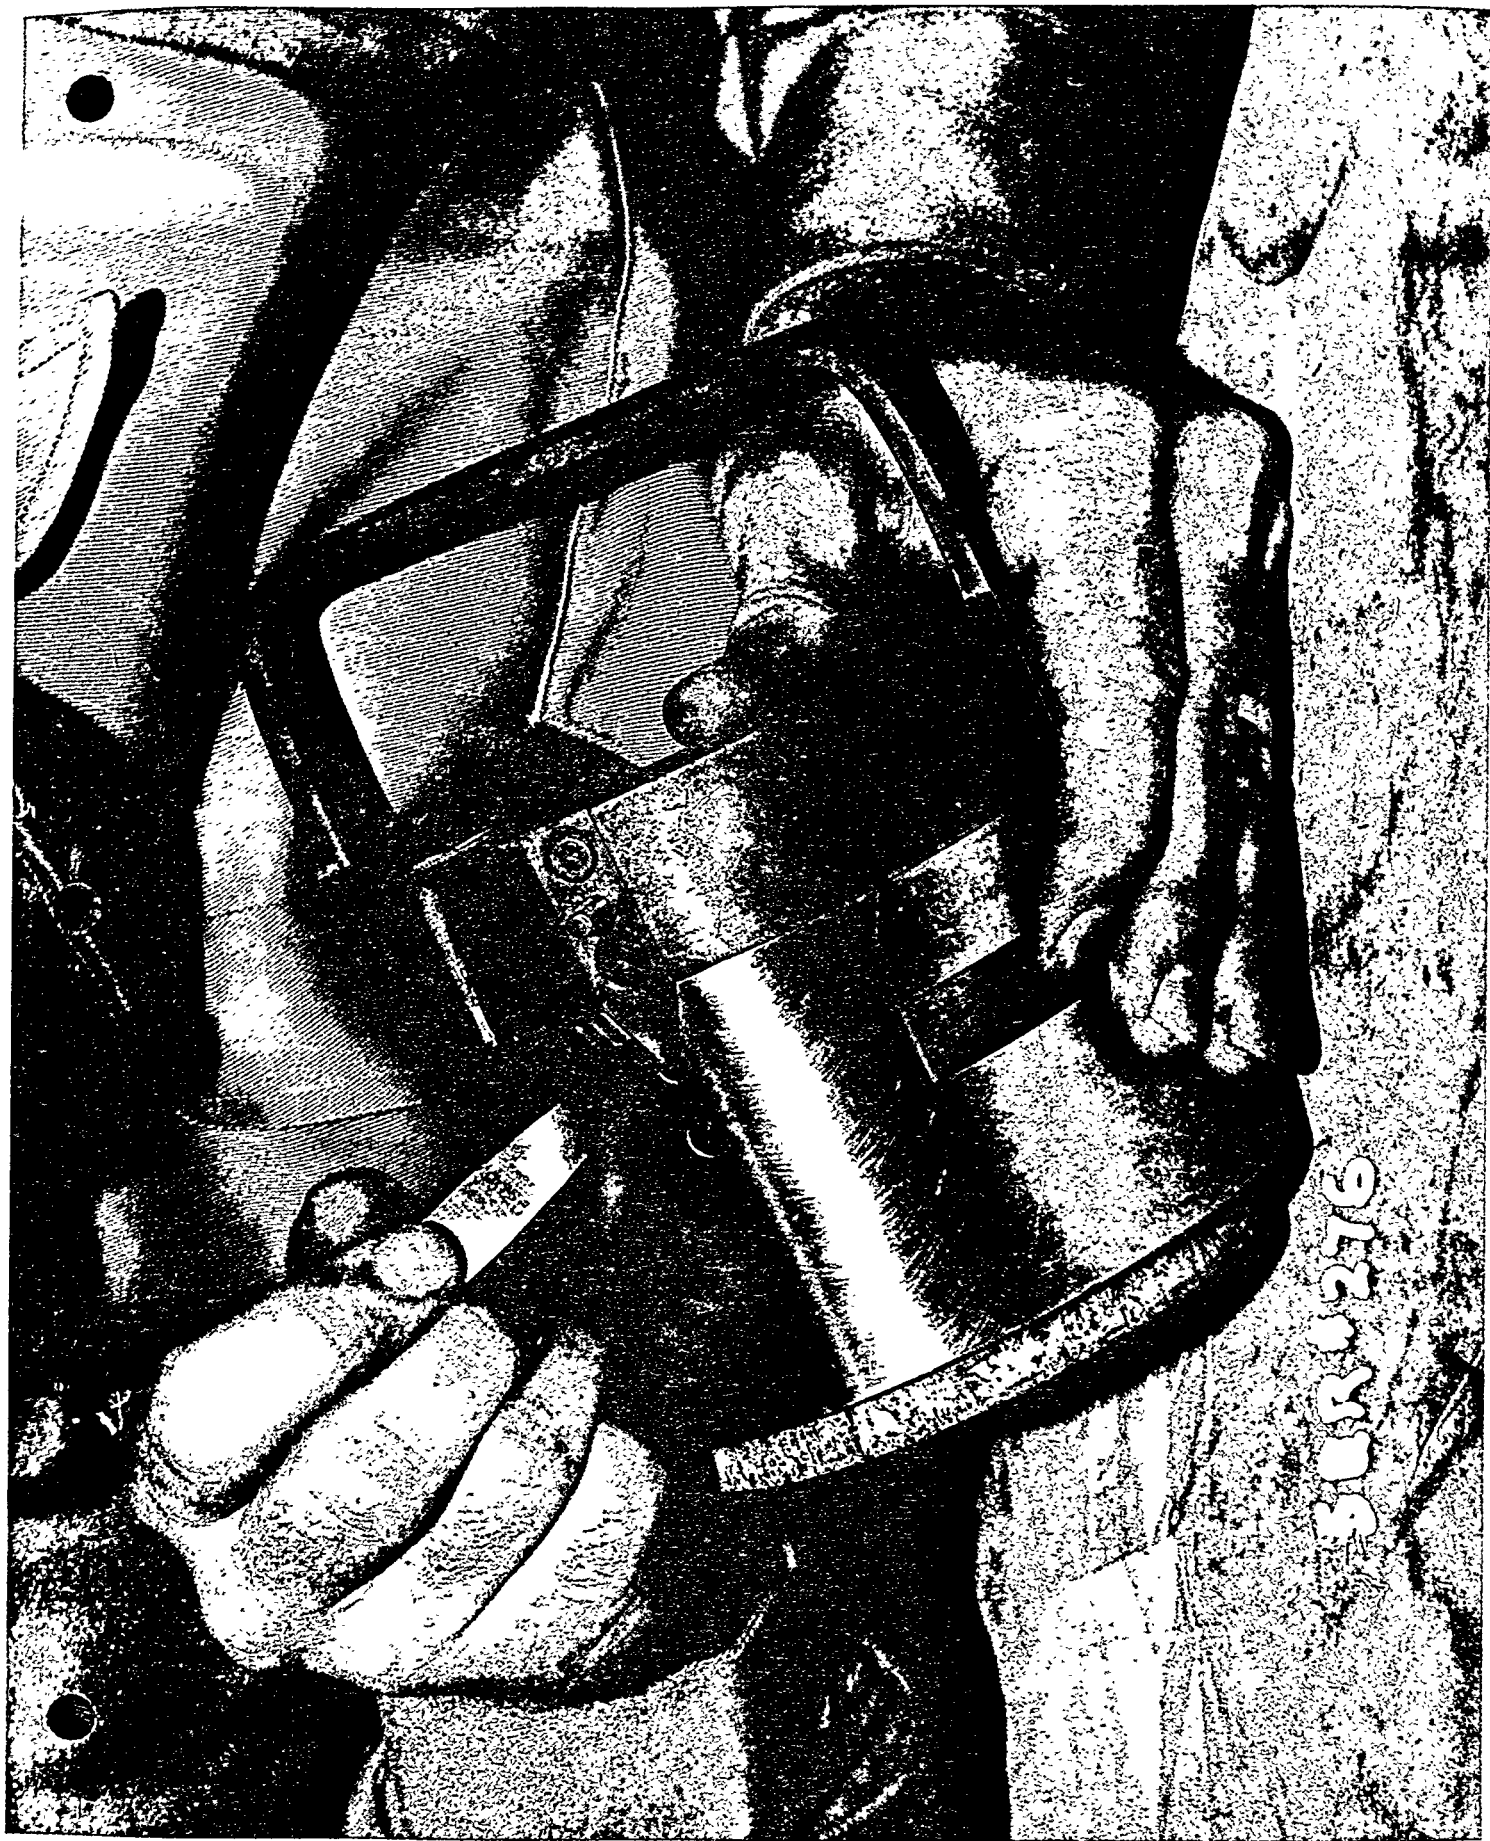
Serial Number 277

During inspection of finished "V" slots on "p" unit plenum chamber, it was discovered that the functional gage flange seated properly, but the "key" fitted tight at points "A" (See photo serial number 277) and loose at points "B". Feeler gages inserted at points "B" indicated the slot was outside the required tolerance; however, at points "A" (see photo serial number 277) it indicated slots were within tolerance. The use of the functional gage in conjunction with feeler gages did not produce accurate data as to whether or not slots were within tolerance. This discrepancy led to the development of the width gage for measuring the 3" "V" slots in the top end of all plenum tubes.

The above condition was due to a change in fabrication and machining procedures, in which the plunger milling method was

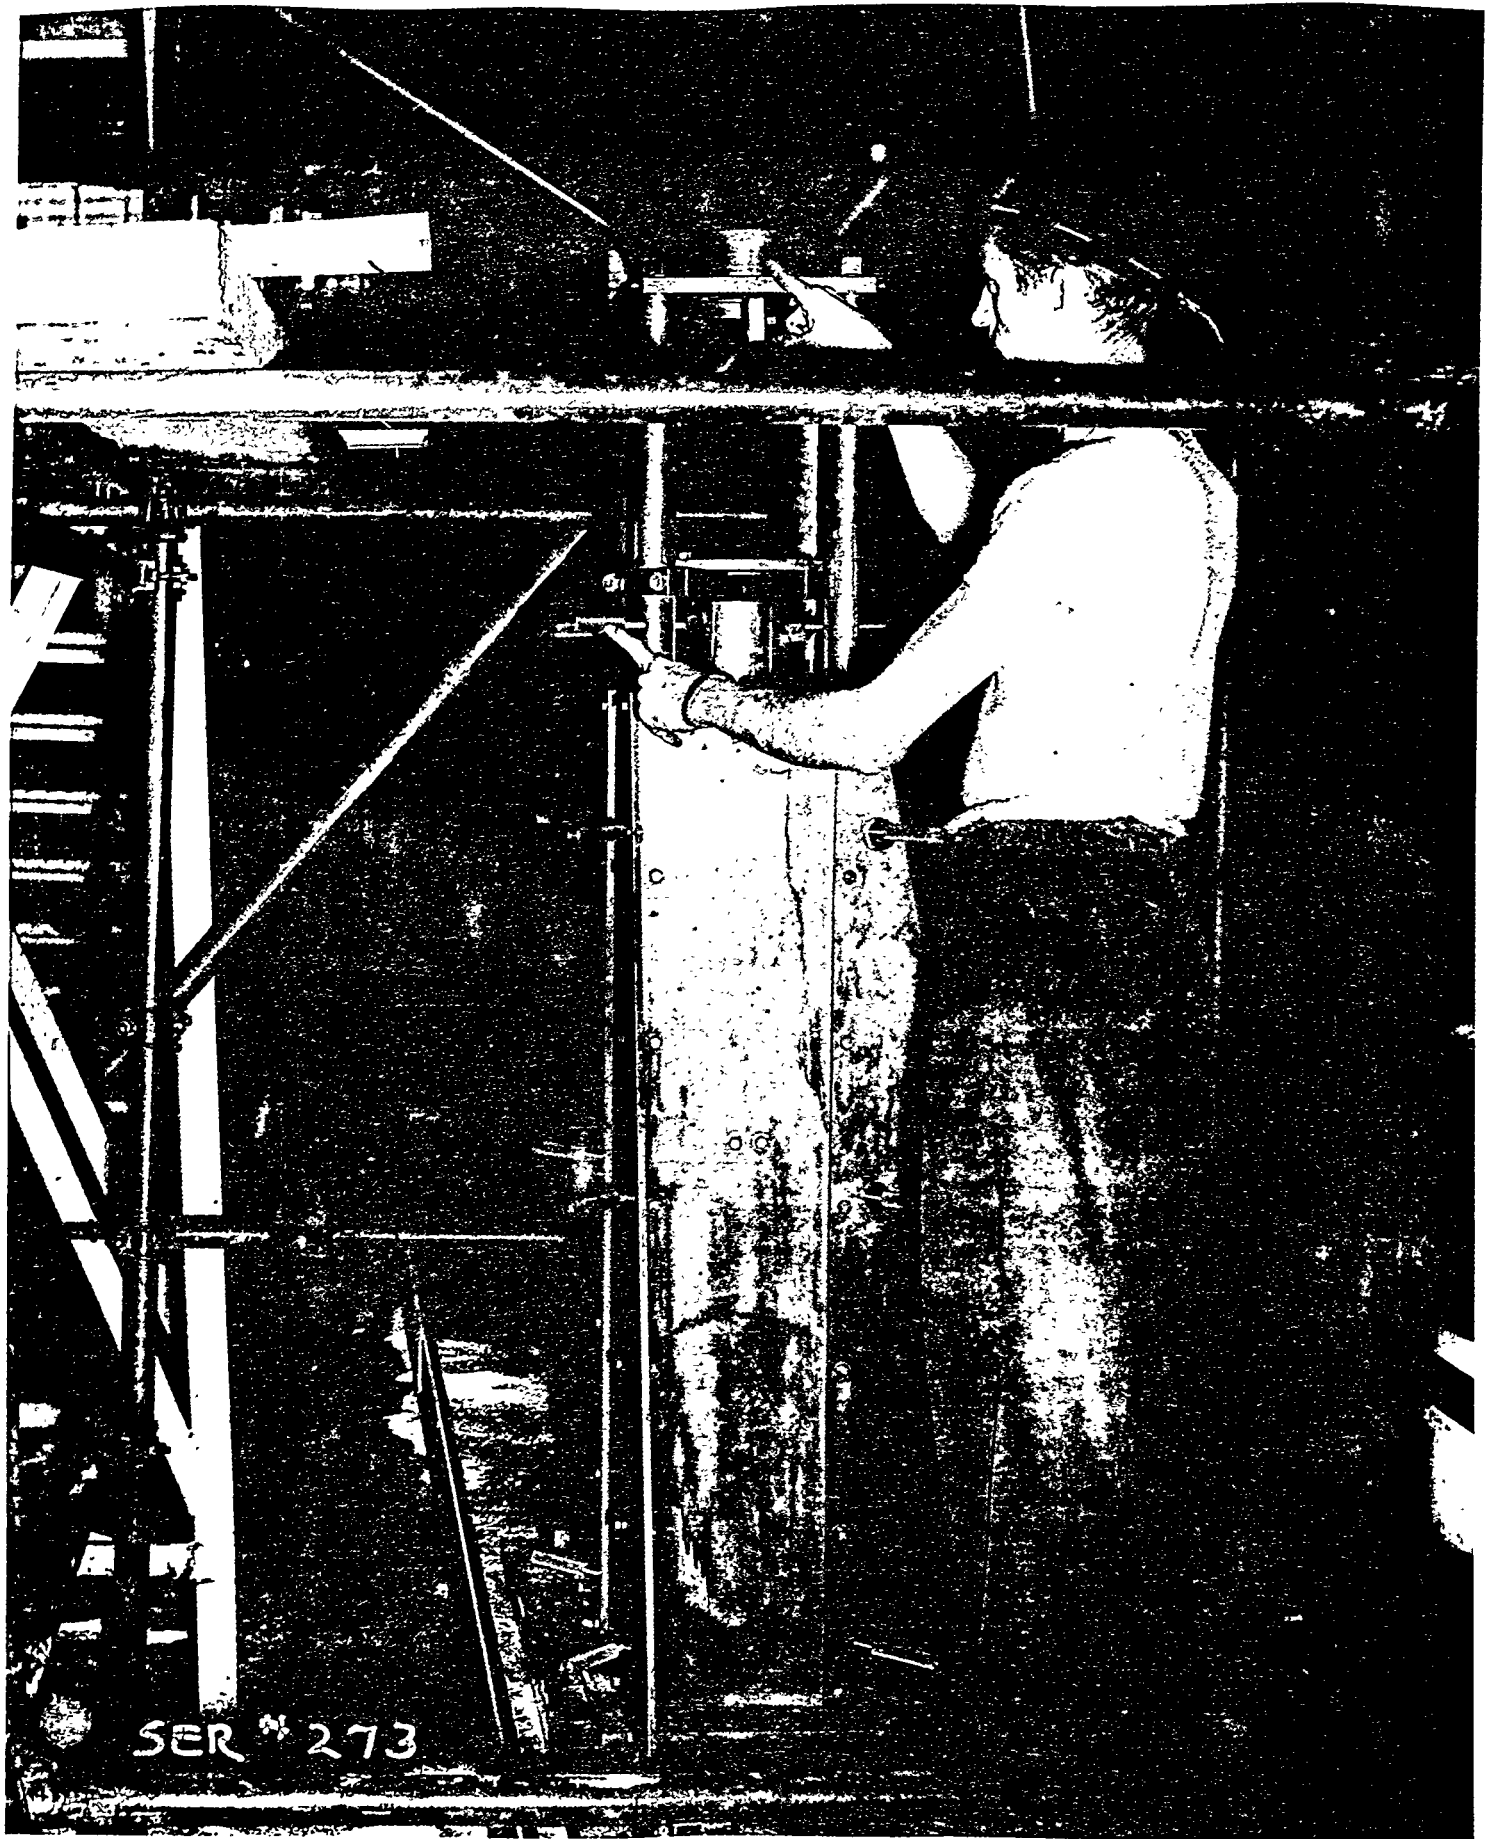
SER 273

The inspectors left hand is pointing to one of the sixteen (16) adjustment screws for centralizing the two master cylinders with the pilot ring which locates the gage in the check stand. The right hand is pointing to the pilot ring.

The above precision honed tube was later replaced with two master cylinders made of high tensile bronze and chrome plated on the I.D. and ground to 4.3750" (I.D.). (In addition, eight more adjustment screws were added to the check stand so that each cylinder's location could be controlled. (See photo serial numbers 273 and 274))

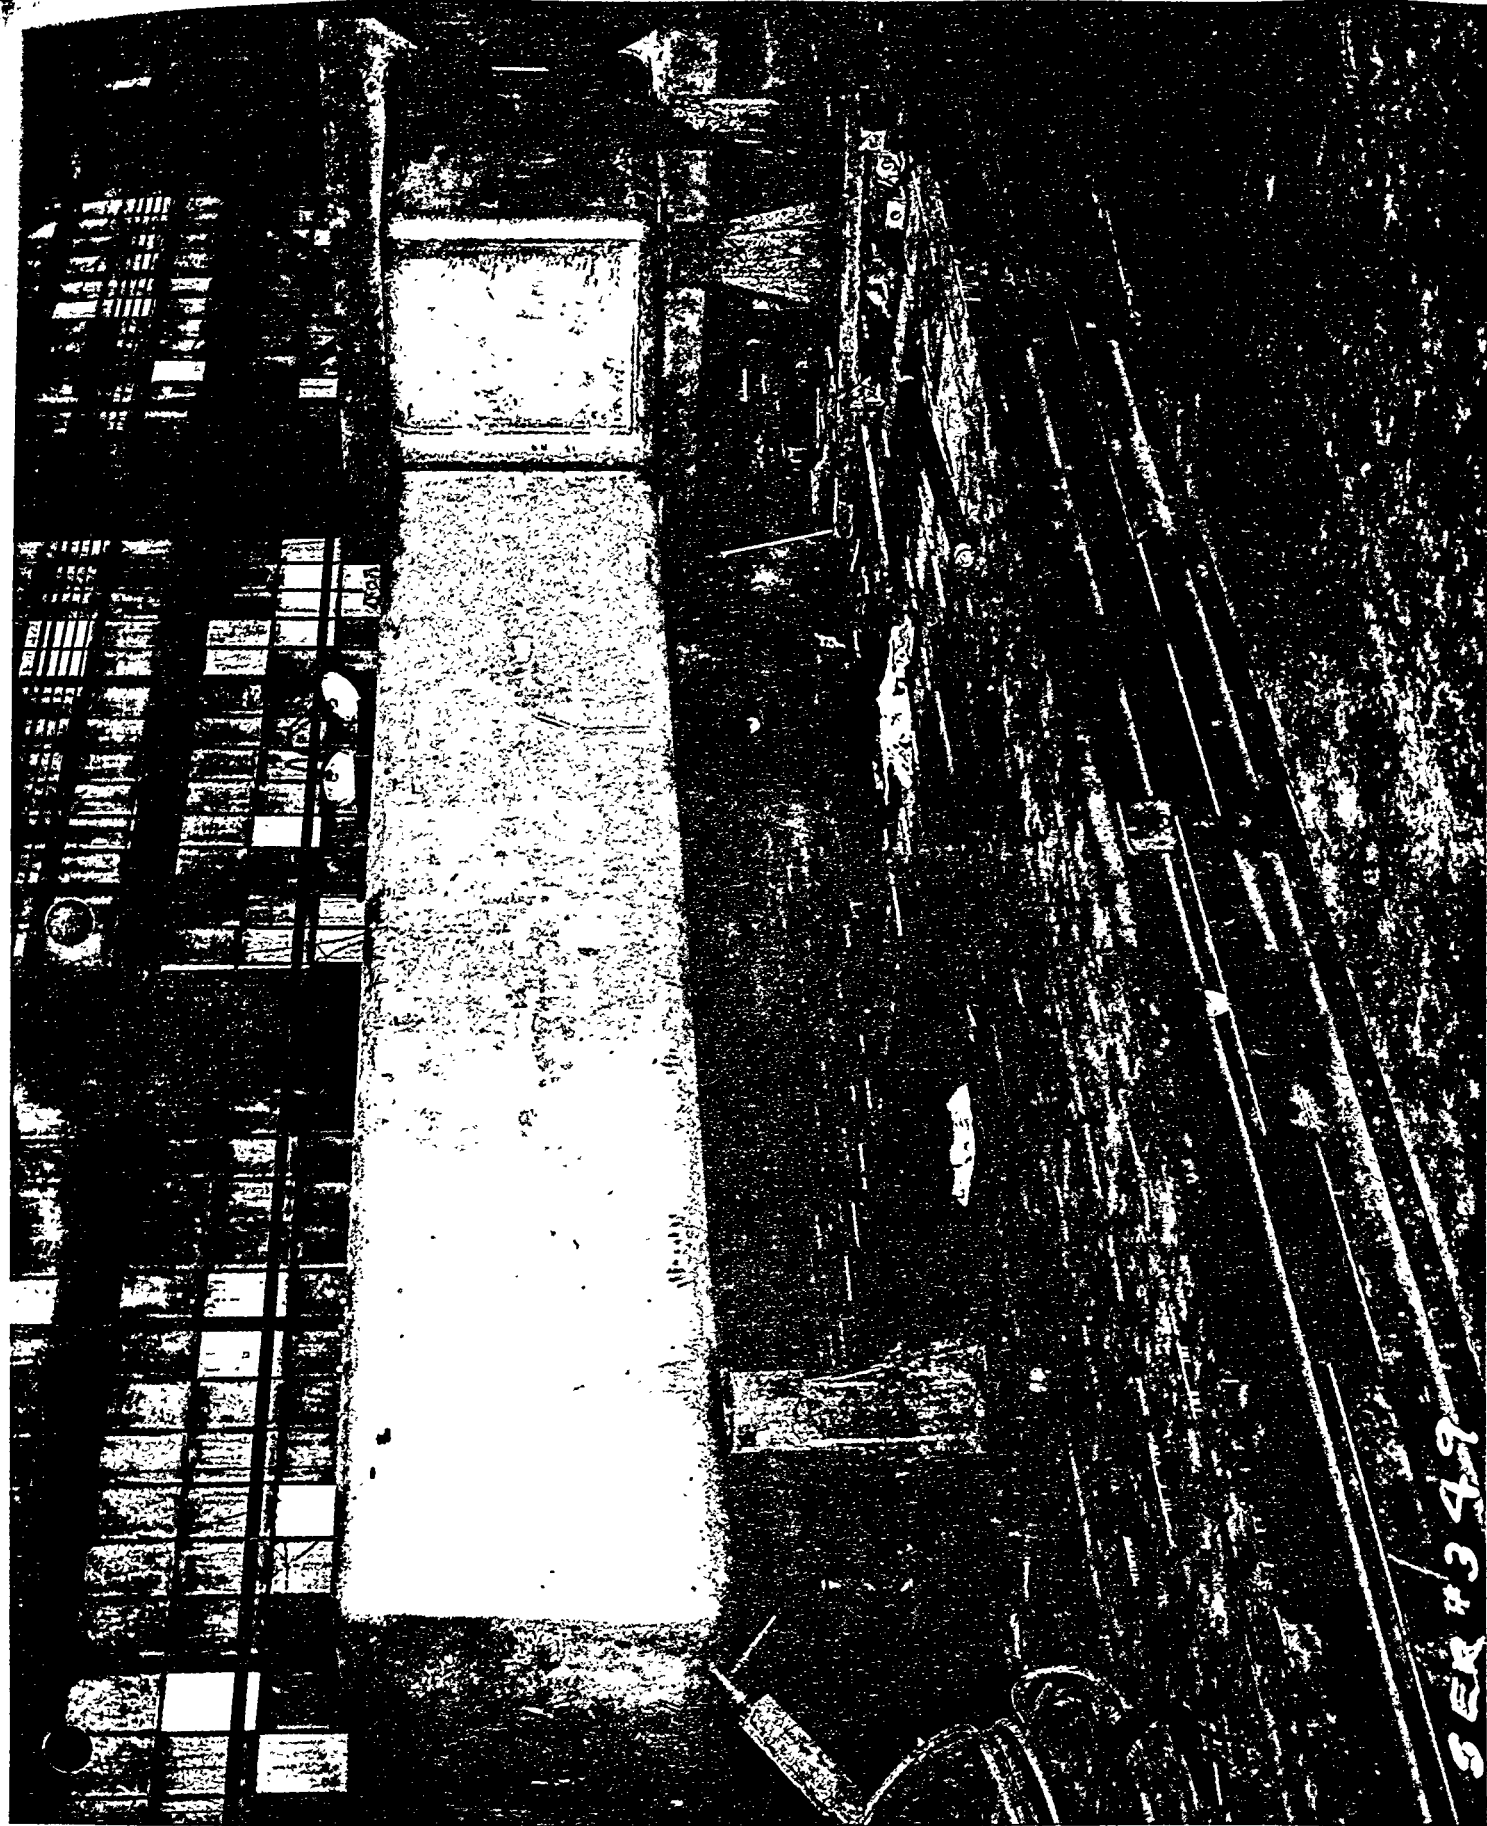
"K" UNIT HOLDING RACK

The tank and the tube nest and enclosure assembly are lined up for checking the vertical centerlines and for fitting the field joint.

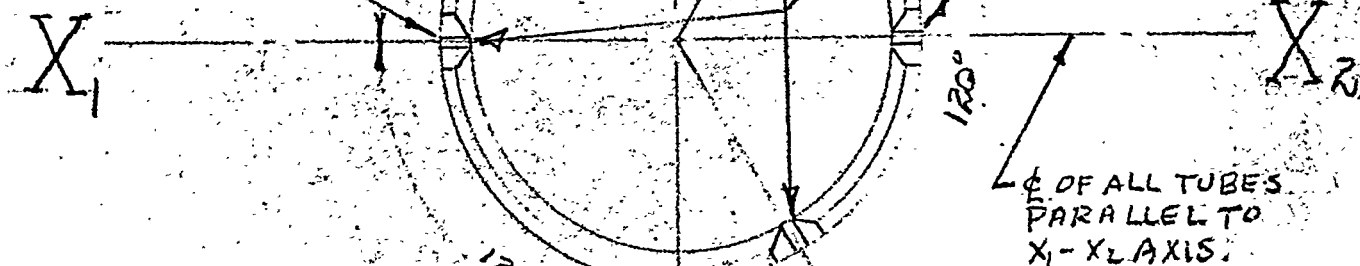
3- ADDITIONAL NOTCHES  
TO BE ADDED TO  
TUBE- FOR NOTCH  
SEE VIEW "Y-Y"

NOTE:  
EXISTING NOTCH  
TO REMAIN IN TUBE

NOTE:  
ALTER AS SHOWN  
HOLDING RACK TUBES  
D-113105-A  
D-113107-A & B  
D-113109-A & B

NOTCH AT TOP OF  
TUBE. REMOVE ALL  
SHARP INSIDE  
CORNERS TO  $63^\circ$   
FINISH
