August 1998

**Monitoring Bank Erosion at the Locke
Island Archaeological National Register District:
Summary of 1996/1997 Field Activities**

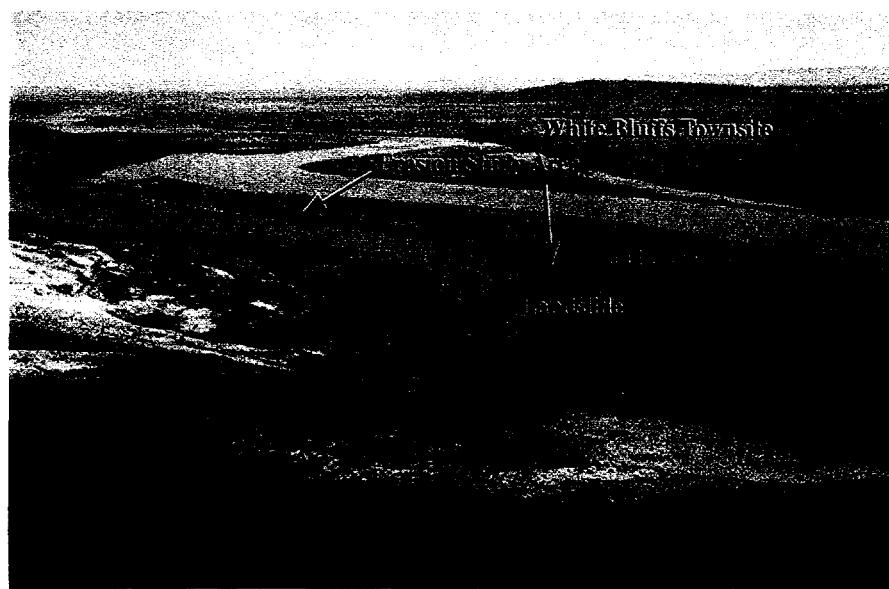
Figure 1.4. Oblique Aerial View to the Southwest From Above the Locke Island Landslide Across Locke Island

On the eastern shoreline of the Columbia River, across the channel from Locke Island, is the Locke Island Landslide (Figure 1.4), one of the largest such geological failures along this stretch of the river. These failures have causally been associated with the onset of nearby irrigation farming activities during the past few decades (Schuster, Chleborad, and Hays 1987; Marratt n.d.). A particularly critical byproduct of irrigation farming and a primary contributor to the Locke Island slide are several wastewater ponds situated on high ground to the east of the bluffs, where water was channeled along a wastewater into and allowed to accumulate for enhanced wildlife management purposes. In time, stored water from these ponds appeared in seeps along the face of the White Bluffs. Seepage continues to contribute to bluff instability in this area even today (Figure 1.5).

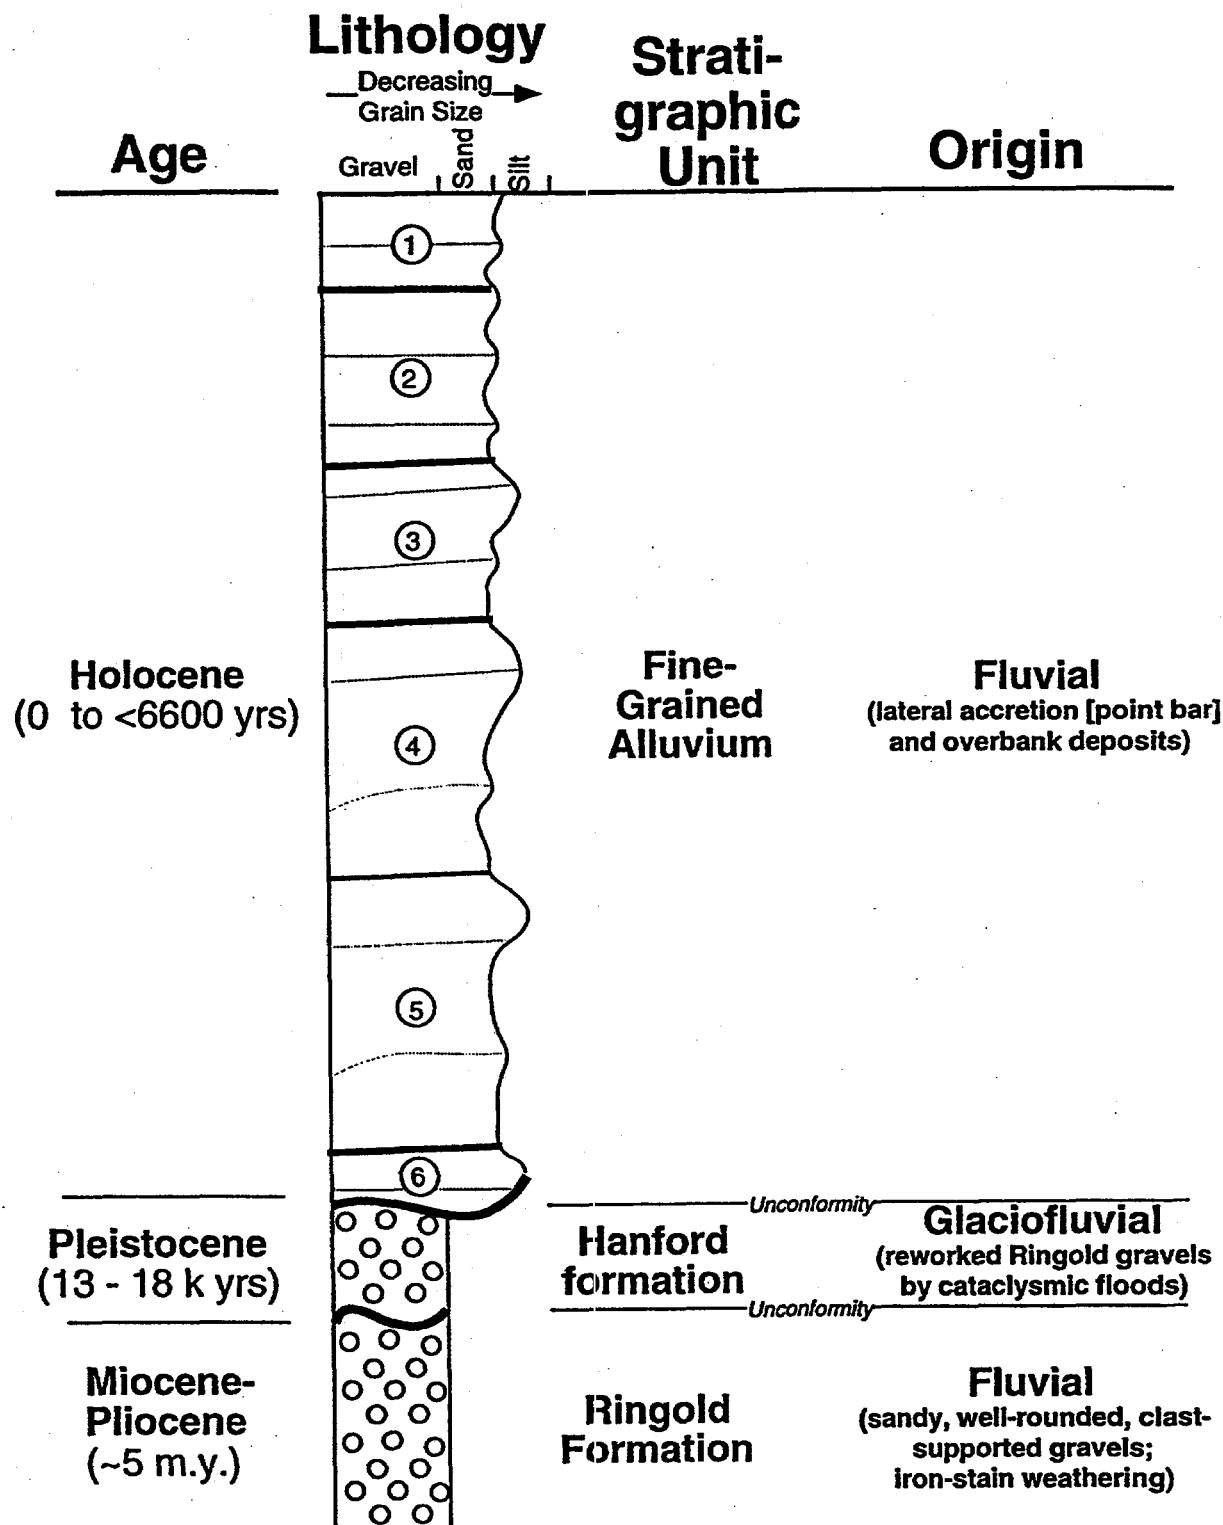
Figure 2.1. Locke Island Stratigraphy

Three principal stratigraphic units are represented at Locke Island. These are: 1) Ringold Formation gravels, 2) cataclysmic flood deposits from Glacial Lake Missoula, referred to as the Hanford formation within the Pasco Basin, and 3) recent Columbia River fine-grained alluvium. Figure 2.1 illustrates ages and stratigraphic relationships between these units. Outcrops of the oldest unit, gravels of the Ringold Formation, are limited to a northwestern portion of the recent cutbank exposure at Locke Island (Figure 2.2). However, it is also possible these gravels represent Ringold sediments reworked by Pleistocene cataclysmic floods. Characteristics that indicate that these gravels belong to the Ringold Formation (Facies Association I of Lindsey 1995), and are in situ, include the quartz-feldspathic composition and the degree of iron oxide staining displayed by the sand matrix. If these are Ringold-age

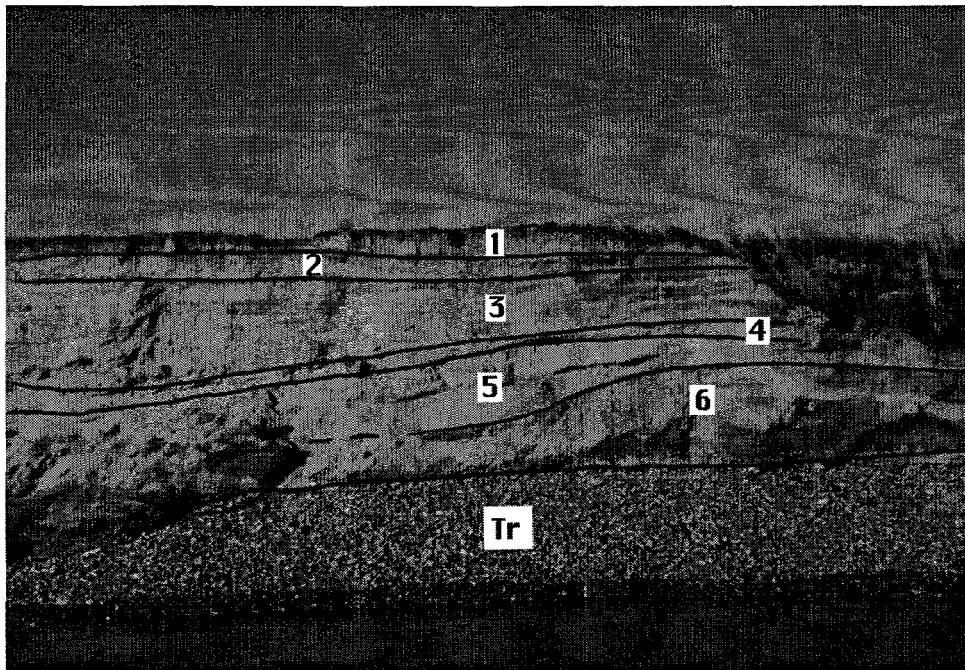
Figure 2.2. East Cutbank of Locke Island Near Transect 800. The bottom third of this exposure consists of well-rounded, clast-supported gravels with a matrix of iron-oxide-stained sand, characteristic of the Ringold Formation (Tr). Above the gravels is a fine-grained alluvial sequence. Six major strata in the fine-grained alluvium, which correlate with the vertical length of the cutbank exposure, are numbered on the photograph.

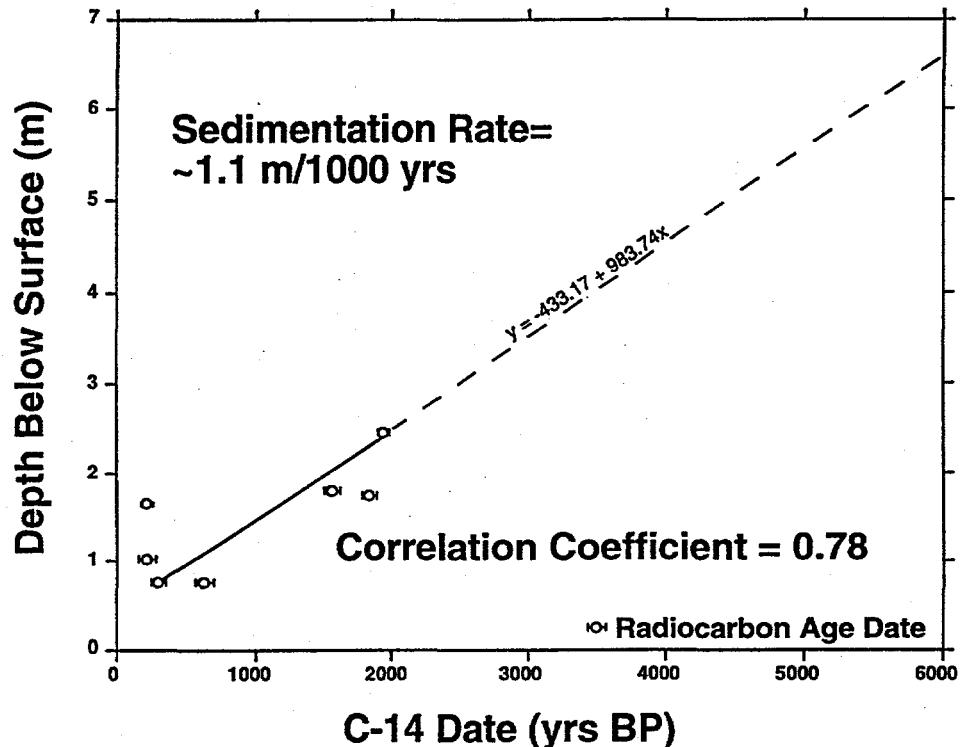
Figure 2.4. Sedimentation Rate of the Fine-Grained Alluvial Unit at Locke Island

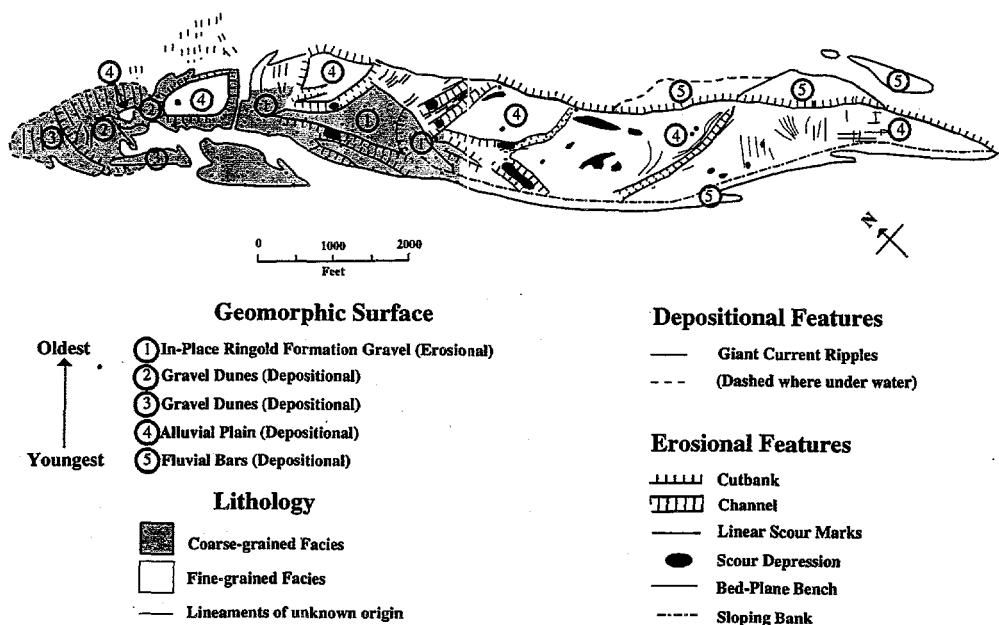
Figure 2.6. Geomorphic Map of Locke Island

Based on an evaluation of historical aerial photographs, five geomorphic surfaces are identified on Locke Island (Figure 2.6). These surfaces are differentiated based on variations in sediment composition, elevation, and vegetation. The relative ages of the different surfaces are estimated based on the combination of radiocarbon dates reported in this study and crosscutting relationships between surfaces observed in aerial photographs.

The northern end of the island is dominated by the three oldest surfaces, which are developed on coarse-grained, pebble-cobble gravels of the Ringold Formation (Figure 2.6). The oldest surface (1), an erosionally scoured surface, is composed of Ringold gravels originally deposited about 5 million years ago. Surface 2 consists of giant current ripples that developed during an older Missoula flood, locally

The middle portion of Locke Island is characterized by a combination of erosional and depositional features (Figure 2.6). The central portion of the island consists of a channelled complex (surface 1) eroded, in places, down to the Ringold gravels, which left behind a series of easterly trending channels, scour depressions, and linear scour marks. One of these east-trending channels is shown in Figure 2.7. This erosion is at least several hundred years old, since the eastern end of some of the channels are

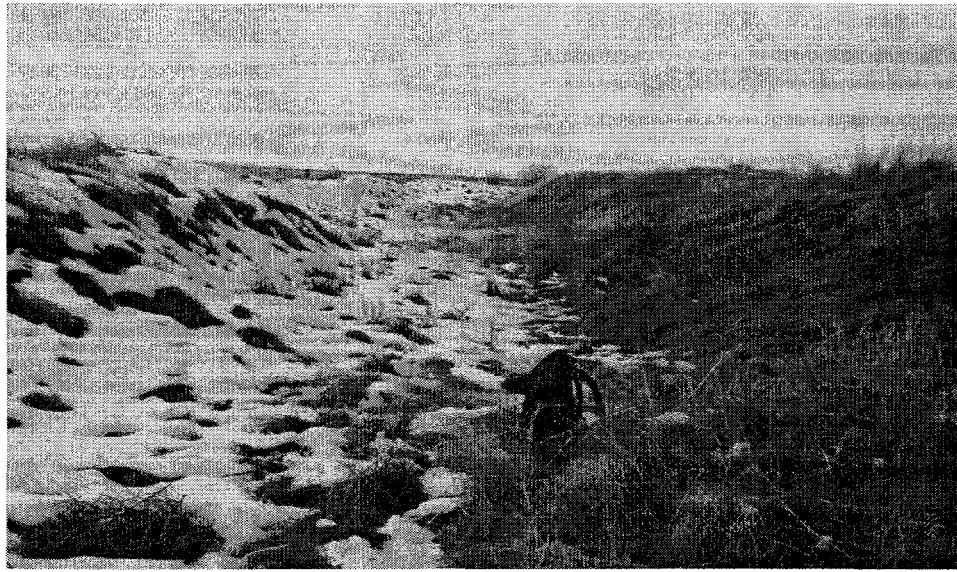
Figure 2.7. Fluvial Channel. One of several that cut diagonally across the fine-grained alluvial unit and are scoured down to the Ringold Formation gravels, located just north of Transect 800.

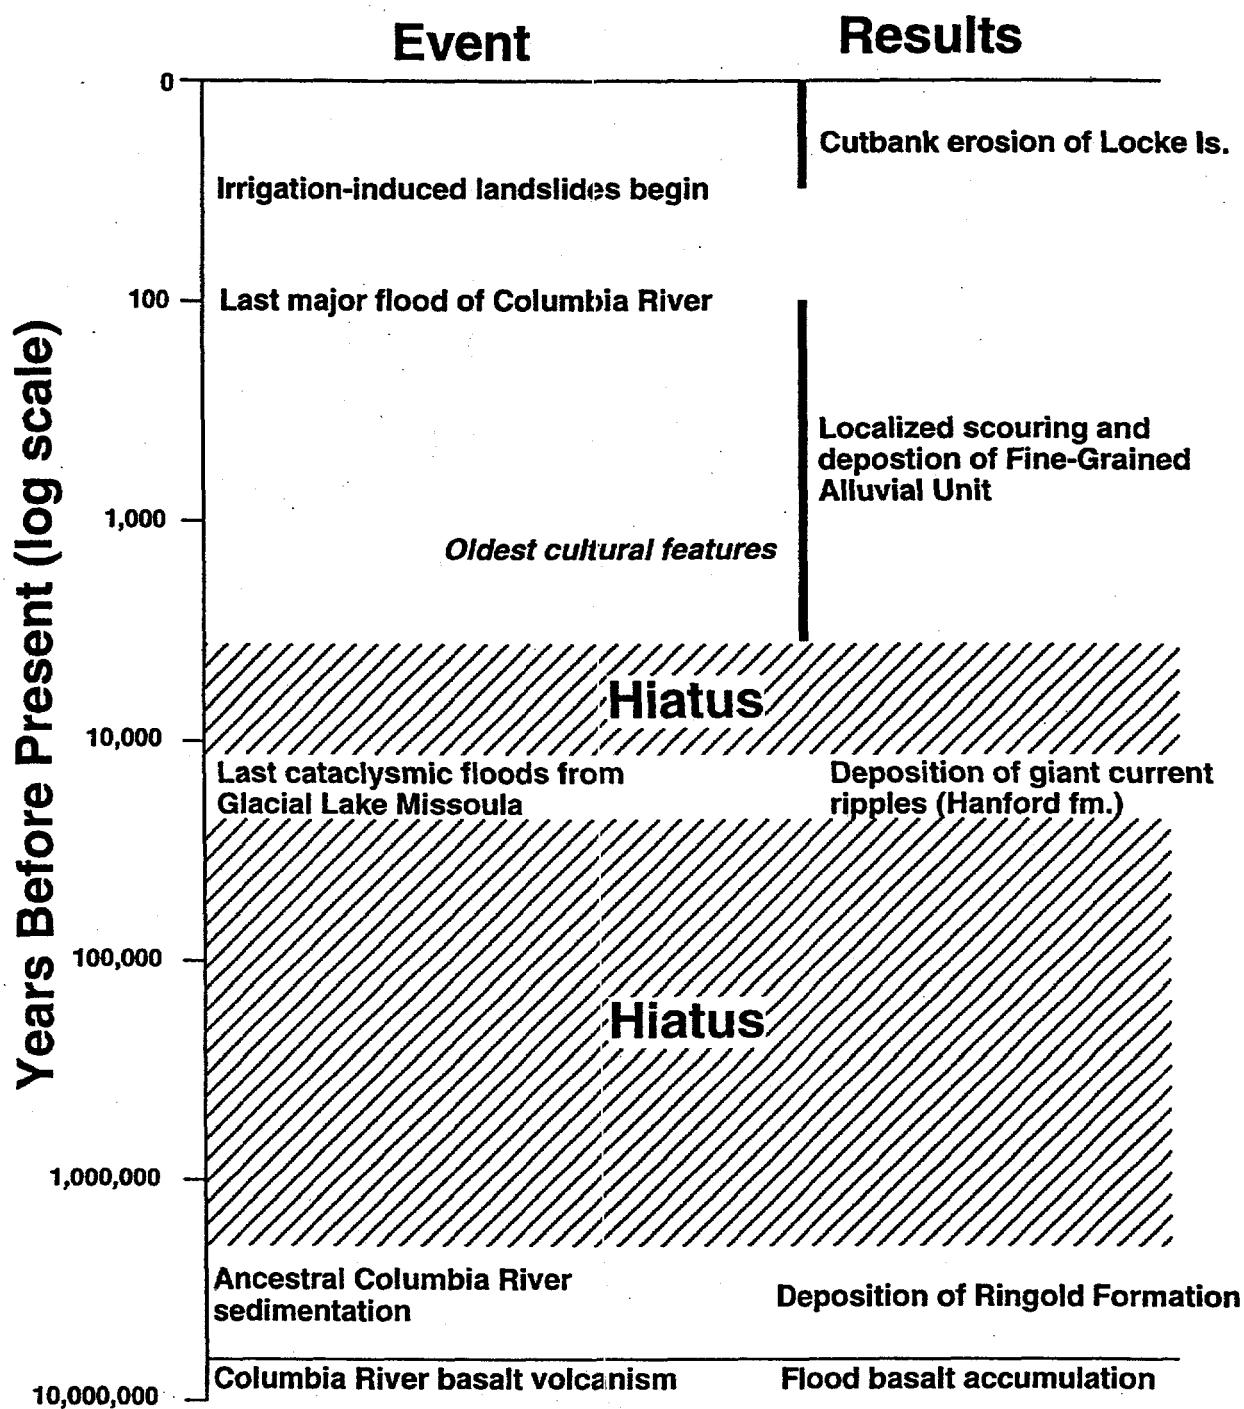
Figure 2.8. Summary of the Geologic History of Locke Island. (Note: time scale on vertical axis is logarithmic.)

Locke Island has a complex history and has developed in several stages (Figure 2.8). The island originated during the Pleistocene, when cataclysmic floods that periodically moved through the Pasco Basin (Baker et al. 1991) deposited large giant current ripples. After the last cataclysmic flood (about

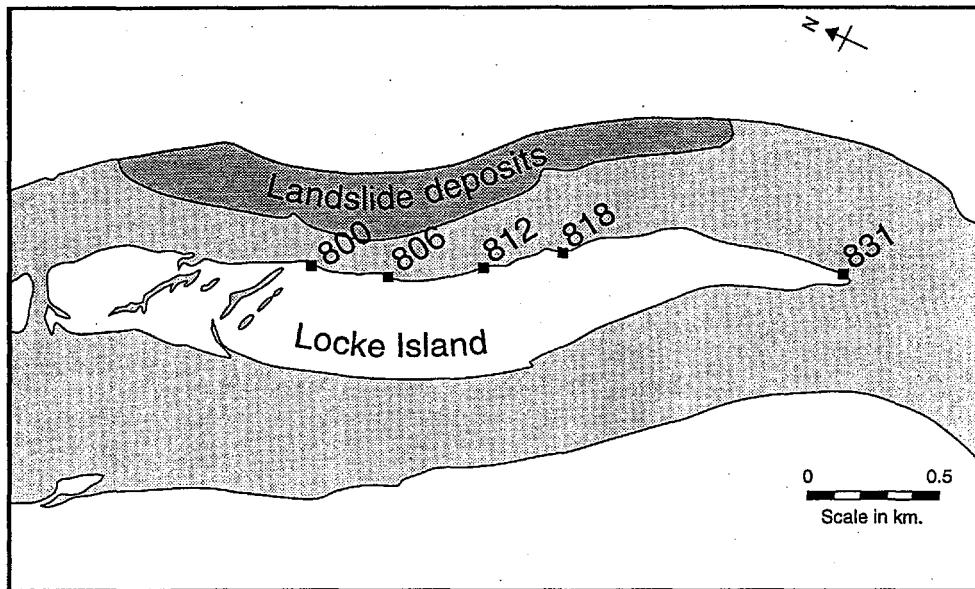
Figure 3.1. Location of Monitoring Transects Along the Eastern Shore of Locke Island

Each transect consisted of a series of wooden stakes, 1 foot long, placed vertically 1 meter apart extending 5 meters back from edge of the bankline, and a 2-foot section of rebar, tagged with the

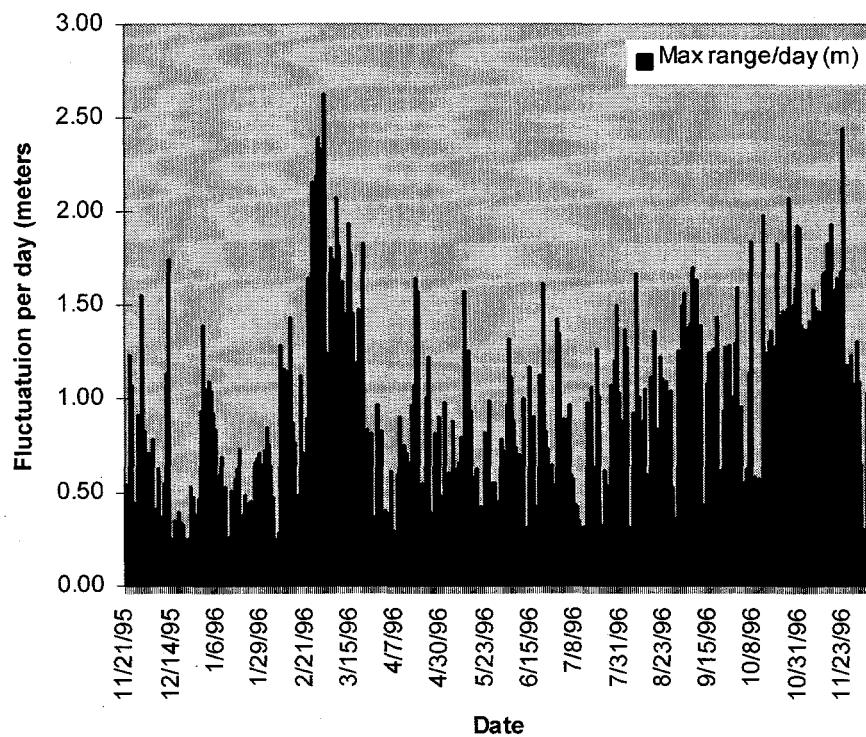
Figure 3.3. Fluctuation of the Columbia River Flow Throughout 1996

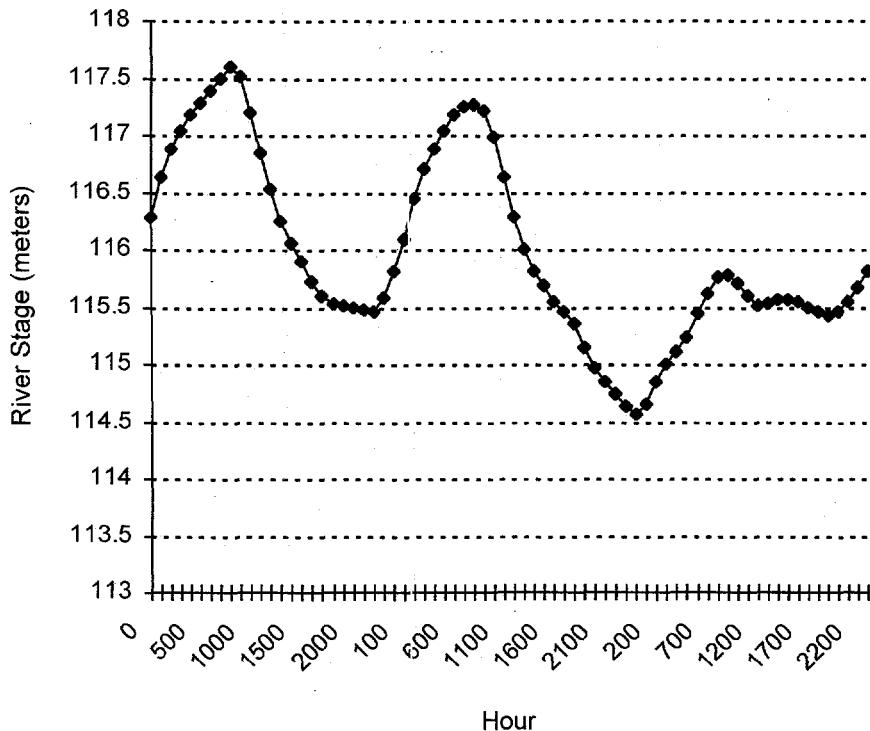
Figure 3.4. River Stage Fluctuation Over a 3-Day Period

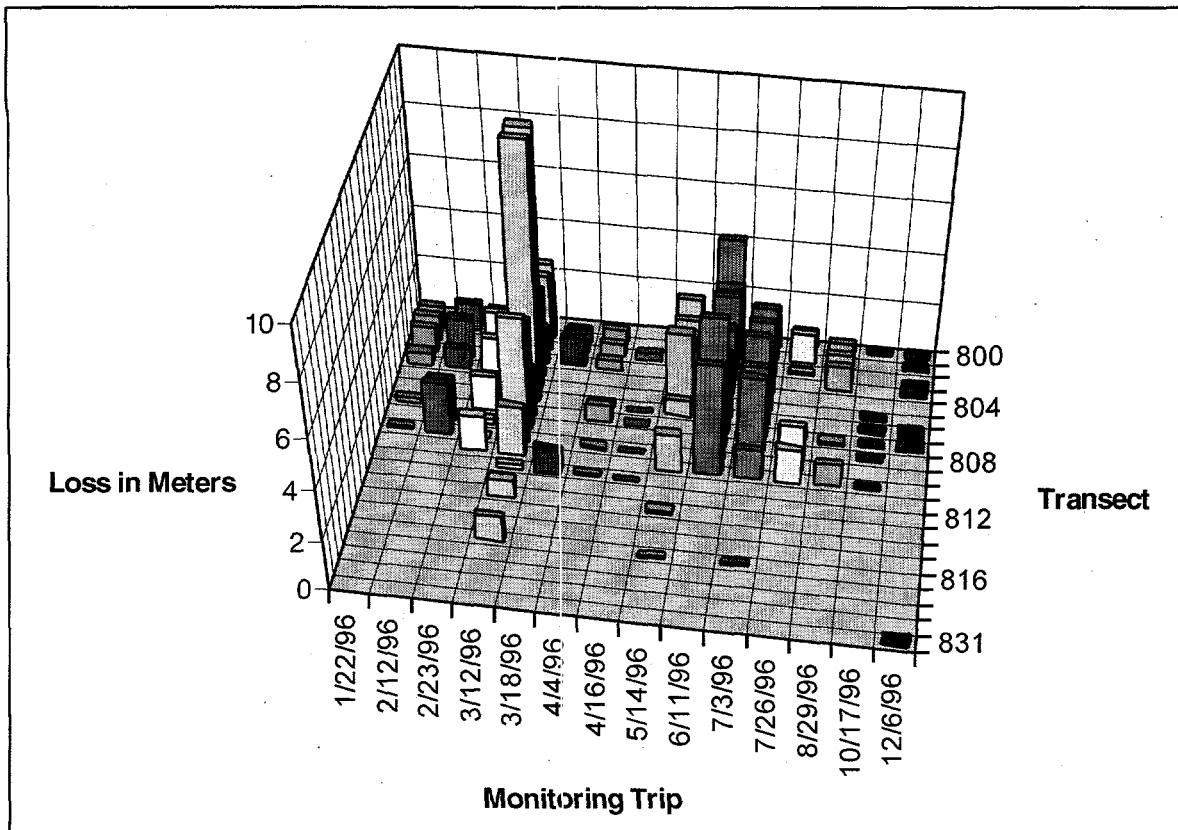
Figure 3.5. Bank Loss by Monitoring Trip for Selected Transects in 1996

Over half the transects experienced severe erosion and recession of the bankline during the 1996 period of analysis. The greatest amount of loss occurred at Transect 806 where more than 16 horizontal meters were lost. Figure 3.5 graphically summarizes the field data by monitoring date, and Figure 3.6 summarizes cumulative loss at each transect by monitoring date. Appendix A itemizes the cumulative measured loss per monitoring trip. An additional 5 meters of loss is estimated to have occurred at Transect 800 since November 21, 1995, before that transect was established in March 1996.

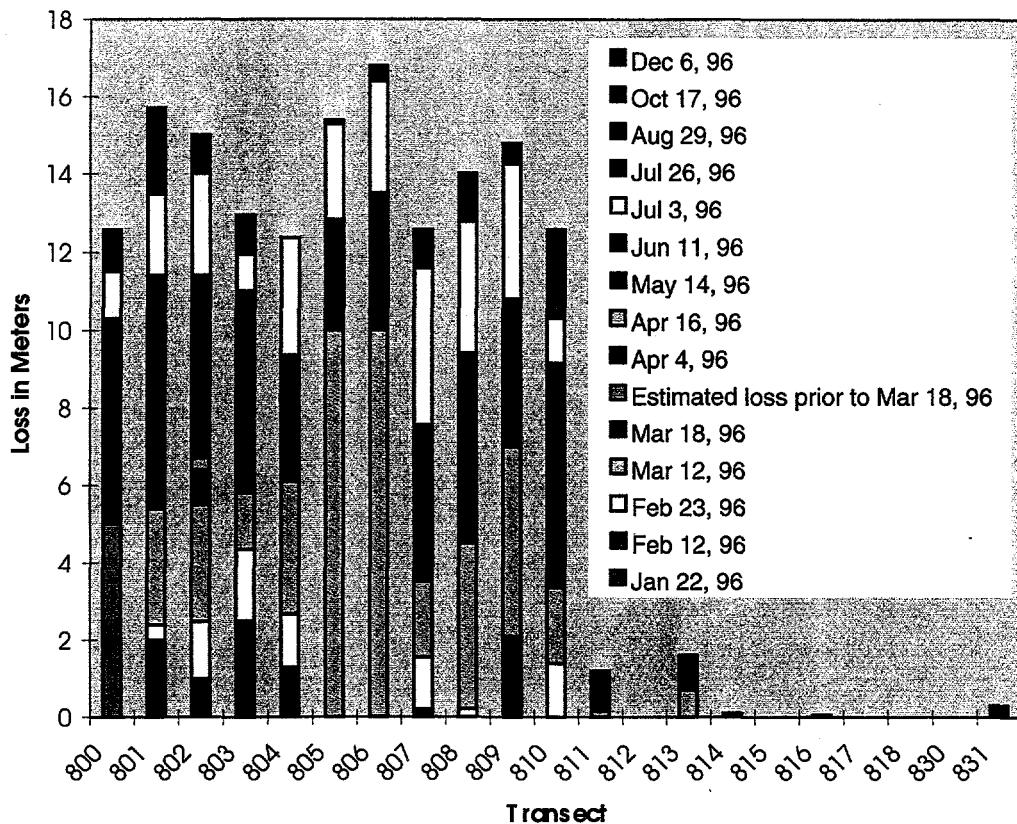
Figure 3.6. Cumulative Bank Loss for Each Transect in 1996 by Monitoring Trip

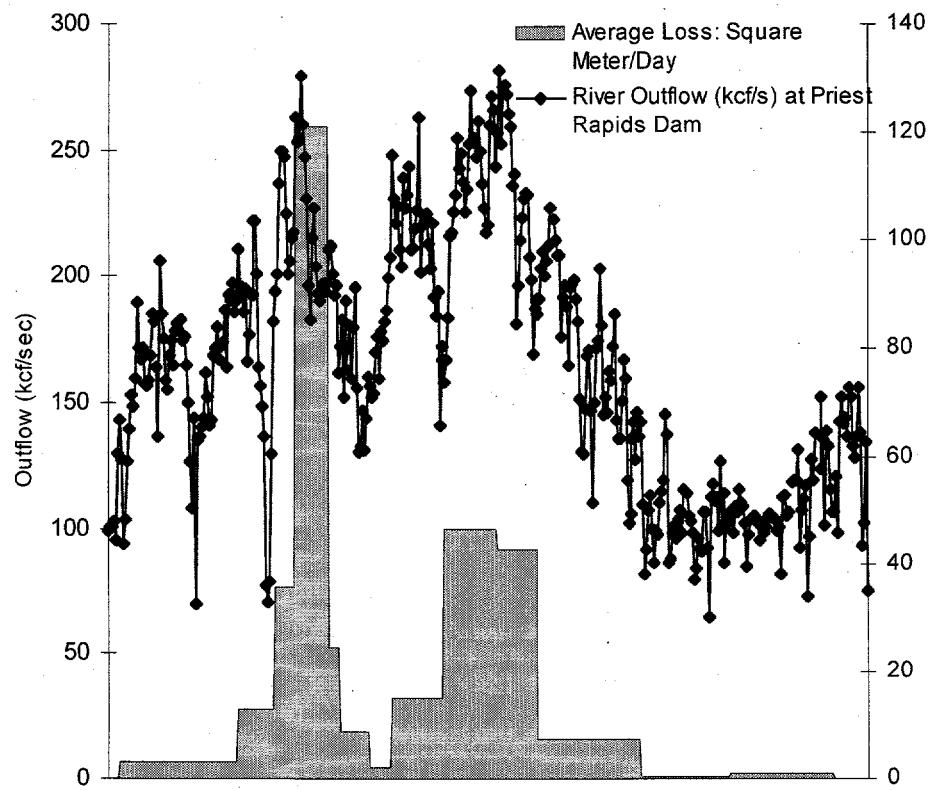
Figure 3.7. Comparison Between High Flow Regimes and Active Bank Erosion at Locke Island in 1996

For the 18-day period between February 23 and March 12, 1996, the average area lost per day equaled 121 square meters. High erosion rates also occurred during the later spring freshet. Between May 14 and June 11, a total of 28 days, the average loss per day was 46 square meters. The slumping tended to follow a cyclical pattern with undercutting and bank failure followed by a period of relative stability as the bank was protected by the accumulated talus (Figure 3.7). Periods of high daily river fluctuation were also positively correlated with periods of high bank erosion (Figure 3.8).

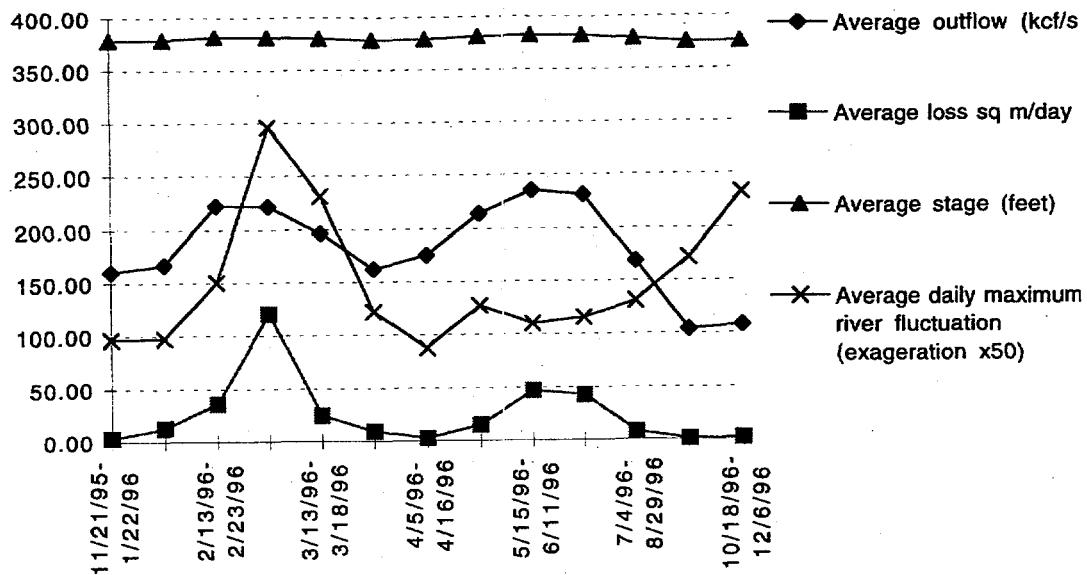
Figure 3.8. Comparison of Bank Loss at Locke Island in 1996 with River Stage and River Fluctuation

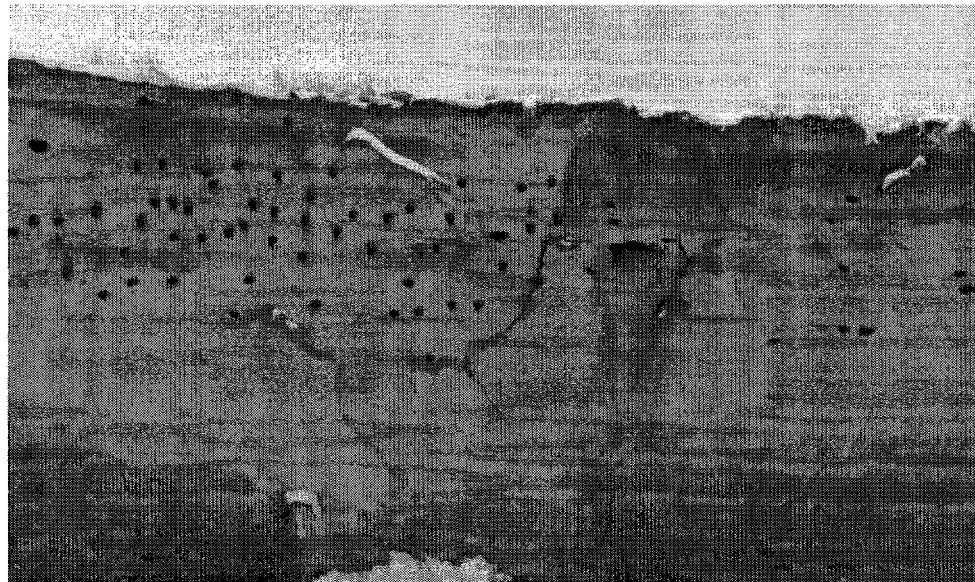
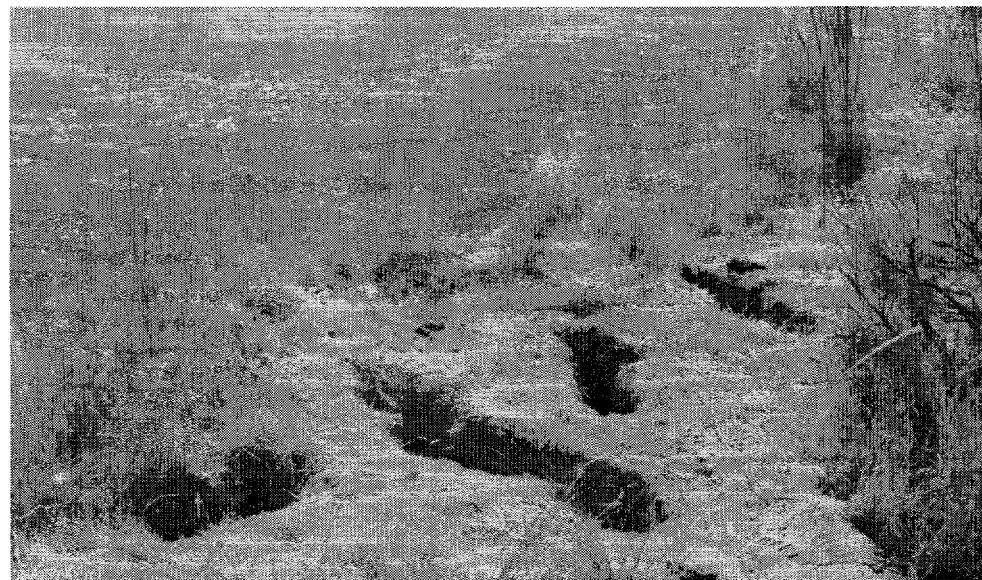
Figure 3.9. Photographic Documentation of Biological Intrusions Contributing to General Bank Instability. Bank swallow nests in the vertical face of the cutbank (top). Trenching by coyotes in an effort to reach the swallow nests (bottom).

Relatively minor agents of erosion included bioturbation from nesting bank swallows and trenching by coyotes adjacent to the bank edge as they attempted to dig into swallow nests from above along the edge of the bank (Figure 3.9). Aside from the initial soil disturbance caused by these animals, the burrowing further added to bank instability during winter months, as surface water in the form of rain and snow is able to penetrate to greater depths, thereby further weakening the bank. Under current conditions, however, the accelerated bank recession easily mitigates the potential adverse effects that animals might have on bank stability during the summer months. In the case of nesting swallows, fairly rapid, incremental loss of the island sediments probably leads to far more detrimental consequences for the birds than the other way around.

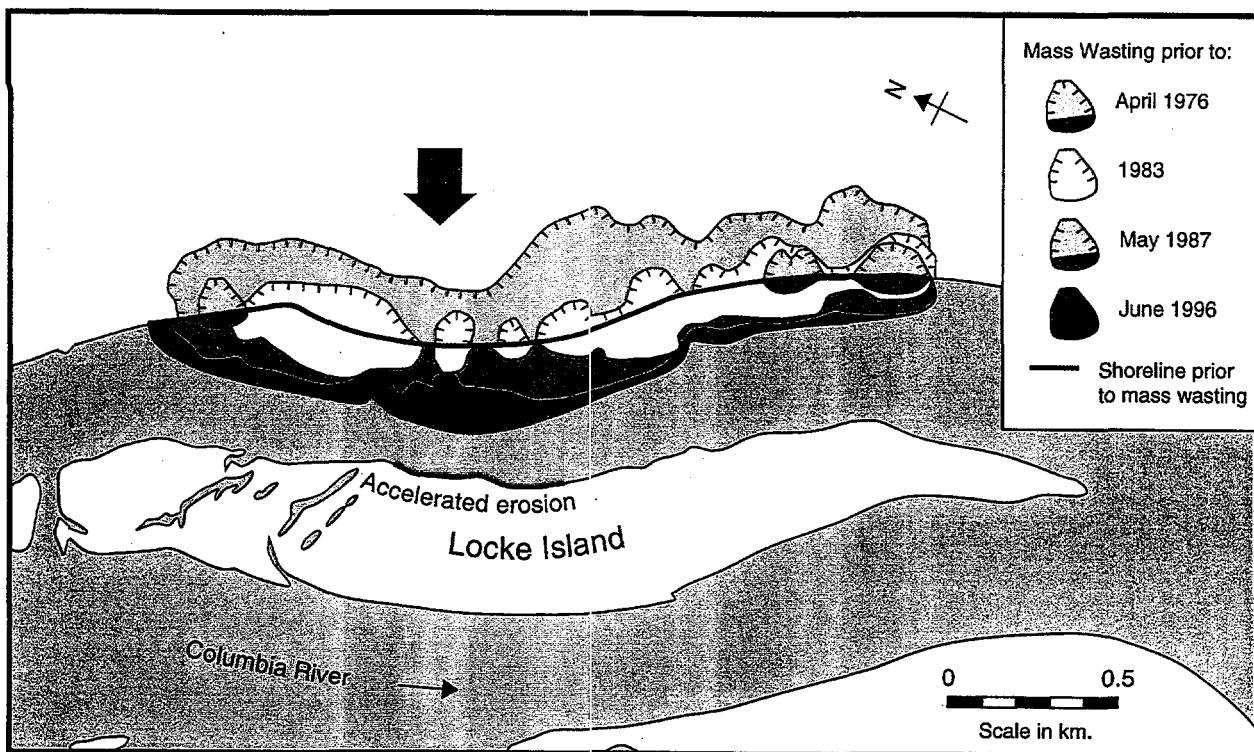
Figure 3.10. Schematic Representation of the Locke Island Landslide Movement at Distinct Points in Time, as Mapped From Aerial Photography

In an earlier analysis of this slide area in the early 1980s, Hays and Schuster (1987) noted that wastewater inflow into the ponds had almost been eliminated and that “within a few years, the seepage and resulting landsliding in this segment of the bluffs may cease.” However, the aerial photographs taken in June 1996 conclusively indicate that water continues to seep out of the bank above the slide and within the lower part of the slide. A line of springs appears to be flowing from near a contact coincident with the original river shore, mobilizing and creating continued movement of the lower part of the slide. Most of the recent movement appears to be within the distal portions of the slides, above what used to be river channel. Water may be moving along contacts between rotational slump blocks; however, the exact mechanisms for the recent movements taking place within the slides are not presently understood.

Achieving a better understanding of the physical dynamics at work in the landslide zone opposite the island is critical to predicting erosion along the eastern perimeter of the island, and for identifying and designing possible protective strategies for the important cultural resources contained in the island’s sediments. If engineered bank protection strategies are to be considered, it is imperative that the dynamics of

the landslide be understood. Although it is evident that the slide is still moving, no quantitative measurements on the rate of movement have been completed. A study of the mechanisms working within the slide area and a program to monitor the movement of the slide are strongly recommended.

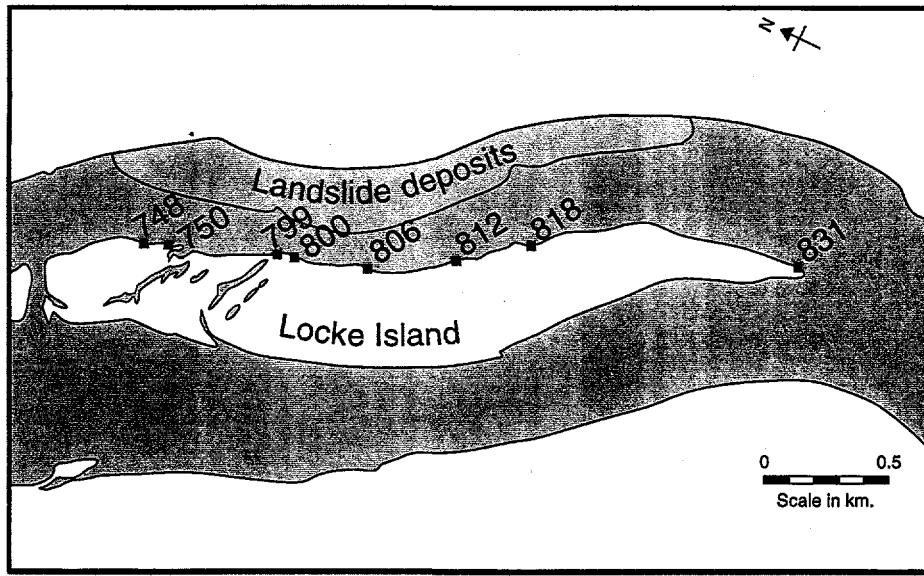
Figure 3.11. Locations of Additional Monitoring Transects Established in 1997

stakes set as needed, and the bank examined for cultural materials as river conditions allowed. Three new transects were also established (748, 750, and 799) (Figure 3.11). Transects 748 and 750 were set up opposite the north end of the landslide where the cutbank was near vertical, sediments fine-grained (sands and silts), and the bank over 5 meters high. These transects were established on May 16, 1997. Transect 799 was set up about 50 meters upstream of Transect 800 on a low gravel terrace that had begun to erode in 1996. Transect 799 was established on December 6, 1996.

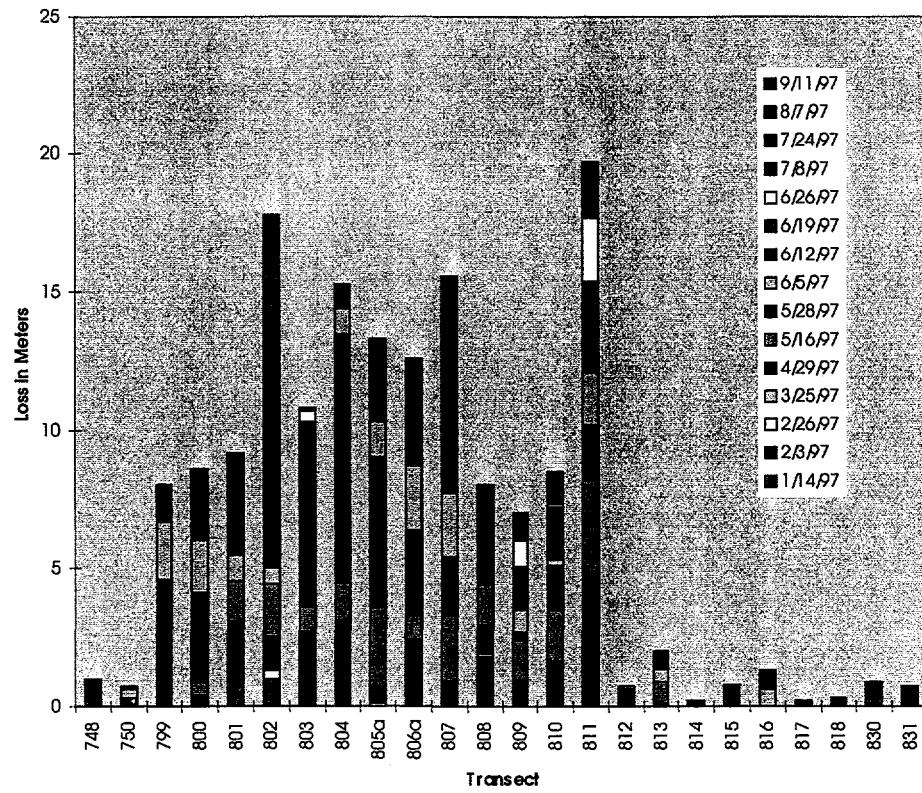
Figure 3.12. Erosion Along the Eastern Bank of Locke Island From December 6, 1996, Through December 11, 1997

Erosion along the east shore of Locke Island and along the entire Hanford Reach was substantial as a result of sustained high waters during the spring flood of 1997. Approximately 2 acres of surface land was lost from the island during this reporting period. Assuming an average bank height of 6 meters, approximately 47,800 cubic meters of sediment entered the river during this time. Figure 3.12 summarizes the erosion that occurred at each transect. Transect 811 experienced the greatest loss (19.6 meters) during 1997 as a result of river current changes. Before the 1997 flood, the bank at Transect 811 had been relatively stable, well vegetated including a tree. Only 1 m was lost at this transect the previous year (Figure 3.13). The actively eroding cutbank expanded both to the north and south during the year. Indeed, much of the perimeter of the island suffered erosion as a result of the sustained high water. Figure 3.14 summarizes the total loss along the monitored bank since the project began in the fall of 1995.

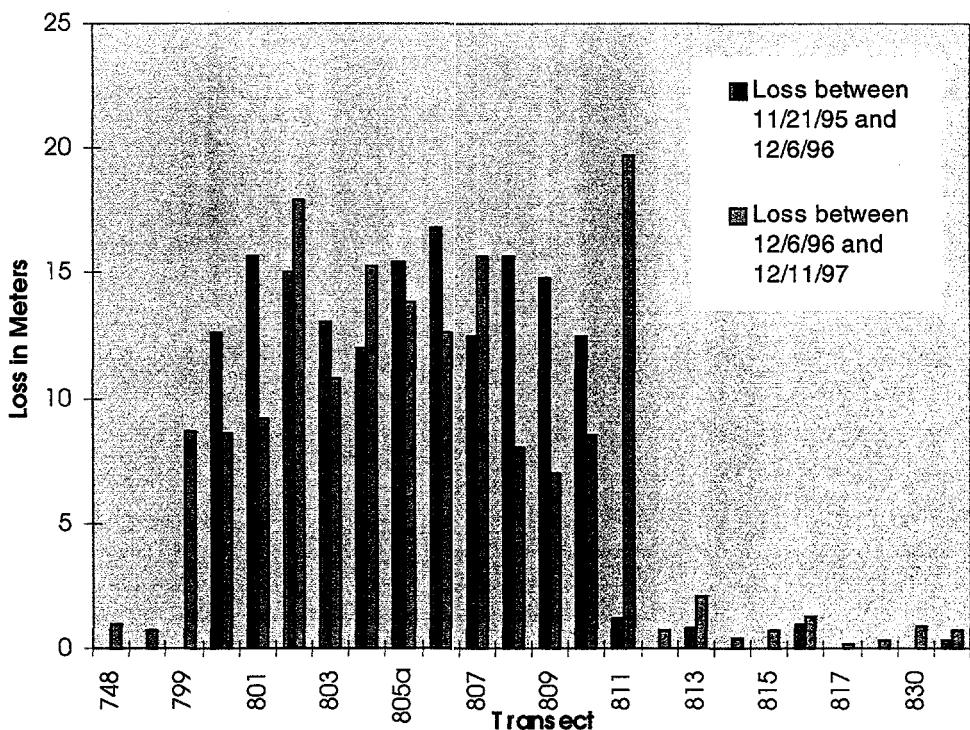
Figure 3.13. Comparison of Bank Erosion by Transect Along the Eastern Edge of Locke Island in 1996 and 1997

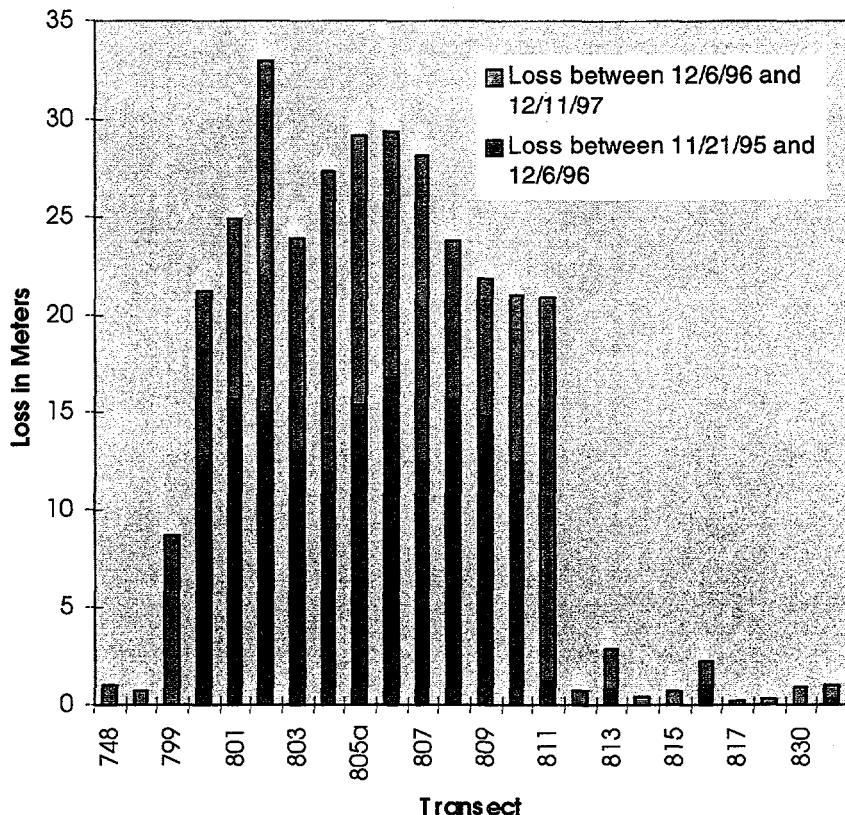
Figure 3.14. Cumulative Bank Erosion Along the Eastern Bank of Locke Island in 1996 and 1997

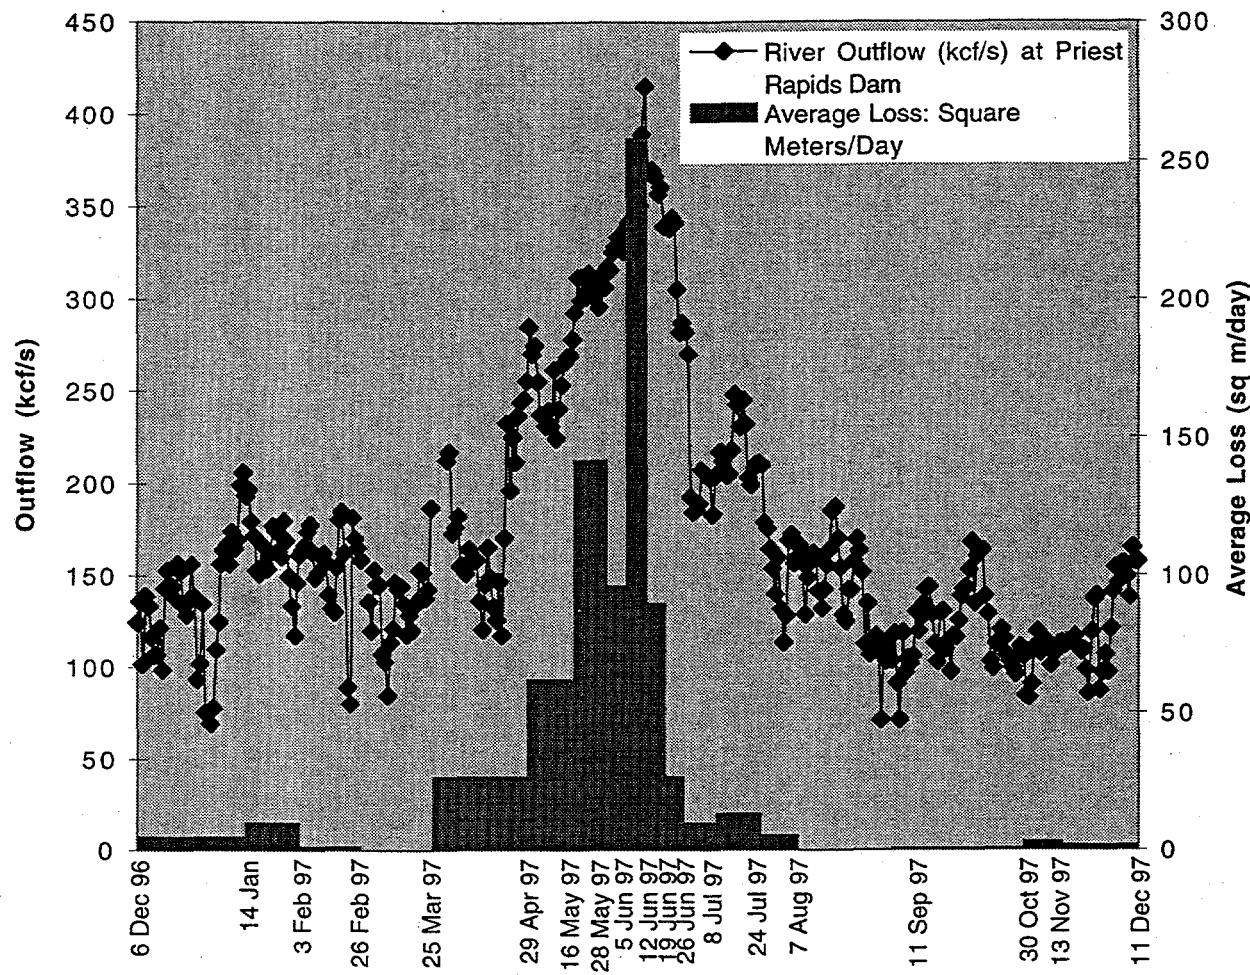
Figure 3.15. Comparison of High River Flow and Periods of Active Erosion in 1997

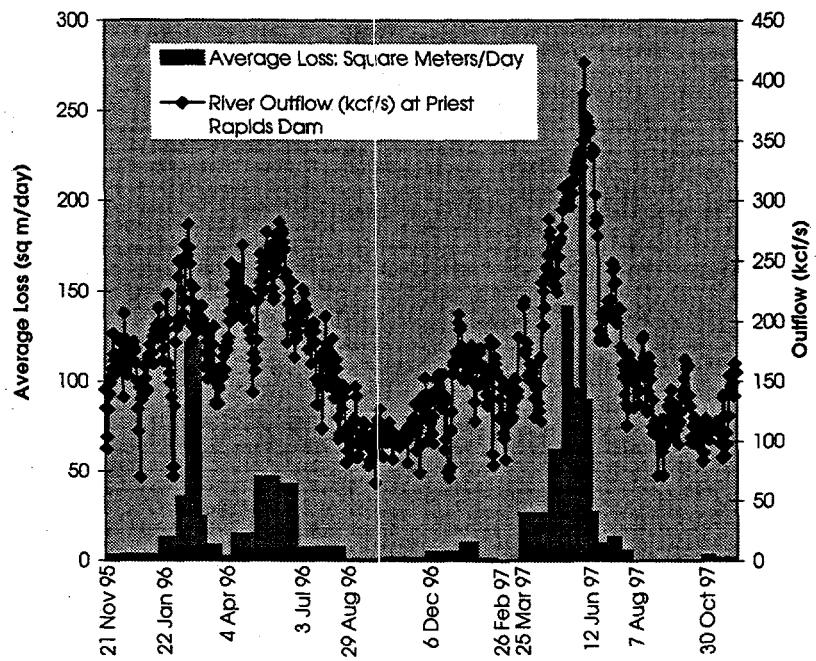
Figure 3.16. Comparison of High River Flow and Active Periods of Erosion in 1996 and 1997

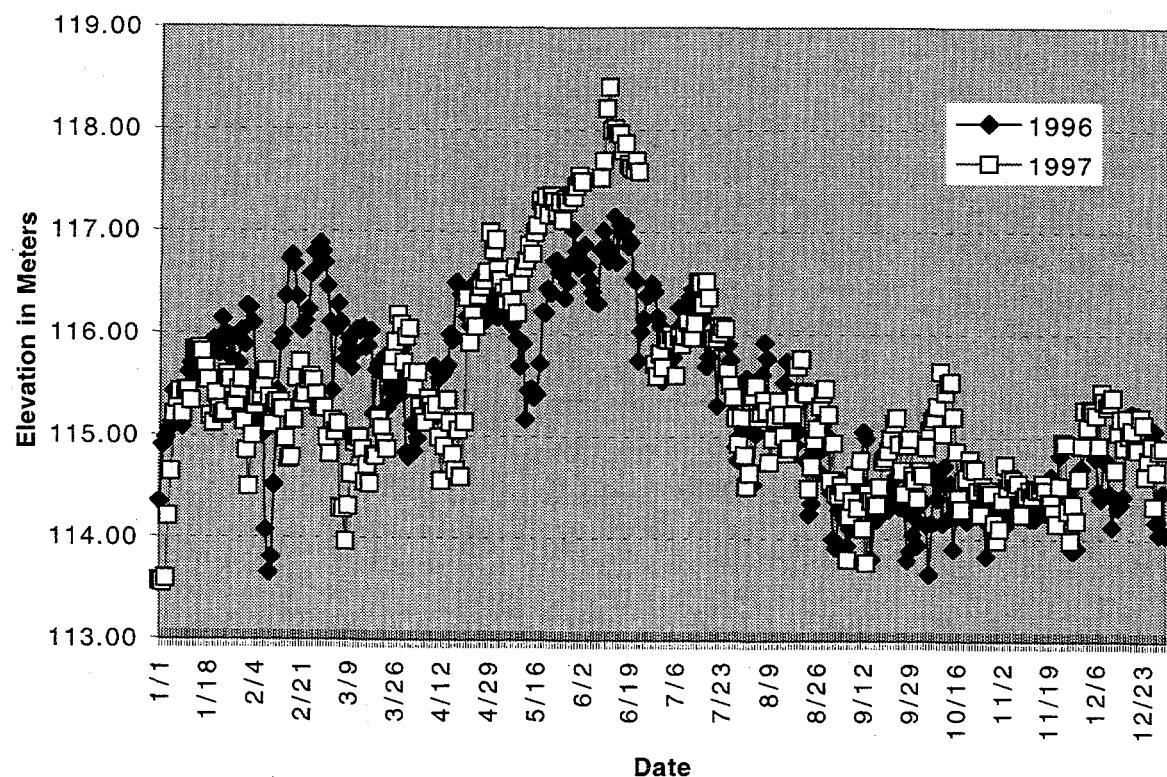
Figure 3.17. Elevation of the Columbia River at the 100-H Gauging Station in 1996 and 1997

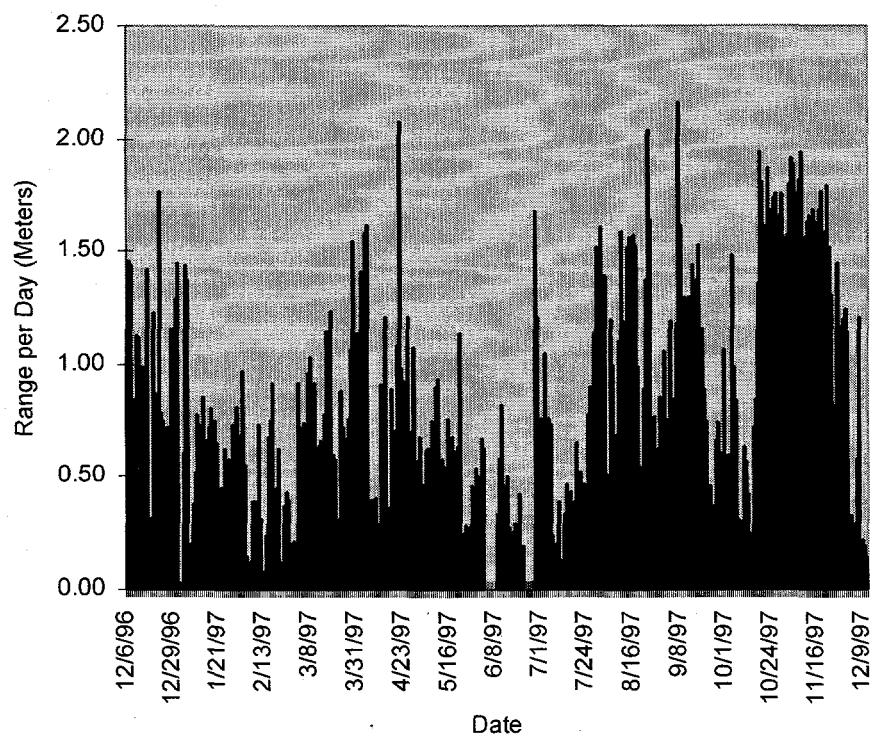
Figure 3.18. Fluctuation of the Columbia River in 1997

The daily river fluctuation was much less severe during 1997 during periods of high water compared to 1996. The maximum fluctuation was 1.14 meter during the period mid-May through June when flows
