August 1998

**Monitoring Bank Erosion at the Locke
Island Archaeological National Register District:
Summary of 1996/1997 Field Activities**

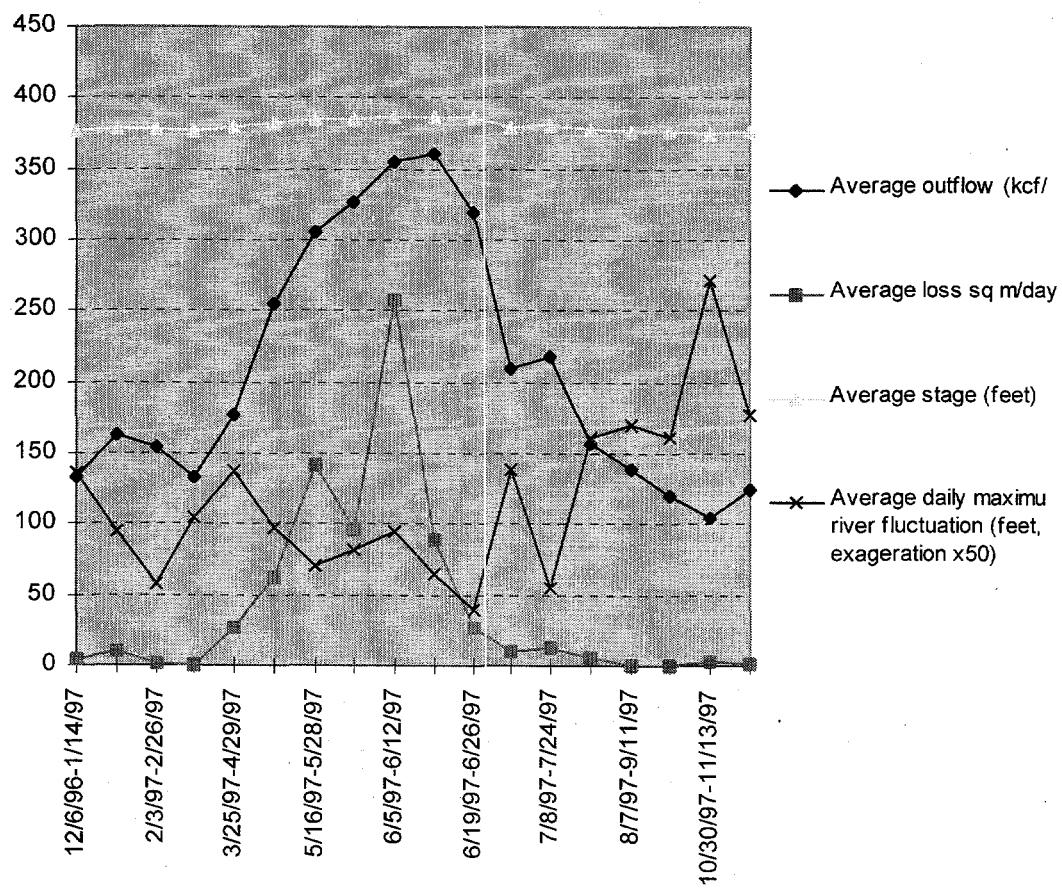
Figure 3.19. Comparison of Bank Loss at Locke Island, River Stage, and River Fluctuation

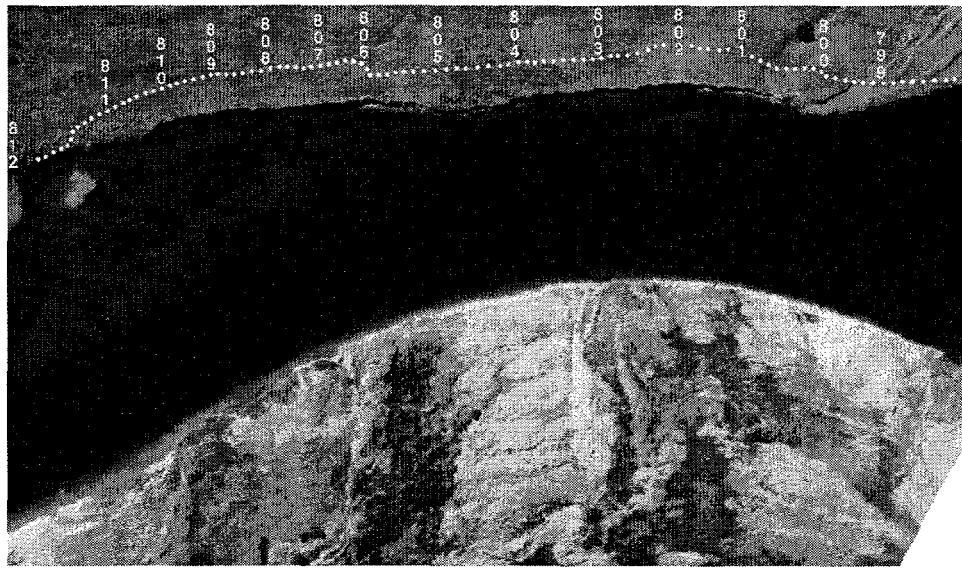
Figure 3.20 Aerial Photograph of the Locke Island Study Area and Landslide (October 5, 1995).
Dotted line indicates bankline position on November 24, 1997, with transect locations indicated. (Photograph #W95-18-23).

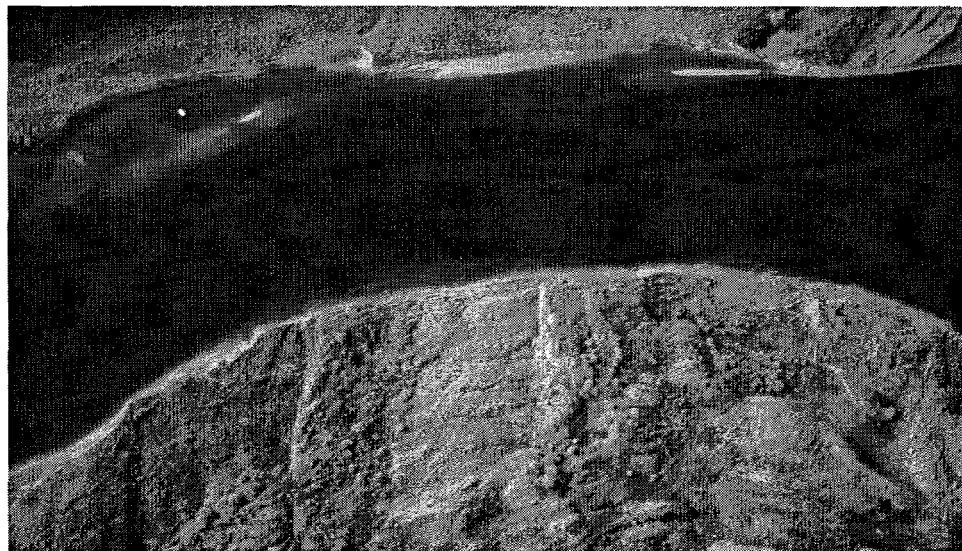
Figure 3.21. Aerial Photograph of the Locke Island Study Area and Landslide (November 1997).
Note newly formed gravel bars and truncated toe of the landslide.
(Photograph #97120302-26CN).

Like all rivers, the Columbia River system in this area is dynamic. Not only is the eastern bank of Locke Island receding, but the toe of the landslide is also being eroded away by the current. Sediment from these sources is being redeposited below in the channel, affecting the flow of the river. As noted above, gravels are being eroded from the shoreline of the upper island and are changing the channel bottom east of Locke Island. Bank recession can be expected to continue along the eastern edge of Locke Island during periods of high flow as long as the river channel continues to be constricted by the major landslide on the opposite bank.

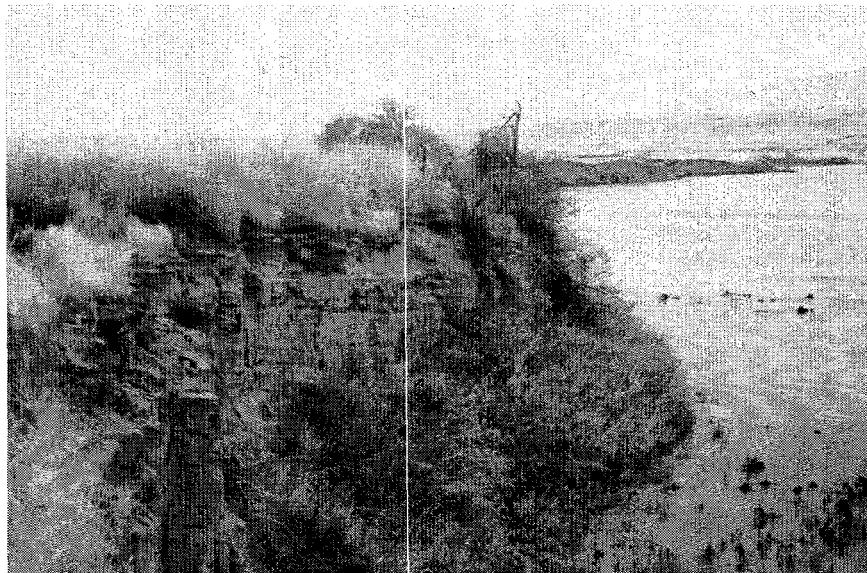
Figure 4.1. View of the Cutbank at Transect 816, Looking Northeast (November 21, 1995). The surface of the bank was weathered and the toe vegetated, suggesting relative stability of the cutbank at that point in time (PNNL 215/33).

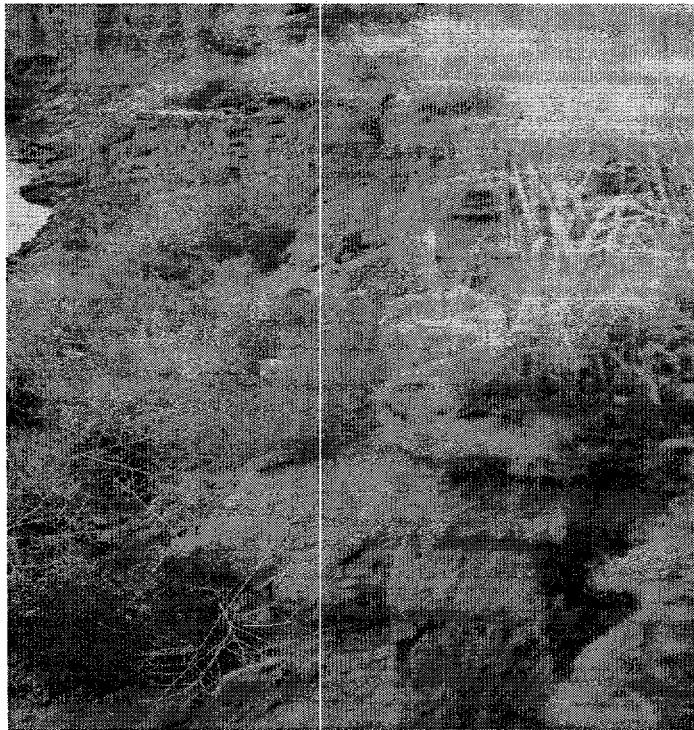
Figure 4.3. The Cutbank Below Transect 806 Appeared Eroded but Stable and Vegetated in 1995 (PNNL 215/08)

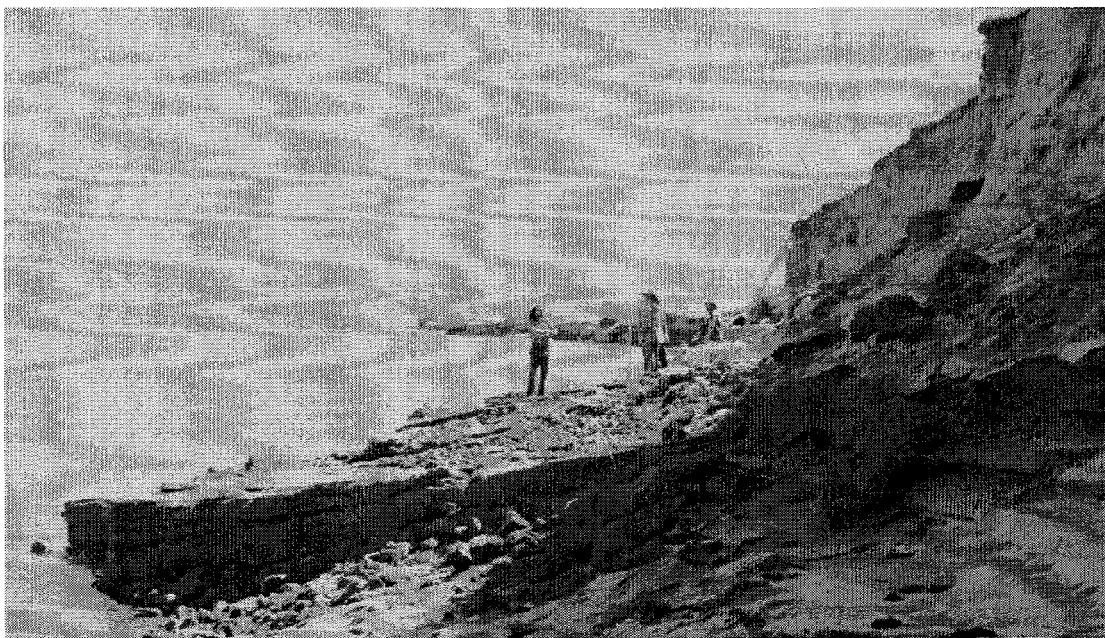
Figure 4.4. Southerly View of the Cutbank at Transect 806 Following the Loss of 10 Horizontal Meters. The individuals shown are standing on a remnant of the original cutbank; its face was to their immediate left of the photograph's lower center (PNNL 221/7).

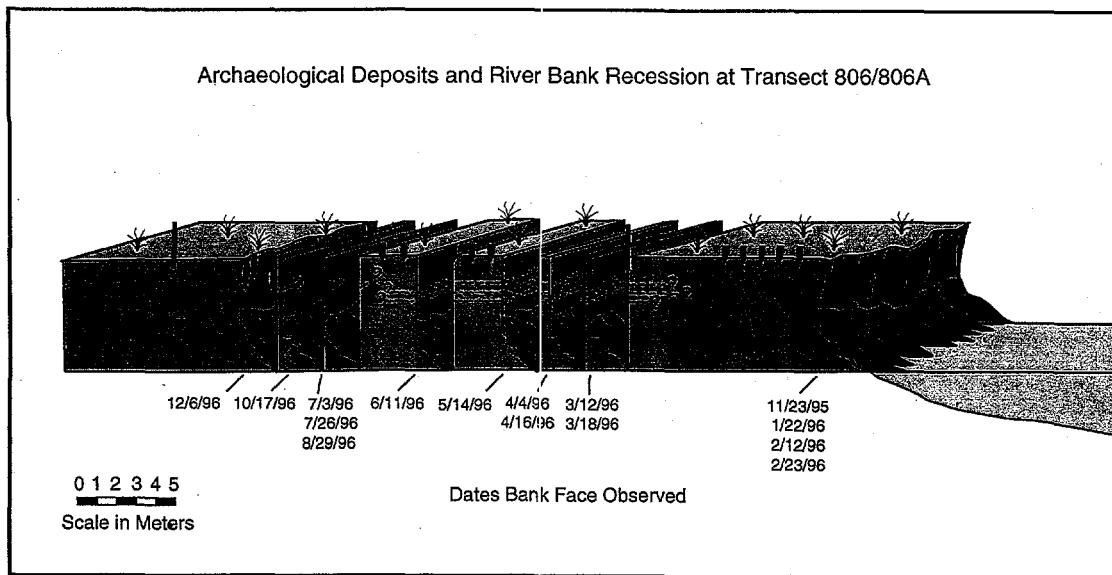
Figure 4.5. Large Cultural Layer Exposed at Transect 806 During the 1996 Monitoring Cycle

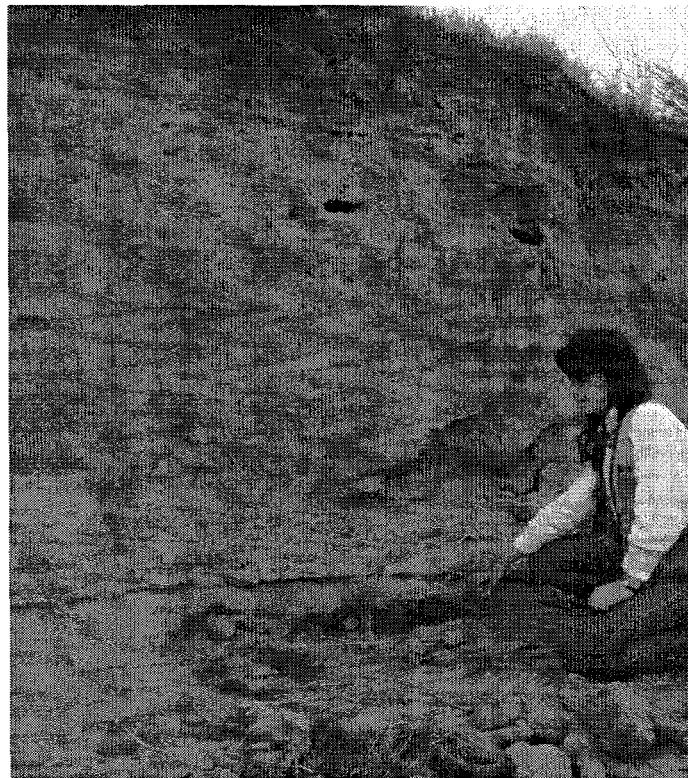
Figure 4.7. Buried Hearth Feature at Transect 831
