# Pre-Transient Characterization of MLOF-1 Test Pin

INL/CON-25-84678

# Addressing Gaps in Transient Behavior of Metallic Fuel

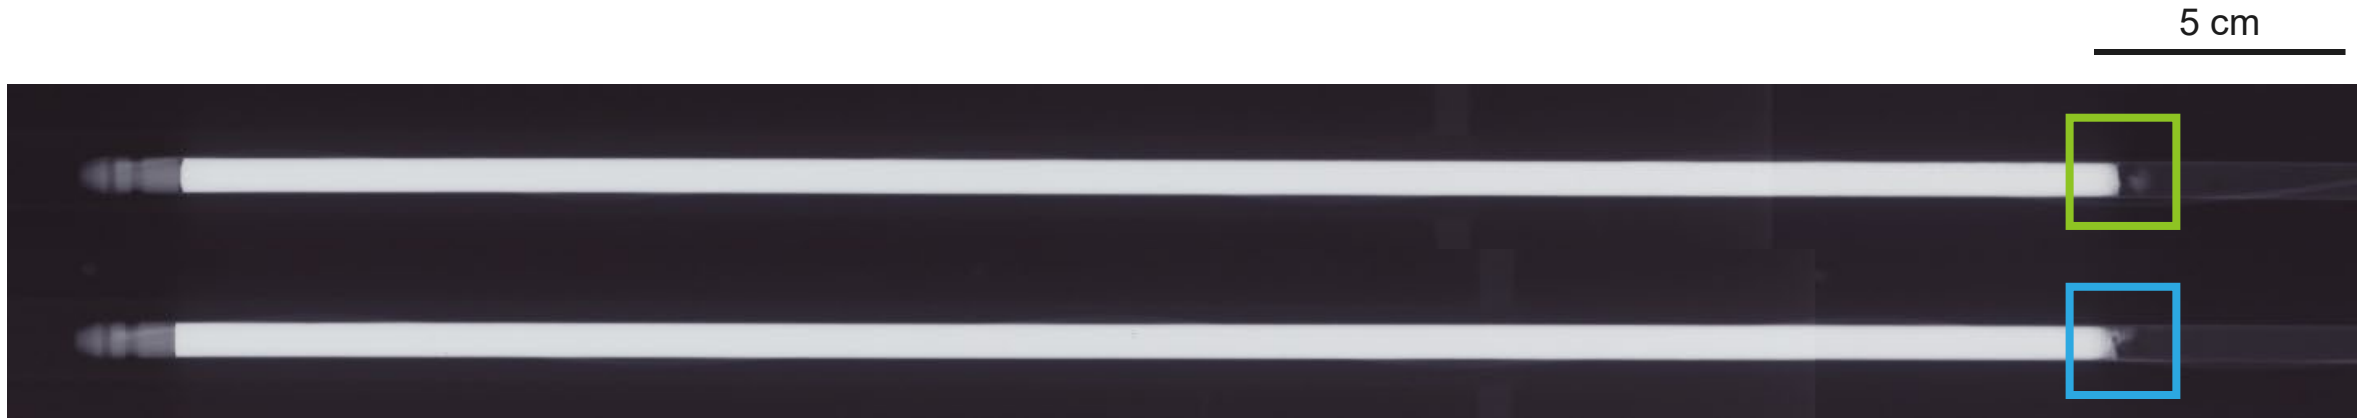
# Axial fuel strain and fluff structure length measured with neutron radiography

Pin	Test	Sibling
Fuel Pin ID	T-679	T-681
Peak BU (at. %)	7.4	7.3
Axial Strain (%)	8.2	8.0
Fluff Length (cm)	0.44	0.71

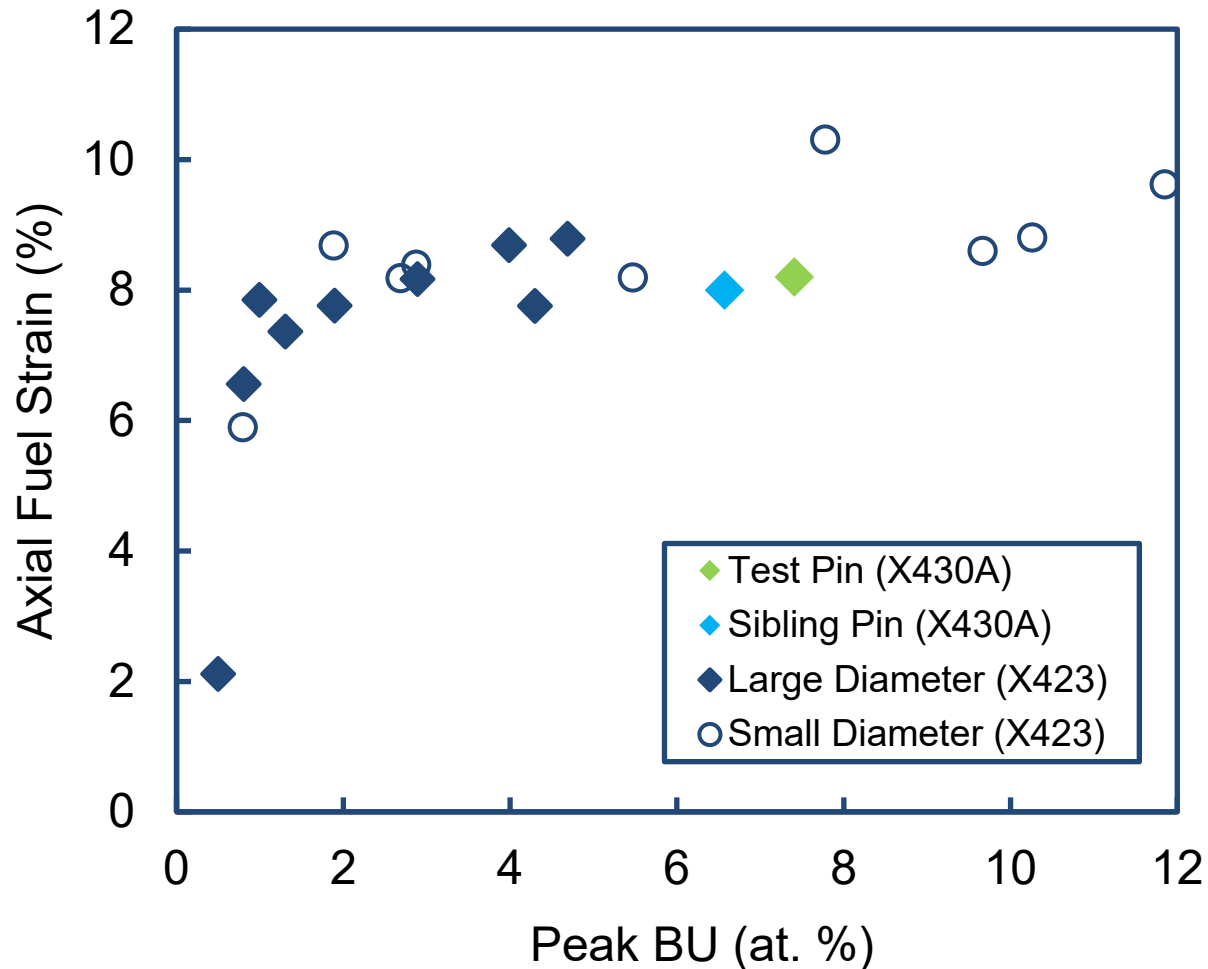
# Axial fuel strain and fluff structure length compare well with reported values

Typical behavior observed for U-Zr alloys  
To consider: X423 ran at lower temp. and 316SS-clad

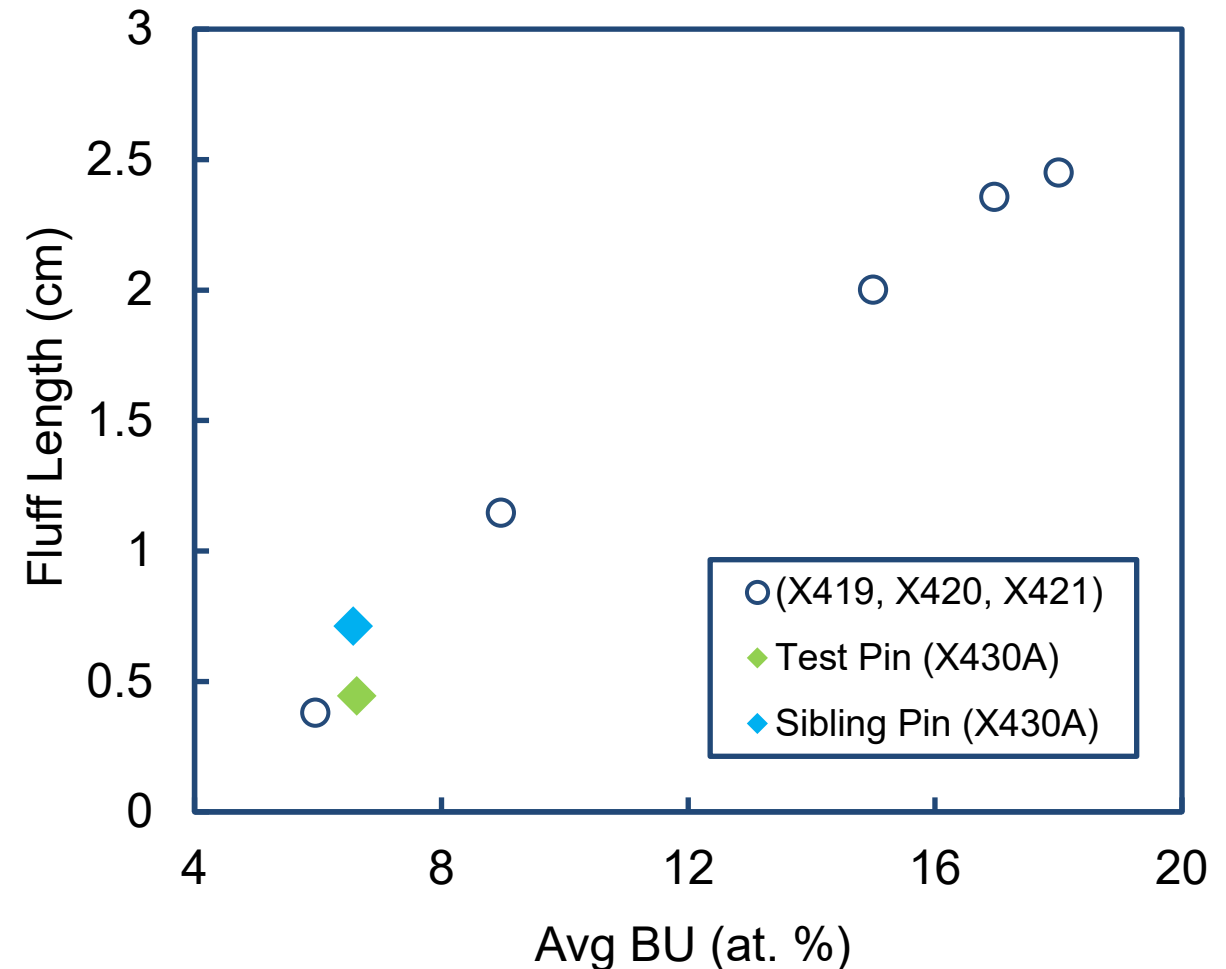
Aligns well with fluff structure trend for U-Zr alloys  
To consider: Smaller diameter pins and D9-clad

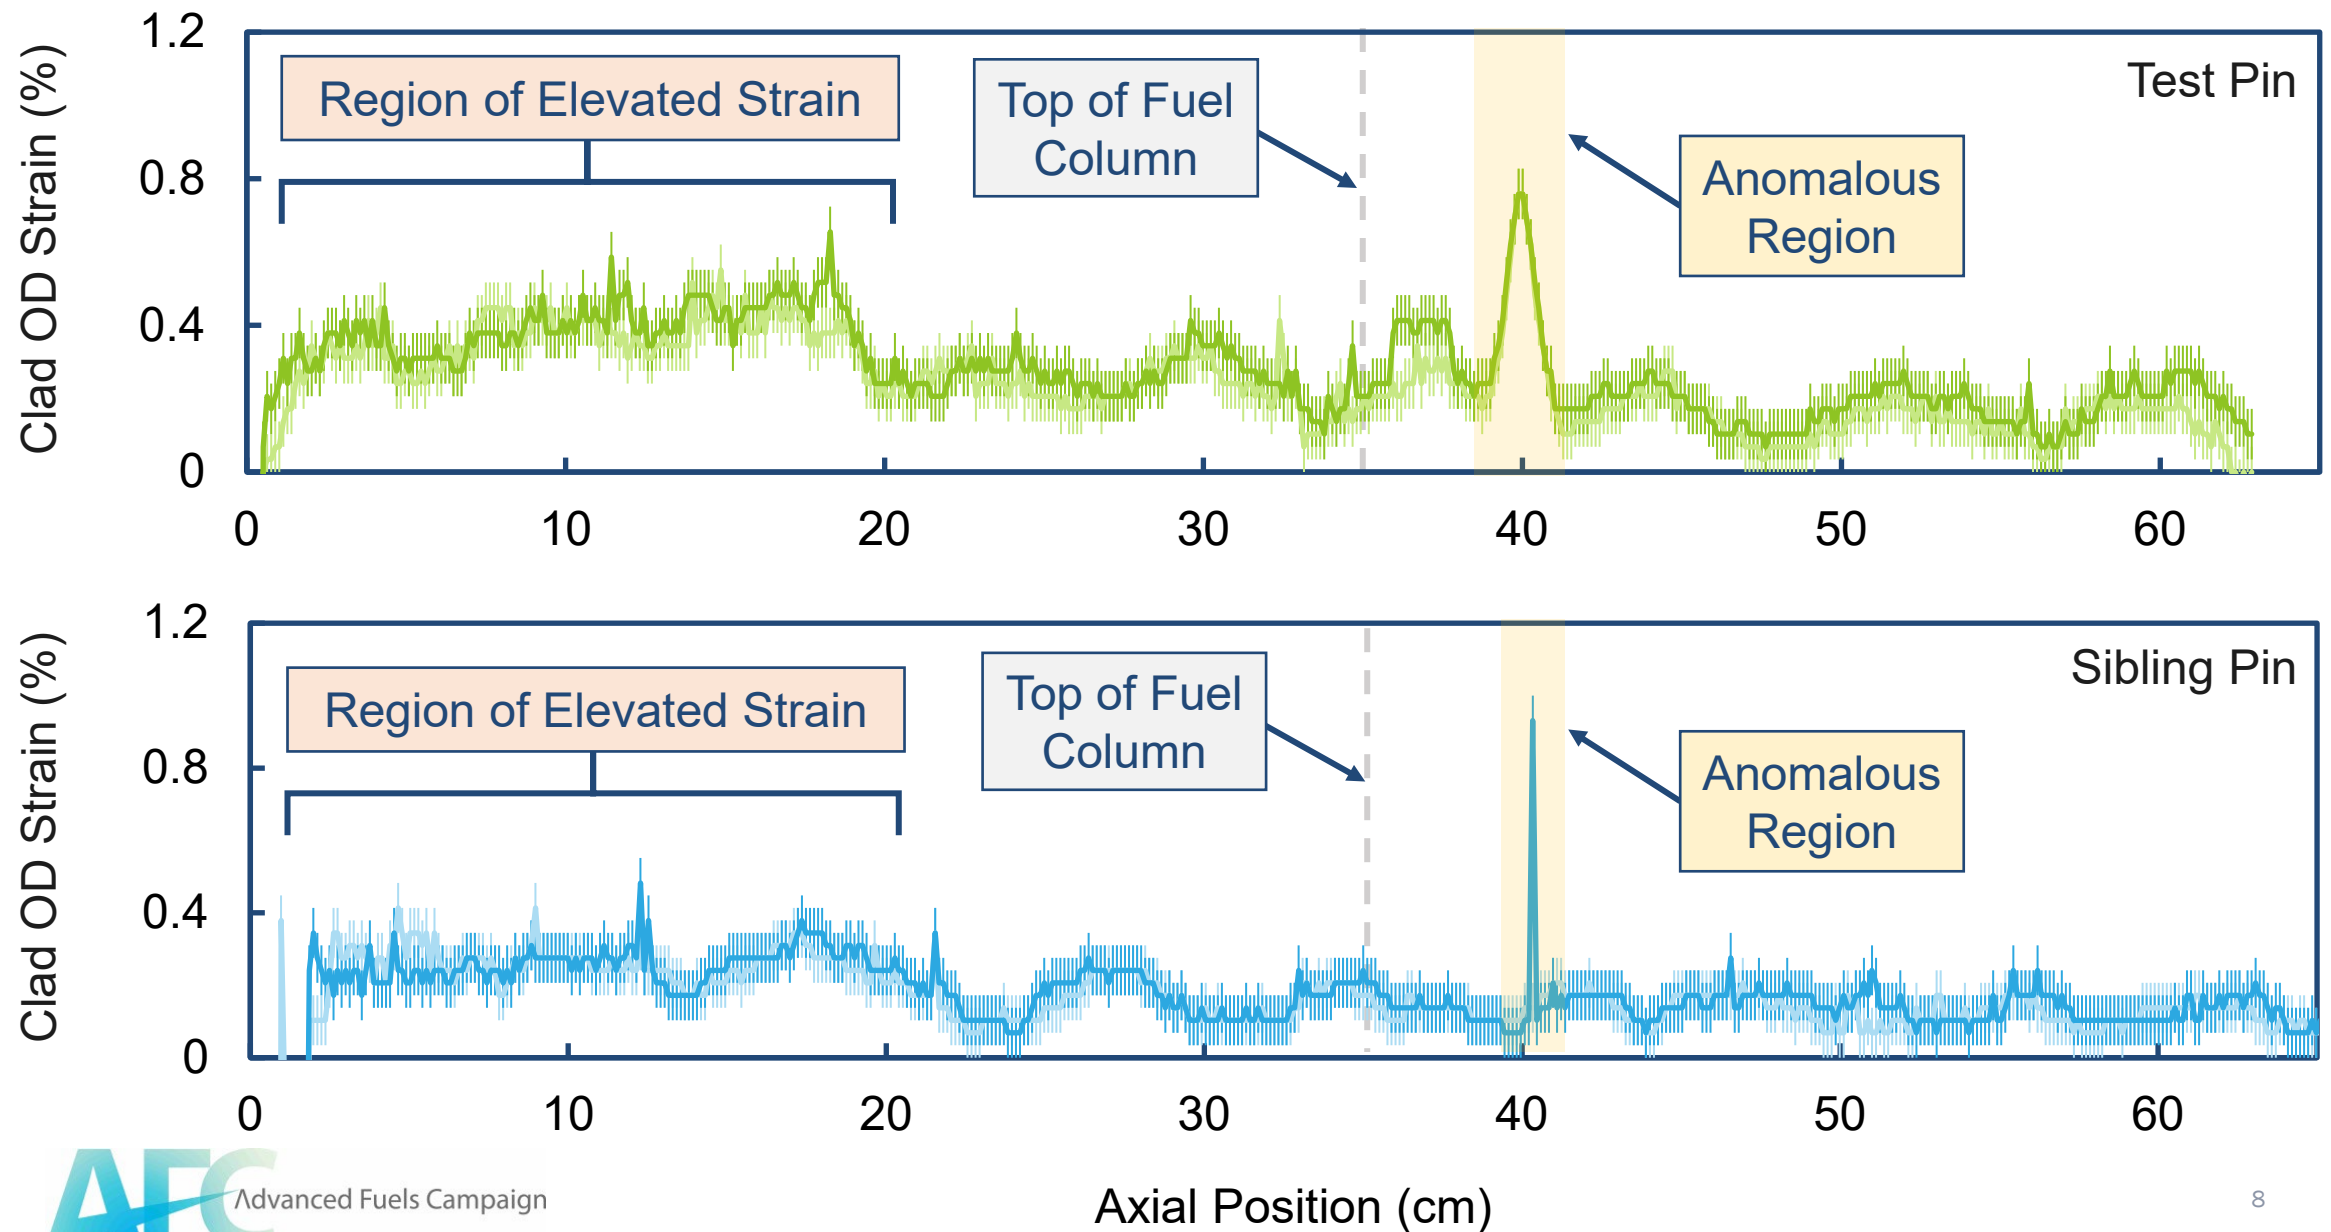
# Typical diametral strain value and location, but anomaly above fuel

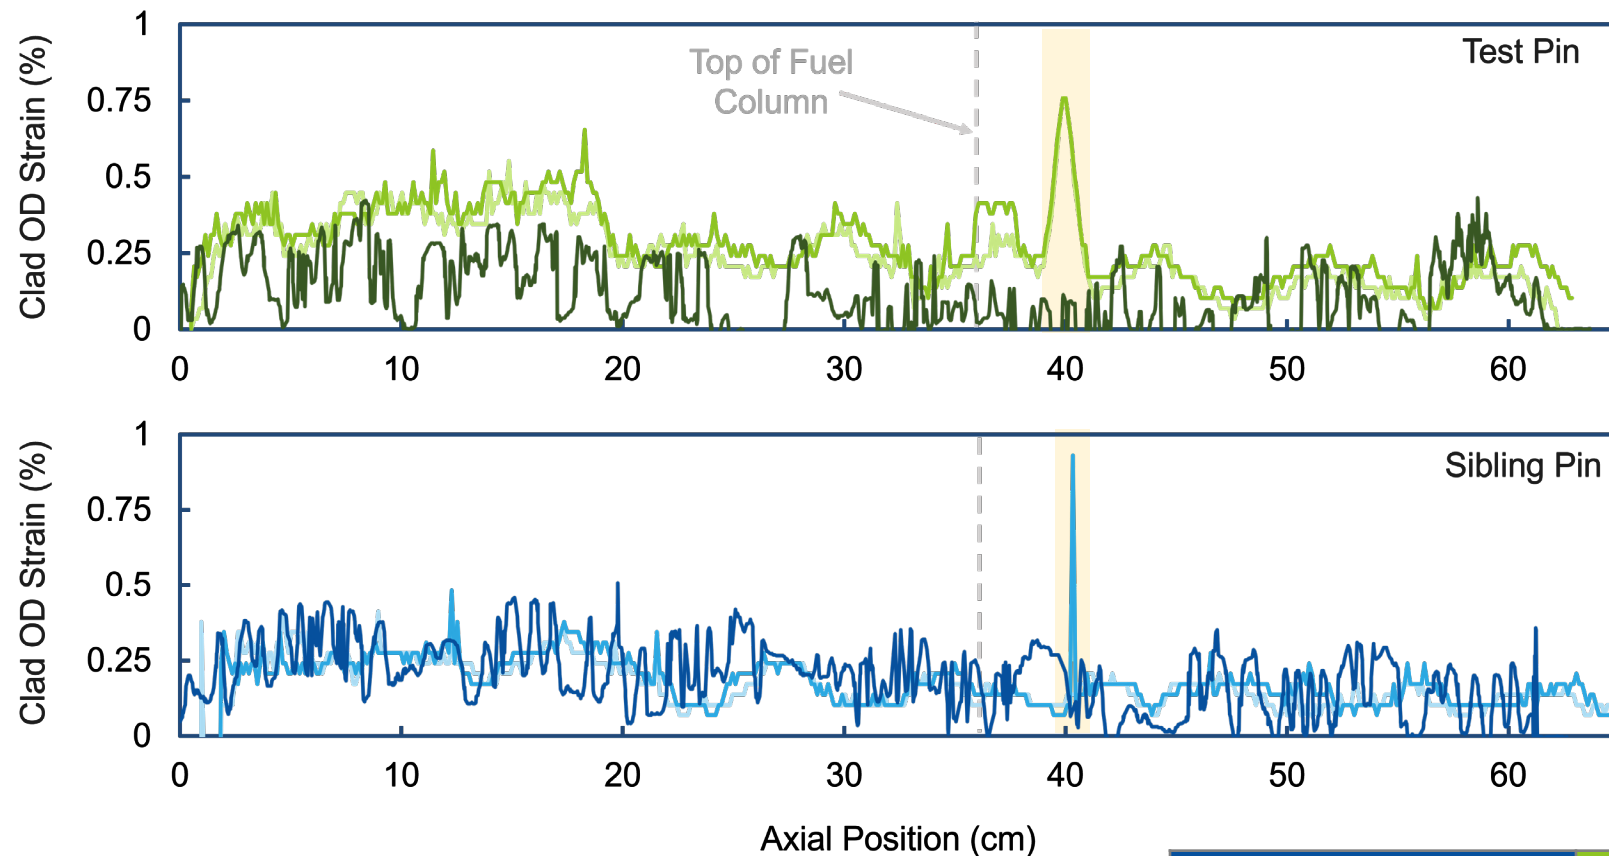
# Mild strain accumulation in X430A, but still within expected values

- Peak above fuel column attributed to loose wire wrap present on the pins
- Strain in lower half of the fuel column shown to be statistically larger than upper half
- Modest and expected outer cladding strain behavior

Pin	Test		Sibling	
Fuel Pin ID	T-679		T-681	
Peak BU (at. %)	5.1	7.4	5.1	7.3
Max. Clad Strain (%)	0.24	0.68	0.34	0.34

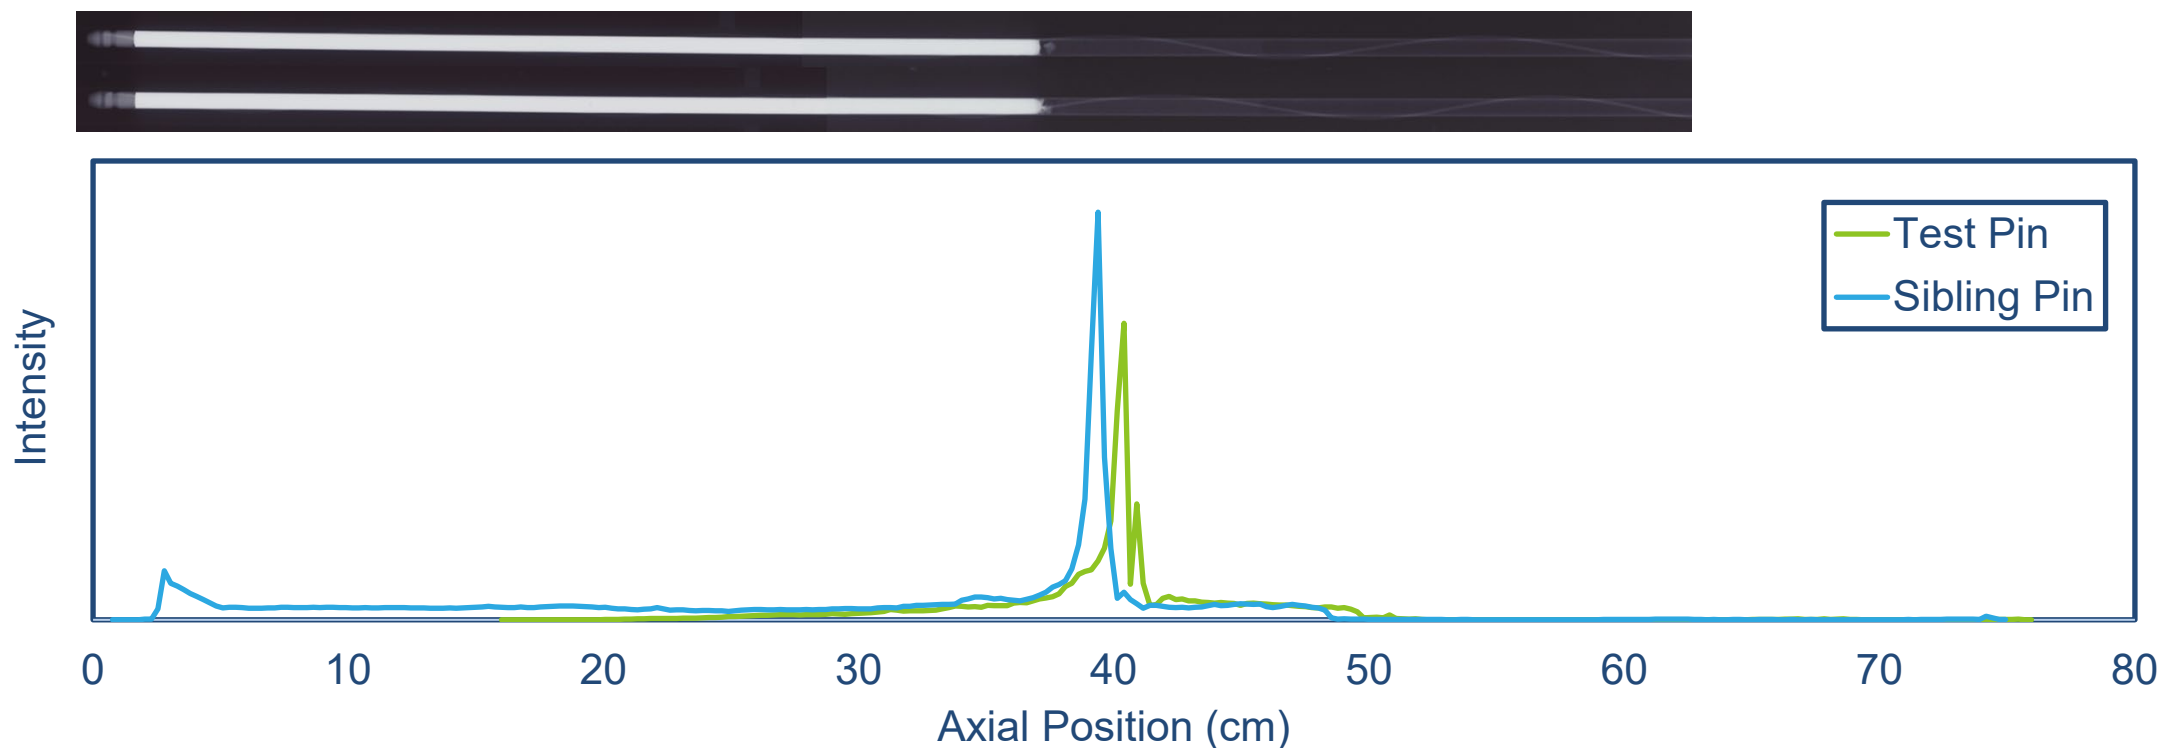
# Axial distribution of Cs-137 measured using Precise Gamma Scanning

- Increased concentration of Cs-137 above the fuel column within Na bond, which suggests fuel is intact
- Limited undulation along the fuel column, which agrees with no visible features from radiography

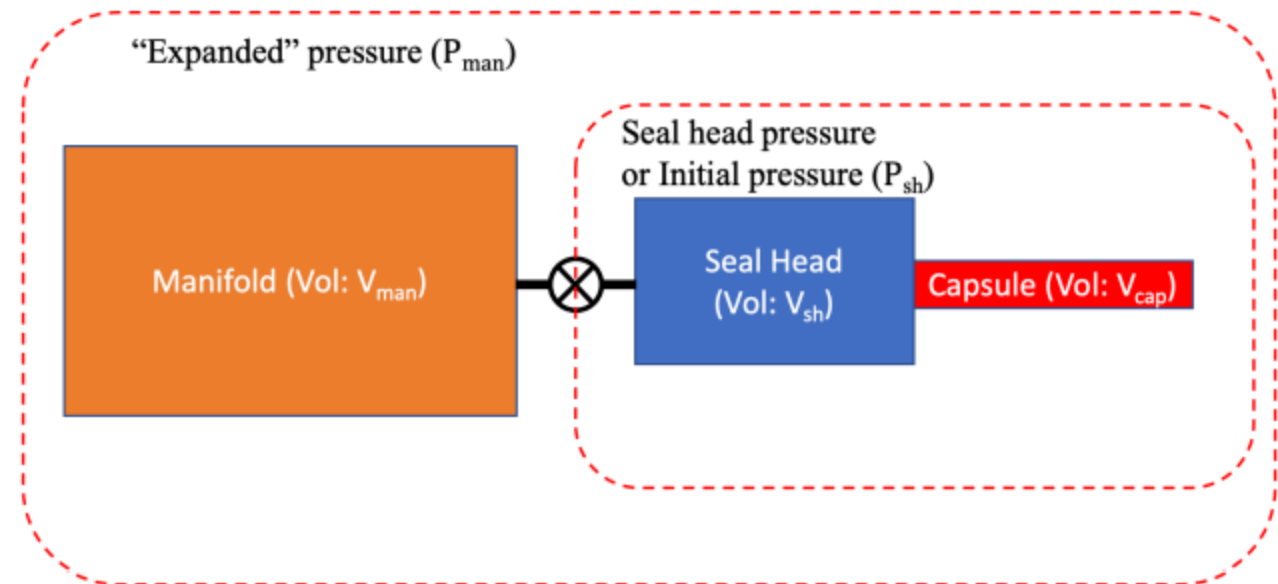
- Sampled fission gas collected in bottle
- Mass spectrometry to determine molar % of fission gas composition
- In mass spectrometry report air contamination of sample was reported
  - Determined by  $3 \leq N_2/O_2 \leq 5$
- Correction factor applied based on natural  $N_2/O_2$  and  $Ar/O_2$  ratios and  $O_2$  as the tracer

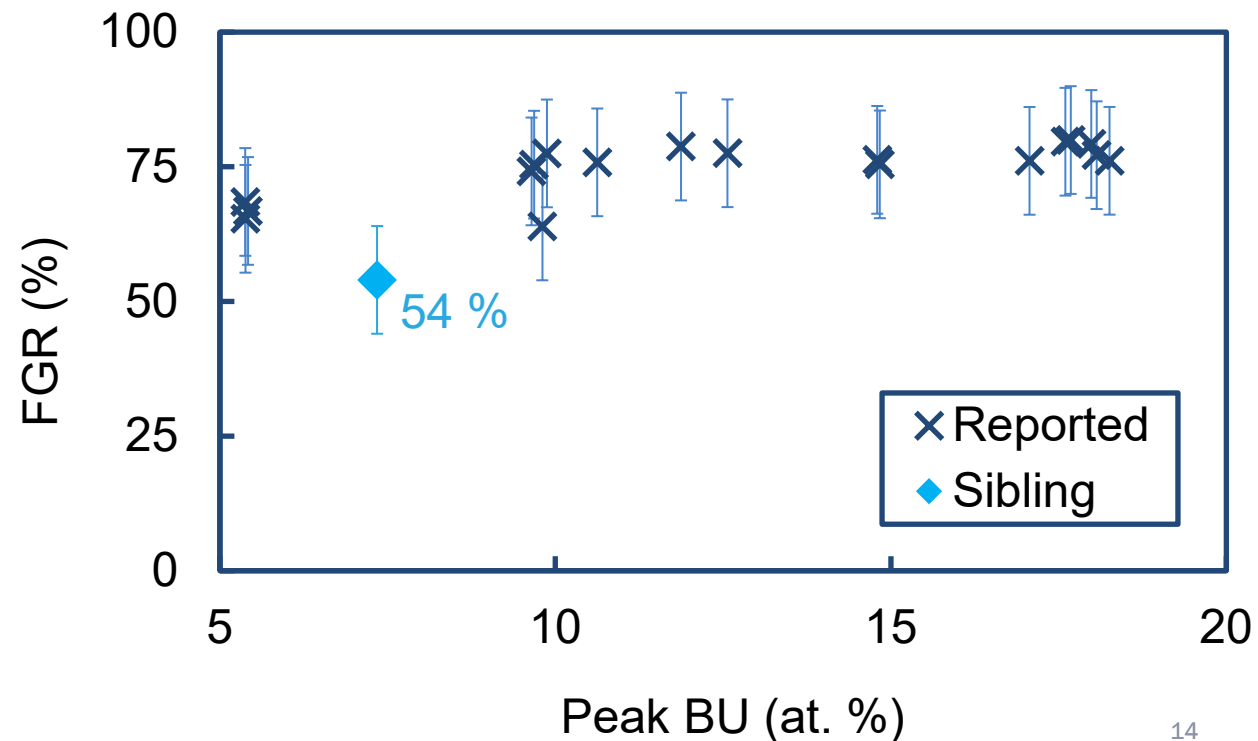
# Measured Fission Gas Release Lower than Expected

- Air contamination likely during sample bottle removal from GASR system, shipping, or attachment to mass spectrometer
- Correction provided by PNNL increased FGR 44% → 54%
  - Higher than expected N %
- Considered decay half life contribution
- Potentially affected by non-uniform mixing

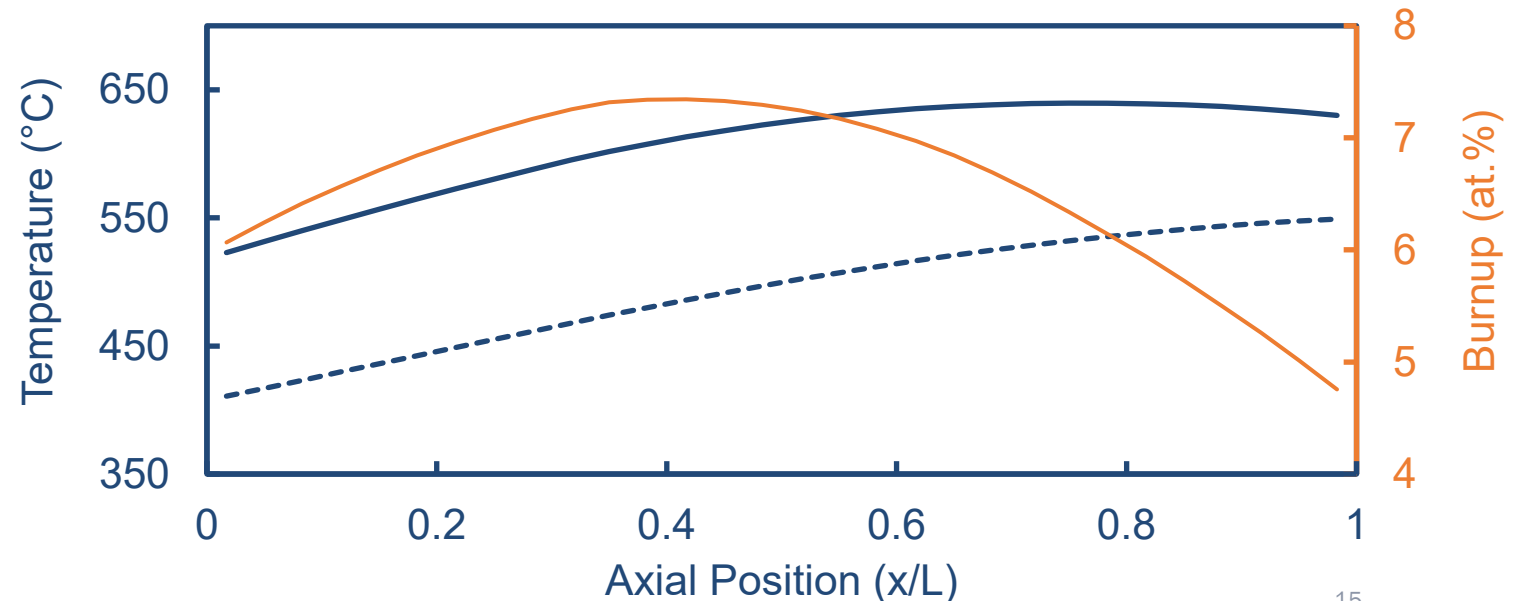
----- Inner Cladding    — Fuel Centerline    — EOL Burnup
