DISCLAIMER

DOE/NV/89233122CNA000255-38-MIT

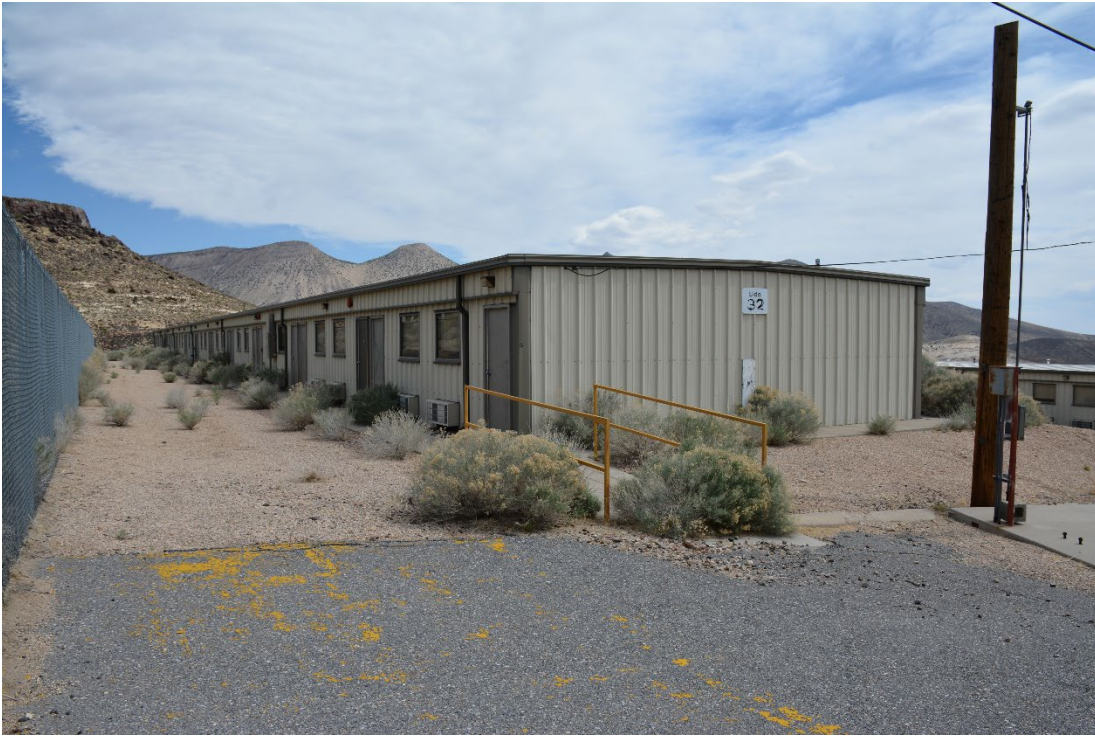
DRI Photo 1: 2531_1596. Overview of the west and south elevations.
Elevation: West/South Direction facing: Northeast Photographer: DRI Date: April 17, 2025

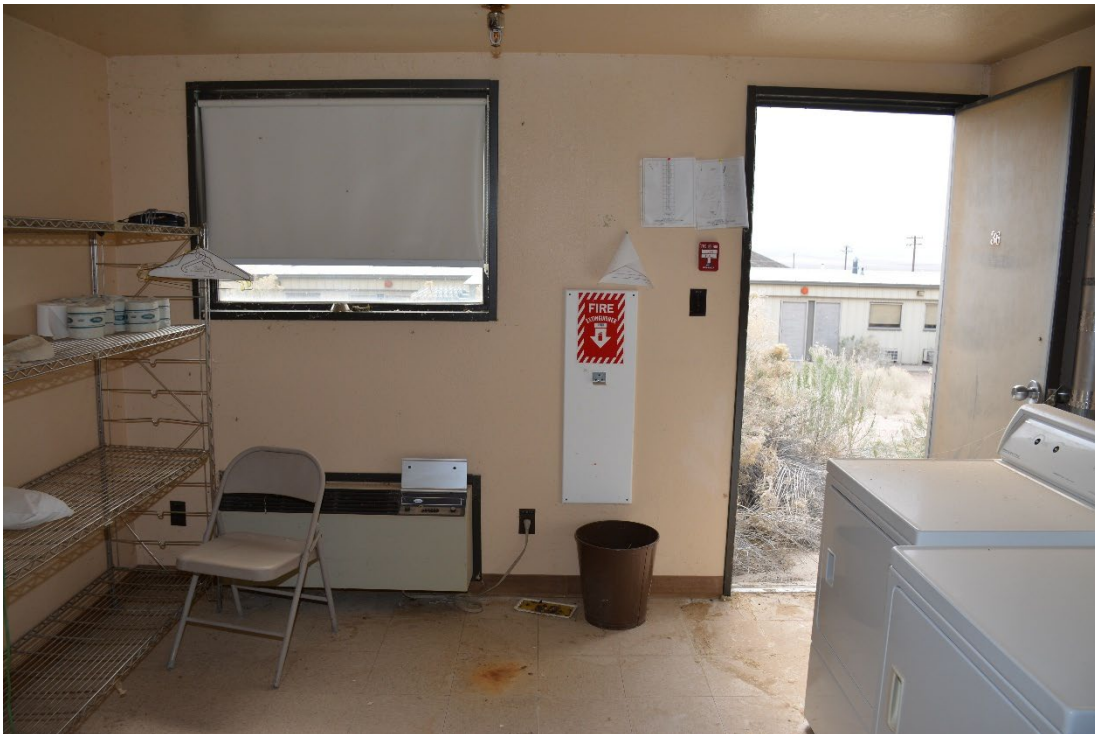
DRI Photo 19: 2531_1574. Room 36, public laundry room interior, dryers, air-conditioner, and wire shelving.
Elevation: NA Direction facing: East Photographer: DRI Date: April 17, 2025

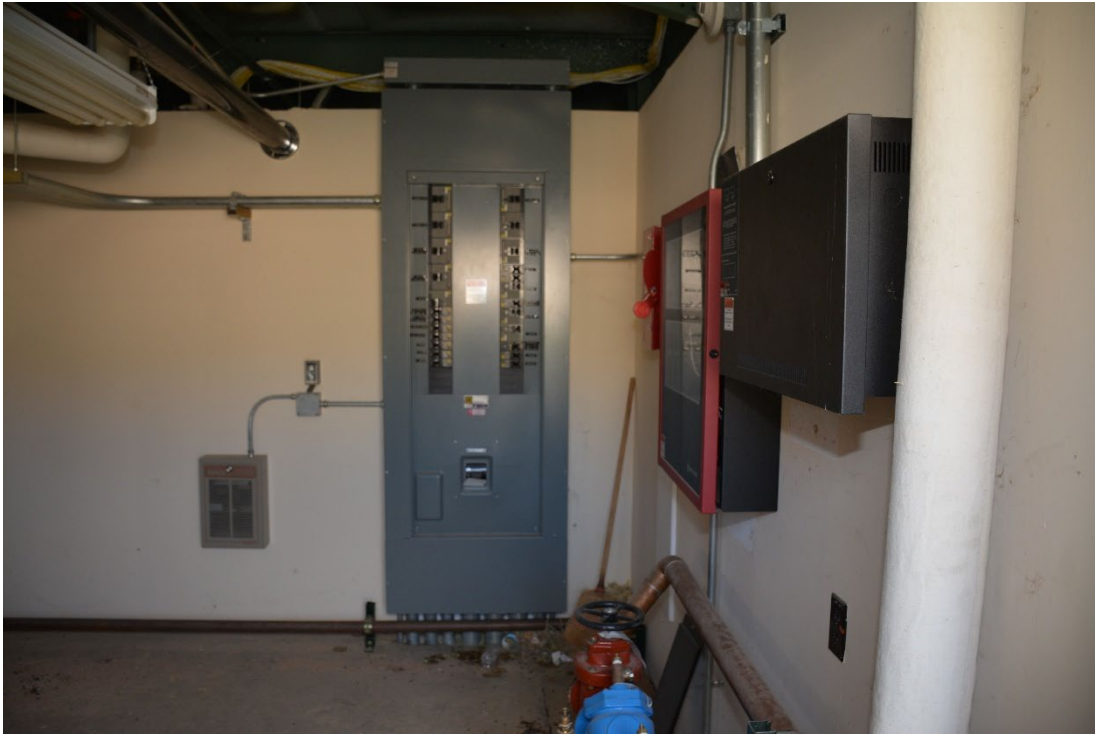
DRI Photo 20: 2531_1610. Room 13, mechanical/equipment room interior, breaker box.
Elevation: NA Direction facing: East Photographer: DRI Date: April 17, 2025

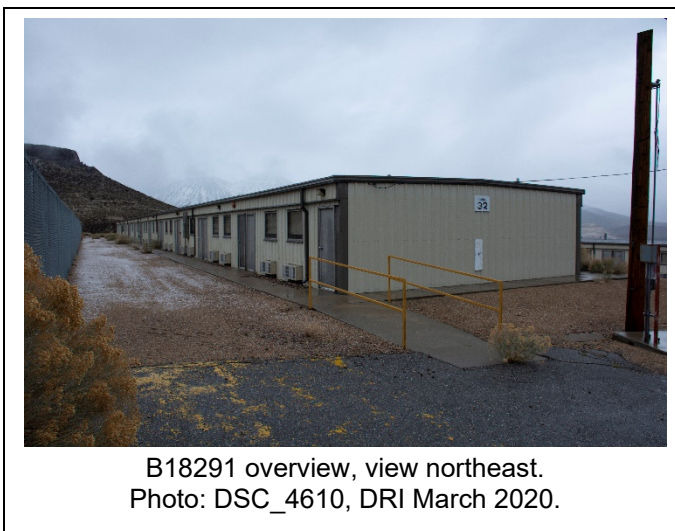
B18291 overview, view northeast.
 Photo: DSC_4610, DRI March 2020.

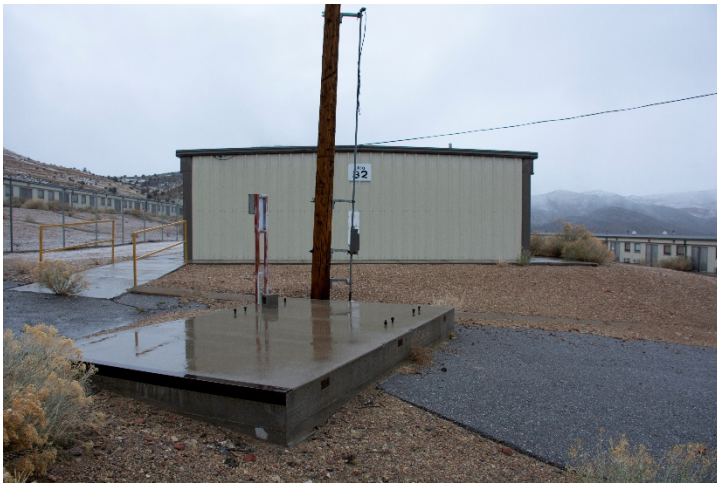
DRI Photo: DSC_4608. AR1 Waste Compactor Foundations.

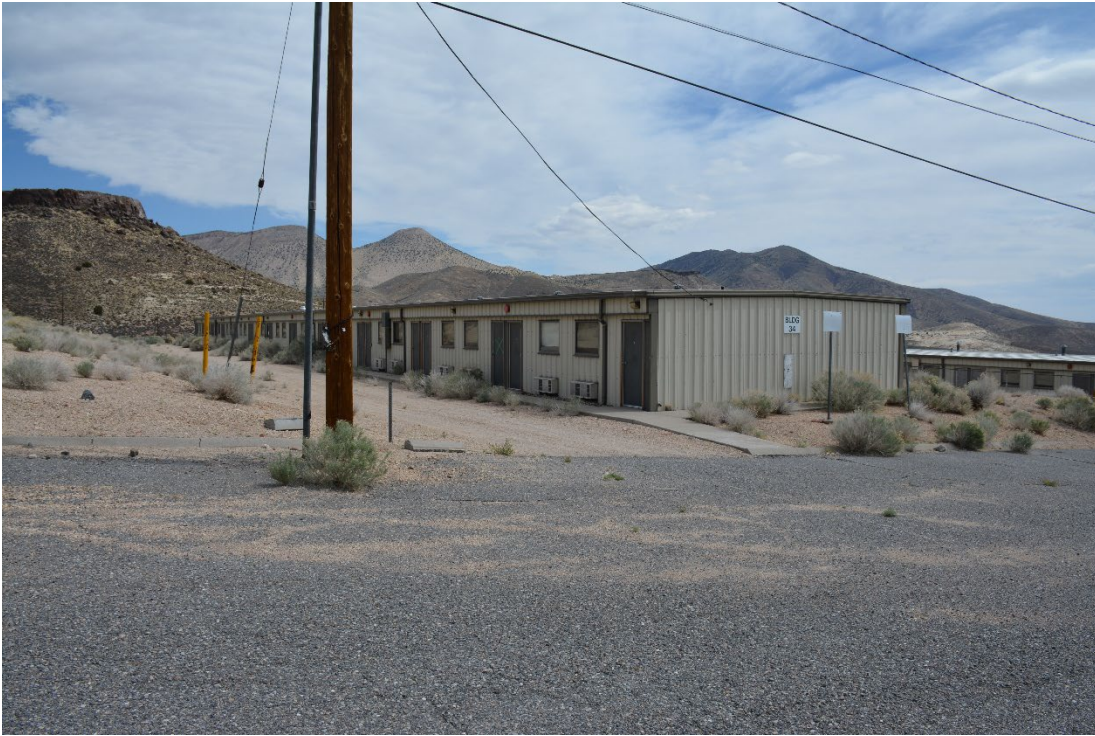
DRI Photo 1: 2531_1595. Overview of the west and south elevations, current condition.
Elevation: West/South Direction facing: Northeast Photographer: DRI Date: April 17, 2025

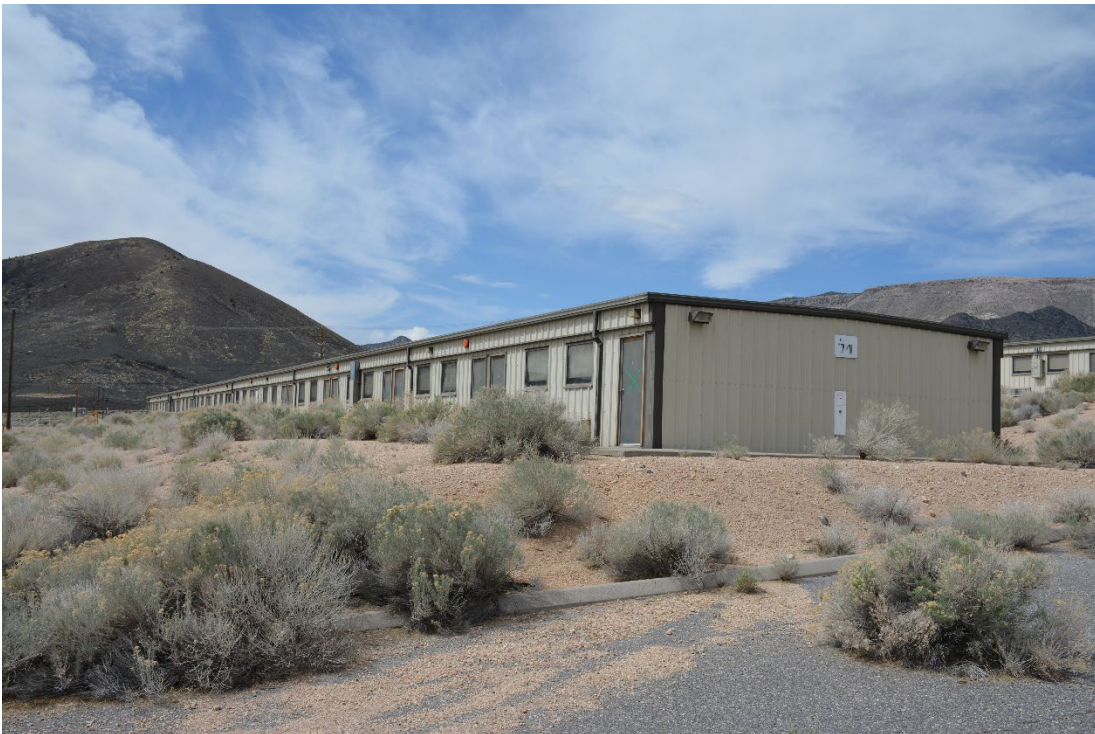
DRI Photo 2: 2531_1605. Overview of the east and north elevations, current condition.
Elevation: East/North Direction facing: Southwest Photographer: DRI Date: April 17, 2025

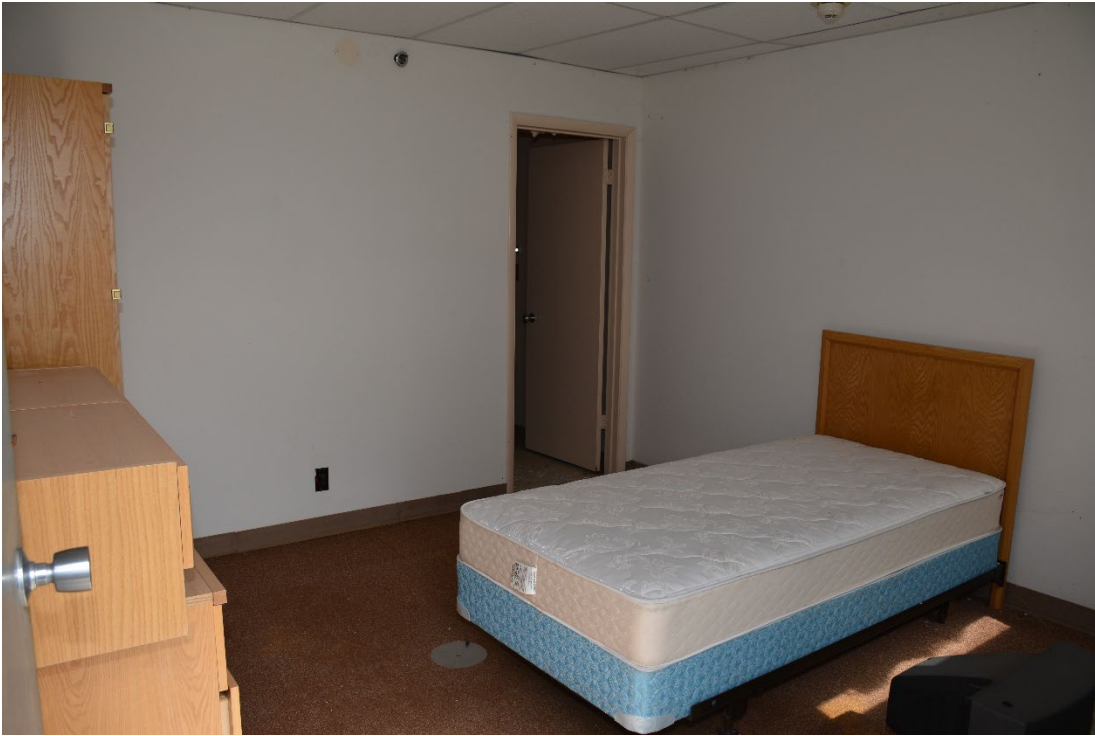
DRI Photo 3: 2531_1578. Room 46, standard bedroom interior.
Elevation: NA Direction facing: Northwest Photographer: DRI Date: April 17, 2025

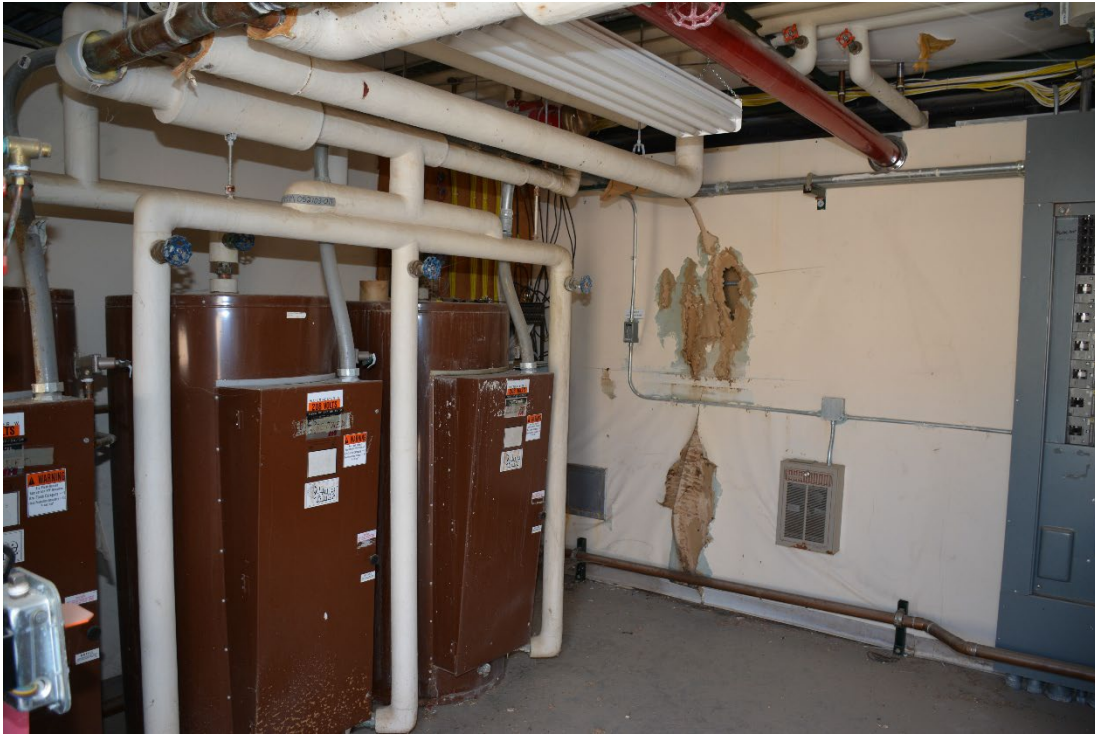
DRI Photo 9: 2531_1616. Room 48, mechanical/equipment room interior, hot water heaters and damaged east wall.
Elevation: NA Direction facing: Northeast Photographer: DRI Date: April 17, 2025

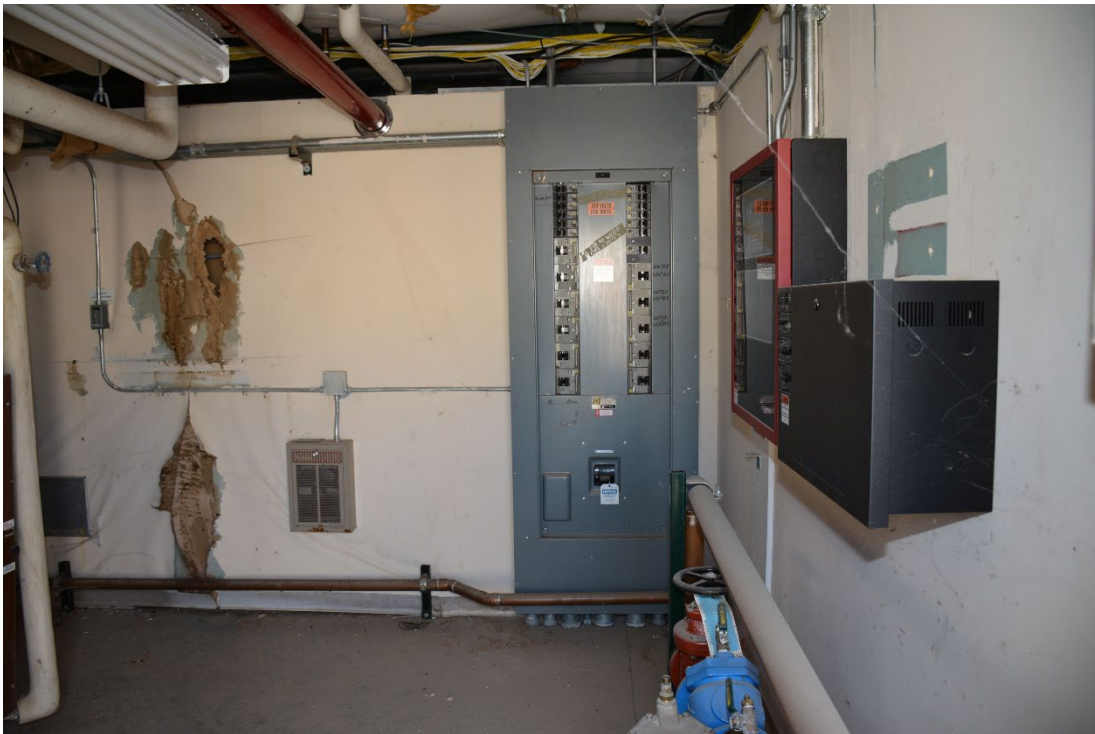
DRI Photo 10: 2531_1617. Room 48, mechanical/equipment room interior, breaker box.
Elevation: NA Direction facing: East Photographer: DRI Date: April 17, 2025

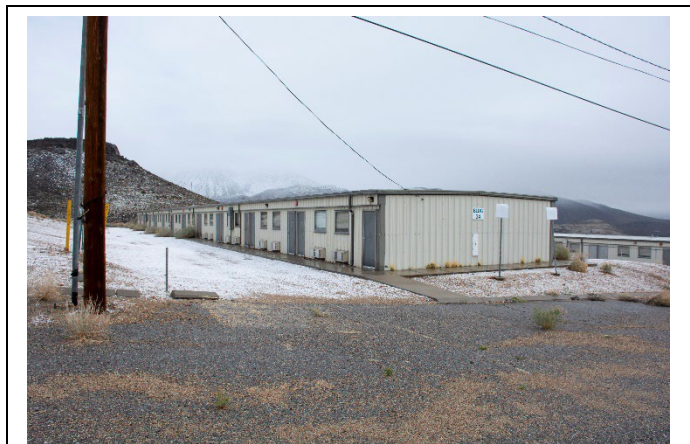
B18292 overview, view northeast.
 Photo: DSC_4650, DRI March 2020.

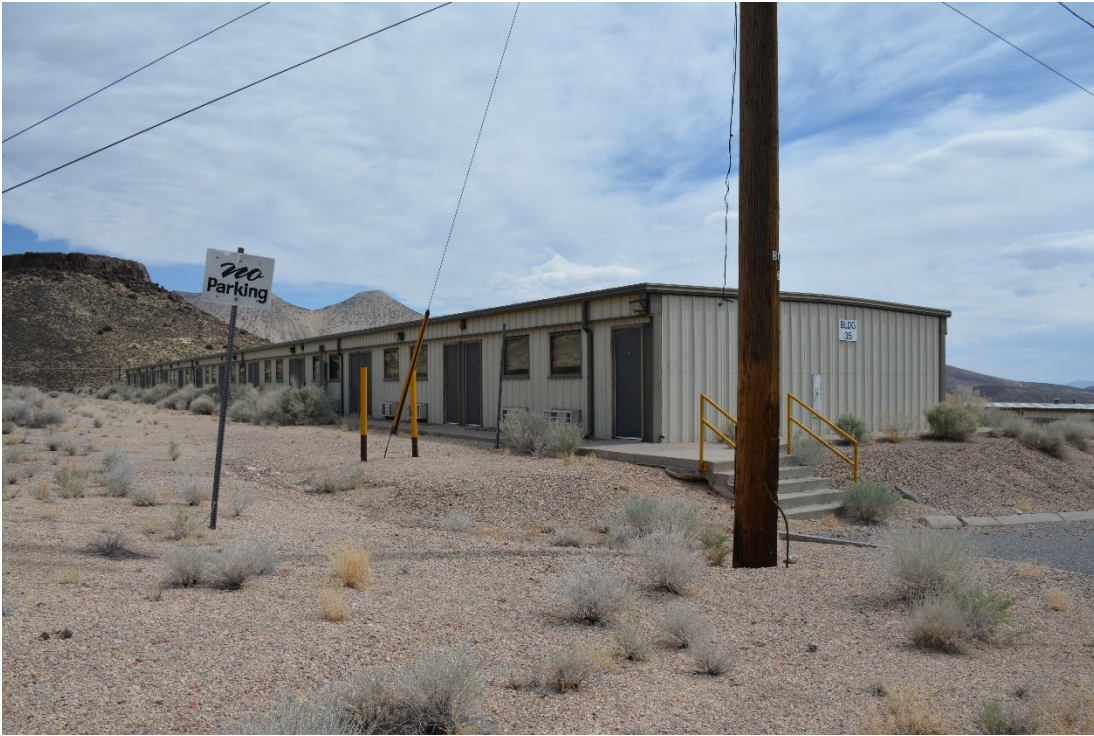
DRI Photo 1: 2531_1592. Overview of the west and south elevations, current condition.
Elevation: West/South Direction facing: Northeast Photographer: DRI Date: April 17, 2025

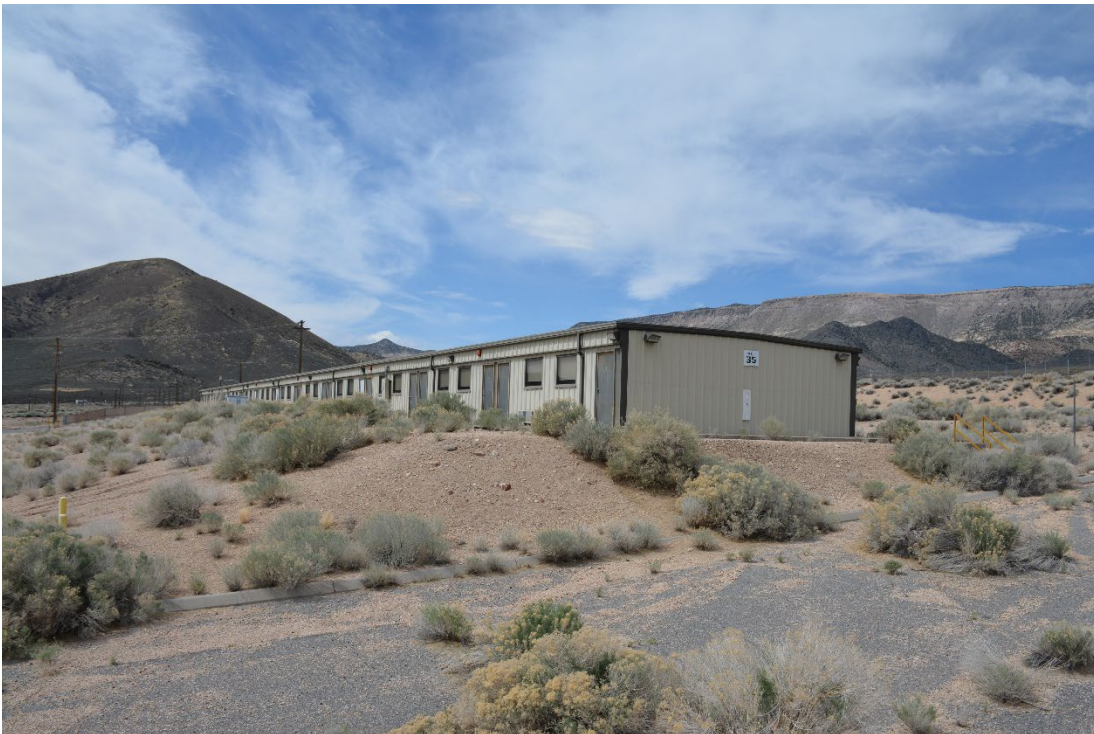
DRI Photo 2: 2531_1606. Overview of the east and north elevations, current condition.
Elevation: East/North Direction facing: Southwest Photographer: DRI Date: April 17, 2025

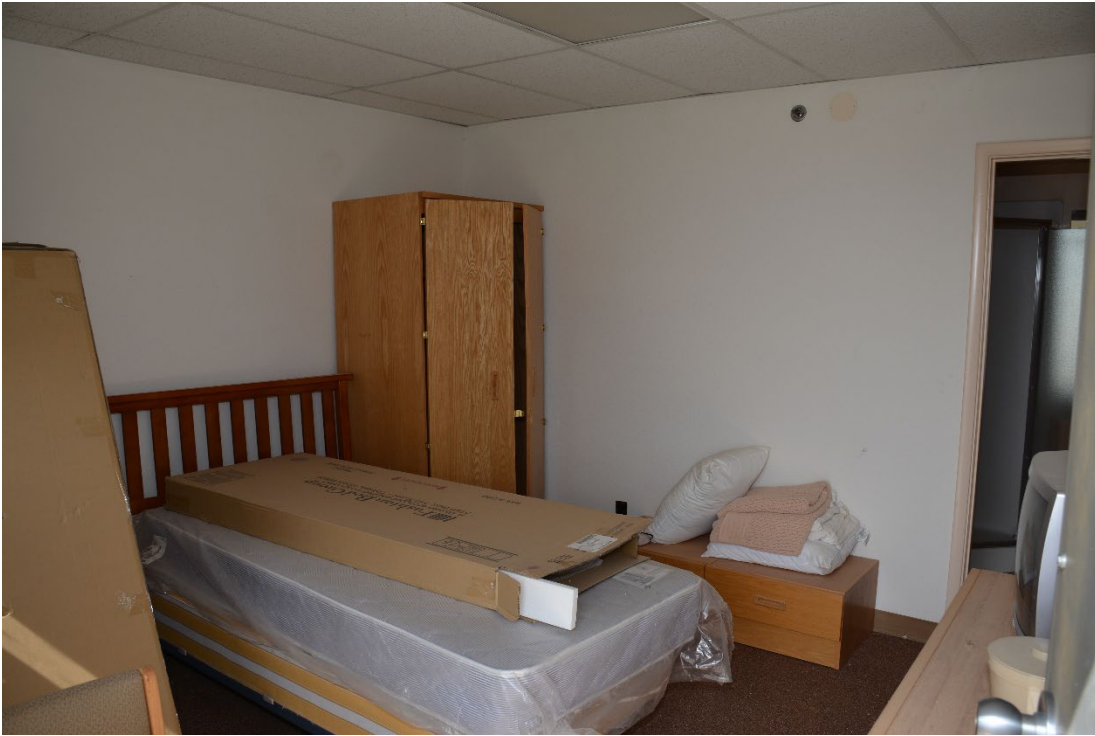
DRI Photo 3: 2531_1584. Room 45, standard bedroom interior.
Elevation: NA Direction facing: Northwest Photographer: DRI Date: April 17, 2025

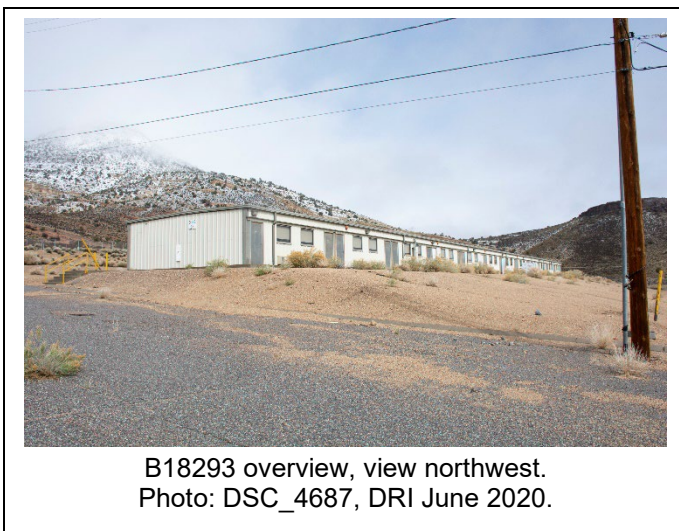
Condition of Resource(s)?	
Good <input checked="" type="checkbox"/>	Fair <input type="checkbox"/> Poor <input type="checkbox"/>
Explanation: Maintained in standby status.

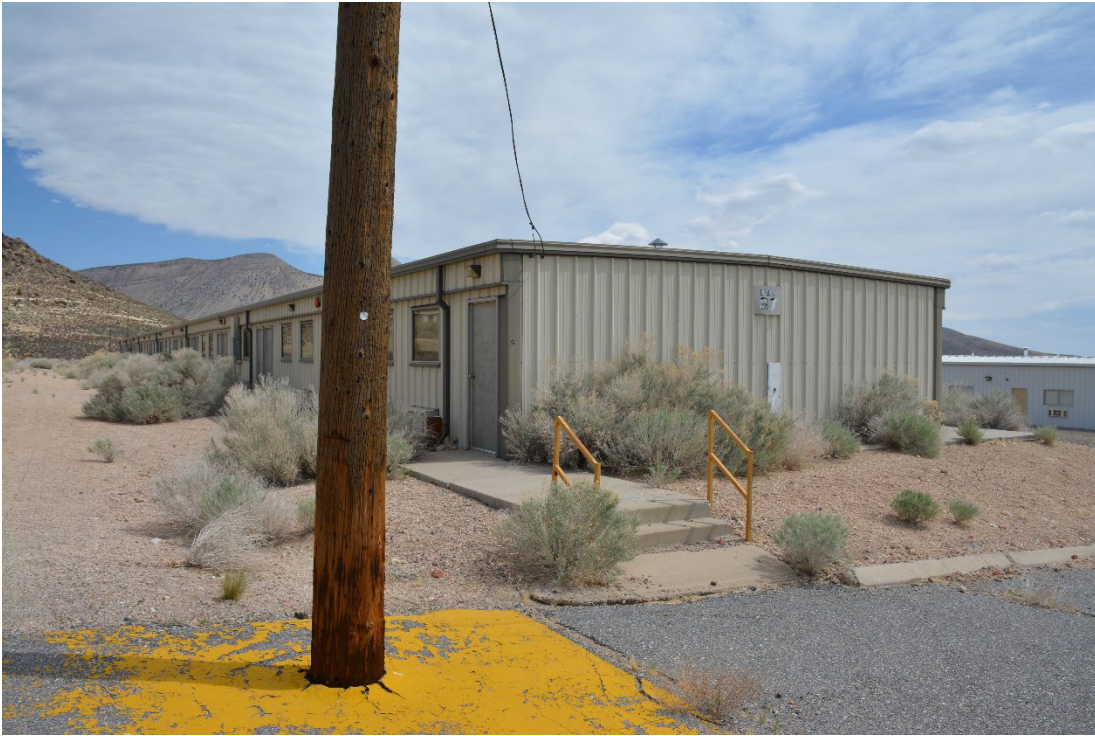
DRI Photo 1: 2531_1598. Overview of the west and south elevations, current condition.
Elevation: West/South Direction facing: Northeast Photographer: DRI Date: April 17, 2025

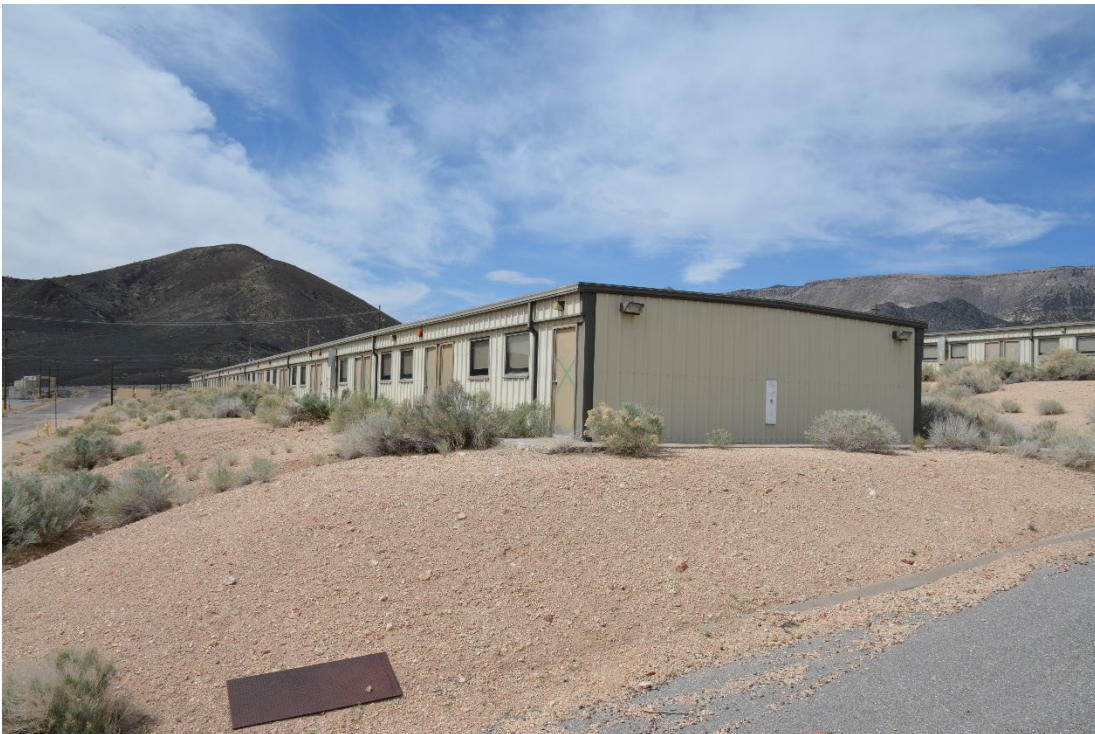
DRI Photo 2: 2531_1600. Overview of the east and north elevations, current condition.
Elevation: East/North Direction facing: Southwest Photographer: DRI Date: April 17, 2025

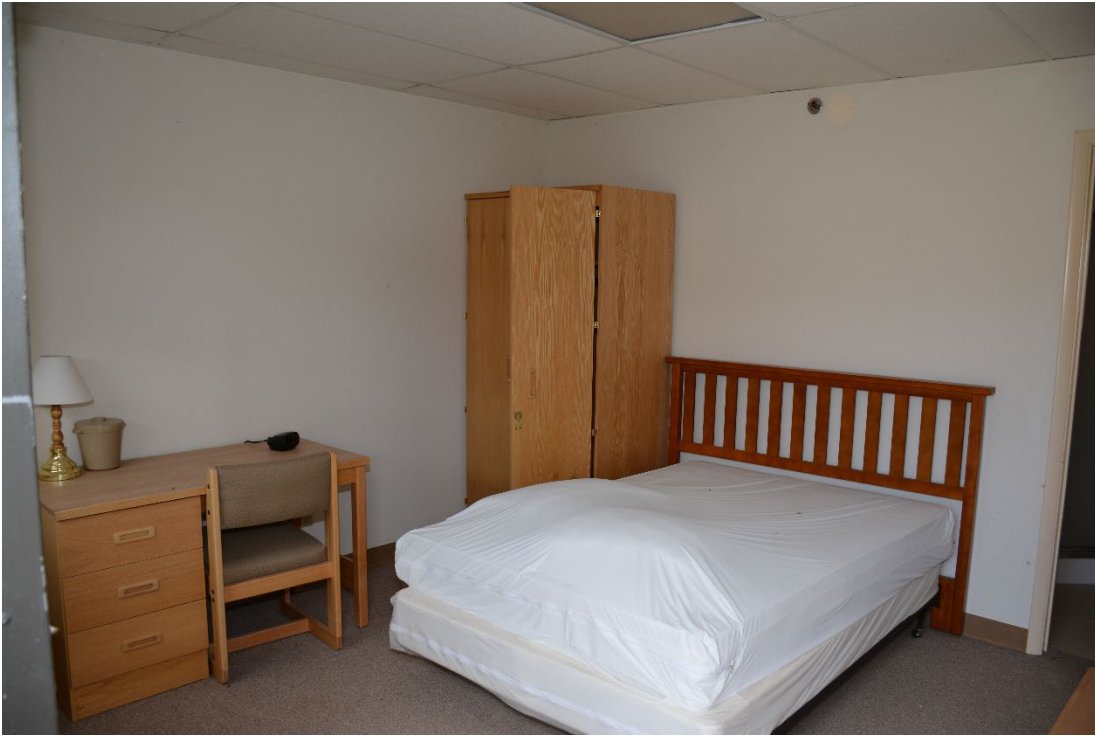
DRI Photo 3: 2531_1536. Room 1, standard bedroom interior.
Elevation: NA Direction facing: Northwest Photographer: DRI Date: April 17, 2025

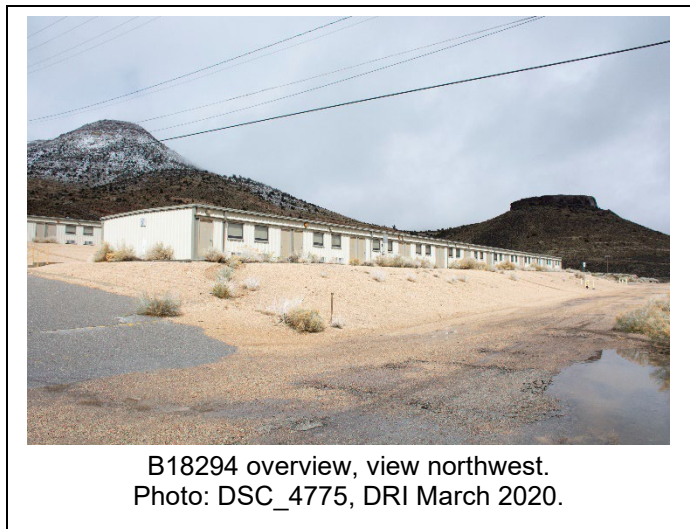
Condition of Resource(s)?			
Good <input checked="" type="checkbox"/>	Fair <input type="checkbox"/>	Poor <input type="checkbox"/>	
Explanation: Maintained in standby status.
