Demonstration of the surveillance test article for an advanced reactor surveillance test program

INL/RPT-25-87662
Revision 0

Advanced Materials and
Manufacturing Program

SEPTEMBER 2025

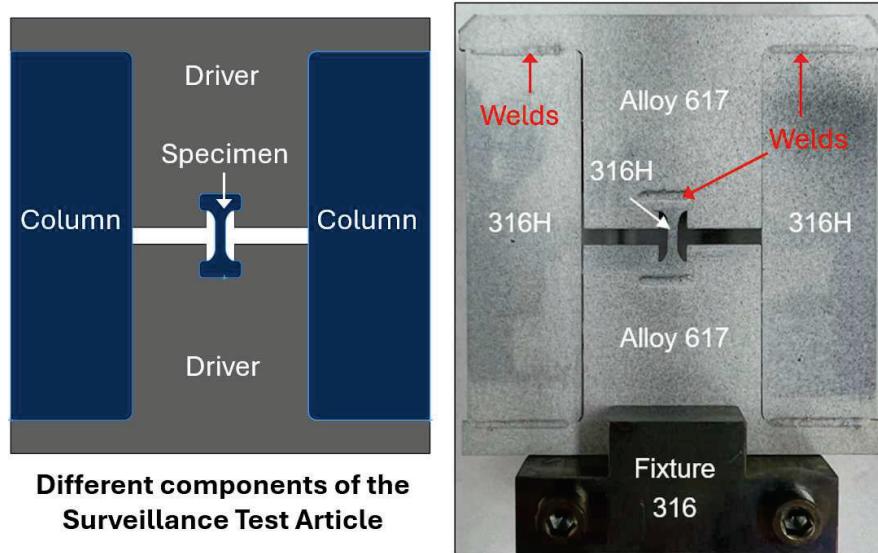
Figure 1. Schematic representation of the surveillance test article design showing specimen (SS 316H), drivers (Alloy 617), and columns (SS 316H).

Initial work conducted has established the proof-of-concept of the STA for cylindrical test articles. Although these studies were successful in capturing the target strain range and elastic follow-up, the large test article size was a drawback. Large STA could influence the fluid flow and thus interfere with the reactor operations. Activated volumes of large STA also pose a limitation on the application of surveillance technology. Hence, in this study flat test articles were designed and fabricated with reduced dimensions. The nominal width and height of the rectangular test article was 50 mm (~2 inch), and the thickness was 1.1 mm. Wire electro discharge machining was used to machine specimen, drivers, and columns. The columns and driver, and drivers and specimen, were welded with an e-beam welder and 316 filler powder as shown in Figure 1.

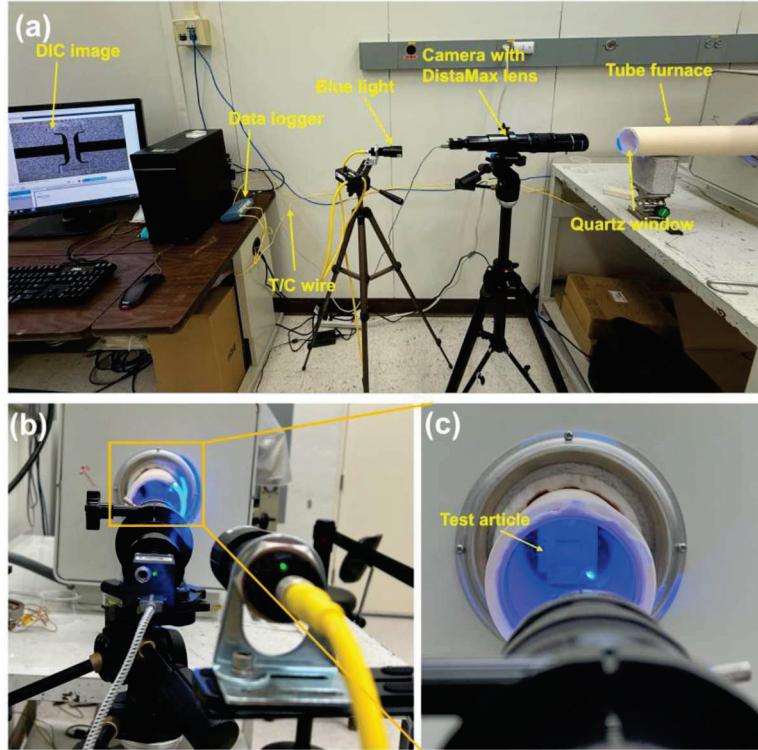
Figure 2. (a) Front view and (b) side view of the furnace testing setup with (c) a test article in cyclic thermal testing. The furnace testing consists of a DIC system to monitor strain evolution with a blue light source, a blue band-pass filter, and a quartz window to enhance imaging quality.

Cyclic thermal testing of STAs was performed using the furnace setup shown in Figure 2. The system consisted of a tube furnace for imposing temperature cycles, a DIC system for monitoring strain evolution, and a data acquisition unit for recording temperature profiles during the experiments. The experiments were conducted in air. The furnace was specially configured for high-temperature DIC measurements by addressing challenges that exist in measuring deformation at elevated temperatures using the DIC technique. These challenges include sample thermal radiation that can saturate images and obscure speckle patterns, degradation of speckle patterns due to prolonged exposure at elevated temperatures, and temperature gradients in the air that can induce refractive index variations and image distortions. To mitigate these effects, multiple strategies were implemented, including the use of a blue light source and a blue bandpass filter to suppress interference from specimen thermal radiation and enhance speckle contrast, the use of a quartz window mounted at the furnace end to limit air convection at the camera viewport and reduce heat-haze effect, and the use of a high-temperature-resistant speckle paint that can withstand temperatures up to ~1000°C. A Type K thermocouple was positioned adjacent to the test articles to record the local temperature during testing. Prior correlation between the furnace control temperature and specimen temperature was established. A more detailed description of the furnace setup and validation experiments is provided in our previous reports (Mahajan et al. 2023, and Zhang et al. 2024).

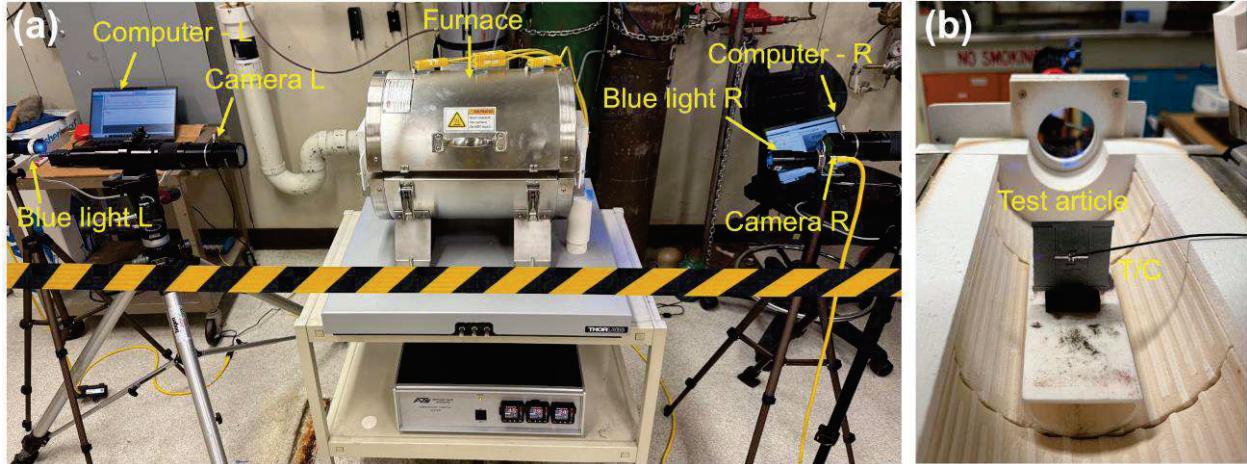
Figure 3. (a) A second furnace testing setup consisting of a dual DIC system with blue light to enable simultaneous testing of two test articles. (b) Furnace interior and placement of a test article and thermocouple in the furnace for system validation.

Cyclic temperature loading with a temperature dwell at peak temperatures was applied to the test articles to accumulate creep-fatigue damage. Since long-term cycling is required to generate measurable damage, testing with a single furnace setup limits efficiency and throughput. To address this, a parallel testing capability was developed as shown in Figure 3, building upon the procedures established in the tube furnace setup (Figure 2). This new configuration incorporates dual DIC systems, enabling simultaneous monitoring of two test articles. Parallel testing was achieved by positioning two test articles within the furnace, each aligned with a dedicated camera viewport for DIC imaging. The setup was validated through temperature calibration and strain measurement tests. For temperature calibration, a thermocouple was placed adjacent to a test article to measure furnace temperatures. The calibration showed the furnace temperature matched the controller readings within $\pm 2^\circ\text{C}$ at 700°C . A maximum cooling rate of $3.5^\circ\text{C}/\text{min}$ was achieved, lower than the typical cooling rate ($10^\circ\text{C}/\text{min}$) used in the tube furnace setup. To verify DIC performance, a test article was subjected to 10 thermal cycles between 500°C and 700°C , with a 30 min dwell at peak and valley temperatures. Both DIC systems measured a consistent strain range of 0.5% through absolute strain values differed. The discrepancy in absolute strain values was attributed to the out-of-plane bending of the specimen relative to the driver-column of the test article which produced residual tension on one side and compression on the other side of the specimen. Overall, the validation testing confirmed the readiness of the new furnace testing system for accelerated creep-fatigue testing.

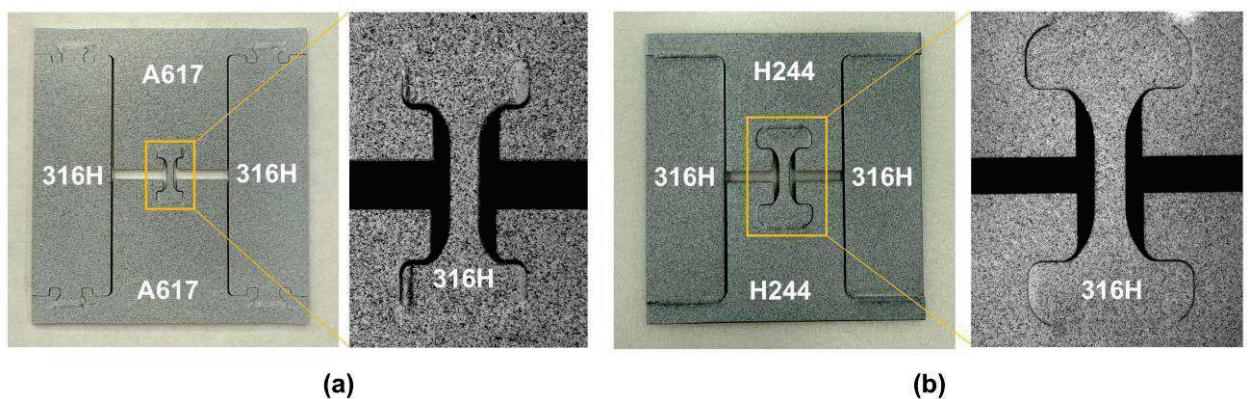
Figure 4. Surveillance test article specimen design with DIC speckle patterns prepared on test articles with (a) Alloy 617 and (b) Alloy 244 as the driver material.

The surveillance specimens were fabricated in a composite configuration consisting of a central coupon of 316H stainless steel embedded within an Alloy 617 frame, with overall dimensions of 2" x 2". This configuration enabled direct comparison of the corrosion behavior of the two candidate structural materials under identical exposure conditions and reflected practical reactor environments in which dissimilar alloys are often in service together. A schematic of the specimen design is shown in Figure 4, highlighting the central 316H coupon and the surrounding Alloy 617 frame.

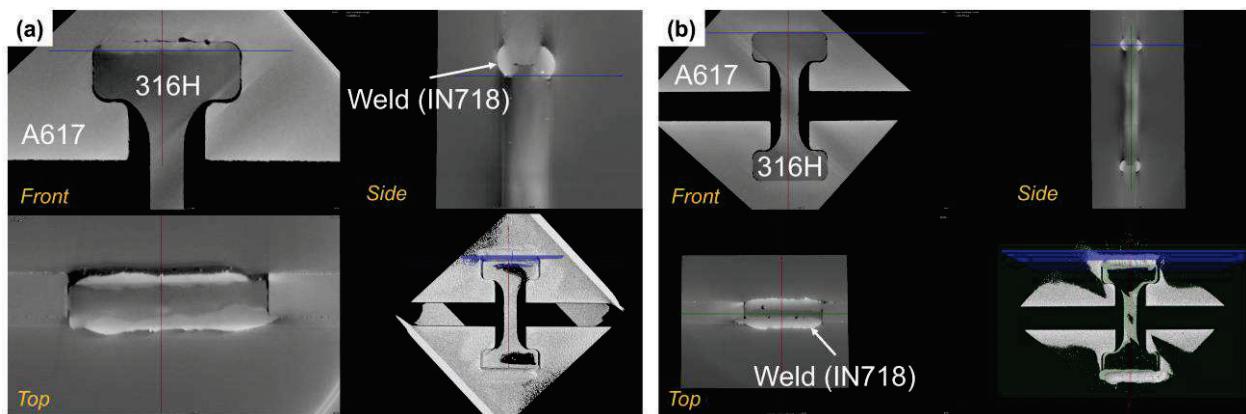
Figure 5. X-CT images of WSTA-S5 and WSTA-S6 before testing.

Previous test-to-rupture cyclic testing on STAs revealed weld failure between Alloy 617 drivers and 316H specimens after a long-term cyclic testing (1012 cycles). Post-test X-ray computed tomography (XCT) analysis confirmed the presence of cracking and defects at the welds. The failed test articles were welded using directed energy deposition (DED) with SS 316 filler material. In FY25, the welding procedure was improved by optimizing welding parameters and replacing the SS 316 filler with Inconel 718 to enhance weld strength. Six test articles (WSTA 1-6) were fabricated using the improved parameters. All six test articles were scanned using XCT to examine the quality of welds. Figure 5 shows XCT images of two test articles, demonstrating defect-free welding. The weld penetration is about 33% through the specimen thickness, and no cracks or defects were identified.

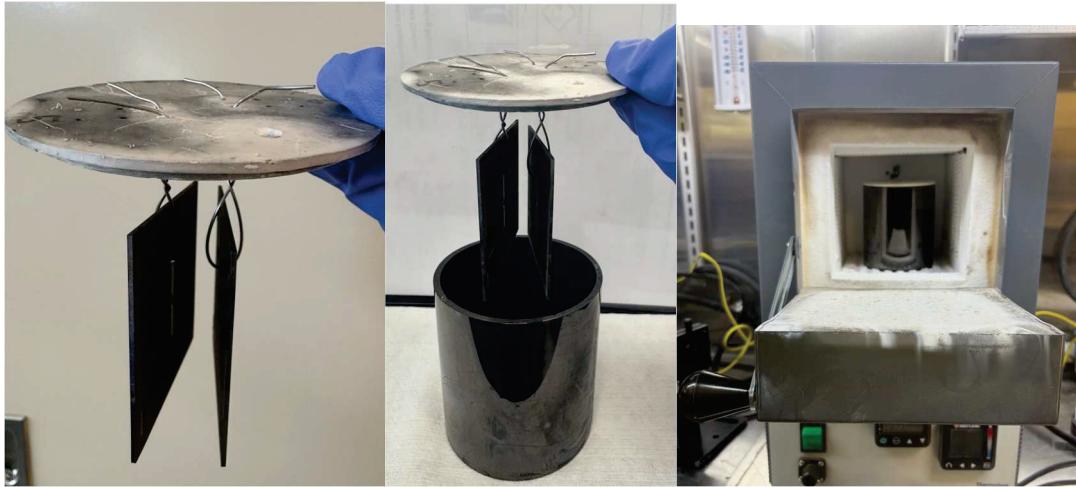
Figure 6. Specimen test setup for molten salt.

For molten salt exposure, the surveillance specimens were suspended vertically within the crucible using SS 316H support wires attached to a boron nitride (BN) lid. The wires were looped and wrapped at designated locations on the specimens such that they contacted only the SS 316H section while deliberately avoiding contact with the Alloy 617 frame. This arrangement minimized the risk of galvanic interactions or dissimilar metal corrosion that could otherwise influence the corrosion response of the alloys under investigation. The BN lid was selected for its chemical inertness and its stability at elevated temperatures. In addition, the use of BN eliminated the possibility of galvanic coupling effects that could arise from metallic holders, thereby ensuring that observed corrosion was attributable solely to salt–specimen interactions. The SS 316H wires provided sufficient mechanical strength to support the specimens during long-term thermal cycling. The entire test article, including both the central SS 316H specimen and the Alloy 617 drivers, was immersed in molten salt. Full immersion was necessary to maintain isothermal state of test article and evaluate the corrosion response of all material regions and alloy interfaces. To accommodate full immersion of the relatively large 2" \times 2" specimen, a large glassy carbon crucible was used, requiring approximately 500 g of salt per batch to maintain complete coverage during the exposure. The crucible assembly used for specimen suspension and furnace test setup is shown in Figure 6.

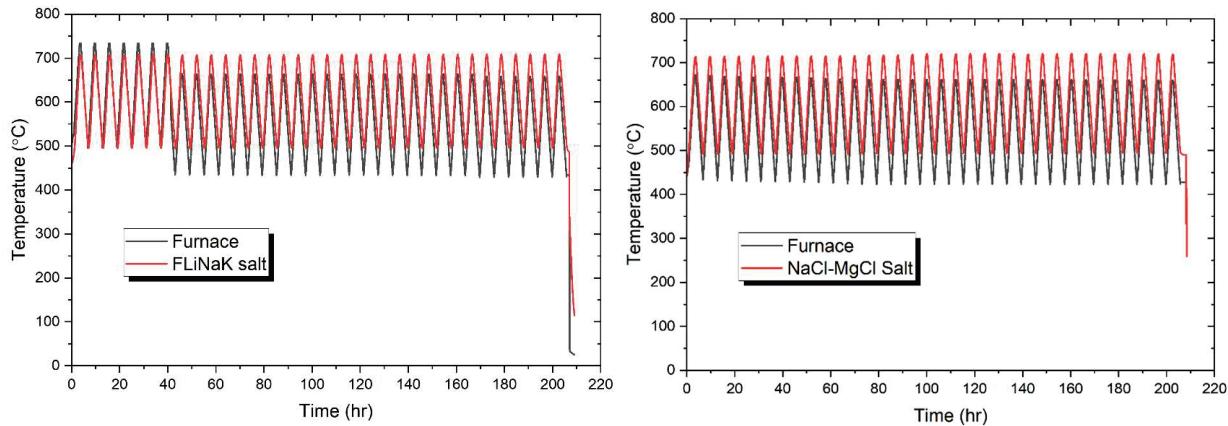
Figure 7. Thermal cycling profile for (a) FLiNaK, and (b) $NaCl-MgCl_2$ test over a 200-hr exposure period showing temperature measurements from two thermocouples: one immersed in the molten salt and the other monitoring the furnace environment with heating ramp from 500°C to 700°C in 150 min, a 30-min soak at 700 °C, and a 180-min cooling phase.

The 500 g salt batch was heated inside glassy carbon crucible under argon to 500°C, to achieve complete melting and homogenization prior to specimen exposure. Once the salts were molten and homogenized, the surveillance specimens were immersed and held for a total duration of 200 hr. The entire crucible assembly was then placed inside a high-temperature box furnace capable of cycling between 500 °C and 700 °C under an argon atmosphere, as illustrated in Figure 7.

During this period, the temperature was cycled between 500 °C and 700 °C to simulate thermal fluctuations representative of advanced reactor operating conditions. Each thermal cycle consisted of a 150-min heating ramp (from 500 °C to 700 °C), a 30-min isothermal soak at 700 °C, and a 180-min cooling phase (from 700 °C to 500 °C). Temperature was monitored using a dual thermocouple arrangement: one thermocouple was positioned directly inside the molten salt to record the melt temperature, while a second was located outside the crucible to monitor the furnace environment. This configuration ensured accurate temperature control and reliable monitoring of both local and bulk conditions. The thermal profile recorded over a period of 200 hr for FLiNaK and NaCl-MgCl₂ is shown in Figure 7. For the test with FLiNaK, the thermocouple recording the furnace temperature noticed drop in measured values after about 50 hr (Figure 7a). This was due to movement of thermocouple during test. This did not affect the temperature cycling as salt temperature remained consistent throughout the test.

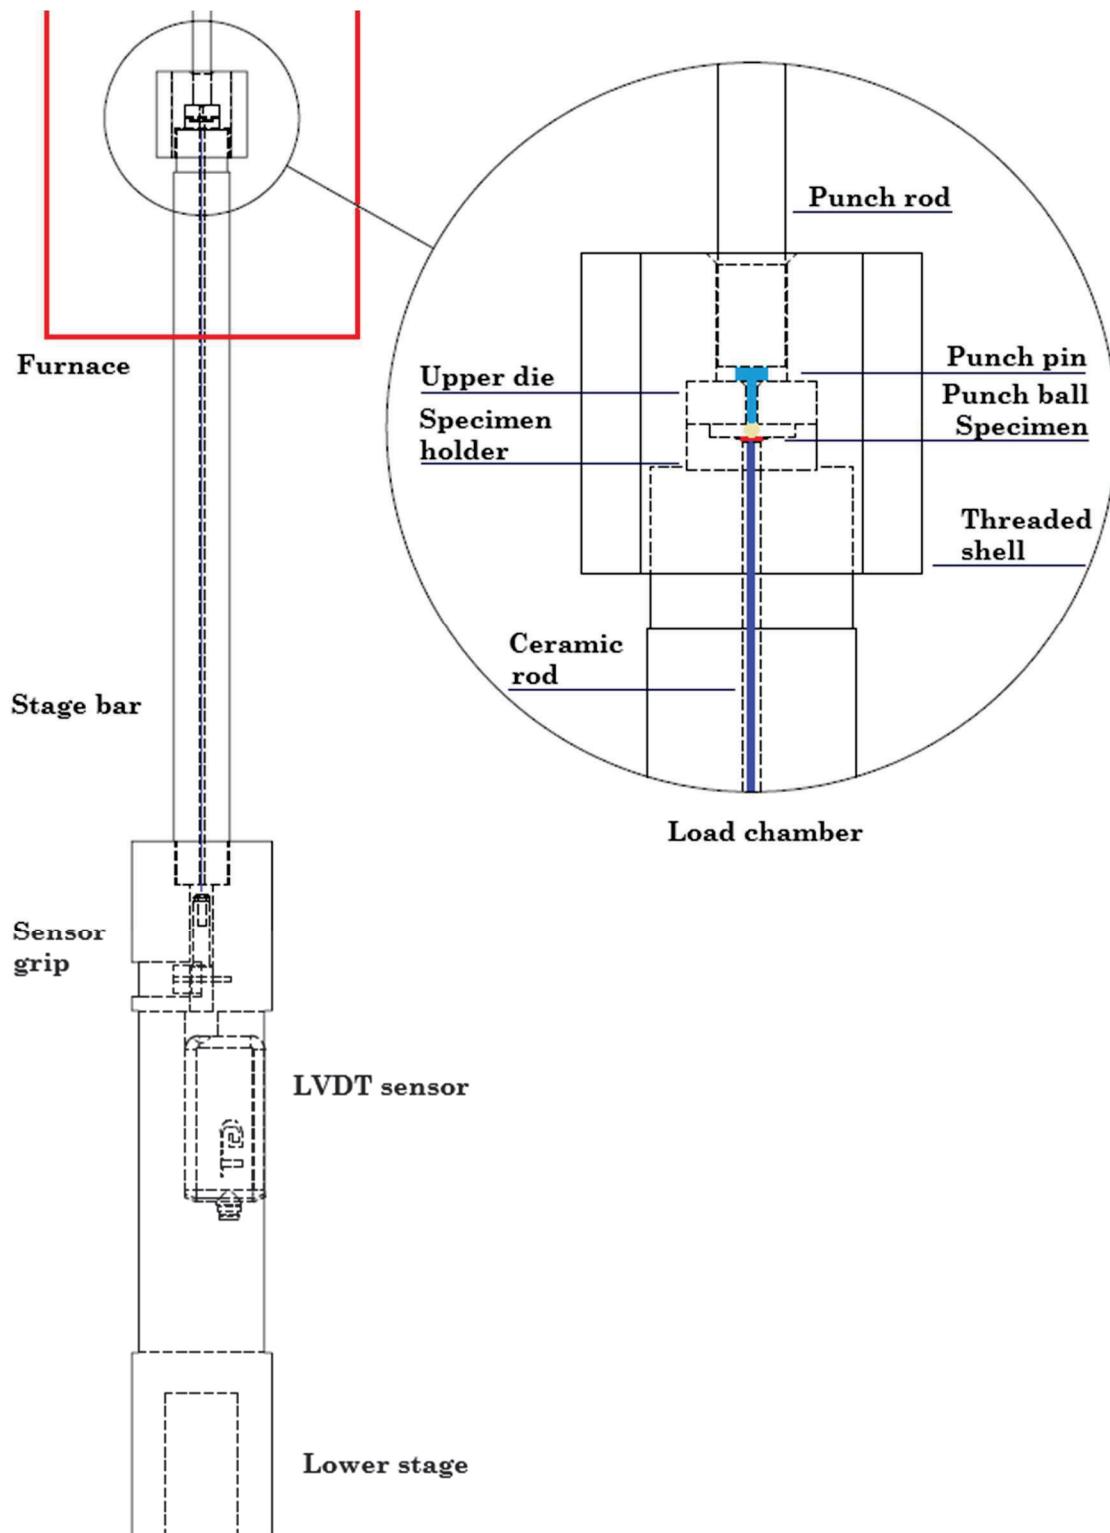
Figure 8. Schematic of the SPTC setup, where the location of the furnace is indicated by the red box, and components in the load chamber are shown in the detailed window.

A new experimental setup (Figure 8) has been designed to perform SPCT. A prepared specimen is held between the specimen holder and the upper die in the load chamber. To accommodate both the miniature and standard specimens, two die combinations are used (shown Figure 9) with the dimensions listed in Table 1. An alumina ball and a 18-8 stainless steel punch screw with the corresponding punch size are inserted into the hole of the upper die. The miniature and standard dies have the same outer diameter and height, and they are secured onto the stage bar by a threaded shell. The stage bar is attached to the lower stage, and an alumina rod is placed inside the hollow stage bar. A Keyence GT2 Linear Variable Differential Transformer (LVDT) sensor is installed in the lower stage, and it is connected to the

specimen via the ceramic rod to measure the deflection due to the high temperature in the load chamber. The lower stage and punch rod are attached to the load frame. An Instron 5848 Microtester universal testing machine and a load cell with a capacity of 2.0 kN have been selected due to the small size of the specimen. An ATS series 3210 three-zone split tube furnace (position shown in Figure 8) with a maximum temperature of 1100 °C is attached to the frame column. Four thermocouples are installed in the system: three in each zone of the furnace, and one is attached to the threaded shell to monitor the temperature of the specimen. Due to the high temperature of the test, all the components in the load chamber and the stage bar are made from Hastelloy X alloy, and other components are made from SS 316L. When a load is applied from the machine, the sample is deformed by the ceramic punch ball through the punch rod and the punch pin. The deflection of the specimen can be measured by the LVDT sensor through the ceramic bar.

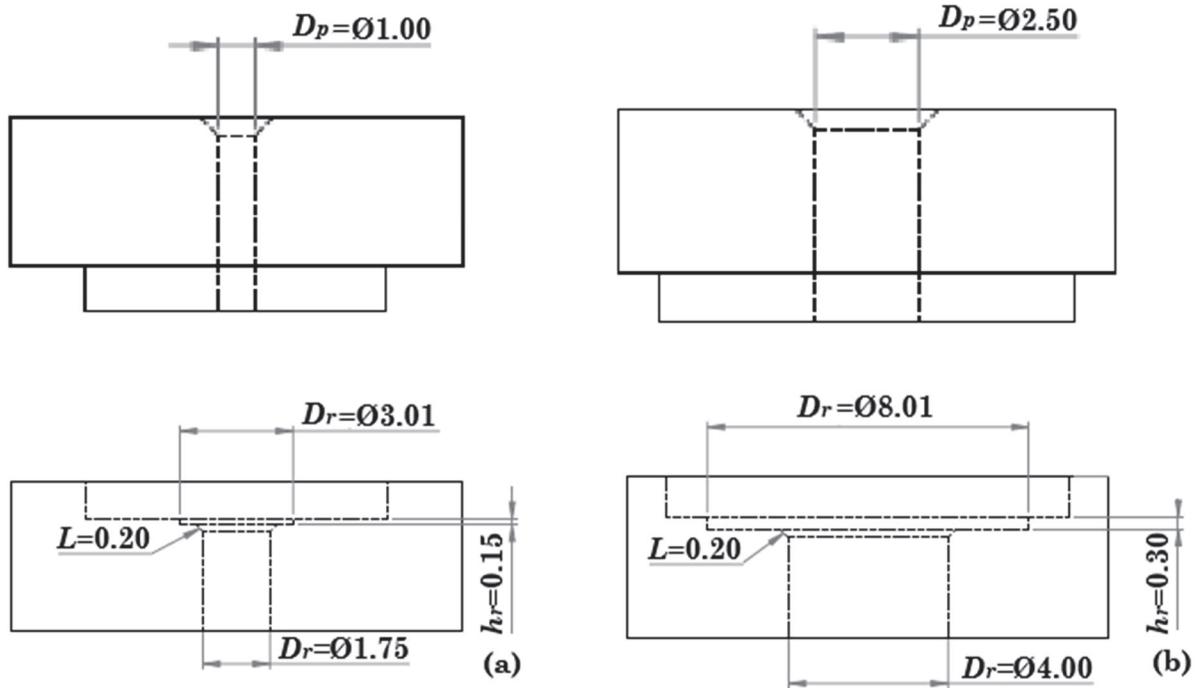
Figure 9. Drawings of the SPCT dies for different sample dimensions: (a) miniature samples (\varnothing 3.00 mm) and (b) standard samples (\varnothing 8.00 mm) (CEN, 2021).

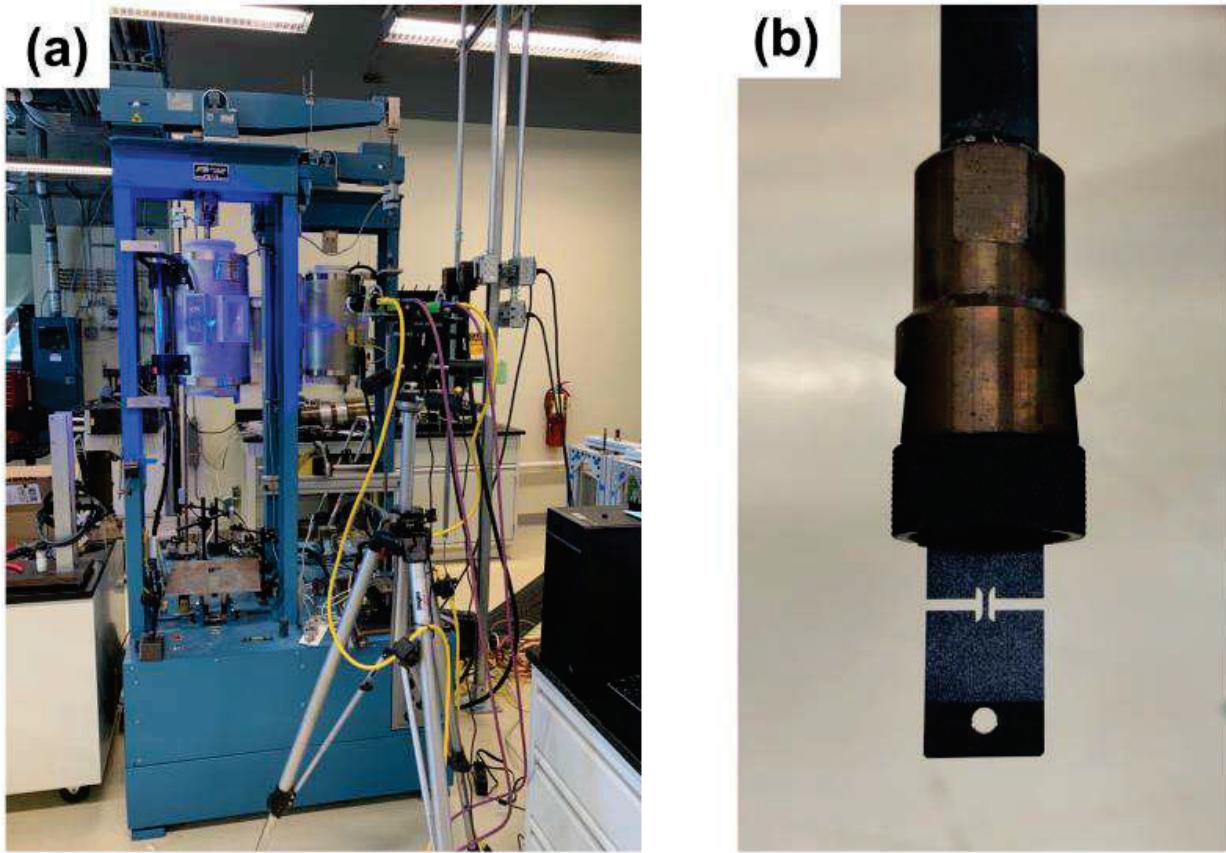
Figure 10. (a) Creep testing with DIC setup for testing pristine SS 316H and post-salt testing specimens. (b) Mounting of a specimen on the grips for creep testing.

Creep testing was conducted on a pristine SS 316H specimen as well as SS 316H specimens removed from a STA subjected to cyclic thermal testing in furnace air and molten salt environments. Figure 10a shows the creep testing setup, which consists of a three-dimensional DIC system to acquire strain data. For post-test specimens, samples were prepared using electric discharge machining to obtain the sample geometry shown in Figure 10b, where the gauge section consisted of SS 316H and the extended ends with two pin holes were Alloy 617 driver material. The pin holes were used for alignment while the specimen was gripped at the driver regions. Prior to testing, a high-temperature speckle pattern was applied. A dual-camera DIC system was used to capture full three-dimensional deformation. Creep testing was conducted on three specimens: cylindrical pristine SS 316H, WSTA-4 after testing in FLiNaK, and WSTA-6 after testing in NaCl-MgCl₂. Creep testing was conducted at 700°C under a stress of 130 MPa. Post-creep fracture surfaces were examined using scanning electron microscopy (SEM). Additional salt-tested duplicates (WSTA-3 and WSTA-5) were analyzed using SEM to examine corrosion damage in the SS 316H gauge section, Alloy 617 driver materials, and welds. Energy dispersive spectroscopy (EDS) was further employed to map elemental distribution in regions affected by corrosion and across the weld interfaces.

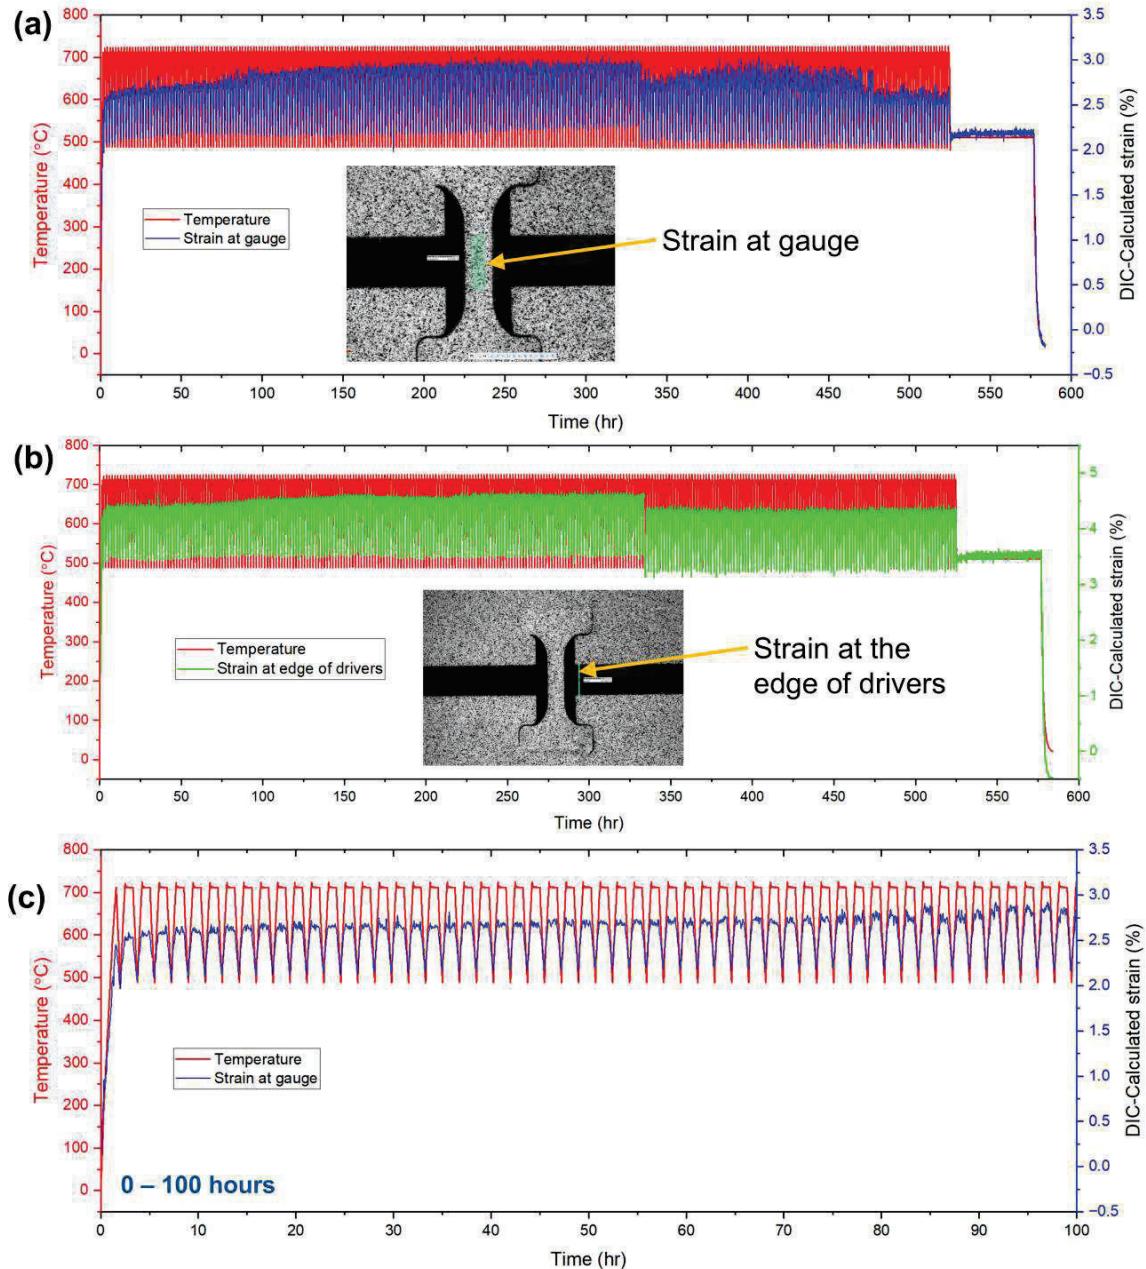
Figure 11. Temperature and strain profiles from the (a) specimen gauge section and (b) edge of Alloy 617 drivers during test-to-rupture testing of WSTA-1 in air. (c) Temperature and strain profiles for the first 100 hr showing gradual increase of strain range with the increase of testing cycles.

A long-term test-to-rupture test was conducted on WSTA-1. Figure 11a, and Figure 11b show the overall temperature profile and strain evolution measured at the specimen gauge (Fig. 6a) and at the driver edges (Figure 11b). Figure 11c and Figure 12 further show the temperature and strain profiles at selected time intervals to reveal detailed response of strain with the increase of thermal cycles. The strain was calculated using the image taken at room temperature (before testing) as the strain-free reference. It can be observed from Figure 11a, and Figure 11c that the strain range gradually increased with the increase of thermal cycles in the beginning 150 h. The increase of strain range was due to cyclic strain hardening under creep-fatigue testing. Beyond this period, the strain range stabilized at ~0.77% (Figure 12a). The constant strain range continued until ~333 hr where a slight reduction of strain range occurred (Figure 12b). However, this strain range reduction was likely an artifact caused by unintended specimen disturbance relative to the DIC camera, as the same event was noticed from the strain profiles at the driver edges (Figure 11b). As the testing continued, a sudden drop of strain range in the specimen gauge section was observed at ~477 hr where the strain range dropped from 0.73% to 0.53%, as shown in Figure 12c. The reduced strain range remained constant for the remaining of the test until the testing was terminated at 525 hr. Figure 11b shows that the strain range across the edges of the Alloy 617 drivers was constant after ~150 hr and till the end of the experiment. The constant strain range across the drivers and sudden drop of strain at the specimen gauge section indicated potential failure of the welds between the

specimen and drivers. When cracks formed in the welds during creep-fatigue, the load from the drivers cannot be effectively transferred to the specimen, leading to a reduced strain range in the gauge but a constant strain range across the drivers. Figure 11b shows that a gradual increase of strain range across the edge of drivers was observed in the beginning of the testing, which is consistent with the strain response from the specimen gauge. This matching strain response indicated that the weldments were effective in the beginning but failed after repeated creep-fatigue cycles. This phenomenon was also observed in FY24 during test-to-rupture cyclic testing of a WSTA which was welded using SS 316 as the filler material. XCT scans of the WSTAs with SS 316 filler material showed defects in the welds, which propagated during testing and reduced in strain range reduction. In FY25, Inconel 718 was used as the filler material to provide better weld strength. XCT scans (Figure 5) of all WSTAs showed crack-free welding prior to testing. However, these weldments did not survive the repeated cyclic creep-fatigue loading.

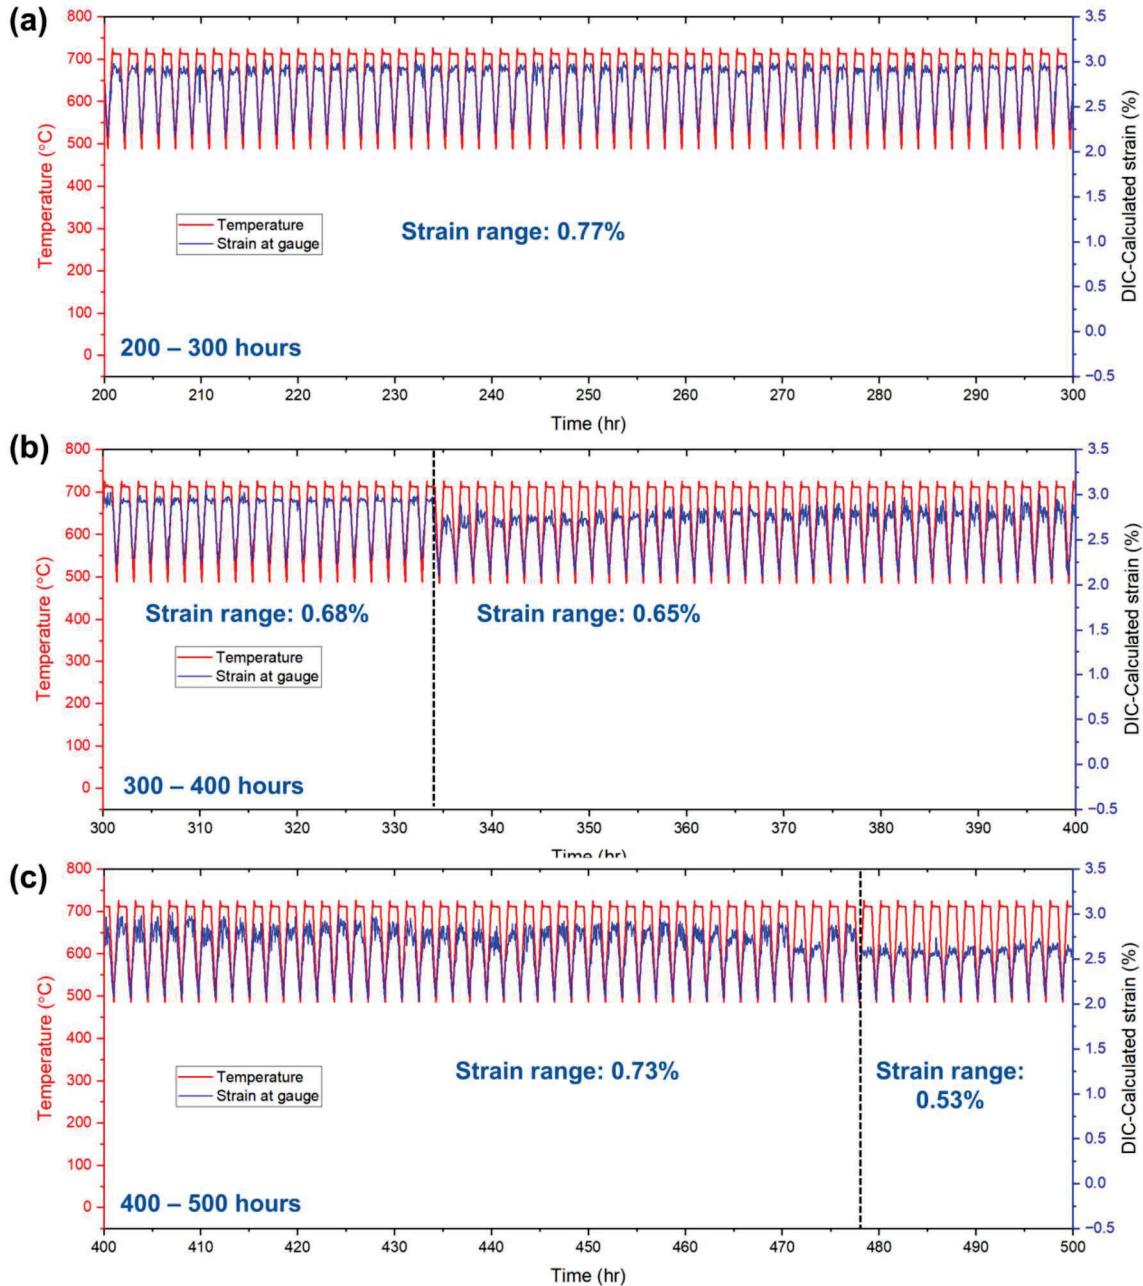
Figure 12. Temperature and strain profiles for (a) 200 – 300 hr, (b) 300 – 400 hr, and (c) 400 – 500 hr from test-to-rupture testing of WSTA-1 in air. A constant strain range of 0.77% was observed during 200 – 300 hr while the strain range reduced to 0.53% at ~477 hr.

Figure 13c-e shows the microstructure at the driver-specimen joint of post-test WSTA-1. As shown in Figure 13c, the joint consisted of three regions: the SS 316H specimen, the Inconel 718 weld, and the Alloy 617 driver. The specimen and driver materials exhibited equiaxed grains typical of wrought plates, while the welds contained elongated grains. A cellular sub-grain structure was observed within the welds (Figure 13e). Cracks were identified at the joint, primarily within the Inconel 718 weld region. These cracks initiated and propagated along the grain boundaries (Figure 13e). These cracks were likely attributed to residual stress generated during welding, compounded by repeated stress and deformation from creep-fatigue testing. These cracks resulted in the reduced strain range from the testing (Figure 12c).

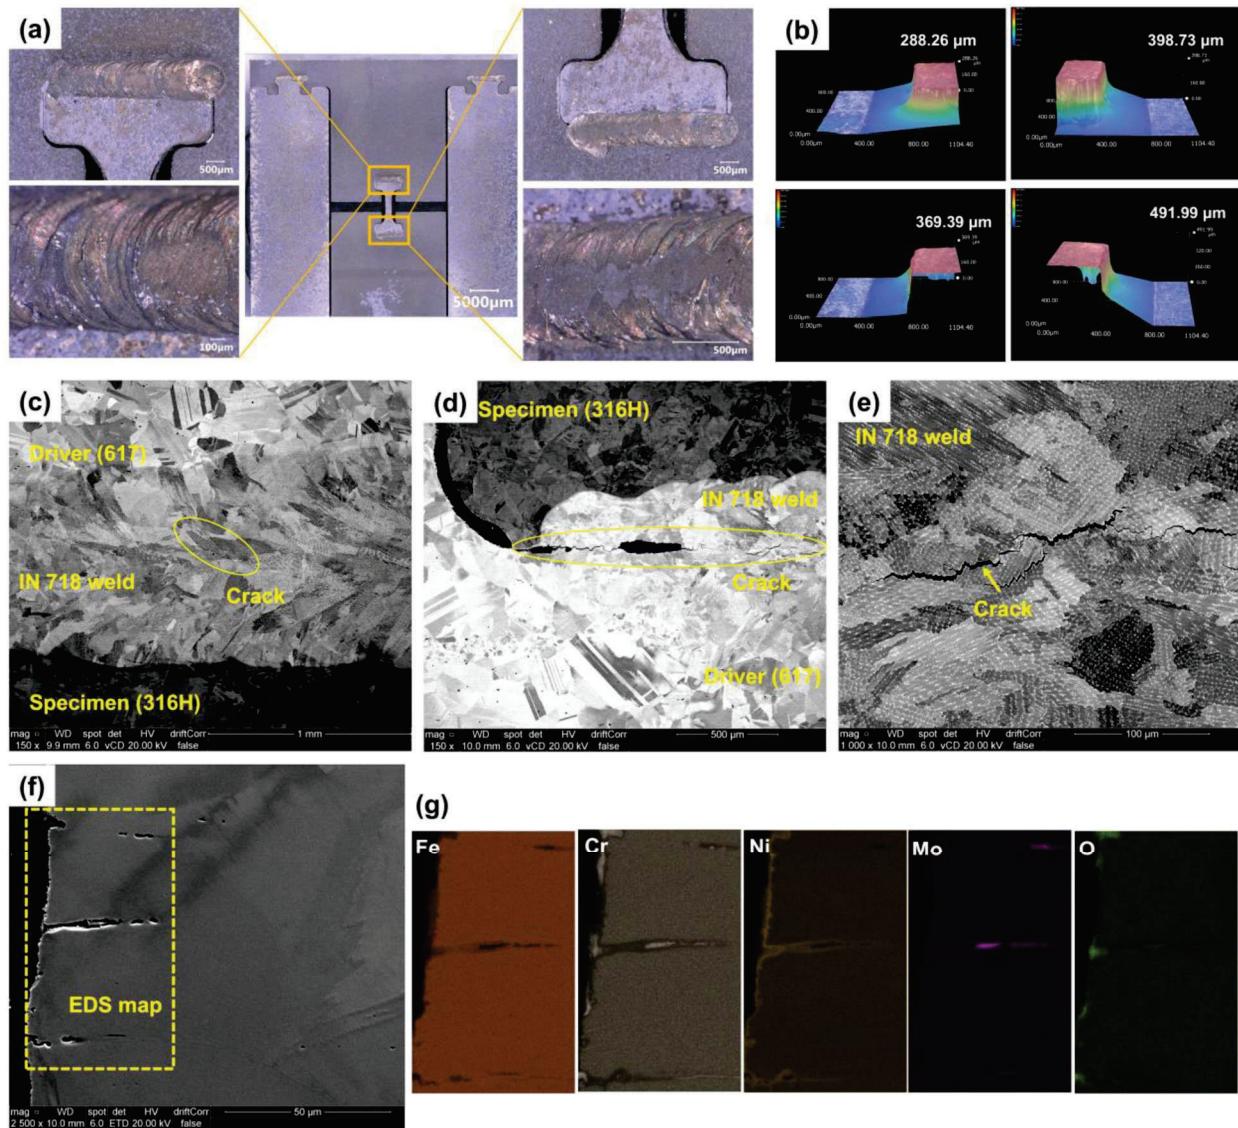
Figure 13. Optical micrographs of the post-test WSTA-1 showing the (a) welds and (b) out-of-plane bending. (c-d) SEM micrographs showing the microstructure at the joints at various locations where cracks were observed. (f) SEM image and (g) elemental distribution at the specimen gauge.

The post-test WSTA-a was examined using optical microscopy and SEM. Figure 13a shows optical micrographs of the two welds between the specimen and drivers. No visible defects were observed under optical microscopy. Optical measurements at areas between edge of drivers and columns (Figure 13b) indicated out-of-plane bending of the drivers relatively to the columns. Similar out-of-plane bending was observed previously due to compressive residual stress in the specimen after testing

Figure 13f shows the micrograph at the specimen gauge and Figure 13g shows the distribution of major elements in this region. A thin Cr- and Ni-rich oxide layer was detected on the gauge surface, formed due to oxidation at elevated temperatures. Although microstructural defects were observed at the gauge, these defects did not cause rupture of the specimen during testing.

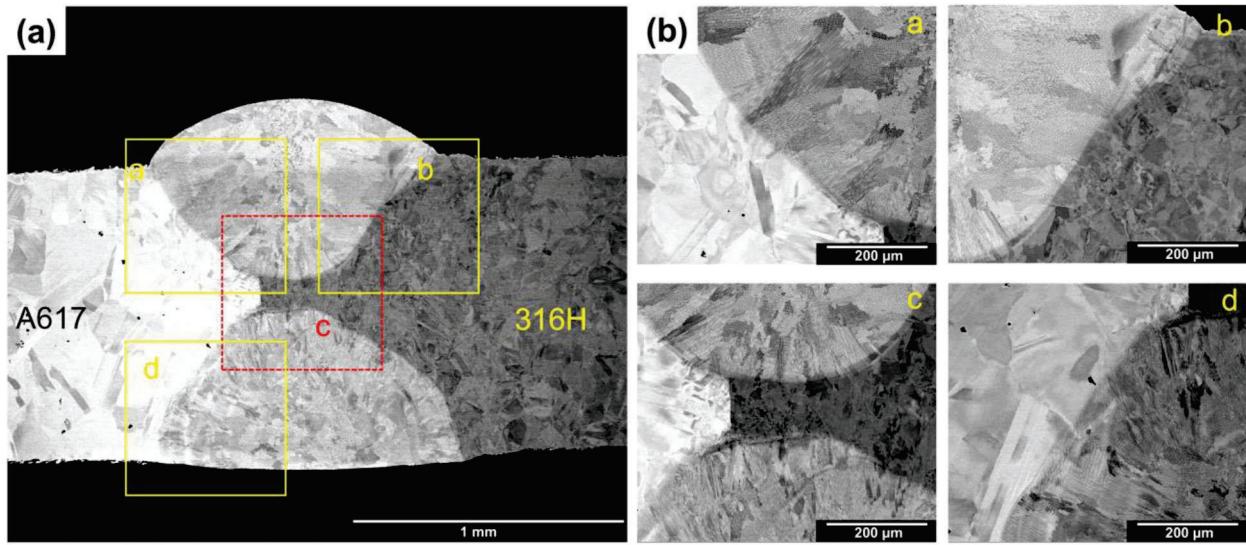
Figure 14. SEM micrographs showing an (a) overview and (b) detailed microstructure of a weldment with double-bevel design at SS 316H and improved welding parameters.

Maintaining defect-free welds is essential to ensure effective transfer of the creep-fatigue loading to the specimen. To improve weld quality, a double-bevel design was adopted to increase welding penetration depth, and welding parameters were further optimized. Multiple dissimilar-metal welds between Alloy 617 and SS 316H were fabricated to validate the revised procedure. As shown in Figure 14, the optimized process achieved ~90% penetration across the specimen thickness, with microstructural examination confirming defect-free bonding. These optimized welding geometries and parameters were subsequently applied to fabricate two additional STAs. At the time of this report, one of these test articles had undergone 500 hr cyclic thermal testing in air.

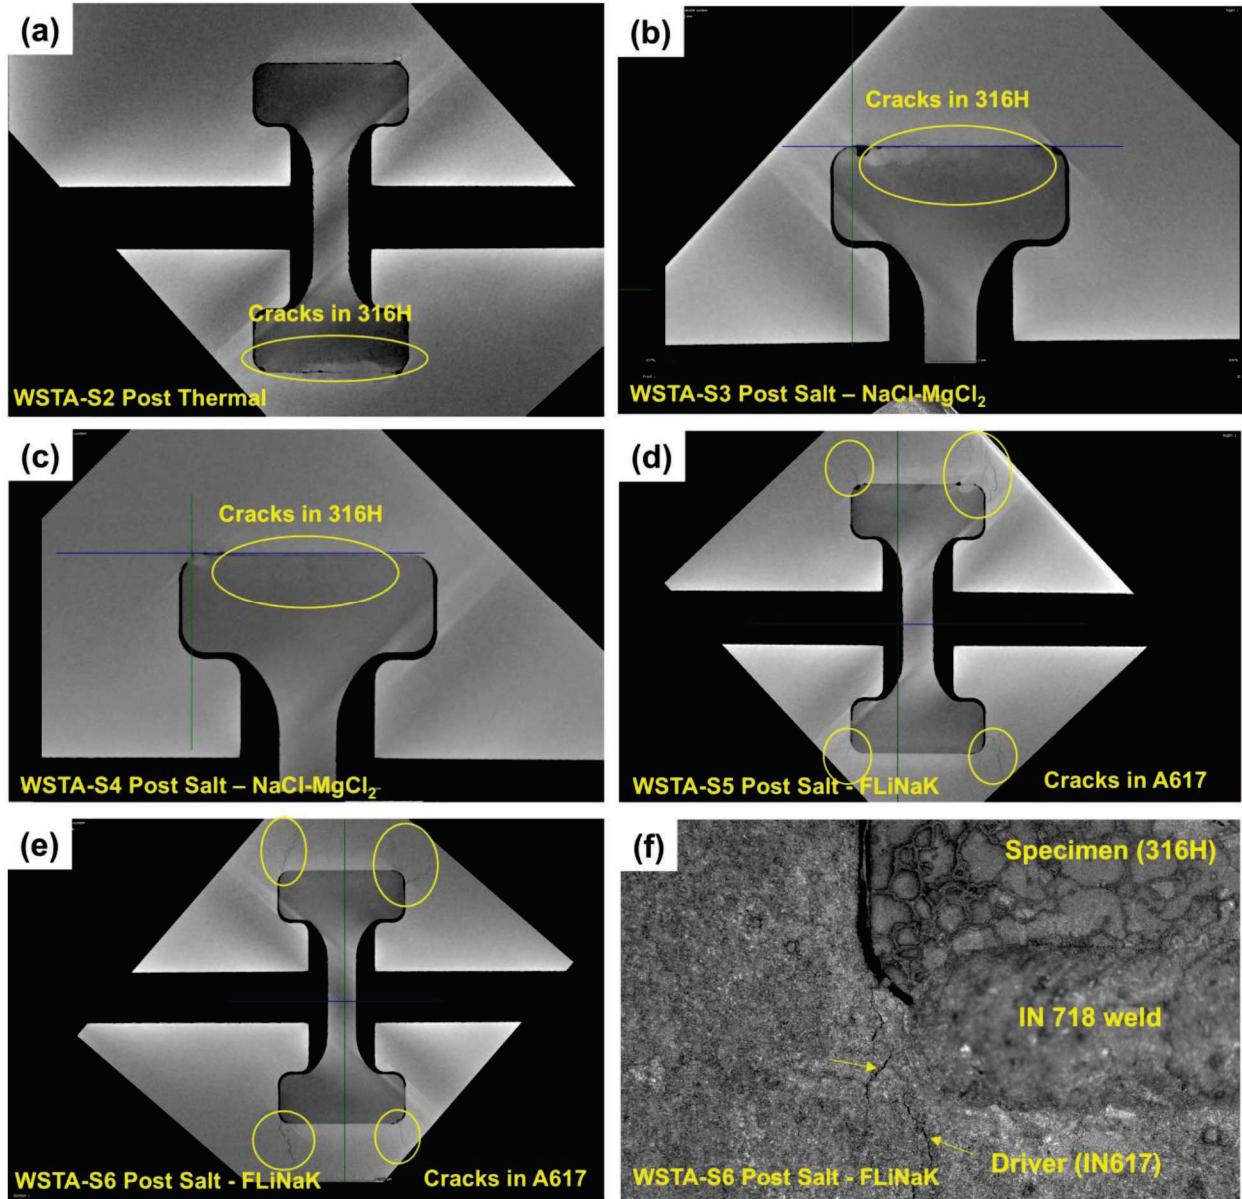
Figure 15. XCT images of the WSTAs after testing in (c, d) NaCl-MgCl₂ and (e, f) FLiNaK salts and the reference WSTAs after identical thermal exposure (no salt) from molten salt testing.

The WSTAs tested in molten salts were examined using XCT to identify cracks or defects in the welds and gauge regions. Figure 15 shows XCT images of test articles after exposure in NaCl-MgCl₂ (Figure 15b and Figure 15c) and FLiNaK (Figure 15d and Figure 15e), as well as the WSTA-2 (Figure 15a) tested in argon as a reference. The XCT analysis revealed crack formation near the welds following molten salt exposure. For the test articles in NaCl-MgCl₂ (WSTA 3 and 4), cracks were observed at the SS 316H section near the welds (Figure 15b and Figure 15c). These cracks were oriented primarily perpendicular to the welds. The XCT resolution (~8 μm) did not reveal visible defects at the specimen gauge. In contrast, FLiNaK-tested specimens exhibited a different cracking morphology, with more extensive cracking in the Alloy 617 drivers adjacent to the specimen (Figure 15d and Figure 15e). These cracks can even be observed from the surface of the test articles under optical microscopy (Figure 15f). Cracks in the specimens were not observed. To further investigate crack morphology, WSTA-3 and WSTA-5 were sectioned, mounted, and polished following standard sample preparation procedures for SEM analysis.

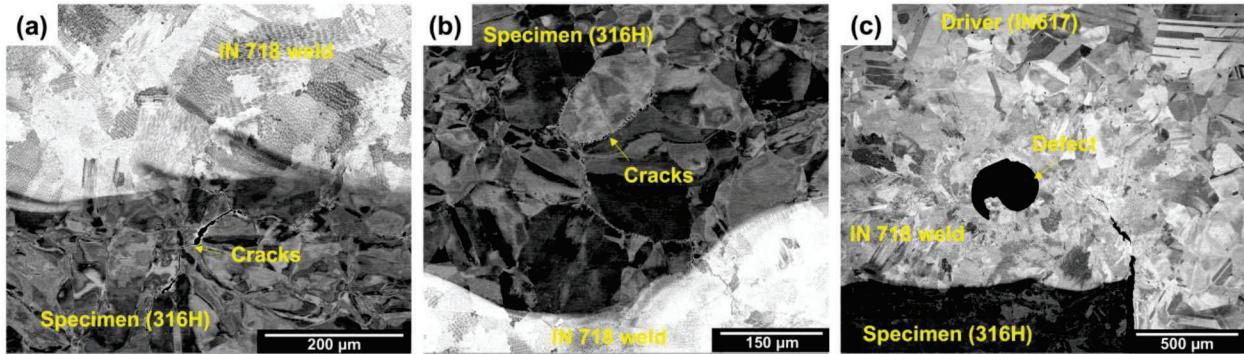
Figure 16. Microstructure at the welds of WSTA-3 after testing in NaCl-MgCl₂.

Figure 16 shows the microstructure at the upper joint (Figure 16 a) and lower joint (Figure 16b) between specimen and weld, as well as an overview of the upper joint (Figure 16c). Multiple cracks were observed in the SS 316H specimen near the welds, consistent with XCT scans. The cracks were at grain boundaries. Additionally, a pore was observed in the weld due to trapped gas during welding. To understand the origin of cracking, EDS mapping was conducted in a region containing cracks, as shown in Figure 17. The EDS maps revealed depletion of Cr along cracks, which indicates selective dissolution of Cr into the salt as a driver for void formation and intergranular crack propagation. Residual stress from the welding process may also promote stress corrosion cracking. Residual stress can accelerate the diffusion of Cr at grain boundaries, creating corrosions that promote intergranular cracking. Salt composition was not detected.

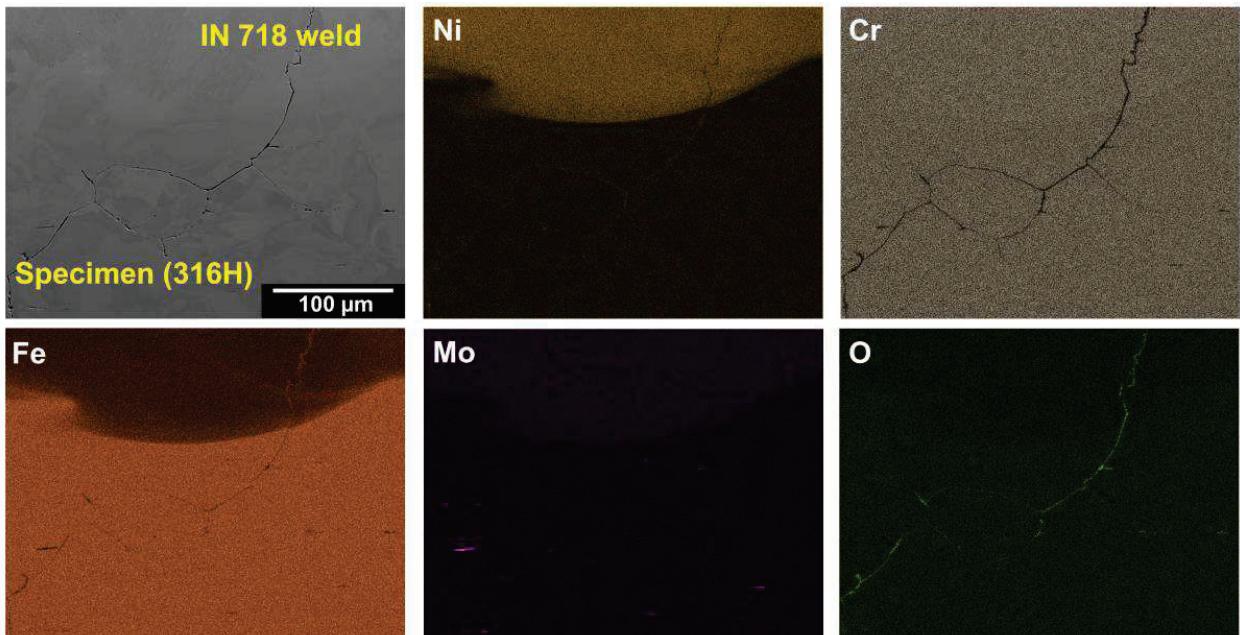
Figure 17. Microstructure and elemental distribution at the welds near SS 316H specimen of WSTA-3.

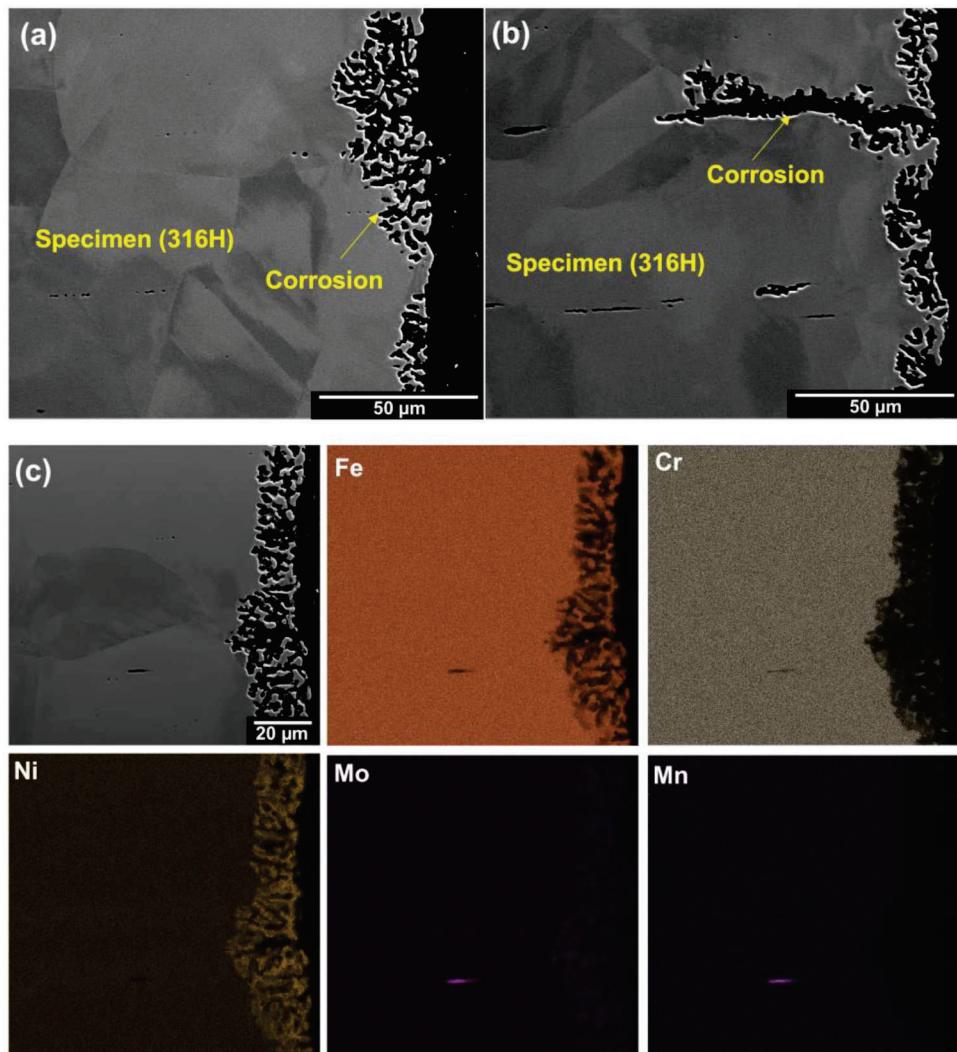
Figure 18. (a-b) Microstructure and (c) elemental distribution at the SS 316H gauge of WSTA-3.

Corrosion attacks at the specimen gauge were revealed as shown in Figure 18. Depletion of Cr can be observed from EDS maps (Figure 18c). Measurements were conducted along the peripheries of the gauge section to evaluate salt attack depth. An average attack depth of 23.6 ± 15.8 mm and a maximum attack depth of 86.6 μm were measured. Therefore, cyclic thermal testing of the test articles in NaCl-MgCl₂ created defects in the SS 316H gauge. Corrosion in A617 driver was also examined. Cr depletion was observed at grain boundaries as marked in Figure 19. The corrosion attack depth was about 30 μm . Additionally, the layer on the A617 surface could be caused by the deposition of corrosion products from the SS 316H specimen and columns since the Alloy 617 has minimal Fe content (max 3 wt.%).
