Demonstration of the surveillance test article for an advanced reactor surveillance test program

INL/RPT-25-87662
Revision 0

Advanced Materials and
Manufacturing Program

SEPTEMBER 2025

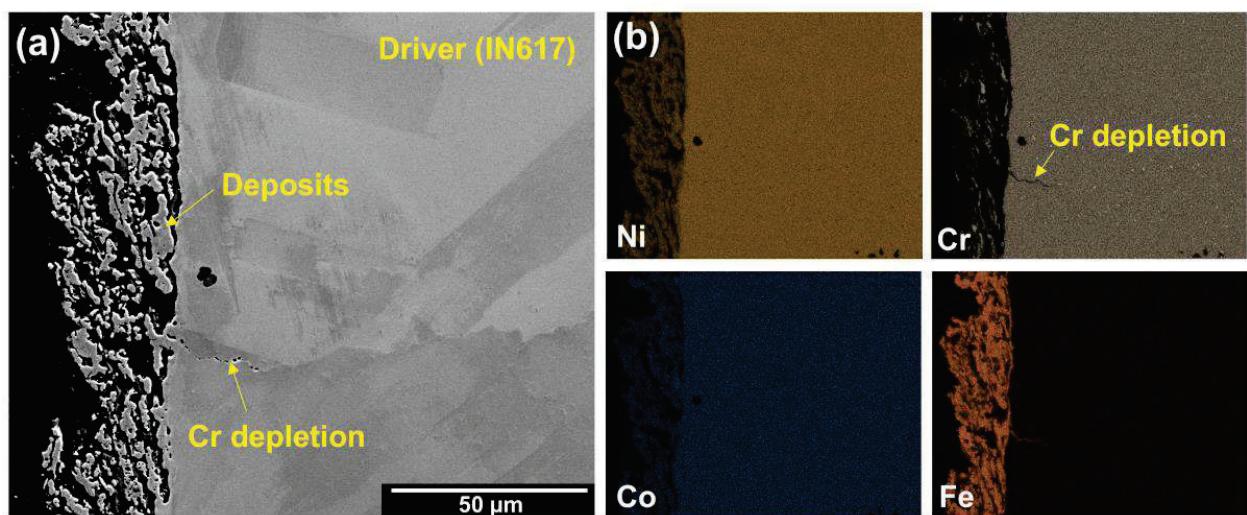
Figure 19. (a) Microstructure and (b) elemental distribution at the edge of A617 driver.

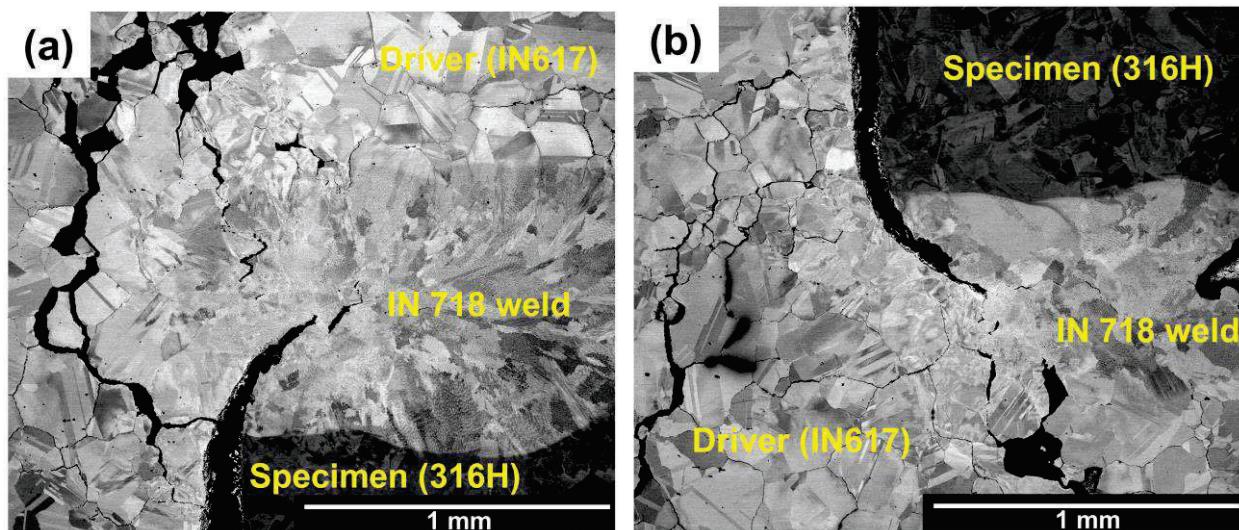
Figure 20. Microstructure at the (a, b) upper and (c) lower joints in WSTA-5 showing presence of intergranular cracking at the Alloy 617 drivers near the welds.

Figure 20 shows the microstructure of WSTA-5 near the joints after testing in FLiNaK salt. Cracks were observed in the test article after salt exposure, and these cracks were mostly distributed in the Alloy 617 driver near the welds. The location of these cracks is consistent with the XCT scans as shown in Figure 20d-f. These cracks propagated along the Alloy 617 grain boundaries. Elemental distribution near these cracks was revealed by EDS. The EDS maps (Figure 21) show depletion of Cr in the grain boundaries as marked by the red arrow. Selective depletion of Cr along grain boundaries caused cracking as marked by the yellow arrow in Figure 21a. Therefore, it is suspected that the cracking in Alloy 617 driver near welds was induced by the combination of salt penetration and welding-induced residual stress.

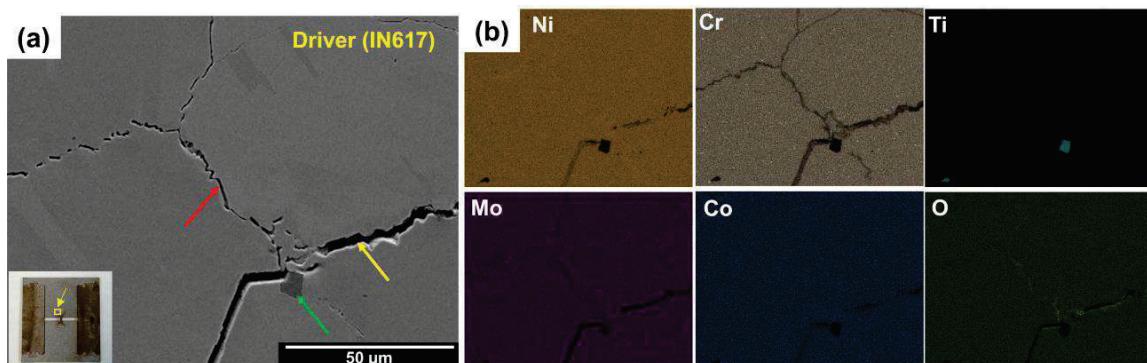
Figure 21. Distribution of major elements near cracks in Alloy 617 driver near the welds and specimen.

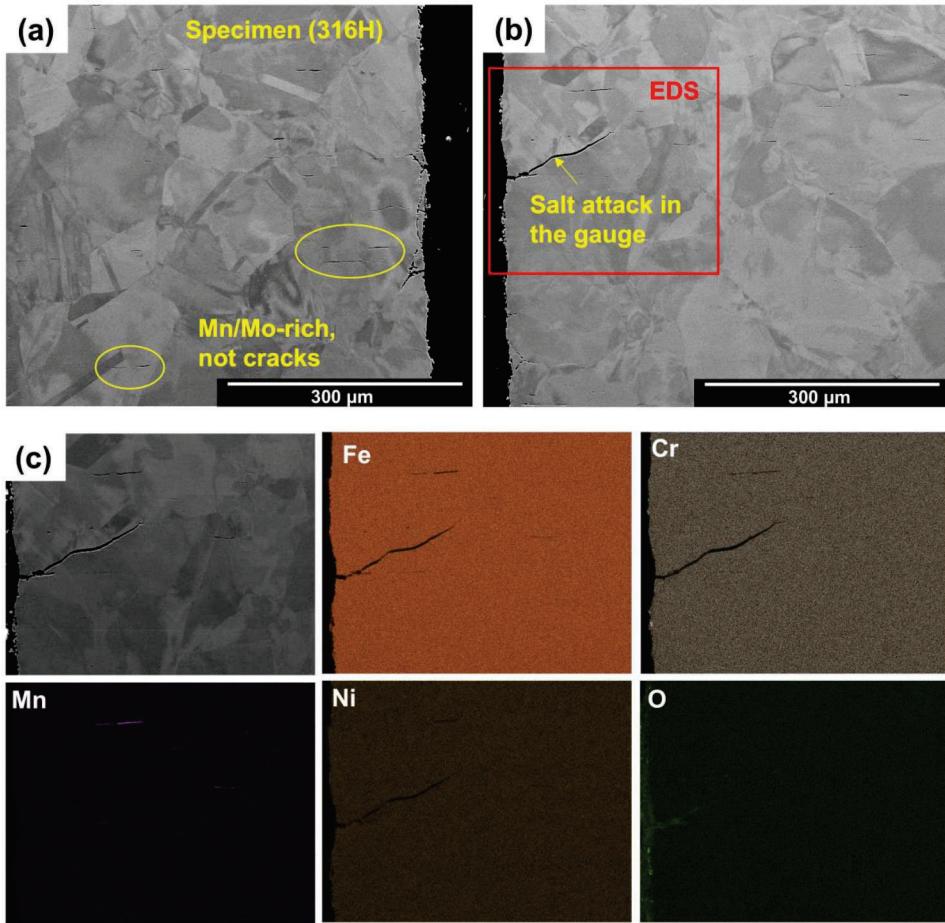
Figure 22. (a) Microstructure and (b) EDS maps of SS 316H at the gauge of WSTA-5 showing the corrosion damage.

Characterization of the microstructure at specimen gauge shown in Figure 22b revealed cracks due to salt attack, as confirmed by EDS maps (Figure 22c). Measurements of salt attack depths were conducted at >20 spots and the average attack depth is 35.8 μm . The maximum attack depth was measured to be 132.5 μm . This figure also shows that 200 hr thermal cyclic testing in FLiNaK salts resulted in more damage in the SS 316H gauge compared to the testing in NaCl-MgCl₂ salts. Additionally, FLiNaK induced more cracking in the test articles compared to NaCl-MgCl₂.

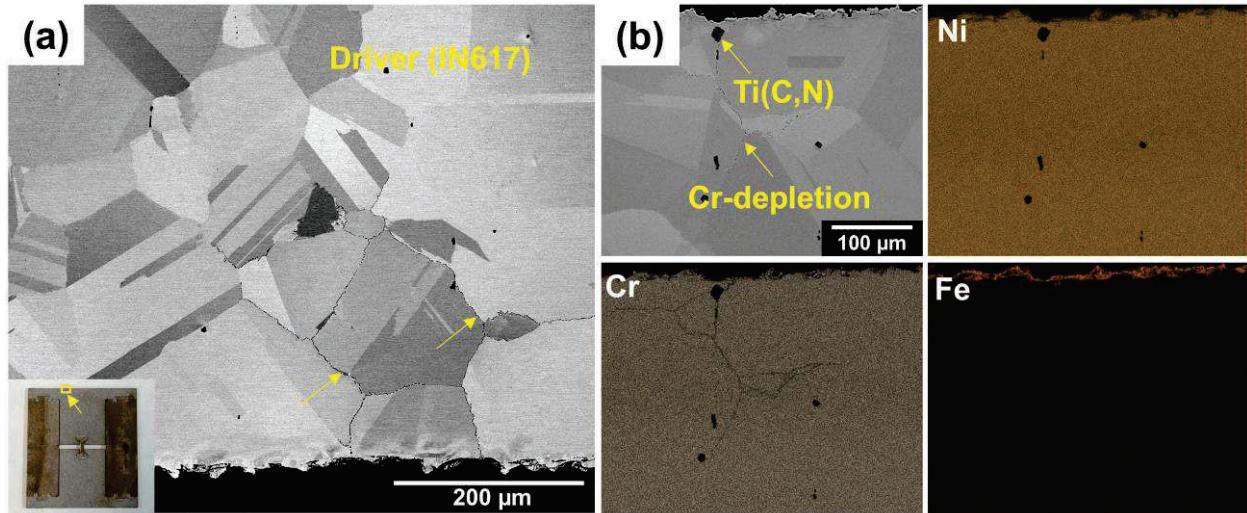
Figure 23. (a) Microstructure and (b) elemental distribution in A617 driver at the edge of test article away from the SS 316H specimen as indicated in the inserted image in (a).

The Alloy 617 driver at the edge of the test article away from the SS 316H specimen (marked in Figure 23a) was examined. The microstructure (Figure 23a) and EDS maps (Figure 23b) clearly reveal Cr-depletion at the grain boundaries. Corrosion attack depth was significant, showing $>200 \mu\text{m}$ corrosion damage. Corrosion in Alloy 617 driver as revealed in Figure 20, Figure 21, and Figure 22 may indicate that concern of using Alloy 617 as the driver material since the driver material was expected to have minimal corrosion compared to the specimen (SS 316H in this case). Corrosion in drivers can cause degradation of the driver material, which affect the creep strength and intended design of the test article. Therefore, this project also evaluated Alloy 244 as the driver material in FY25. A revised test article design as shown in Figure 4b was finalized to adopt Alloy 244 as the driver material. Alloy 244 as the driver material can provide several benefits. First, Alloy 244 has much less Cr content (8 wt.%) compared to Alloy 617 (20 to 24% of Cr). Therefore, Cr depletion-induced cracking is expected to be mitigated in Alloy 244. Moreover, Alloy 244 does not have cobalt in its composition whereas Alloy 617 has 10 to 15 wt.% of cobalt. The cobalt in Alloy 617 limited the location where the test article can be placed to eliminate the formation of cobalt-60. In addition, Alloy 244 has a lower coefficient of thermal expansion (CTE, $8.9 \times 10^{-6}/\text{C}$) compared to Alloy 617 ($11.6 \times 10^{-6}/\text{C}$). The larger mismatch of CTE between Alloy 244 and SS 316H enables the further shrinkage of the size of test articles to apply same stress as Alloy 617, or increase of the stress with the same test article geometry. Welding of Alloy 244 to SS 316H is currently being analyzed using XCT to ensure the quality of welds before furnace and molten salt testing.

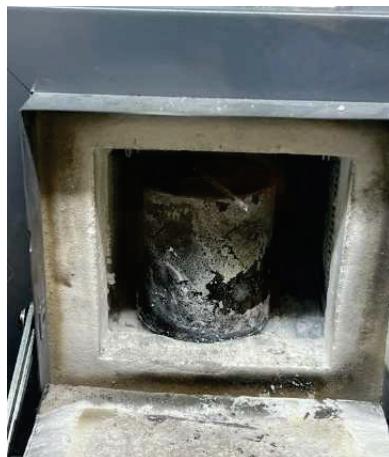
Figure 24. Condensation of salt vapors observed on the outer surface of the crucible and along the interior walls of the furnace following thermal cycling. These deposits are indicative of partial vaporization of NaCl–MgCl₂ salt during repeated exposures to peak temperatures slightly exceeding 700°C

Following the 200-hr thermal cycling test, visible condensation of salt vapors was observed on the outer surface of the crucible and along the interior walls of the furnace (see Figure 24). Although NaCl–MgCl₂ salt is generally stable up to 700 °C, it begins to vaporize at temperatures exceeding this threshold. To maintain a target temperature of 700 °C during the soak phase, the furnace setpoint had to be slightly elevated, resulting in peak salt temperatures reaching approximately 713 °C during each cycle. This marginal overshoot led to incremental vaporization of the salt with each cycle. Post-test inspection revealed a noticeable reduction in salt level, indicating that the specimens—initially fully submerged—experienced a gradual change in immersion depth over time. As a result, weight loss measurements from this test may not reliably reflect uniform exposure conditions across all cycles. Given the thermal instability of the NaCl–MgCl₂ system under these conditions, future exposure tests will instead focus on the more stable FLiNaK salt.

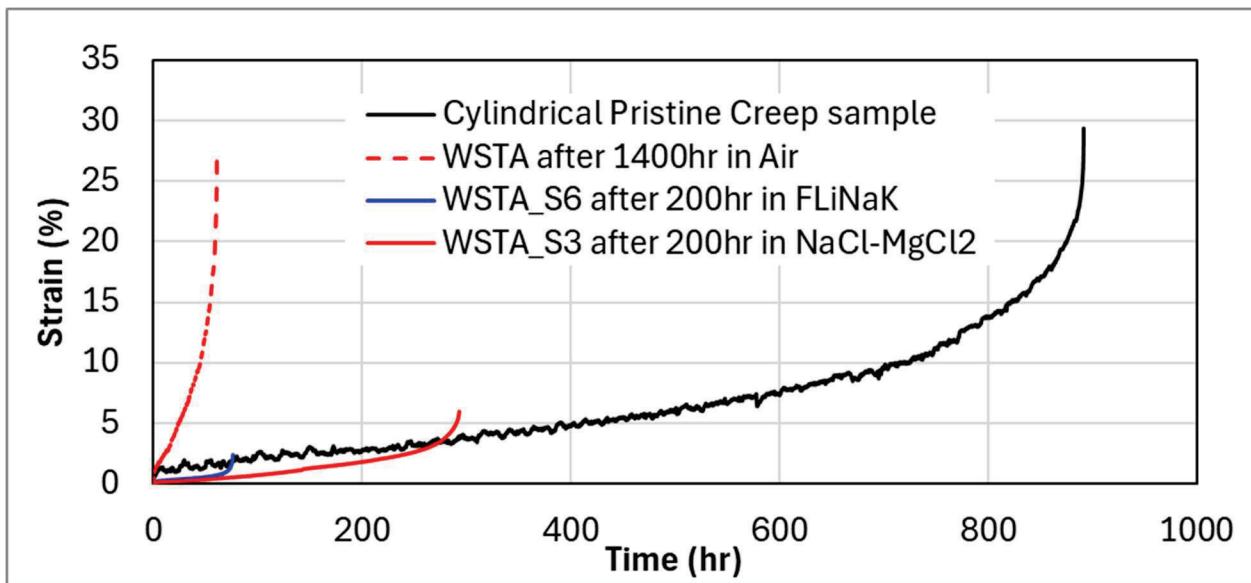
Figure 25. Creep curves tested at 700°C and 130 MPa of pristine SS 316H, SS 316H specimens after 1400 hr of cyclic testing in air, and SS 316H specimens after 200 hr cyclic thermal testing in FLiNaK and NaCl-MgCl₂ salts.

Figure 25 shows the creep curves of a pristine SS 316H and specimens after testing in molten salt. The pristine SS 316H had a creep-rupture life of 891 hr while the specimen after testing in NaCl-MgCl₂ and FLiNaK had a reduced creep-rupture life of 293 hr and 76 hr, respectively. The creep strain follows a similar trend. The creep strain of pristine SS 316H was 29.4% while the test articles after testing in NaCl-MgCl₂ and FLiNaK had a creep strain of 6.0% and 2.4%, respectively. Post-salt creep testing shows the specimens after salt exposure had a significant decrease in creep rupture life and creep strain compared to the wrought material. Therefore, accumulation of damage was evidenced in the test articles during molten salt environment and cyclic thermal loadings. The post-test creep experiments demonstrated the method to estimate material remaining life for material degradation analysis. Figure 26 shows the morphologies of fracture surfaces in the longitudinal section. The result shows that the cracks initiated in the corrosion attacked region and propagated along grain boundaries under creep loading. The corrosion attack depth in SS 316H specimen after exposure in FLiNaK was larger compared to that in the specimen after testing in NaCl-MgCl₂, which caused shorter rupture life and strain of the WSTA-6 compared to WSTA-3.

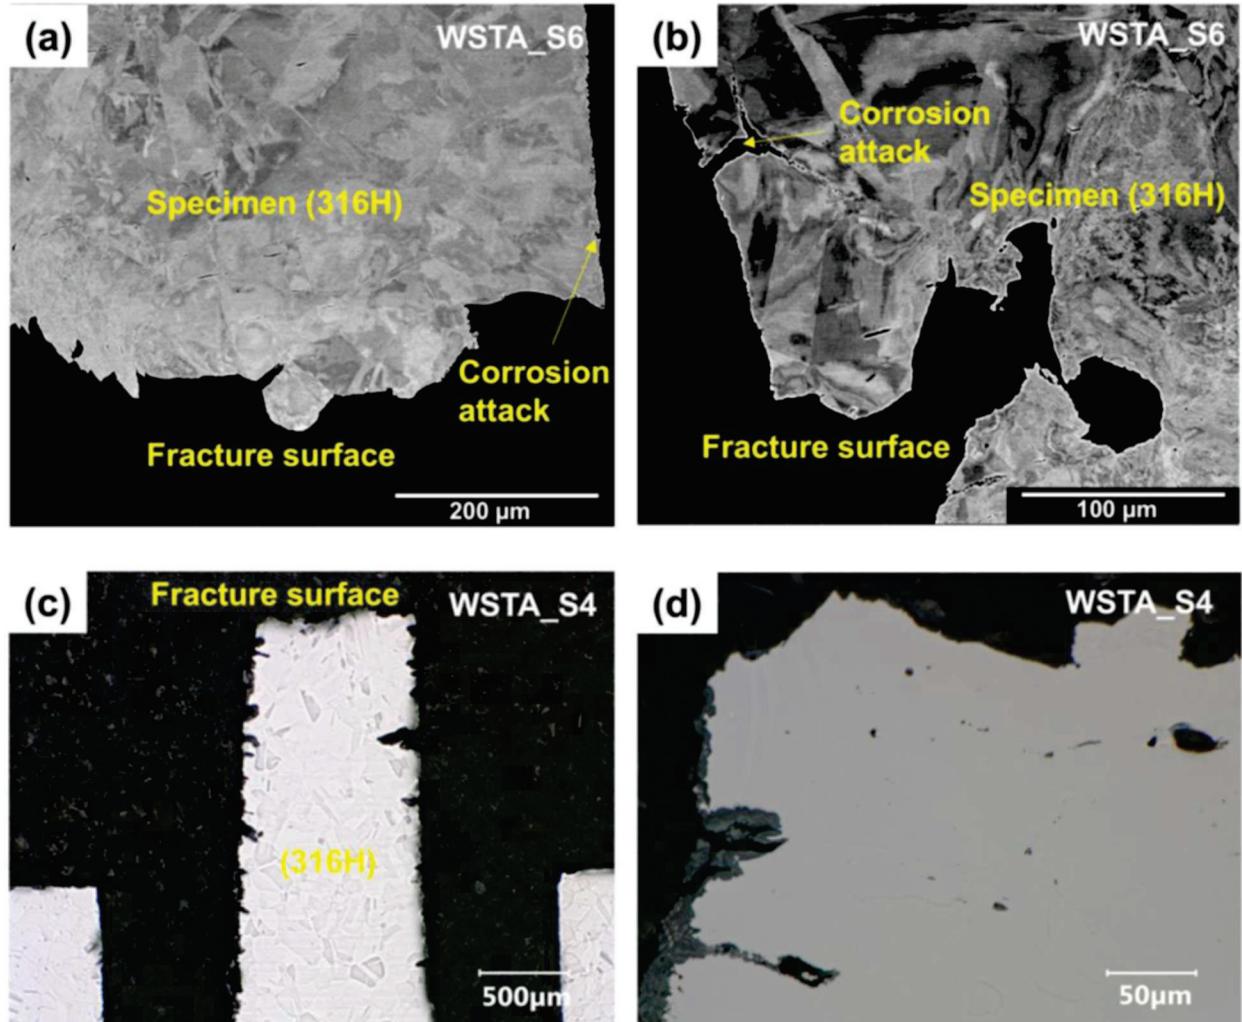
Figure 26. Fracture morphologies of test articles after testing in (a, b) FLiNaK and (c, d) NaCl-MgCl₂ salts.

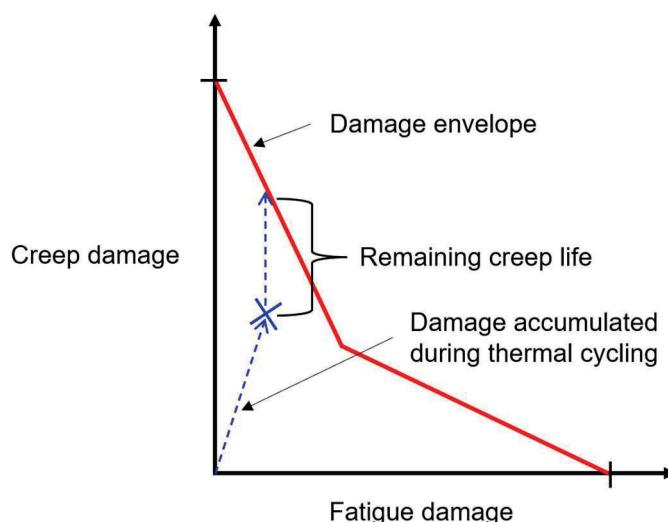
Figure 27. Schematic representation of remaining creep life assessment based on damage envelope.

For test article tested in air environment, the strain range reduction was observed around 350th cycle and reached nearly zero mechanical strain range. Hence, damage fractions are calculated up to the 350th cycle. For articles in salt environment, test was discontinued after 200 hr of thermal cycles, which indicates total of 33 cycles of thermal cycles. For salt environment tests, mechanical strain range is assumed to be same as strain range of specimen tested in air. Hence, the average cycles to failure is same for all tests. Fatigue and creep damage fractions are calculated for applied thermal profiles. The remaining life is assed by the difference of calculated damage fractions and the nearest intersection of damage envelope for a given fatigue damage fraction, shown schematically in Figure 27. The remaining creep life is calculated by multiplying the remaining creep damage fraction by the time to rupture on the pristine ASTM circular sample (891 hr). The anticipated creep lives are compared against the observed time to rupture and presented in Table 2.
