Sampling of Contamination - Lessons for Nuclear Forensics Collections and Analysis

Idaho National Laboratory

Overview

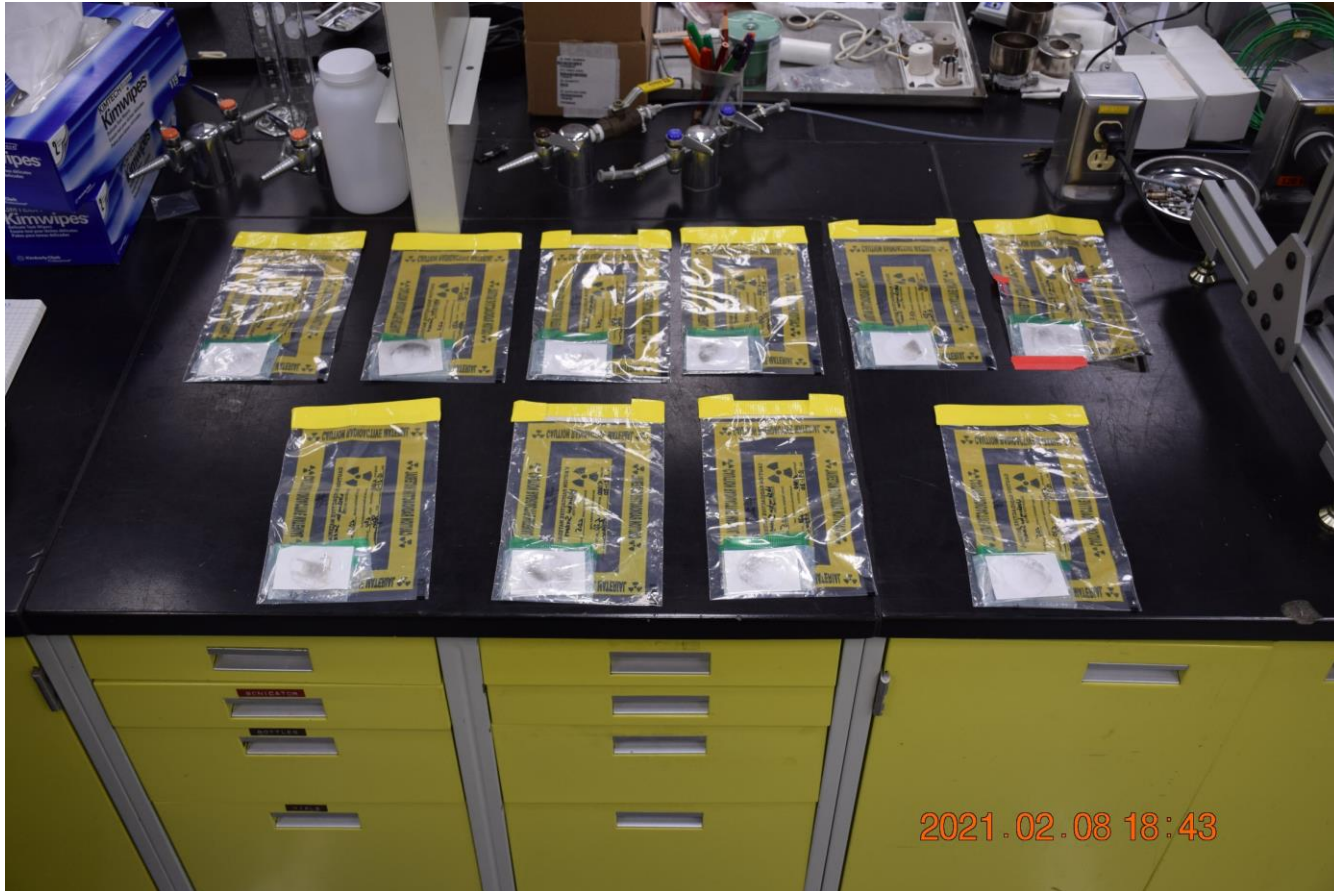
Ten Harborview cesium "HP" smears

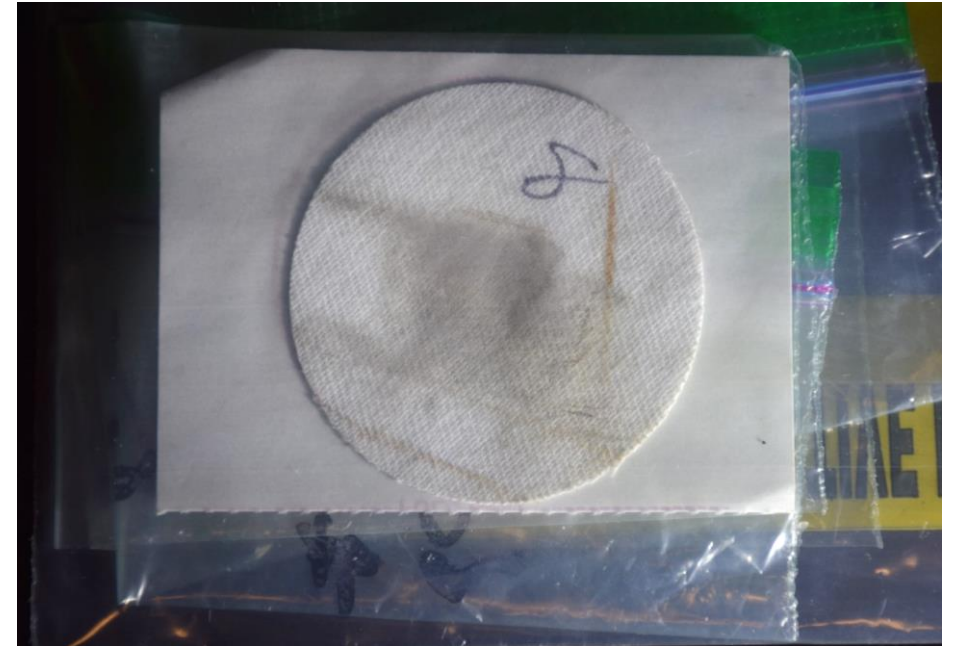
Close-up view of cotton-fiber HP smear, still attached to wax paper backing

Standard HP smears are too fibrous, very small particles can be caught inside the weave and make SEM detection difficult

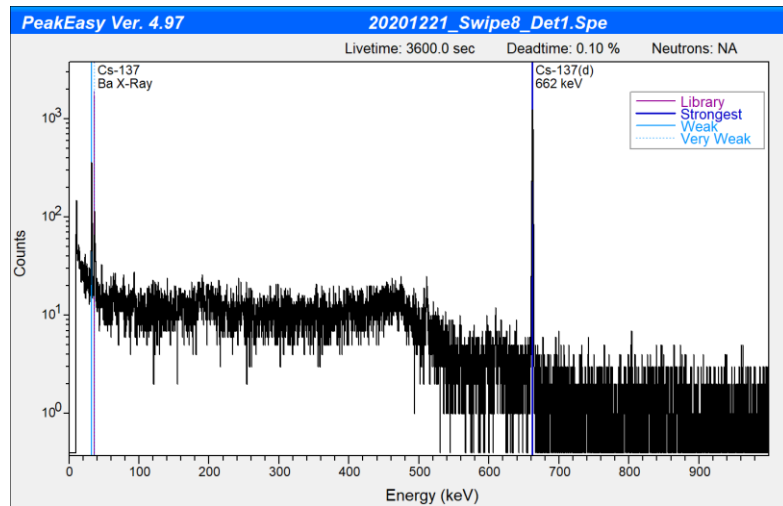
- Performed gamma-ray spectrometry to confirm understanding of activity, exclude presence of other radioisotopes
 - ^{137}Cs observed, along with Ba x-rays (not seen in sealed sources)
 - No sign of ^{134}Cs or other significant radioisotopes
- Reasonably good correlation between measured "on-contact" $\beta + \gamma$ dose rates and estimated ^{137}Cs activity (γ dose rates were all 0 on contact)

Representative gamma-ray spectrum

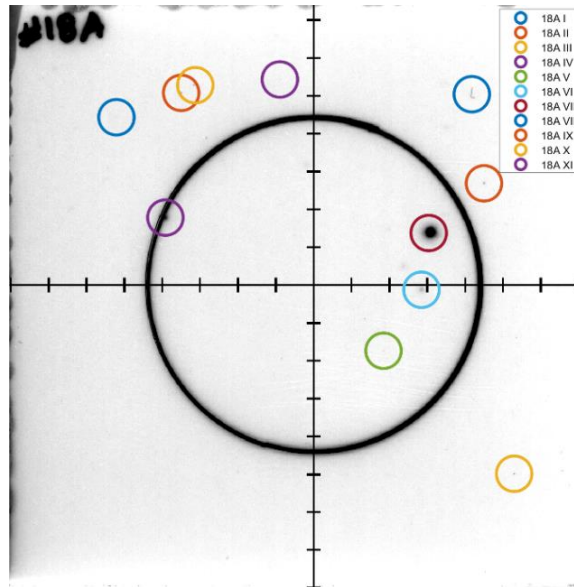
Analyzed ARAD image

Estimated ¹³⁷Cs activity per localized ROI

Region of Interest	Activity, Bq
VII	104
XI	5
VI	3
VIII	2
III	1
Balance	1
Total	116 ± 3

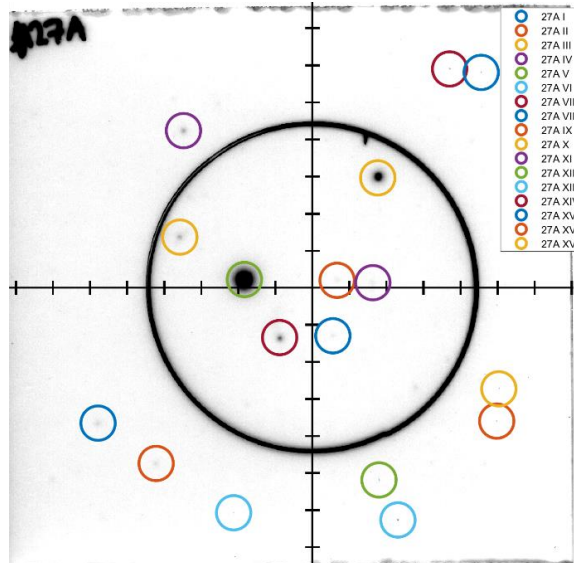
Analyzed ARAD image

Estimated ¹³⁷Cs activity per localized ROI

Region of Interest	Activity, Bq
V	528
X	89
VII	21
IV	7
I	3
Balance	11
Total	659 ± 15

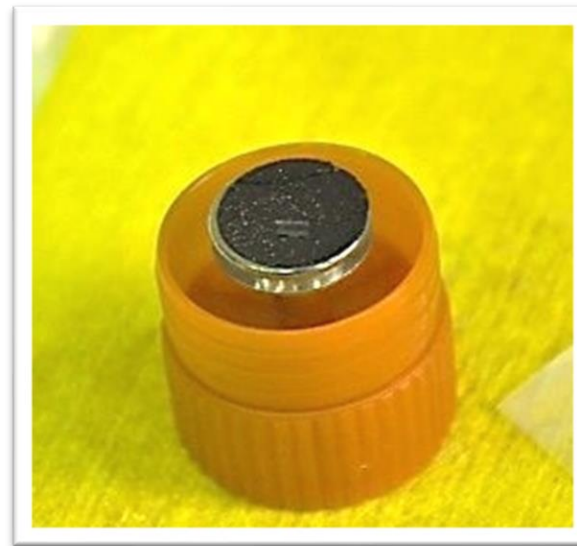
SEM stub in holding mount

Need to develop a better way to hold samples for storage and transport, consider mounting smear onto a SEM stub, and then use SEM sample holders
