CRADA Final Report
for

CRADA Number C/ORNL 92-0076

In-Service Testing of Ni₃Al Coupons and
Trays in Carburizing Furnaces at Delphi Saginaw

Date Published: August 1998

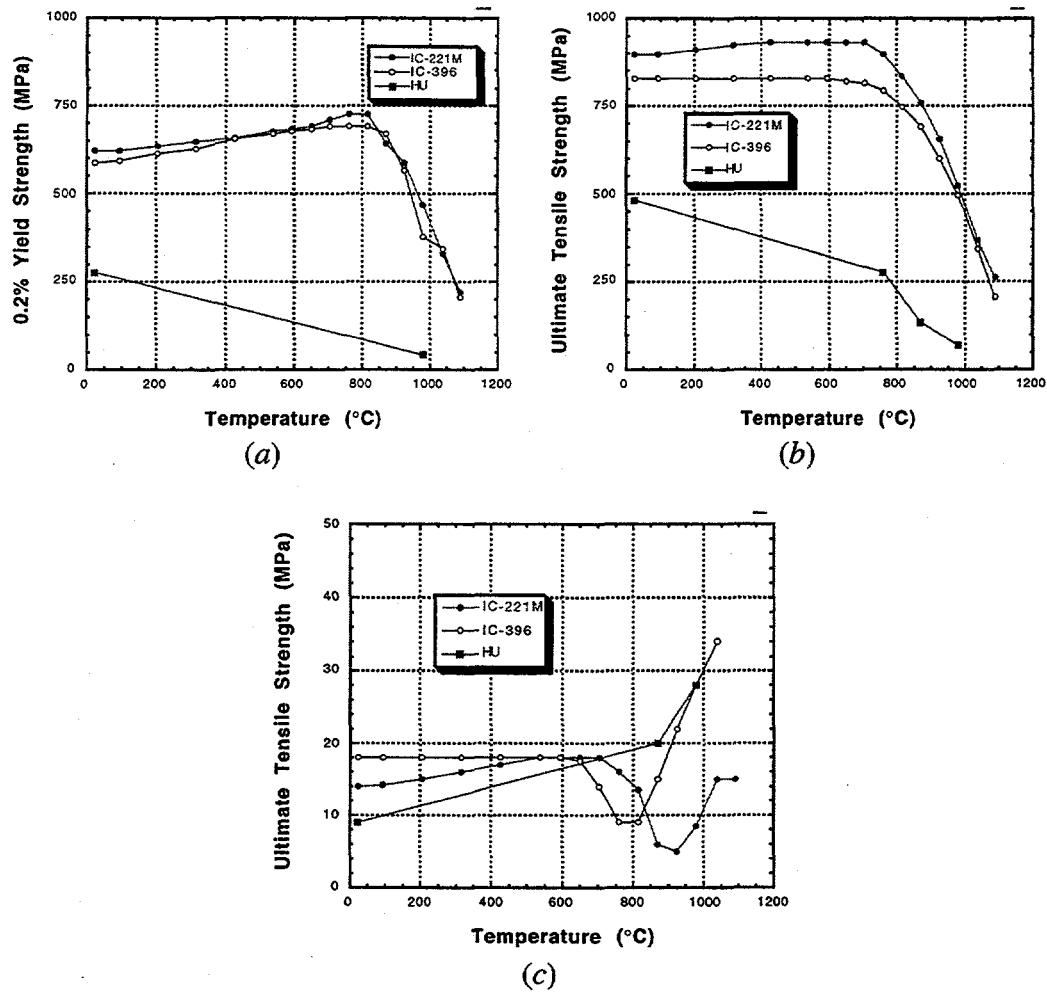
Fig. 3. Comparison of tensile properties of cast Ni₃Al-based alloys with cast HU alloy: (a) 0.2% yield strength, (b) ultimate tensile strength, and (c) total elongation.

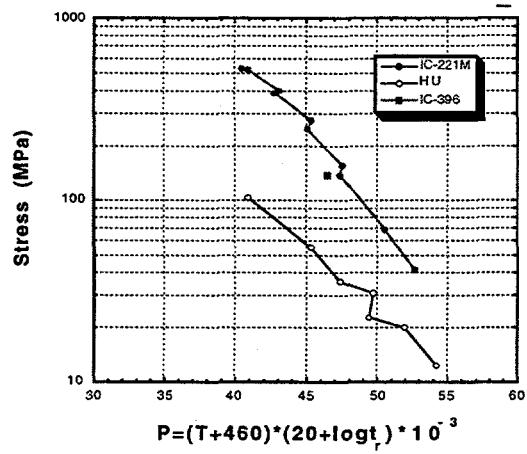
Fig. 4. Comparison of creep-rupture strength of cast Ni₃Al-based alloys with cast HU alloy.

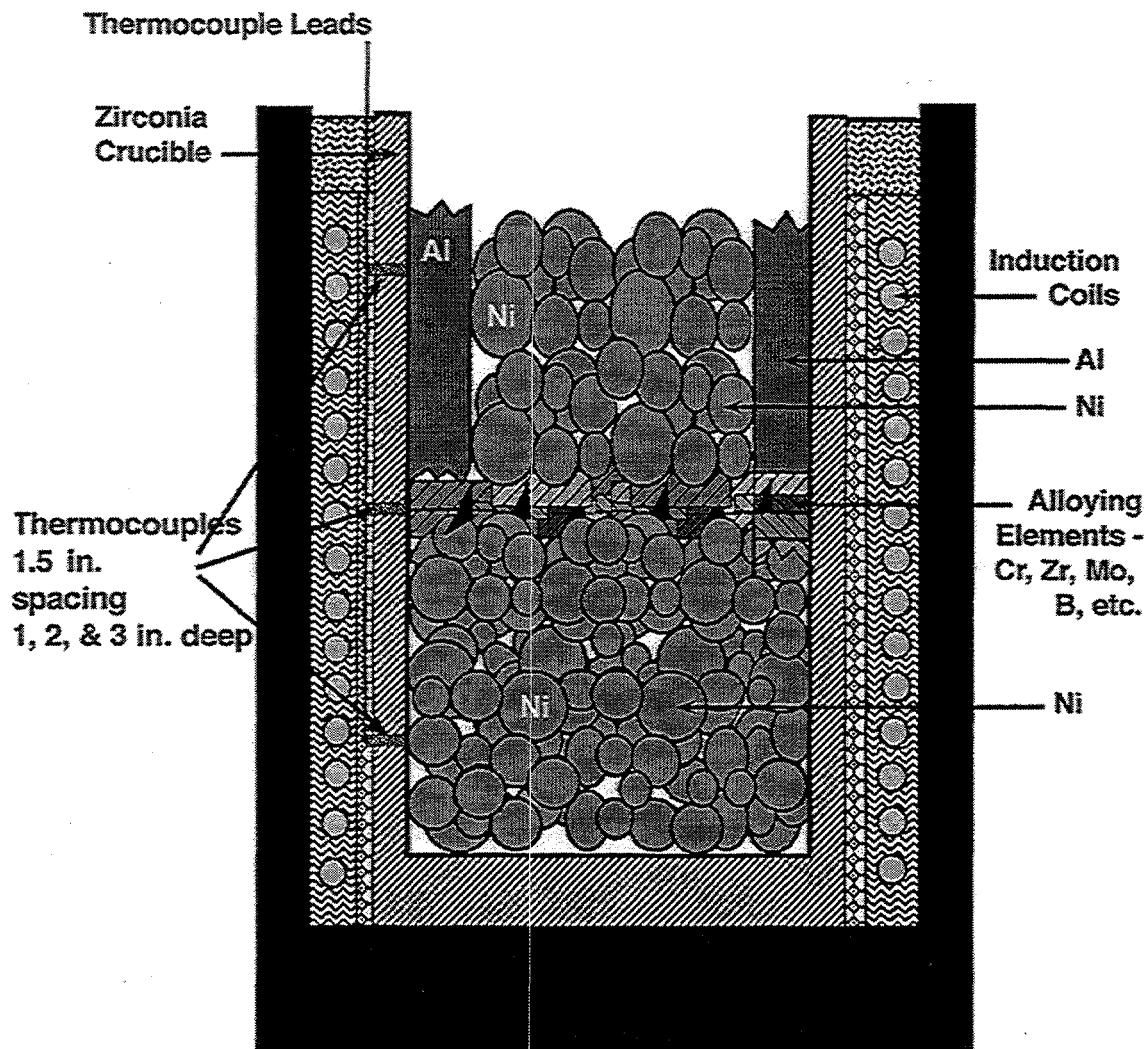
Fig. 5. Schematic of furnace-loading sequence employed for the Exo-Melt™ process to melt nickel aluminides.

A new process known as Exo-Melt™ was developed for melting Ni_3Al -based alloys. The process is based on loading techniques of component elements so that the heat of formation of Ni_3Al from its elements nickel and aluminum is used most effectively. The Exo-Melt™ process was developed using a 15-lb capacity air-induction-melting furnace at ORNL. The process has also been successfully demonstrated for several 600-lb heats at Alloy Engineering & Casting Company (AEC) [Champaign, Illinois]. AEC is the foundry used by Delphi Saginaw for the manufacture of their heat-treating fixtures from HU alloys. The Exo-Melt™ process has many advantages for melting Ni_3Al -based alloys: (1) it uses 50% less energy than the conventional process, (2) it uses 50% less time than the conventional process, (3) it prevents overheating of the melt, (4) it minimizes the excessive reaction with the furnace crucible, (5) chemical analyses are more reproducible, and (6) inclusions are minimized because of less time at temperature and no overheating.

The Exo-Melt™ process has been used for melting virgin heats and remelt stock. The furnace-loading sequence for Ni_3Al -based alloy IC-221M is shown in Fig. 5.

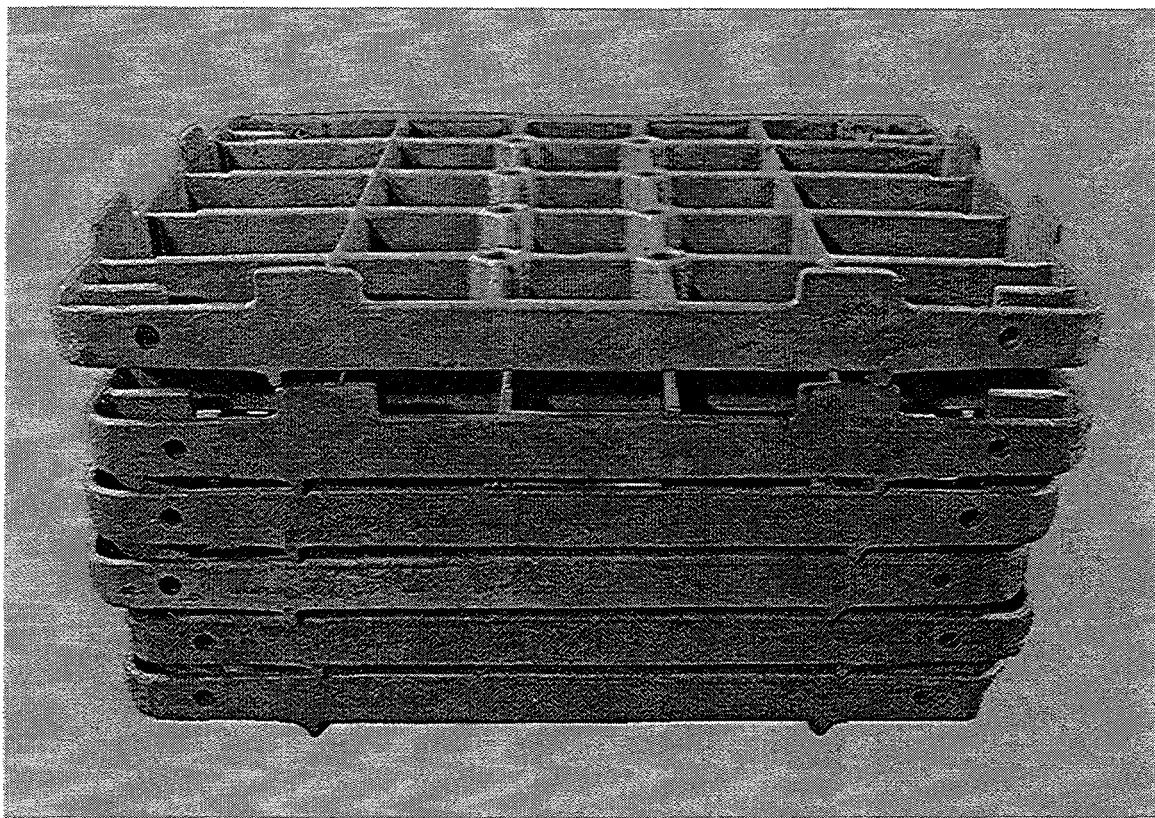
Fig. 6. Stack of six cast batch furnace trays of IC-221M.

The castings for Figs. 6 and 7 were inspected for casting defects. The areas with defects were gauged by grinding and were weld repaired. The weld repair was carried out using IC-221LA (see Table 2 for composition) weld wire and gas tungsten arc process. The number of repair welds and their locations are summarized in Table 3. No problems were encountered during these weld repairs and, thus, it is concluded that the cast parts of Ni₃Al-based alloy IC-221M can be weld repaired.

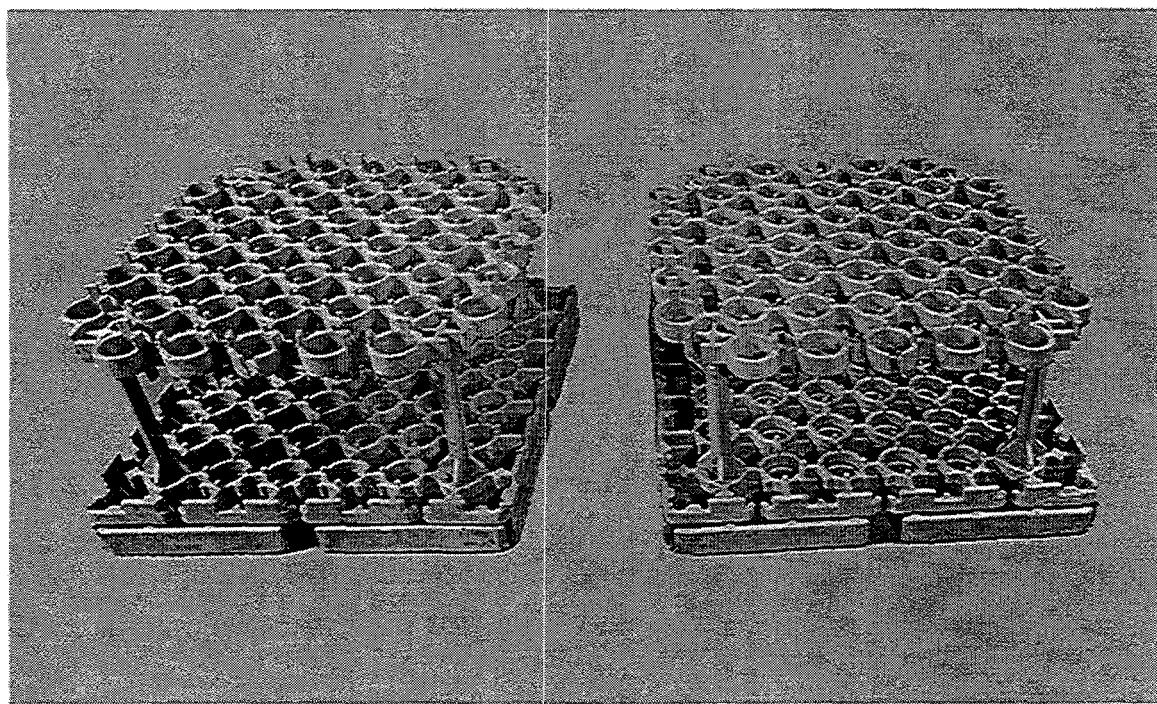
Fig. 7. Two cast tray and fixture assemblies of IC-221M for pusher carburizing furnace.

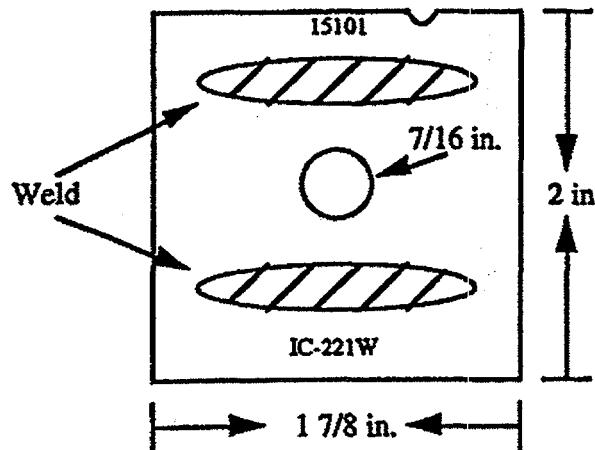
Low-Silicon Tray Coupon

- o Welds on machined surface.
- o All other surfaces are in the as-cast condition.

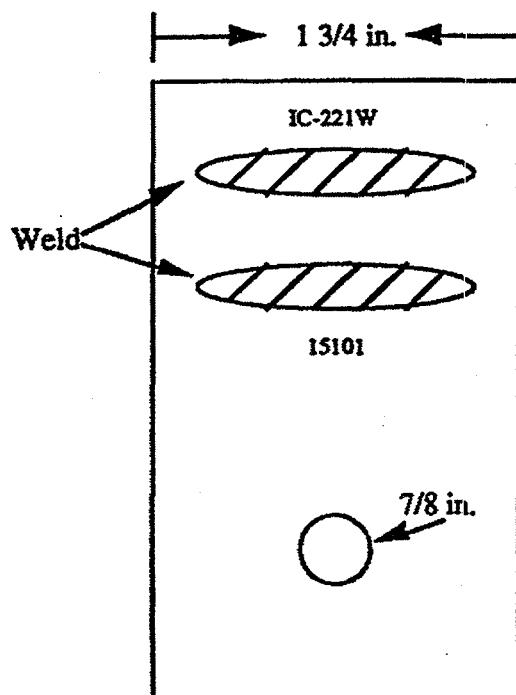
High-Silicon Tray Coupon

- o Welds on machined surface.
- o All other surfaces are in the as-cast condition.

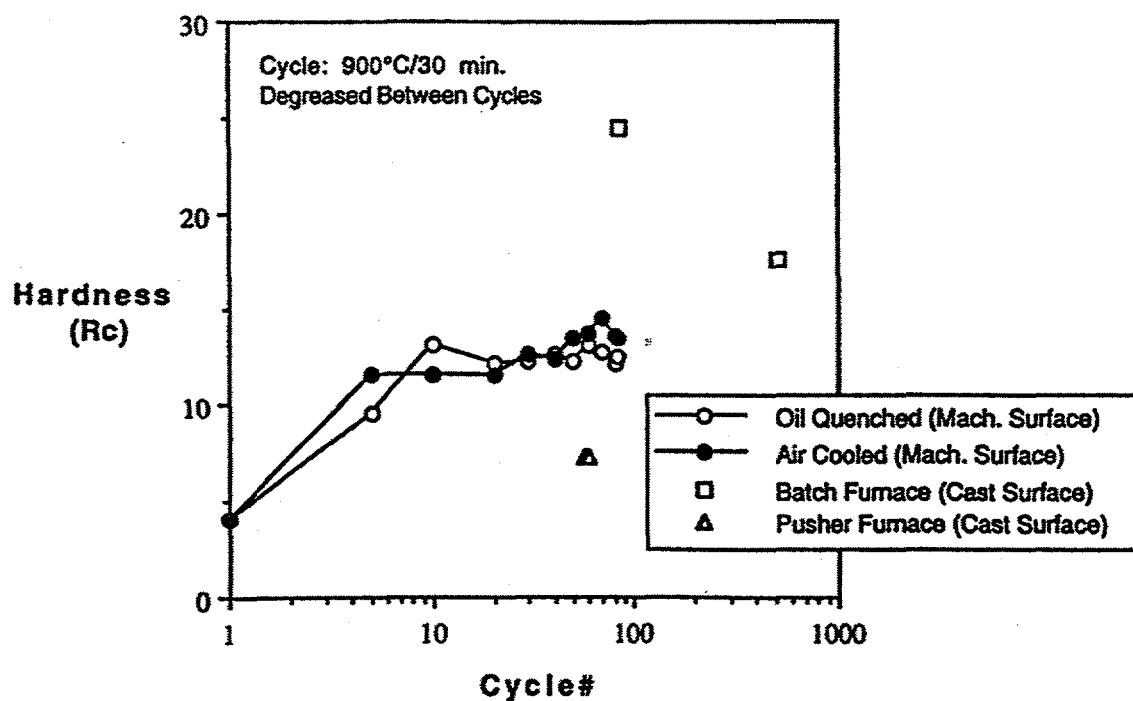
Fig. 10. Thermal cycle hardness data of HU.

Figs. 10 through 12. In the as-cast condition, the HU coupons exhibited low hardness. The hardness increased with either the simulated cycles in the laboratory or actual cycles in the carburizing furnace. The IC-221M coupons either showed no change in hardness or it dropped in some cases. There was substantial scatter in the data for coupons removed from the carburizing furnaces. This scatter could result from the way the coupons were handled. For example, some coupons were sand blasted after removal and some were removed after a carbon burn-off cycle.

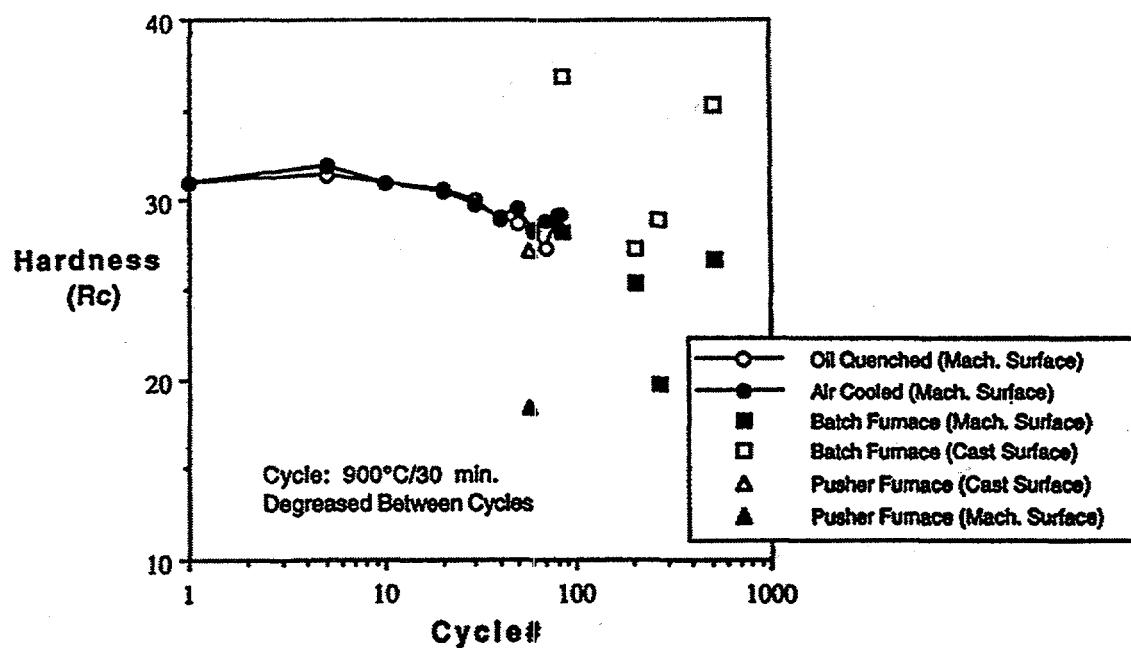
Fig. 11. Hardness data as a function of thermal cycles on coupons from tray sections of IC-221M alloy containing low silicon.

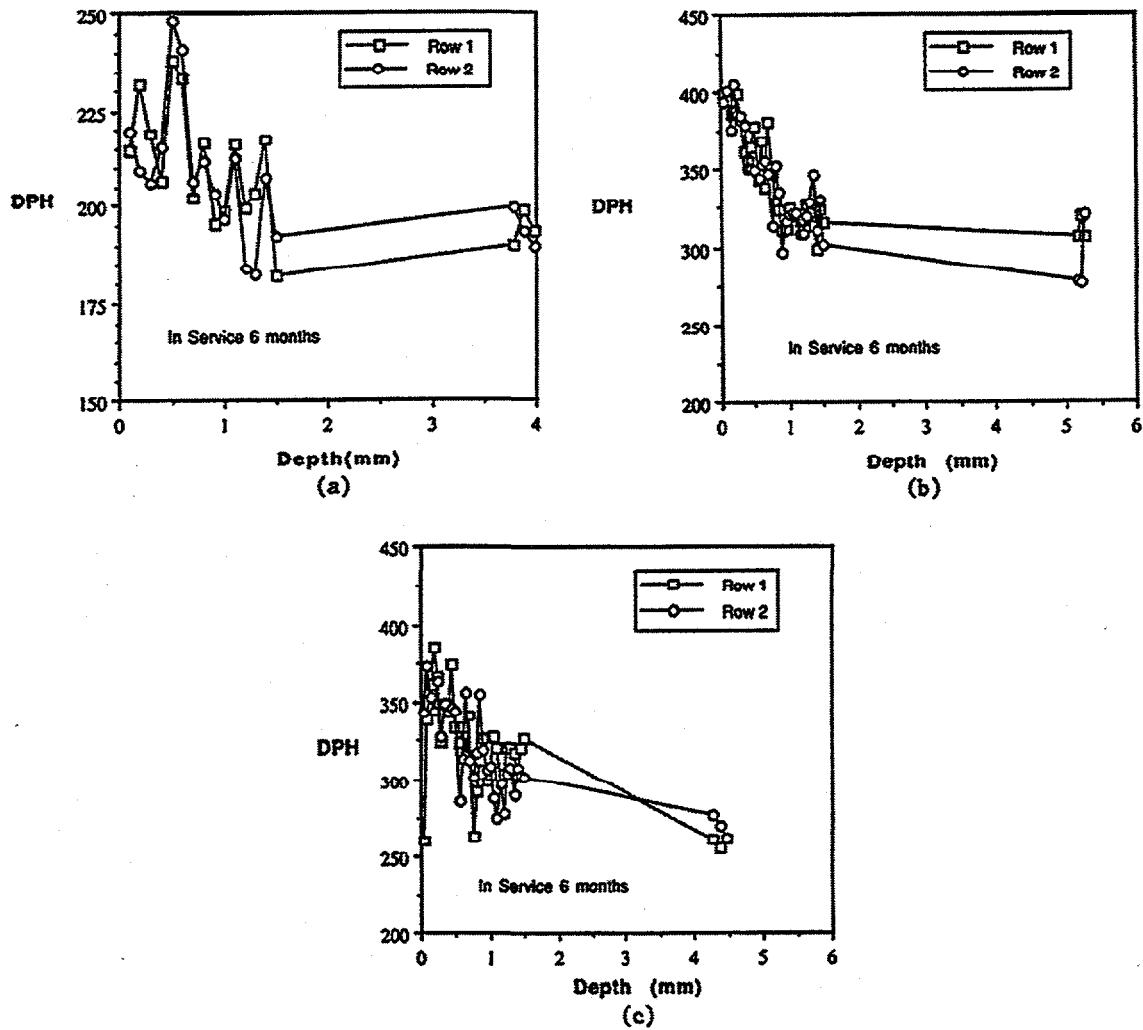
Fig. 14. Depth of carbon penetration after six-months exposure in a batch furnace throughout the coupon thickness for: (a) HU, (b) low-silicon nickel aluminide, and (c) high-silicon nickel aluminide.

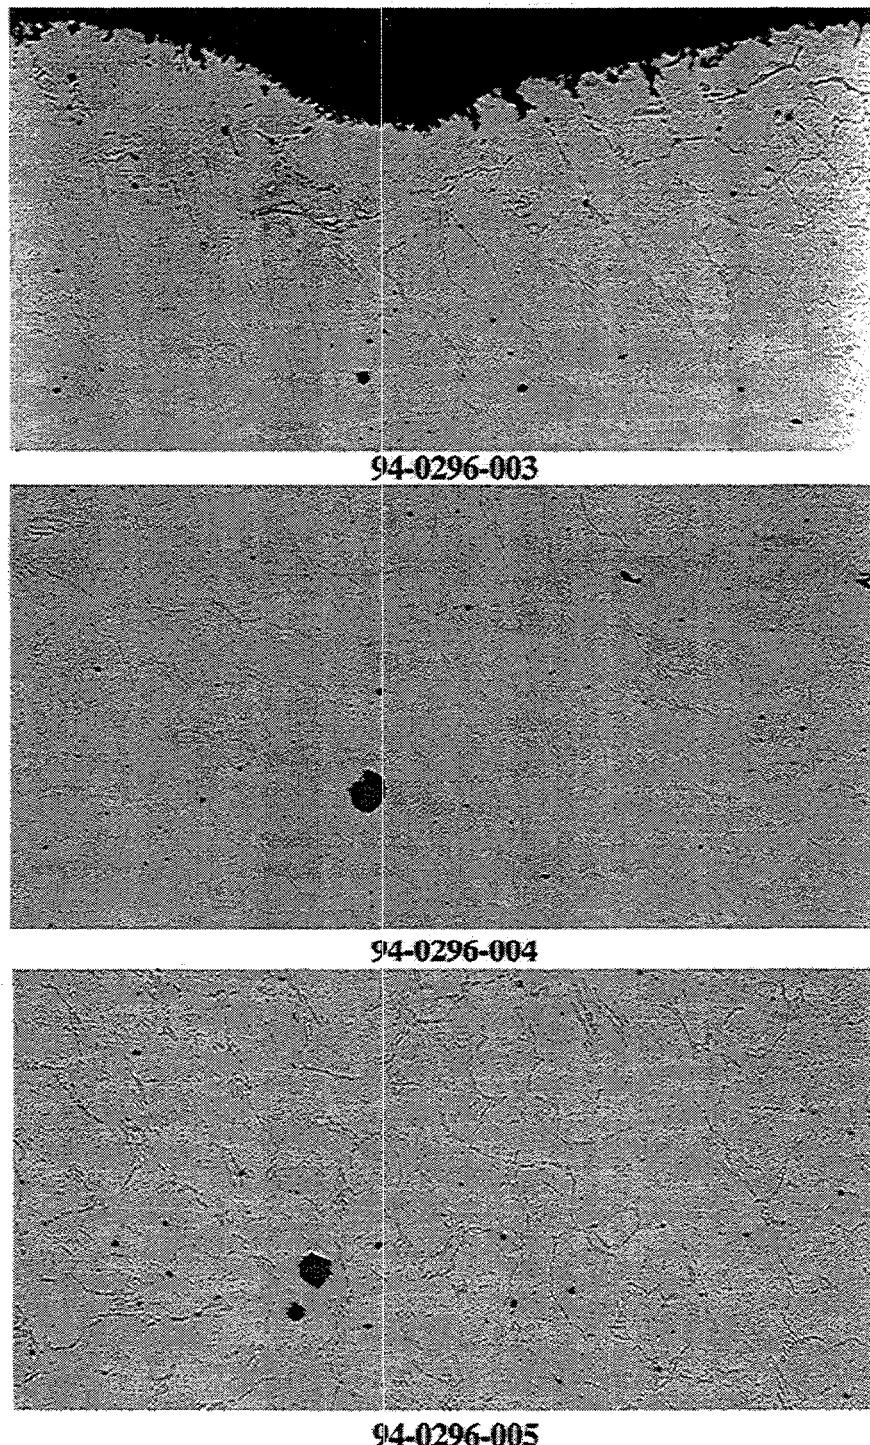
Fig. 15. Optical micrographs showing the variation of microstructure from the edge to the center of the HU coupon exposed for six months in a carburizing batch furnace at Delphi Saginaw.

Photomicrographs of coupons of HU and IC-221M of low and high silicon after six months exposure in the batch carburization furnace at Delphi Saginaw are presented in Figs. 15 through 17. The photomicrographs show the variation of microstructure from the edge to the coupon center. The HU coupons show no surface scale, and the carburization product appears to have propagated through the coupon thickness. The IC-221M coupons show surface-scale and carburization-related changes only to a small distance beneath the scale. The scale thicknesses of IC-221M coupons after exposure in batch and pusher furnaces are summarized in Table 6. Data in this table include the measurements for the base- and weld-metal regions. The scale thickness for the exposed coupons of IC-221M is plotted as a function of the number of cycles in Fig. 18.

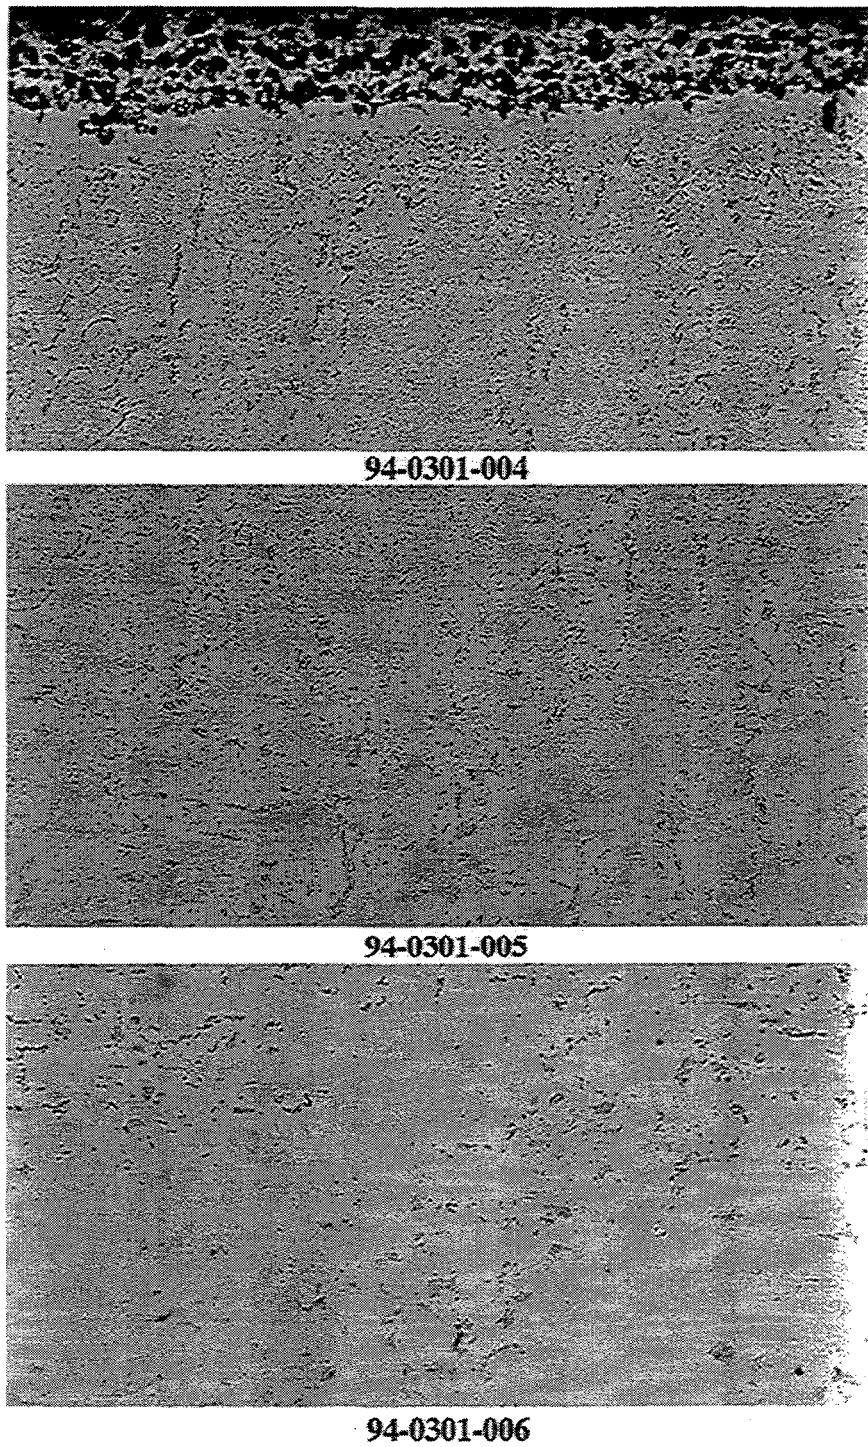
Fig. 16. Optical micrographs showing the variation of microstructure from the edge to the center of the low-silicon nickel-aluminide coupon exposed for six months in a carburizing batch furnace at Delphi Saginaw.

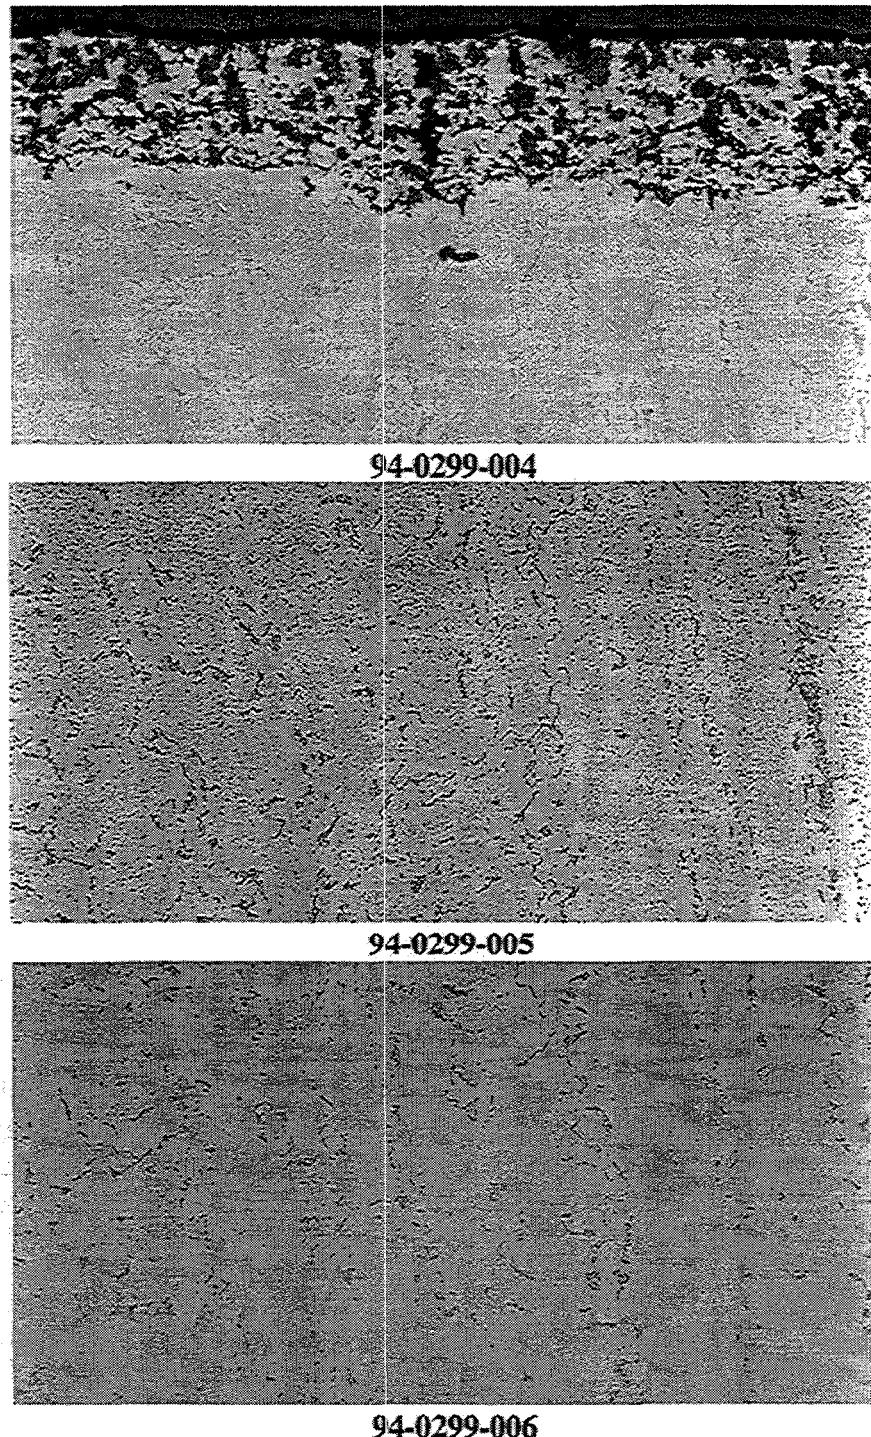
Fig. 17. Optical micrographs showing the variation of microstructure from the edge to the center of the high-silicon nickel-aluminide coupon exposed for six months in a carburizing batch furnace at Delphi Saginaw.

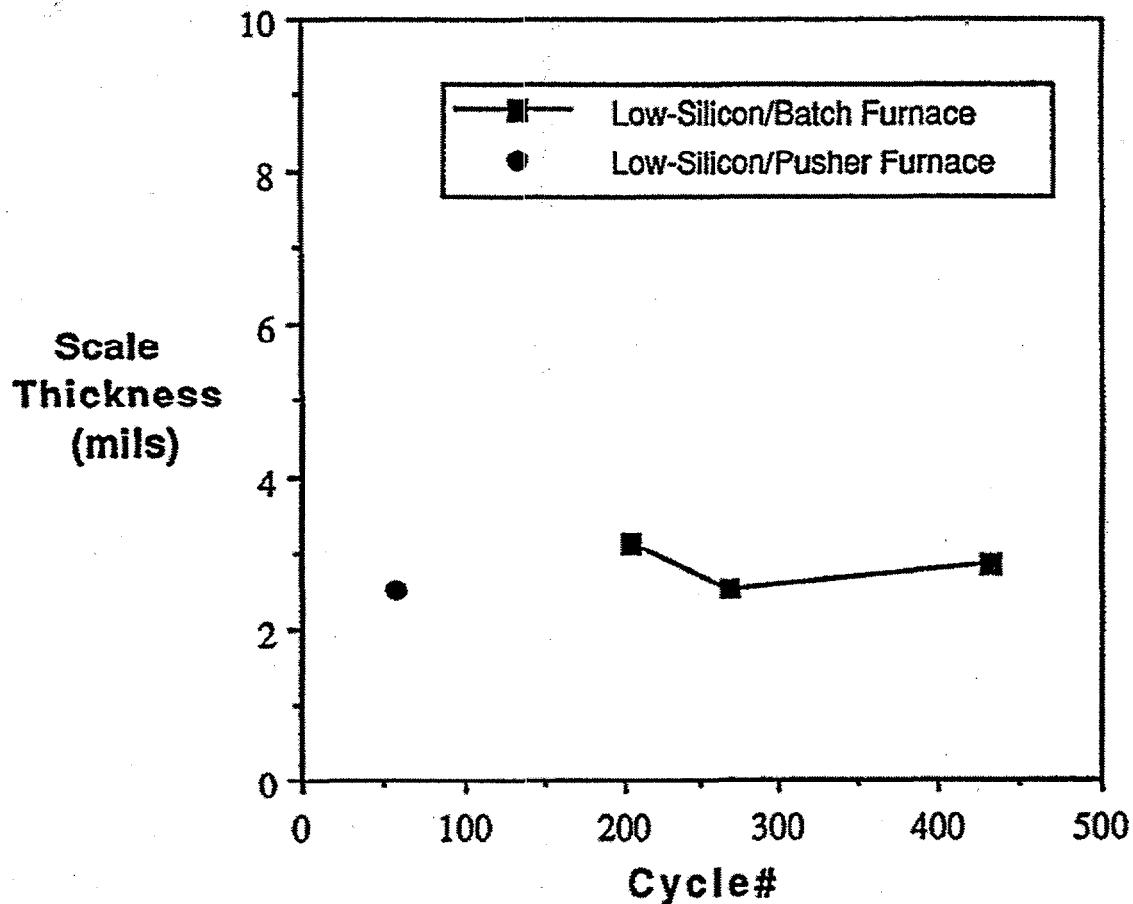
Fig. 18. Surface scale thickness of nickel-aluminide coupons versus exposure time in batch and pusher carburizing furnaces at Delphi Saginaw.

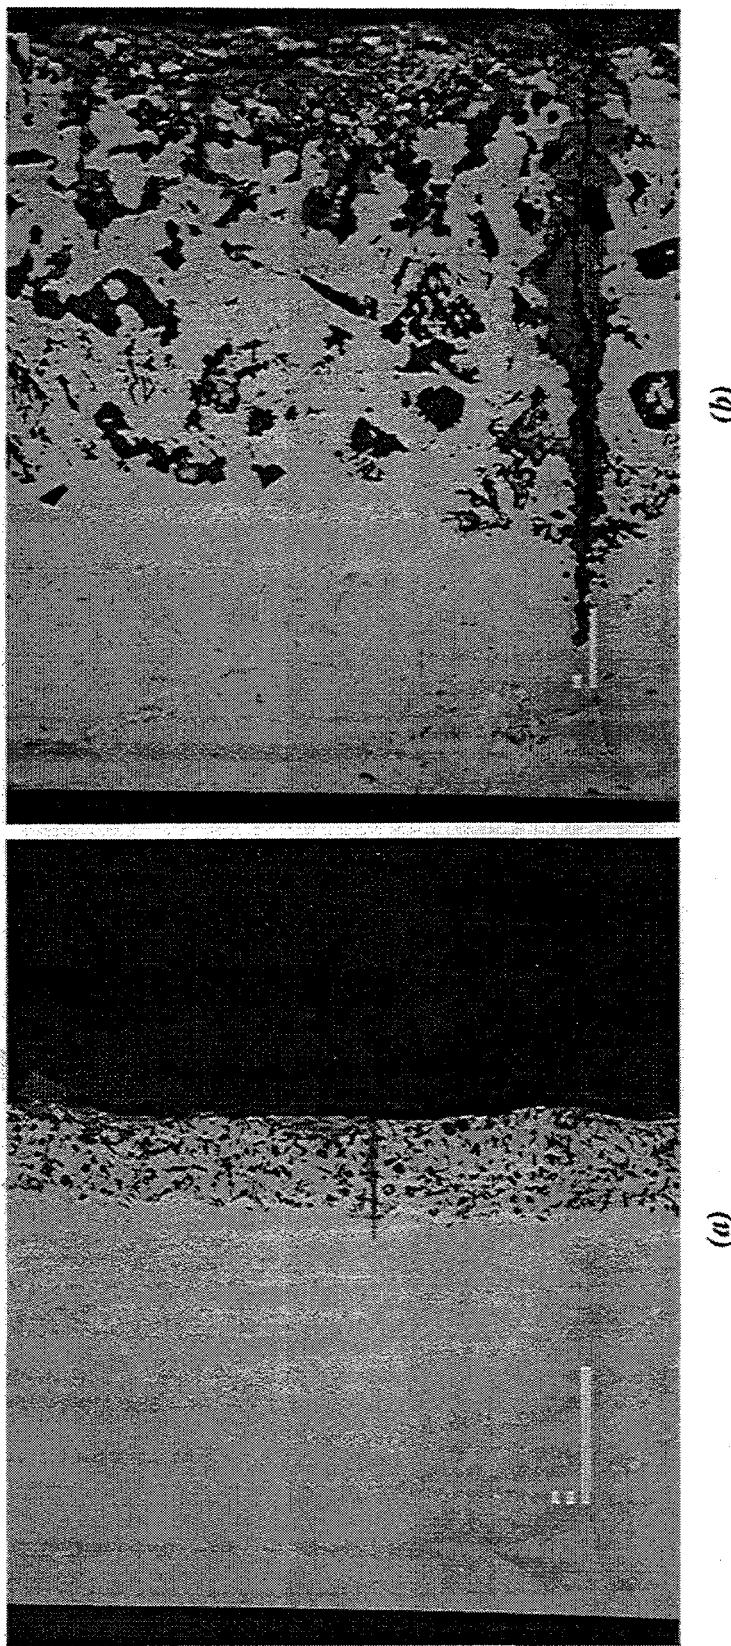
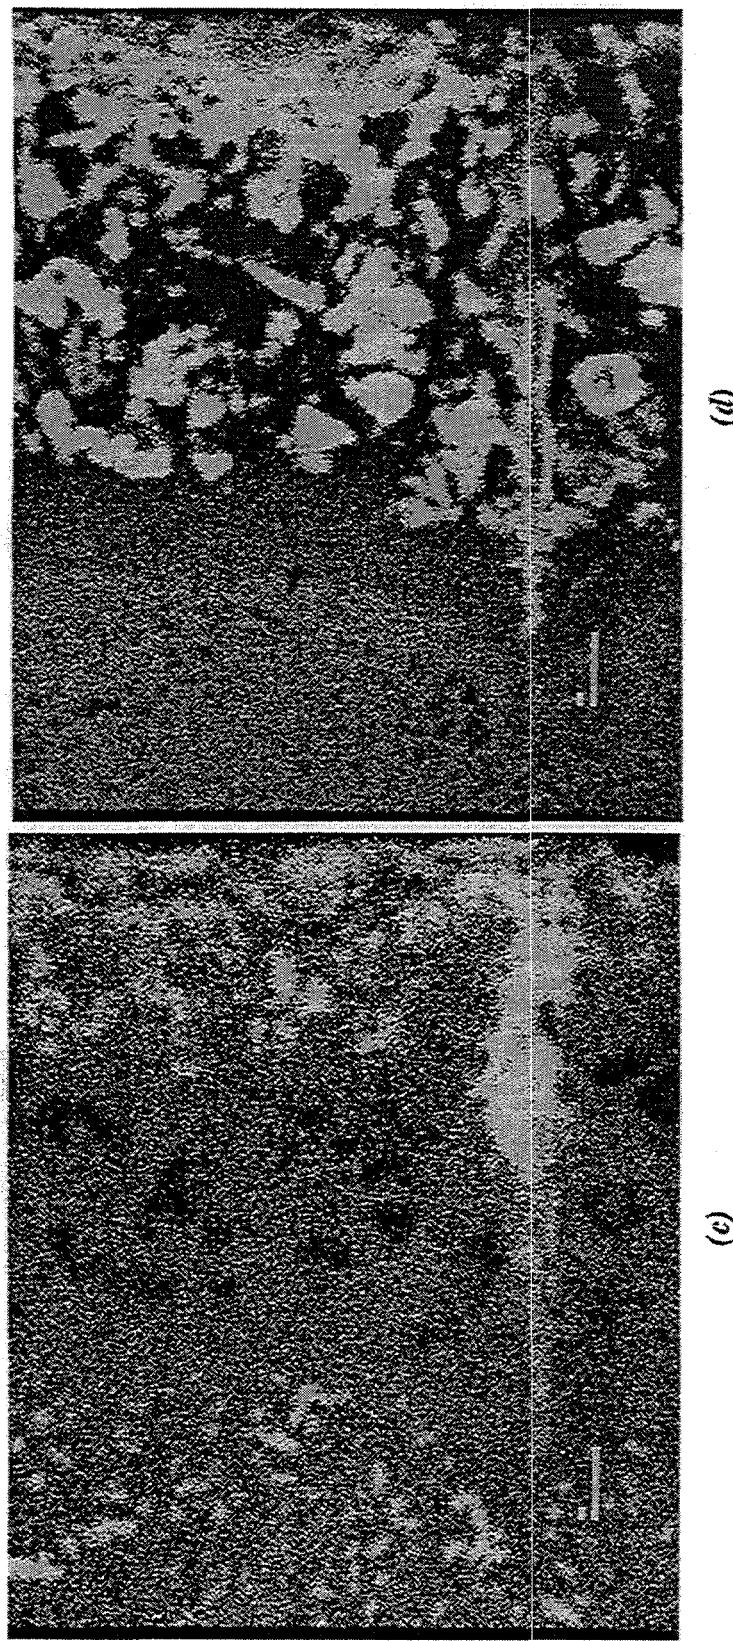
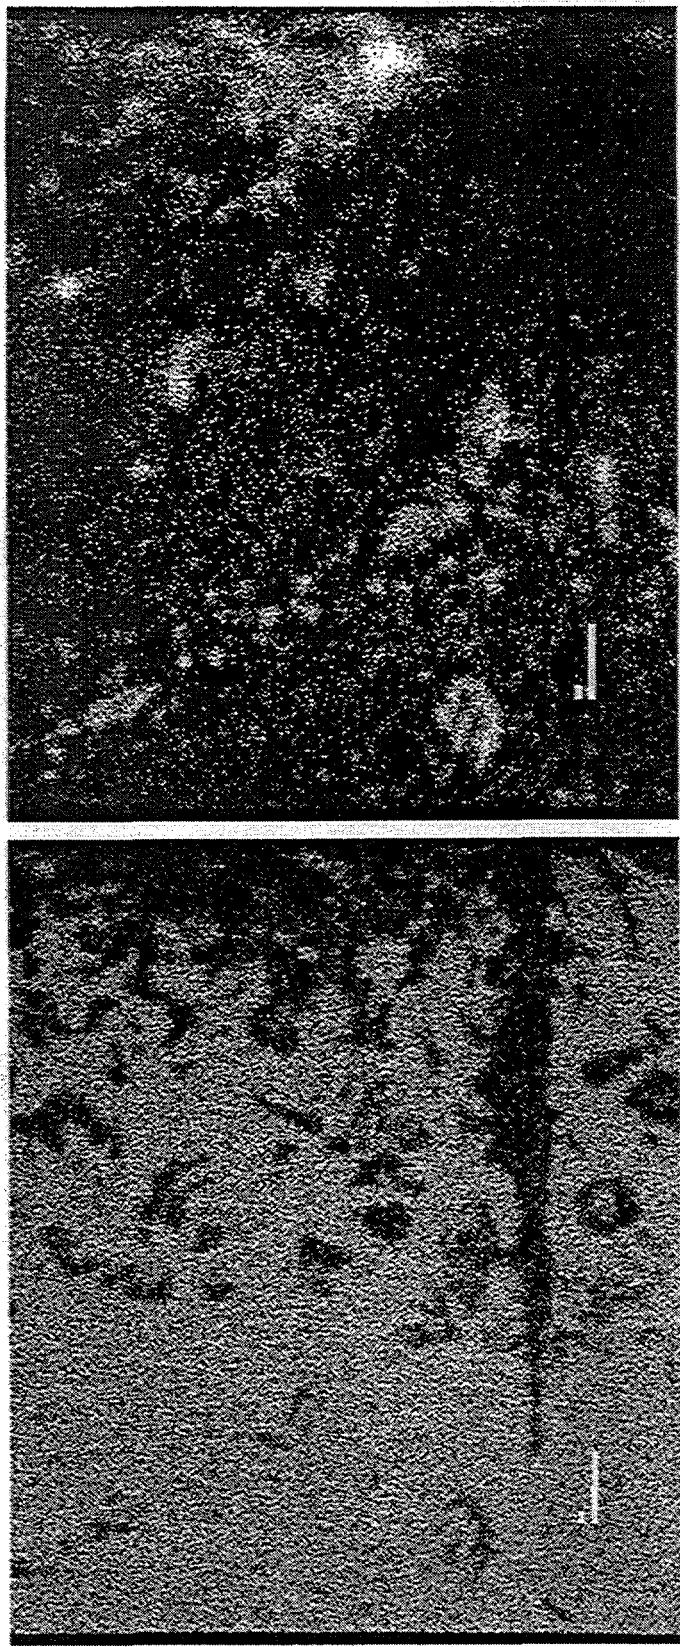
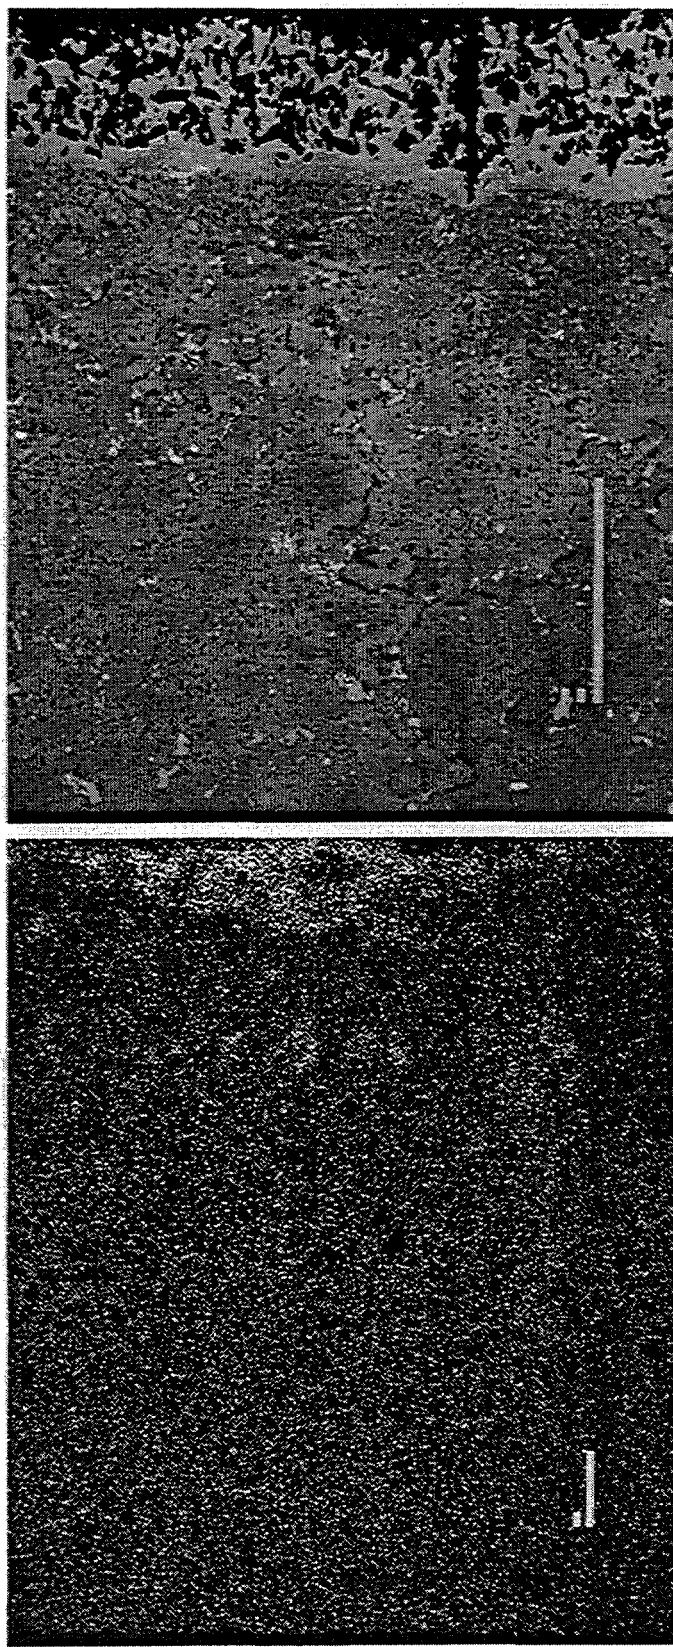
Fig. 19. Backscattered electron image of low-silicon nickel-aluminide coupon exposed 18 days in a batch furnace at Delphi Saginaw:
(a) low magnification of 200 \times and (b) high magnification of 100 \times .

Fig. 20. (c) and (d) are chromium and aluminum maps of the region shown in the backscattered electron image shown in (b) of Fig. 19 of the low-silicon nickel-aluminide coupon exposed for 68 days in a batch furnace at Delphi Saginaw.

Fig. 21. (e) and (f) are nickel and zirconium maps of the region shown in the backscattered electron image shown in (b) of Fig. 19 of the low-silicon nickel-aluminide coupon exposed for 68 days in a batch furnace at Delphi Saginaw.

Fig. 22. (g) and (h) are carbon and oxygen maps of the region shown in the backscattered electron image shown in (b) of Fig. 19 of the low-silicon nickel-aluminide coupon exposed for 68 days in a batch furnace at Delphi Saginaw.

Fig. 23. (i) is silicon map at 1000 \times and (j) is the backscattered electron image at 300 \times of the backscattered electron image shown in (b) of Fig. 19 of the low-silicon nickel-aluminide coupon exposed for 68 days in a batch furnace at Delphi Saginaw.

Scanning electron microscopy and microprobe analysis were carried out to determine the nature of the scale and microstructural changes in the matrix. A typical set of back-scattered electron images and the maps of Cr, Al, Ni, Zr, C, O, and Si are shown in Figs. 19 through 23. A similar set of micrographs for HU are shown in Figs. 24 through 27. The quantitative electron microprobe data showing the composition of various species observed in the exposed coupons of IC-221M and HU are summarized in Tables 7 and 8. The microstructural changes in the Ni₃Al-based alloy IC-221M consisted of four distinct areas: (1) the base metal appeared unaffected by the carburization treatment, (2) a zone between the corrosion layer and the matrix (more than 200 μm thick) showed a slight nickel enrichment with a corresponding decrease in chromium, (3) a 10- μm -thick band under the corrosion layer exhibited substantial nickel enrichment with a corresponding decrease in chromium and aluminum, and (4) the corrosion layer made up of a matrix that contained a high concentration of nickel with severe depletion of chromium and aluminum and low Z inclusions that ranged from chromium oxide to aluminum oxide.

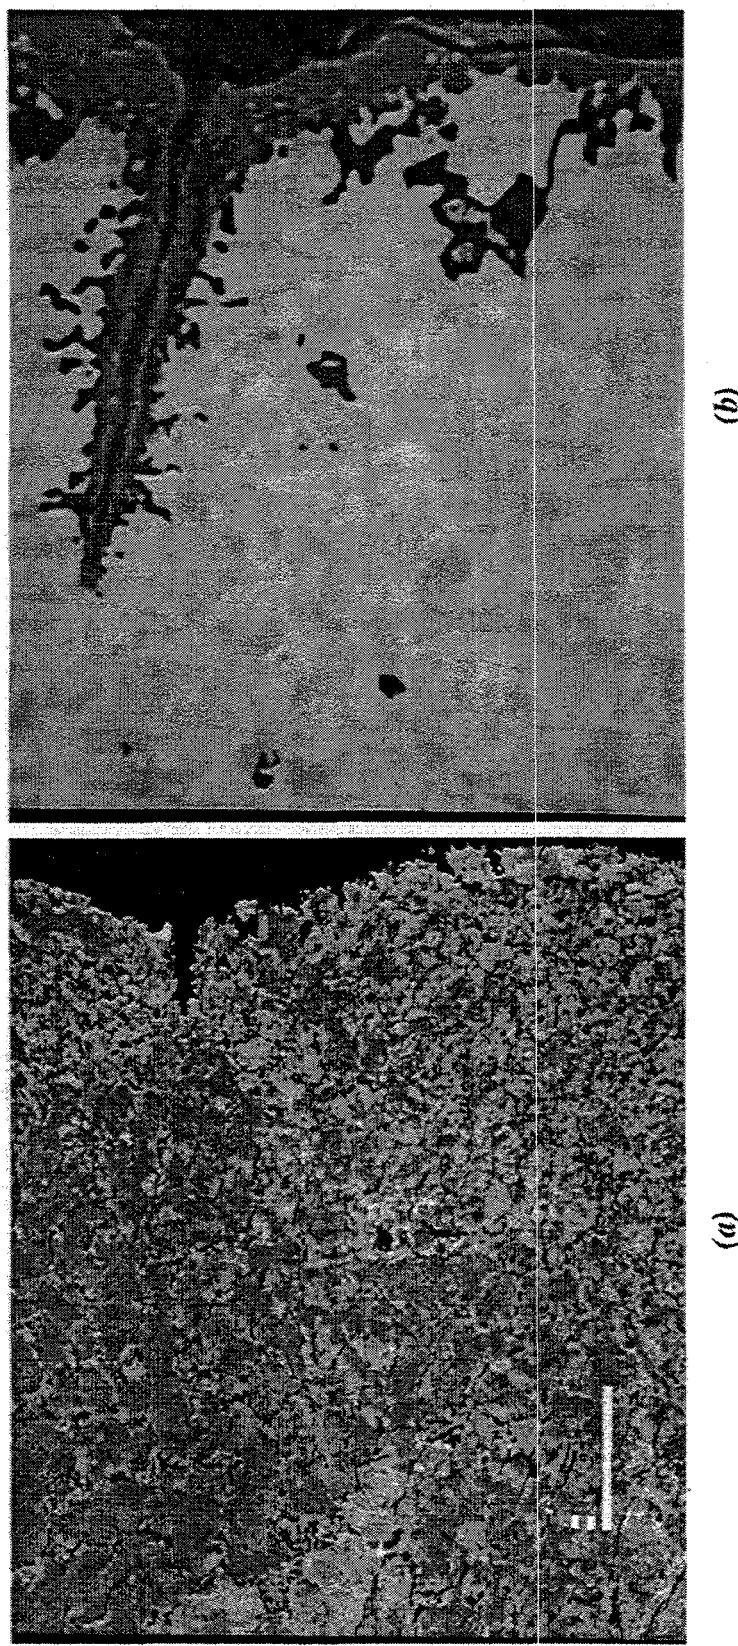
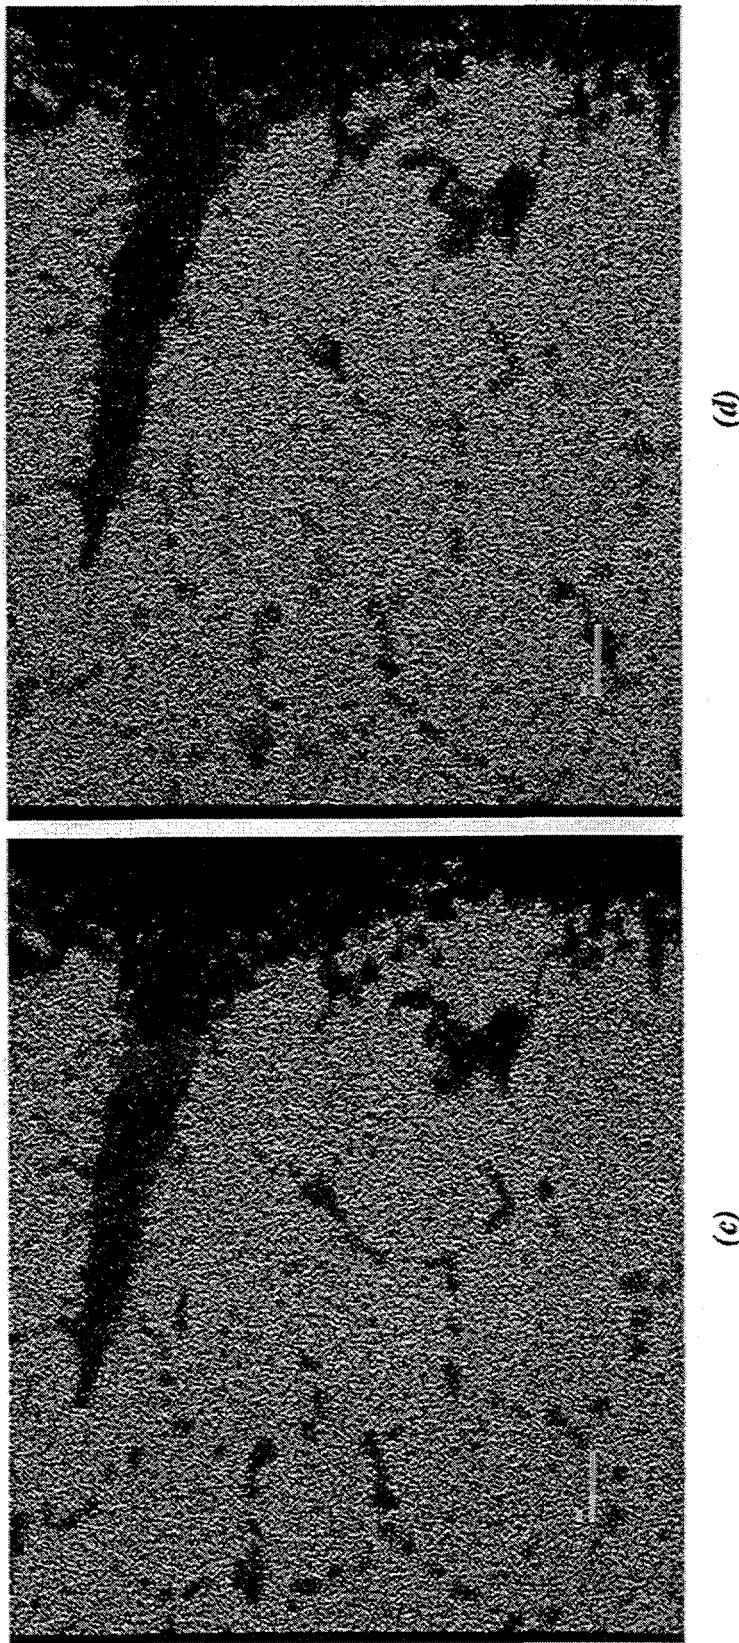
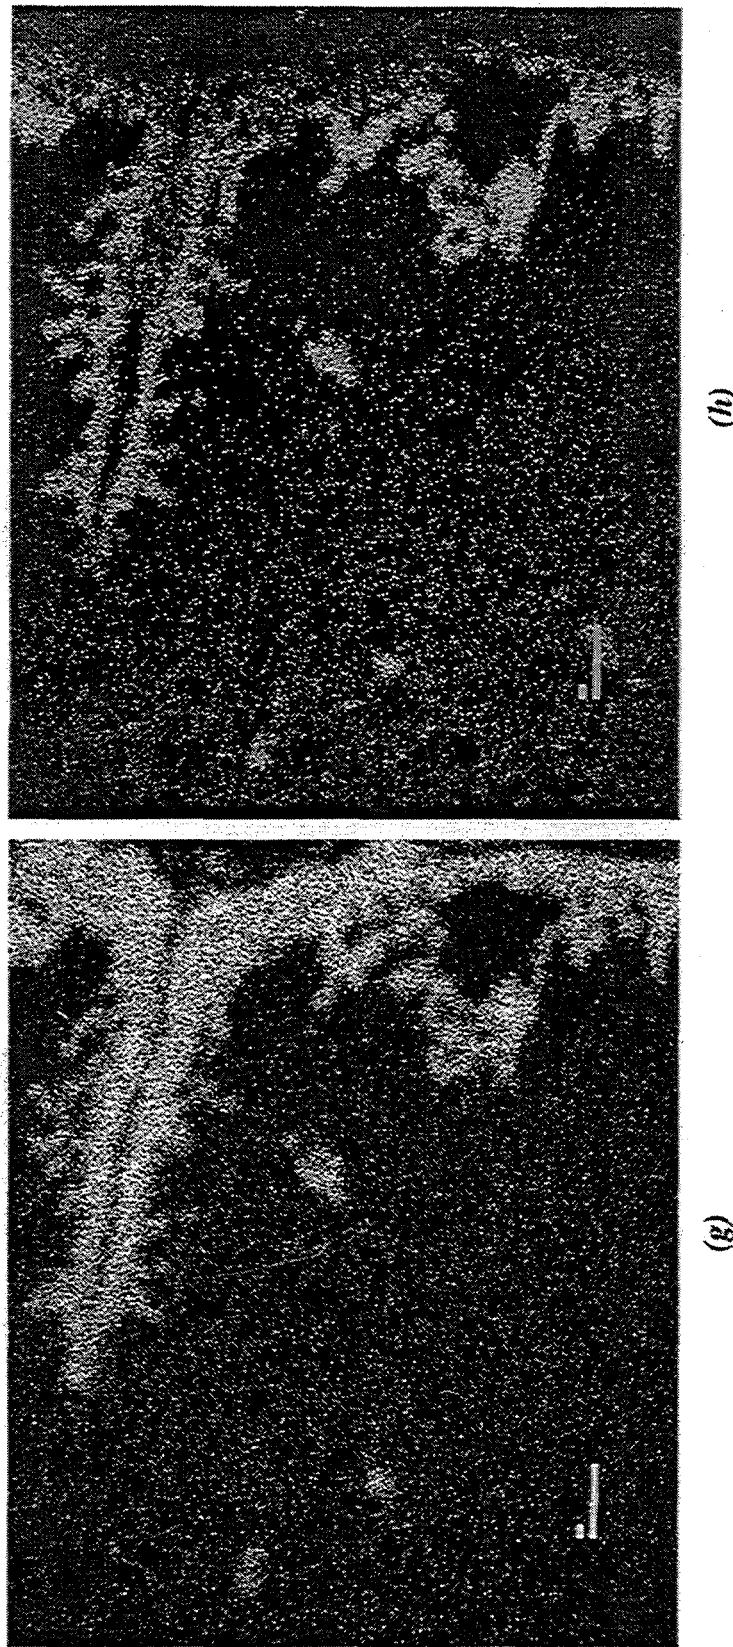
Fig. 24. Backscattered electron image of HU coupon exposed for 258 days in a carburizing batch furnace at Delphi Saginaw: (a) low magnification is 200 \times and (b) high magnification is 1000 \times .

Fig. 25. (c) and (d) are nickel and iron maps of the region shown in the backscattered electron image shown in (b) of Fig. 24 of HU coupon exposed for 258 days in a carburizing batch furnace at Delphi Saginaw.

Fig. 26. (e) and (f) are chromium maps of the region shown in the backscattered electron image shown in (b) of Fig. 24 of HU coupon exposed for 258 days in a carburizing batch furnace at Delphi Saginaw.

Fig. 27. (g) and (h) are oxygen and silicon maps of the region shown in the backscattered electron image shown in (b) of Fig. 24 of HU coupon exposed for 258 days in a carburizing batch furnace at Delphi Saginaw.

For the HU material, the matrix grain boundaries were enriched with chromium and carbon; the outer corrosion layer was chromium oxide and the inner corrosion layer was primarily silicon oxide.
