CRADA Final Report
for

CRADA Number C/ORNL 92-0076

In-Service Testing of Ni₃Al Coupons and
Trays in Carburizing Furnaces at Delphi Saginaw

Date Published: August 1998

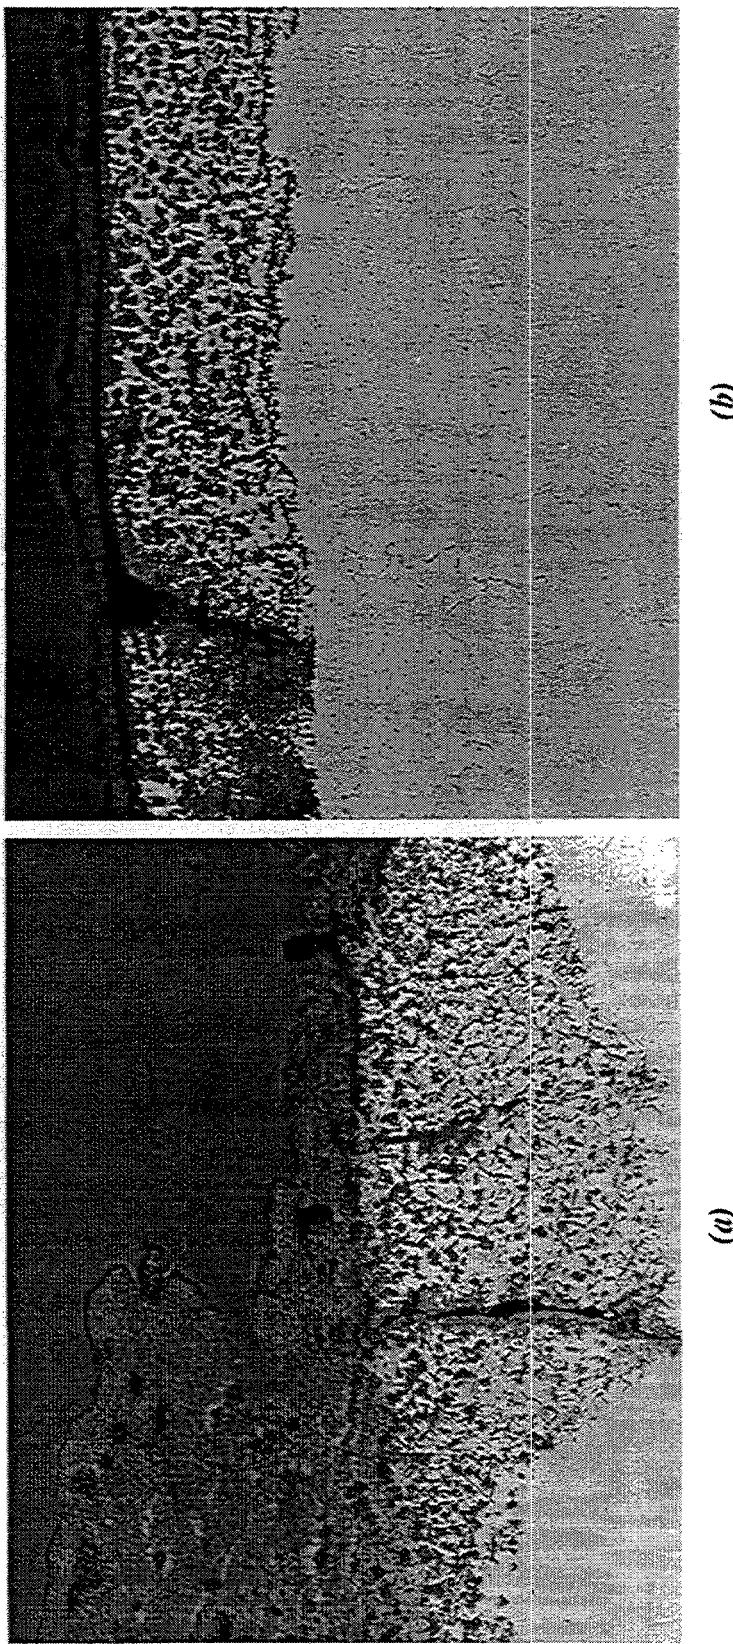
Fig. 29. Optical microstructures of the (a) edge and (b) center of coupon No. 51. This coupon was exposed in a preoxidized condition for 336 days in a batch carburizing furnace at Delphi Saginaw.

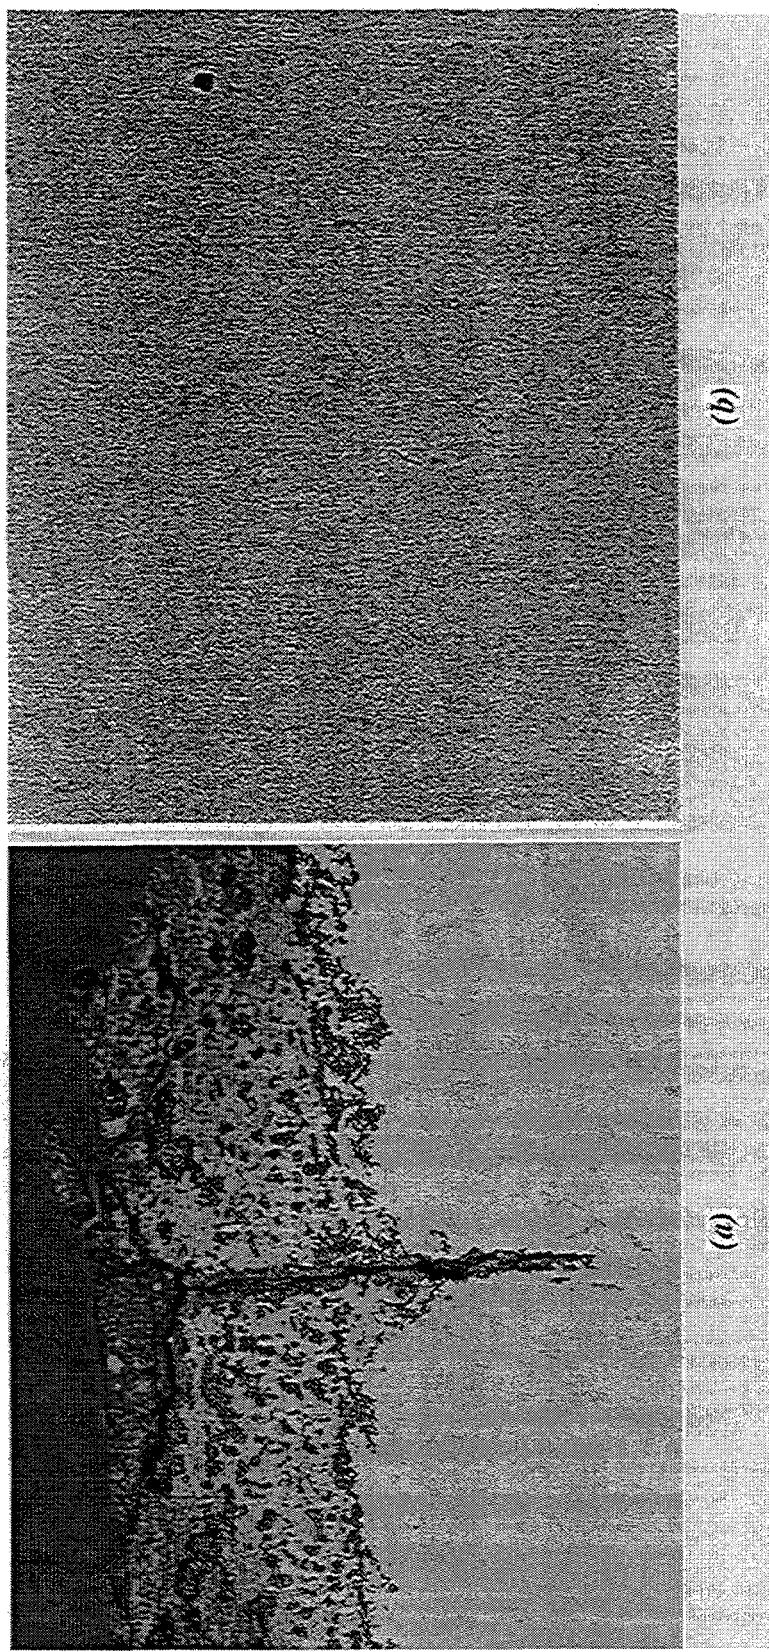
Fig. 30. Optical microstructure of the (a) edge and (b) center of coupon No. 61. This coupon was exposed in an as-cast condition for 208 days in a batch carburizing furnace at Delphi Saginaw.

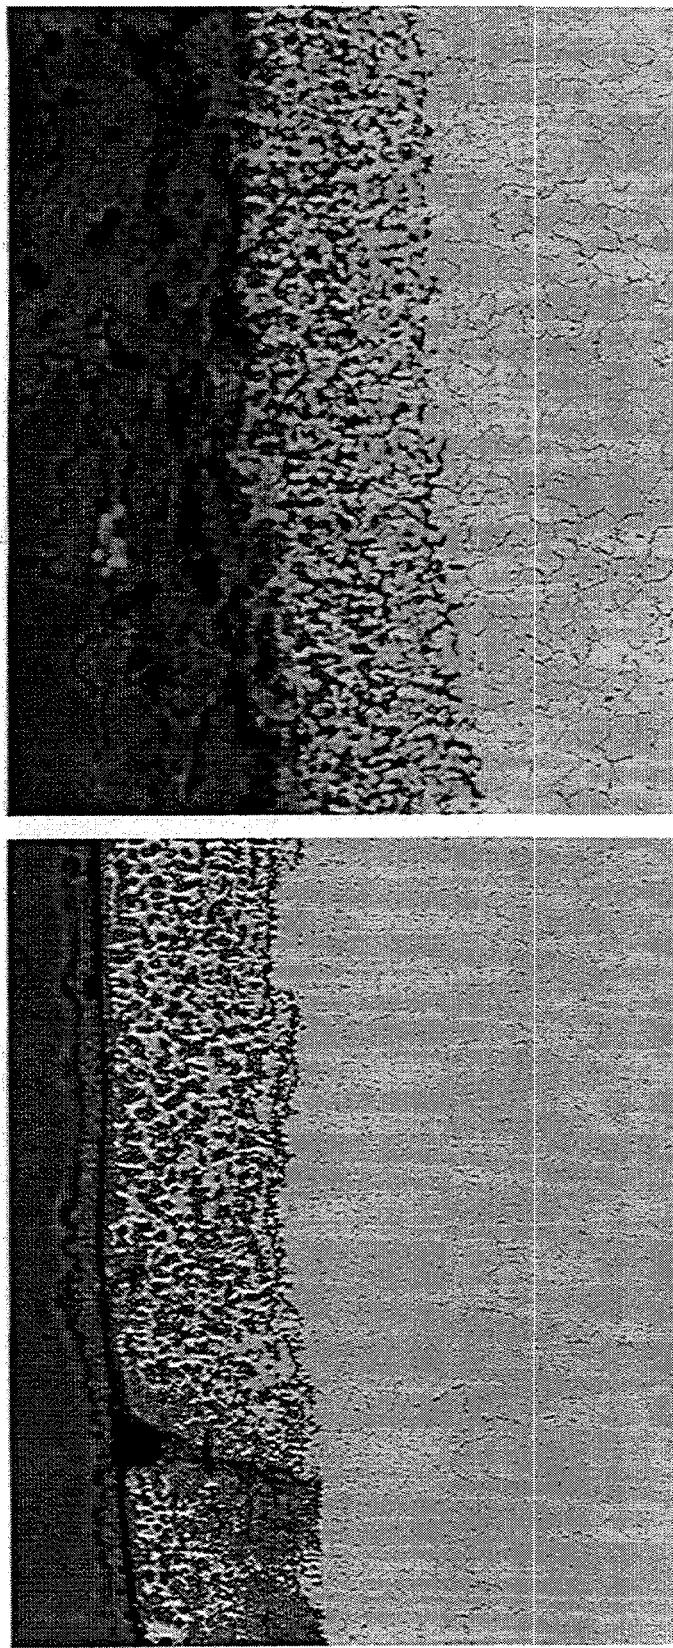
Fig. 31. Optical microstructures comparing the weld crowns of IC-221LA and IC-221W on coupon No. 51 after 336 days of exposure in a batch carburizing furnace at Delphi Saginaw. The welds on the coupon were preoxidized.

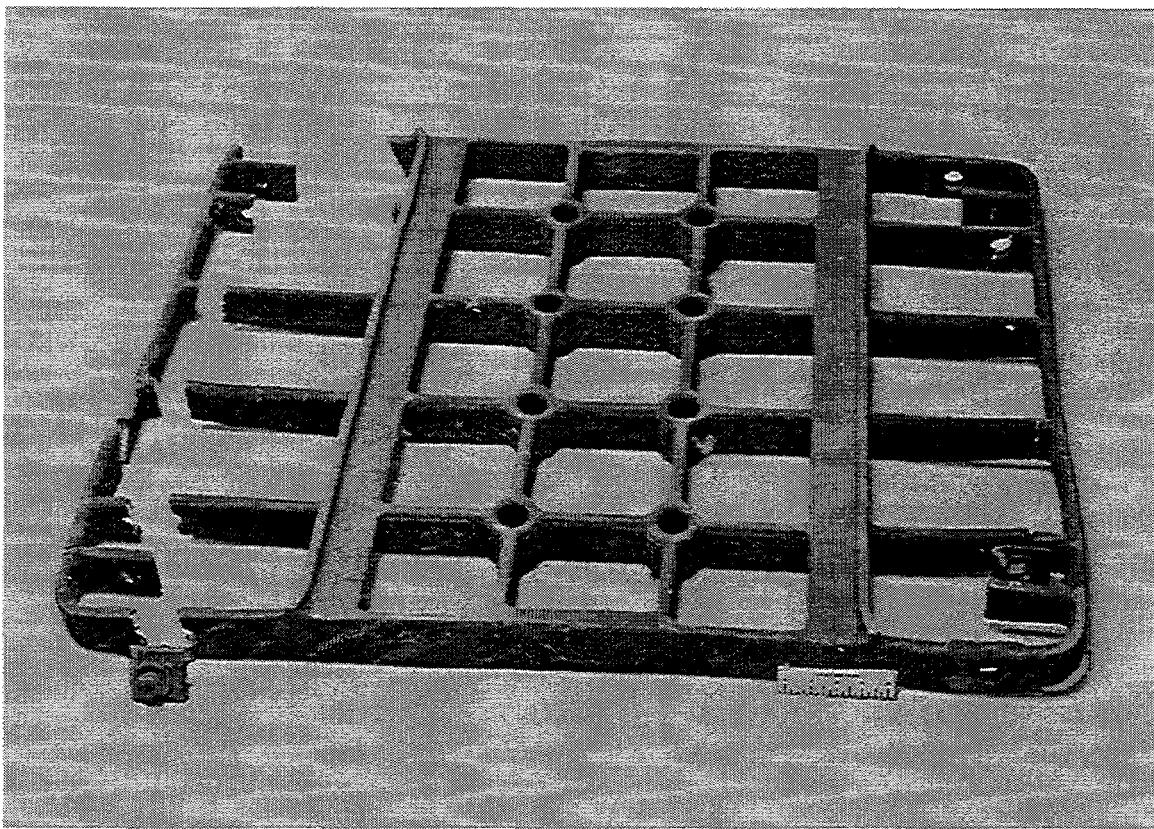
Fig. 32. Broken HU tray removed from a batch carburizing furnace at Delphi Saginaw after 18 months of service.

4. The results of the coupon testing were verified on an actual tray, where an HU tray failed because of extensive carburization as opposed to essentially no observable change for the IC-221M tray.

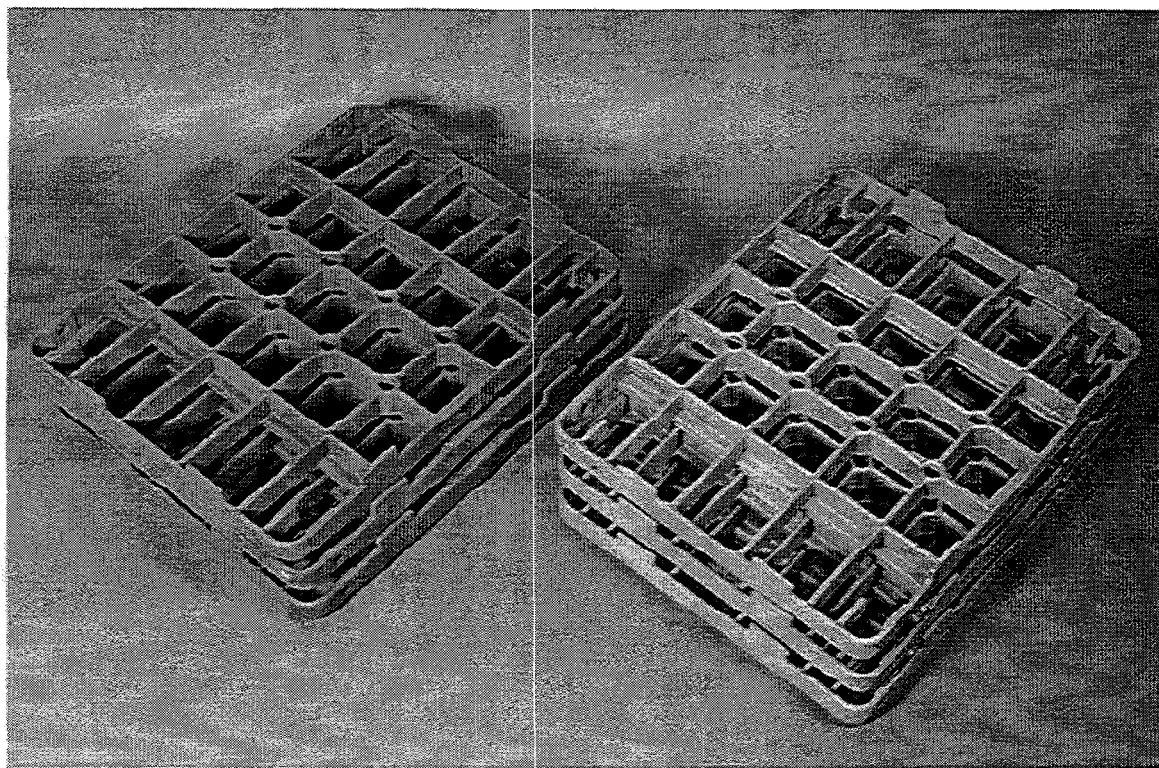
Fig. 33. The preoxidized (left) and as-cast (right) trays of IC-221M for installation in batch furnaces at Delphi Saginaw.

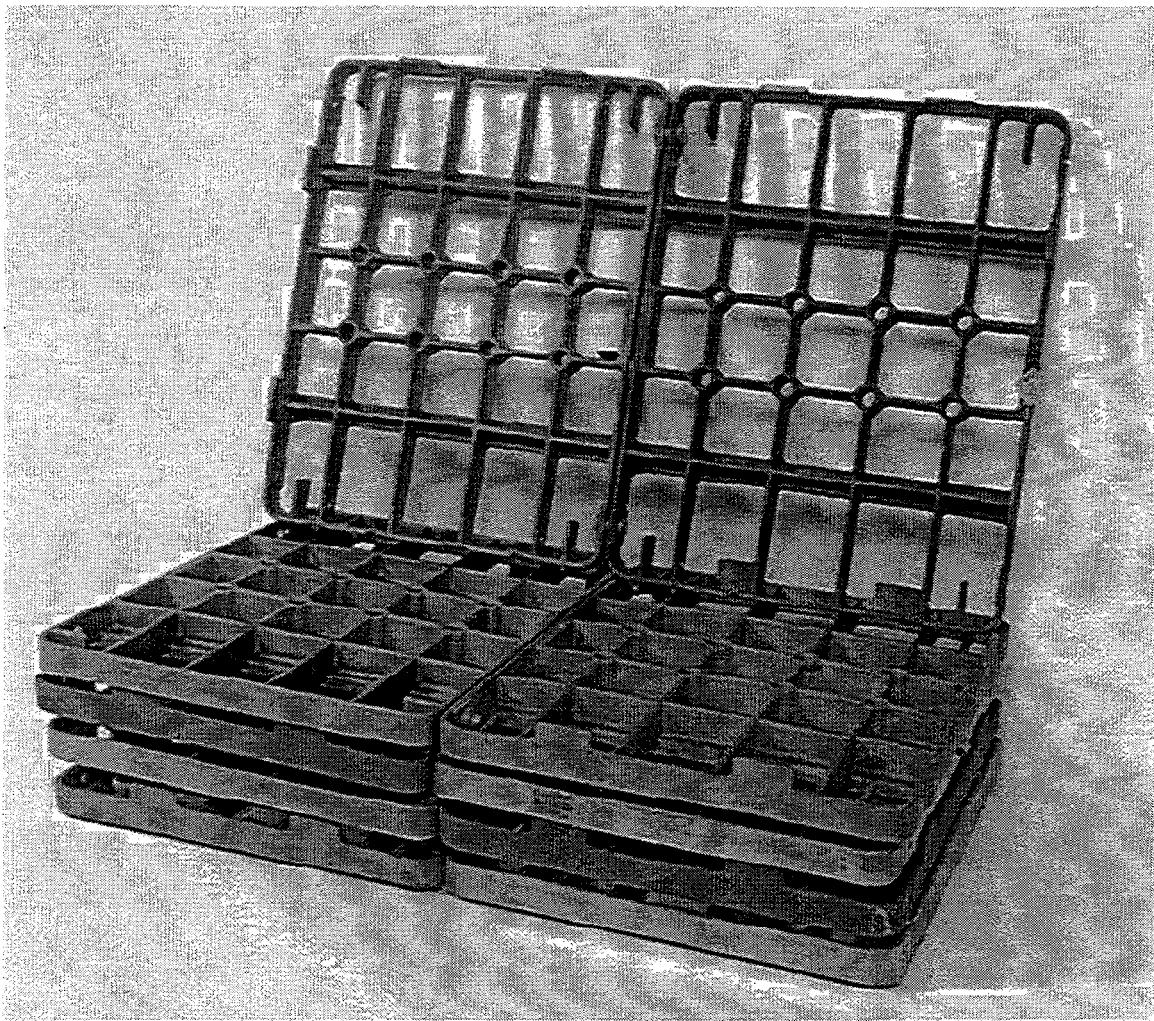
Fig. 35. Assembled pair of batch furnace trays.

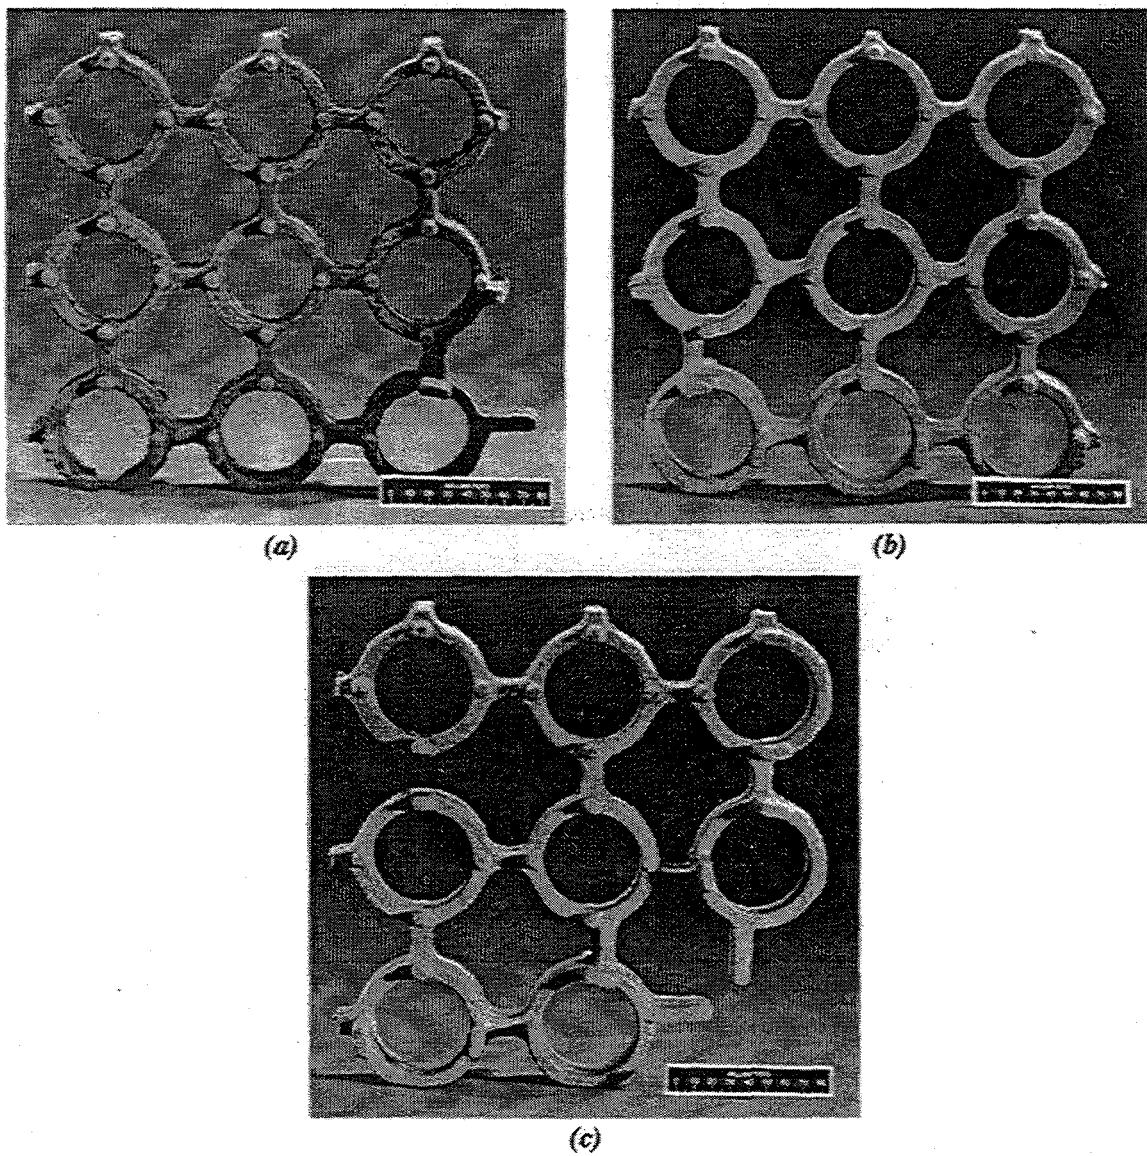
Fig. 36. Photograph of three pieces of IC-221M in pusher furnace at Delphi Saginaw:
(a) as-removed and (b) and (c) sand blasted.

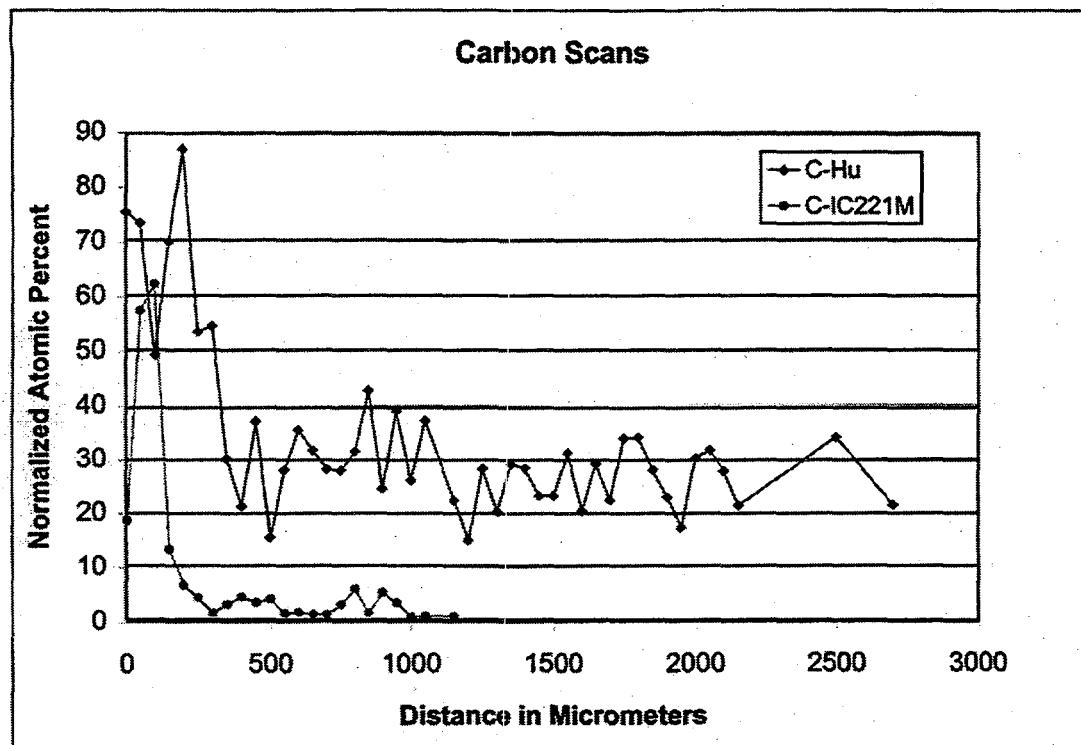
Fig. 37. Comparison of carbon traverse as a function of distance for broken HV tray and the IC-221M fixture removed from pusher carburizing furnace at Delphi Saginaw after 14 months of service.

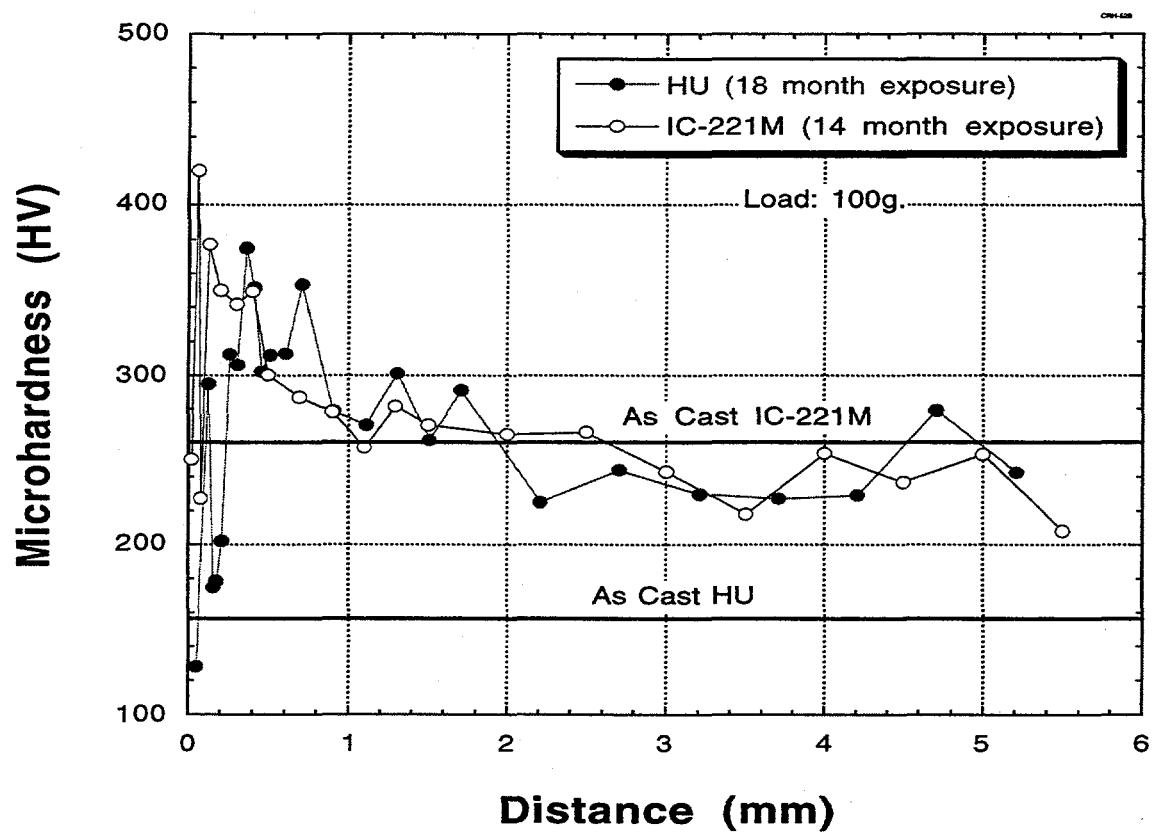
Fig. 38. Comparison of microhardness traverse as a function of distance for broken HU tray and the IC-221M fixture removed from pusher carburizing furnace at Delphi Saginaw after 14 months of service.
