CRADA Final Report
for

CRADA Number C/ORNL 92-0076

In-Service Testing of Ni₃Al Coupons and
Trays in Carburizing Furnaces at Delphi Saginaw

Date Published: August 1998

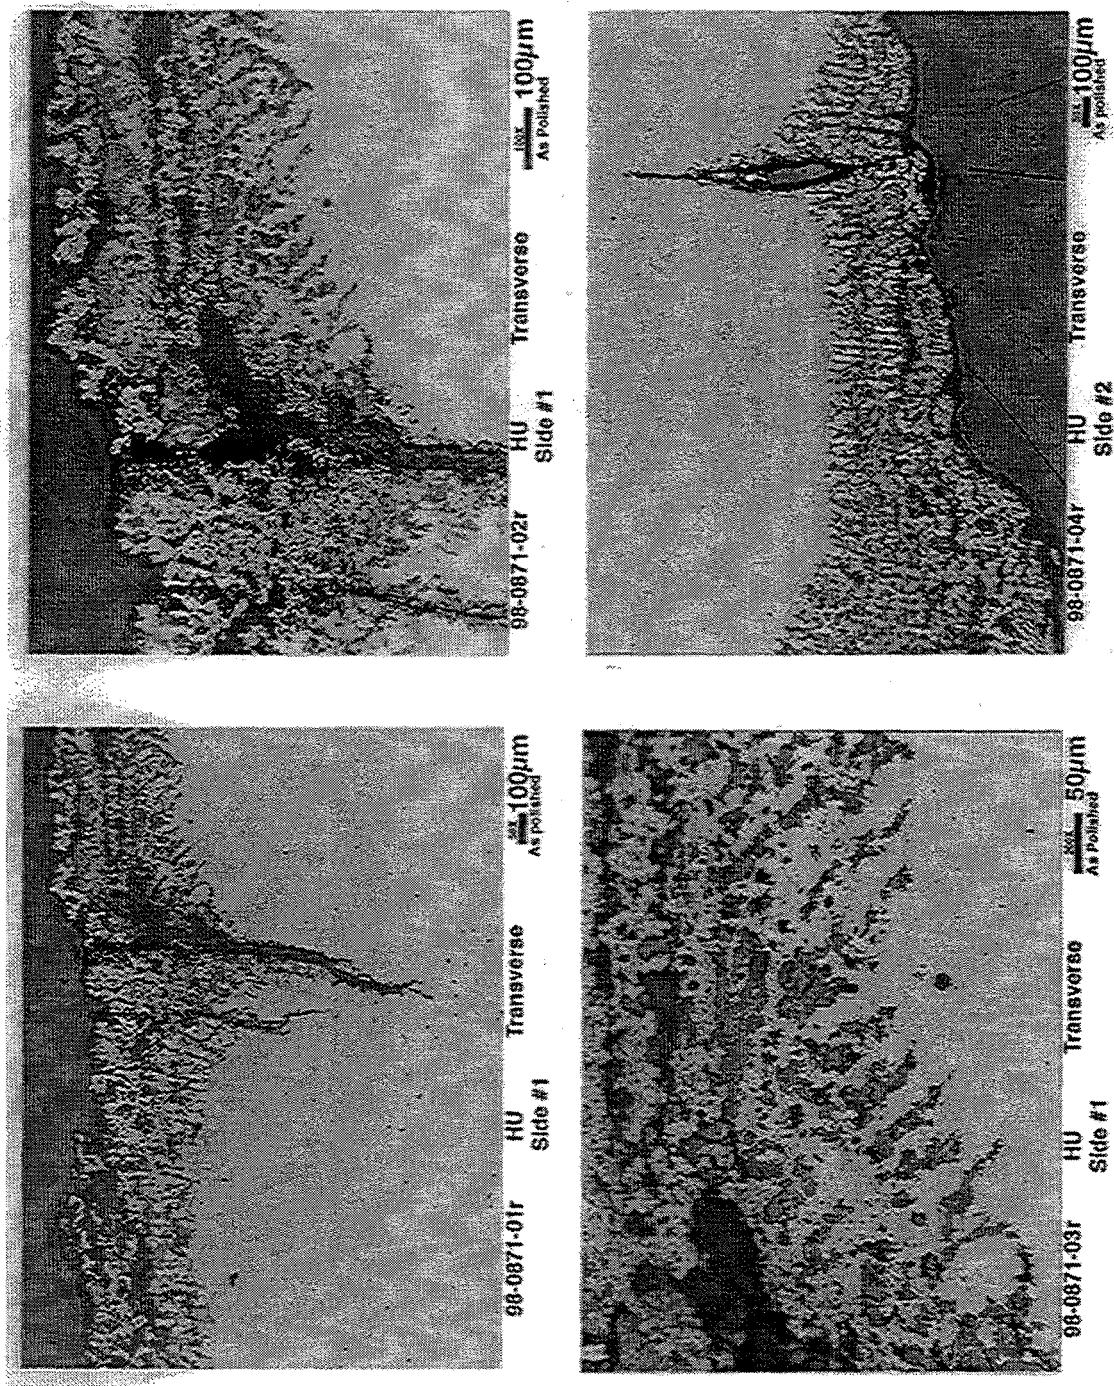
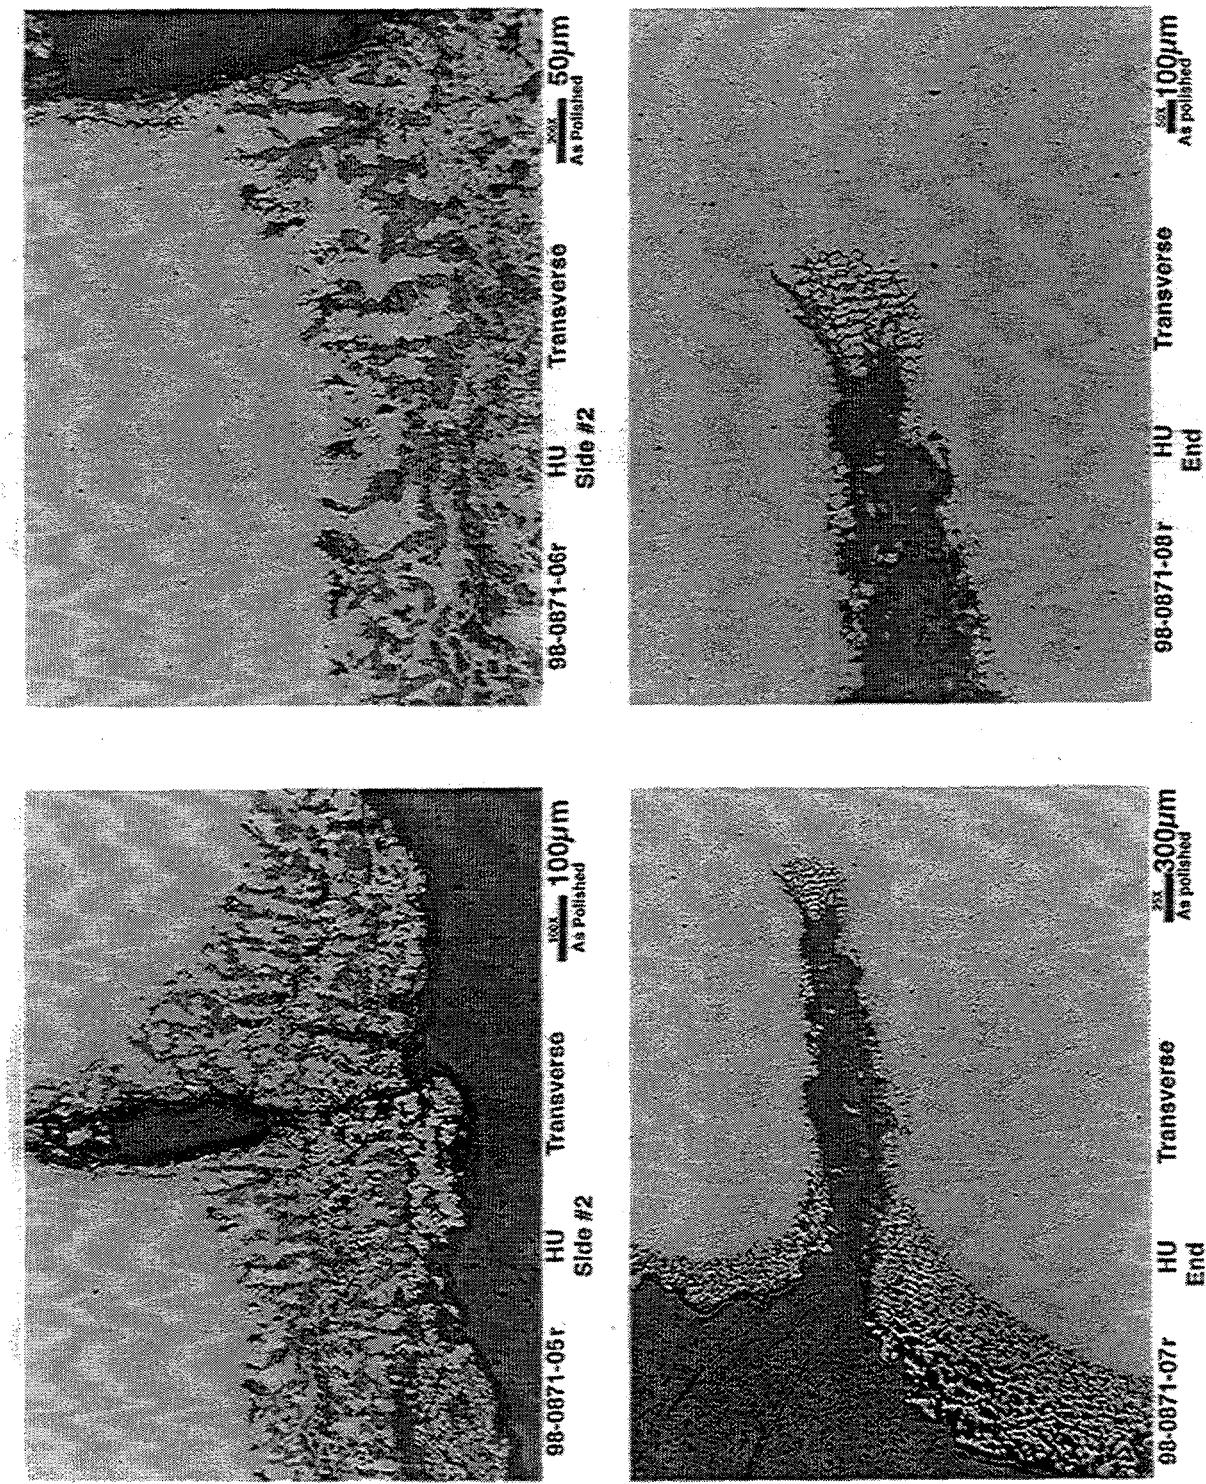
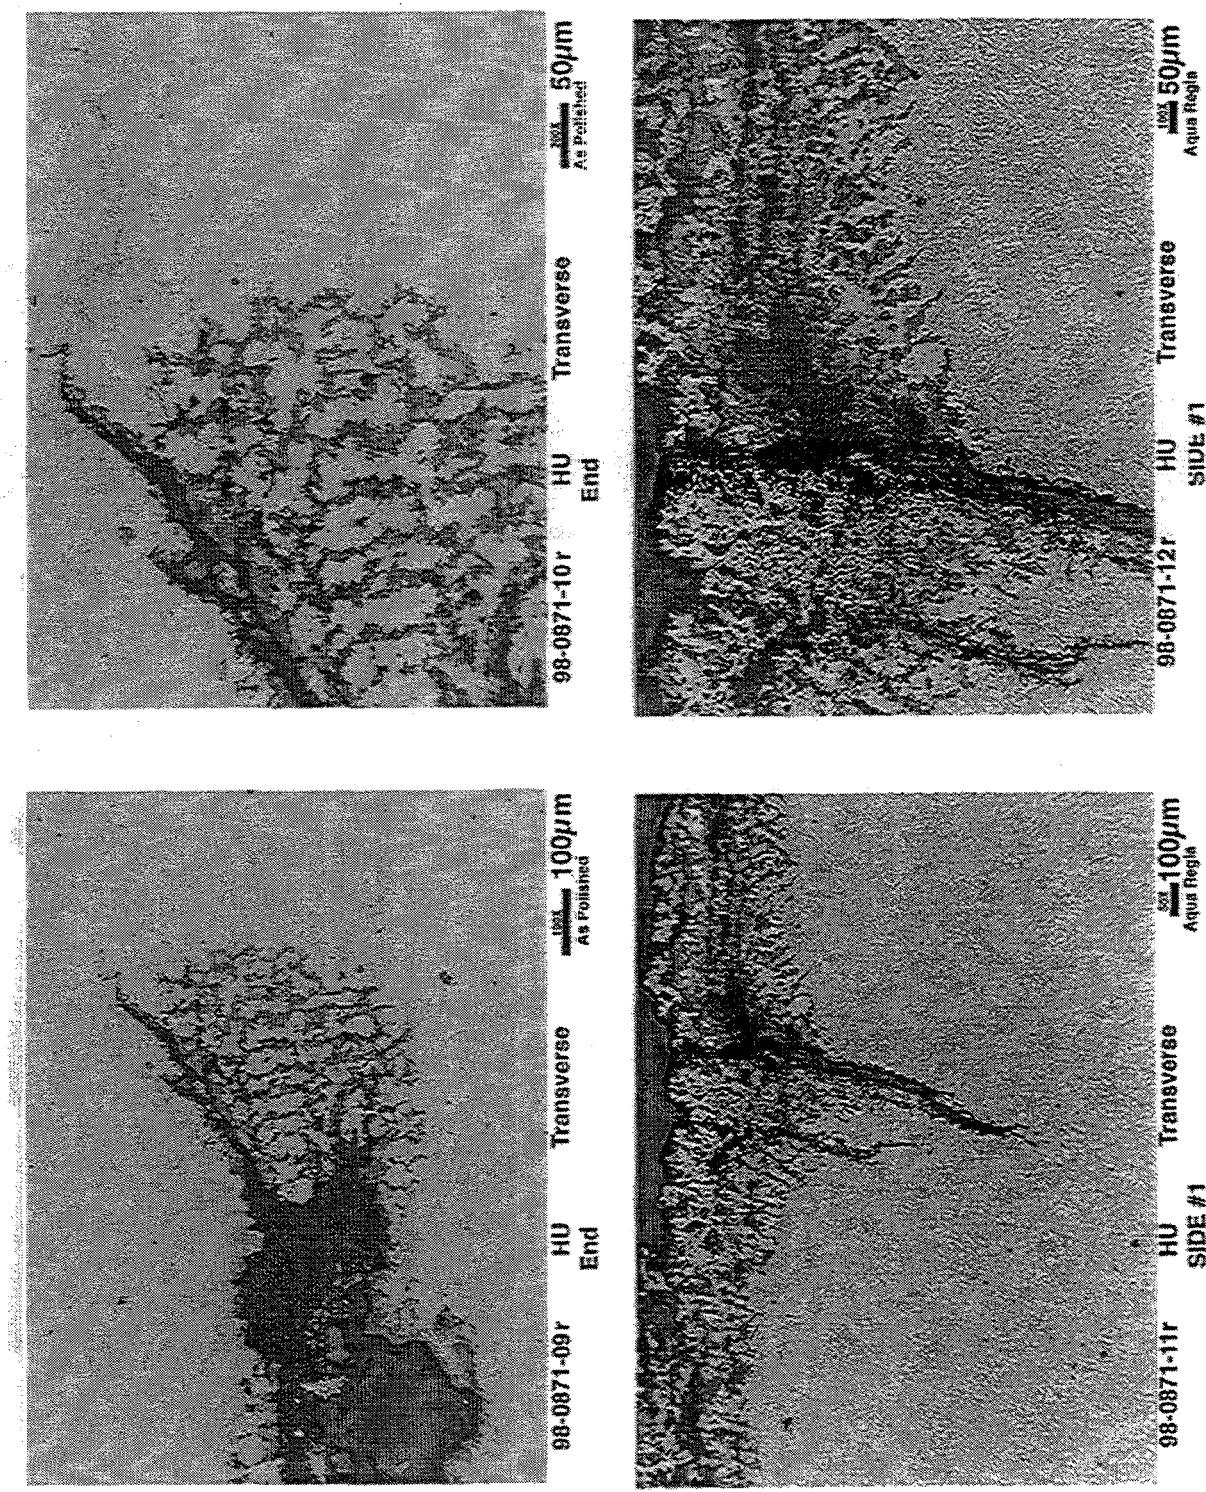
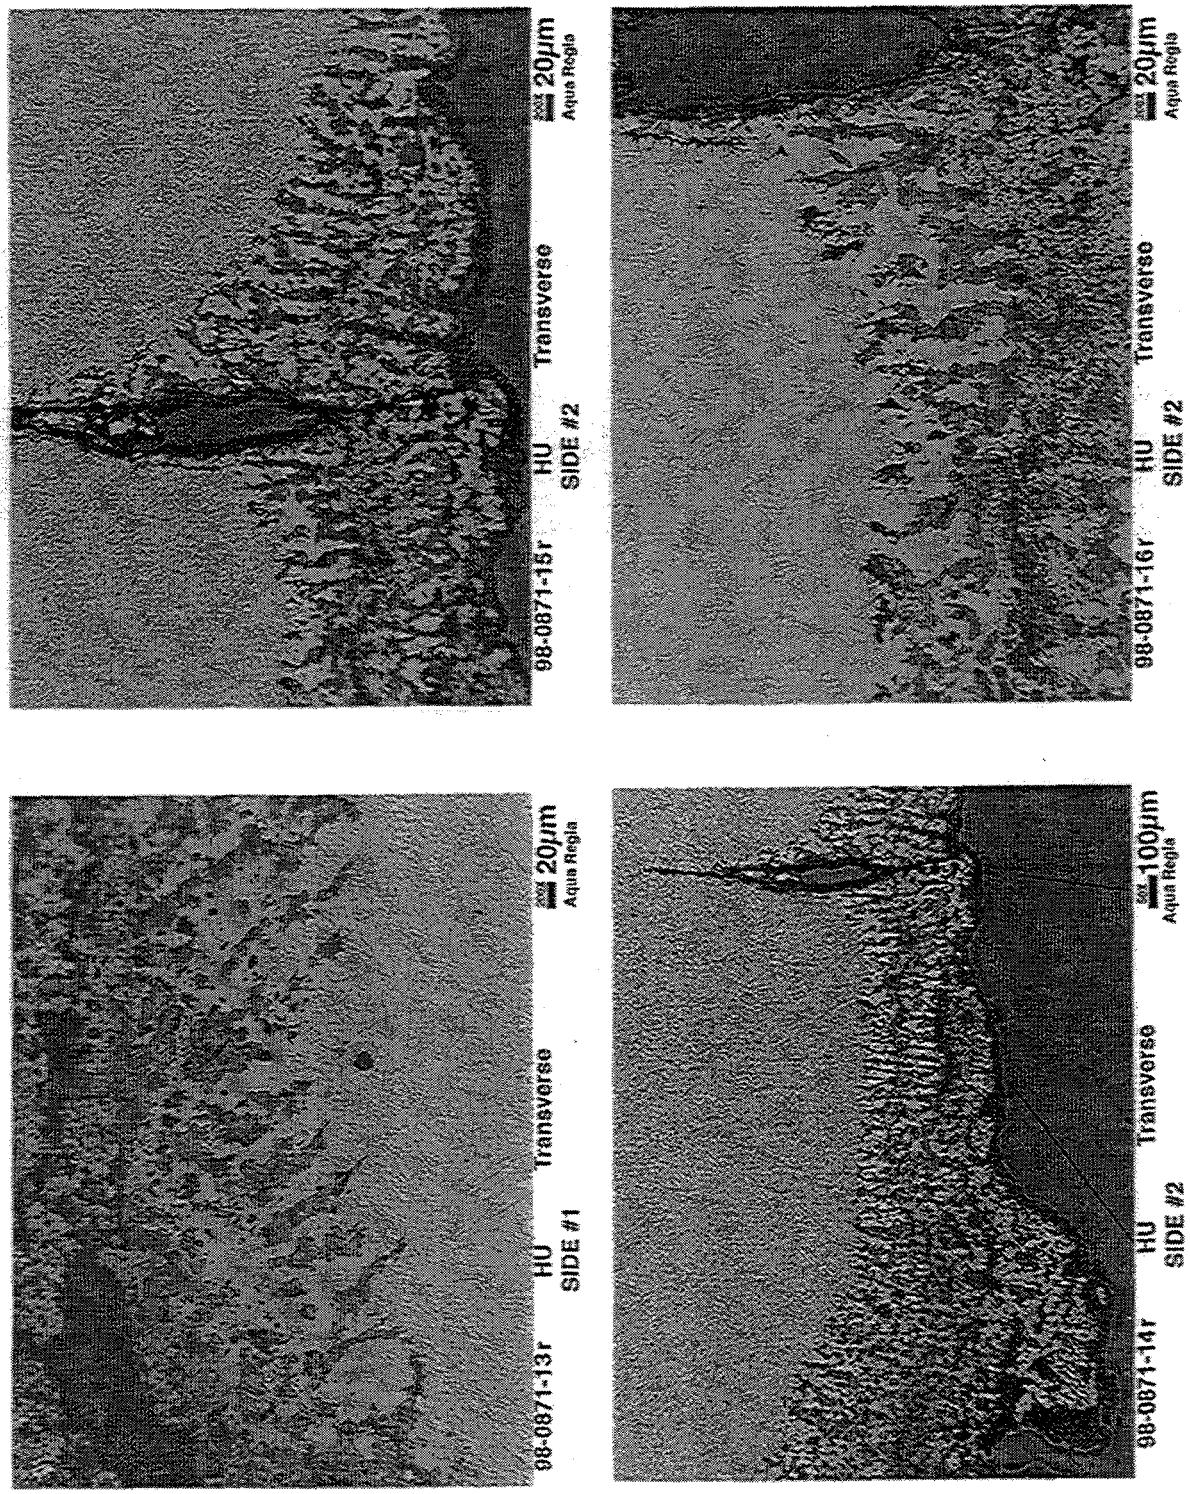
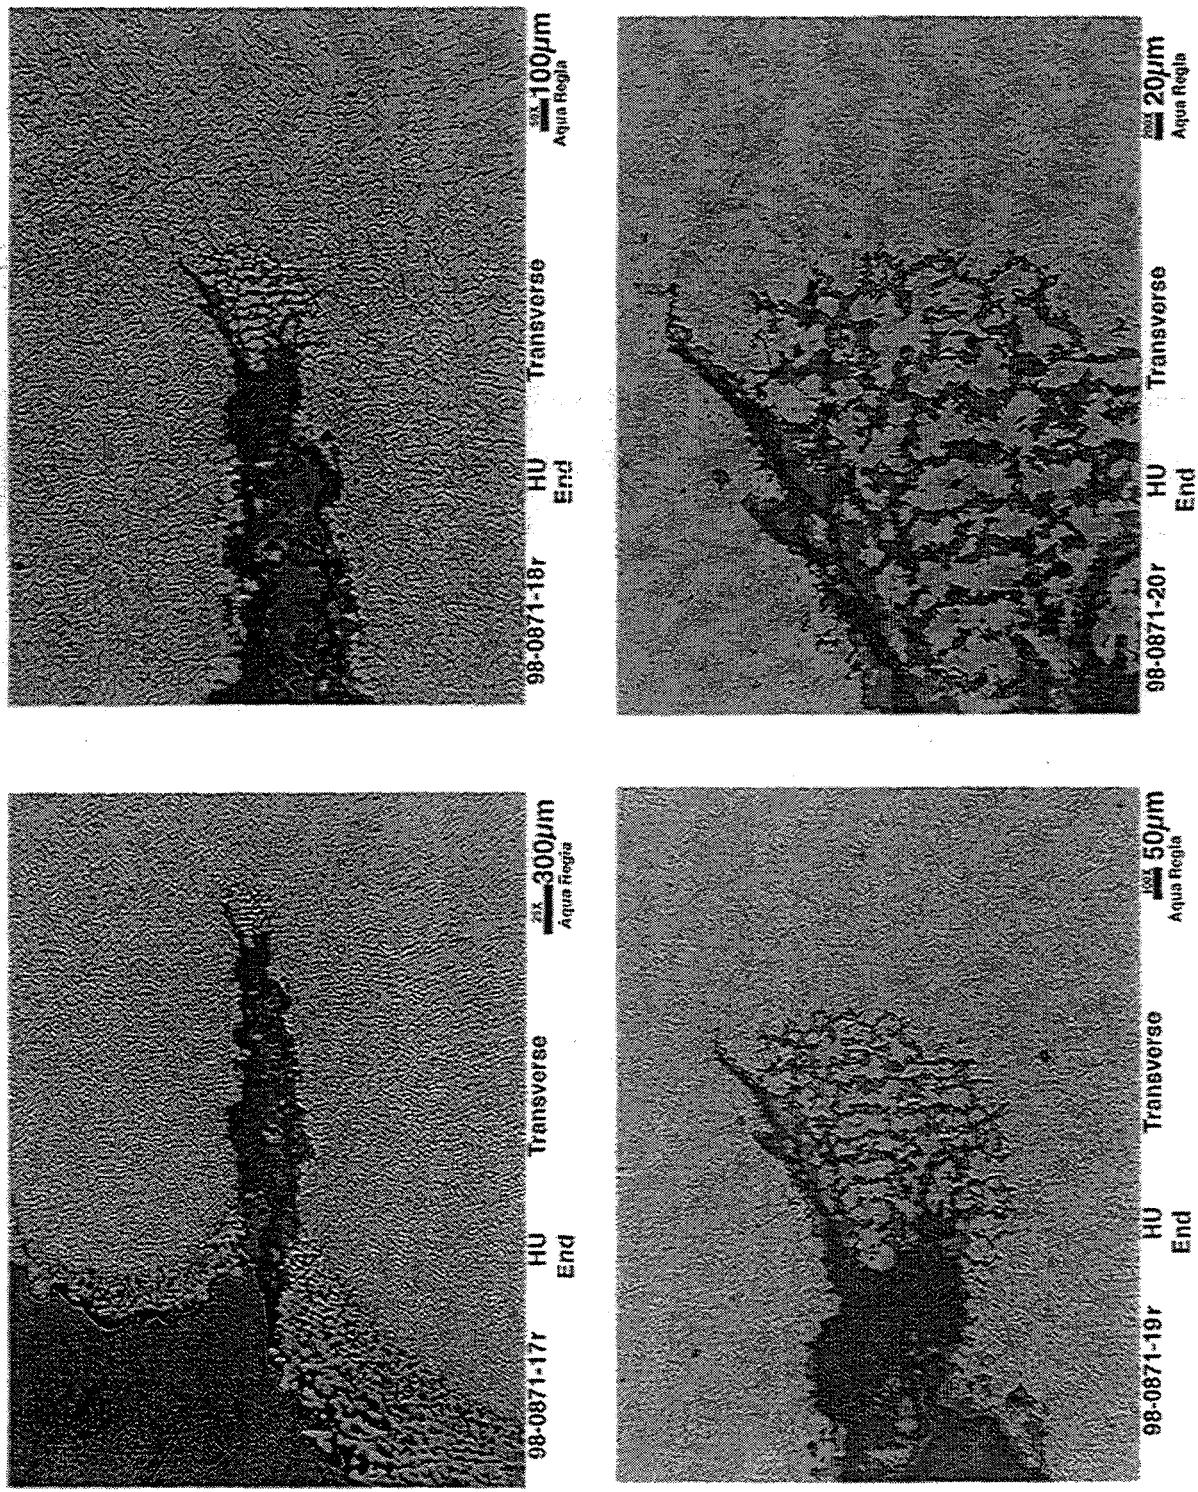
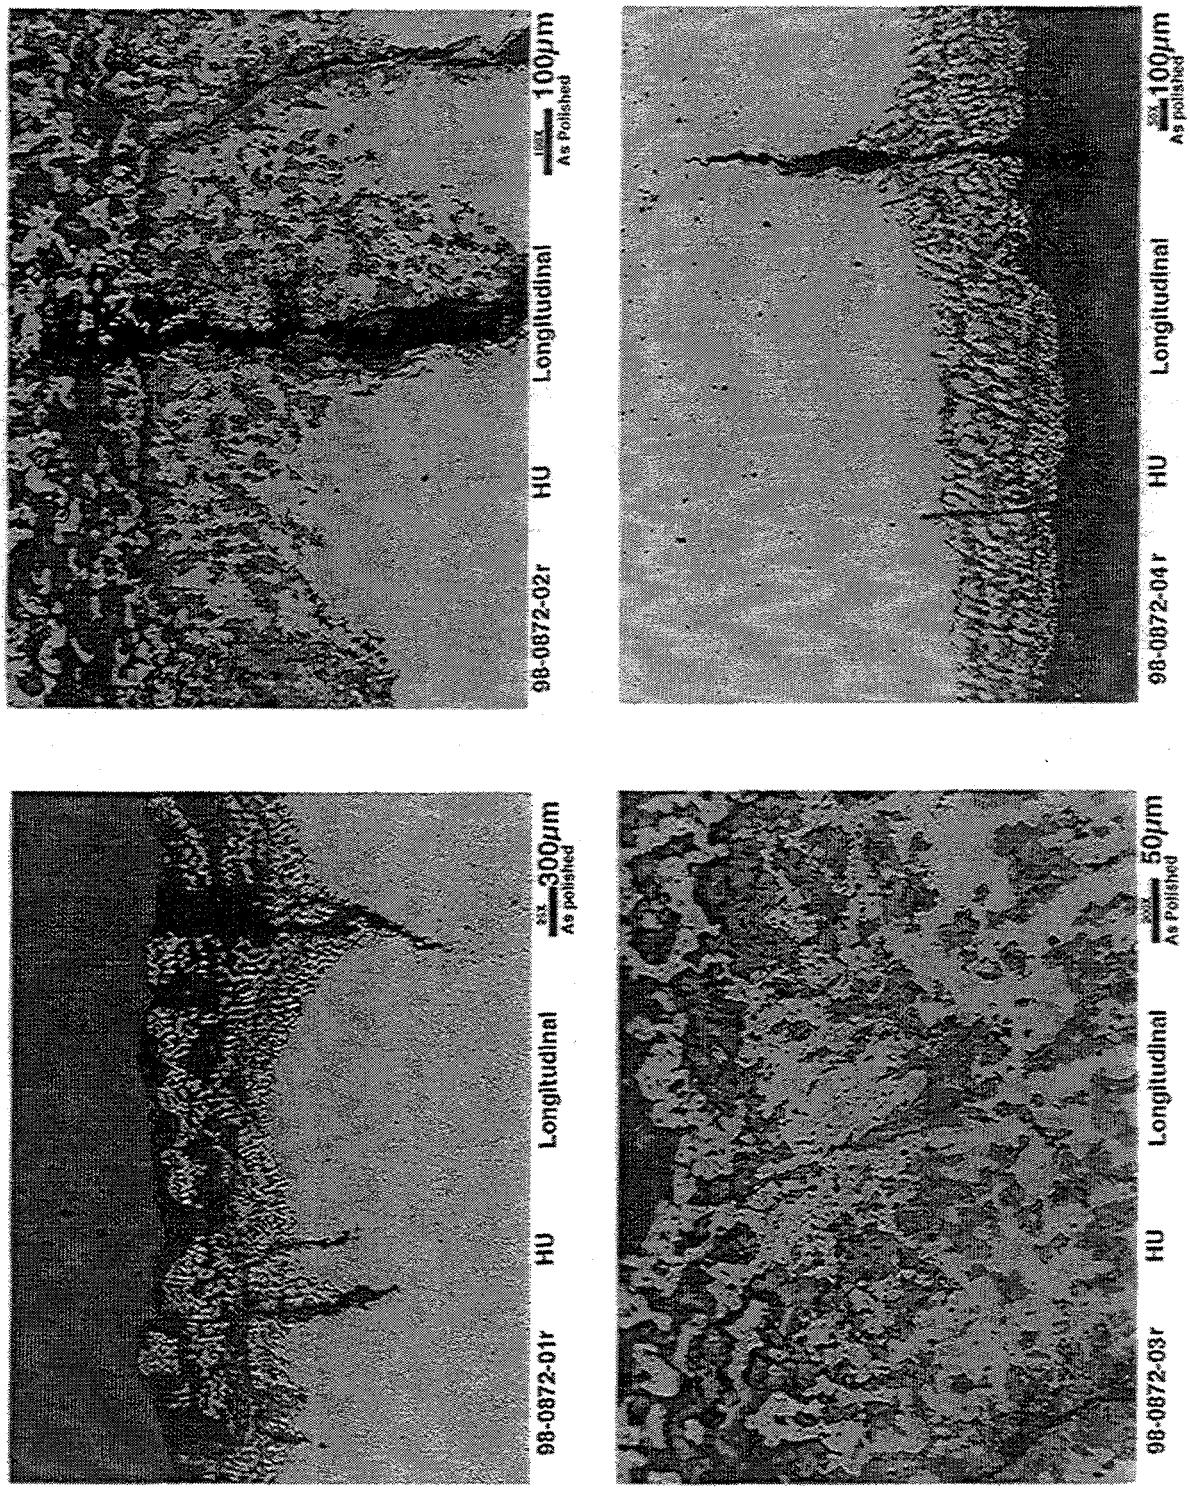
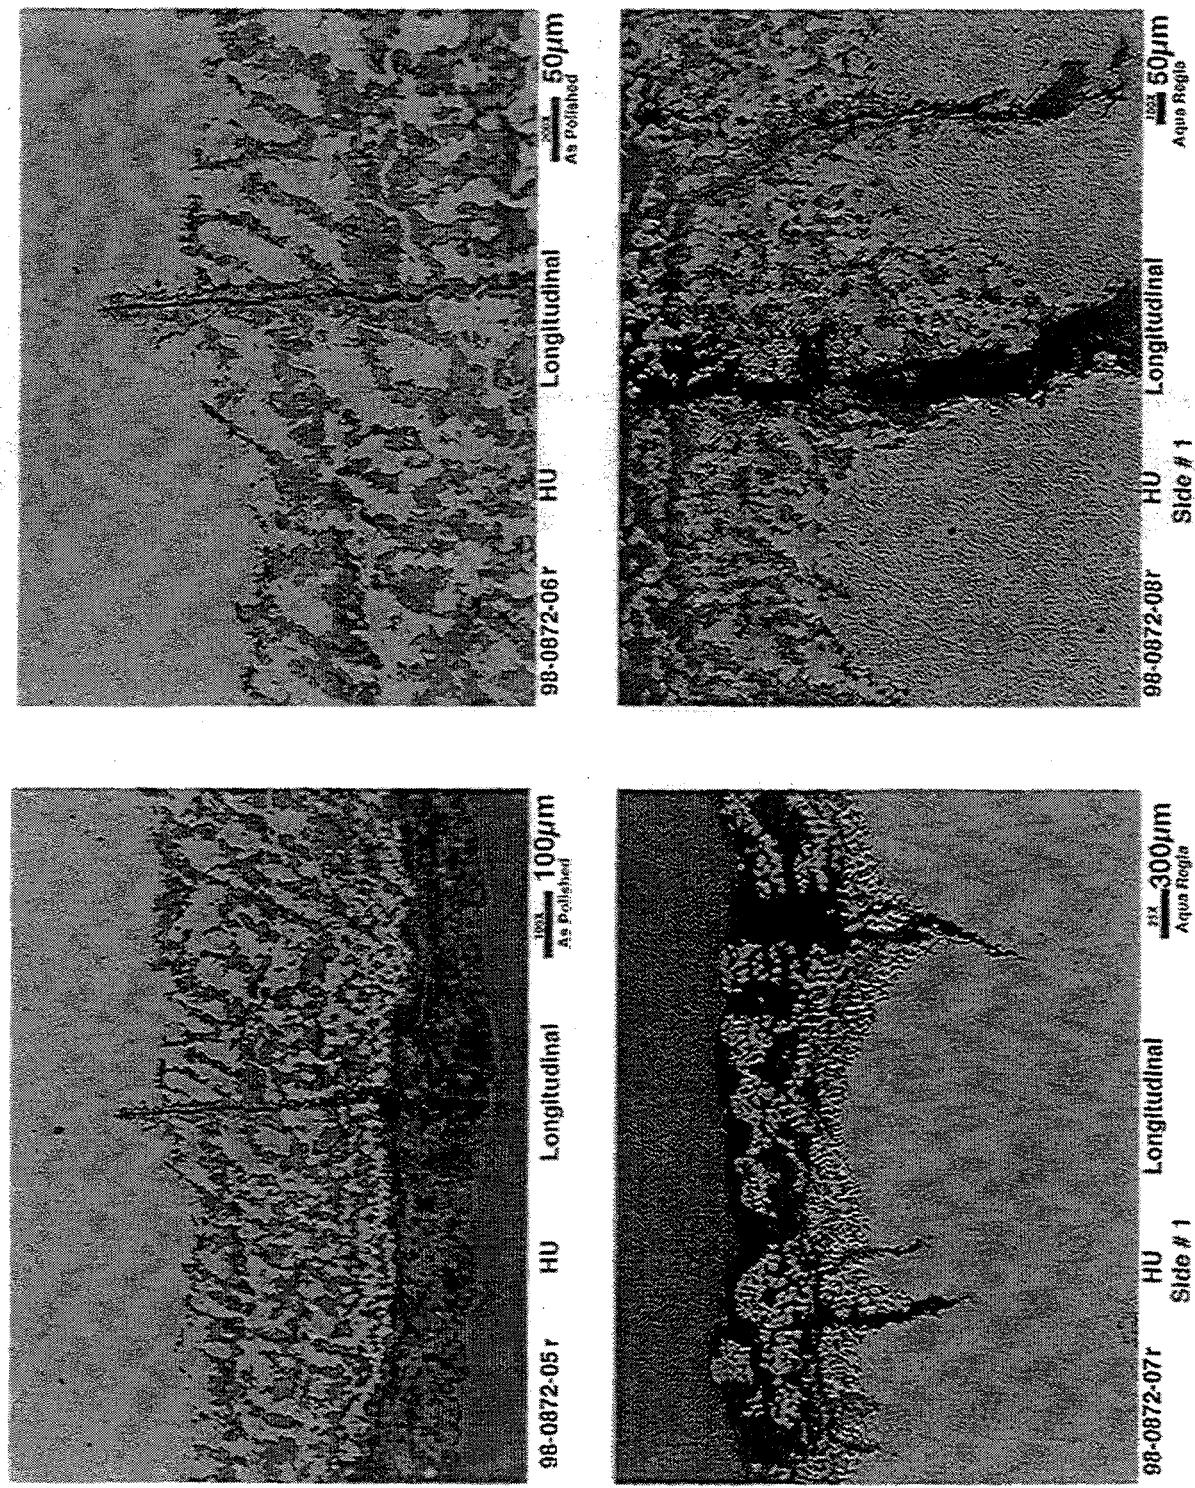
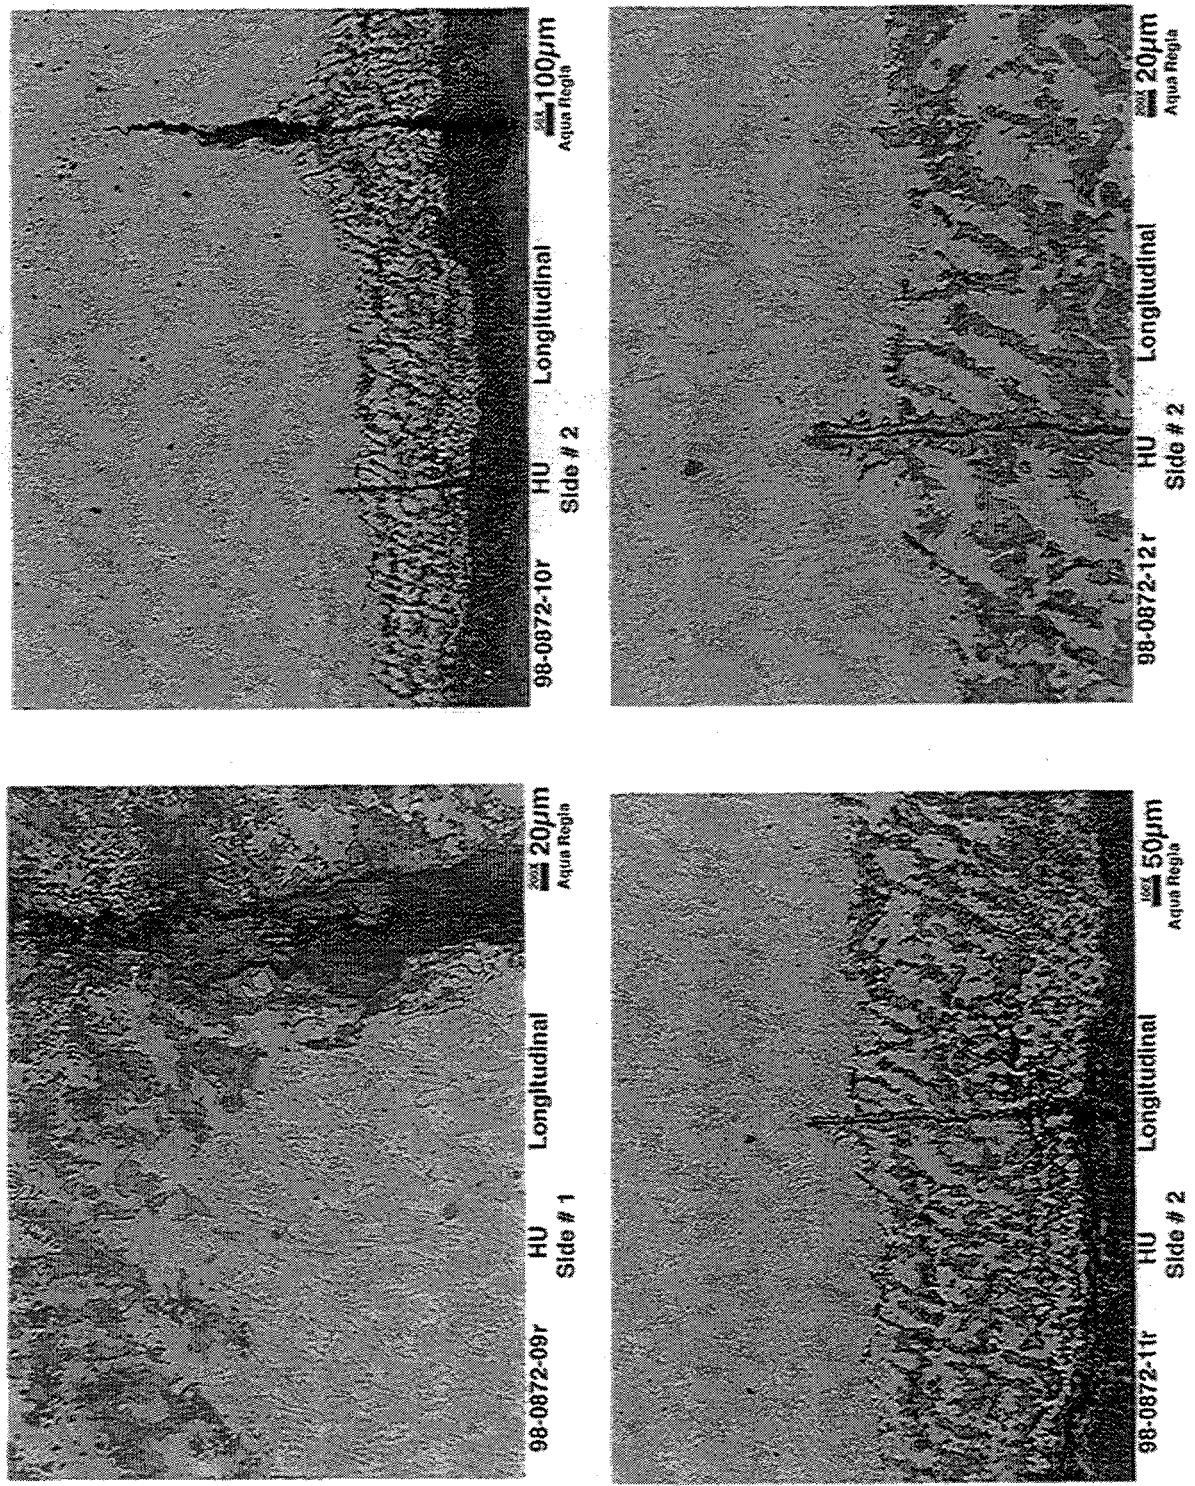
Fig. 39. Optical micrographs of the broken HU tray (sides 1 and 2) in the transverse unetched condition.

Fig. 40. Optical micrographs of the broken HU tray (side 2 and end) in the transverse unetched condition.

Fig. 41. Optical micrographs of the broken HU tray (end and side 1) in the transverse unetched and etched conditions.

Fig. 42. Optical micrographs of the broken HU tray (sides 1 and 2) in the transverse etched condition at both low and high magnification.

Fig. 43. Optical micrographs of the broken HU tray (end section) in the transverse etched condition at both low and high magnification.

Fig. 44. Optical micrographs of the broken HU tray in the longitudinal unetched condition.

Fig. 45. Optical micrographs of the broken HU tray (side 1) in the longitudinal unetched and etched conditions.

Fig. 46. Optical micrographs of the broken HU tray (sides 1 and 2) in the longitudinal etched condition.
