CRADA Final Report
for

CRADA Number C/ORNL 92-0076

In-Service Testing of Ni₃Al Coupons and
Trays in Carburizing Furnaces at Delphi Saginaw

Date Published: August 1998

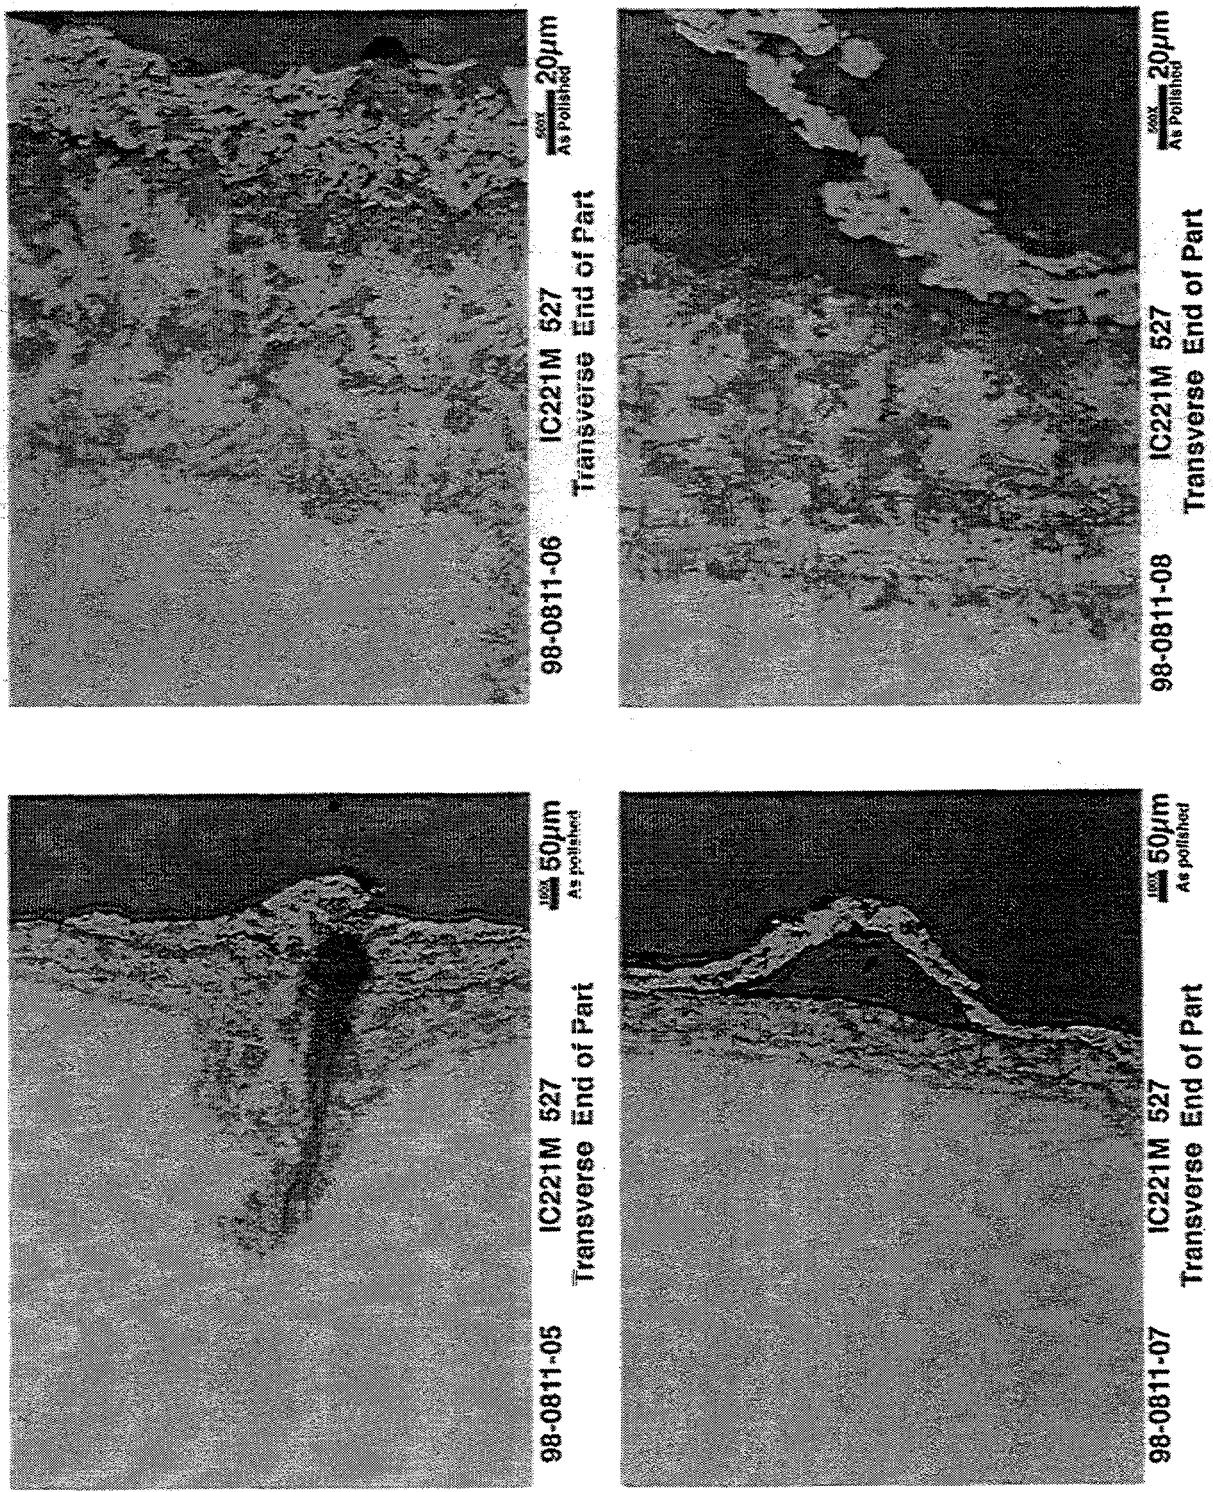
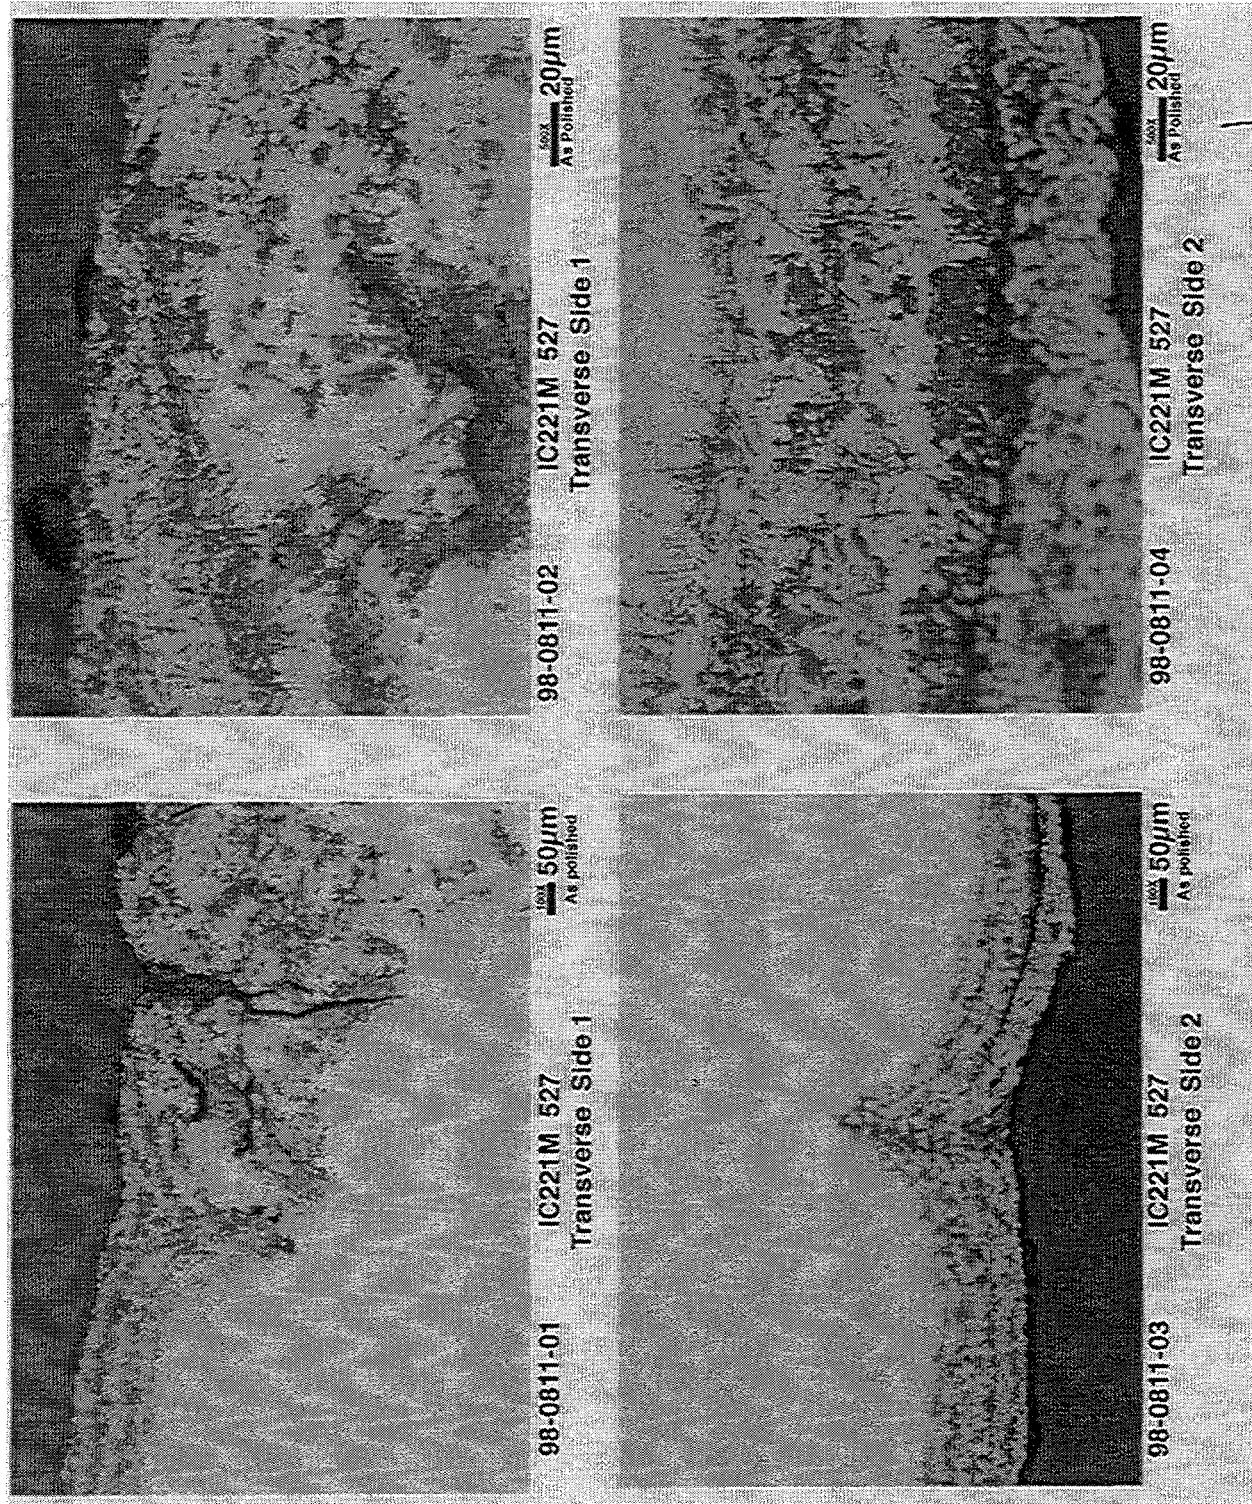
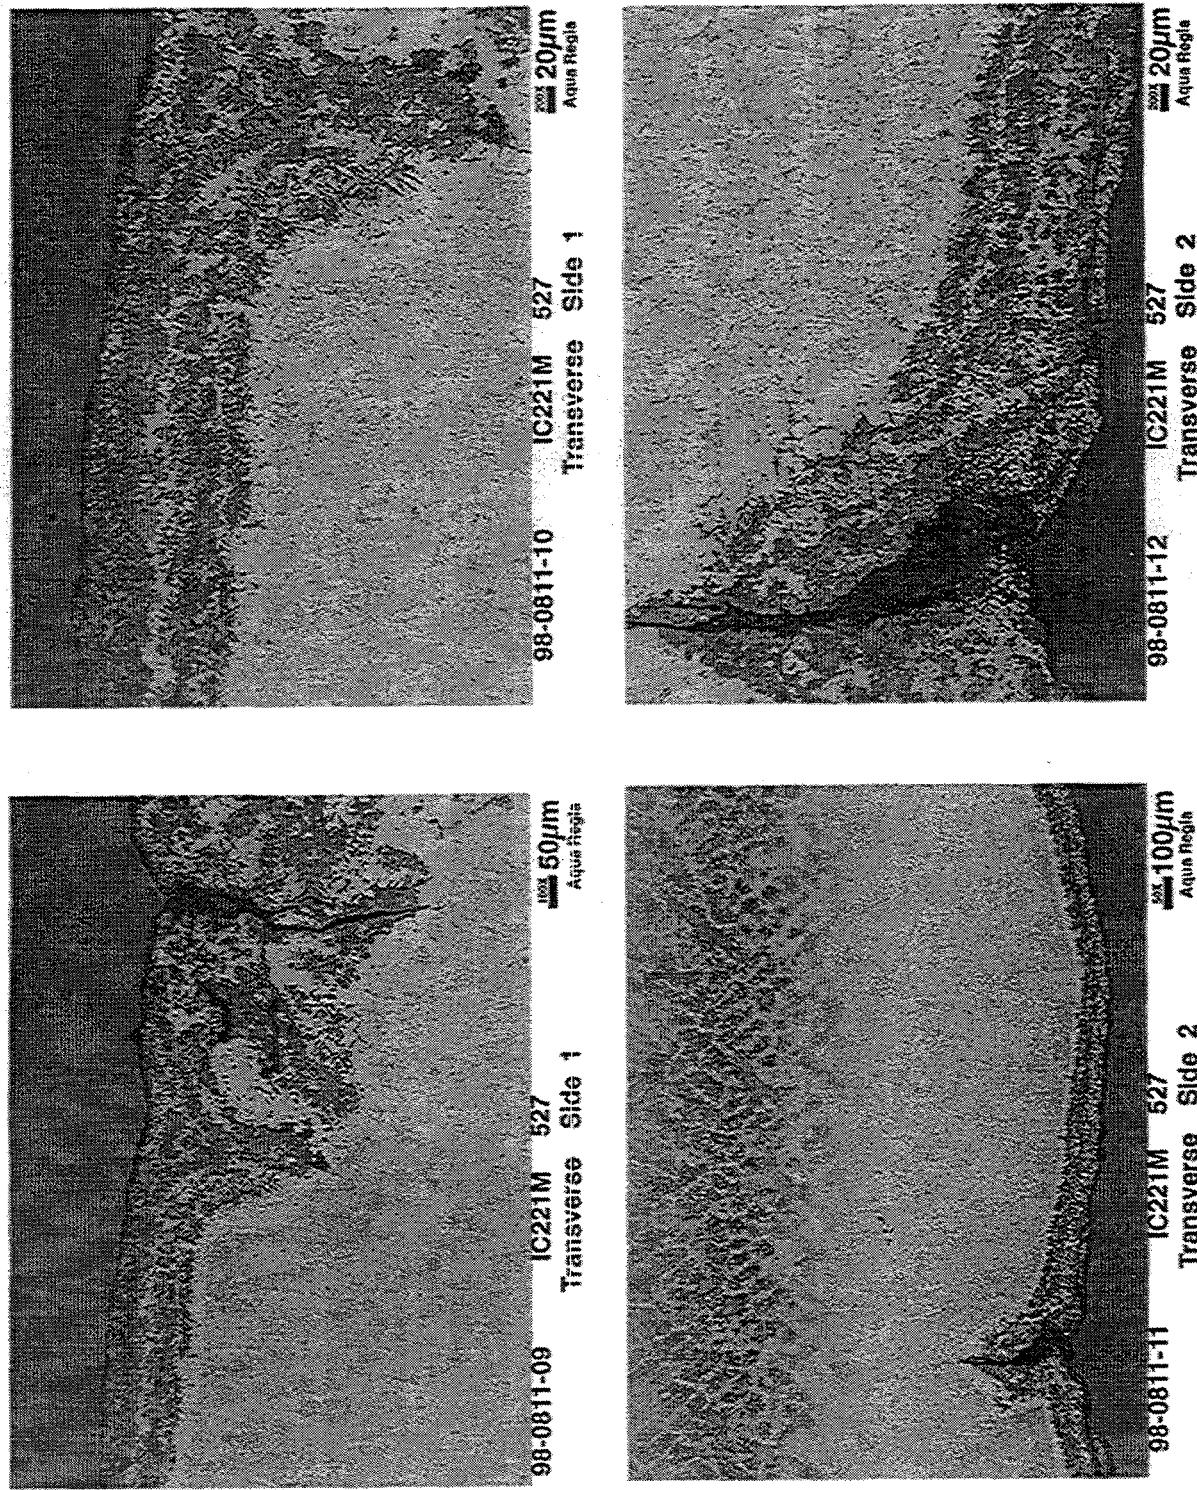
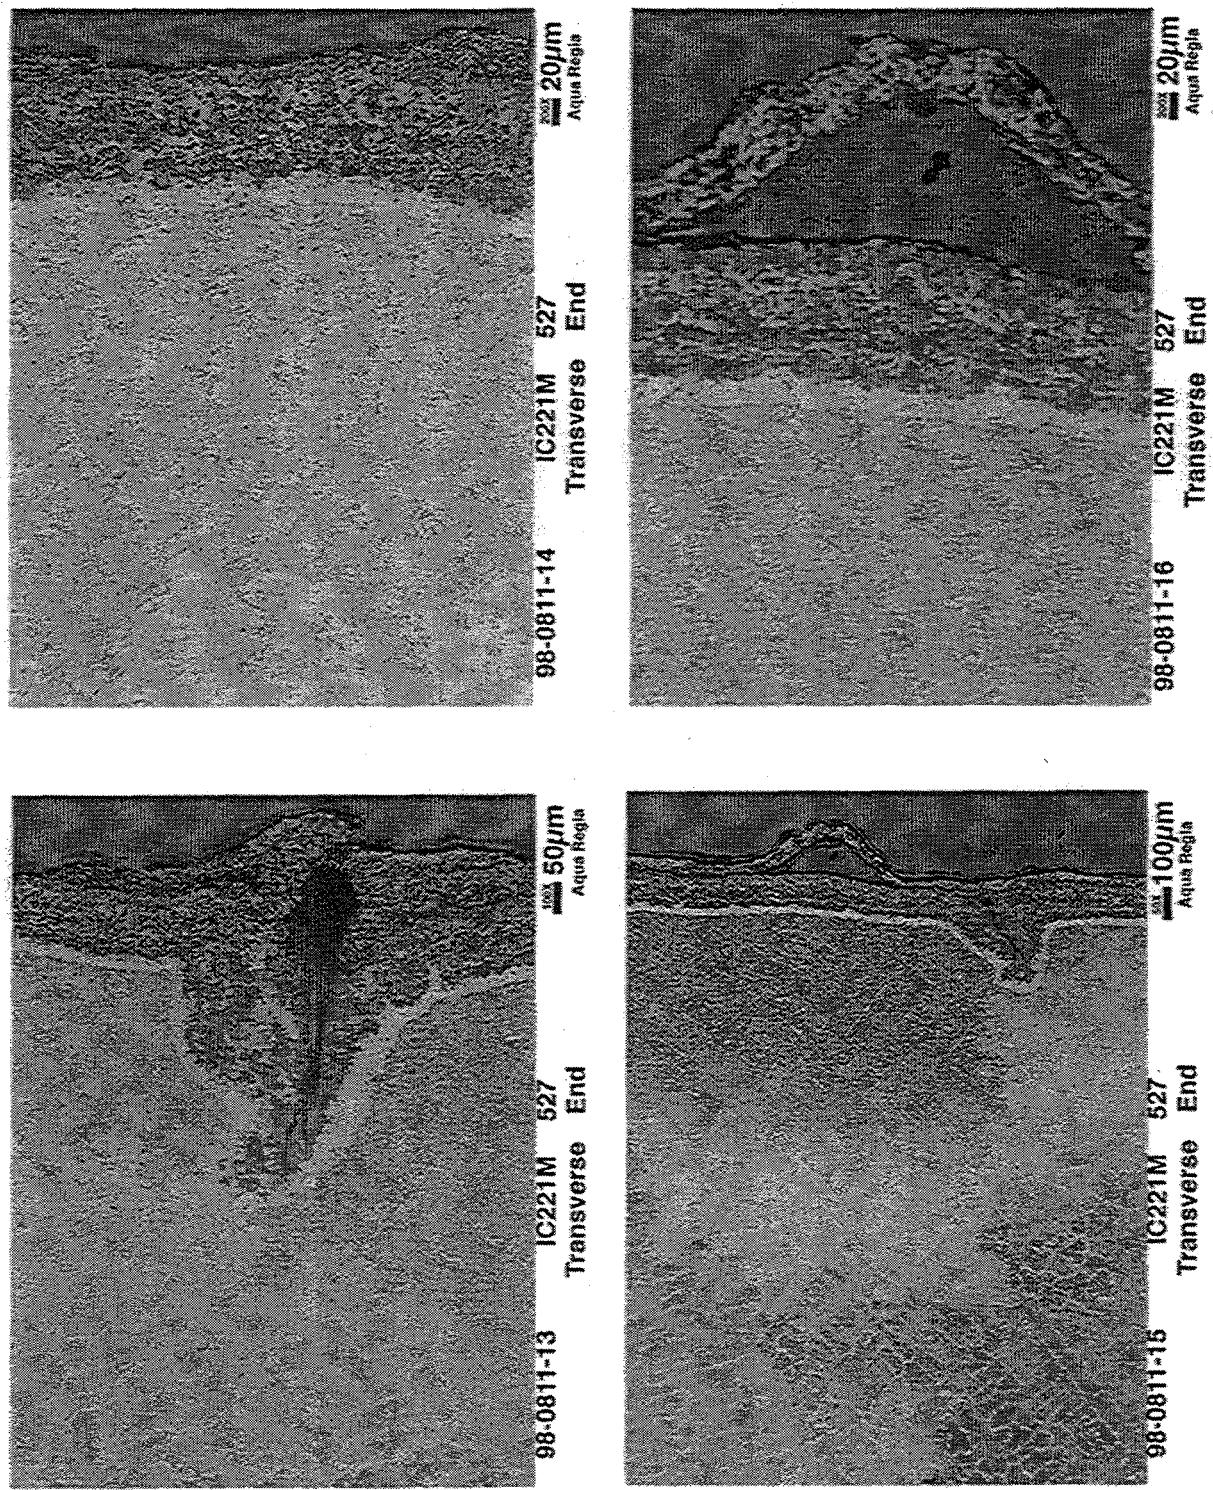
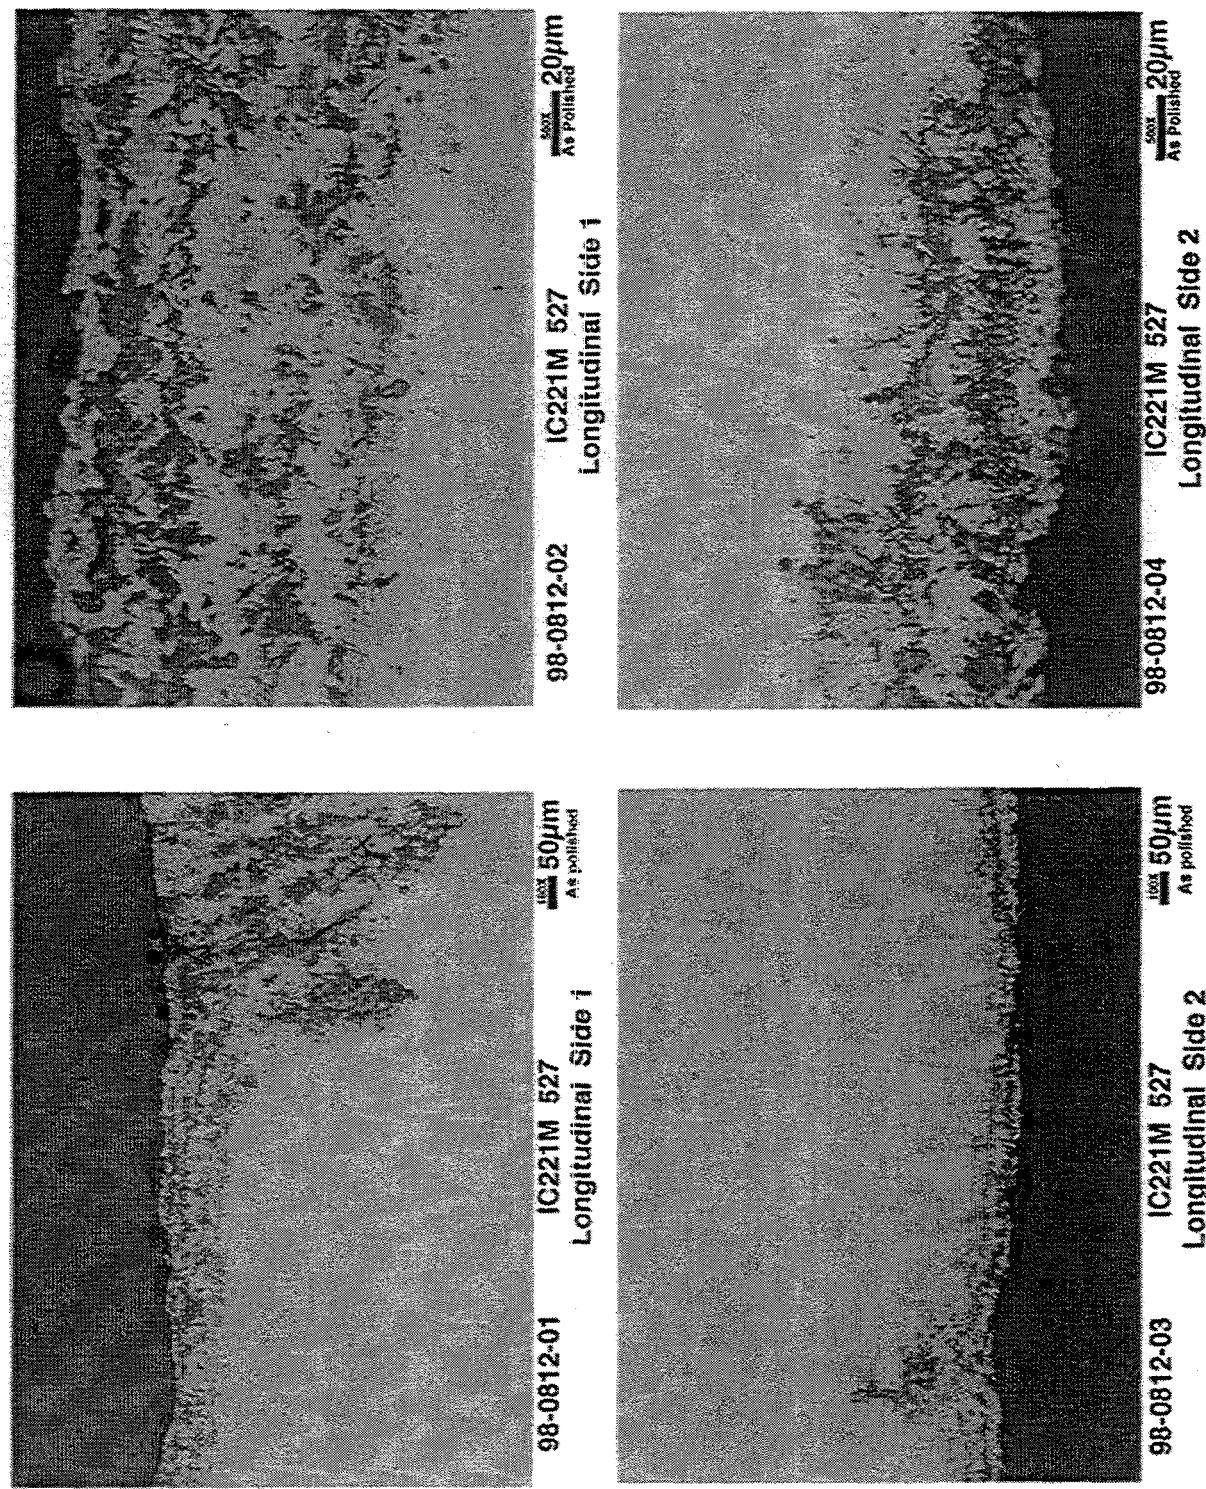
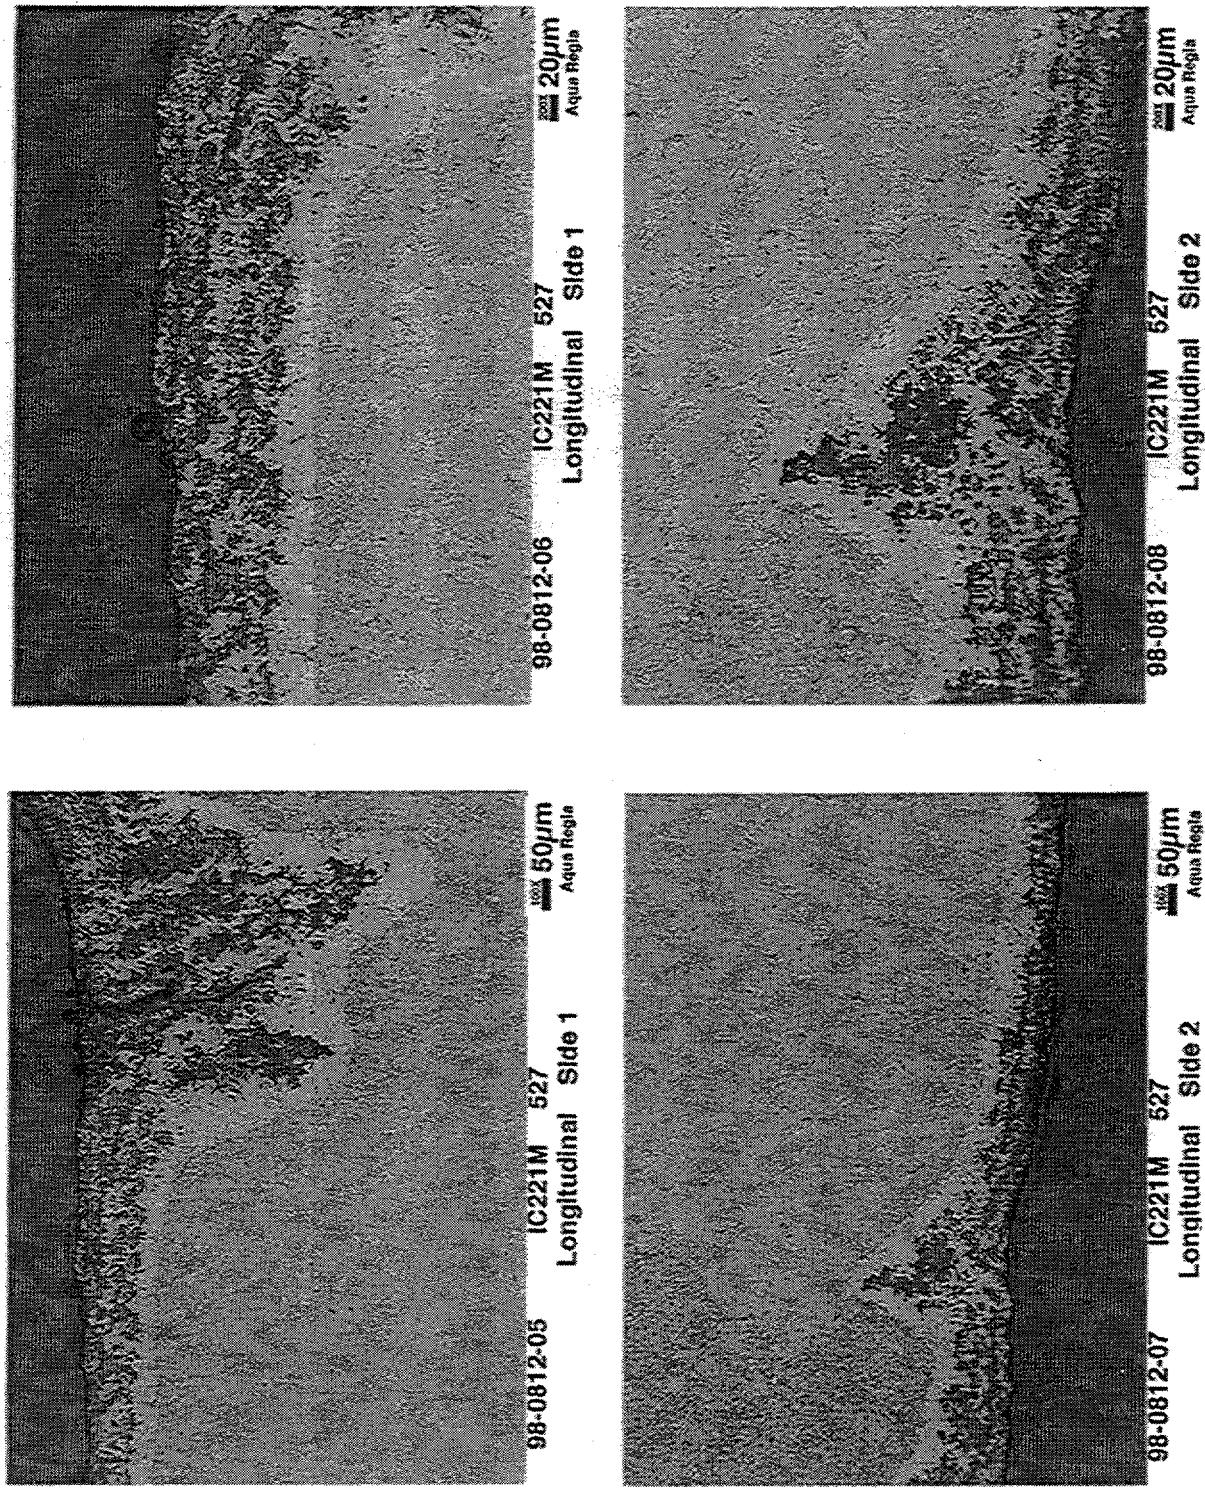
Fig. 47. Optical micrographs of the IC-221M fixture (unetched transverse end section) and removed from pusher carburizing furnace at Delphi Saginaw after 14 months of service.

Fig. 48. Optical micrographs of the IC-221M fixture (sides 1 and 2) removed from pusher carburizing furnace at Delphi Saginaw after 14 months of service.

Fig. 49. Optical micrographs of the IC-221M fixture (etched at transverse sides 1 and 2 locations) removed from pusher carburizing furnace at Delphi Saginaw after 14 months of service.

Fig. 50. Optical micrographs of the IC-221M fixture (etched at transverse end) removed from pusher carburizing furnace at Delphi Saginaw after 14 months of service.

Fig. 51. Optical micrographs of the IC-221M fixture (unetched at longitudinal sides 1 and 2) removed from pusher carburizing furnace at Delphi Saginaw after 14 months of service.

Fig. 52. Optical micrographs of the IC-221M fixture (etched at longitudinal sides 1 and 2) removed from pusher carburizing furnace at Delphi Saginaw after 14 months of service.

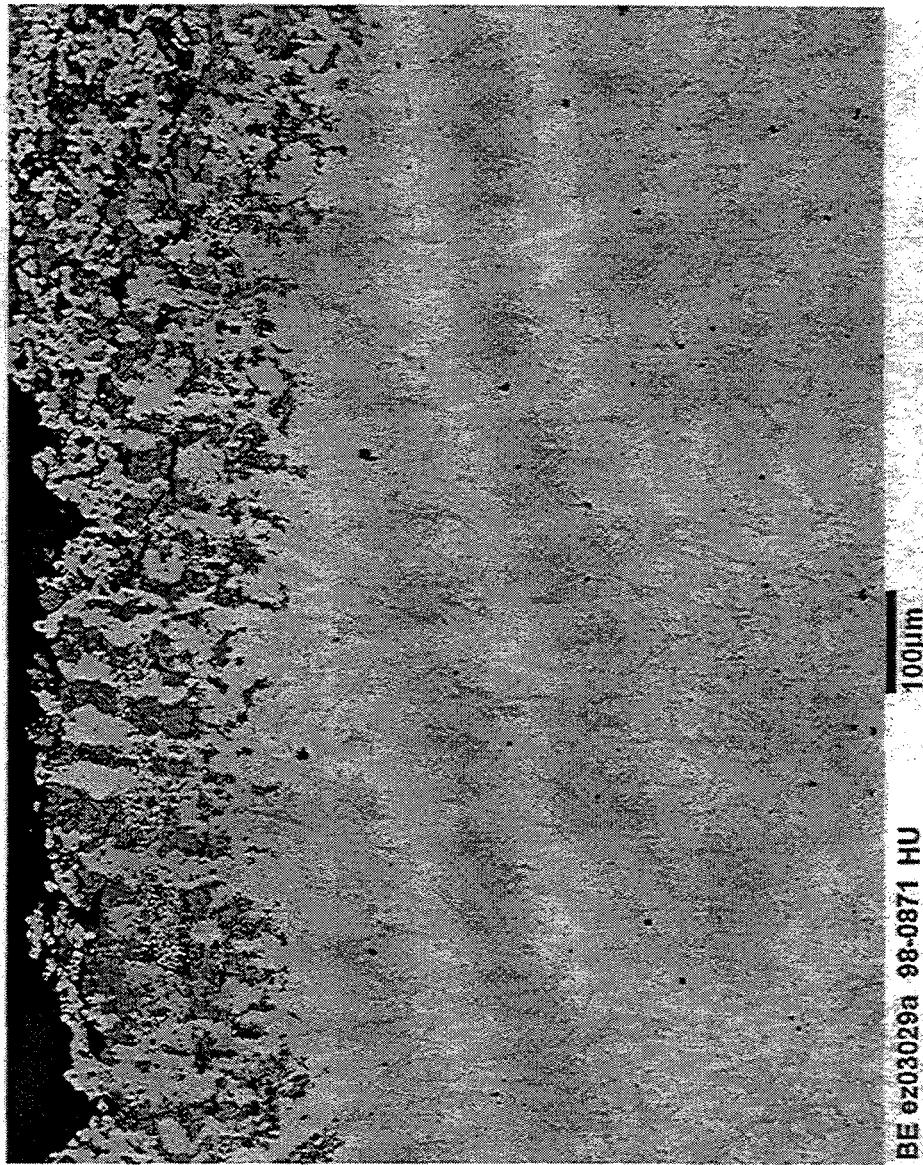
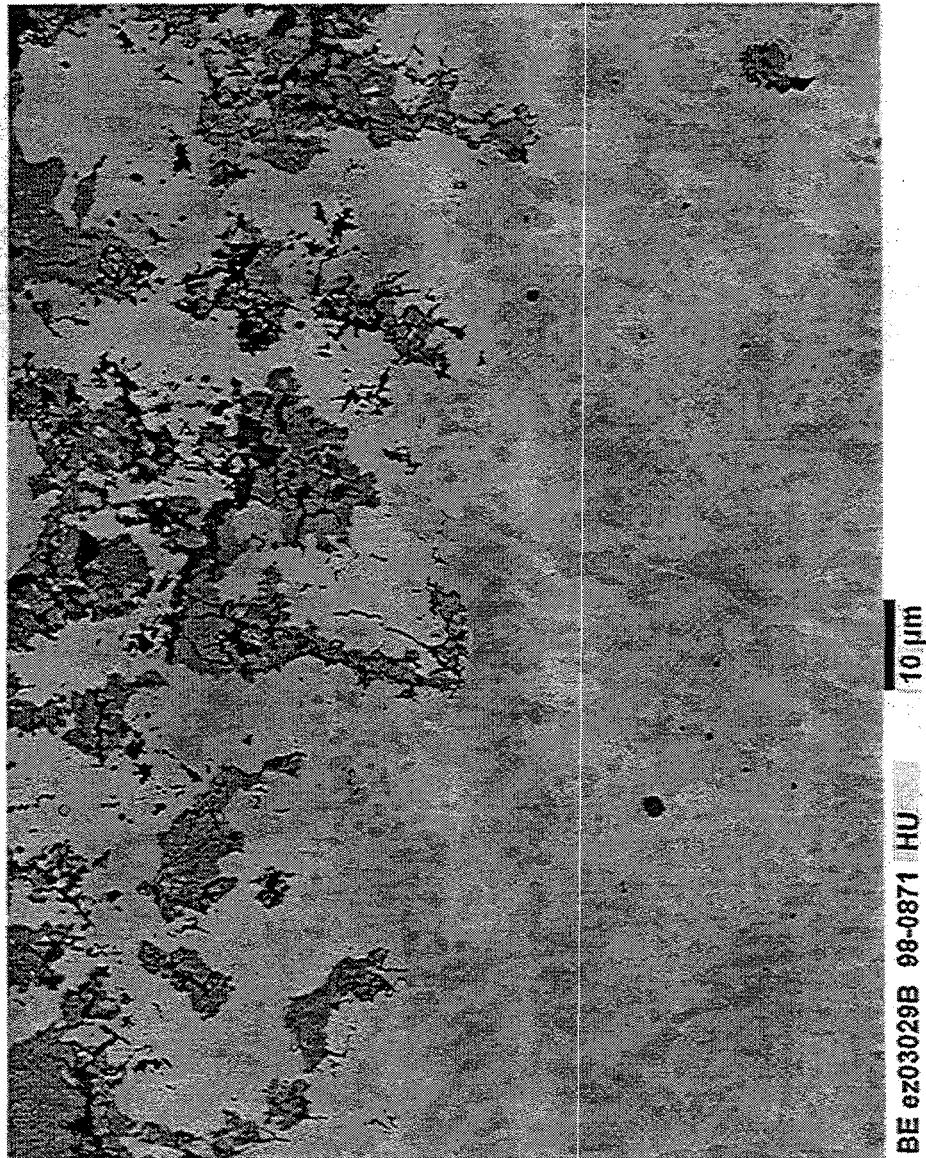
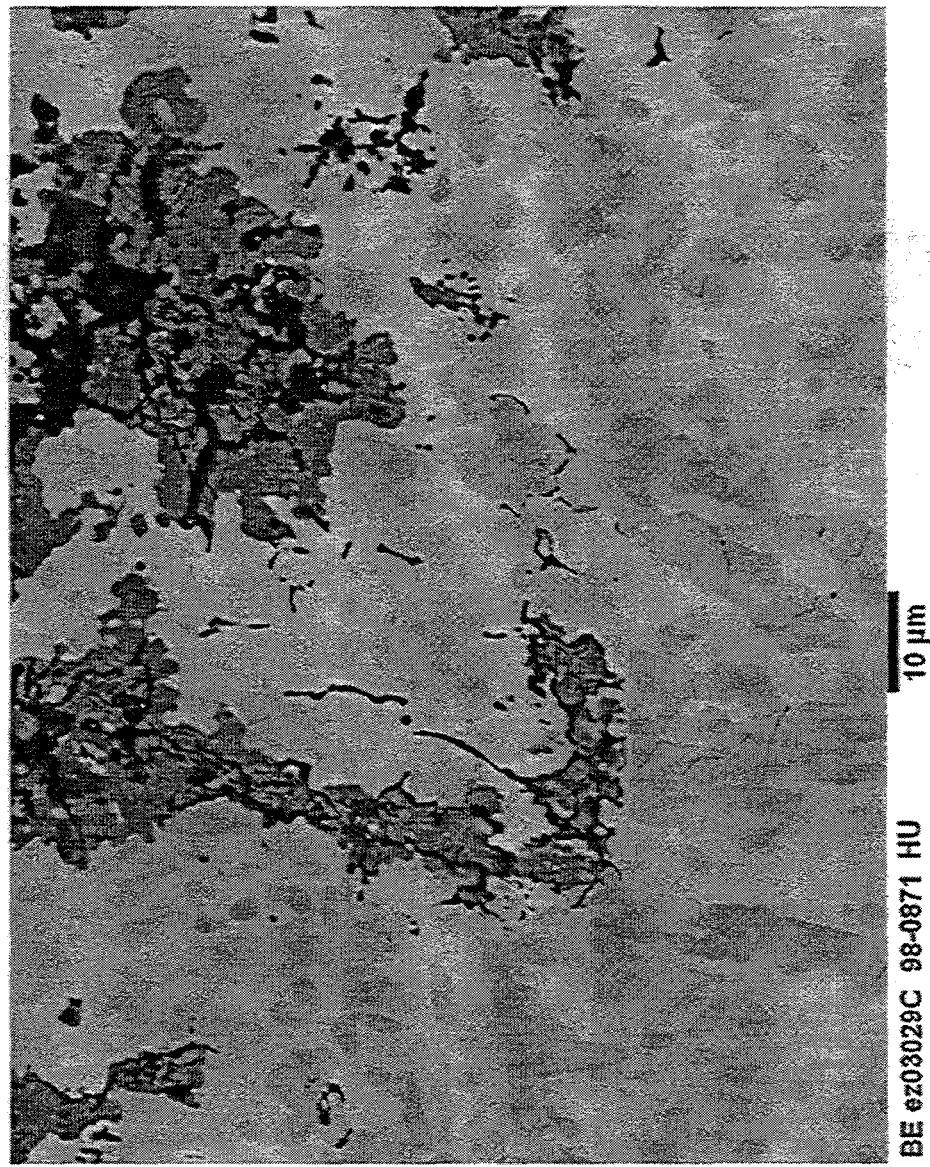
Fig. 53. Backscattered electron image of the sample from HU tray after 18 months of exposure in the batch furnace at Delphi Saginaw.
Low magnification showing corrosion layer at surface.

Fig. 54. Backscattered electron image of the sample from HU tray after 18 months of exposure in the batch furnace at Delphi Saginaw.
High magnification showing metal/corrosion layer at surface.

Fig. 55. Backscattered electron image of the sample from HU tray after 18 months of exposure in the batch furnace at Delphi Saginaw.
High magnification showing more details of corrosion product into the base metal.

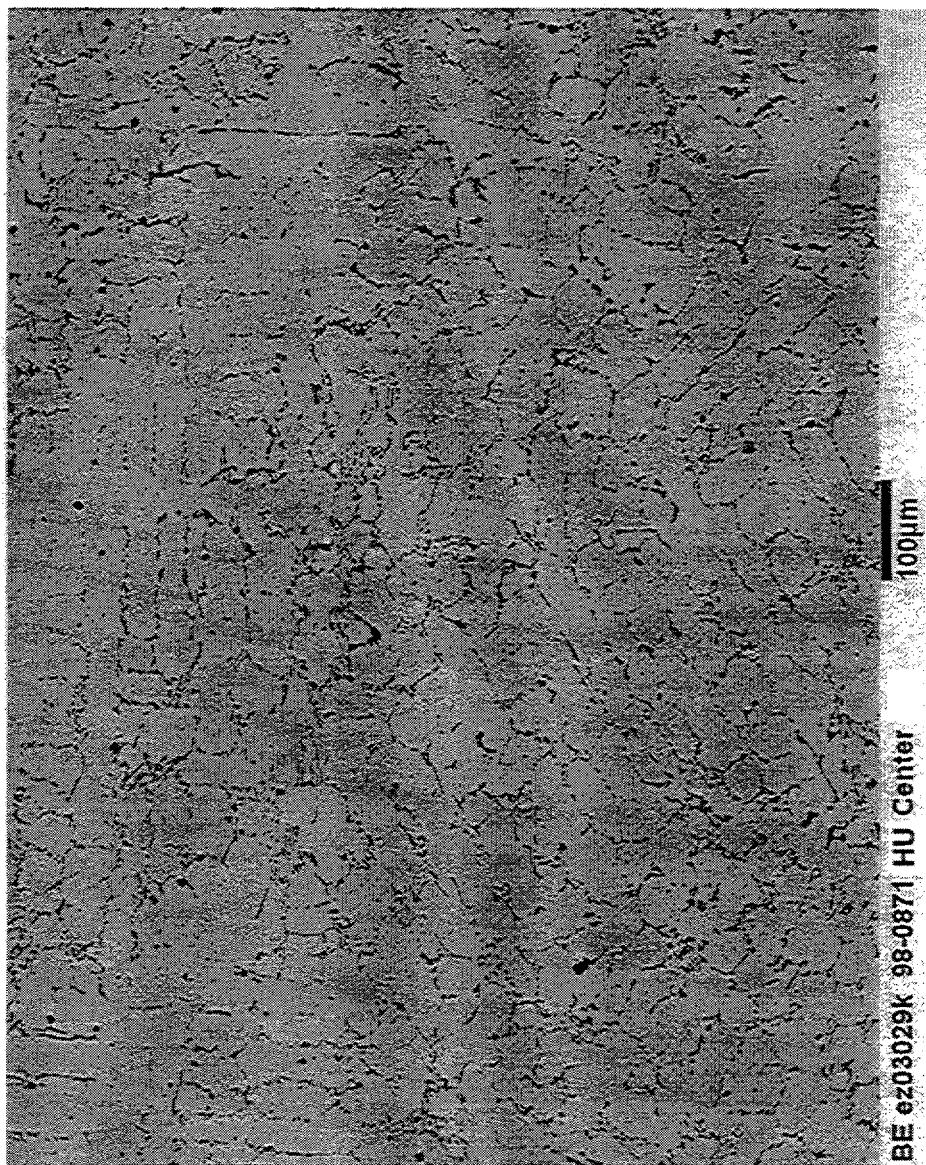
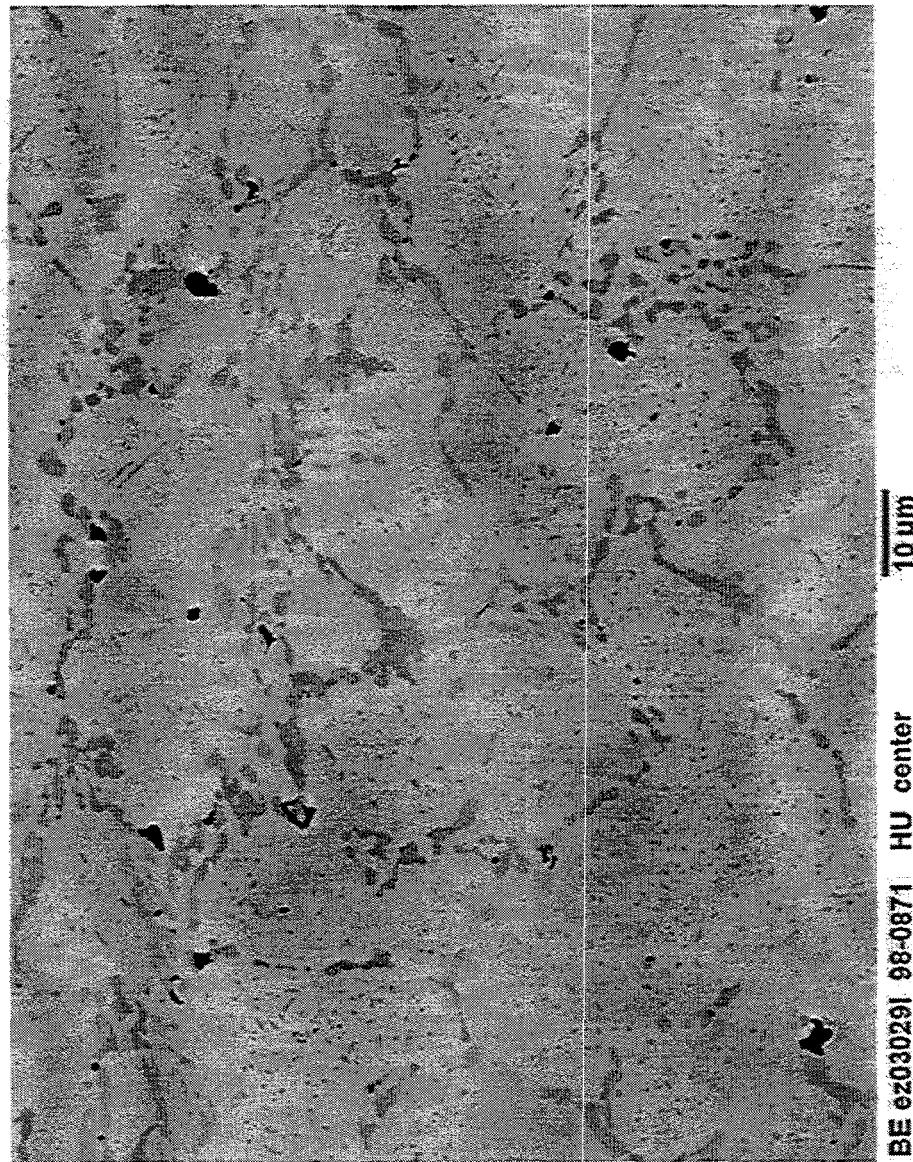
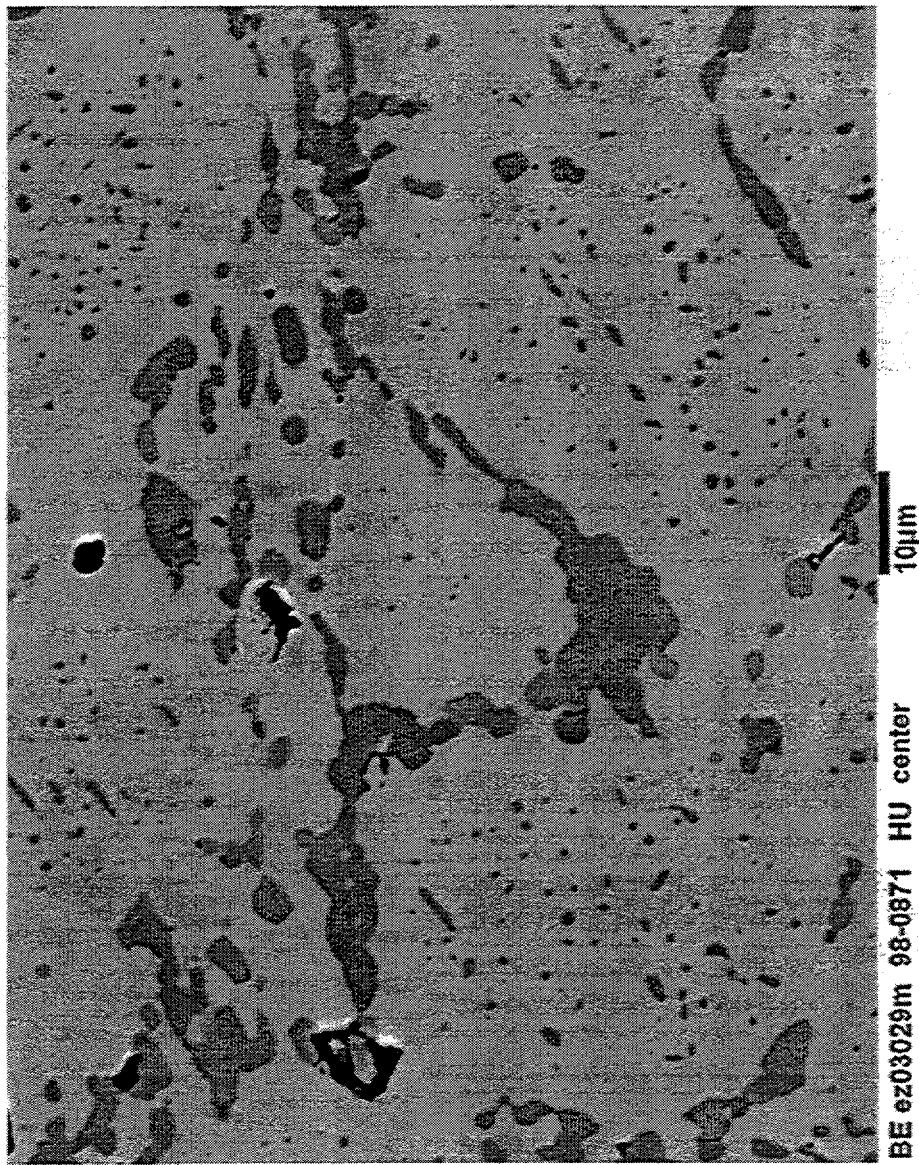
Fig. 62. Backscattered electron image of the sample from the HU tray after 18 months of exposure in the batch furnace at Delphi Saginaw. Low magnification showing center of the tray section (base metal).

Fig. 63. Backscattered electron image of the sample from the HU tray after 18 months of exposure in the batch furnace at Delphi Saginaw. High magnification showing center of the tray section (base metal).

Fig. 64. Backscattered electron image of the sample from the HU tray after 18 months of exposure in the batch furnace at Delphi Saginaw. Highest magnification showing center of the tray section (base metal).

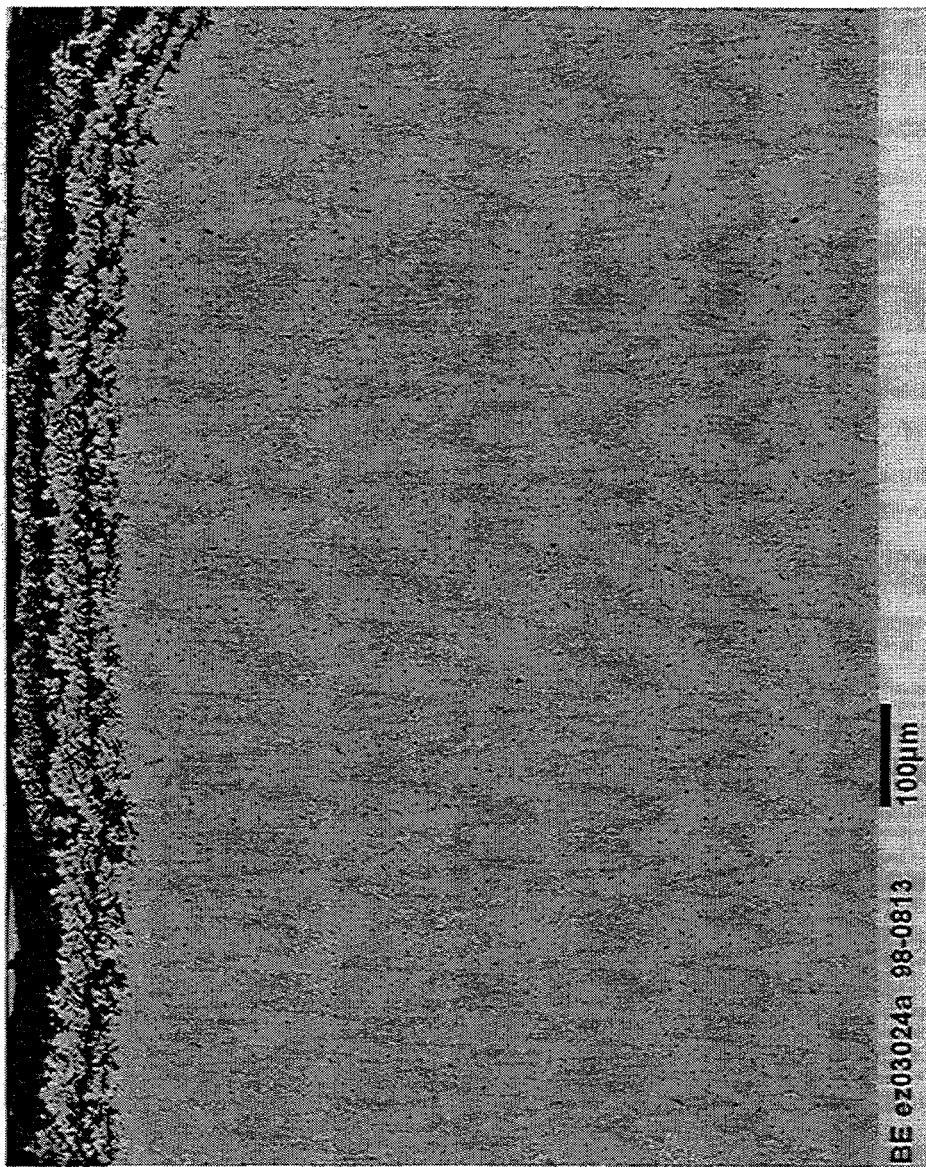
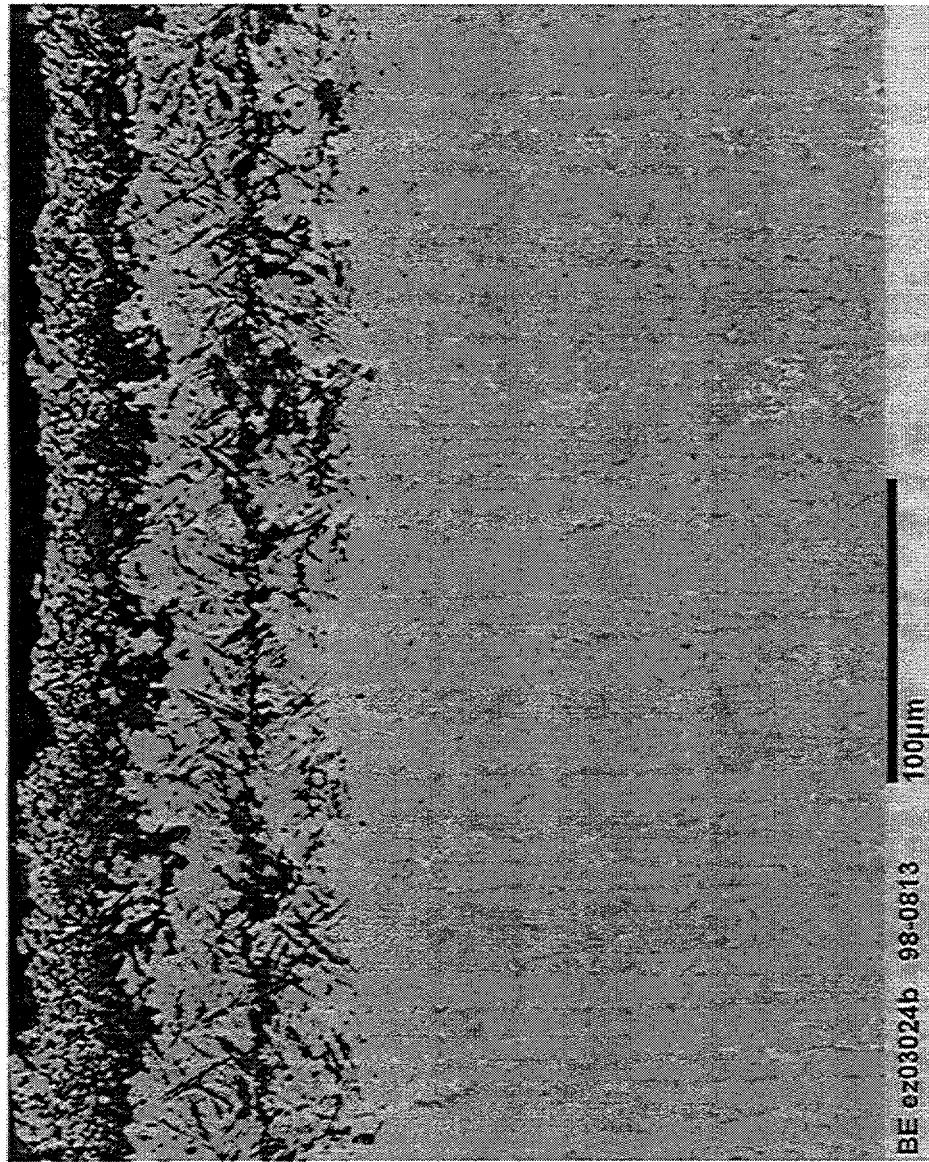
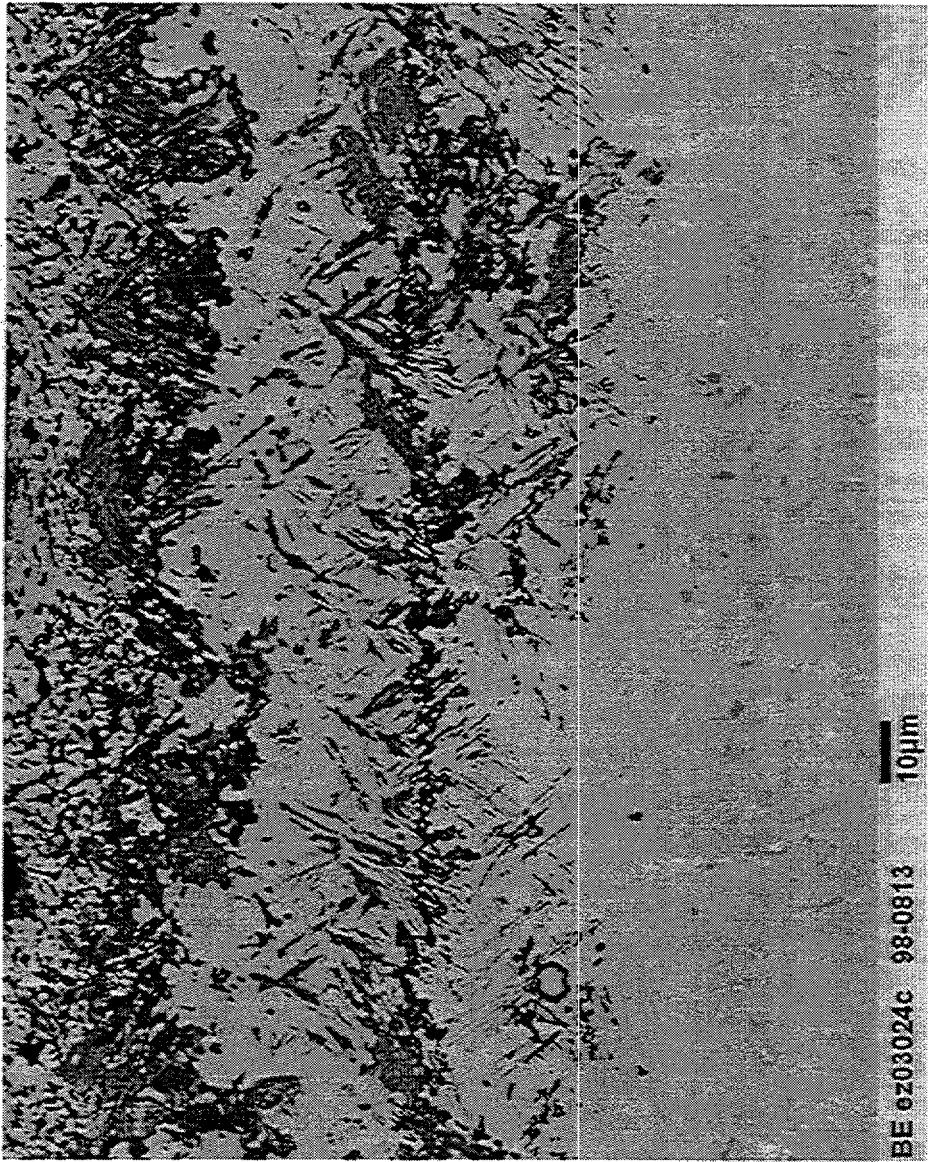
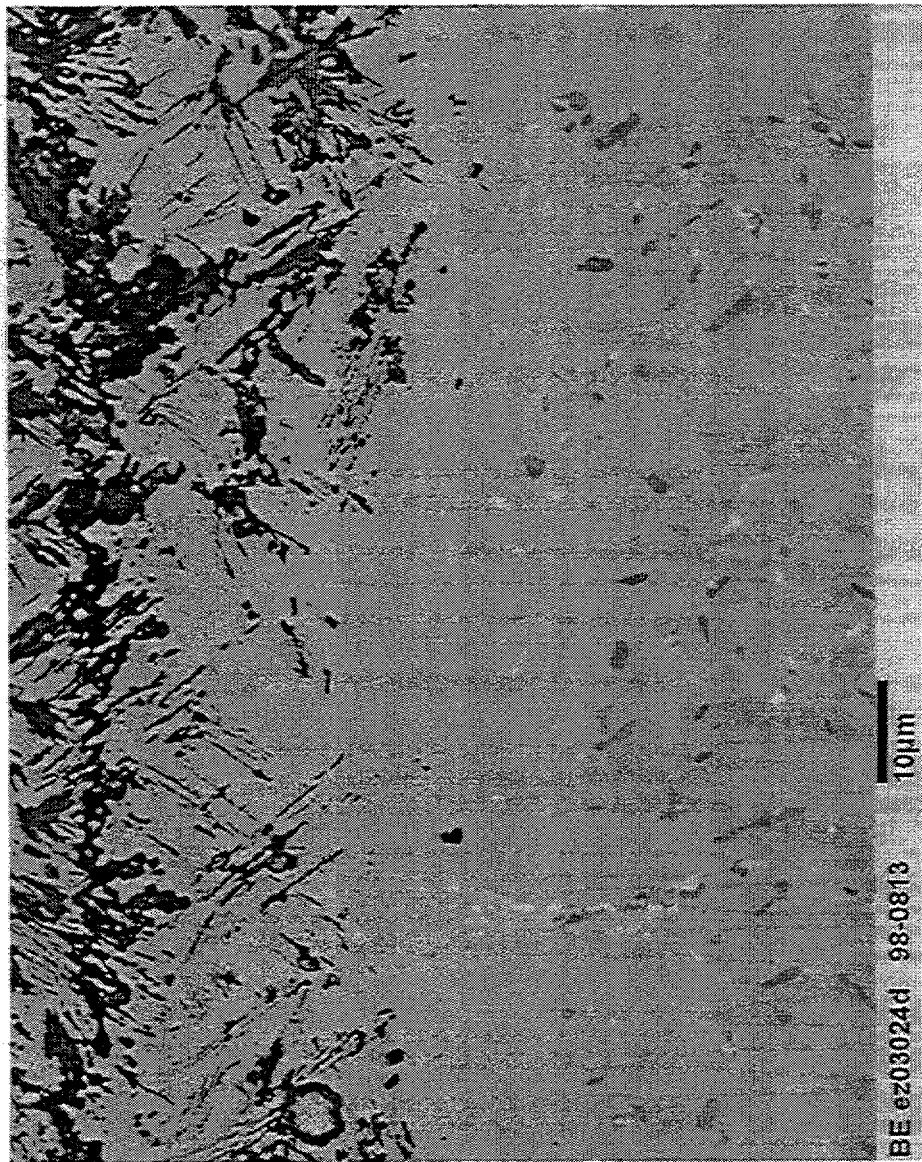
Fig. 70. Backscattered electron image of the surface of IC-221M fixture removed from pusher carburizing furnace after 14 months of service from Delphi Saginaw. Low magnification.

Fig. 71. Backscattered electron image of the surface of IC-221M fixture removed from pusher carburizing furnace after 14 months of service from Delphi Saginaw. High magnification.

Fig. 72. Backscattered electron image of the surface of IC-221M fixture removed from pusher carburizing furnace after 14 months of service from Delphi Saginaw. Highest magnification.

Fig. 73. Backscattered electron image of the depleted region at the base metal/surface reacted layer of IC-221M fixture removed from pusher carburizing furnace after 14 months of service from Delphi Saginaw. High magnification.
