CRADA Final Report
for

CRADA Number C/ORNL 92-0076

In-Service Testing of Ni₃Al Coupons and
Trays in Carburizing Furnaces at Delphi Saginaw

Date Published: August 1998

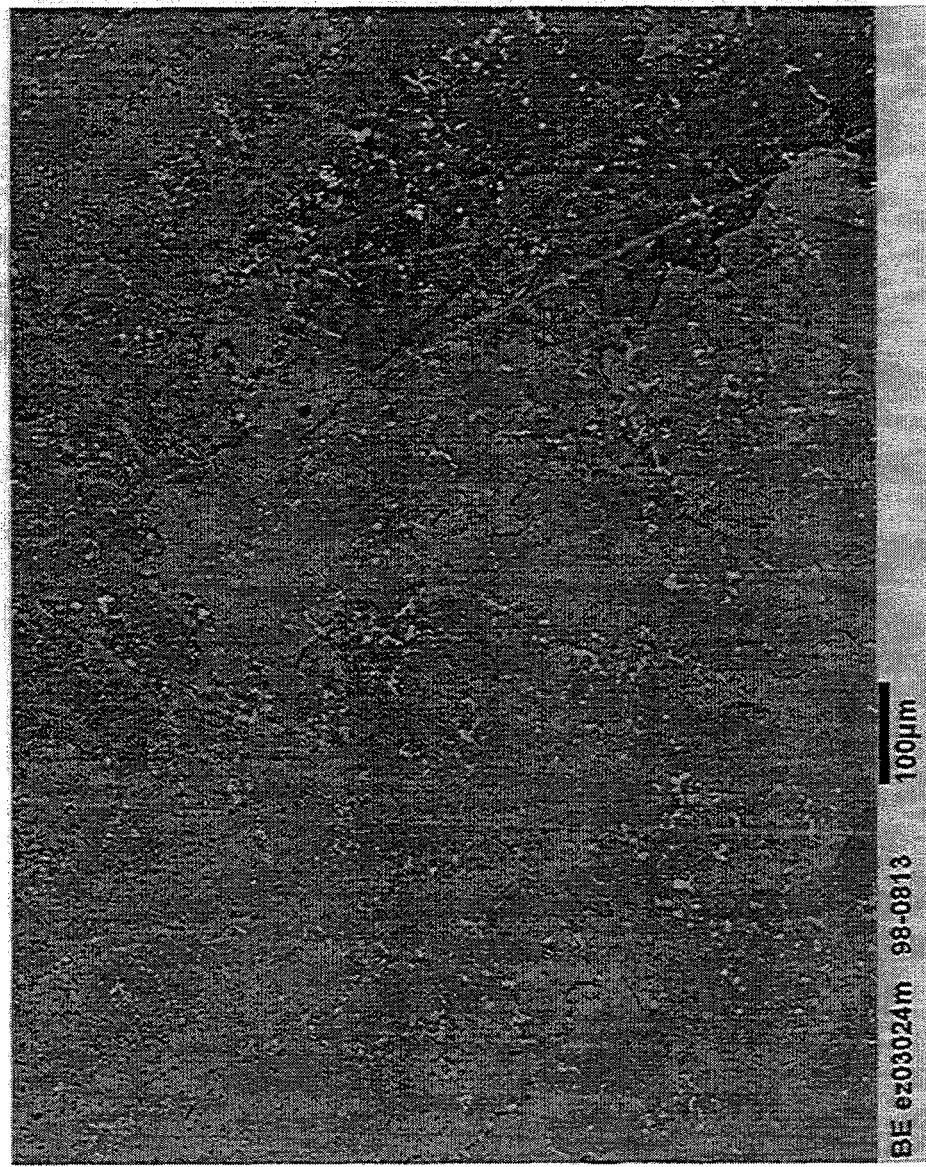
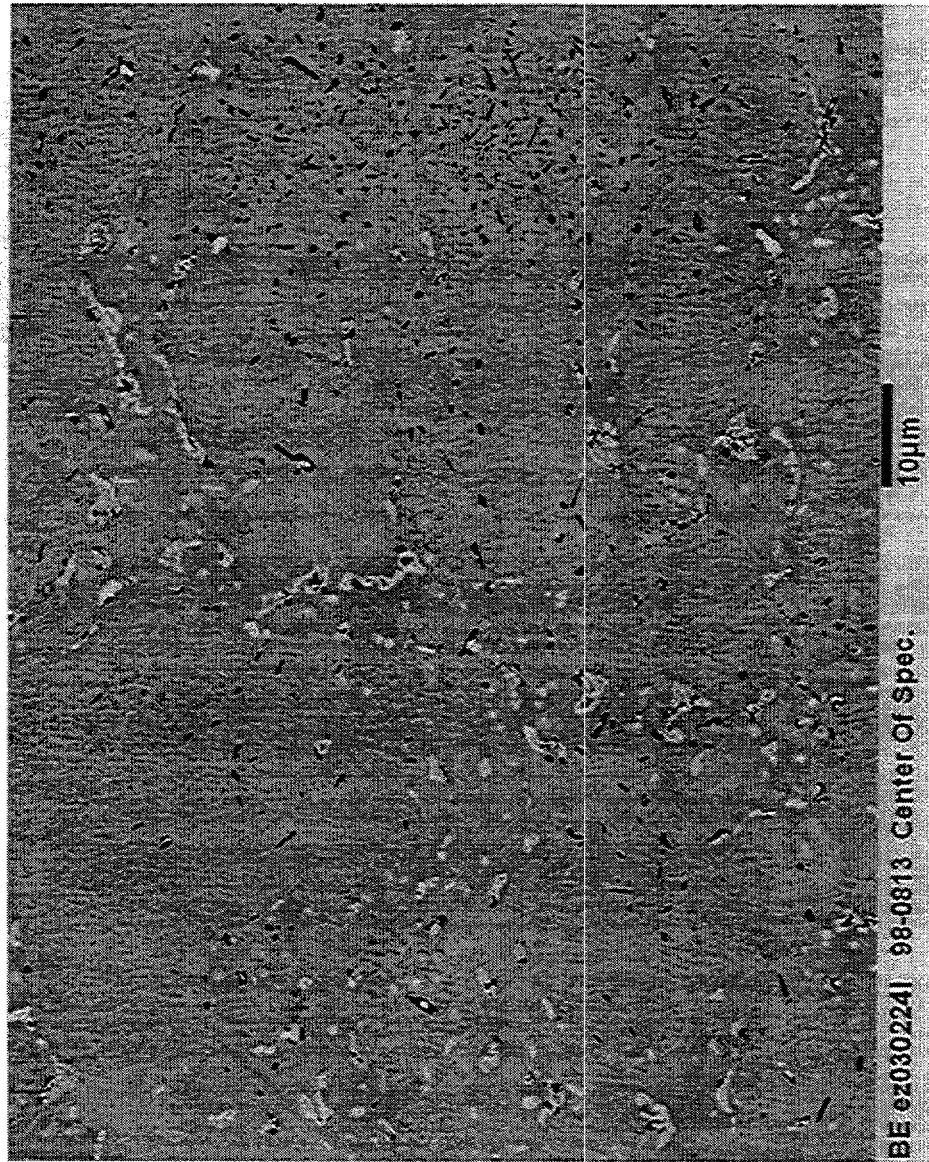
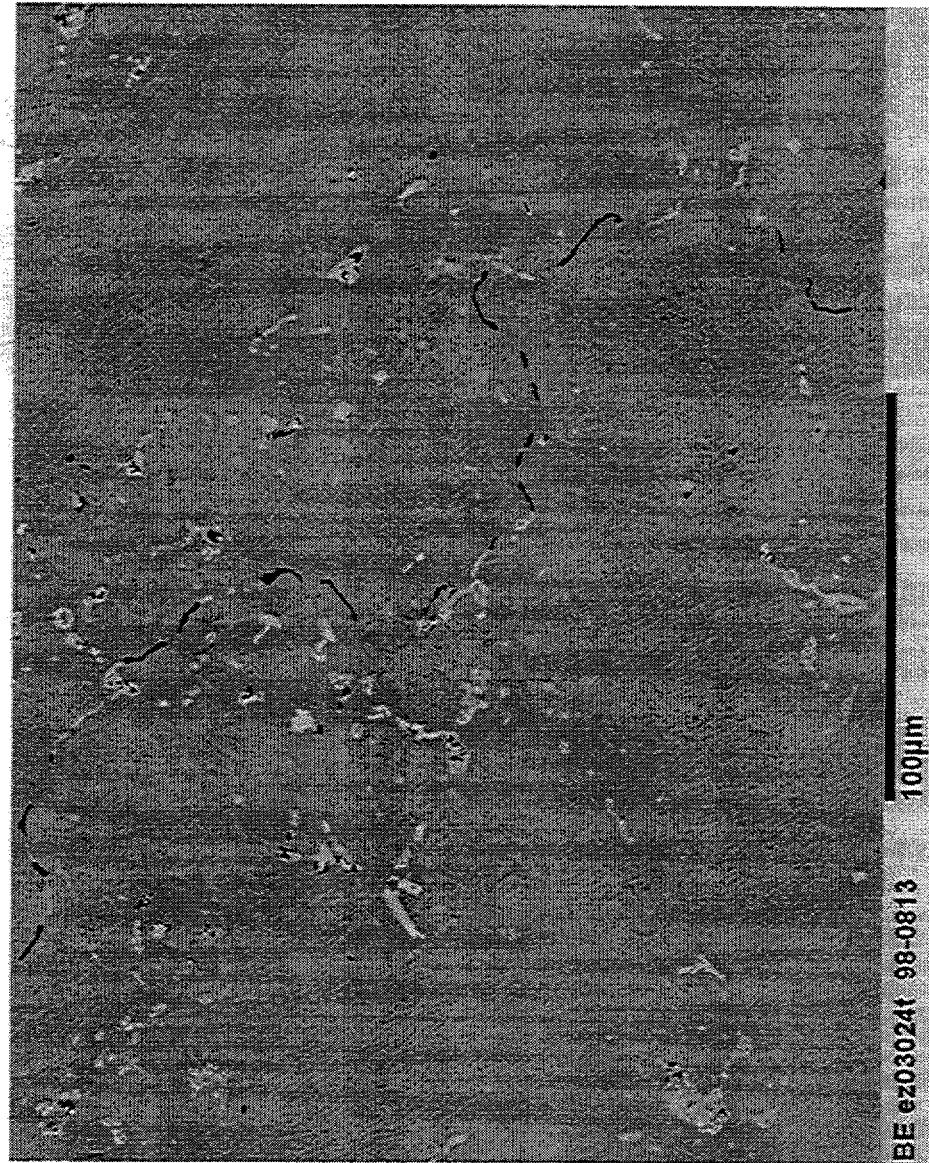
Fig. 81. Backscattered electron image of the matrix section of the IC-221M fixture removed from pusher carburizing furnace at Delphi Saginaw after 14 months of service. Low magnification.

Fig. 82. Backscattered electron image of the matrix section of the IC-221M fixture removed from pusher carburizing furnace at Delphi Saginaw after 14 months of service. High magnification.

Fig. 83. Backscattered electron image of the matrix section of the IC-221M fixture removed from pusher carburizing furnace at Delphi Saginaw after 14 months of service. Highest magnification.

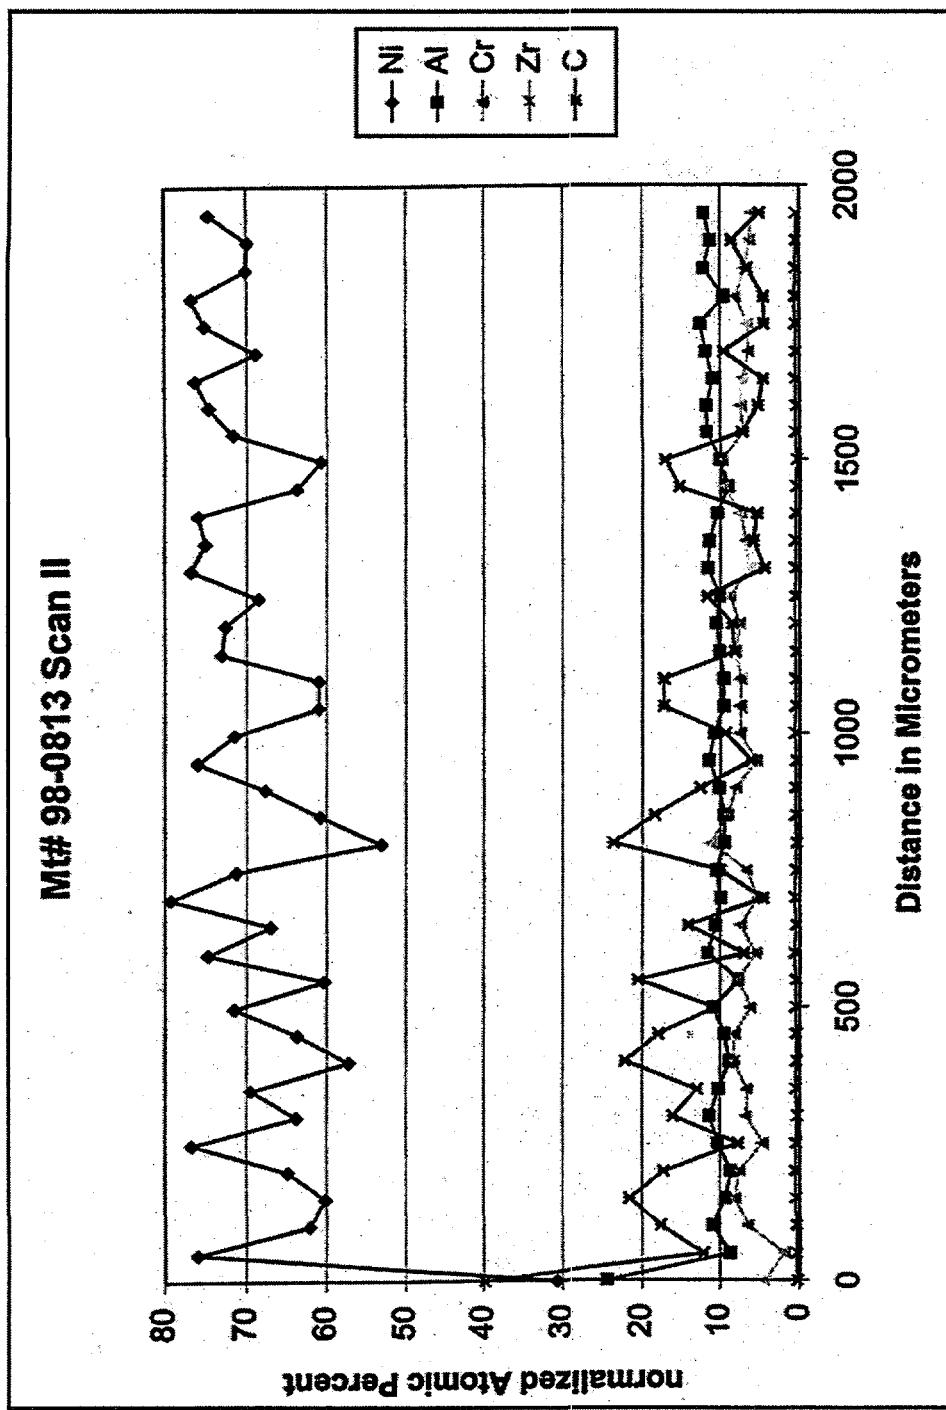
Fig. 88. Microprobe scan of carbon, aluminum, zirconium, chromium, and nickel from the surface to the matrix for the IC-221M fixture removed from the pusher carburizing furnace at Delphi Saginaw after 14 months of service.

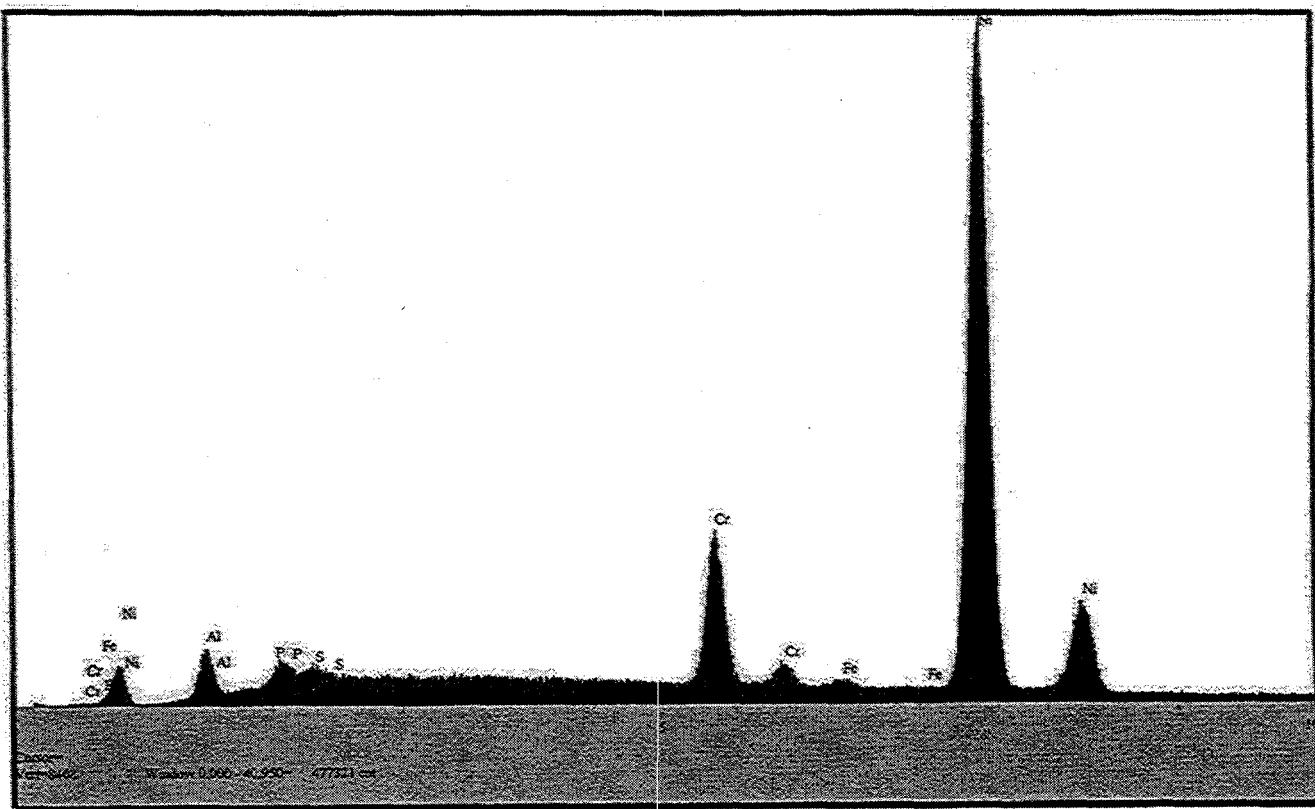
Fig. A2. Spectrum: D1359 Ni₃Al furnace tray.
